Restoring and Preserving the Incan Cultural Wonder of Saqsaywaman

A Thesis Presented to The Faculty and Staff of Engineering and Applied Science University of Virginia

> > by Kenneth Scott Lohr May 2014

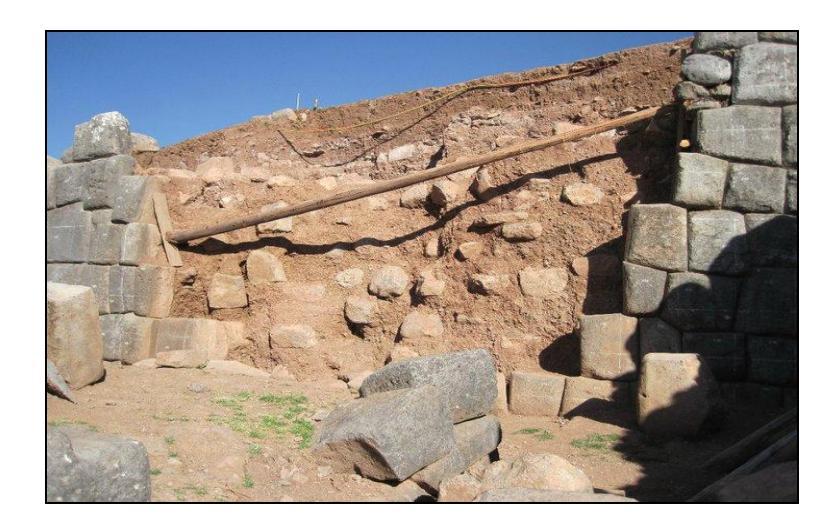
This cementicious clay was added in 2009 and visible damage could be seen by 2010. The damage started off as a change in batter of the walls. Inca walls are normally built at around a 10 percent batter which means that they lean back into themselves which makes them more stable. This batter has been reduced and when it nears 0 percent the walls become very unstable and can fail. Other types of damage that can be seen are wall bulges where stones are being pushed out of the wall from the increase in hydrostatic pressure behind the wall caused by excess water buildup. The stones are also starting to shear and separate in some places there are large cracks where the rocks once fit perfectly together.

A large rainstorm collapsed a large portion of the wall in 2010. This collapsed portion can be seen in figure 11. The rocks from the wall have been completely pushed out of the wall. The damage is only getting worse as shown in figure 12, taken in 2013, at the same location of figure 11. The damage is now extending along longer portions of the third wall.

Figure 11. Major Collapsed Section of Third Wall (Wildfire, 2011)

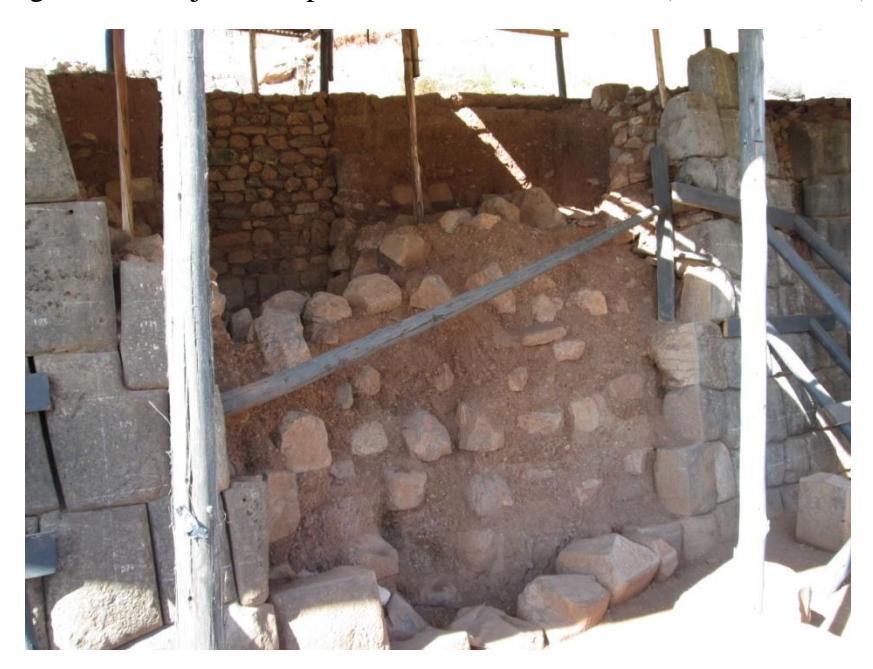
Figure 12. Completely Collapsed Portion of the Third Wall (Lohr, 2013)

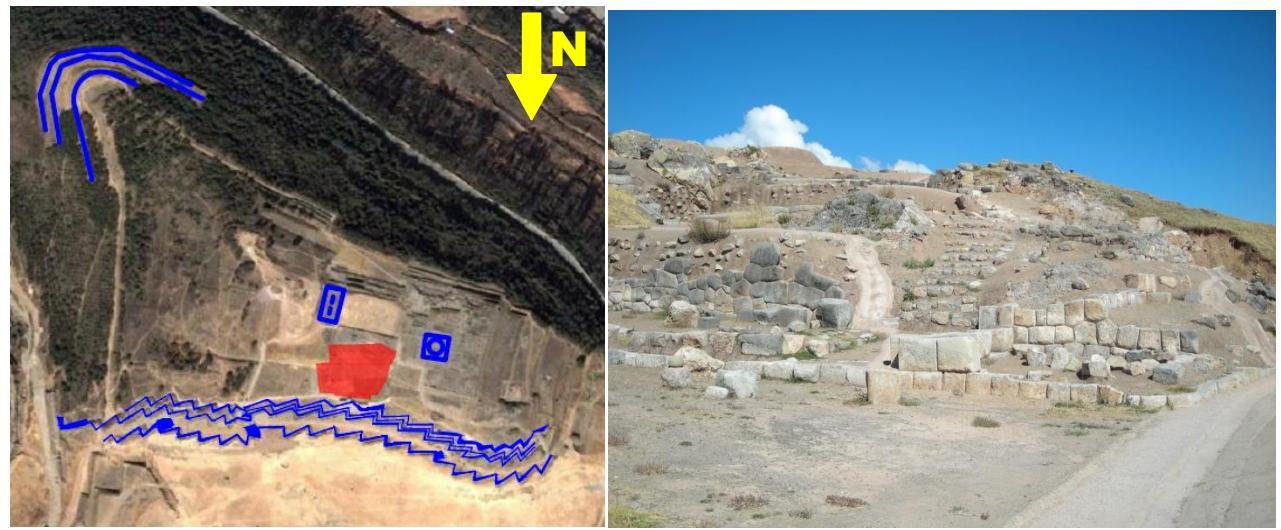
The cementicious clay ground cover is believed to be the major cause of the recent collapses. The clay was placed on the ground in order to preserve ruins that were at the top of the complex, but without realizing this they created extra runoff and a smooth surface for the water. This clay covers approximately 2,000 square meters of the site as seen in red in figure 13. It is located in what will be referred to as the 2009 excavation sector. In figure 14, it can easily see the clay mounds which work to funnel the water to the bottom of the hill and towards the third wall. This

concentrates the runoff to a very small area and causes the water to gain high velocities which help it to overflow the drainage channels and reach the third wall.

Figure 13. The 2009 Clay Area Location and Size (Google, 2014)

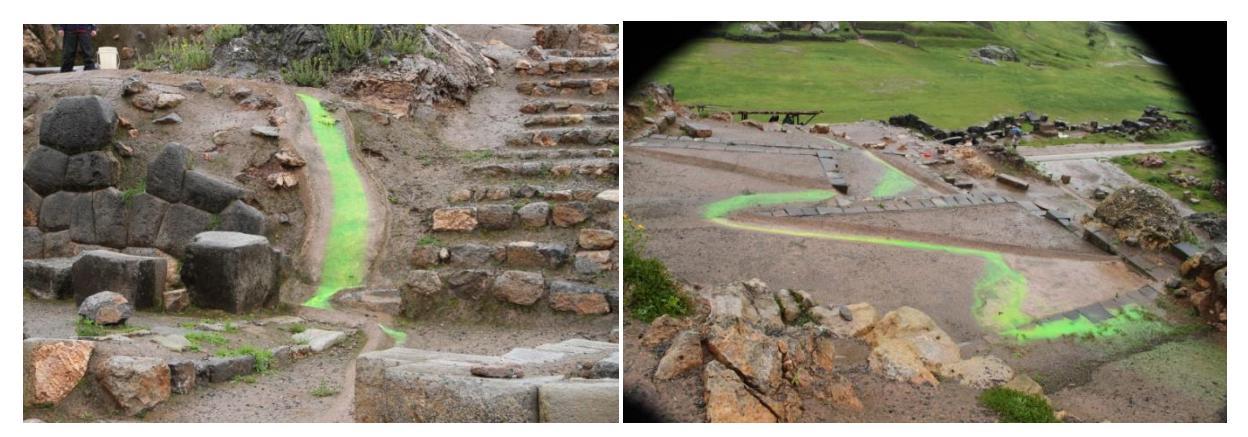
During the rainy season (January) of 2013, dye trace experiments were conducted using environmentally friendly Bright Dyes water tracer. During these tests it became apparent that the cementicious clay, along with the smooth channels, creates a "water slide" effect that collects all the water and allows it to flow very quickly down towards the third wall. This water is in such a large quantity and has such a great speed that it flows over the sides of the ad hoc drainage channel and to the third wall. This is cause of the major collapsed section just across from the 2009 excavation sector. Images from these dye trace experiments are shown below in figure 15.

Figure 15. Dye Trace Flows in 2009 Excavation Sector Highlighted Conducted in January of 2013 (Miksad, 2013)

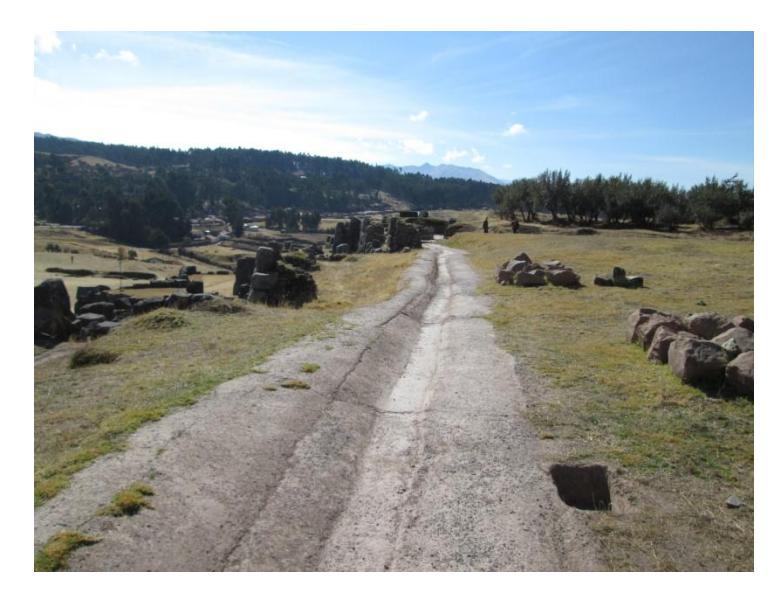
the peak water runoff demand. This particular channel is constructed from a cementicious material with a trapezoidal base along with a clay wing on either side. The major purpose of this channel is to collect any water that is running north towards the third wall and carry to safely to either the east or west side of the complex where it can harmlessly flow into one of the ravines.

Figure 17. Ad-hoc Drainage Channel near Main Collapses Site (Lohr, 2013)

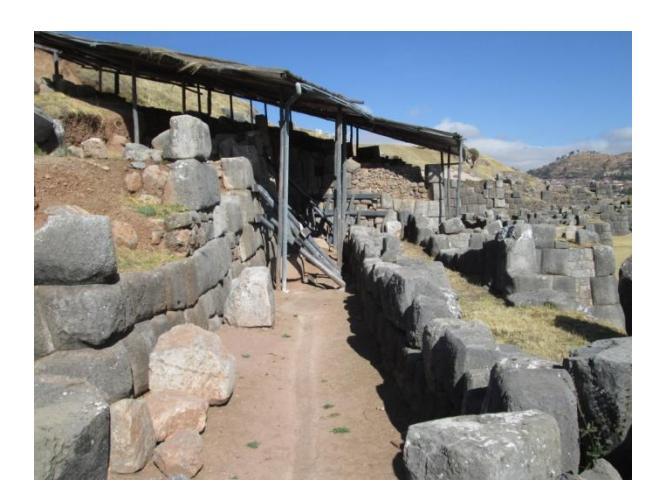
Another set of channels are located along the second terrace. These channels are considerably smaller than the ones on top of the third wall and while most are made of clay some are simply channels dug into the dirt. A portion of this channel is shown in figure 18. These channels are much shorter in length than the major channel on top of the wall and many collect water and direct it into one of the many drainage ports that are located along the second terrace.

Figure 18. Ad-hoc Drainage Channel along Second Terrace (Lohr, 2013)

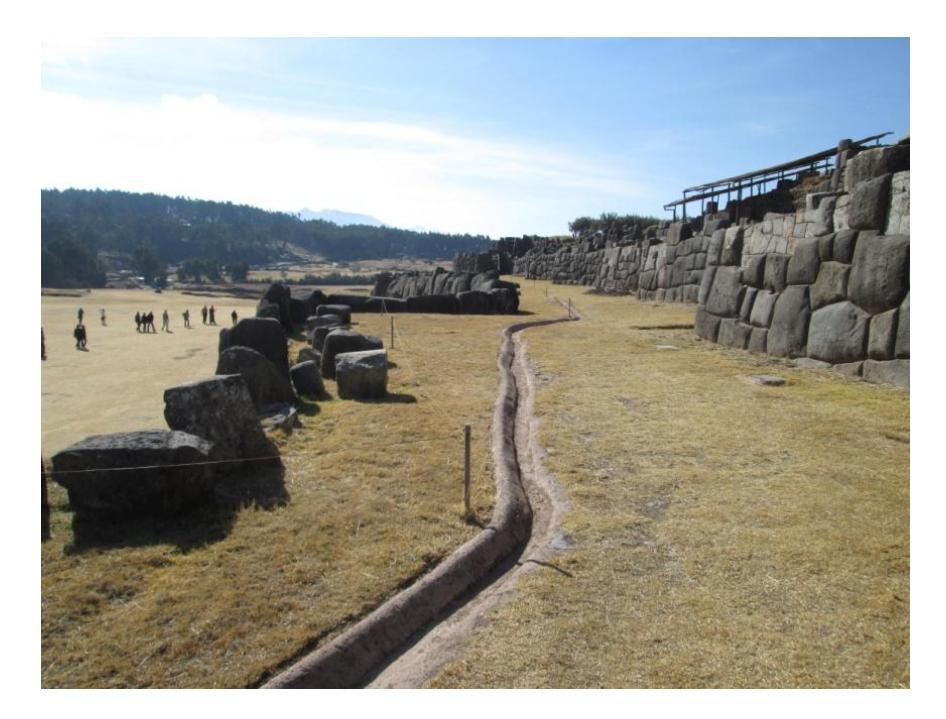
side to prevent water from running over top of the channel. This channel is larger than the one running along the second terrace but smaller than the one running along the top of the third wall. This is likely because this channel mainly receives its water from the rainfall that lands on the first terrace which is larger than the second terrace but not nearly as large as the water that lands above the third wall which flows into the drainage channel above the third wall.

Figure 19. Ad-hoc Drainage Channel Running along the First Terrace (Lohr, 2013)

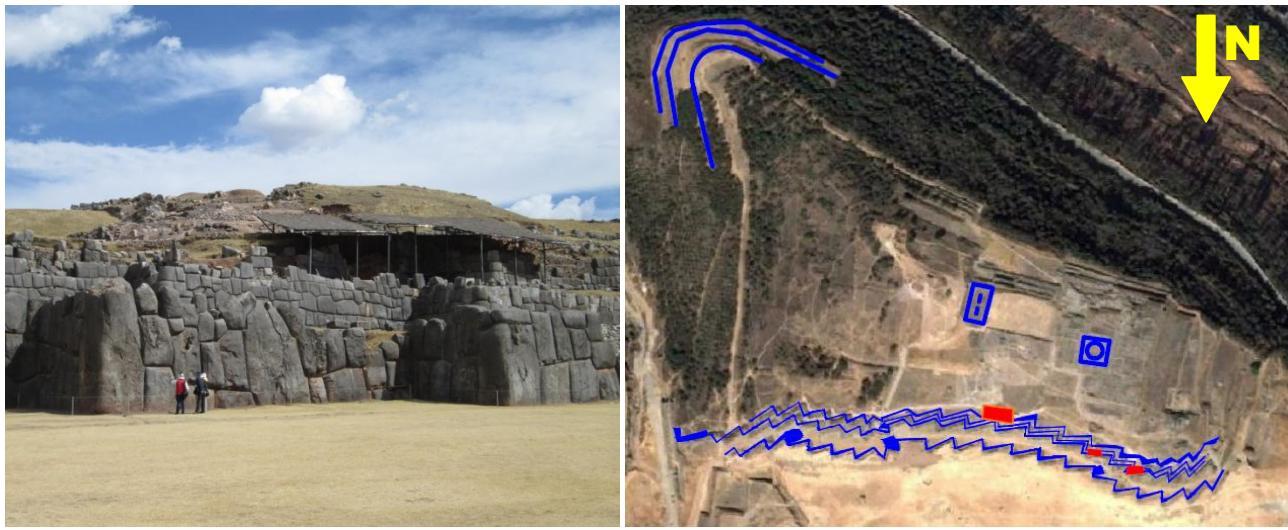
Another attempt to help fix the problem was the construction of roof structures to help protect the collapsed sections of the wall from receiving direct rainfall. The largest of the sheds is shown below in figure 22a. It covers the original and largest collapsed section of wall that started in 2010 and has been in steady decline since. These sheds are made from wooden poles that hold up a corrugated metal material that acts as a roof on a normal house would and carries the water to the end of the roof where it flows off. The metal is then covered in a grass/thatch material in order to prevent it from standing out to the many tourists who tour the site every day. There are three of these roof areas the locations of which are shown below in figure 22b.

Figure 22a. Shed Roof Covering Major Three Collapsed Area (Lohr, 2013)

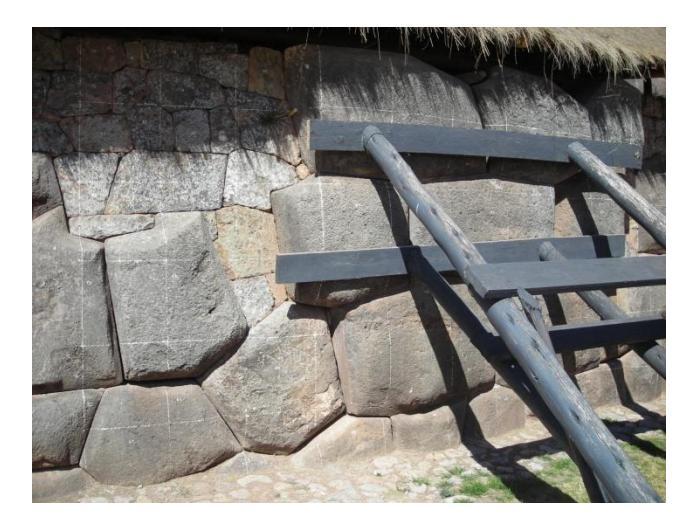
Braces were put in place, not to fix the problem, but merely to prevent/delay further collapse of the walls. These braces are made of large wooden poles and boards which are mounted into the ground and angled to lay flat against the large walls as shown in figure 23. This keeps pressure on the stones in hope of counteracting the hydrostatic pressure that is pushing on the opposite side of the wall. In theory, these braces should help prevent the batter of the walls from deteriorating as well as preventing bulges of large stones which can compromise the structural integrity of the wall, but they fail to fix the source of the problem.

Figure 23. Large Wooden Brace Used to Support Wall (Lohr, 2012)

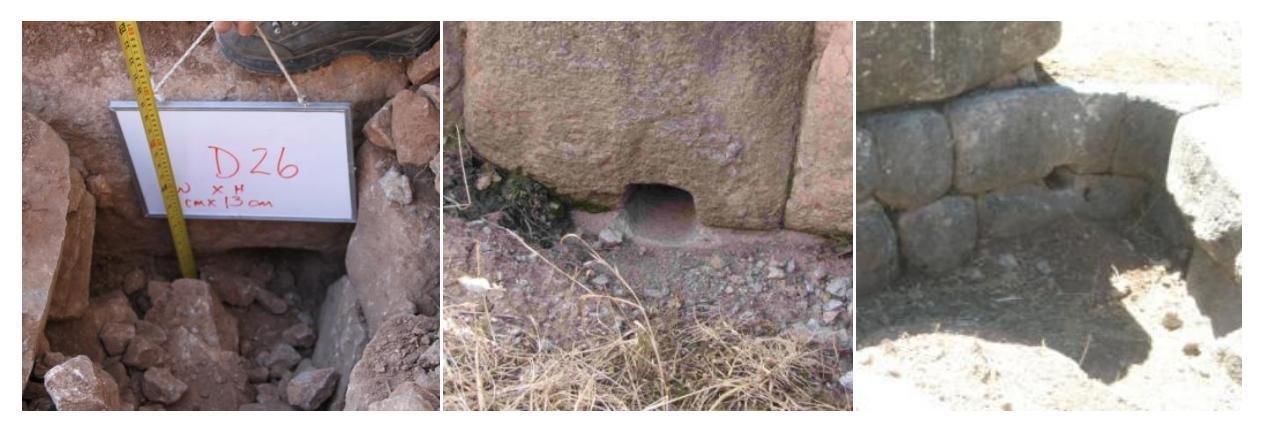
Figure 42. Left: Buried Drainage Port (Miksad, 2010) Middle: Ideal Port Inlet Location at Ground Level (Miksad, 2010) Right: Elevated Drainage Port Inlet (Luke, 2010)

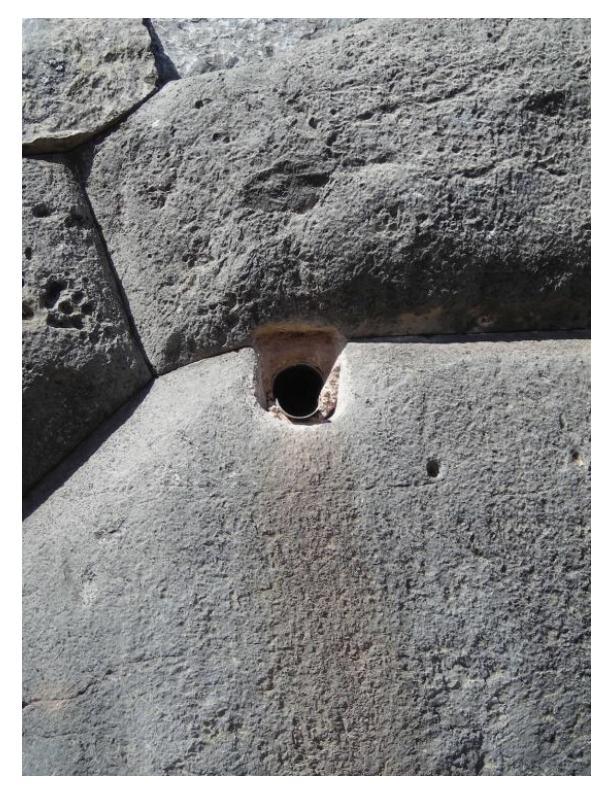
Eleven of the ports have recently been installed with liners to prevent seepage of water into the stone walls. Some of these liners are made of plastic while others are wood. The ports that now have these liners are 19, 20, 23, 24, 26, 27, 28, 30, 31, 32, and 33. An example of one of these liners can be seen below in figure 45. These pipes change the flow rates of the ports and the new maximum flow rates can be seen below in table 6. On average the flow through the ports increased by 150 percent with the introduction of the liners. The main cause of this is a drastic reduction in the manning's roughness coefficient.

Figure 45. Drainage Port with PVC Liner (Lohr, 2012)

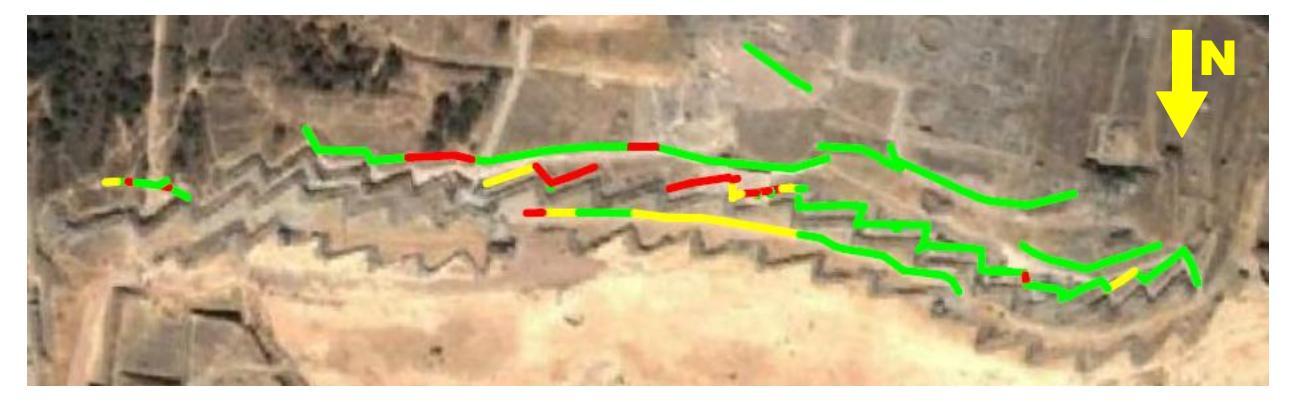
Figure 48. Drainage Channel Problem Areas (red: problem area, yellow: possible problem area, green: no problems)

The first recommendation is a short term solution. In order to prevent further damage to the walls, the drainage channels should be modified so they can carry the runoff load during a major storm event. The main problem areas were highlighted earlier in this report. At these problem areas, the channels can be enlarged so that they can handle the water runoff loads during larger storm events.

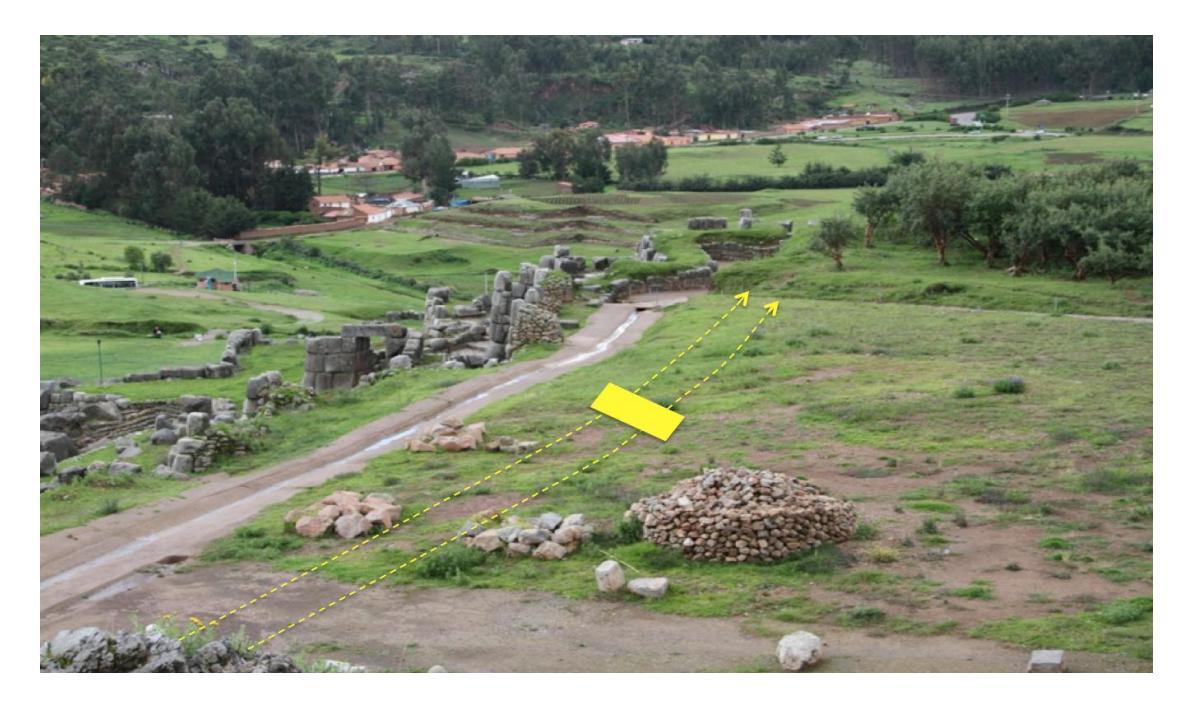
Figure 51. Newly Excavated Gravel Drain Used to Divert Runoff Away from the Third Wall (Miksad, 2013)
