High Temperature Salt Deposit-Assisted Corrosion of Silicon
Carbide-Based Ceramic Matrix Composites: Effects of Composite
Chemistry and Architecture

A Dissertation Presented to the Faculty of the
School of Engineering and Applied Science
University of Virginia

Department of Materials Science and Engineering

May, 2015

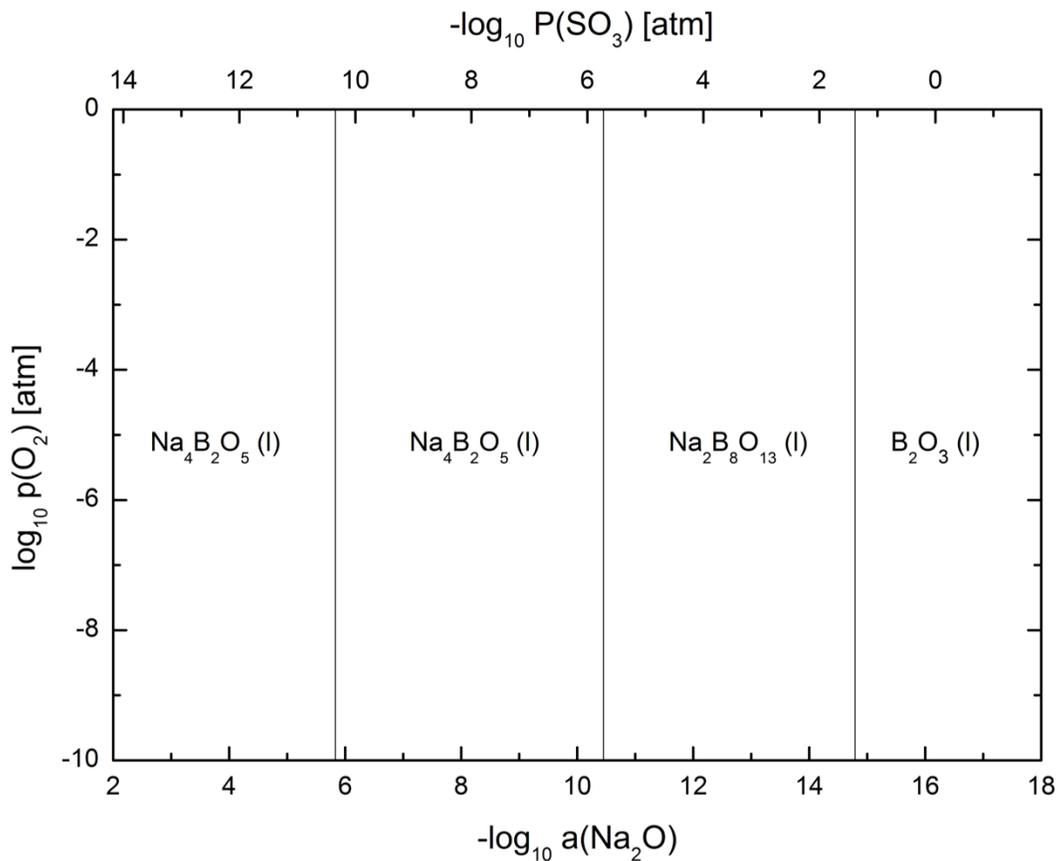
Figure 3 - Phase stability diagram for Na₂O and B₂O₃ at 900°C with the basic end on the left and the acidic end on the right. All phases are predicted to be liquid at 900°C.

liquid at 900°C, so their reactivity and rate of inward oxygen diffusion is likely to be higher. The phase stability diagram for Na₂O and B₂O₃ at 1000°C is shown in Figure 4. The dissolution of boria in Na₂O is shown in Equation 10. Note that the reaction in Equation 10 can also be written in terms of Na₂SO₄ reacting and releasing SO₃ gas as shown in Equation 11. As boron-containing compounds are present in SiC CMCs, it is of interest to explore the solubility of boria in molten sodium sulfate, however these data do not exist in the literature.

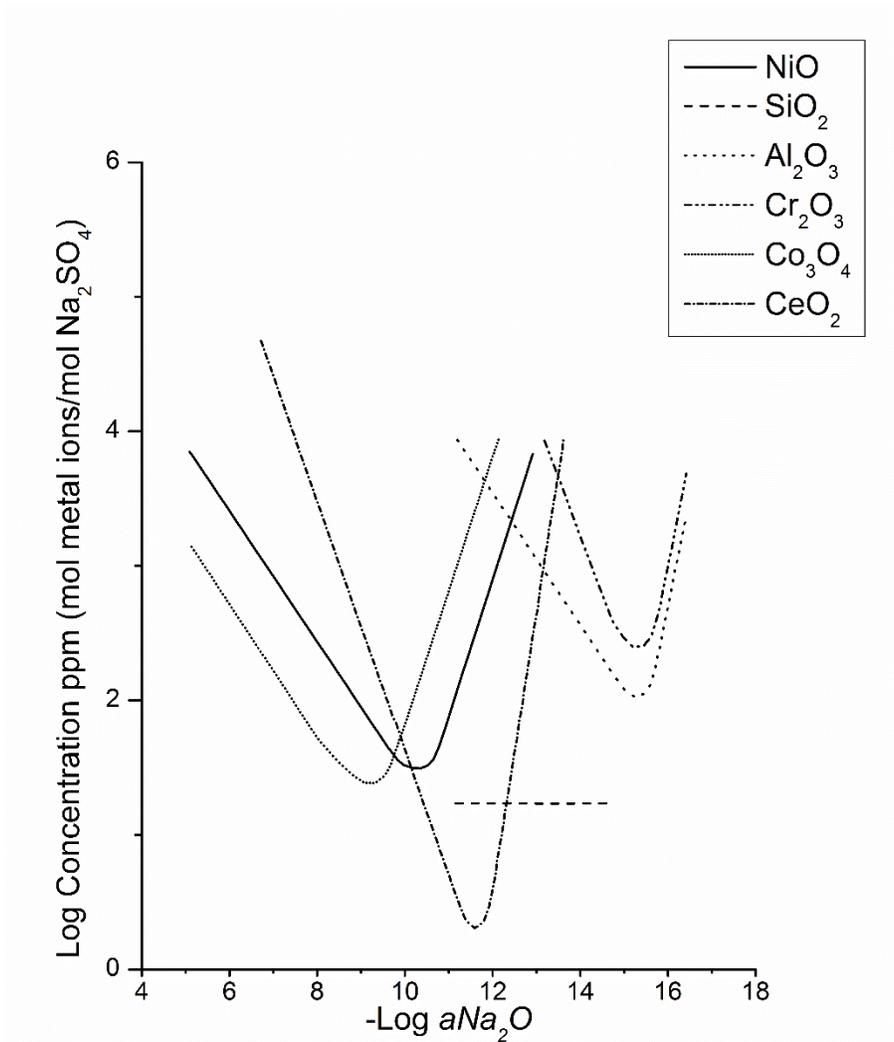
Figure 5 – Compilation of measured solubilities for several oxides in fused pure Na_2SO_4 at 1200 K, recreated from Rapp²³.

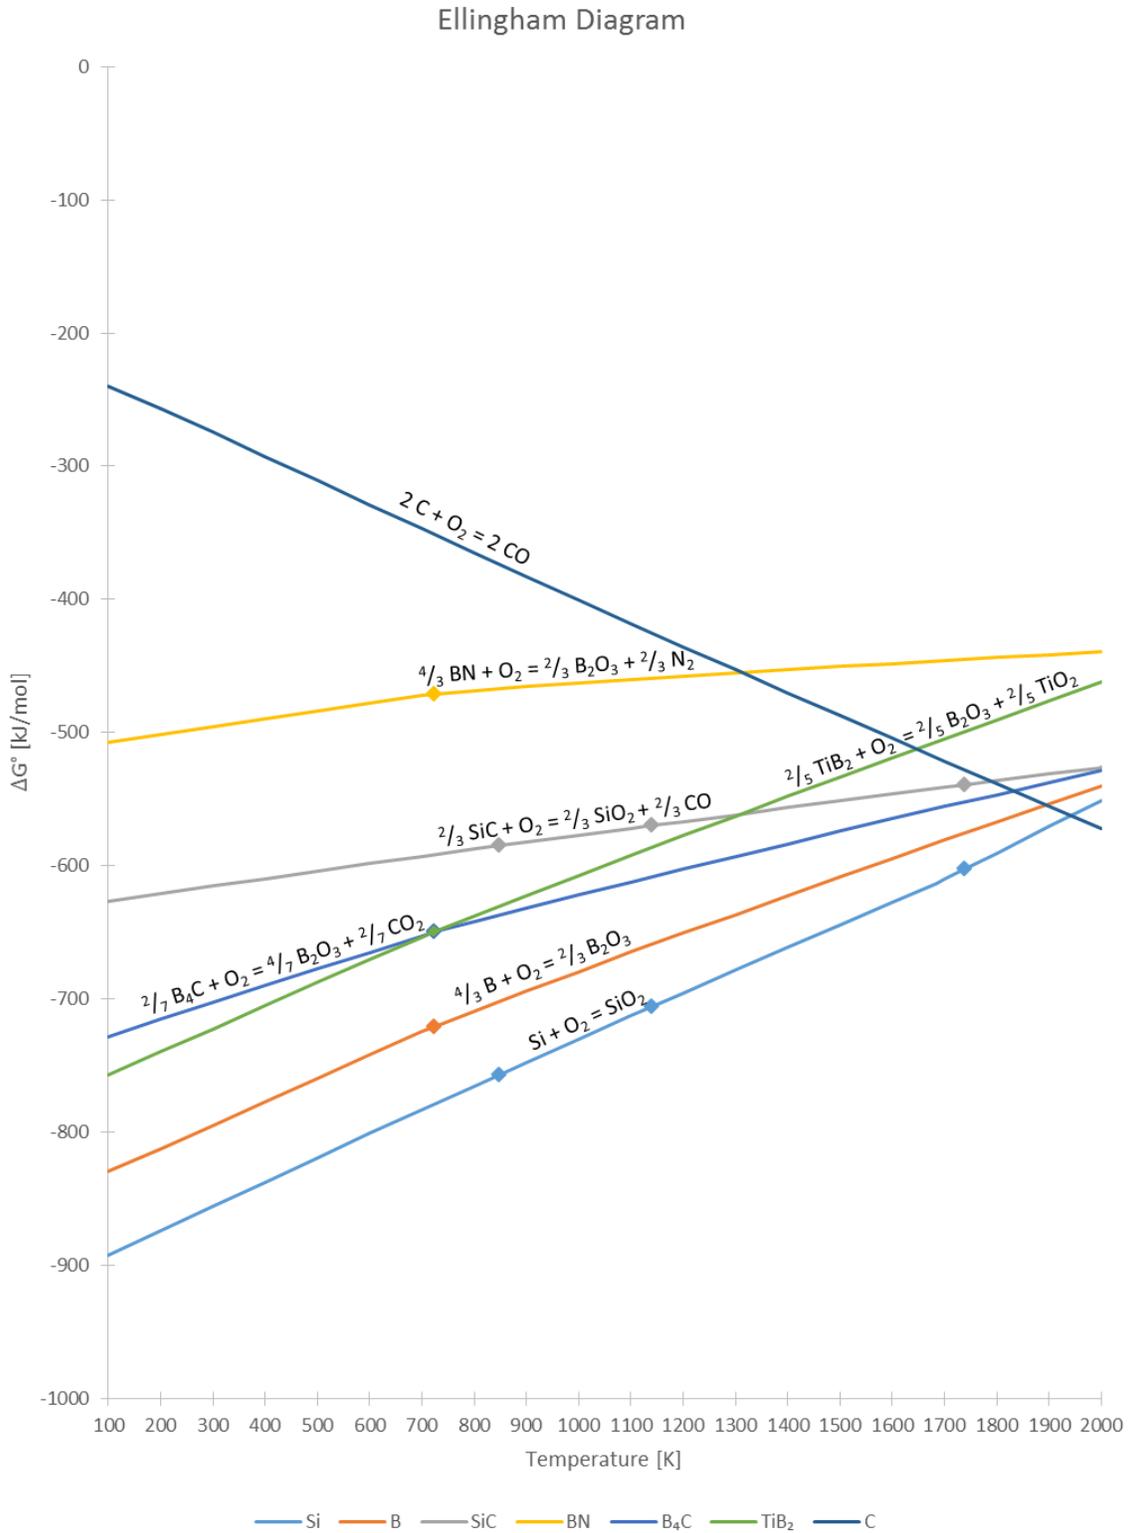
Figure 6 - Ellingham diagram showing relative thermodynamic stability of composite constituents toward oxidation.

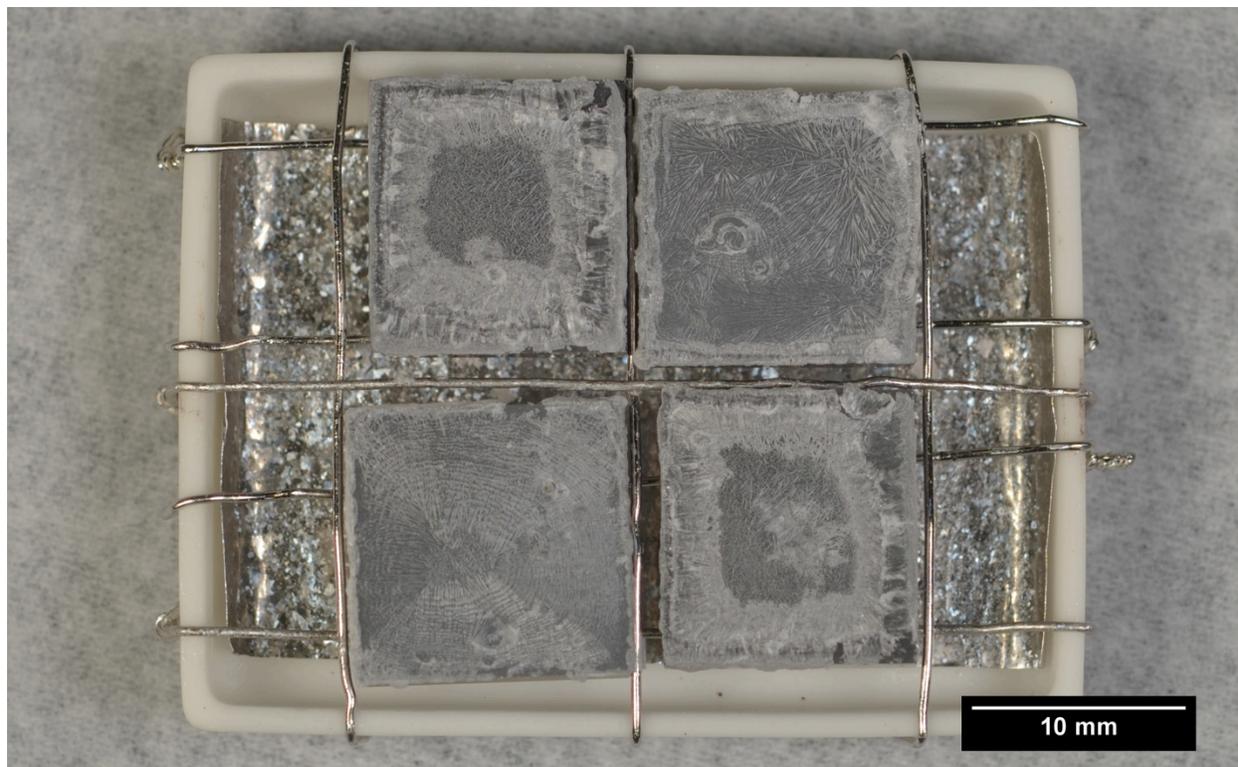
Figure 8 - Loaded sample carrier (with 4 samples) before being placed into furnace.

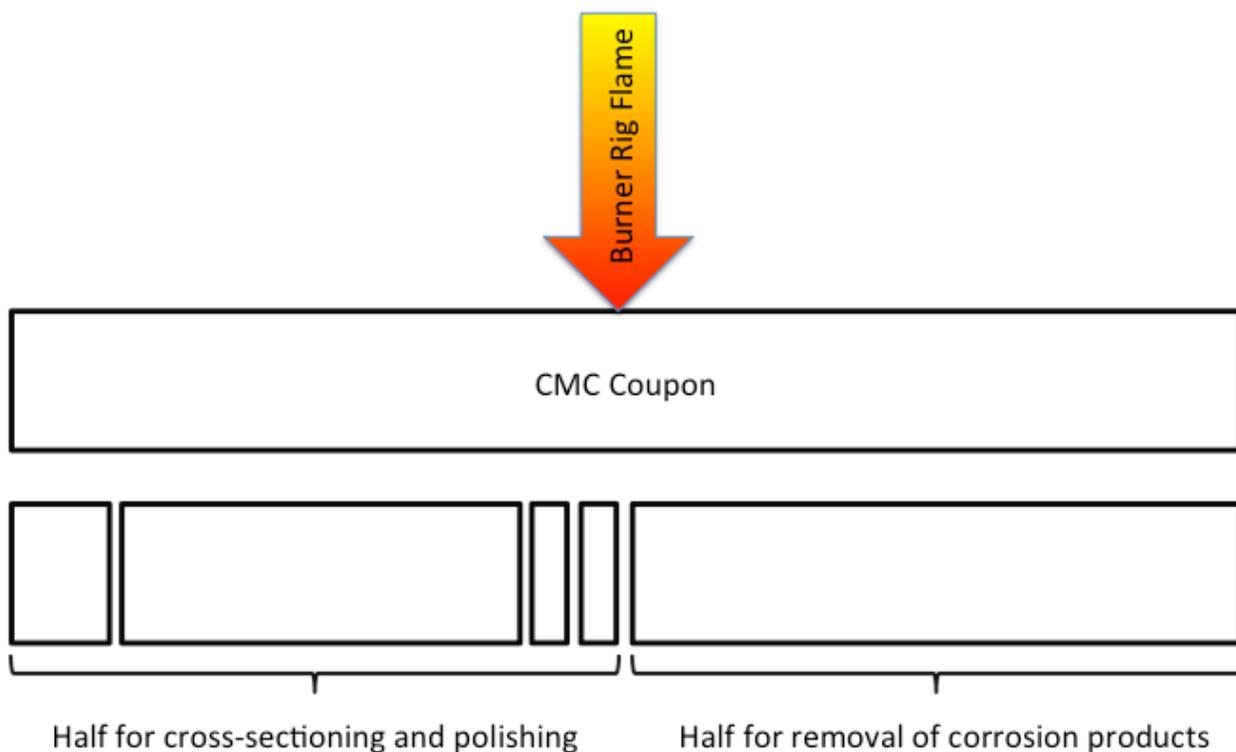
Figure 11 – Schematic of the sectioning plan for the burner rig coupons.

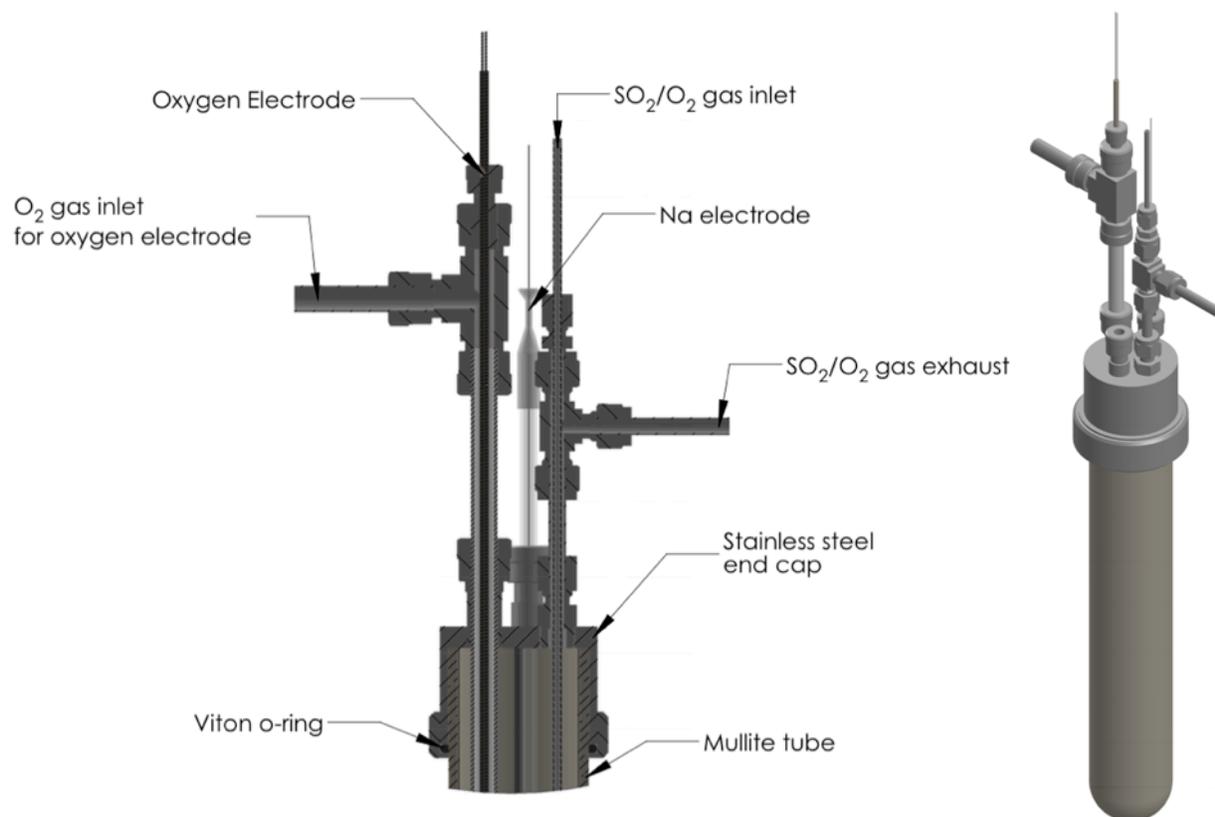
Figure 12 – Cutaway schematic of the end cap assembly on the left showing the location and configuration of electrodes and components. The right schematic is an isometric view of the whole end cap and furnace tube assembly.

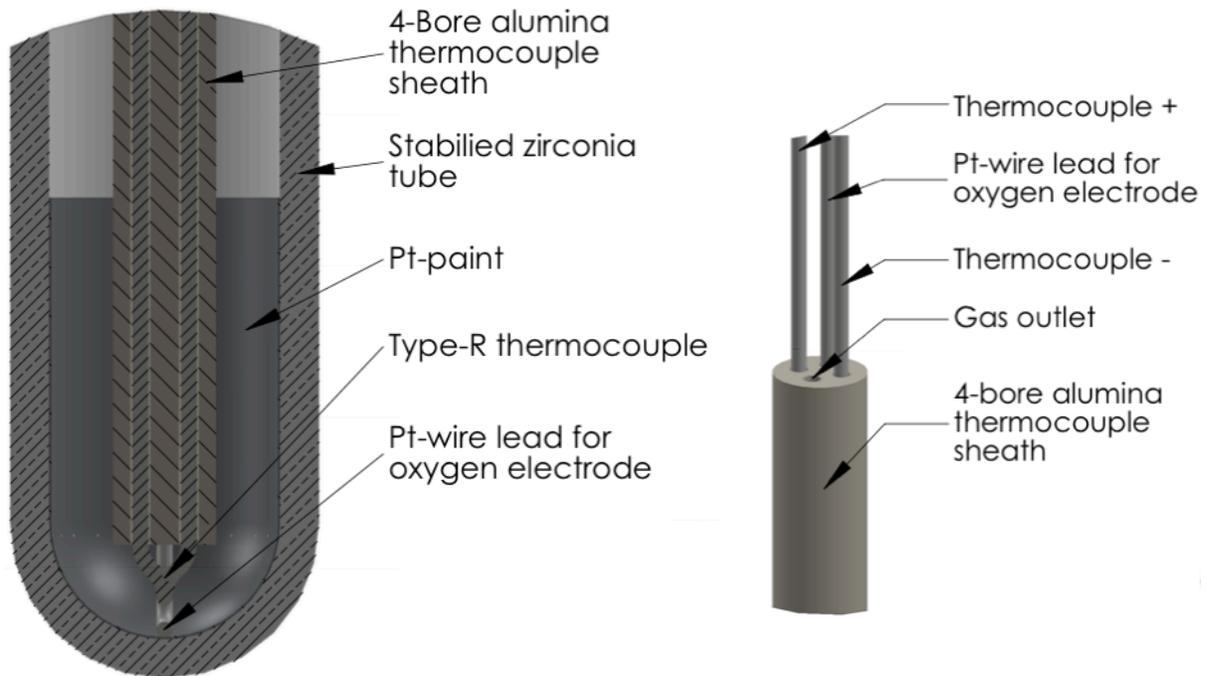
Figure 14 – Cutaway schematic of the closed end of the oxygen electrode on the left and the top of the 4-bore alumina sheath on the right showing arrangement of the components.

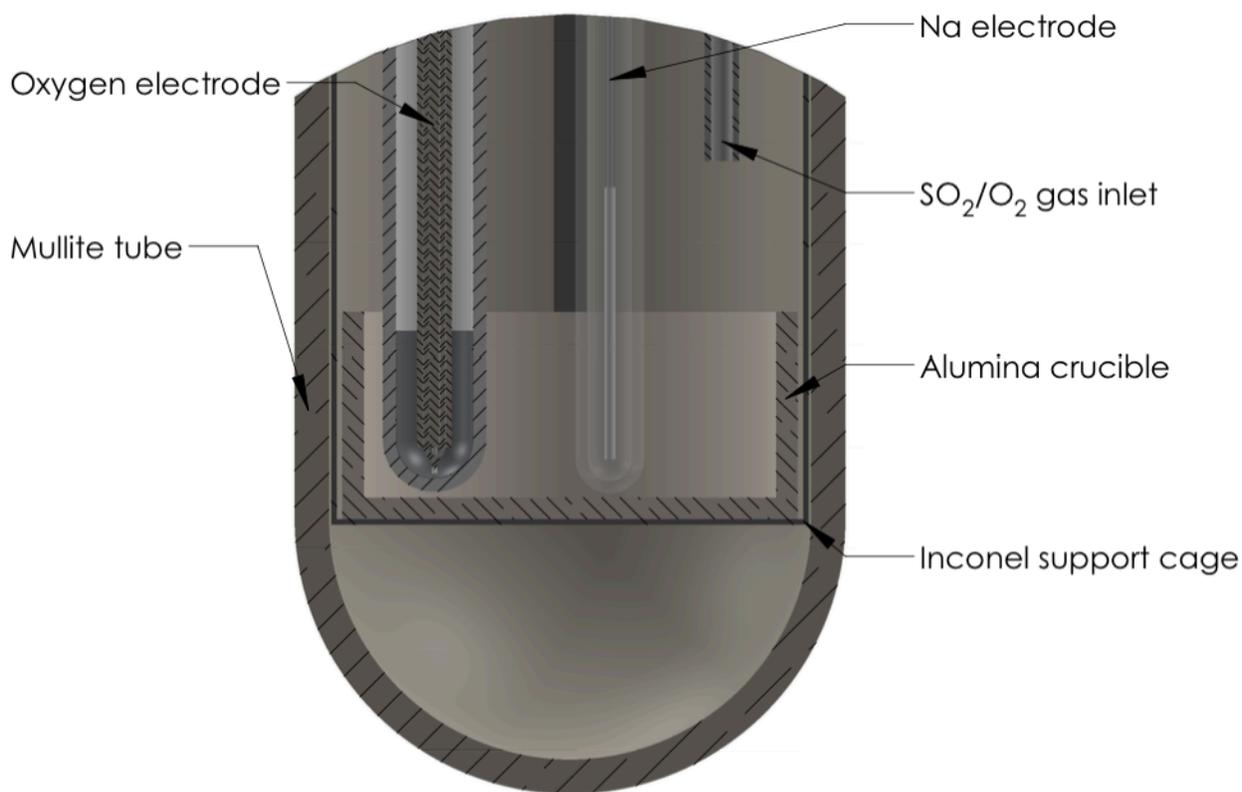
Figure 15 – Cutaway schematic of the bottom of the furnace tube showing the alumina crucible, oxygen electrode, sodium electrode, and gas inlet.

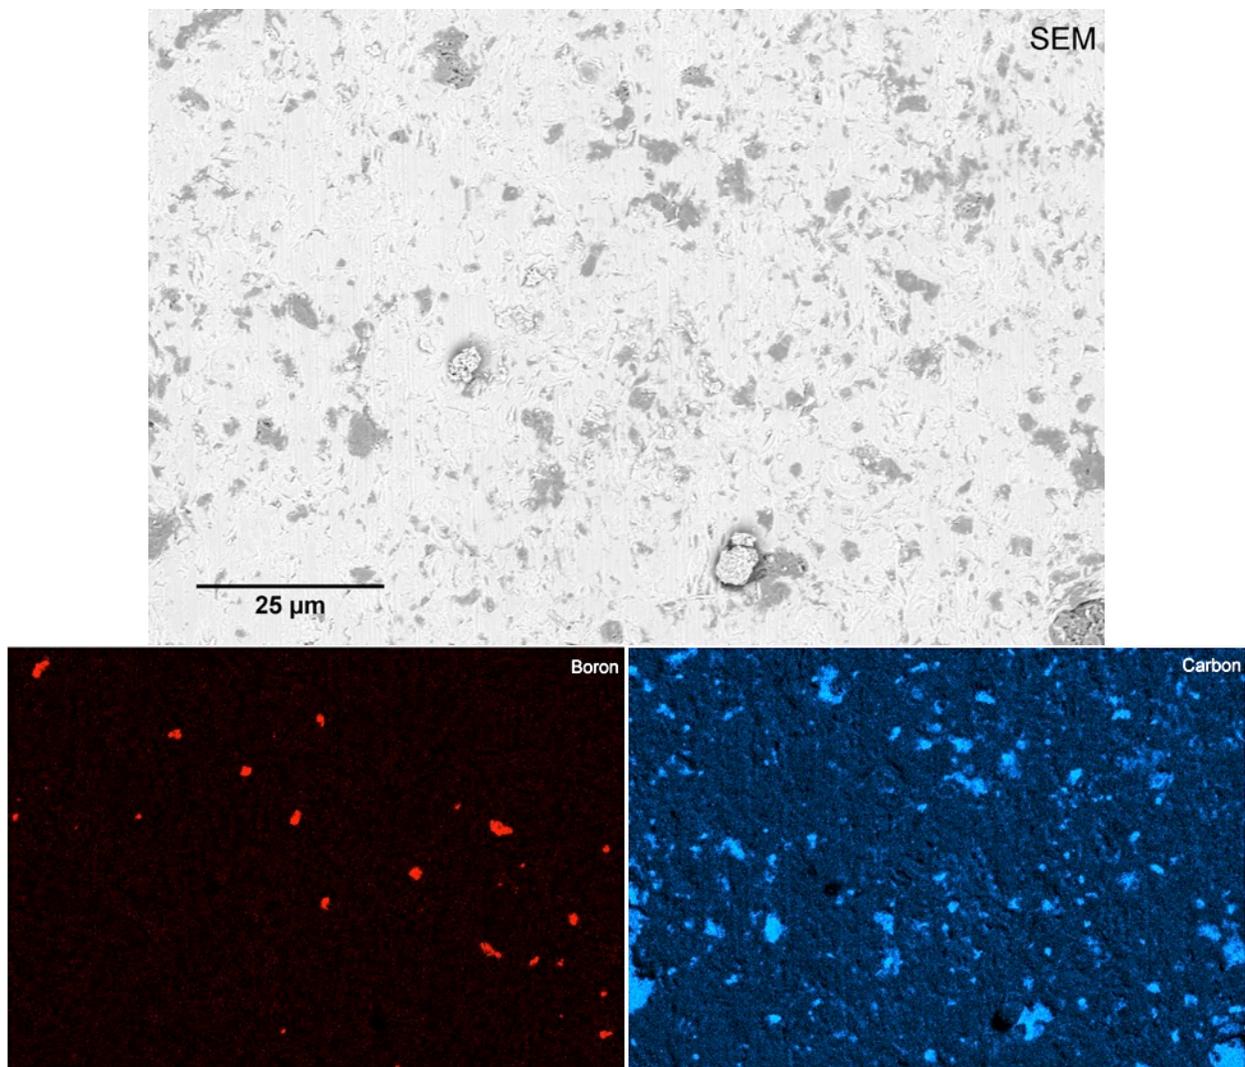
Figure 18 – Electron micrograph of the top surface of a Hexoloy coupon, EDS map of B, and EDS map of C.

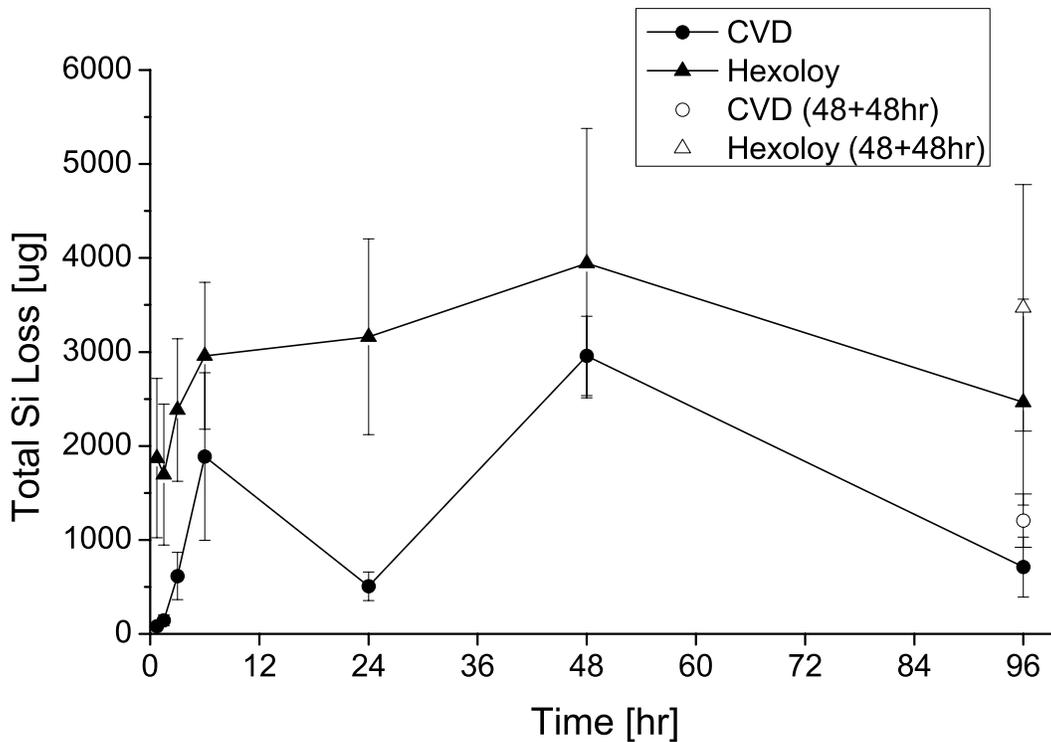
Figure 21 - Total Si found in corrosion products (µg) using ICP-OES as a function of exposure time (hr) for CVD SiC and Hexoloy coupons exposed at 1000°C.

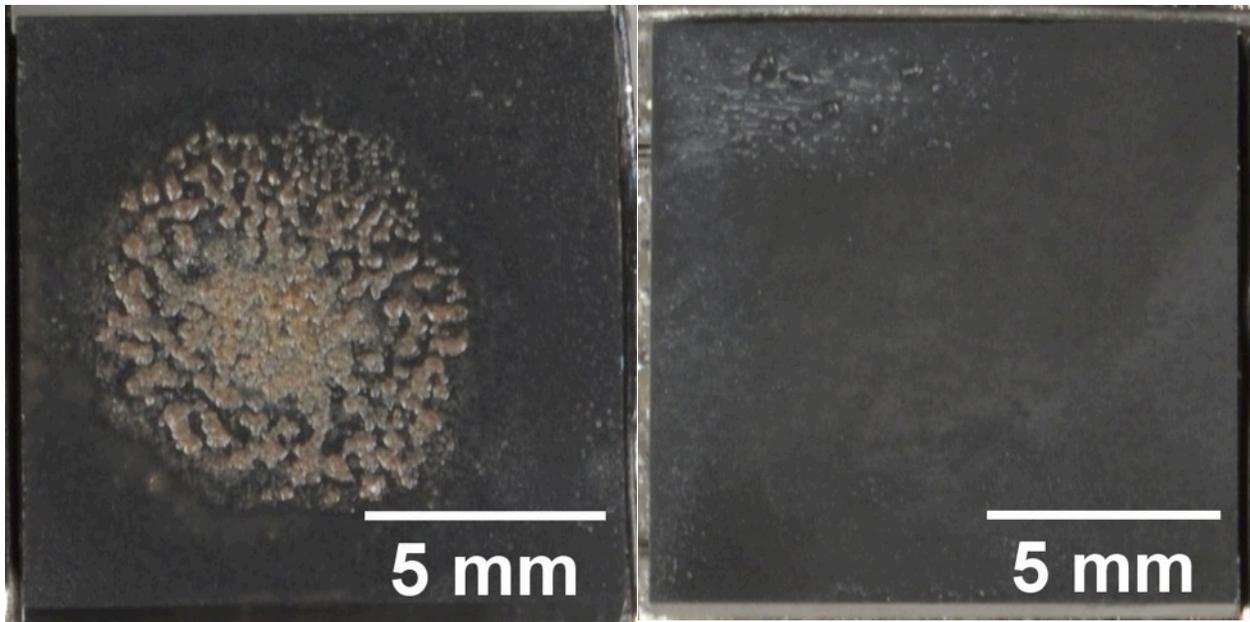
Figure 22 – Examples of non-uniform corrosion on CVD SiC coupons exposed at 1000°C for 6-hr.

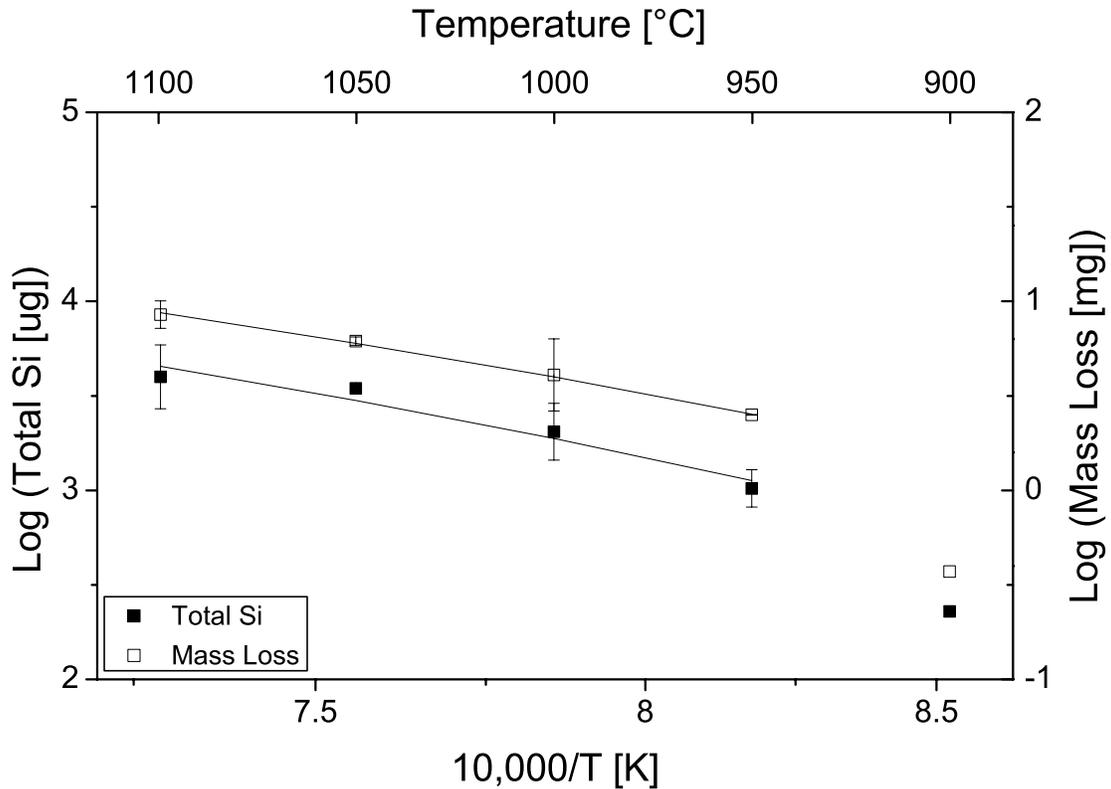
Figure 23 – Temperature dependence of sodium sulfate induced hot corrosion of SiC (Hexoloy) plotted as the log of total Si found in the corrosion products (μg) and log of mass loss after corrosion products are removed (mg) vs. inverse temperature (K). In the temperature range of 950-1100°C the apparent activation energy is 71.5 kJ/mol \pm 34 kJ/mol for linear mass loss and 80.8 kJ/mol \pm 40 kJ/mol (95% confidence intervals) for linear total Si in the corrosion products.

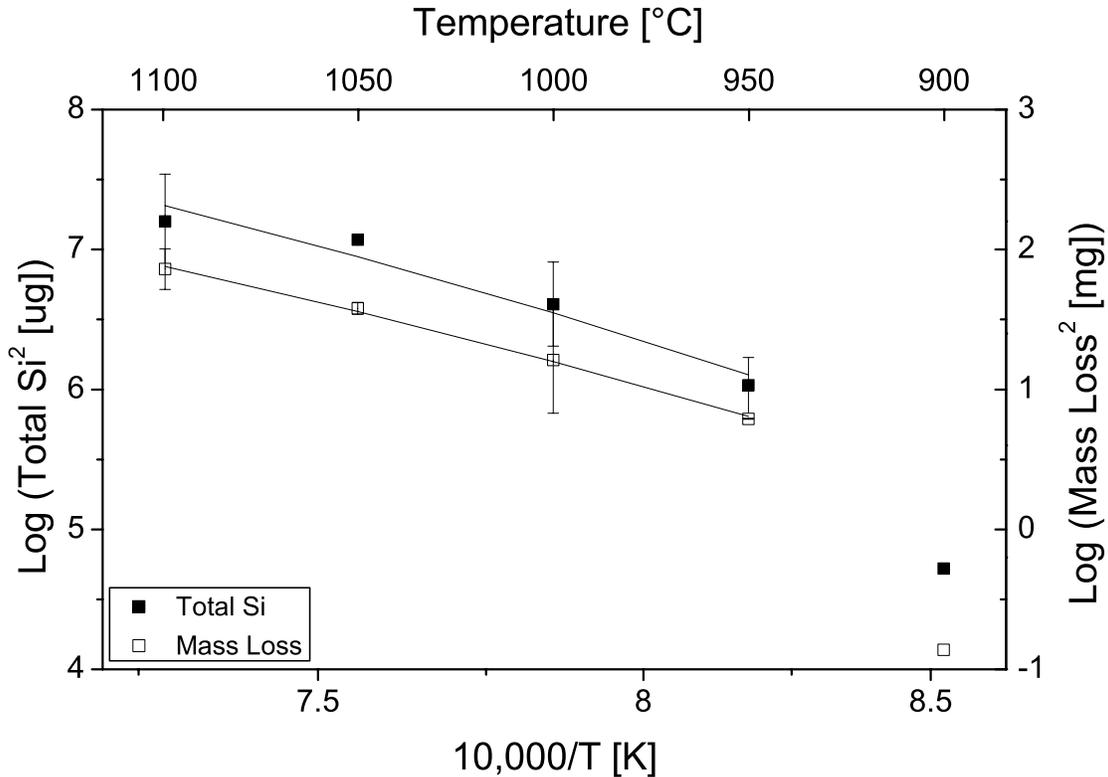
Figure 24 - Temperature dependence of sodium sulfate induced hot corrosion of SiC (Hexoloy) plotted as the log of total Si found in the corrosion products squared (μg) and log of mass loss after corrosion products are removed squared (mg) vs. inverse temperature (K). In the temperature range of 950-1100°C the apparent activation energy is 143.0 kJ/mol \pm 68 kJ/mol for parabolic mass loss and 161.5 kJ/mol \pm 80 kJ/mol (95% confidence intervals) for parabolic total Si in the corrosion products.

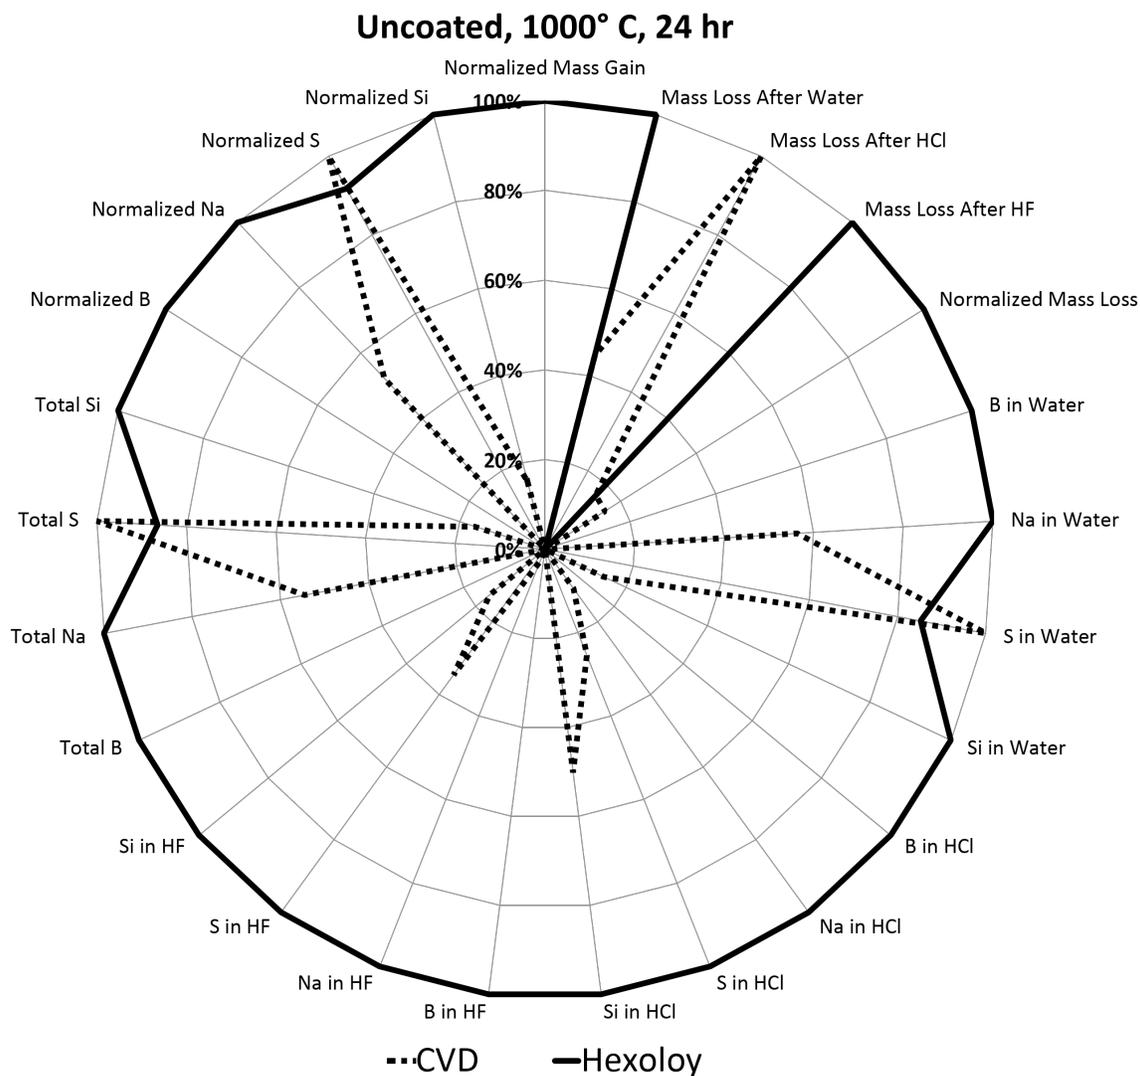
Figure 25 – Radar plot comparing relative hot corrosion resistance of uncoated CVD SiC and Hexoloy coupons exposed for 24 hr at 1000°C.

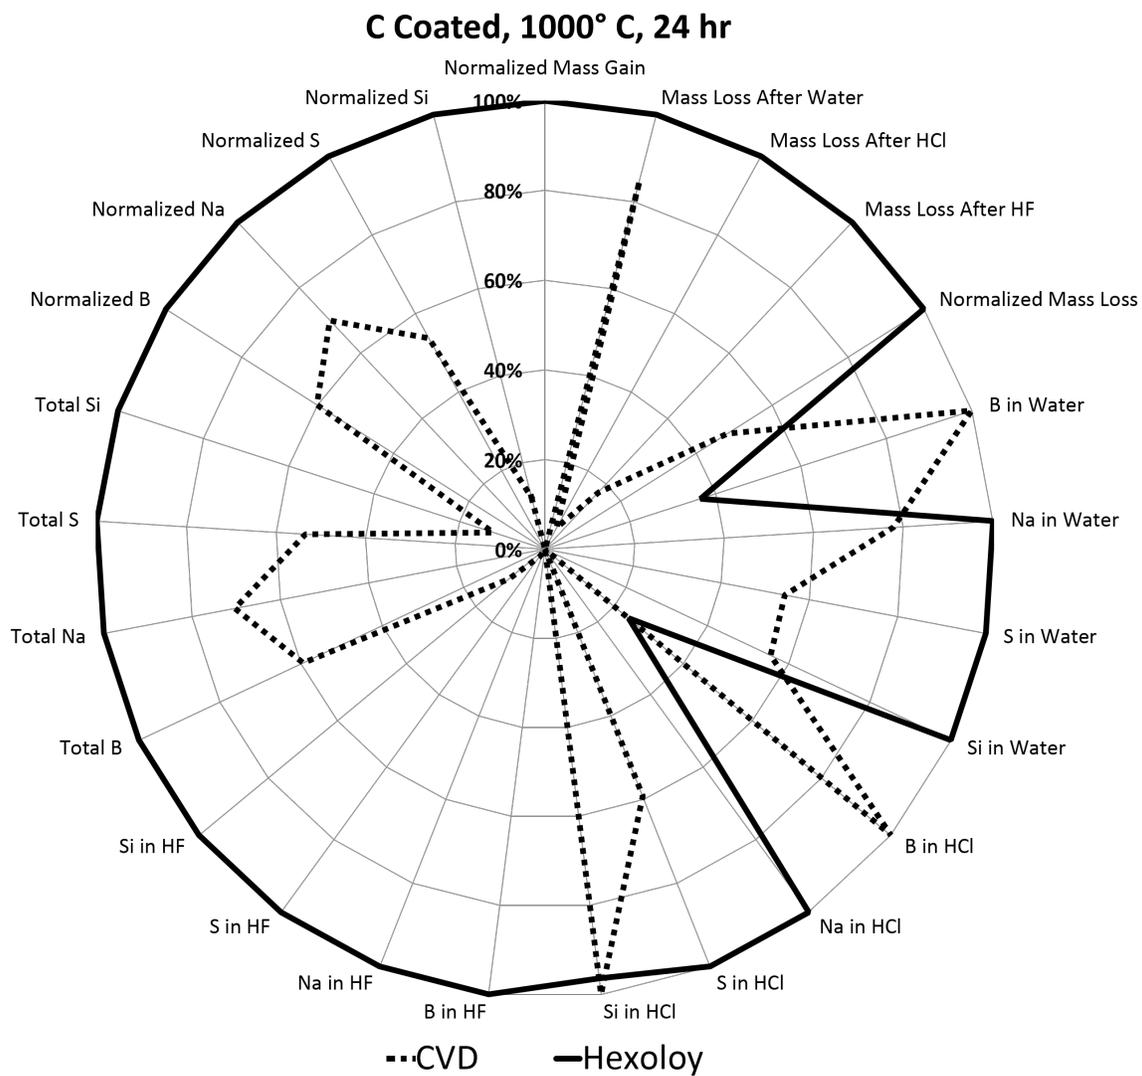
Figure 26 – Radar plot comparing relative hot corrosion resistance of C coated CVD SiC and Hexoloy coupons exposed for 24 hr at 1000°C in 0.1% SO₂/O₂ .

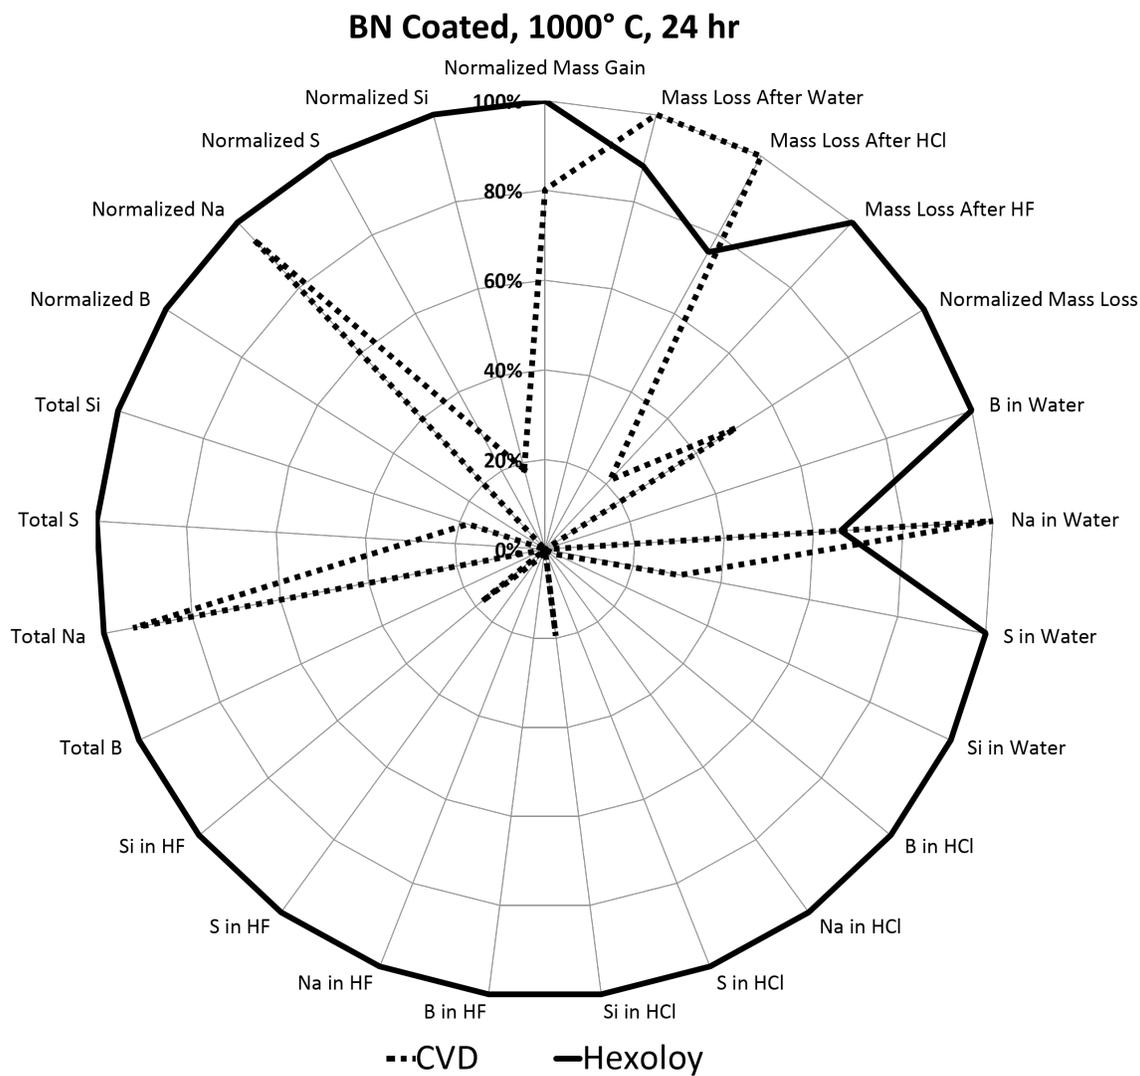
Figure 27 – Radar plot comparing relative hot corrosion resistance of BN coated CVD SiC and Hexoloy coupons exposed for 24 hr at 1000°C in 0.1% SO₂/O₂.

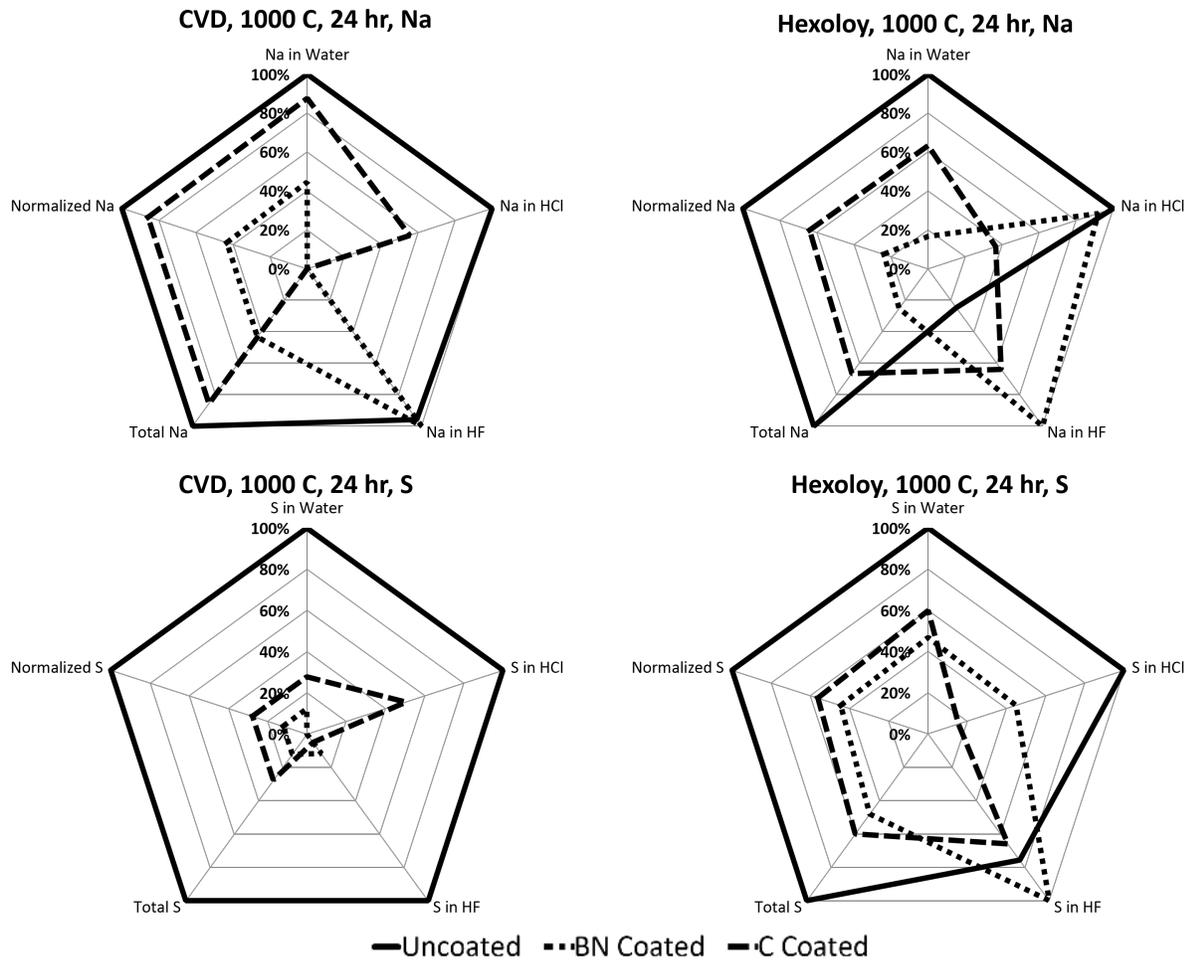
Figure 28 – Radar plots showing Na and S found in each of the digestion steps as well as total Na and S for CVD SiC and Hexoloy coupons as a function of surface coating after hot corrosion for 24 hr at 1000°C in 0.1% SO₂/O₂.

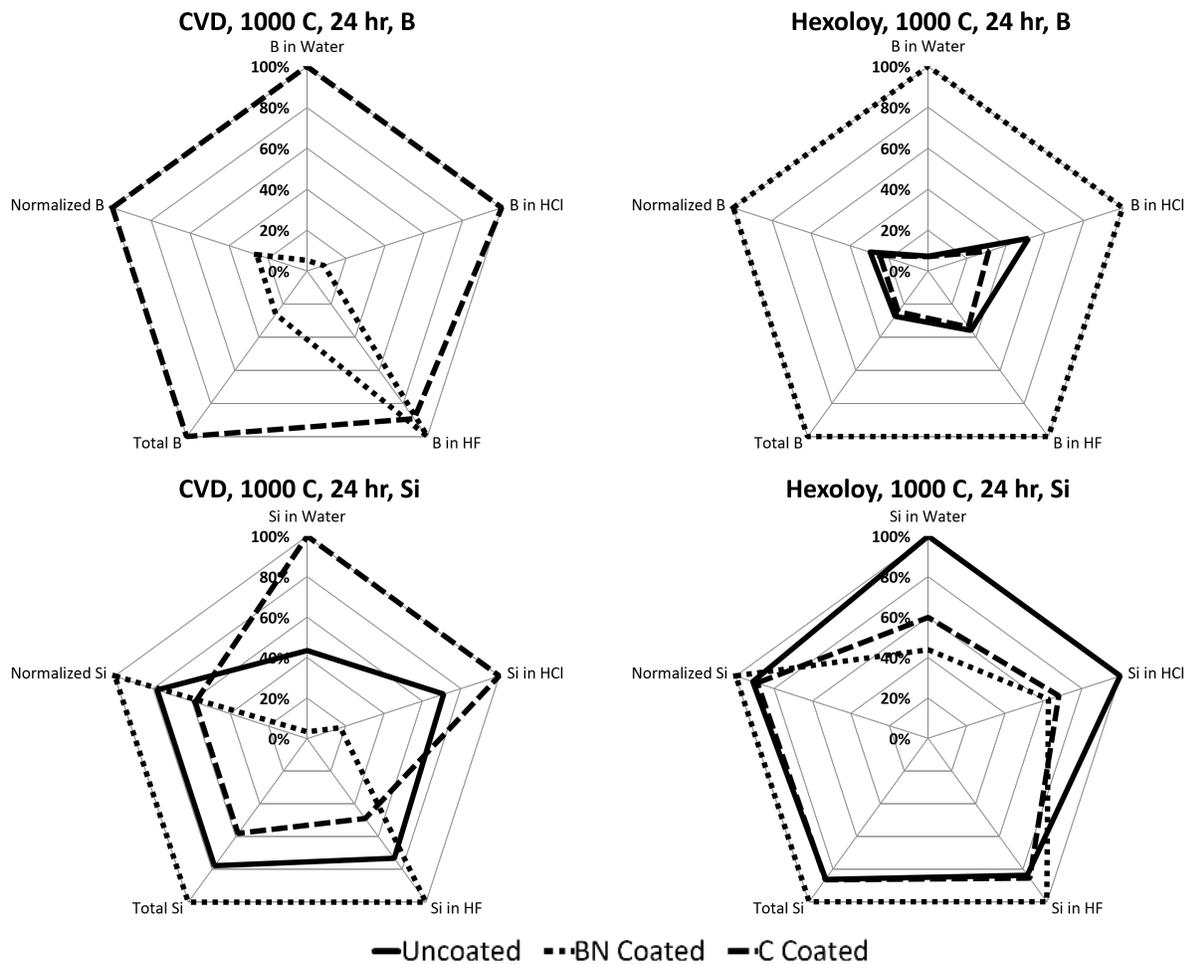
Figure 29 – Radar plots showing B and Si found in each of the digestion steps as well as total B and Si for CVD SiC and Hexoloy coupons as a function of surface coating after hot corrosion for 24 hr at 1000°C in 0.1% SO_2/O_2 .

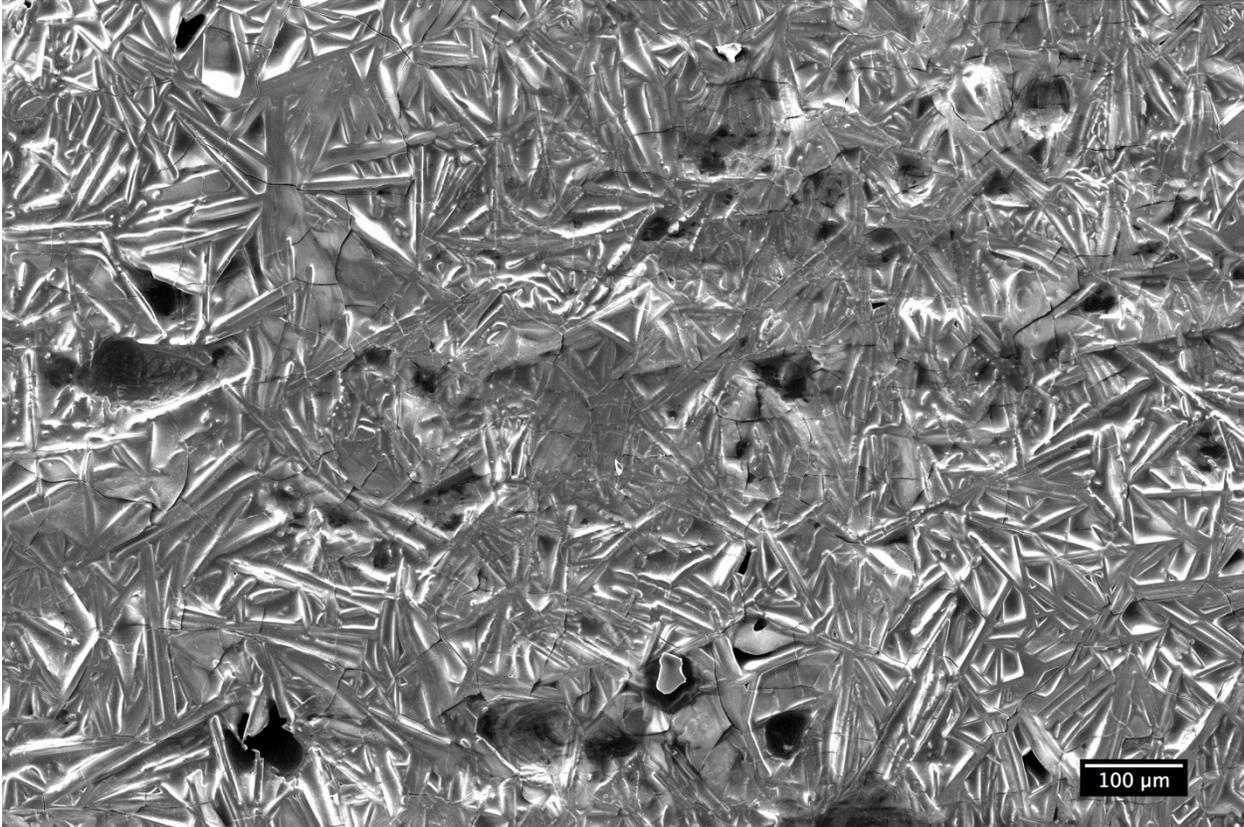
Figure 31 -SEM micrograph of a coupon after exposure for 24 hours at 1000°C in 2.5 ppm SO₂/O₂.

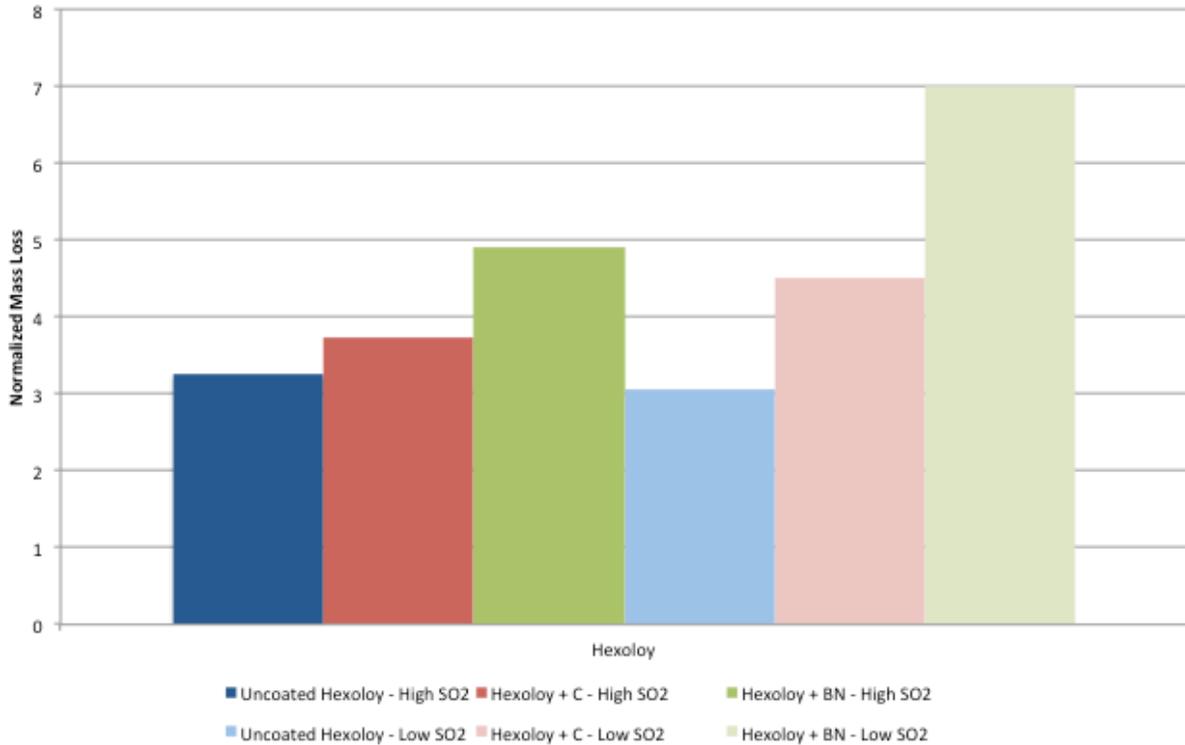
Figure 32 – Plot showing the difference in normalized mass loss between the three Hexoloy coupon types exposed in 1000ppm SO₂/O₂ and 2.5 ppm SO₂/O₂.

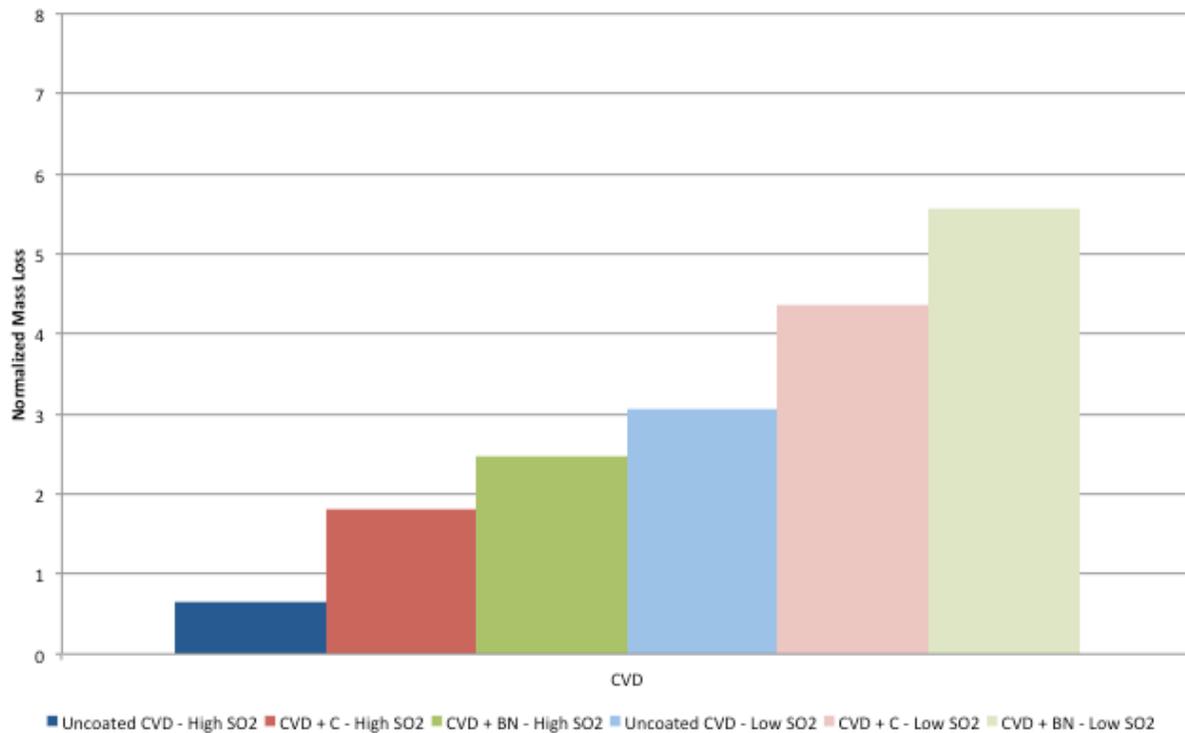
Figure 33 – Plot showing the difference in normalized mass loss between the three CVD coupon types exposed in 1000ppm SO₂/O₂ and 2.5 ppm SO₂/O₂.
