High Temperature Salt Deposit-Assisted Corrosion of Silicon
Carbide-Based Ceramic Matrix Composites: Effects of Composite
Chemistry and Architecture

A Dissertation Presented to the Faculty of the
School of Engineering and Applied Science
University of Virginia

Department of Materials Science and Engineering

May, 2015

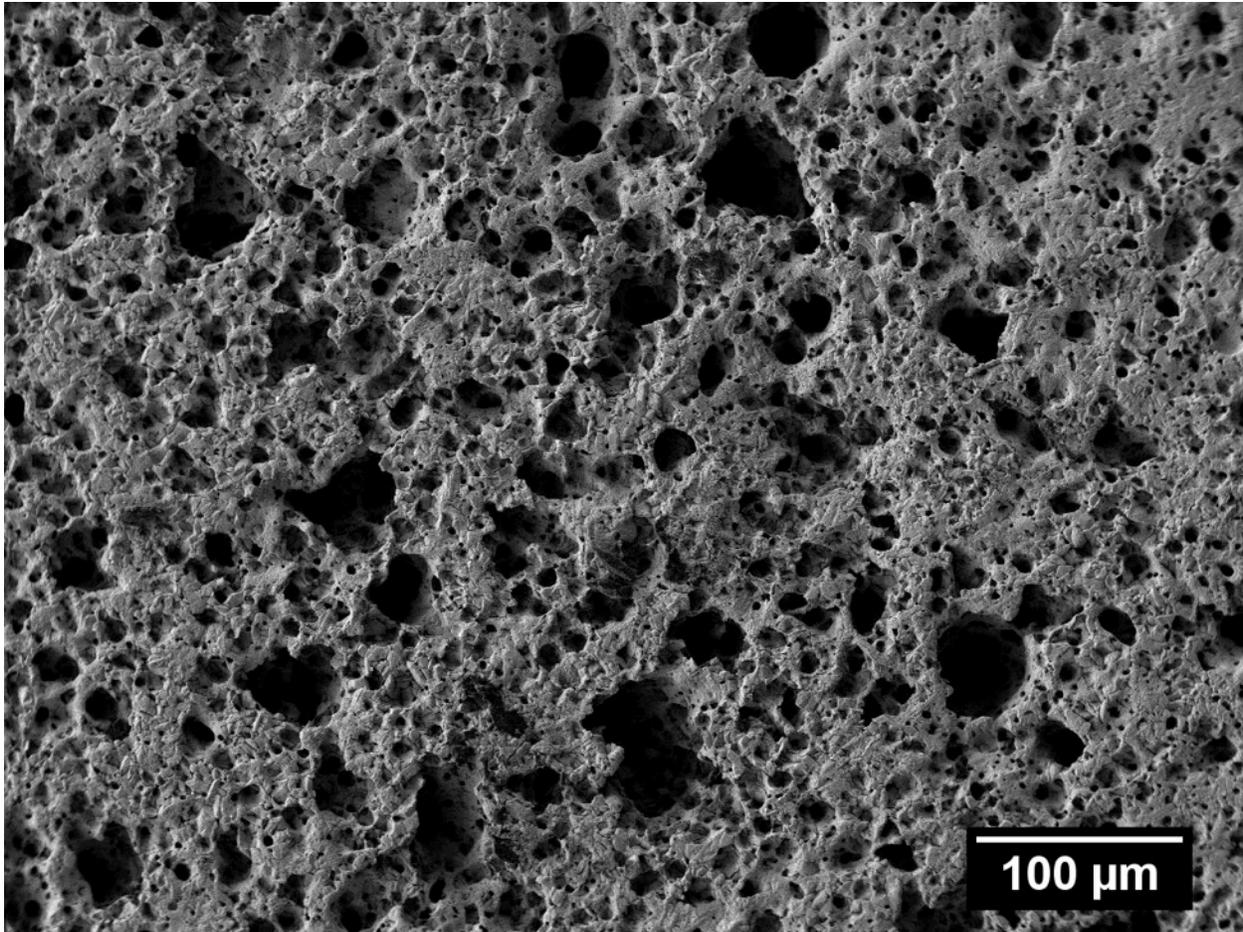
Figure 34 – Electron micrograph of a Hexoloy coupon exposed for 24 hr at 1000°C showing extensive pitting of the sample surface.

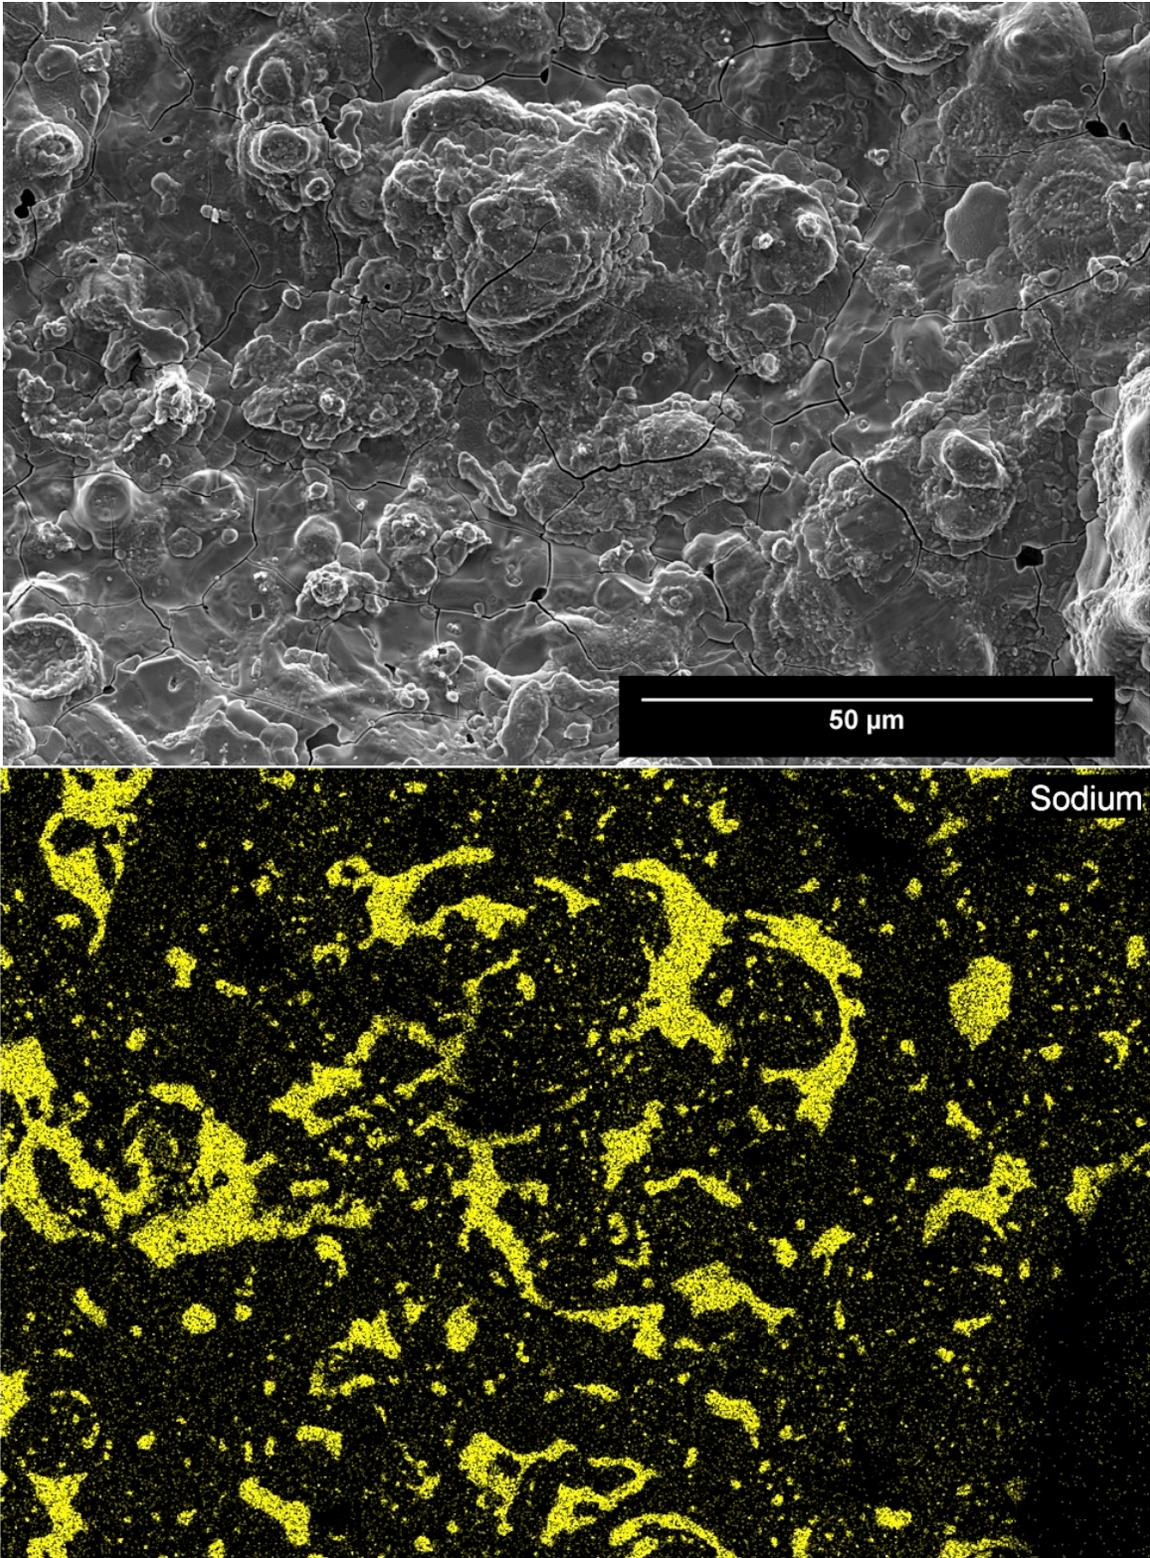
Figure 38 - Electron micrograph and corresponding Na EDS map of a Hexoloy coupon exposed for 24 hr at 1000°C.

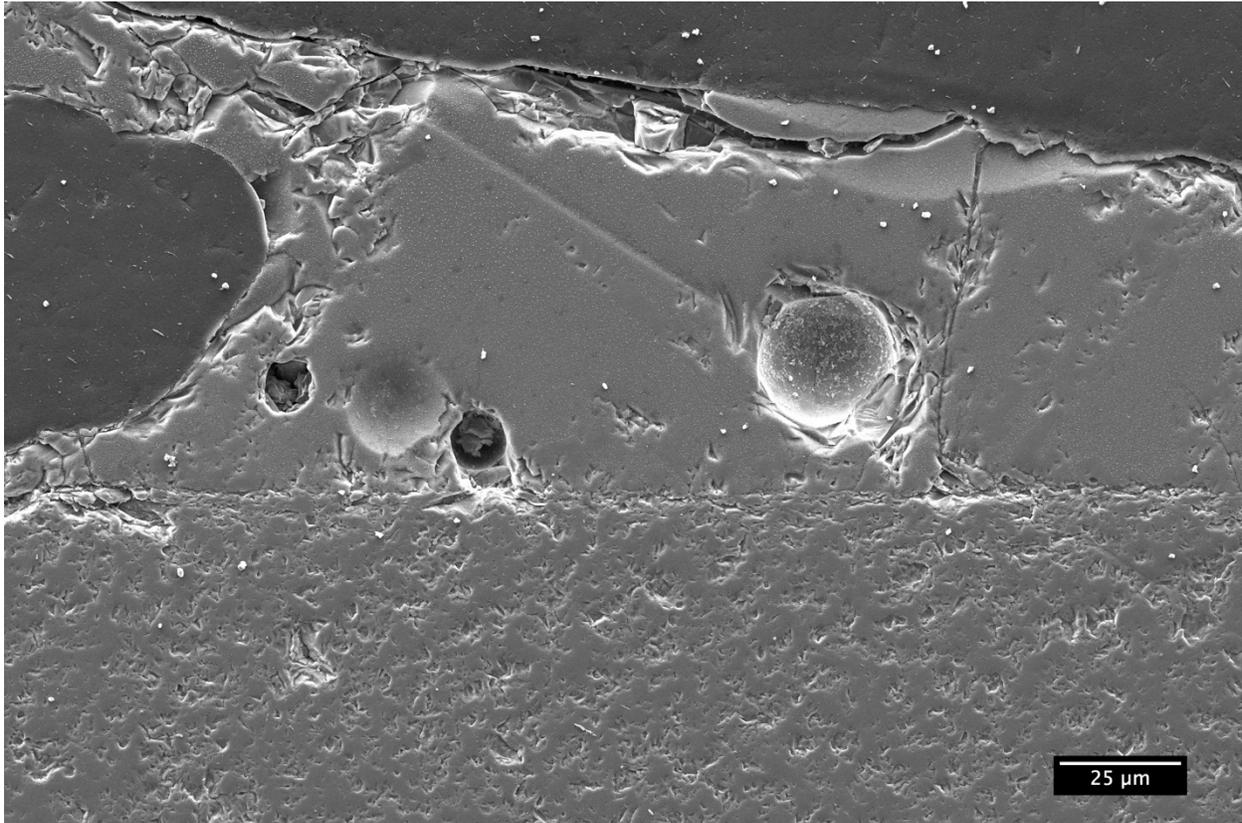
Figure 39 – Backscattered electron micrograph of a cross-sectioned CVD-SiC coupon exposed for 24 hr at 1000°C showing a thick section of the scale.

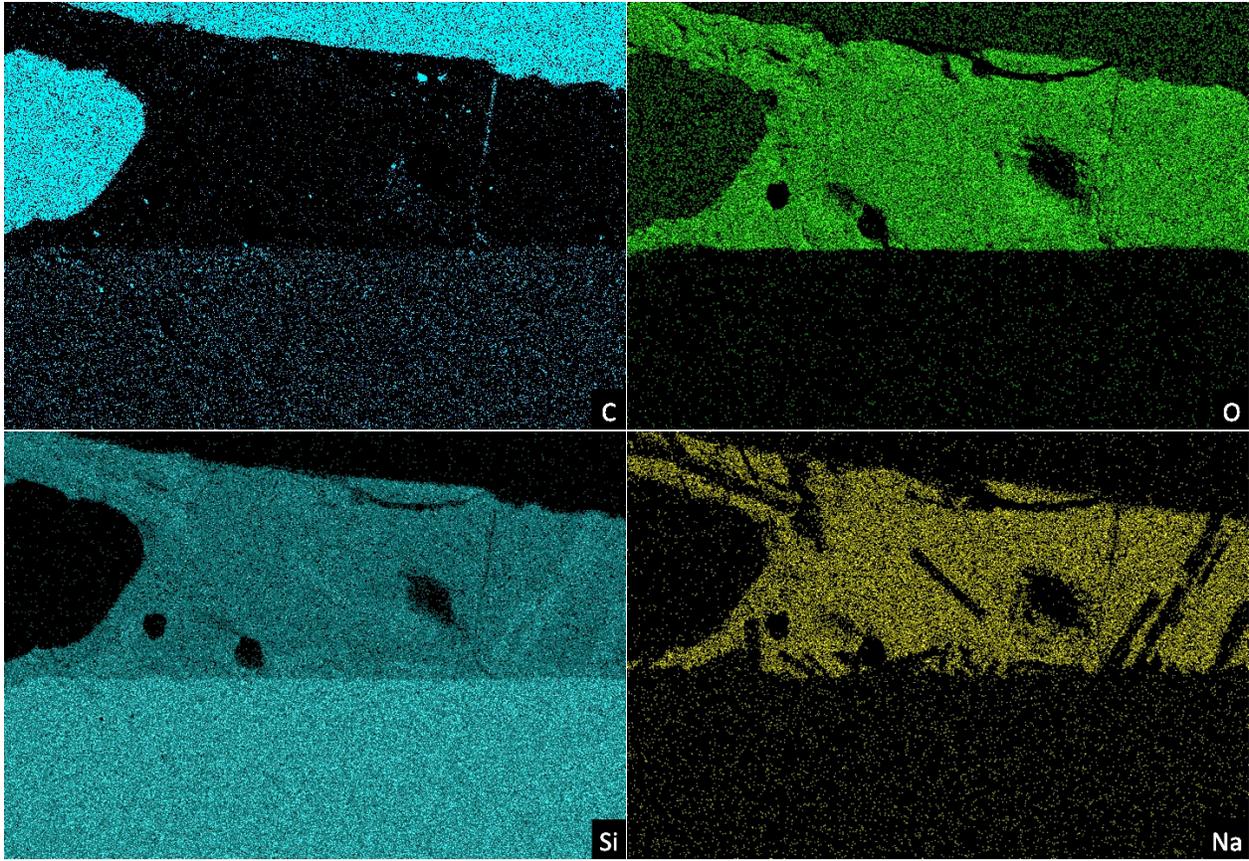
Figure 40 – EDS maps for (clockwise from top left) C, O, Na, and Si that correspond with the micrograph in Figure 39, showing a thick sodium-silicate layer which contains silica laths on top of a thin silica layer at the scale-substrate interface.

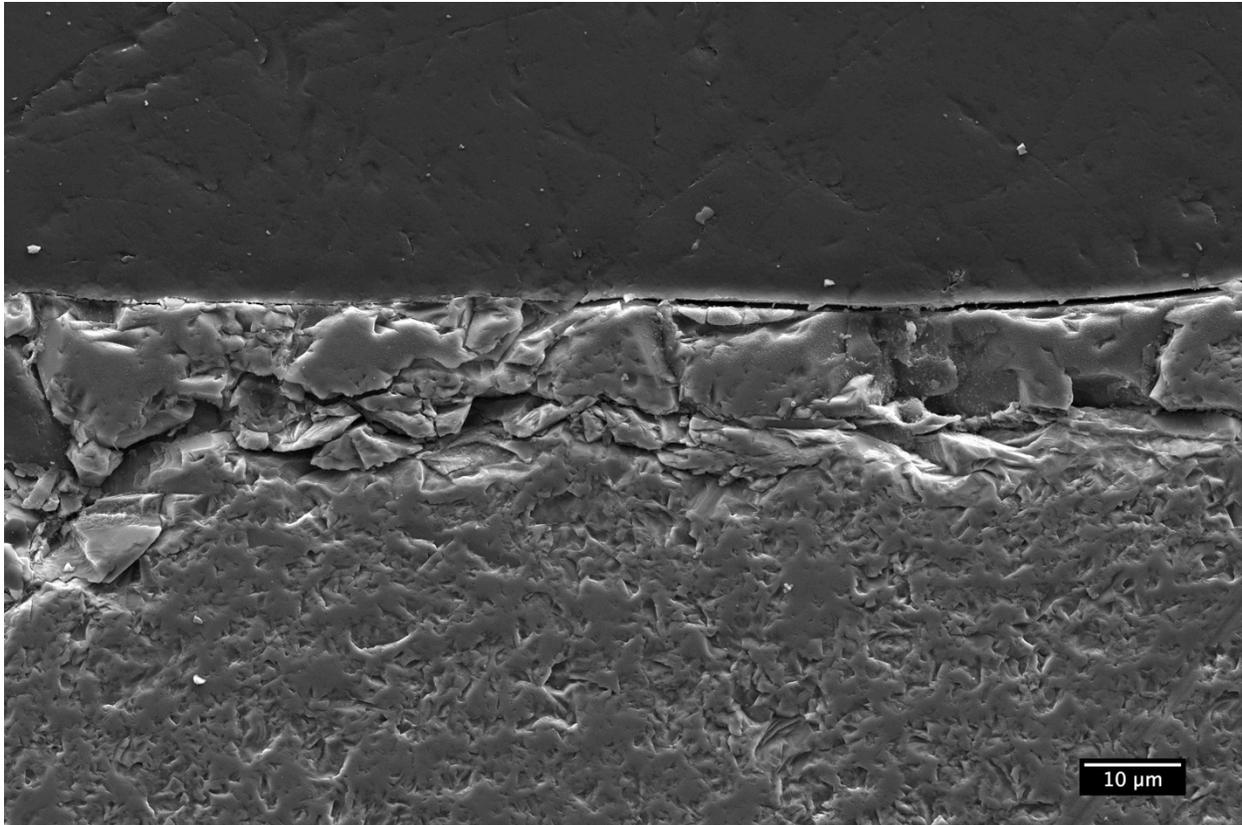
Figure 41 - Electron micrograph of a cross-sectioned CVD-SiC coupon exposed for 24 hr at 1000°C showing a thin section of the scale.

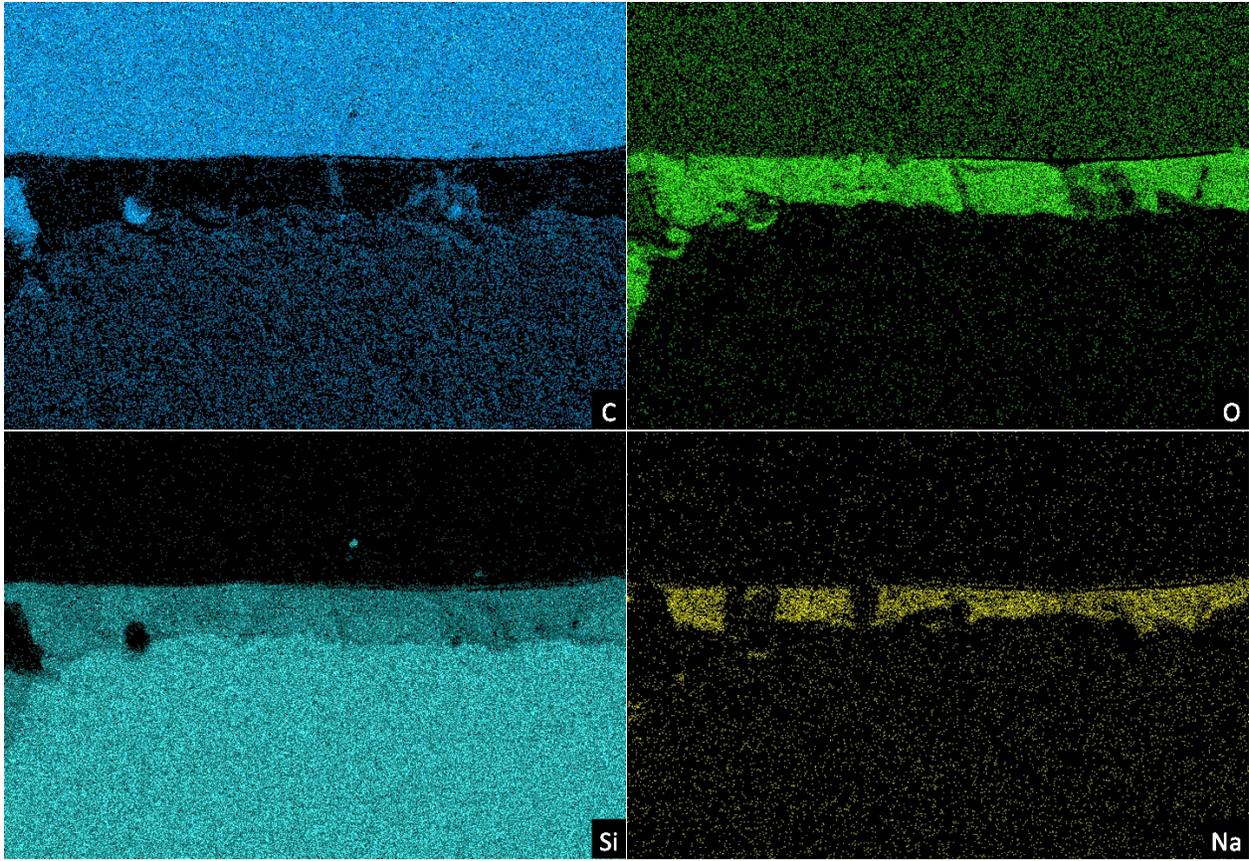
Figure 42 – EDS maps for (clockwise from top left) C, O, Na, and Si that correspond with the micrograph in Figure 41, showing a thin sodium-silicate layer on top of a thin silica layer at the scale-substrate interface.

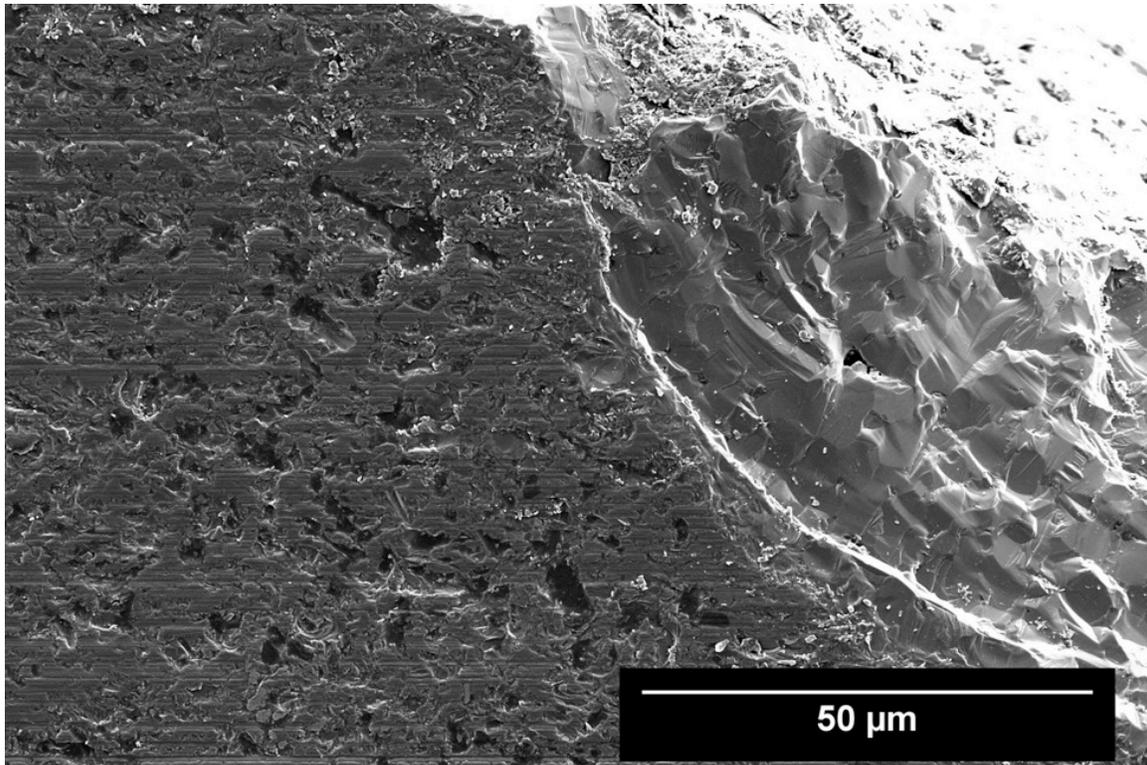
Figure 43 – Electron micrograph of a Hexoloy coupon before exposure.

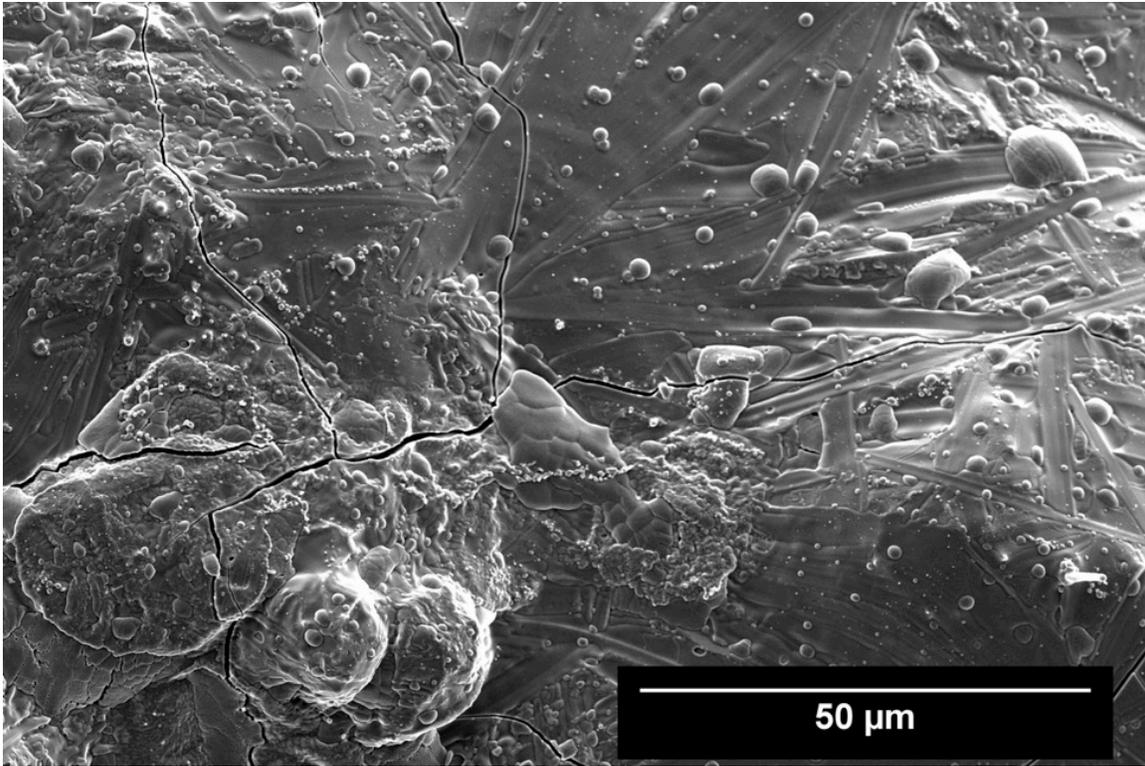
Figure 44 - Electron micrograph of a Hexoloy coupon after corrosion for 24 hr at 1000°C.

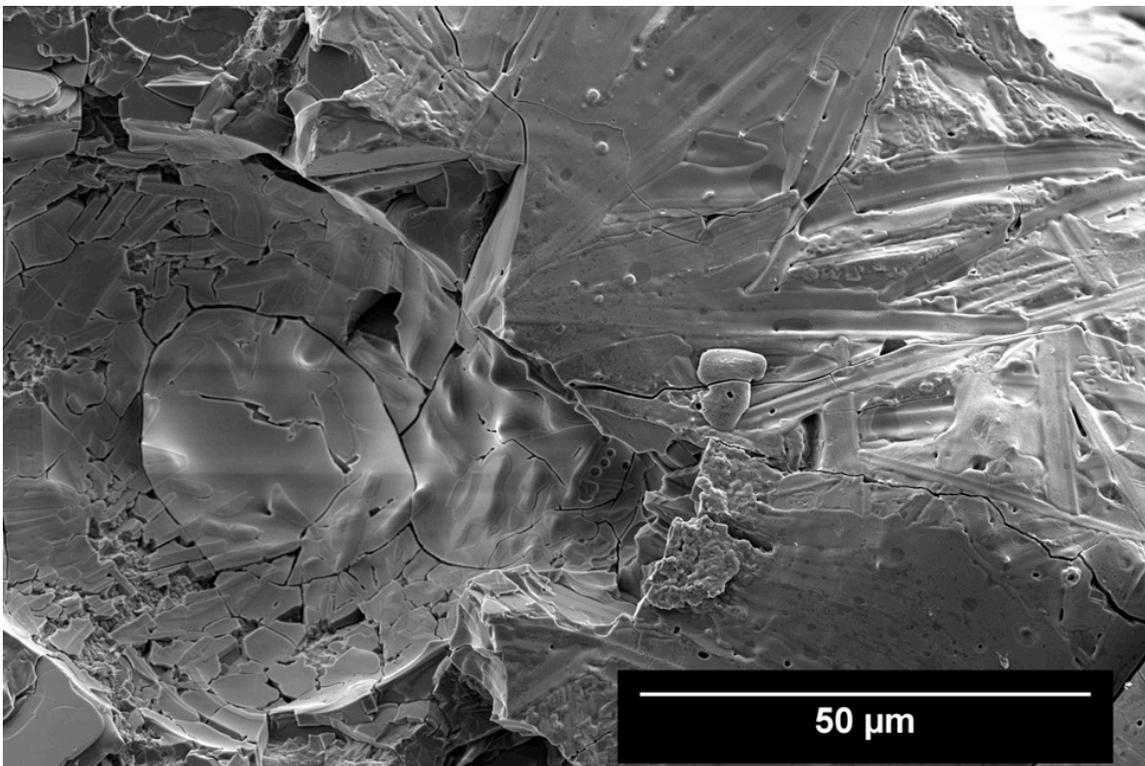
Figure 45 - Electron micrograph of a Hexoloy coupon after the water digestion step.

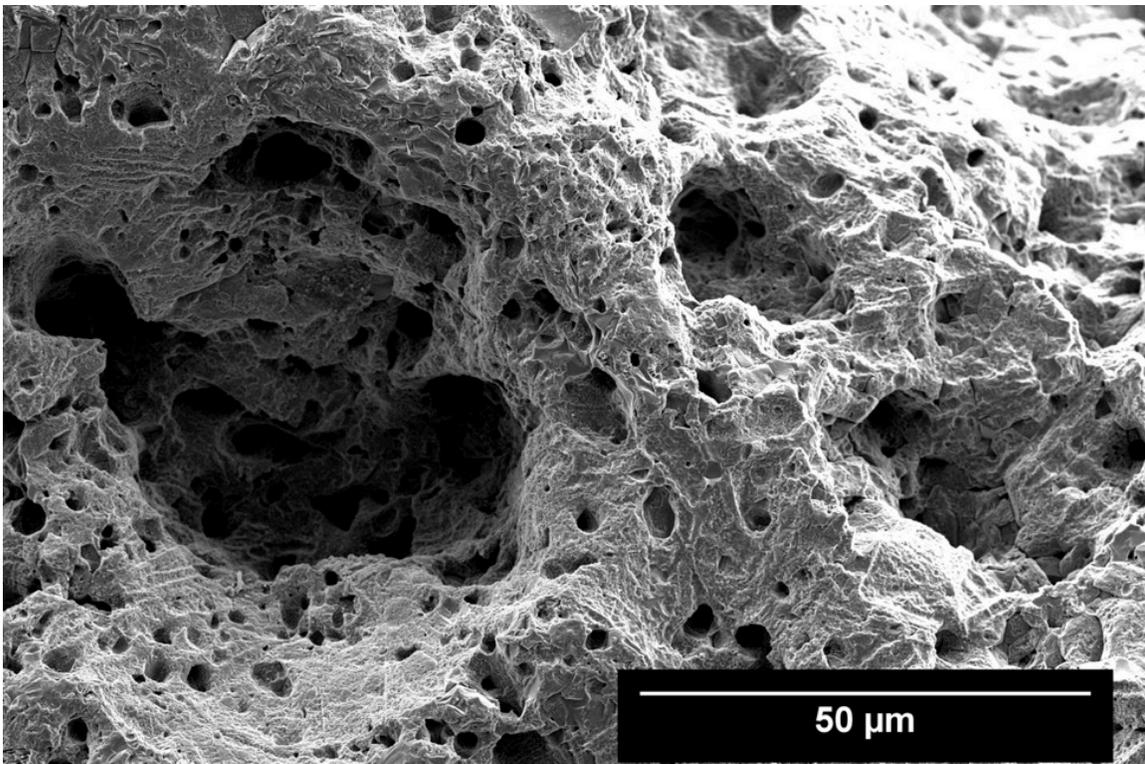
Figure 47 - Electron micrograph of a Hexoloy coupon after the HF digestion step.

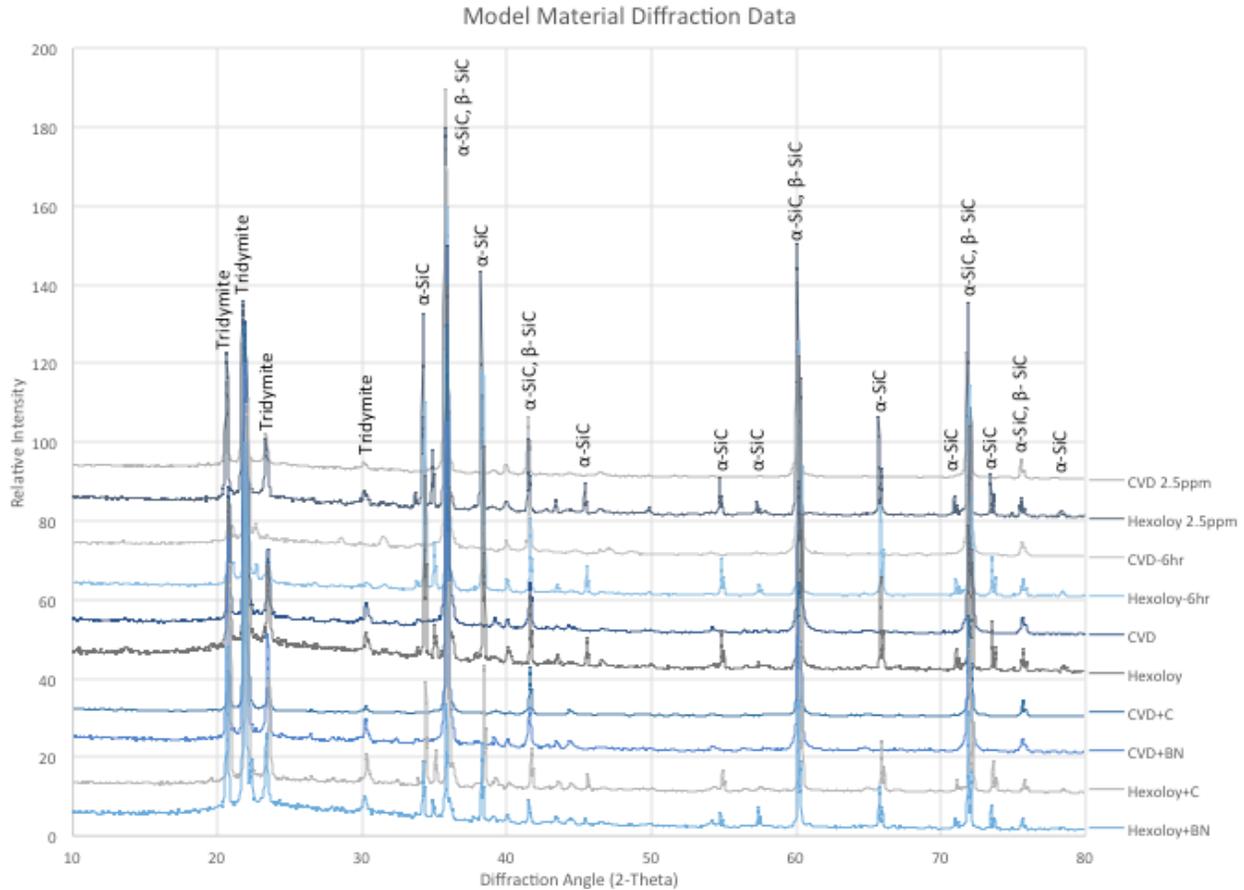
Figure 48 – X-Ray diffraction data for selected model material coupons.

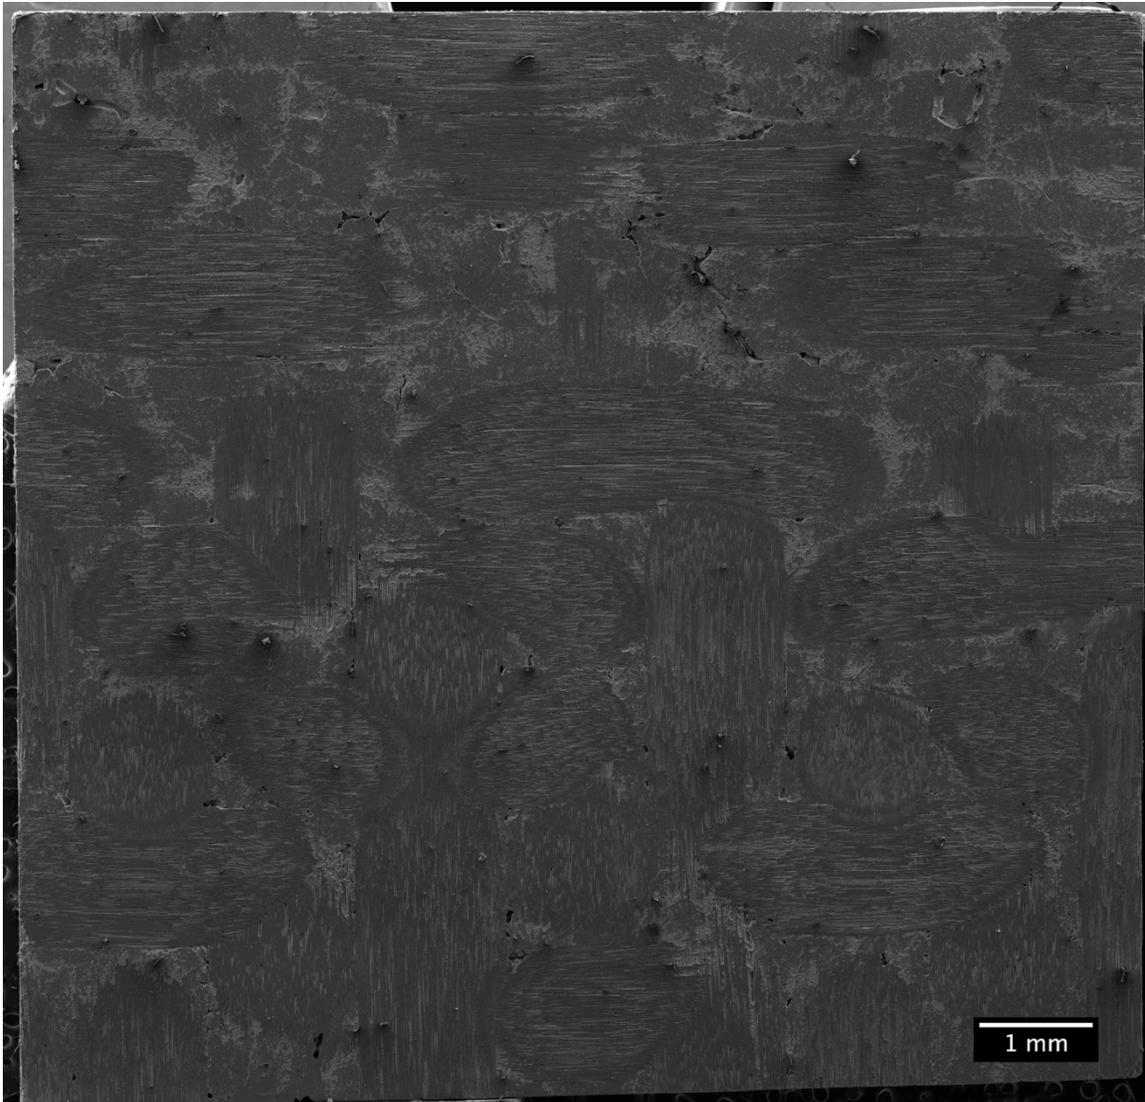
Figure 50 – SEM micrograph of the one of the CVI-F composites with the seal coat ground off before exposure in the furnace.

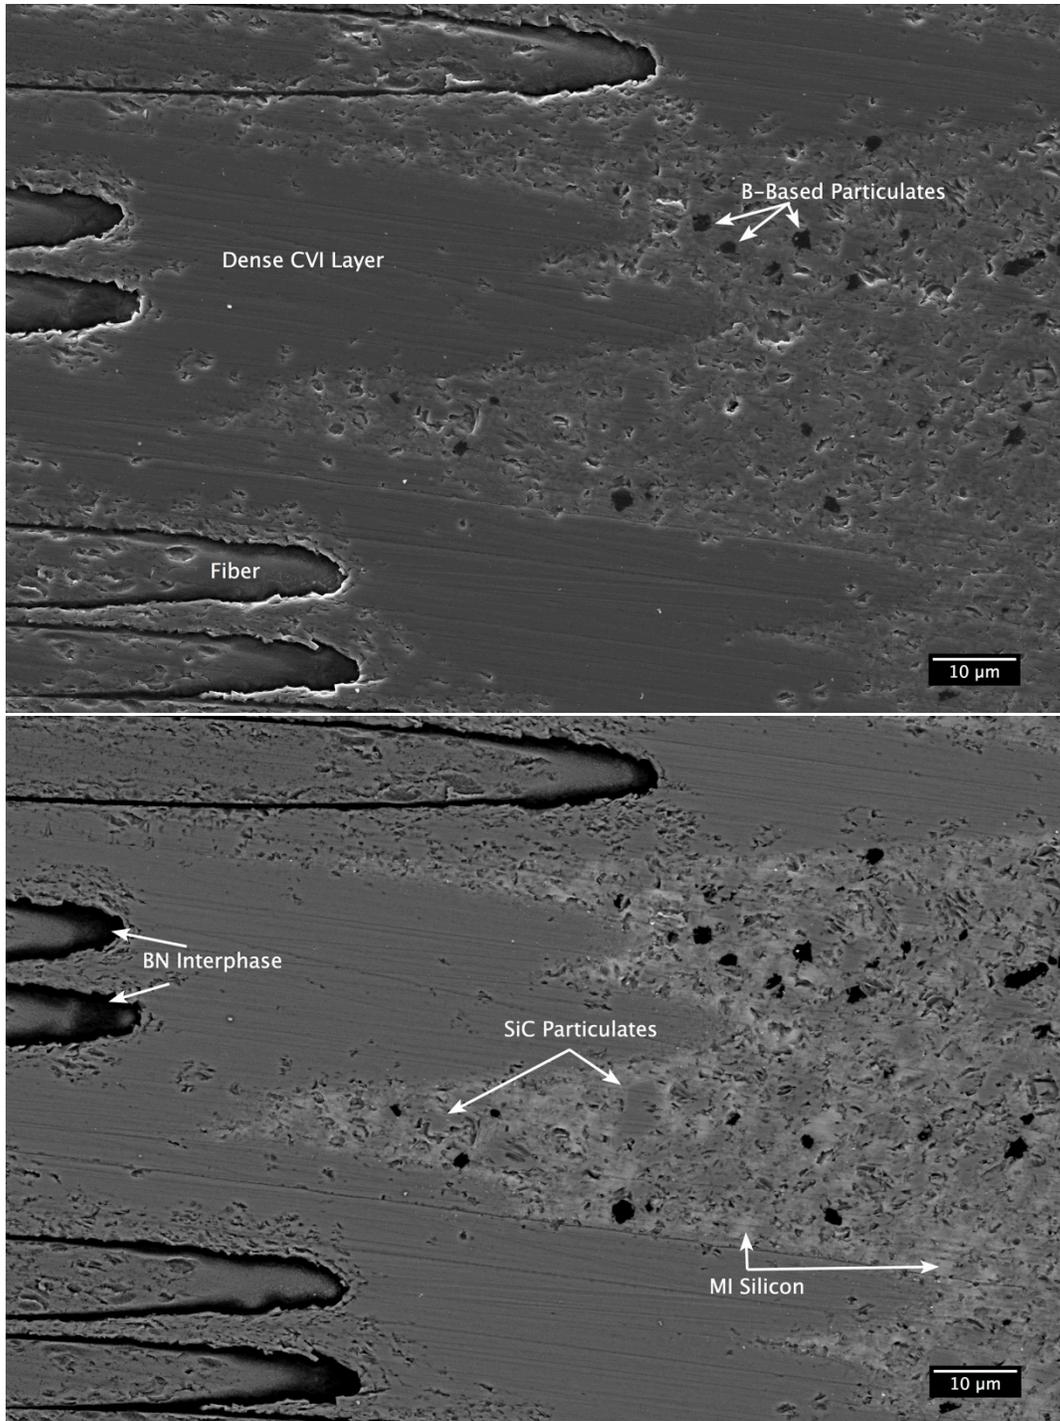
Figure 51 - Two micrographs of the CVI-F composite, SE on top and BSE on bottom. The micrographs show the SiC fibers, BN interphase, dense CVD layer, PIP slurry with SiC particulates, and MI Si.

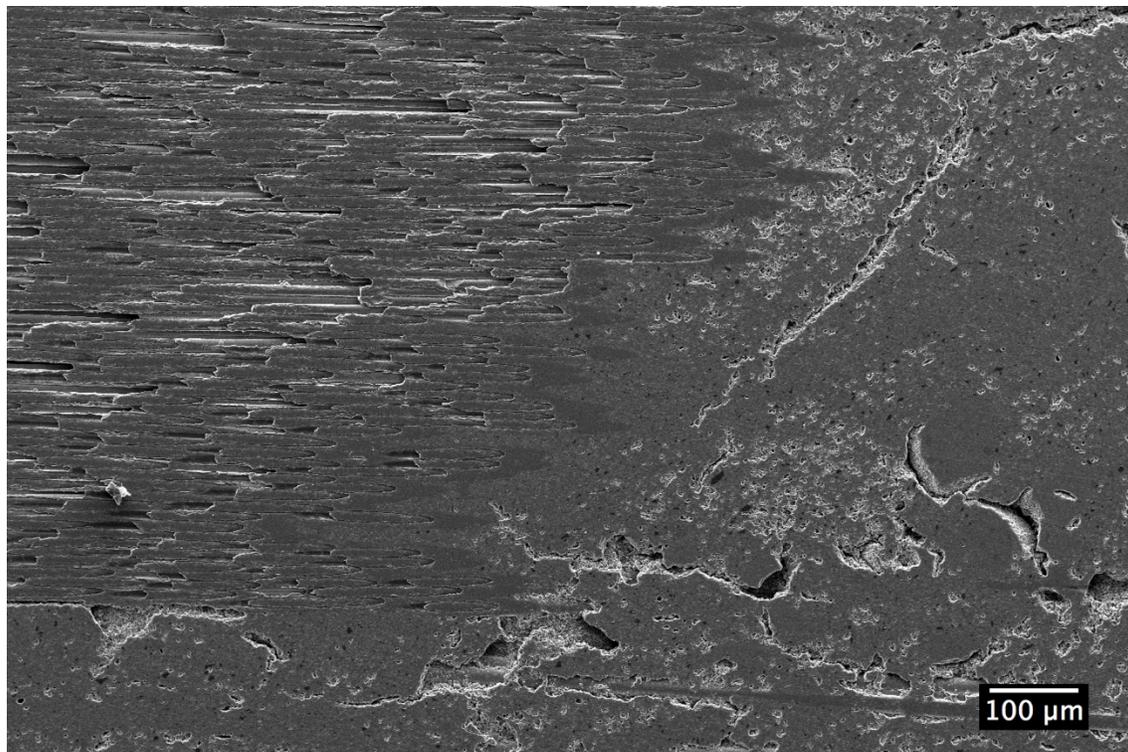
Figure 53 – SEM micrograph of one of the CVI-F coupons before exposure showing large voids present in the matrix between the Sylramic fiber tows.

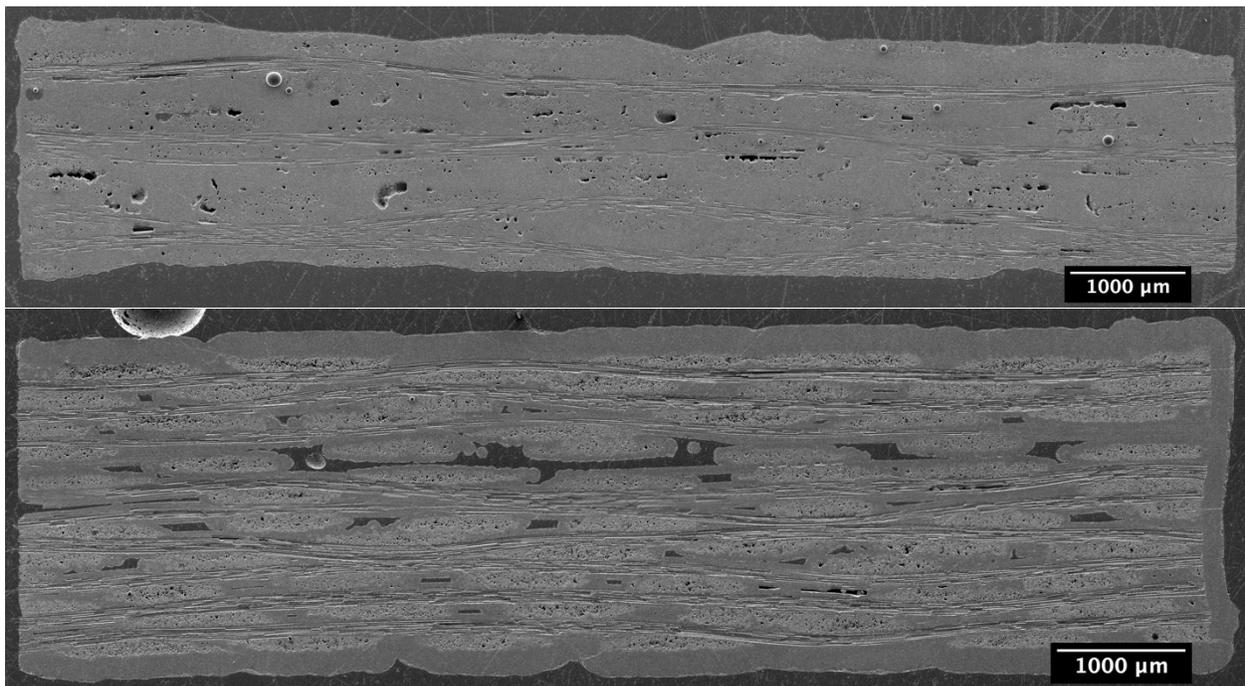
Figure 54 – SEM micrographs of the burner rig composite cross sections taken near the end of the coupon. The MI-BR composite is on the top and the CVI-BR composite is on the bottom.

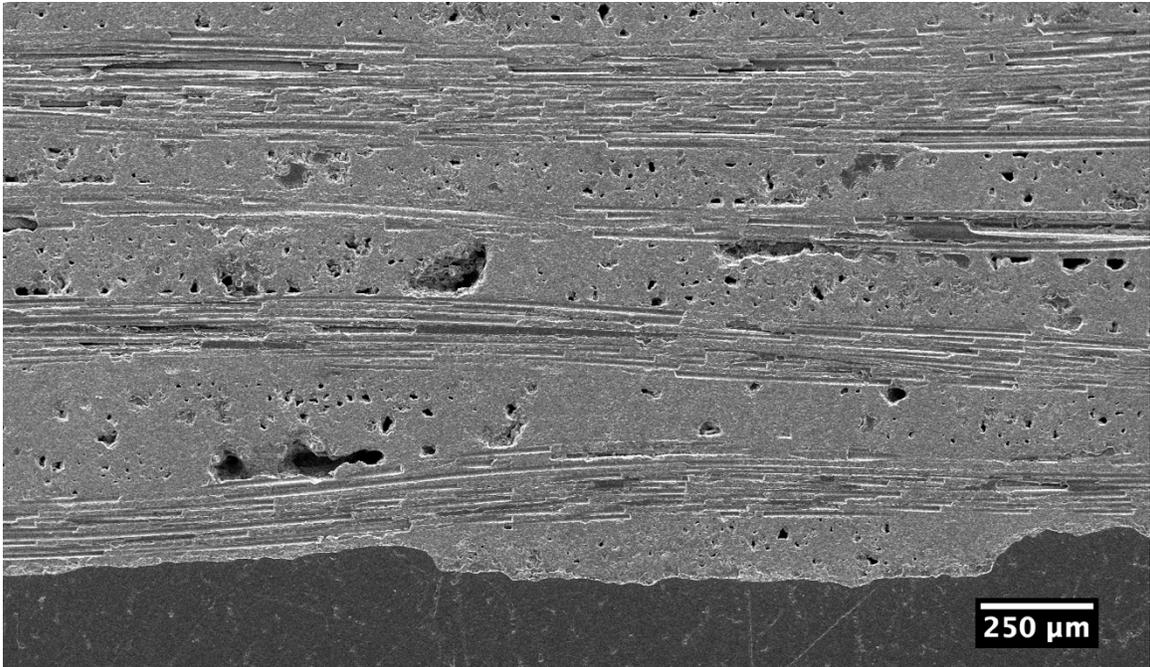
Figure 55 – SEM micrograph of an MI-BR coupon showing the fairly dense matrix with some small pores/voids.

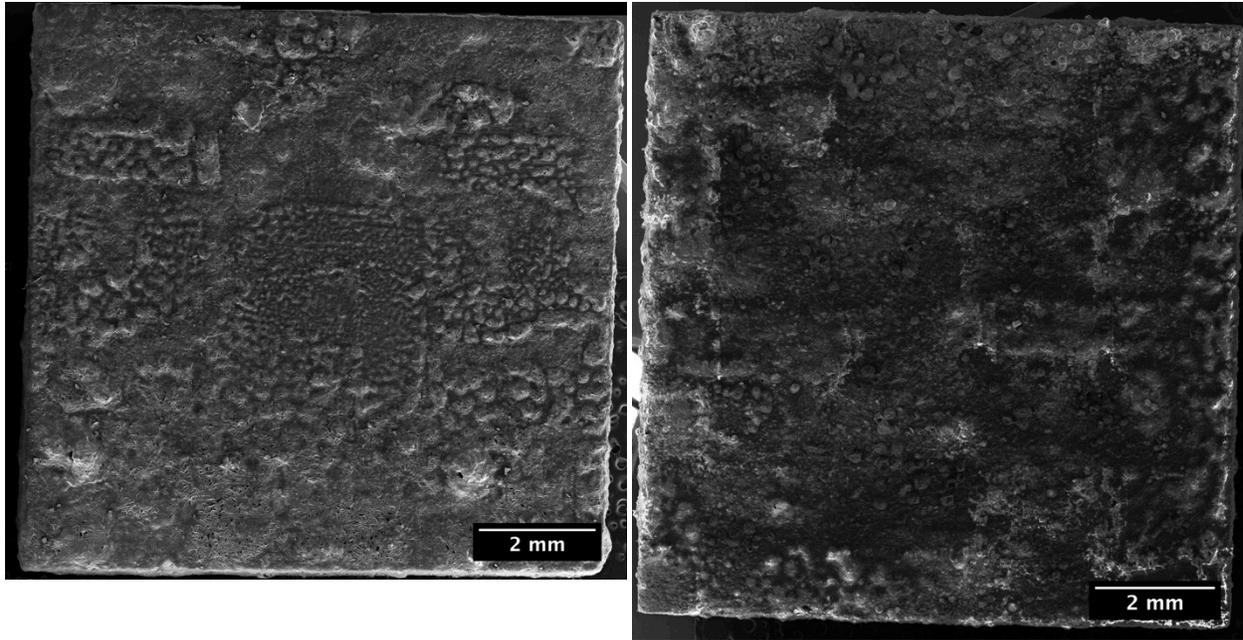
Figure 58 – Two SEM micrographs of the CVI-F composites after exposure for 24 hours at 1000°C. The coupon on the left was exposed in 2.5 ppm SO₂/O₂ while the coupon on the right was exposed in 1000 ppm SO₂/O₂.

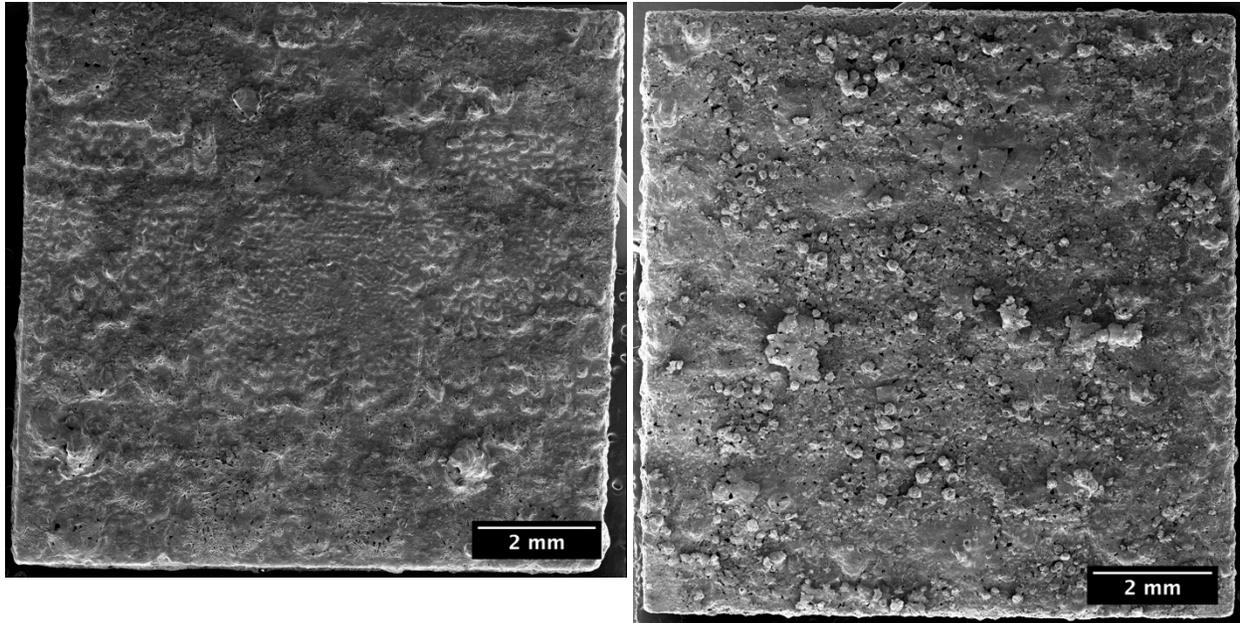
Figure 60 – Two SEM micrographs of the CVI-F composites after the water digestion step. The coupon on the left was exposed in 2.5 ppm SO₂/O₂ while the coupon on the right was exposed in 1000 ppm SO₂/O₂.

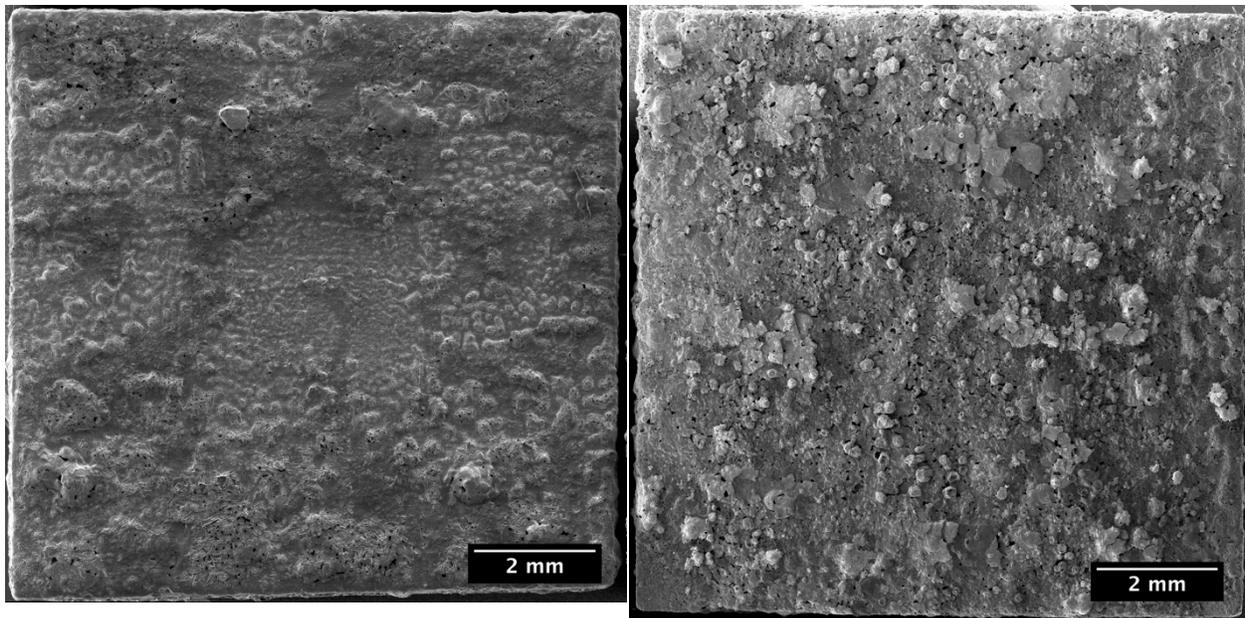
Figure 61 - Two SEM micrographs of the CVI-F composites after the HCl digestion step. The coupon on the left was exposed in 2.5 ppm SO₂/O₂ while the coupon on the right was exposed in 1000 ppm SO₂/O₂.

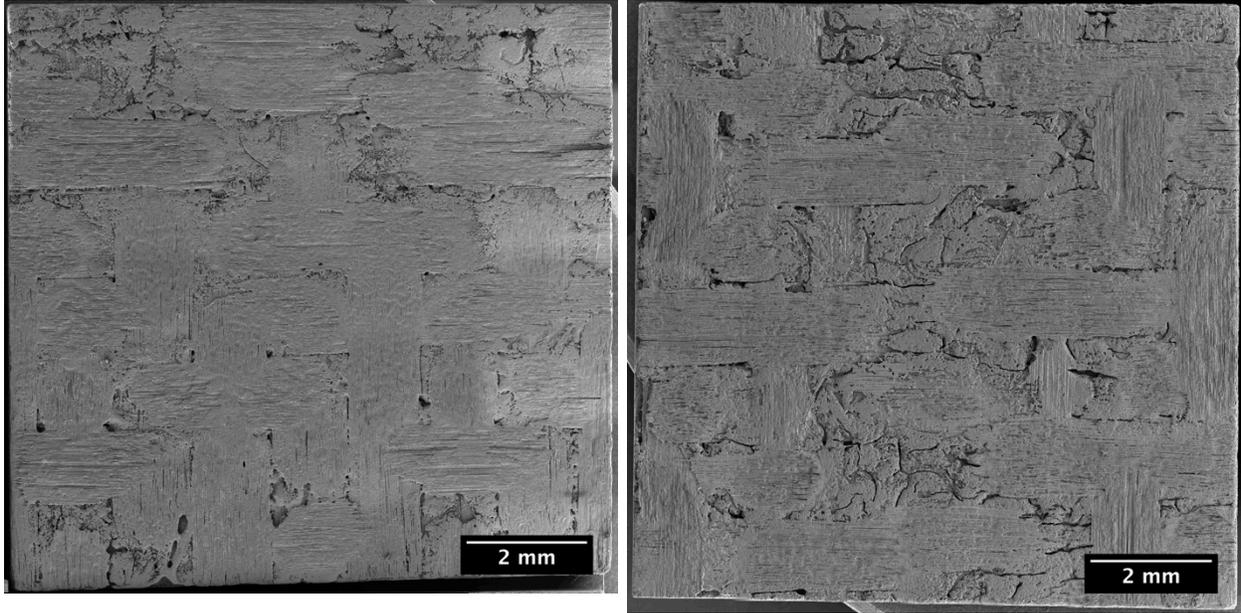
Figure 62 – Two micrographs of the CVI-F composites after the HF digestion step. The coupon on the left was exposed in 2.5 ppm SO₂/O₂ while the coupon on the right was exposed in 1000 ppm SO₂/O₂.

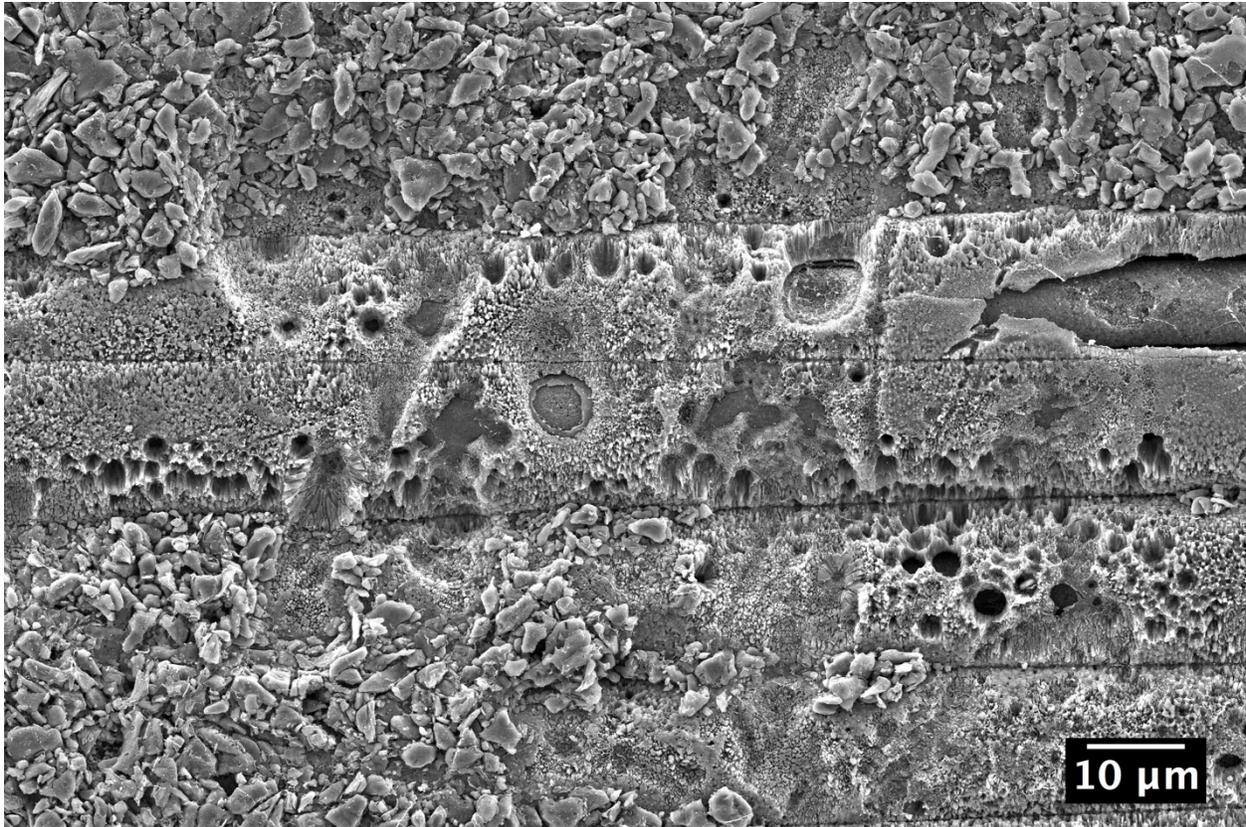
Figure 65 – SEM micrograph of the CVI-F composite after HF digestion showing attack on the matrix. Note the dense CVD layers and distinct SiC particulates remaining from the PIP/MI process.

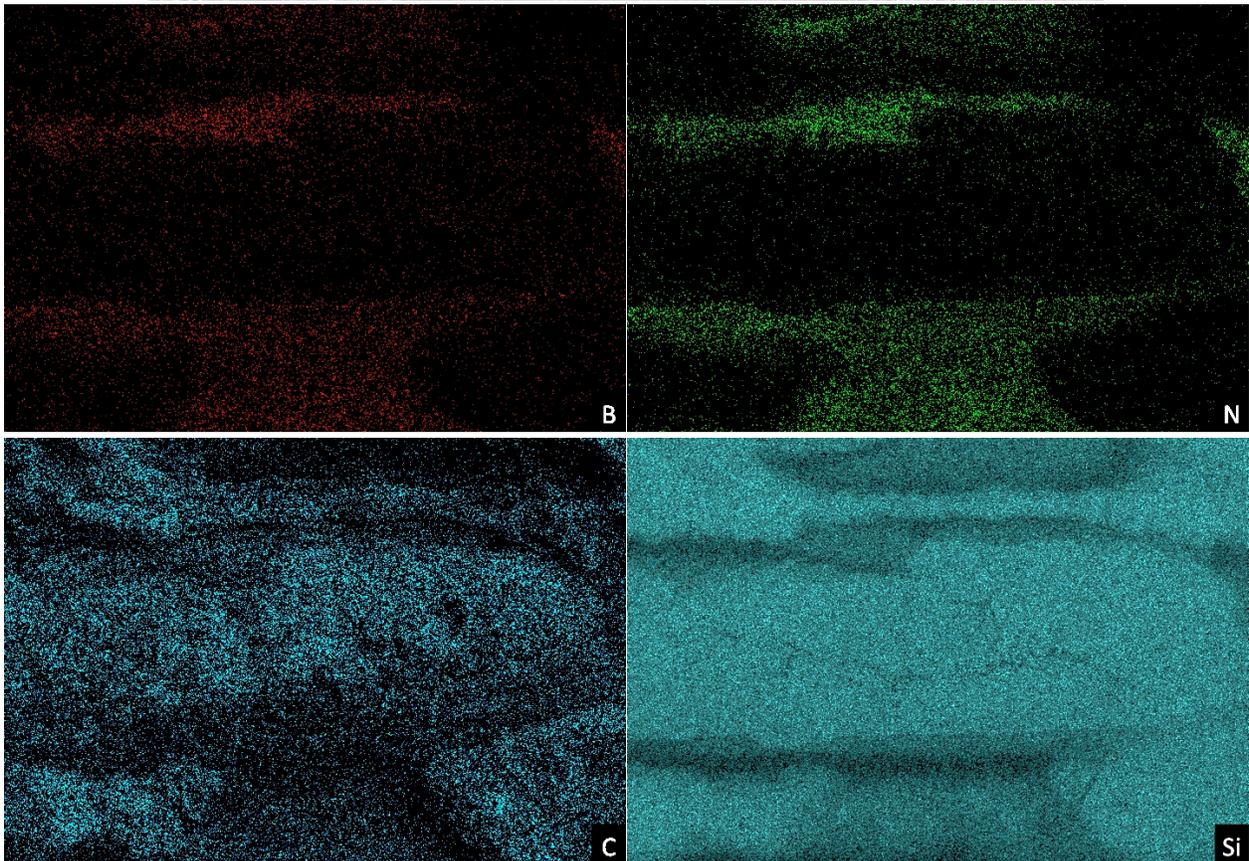
Figure 66 – Top: An SEM micrograph showing a Sylramic fiber after HF digestion with residual BN and dense CVD SiC. Middle: EDS maps for B (left) and N (right). Bottom: EDS maps for C (left) and Si (right).
