High Temperature Salt Deposit-Assisted Corrosion of Silicon
Carbide-Based Ceramic Matrix Composites: Effects of Composite
Chemistry and Architecture

A Dissertation Presented to the Faculty of the
School of Engineering and Applied Science
University of Virginia

Department of Materials Science and Engineering

May, 2015

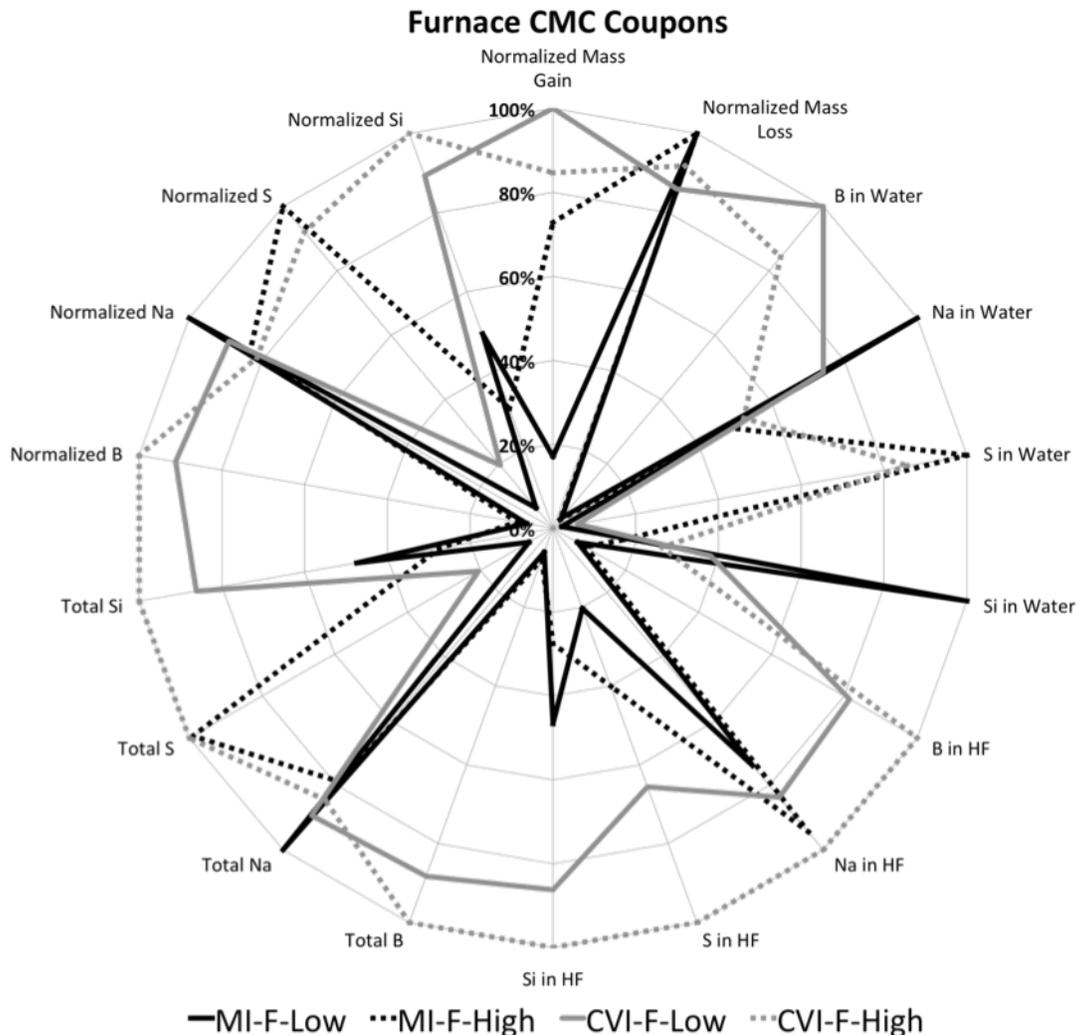
Figure 67 – Radar plot comparing relative hot corrosion between the MI-F and CVI-F coupons exposed at low (2.5 ppm) and high (1000 ppm) SO₂ levels.

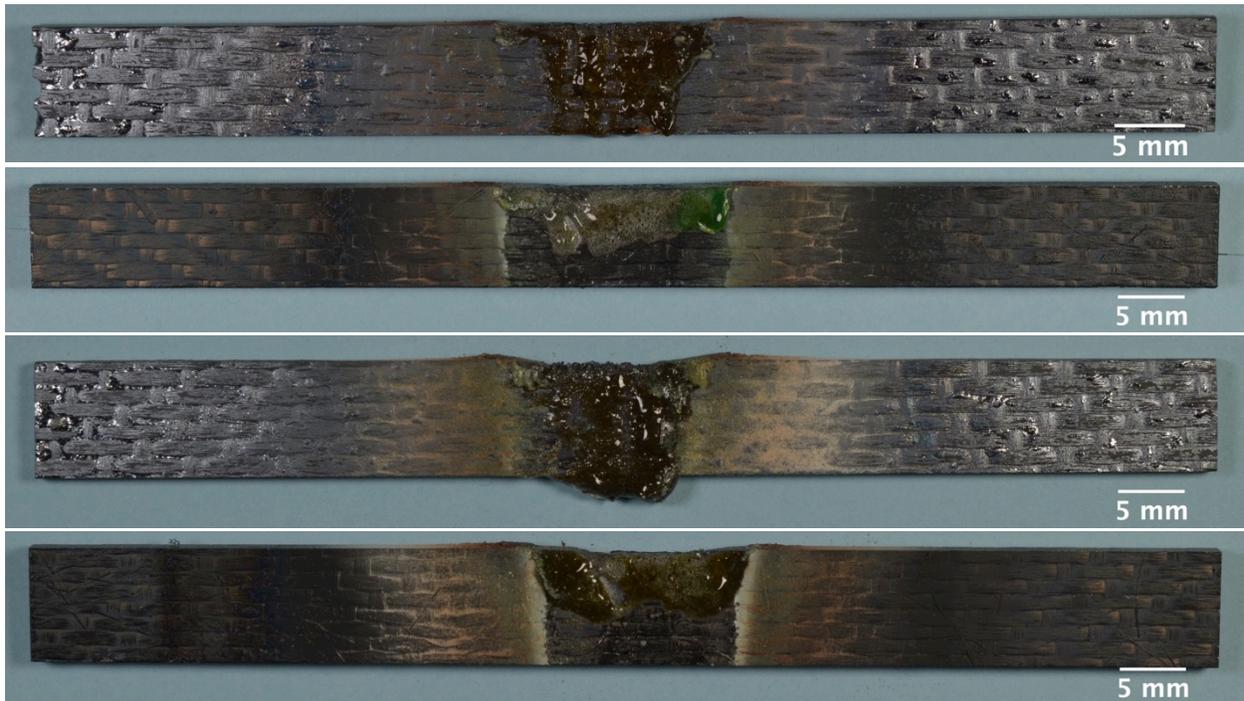
Figure 68 – Macro photos of the burner rig coupons after exposure. Note that the leading edge of each coupon is presented on top. From top to bottom: MI-BR-24, CVI-BR-24, MI-BR-45, CVI-BR-45. All coupons measure approximately 10.8 cm x 1.25 cm.

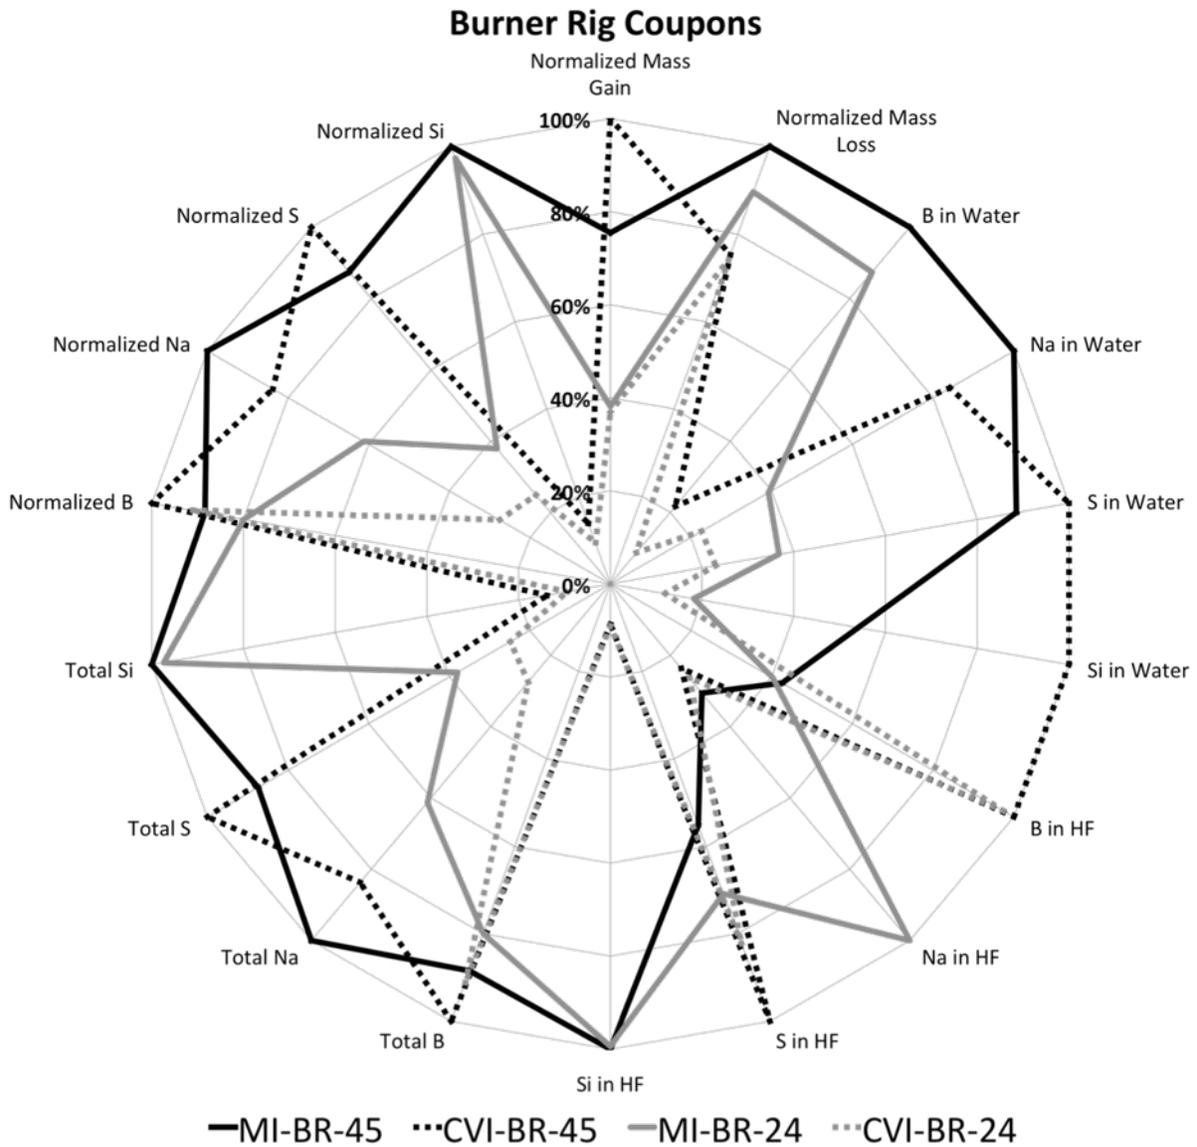
Figure 69 – Radar plot comparing relative hot corrosion between the MI-BR and CVI-BR coupons exposed for 24 and 45 hours.

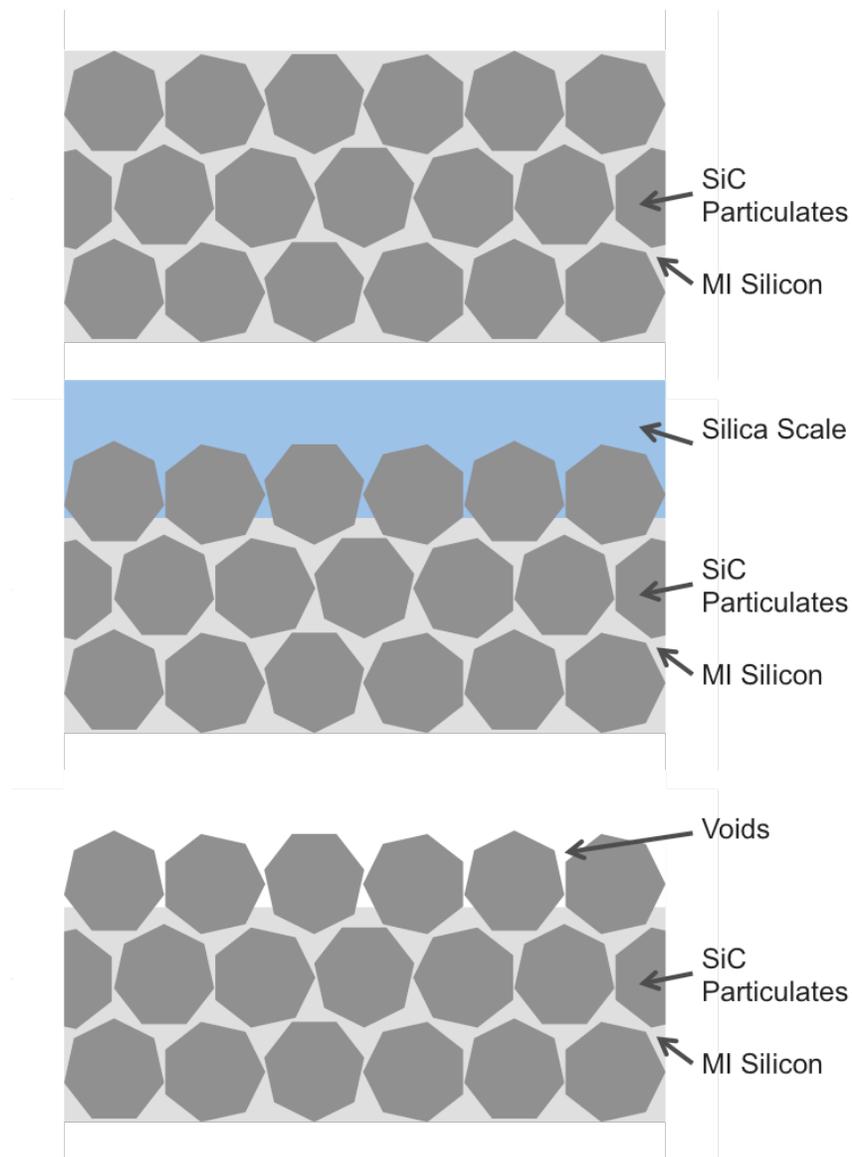
Figure 70 – Schematics showing the selective attack of the MI silicon. Top: SiC particulates are surrounded by MI Si. Middle: Silica scale grows on top, consuming Si first. Bottom: After HF digestion, voids left where MI Si was oxidized and removed.

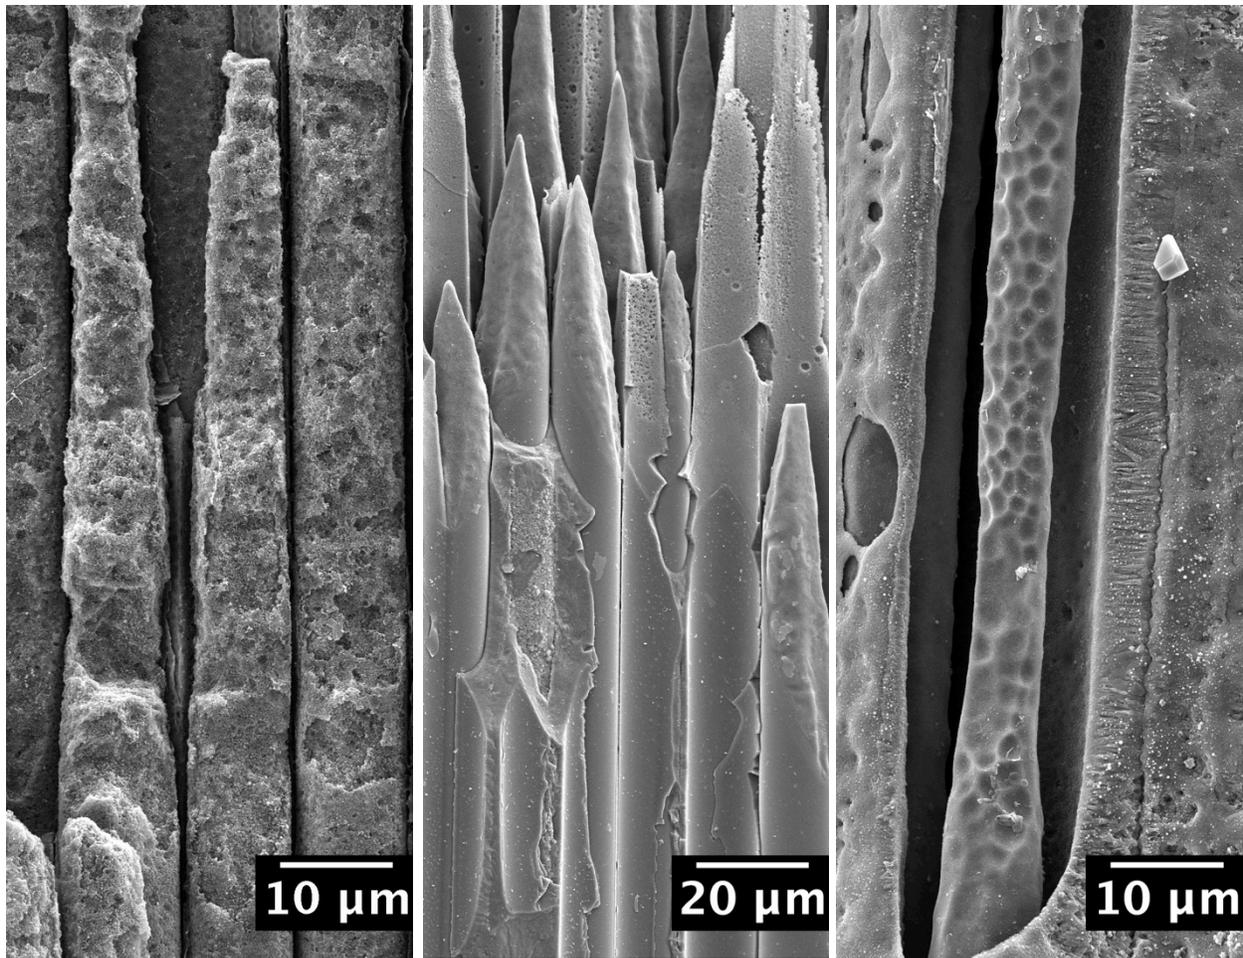
Figure 71 – SEM micrographs showing the difference in hot corrosion attack on Syllramic, Hi-Nicalon, and Hi-Nicalon-S fibers after corrosion products are removed.

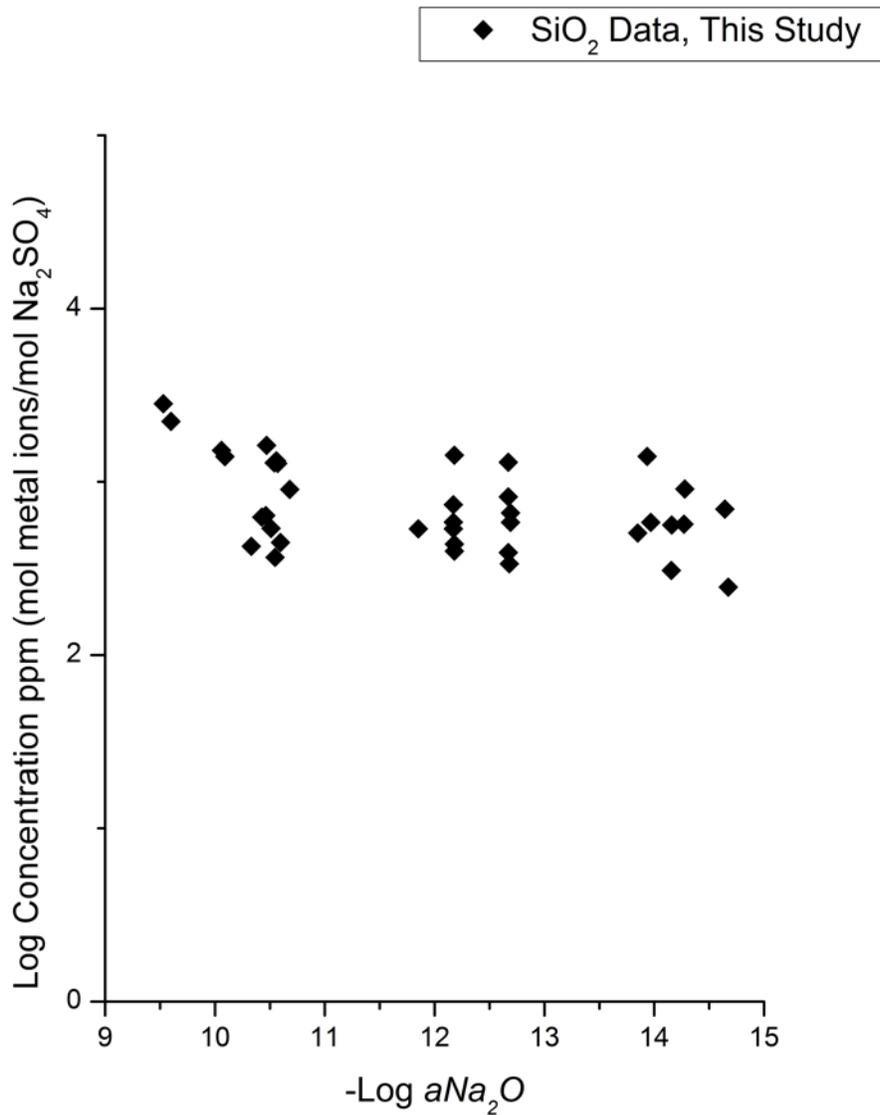
Figure 76 – SiO₂ solubility data plotted as a function of Na₂O activity.

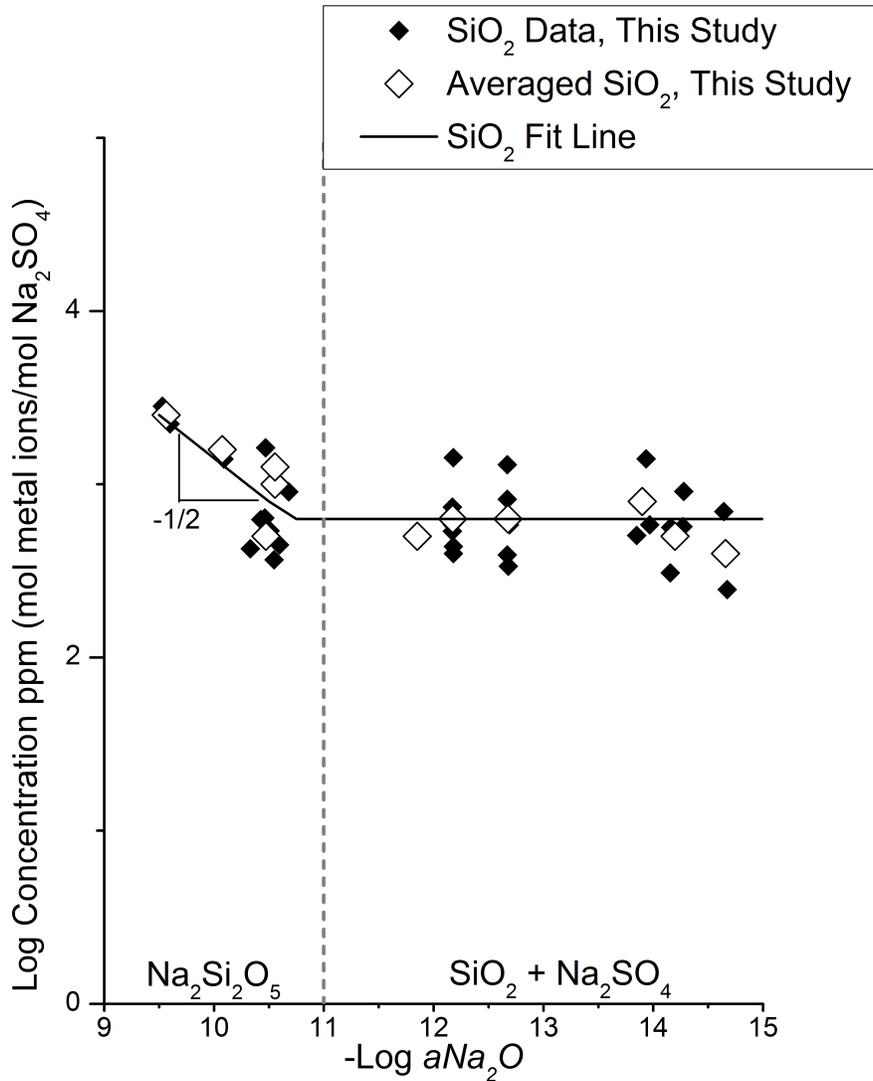
Figure 78 – SiO_2 solubility data plotted as a function of Na_2O activity. Open diamonds indicate averaged solubilities for a given run and the black line is a trend line fitted to the averaged data. The vertical dashed grey line is the predicted stability boundary between $\text{Na}_2\text{Si}_2\text{O}_5$ and $\text{SiO}_2 + \text{Na}_2\text{SO}_4$.

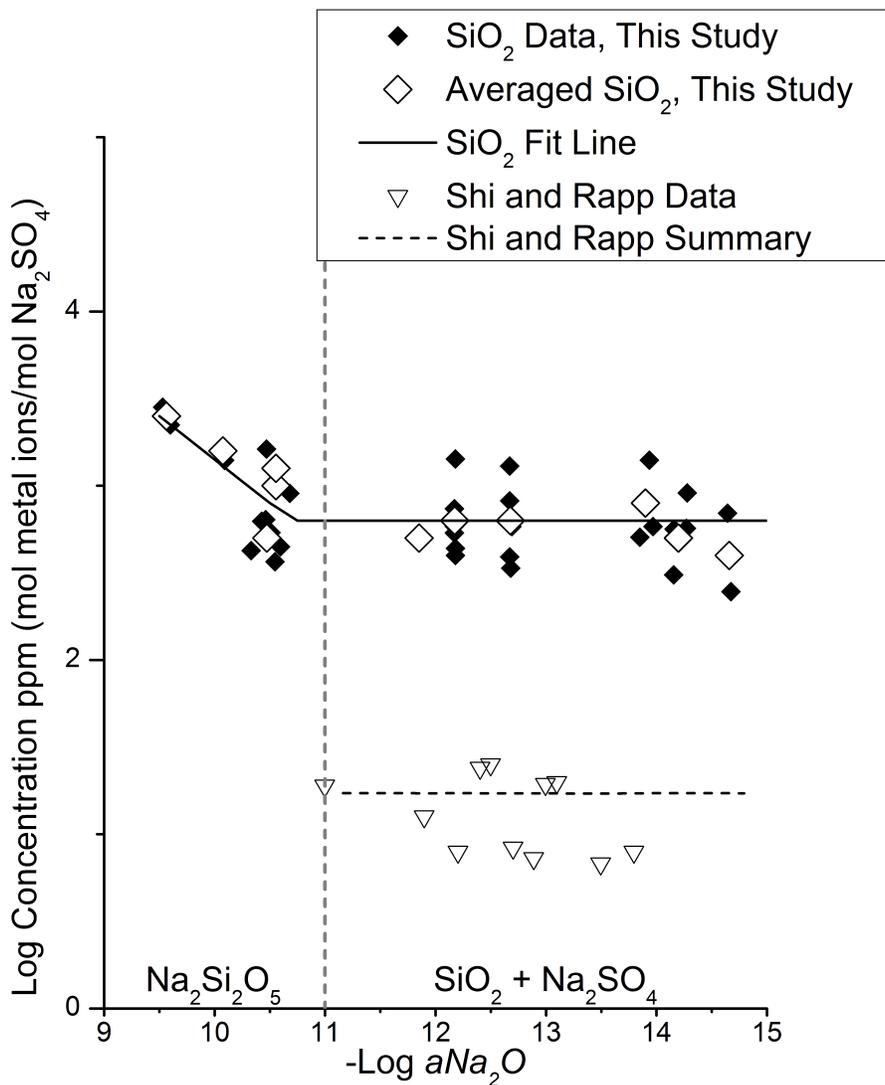
Figure 79 – SiO₂ solubility data plotted as a function of Na₂O activity. Open diamonds indicate averaged solubilities for a given run and the black line is a trend line fitted to the averaged data. The open triangles are the data from Shi and Rapp and the horizontal dashed line is the average of that data. The vertical dashed grey line is the predicted stability boundary.

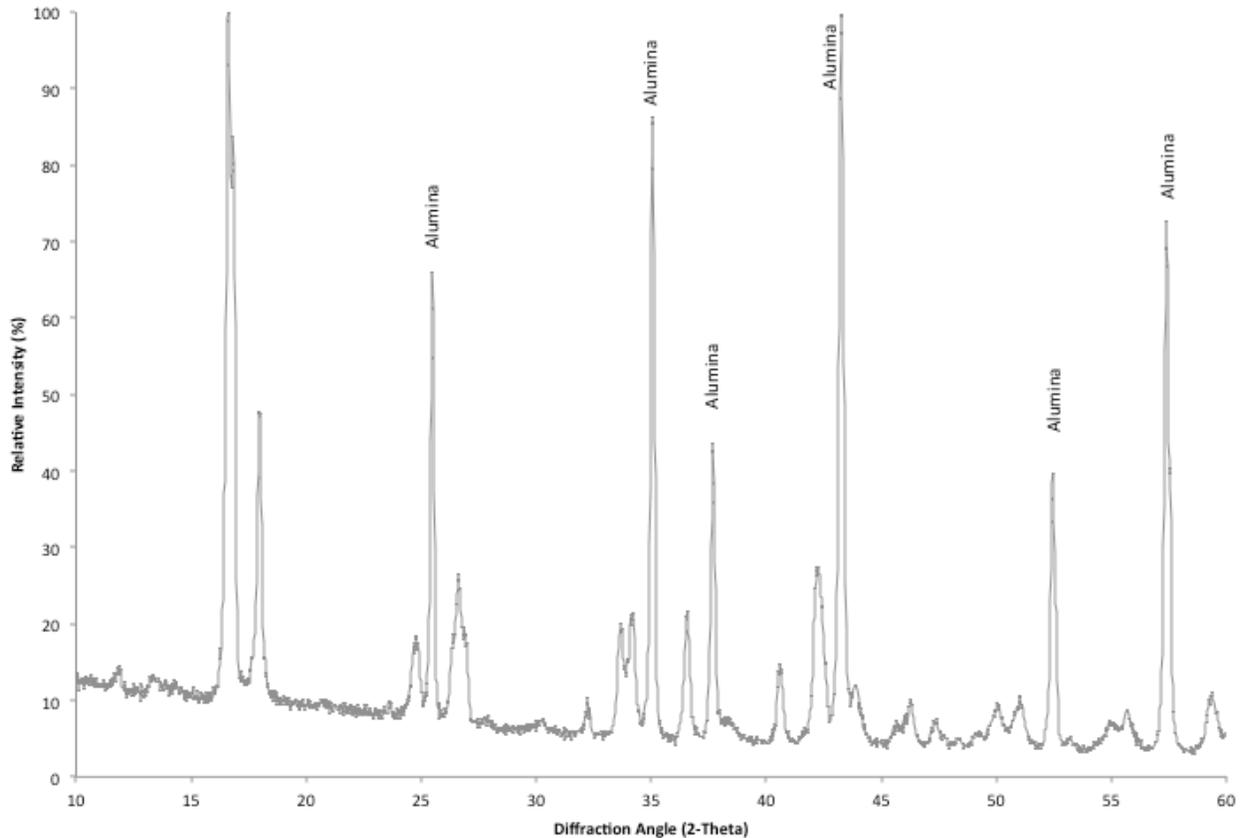
Figure 80 – XRD pattern for one of the aluminoborate samples. All peaks not labeled as alumina peaks correspond with the 2:1 aluminoborate phase.

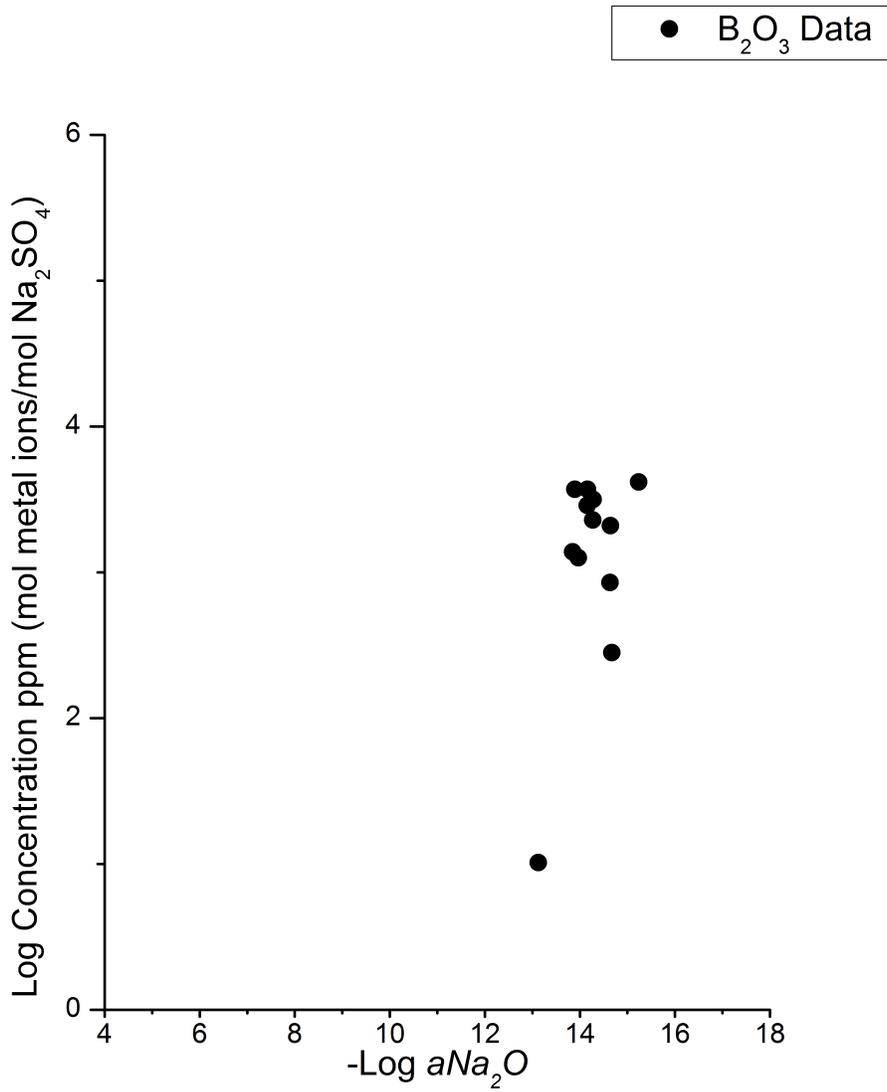
Figure 81 - B₂O₃ solubility data plotted as a function of Na₂O activity.

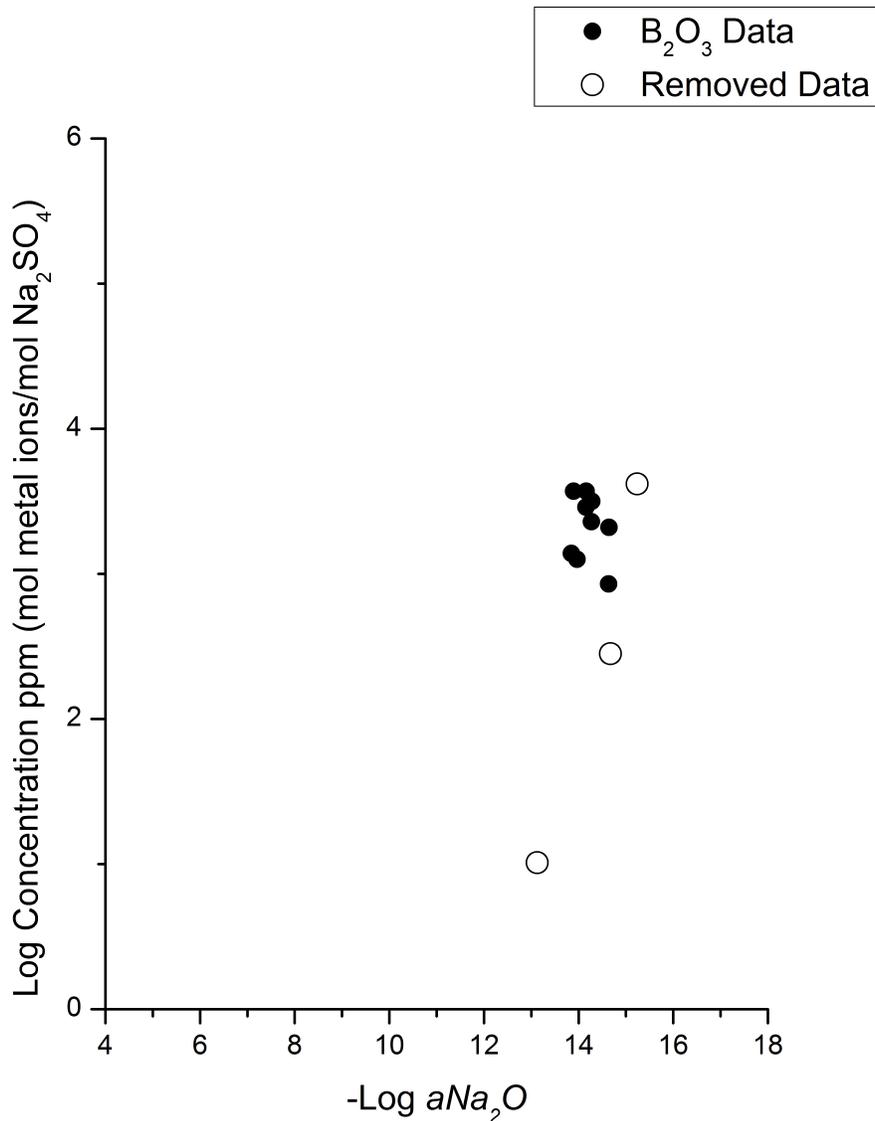
Figure 82 - B₂O₃ solubility data plotted as a function of Na₂O activity. The open circles are data that were removed due to B depletion or improper sampling.

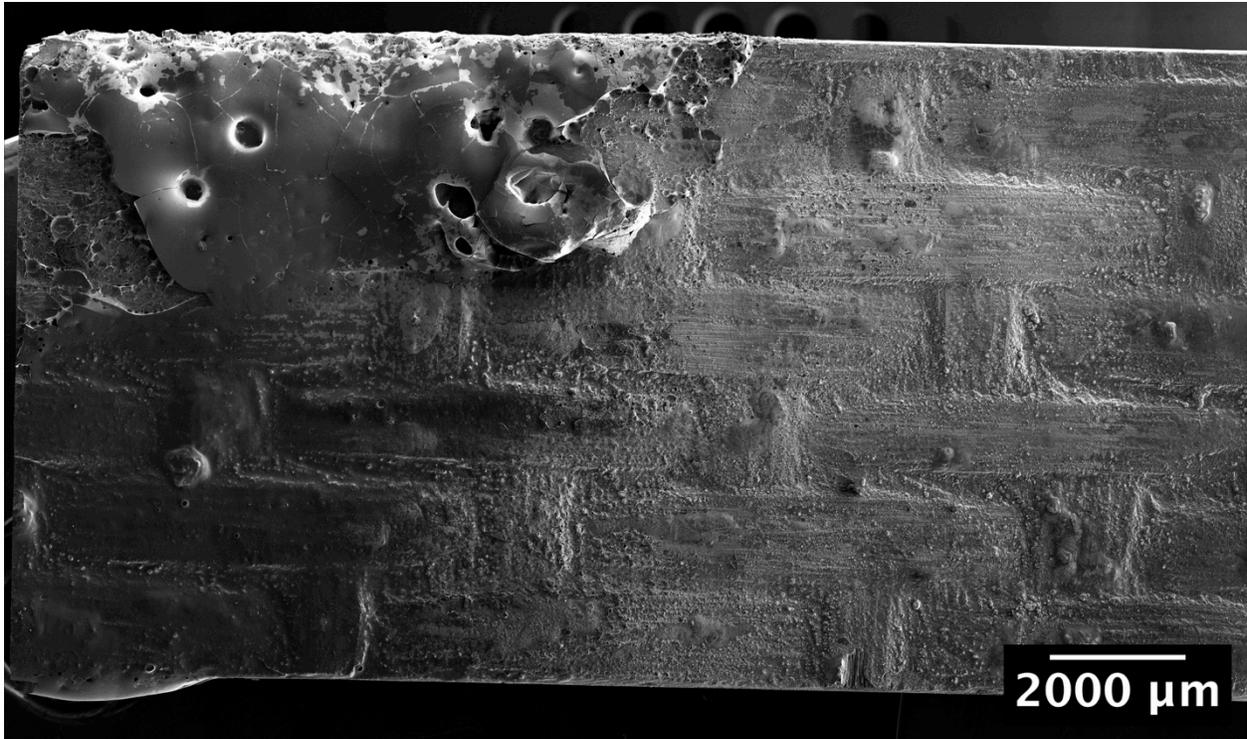
Figure C-9 – SEM Micrograph of the face of MI-BR-24 after sectioning and water digestion, leading edge on top, cut edge (formerly the center of the impingement site) on the left.

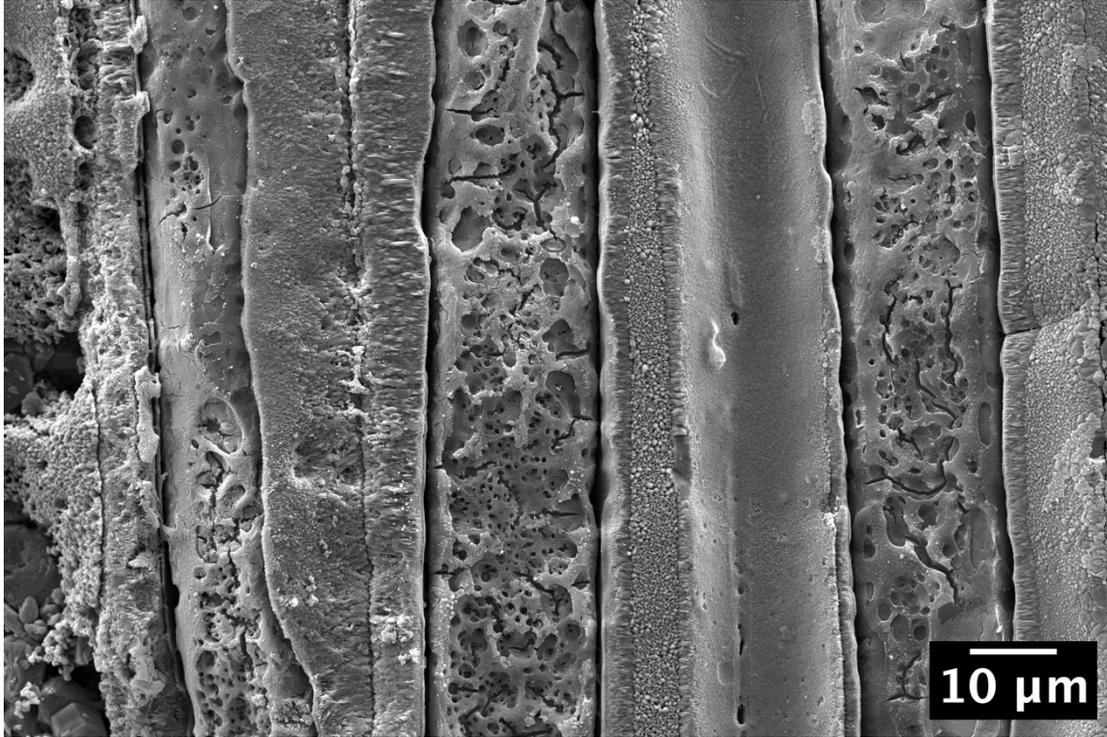
Figure C-30 – SEM micrograph of the face of MI-BR-45 after HF digestion showing pitting and attack of the Hi-Nicalon fibers. The dense CVI SiC layer appears fairly resistant to hot corrosion attack.

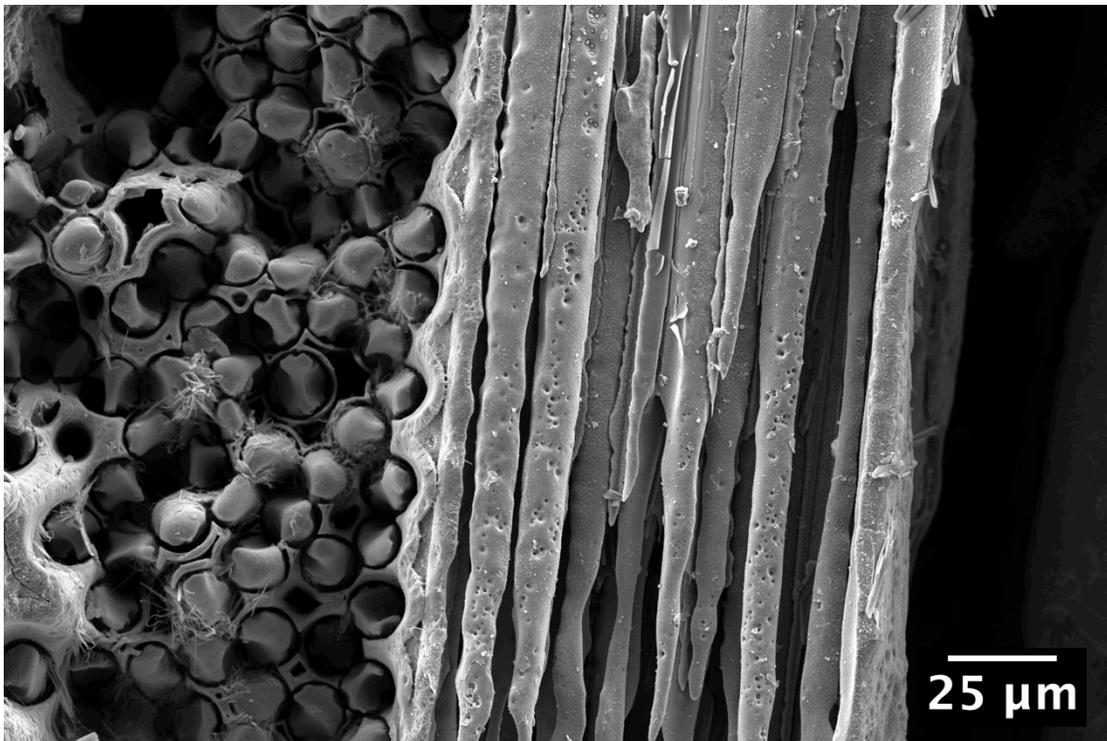
Figure C-31 – SEM micrograph of the leading edge of CVI-BR-24 after HF digestion showing pitting and attack of the Hi-Nicalon-S fibers.

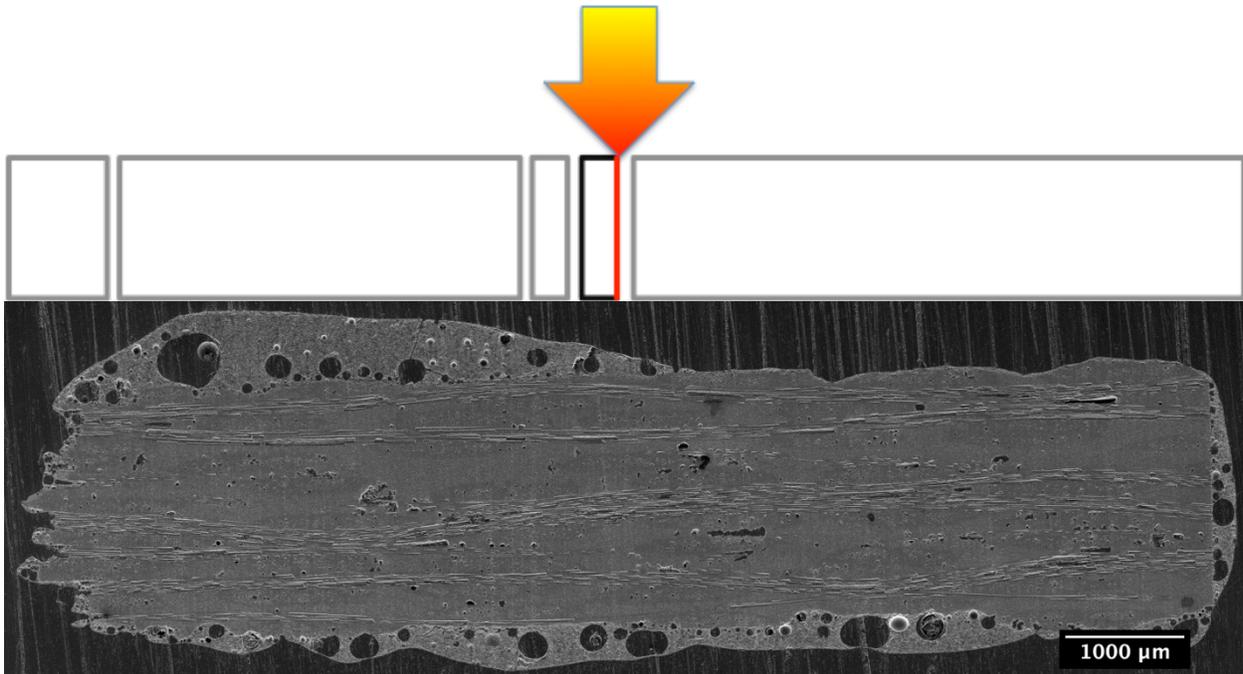
Figure C-40 – SEM Micrograph of the first cross-section of MI-BR-24 after exposure in the burner rig, leading edge on the left.

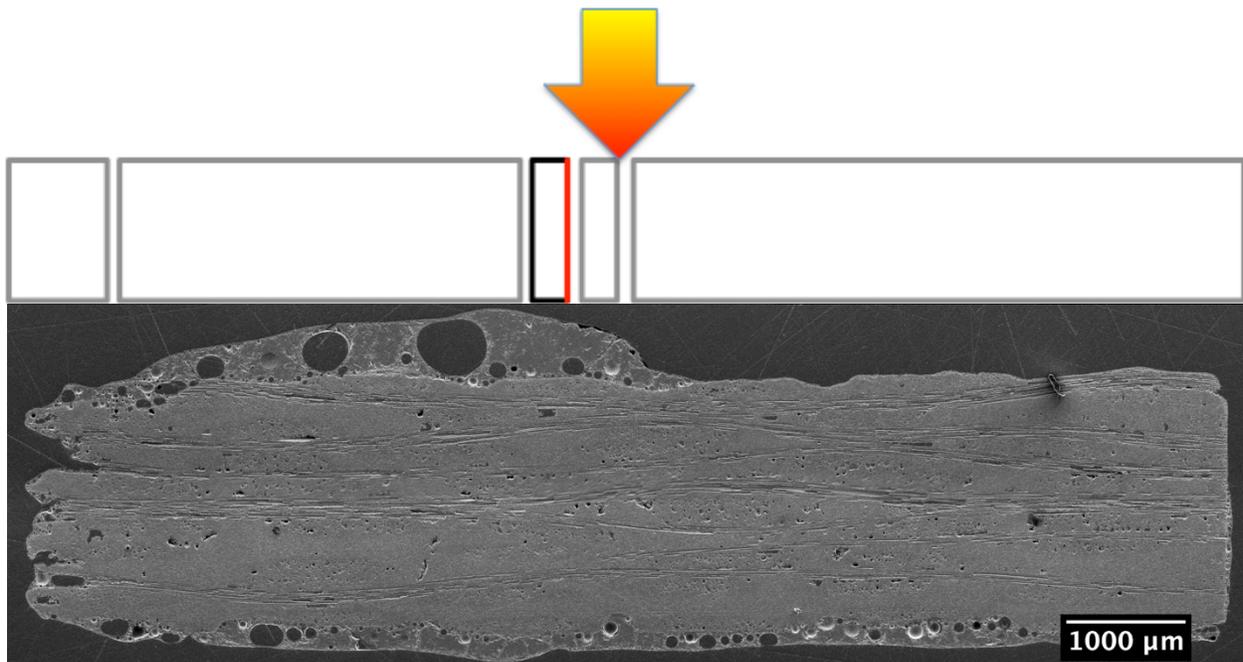
Figure C-41 – SEM Micrograph of the second cross-section of MI-BR-24 after exposure in the burner rig, leading edge on the left.

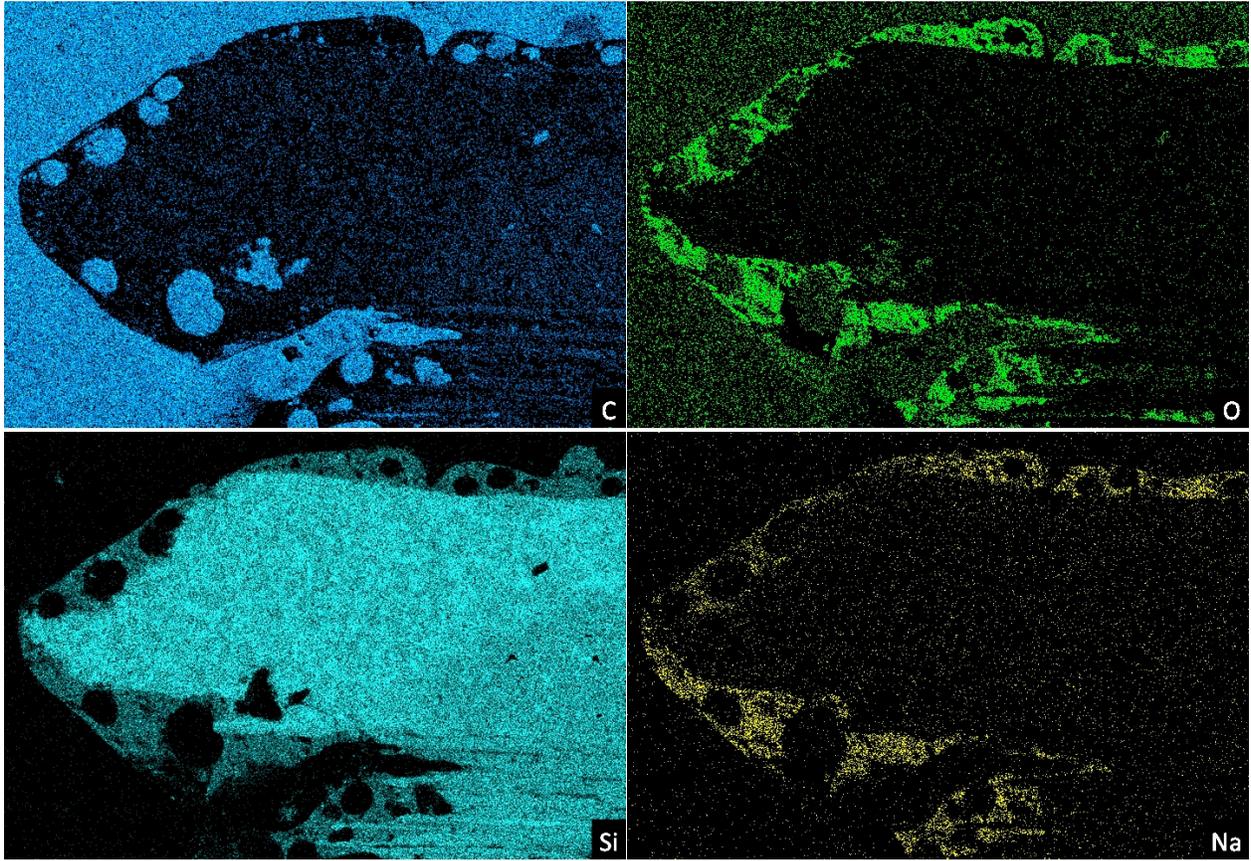
Figure C-42 – Top: An SEM micrograph of the second cross-section of MI-BR-24. Middle: EDS maps for C (left) and O (right). Bottom: EDS maps for Si (left) and Na (right). The fiber tows exposed end-on are attacked most aggressively, and the matrix is fairly resistant to hot corrosion attack.

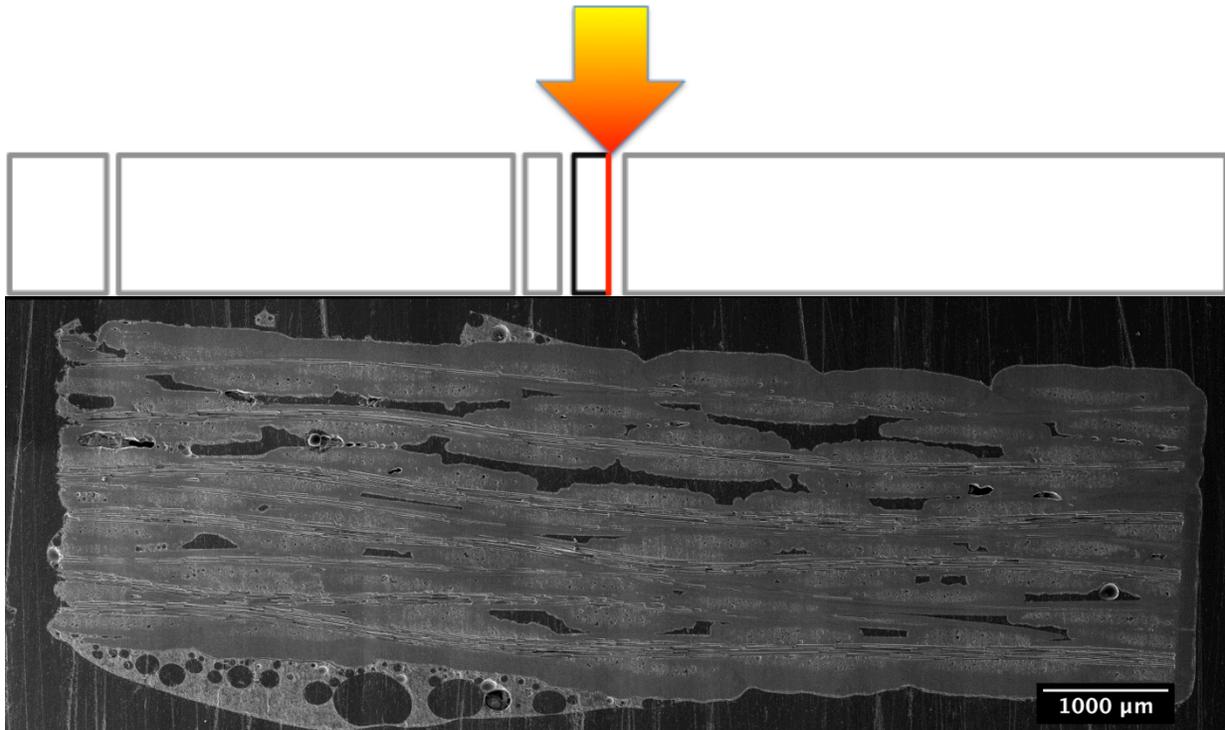
Figure C-43 – SEM Micrograph of the first cross-section of CVI-BR-24 after exposure in the burner rig, leading edge on the left.

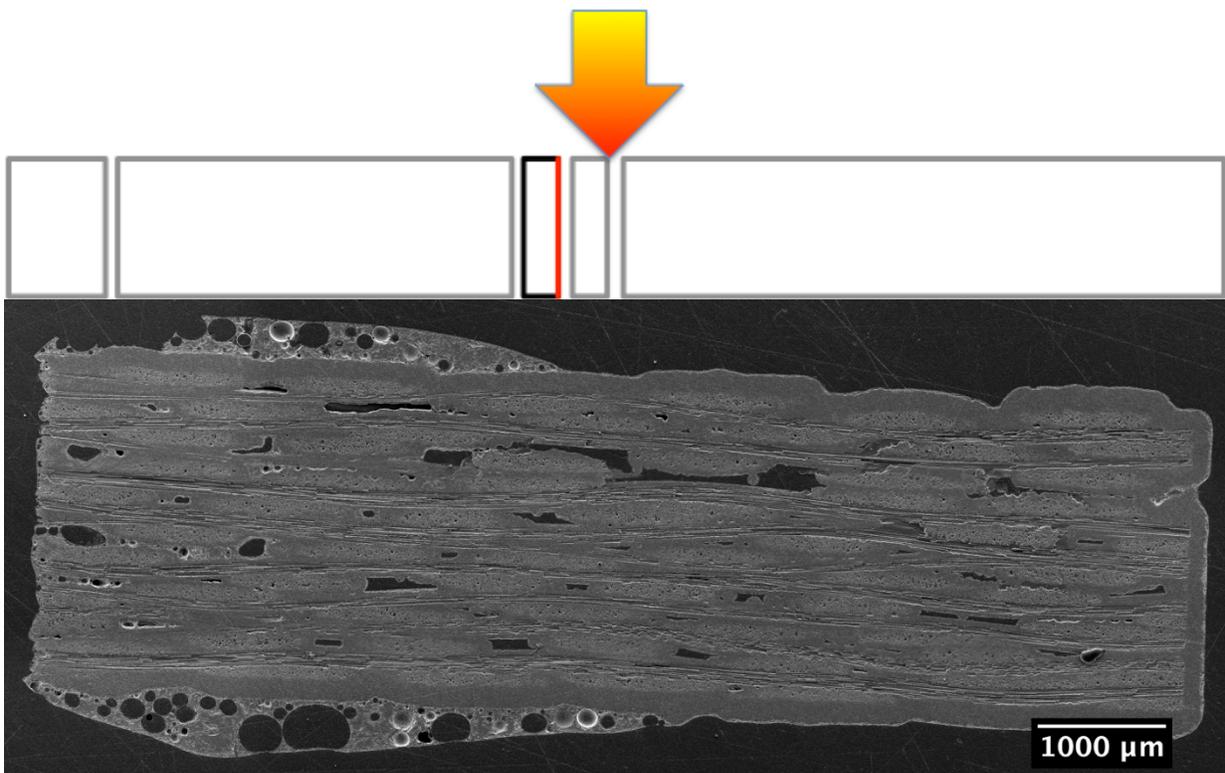
Figure C-44 – SEM Micrograph of the second cross-section of CVI-BR-24 after exposure in the burner rig, leading edge on the left.

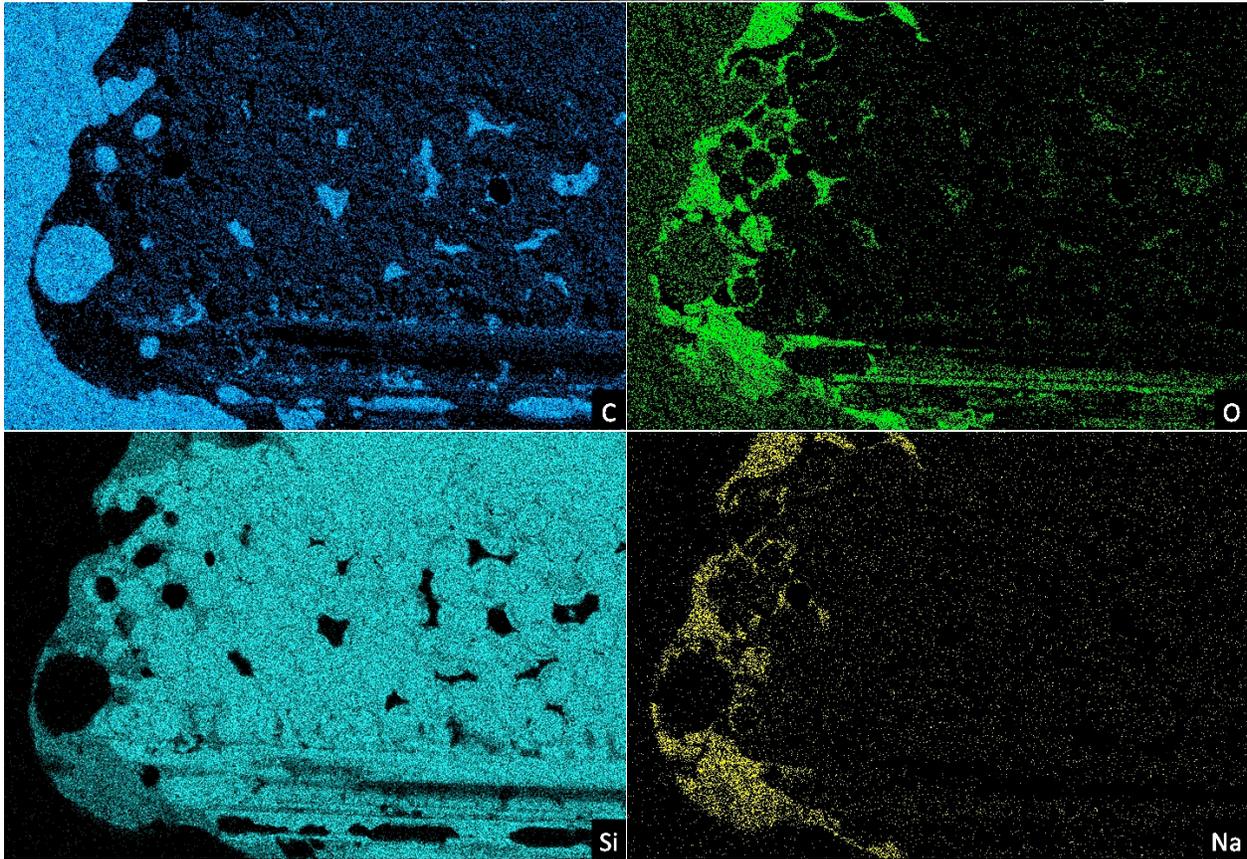
Figure C-45 - Top: An SEM micrograph of the second cross-section of CVI-BR-24. Middle: EDS maps for C (left) and O (right). Bottom: EDS maps for Si (left) and Na (right). Attack is fairly uniform, but corrosion proceeds down the fiber lengths and in between individual fibers.

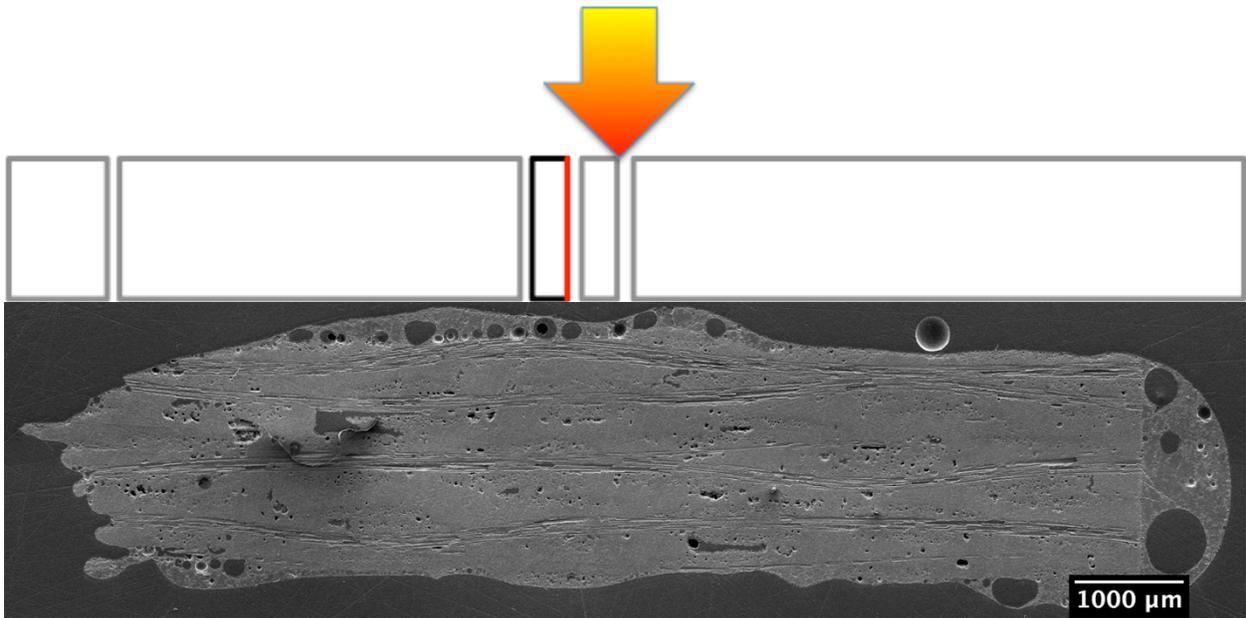
Figure C-47 – SEM Micrograph of the second cross-section of MI-BR-45 after exposure in the burner rig, leading edge on the left.

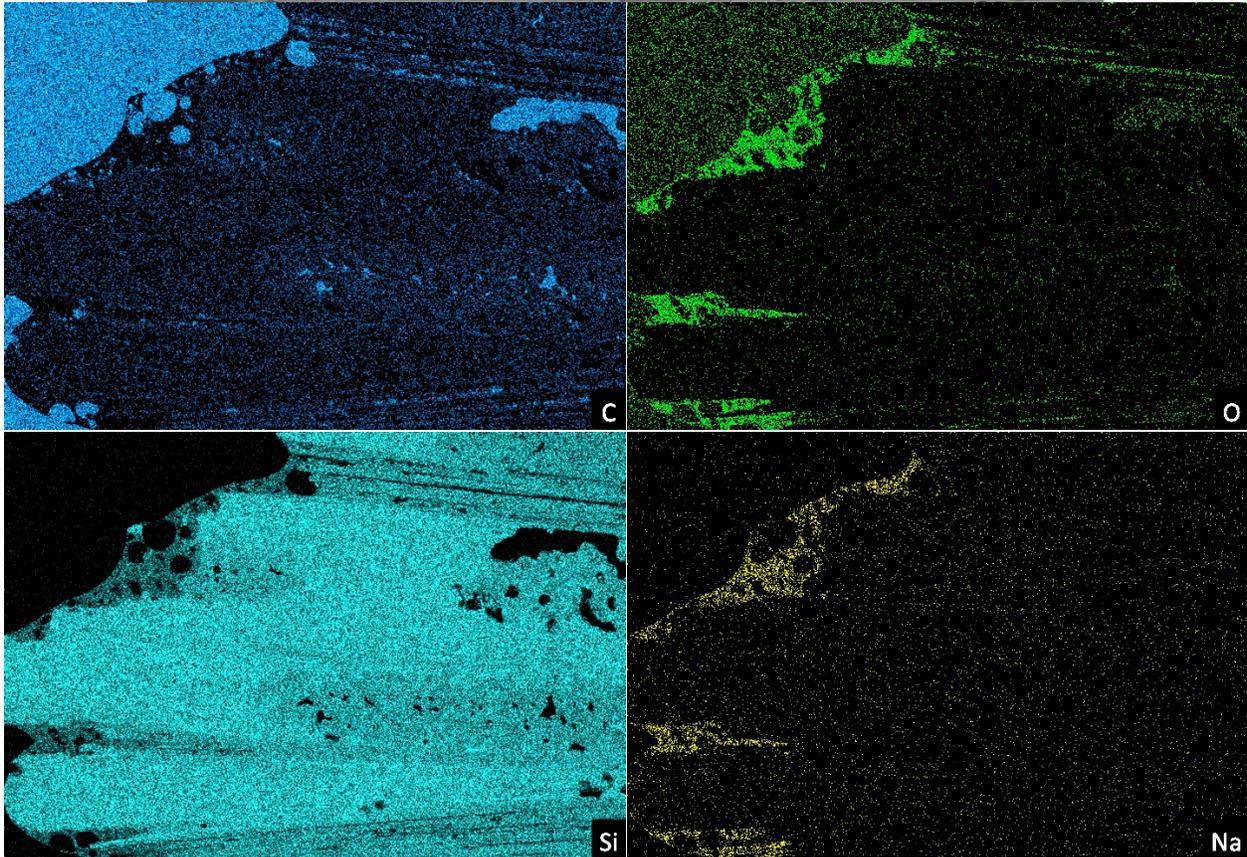
Figure C-48 – Top: An SEM micrograph of the second cross-section of MI-BR-45. Middle: EDS maps for C (left) and O (right). Bottom: EDS maps for Si (left) and Na (right). The fiber tows exposed end-on are attacked most aggressively, and the matrix is fairly resistant to hot corrosion attack.
