High Temperature Salt Deposit-Assisted Corrosion of Silicon
Carbide-Based Ceramic Matrix Composites: Effects of Composite
Chemistry and Architecture

A Dissertation Presented to the Faculty of the
School of Engineering and Applied Science
University of Virginia

Department of Materials Science and Engineering

May, 2015

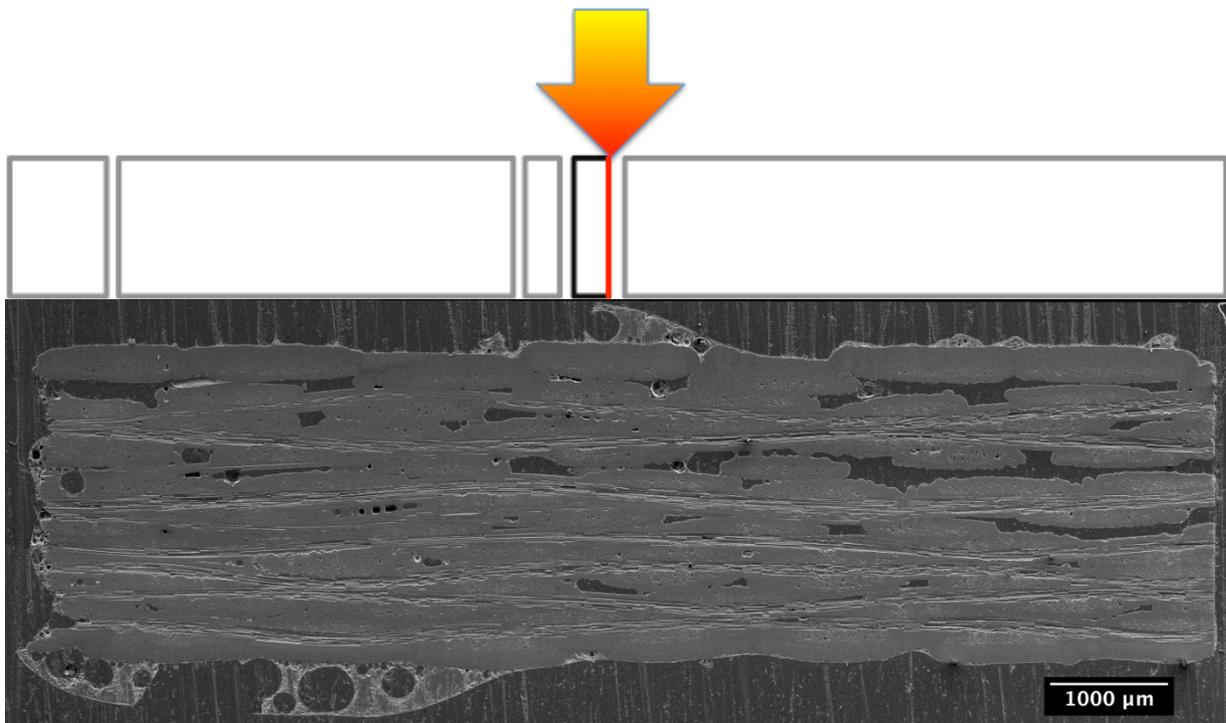
Figure C-49 – SEM Micrograph of the first cross-section of CVI-BR-45 after exposure in the burner rig, leading edge on the left.

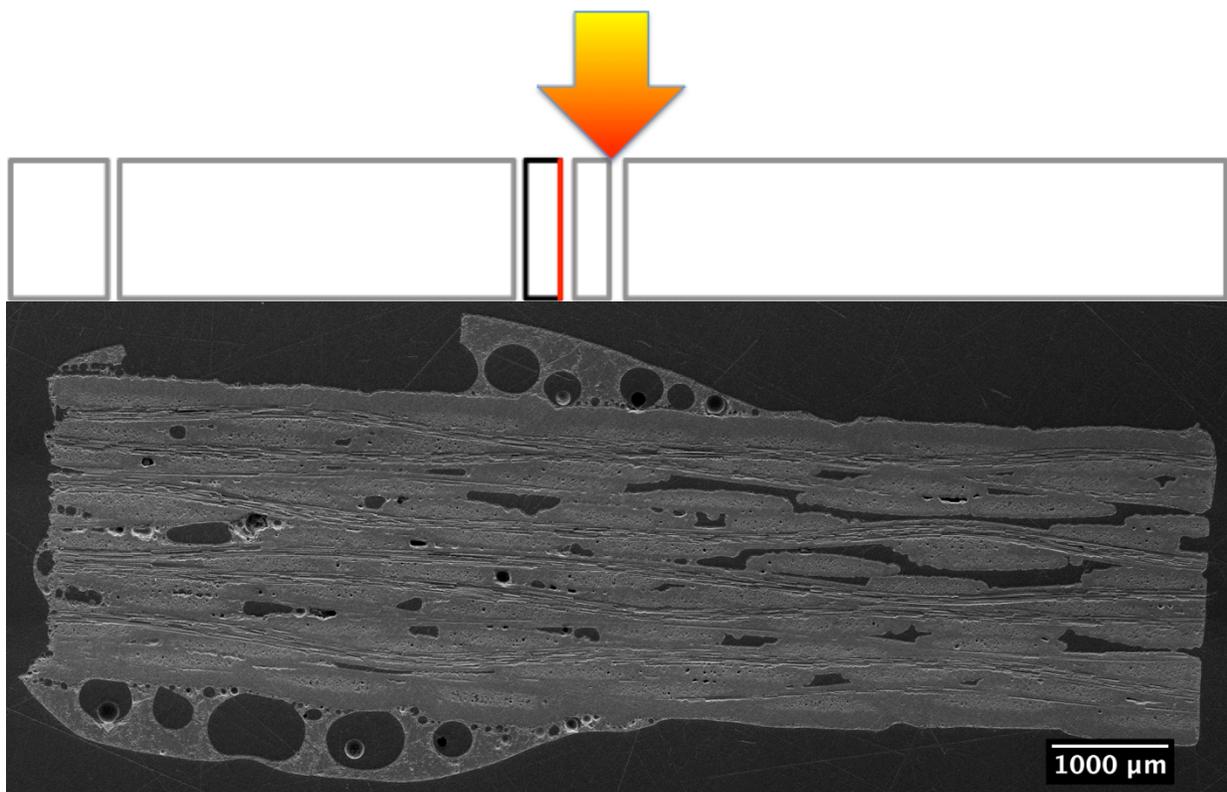
Figure C-50 – SEM Micrograph of the second cross-section of CVI-BR-45 after exposure in the burner rig, leading edge on the left.

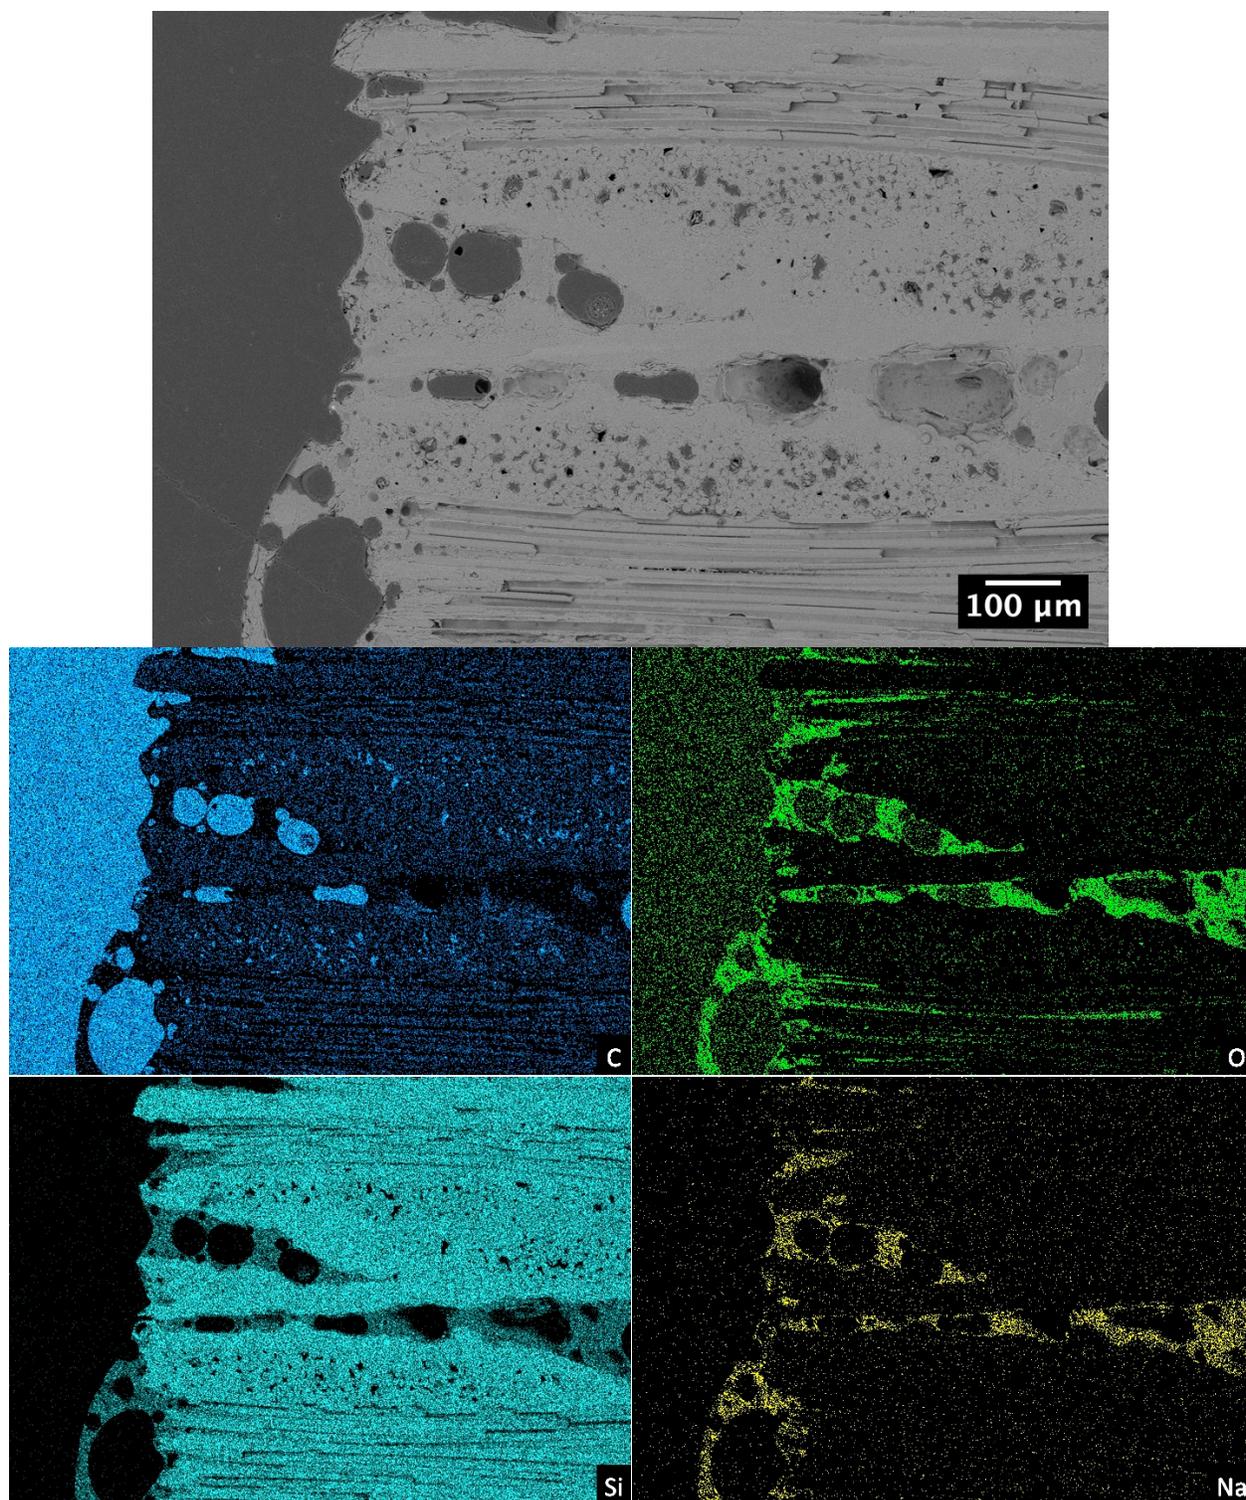
Figure C-51 - Top: An SEM micrograph of the second cross-section of CVI-BR-45. Middle: EDS maps for C (left) and O (right). Bottom: EDS maps for Si (left) and Na (right). The large voids in the CVI matrix allow for easy ingress of corrosion products.

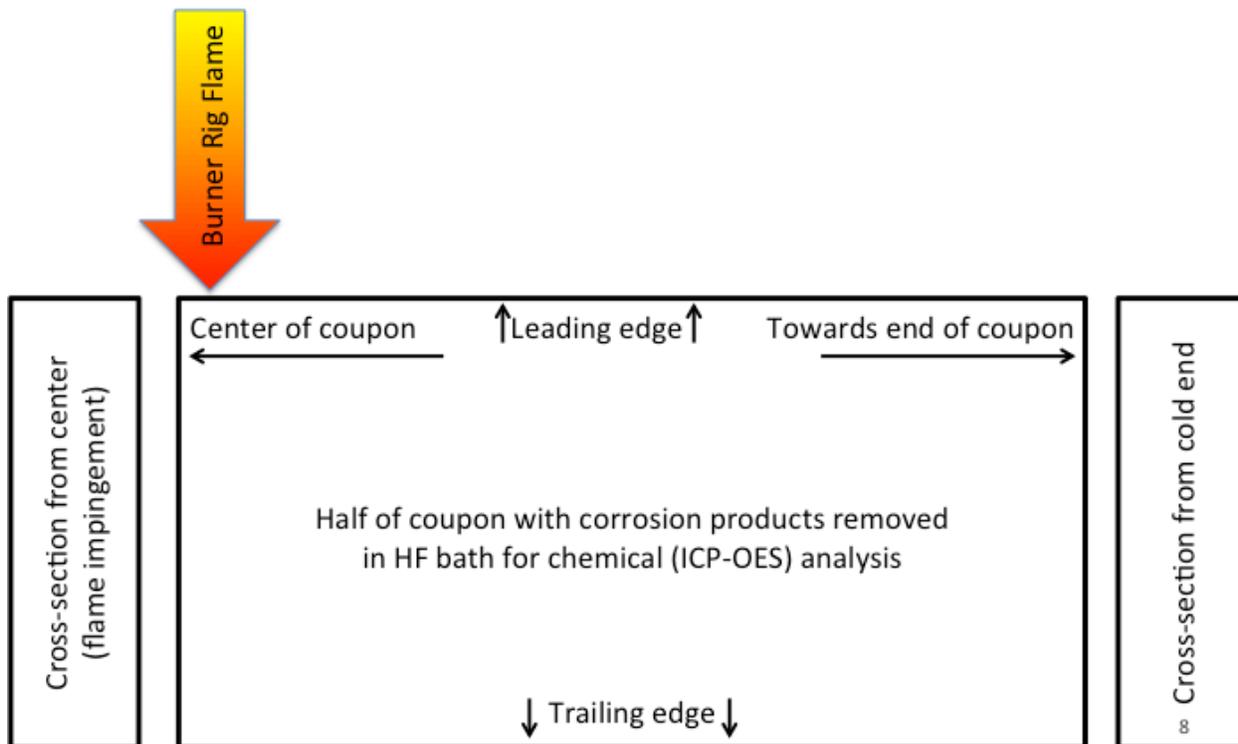
Figure C-52 – Schematic diagram of the arrangement of micrographs for determining recession in the burner rig coupons.

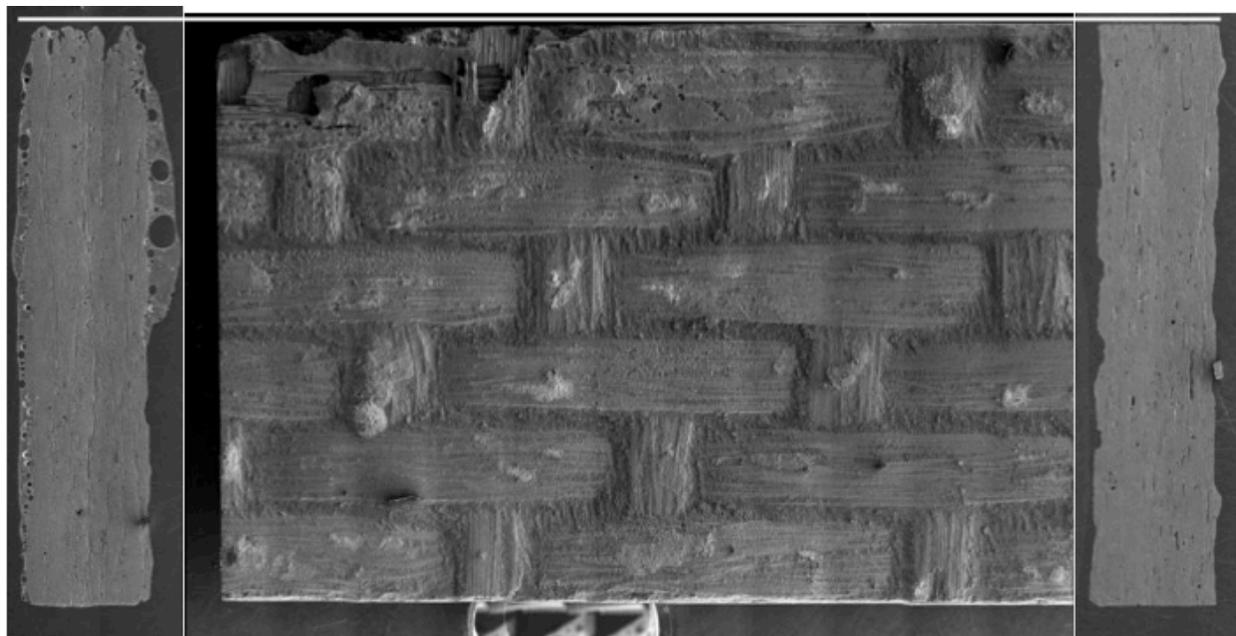
Figure C-53 – Recession for the MI-BR-24 coupon was approximately 1mm.
