North Grounds Stream Restoration

A Technical Report submitted to the Department of Civil Engineering

Spring, 2024

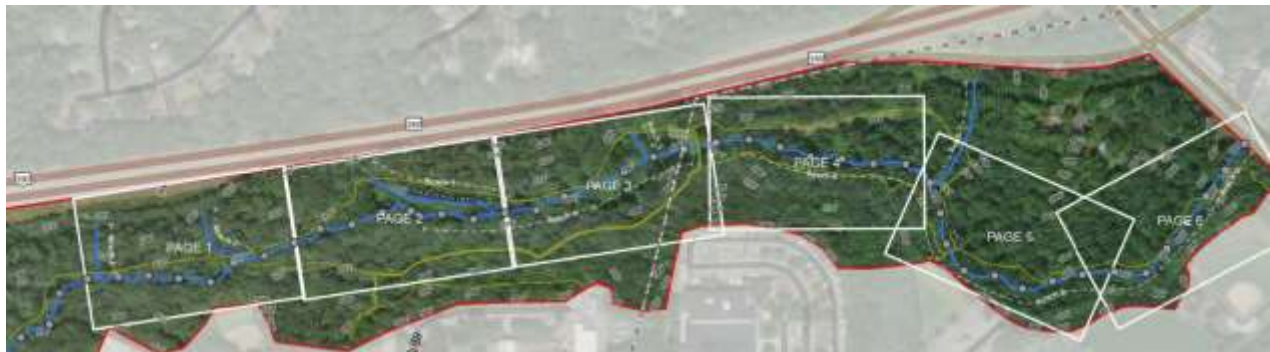
Figure 1-1. Biohabitats Division of Reaches

As is shown in Figure 1-1, reaches (3 and 5) are tributaries to the stream fed by outfalls that run under US 250/Route 29 Bypass. These reaches are of particular interest because there is concern about the influence of increased flow contributions on sediment load and phosphorus and nitrogen concentrations. Therefore, our research and design are primarily centered around Reach 3 and Reach 5. Figure 1-2 provides a more detailed view of these reaches.

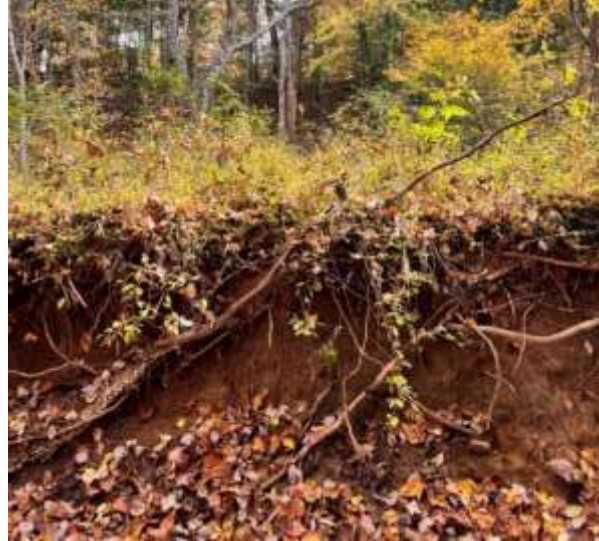
Figure 3-4. Incised Banks on Reach 3

The previous water quality datasets imply that sediment and nutrients are not actively being conveyed by Reaches 3 and 5. However, the severe physical incising (Figure 3-4) is indicative of historical erosion in the reaches and probable erosion during future, larger storm events. Therefore, to accurately determine the extent of erosion and inform TMDL and MS4 credit calculations, a Bank Erosion Hazard Index (BEHI) of Reaches 3 and 5 was employed.

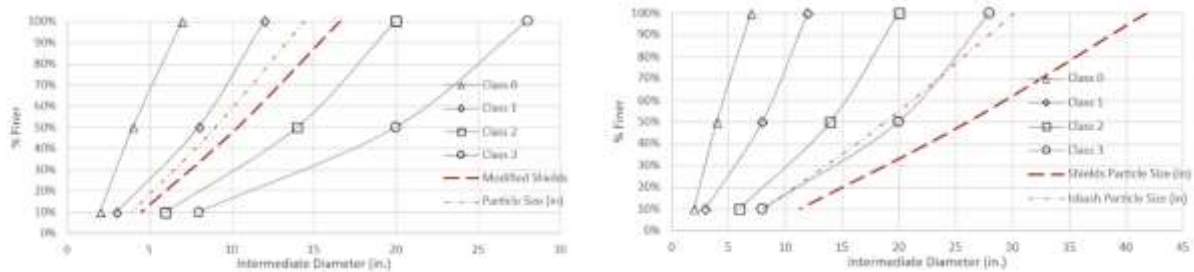
Figure 6-3. Reach 3 (left) and Reach 5 (right) Rock Sizing Diagram

The results of the design were promising. The shear stress of the Reach 3 design was 4 pounds per square foot. This influenced the designed rock size requirement for the riffles and plunge pool across the reach. Using a spreadsheet provided by Biohabitats, the median rock size (D50) for Reach 3 was 10.4 inches. For Reach 5, with a shear stress of 10.06 pounds per square foot, the median rock size requirement for a factor of safety of 1 is 26.1 inches. Figure 6-3 shows the rock sizing diagram, with the shielding line. Both designs are safely below the shields line.

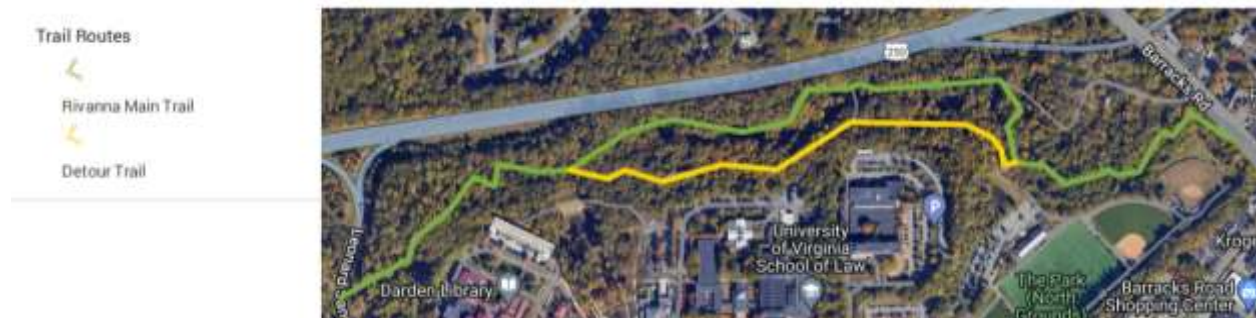
Figure 7-2. Plan View of Main and Detour Trail Alignments

During construction, a temporary detour will take the route of the North Field Spur Loop, which has a similar difficulty to the Rivanna Trail in terms of length, elevation change, and trail surface. The plan view of the existing and detour trail is presented in Figure 7-2 and the CAD drawing in Figure 7-3.

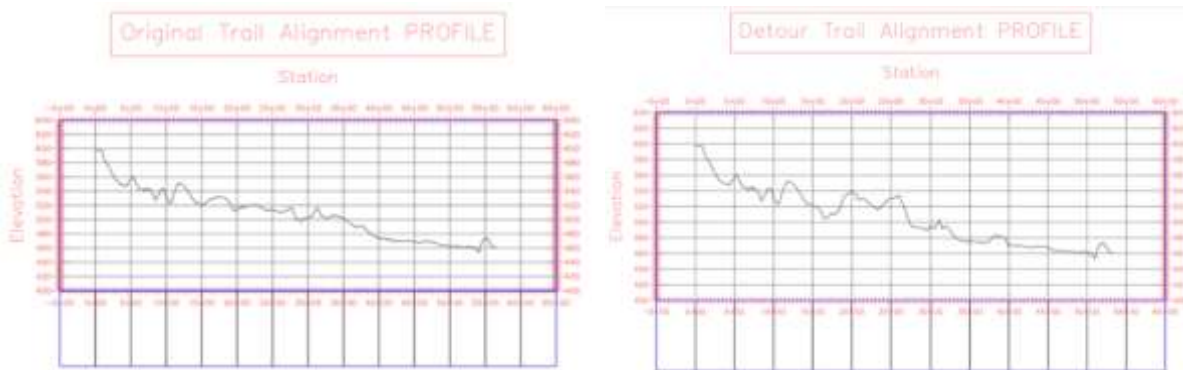
Figure 7-4. Profile Views of Existing and Detour Trails

The profiles of the existing and detour trails are displayed in Figure 7-4.

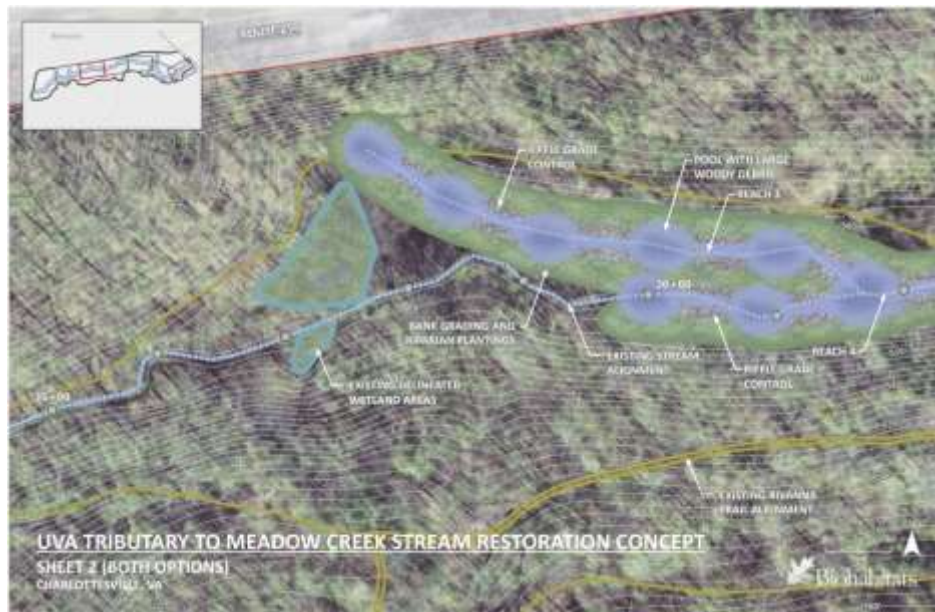
Reach 3 Initial Design Provided by Biohabitats

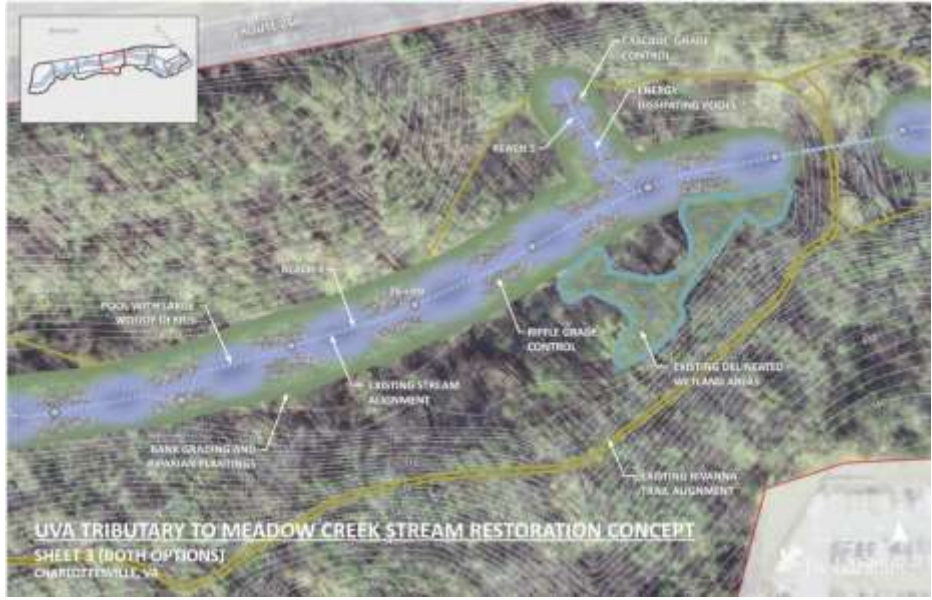
Reach 5 Initial Design Provided by Biohabitats

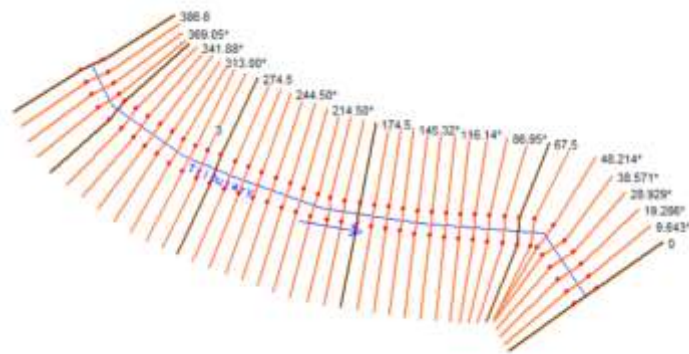
Reach 3 HEC-RAS Model Layout with Cross Sections at Delineated Stations

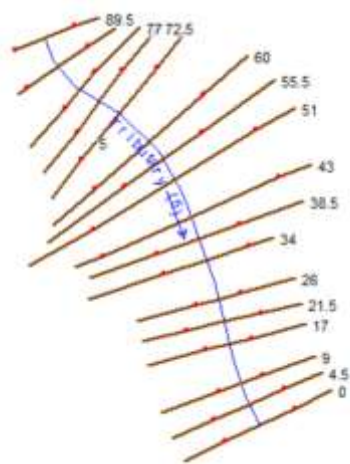
Reach 5 HEC-RAS Model Layout with Cross Sections at Delineated Stations

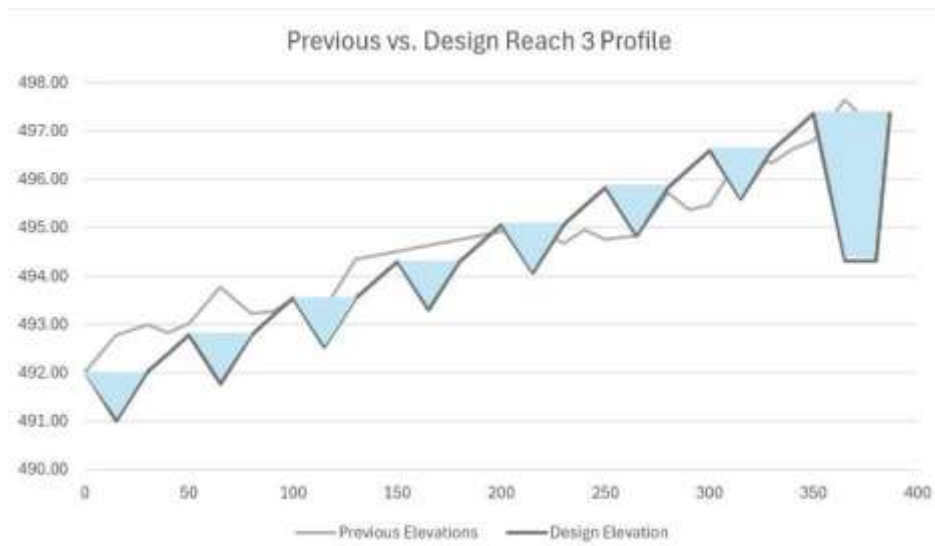
Reach 3 Profile View of Existing vs Proposed Elevations

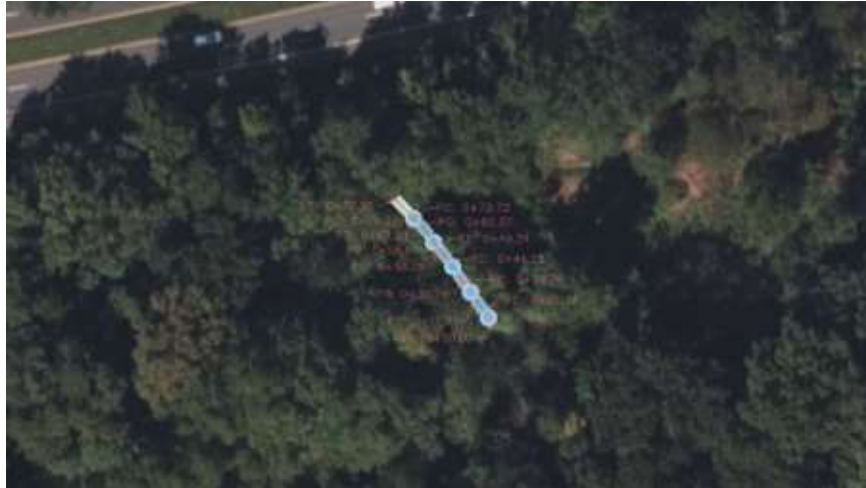
Reach 5 Final Draft Design (Plan View)

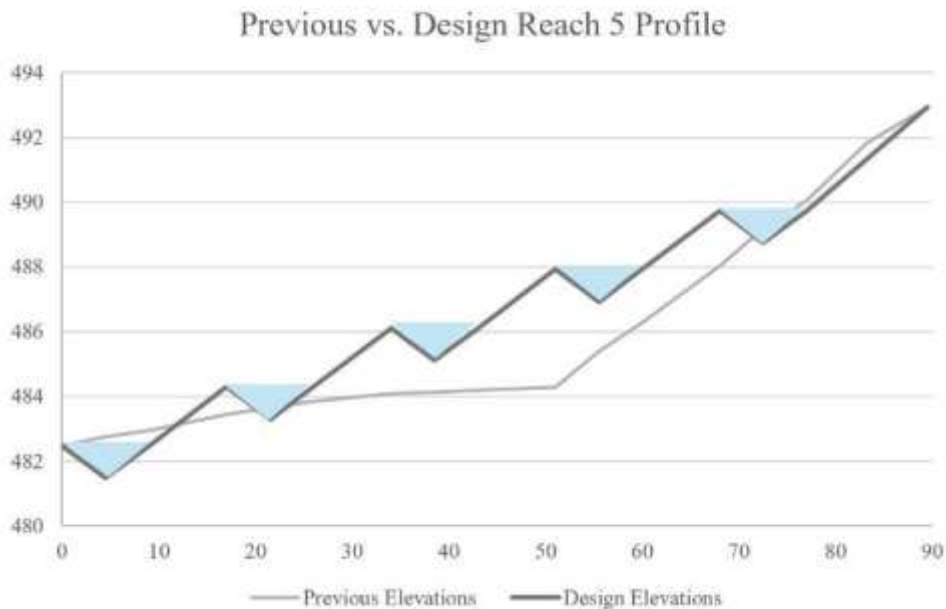
Reach 5 Profile View of Existing vs Proposed Elevations
