Biomechanical response of the human pelvis: a high-rate vertical loading pilot study

A Thesis

Master of Science

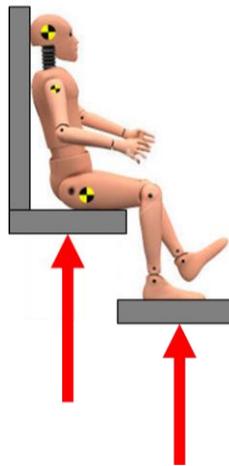
Figure 1 - This schematic shows the two primary load paths into a seated occupant during a UBB event.

Due to the high likelihood that lower extremities would be injured in a UBB event, initial research studies focused their investigations on that body region's response (Ramasamy 2011). Additionally, new mechanisms of lower extremity injuries, such as brisance effect fractures, led researchers to focus their efforts on understanding the mechanism of such injuries, and establishing prevention and treatment techniques (Ramasamy 2011; Bailey 2013). While the initial research focus was on the lower extremities, the second primary load path into a seated soldier is through the pelvis (Figure 1).

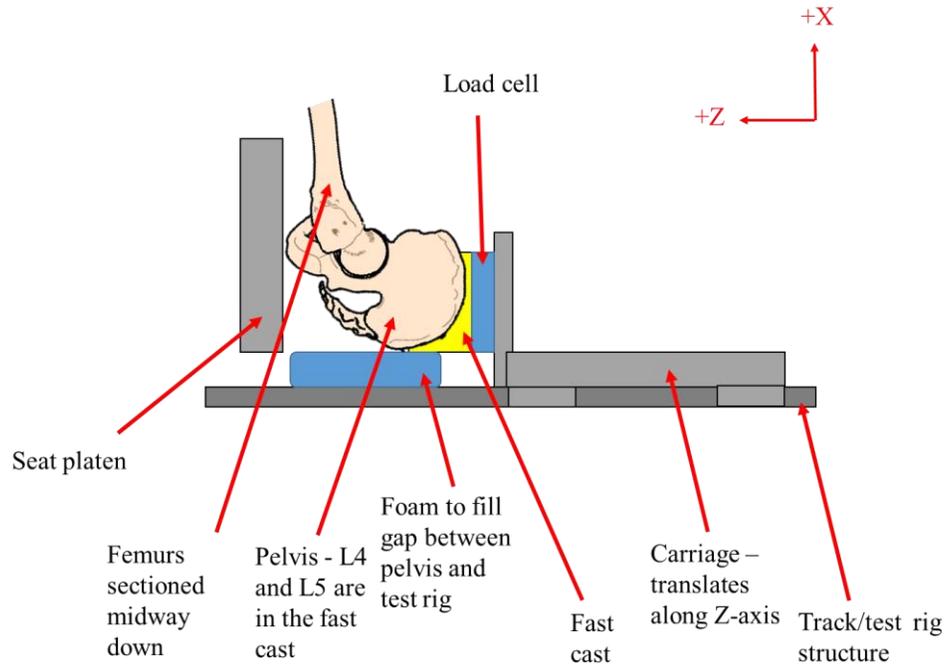
Figure 4 - A detailed schematic showing how the pelvis is situated in the testing rig.

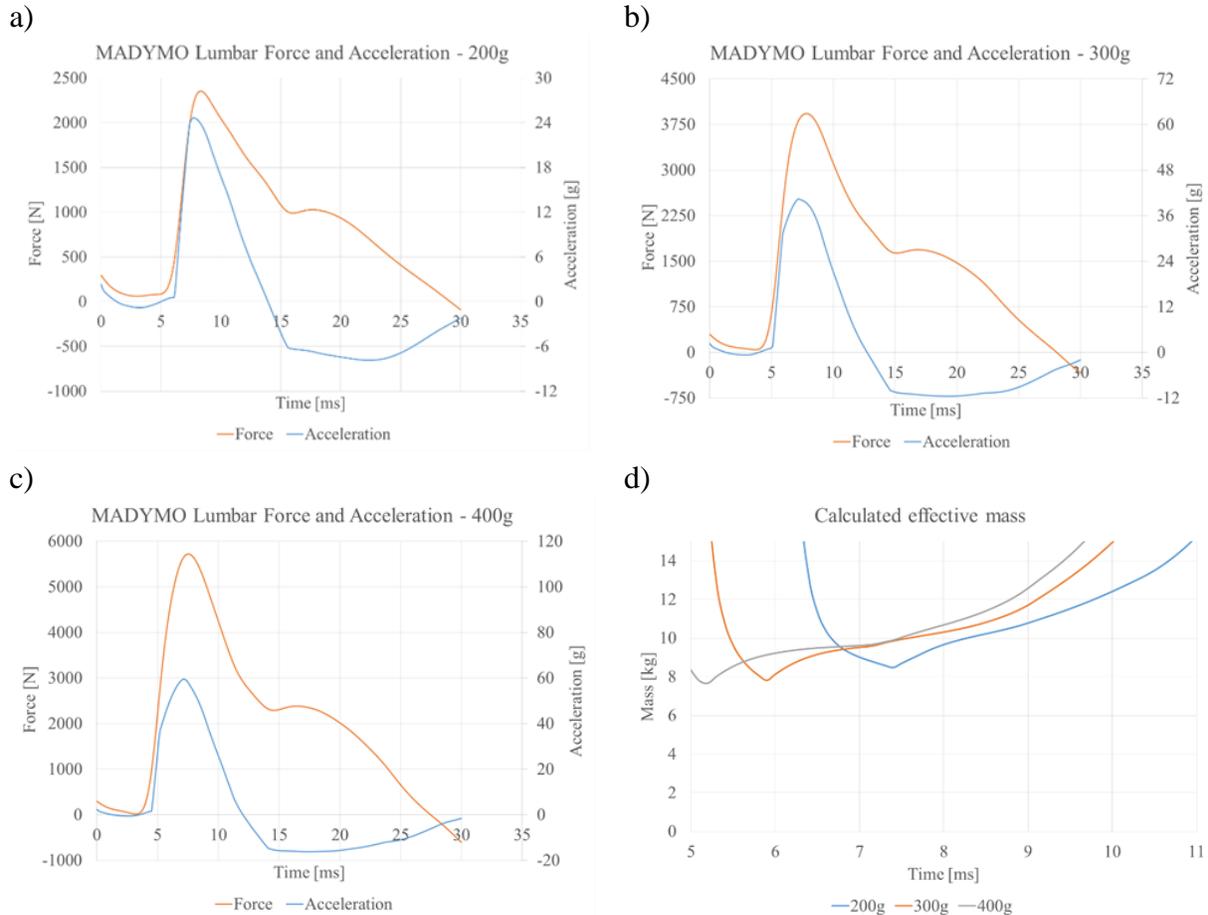
Figure 6 – a-c) MADYMO force and acceleration plots for 200, 300, and 400g input accelerations. d) Calculated effective mass plots. The final effective mass on Telemachus had a mass of 12 kg.

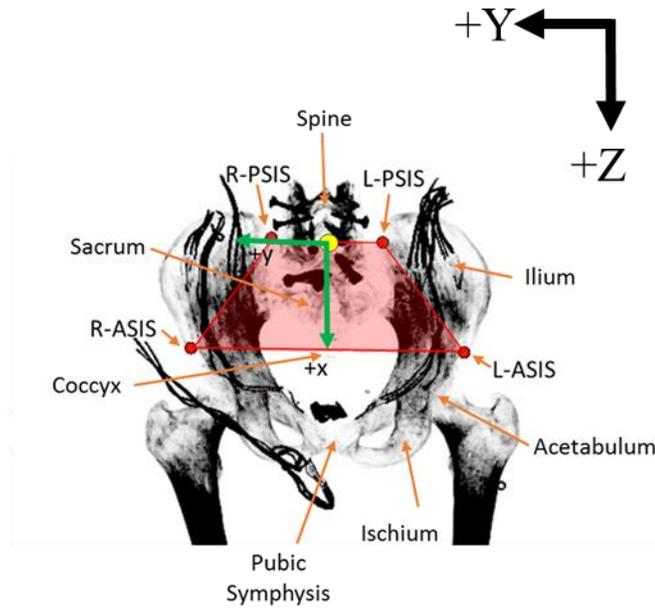
Figure 7 – General pelvis anatomy with local coordinate system defined by Wu. Specimens for this study were sectioned from L4 to mid-femur.

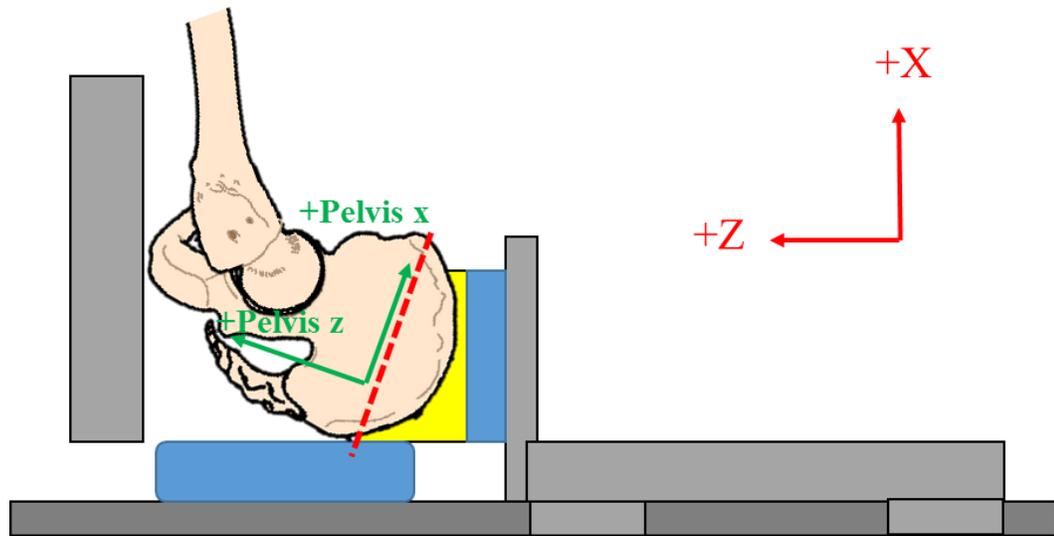
Figure 8 - A detailed schematic showing how the pelvis is positioned in the testing rig with the local pelvis coordinate system.

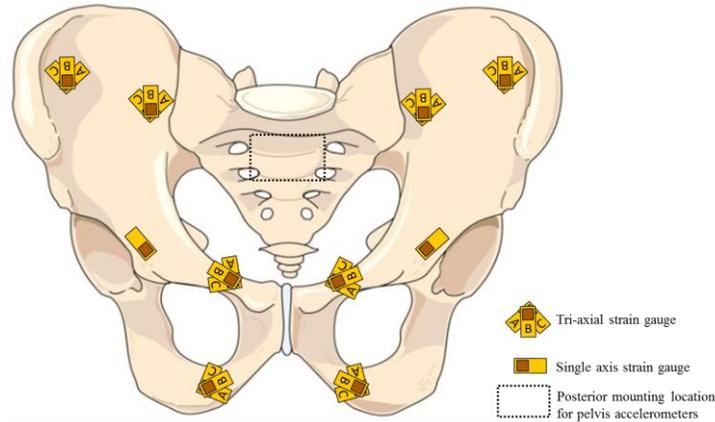
Figure 10 - Pelvis schematic showing targeting locations for strain gauges and the posterior mount of the acceleration block.

were used for tests 2 thru 10 for fracture detection and a host of strain elements were used throughout the pelvis (Figure 10). The majority of the strain gauges were tri-axial rosettes. Once each specimen was fully instrumented, a pre-test CT scan was ordered to be able to precisely measure instrument location before testing. Figure 11 shows a sagittal x-ray image of a pelvis potted in position with the sacrum acceleration block in view.

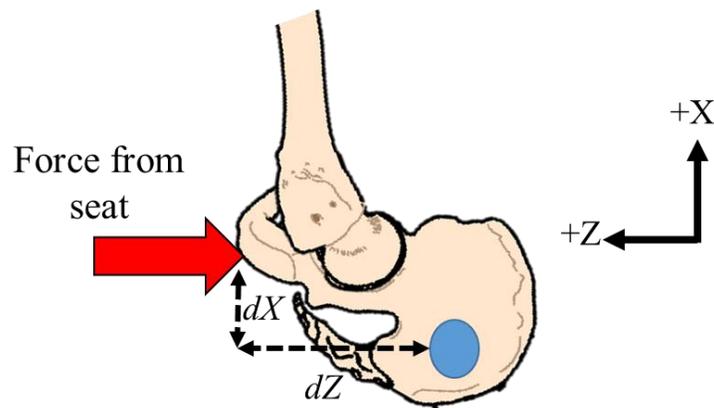
Figure 12 – Schematic showing moment arms and forces acting on a point.

$$dX = \frac{My - (Fx * dZ)}{Fz} \quad (\text{Eq. 2})$$

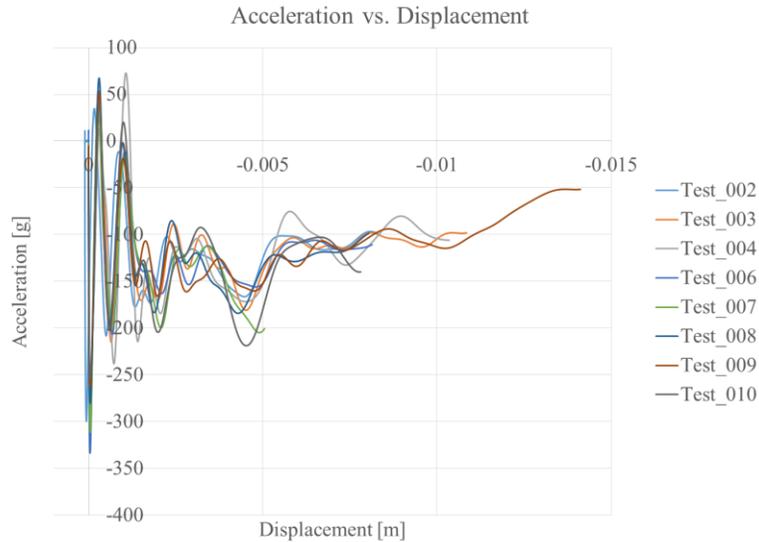
Figure 14 – Acceleration vs. displacement plot up to time of failure. Test 005 was omitted from this plot due to excessive acceleration ringing. The consistent acceleration from test to test shows that the input was not affected by the pelvis.

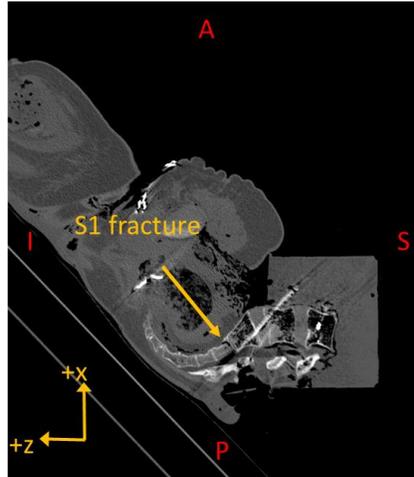
Figure 15 - Test 004: Sagittal CT image of the pelvis, post-test, at the midline of the sacrum. Also in view are the potted L4 and L5 vertebral bodies. The yellow arrow indicates the fracture that was sustained during testing. This image is oriented to show the sacrum in a testing position even though the imaging was done in a hospital CT machine. The hip is extended because of how the specimen is positioned for scanning.

of the sacroiliac joints. Injury descriptions and images are listed below for each test. A representative CT image of a sacral fracture is shown in Figure 15.

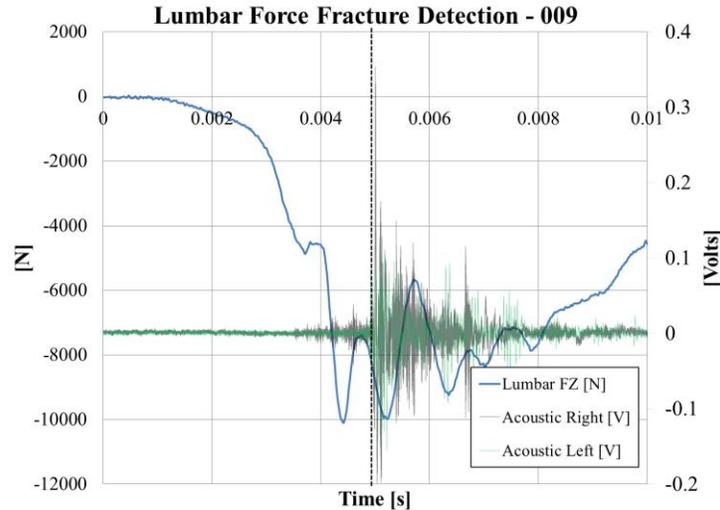
Figure 16 – Acoustic emission signals plotted with a force trace to determine fracture timing and force at fracture. The dotted line indicates the point at which the acoustic signal significantly increases (greater than 1 order of magnitude of the base signal), indicating there was a fracture.

Since all of the specimens fractured at the potting interface, only data up to time of fracture is reported. Time of fracture was determined for nine of the ten tests using the acoustic emission sensors in a similar manner as previous studies conducted by Salzar and Funk (Salzar 2006; Funk 2002). When the acoustic data recorded an amplified, near instantaneous response, the time corresponding to the initiation of the response was considered the failure time. Test one did not have acoustic sensors employed. Figure 16 depicts acoustic signals plotted with lumbar F_z to determine fracture time and force at failure. Table 8 summarizes times of failure, as well as axial forces and moments about the y-axis at the fracture time. The average axial force when the potting failed for tests 2-10 was -5949 ± 1777 N and the average moment about the y-axis at fracture was 311 ± 157 Nm. The average shear force was -1845 ± 825 N. The average failure time was 4 ± 0.6 ms.

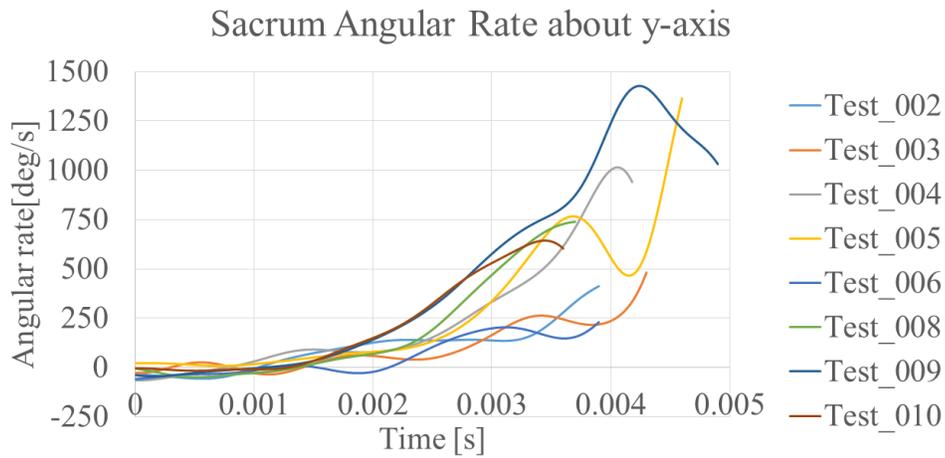
Figure 17 – Sacrum angular rate data about the y-axis. All tests exhibited a positive rotation about the y-axis.

Sacrum angular rate about the y-axis is plotted in Figure 17. Angular rates at fracture range from about 250-1400 deg/s. The positive trend in the kinematics is in agreement with the positive moments about the y-axis.

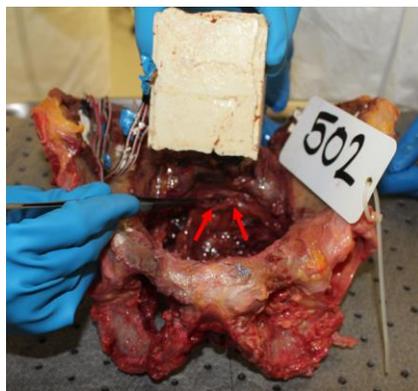
Figure 21 - Injury picture for test 001. Non-displaced, linear fracture with small comminuted bony fragment was noted extending laterally through the entire sacrum at the level of the most cephalad sacral foramen.

Non-displaced, linear fracture with small comminuted bony fragment was noted extending laterally through the entire sacrum at the level of the most cephalad sacral foramen. Figure 21 shows a picture from the dissection of a fracture.

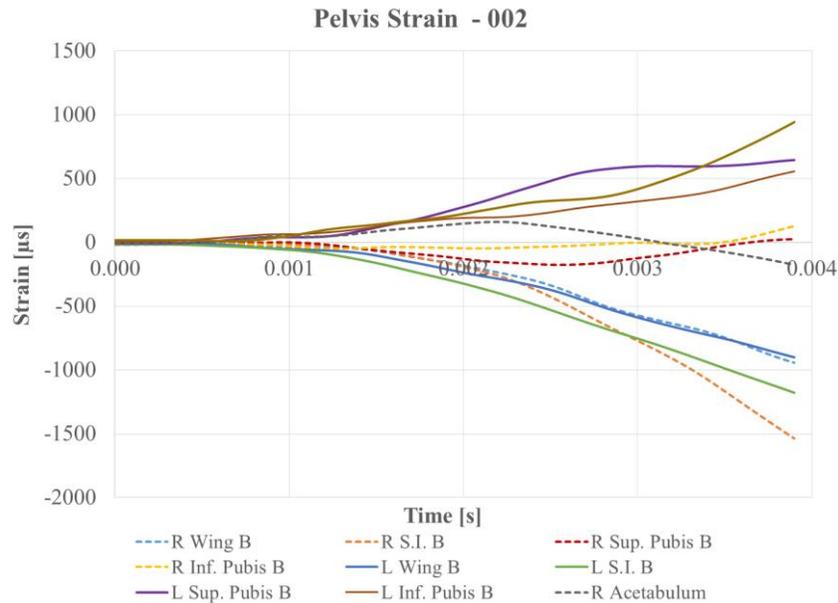
Figure 22 – Pelvis strains for test 002. The left and right S.I. gauges experienced the largest compressive strains.

Figure 22 shows the strain in the pelvis up to failure. The data indicate that the pelvis underwent compression bilaterally at the SI joints, as well as on the ilium (denoted as ‘wings’ in the plots). The left inferior pubis, left acetabulum, and left superior pubis all measured tension. The right acetabulum measured tension and then went into compression, while the right inferior and superior pubis gauges started in compression and then went into tension.

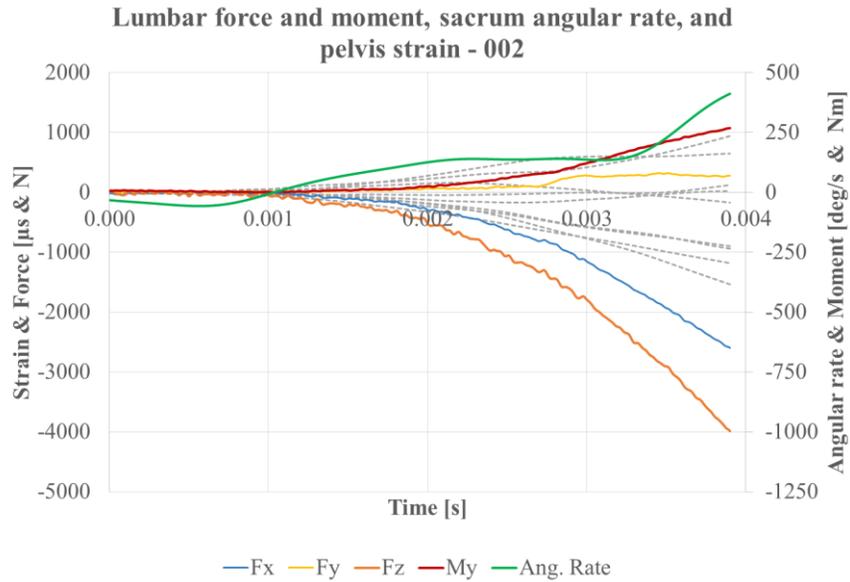
Figure 23 — Pelvis forces and moments, as well as sacrum angular rate for test 002. The gray dotted lines are the strains from the previous figure. Fz was the dominant force. My and the angular rate sensor both had positive trends.

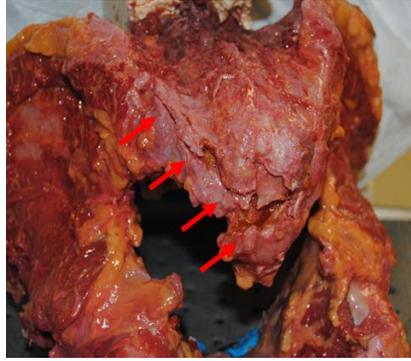
Figure 27 - Injury picture for test 002. An 8cm fracture was noted extending from the coccyx to the level of S3 on the left lateral sacrum.

Mobile fragment ~5mm at the most inferior portion of the ischium on the left and right. An 8cm fracture was noted extending from the coccyx to the level of S3 on the left lateral sacrum.

Coccyx was noted to have a comminuted fracture. Figure 27 shows a picture from the dissection of a fracture.

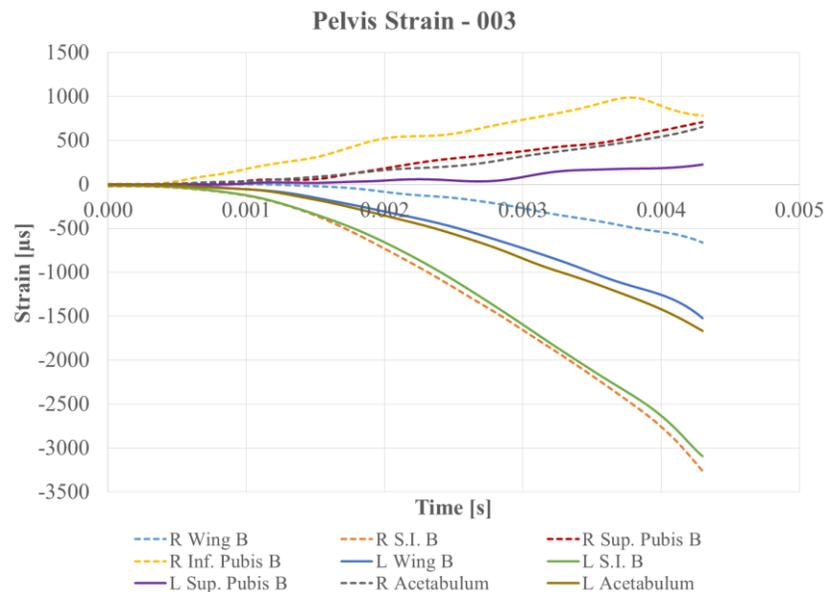
Figure 28 - Pelvis strains for test 003. The left and right S.I. gauges experienced the largest compressive strains.

Figure 28 shows the strain in the pelvis up to failure. The left inferior pubis gauge failed and yielded no usable data. The left and right SI gauges both underwent similar compressive loading. Similarly, the left acetabulum and left wing both experienced similar compressive strain. The right inferior pubis gauge was put into tension and peaked before failure.

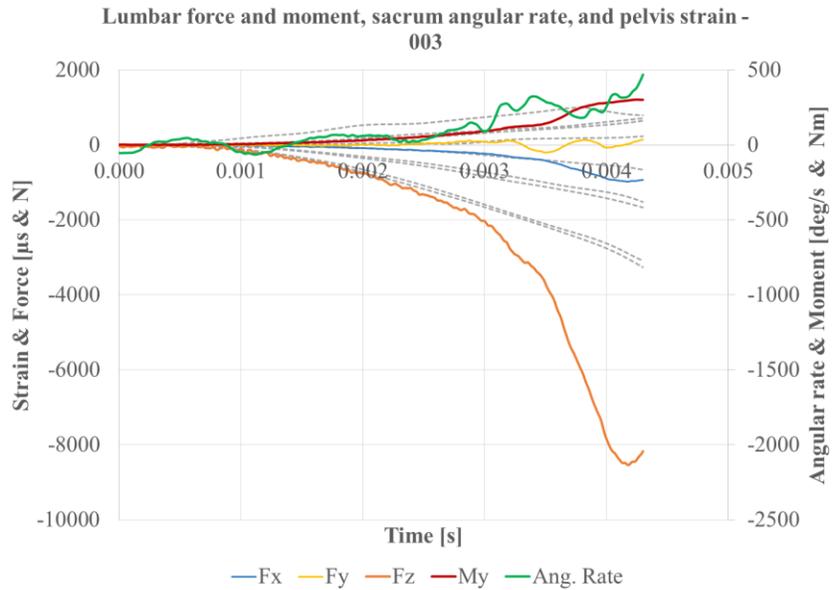
Figure 29 - Pelvis forces and moments, as well as sacrum angular rate for test 003. The dominant Az acceleration has a steep positive rise up to a peak just after 4 ms. The time corresponds to the peak in Fz load.

Figure 29 shows the strain data as gray dotted lines with the pelvis forces and moment about the y-axis plotted in color. Fz was the dominant force, but there was a small shear contribution of about 1 kN along Fx and very little lateral loading along Fy. My and the angular rate sensor both followed a positive trend. In Figure 30, the dominant Az acceleration, as well as the angular rate, have a steep positive rise up to a peak just after 4 ms, which corresponds to the peak in the Fz load. Given the nature of the fractures, these data suggest that the fractures could have been initiating just after 4 ms (in line with the peaks), followed by catastrophic failure at the end of the trace. The positive Az accelerations can be attributed to sacrum rotation about the fixed superior end despite the loading from the seat along the negative z-axis.

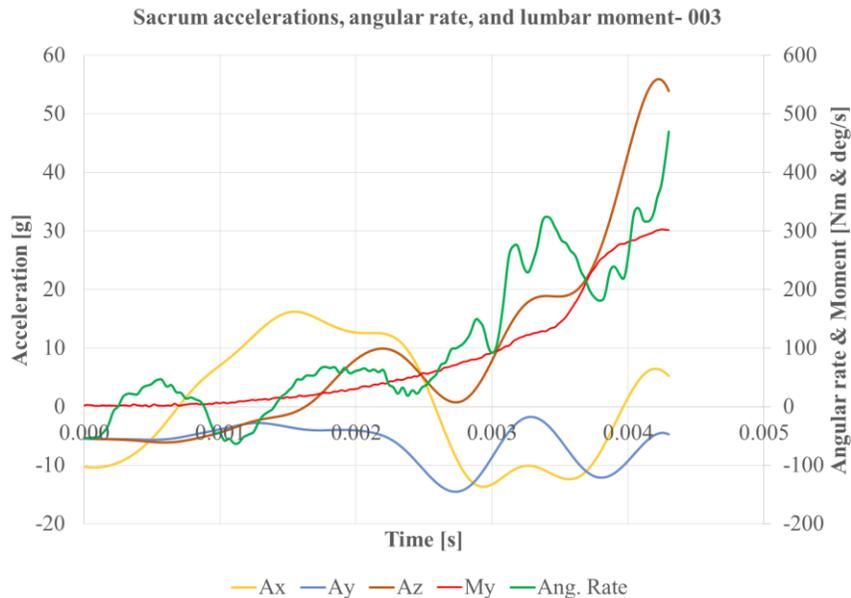
Figure 30 - Sacrum accelerations and angular rate, and pelvis moment about the y-axis for test 003. The dominant Az acceleration has a steep positive rise up to a peak just after 4 ms. The time corresponds to the peak in Fz load.

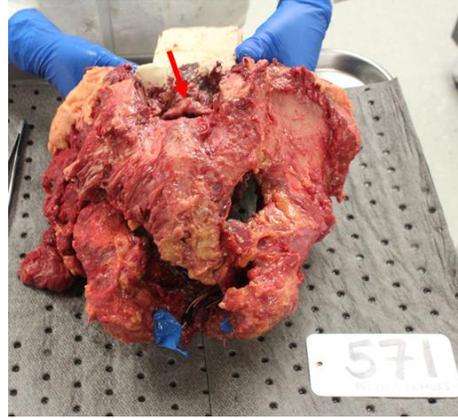
Figure 33 – Injury picture for test 003. Transverse fracture of the medial sacrum ~1cm below the superior aspect of the sacrum.

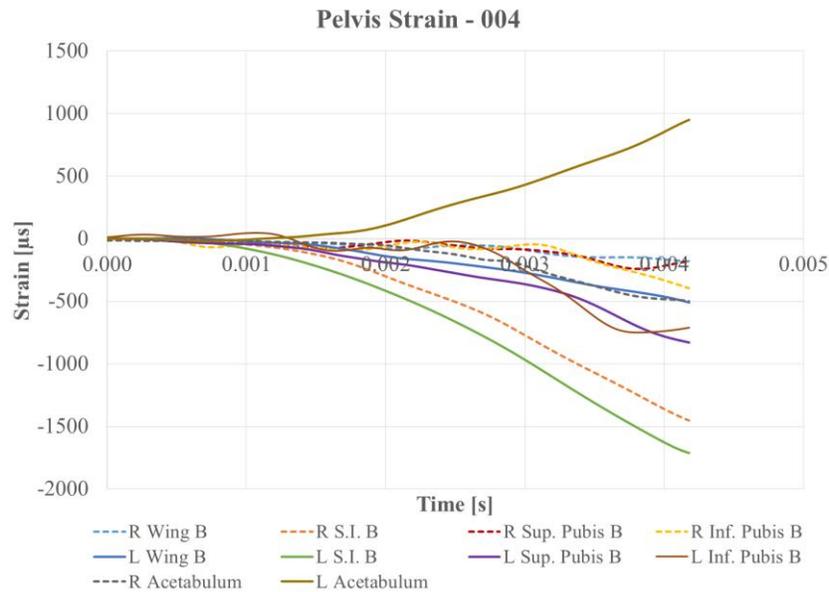
Figure 34 - Pelvis strains for test 004. The left and right S.I. gauges experienced the largest compressive strains.

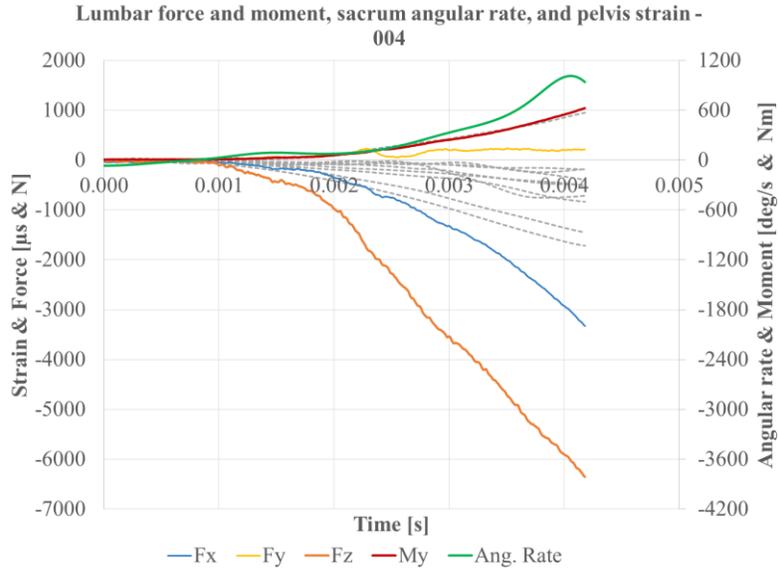
Figure 35 - Pelvis forces and moments, as well as sacrum angular rate for test 004. The gray dotted lines are the strains from the previous figure. Fz was the dominant force, and My and the angular rate sensor both had positive trends.

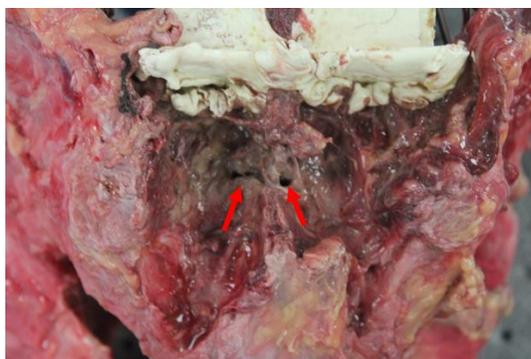
Figure 39 – Injury picture for test 004. The view of the posterior sacrum. Transverse fracture extending the length of the sacrum at the level of the inferior edge of the first sacral foramen.

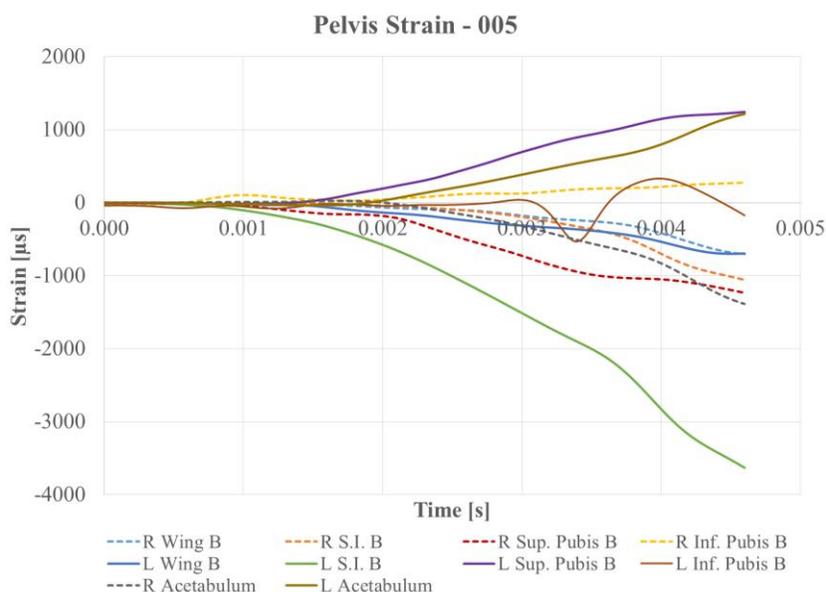
Figure 40 - Pelvis strains for test 005. The left and right S.I. gauges experienced the largest compressive strains.

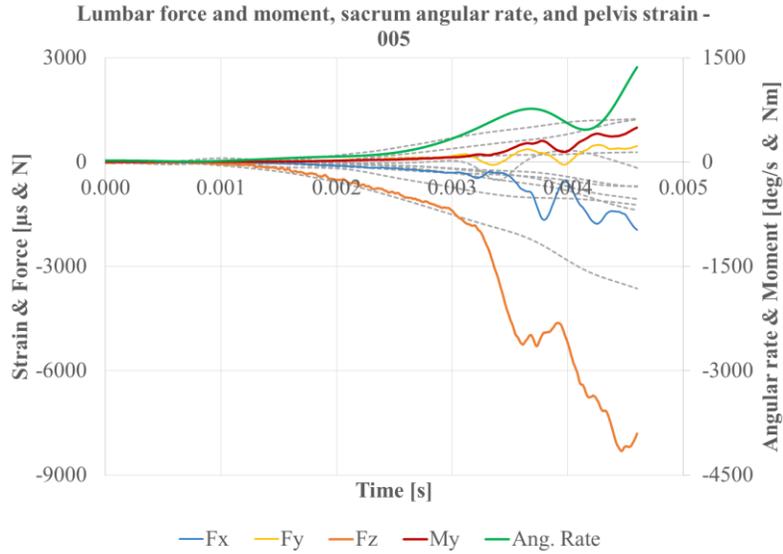
Figure 41 - Pelvis forces and moments, as well as sacrum angular rate for test 005. The gray dotted lines are the strains from the previous figure. Fz was the dominant force, and My and the angular rate sensor both had positive trends.

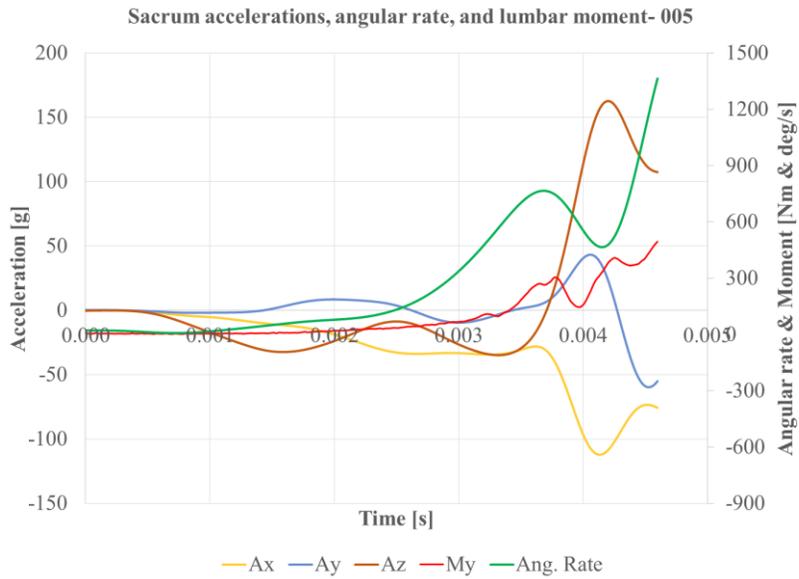
Figure 42 - Sacrum accelerations and angular rate, and pelvis moment about the y-axis for test 005. Ax, Ay, and Az all experienced peaks just after 4 ms, which correspond to the reloading in Fz. After the peaks, the angular rate sensor recorded a faster change in rotation until failure was detected by the acoustic sensors.

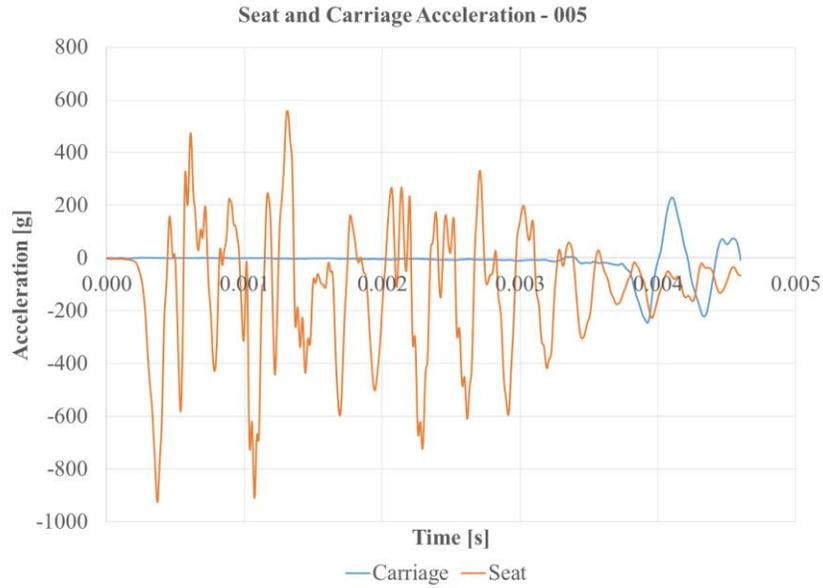
Figure 43 - Seat and carriage accelerations for test 005. The carriage does not start to accelerate until ~3ms. There is significant ringing in the seat accelerometer.

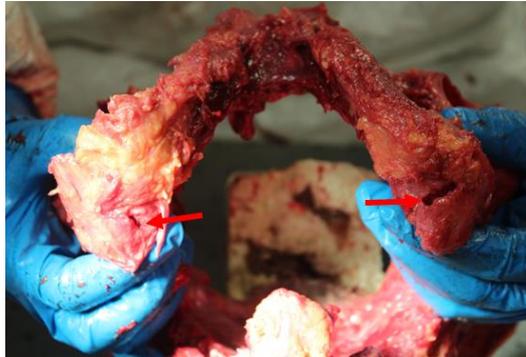
Figure 45 – Injury picture for test 005. Non-displaced right and left ischial spine fractures

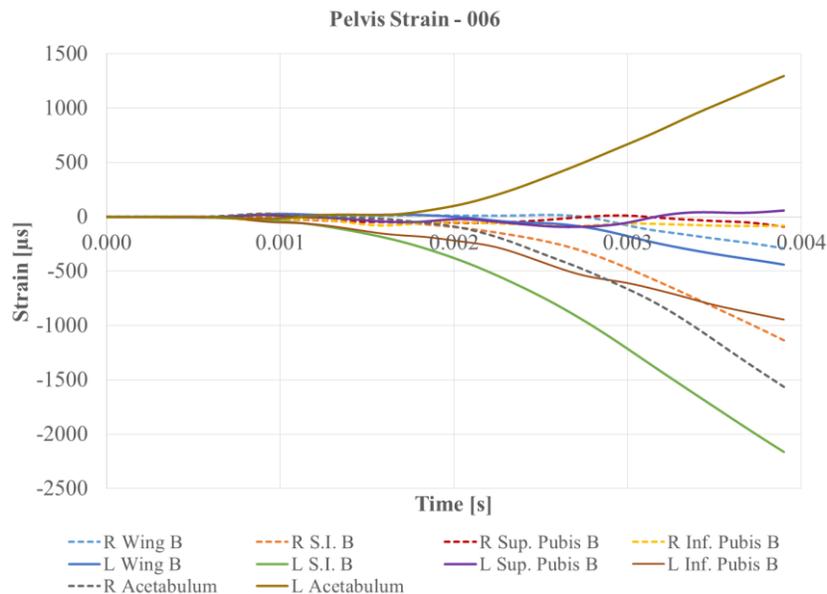
Figure 46 - Pelvis strains for test 006. The left S.I. gauge experienced the largest compressive strain.

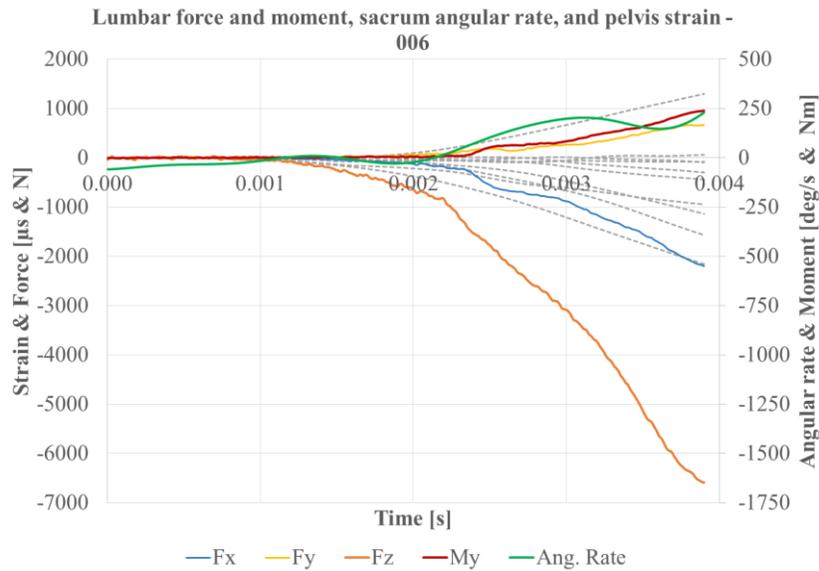
Figure 47 - Pelvis forces and moments, as well as sacrum angular rate for test 006. The gray dotted lines are the strains from the previous figure. Fz was the dominant force, and My and the angular rate sensor both had positive trends.

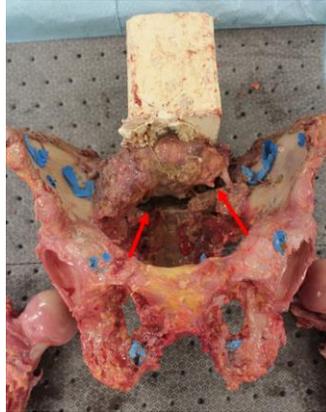
Figure 51 – Injury picture for test 006. A transverse fracture extended across the entire anterior sacrum at the level of the second foramen.

the second foramen. Comminuted coccyx fracture. Figure 51 shows a picture from the dissection of a fracture.

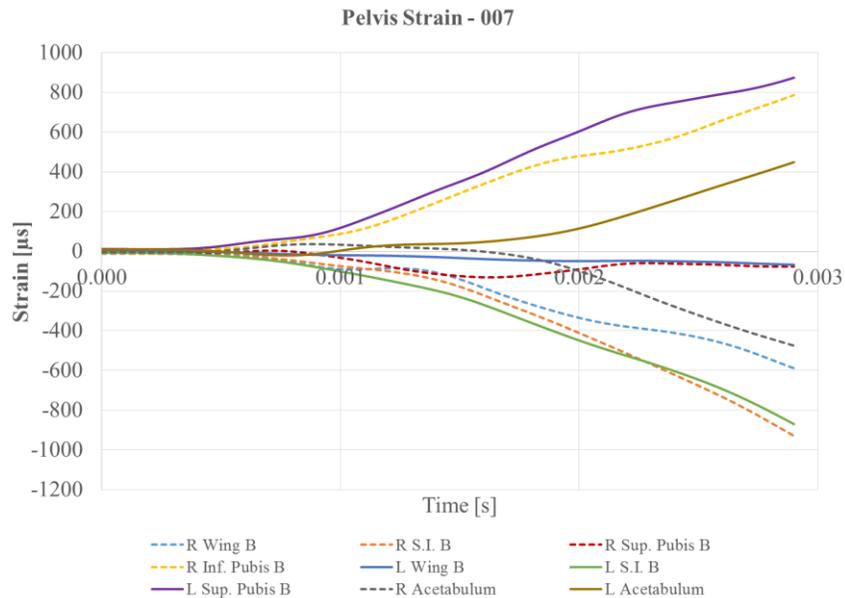
Figure 52 - Pelvis strains for test 007. The left and right S.I. gauges experienced the largest compressive strains.

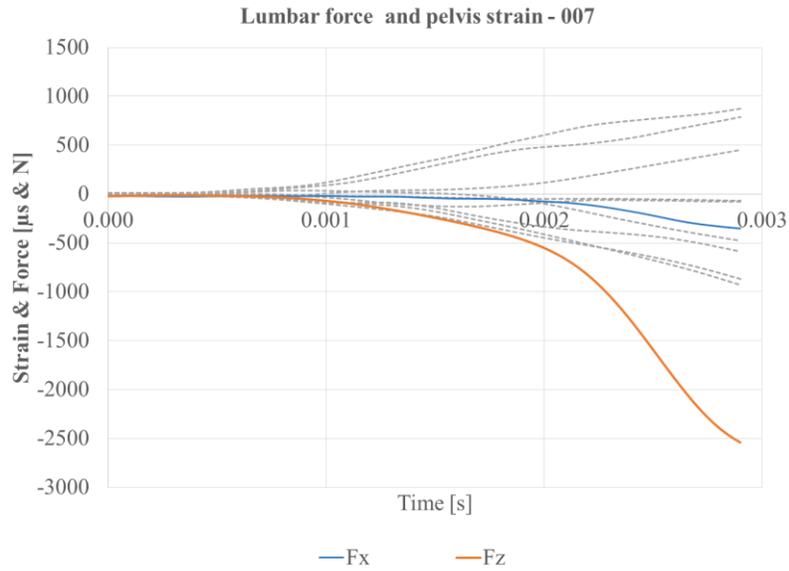
Figure 53 - Pelvis Fx and Fz for test 007. The gray dotted lines are the strains from the previous figure. Fz was the dominant force and reached over 2.5kN before failure.

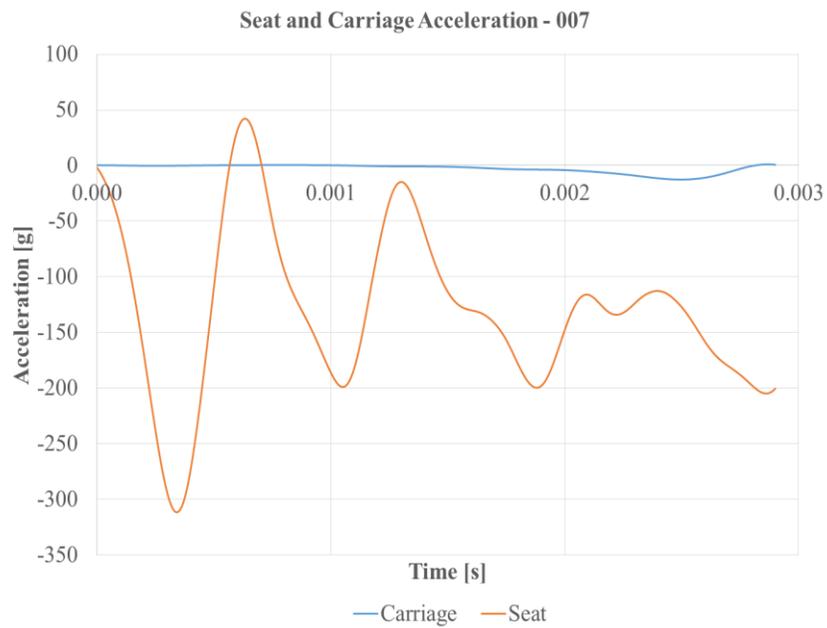
Figure 54 - Seat and carriage accelerations for test 007. The carriage does not start to accelerate until ~1.75ms.

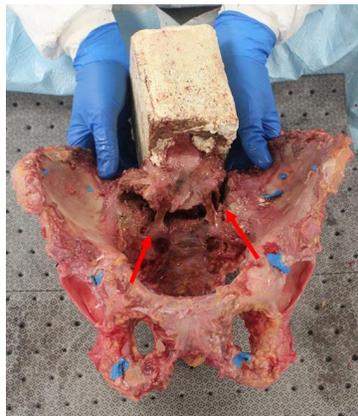
Figure 56 – Injury picture for test 007. Transverse fracture between the first foramen.

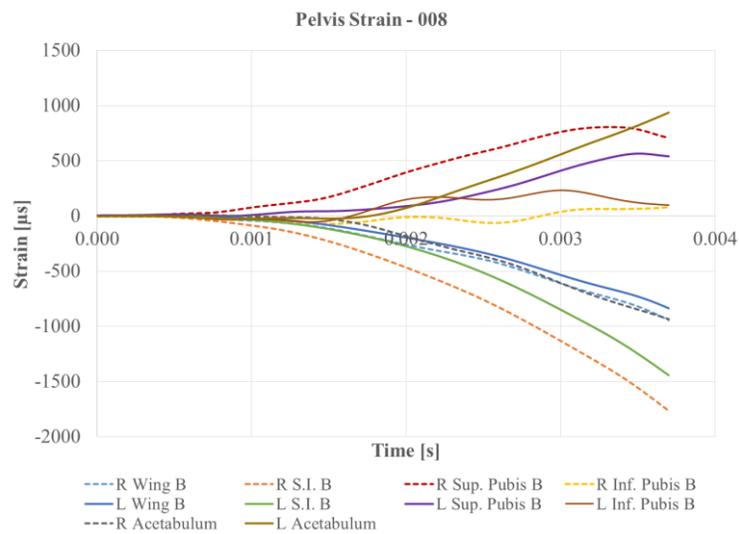
Figure 57 - Pelvis strains for test 008. The left and right S.I. gauges experienced the largest compressive strains.

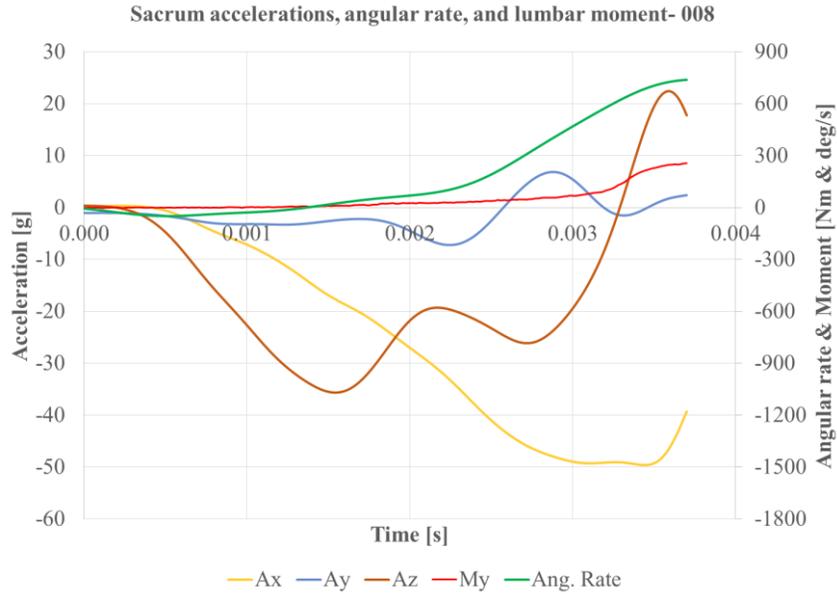
Figure 59 - Sacrum accelerations and angular rate, and pelvis moment about the y-axis for test 008. Az was negative until ~1.5ms. Ax experienced acceleration in the negative direction and reached a minimum just before the angular rate sensor reached its peak.

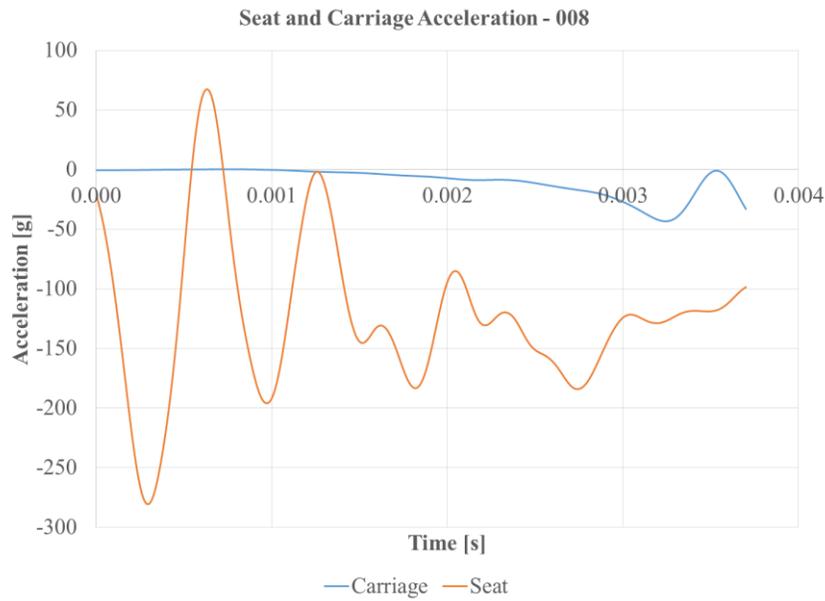
Figure 60 - Seat and carriage accelerations for test 008. The carriage does not start to accelerate until ~1.5ms.

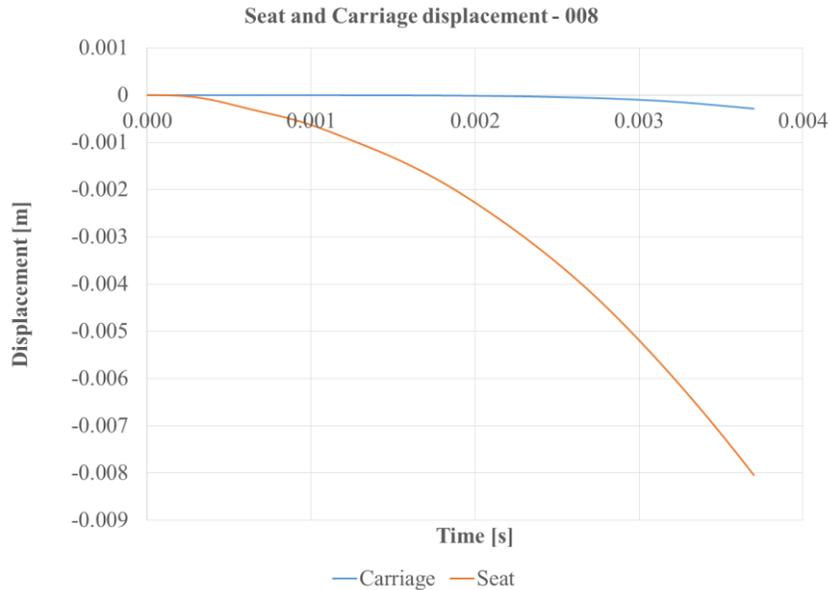
Figure 61 - Seat and carriage displacements for test 008. The displacements were calculated from double integrating the seat and carriage accelerometers. The total seat displacement was ~8mm.

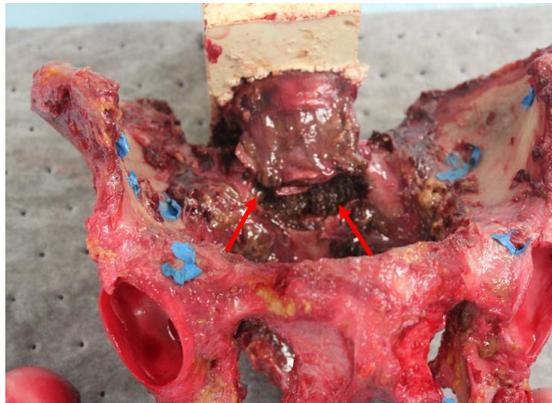
Figure 62 – Injury picture for test 008. There was transverse fracture extending between the first sacral foramen.

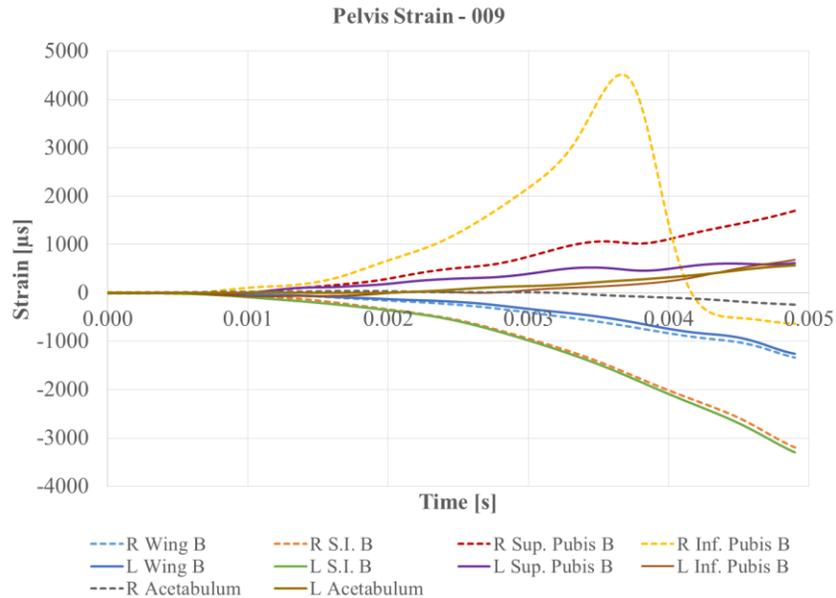
Figure 63 - Pelvis strains for test 009. The left and right S.I. gauges experienced the largest compressive strains. The large peak measured by the right inferior pubis gauge is attributed to a localized fracture diagnosed in the post-test dissection.

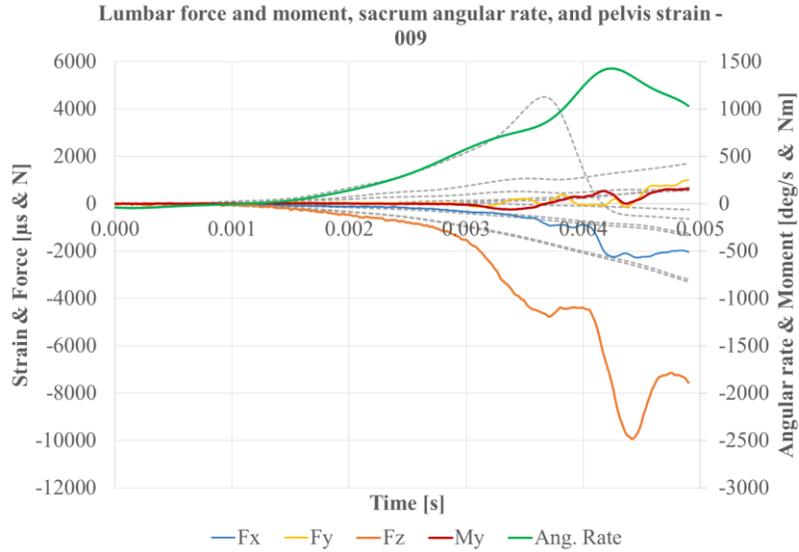
Figure 64 - Pelvis forces and moments, as well as sacrum angular rate for test 009. The gray dotted lines are the strains from the previous figure. As the dominant force, experienced a loading phase up to about 3.75 ms before it unloaded and reloaded, which corresponds to the peak in the right inferior pubis gauge and reflects fracture in the ischial tuberosities. My and the angular rate sensor both had positive trends.

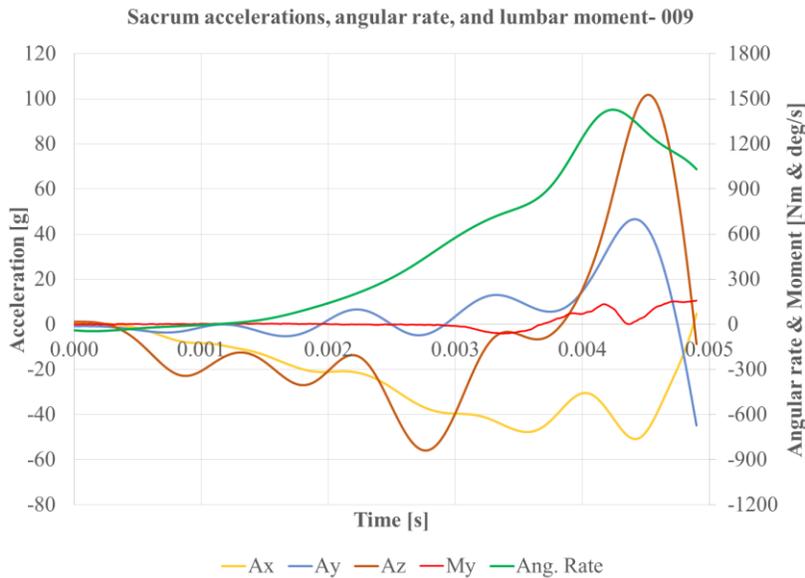
Figure 65 - Sacrum accelerations and angular rate, and pelvis moment about the y-axis for test 009. Ax, Ay, and Az all experienced peaks just after 4 ms, which correspond to the reloading in Fz and likely represent failure in the sacrum.

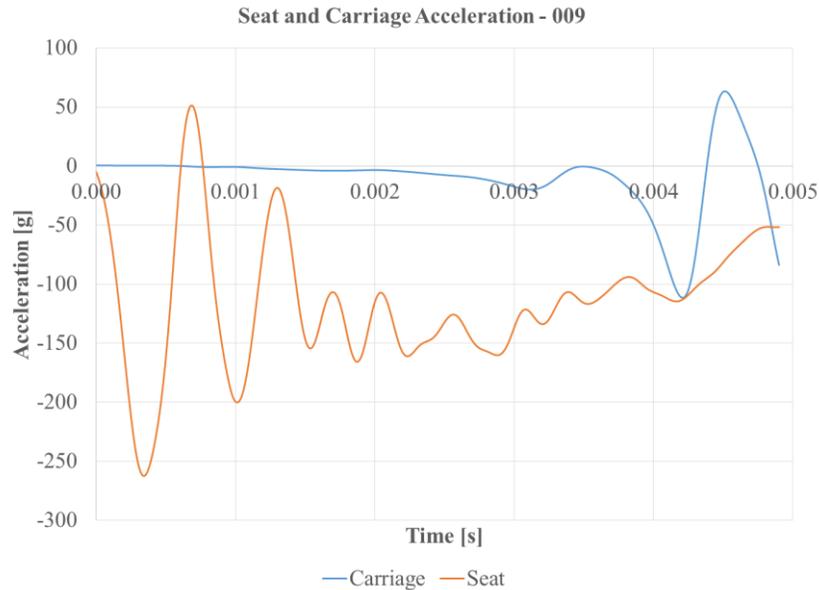
Figure 66 - Seat and carriage accelerations for test 009. The carriage does not start to accelerate until ~1.5ms.

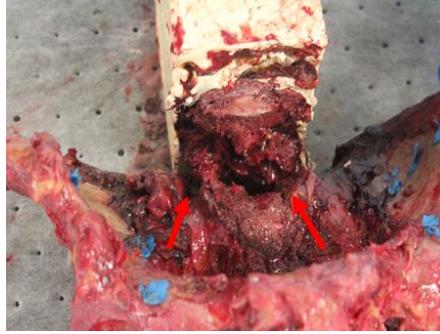
Figure 68 – Injury picture for test 009. The fracture line passed through the first and second sacral foramen then traveled to the left anterior edge of the sacrum at the level of the fourth foramen.

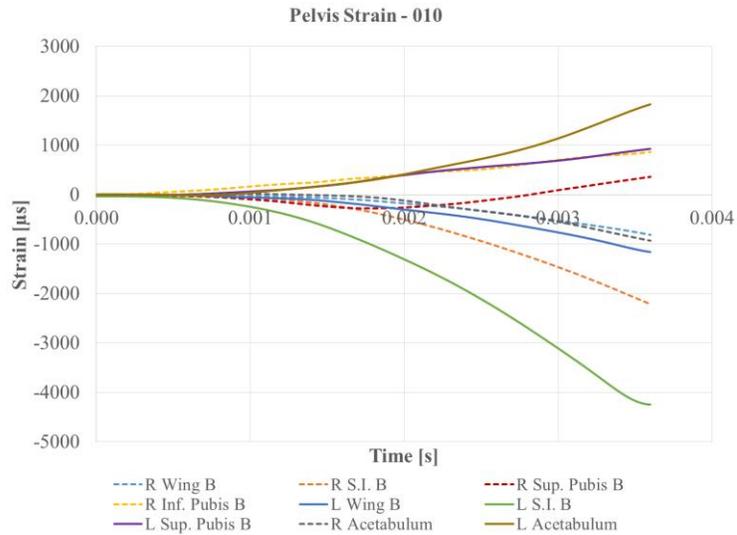
Figure 69 - Pelvis strains for test 010. The left and right S.I. gauges experienced the largest compressive strains.

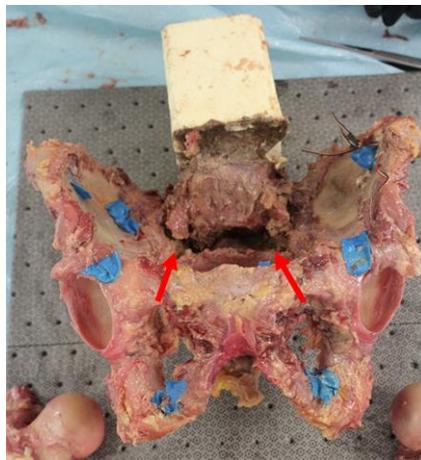
Figure 74 – Injury picture for test 010. Transverse fracture at the level of the inferior edge of the first sacral foramen.

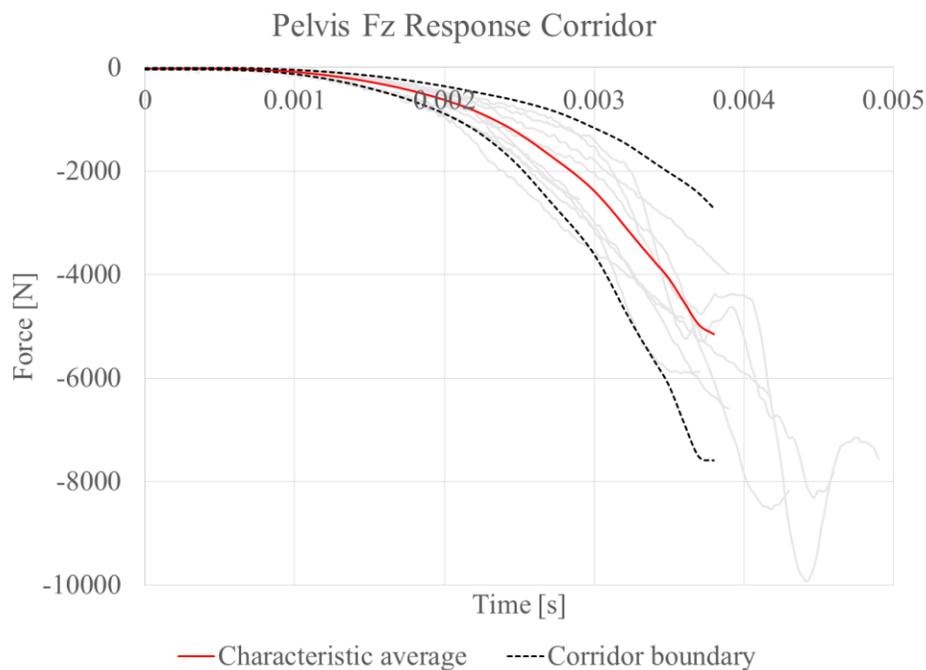
Figure 75 – Response corridor of Fz forces. The red line is the calculated characteristic average and the dotted black lines are the bounds of the corridor. The light gray lines are the data traces that Fz data traces that are terminated at time of failure.
