Biomechanical response of the human pelvis: a high-rate vertical loading pilot study

A Thesis

Master of Science

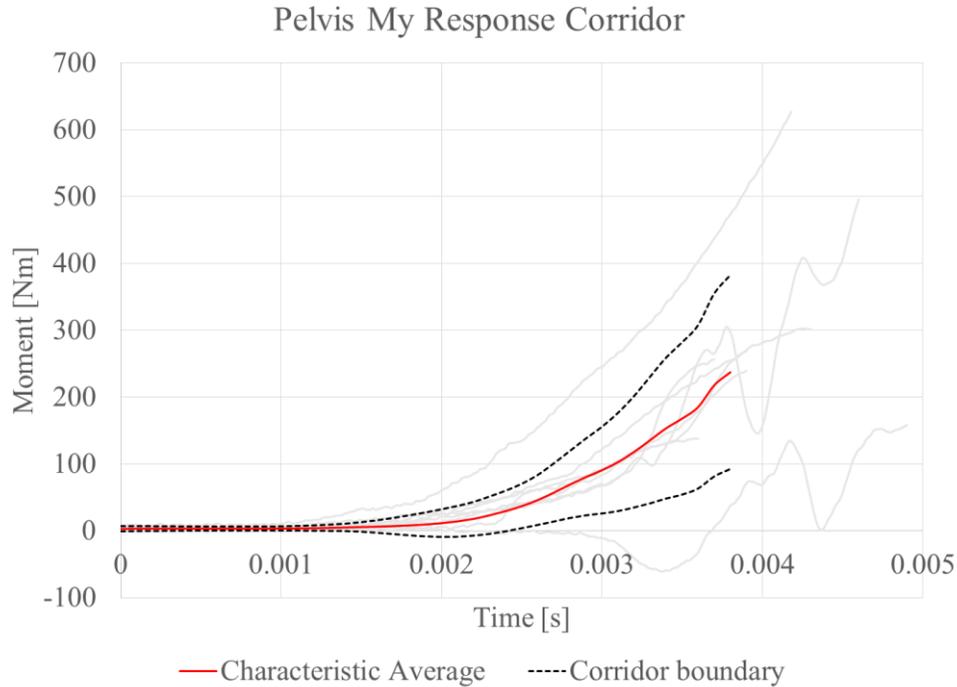
Figure 76 - Response corridor of My moments. The red line is the calculated characteristic average and the dotted black lines are the bounds of the corridor. The light gray lines are the data traces that My data traces that are terminated at time of failure.

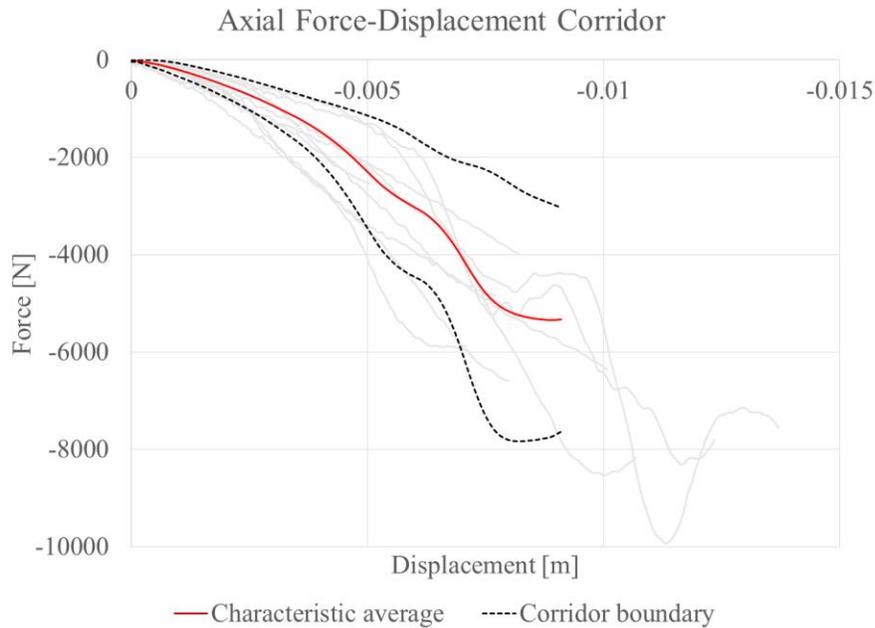
Figure 77 – Axial force-displacement plots up to fracture. A linear relationship was assumed for the stiffness calculation. The light gray lines are force-displacement traces that are terminated at time of failure.

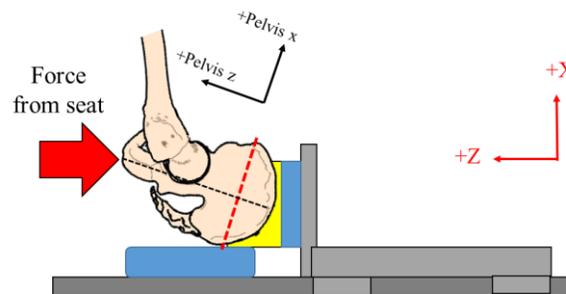
Figure 78 – Schematic of the pelvis being loaded by the seat.

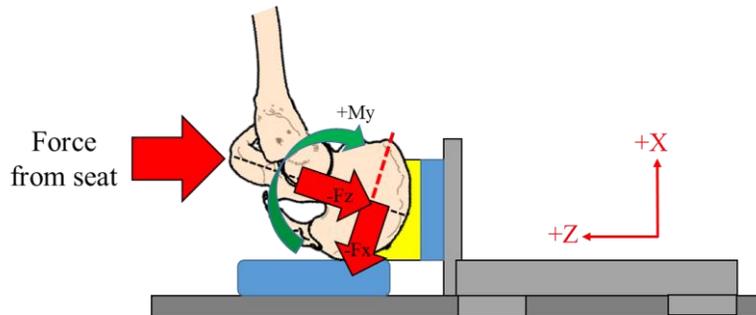
Figure 80 – Schematic of the axial and shear forces experienced by the pelvis, as well as the positive moment about the y-axis.

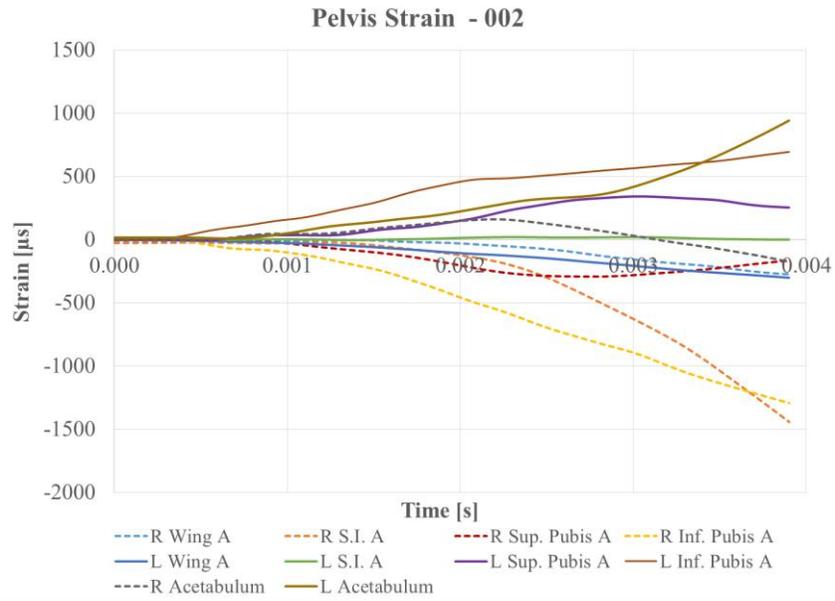
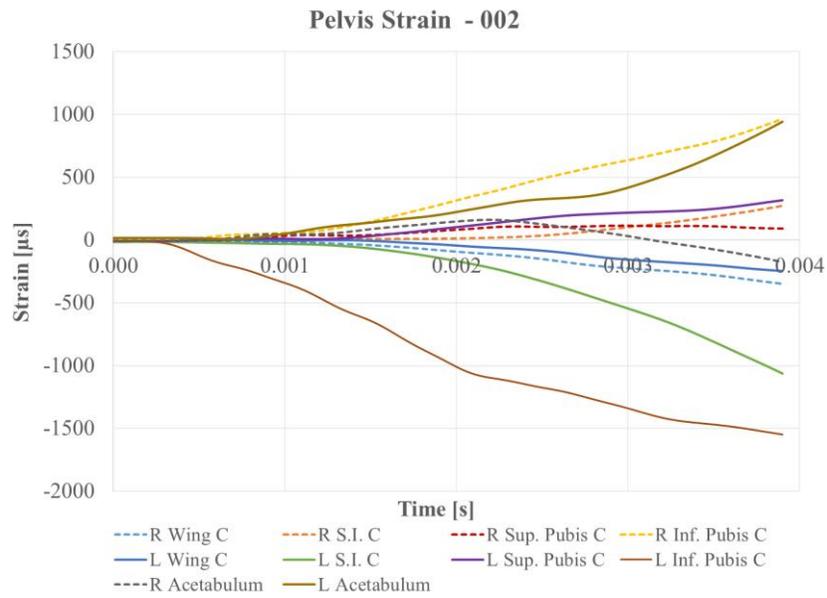
Pelvis 002

Figure A-1: Strain gauge data from the 'A' gauges for test 002.

Figure A-2: Strain gauge data from the 'C' gauges for test 002.

Below are detailed plots of all sensor data recorded. Since rosette strain gauges were used throughout the pelvis, it should be noted that only the 'B' gauges are plotted below since they were the gauges used for alignment when applying to the bone. Gauges 'A' and 'C' appear in Appendix B.

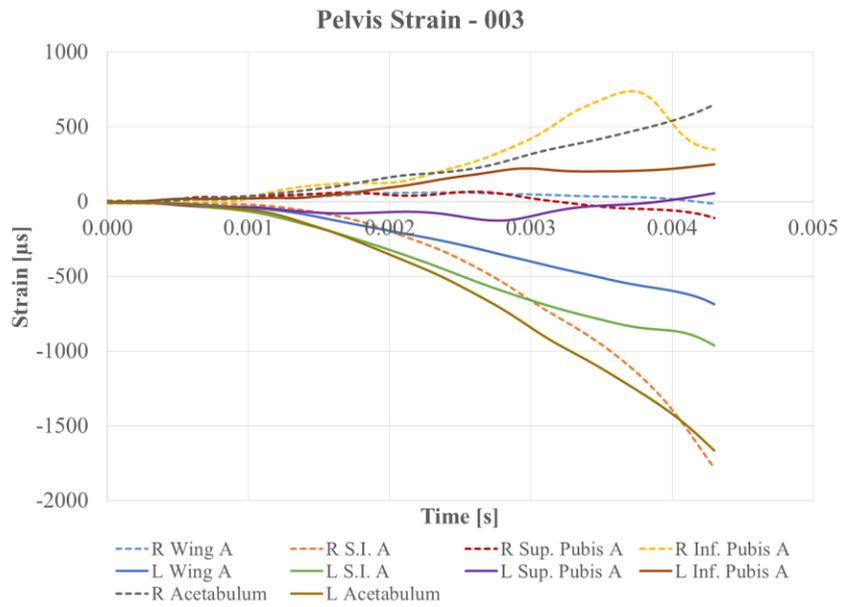
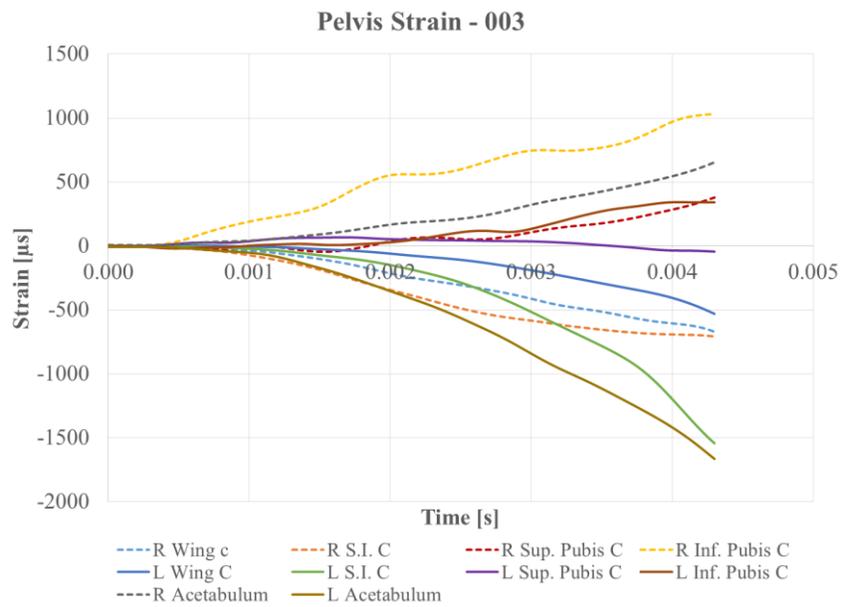
Pelvis 003

Figure A-3: Strain gauge data from the 'A' gauges for test 003.

Figure A-4: Strain gauge data from the 'C' gauges for test 003.

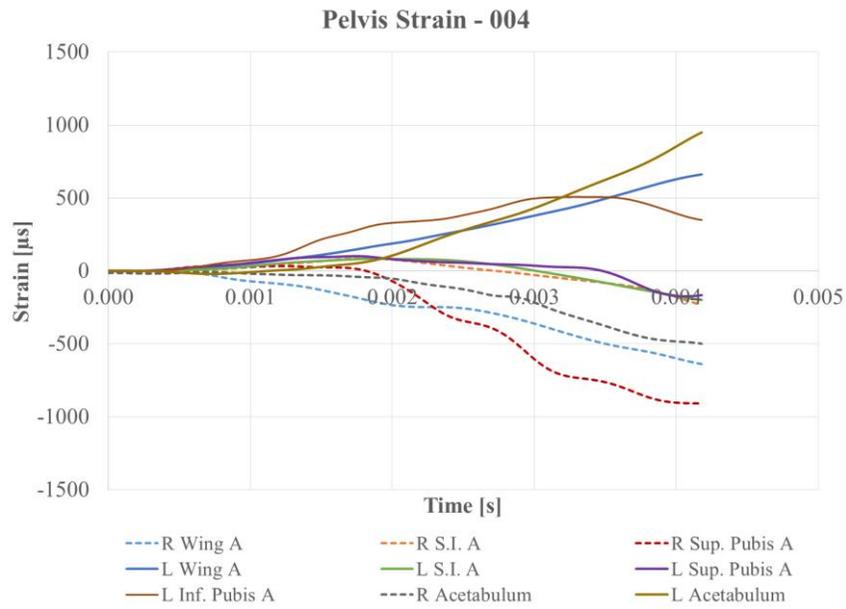
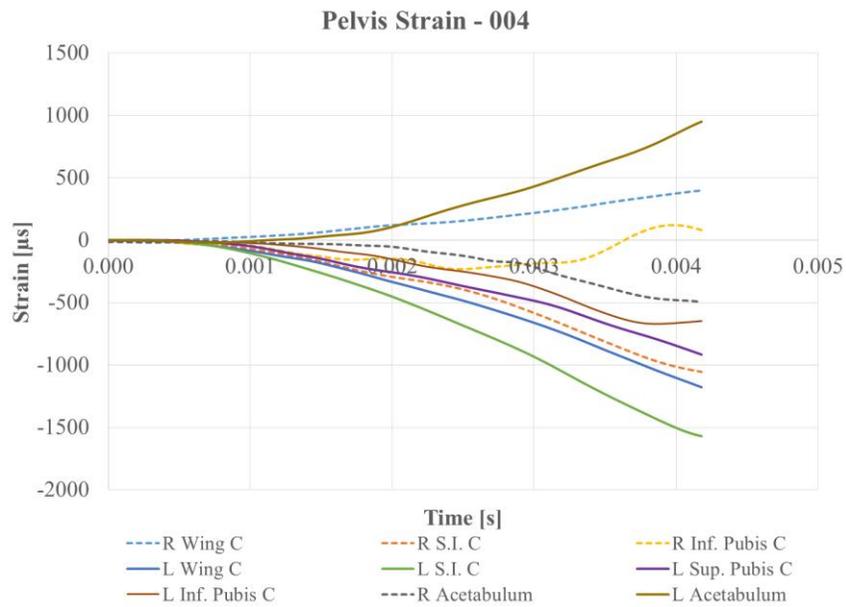
Pelvis 004

Figure A-5: Strain gauge data from the 'A' gauges for test 004.

Figure A-6: Strain gauge data from the 'C' gauges for test 004.

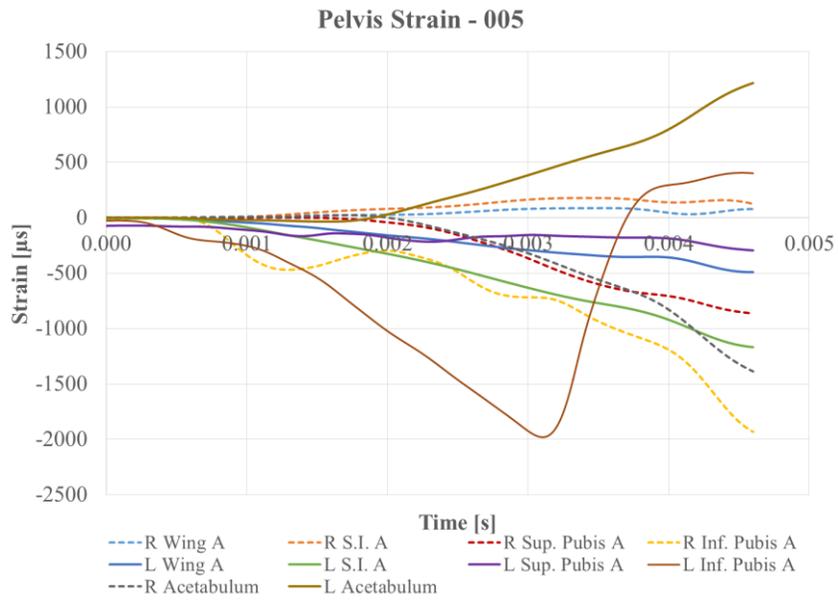
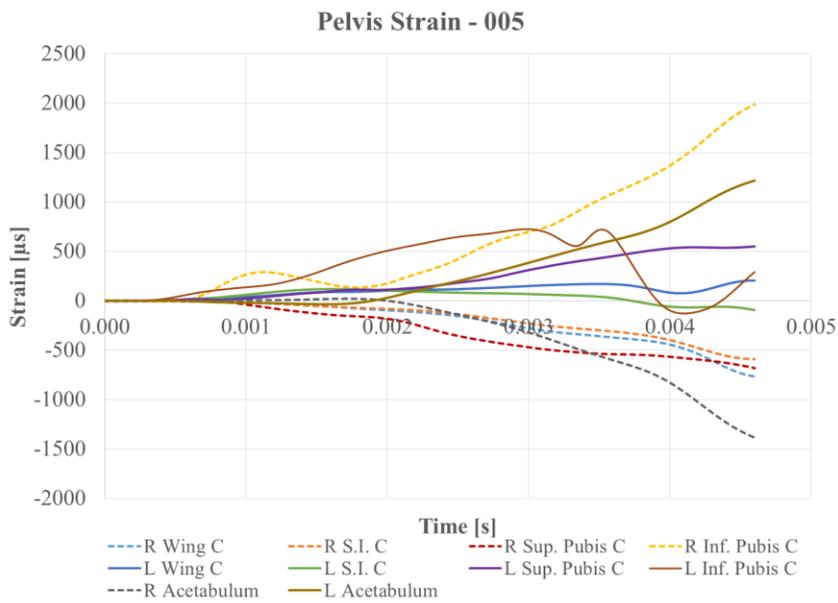
Figure A-7: Strain gauge data from the 'A' gauges for test 005.

Figure A-8: Strain gauge data from the 'C' gauges for test 005.

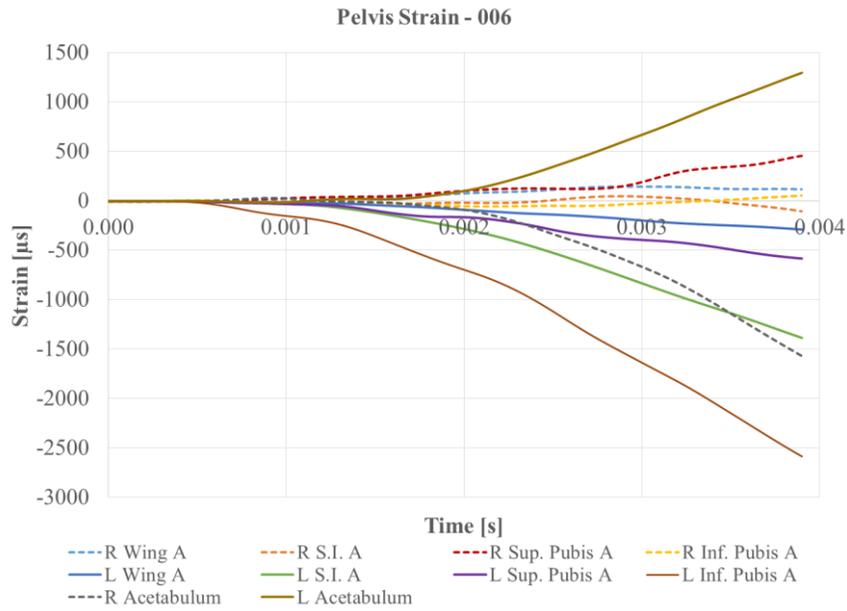
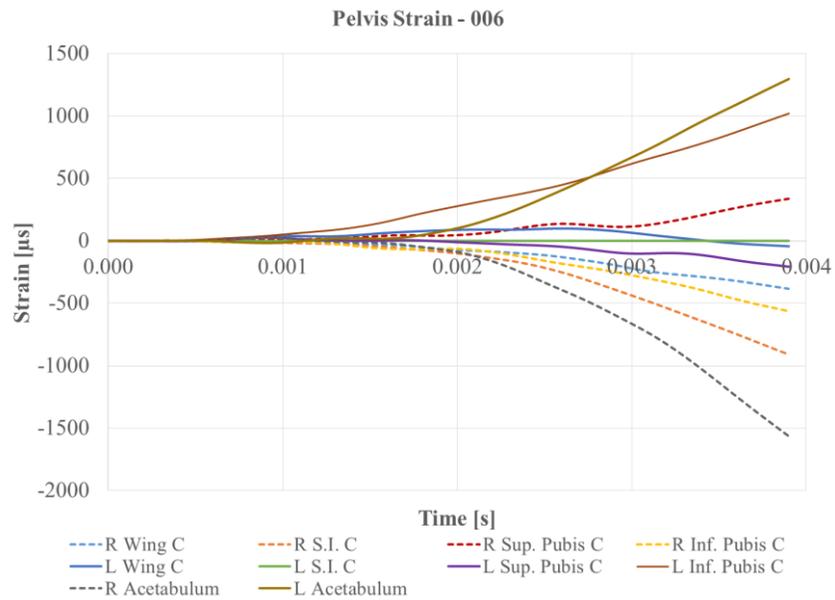
Figure A-9: Strain gauge data from the 'A' gauges for test 006.

Figure A-10: Strain gauge data from the 'C' gauges for test 006.

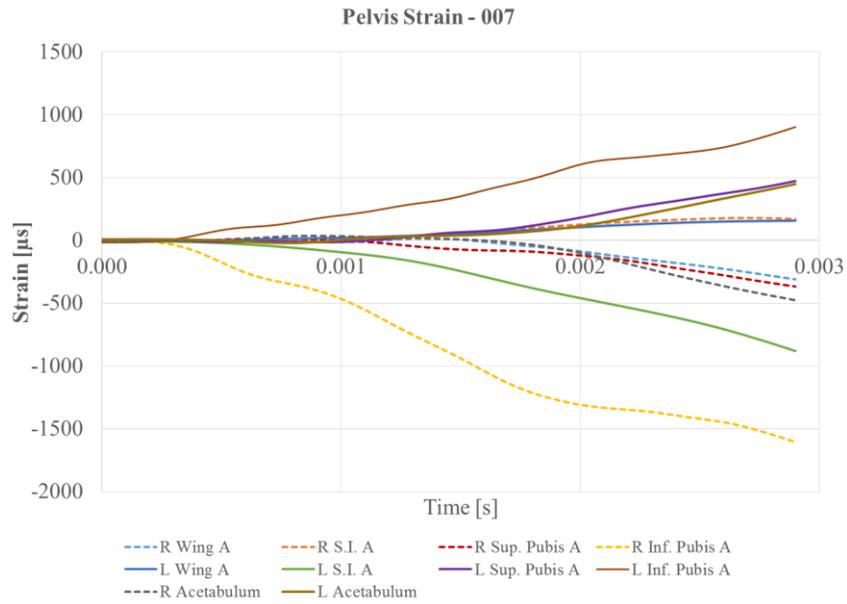
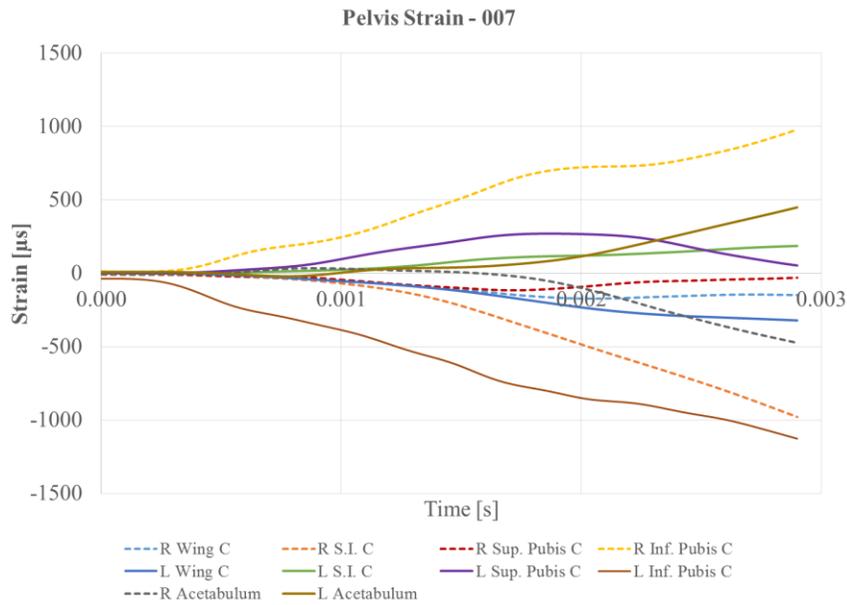
Figure A-11: Strain gauge data from the 'A' gauges for test 007.

Figure A-12: Strain gauge data from the 'C' gauges for test 007.

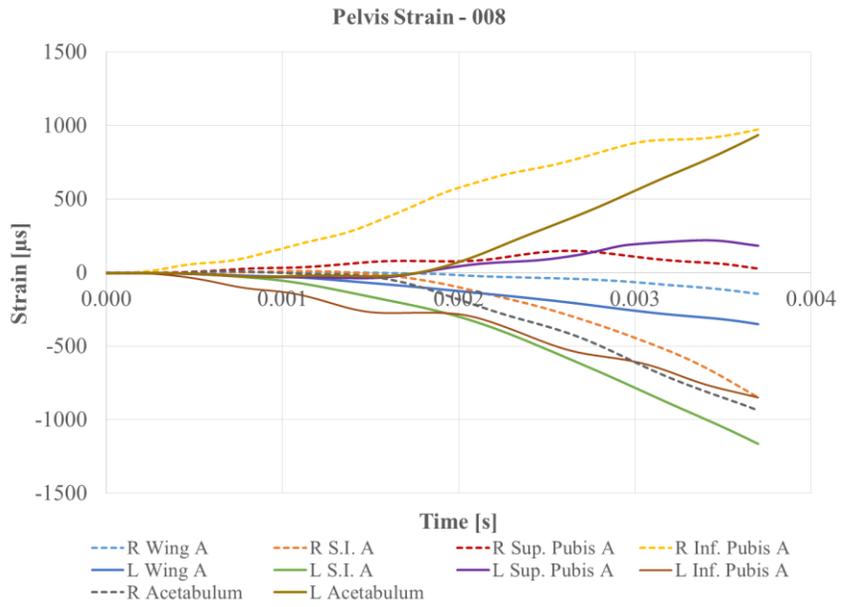
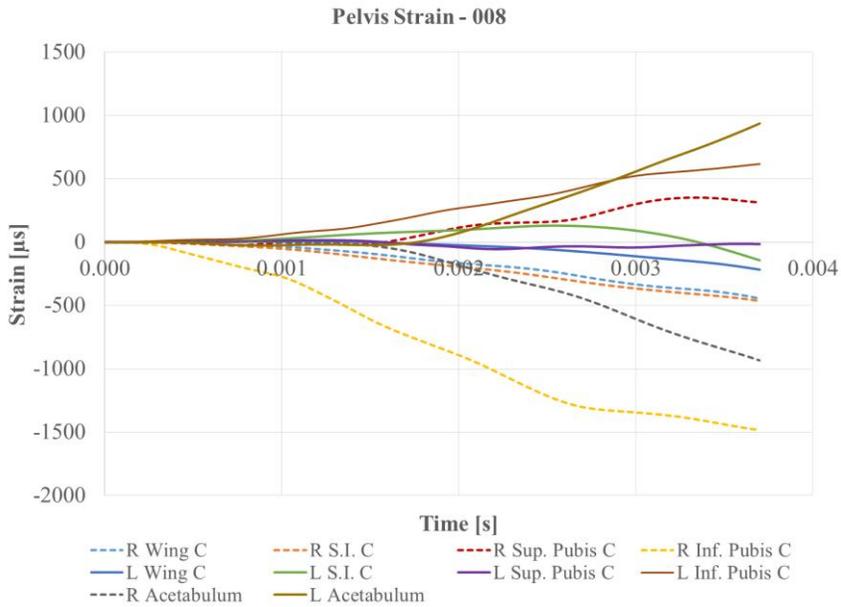
Figure A-13: Strain gauge data from the 'A' gauges for test 008.

Figure A-14: Strain gauge data from the 'C' gauges for test 008.

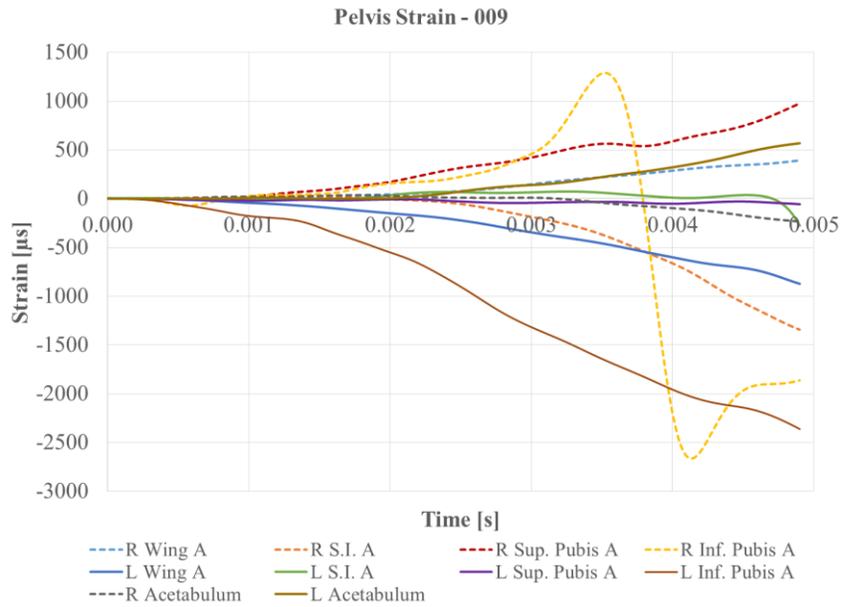
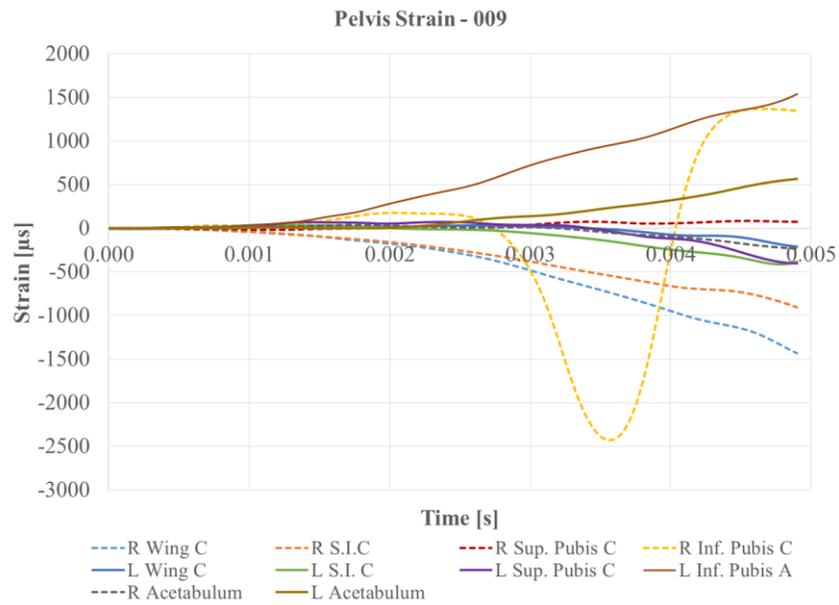
Figure A-15: Strain gauge data from the 'A' gauges for test 009.

Figure A-16: Strain gauge data from the 'C' gauges for test 009.

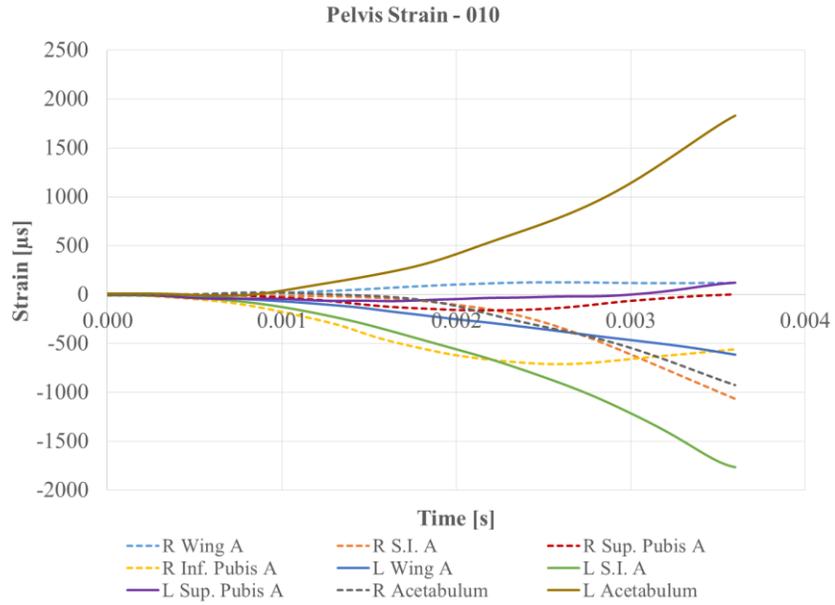
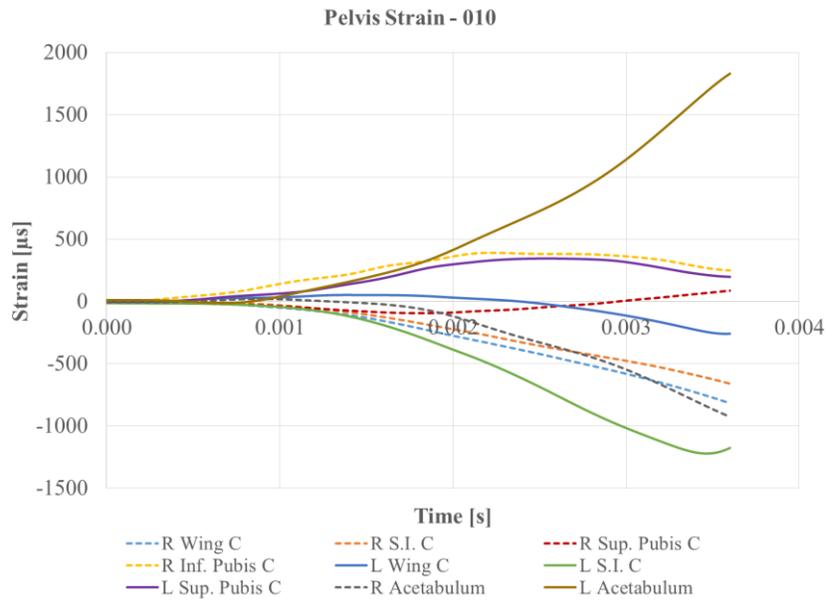
Figure A-17: Strain gauge data from the 'A' gauges for test 010.

Figure A-18: Strain gauge data from the 'C' gauges for test 010.
