**Protecting the Great Walls of Saqsaywaman
by restoring the original Incan drainage
infrastructure**

A Thesis

Presented to
the faculty of the School of Engineering and Applied Science
University of Virginia

Helena C. Nicholakos

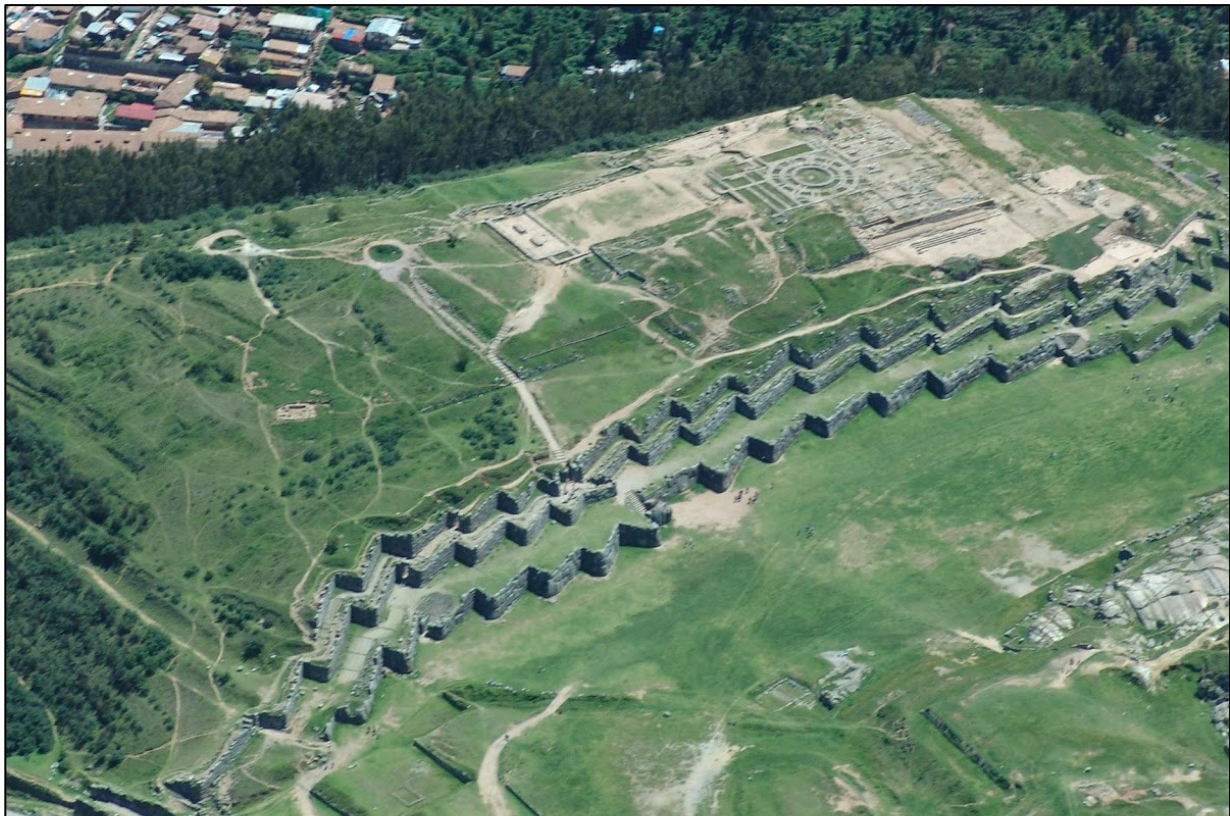
Figure 1.1: Overhead view of Saqsaywaman (Mavity et al., 2017)

Saqsaywaman (Figure 1.1), one of the most impressive Incan archeological sites in Peru, has a major problem. The site's most remarkable features – its three megalithic walls (Figure 1.2) – have begun to fail after five centuries of remaining structurally sound. A section of the third Great Wall collapsed in 2010 due to large volumes of uncontrolled stormwater runoff. The runoff created a hydrostatic pressure buildup behind the wall, and the pressure load caused the wall to overturn (Figure 1.3). The runoff had unintentionally been routed towards the third wall by an impermeable clay cover that was placed above it in 2009. This collapse was unexpected because the Great Walls are constructed of massive, tightly fitted boulders (Figure 1.4), some of which are 15 feet tall and weigh over 200 tons (O'Neil, 2016).

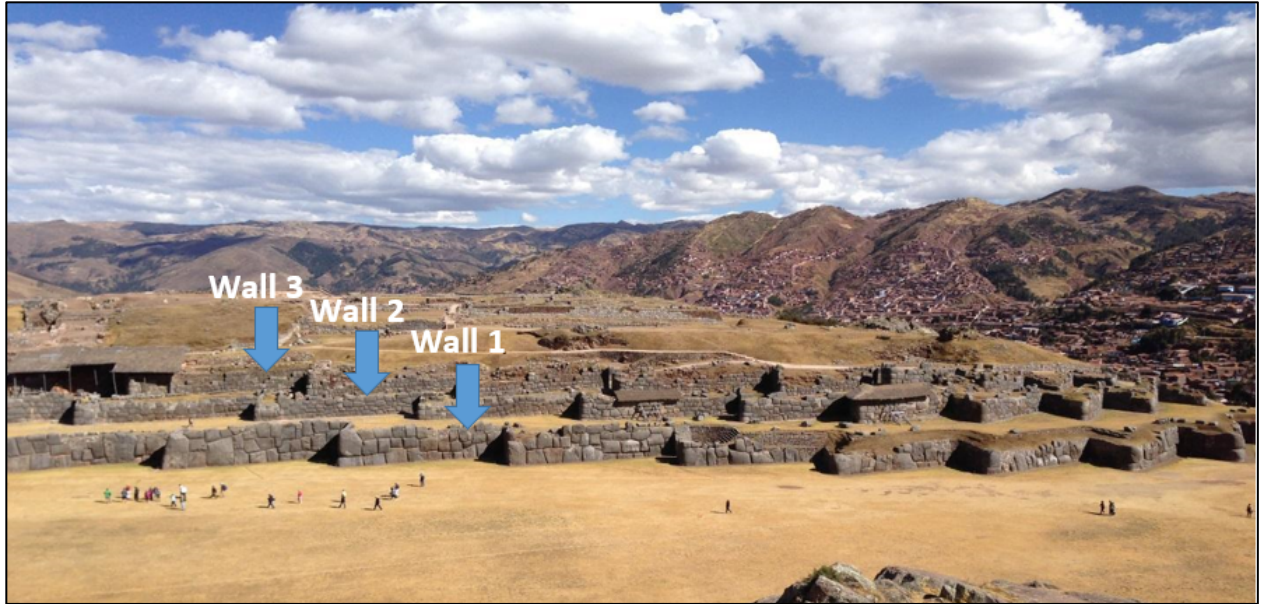
Figure 1.2: The three Great Walls of Saqsaywaman (O'Neil, 2016)

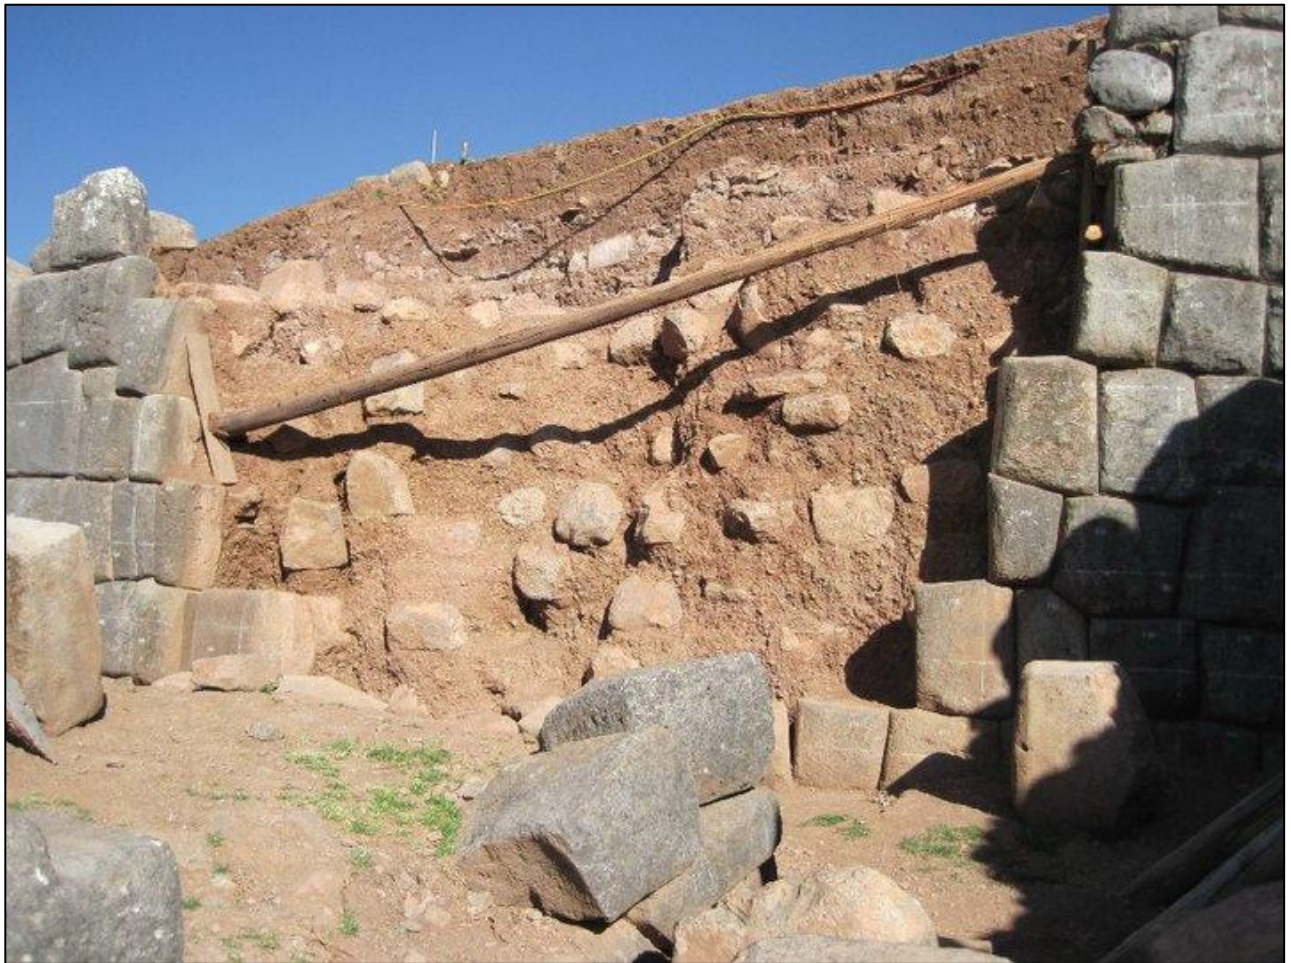
Figure 1.3: Collapsed section of the third Great Wall (Wildfire et al., 2011)

Although this collapse was triggered by recent man-made changes in the land cover and topography, it is indicative of a wider problem with the site. Once a marvel of the careful and thorough engineering skills of the Inca, 500 years of damage and abuse have undone their engineering work. Saqsaywaman has not been fully functioning since the early 1500s, and the Great Walls are one of the only original pieces of the site still mostly intact. The Inca were expert civil engineers, and if Saqsaywaman was still operating as they designed it, it is possible that the Great Walls would not be in the danger they are in now.

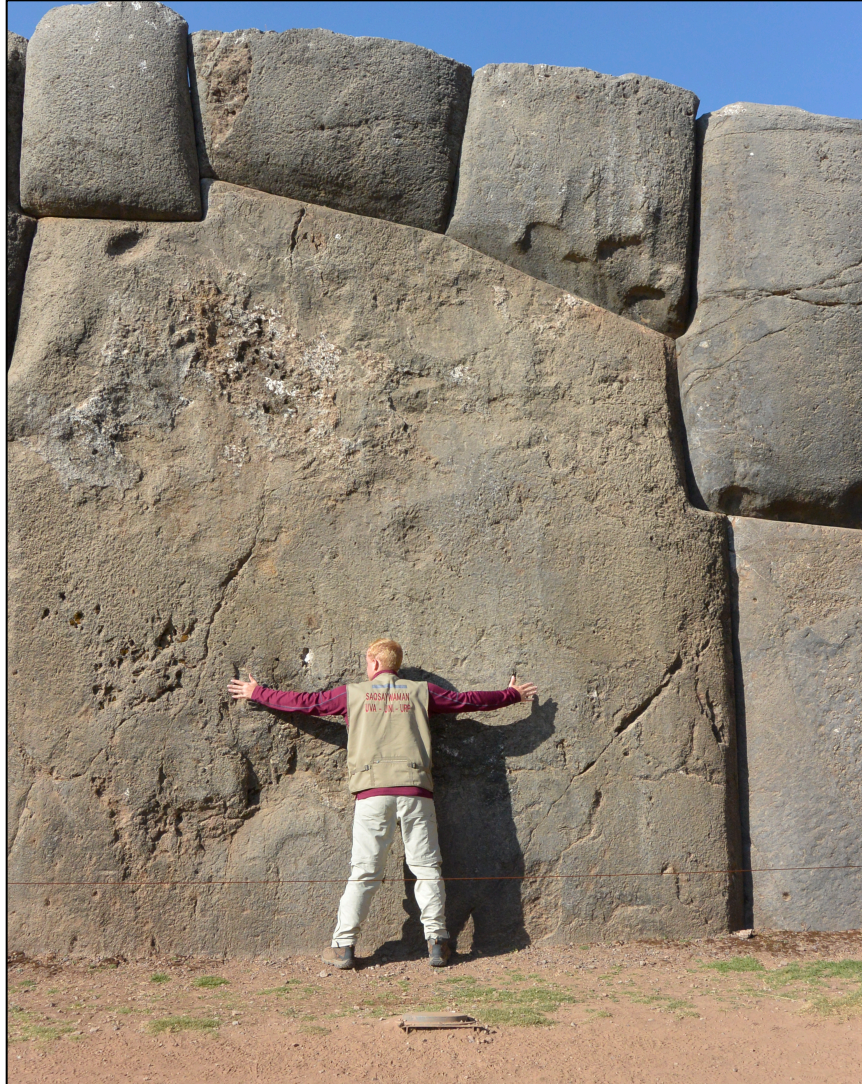
Figure 1.4: A megalithic boulder in the Great Walls (Jarriel, 2016)

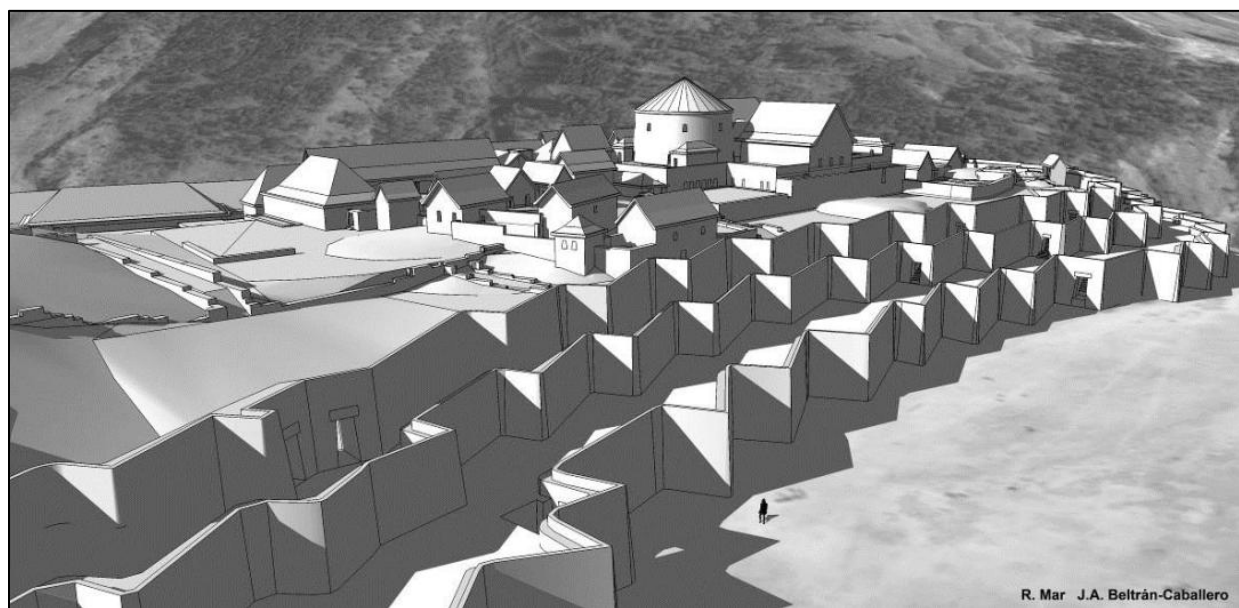
Figure 2.3: Three-dimensional digital reconstruction of the towers sector at Sagsaywaman (Mar & Beltran-Caballero, 2014)

representation of this area created by Mar & Beltrán-Caballero (from Figure 2.3) showed other small buildings adjacent to the towers in this area. The density of the buildings in these representations led to the assumption that this area's original land cover could most closely be approximated to our modern-day residential land cover.

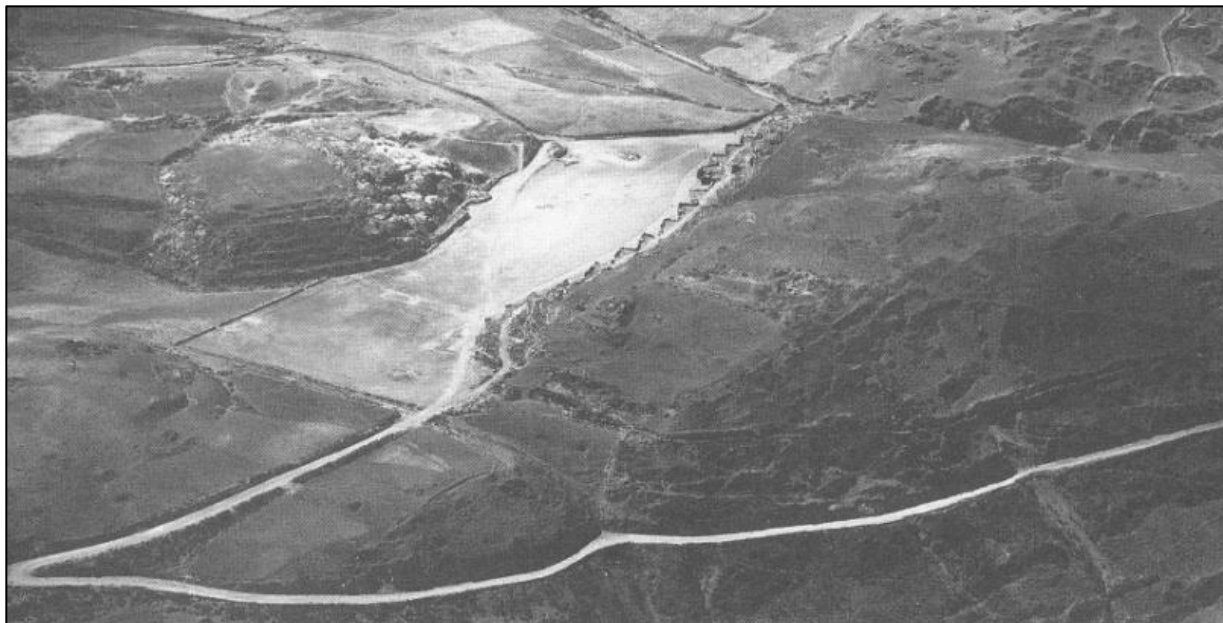
Figure 2.5: Unexcavated Sacsaywaman in 1930 (Bauer, 2004)

The first major excavation of Saqsaywaman was conducted in 1933 by Luis Valcarcel, a preeminent Peruvian anthropologist. When Valcarcel reached Saqsaywaman, the site was mostly covered in soil and debris (Figure 2.5). After his excavations, the tower sector foundations became visible and the west hill terraces were uncovered (Figure 2.6). In the 21st century, the tower sector was further excavated, and archeologists sealed these new excavations with protective cement coverings. Figures 2.7 and 2.8 show Google earth images of the site in 2002 and 2011, respectively. Comparing these images side by side, one can see that the cement covers appear in the tower sector between 2002 and 2011.

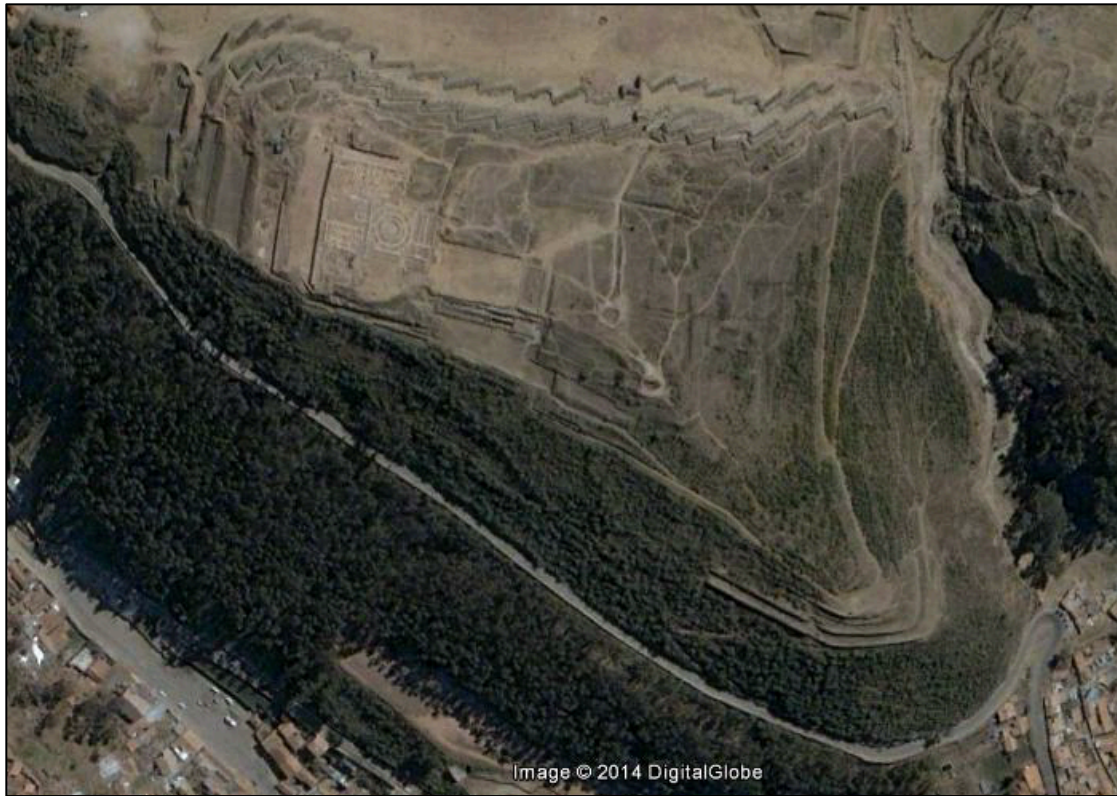
Figure 2.7: Sacsaywaman in 2002 (Lohr, 2014)

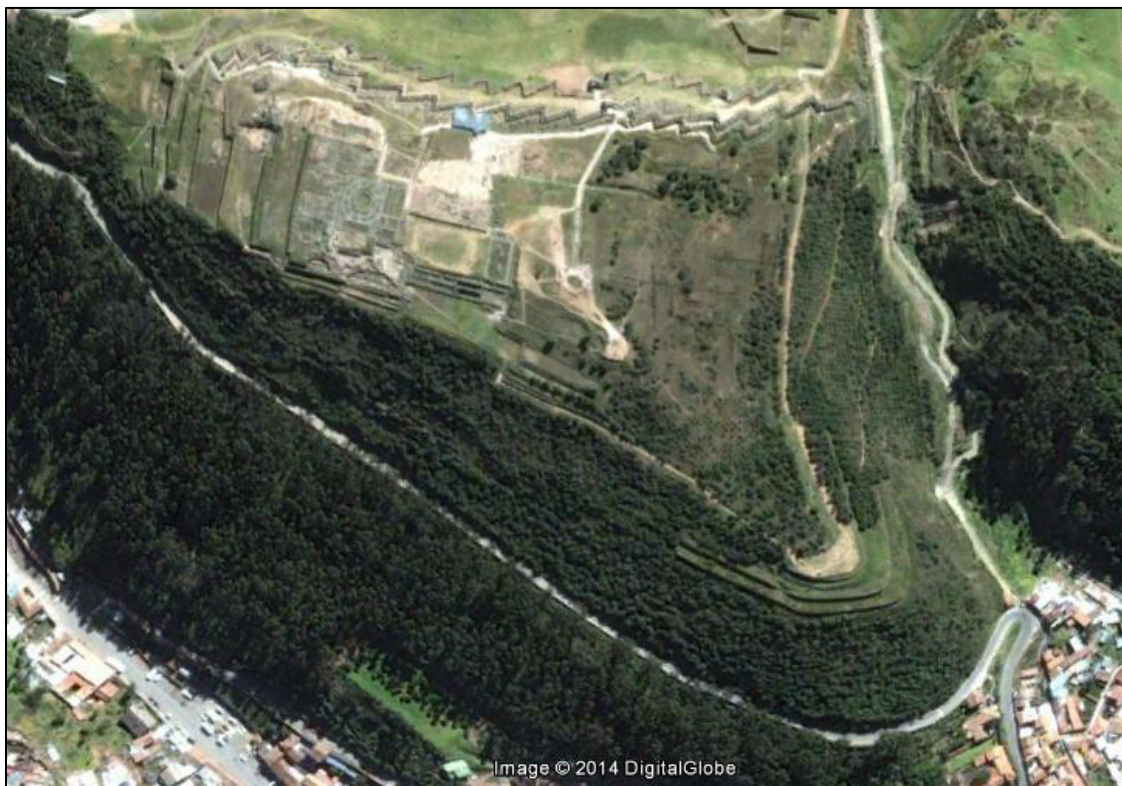
Figure 2.8: Sacsaywaman in 2011 (Lohr, 2014)

cement covers in the tower sector were put in place for similar reasons – to protect the foundational remains from eroded soil by simply covering the soil with an impermeable pavement. Unfortunately, the new cement covers had the unintended consequence of changing the runoff patterns in the northern area of the site. In particular, the sloped cement cover directly above the center of the Great Walls (Figure 2.9) redirected large volumes of runoff towards the third Great Wall. This eventually caused the collapse of a large section of the third wall after it was no longer able to bear the pressure load from the runoff.

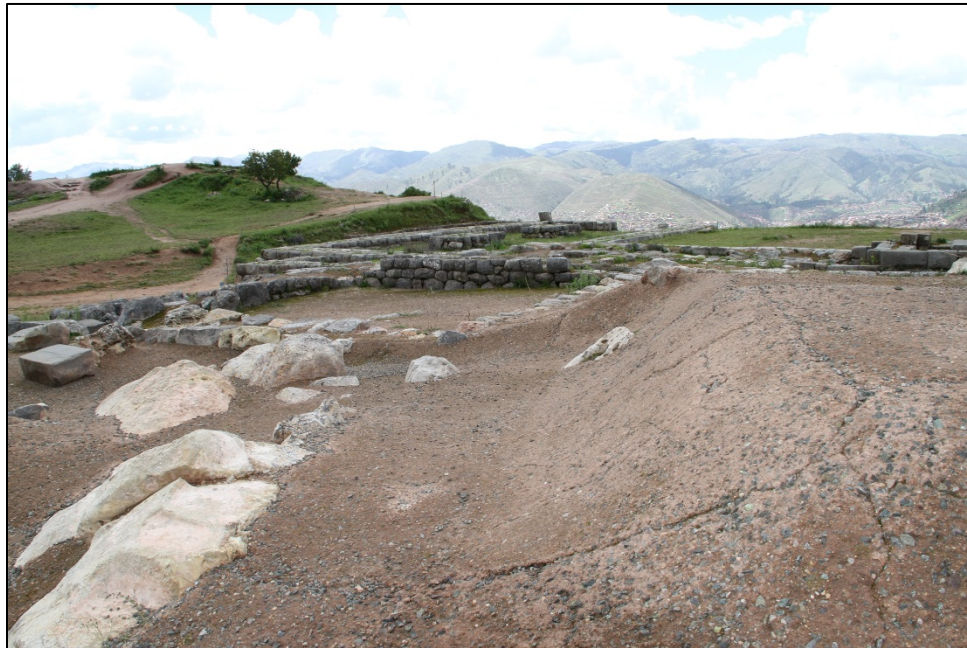
Figure 2.9: Impermeable clay cover above the third wall (Miksad)

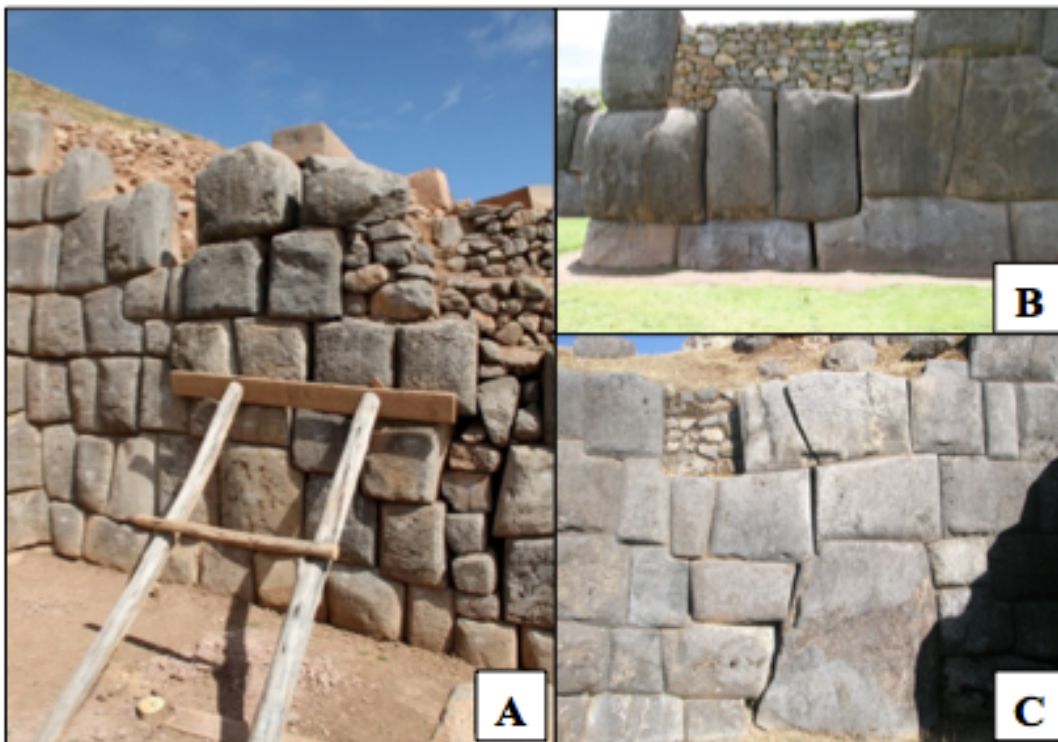
Figure 3.1: Physical evidence of damage to the third Great Wall due to hydrostatic pressure build-up: a) Support structures needed for bulging walls; b) Separation of stones; c) Vertical shearing (Miksad)

After centuries of the Great Walls remaining relatively stable and unchanged, this unexpected collapse led to the conclusion that the walls were not originally designed to handle large quantities of runoff. This conclusion was further substantiated by examining the choice of backfill materials used in the construction of the third wall (Wildfire et al., 2011). The backfill consisted of a mostly impervious soil and rock mixture, which did not allow water to drain effectively behind the wall. As a result, this backfill trapped any water that drained into it, causing hydrostatic pressure to build up behind the wall during storm events. When the hydrostatic pressure load became too large during the storm in 2010, the structural stability of the walls became compromised and prone to failure. Figure 3.1 below shows evidence of hydrostatic

damage in multiple locations on the third wall. The wall is bulging out in many places, putting it in danger of collapsing in those areas as well.

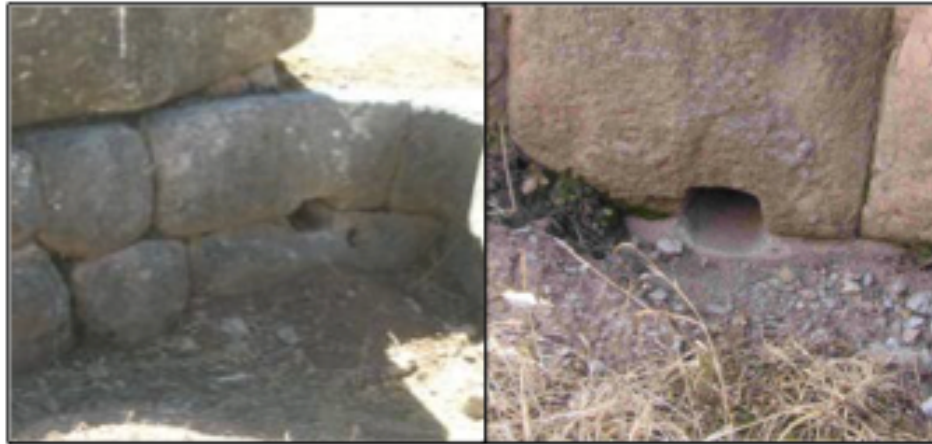
Figure 3.2: Examples of drainage ports in the second Great Wall (Miksad)

Besides lacking a porous backfill, the third wall also lacked any drainage ports, which would have provided an outlet for water to flow through after it percolated through the backfill. Porous backfills and drainage ports (Figure 3.2) were both used in the first and second Great Walls, as well as in walls at other Incan sites (Wildfire et al., 2011). The lack of these two characteristics in the third wall justifies the conclusion that it was never designed to handle large quantities of water. If the third wall was not designed to drain water, then the Incan engineers must have utilized some other form of drainage technology to control runoff in that area.

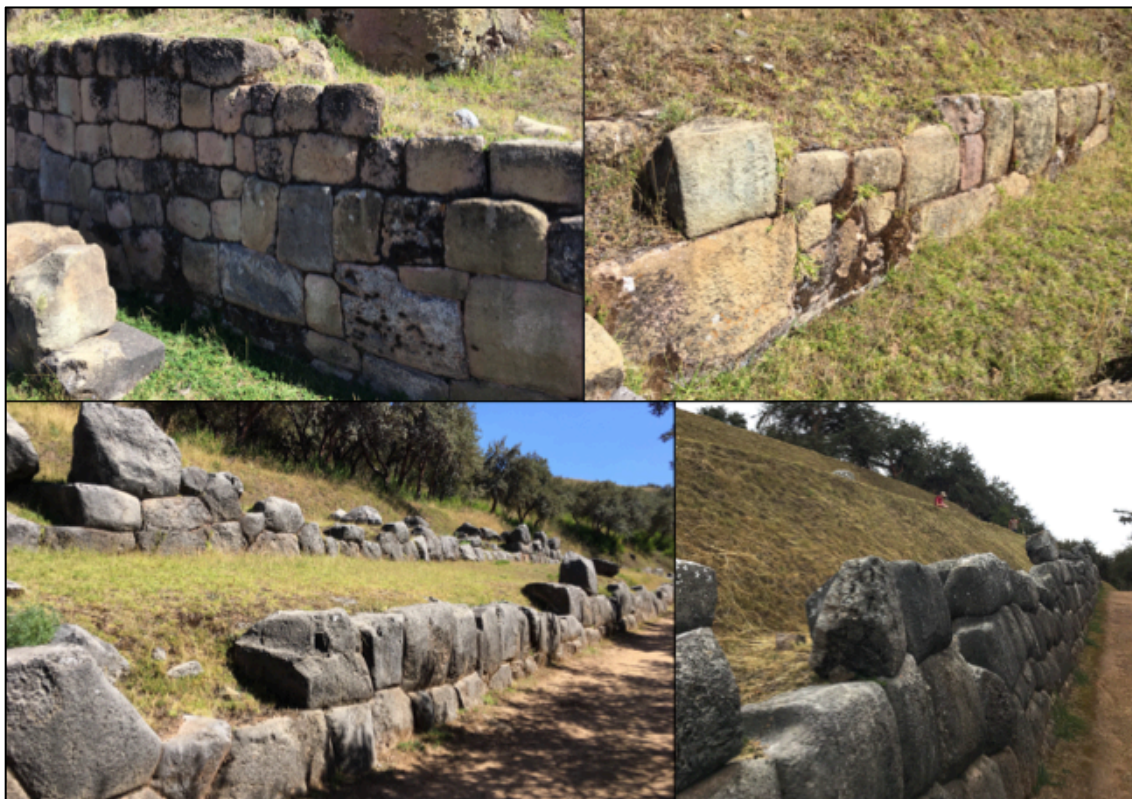
Figure 4.3: Examples of terrace walls missing several stones at Saqsaywaman

large or too tightly packed into the ground to be moved. For this reason, most of the terrace wall remains on site today are missing many of their top-layer stones (Figure 4.3), because they were the easiest stones to pick up and remove.

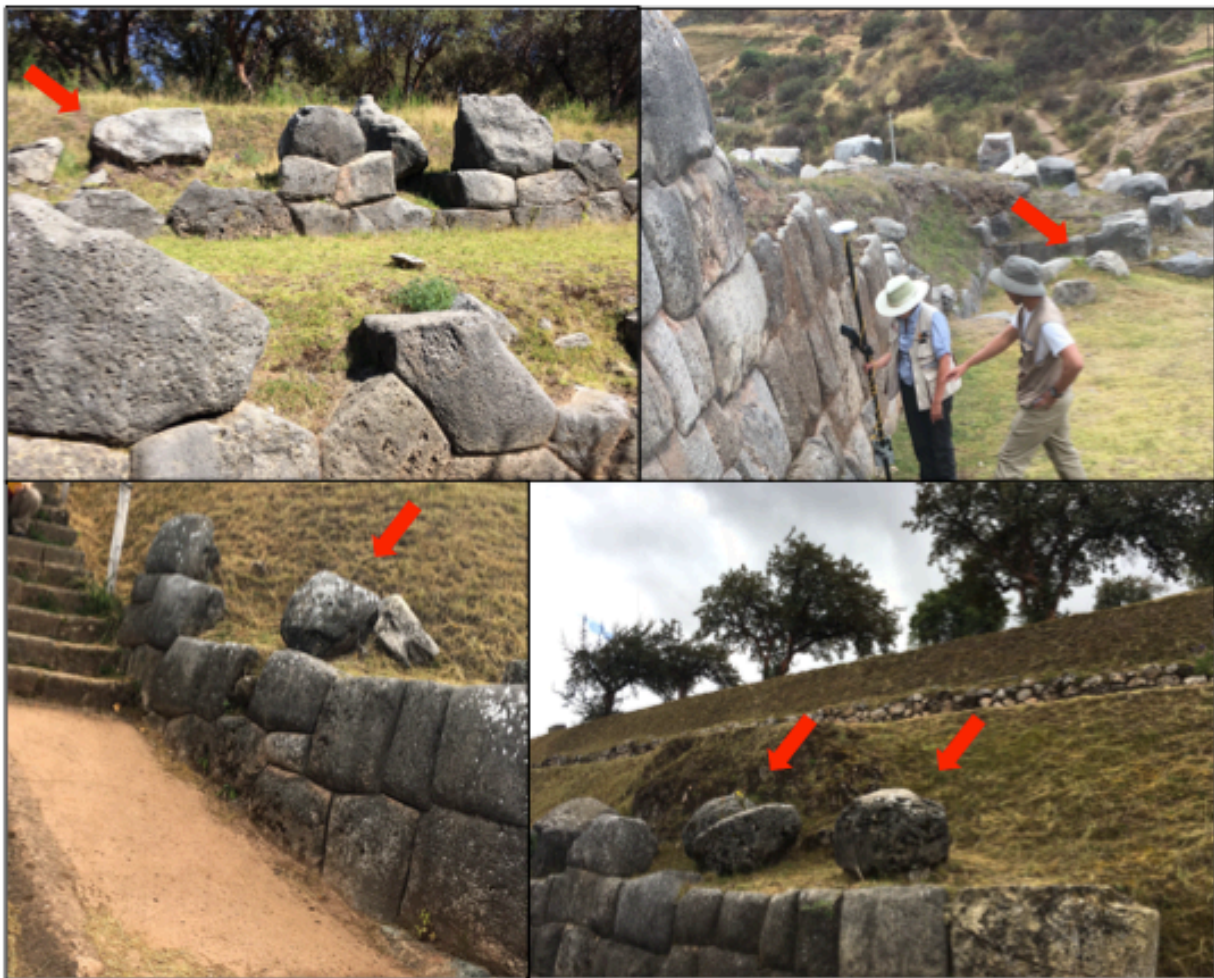
Figure 4.5: Examples of stray stones near terrace remains at Saqsaywaman

that were removed from a structure by Spanish conquerors and left lying on the ground. Today, there are still scattered, lost stones laying on the ground throughout the site (Figure 4.5), so it is reasonable to believe that there were even more misplaced stones lying around amongst the actual terrace remains after Saqsaywaman's initial destruction and abandonment. These scattered stones would have been become buried by erosion just as the terrace remains did, which contributes to our current uncertainty about the true identity of our GPR and SR anomalies.

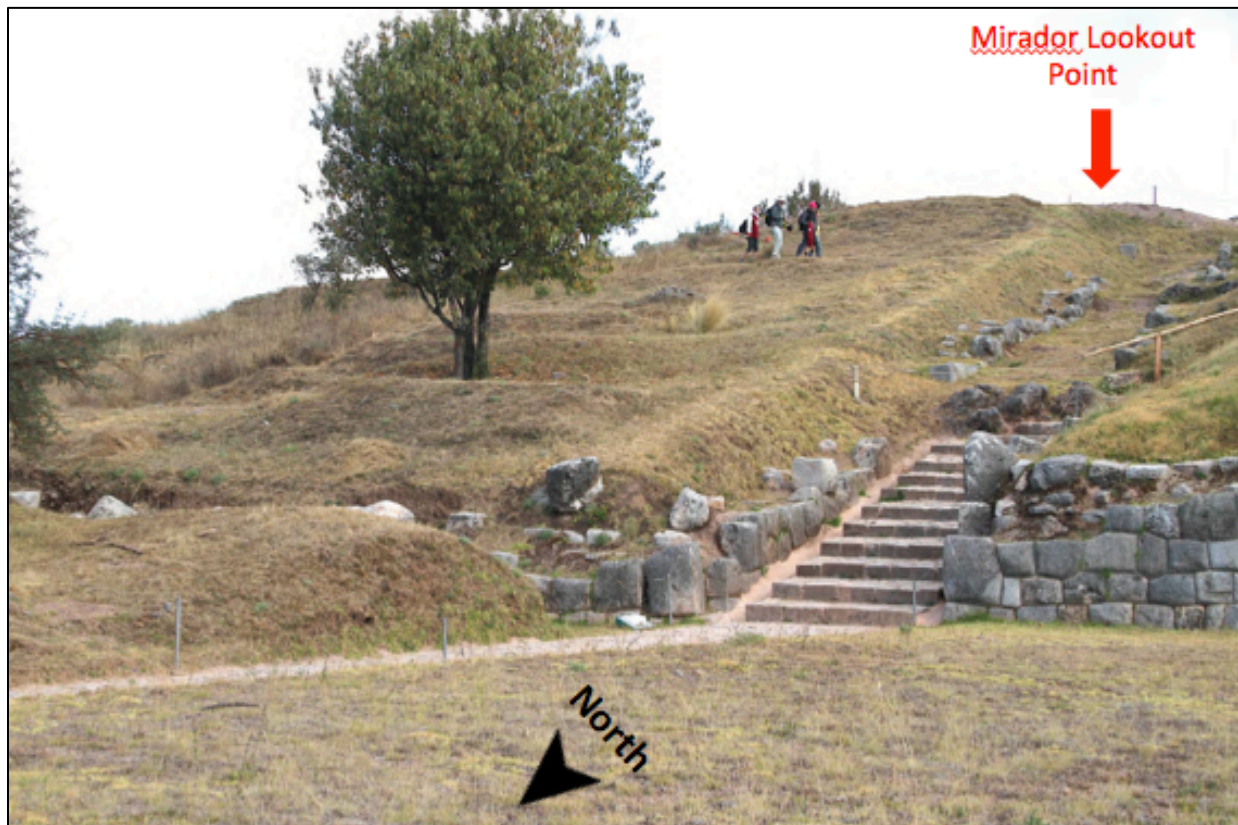
The Mirador area is one of the more hydrologically important regions on the site because the northern section of this area (Figure 5.3) slopes down towards the Great Walls at a roughly 30% slope. This slope is dangerous for the walls because as it is currently, it directs runoff straight towards the third wall. In order to protect the Great Walls, I assumed that this area was

Figure 5.3: Northern hillslope of the Mirador area (Miksad)

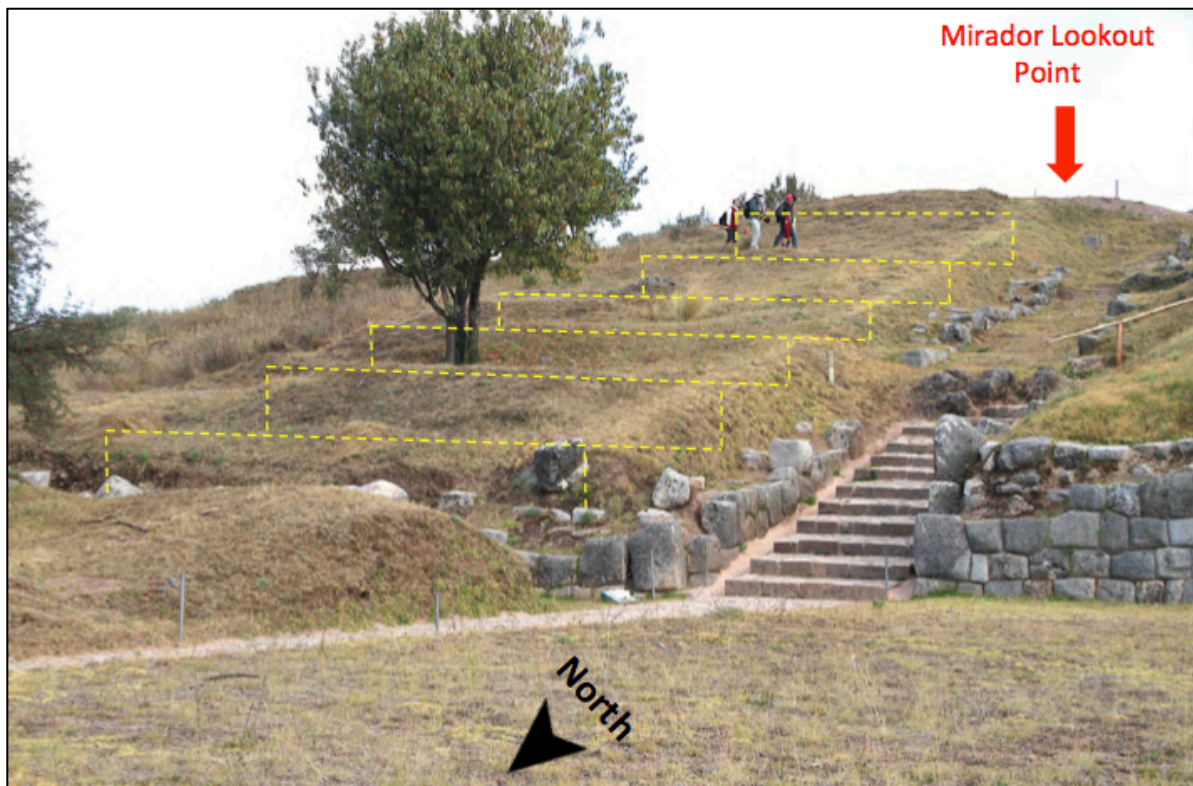
Figure 5.4: Potential locations of original terraces on the northern hillslope of the Mirador area, outlined by dashed yellow lines (Miksad)

originally terraced in order to control runoff on this hillslope. The contours present in this area corroborate this assumption because they appear to be smoothed, eroded versions of terraces. These smoothed “terraces” were roughly identified by visual inspection, and are shown by the dashed yellow lines in Figure 5.4 below.

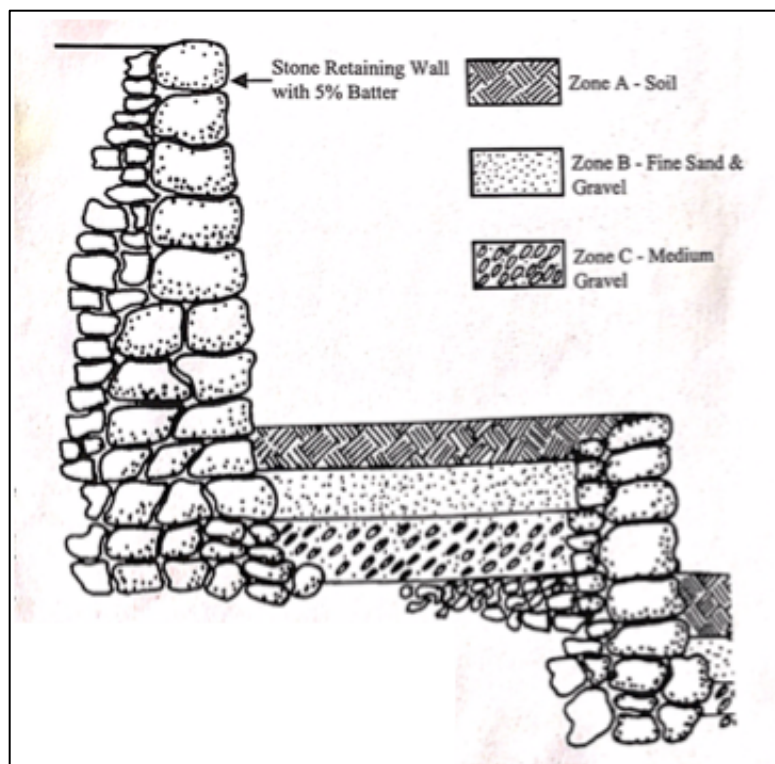
Figure 5.16: Typical subsurface drainage strata of terraces at Machu Picchu (Wright & Zegarra, 2000)

layered backfills to facilitate sub-surface drainage. Backfills of this nature have been found in the terraces at other Incan sites that were built around the same time as Saqsaywaman, such as Machu Picchu and Ollantaytambo (Wright & Zegarra, 2000; Wright et al., 2016). This led to the assumption that Saqsaywaman may also have employed this drainage method.

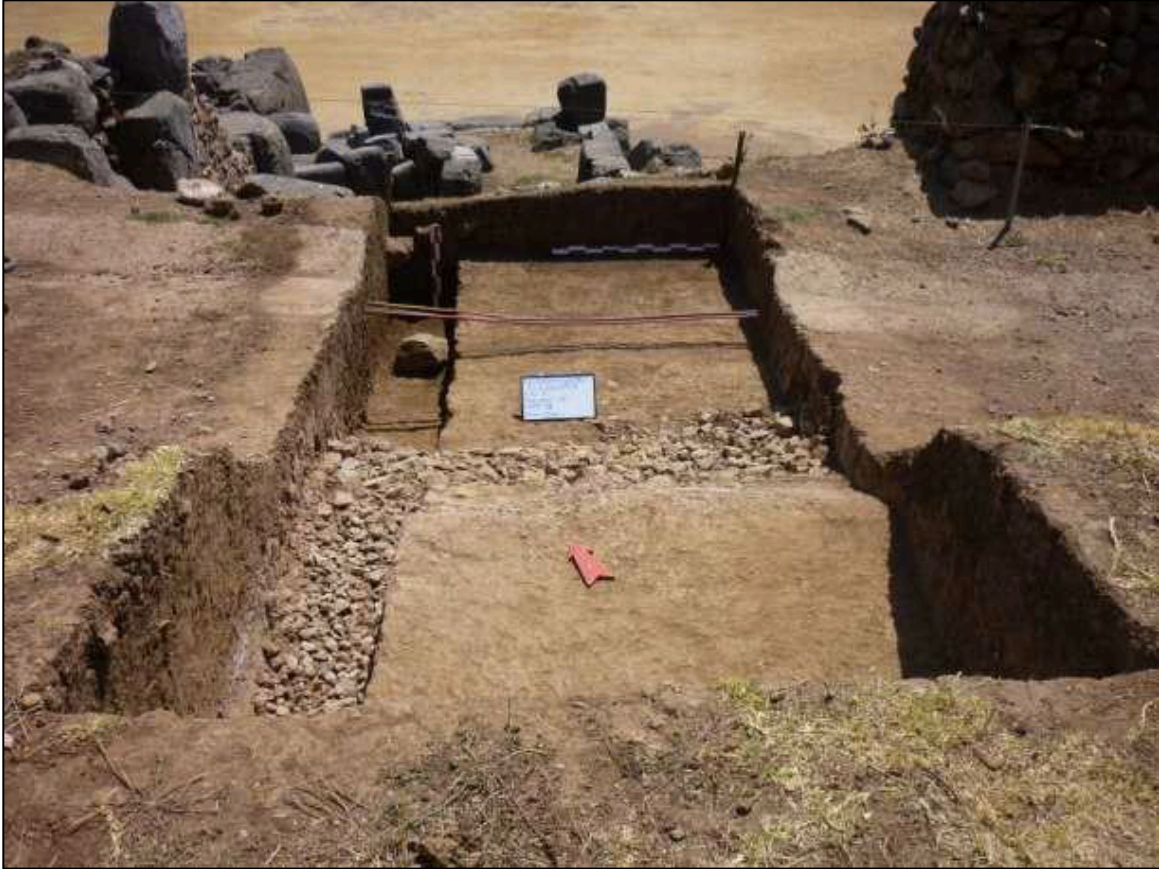
Figure 5.17: Excavation of a buried gravel drain above the third Great Wall (Palma, 2013)

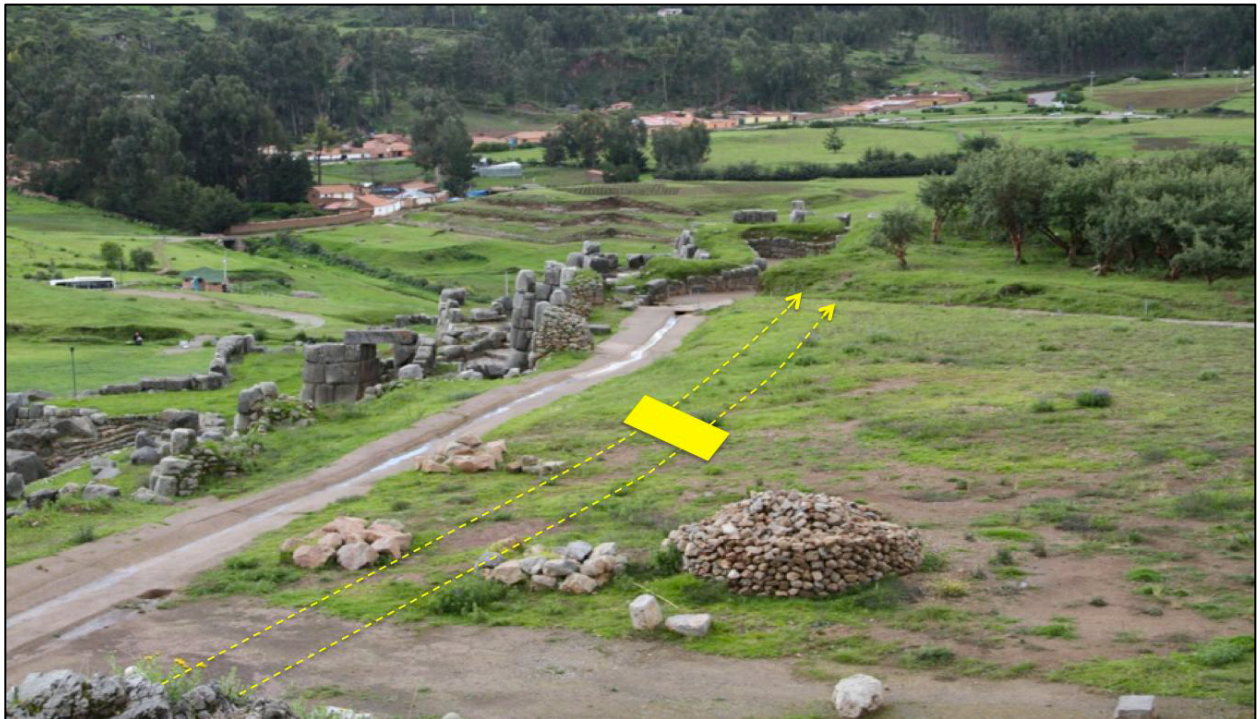
Figure 5.18: Location and direction of flow of buried gravel drain (Miksad)

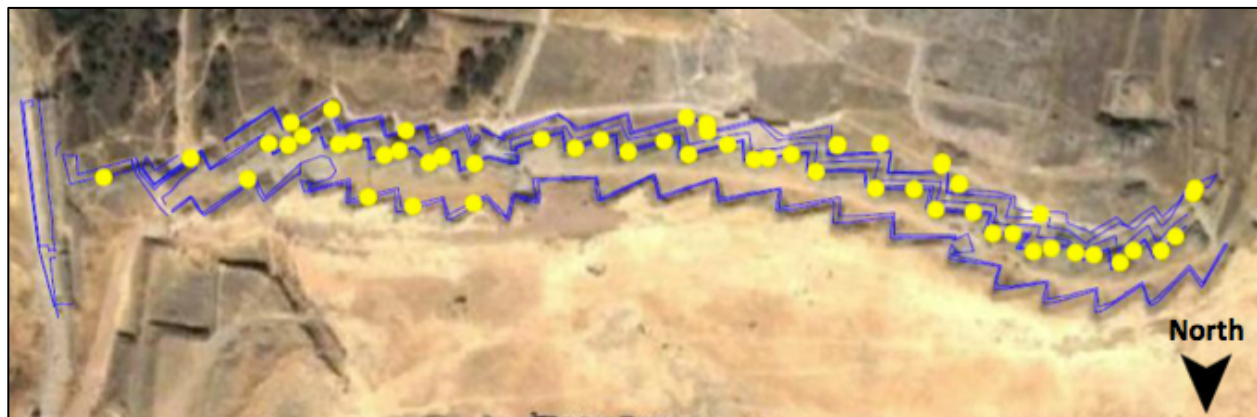
Figure 6.4: Locations of all known drainage ports (yellow circles) on the Great Walls (blue lines) (Lohr, 2014)

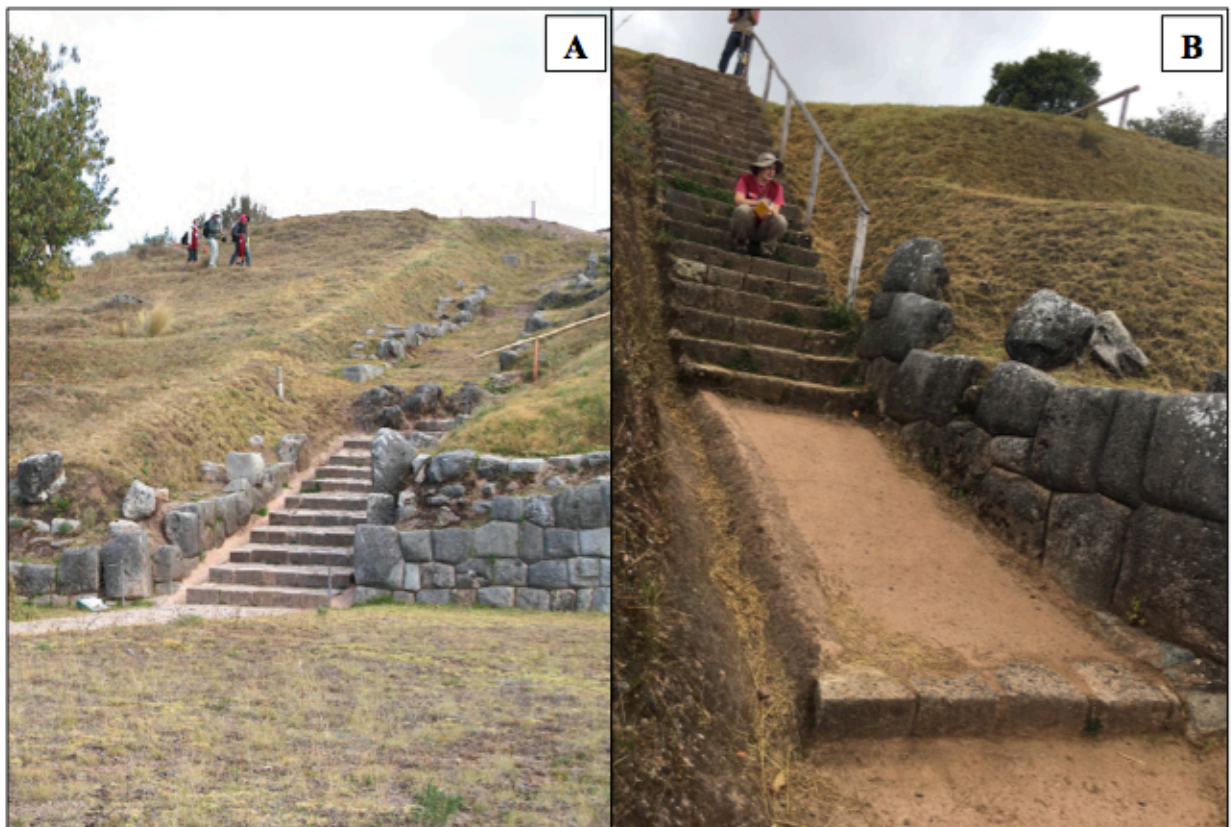
Figure 6.5: a) Mirador staircase (Miksad); b) South hill staircase

There are two large staircases on site (Figure 6.5) – one in the Mirador area and one on the south hill. The current states of these staircases made it difficult to tell whether they originally had channels lining them. The south hill staircase has been completely rebuilt in a modern way and almost none of the original stones are visible. The Mirador staircase has been modernly rebuilt in the lower part, while the top part is almost completely decayed and is still partially buried. However, because these staircases are the only remaining evidence of paths with controlled elevation changes on site, I assumed that they were originally used as the main hydraulic drops. Channels lining staircases have been found at several other Incan sites built around the same time as Saqsaywama, including at the Suchuna area across the plaza from

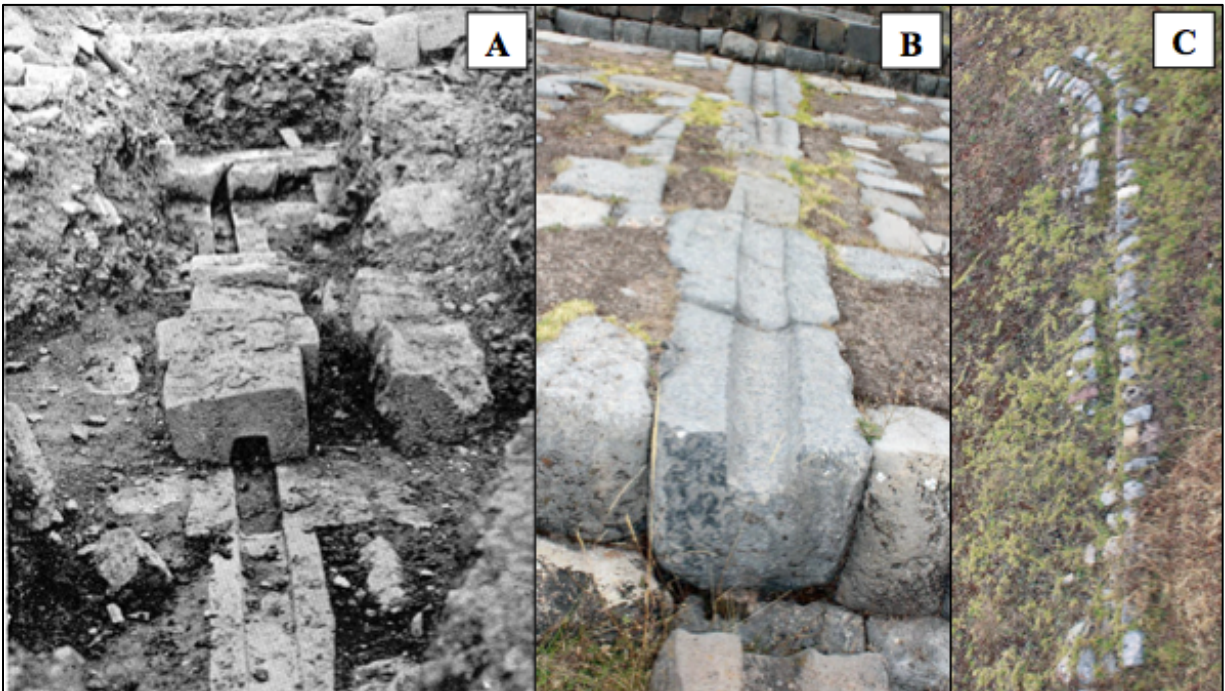
Figure 6.7: Examples of channel remains at Saqsaywaman: a) Channel section discovered in 1934 (Valcarcel); b) Reconstructed channel in the tower sector (Morrisset, 2016); c) Partially buried channel on a west hill terrace (Morrisset, 2016)

At Saqsaywaman today, some remains of carved channel sections are present (Figure 6.7), implying that there could have been a network of surface channels on site during the Incan era. While some of these channel sections have been restored based on their initial locations, many others are no longer in their original positions (Morrisset, 2016), making it nearly impossible to determine definitively where channels were originally located on site.

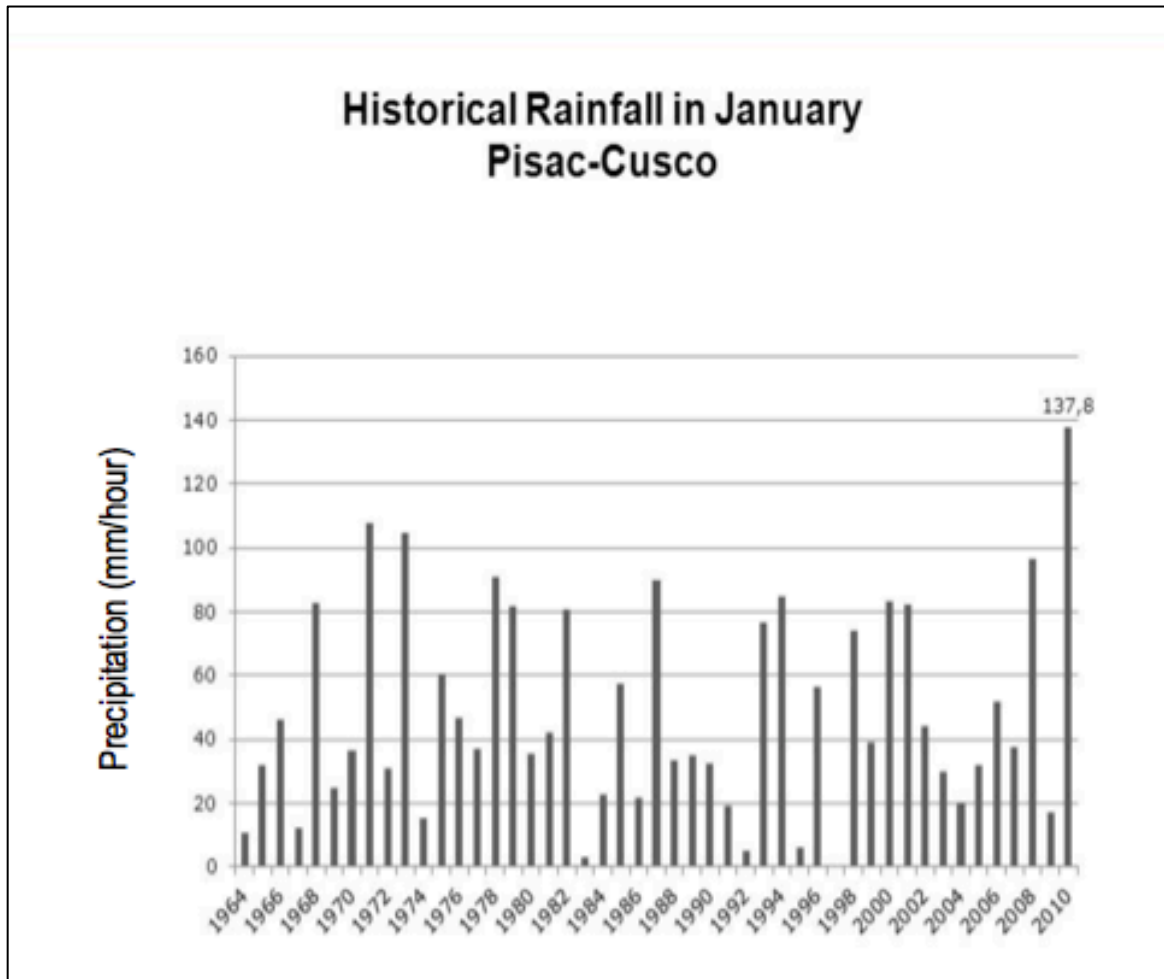
Figure 7.1: Annual maximum precipitation occurring over a 24-hour period in January from 1964 to 2010 in the Cusco-Pisac region (UNSAAC)

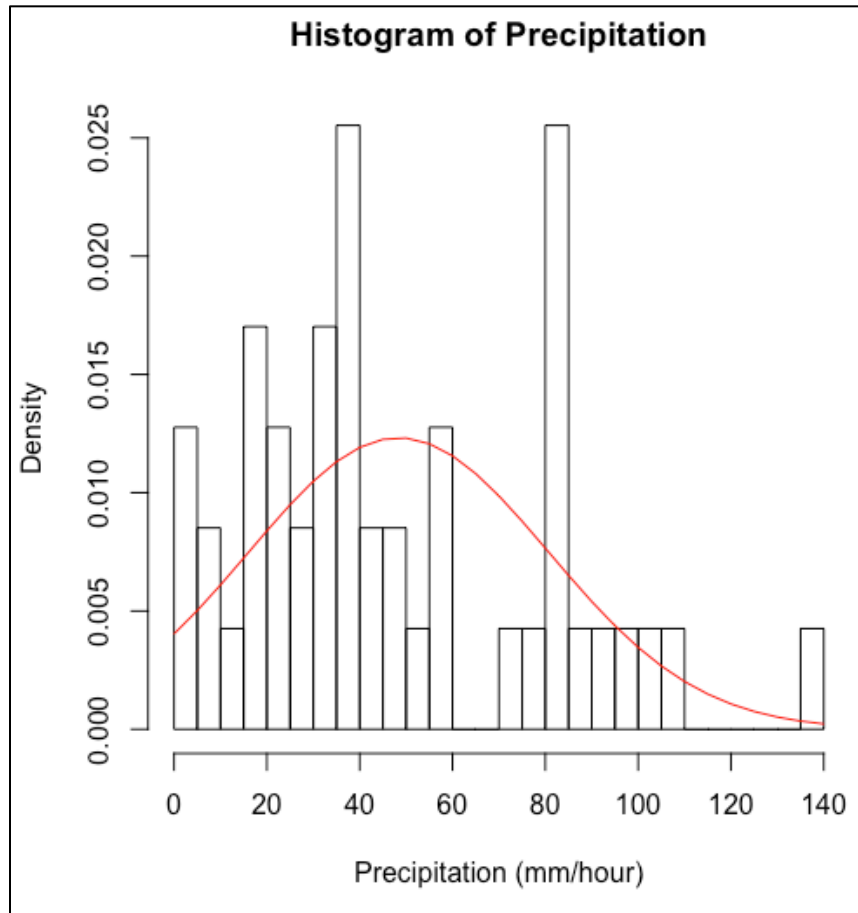
Figure 7.3: Annual maximum precipitation occurring over a 24-hour period in January from 1964 to 2010 in the Cusco-Pisac region, sorted by density of occurrence and fitted with a normal distribution (red line)
