**Protecting the Great Walls of Saqsaywaman
by restoring the original Incan drainage
infrastructure**

A Thesis

Presented to
the faculty of the School of Engineering and Applied Science
University of Virginia

Helena C. Nicholakos

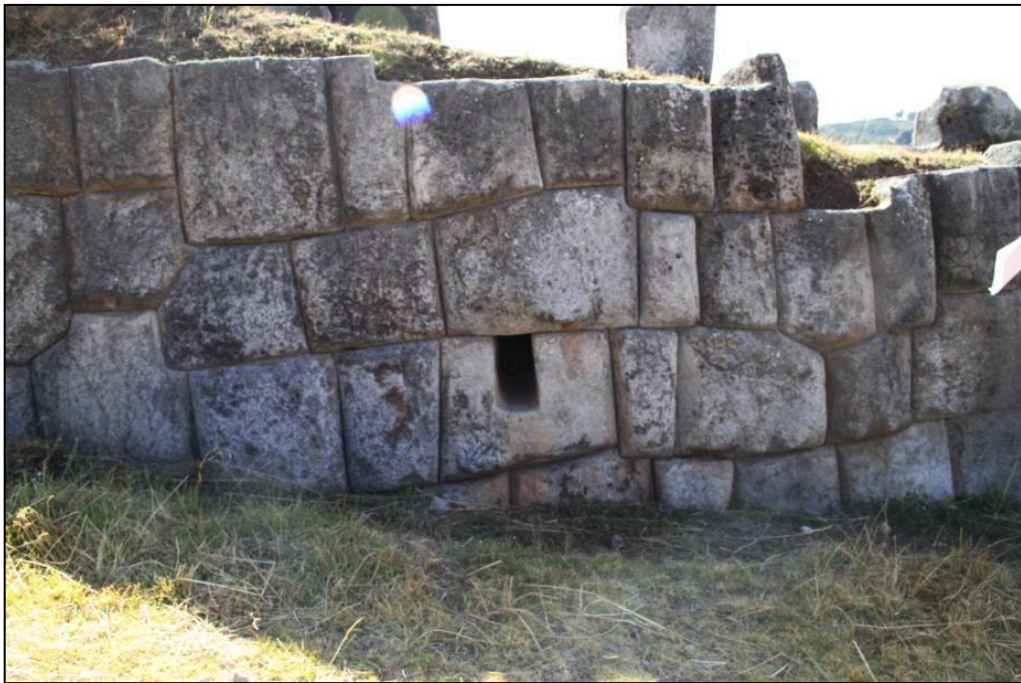
Great Wall sat at the north end of this terrace (Figure 7.5). I assumed that this port's purpose was mainly ceremonial because it was carved out of finely cut stonework and, unlike the other ports in the Great Walls, directed water south instead of north, routing water towards the ceremonial Cruz Mo'qo area. The terrace connecting the port to the Cruz Mo'qo would have carried water directly from the port to the Cruz Mo'qo, leading to the assumption that the terrace was also ceremonial, and therefore would have also been covered in gravel.

Figure 7.5: Large south-facing port in the second Great Wall (Miksad)

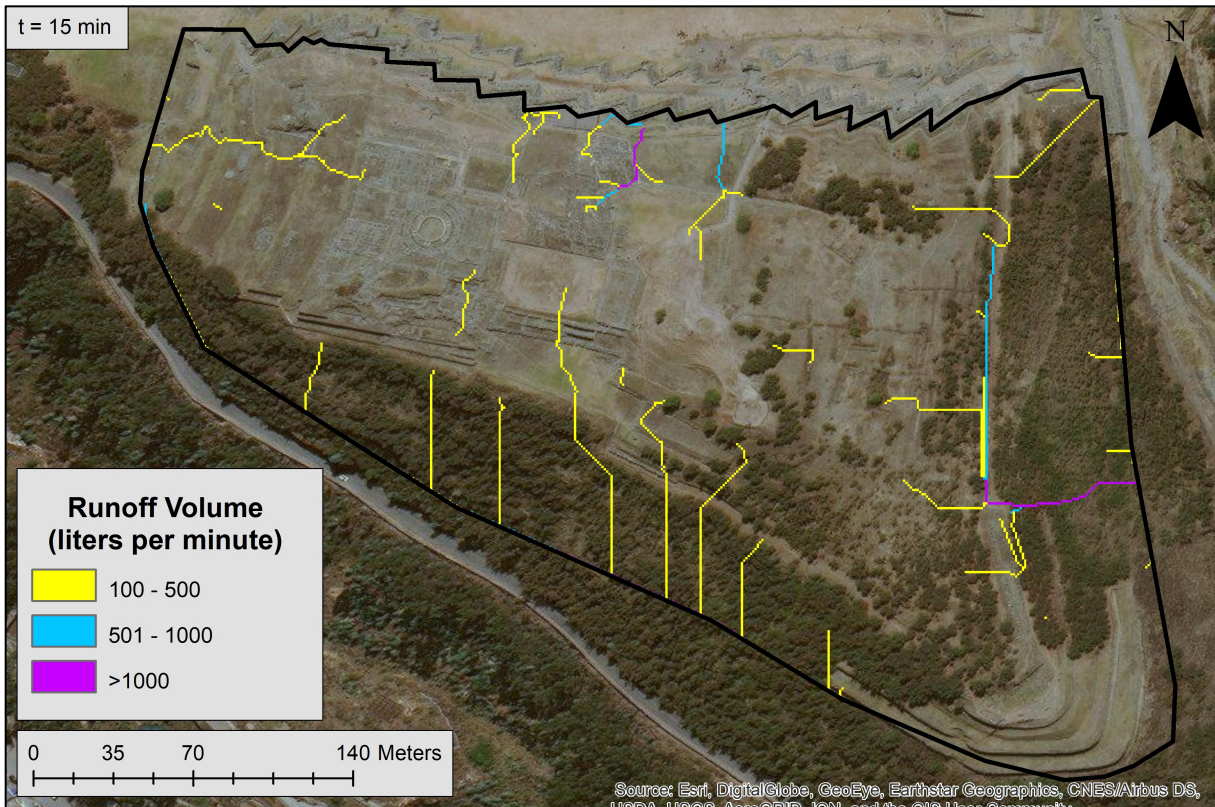
Figure 7.12 (continued on next page): Runoff flow rates during each step of the design storm for current land cover

Figure 7.12 (continued from previous page): Runoff flow rates during each step of the design storm for current land cover
