Electron Beam Freeform Fabrication of Aluminum: Investigating Properties and Cracking in Alloys 2219 and 7075

A Thesis

University of Virginia

December 2019

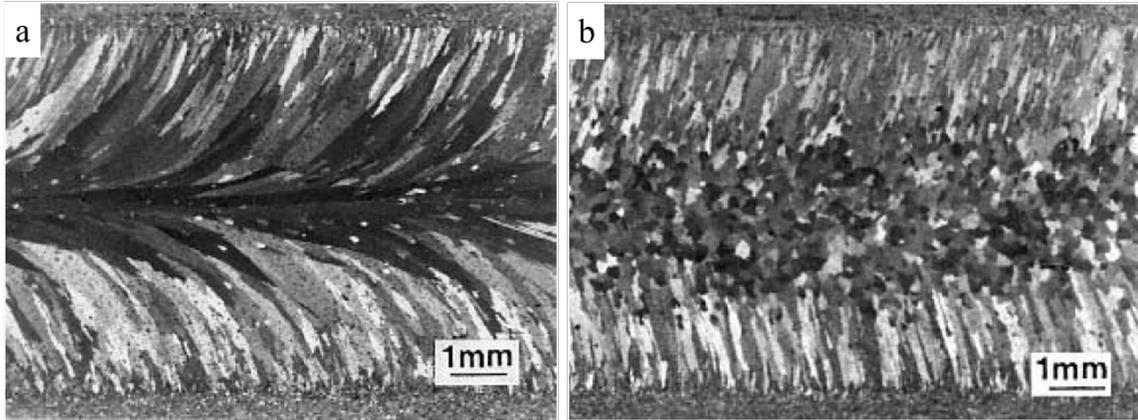
Figure 2.2: Top view of weld beads exhibiting (a) columnar grain growth in the direction of solidification and (b) equiaxed grains in the FZ [27].

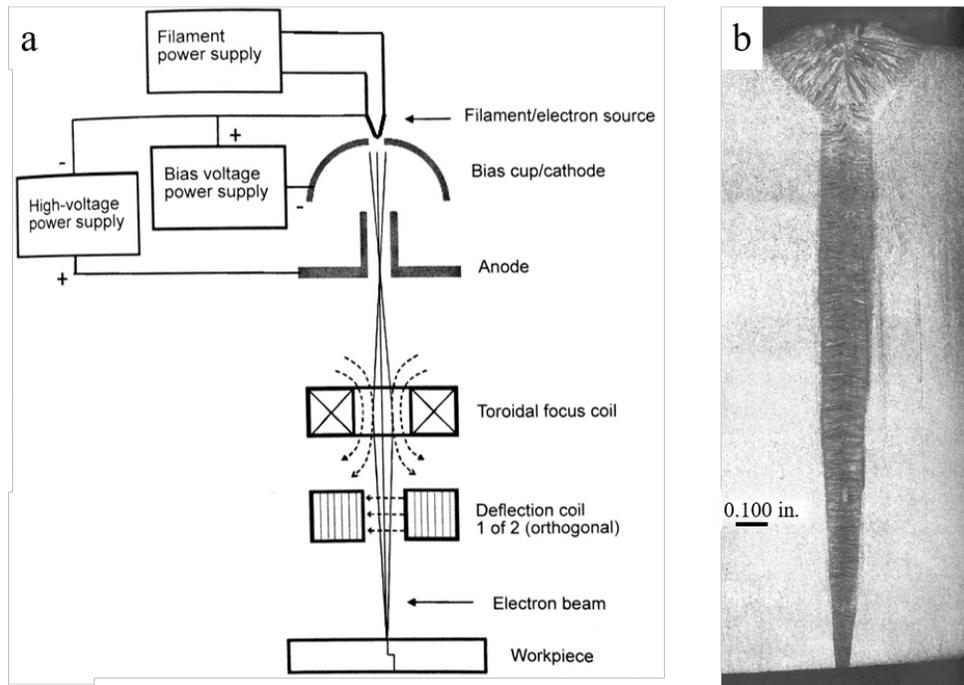
Figure 2.8: (a) Schematic of the EB gun column assembly and the impingement of the focused beam on the workpiece surface, and (b) a resulting keyhole weld in Inconel 718 [1].

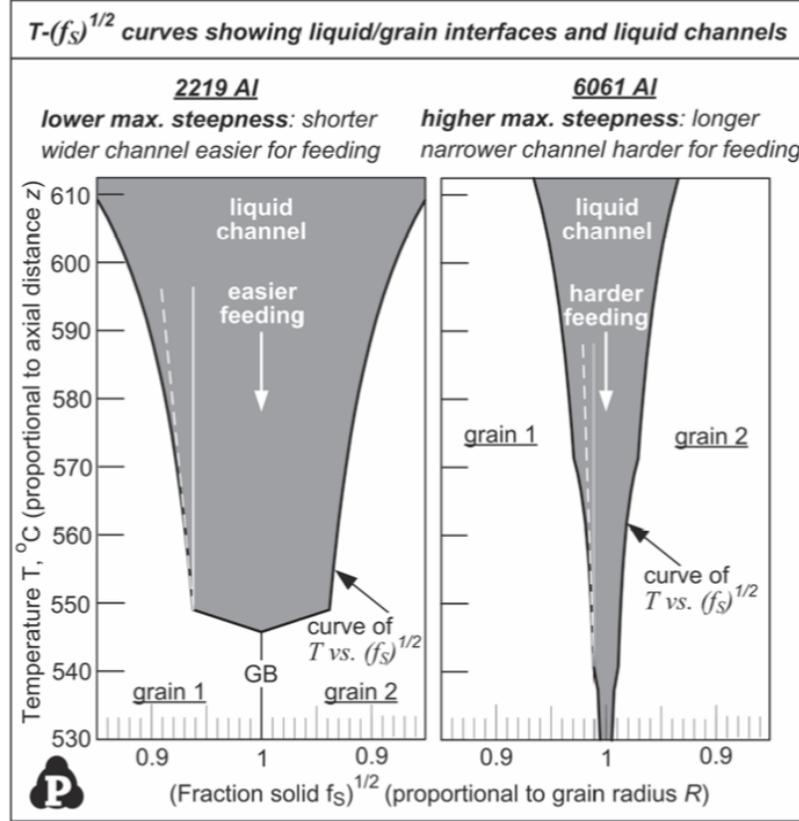
Figure 2.16: Schematic showing the differences in T - f_s curves for alloys with low versus high maximum steepnesses and the ease of liquid feeding to dendrite roots [62].

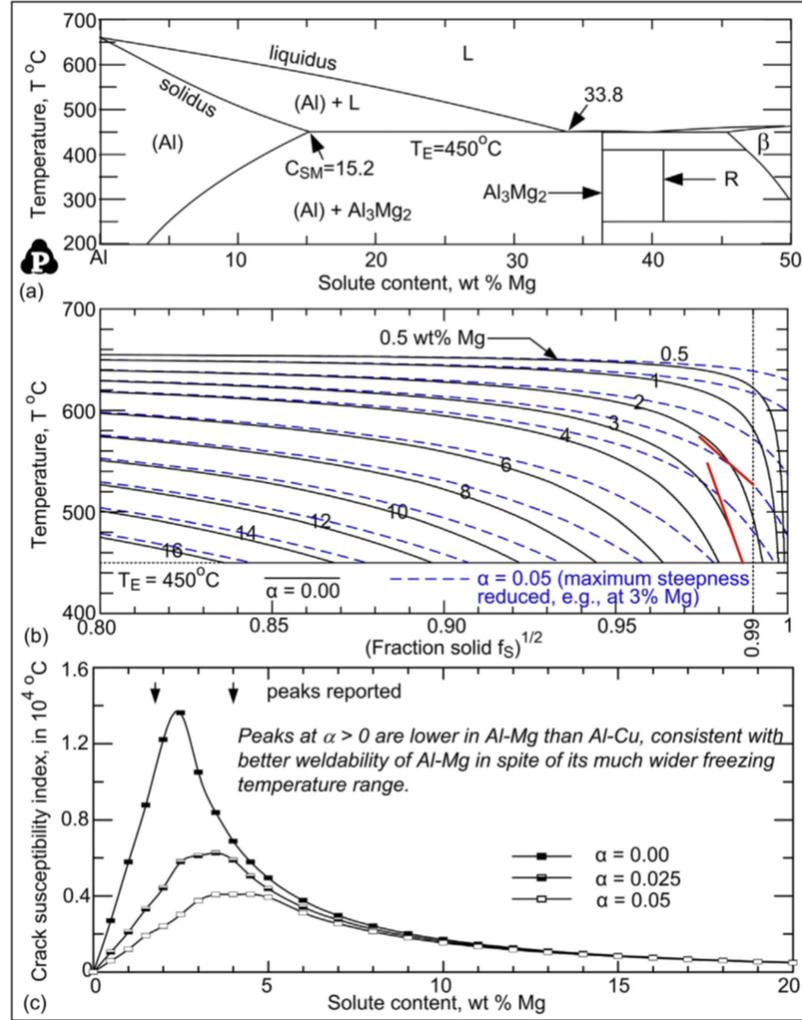
Figure 2.17: Plots showing (a) the Al-Mg phase diagram, (b) the T - f_s plots for various alloy compositions, both with and without a back-diffusion coefficient of $\alpha = 0.5$, and (c) crack susceptibility Λ curves showing the effect of back-diffusion on lessening overall susceptibility and shifting the peak to higher Mg compositions [63].

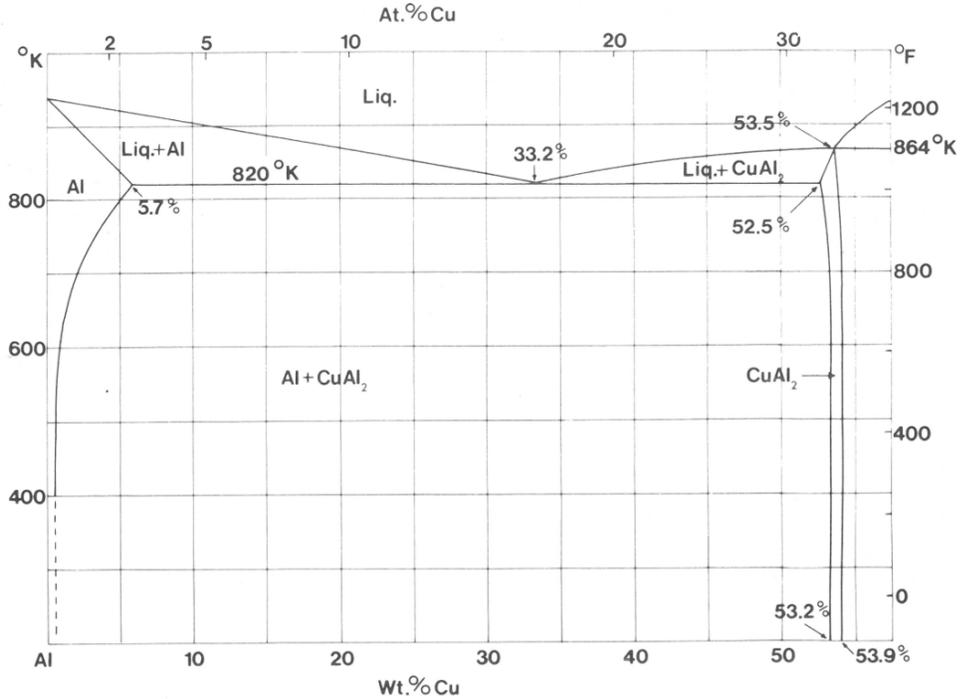
Figure 3.1: Al-Cu partial phase diagram showing the solid solubility limit of Cu in Al at 5.7 wt.%, the Al-Cu eutectic at 33.2 wt.%, and the θ phase, Al_2Cu , at 53.2 to 53.9 wt.% [67].

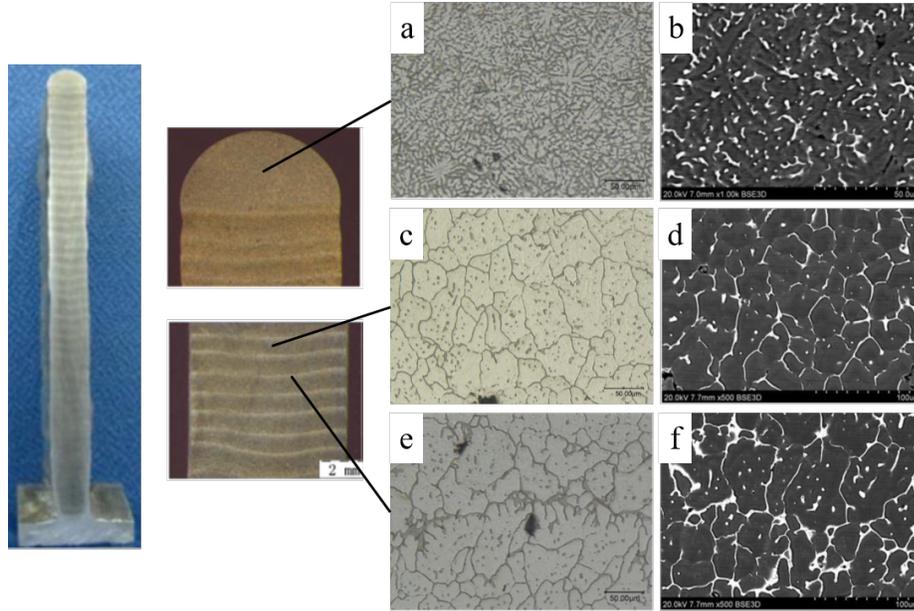
Figure 3.4: Weld microstructures from GTA-additive deposits showing (a) etched dendritic microstructure of the final layer of the deposit, (b) SEM-BSE image of the top layer's dendritic microstructure with discontinuous eutectics, (c) etched microstructure of a lower layer in the build, (d) SEM-BSE image of a layer showing continuous eutectics, (e) etched microstructure of an inter-layer region, and (f) SEM-BSE image of an inter-layer region showing continuous eutectics. Modified from [79].

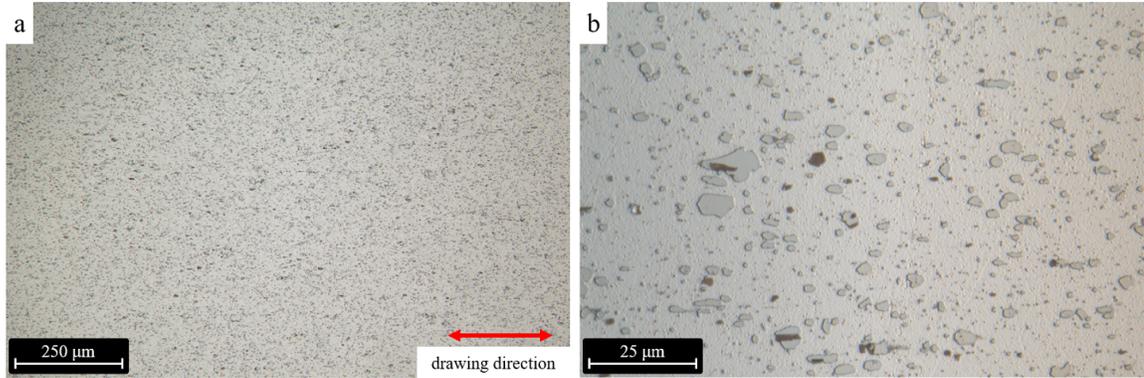
Figure 3.5: Microstructure of the 2319 wire used for constructing the 2219 deposits. (a) 100x view showing the uniform precipitate distribution, and (b) 1000x image of the Cu-bearing (grey) and Fe-bearing (red-brown) phases.

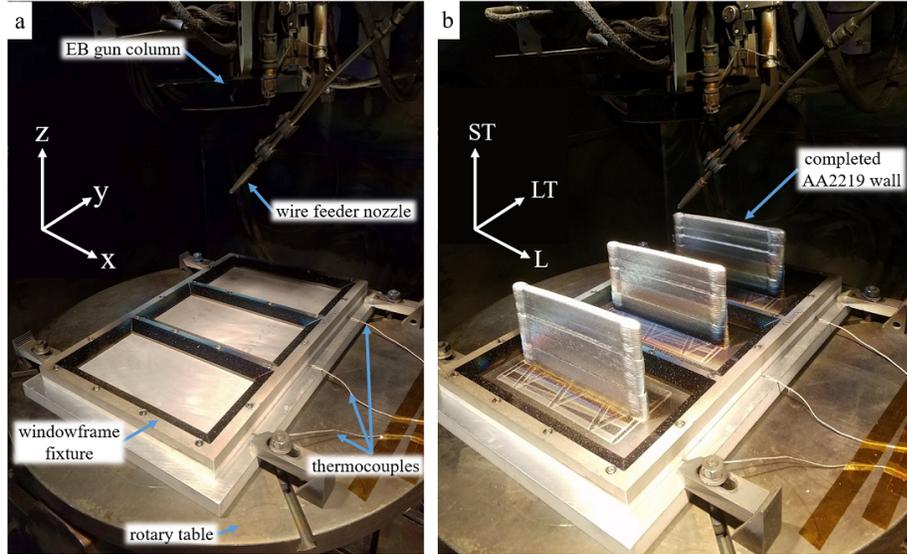
Figure 3.6: (a) Machine setup with windowframe fixture and 0.25 in. baseplates installed, including thermocouples centered beneath each plate. (b) Windowframe fixture securing three co-deposited 2219 walls.

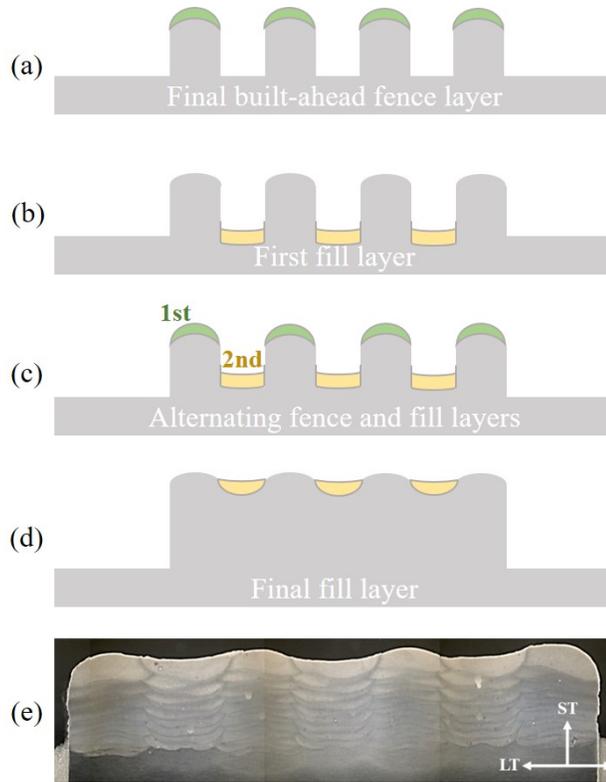
Figure 3.9: Brick deposition sequence of fence (green) and fill (yellow) layers to maintain a consistent, 3 in. width along the build height. (a) Final fence built-ahead layer, (b) first fill layer, (c) subsequent layers alternating with first fences, then fills, followed by (d) the final fill layers to even out the deposit height. This sequence results in (e) an as-built test brick microstructure.

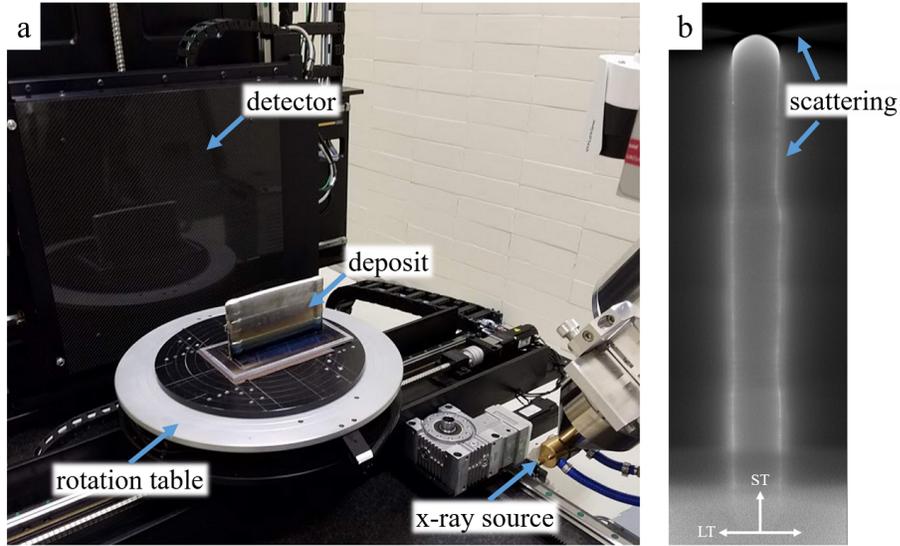
Figure 3.11: (a) Nikon Metrology C2 XCT machine setup for scanning a wall deposit, and (b) sample data from the LT-ST plane showing beam scattering effects.

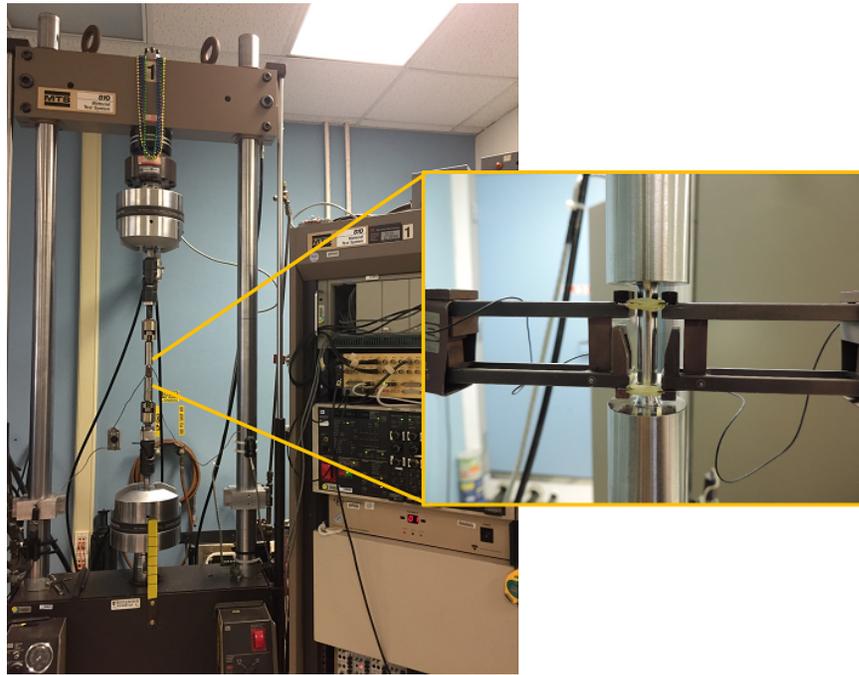
Figure 3.12: Testing configuration for subsize tensile specimens with back-to-back 1 in. gauge length extensometers.

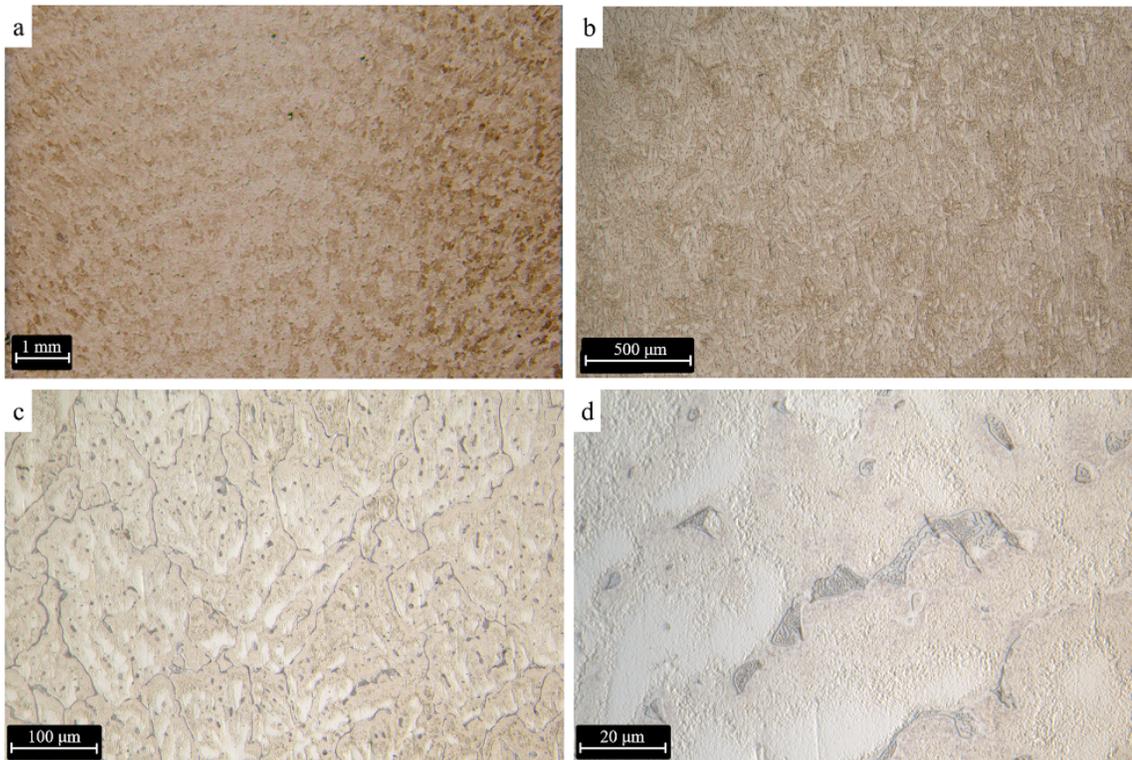
Figure 3.15: Typical LT-ST etched cross section for 2219 AD wall builds. The macroscopic view in (a) shows the layers, while (b) and (c) depict the varying etch response with dendrite coring, and (d) displays the eutectic particles in the microstructure.

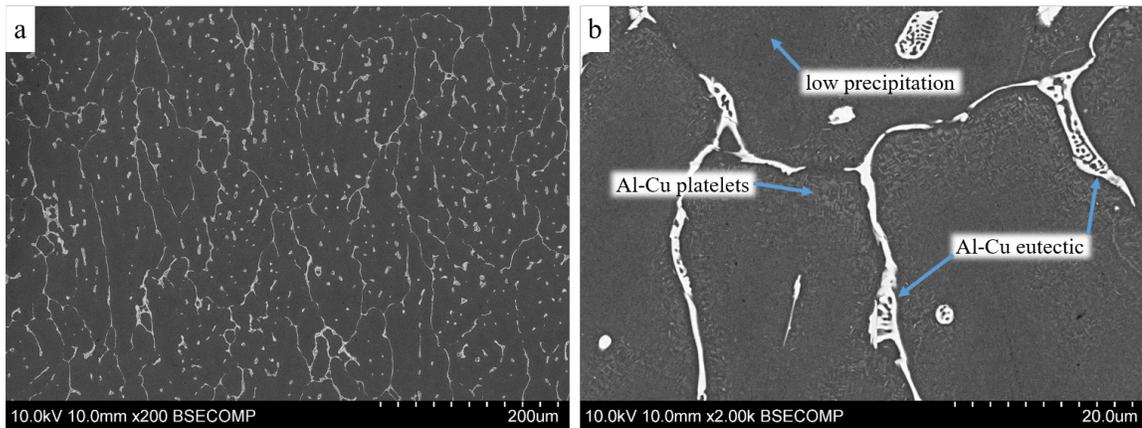
Figure 3.16: (a) Backscatter image of the 2219 AD microstructure, and (b) grain boundaries showing increasing precipitation from core to edges, with Al-Cu eutectic on grain and interdendritic boundaries.

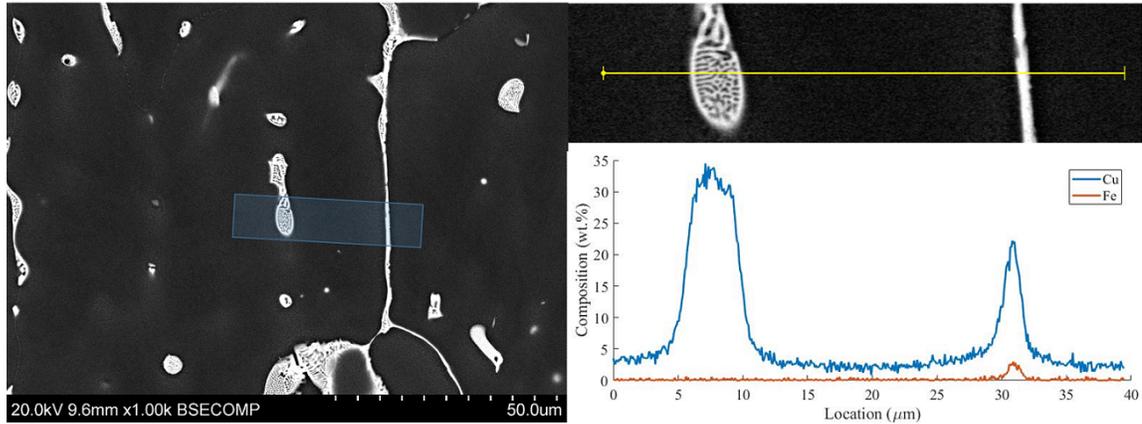
Figure 3.17: Backscatter images and associated linescan sampling regions between interdendritic boundaries showing Cu and Fe concentration in the matrix and the second phase particles. The balance is Al and is not shown for scaling purposes.

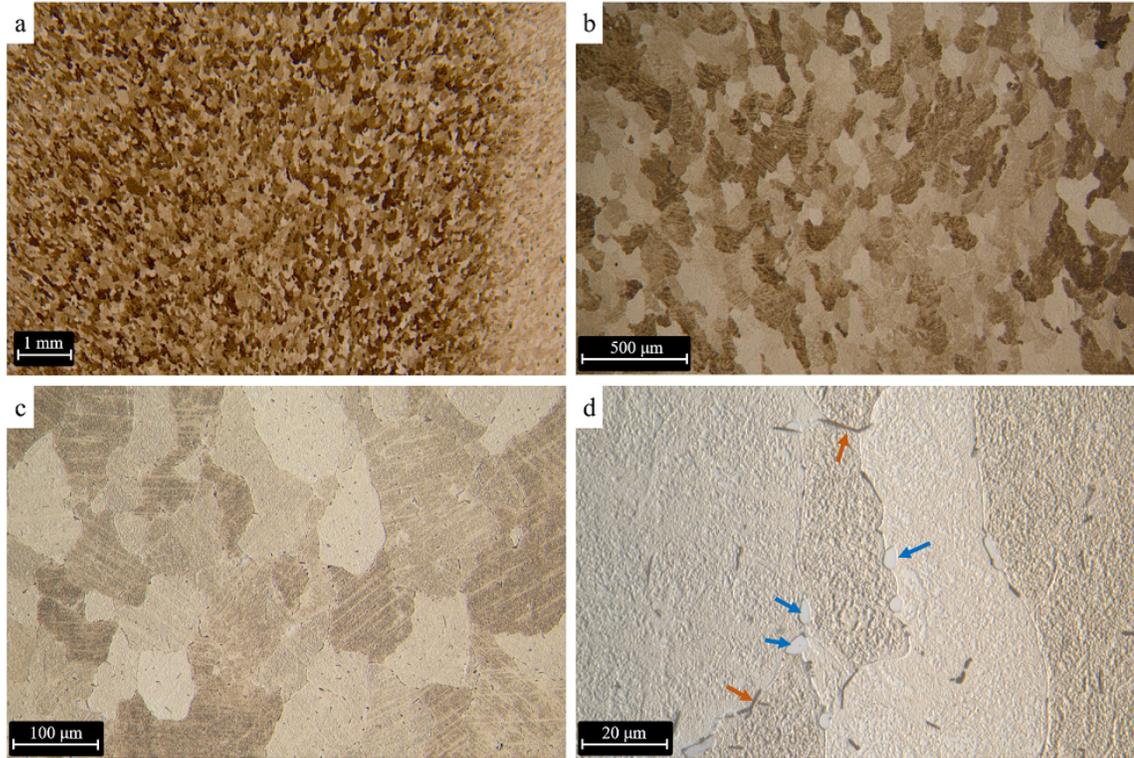
Figure 3.18: (a) Typical etched LT-ST cross section for 2219 HT wall builds with indiscernible layers, and (d) higher resolution image showing orange arrows highlighting Fe-containing phases and blue arrows pointing to the globular Cu-rich phase on grain boundaries.

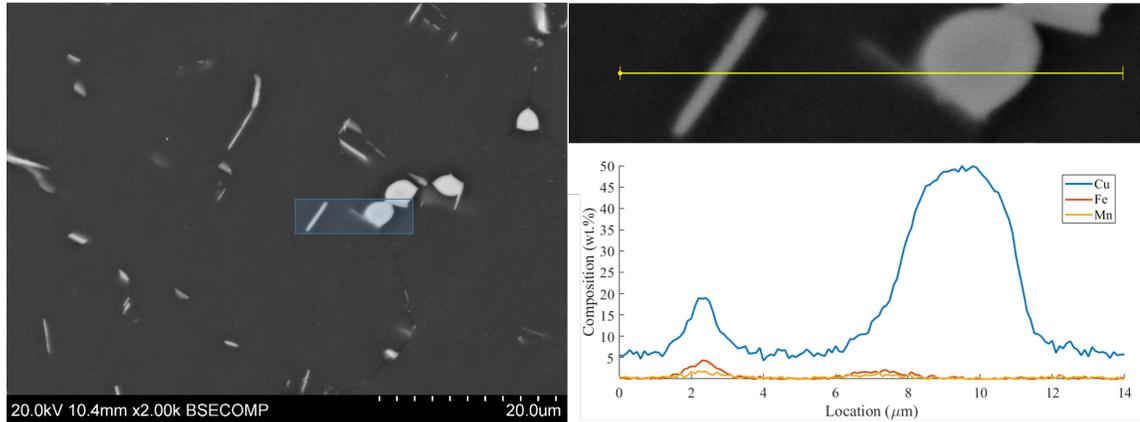
Figure 3.19: Backscatter image of the HT wall microstructure and associated linescan sampling precipitates showing Cu, Fe, and Mn concentrations. The rounded particle has the θ phase composition while the spindle-like particle contains Cu, Fe, and Mn.

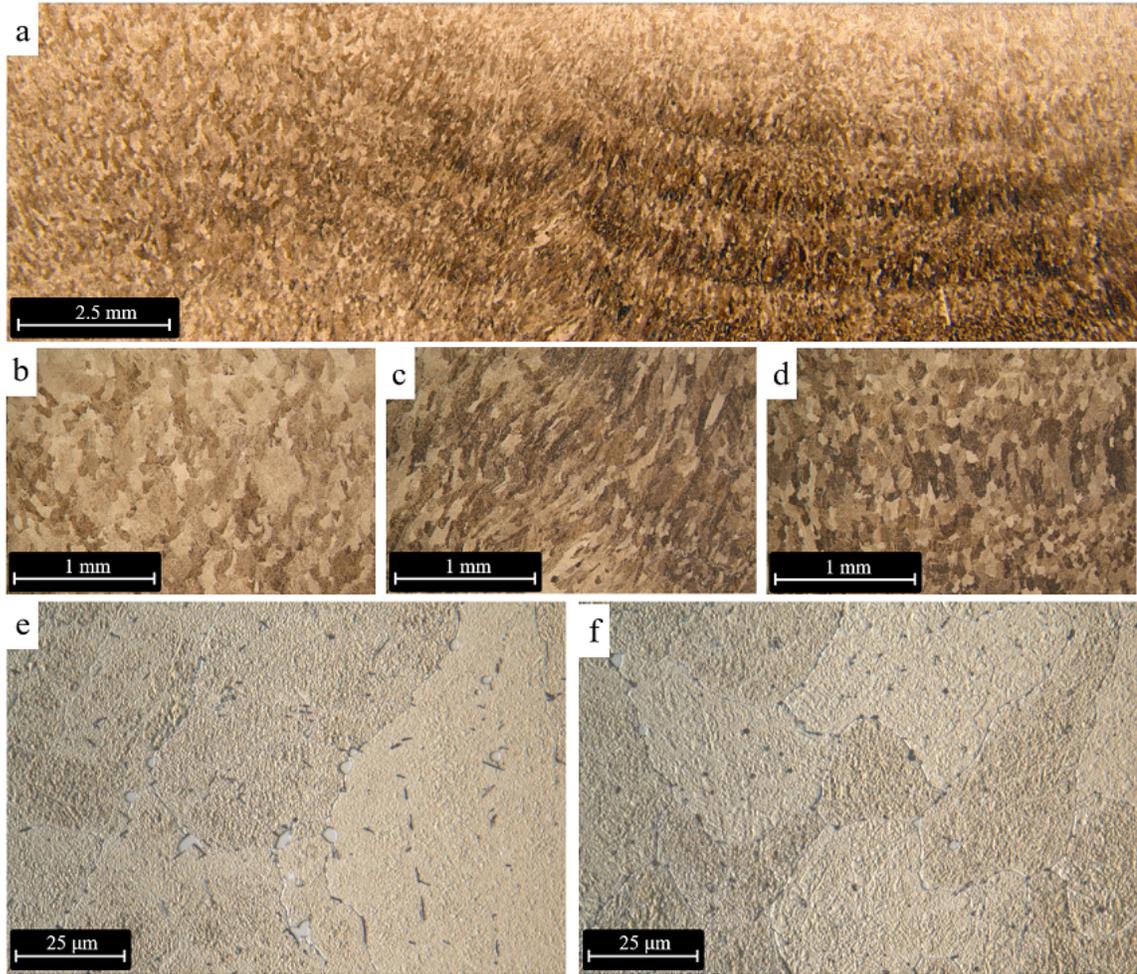
Figure 3.20: HT brick microstructure in the LT-ST plane depicting (a) an overall view of a fence and fill, with subfigures showing 50x images of grain structures for (b) a fence, (c) an overlap, and (d) a fill, and 1000x images showing (e) fence precipitates and (f) fill precipitates.

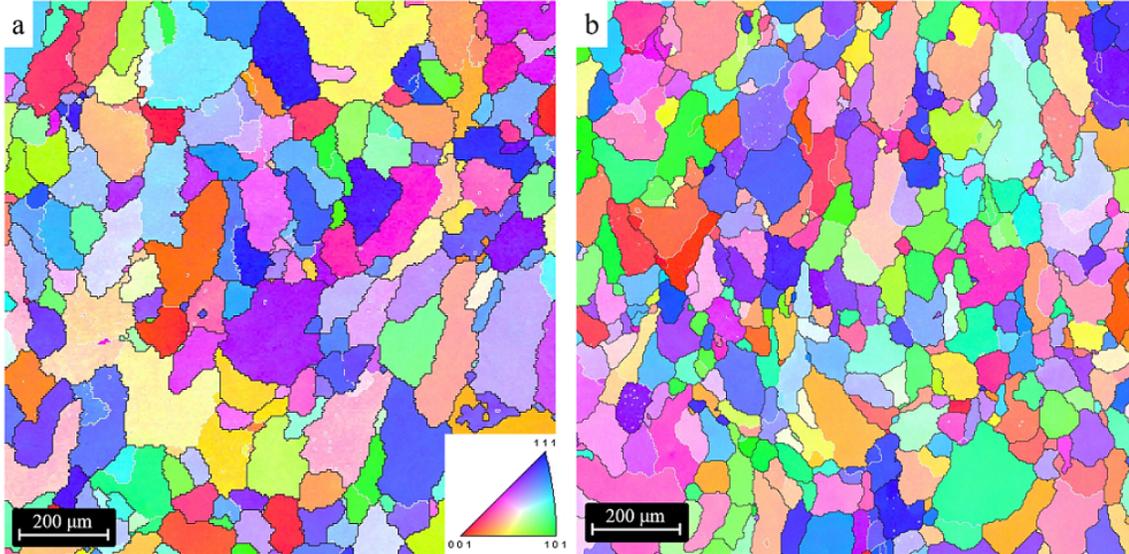
Figure 3.22: EBSD normal direction IPF maps from (a) AD and (b) HT wall LT-ST microstructures.

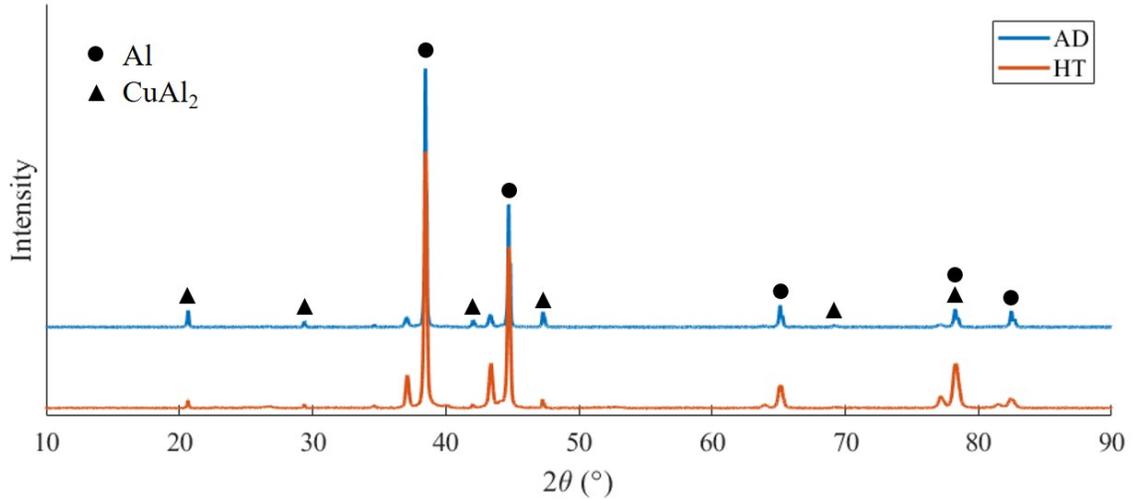
Figure 3.23: XRD results for the as-deposited and heat treated wall metallurgical specimens.

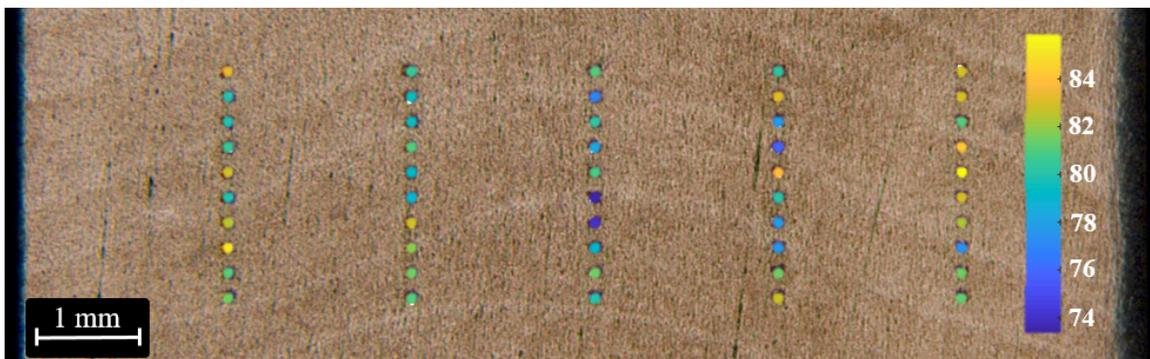
The AD 2219 exhibited an average microhardness of 81 ± 2.5 HV_{0.3} from the indents shown in Fig. 3.24. Despite sampling over regions that showed various etch responses corresponding to interlayer boundaries, which were thought to possibly indicate a variation in hardness, no correlation of microhardness with microstructure was found. This invariance may be due to the relatively homogeneous grain size distribution across interlayer boundaries in the walls or the even distribution of precipitates across layers.

Figure 3.24: HV_{0.3} of AD material sampling across deposit layers.

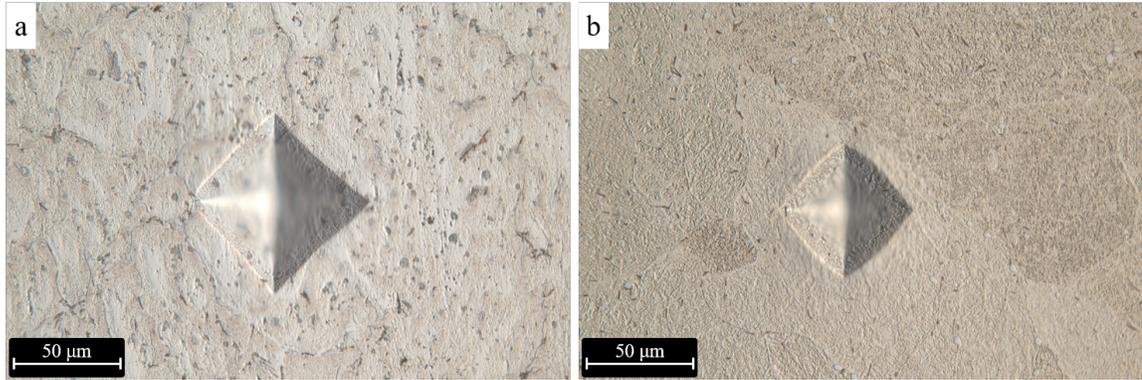
Figure 3.26: HV_{0.3} indents of (a) AD material and (b) HT material. Both indents, particularly for the AD material, exhibit some warping of the indent shape.

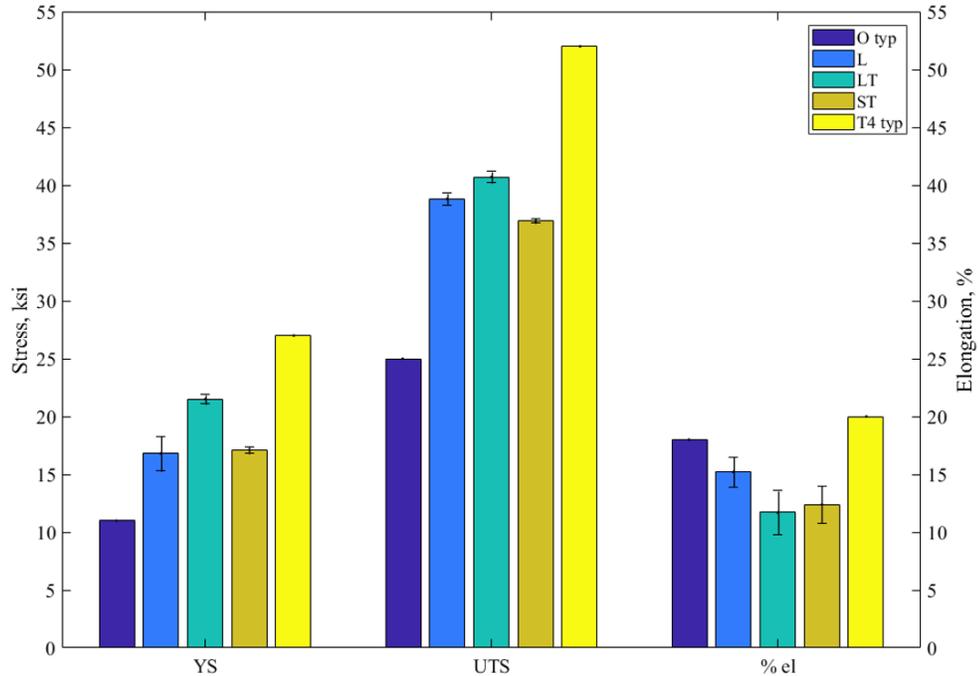
Figure 3.27: AD tensile properties for each sample orientation compared with typical O and T4 temper YS and UTS values and the typical 2 in. gauge length % el. value.

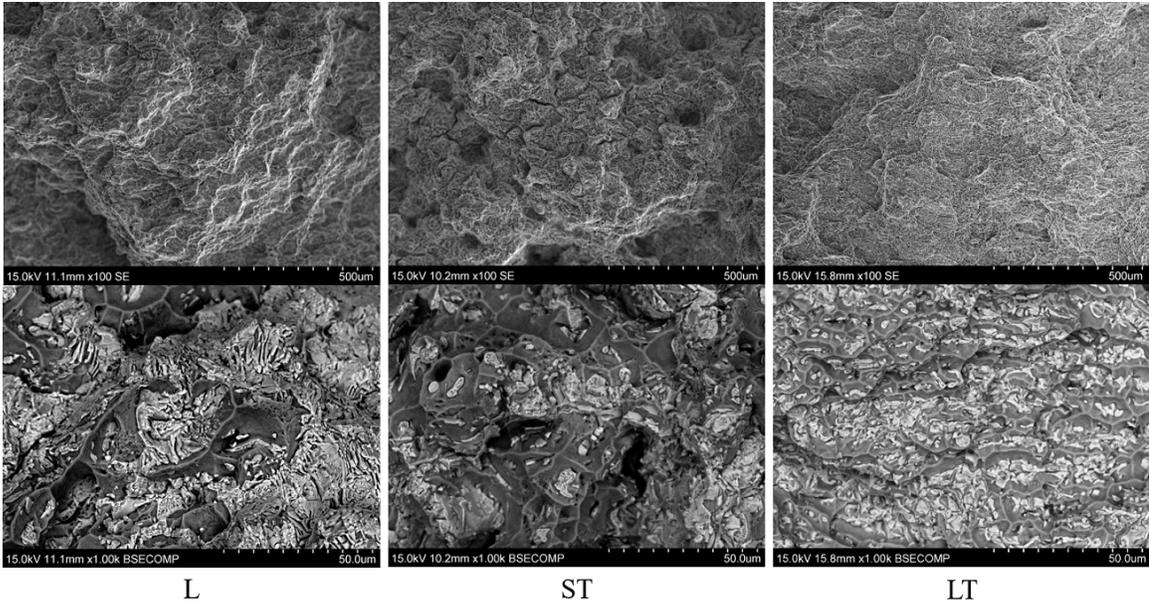
Figure 3.28: Typical AD tensile sample fracture surfaces in the three specimen orientations. 100x topological views are shown in the top row, and 1000x BSE compositional images are shown in the bottom row.

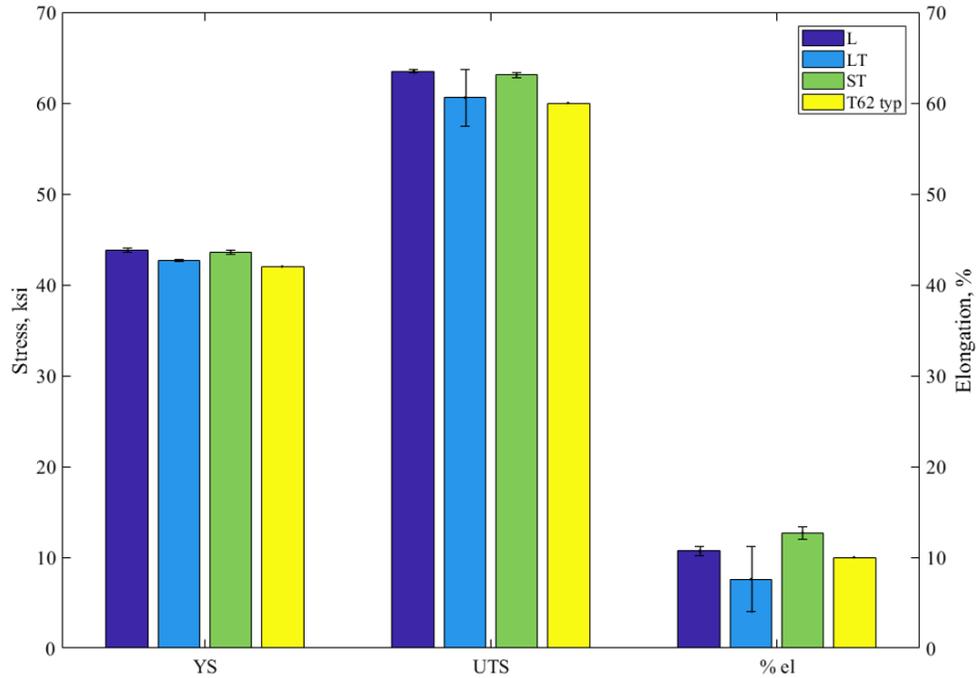
Figure 3.29: HT tensile properties for each deposit direction compared with typical T62 values for a 2 in. gauge length.

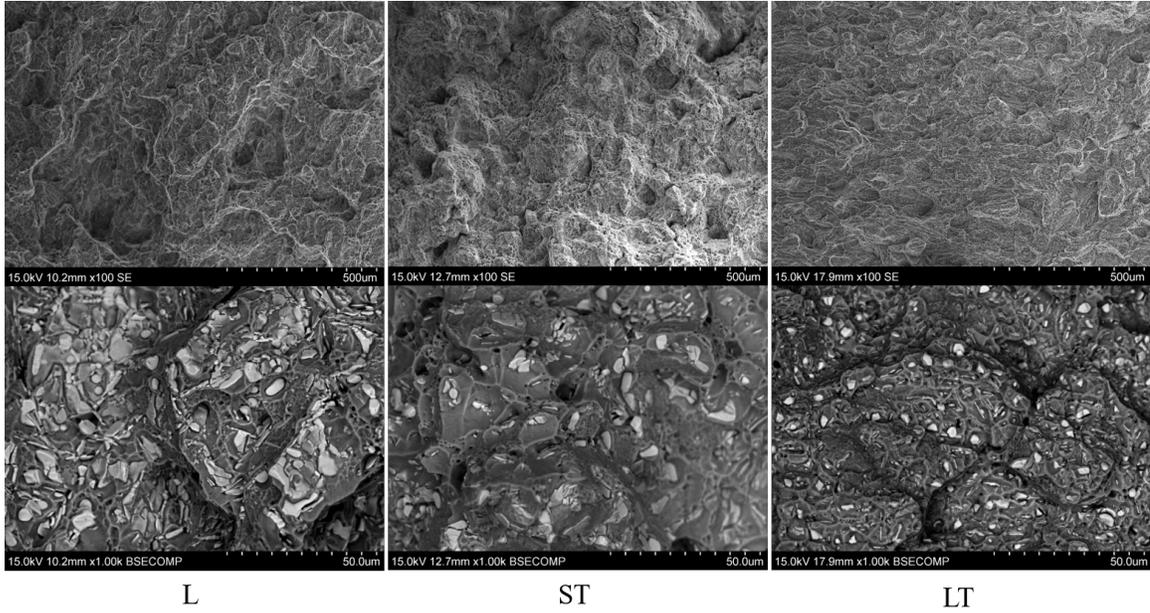
Figure 3.30: Typical HT sample fracture surfaces for the three specimen orientations, with 100x SE images showing fracture surface topology and 1000x BSE images below showcasing precipitate distributions and dimples.

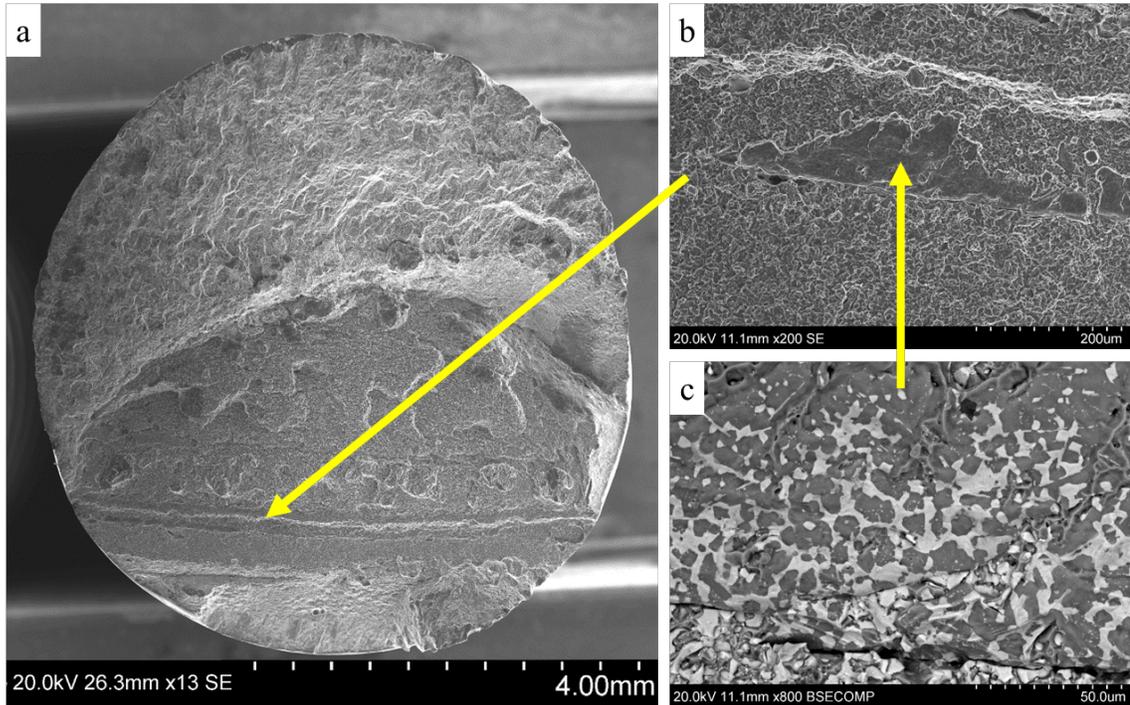
Figure 3.31: Atypical features on the fracture surface of the HT, low-elongation LT-13 specimen, including (a) a macrograph showing banding of atypical features that include: (b) an intercepted large grain and (c) an interconnected θ phase.

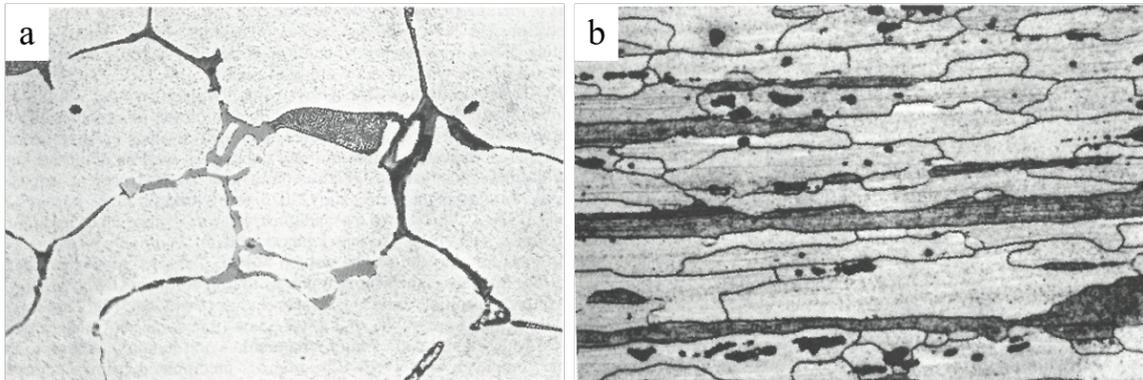
Figure 4.1: (a) 445x as-cast microstructure of ingot 7075, with coarse eutectic and second phase particles on the grain boundaries and fine precipitates from ingot cooling in grain interiors. (b) 445x wrought plate microstructure showing recrystallized (light) and unrecrystallized (dark) grains. [74].

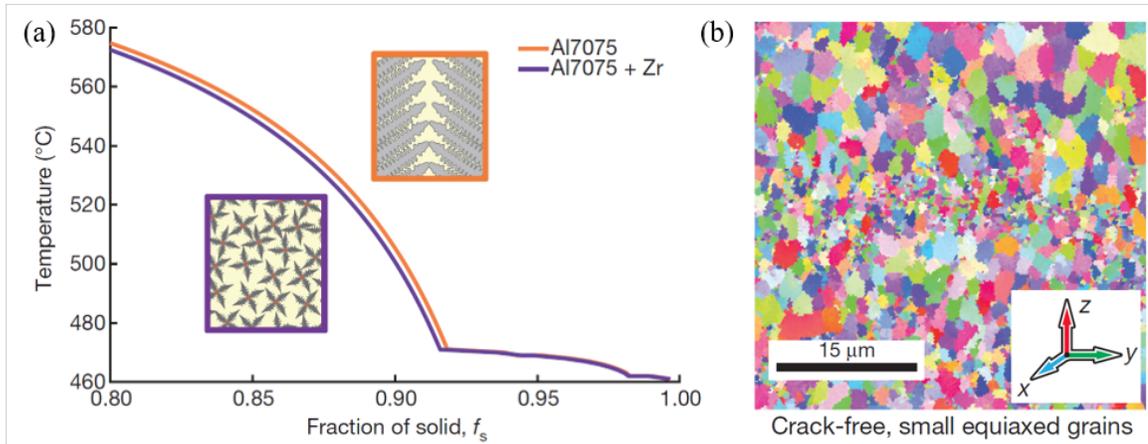
Figure 4.4: (a) Scheil solidification curves for the unmodified 7075 powder and the 7075 + Zr nanoparticle-dusted powder. (b) Microstructure transformed to fine, equiaxed grains that can accommodate strains during solidification to produce crack-free 7075 SLM deposits [17].

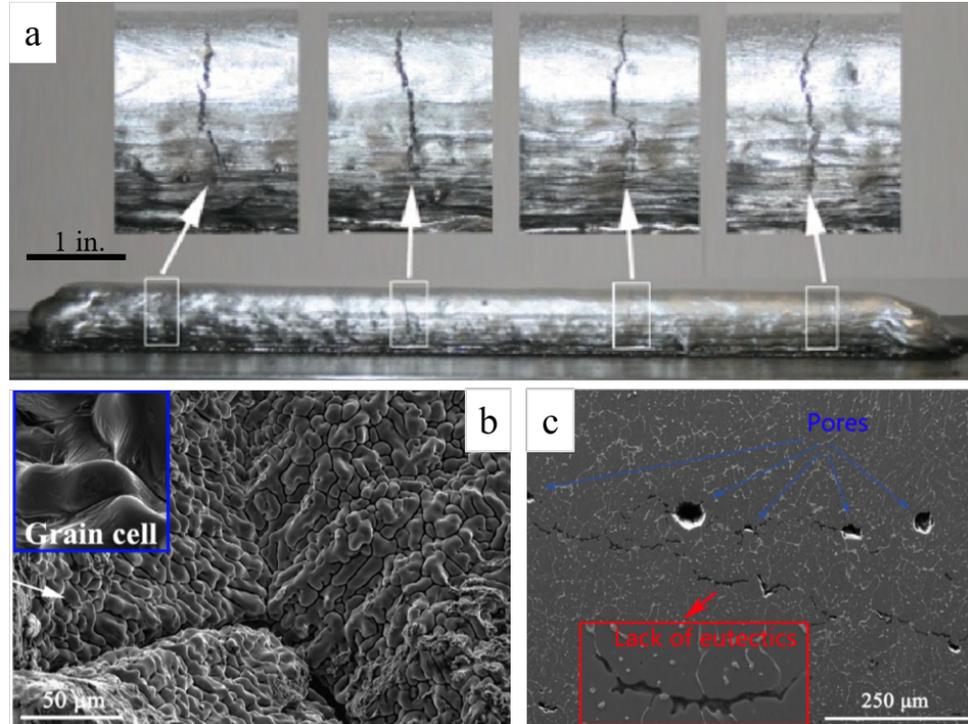
Figure 4.5: (a) WAAM deposit made from co-depositing Al-Cu and Al-Mg feedstock to tailor chemistry and assess HCS. Solidification “macro cracks” run through the height of the deposit for certain susceptible compositions. (b) Fracture surface of a macro crack, and (c) polished cross section revealing liquation cracking in a deposit without macro cracks. [96].

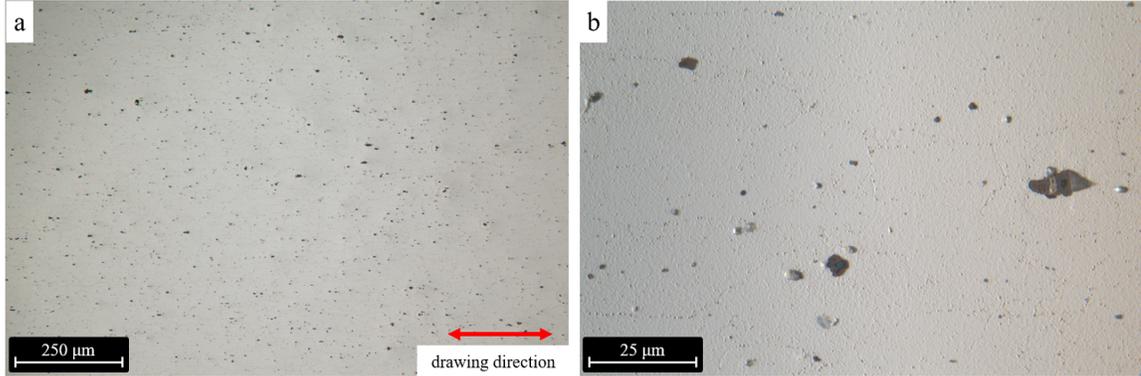
Figure 4.6: Etched microstructure of the 7075 wire used for constructing the deposits. (a) 100x view showing the particle distribution in the wire, and (b) 1000x image of the bulky, Al-Fe-Cu particles and other smaller particles containing Zn or Cu.

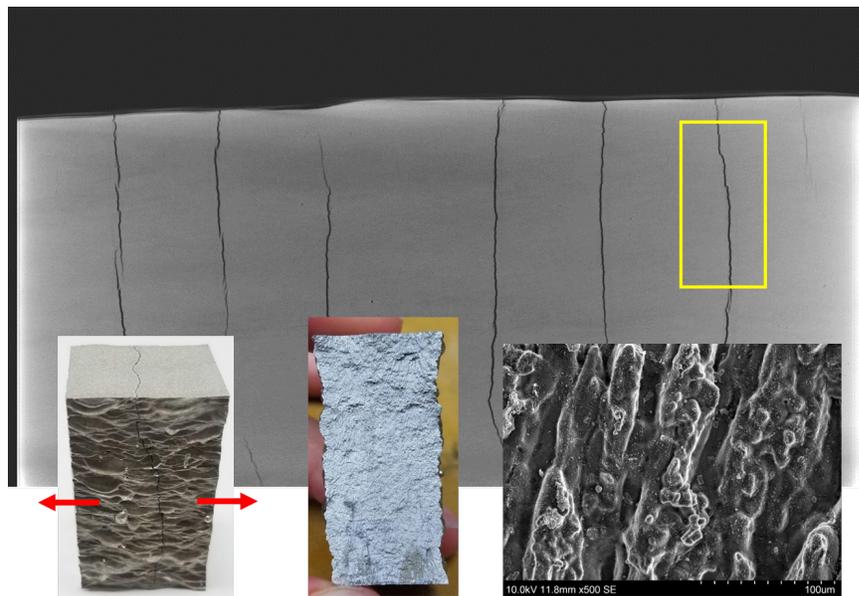
Figure 4.8: Procedure for identifying and opening macrocracks for observation of the crack surface morphology in the SEM.

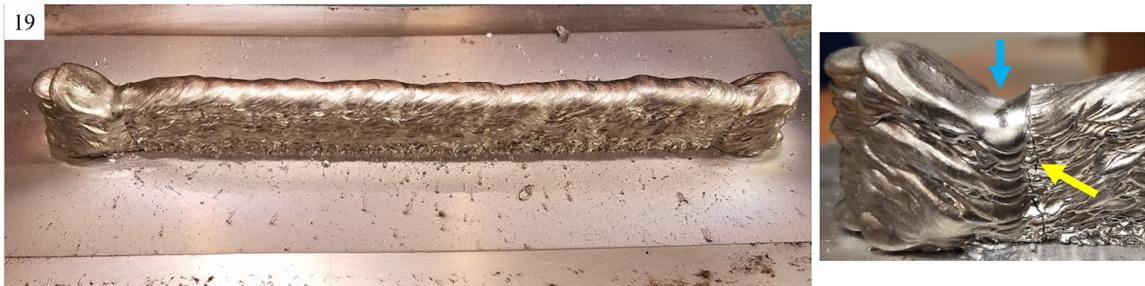
Plate 19 replicated the machine parameters of the 2219 walls, which included a beam focus (BF) condition of $BF = 323$, or 18 points under-focused. The deposit was built with the same deposition procedure as the 2219 walls (including runbacks) but was limited to 28 layers to study the material behavior before attempting a full 5 in. tall wall. Furthermore, it was expected that alloying element losses would occur due to the volatility of Zn and Mg under vacuum while at the melting temperature of Al (see Fig. 2.14), so this deposit was limited in height to check the composition before proceeding to taller builds. Due to viscosity differences between 2219 and 7075, the runbacks at the deposit ends resulted in a crater and large slump that led to dripping and discontinuity of the build layer with increasing height. Figure 4.10 shows the Plate 19 deposit, with the inset highlighting a macrocrack (yellow arrow) and the crater formed during the runbacks (blue arrow).

Figure 4.10: Image of the completed Plate 19 deposit. The inset shows an end of the deposit with slumping and cratering from the runbacks, as well as a macrocrack.

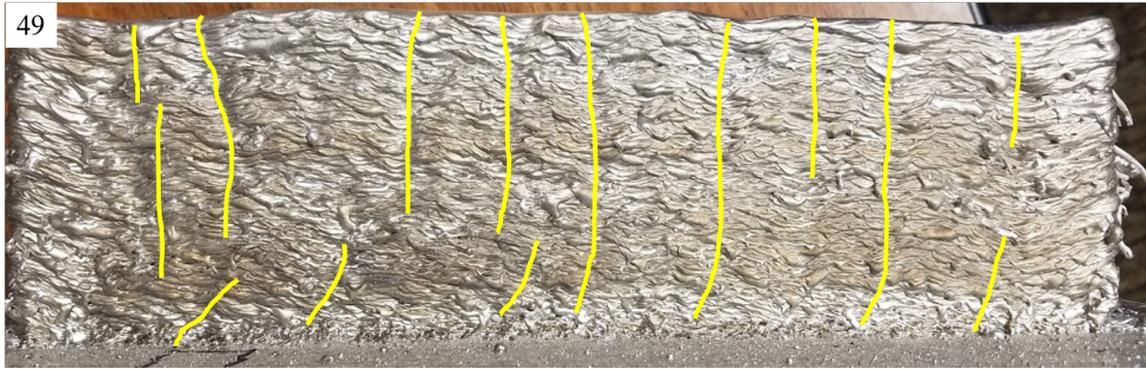
To study the effects of a high preheating and deposition temperature on cracking, the preheat temperature for Plate 49 was increased to 300°C while retaining the Plate 46 machine parameters. This was accomplished by decreasing Δz by 0.007 in. to account for thinner layers spreading from the higher temperature. Plate 49 was built the tallest, with an input of 172 layers since the deposit geometry appeared very stable during deposition. However, upon removal from the build chamber, it was discovered that the deposit contained wide macrocracks that were angled approximately 65° near the baseplate and turned vertically after the first 0.6 in. of the deposit height. These cracks appeared in a near-periodic fashion along the length of the deposit, suggesting high stresses in operation, with an average spacing of 0.70 in. Furthermore, the elevated temperature of deposition resulted in significant alloy losses, with 36% Zn and 19% Mg lost from the deposit. Figure 4.11 shows a side view of the Plate 49 deposit, with visible macrocracks highlighted in yellow.

Figure 4.11: Image of the completed Plate 49 deposit, with macrocracks highlighted in yellow and widened for visibility.

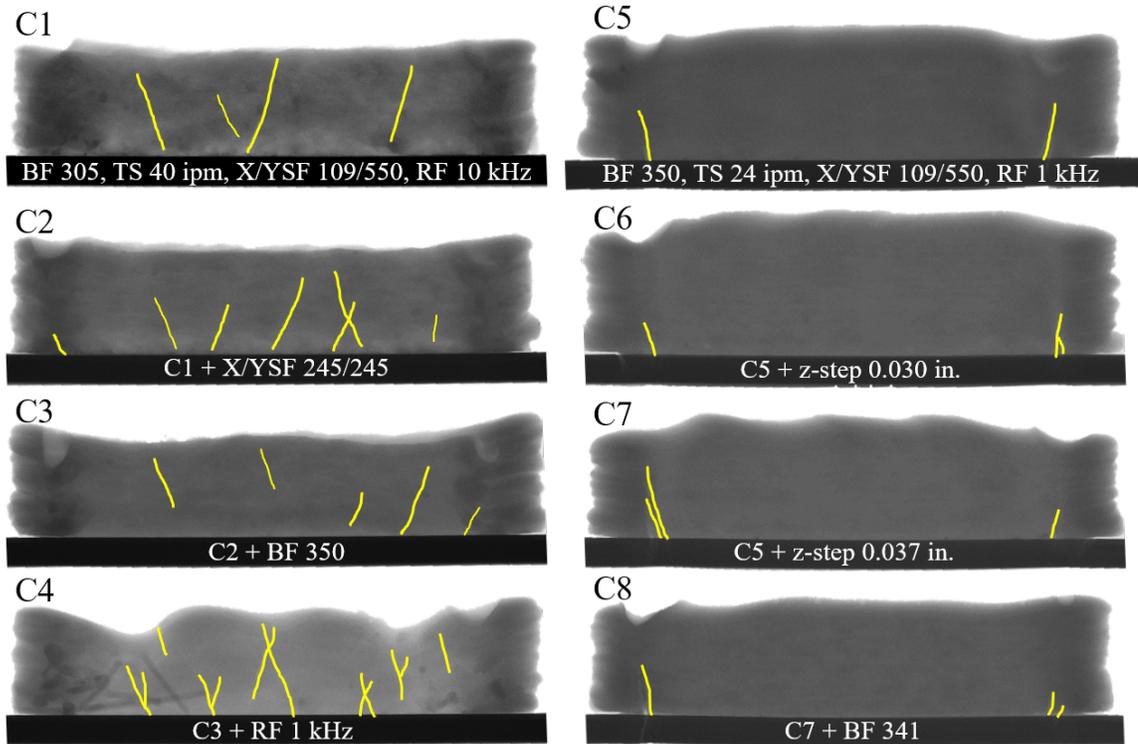
Figure 4.12: Radiographs of the 4 in. 7075 deposits built on Plate 60.
