Electron Beam Freeform Fabrication of Aluminum: Investigating Properties and Cracking in Alloys 2219 and 7075

A Thesis

University of Virginia

December 2019

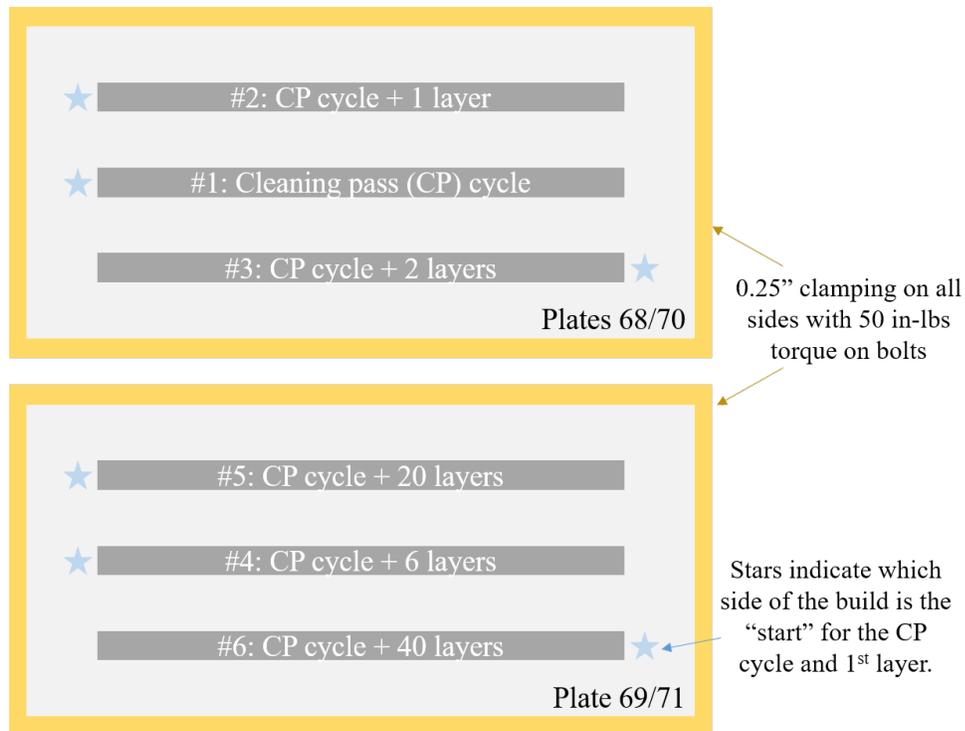
Figure 4.13: Build plans for Plates 68-71, where 68-69 were built on 1 in. plate and 70-71 were built on 0.25 in. plate to compare the effects of constraint on developing cracks in few-layer builds in 7075.

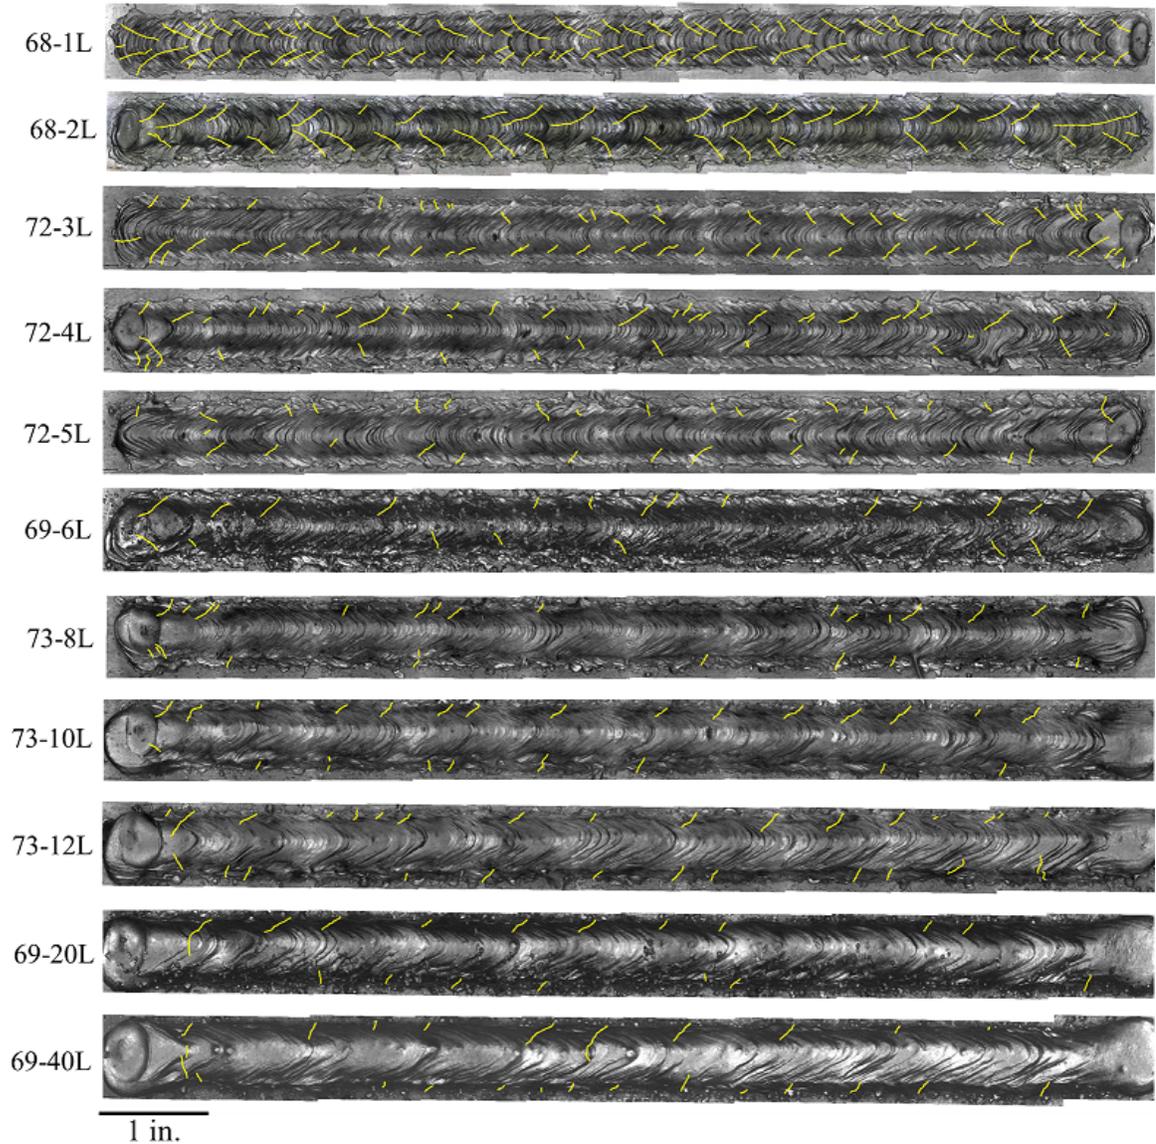
Figure 4.14: Series 3 deposits on 1 in. baseplate highlighting the macrocrack initiation and progression with increasing number of layers. Only cracks that broke the top surface and were visible with the stereo microscope were highlighted.

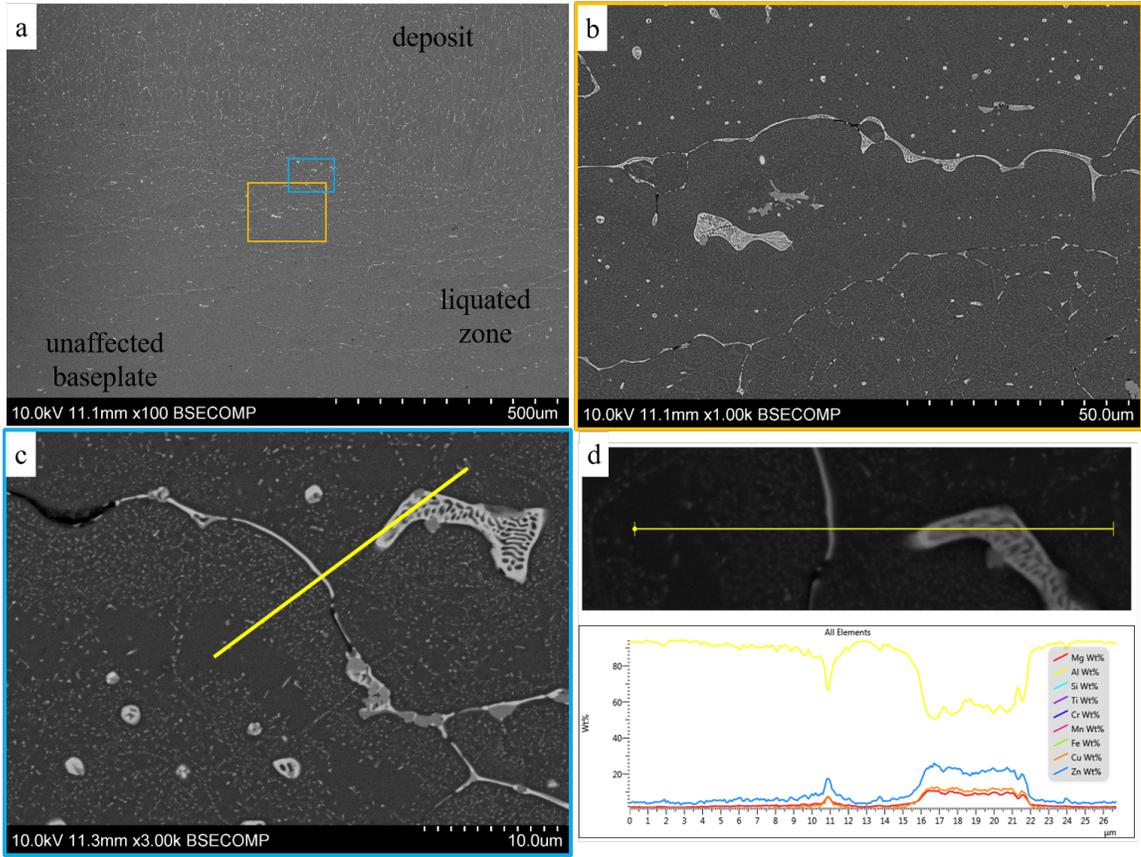
Figure 4.16: (a) Polished microstructure showing the intersection of the Plate 49 deposit with the baseplate, (b) copious grain boundary liquation, (c) region outlined in blue for linescan, (d) linescan showing Al-28Zn-14Cu-13Mg eutectic draping the grain boundaries.

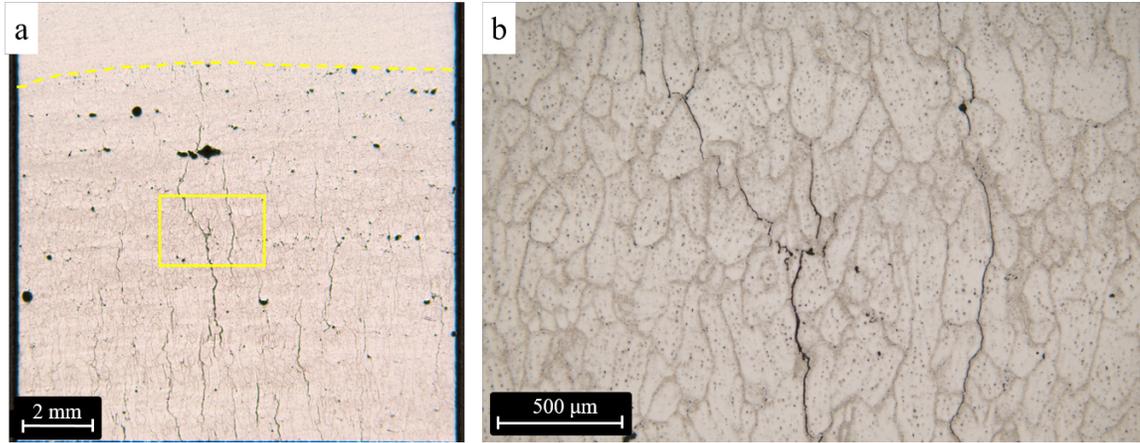
Figure 4.17: (a) L-ST etched cross section showing a field of microcracks below the FZ boundary (dotted yellow line) in Plate 49, and (b) 50x micrograph showing two of these interdendritic microcracks running between elongated grains in the microstructure.

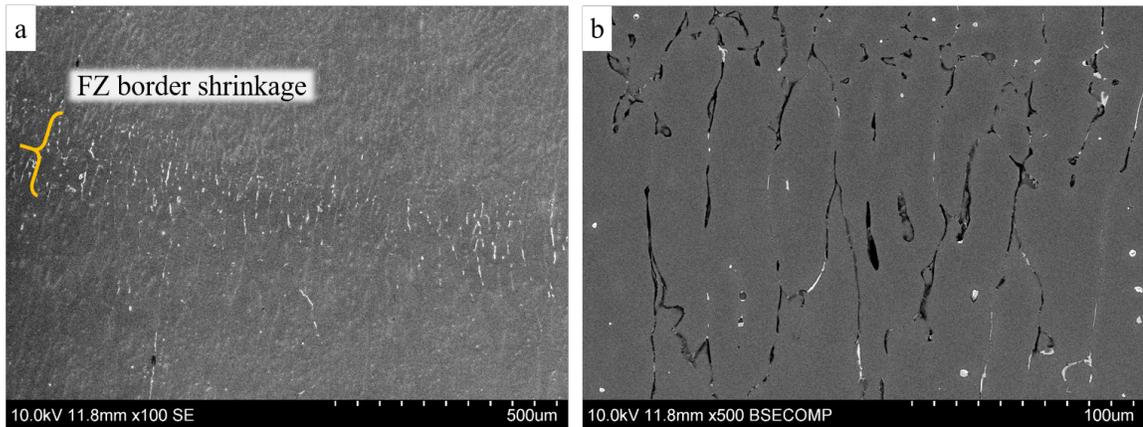
Figure 4.18: (a) Shrinkage at the border of the topmost layer's FZ with the layers below, (b) 500x image of the low-density region, with Mg-rich particles and voids inhabiting the interdendritic spaces.

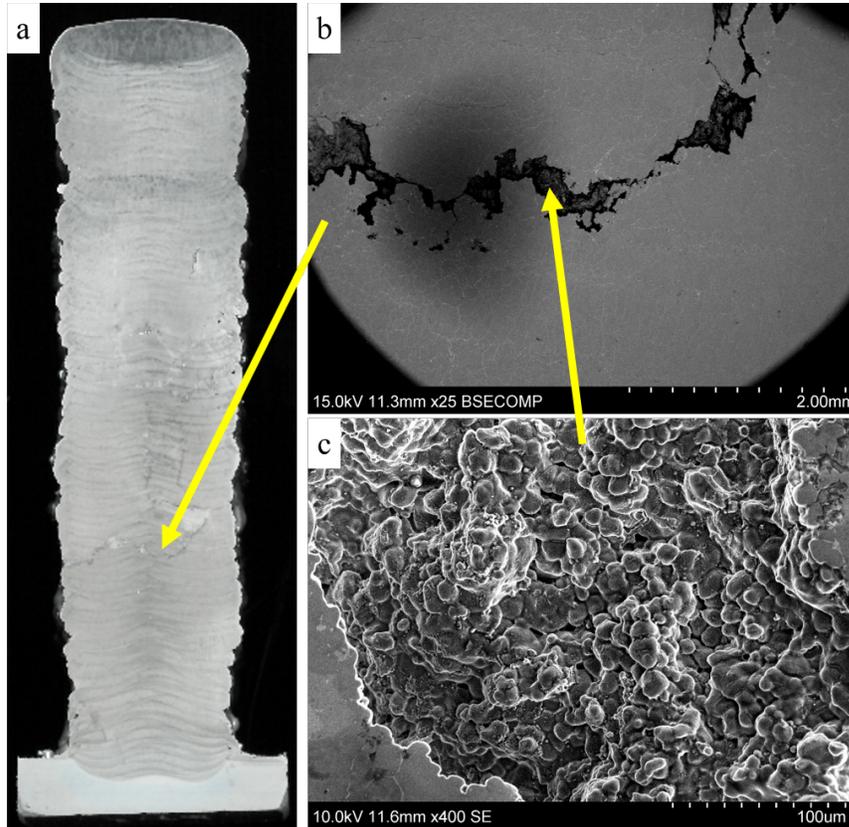
Figure 4.19: (a) The initial Plate 49 metallurgical sample intercepted a macrocrack running through the deposit. (b) BSE image highlighting the intercepted macrocrack. (c) The exposed crack surface appears to have a dendritic character.

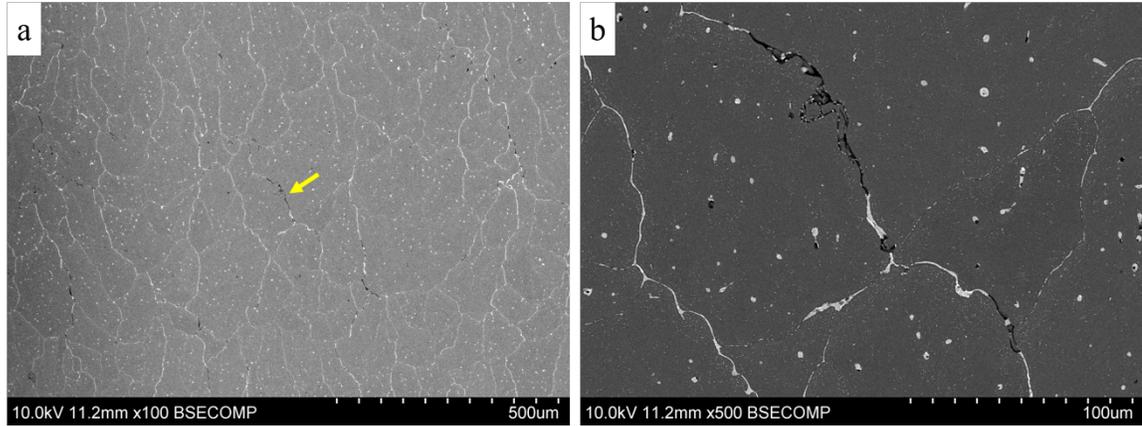
Figure 4.20: (a) 100x BSE image from the Plate 49 deposit showing liquated grains with low-density regions corresponding to microcracks, (b) 500x BSE image showing a microcrack and liquated grain boundaries.

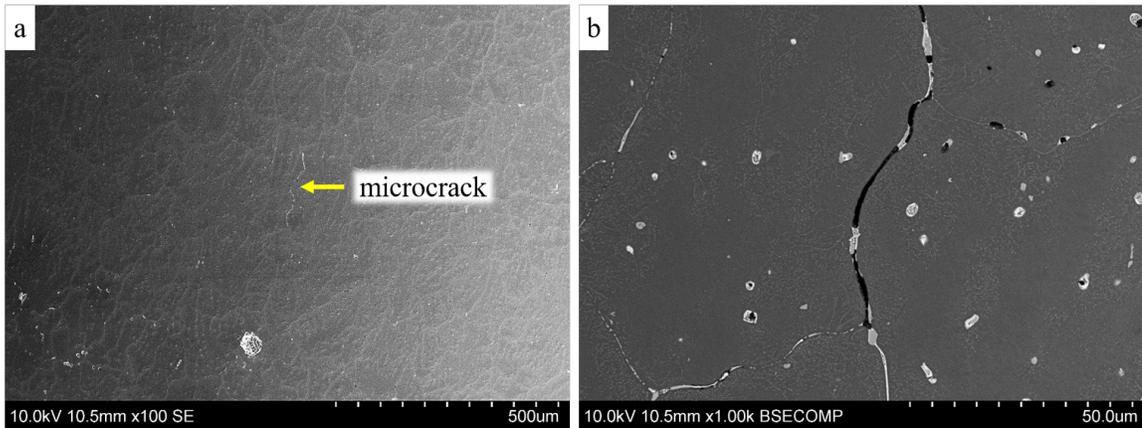
Figure 4.21: (a) 100x SE image showing elongated grains in the Plate 46 microstructure, with a microcrack denoted by the yellow arrow. (b) 1000x BSE image of the microcrack, as well as nearby eutectic and Al-28Cu-10Mg-4Zn precipitates decorating other grain boundaries.

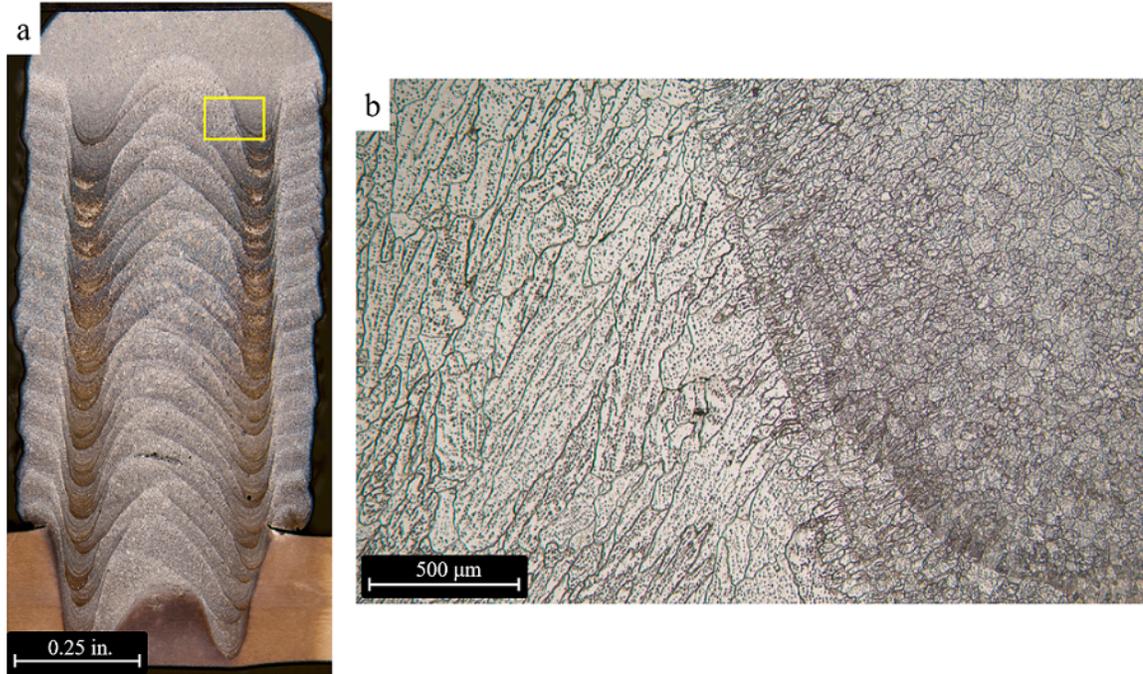
Figure 4.22: (a) Polished and etched LT-ST cross section of the Plate 60-C8 deposit. The pointed, heavily-etched regions of the deposit are where the sharply-focused and rastered beam struck the sample. (b) Higher magnification image showing the border between the deep melt pool with fine, equiaxed grains and the region outside containing large, elongated grains angled towards the keyholed region.

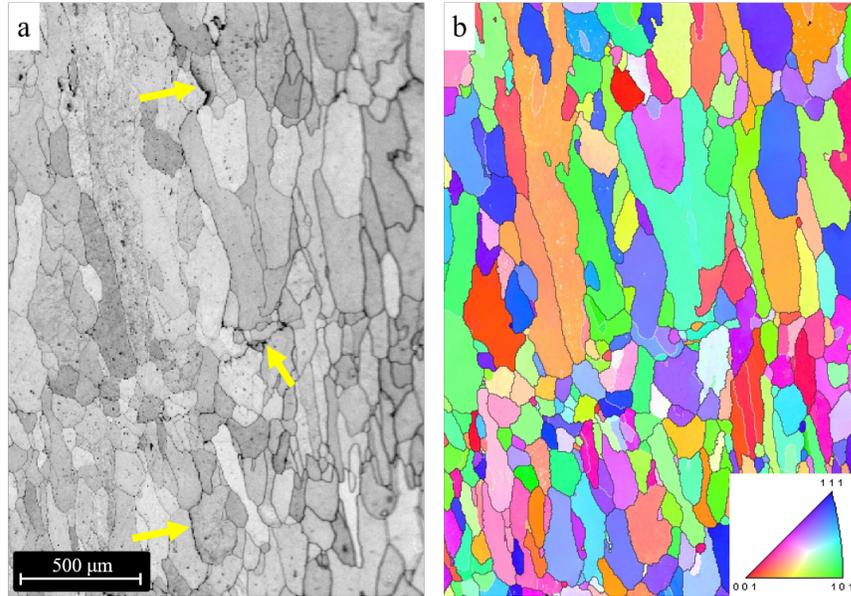
Figure 4.23: (a) Image quality map showing microcracks running between elongated grains in the Plate 49 microstructure, (b) EBSD IFP normal direction map showing grain orientations and sizes.

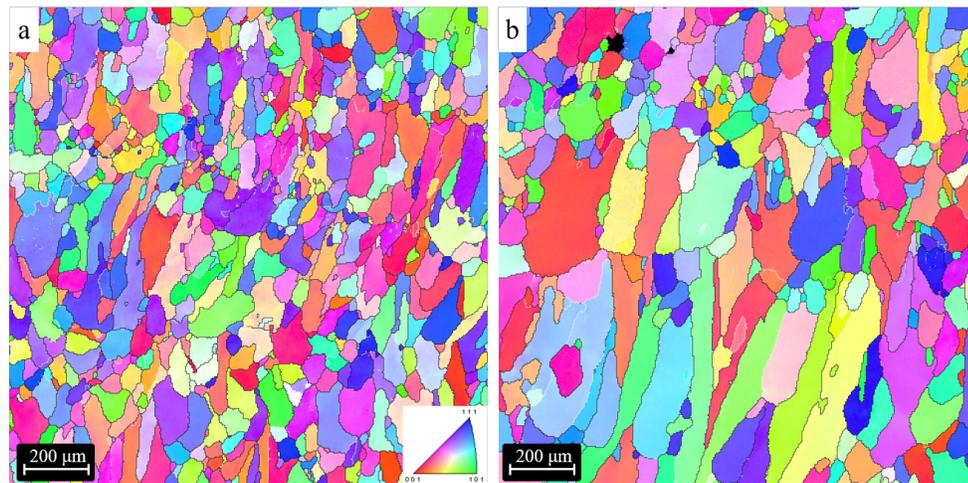
Figure 4.24: (a) EBSD IFP normal direction map showing grain orientations and sizes in a typical region in the Plate 50 microstructure, (b) EBSD map showing larger grains in a region directly above a macrocrack which lost thermal conductivity with the deposit below.

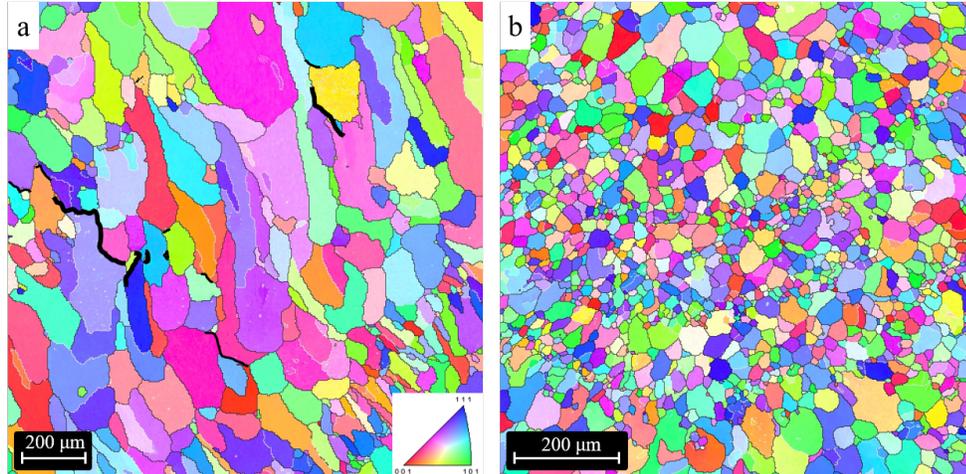
Figure 4.25: (a) EBSD IFP normal direction map showing elongated grains in the large-grained region of the Plate 60-C8 microstructure. Microcracks between large grains are outlined and bolded in black for emphasis. (b) EBSD map showing refined, equiaxed grains in the sharp-focused region of 60-C8 sample.

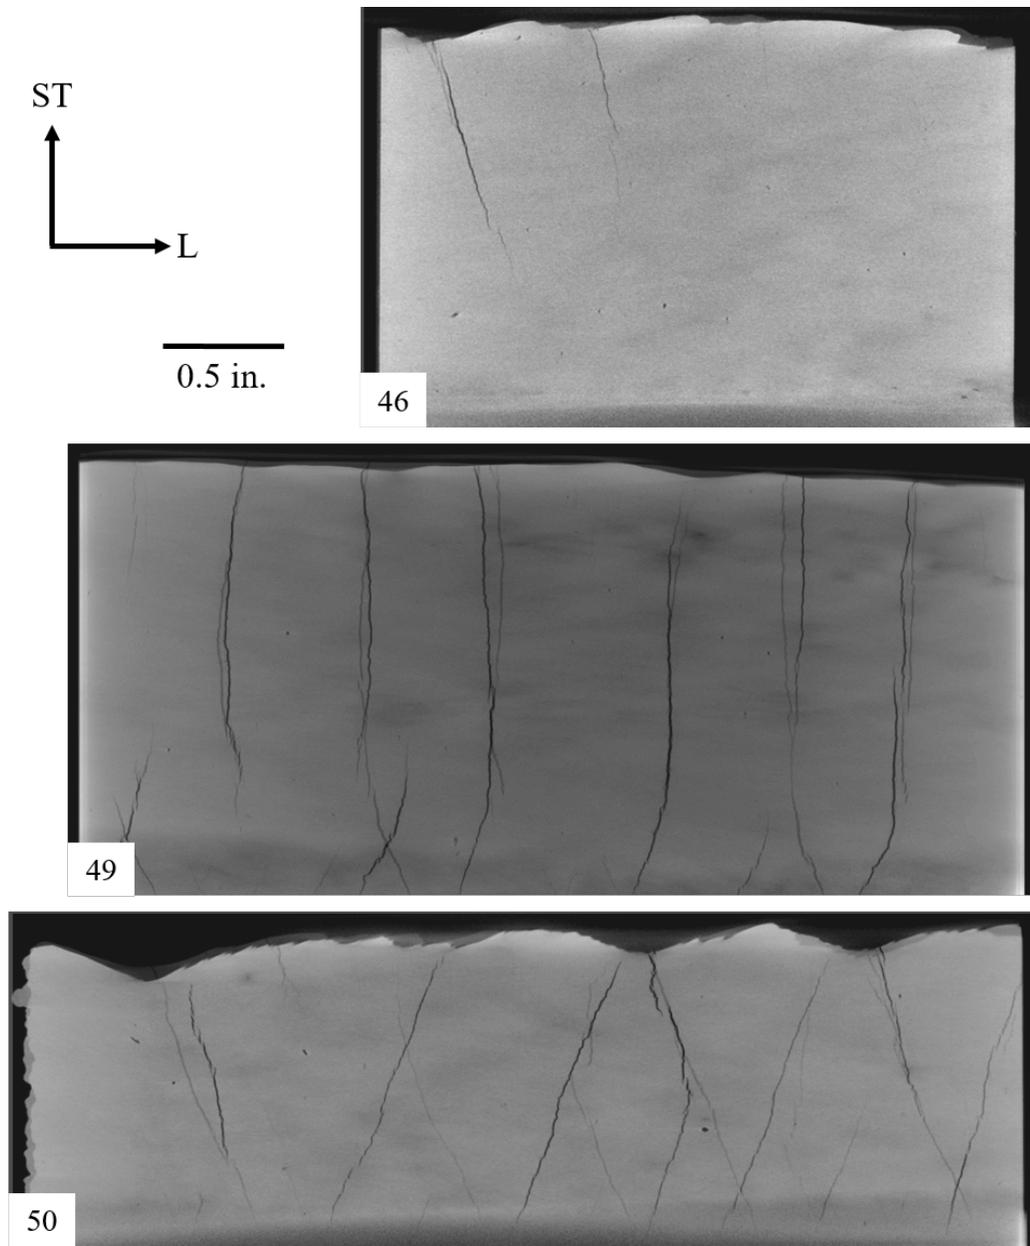
Figure 4.26: Low-resolution XCT composite images of the Plate 46, 49, and 50 deposits highlighting macrocracks on the front (darker) and back (lighter) faces of each deposit.

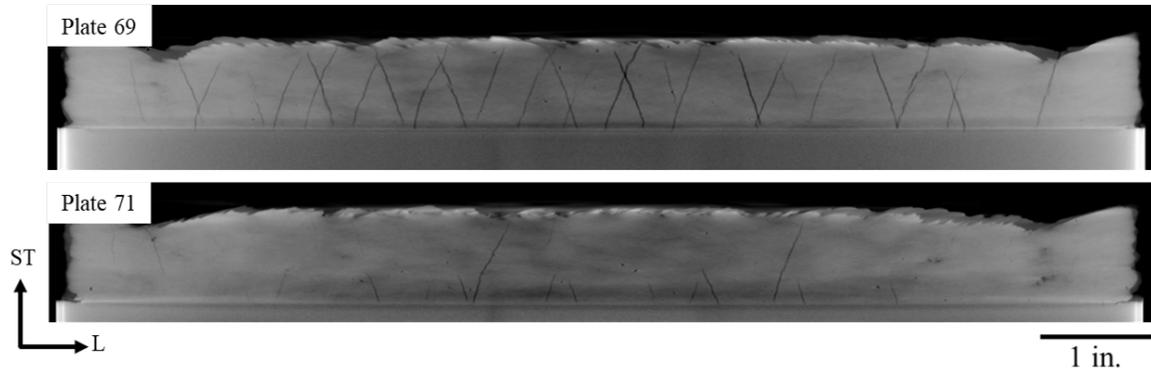
Figure 4.27: XCT composite images of the Plate 69 and 71 40-layer deposits showing macrocracks on the front and back faces of each deposit.

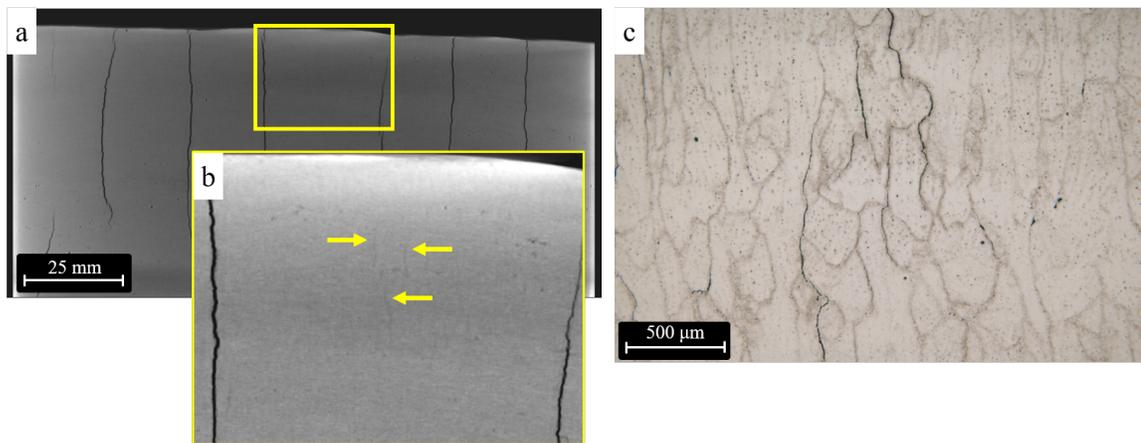
Figure 4.28: (a) 70 μm XCT scan showing (b) blurry regions of microcracks. (c) A polished cross section of this region better captures the microstructural level cracking between columnar grains.

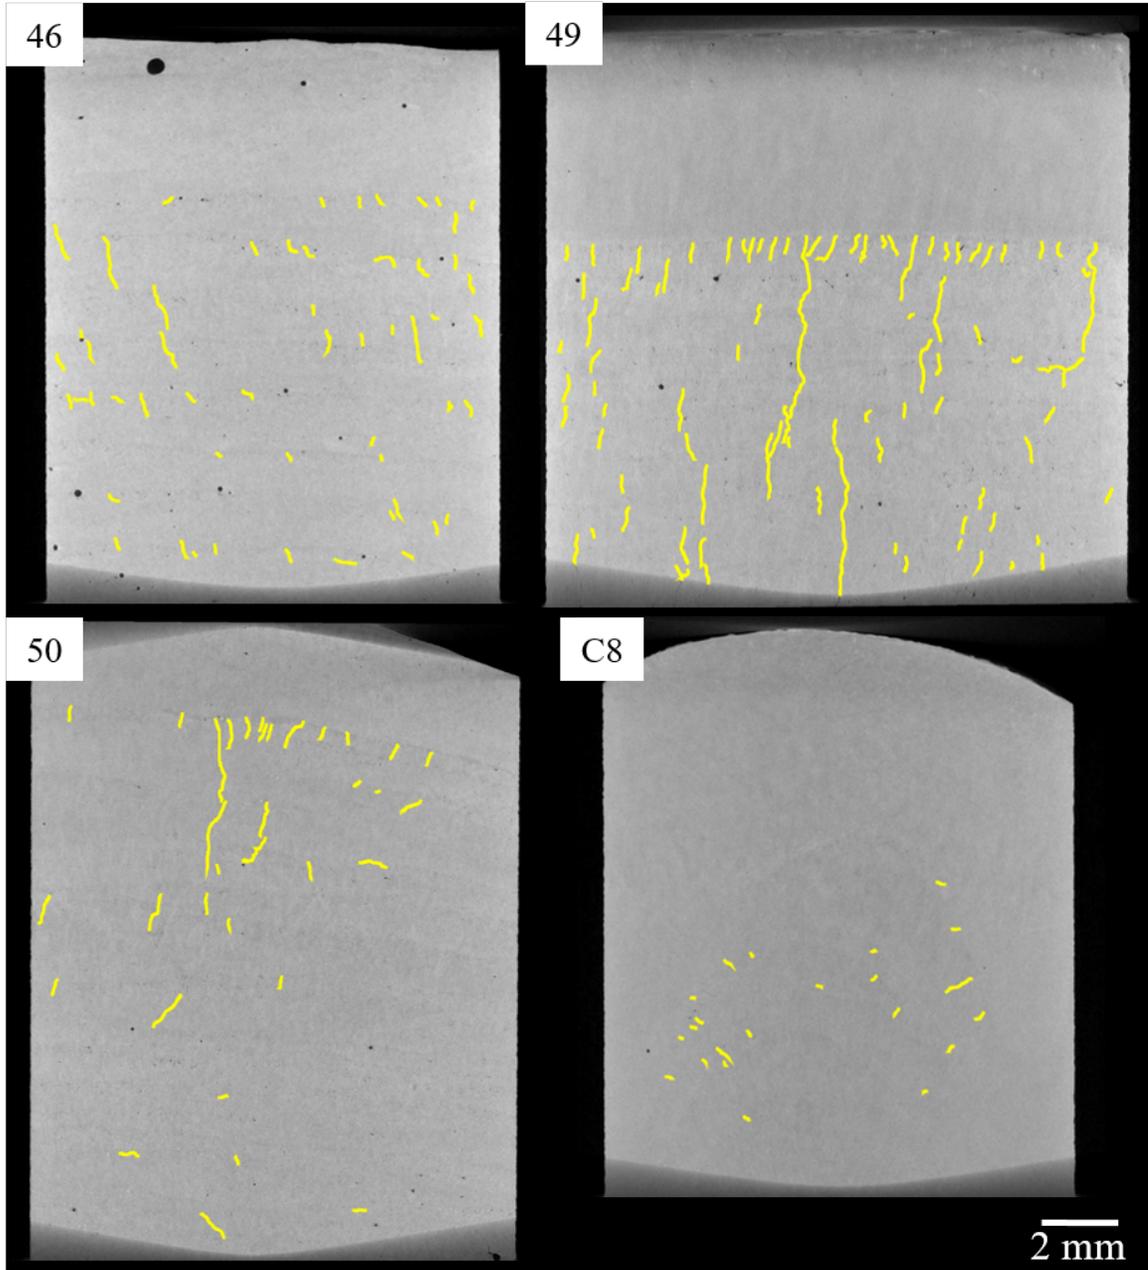
Figure 4.29: Comparison of microcracking between Plates 46, 49, 50, and 60-C8. Note that the planes selected for cracking image analysis depending on the major direction of the cracks so that the slices would be selected normal to the cracks.

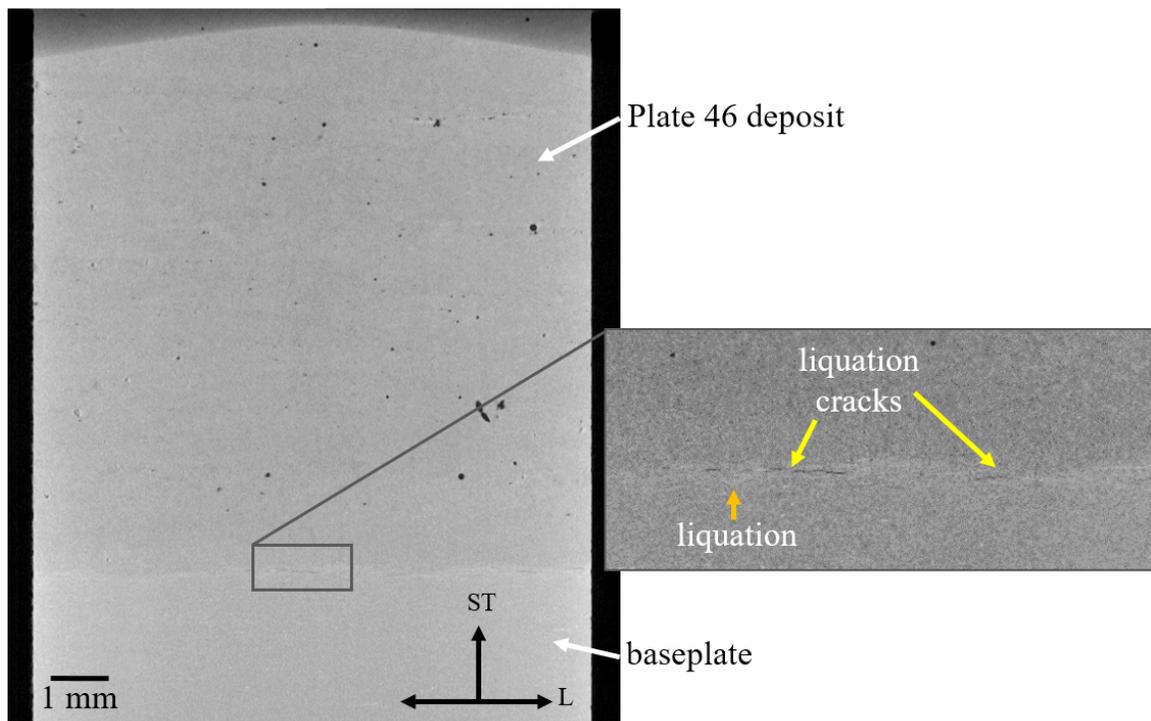
Figure 4.30: 8 μm XCT scan of the Plate 46 deposit highlighting the intersection of the deposit with the baseplate. The inset shows an enlarged region where both liquation and liquation cracking occur at the interface. The change in contrast between the deposit and baseplate is due to the vaporization of alloying constituents in the deposit, making it less dense.

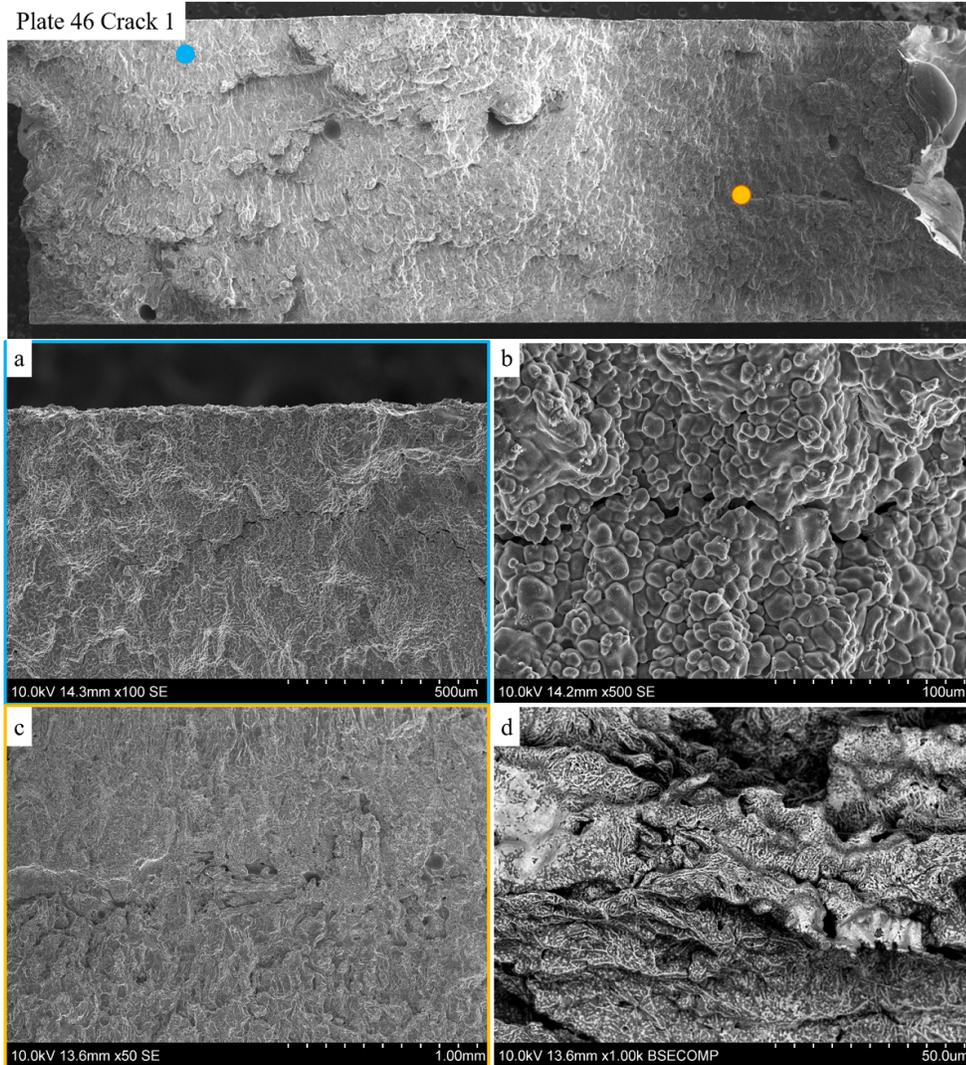
Figure 4.31: (a) Typical dendritic region of the crack surface, (b) 500x image of the dendrites and a secondary crack, (c) Another dendritic region, with horizontal features, (d) 1000x BSE image showing a thin, Al-10Zn-5Mg film coating dendritic features

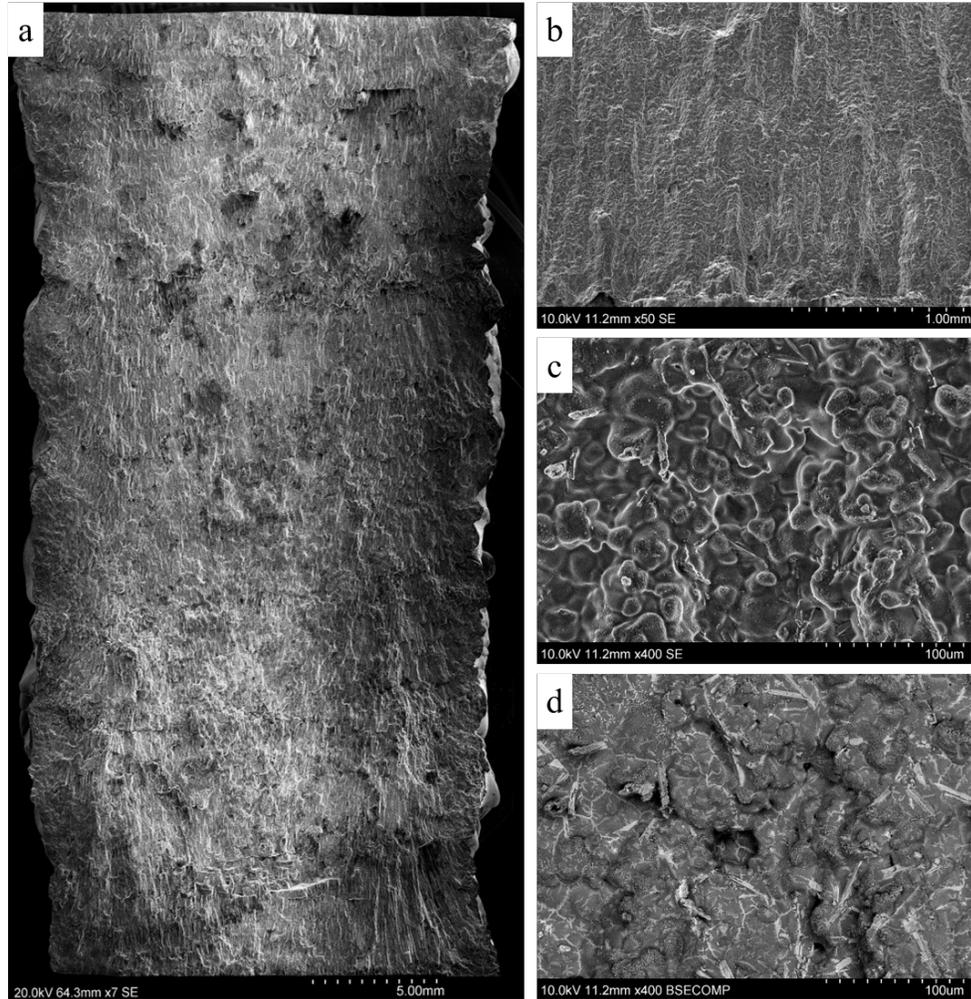
Figure 4.32: (a) Plate 49 overall Crack 2 surface, with (b) typical dendritic region of the crack surface, (c) and (d) are SE and BSE images, respectively, of the dendrite tips and feathery precipitates decorating them.

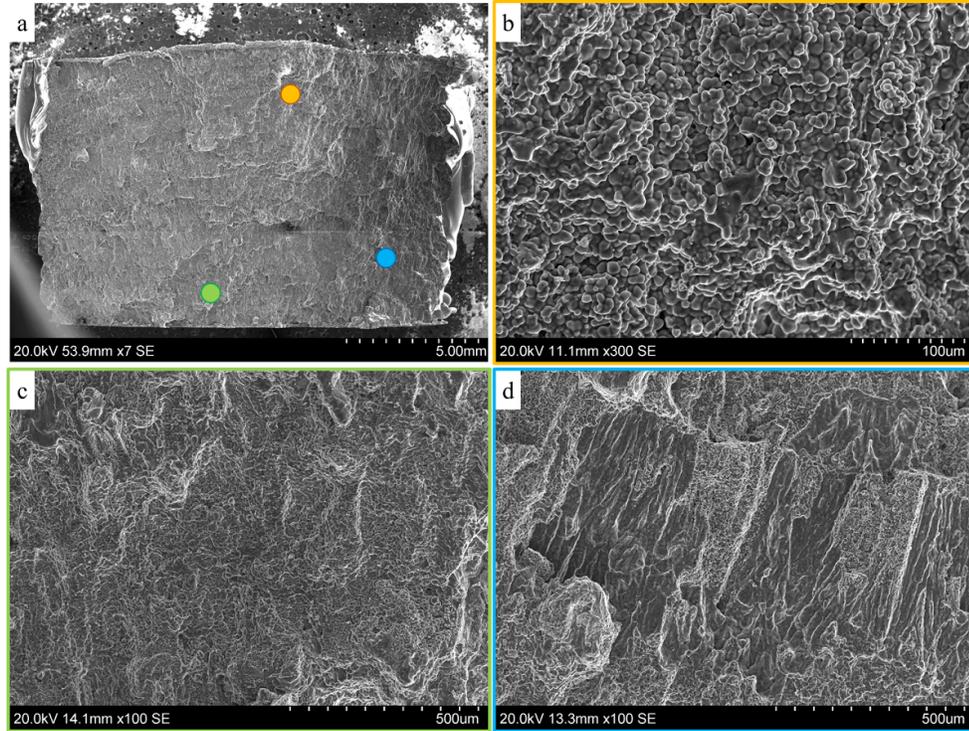
Figure 4.33: (a) Plate 50 crack surface macrograph, (b) and (c) are typical dendritic regions on the surface, and (d) patchy dendritic and smooth regions.

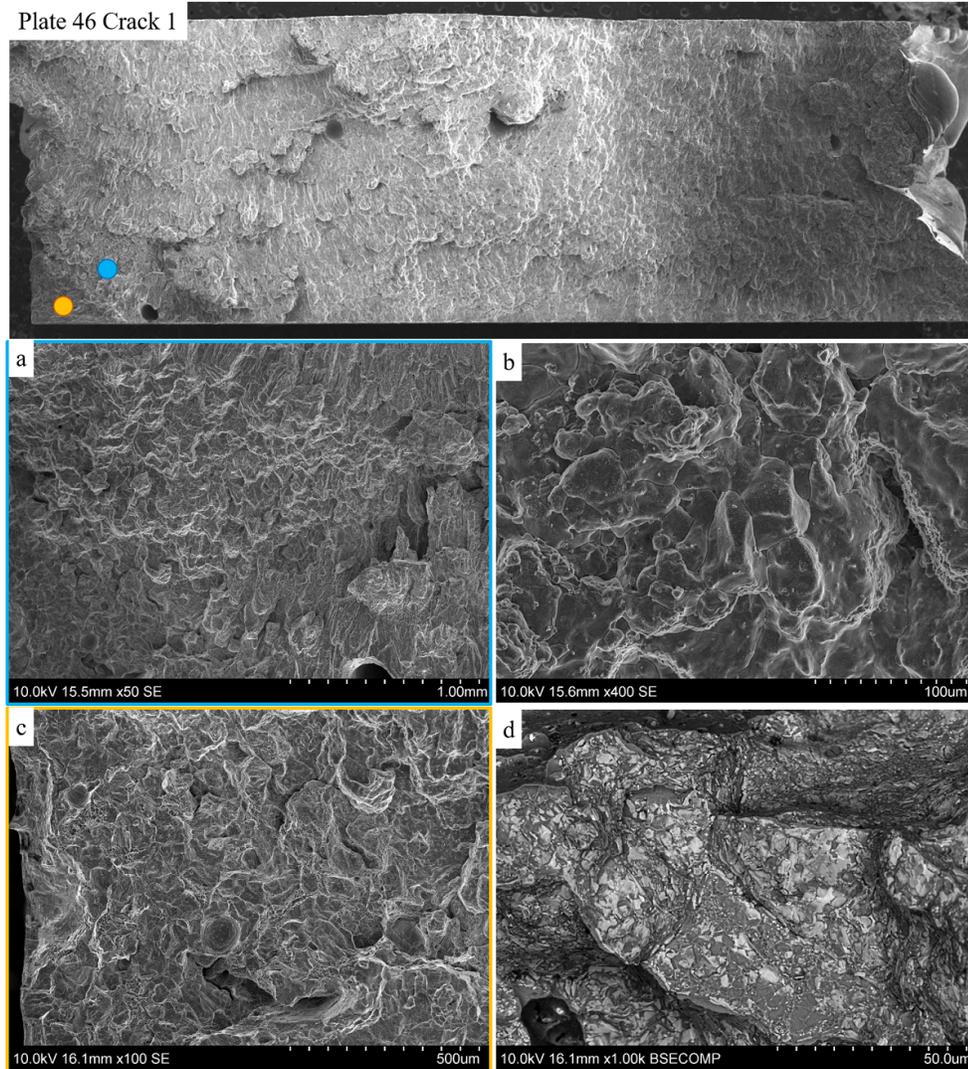
Figure 4.34: (a) Region composed completely of smooth, almost-equiaxed grain-like features, (b) 400x image showing such grains, (c) region neighboring the smooth-grained region where fracture has occurred (from crack separation) preferentially along grain boundary eutectics, and (d) 1000x BSE image showing those eutectics.

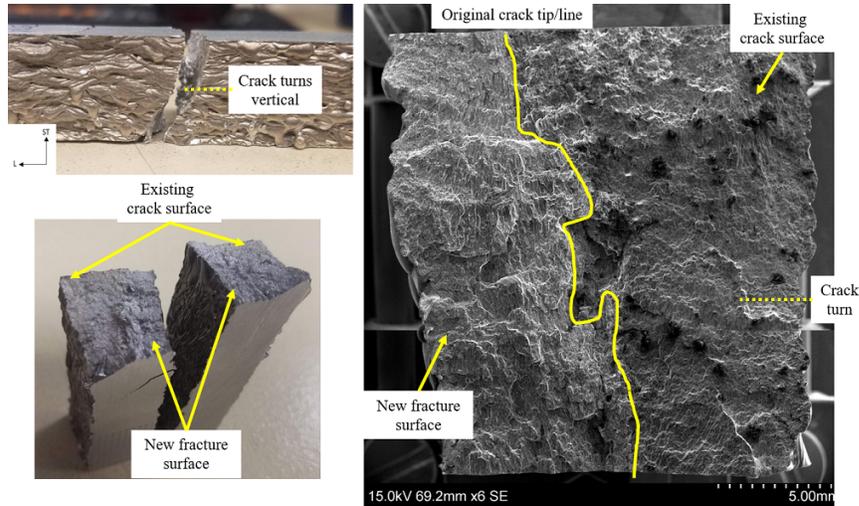
Figure 4.35: Near-baseplate fractured sample to open the partial-width macrocrack. The image on the right shows the crack surface containing the existing and newly-fractured crack surfaces. The yellow line divides the new fracture from the old and shows an increase in the macrocrack width with increasing height in the deposit.

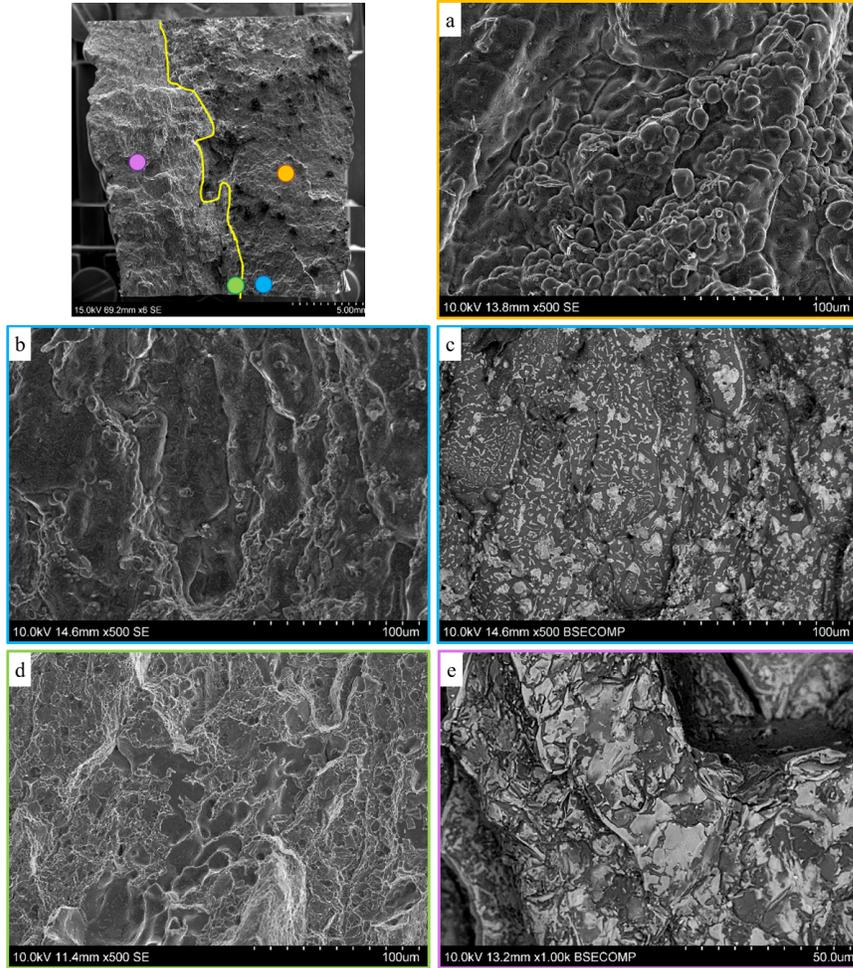
Figure 4.36: Near-baseplate macrocrack map, with subfigures showing (a) typical dendritic character of the majority of the existing crack surface, (b) and (c) SE and BSE images of smooth, liquated features at the crack tip, (d) partial grain bridging near the crack tip, and (e) BSE image of the newly-fractured surface, with fracture through Al-31Cu-10Mg-4Zn eutectics.

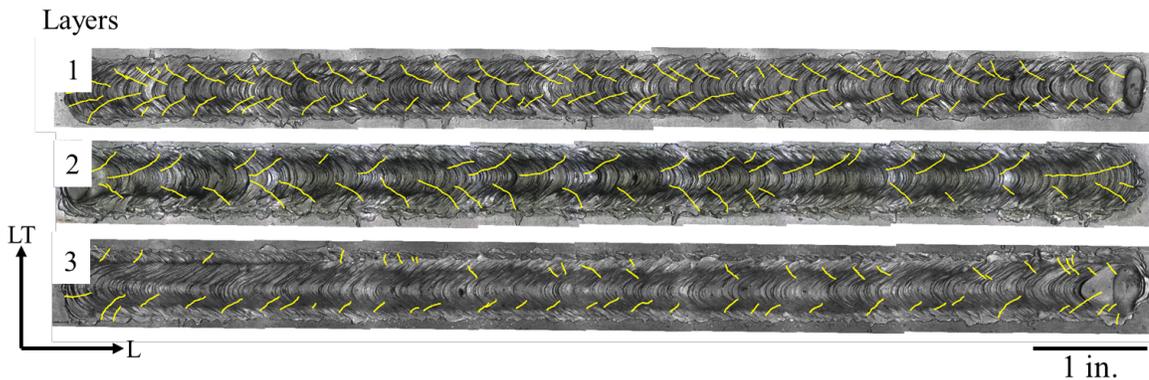
Figure 4.37: Comparison of the Plate 68-1L, 68-2L, and 69-3L builds. Note the changing crack shape and orientation with increasing number of layers, particularly between 2 and 3 layers.

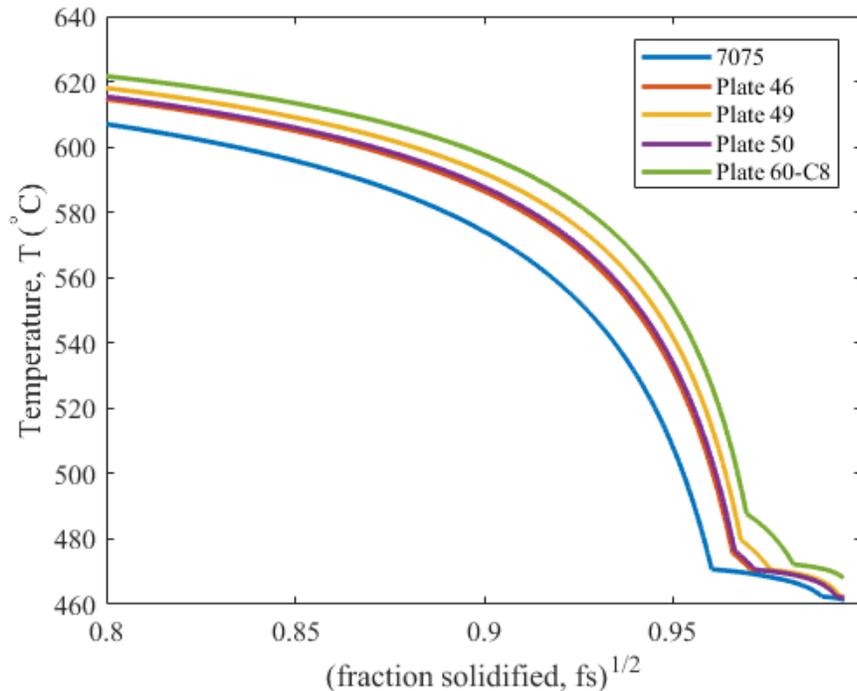
Figure 4.51: Scheil solidification $T-f_s^{1/2}$ diagrams for the 7075 wire composition and various deposit compositions.
