**University of Virginia North Grounds Campus Rivanna Stream and Trail Restoration
Project with Biohabitats, Inc.**

A Technical Report submitted to the Department of Civil and Environmental Engineering

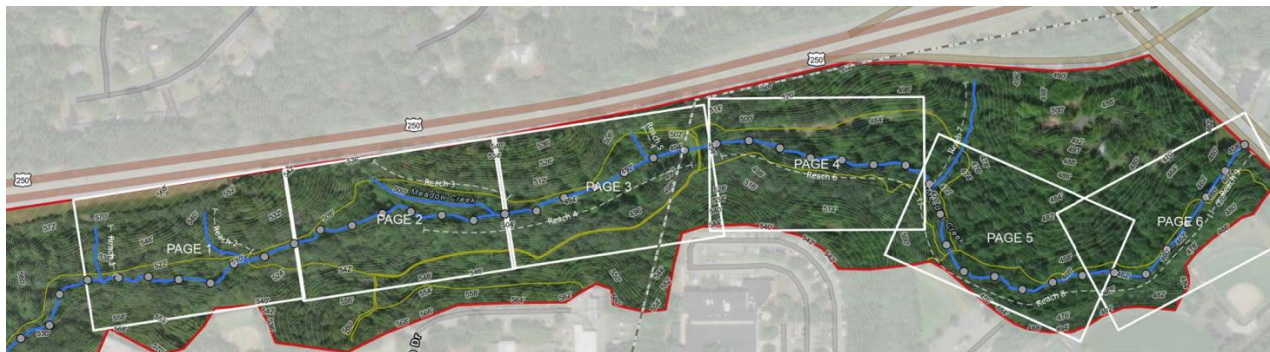
Figure 1-1. Biohabitats Division of Reaches

As is shown in Figure 1-1, reaches (3 and 5) are tributaries to the stream fed by outfalls that run under US 250/Route 29 Bypass. These reaches are of particular interest because there is concern about the influence of increased flow contributions on sediment load and phosphorus and nitrogen concentrations. Therefore, our research and design are primarily centered around Reach 3 and Reach 5. Figure 1-2 provides a more detailed view of these reaches.

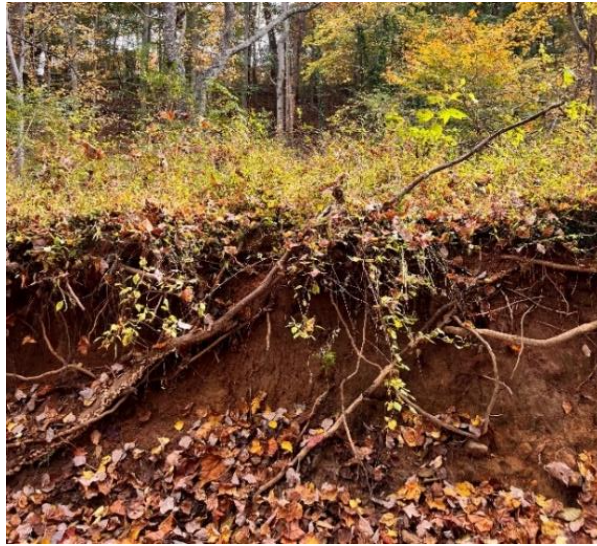
Figure 3-4. Incised Banks on Reach 3

The previous water quality datasets imply that sediment and nutrients are not actively being conveyed by Reaches 3 and 5. However, the severe physical incising (Figure 3-4) is indicative of historical erosion in the reaches and probable erosion during future, larger storm events. Therefore, to accurately determine the extent of erosion and inform TMDL and MS4 credit calculations, a Bank Erosion Hazard Index (BEHI) of Reaches 3 and 5 was employed.

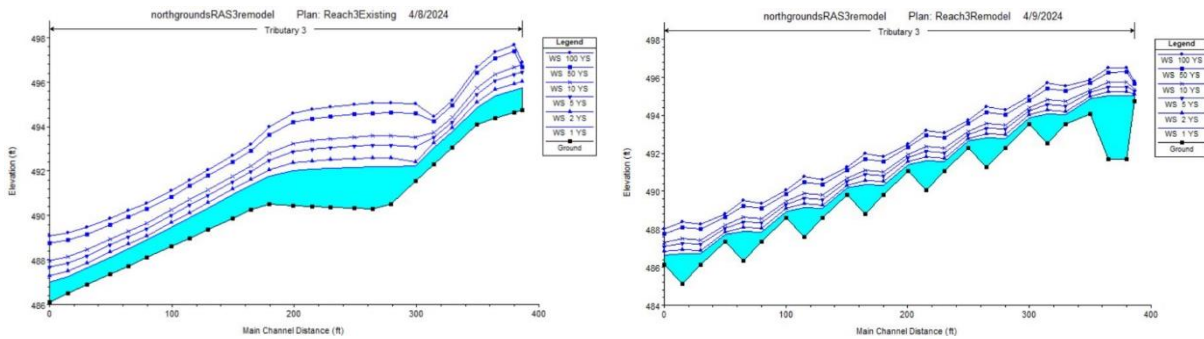
Figure 6-1. Reach 3 HEC-RAS Profile Views, Existing (left) and Proposed (right)

Figure 6-1 and 6-2 below, you can see the Reach 3 existing profile view from RAS and the proposed profile view for the reach.

The results of the design were promising. The shear stress of the Reach 3 design was 4 pounds per square foot. This influenced the designed rock size requirement for the riffles and plunge pool across the reach. Using a spreadsheet provided by Biohabitats, the median rock size (D50) for Reach 3 was 10.4 inches. For Reach 5, with a shear stress of 10.06 pounds per square foot, the median rock size requirement for a factor of safety of 1 is 26.1 inches. Figure 6-3 shows the rock sizing diagram, with the shielding line. Both designs are safely below the shields line.

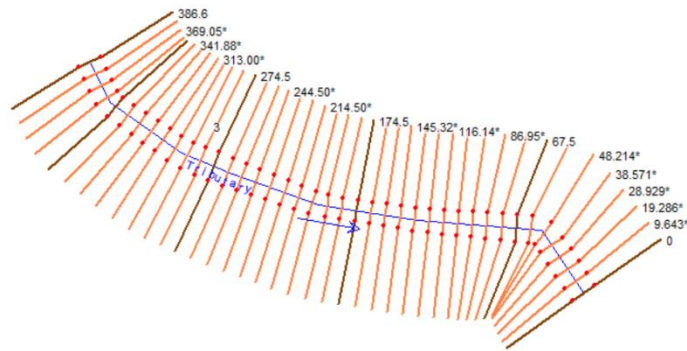
Reach 3 HEC-RAS Model Layout with Cross Sections at Delineated Stations

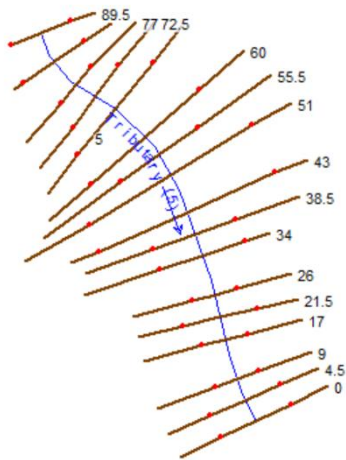
Reach 5 HEC-RAS Model Layout with Cross Sections at Delineated Stations

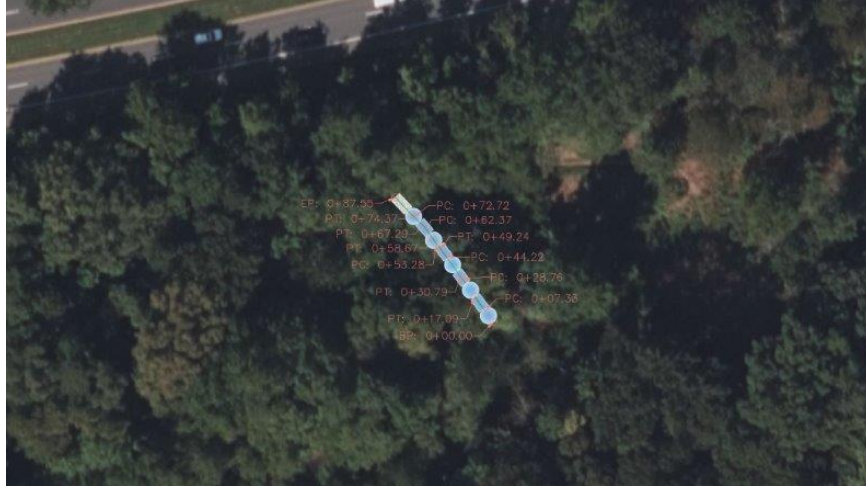
Reach 5 Final Draft Design (Plan View)
