North Grounds Stream Restoration

May 3, 2024

Department of Civil & Environmental Engineering | University of Virginia

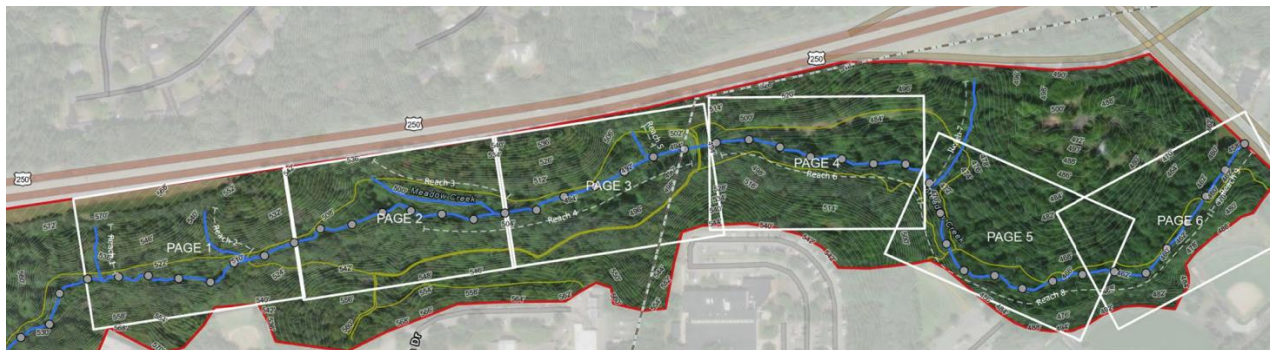
Figure 1-1. Biohabitats Division of Reaches

As is shown in Figure 1-1, reaches (3 and 5) are tributaries to the stream fed by outfalls that run under US 250/Route 29 Bypass. These reaches are of particular interest because there is concern about the influence of increased flow contributions on sediment load and phosphorus and nitrogen concentrations. Therefore, our research and design are primarily centered around Reach 3 and Reach 5. Figure 1-2 provides a more detailed view of these reaches.

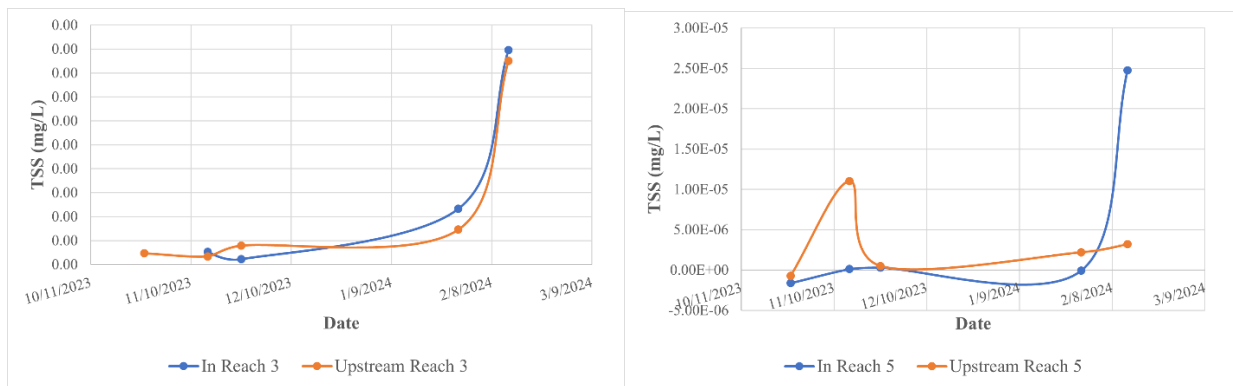
Figure 3-3. Upstream and In-Stream TSS Concentrations

Again, there are no discernible TSS trends upstream or in-stream for Reach 3 and 5. This implies that the reaches did not add much sediment to the main tributary on these dates.

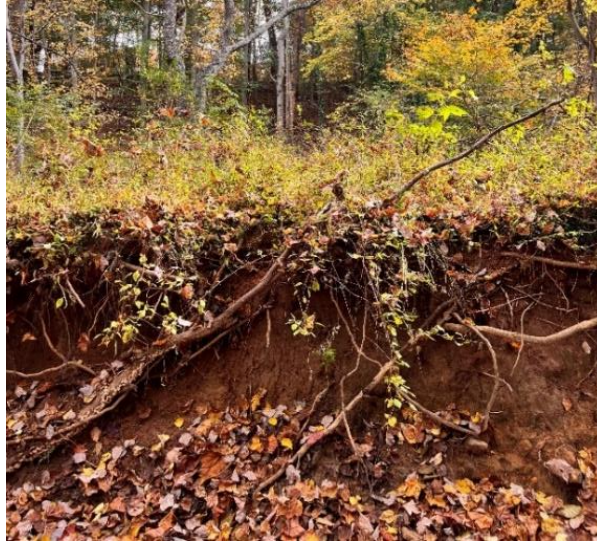
Figure 3-4. Incised Banks on Reach 3

The previous water quality datasets imply that sediment and nutrients are not actively being conveyed by Reaches 3 and 5. However, the severe physical incising (Figure 3-4) is indicative of historical erosion in the reaches and probable erosion during future, larger storm events. Therefore, to accurately determine the extent of erosion and inform TMDL and MS4 credit calculations, a Bank Erosion Hazard Index (BEHI) of Reaches 3 and 5 was employed.

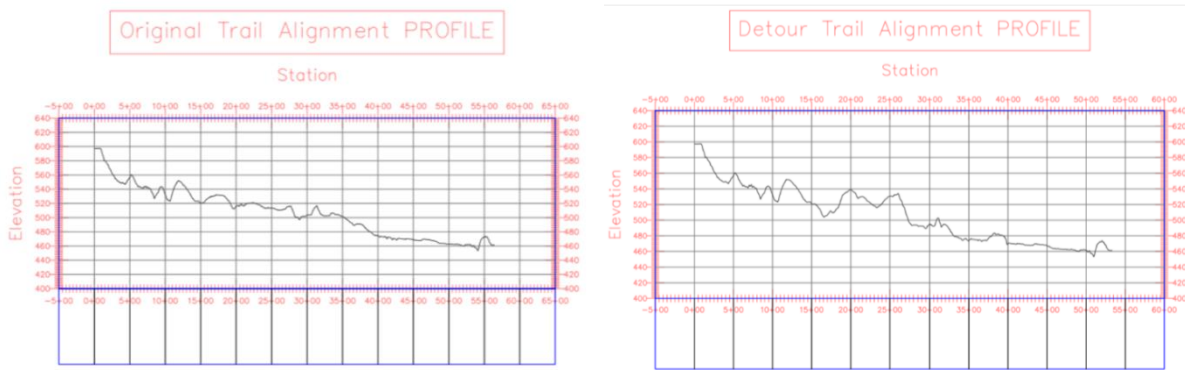
Figure 7-4. Profile Views of Existing and Detour Trails

The profiles of the existing and detour trails are displayed in Figure 7-4.
