Finding a Replacement for Hexavalent Chromium Sacrificial Paint
Capstone Final Report

MSE 4592 - Materials Design Capstone II

In collaboration with Rolls-Royce Corporation and Luna Labs USA LLC

May 7th, 2025

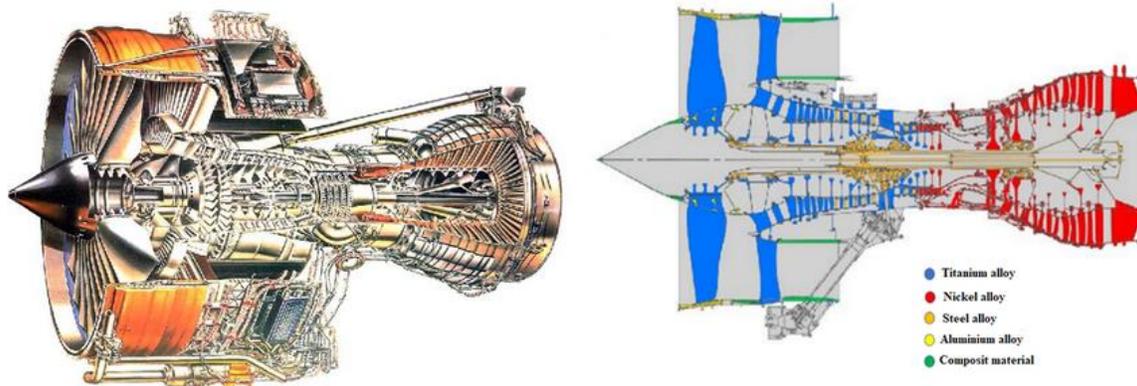
Figure 1. Schematic of Rolls Royce Trent 800 series engine with gold color in right schematic showing the steel shaft (Mustafa et al, 2024).

The goal of this project was to find alternatives to an aluminum-based hex-chrome sacrificial paint matrix meant to protect the steel shaft of turbine engines (Figure 1). Viable replacements must have long-term corrosive and thermal resistance properties comparable to hex-chrome, survive at least 400°C, and be nontoxic.

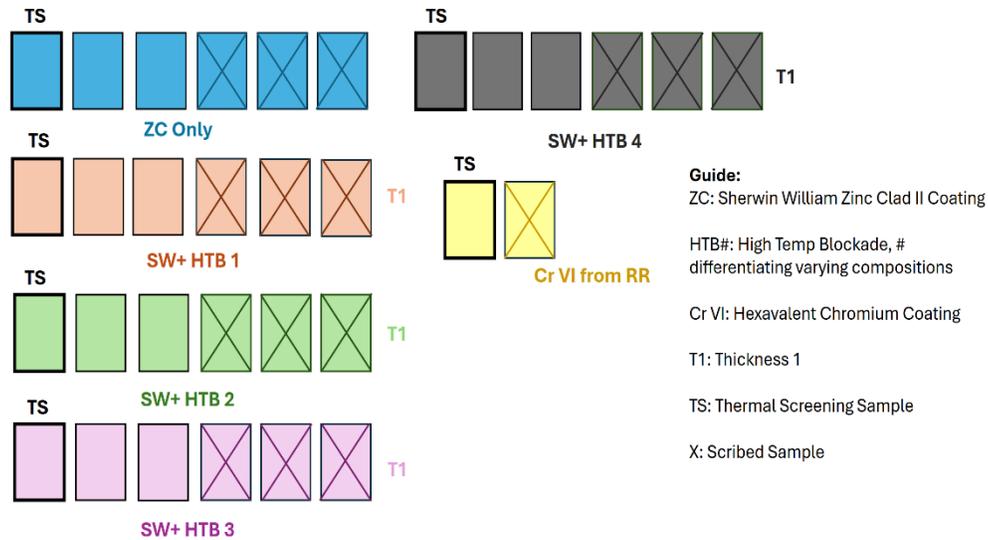
Figure 3. Final substrate distribution.

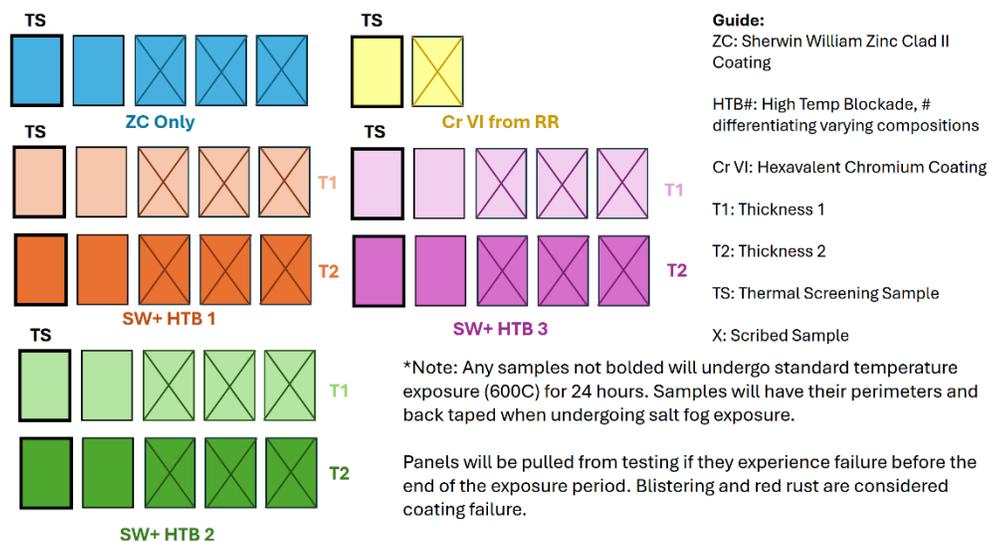
Figure 4. Proposed alternative substrate distribution.

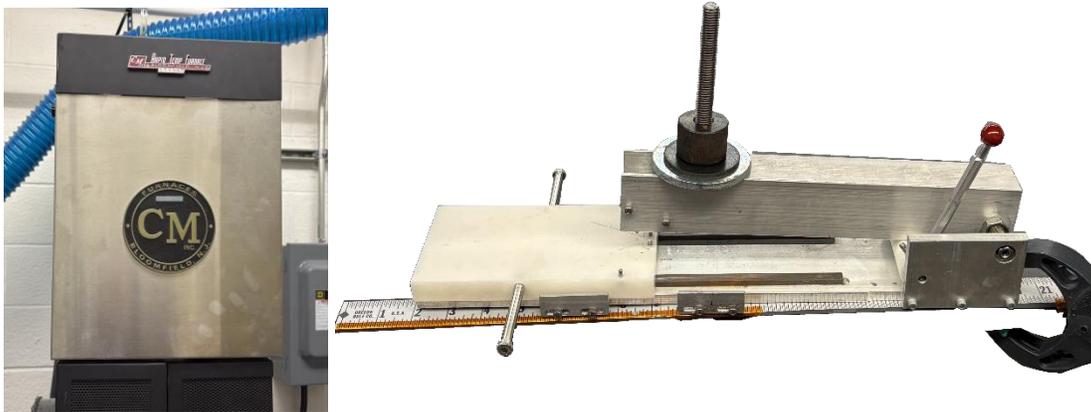
Figure 5. CM Furnace 1218BL; Luna scribing device, clamped to table

Following the isothermal holds, samples were scribed, taped, then placed within a Singleton SCCH23 chamber running the ASTM B117 procedure. A custom Luna device was used to scribe samples. The substrates were exposed to this environment from April 8th to April 18th, with images being taken every 24 hours. On the 18th, one scribed and one un-scribed substrate were removed from the chamber and examined optically using the Hirox RH-8800 Light Microscope for any signs of corrosion (red rust, etc.). Substrates were then sectioned and examined in the SEM, with EDS to examine corrosion products and other compositional information.

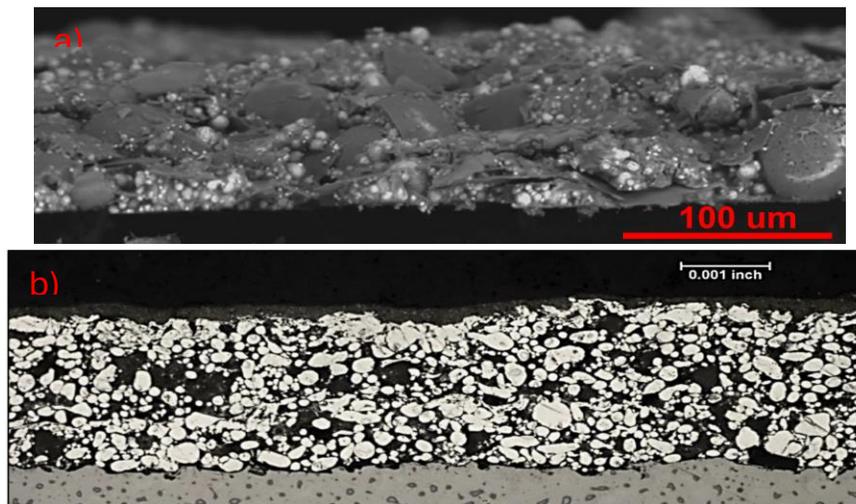
The surface topography of the SW coating appeared like typical IOZ (inorganic zinc) coatings (Figure 6a). The zinc particles are spherical, with the silicate material filling in gaps with more irregular shapes.

Figure 6. Surface topography (a) of an unnamed Jotatemp IOZ coating (Jotun, n.d). Rolls Royce publication (b) showing cross section of IPcote 9183R1 coating (Wiley, 2022).

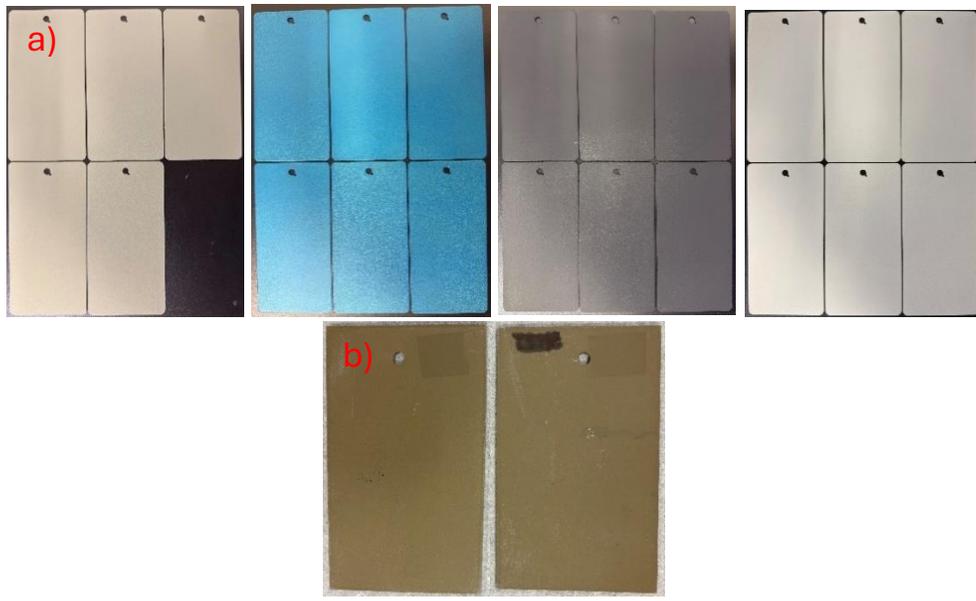
Images of coupons immediately after applying sol-gel coatings with HVLP spray, before curing of sol-gel coatings, can be seen in the figure below. Images of SAE 4340 steel coated with IPcote are included in this figure for direct comparison with the control—the substrate is 4340 for IPcote samples because they are leftovers from a RR project.

Figure 7. (a) Substrate appearance directly after sol-gel application (before sol-gel curing); (b) IPcote samples sent by RR.

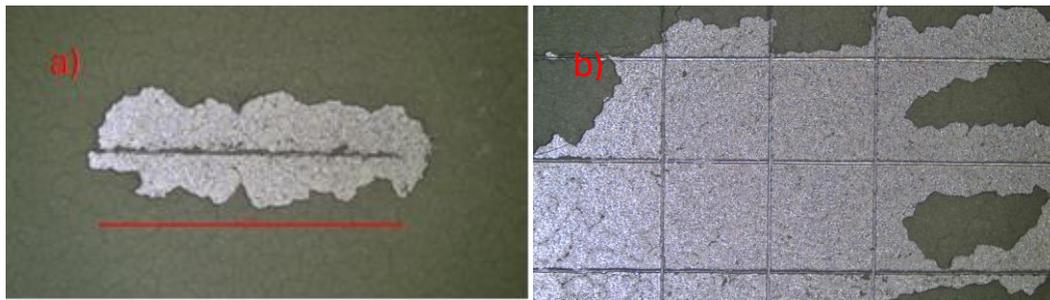
The coating has flaked along the edges of cuts in large ribbons and entire squares have detached. The area affected is 35 to 65% of the lattice.
0B	Flaking and detachment in excess of 65%.

ASTM D714-25 was used to evaluate the degree of blistering experienced by the topcoat of this panel. The standard leverages references to help determine the size and frequency of the blisters. Size is on a scale from 10 to 0, with No. 10 referring to no blistering. Size 8 blisters are the smallest on the scale that can be seen macroscopically (ASTM, 2025). The frequency is on step wise scale going few to dense. ZC only featured no blistering before salt fog, however, prominent blisters formed while the coupons were in the salt fog which can be seen in the Appendix. The resulting blisters are size 2 with a distribution of a few.

Figure 8. Scribe adhesion testing (a) and ASTM D3359 (b) crosshatch adhesion testing of ZC base coat.

There was also significant cracking in the ZC-only coating (Figures 8 and 9b). In the SEM, spherical, light particles of zinc contrast with the dark, more irregular pieces of silicate-based material (Figure 9a).

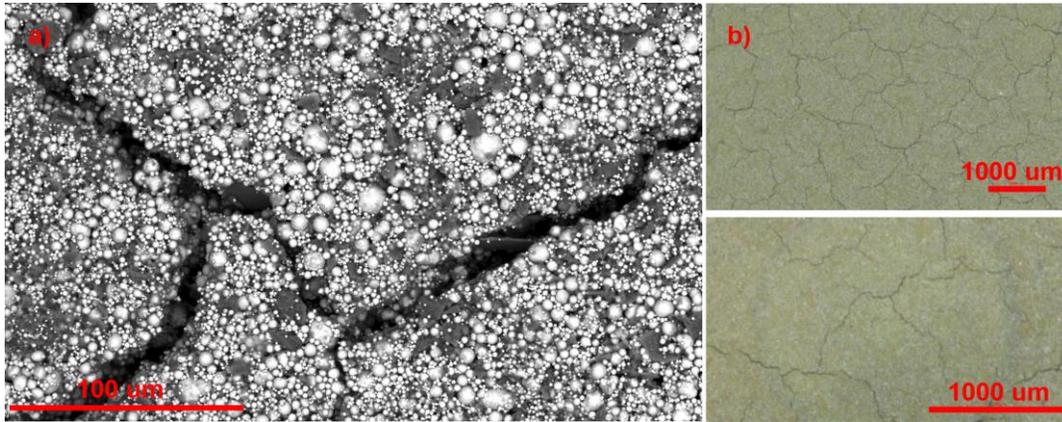
Figure 9. ZC-only coupon surface view from (a) SEM at 1650x and (b) light microscope.

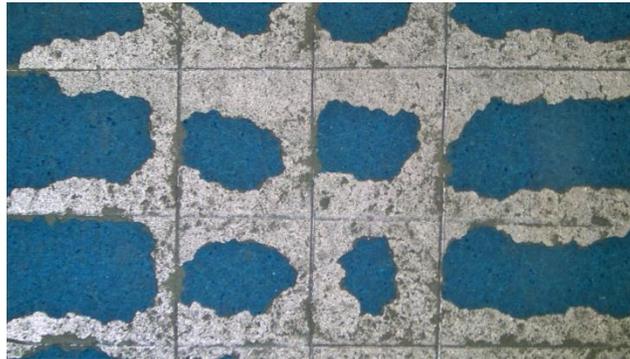
Luna added blue pigment to the HTB1 coating, giving it the most distinct appearance of the topcoats. Between Figures 10 and 8a, adhesion improvement from 0B to 1B can be seen. The 1B rating indicates that “the coating has flaked along the edges of cuts in large ribbons and whole squares have detached; the area affected is 35 % to 65 % of the lattice” (ASTM, 2023). HTB1 also featured no blistering, therefore giving it a rating of 10.

Figure 10. ASTM D3359 crosshatch adhesion test of HTB1 coating matrix.

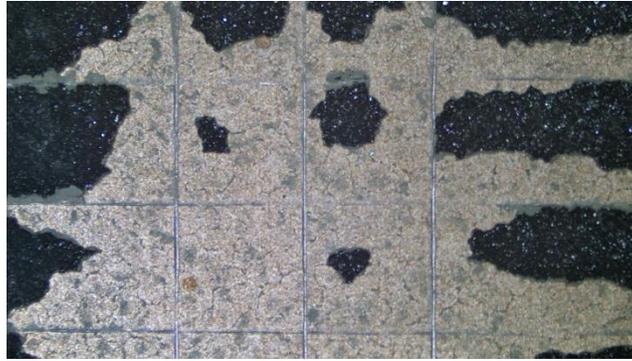
Meanwhile, the HTB2 coating was initially black with zinc metal flakes embedded (Figure 11). The poor adhesion of this topcoat was the same as the SW only sample, a 0B on the ASTM D3359 scale. There was also no blistering on the surface of the panel.

Figure 11. ASTM D3359 crosshatch adhesion test of HTB2 coating matrix.

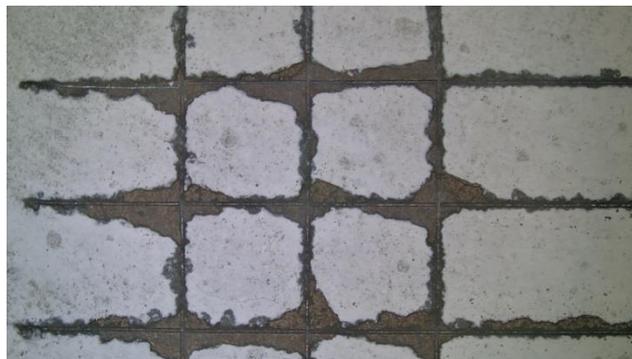
HTB3 had white pigment, extremely small blisters on its surface, and out of all topcoats performed the best in adhesion testing. According to ASTM D714-25, the blisters can be classified as a size 9 with a dense distribution across the panel. Its 2B rating indicates that “the coating has flaked along the edges and on parts of the squares; the area affected is 15 % to 35 % of the lattice” (ASTM, 2023).

Figure 12. ASTM D3359 crosshatch adhesion test of HTB3 coating matrix.

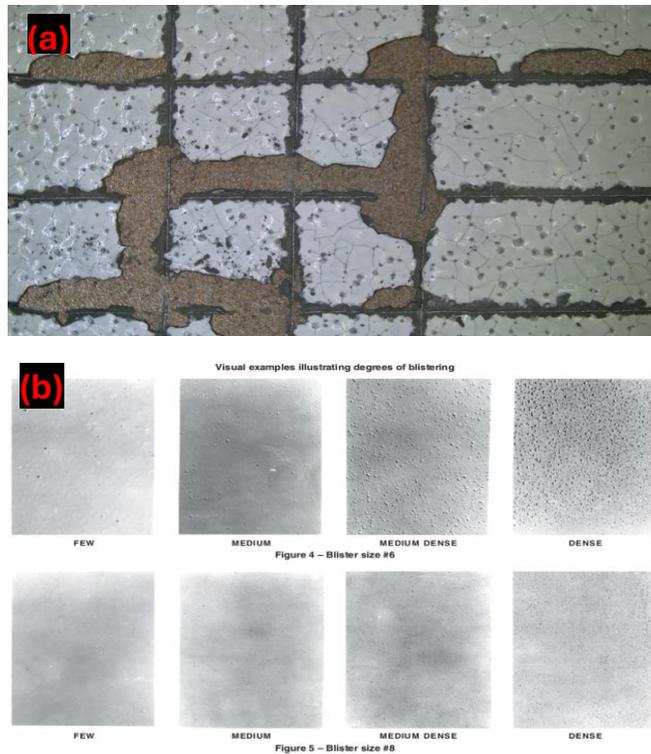
Slightly more yellow-white than HTB3, the HTB4 group had extreme blistering and deep mud cracking. While similar pore and crack patterns appeared in HTB3 and HTB4, no deep cracks appeared in the HTB3 coating. HTB3 pores were also far less developed. Based on ASTM D714-24, the blisters on HTB4 can be classified as size 8, with a medium-dense distribution across the coupon surface. With its crosshatch adhesion rating of 1B, HTB4 adhesion was significantly better than ZC-only and HTB2, but not as good as HTB3. (Figure 13)

Figure 13. (a) ASTM D3359 crosshatch adhesion test of HTB4 coating matrix and ASTM D714
 (b) blistering scale.

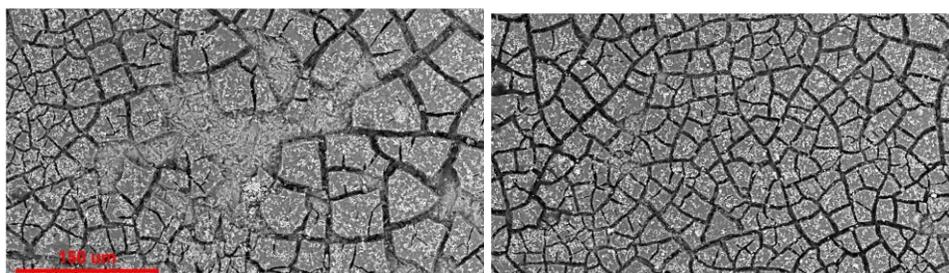
The chromium-based IPcote cracked in a more angular manner than ZC only and ZC-based matrices. EDS helped the team determine that the IPcote was a two-component system: the flat areas in Figure 14 were the aluminum-containing base coat, while the top seal contained chromium and phosphorus. Wiley confirmed the sealant to have a polymeric base derived from phosphoric and chromic acid.

Figure 14. HC coupon surface view from SEM at 1000x.

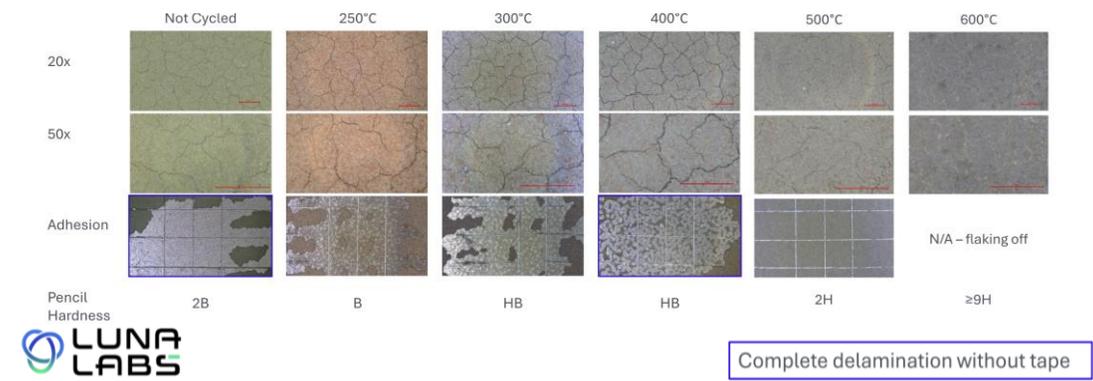
ZC-only hardness increased as screening temperature increased. However, thermal screening also revealed how poorly the Zinc Clad II Plus adheres to the AISI 1010 substrate by itself. Fortunately, the addition of the HTB topcoats seemed to prevent the ZC from peeling off from the substrates as quickly. (Figure 15)

Figure 15. ZC-only coating surface and adhesion testing after thermal cycling.

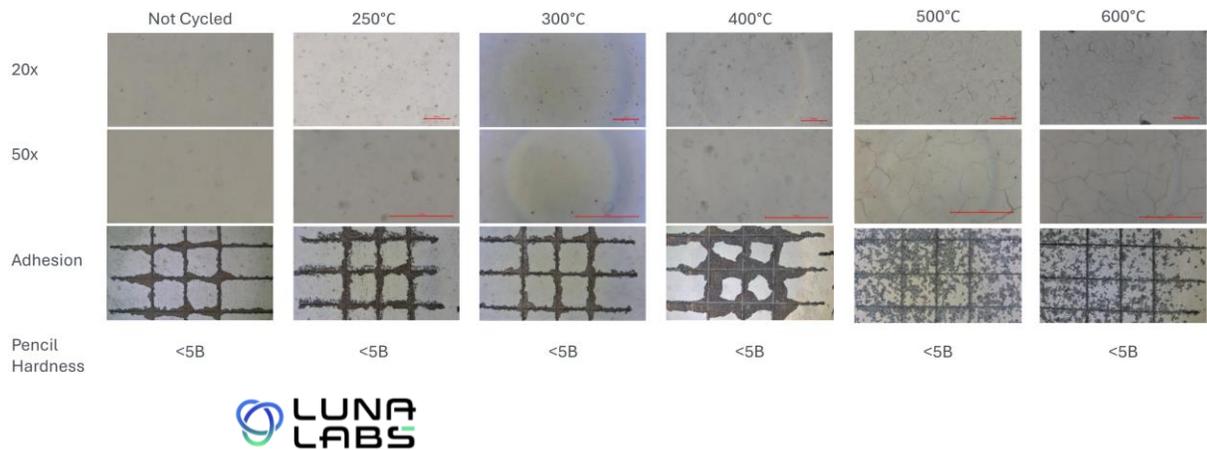
High temperatures induced similar microcracking patterns throughout the HTB coatings. The HTB3 had the best macroscopic appearance at higher temperatures, resulting in this group having the highest recommended temperature: 400°C. Moreover, significant microcracking only began at 500°C. However, since the HTB3 lost adhesion at 400°C and adhesion loss temperature was more important in determination of the isothermal hold temperatures, the recommended temperature was set to the lower bound of 400°C. For HTB2 and HTB4, microcracking began at 300°C; the HTB1 group began to crack immediately in the 250°C hold. Complete sets of micrographs for all lower temperature combinations—HTB1, HTB2, and HTB4—can be found in the appendix. (Figure 16)

Figure 16. ZC+HTB3 thermal screening

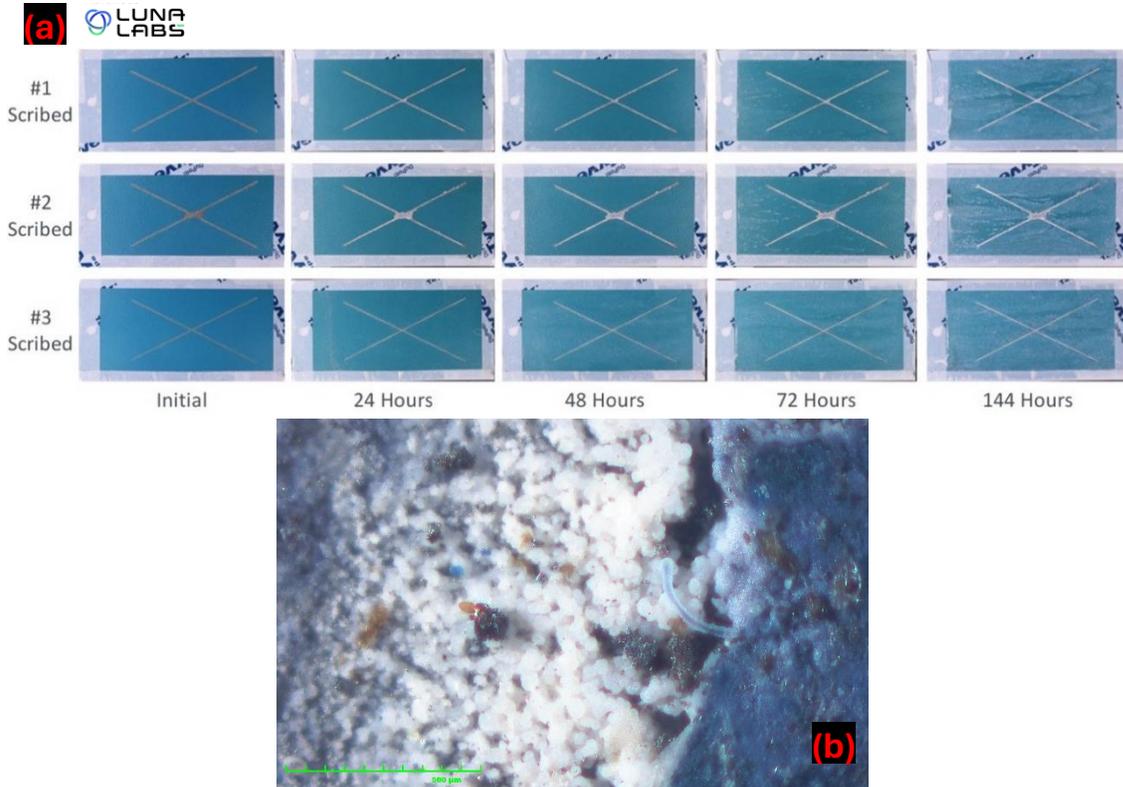
White streaks increased across the HTB1 sample with increased exposure to salt fog. A white film developed across the scribe area. The second coupon in the testing group developed a chipped area in the internal section of the scribe. This was a product of the scribing and masking process. No macroscopic red rust appeared over the recorded exposure periods; very few specks of rust appeared in scribes. (Figure 17)

Figure 17. (a) ZC+HTB1 after 200°C hold and salt fog testing (Luna, 2025); (b) 150X Hirox micrograph showing red rust in scribe.

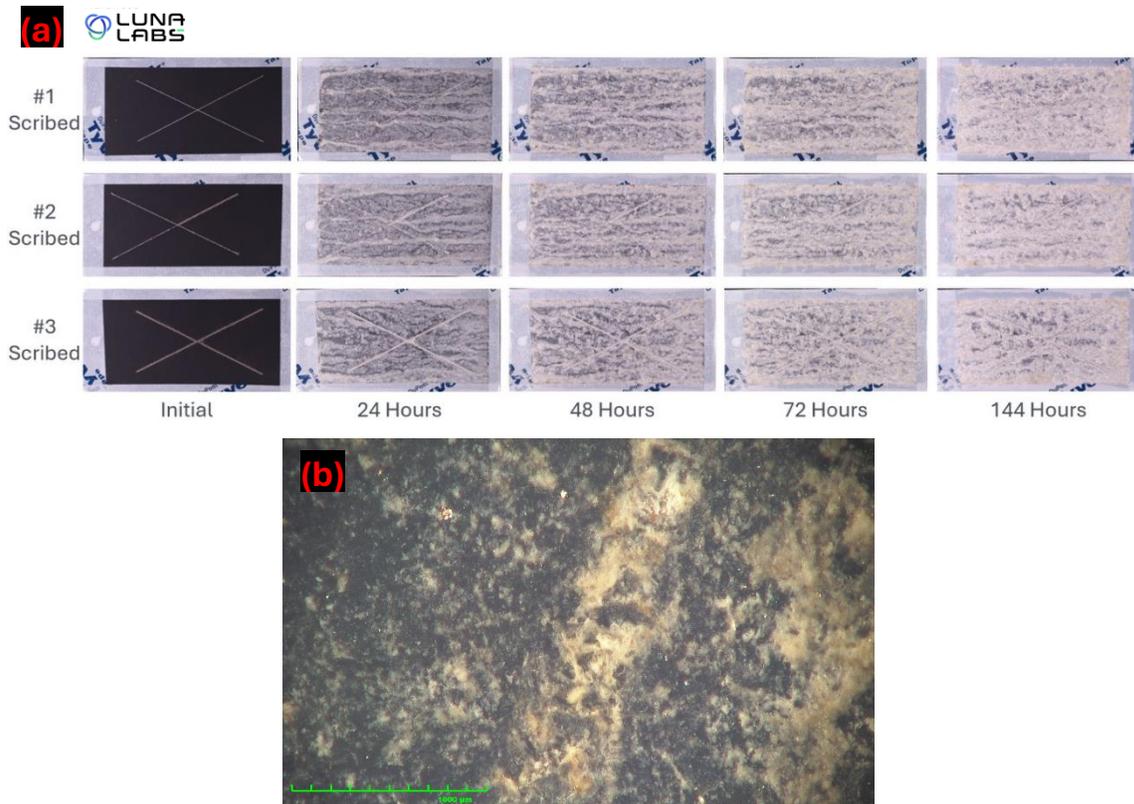
White streaks also developed across the HTB2 samples, in Figure 18, which appear thicker than on the HTB1 samples. Large regions of the film that developed on this coupon group took on a faintly orange hue—red rust almost as pervasive in the HTB2 samples as the ZC-only. (Figure 18)

Figure 18. (a) ZC+HTB2 after 300°C hold and salt fog testing (Luna, 2025); (b) 100X Hirox micrograph of HTB2 scribe.

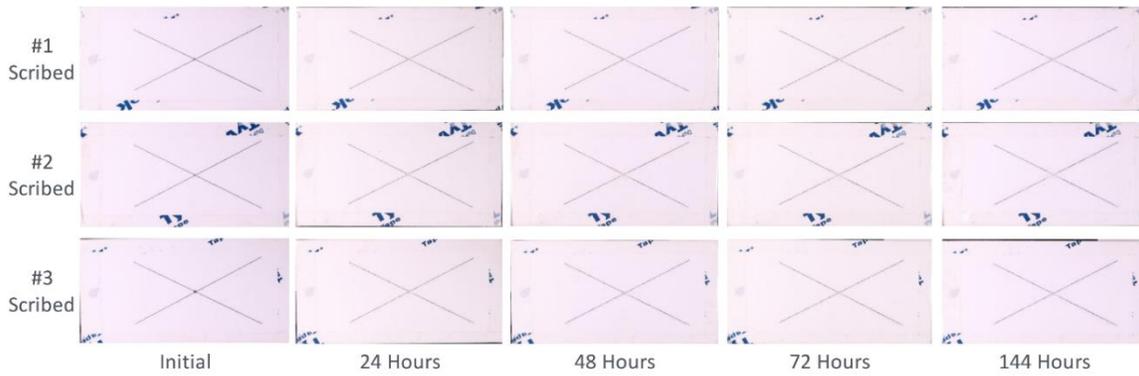
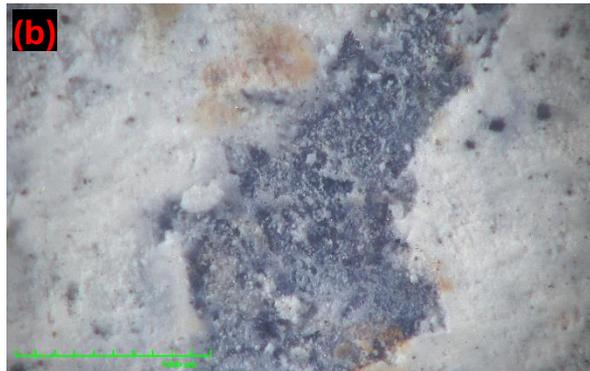
Corrosion products on the HTB3 group are difficult to see in macro-scale images due to the coating being white. While no red rust could be seen macroscopically, small spots of red rust could be seen at higher magnifications under the Hirox Light Microscope (Figure 19).

Figure 19. (a) ZC+HTB3 after 400°C hold and salt fog testing (Luna, 2025); (b) 100X Hirox micrograph of HTB3 scribe.

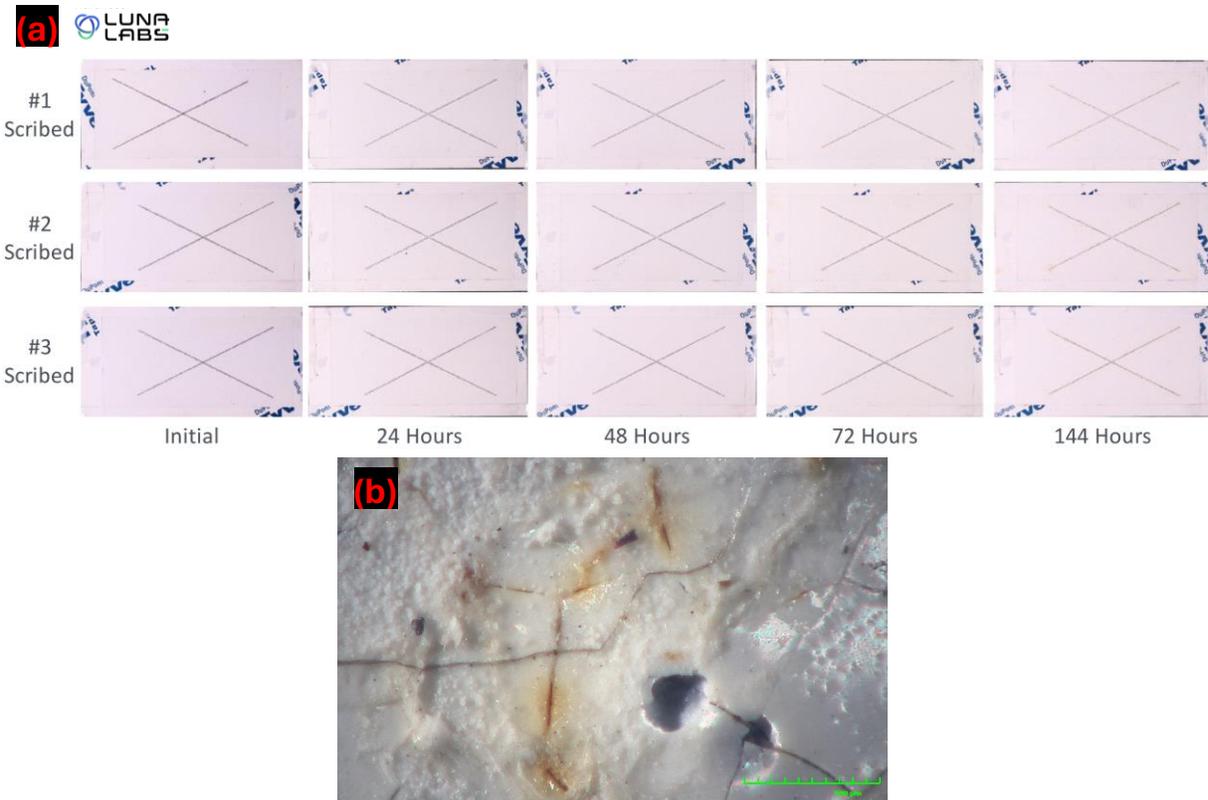
In macroscopic HTB4 images, red rust can be seen around the scribe. Microscopically, mud cracking and large divots are pervasive; even away from the scribe, red rust can be seen in mud cracks. (Figure 20)

Figure 20. (a) ZC+HTB4 after 300°C hold and salt fog testing (Luna, 2025); (b) 150X HTB4 Hirox micrograph.

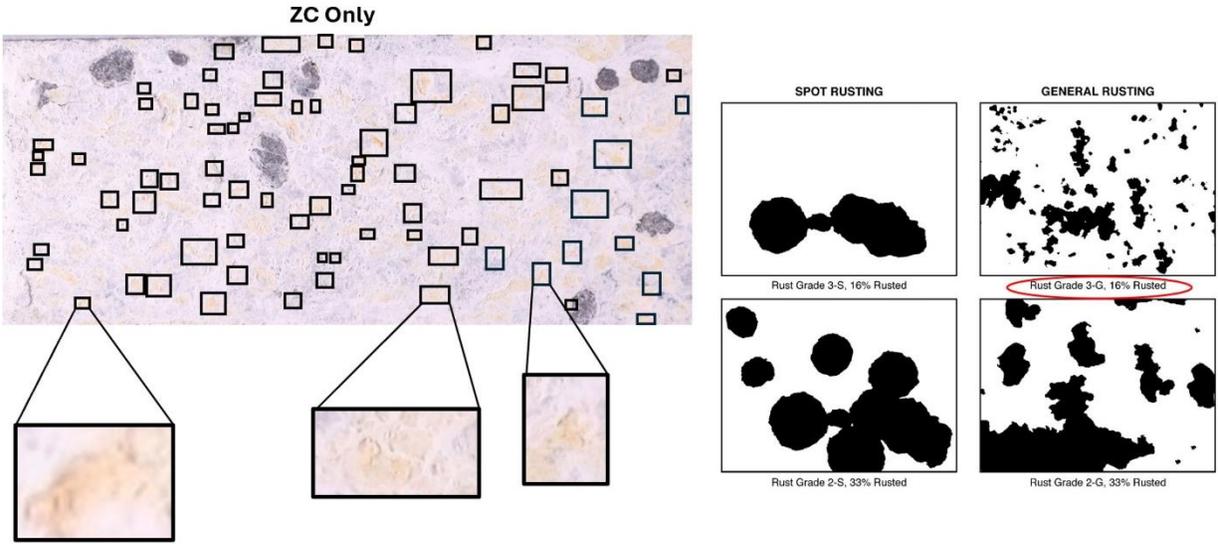
Rust analysis was conducted by increasing the contrast of coupon images and averaging the number of spots across the two unscribed coupons. Since ASTM D610-08 appears to only quantify rust on unscribed samples, the two unscribed coupons from each group were analyzed. No figure for HTB1 was included because no rust being macroscopically visible on unscribed coupons. As HTB2 completely delaminated, performing worse than the ZC-only (when comparing unscribed samples), it was too difficult to determine individual spots of rust. The average quantity of rust spots across the two unscribed ZC-only samples was 74 (Figure 21).

Figure 21. ASTM D610-08 for ZC Only. General rust count inside the boxes: 74.

All the unscribed coupons except for the ZC scored the lowest rust grade for their identified rust type. The HTB3 showed pinpoint rusting while the HTB4 showed general rusting. The difference in rust types could be attributed to the difference in composition between the two HTB groups. The performance of the ZC could be attributed to the thermal exposure temperature it was exposed to, which was beyond the recommended level recommended by Sherwin Williams and above the melting point of zinc around 400°C. The inconclusive HTB2 results in a lack of understanding for the rusting behavior of that group. The HTB1 showed no level of red rust, which makes it an optimal coating at that coating temperature.

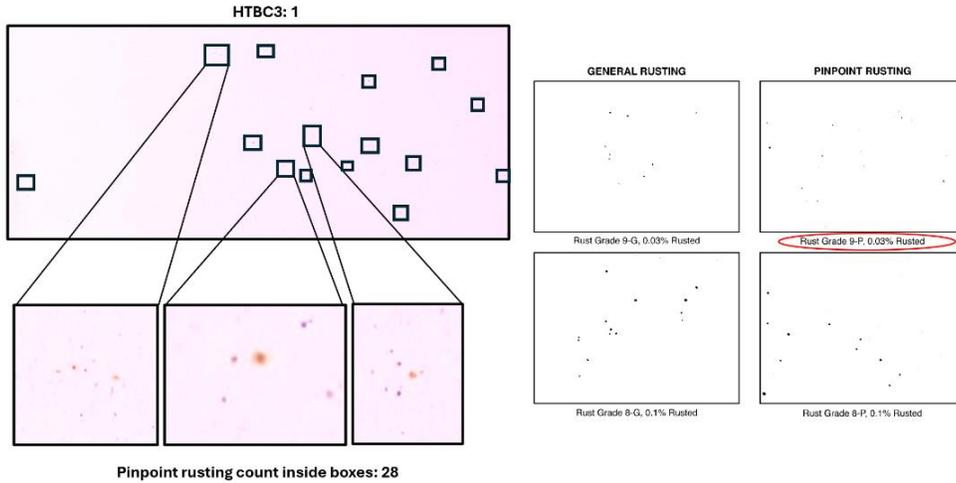
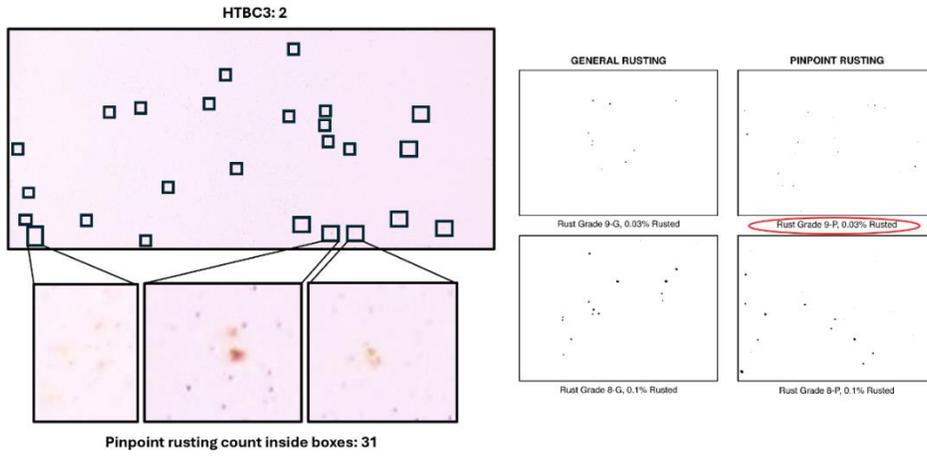
ASTM D610 only worked to quantify spots of rust on HTB3 and HTB4 samples: on HTB3 samples, small spots of rust appeared, while HTB4 had larger regions of red rust that appeared with slightly less frequency (Figure 22).

Figure 22. ASTM D610-08 for HTB3, from two different substrates. The average number of rust spots is 29.

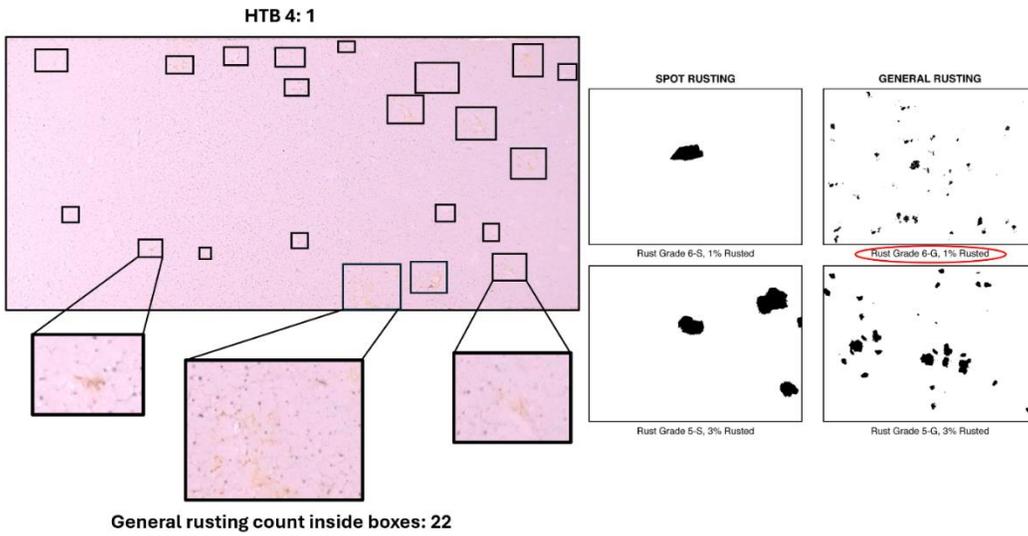
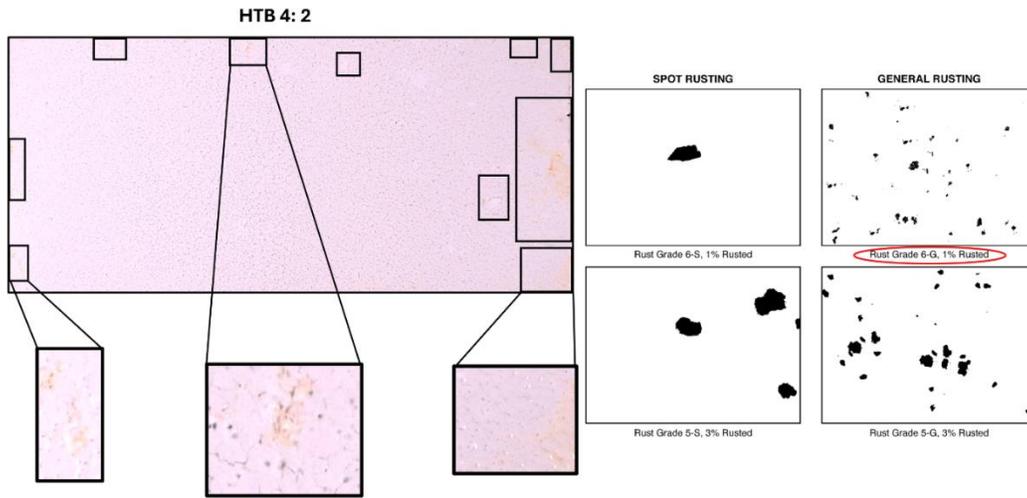
Figure 23. ASTM D610-08 for HTB4, from two different substrates. The average number of rust spots is 16.

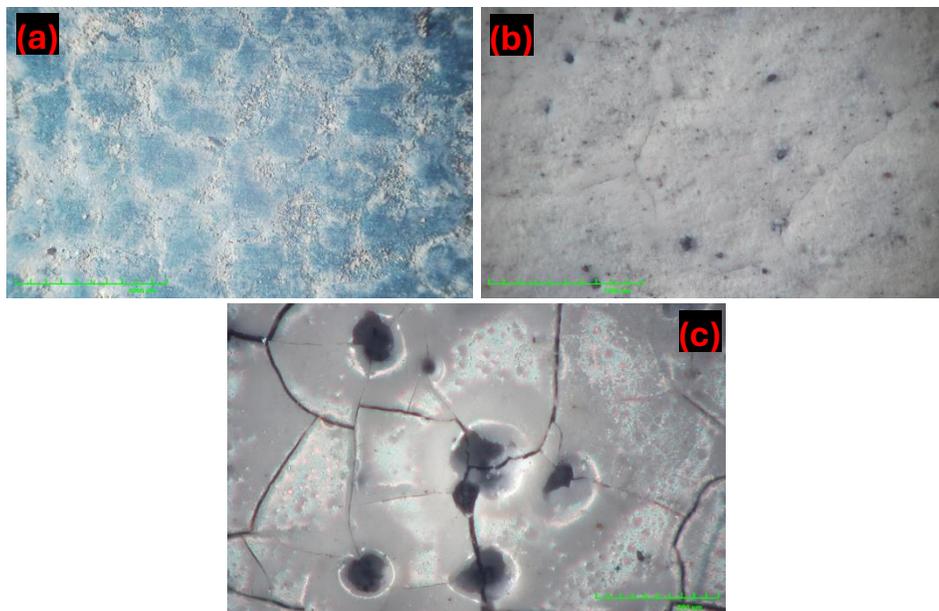
Figure 23. Mud cracking in different HTB-coated samples: (a) HTB1 at 100X, (b) HTB3 at 100X, (c) HTB4 at 150X.

Most issues in the results arose from SW having applied too thick a layer of Zinc Clad to substrates. Luna Labs measured the ZC base coat to be 8-10 mils; SW specifications denote that typical ZC application should be 2-3 mils. The cracks in HTB1, HTB3, and HTB4 samples shown below, a well-known phenomenon called mud cracking, are all caused by overcoating. These cracks “resemble the appearance of a dried-up riverbed during a severe drought” (*Chemistry and Physics of Coatings*, 2004). Adhesion issues with ZC seemed to affect HTB topography, reducing the thermal barrier capabilities of HTB variants, but HTB4 in particular—the HTB thermal barrier coatings would ideally coat samples uniformly. Any cracking in barrier coatings severely reduces coating protection. When asked to confirm if the overcoating was intentional, Sherwin Williams said that the coating should have been in the range of two to three thousandths of an inch.

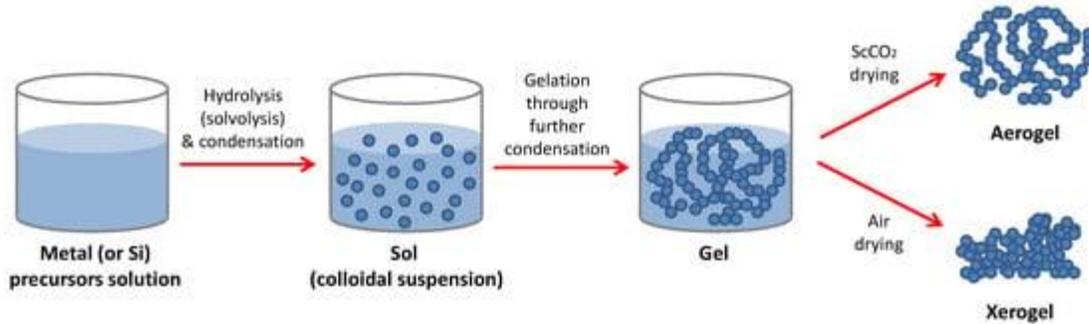
air. Included in the figure below are chemical reactions for each step in the process. (Singh et al., 2014 & Aurobind et al., 2006)

Figure 23. Sol-gel reactions (above); diagram of sol-gel synthesis (below). (Singh et al., 2014; Tao & Pescarmona, 2018)

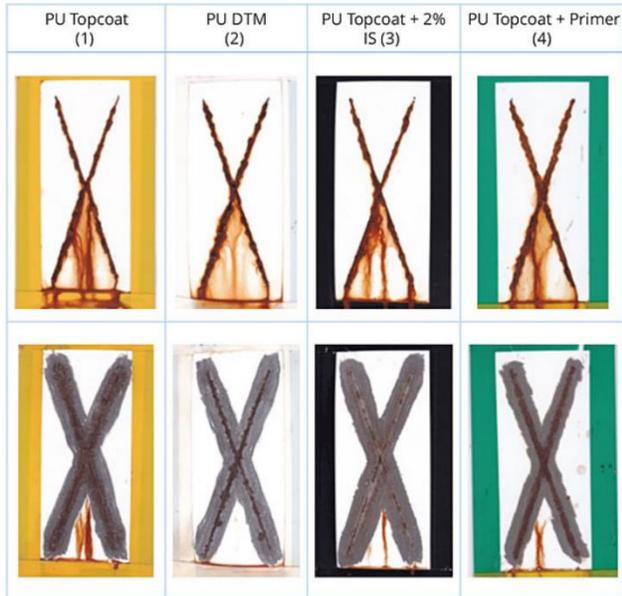
Figure A1. Typical appearance for ASTM 1654.

The final challenge that occurred during the project was the removal of coatings for red rust evaluation using ASTM D-1654-24. This standard involves the removal of the coating matrix around the scribe to observe potential rust creepage or undercutting. An example of how

this process should look can be seen in the Appendix. The mean creepage would then be established and a rating would be given from 10 to 0, with No.10 referring to no creepage and No.0 over 16mm to creepage (ASTM, 2024). However, due to the Zinc Clad II being chemically bonded to the low carbon substrate, it was impossible to remove the bond coat. This made it extremely difficult to determine the degree of red rust using this methodology. For that reason, the team switched to using ASTM 610–08 as the primary evaluation method, described in Table III. This standard involves visually inspecting the substrates to determine the type of rust distribution using preset definitions and estimating the surface area of rust (ASTM, 2019).

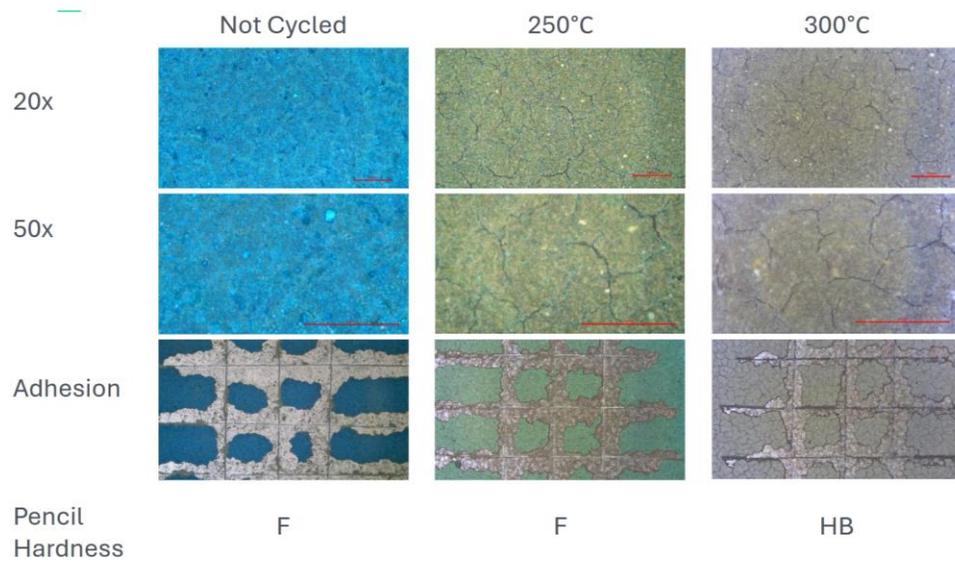
Figure A1. ZC+HTB1 thermal screening and adhesion.

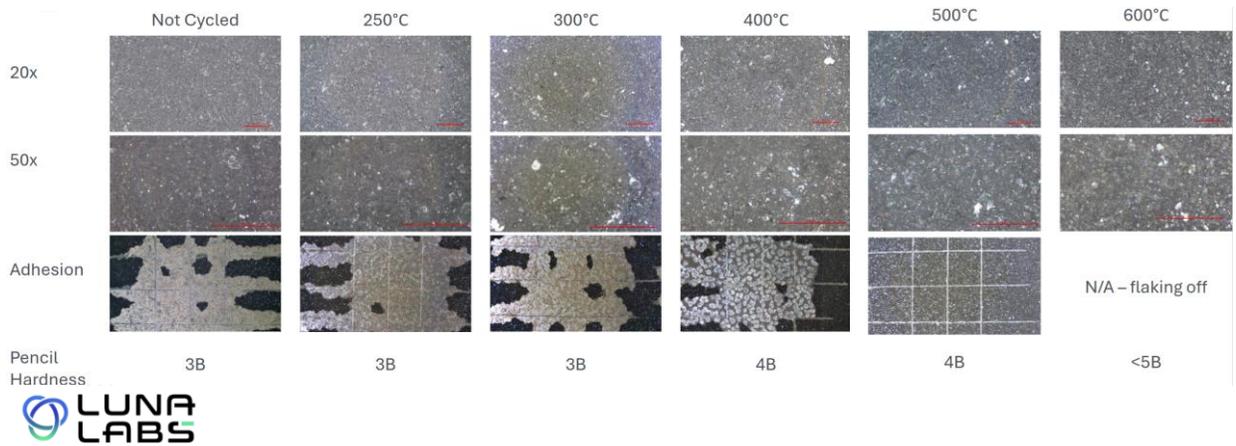
Figure A2. ZC+HTB2 thermal screening and adhesion. Note: microcracking evident past 300°C°.

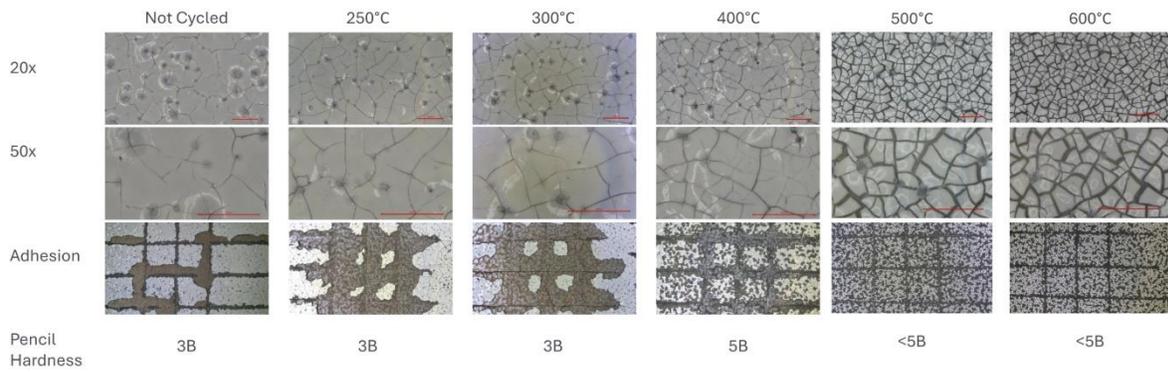
Figure A3. ZC+HTB4 thermal screening and adhesion.

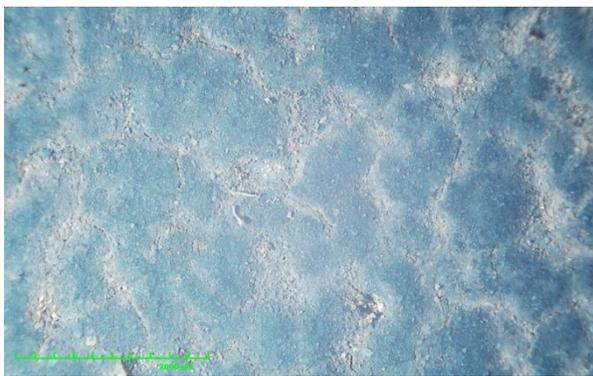
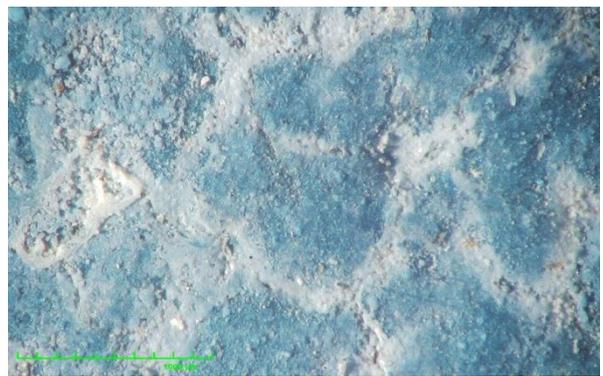
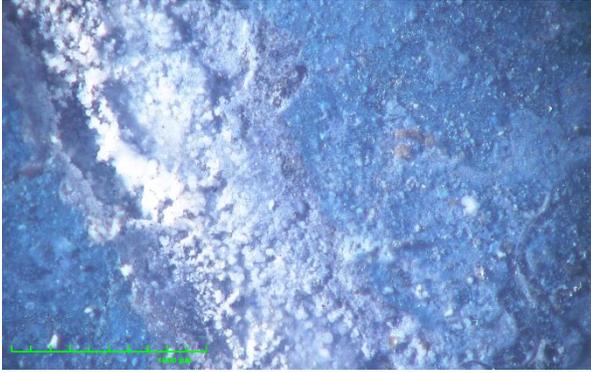
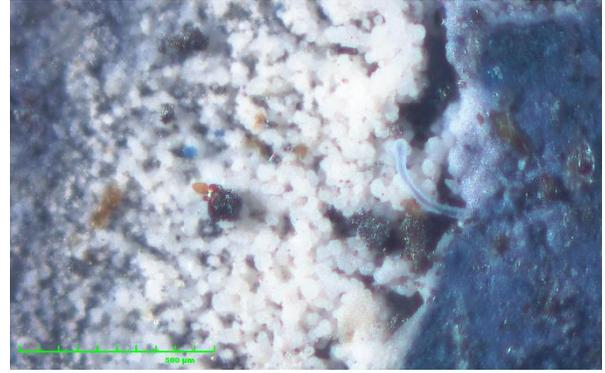
Figure A4. Comprehensive light micrograph summary for ZC+HTB1

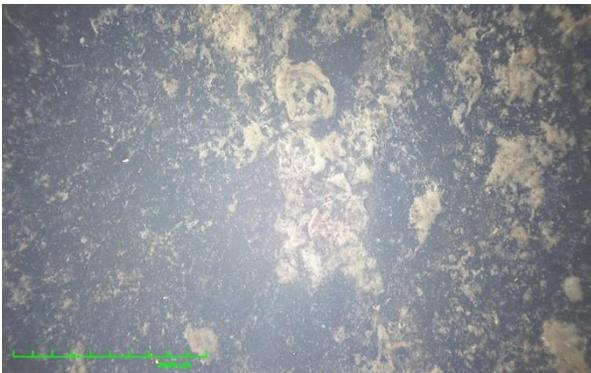
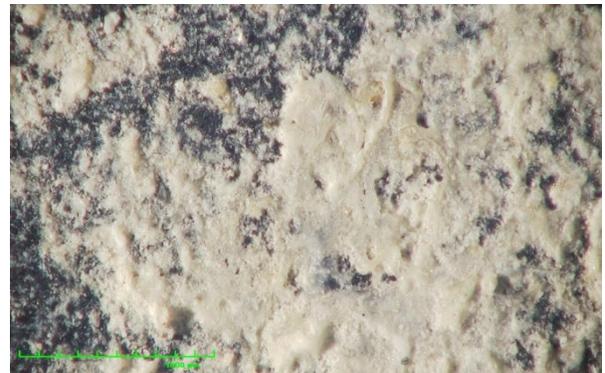
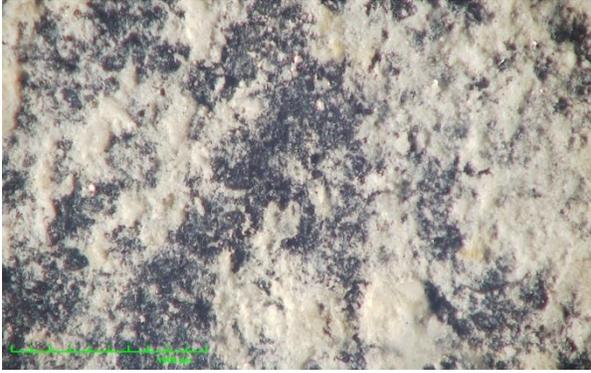
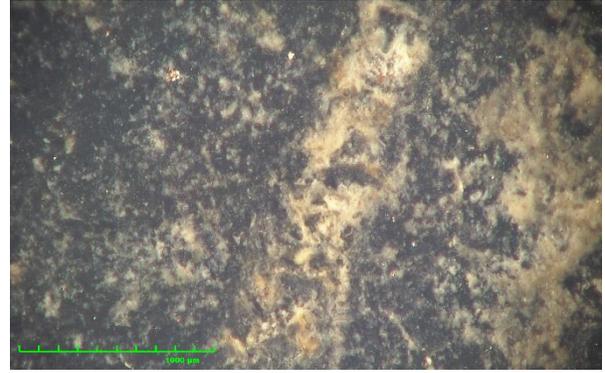
Figure A5. Comprehensive light micrograph summary for ZC+HTB2

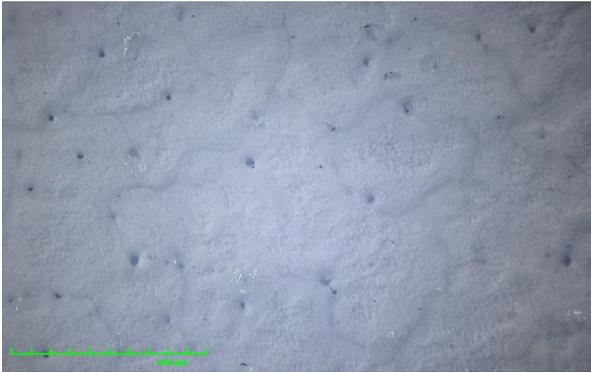
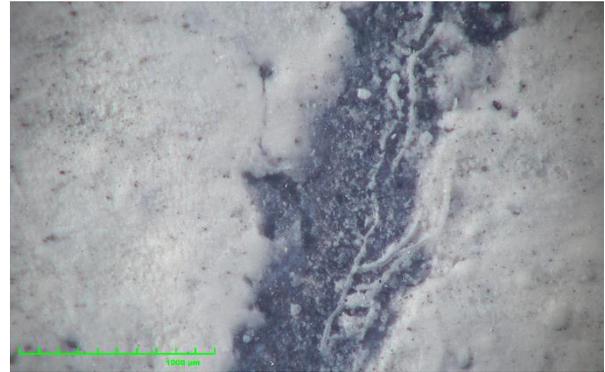
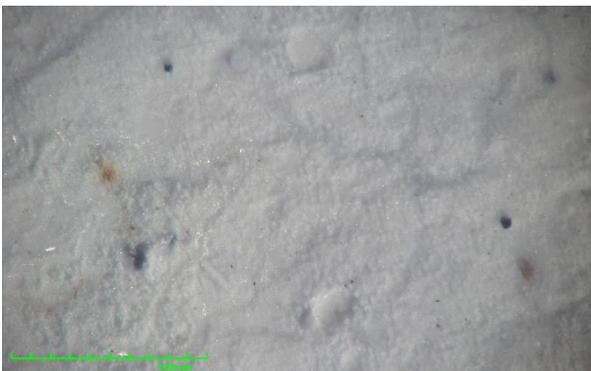
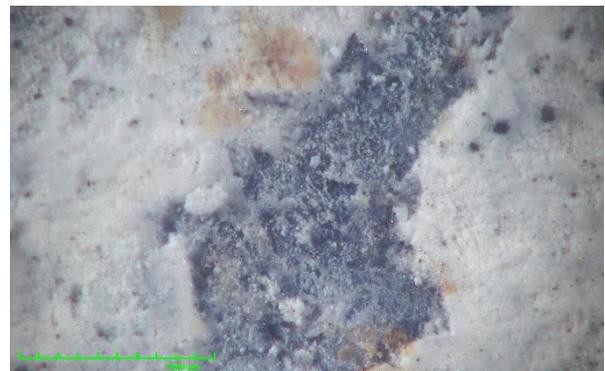
Figure A6. Comprehensive light micrograph summary for ZC+HTB3

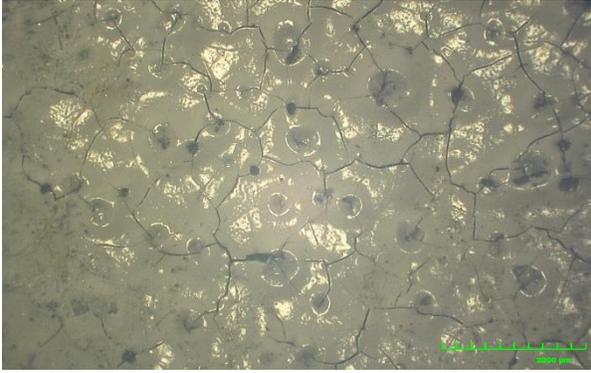
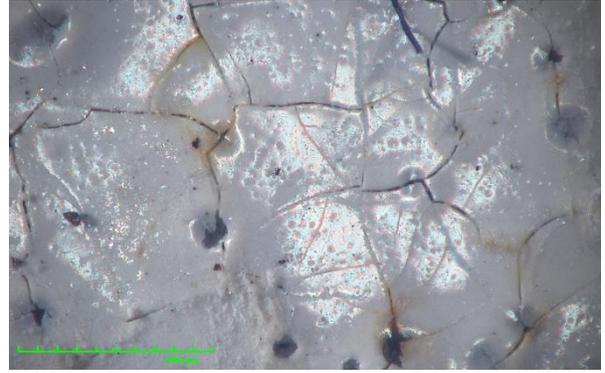
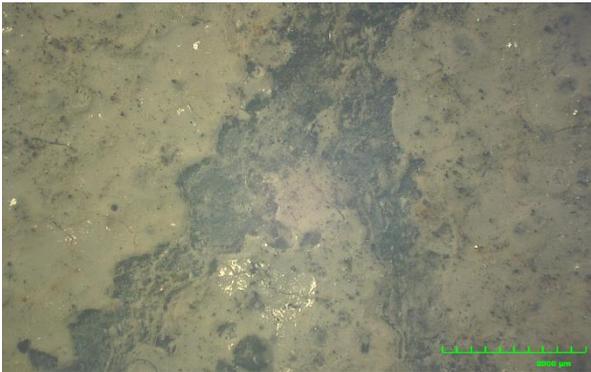
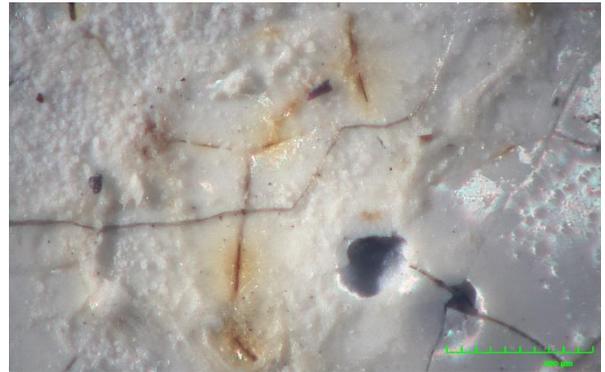
Figure A7. Comprehensive light micrograph summary for ZC+HTB4

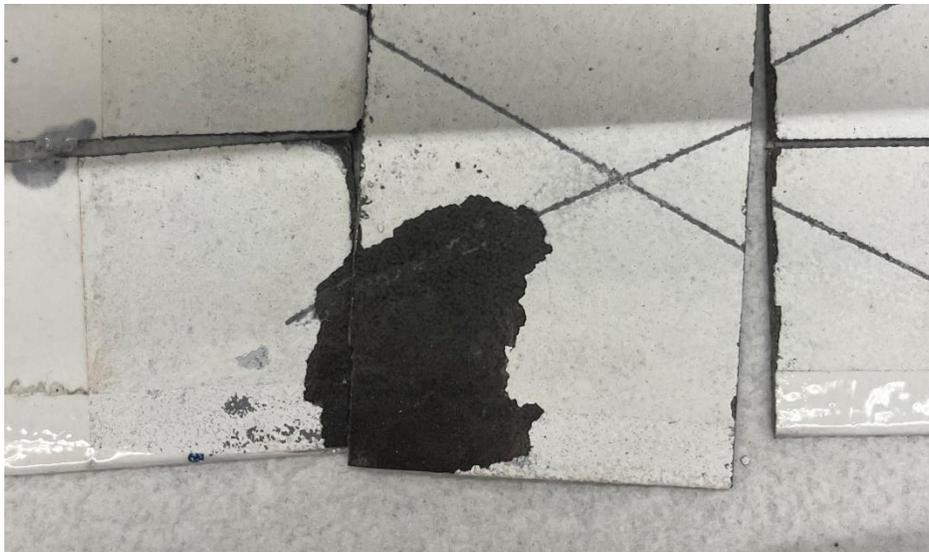
Figure A8. Delaminated HTB3 and ZC coating from scribed coupon.
