Presented to
the faculty of the School of Engineering and Applied Science
University of Virginia

Abstract

Goals of Study: The main goal of this study is to develop an injury criteria for the iliac wings under frontal lap belt loading conditions. To achieve the goal of developing an injury criteria, I first need to recreate similar fractures using a similar loading/injury mechanism. I will design an experiment to characterize belt-to-pelvis loading with the goal of recreating the same fracture at the same isolated lap-belt-to-pelvis orientation that caused fracture in Richardson et al 2020. After replicating these fractures on a full scale test, I will then design a component level test to measure the tolerance of fracture on isolated pelvic wings, and do so across a variety of pelvises. I will then use the tolerance data to perform a statistical analysis to predict risk across the population to achieve the desired injury criteria.

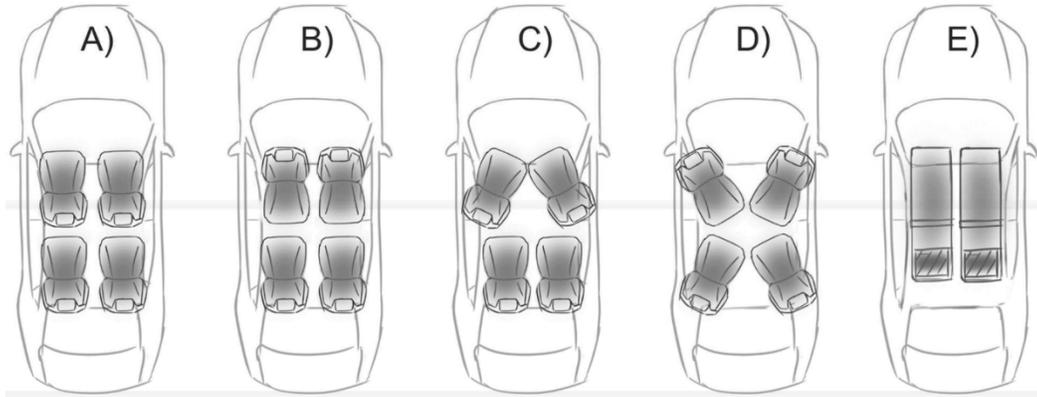
1.1-1 Östling 2019 Seating Configuration Options Diagram

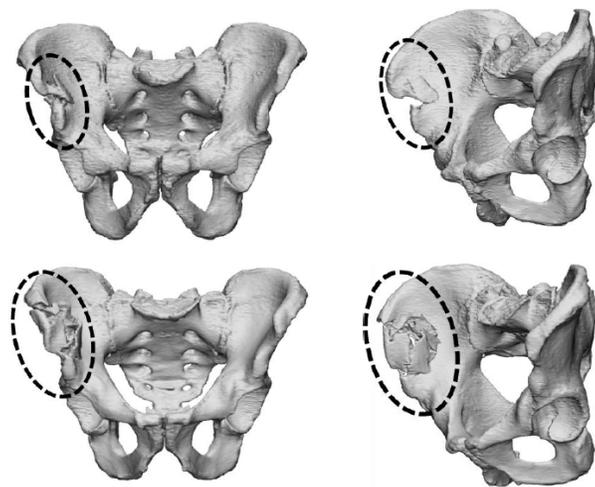
1.1-2 Pelvis Injuries from Richardson et al 2020

likelihood of submarining (Rawska 2019, Gepner 2019, Forman 2018). Each PMHS torso was reclined to approximately 50 degrees from vertical. Of the five PMHS, two sustained pelvis fractures between the anterior superior iliac spine (ASIS) and the anterior inferior iliac spine (AIIS) on the outboard side (Figure 1.1-2), and one subject submarined on the inboard side (Richardson 2020). Peak lap belt loads for the two subjects that sustained fracture were 7.8 kN and 6.6 kN, respectively.

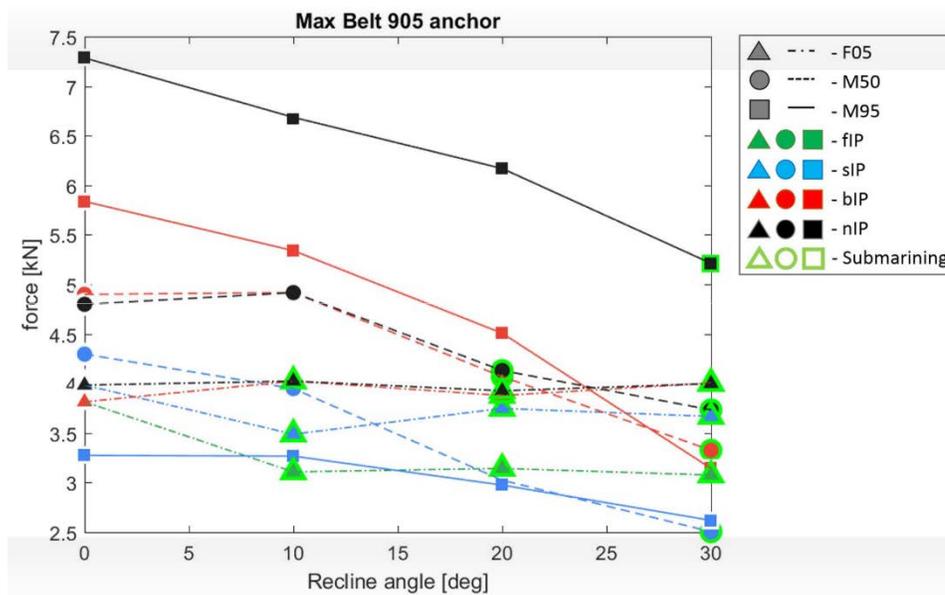
2.2-1 – Gepner 2019 Force vs Recline Angle plot. Plot clearly shows that a more forward knee bolster usually results in a much lower lap belt force.

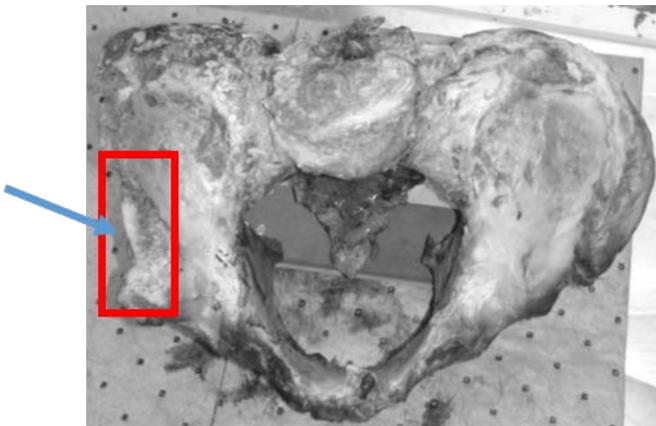
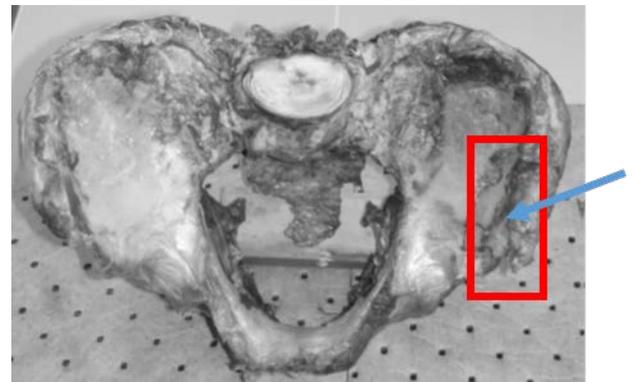
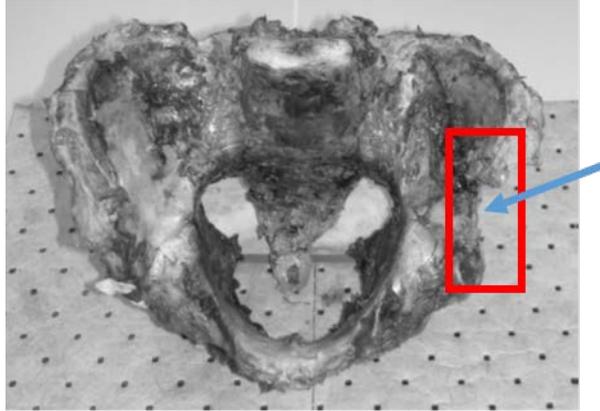
2.3.6-1 Pelvis Fractures from Luet 2012

In 2012, a series of sled tests were conducted to understand the occurrence of submarining (where the lap belt slides over the pelvis and loads the abdomen) in Anthropomorphic Test Devices (ATDs) and cadavers. Three different configurations were tested: a 40 km/h pulse with a rearward lap belt anchor position, a 50 km/h pulse with forward lap belt anchor position, and a 50 km/h pulse with rearward lap belt anchor position and slightly inclined seat pan. Each subject was tested in a rigid seat with a restraint system consisting of a two point shoulder belt and two point lap belt. Because of the two point lap belt, lap belt loading was usually symmetric on both sides. Of the 9 cadavers tested, 5 sustained iliac wing fractures. The left iliac wing broke on three subjects, while the right iliac wing broke on the other two. The iliac wing fractures occurred in all three configurations of the sled test environment. Strain gauges were affixed to the pelvis pre-test to determine fracture timing. All fractures occur between 3-7 kN of lap belt force. The authors note that it was difficult to draw conclusions as to if the occurrence of submarining affected the fractures, or if the fractures could have possibly prevented the occurrence of submarining.

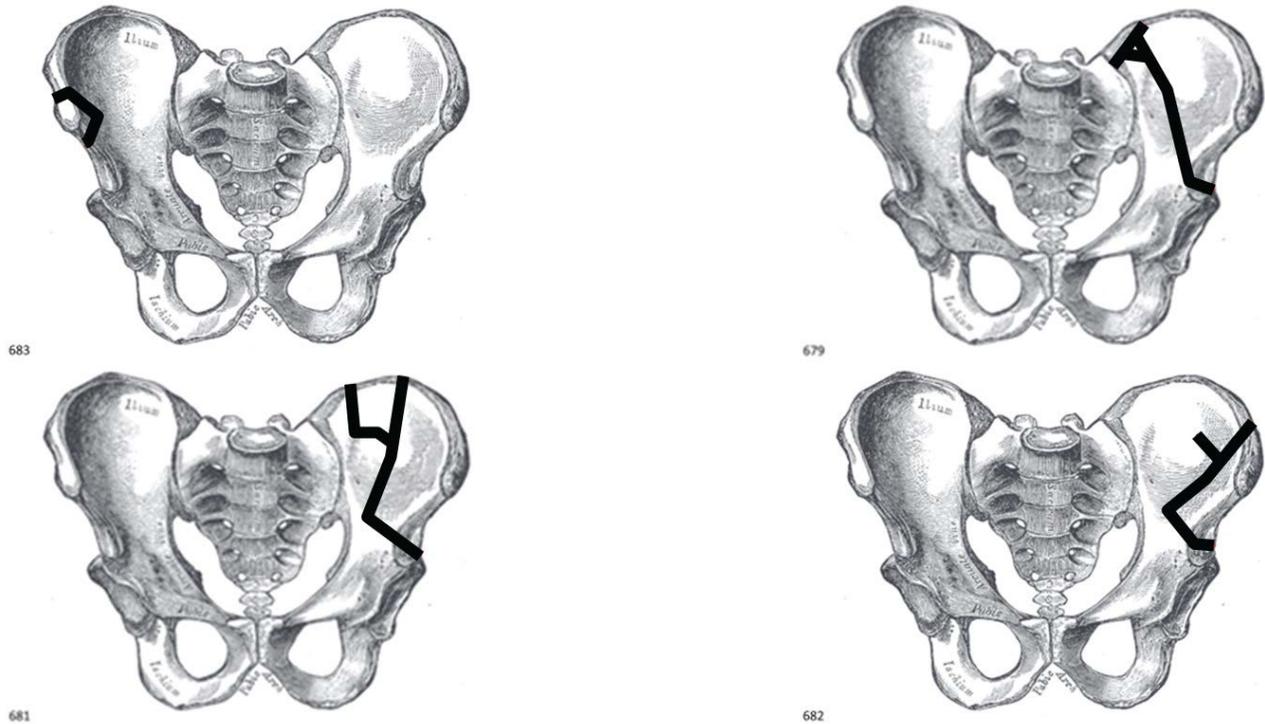
2.3.7-1 Pelvis Fractures from Uriot 2015

position on the pelvis (all positions were “higher” in the rear seat configuration in comparison to the front seat configuration), as well as the direction of loading differences between the two configurations (the rear seat configuration had around a 15 degree more horizontal initial lap belt angle than the front seat configuration).

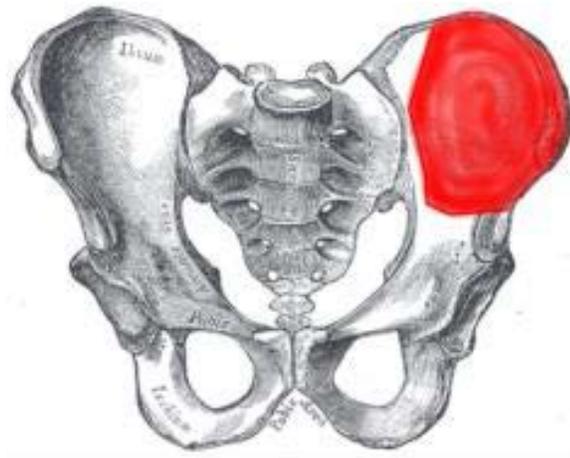
2.3.8-1 Location of Pelvis Fractures from Trosseille 2018

these two configurations (50 km/h pulse). The only differences between configuration 2 and 3 was the initial position of the belt relative to the pelvis, with configuration 2 having a much higher belt position. Pelvis fractures occurred in three of the nine cadavers where peak lap belt forces ranging from 2-4 kN were seen. No pelvis fractures occurred in configuration 2 despite higher lap belt forces compared to the other two configurations. This is most likely due to the fact the belt was placed higher up relative to the ASIS – so far up, that the belt slid over the pelvis well before peak belt force was reached.

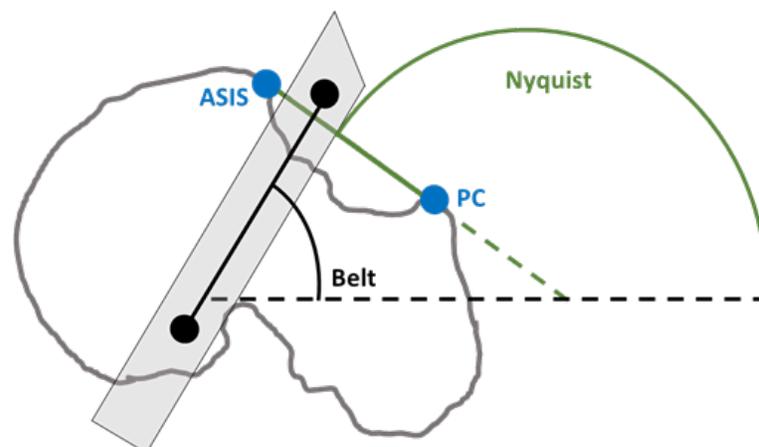
3.1-1 Nyquist Angle Definition

In Luet 2012, Uriot 2015, Trosseille 2018, and Richardson 2020, the pelvis orientation was described by the Nyquist plane/angle. The Nyquist plane is defined by a line connecting the anterior superior iliac spine (ASIS) and pubic crest (PC), and the global horizontal or vertical (Figure 3-1) (Nyquist and Patrick 1976). These points represent a gross measure of orientation of the anterior portion of the pelvis.

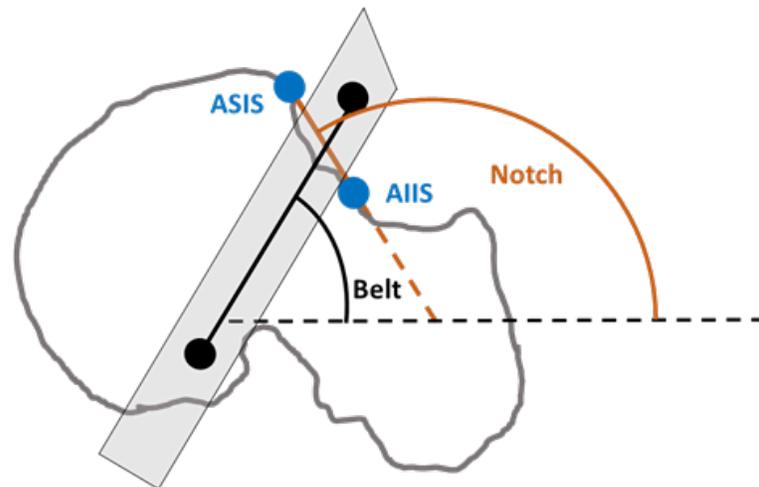
3.1-2 Notch Angle Definition

A new proposed measure of the pelvis angle was created as a part of this thesis. The fractures seen in the sled tests kept occurring between the ASIS and the anterior inferior iliac spine (AIIS). It was hypothesized that a better measure of the pelvis orientation relative to the belt would be defined by a line connecting these two landmarks. This measure, defined as the Notch Angle, incorporates subject specific geometry in addition to orientation of the pelvis relative to the world (Figure 3-2).

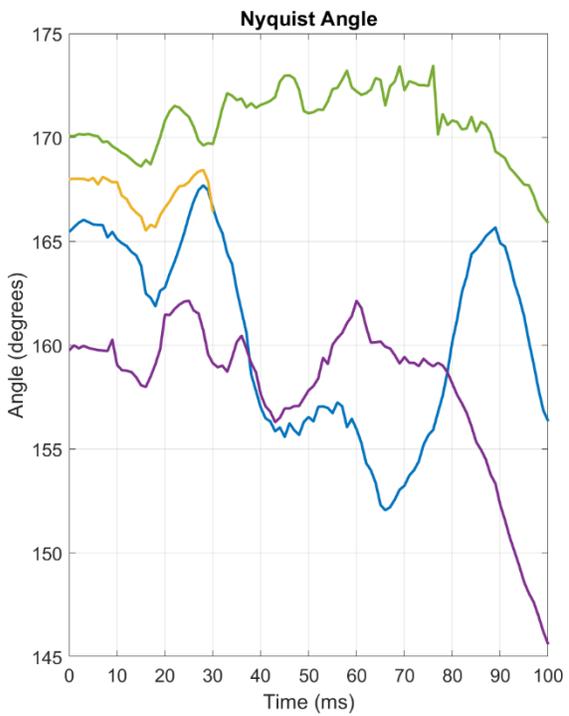
3.3-1 Nyquist Angle Time Histories from Richardson et al 2020

this subject may have submarined partly because of the more rearward pitched pelvis in comparison to other subjects. Subject 1 sustained an iliac wing fracture, and had a more inclined pelvis (155 degrees,) at the time of fracture relative to Subject 4 (162 degrees), which sustained no injury or submarining. However, the Nyquist to Belt angle was more horizontal for Subject 1 (117 degrees) than for Subject 4 (106 degrees), indicating a more horizontal load path at this time. However, this still was not as horizontal of a load path for Subject 1 as it was for Subject 5 (125 degrees). This suggests that a more horizontal lap belt angle oriented with respect to the pelvis could cause submarining, with the threshold being somewhere between Subject 1 and Subject 5.

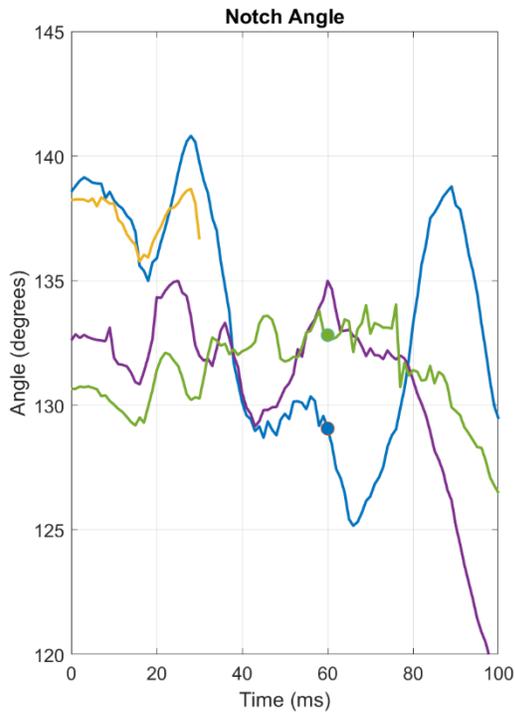
3.3-4 Notch Angle Time Histories Richardson et al 2020

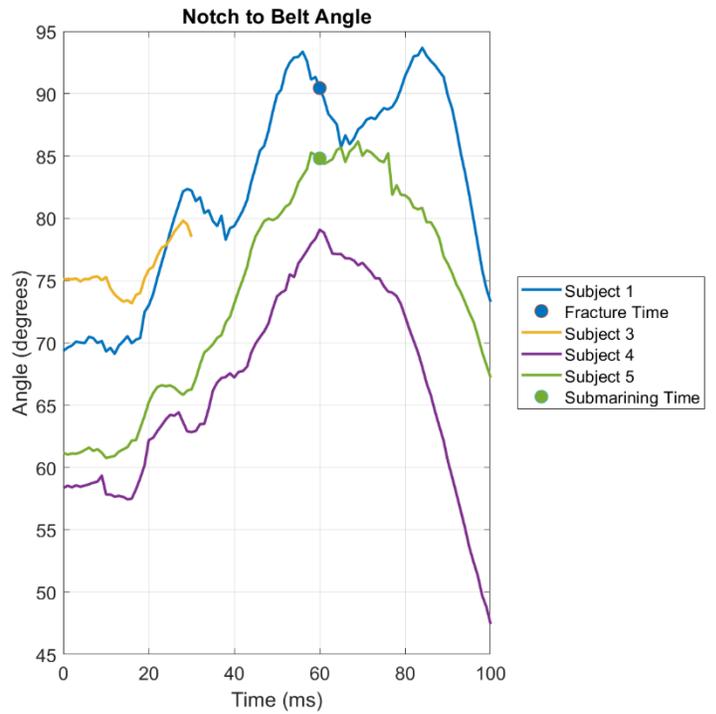
3.3-5 Notch to Belt Angle Time Histories Richardson et al 2020

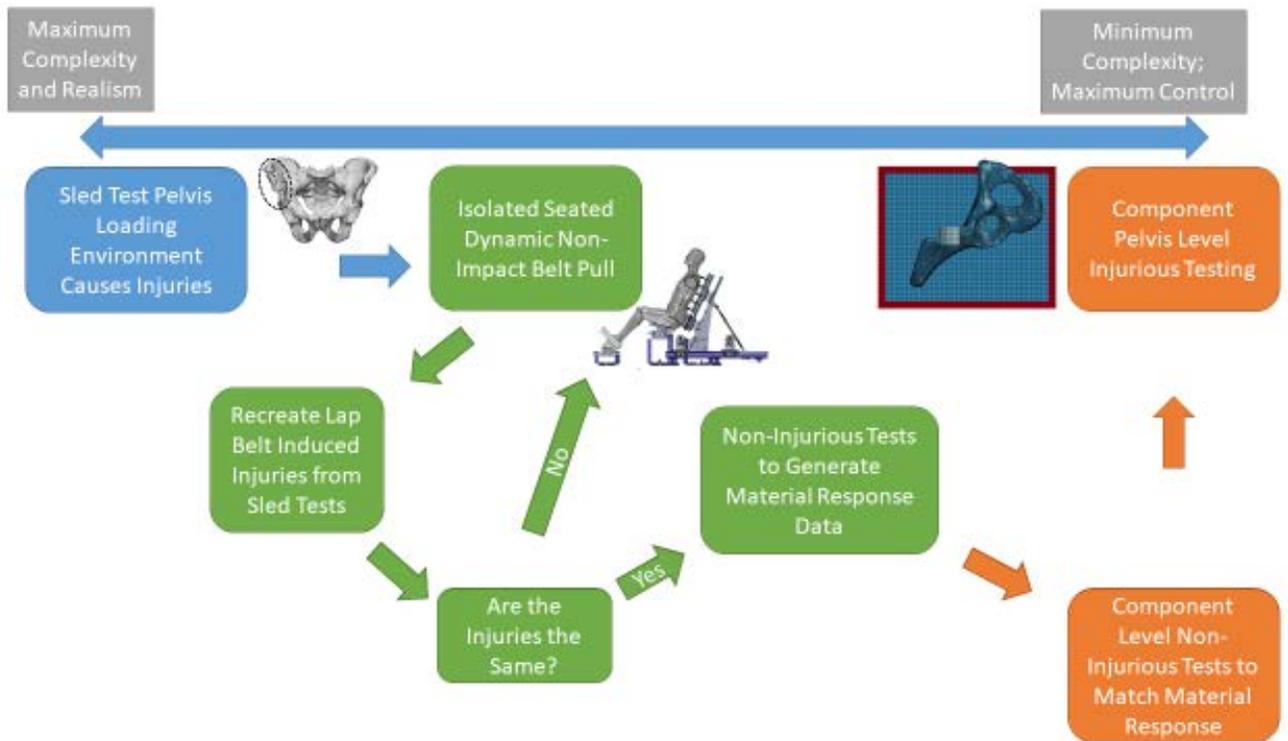
3.4-1 Flow Chart of Experimental Testing

Below details a flow chart of the steps taken in this thesis to connect the lap belt loading environment of a sled test to the component level testing necessary to create an injury risk function (Figure 3.4-1). Task 1 (this chapter) has detailed the lap belt loading targets derived from sled tests, noted in blue in the flow chart. The details in green will be explained in Task 2

(Chapter 4), which details the methodology and results of testing whole-body PMHS in a dynamic, non-impact environment by isolating a single lap belt loading instance. Then, based on the results gathered in Task 2, an environment will be developed in Task 3 (outlined in orange, Chapter 5) to re-create the loading environment that caused fractures in Task 2 on component level wings.

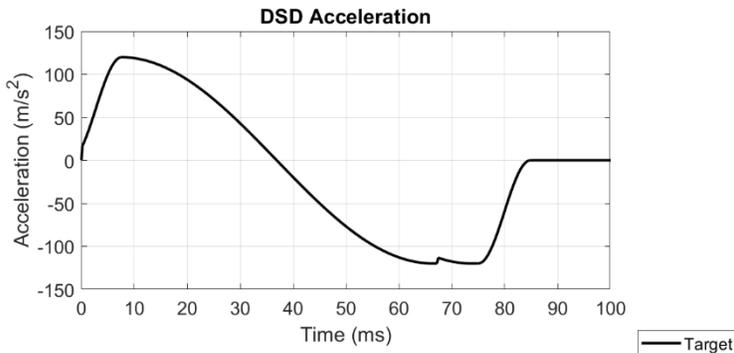
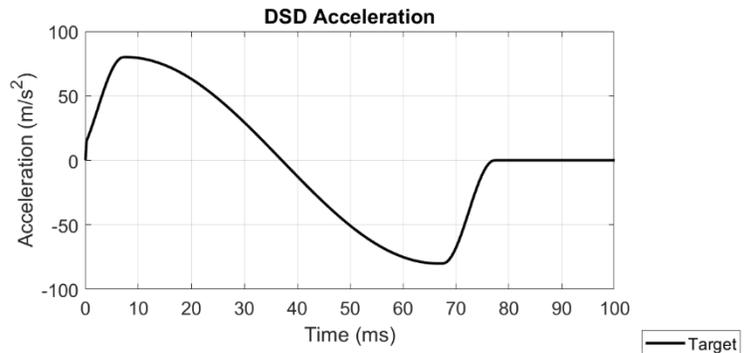
4.1.1-2 High Force Test Target Pulse Information

was able to be reached, and the honeycomb crushed. Thus, for the injurious PMHS tests, it was decided to use the 120mm/80ms pulse as a precautionary measure to ensure enough force could be generated to fracture the pelvis (Figure 4.1.1-2). For the subinjurious tests, the smaller, 80 mm/80 ms pulse was chosen to ensure that no overshoot occurred in the system that would cause injury to the PMHS.

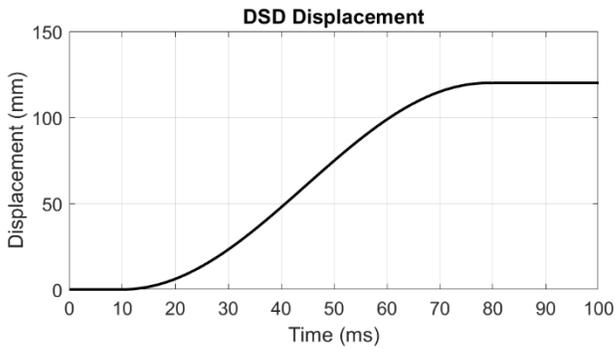
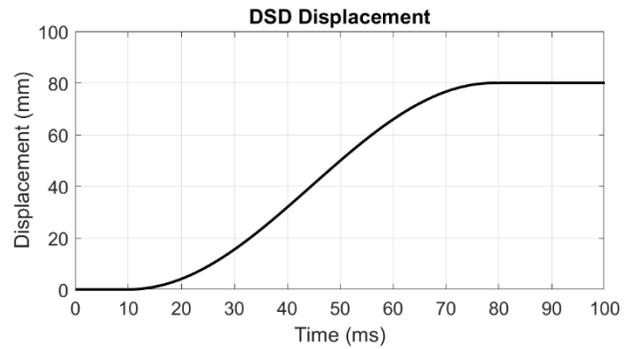
4.1.1-3 Low Force Test Target Pulse Information

The DSD control system was tuned by ensuring the system input the maximum amount of energy into the pulse. This was achieved by setting the free travel distance to 0 mm, essentially forcing the system to have to put enough energy in to crush the force limiting honeycomb. By training the control system to generate enough energy to match the necessary displacement in this configuration, the DSD would be trained to achieve the required displacement despite if it was pulling the lap belts against a completely rigid object. By tuning the system in this way, it ensured that the system was capable of having enough energy to match the desired force limit. For the High Force tests, this meant that the DSD was trained to have enough energy to crush the 8 kN honeycomb. For the Low Force tests, this meant that the DSD was trained to avoid overshoot of the acceleration in the system due to the lower force limiting honeycomb that was present.

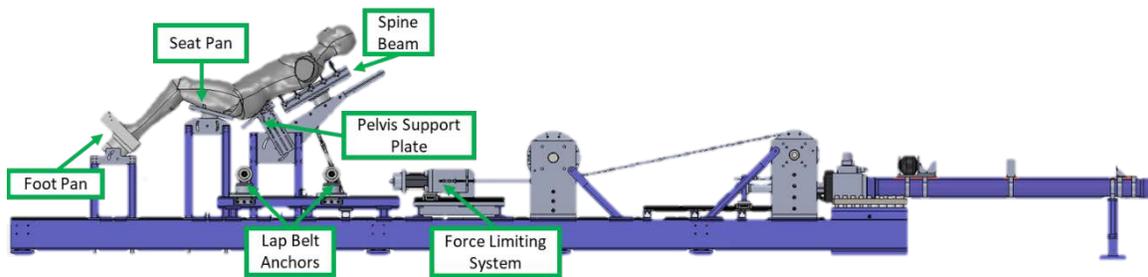
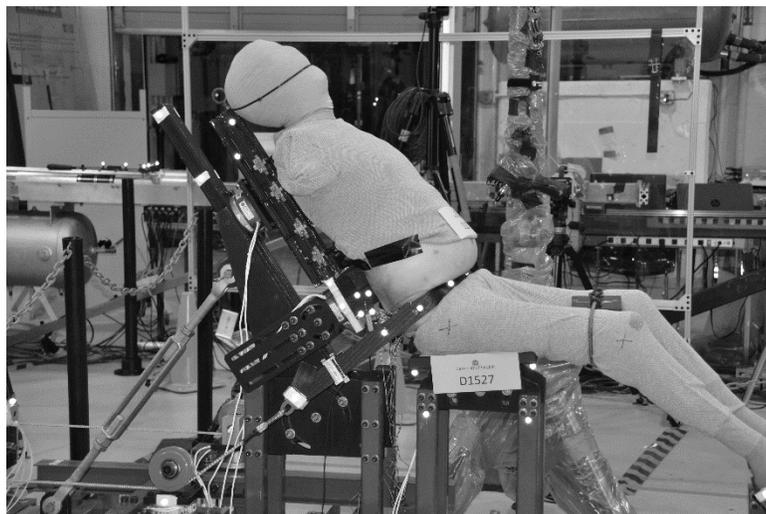
4.1.2-1 Full Seat Fixture

A rigid seat system was designed with multiple degrees of freedom to assist in positioning each PMHS to its target posture (Figure 4.1.2-1). Each PMHS targeted a Notch Angle of 130 degrees relative to the global horizontal and a spine angle (defined as the line between T8 and L1 vertebra of the spine) of 45 degrees from vertical. For all of the high force tests, the target Notch to Belt Angle was 90 degrees, which was the Notch to Belt Angle that caused fracture in the Richardson et al 2020 tests. In the low force tests, the target Notch to Belt Angles were 90 degrees and 75 degrees (which was the Notch to Belt Angle of Subject 4 at the time of peak force).

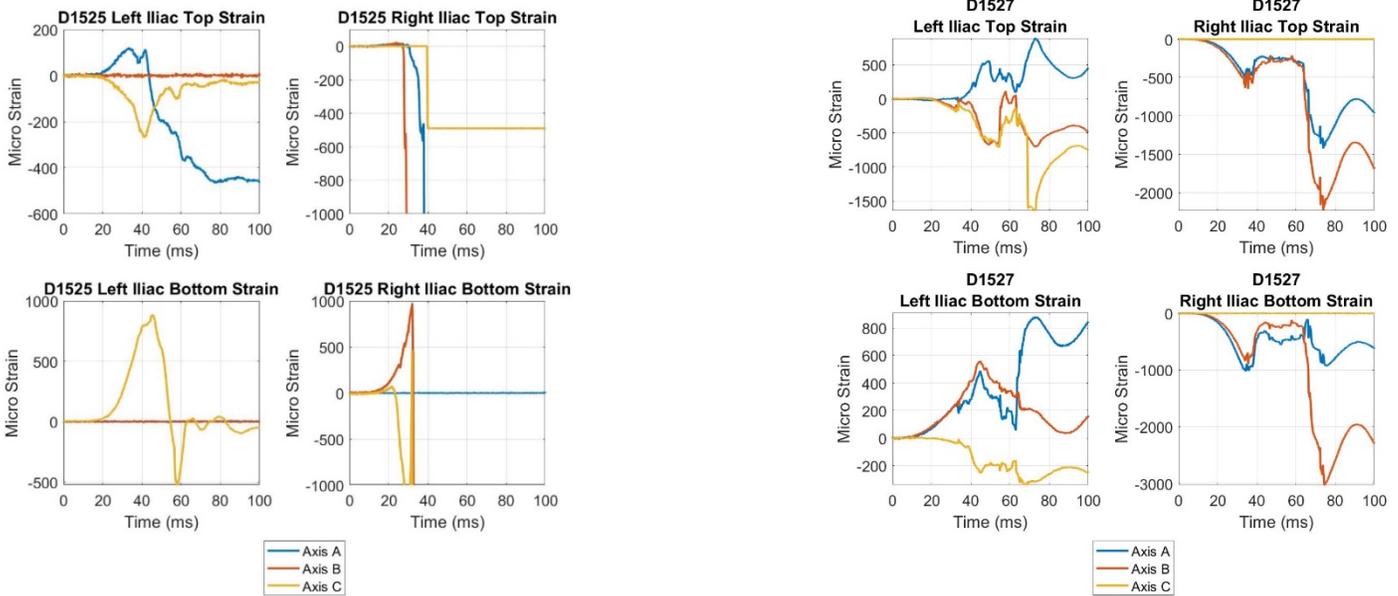
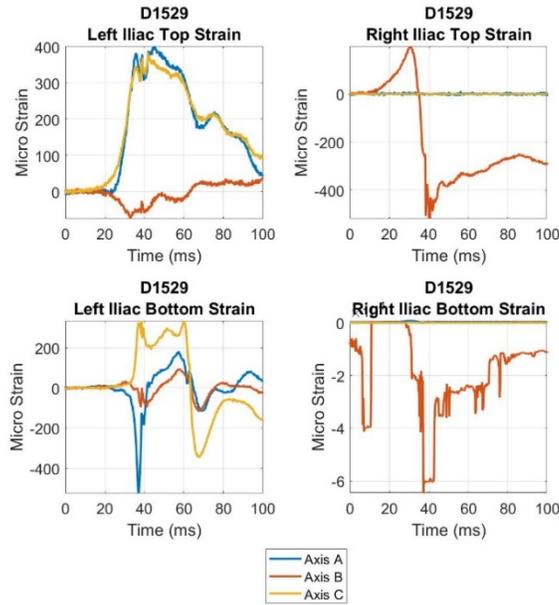
4.2.1.2.3-1 Strain Gauge Data from High Force Tests

When possible, injury timing was determined through strain gauge data (Figure 4.2.1.2.3-1). Subject UVA_663 experienced fracture on the right side at around 40 ms, as

shown by a severe drop in strain. This is after the time of peak force, and occurred at 4.3 kN. Time of injury was not able to be determined for Subject UVA_1001 through the strain data as there were no severe drops in strain. Subject UVA_895 submarined at 36 ms at 3.2 kN of force. While no pelvis injuries occurred, the subject had severe lap belt “burn,” and the subcutaneous fat had sheared from the fascia layer in regions superficial to the iliac wings. Strain gauges in each rosette failed for nearly every strain gauge of these tests, either from mechanical failures at the start of the test or due to the loading.

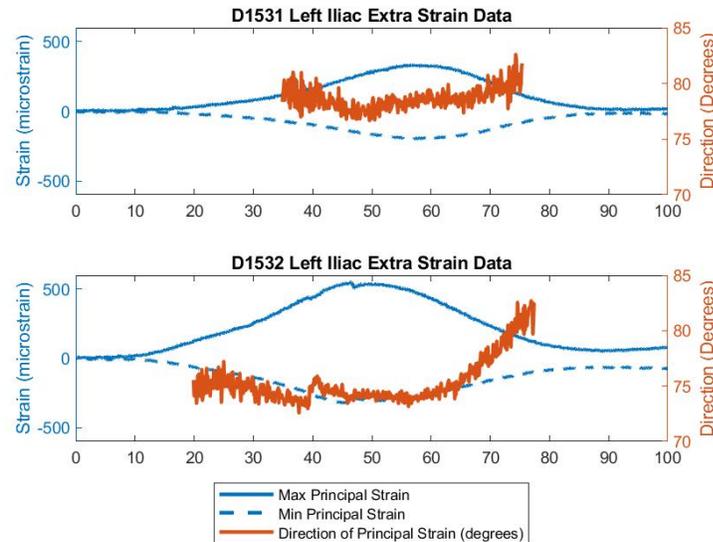
4.2.2.2.3-1 Left Iliac Extra Strain Data, Tests D1521 and D1532

direction of principal strain at peak force changed by 5 degrees with a change in belt angle of 13 degrees.

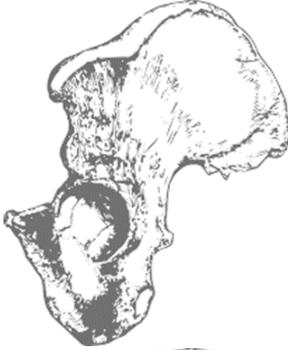
Table 4.3.1.1-1 Injury Reconstructions from High Force Tests

Subject	Frontal	Right	Left
UVA_663

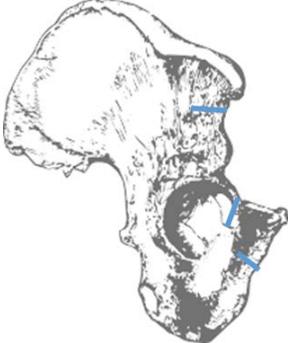
UVA_1001

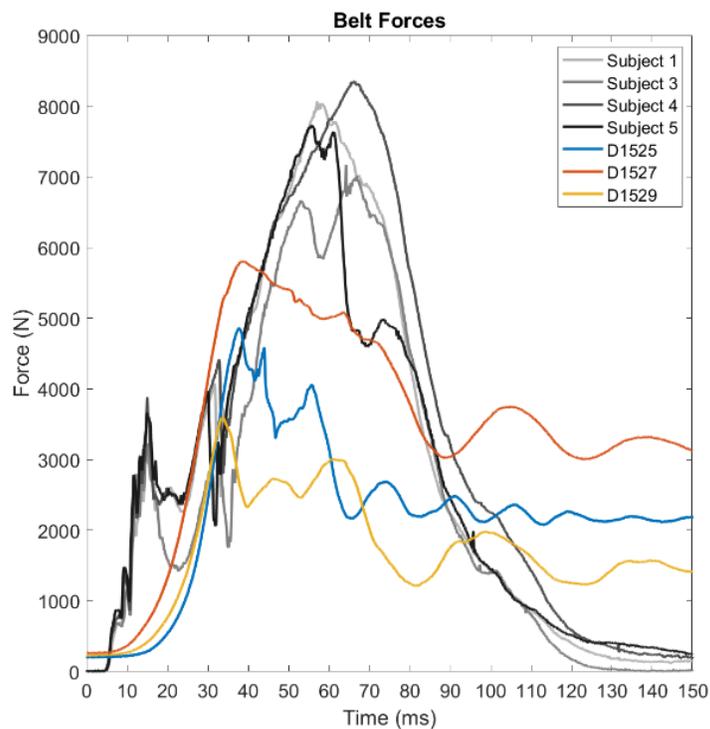
4.3.1.2-1 Lap Belt Force Comparison from High Force Tests to Richardson et al 2020 Outboard Lap Belt Forces

The test environment created in this task was designed to replicate the lap belt loading conditions that caused fracture in Richardson et al 2020. Section 4.3.1.1 showed that one of the three subjects sustained similar fractures to those seen in the Richardson 2020 sled tests. In addition, as shown in Figure 4.3.1.2-1, lap belt loading rates were also similar to those from the sled tests. Certain differences can be seen in the Figure due to

the simplified loading environment created in Task 2. First, there was no pre-tensioner fired at the start of the pulse; rather, as seen in the Figure, pre-tensioning occurred before the test was run. This causes the lap belt force values to start above 0 N. However, for the main loading phase of the pulse, the loading rates lie right on top of each other. Peak forces are not the same as in the sled tests, but that can be attributed to pelvis fracture in test D1525, lack of pelvis support in test D1527, and submarining occurring in test D1529.

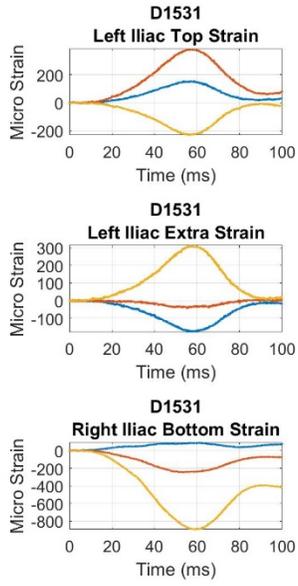
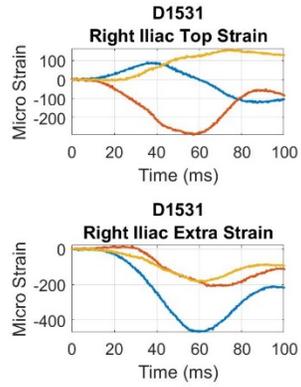
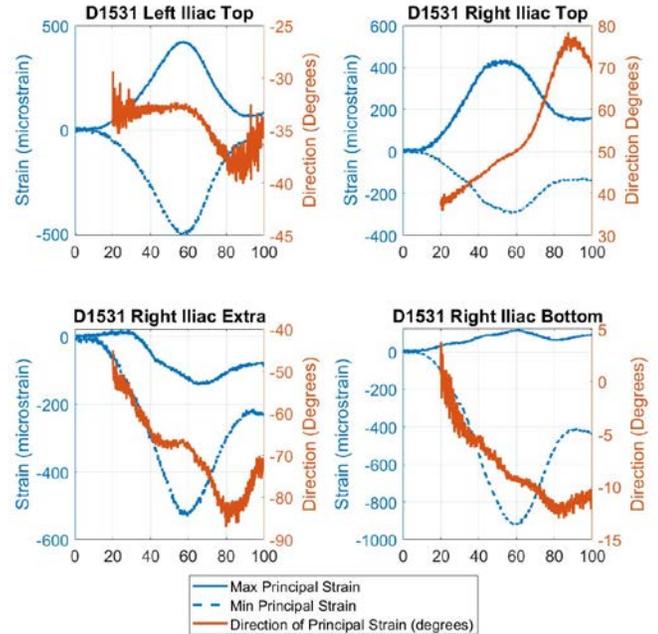
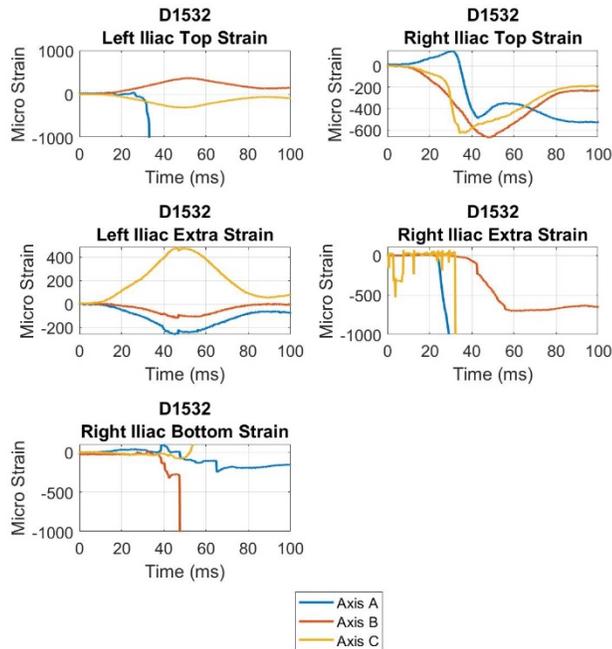
4.3.2.1-1 Strain Data from Low Force Tests

However, the main limitations of these tests were the failures of the strain gauges. While the Data Acquisition System showed no errors in the gauges, it is clear that looking at the below figures that the strain data is completely different between tests. This is not expected; shapes of the graphs are jagged and inconsistent, indicating that the gauges themselves were damaged or removed from the surface of the bone between the end of the first test and the beginning of the second test.

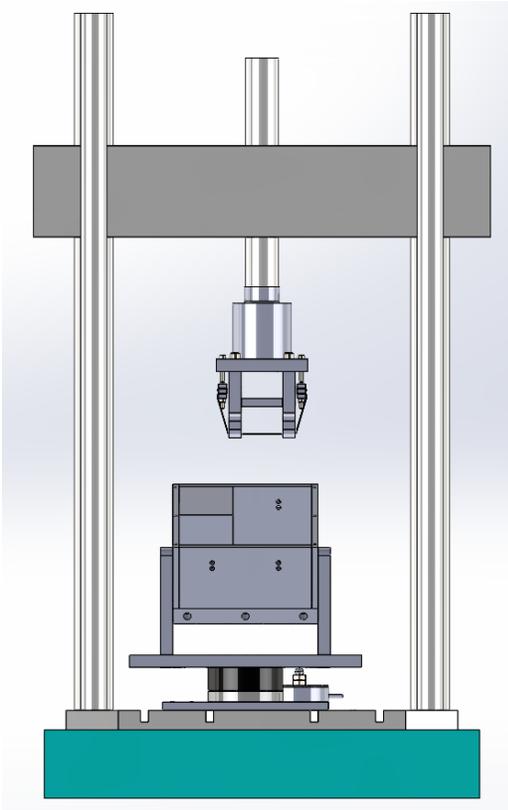
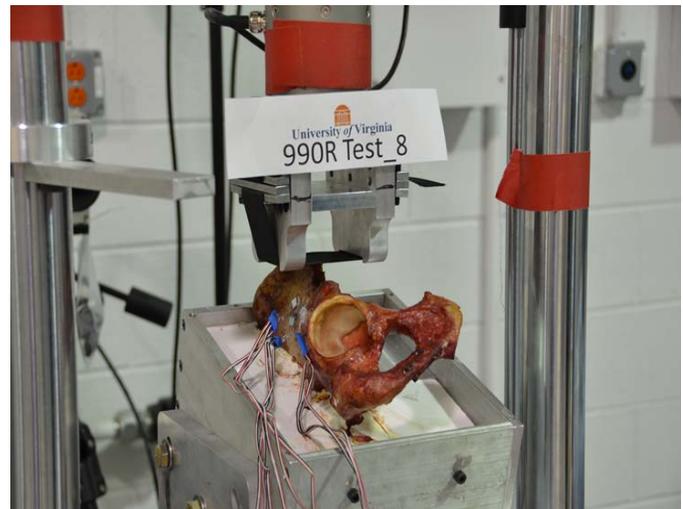
5.1.1-1 Component Pelvis Injury Test Fixture

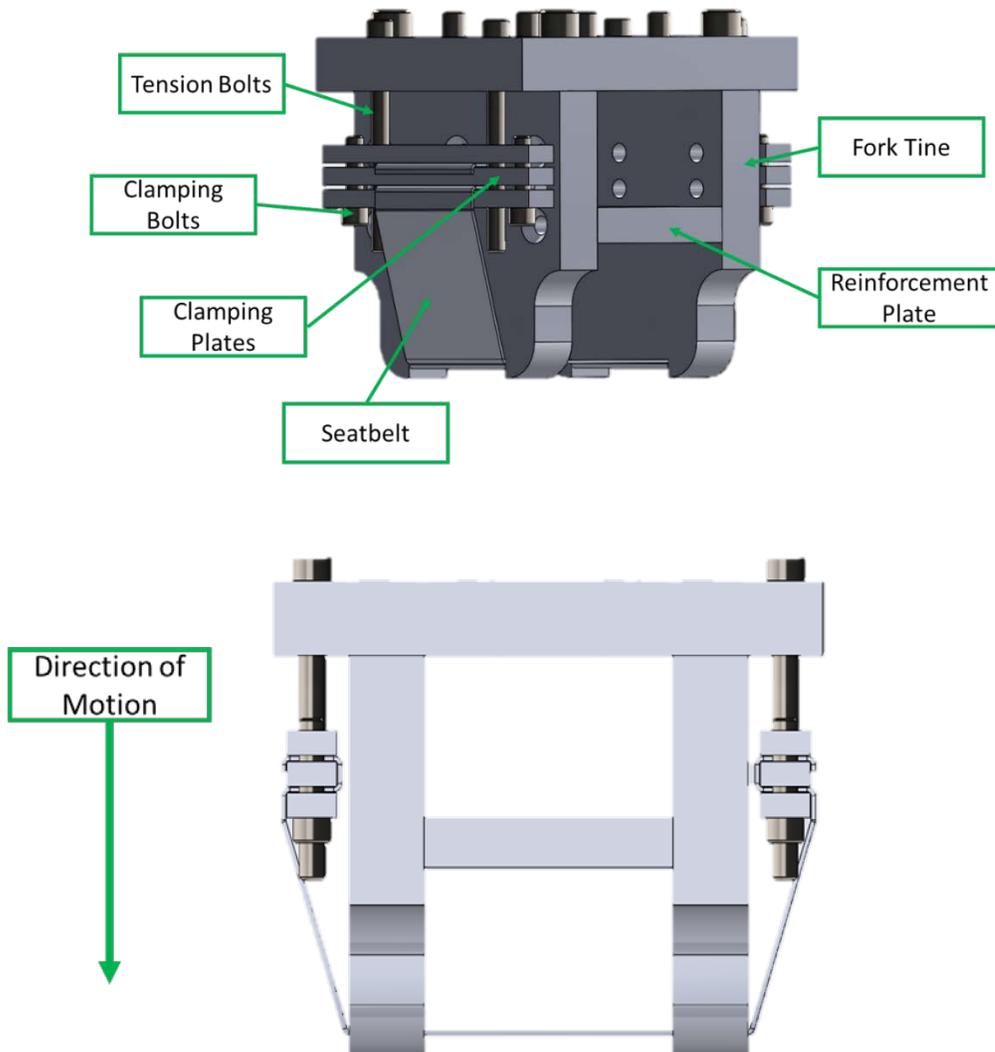
5.1.1-2 - Belt Fork Tine CAD

In an effort to load the pelvises in the same way they are loaded in a sled test, it was decided that a seat belt should be the mechanism to deliver the load. To achieve maximum positioning capability as well as simplifying the environment for modelling purposes in the future, the loading device used was a “fork “directly attached to the Instron head. Seatbelt webbing could stretch between two, reinforced aluminum tines. Screws on each side of the belt fork provided the ability to clamp the seatbelt webbing using steel plates to prevent slippage during loading. Then, jack screws on both sides of the fork tines allow the belt to be pre-tensioned. Due to the size of the fork, it was impossible to get a belt tension gauge positioned to

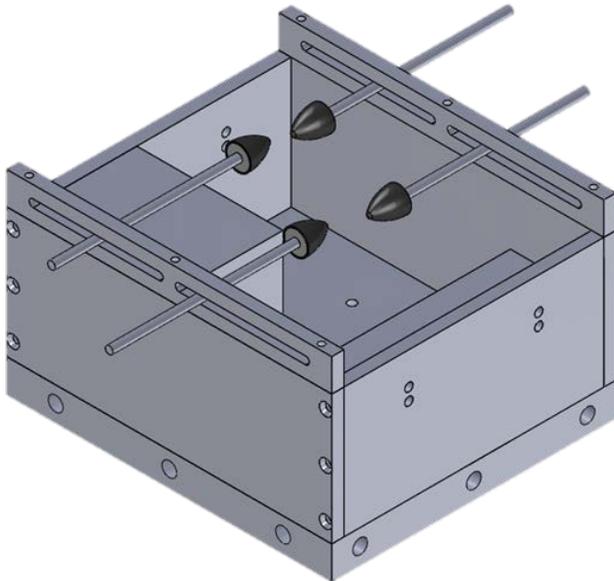
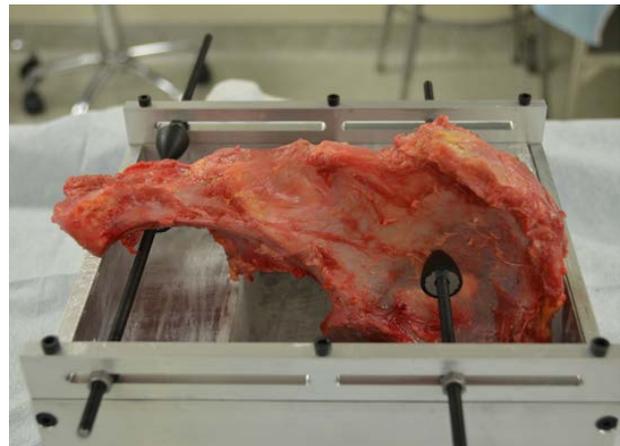
5.1.2-1 – Potting cup; plungers helped hold the pelvic wing in place while pouring the resin to ensure that the wing did not move as it was secured into its desired orientation.

- 1) Aligning the Notch plane (denoted by a line connecting the ASIS to the AIIS) as parallel with the top of the potting cup as possible.
- 2) Minimize the overall bend of the wing above the potting material to promote a pure compressive load.

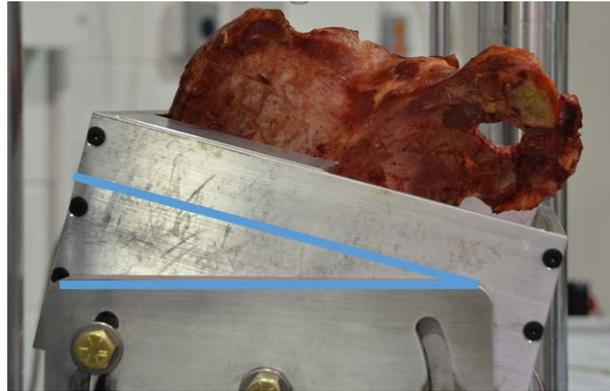
5.1.2-2 - Potting Cup Adjustment Used to Account for Potting Variability

The potting cup was clamped to the Instron base via clamping plates and bolts. These plates could be attached on either side of the potting cup to allow for rotation in different directions (only one direction at a time, however). The rotation capabilities were +/- 22.5 degrees, which allowed ample room for correcting the difference between the angle of the Notch Plane and the potting cup. The pelvis was positioned in a way that would maximize the total stroke available. Because pelvis geometry is so variable, it was decided that the top edge of the seatbelt would always align with the most anterior, superior part of the Iliac Spine. This was to ensure consistent contact surface between pelvises of different shape.

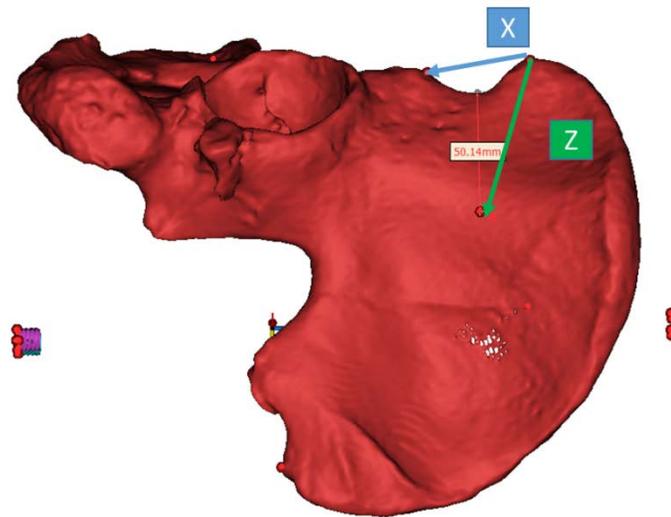
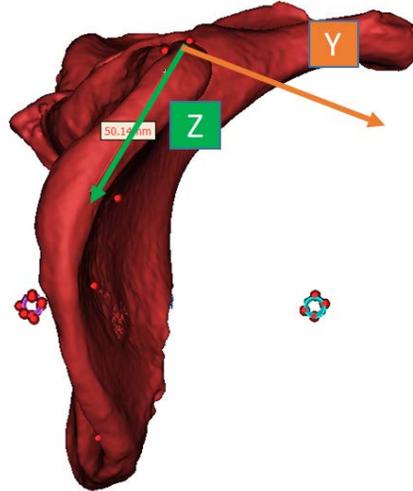
5.2.1-1 Potting Independent Coordinate System

Both coordinate systems had origins at the ASIS. Construction of the potting independent coordinate system was done by connecting a line between the ASIS and AIIS, and a line between the ASIS and a point 50 mm below the lowest point of the “Notch.” This coordinate system was anatomic based, meaning that it would measure the roll angle as a function of the pelvis geometry relative to the threaded inserts. The lateral Y direction of the coordinate system was found by the cross product of these two vectors.

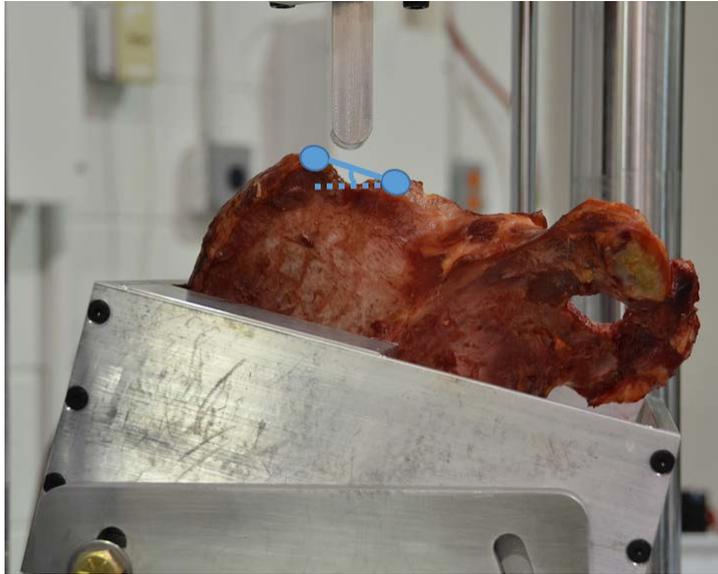
Figure 5.2.1-3 Notch Angle wrt Instron (Measurement A, Blue)

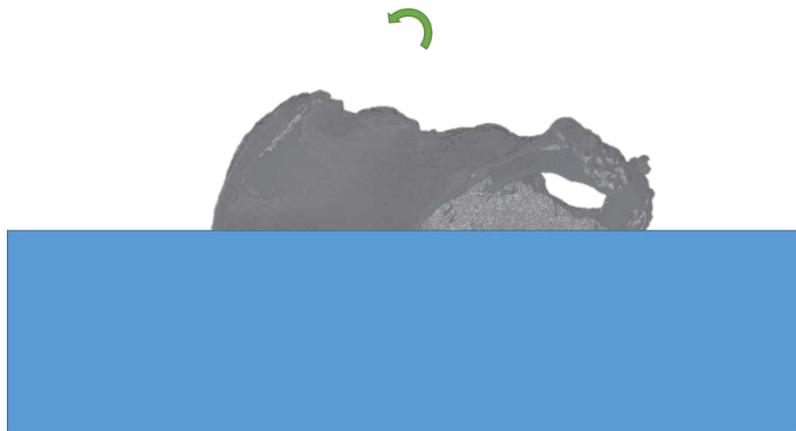
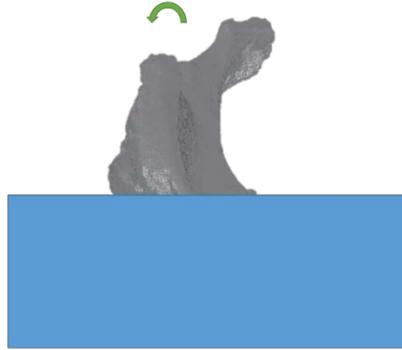
5.2.2.1-1 Notch Angle Adjustment Direction (top) and Roll Angle Adjustment (bottom)

In an effort to find the condition that most closely matched the strain data from Task 2, each pelvis wing was tested in five different conditions. Two conditions were the same Notch to Belt Angles (75 degrees and 90 degrees) tested in Task 2, which was predicted to be the two conditions that would result in the same strain distributions. However, to mimic the arc of the seatbelt in a whole body test, a condition that changed the lateral-to-medial loading direction was also checked to see whether adjustments in that direction would be necessary to better match the strain distribution (Figure 5.2.2.1 and Figures 5.2.1-3 through Figures 5.2.1-6).

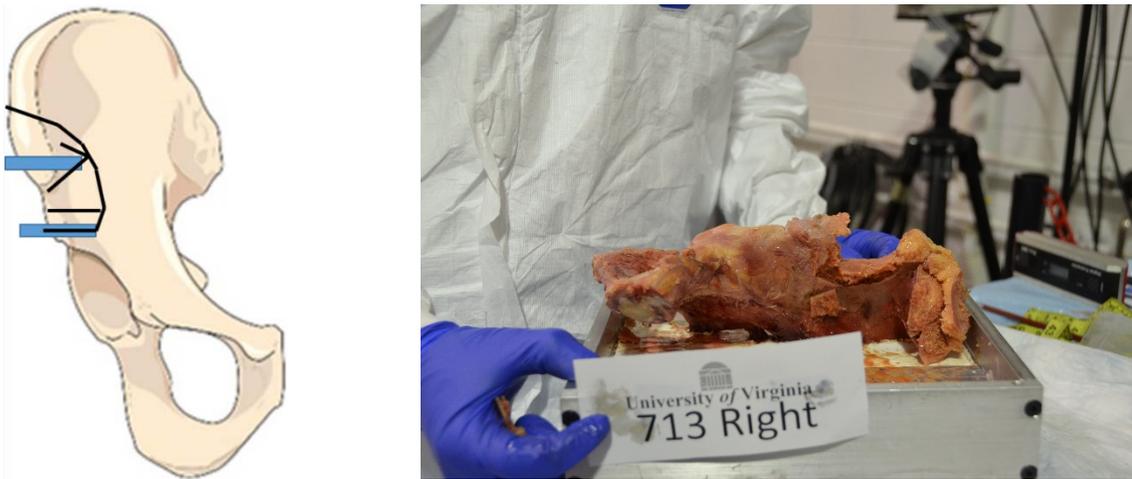
5.2.3.1-1 Fracture Diagram of Test 713R ("Snapping" Fracture). Blue boxes indicate the top and bottom edge of the seatbelt webbing

The fractures that occurred in Task 3 can be broken down into three categories. The first type of fracture that occurred can be described as a large break where the top half of the pelvic wing breaks off from the rest of the bone. It appeared like the superior piece of the wing bent and “snapped” off from the bone. This type of fracture occurred in tests 714R, 713R, and 792R. These fractures were not the same seen in Richardson et al 2020, but have been documented in Uriot et al 2015.

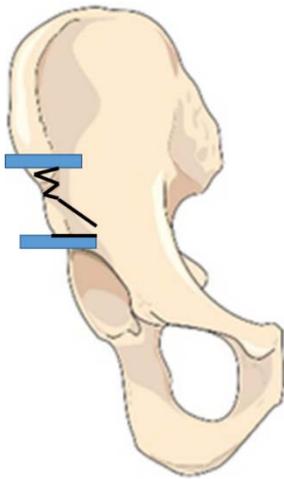
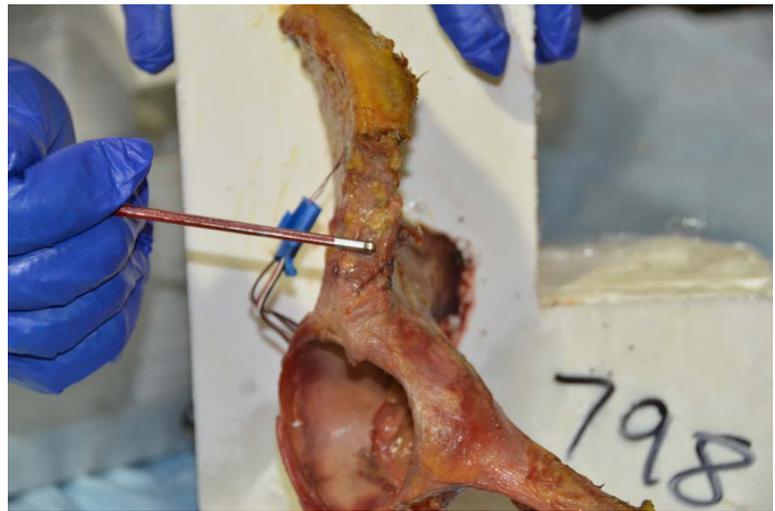
5.2.3.1-2 Fracture Diagram of 798R ("Localized" Fracture.) Blue boxes indicate the top and bottom edge of the seatbelt webbing

that sustained this style of fracture required larger forces to fracture than the other specimens, indicating that they were stronger pelvises to begin with. For the most part, these fractures were difficult to determine from High Speed Video, and required post test review of the pelvis to determine whether fracture actually occurred or not. Two of these tests were the left censored data points, where exact time and force of fracture was unable to be determined.

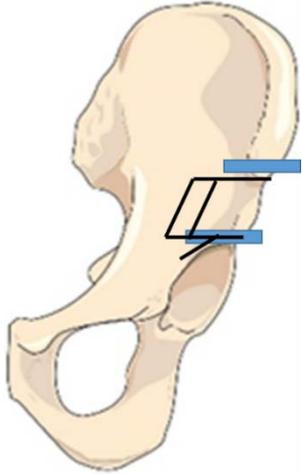
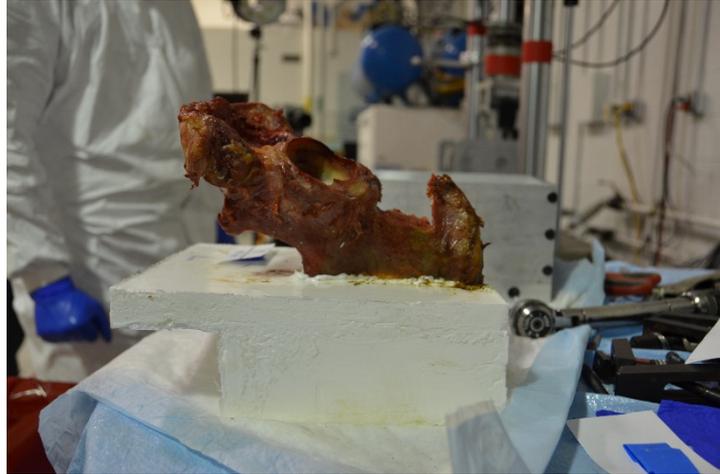
5.2.3.1-3 Fracture Diagram of 997L ("Crushing" Fracture.) Blue boxes indicate the top and bottom edge of the seatbelt webbing

All other tests where pelvis fractured sustained the “crushing” fracture between the ASIS and AIIS that were noted in Richardson et al 2020 (n = 11). These fractures were similar in shape, size, and severity to the fracture documented in Task 2, test D1525. These were the targeted style of fracture, and were successfully replicated over 50% of the time.

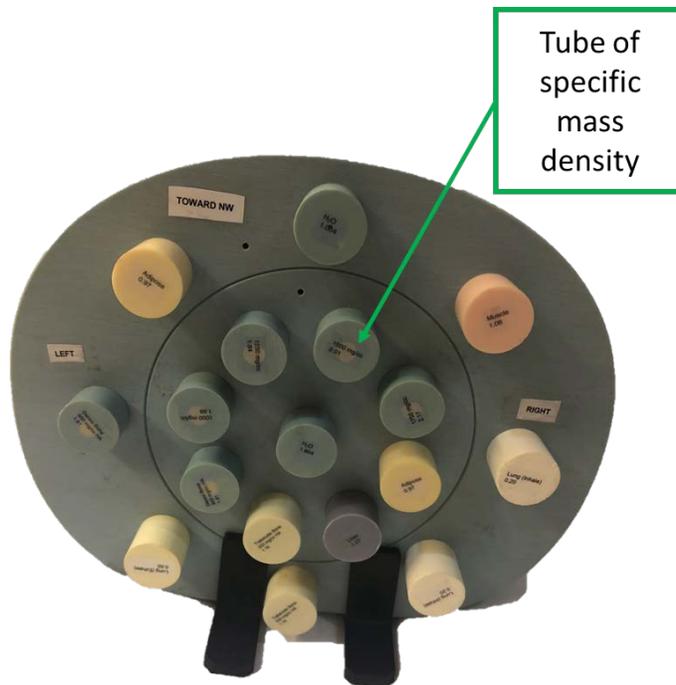
6.1-1 Electron Density Phantom

To achieve a consistent measurement procedure, an electron density phantom (EDP) was used in each pre-test CT scan. An EDP (pictured below) is a measurement device used to provide landmark intensities of Hounsfield units (HU). Hounsfield units are the measure of the amount of scatter given off by a pixel in a CT scan. The higher the scatter, the higher the measured HU, which leads to a higher BD measurement. In an EDP, various tubes of known BD are placed in a known configuration. Then, in post processing of CT scans, measurements of the HU in a given area can be taken. Since the BD of that section is known, a linear fit between these points can be created, and a BD measurement of any HU point along that line can be found through extrapolation. However, CT scanners are recalibrated almost every day. So, slight variations in the measured HU for the same BD landmark can occur. For this study, every scan taken had the EDP present in the scan so that all points could be aggregated into one, linear fit model and account for this variation.

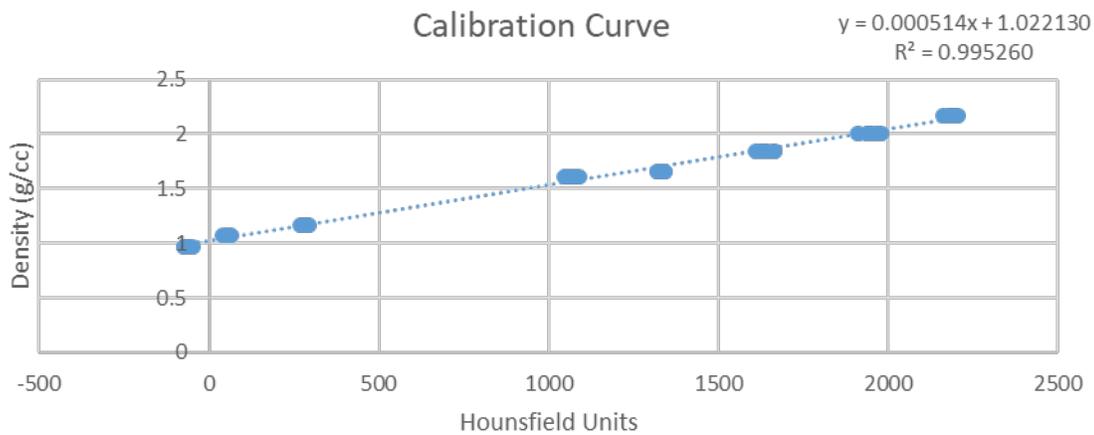
6.1-2 - BD Linear Extrapolation Function
