Presented to
the faculty of the School of Engineering and Applied Science
University of Virginia

Abstract

Goals of Study: The main goal of this study is to develop an injury criteria for the iliac wings under frontal lap belt loading conditions. To achieve the goal of developing an injury criteria, I first need to recreate similar fractures using a similar loading/injury mechanism. I will design an experiment to characterize belt-to-pelvis loading with the goal of recreating the same fracture at the same isolated lap-belt-to-pelvis orientation that caused fracture in Richardson et al 2020. After replicating these fractures on a full scale test, I will then design a component level test to measure the tolerance of fracture on isolated pelvic wings, and do so across a variety of pelvises. I will then use the tolerance data to perform a statistical analysis to predict risk across the population to achieve the desired injury criteria.

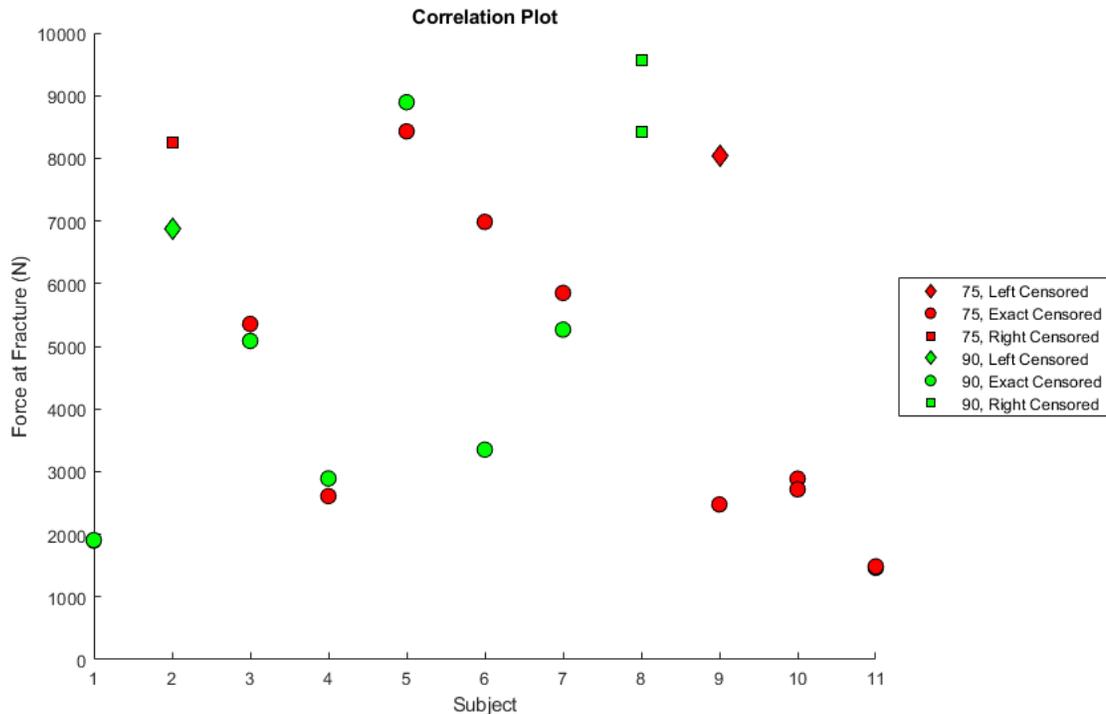
6.3-1 Correlation plot of force at fracture for each subject. In plot, the measured force at fracture (or peak force for those that did not fracture) is plotted for the left and right sides of the same subject. It clearly shows that left and right sides are correlated to each other and, generally, not random.

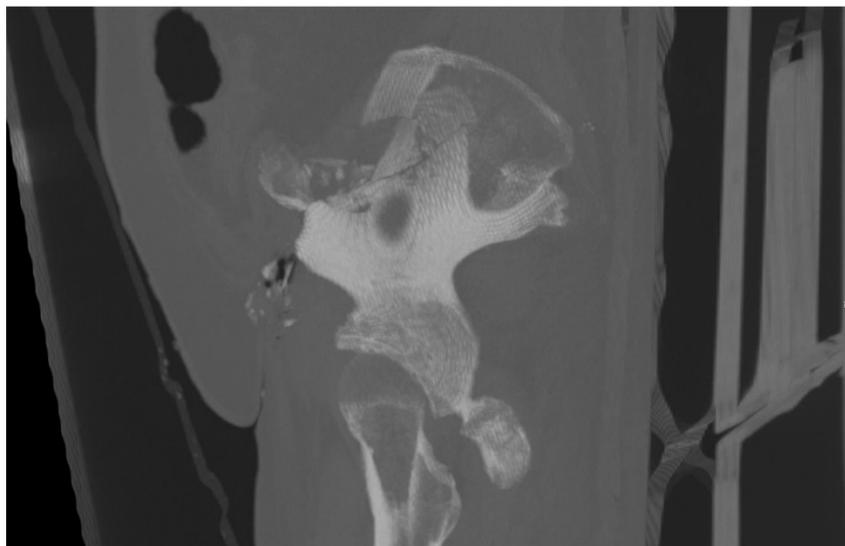
Specimen #663
CT Report: Post-Test, RCCADS Belt Pull
Scan Date: 10/22/2020
Received: 10/31/2020

1. Complex and segmented right iliac fracture involving the pelvic rim and extending posteriorly to the SI joint without involving the sacrum on the right, and anteriorly into the anterior inferior iliac spine.
2. Non-displaced new sacral wing fracture extending from the inferior left transverse process of L5 through the S1 sacral wing and likely involves the superior aspect of S2.
3. Multifocal bilateral anterior rib fractures as described above in addition to non-displaced sternal fractures, these are similar to pre-test imaging and likely represent traumatic injury sequela of CPR.
4. Cortical irregularity without high loss involving T1 vertebral body likely sequela of instrumentation.
