Coilolo River Pedestrian Bridge

A Technical Report submitted to the Department of Civil Engineering

Capstone Design and Construction Report

Capstone Report
Coilolo, Bolivia 2023
University of Virginia

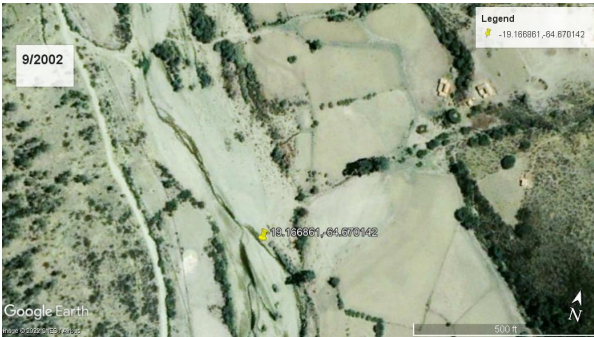
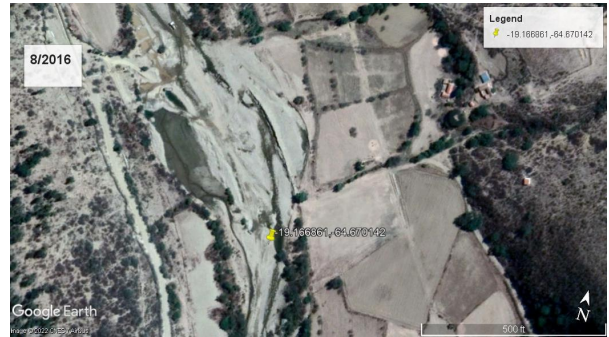
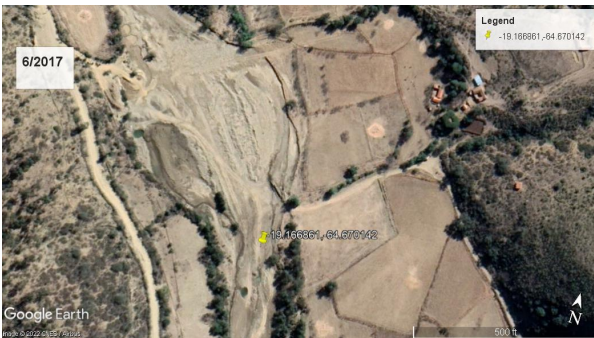
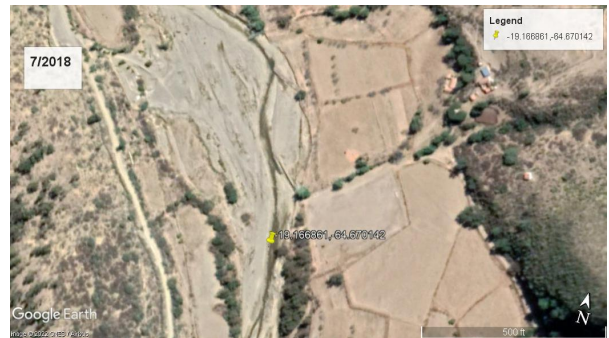
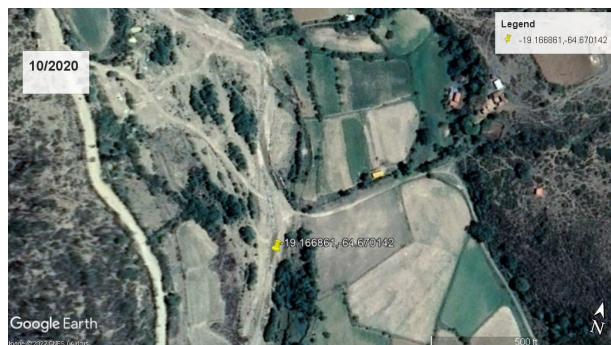
Changes over time in the Coilolo River can be viewed from the Google Earth images in Figures 3.5.6-10 below from September, 2002, to October, 2020. The most notable change involves the location and abundance of vegetation. From Figure 3.5.6 to Figure 3.5.7, the vegetation decreases, particularly towards the northwest region of the channel. This decrease in vegetation is due to particularly intense flooding during this time period. The vegetation stays relatively stagnant between Figures 3.5.7, 3.5.8, and 3.5.9 before increasing in quantity in Figure 3.5.10.
