North Grounds Stream Restoration

A Technical Report submitted to the Department of Civil and Environmental Engineering

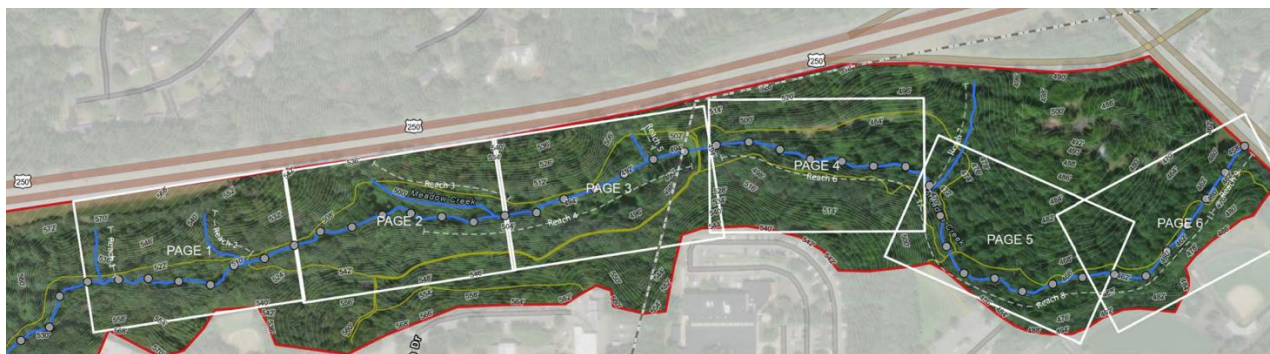
Figure 1-1. Biohabitats Division of Reaches

As is shown in Figure 1-1, reaches (3 and 5) are tributaries to the stream fed by outfalls that run under US 250/Route 29 Bypass. These reaches are of particular interest because there is concern about the influence of increased flow contributions on sediment load and phosphorus and

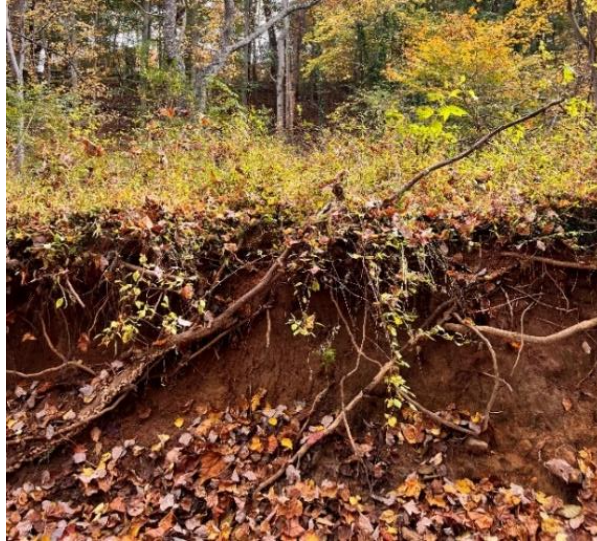
Figure 3-4. Incised Banks on Reach 3

The previous water quality datasets imply that sediment and nutrients are not actively being conveyed by Reaches 3 and 5. However, the severe physical incising (Figure 3-4) is indicative of historical erosion in the reaches and probable erosion during future, larger storm events. Therefore, to accurately determine the extent of erosion and inform TMDL and MS4 credit calculations, a Bank Erosion Hazard Index (BEHI) of Reaches 3 and 5 was employed.

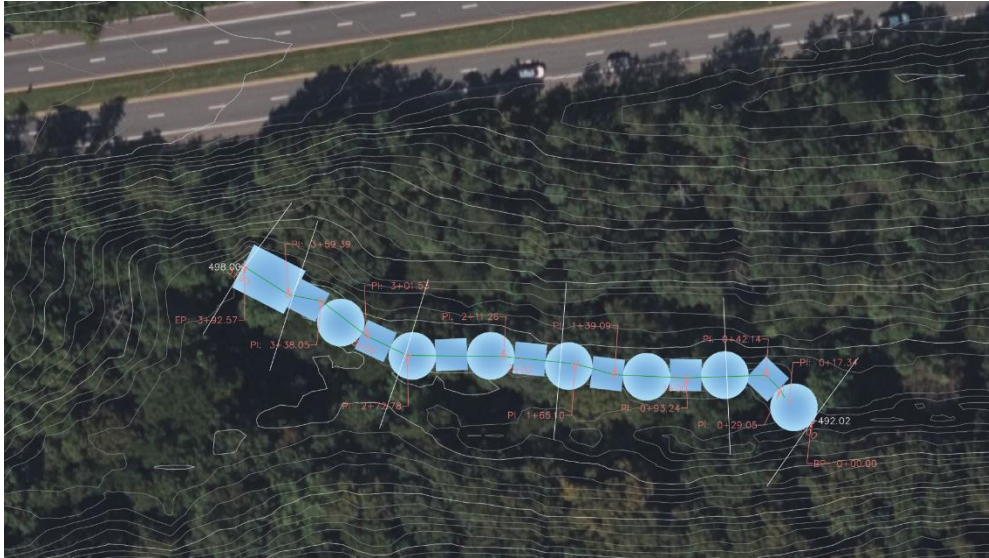
Figure 5-3. Reach 3 Design Layout

Each reach's alignment has been mapped in Civil3D and each component of the SPCS positioned. The previously generated DEMs were imported to the Civil3D file and profile views for the design were produced. Finally, cross sections at key locations in each reach were plotted, corresponding to the previously surveyed cross-sections. The cross-sections show typical arrangements of the components of the SPCS, like attenuation ponds, the sand seepage filter, riffle weirs, and cascade weirs. Below is a profile view image of the stream Civil3D file created. Figures 5-3 and 5-4 show the plan view layout of the attenuation ponds, riffles, cascades, and plunge pools

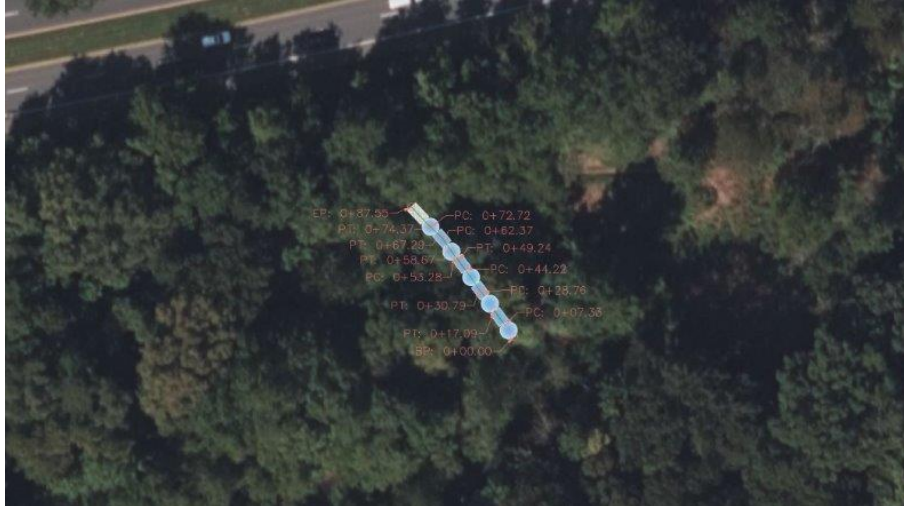
Figure 5-4. Reach 5 Design Layout

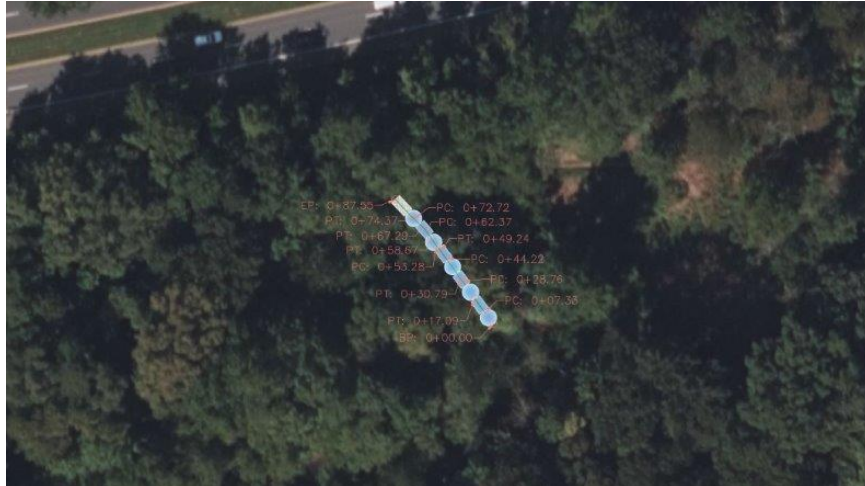
Reach 5 Final Draft Design (Plan View)
