Methods for Post-Construction Evaluation of Horizontal Directional Drilled Utilities

A Thesis

Presented to
the faculty of the School of Engineering and Applied Science
University of Virginia

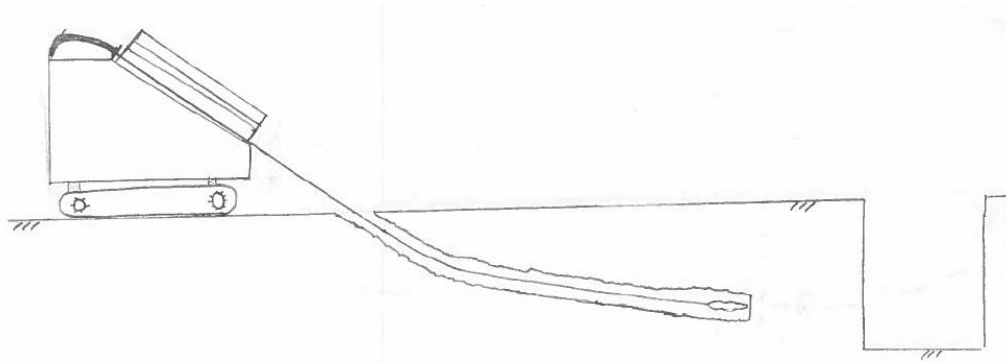
The first step in HDD construction entails drilling a pilot hole. It is imperative that the correct pitch is made while drilling the pilot hole, for the centerline of the larger bit will naturally follow the pilot hole. Normally, an excavation is made on the opposing end of the drill path. The excavation is often referred to as the receiving pit (Hashash and Javier, 2011). The receiving pit is necessary for pumping soil cuttings produced during drilling. The pit also allows for the utility to slide easily into the future hollowed hole. Initial advancements are performed with a smaller conic-shaped drilling bit, ranging from 3-inches to 6-inches in diameter. Additional drilling rods are stored on the drill rig so that sections may be added as drilling continues. Normally, rod sections are 10-feet long; therefore, a new section is added every 10-feet of drill length. Please refer to Figure 1 for the first step in drilling.

Figure 1. Drilling of the Pilot Hole.

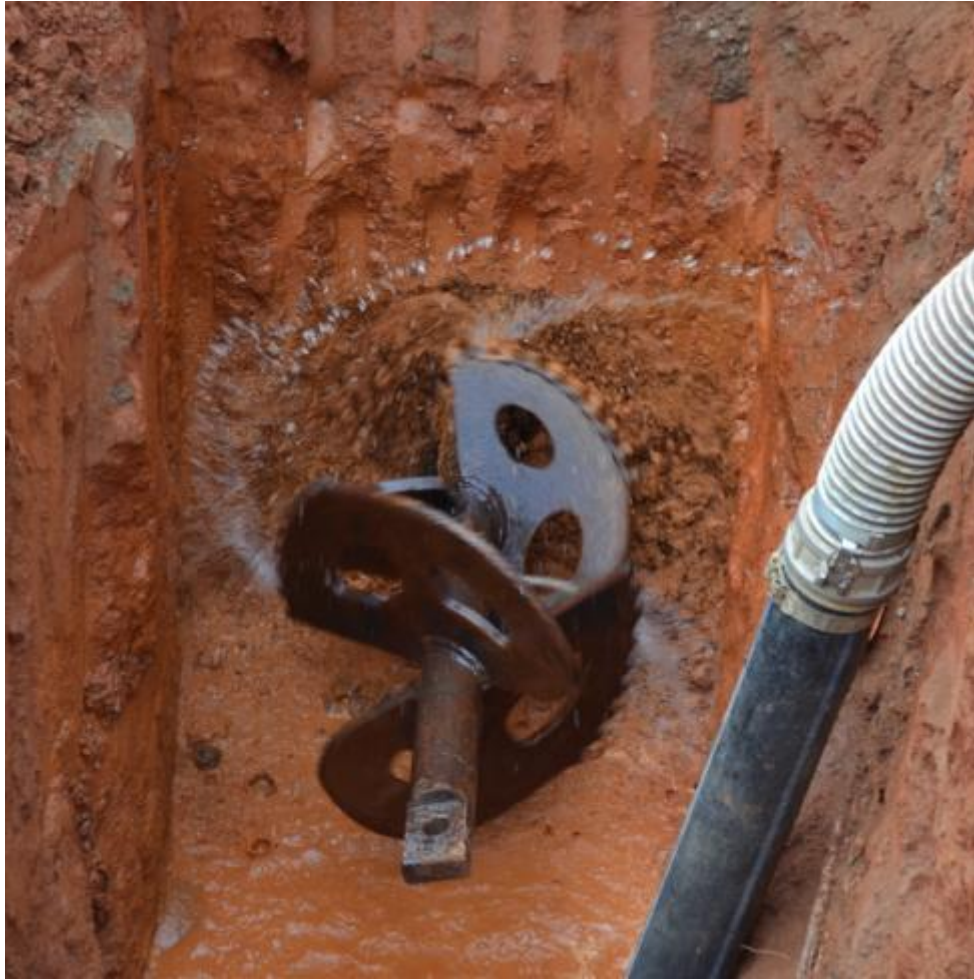
Once the pilot hole reaches the excavation on the opposing end, the small bit is removed, and a large auger bit is attached to the rods. The large auger bit normally has small weep holes in the center, allowing bentonite slurry to be pumped into the borehole. Bentonite slurry is a mixture of water and calcium or sodium bentonite, necessary for lubricating the drill hole and reducing potential swell of the borehole. The slurry is mixed thoroughly in a separate tank and pumped to the hosing at the back of the rig. The slurry then travels through the center of the hollow drilling rods, exiting through the weep holes in the auger bit. As the auger bit turns, the bentonite slurry is flung out from the weep holes and onto the outer walls of the borehole. Simultaneously, the cutting teeth on the auger bit tear through soil, reaming a borehole. Figure 2 is a depiction of the large auger bit releasing bentonite slurry from its weep holes as rod rotation occurs.

Figure 2. Bentonite Slurry being released from the large auger bit (Photo by Frank Morris).

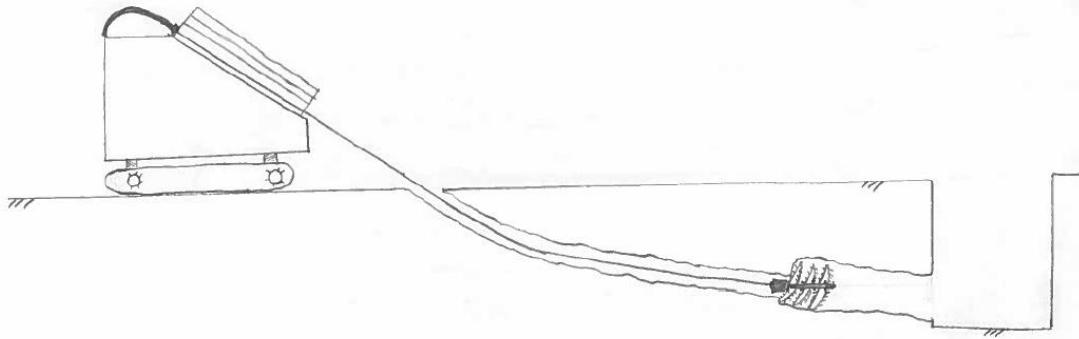
Generally, the back ream (large auger bit) diameter is 1.5 times the diameter of the pipe being installed (Hashash and Javier, 2011). The larger ream accounts for swell of the soil and varying angles of pitch. As the drill rig turns the rods, the bentonite slurry is pumped out of the weep holes in all directions, cutting the soil easily. This step of the drilling process follows the pilot hole back toward the rig as shown in Figure 3.

Figure 3. Augering of the larger diameter borehole.

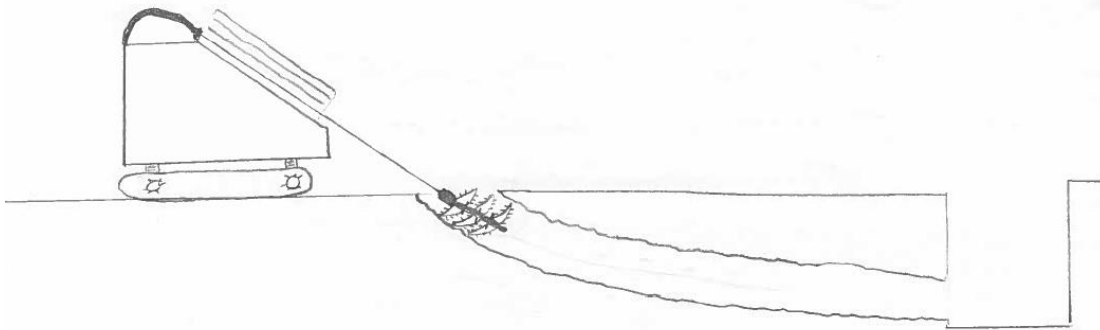
The slurry is pumped out of the excavation as drilling advances. Once the larger diameter auger bit reaches the start, the rig pushes the bit back to the opposing end. During pushing the bit back toward the excavation, slurry is pumped as needed. The pushing further cleans and reams the borehole as displayed in Figure 4.

Figure 4. Pushing the large auger bit to the excavation.

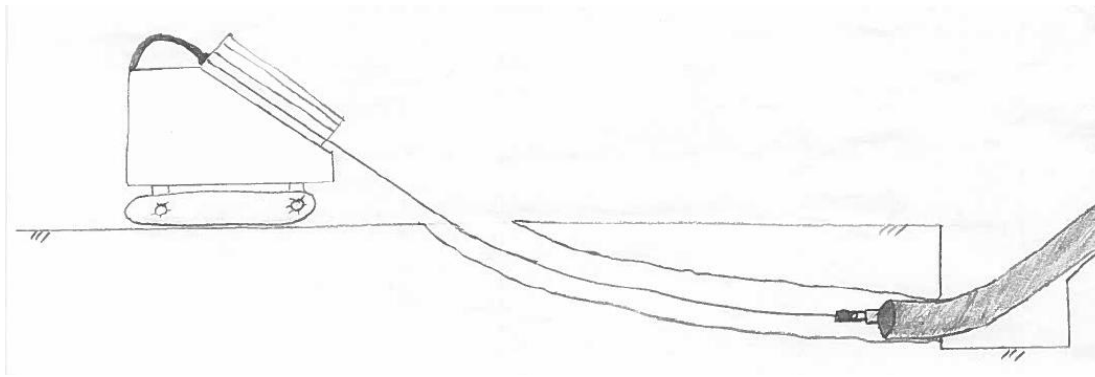
Finally, the utility is pulled from the excavation to the initial until it reaches the rig. Please refer to Figure 5 for the last step in HDD construction. Due to the overcut of the back ream, a "filter cake," forms between the outer diameter of the utility and inner borehole walls. The "filter cake," is a mixture of soil cuttings and bentonite, forming around the outer perimeter of the utility. Theoretically, the "filter cake" fills the annular space for the whole length of the borehole. The "filter cake" is variable, for the consistency depends upon soil and bentonite conditions. Oftentimes, engineers call for grouting of the annular space in project specifications. Pumping grout solidifies the annular space, allowing overburden soil stresses to be re-distributed.

Figure 5. Pulling the utility.

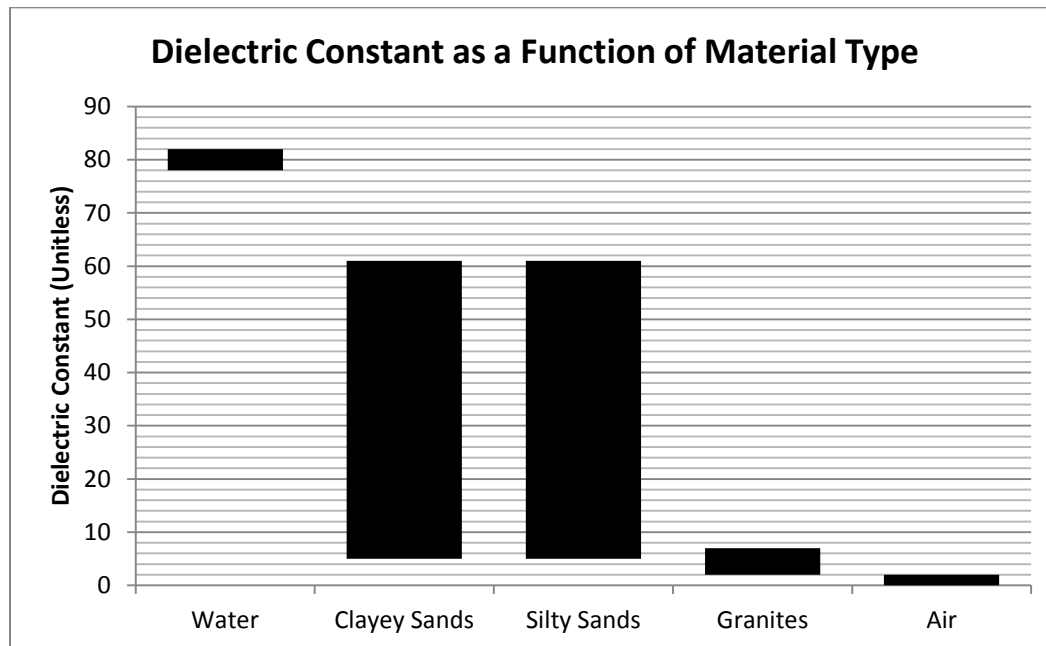
The soil types on the sites have known dielectric constants within a specified range. One should expect the Burnt Chimney project site soils to have dielectric constants within the range of 5-to-60. One should expect the VA-635 project site soils to have dielectric constants within the range of 3-to-5. Figure 6 incorporates dielectric constant values as a function of varying soil types, specific to the project sites.

Figure 6. Dielectric Constants and Material Types (Wightman et al., 2003).

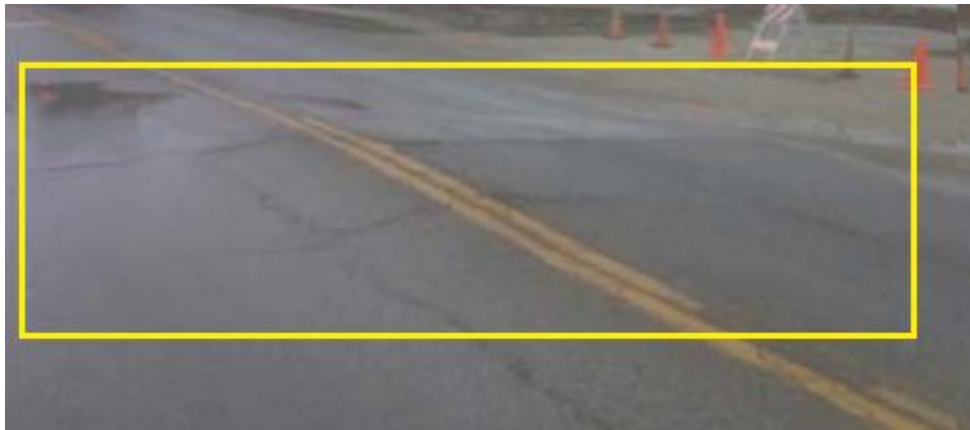
A case study, that took place in Newton, Illinois by Youssef Hashash and Jamie Javier, displays asphalt failure due to HDD construction. The project site had variable soil conditions: a mix of rock and soft fills. An 18-inch reamer bit drilled the open borehole, and dual 6-inch PVC waterlines were installed. Shortly after construction, heaving of the roadway caused mounding of the surface asphalt. Figure 7 displays the highlighted basal upheave of the roadway, creating bumpy driving conditions. The conditions worsened with a crack in the waterline, and the municipality immediately remediated the roadway with an open-cut trench.

Figure 7. Newton, Illinois HDD Failure (Hashash and Javier, 2011).

case of the Newton, Illinois project site, FutureScan results would indicate a larger ream-hole diameter than was drilled. In addition, dielectric permittivity values of water may have been sensed close to the ground surface by either device.

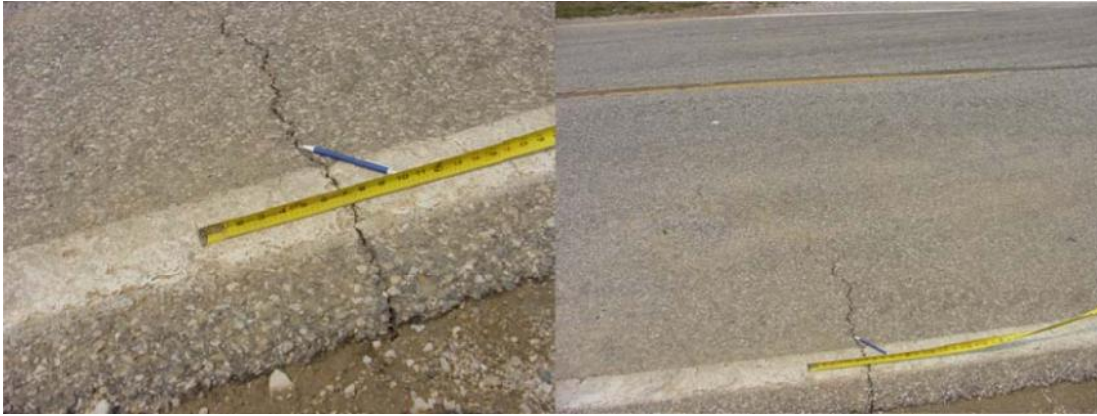
A similar case study by Hashash and Javier took place in Salem, Illinois. A steel 8-inch casing was installed beneath an existing roadway using trenchless methods, and cracking of the existing roadway occurred. Moisture, on either side of the cracking, was noted, for drilling fluid was the most likely cause of the surface moisture cracking. Figure 8 depicts longitudinal cracking in the direction of the utility. Hydrofracture is the probable cause of failure in this case. If FutureScan or GPR had been used on the project sites, the infrastructure failures could have been pre-determined, and issues would have been addressed on-site. The radar gram (FutureScan or GPR results) would indicate anomalies in the cracked region. In the

Figure 8. Salem, Illinois HDD Failure (Hashash and Jamie Javier, 2011).

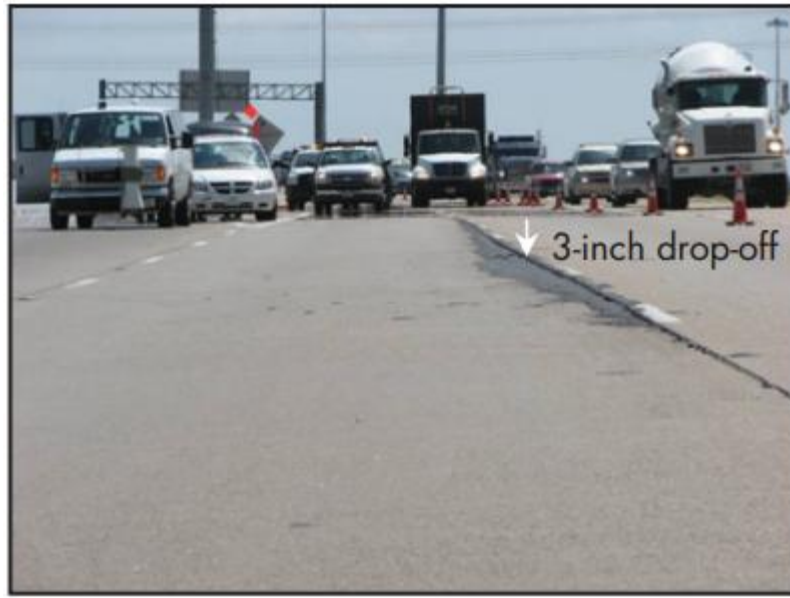
The Texas Department of transportation used GPR technologies to locate voids and reduce further damage to existing facilities. GPR was successful in locating a 1,080 cubic-foot void beneath U.S. 290 near Austin, Texas (Chen, 2010). A section of U.S. 290, southwest of Austin, was built on top of an MSE (Mechanically-Stabilized Earth Wall). An underground drain pipe, spanning longitudinal (parallel) to lanes, broke at a joint, causing soil fines to wash out of the pipe itself. Thus, a large void formed below the roadway surface. Subsidence and cracking at the surface indicated soil failure below existing grades. Settlements of up to 3-inches were observed. Figure 9 displays the large subsidence between traffic lanes.

Figure 9. Settlement of the Roadway (Chen, 2010).

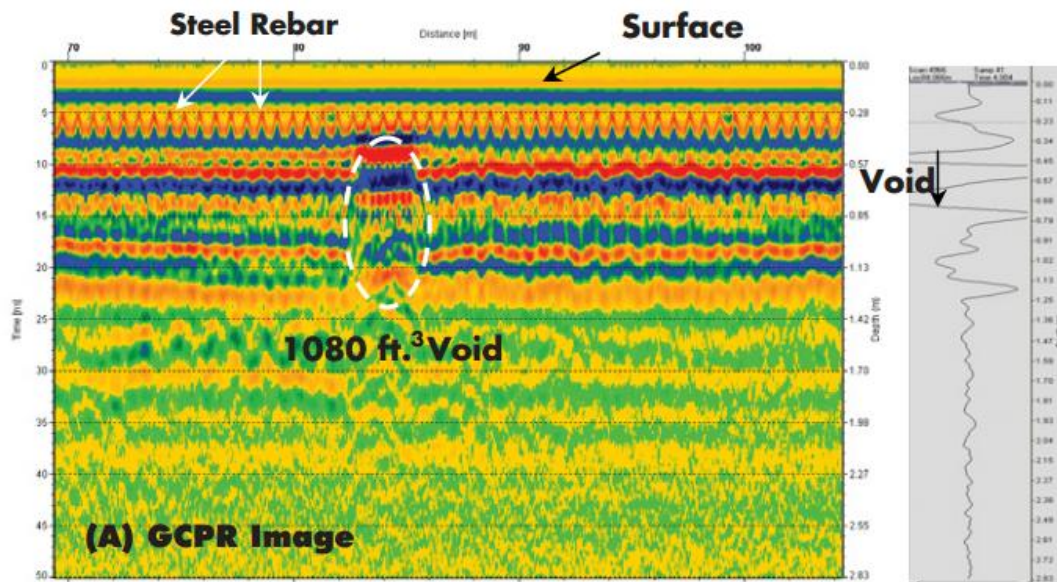
After evaluating the site using a 400 Megahertz antenna GPR system, an inversion of voltage was noticed on the radar gram in Figure 10 (Chen, 2010). The void dimensions were listed as such: 6 feet deep, 15 feet long, and 12 feet wide (Chen, 2010).

Figure 10. Radar Gram Results for U.S. 290 near Austin, T.X. (Chen, 2010).

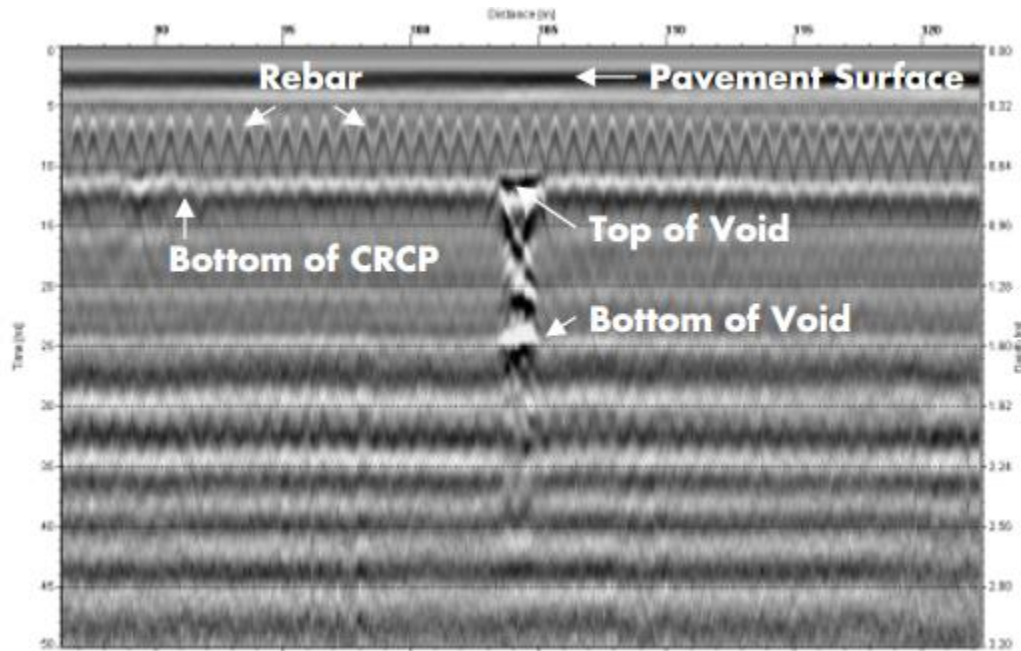
Chen outlines an additional case study in Amarillo, Texas, concerning Interstate 40 (I-40). Similarly, a storm drain pipe had failed and soil fines were observed seeping out of the asphalt surface. After using GPR to survey the area, anomalies were noted on the radar gram in Figure 11.

Figure 11. Anomalies from I-40 in Amarillo, Texas (Chen, 2010).

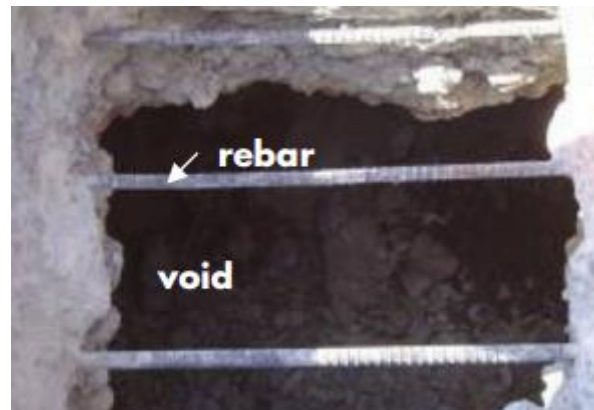
A section of the roadway was cut, and a 135 cubic foot void was realized (Chen, 2010). Figure 12 depicts the cut roadway, revealing a large void beneath the roadway surface. Remediation included grouting the void space.

Figure 12. Void beneath I-40 detected by GPR (Chen, 2010).

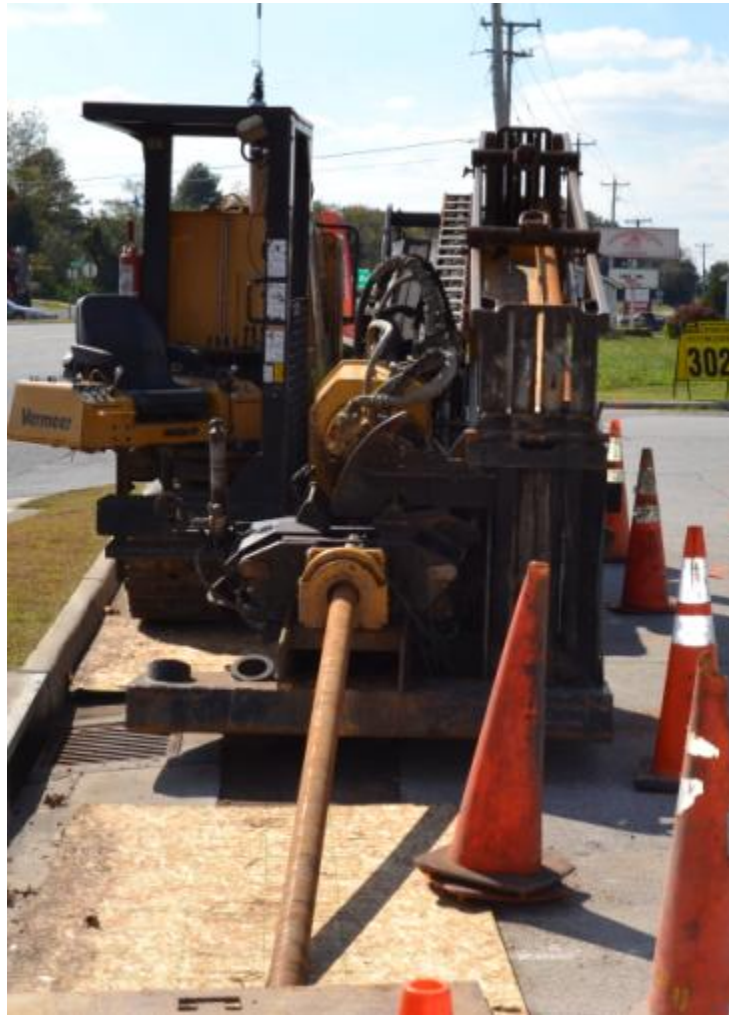
The contractor used a Vermeer D80x100 Navigator (Figure 14) directional drilling rig, which is capable of 20-degree pitches into the ground.

Figure 14. Vermeer Directional Rig (Photo by Frank Morris).

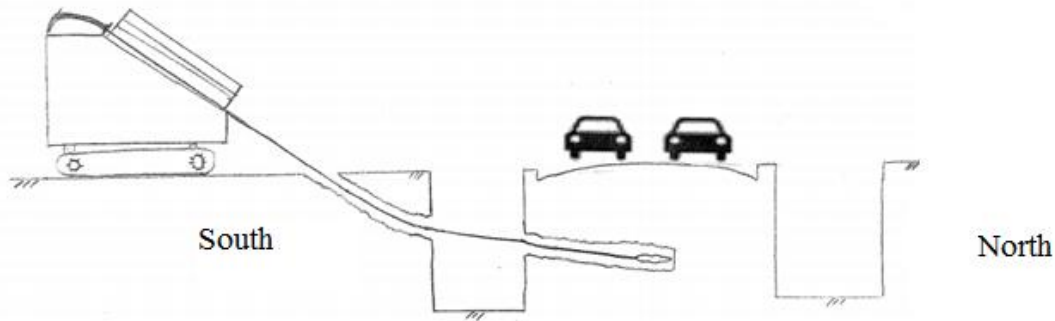
The first step in the 18-inch HDPE casing installation entailed drilling a pilot hole, using a 6-inch diameter conic bit. Drilling was performed from the south end of the intersection, and advancements were made toward the north end. Two receiving pits were dug for ease of pumping cuttings. Figure 15 depicts the drilling rods traversing through the southern receiving pit, pitching beneath the existing roadway.

Figure 15. Drilling of the Pilot Hole beneath roadway.

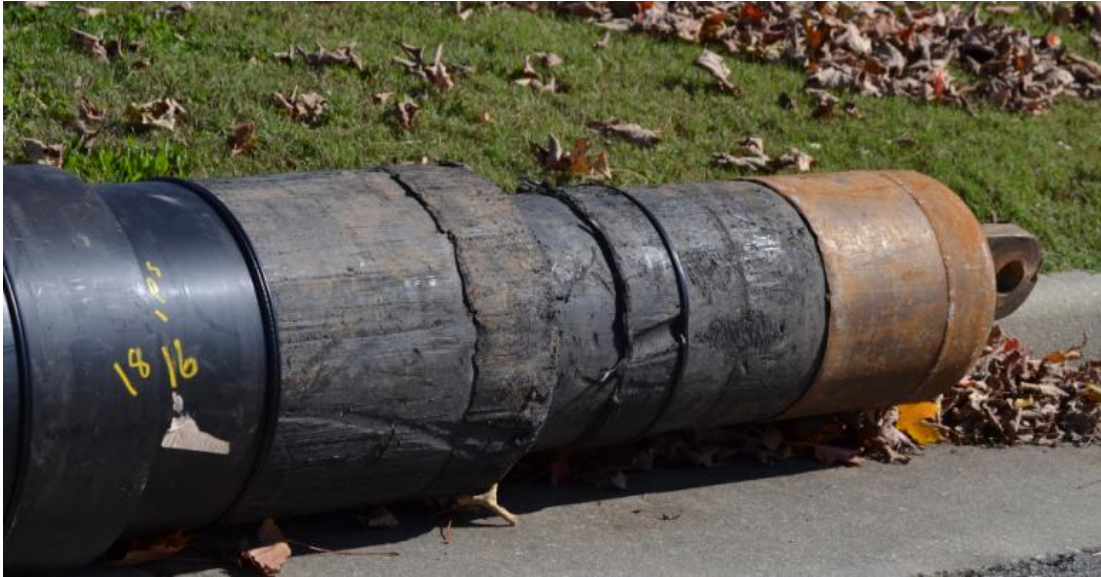
Once the large auger bit reached the north end, the bit was removed, and a spindle was attached to the rod's end. Figure 16 displays the fitting plug on the end of the 18-inch HDPE casing attached to the spindle and kept the open casing from becoming filled with any soil. A closed-ended hook on the fitting plug allowed for shackle attachment at the drilling rod's end (Figure 17). After shackling the casing to the rods, the casing was pulled towards the rig from the north end to the south end, through the established drill path, thus completing the drilling.

Figure 16. Plug on end of 18-inch HDPE casing.

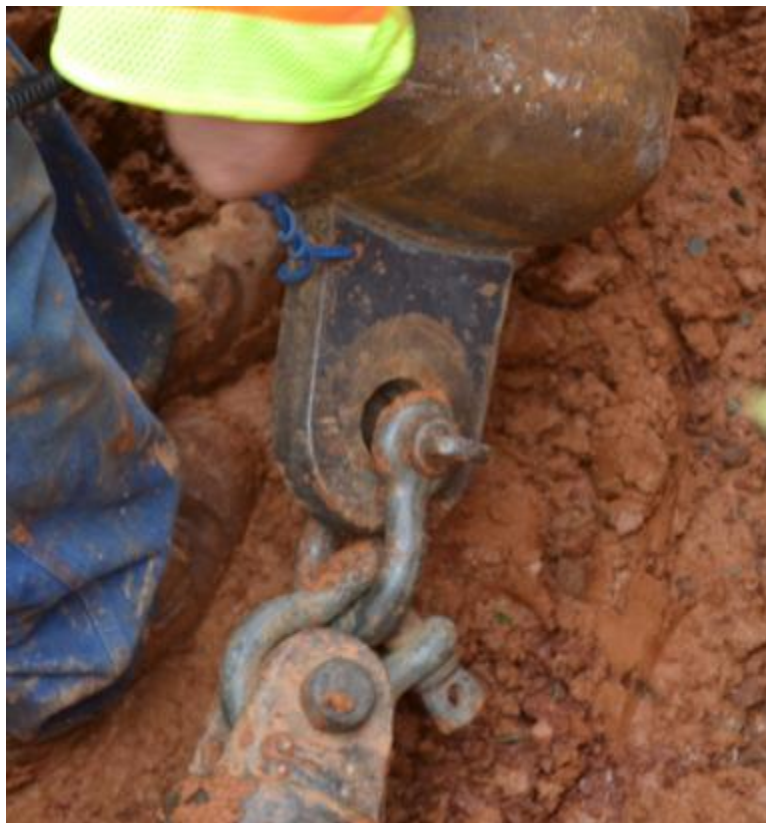
Figure 17. Spindle – Fitting Plug Connection.

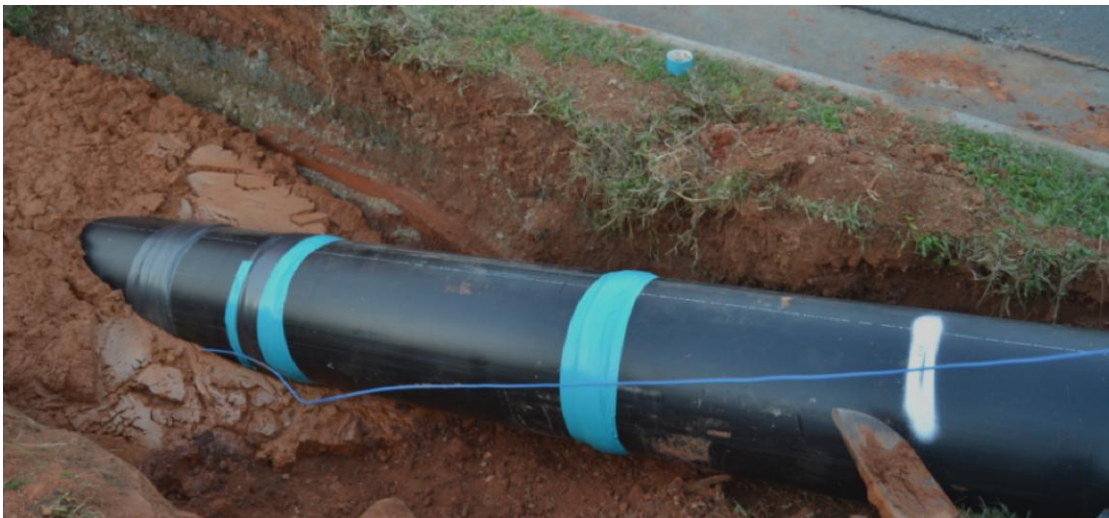
To establish control and evaluate the reliability of FutureScan and GPR, target anomalies were installed prior to pipe inspection at The Burnt Chimney project site. The target anomalies were made of polyethylene foam wrapping. Manufactured in 1/16th of an inch thickness, the wraps were cut and rolled around the pipe accordingly. The foam wrapping was then covered lightly with duct tape. Targets were installed along a non-critical section of pipe, meaning no foam wrapping was placed beneath the roadway or existing infrastructure. Refer to Table 3 for sizes and locations of targets. Figure 18 shows the pipe during insertion, displaying targets 2,3, and 4.

Figure 18: (Left → Right) White Marking, Target 4, Target 3, and Target 2. Target 1 not pictured.

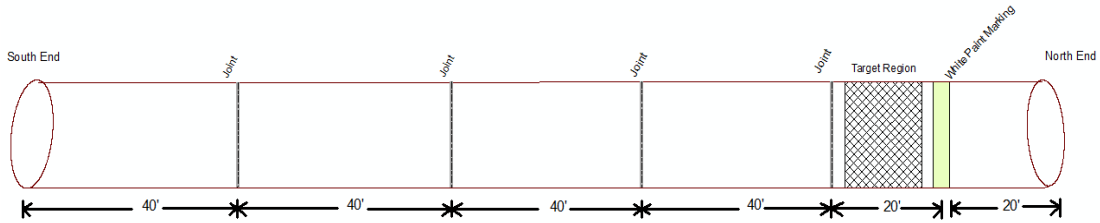
Figure 19 is a depiction of the target region relative to the whole pipe. Note the pipe sections are 40-foot in length and were seam-welded at the joint locations. The seams are noted on the figure. Figure 20 is a “zoomed-in” view of the target location region, the last 40-foot section to be pulled beneath the ground.

Figure 19. Target Region Relative to the Entire Length of Pipe.

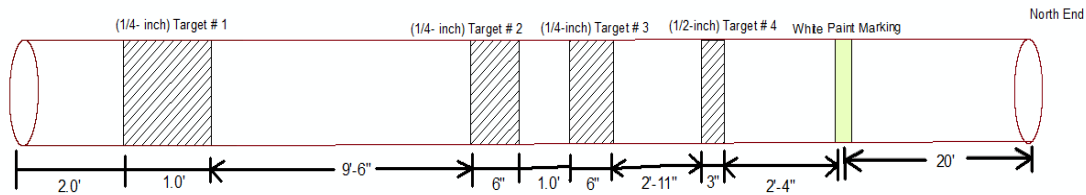
Figure 20. Target Region “zoomed-in.”

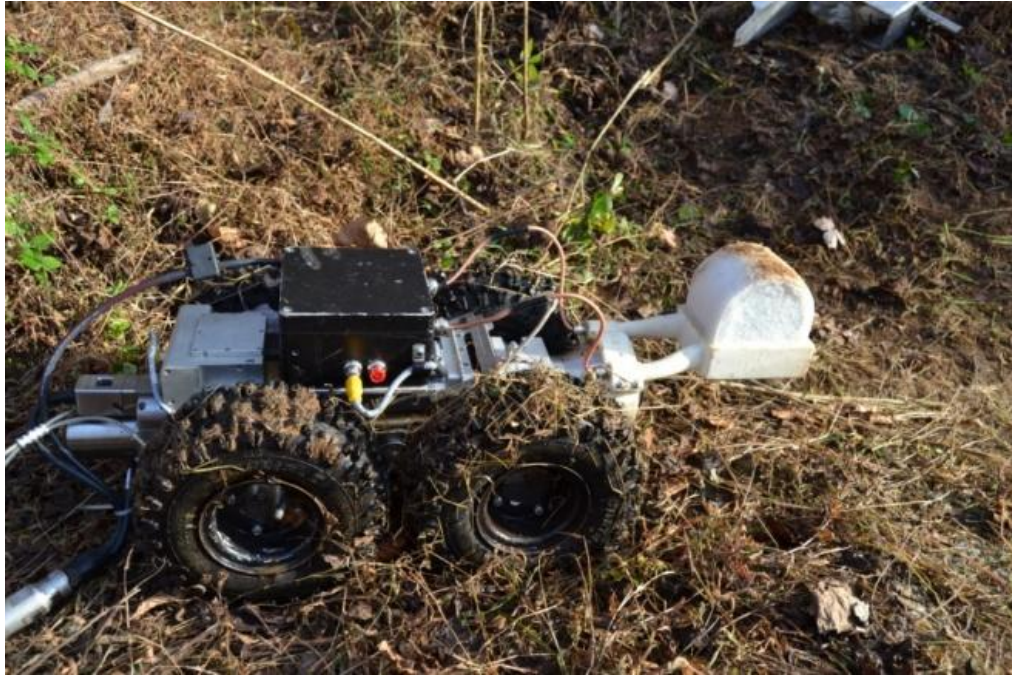
The target anomalies act as voids, for a change in dielectric constant indicates anomaly on the FutureScan radar screen. The target anomalies allow for three degrees of accuracy on account of FutureScan: spacing (location), target length, and target thickness. By establishing degrees of accuracy, FutureScan reliability can be determined.

Figure 21. FutureScan Robot (Photo by Frank Morris).

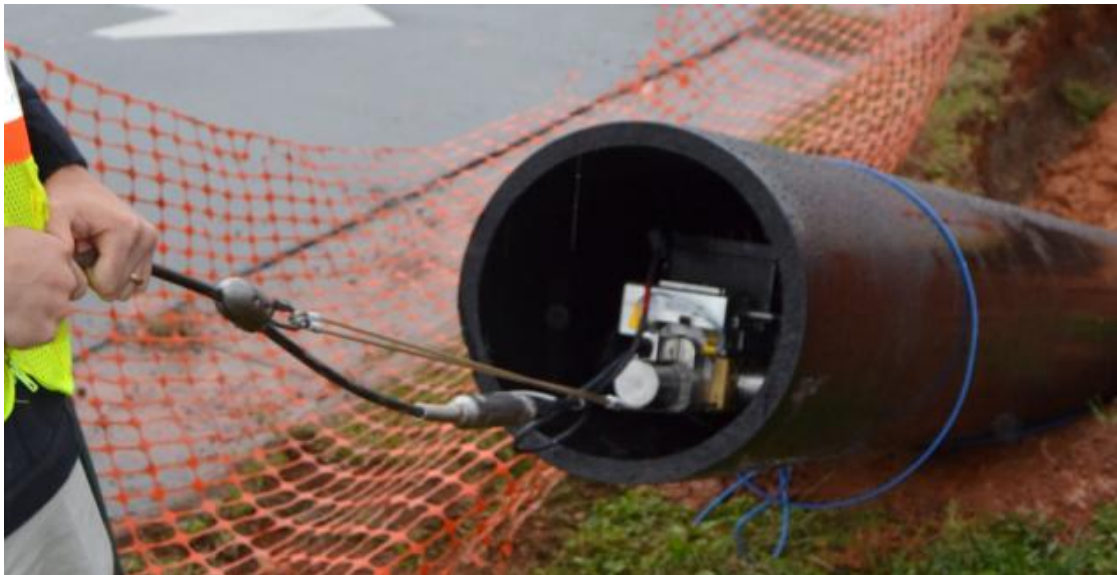
Two methods of non-destructive testing were used to find the pre-inserted voids at the site: Futurescan and GPR. Developed by Louisiana Tech University, FutureScan is now operated by an in-situ testing firm named CUES, Inc. FutureScan is a robot that can be sent directly inside the utility. Figure 21 shows a side-view of the FutureScan technology. Wheels are mechanically powered, and a coaxial cable attaches to the radar scanning device so that results are relayed through the coaxial cable during pipe entry. (See Figure 22.)

Figure 22. FutureScan Robot being inserted into Utility at Burnt Chimney Site (Photo by Lindsay Ivey Burden).

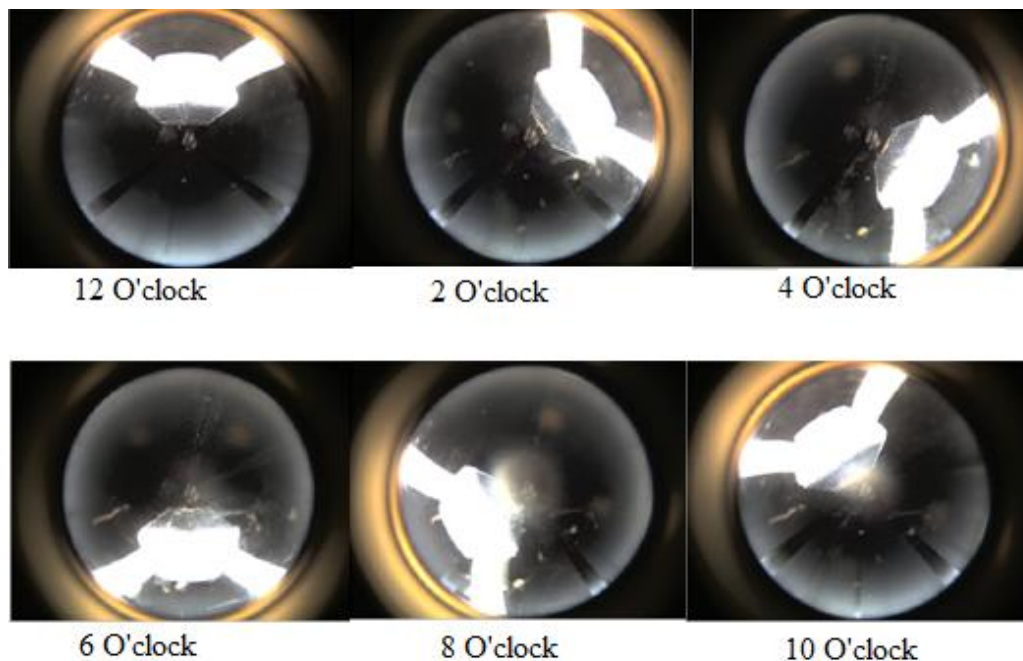
The technology can perform radar scans at 30-feet per minute along with camera frontal view. Coupled with a coaxial cable, FutureScan radar signals are transmitted simultaneously back to the source. Signal processing algorithms, setup by CUES, Inc., run in real-time as the robot advances further into the utility. The radar scanning antenna sits in front of the machine and receives reflections based on dielectric constant. Any change in dielectric constant will reflect a change on the radar gram; this would be considered an anomaly. The antenna can be shifted at various angles to complete a 360-degree rotation so that all of the utility can be inspected. Therefore, anomalies can be detected around the entire outer perimeter of the utility. Six equally spaced antenna shifts, also known as clock angles, allows for full antenna rotation: 12 O'clock, 2 O'clock, 4 O'clock, 6 O'clock, 8 O'clock, and 10 O'clock. Note that a new run must be performed for each new clock angle. Thus, six (6) runs were performed on site. Figure 23 displays the camera frontal view during advancement and the various clock angles.

Figure 23. Various Clock Angles of FutureScan, Viewed from FutureScan Camera (Yestrebsky & Winiewicz, 2013).

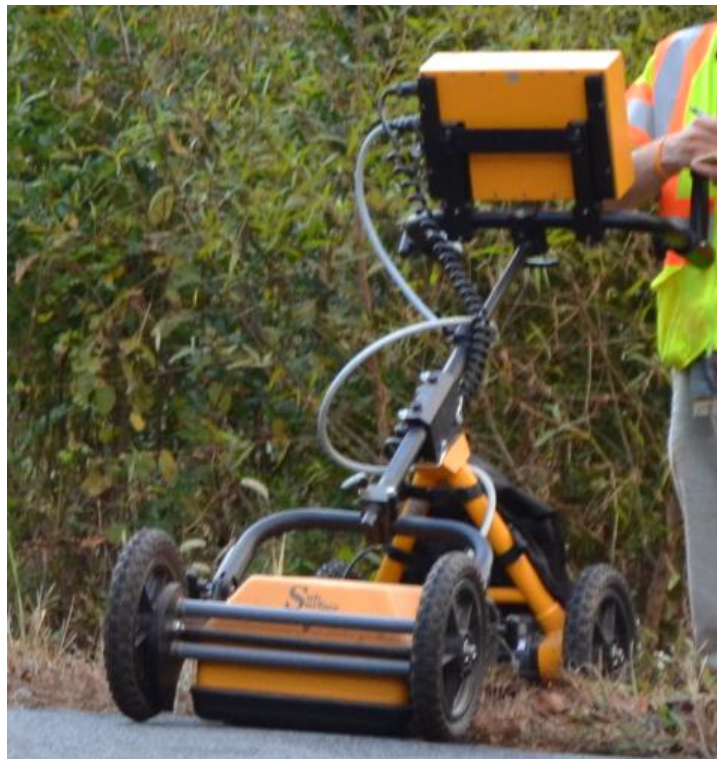
GPR is primarily used to locate subterranean utilities. Shallow anomalies can most likely be detected by this method. Figure 24 is a depiction of the GPR cart system used for the Burnt Chimney project.

Figure 24. GPR Cart System (Photo by Lindsay Ivey Burden).

Passes in the vicinity of the utilities on both sites are accomplished by simply pushing the cart system. Made at the asphalt surface, parallel and perpendicular passes are utilized at the VA-635 sites, where only parallel passes are made at the Burnt Chimney site due to safety constraints.

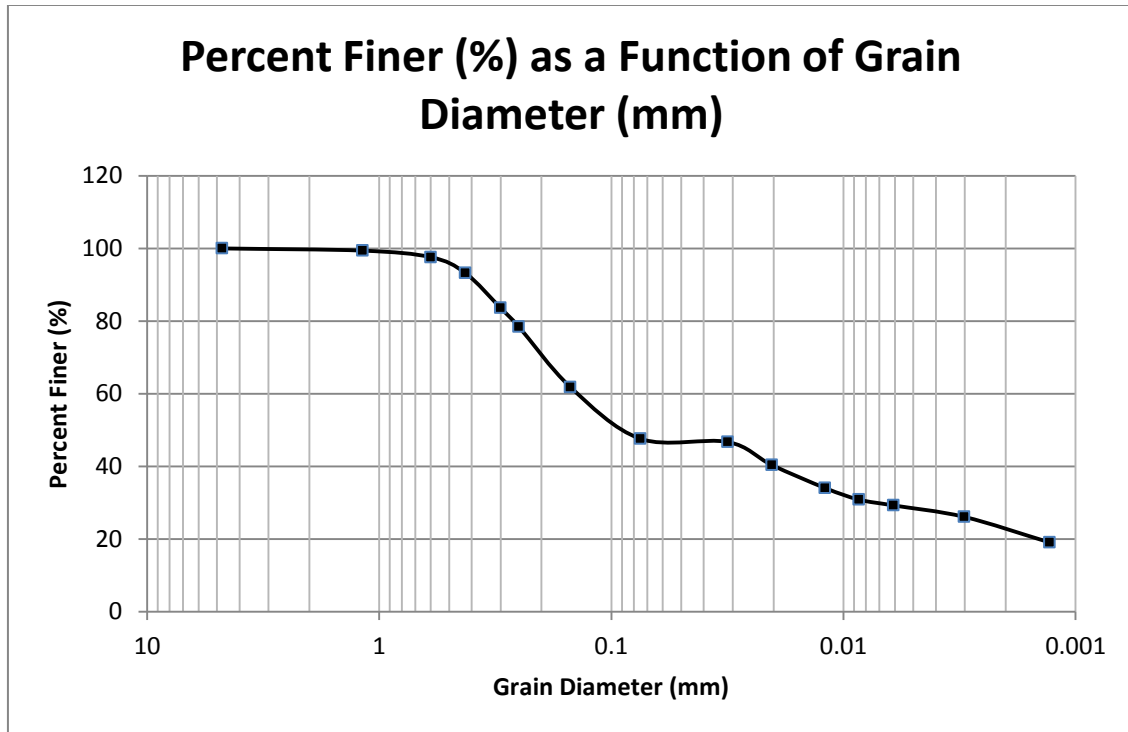
In combining the results from the sieve analysis and Hydrometer, Figure 25 is obtained. A full representation of the present grain sizes is displayed.

Figure 25. Grain-Size Distribution for Average Soil Condition.

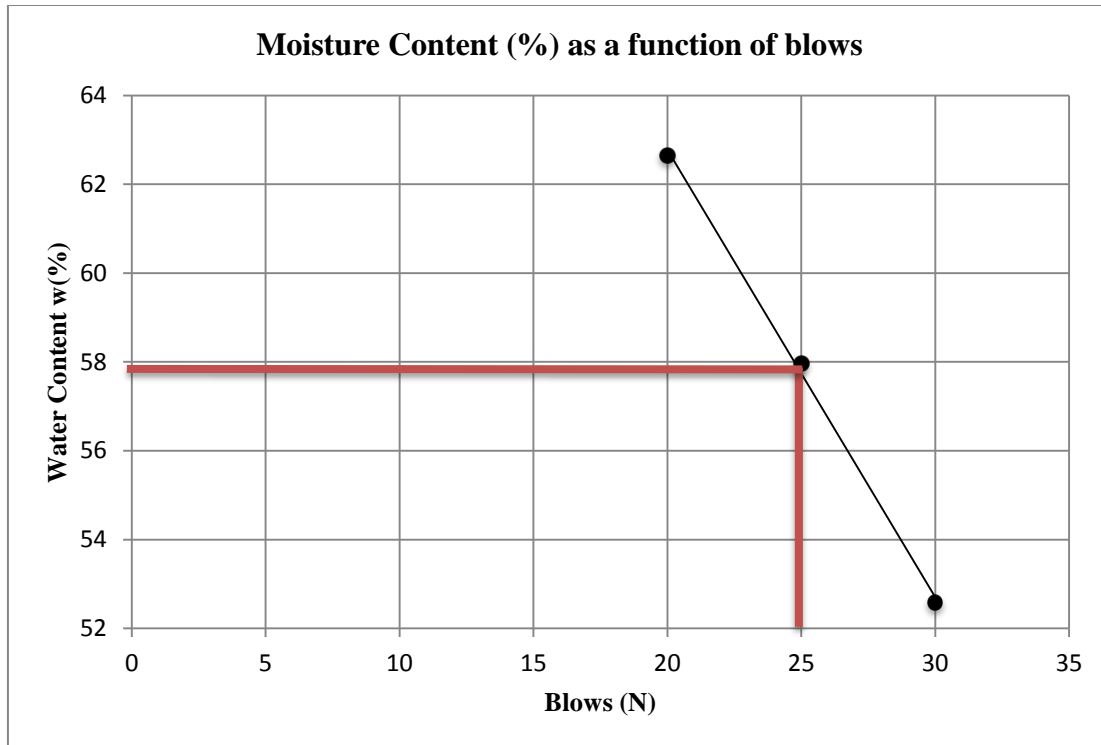
Figure 26. Atterberg Results plot.

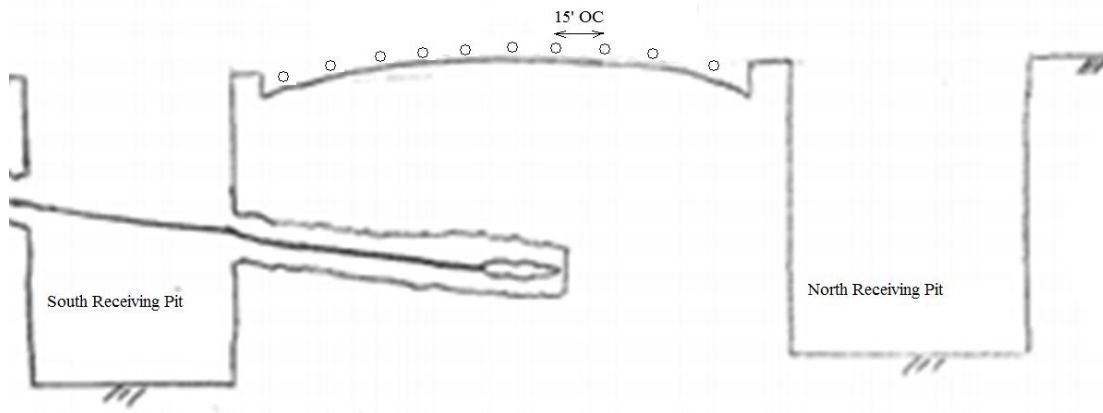
Ten (10) relative elevations were logged across the entire roadway on approximate 15-foot centers. Figure 27 is a generalized depiction of the roadway and drill path during logging relative elevations.

Figure 27. Cross-section of Roadway and Elevation Points.

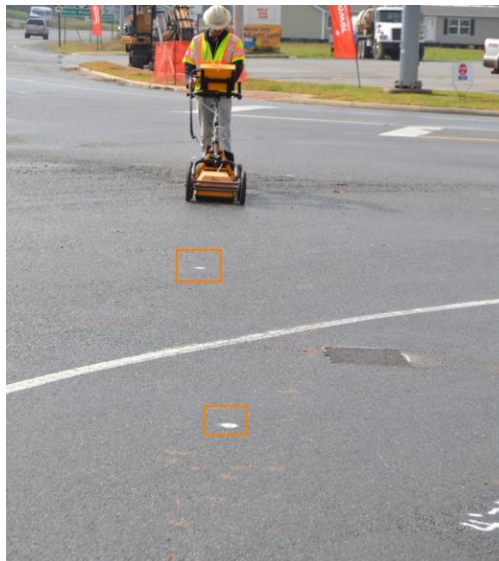
Relative elevations are measured from Benchmark 1. Benchmark 1 is the top anchor bolt for a stop light pole on the south side of the intersection. The physical location of the elevations was marked on the asphalt in white spray paint so that the elevation recordings may be repeated. Figure 28 highlights road elevation points 2 and 3, facing in the northern direction.

Figure 28. Road Elevation Points 2 and 3 (Photo by Lindsay Ivey Burden).

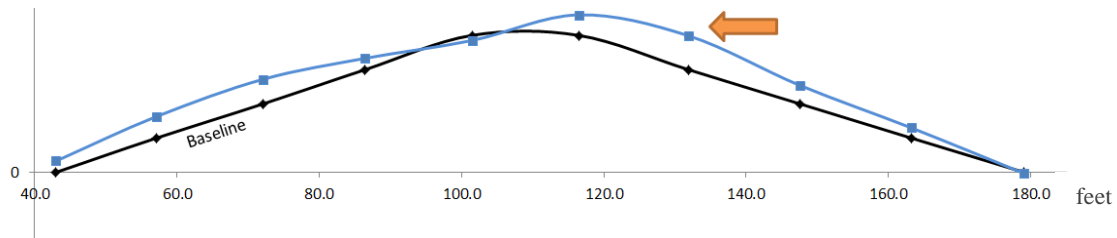
A heaving trend was noticed during reaming. Two (2) sets of elevation data were recorded during reaming stages of the project. The average of the two sets of data is depicted below. Figure 29 is a cross-sectional view of the roadway during reaming, based on an exaggerated scale. The critical point, which appears approximately 150-feet from the north end of the pipe, experiences 1-inch of upheave. Heaves, ranging from 0.33-inches to 1.0-inch, are realized in Figure 29.

Figure 29. Roadway Movement during reaming.

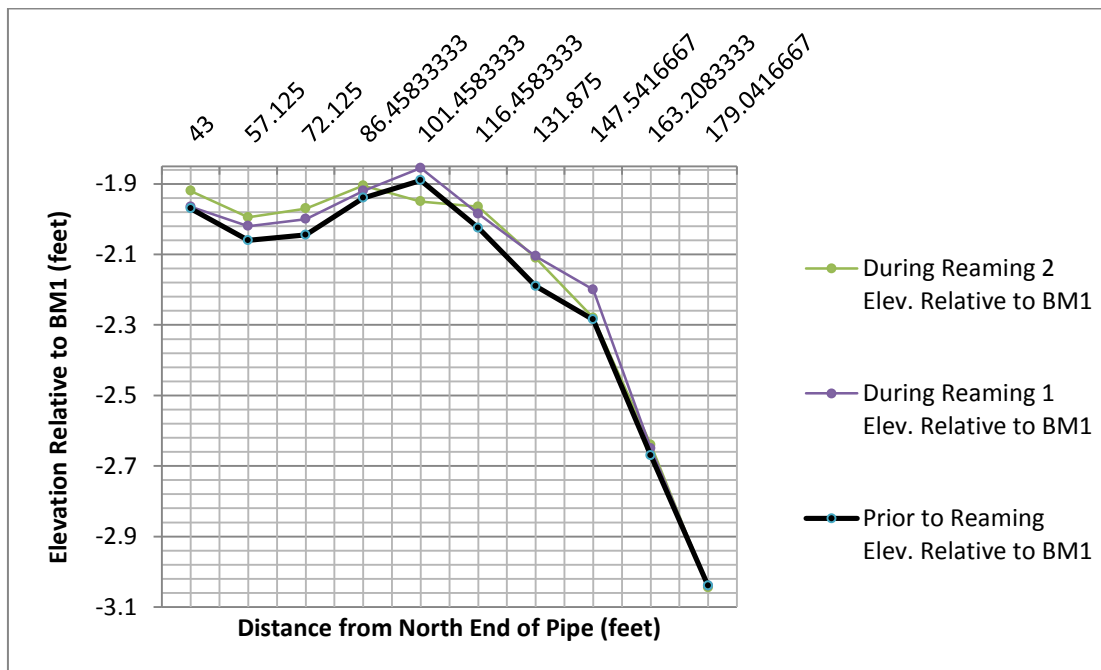
The next figure displays the two actual sets of data recorded during reaming operations, relative to Benchmark 1. The baseline is also plotted on the same scale. One point in the crown of the road during the second round of reaming data seems to be especially low at 101.45-feet south of the north outlet of the pipe. The low point could be caused by surveying error. The basal upheave shown in Figure 30 is likely caused by drilling fluid pressures and the force of the reaming bit or by hydrofracture.

Figure 30. Relative Elevations during both reaming schemes.

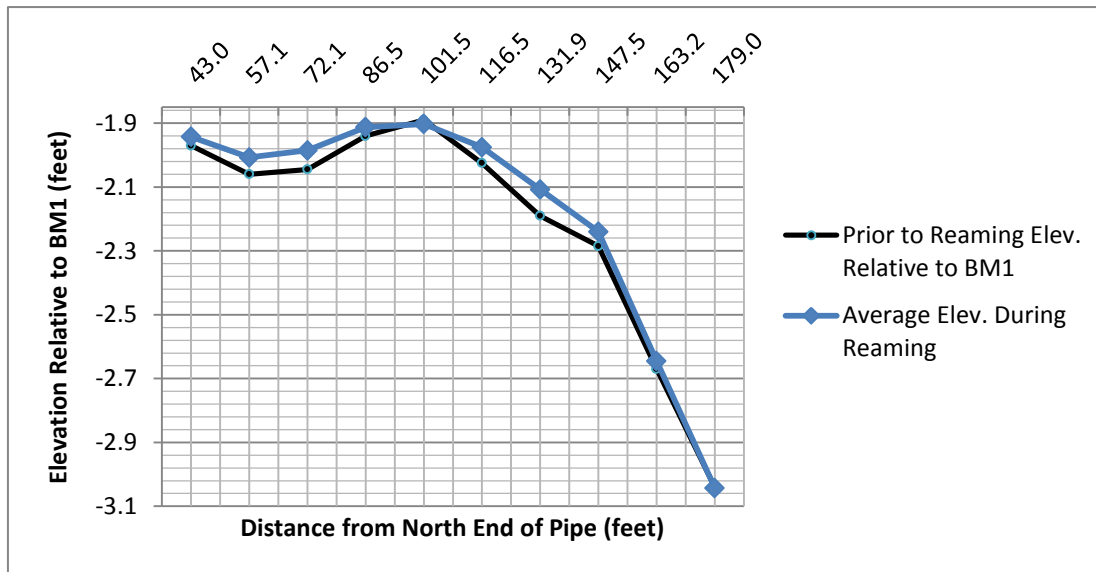
Figure 31 displays the average of the two sets of reaming data versus the elevation data taken prior to drilling. Surveying error is minimized by averaging the sets of relative elevations. Notice that there still is a general upheave trend.

Figure 31. Average Reaming Schemes.

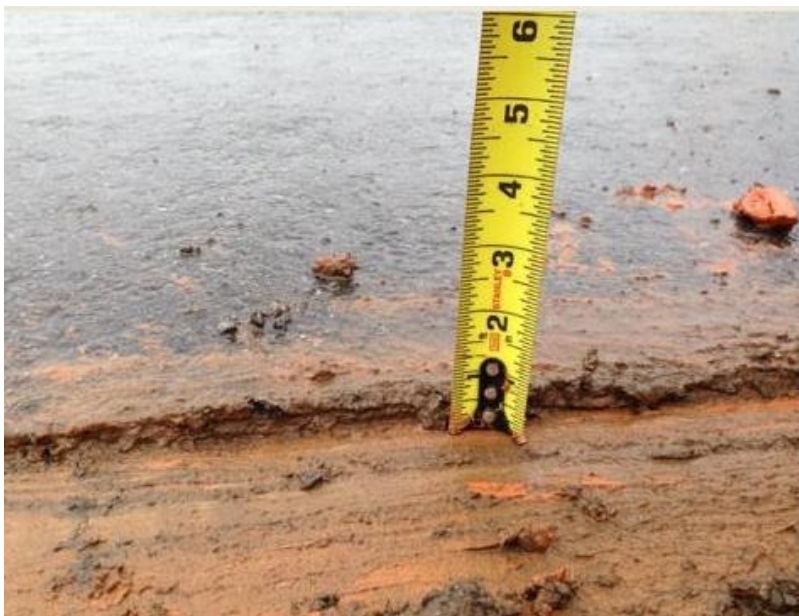
The drilling fluid pressures may have caused hydrofracture to occur within the soil above the pipe. Throughout reaming, heaving of the asphalt relative to the concrete gutter was noted. In Figure 32, approximately 3/4-inch of heave was noted between the south curb and concrete gutter.

Figure 32. Heaving of Asphalt relative to Curb and Gutter (Photo by Lindsay Ivey Burden).

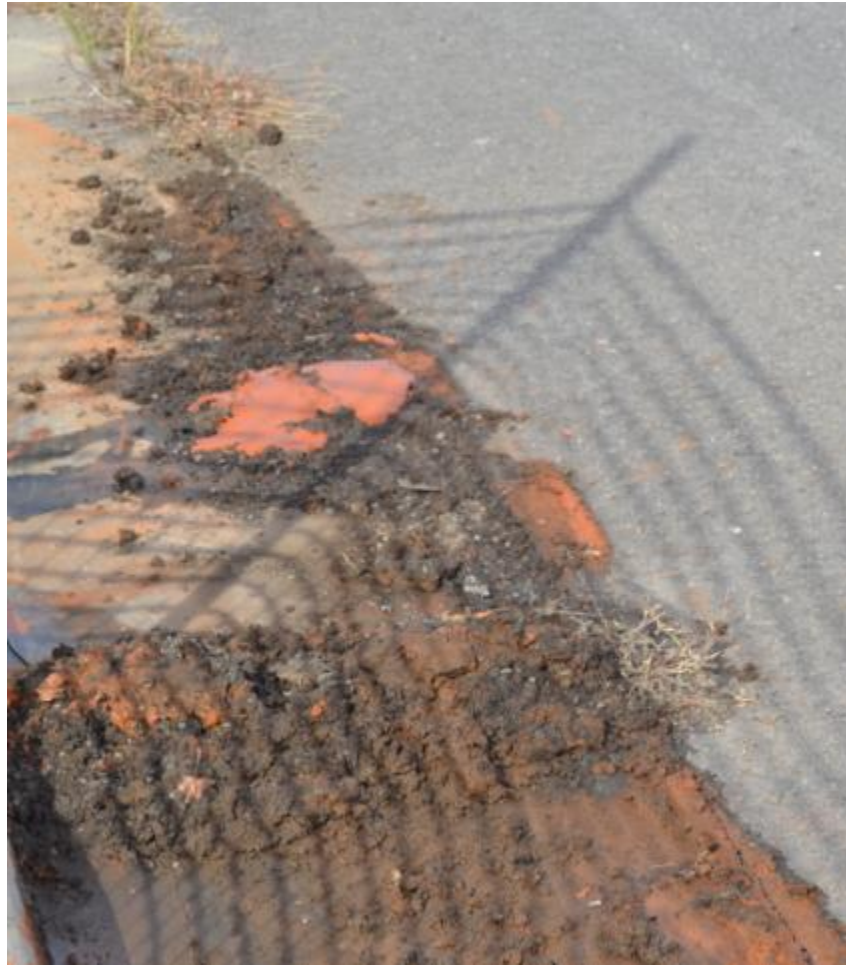
While pushing the auger to the north end (During Reaming 2), drilling fluid started to come out of the edge of the asphalt on the south end (Figure 33). Moisture migrating from cracks or discontinuities in roadways is characteristic of hydrofracture. During hydrofracture, drilling fluid pressures exceed natural soil pressure of outer borehole walls, and cracks in the vertical direction begin forming. Fluid migrates through these cracks toward the ground surface. Drilling fluid comes to the surface to relieve hydrostatic pressures as shown in Figure 33.

Figure 33. Drilling Fluid migrating to the roadway surface (Photo by Frank Morris).

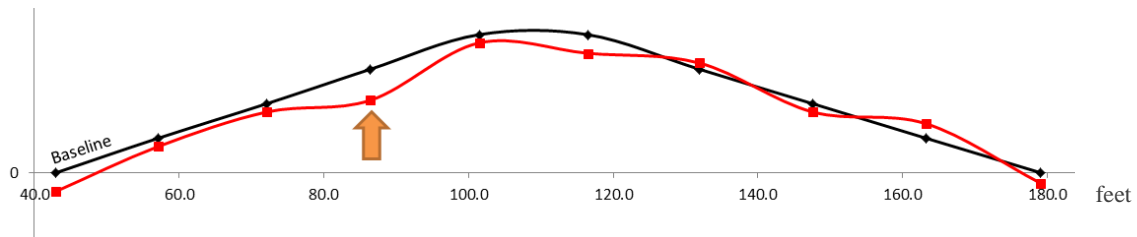
0.90-inches of settlement. Settlements, ranging from 0.24-inches to 0.90-inches, are realized in Figure 34.

Figure 34. Roadway Movement after pipe insertion.
