Methods for Post-Construction Evaluation of Horizontal Directional Drilled Utilities

A Thesis

Presented to
the faculty of the School of Engineering and Applied Science
University of Virginia

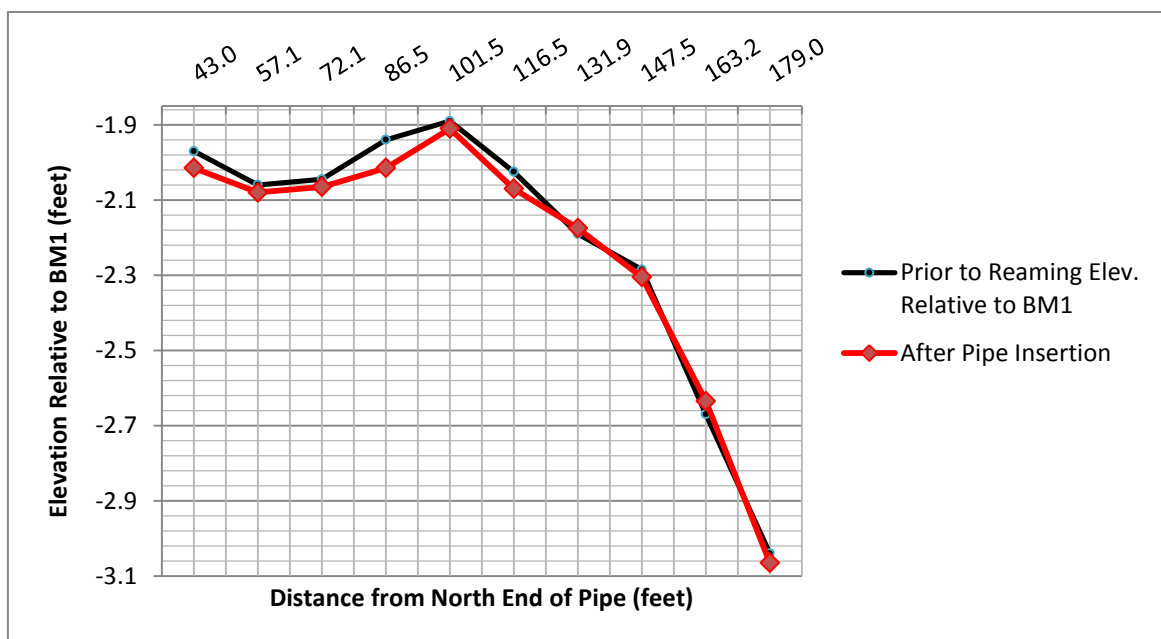
The actual elevation data is plotted in Figure 35, relative to Benchmark 1. A general settling trend is noticed in Figure 35. By this time, the borehole has had time to recede, and a slight amount of settlement occurred in the meantime. Potential weaknesses caused by hydrofracture and increased water content had likely caused the hole to recede. Note that October 31, 2013 was also the date in which FutureScan results were obtained.

Figure 35. Elevations recorded the day after drilling operations.

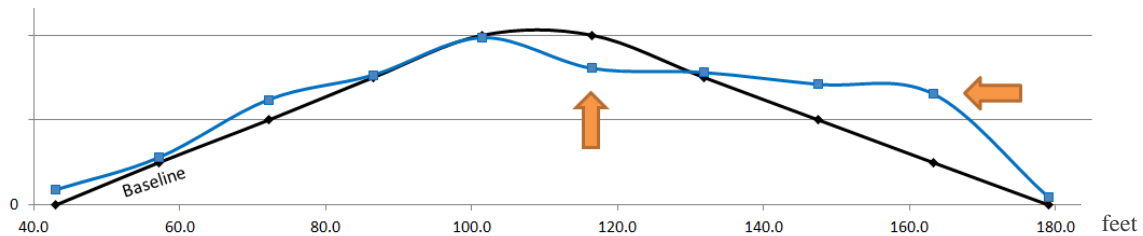
0.78-inches. The range of upheaves on the ends of the pipe is between 0.06-inches and 1.62-inches.

Figure 36. Roadway Movement four months after project completion.

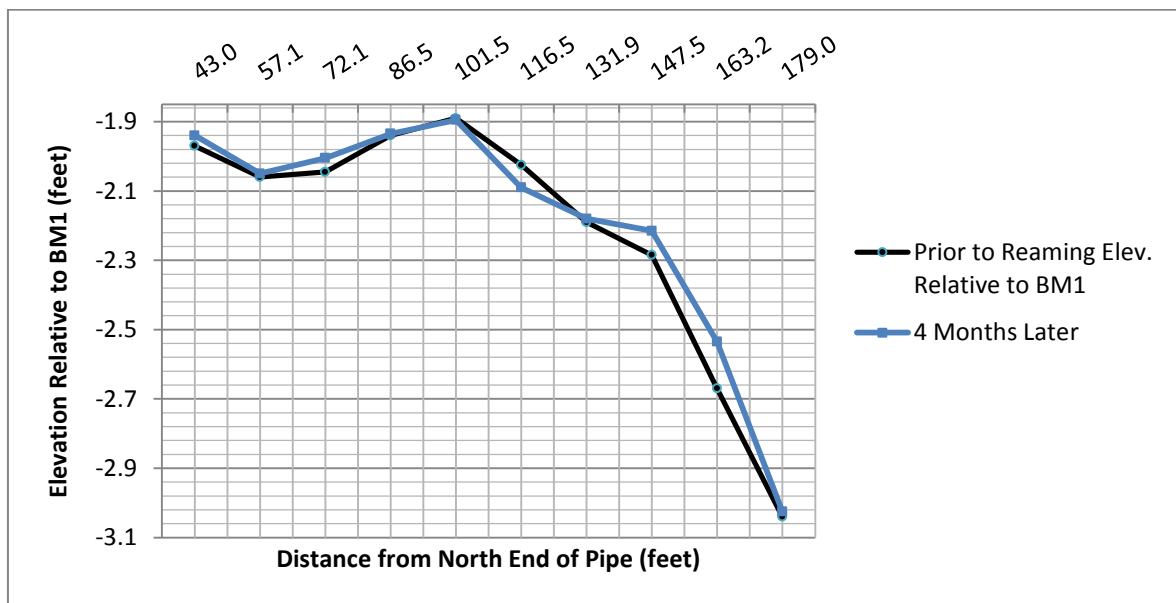
Figure 37. Elevations recorded 4-months after project completion.

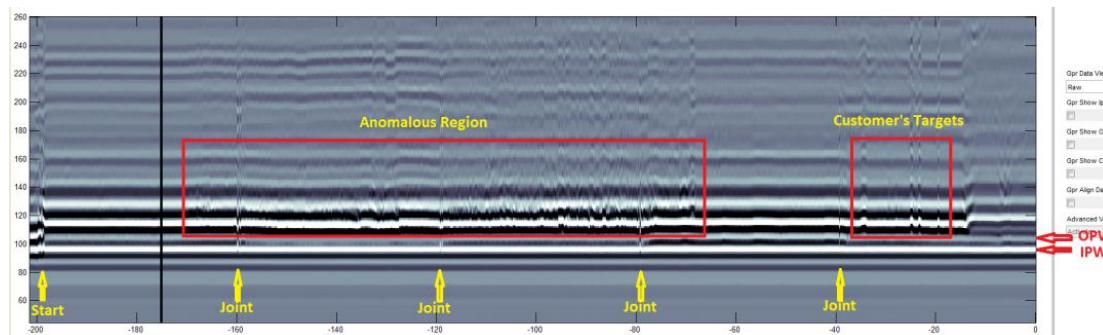
Figure 38. FutureScan Radar Gram at 12 O'clock position (Yestrebky & Winiewicz, 2013).

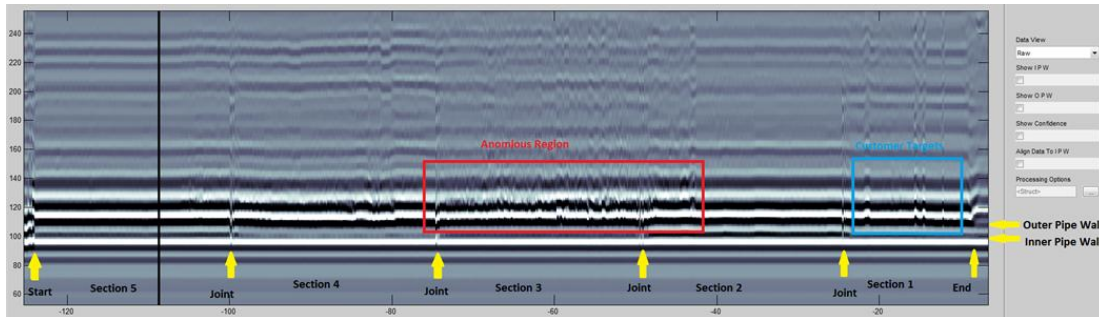
Figure 39. FutureScan Radar Gram at 2 O'clock position (Yestrebky & Winiewicz, 2013).

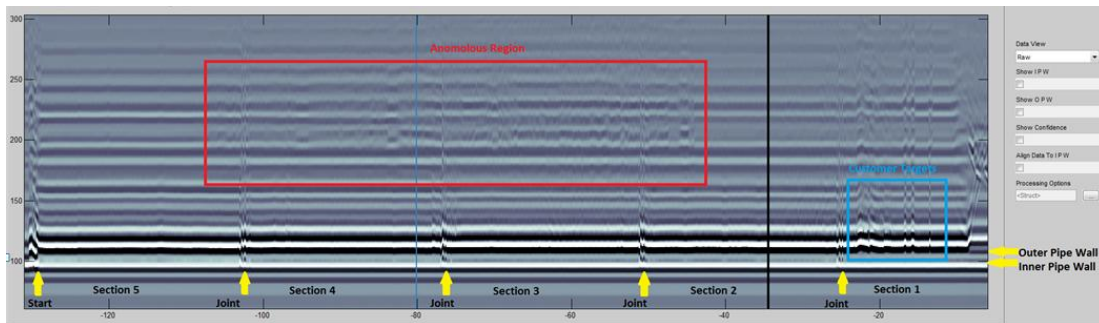
Figure 40. FutureScan Radar Gram at 8 O'clock position (Yestrebky & Winiewicz, 2013).

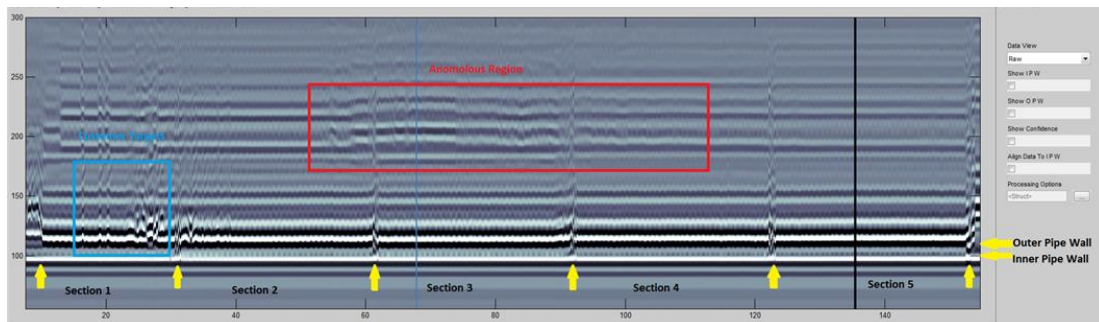
Figure 41. FutureScan Radar Gram at 6 O'clock position (Yestrebky & Winiewicz, 2013).

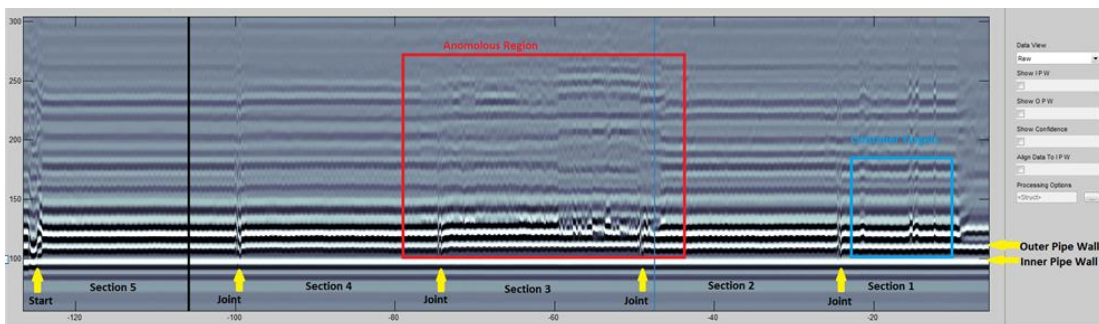
Figure 42. FutureScan Radar Gram at 10 O'clock position (Yestrebky & Winiewicz, 2013).

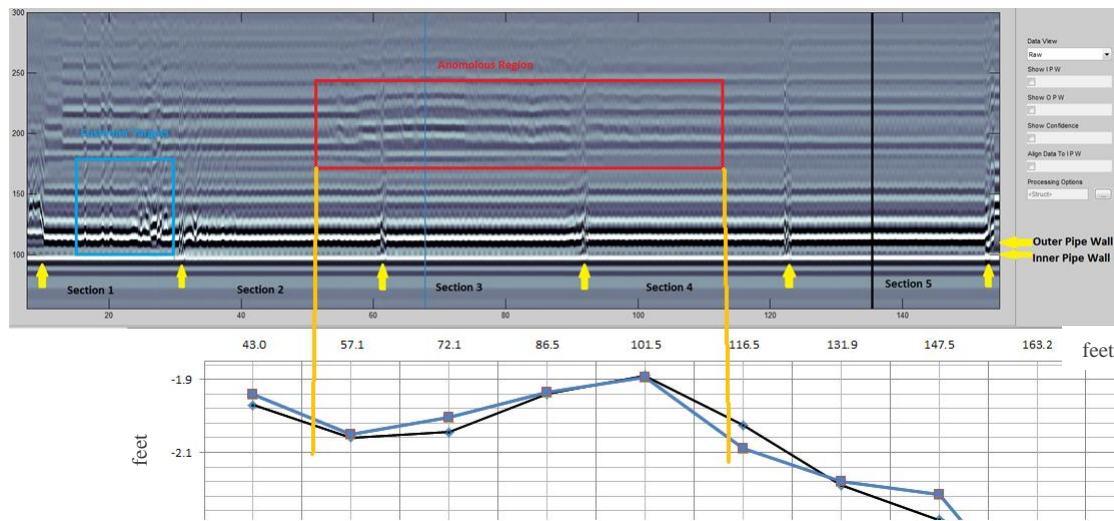
Figure 43. Elevation data relative to anomalous region (4-months after project completion).

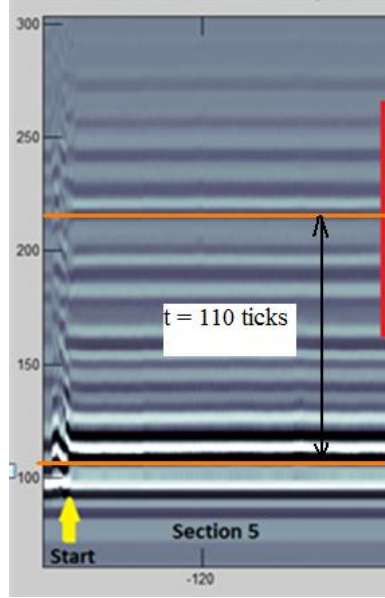
Figure 44. The number of ticks from OPW to the bottom of Anomalous Region.

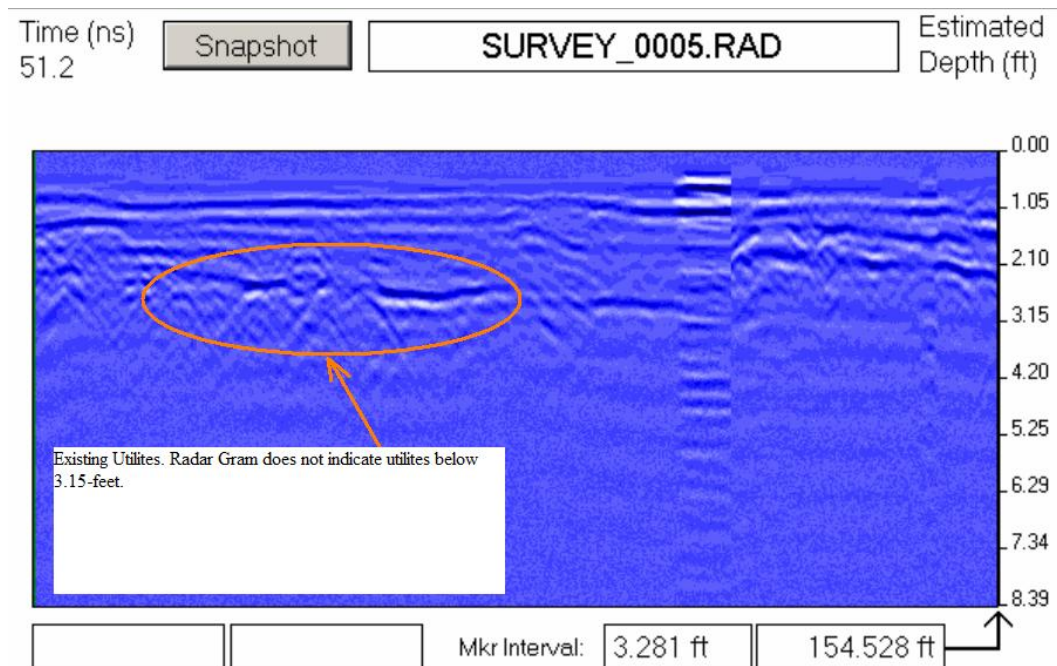
Figure 45. GPR radar gram.

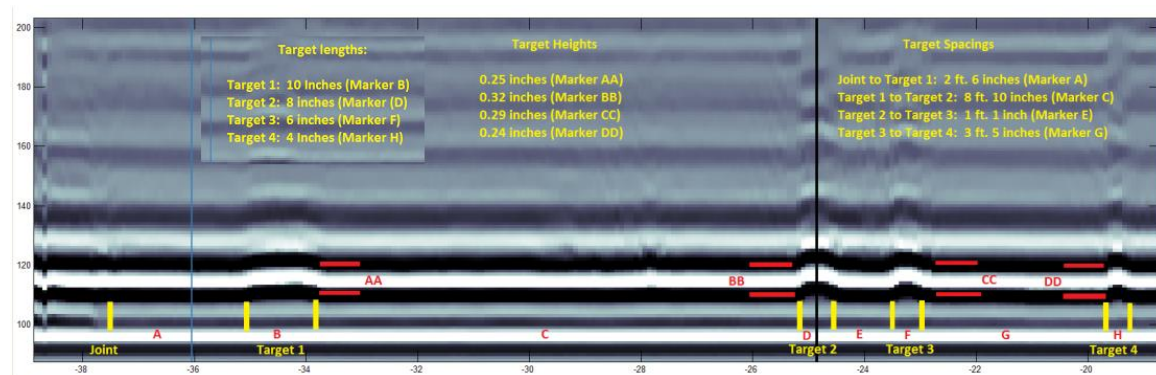
Figure 46. FutureScan radar gram “zoom-in” on Target Region (Yestrebsky & Winiewicz, 2013).

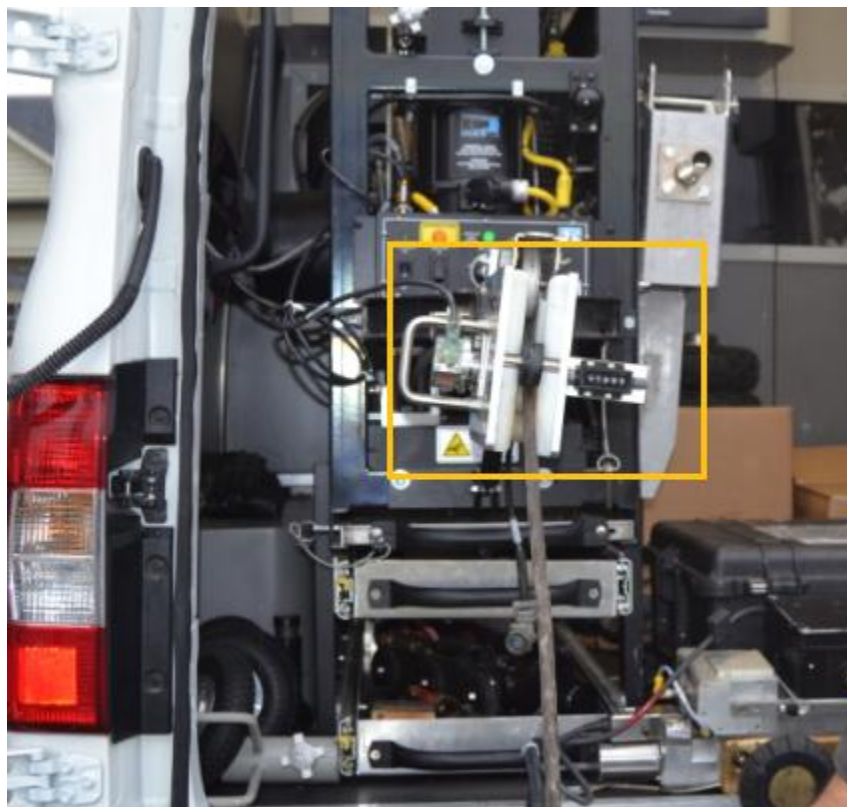
Figure 47. The Manual Counter with Cable Feed (Photo by Frank Morris).

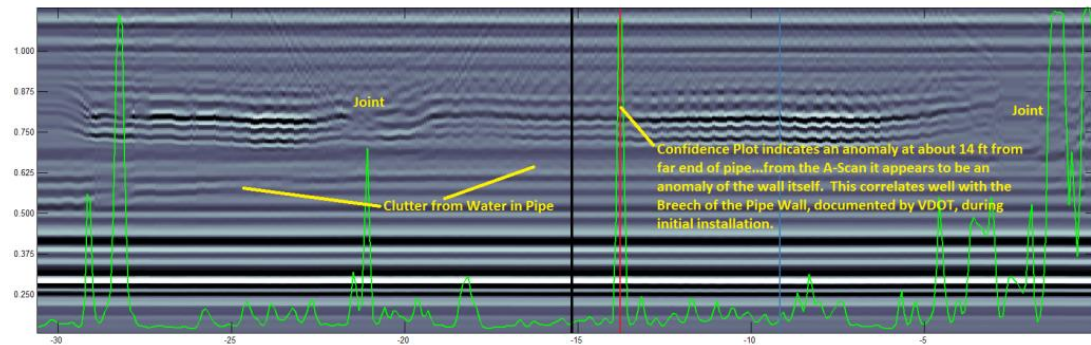
Figure 53. FutureScan Radar Gram at 12 O'clock position for VA-635 48-inch PP pipe (Yestrebky & Winiewicz, 2014).

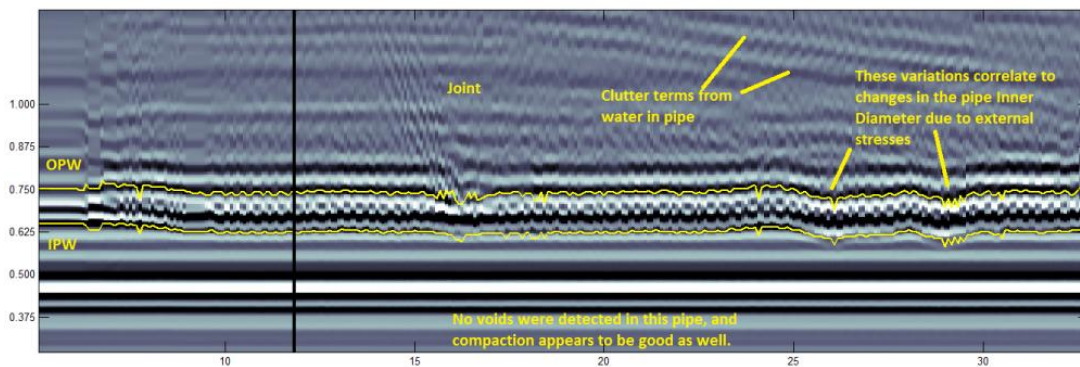
Figure 54. FutureScan Radar Gram at 12 O'clock position for VA-635 30-inch PP pipe (Yestrebky & Winiewicz, 2014).

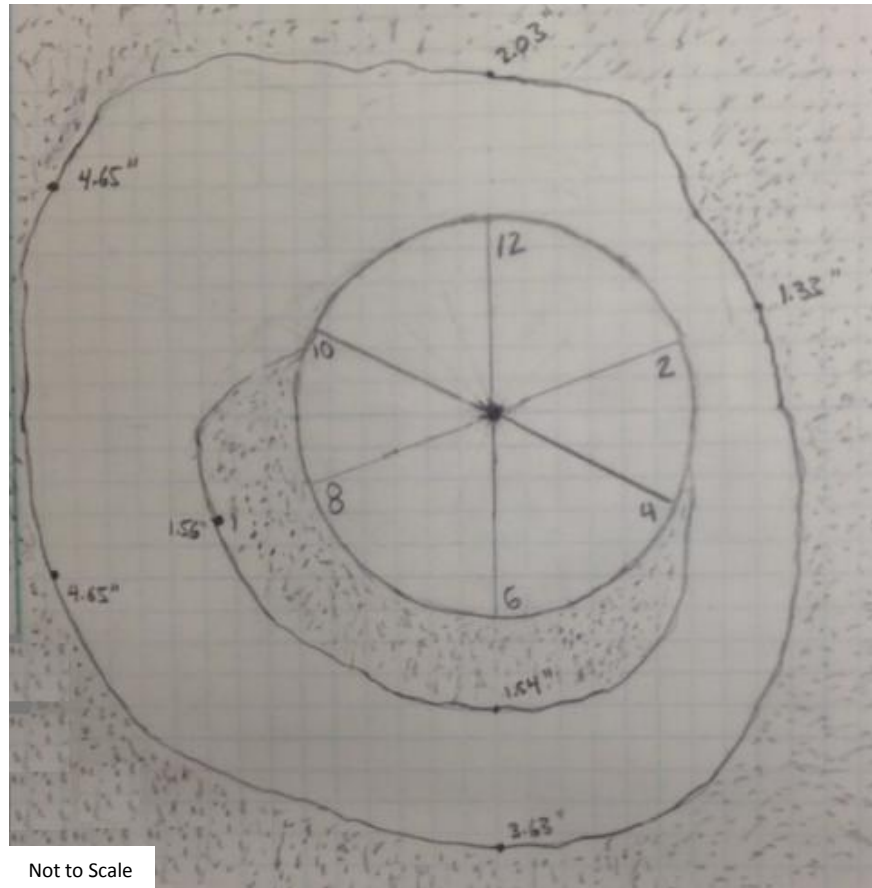
Figure 55. Anomaly detected by FutureScan near the middle of the piping system.
