DESIGN AND CONSTRUCTION OF A SUSPENDED FOOTBRIDGE FOR THE COMMUNITY OF COILOLO, BOLIVIA

Capstone Design and Construction Report

Coilolo River Pedestrian Bridge

Capstone Report
Coilolo, Bolivia 2023
University of Virginia

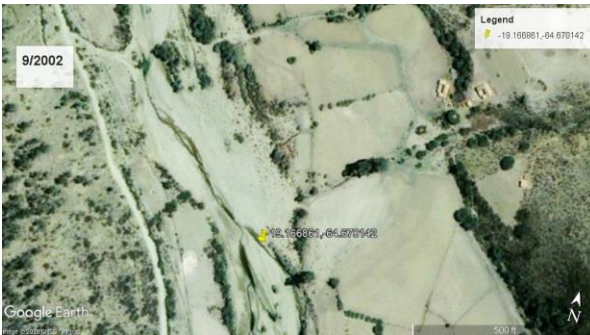
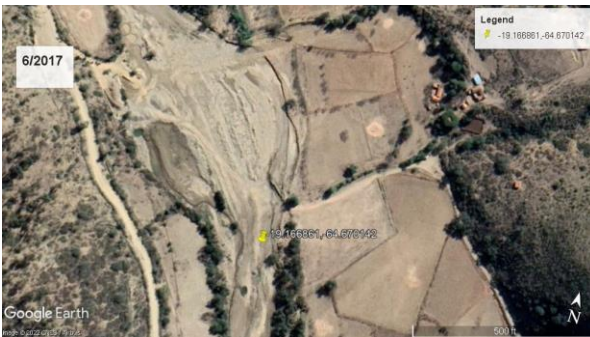
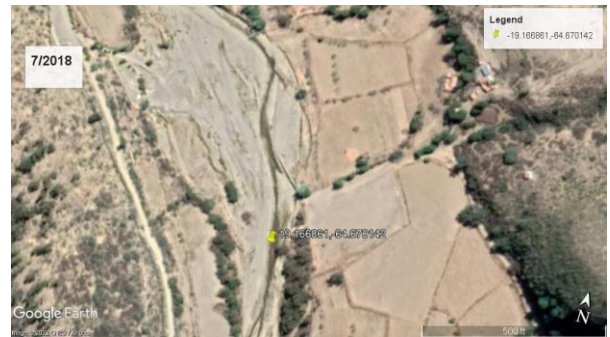
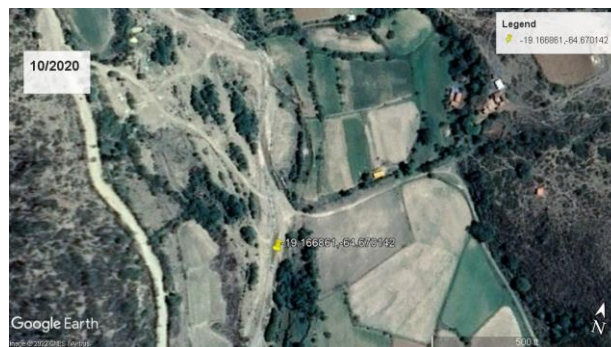
Changes over time in the Coilolo River can be viewed from the Google Earth images in Figures 3.5.6-10 below from September, 2002, to October, 2020. The most notable change involves the location and abundance of vegetation. From Figure 3.5.6 to Figure 3.5.7, the vegetation decreases,

particularly towards the northwest region of the channel. This decrease in vegetation is due to particularly intense flooding during this time period. The vegetation stays relatively stagnant between Figures 3.5.7, 3.5.8, and 3.5.9 before increasing in quantity in Figure 3.5.10.
