Engineers in Action: Coilolo River Pedestrian Bridge

A Technical Report submitted to the Department of Civil and Environmental Engineering

Coilolo River Pedestrian Bridge

Capstone Report
Coilolo, Bolivia 2023
University of Virginia

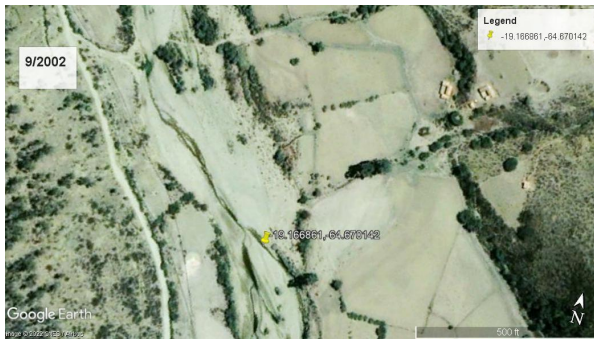
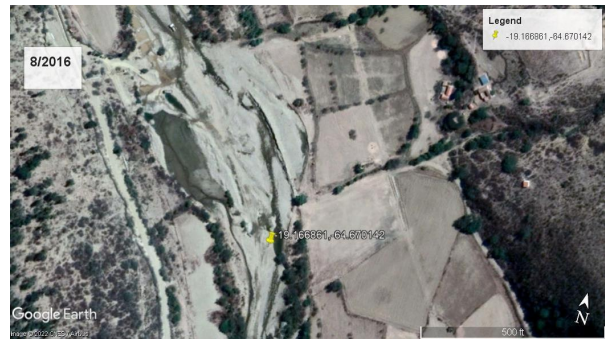
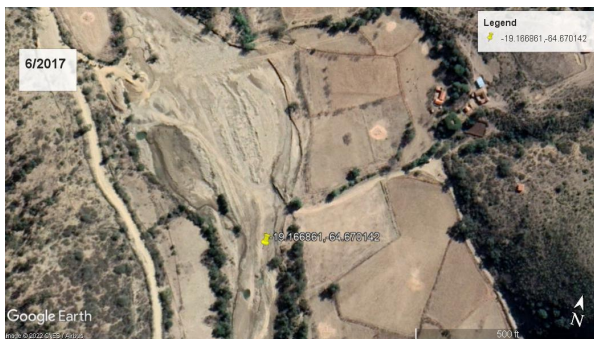
Changes over time in the Coilolo River can be viewed from the Google Earth images in Figures 3.5.6-10 below from September, 2002, to October, 2020. The most notable change involves the location and abundance of vegetation. From Figure 3.5.6 to Figure 3.5.7, the vegetation decreases, particularly towards the northwest region of the channel. This decrease in vegetation is due to particularly intense flooding during this time period. The vegetation stays relatively stagnant between Figures 3.5.7, 3.5.8, and 3.5.9 before increasing in quantity in Figure 3.5.10.
