## **A look into Bridges to Prosperity**

# Guayabitos Suspended Bridge

## Concept Definition Report

**Guayabitos Suspended Bridge**  
Concept Definition Report  
Guayabitos, Bolivia 2020  
Engineers in Action UVA Capstone Group

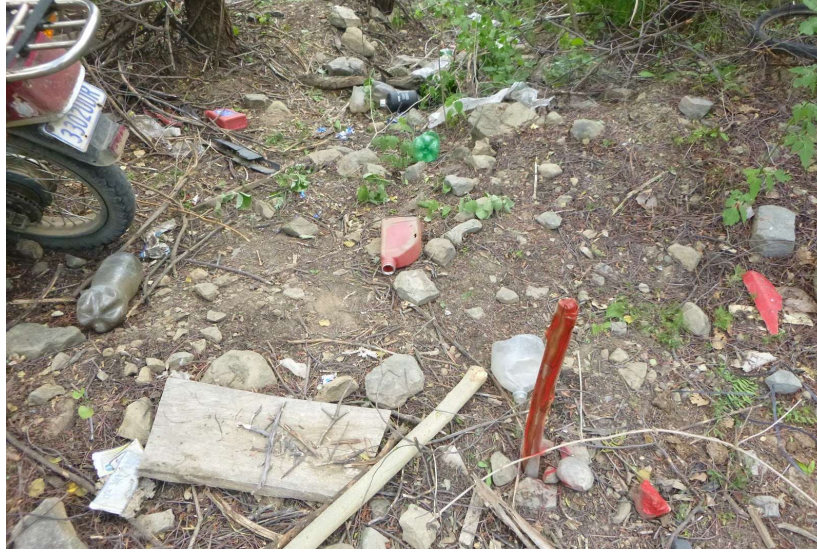
Figure 2: Left Side Soil Closeup

Given the information in the technical report provided to us (See Appendix 5.5), the left side's soil is characterized as sandy soil with small rocks, while the right side is classified as silty soil experiencing erosion. Figure 2 and 3 show both of these soils.

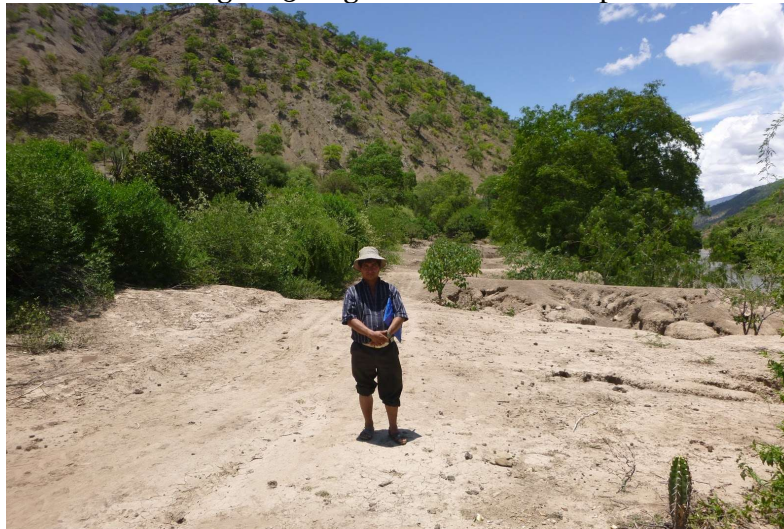
Figure 3: Right Side Soil Closeup

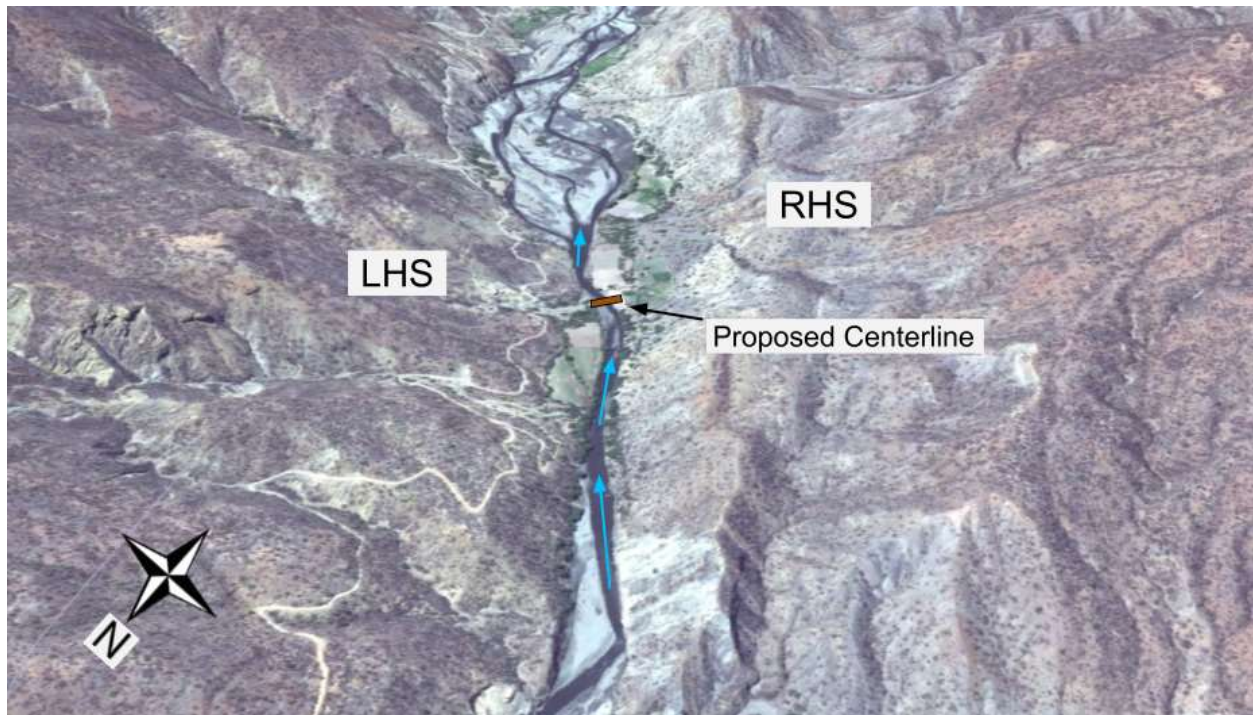
Figure 2: 3D view of the Pojo River, looking downstream.

The river's flowline can be seen broadly from Figure 2, with the centerline outlined in brown and the flow direction of the river indicated with blue arrows. The site is located at a curve in the river, after which the river temporarily splits into several smaller tributaries.

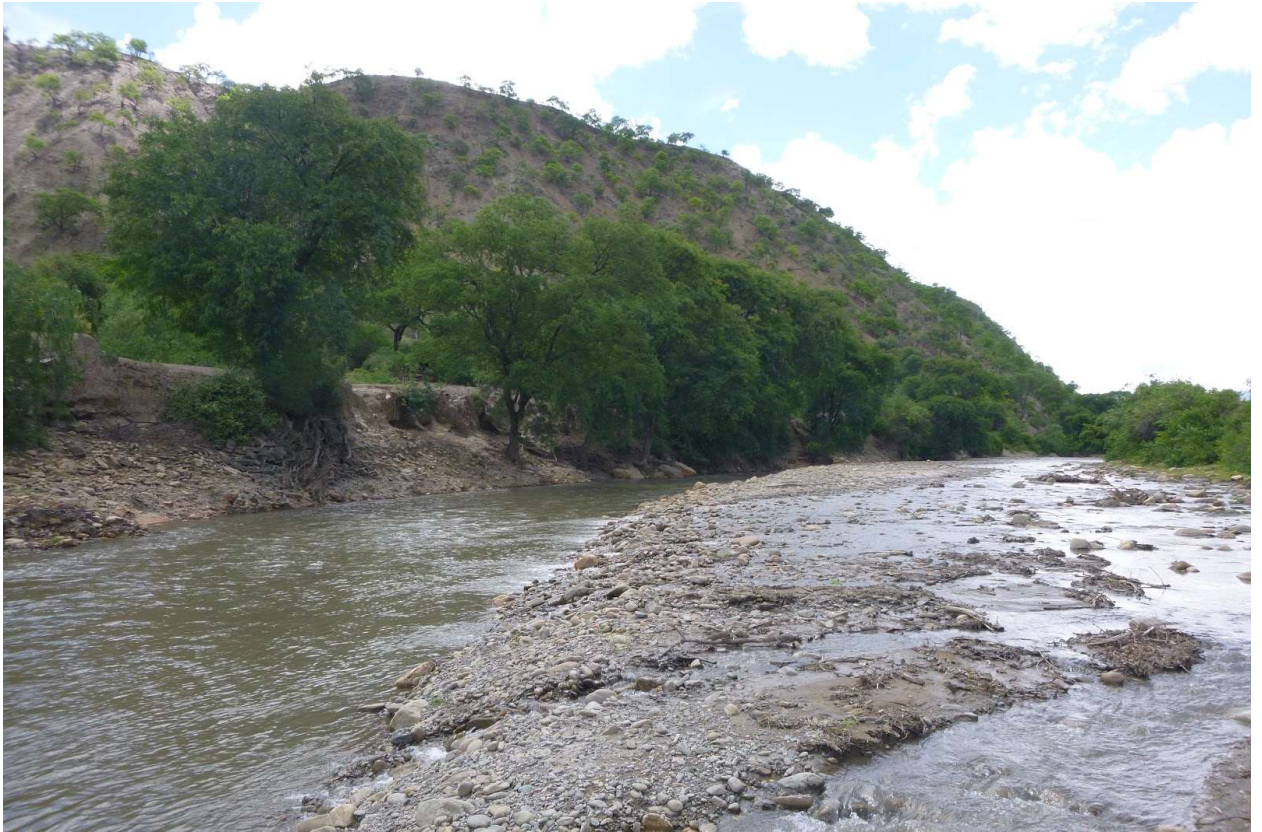
Figure 4: View of trees on eroding right bank, upstream

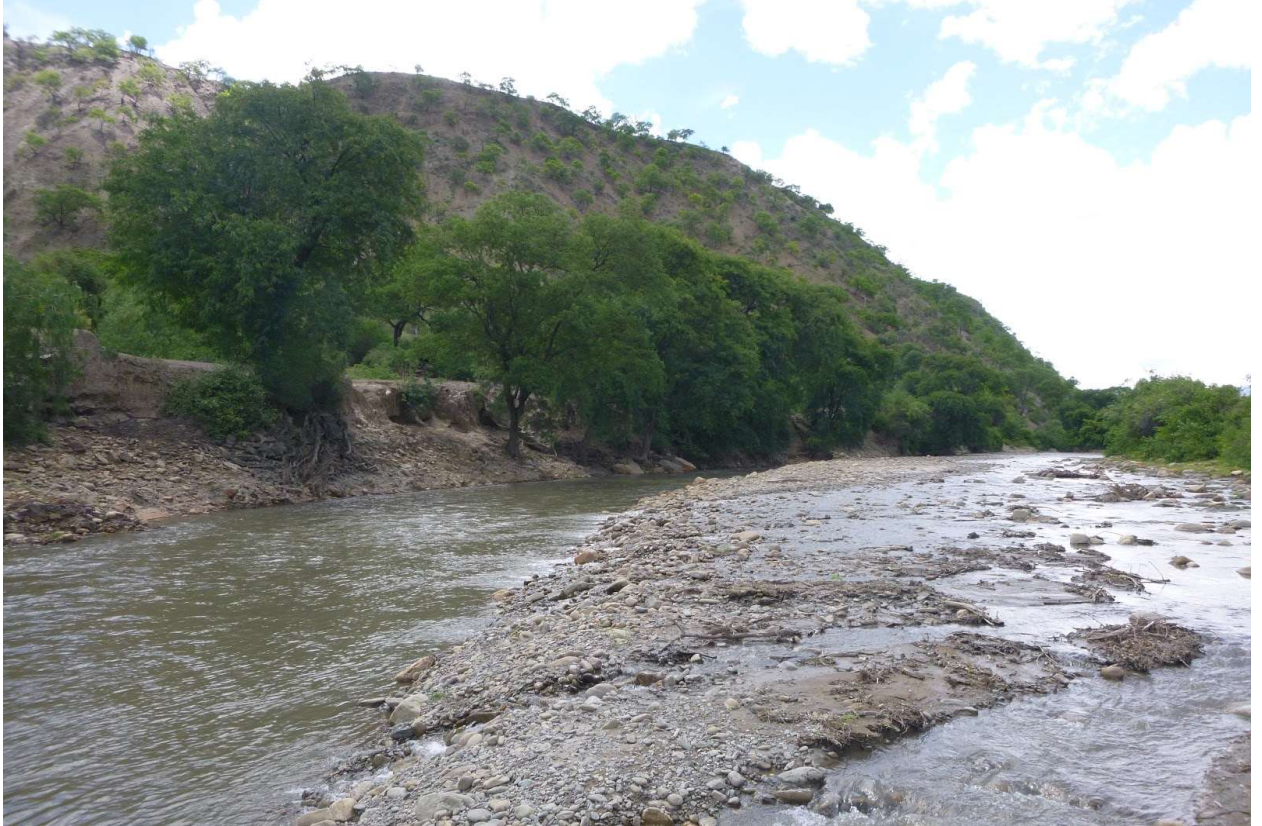
Figure 5: Closeup of exposed root systems in upstream trees

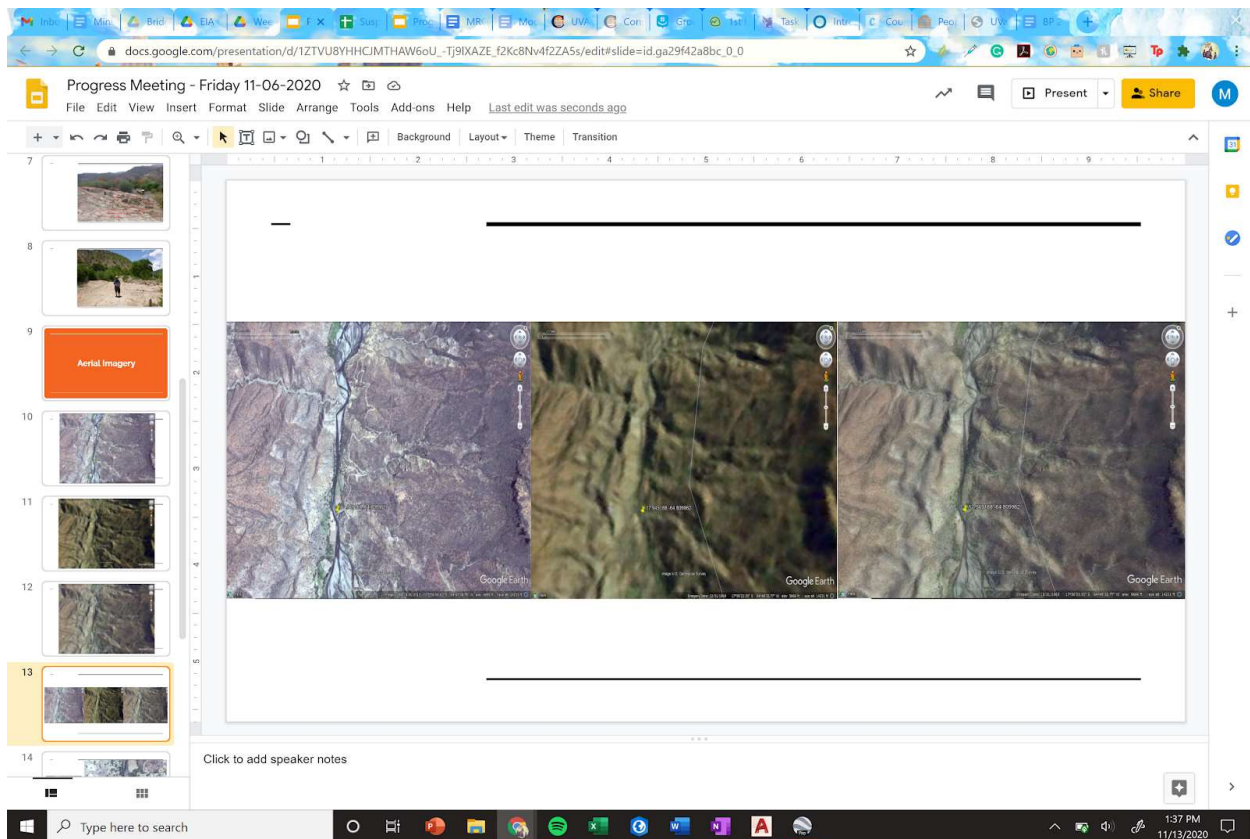
Figure 4: Aerial Imagery from 2013 & 1970 respectively, overlaid in third shot.

Historically, the river does not appear to have shifted significantly over the last 40 years - Figure 4 shows an overlay of the two available aerial images available from Google Earth Pro to characterize the site, and while the 1970 imagery's quality is lacking, it can still be seen that the river's path is fairly stable. In the winter months, it can be expected that water level will be higher, because of the rainy season.
