Using 3D Terrace Modeling to Preserve the Incan Site of Saqsaywaman

A Thesis

**In Partial Fulfillment
of the requirement for the Degree
Masters of Science (Civil Engineering)**

**By
Teresa Marie Jarriel
May 2016**

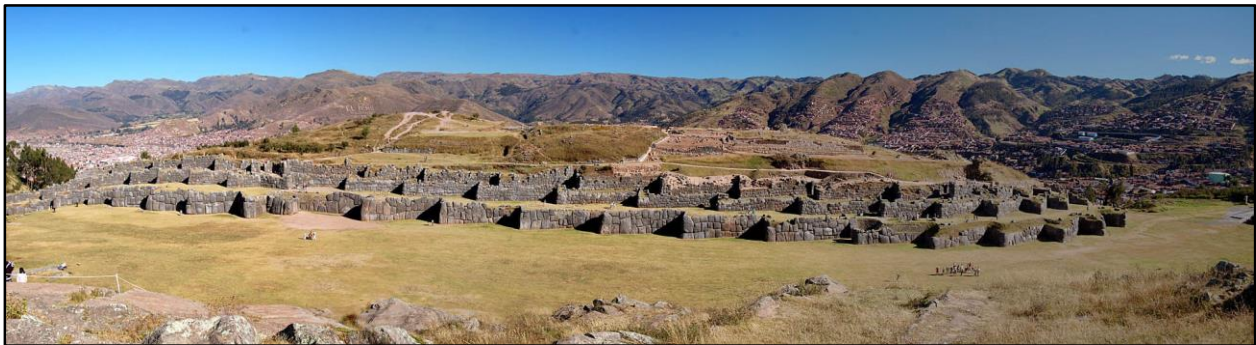
Figure 1: Three Great Walls of Saqsaywaman [15]

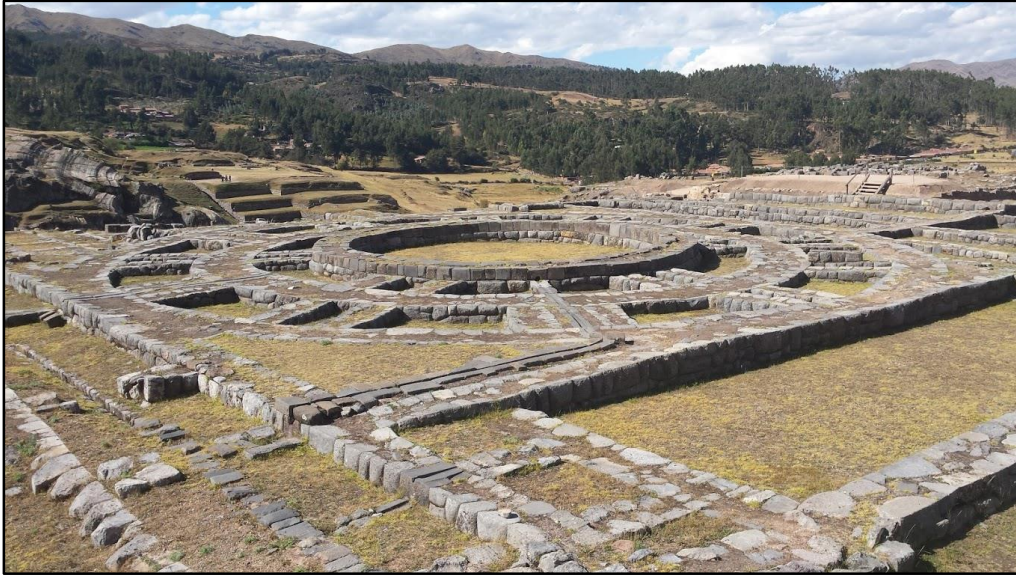
Since 1935, various excavations have taken place at Saqsaywaman. In some areas excavations were very successful at unearthing the bases foundation of important ruins. The excavation of Muyuqmarka on the top West side of the site is one example of success (Figure 2).

Figure 2: Excavated ruins of Muyuqmarka

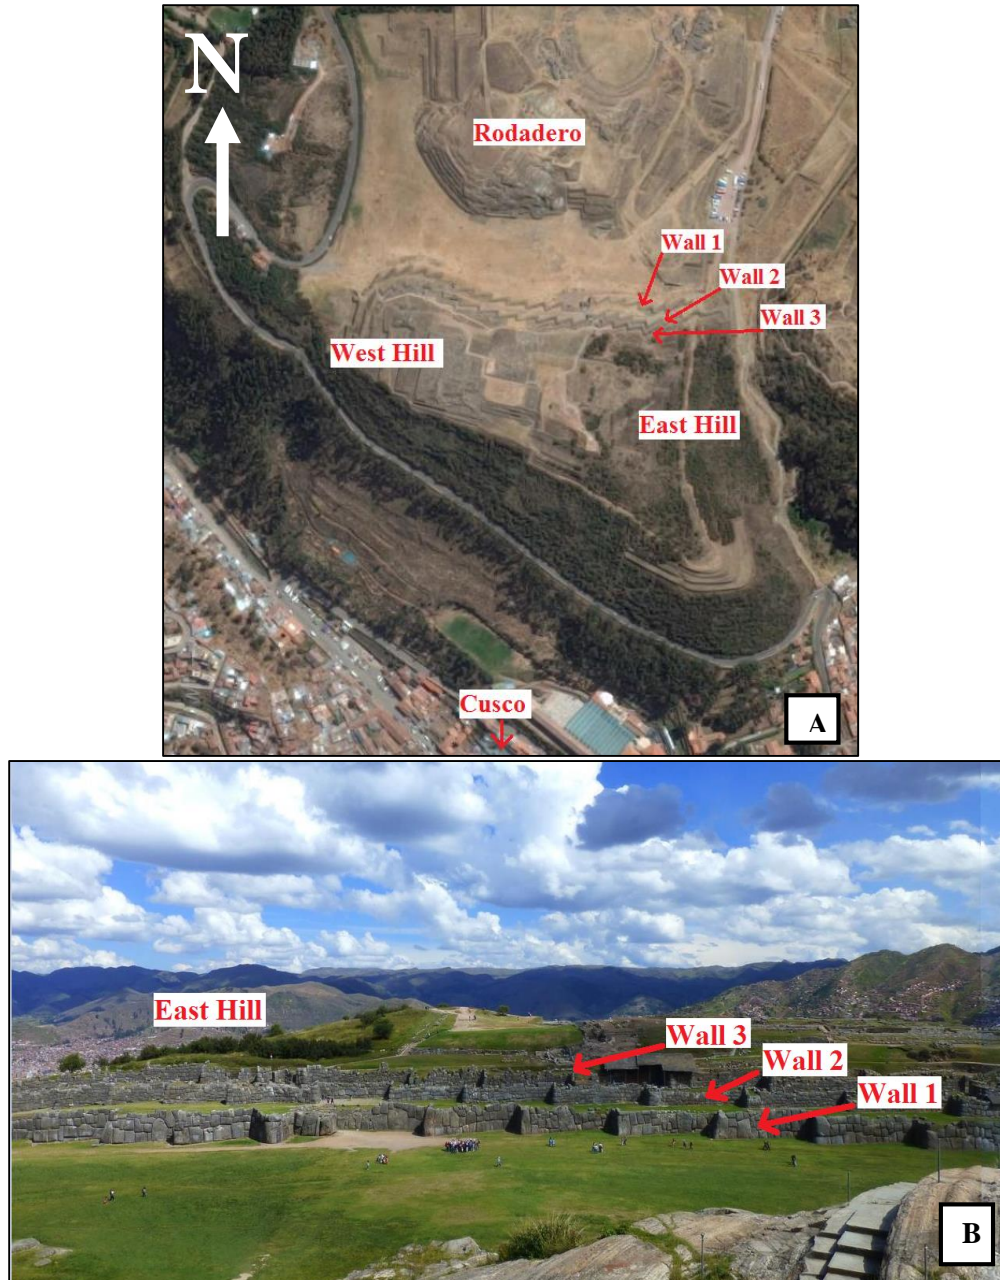
Figure 4a shows the entire site of Saqsaywaman with North pointing upwards. A flat grassy plaza about 80 meters across separates Saqsaywaman from a large granite outcropping hill called Rodadero. From atop Rodadero, one can see the most notable feature of Saqsaywaman, the three great monolithic walls spanning over 350 meters across laterally. In addition, the East and West hillsides of the site that will be included in the focus of this study are labeled. Figure 4b shows the three Great Walls labeled and viewed from atop Rodadero.

Figure 4: Scope of the entire Saqsaywaman complex (a) plan view (b) from Rodadero

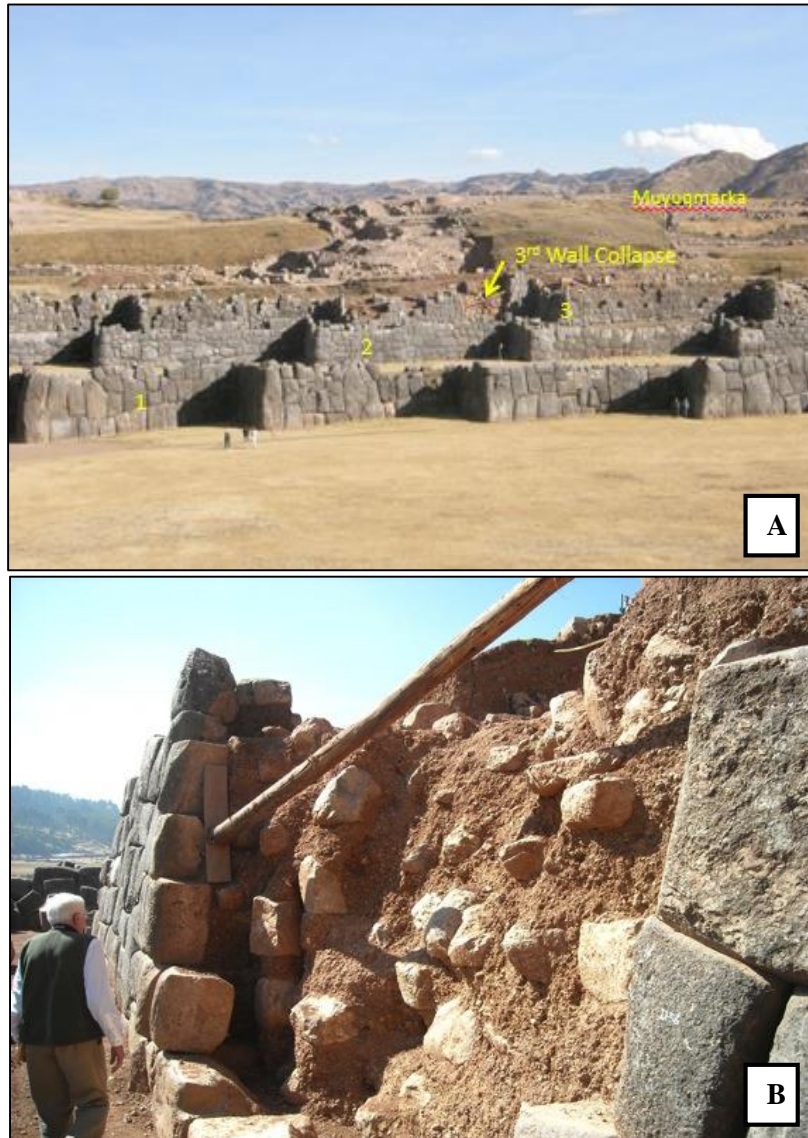
collapsed suddenly. As one can see in Figure 8, the collapse involved the movement of huge stones that had remained relatively stationary for centuries.

Figure 8: Collapsed section of the third wall (a) relative location (b) collapse [16]

A team of UVA students led by Dr. Richard Miksad was recruited to investigate the causes of the collapse. It was discovered that a buildup of hydrostatic pressure behind the central portion of the third wall caused the collapse. An archeological dig was conducted in the ground above the third wall in the months before the collapse. This dig uncovered important original Inca

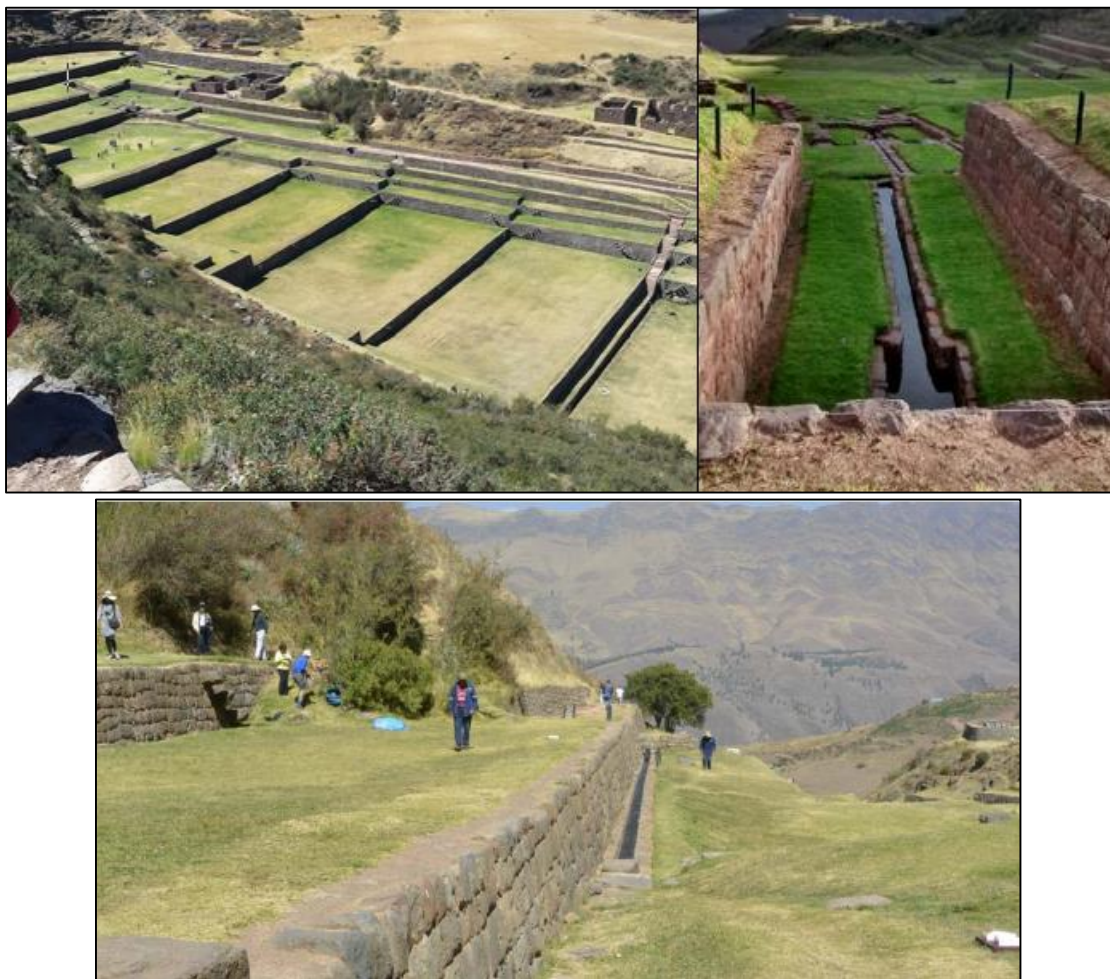
In this case, the water flows to the lowest terrace and then into a series of religious fountains at the base of Ollantaytambo. Another site by the name of Tipon that implements similar water control methods is pictured in Figure 18. Again, one can see that terraces are used to prevent the flow of water directly perpendicular to the slope and instead water is gathered by a series of terraces and culverts until it can be re-distributed in the form of an artful fountain. Tipon is a great example of the previously mentioned base channel culverts along terraces that we expect to see at Saqsaywaman. In addition, the well-known site of Machu Picchu has various terrace culvert designs that can be seen as you walk through the ruins that control and manipulate water in similar ways (Figure 19).

Figure 18: Tipon terraces and drainage channels [17] [16]

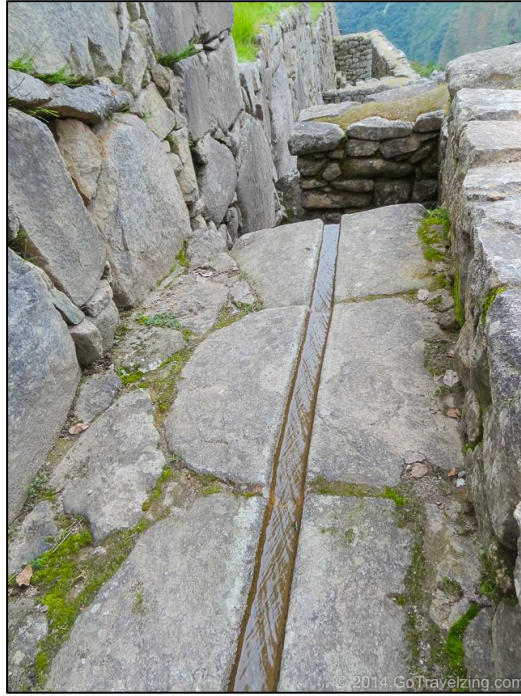
Figure 19: Machu Picchu culvert [18]

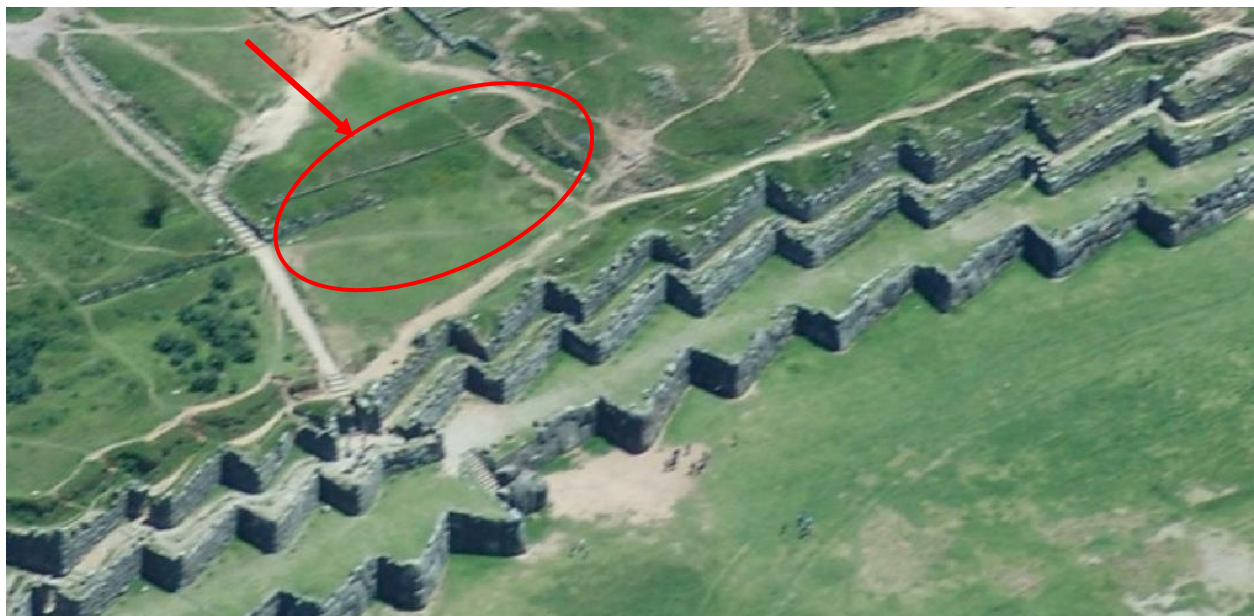
The next piece of evidence to substantiate the formation of the terrace hypothesis came from aerial imagery showing the existence of at least one section of a terrace wall that has since then been covered by soil deliberately for unknown reasons (Figure 20). In addition to this previously visible terrace wall, there is evidence of terraces along the stair case on the East upper side of the site. As you can see in Figure 21b, there are distinct levels that could indicate terraces used to exist in these locations. Lastly, the grades of the East side of the site are sloped in such a way that one can almost see evidence of where terraces used to be simply by walking along and observing. This piece of evidence is the least strong because the back side of the site has been regraded during various excavation when soil was moved in an unregulated manner, but is evidence nonetheless. This slope is shown in Figure 21a.

Figure 20: Old picture of Saqsaywaman showing terrace that has since been buried [16]

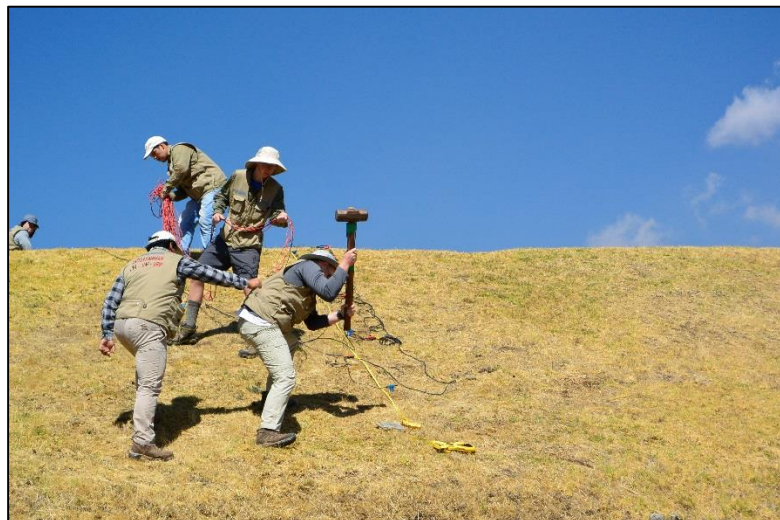
For the summer 2015 project, students from UNI and RP collaborated using a *SmartSeis ST Geometrics* model seismic refractor. A series of 24 geophones operating at 14 Hz frequency were laid across cross-sections of interest [9]. In order to initiate the data collection, the end of the device was hit with a heavy hammer (Figure 22). This impact creates P-waves and the arrival time of these P-waves at various geophone nodes along the length of the ladder can be measured. When an object inhibits the P-waves motion, it shows up as a disturbance on the machine. An example of a reading of the seismic refraction machine can be seen below in Figure 23, where points of interest are marked with arrows.

Figure 22: Team conducting seismic refraction test

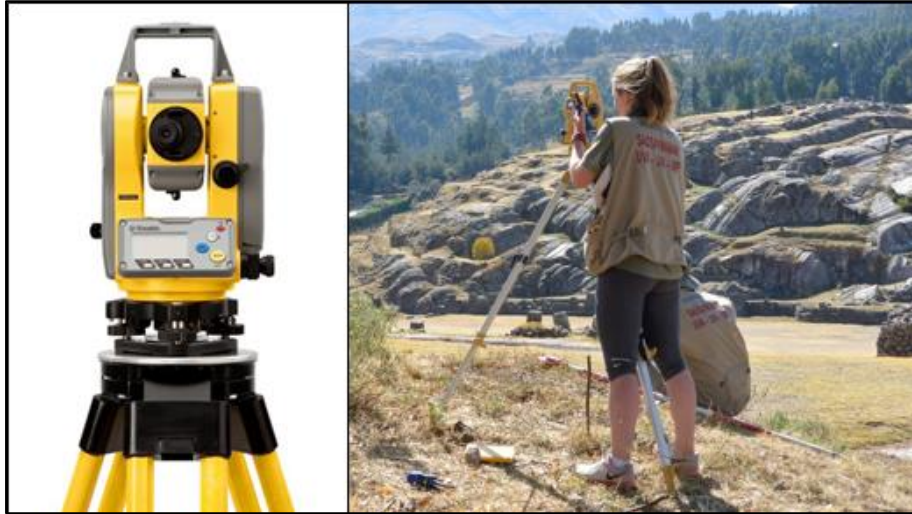
The final piece of data used to corroborate the location and existence of buried terraces on the back side of Saqsaywaman was visual evidence. Using a *Topcon GTS-240 HW Series electronic Total Station* model (Figure 27), a small group of UVA students including myself walked around the site looking for segments of terrace that remained above ground. One area showing three clear terraces can be seen in Figure 28.

Figure 27: Total station model and use

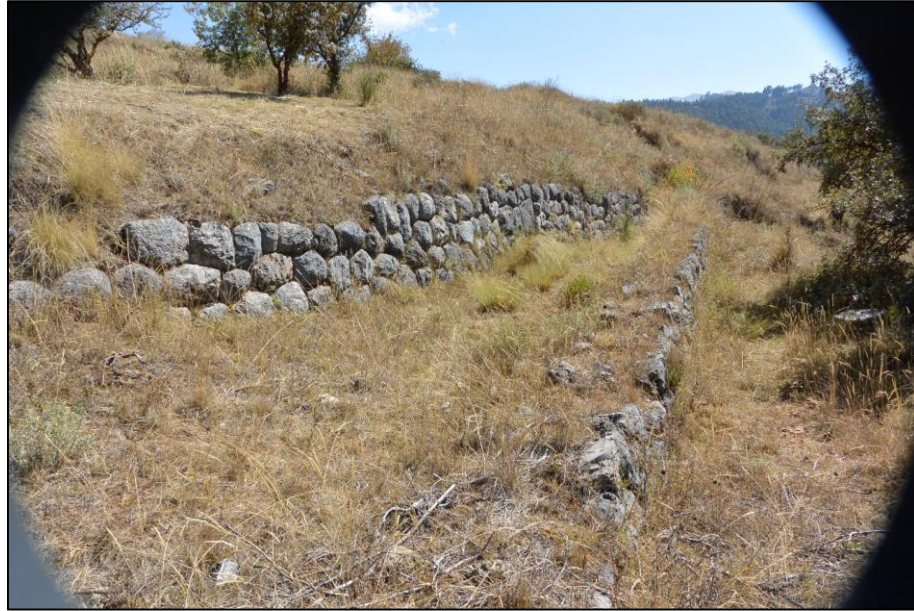
There are a few areas of the site east slope where there are clear terraces such as in Figure 28; however, there are multiple places on the site where soil and rock have been moved in unregulated manners, and excavations have been started and abandoned leaving piles of rubble and mounds of soil. These factors make it difficult to say what is a collapsed terrace, what is a moved stone, and what is simply the ruins of a different kind of structure. The clear terraces shown in Figure 28 and the results of the GPR and seismic refraction are more heavily considered as evidence in the terrace location determination steps following.

Figure 28: Example of some of the visual terraces on the East side of the site that remain above ground level [16]

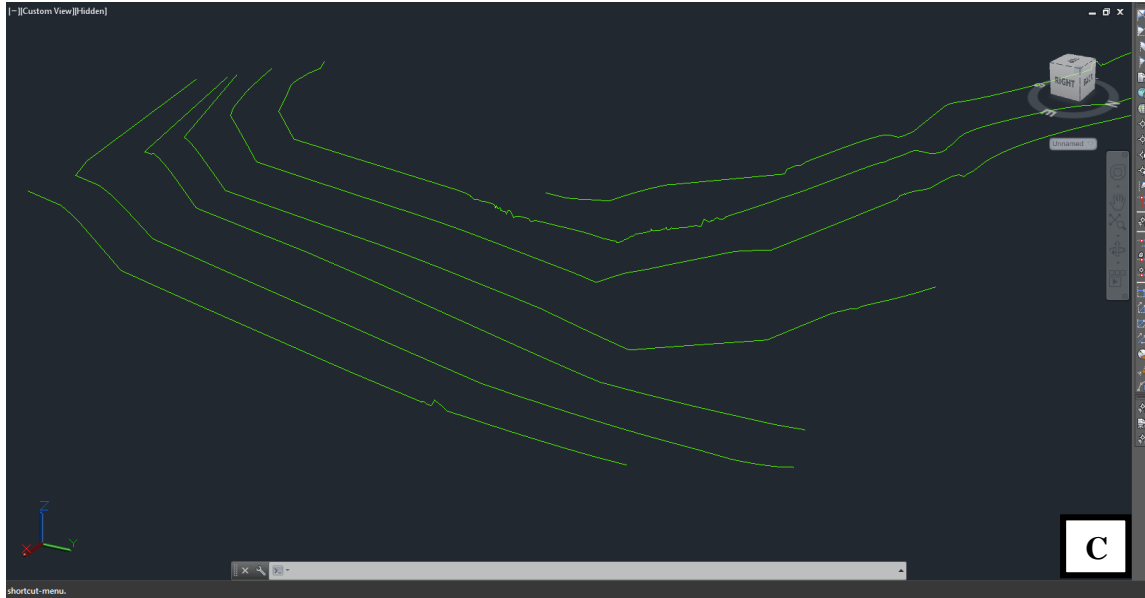
One issue with this “elevations from surface” tool is that our current surface model has multiple erroneous points (points 1-5 meters above or below the actual surface, shown in figure 35a). When the “elevations from surface” tool was implemented, a few of the spikes in elevation were projected onto the feature line (Figure 35b). Based on ground truth field observations I made while actually present on the site in Peru, I deemed these points to be erroneous and not representative of the actual surface. As such, I deleted these corrupted data points from the surface and recreated the feature lines from this corrected surface. The smoothed and corrected final terrace lines are displayed in Figure 35c.

Figure 35: Error corrections for feature lines
