North Grounds Stream Restoration Design

A Technical Report submitted to the Department of Civil Engineering

Presented to the Faculty of the School of Engineering and Applied Science
University of Virginia • Charlottesville, Virginia

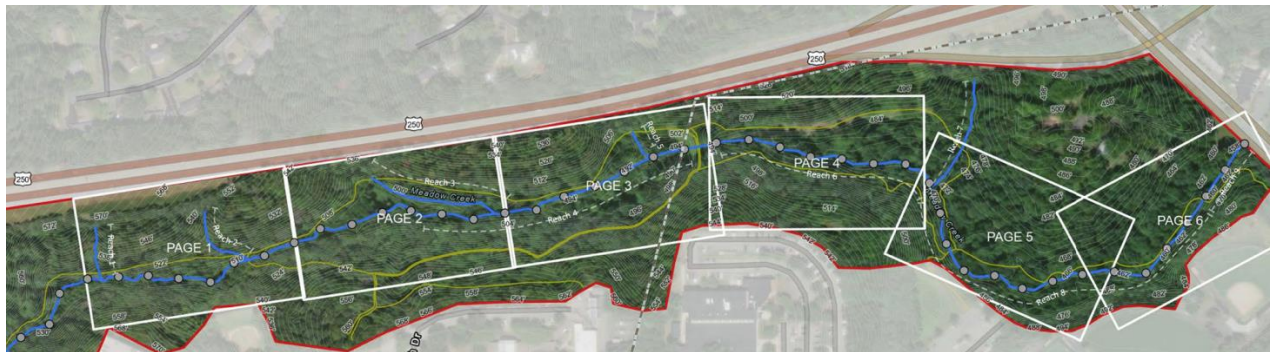
Figure 1-1. Biohabitats Division of Reaches

As is shown in Figure 1-1, reaches (3 and 5) are tributaries to the stream fed by outfalls that run under US 250/Route 29 Bypass. These reaches are of particular interest because there is concern about the influence of increased flow contributions on sediment load and phosphorus and nitrogen concentrations. Therefore, our research and design are primarily centered around Reach 3 and Reach 5. Figure 1-2 provides a more detailed view of these reaches.
