The Six Building Campaigns at Sylvania:

The Transformation of Sylvania from a Folk Plantation House to a Fashionable Plantation,

1790-1865

Victoria Mae Bitrick

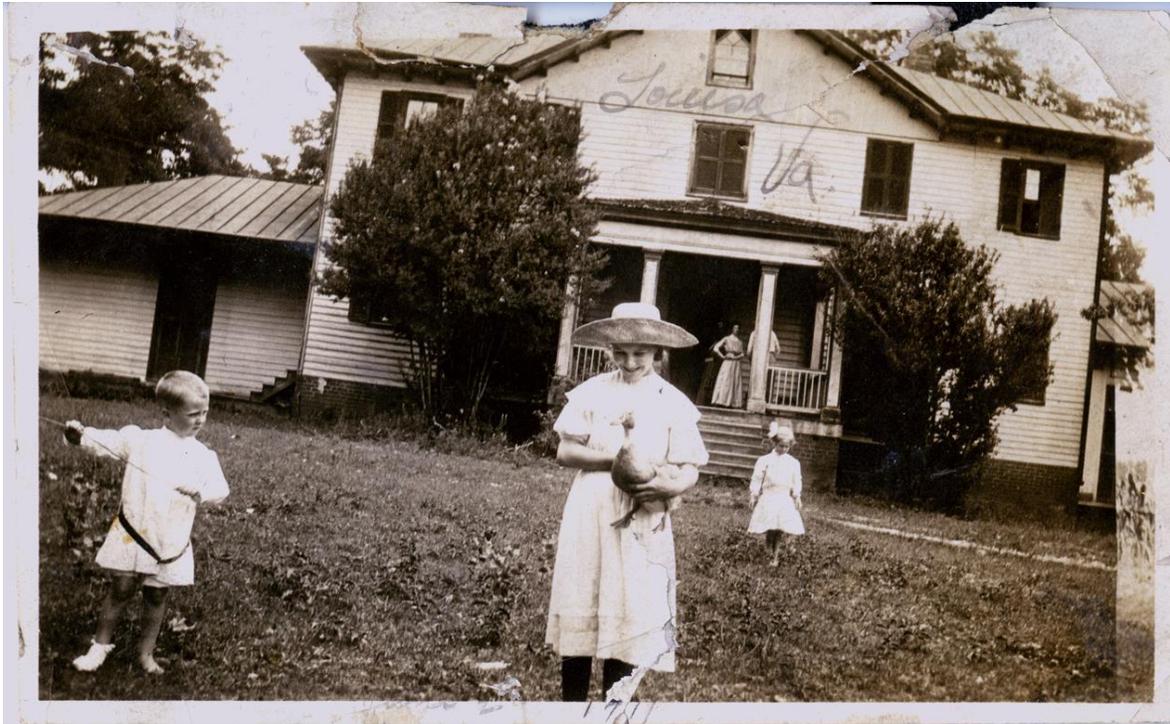
Figure 4: The first known photograph of Sylvania’s south elevation taken in 1911 including Harriette Morris standing in the center, two unknown children, and her father John Morris and stepmother Minnie standing on the porch. Courtesy of Nancy McEntee, granddaughter of Harriette Morris.

After James and Nancy's lifetime, there is no evidence of work being done at the house until 1911 when the first known photograph was taken of the south elevation of the house (Fig 4). In the 1911 photo, Sylvania displays a few alterations since 1815. Two wings have been added to the house: one on the east side and one on the west side. On the east wing, an orangery is visible. Although the roof was drawn gabled in 1802, in 1911 the roof is hipped with a gable and window added to its south side. The porch appears to be similar to the one drawn in 1802. This photograph is also the first piece of evidence for the windows at Sylvania. Although partially obscured by bushes, the two large tripartite windows on Sylvania's south elevation are visible, with their shutters closed, in this photograph. It is also important to note that a faint line in the siding can be detected on the right side of the main block of the house.

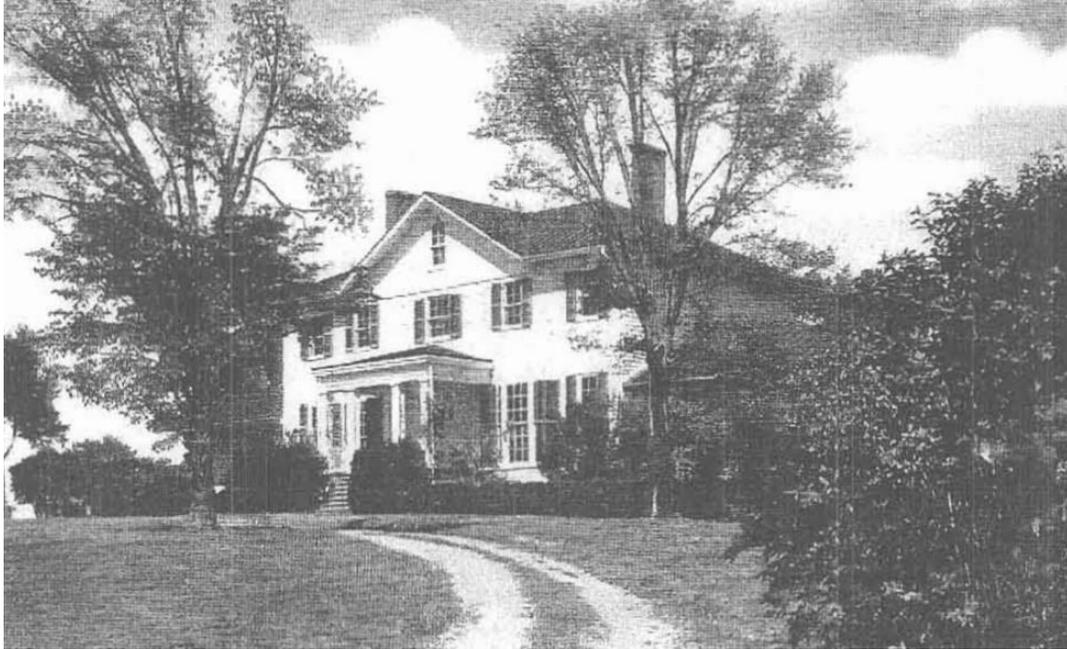
Figure 6: Southeast view of Sylvania in 1950 with the southern porch, hipped roof and southern gable, and tripartite windows visible. Stevens and Company. "Sylvania." Real Estate Brochure. Louisa County Historical Society.

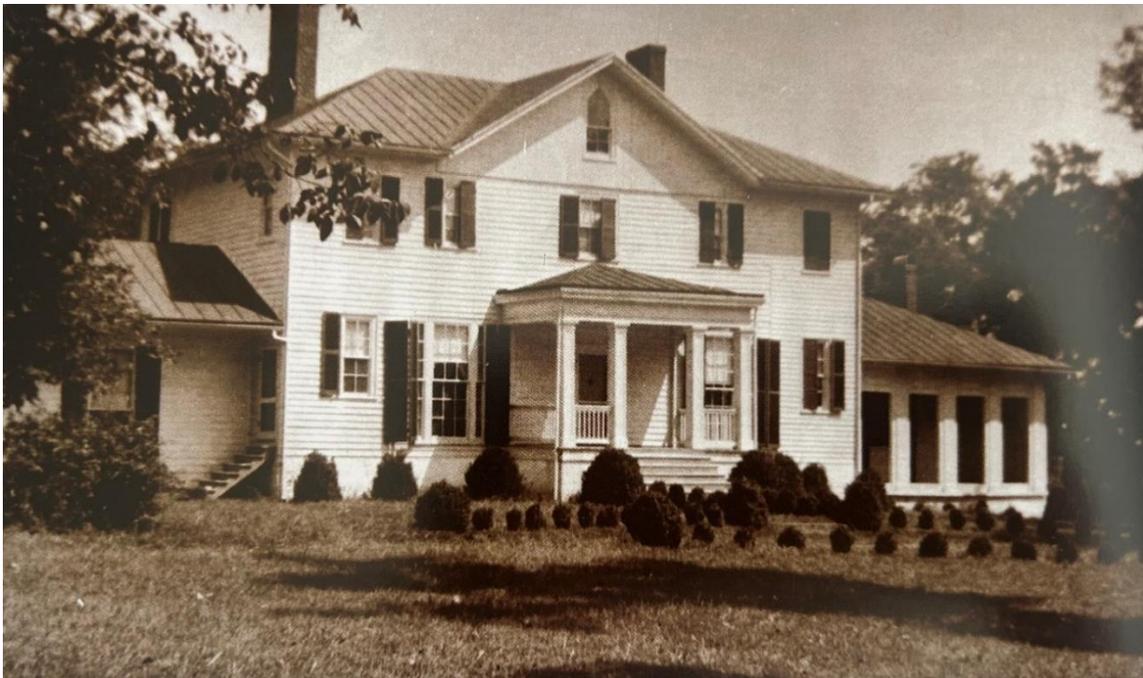
Figure 11: Undated photograph of Sylvania during Richard Allen's ownership viewing the south elevation with the orangery visible on the right wing. In *Old Home Places of Louisa County Revisited*, Louisa County Historical Society, 2012, 266.

The next piece of photo evidence is a photograph of the south side of the house taken after Richard Allen purchased the home in 1955 (Fig 11). In this photo, the house has not been altered on its south side, and the tripartite windows and the change of the siding on the right side of the main block of the house are more visible. This photograph is supplemented by descriptions of the house that were given in a series of newspaper articles published during Allen's ownership, unfortunately all undated. One article describes Sylvania as having an "L-shaped entrance hall", "den and office on left", and a "living room and dining room lead through to a second screened porch viewing gardens". The west wing is described as having a "kitchen, pantry, servants' room and bath" and the east wing is described as stepping down to a "guest bedroom and bath". The upstairs is described having "four master bedrooms" with three of the four having fireplaces and adjoining dressing rooms.⁶⁶ Another article describes Sylvania as having "hand-beaded weatherboarding" with framing that is "morticed and held together with pegs" and "large hand-hewn timbers" with older nails that are handmade. The interior is noted to have "numerous cross-and-bible doors", "seven fireplaces with hand-made mantels", and "wide pine floors". The layout is described having six bedrooms and five baths, a "double pullman kitchen", a living room, dining room, den, L-shaped hall, and a large basement.⁶⁷

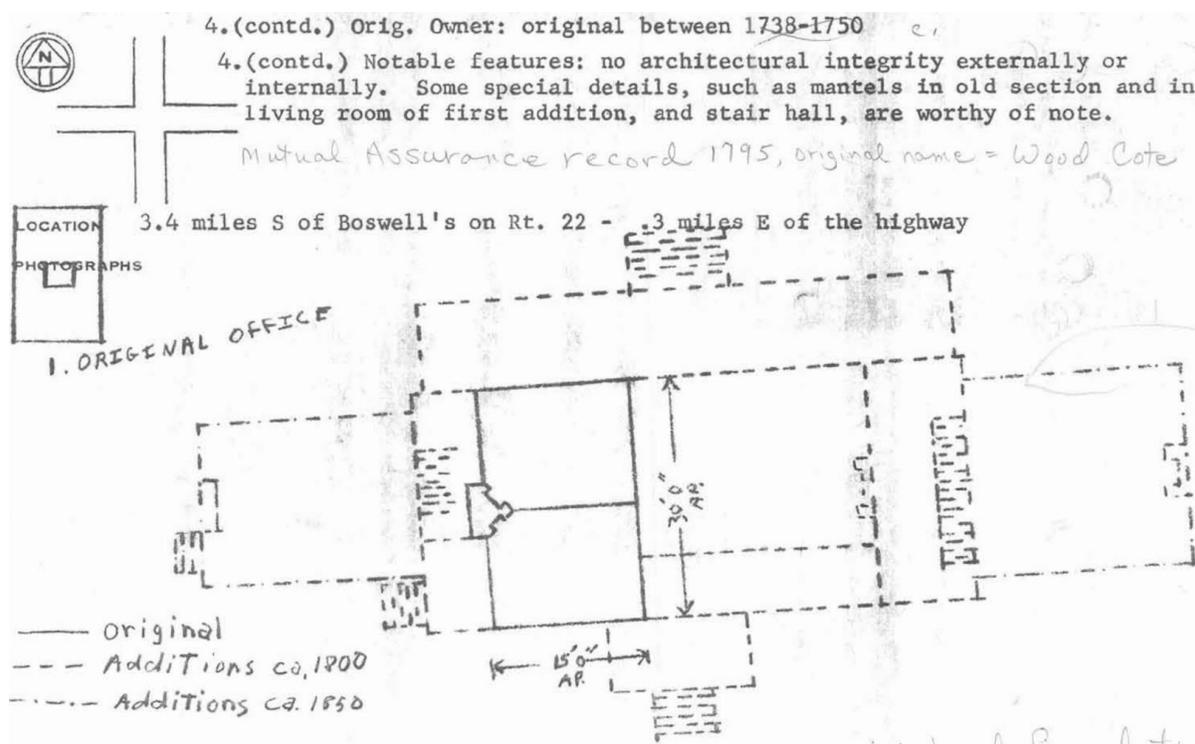
Figure 12: First floor plan of Sylvania in 1958 with HABS' theory for the sequence of its additions denoted by line types. HABS survey, February 7, 1958, Louisa County Historical Society.

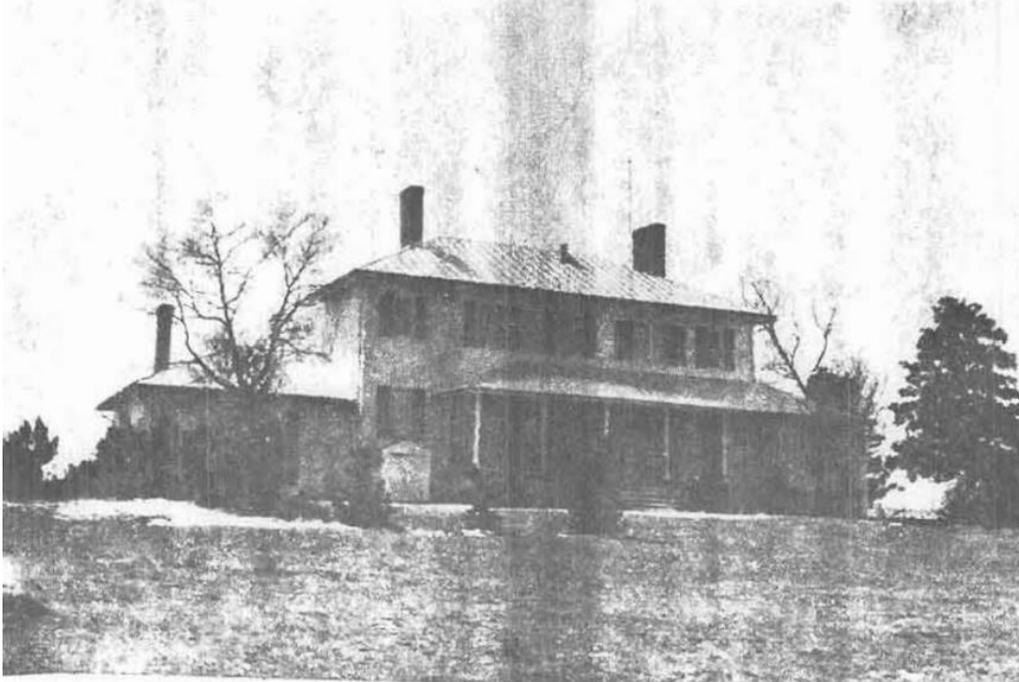
Figure 13: Photograph of the north elevation of Sylvania in 1958 with the northern porch and hipped roof visible. Taken by HABS, recorded February 7, 1958, and kept at the Louisa County Historical Society.

provide value in its photos from the interior and exterior of the house. The survey provides a photo of the north side of the house (Fig 13). Here, a one-story porch is visible on the north side of the house. The hipped roof is also visible in this photo, with no gable on the north end. Other than the absence of the roof, shutters, chimneys, and porch due to the earthquake and tornado damage, the north end of the house has remained relatively unchanged since 1958. The HABS survey includes interior photos as well, including the entrance hall (Fig 14), living room mantel (Fig 15), and dining room mantel (Fig 16). The outbuilding, labeled as an “office” is also pictured (Fig 17). Other than the deterioration of these spaces, these spaces appear relatively unchanged since 1958.

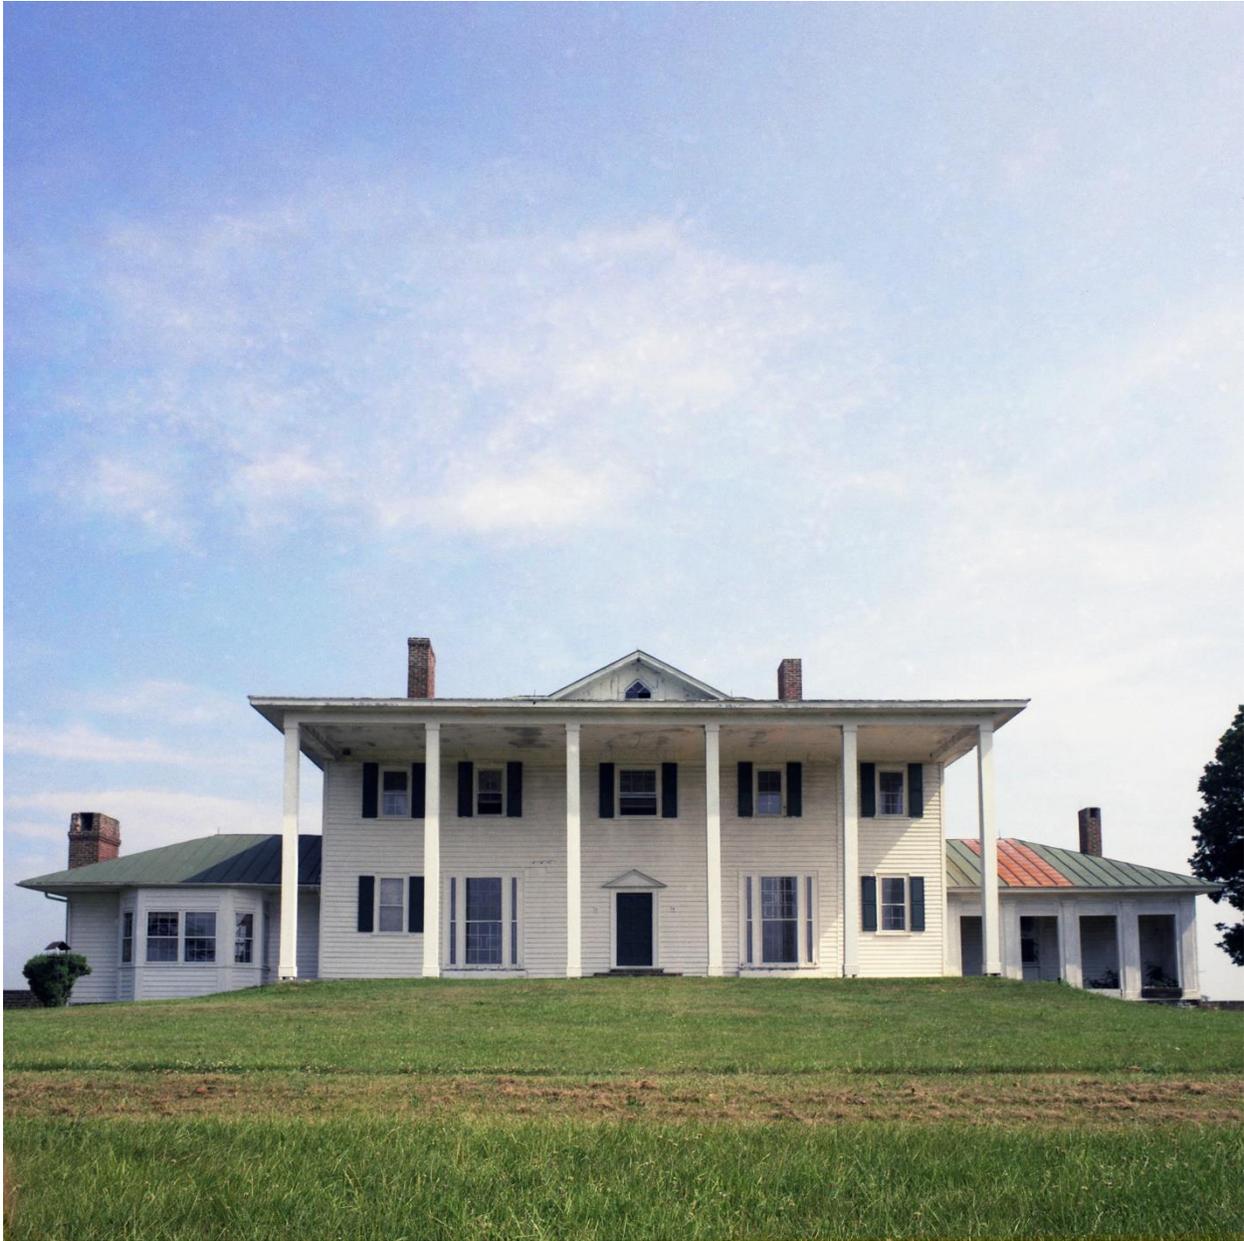
Figure 18: The southern elevation of Sylvania in 1991. Alterations made by Richard Allen shown in this photo include a new porch attached to the main block of the house and a bay window added to the western wing. The grade of the landscaping has also been changed to slope up to the porch addition. Taken by Nancy McEntee in 1991.

In 1991, a set of photographs were taken of the interior and exterior of Sylvania by Nancy McEntee, the granddaughter of Harriette Morris. These photos document the porch and bay window additions that Richard Allen made to Sylvania after the 1958 HABS survey (Figs 18-26). The interior photos document the majority of Sylvania's interior, and they include the first documented photos of many of its spaces. (Figs 27-43). Compared to the 1958 photos of the grand staircase and first floor mantels, those two elements appear unchanged in 1991. Unfortunately, there are no other photographic references to assess if or how the interior of Sylvania changed between 1958 and 1991. The exterior of Sylvania was photographed again in 1997, documenting no change since 1991 (Fig 44). In 2005, another photo was taken of the southern elevation, with the only change being the removal of the house's shutters (Fig 45).

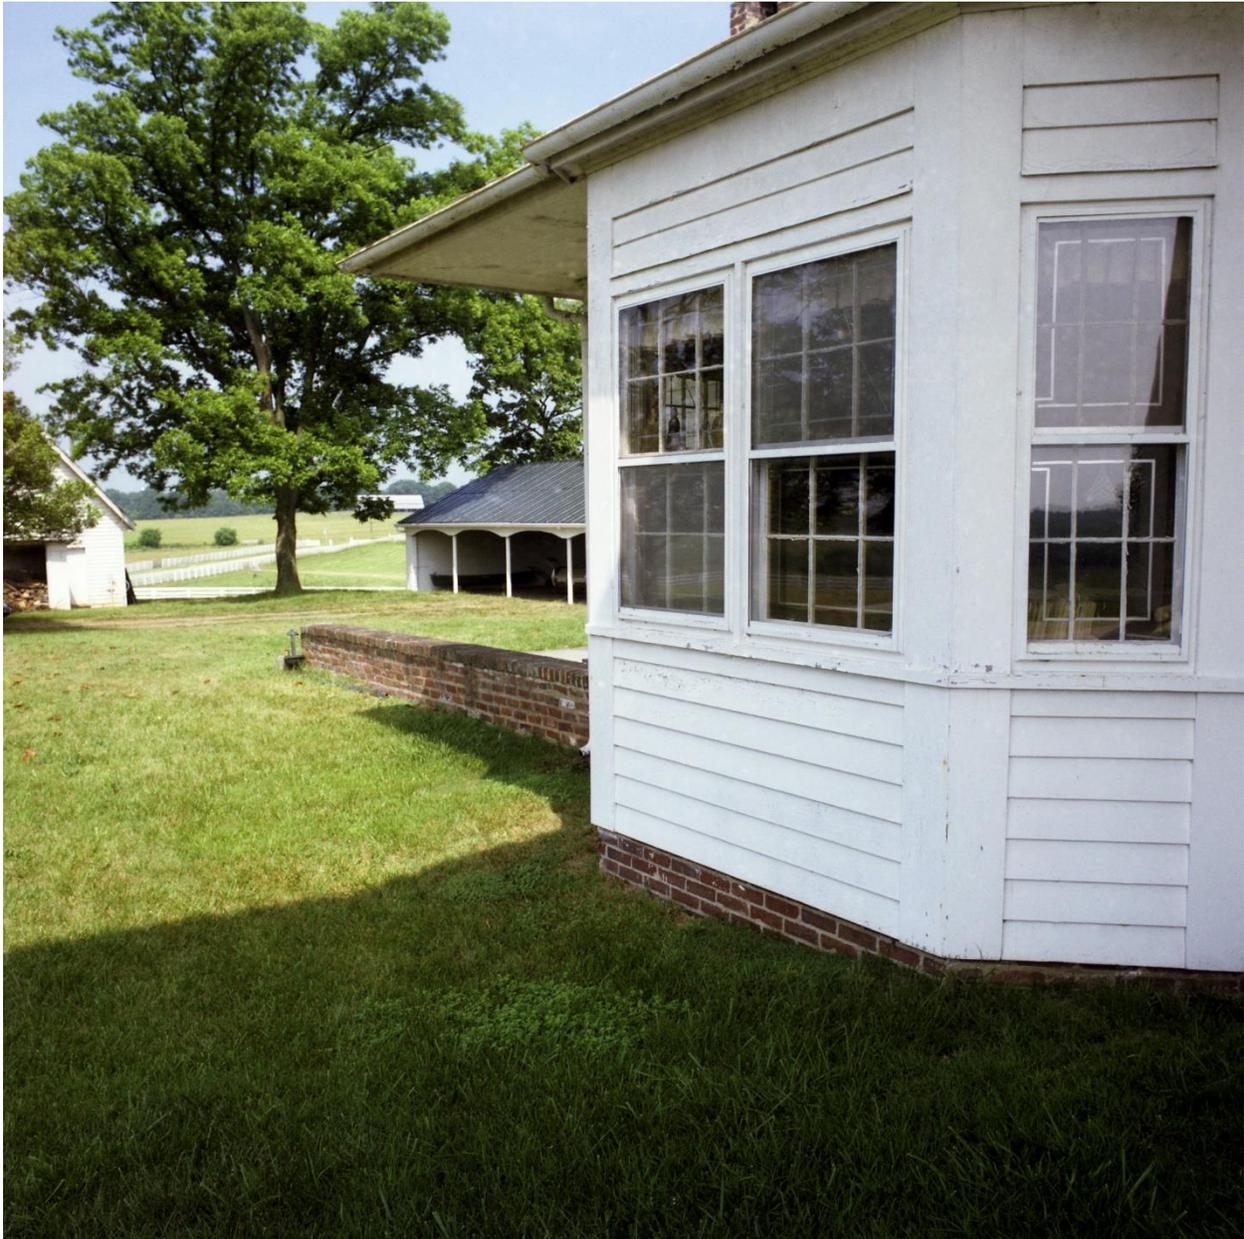
Figure 19: A closer view of the bay window addition made to the west wing by Richard Allen. In the background, the outbuilding is visible to the left, and a garage, which no longer stands, is visible to the right. Taken by Nancy McEntee in 1991.

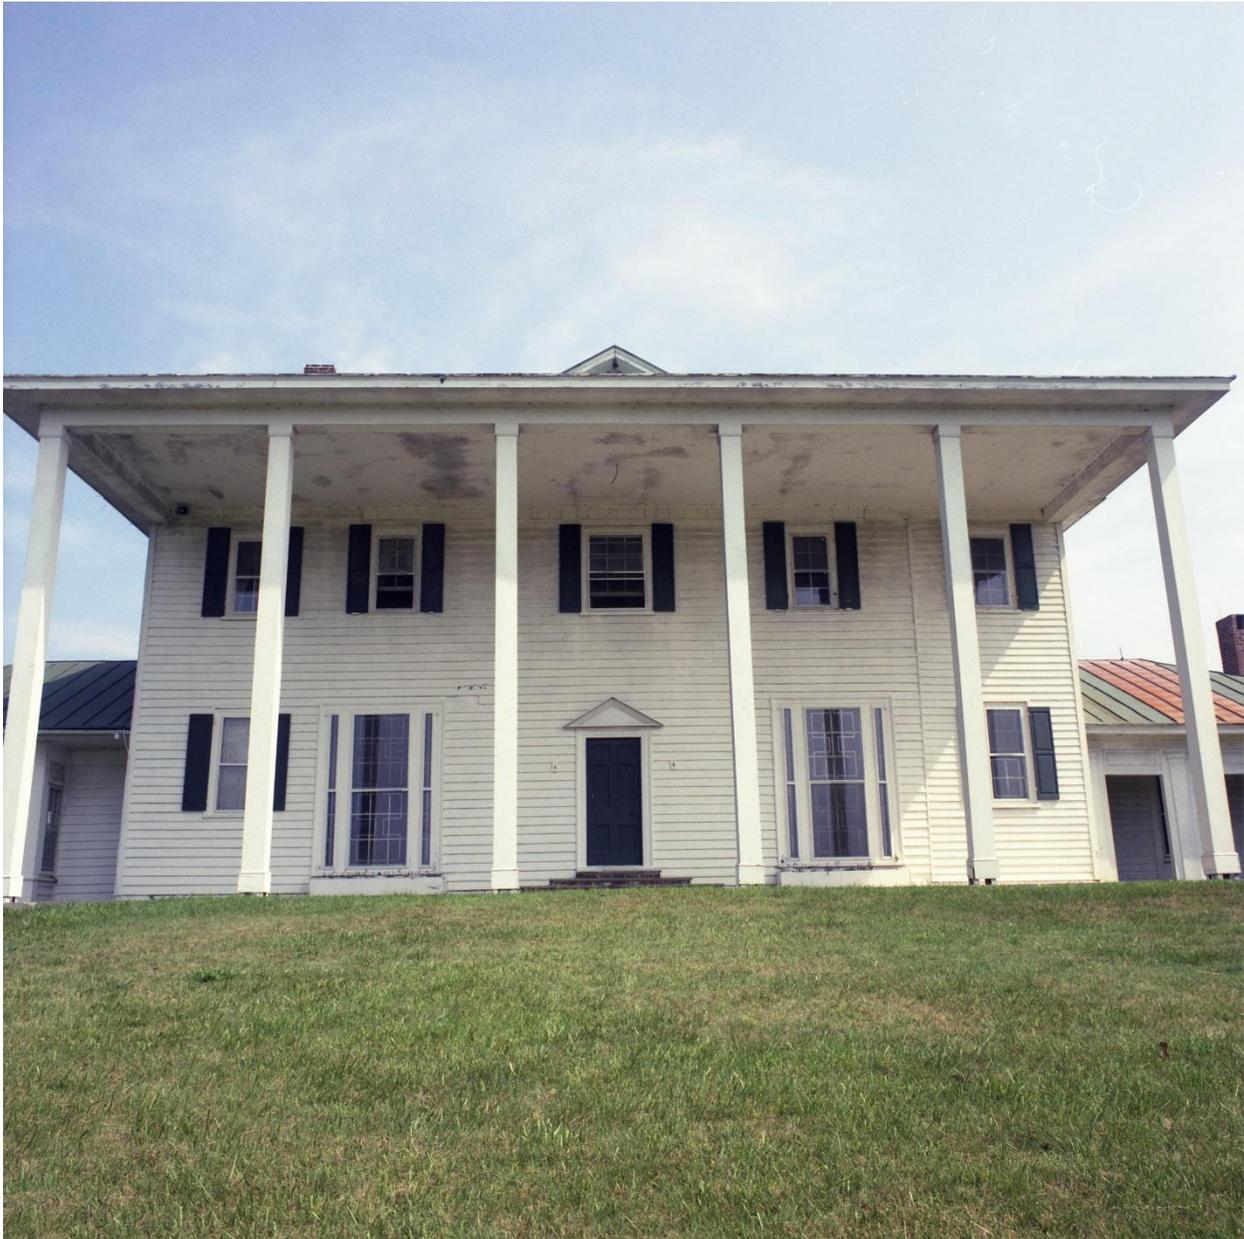
Figure 20: A closer view of the southern porch addition made by Richard Allen. Taken in 1991 by Nancy McEntee.

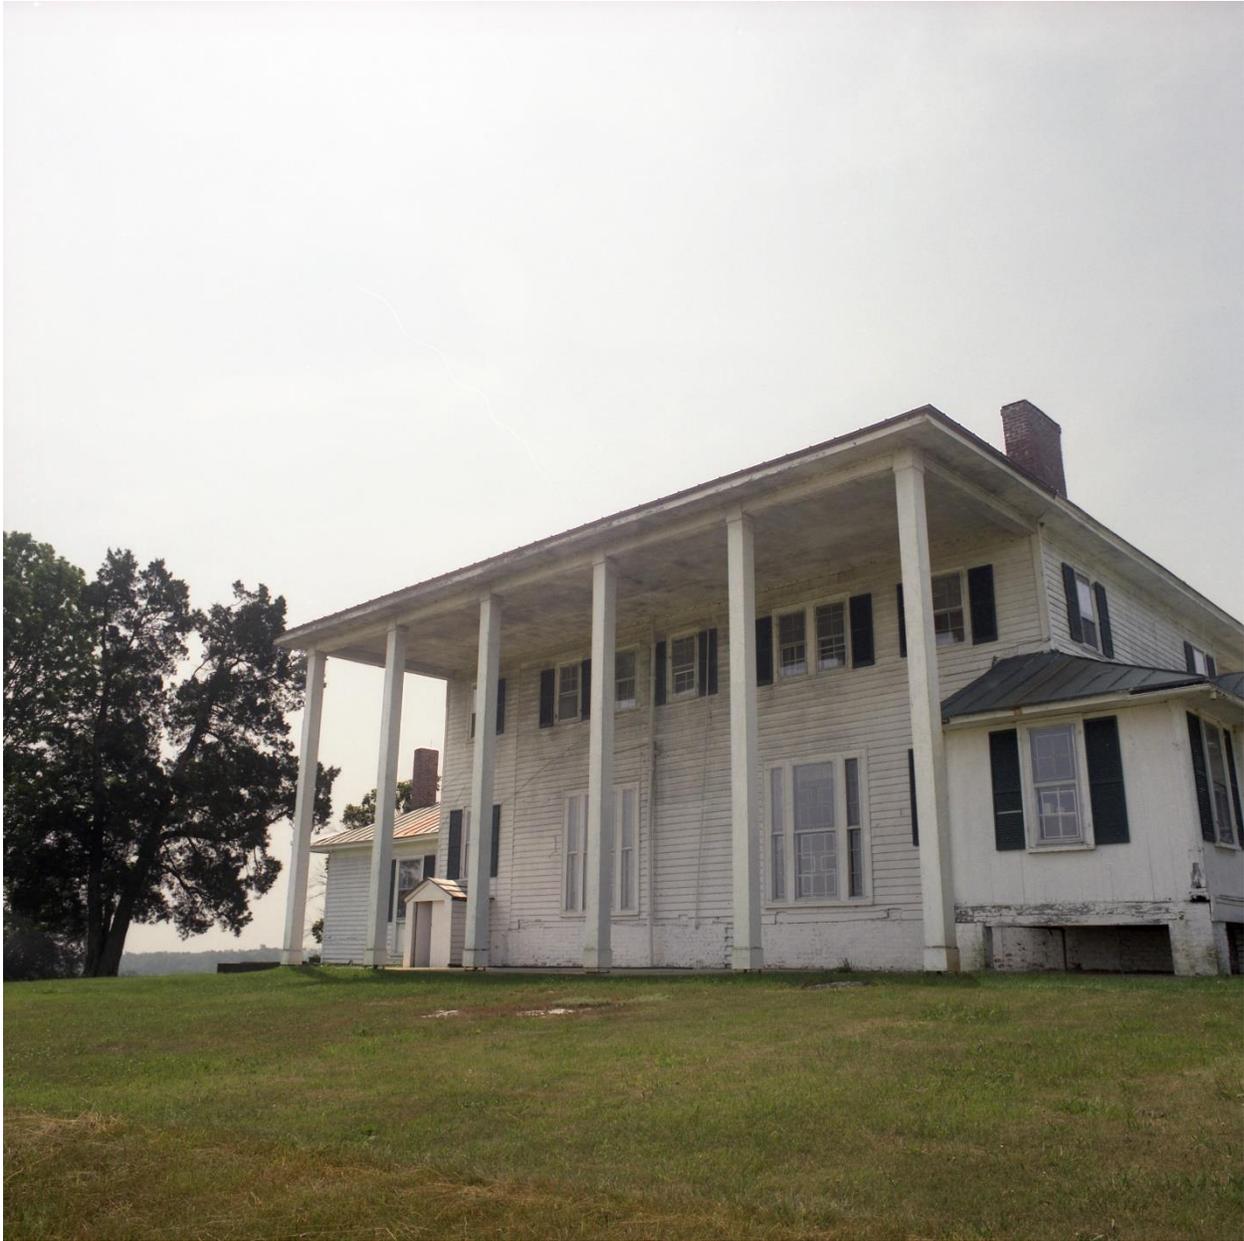
Figure 25: Photo of Sylvania's northern elevation with the northern porch addition made by Richard Allen after 1958. Taken by Nancy McEntee in 1991.

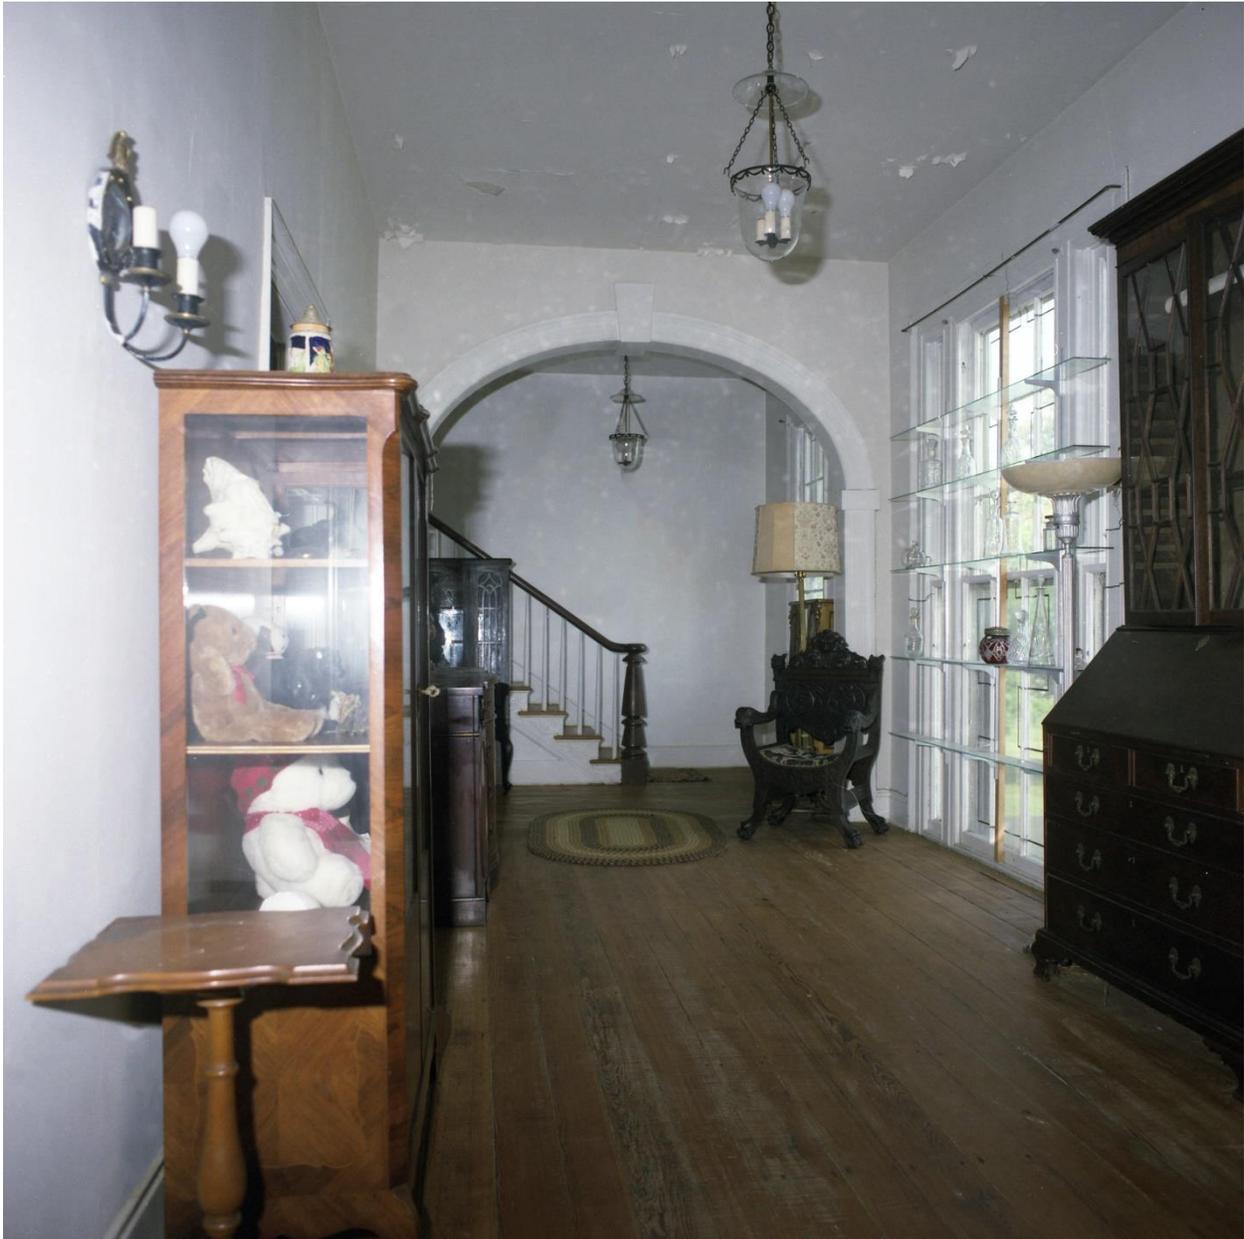
Figure 29: Photo taken in the southern entrance hall facing the eastern stair hall and the grand staircase, featuring the arch and tripartite window in the southern entrance hall. Taken by Nancy McEntee in 1991.

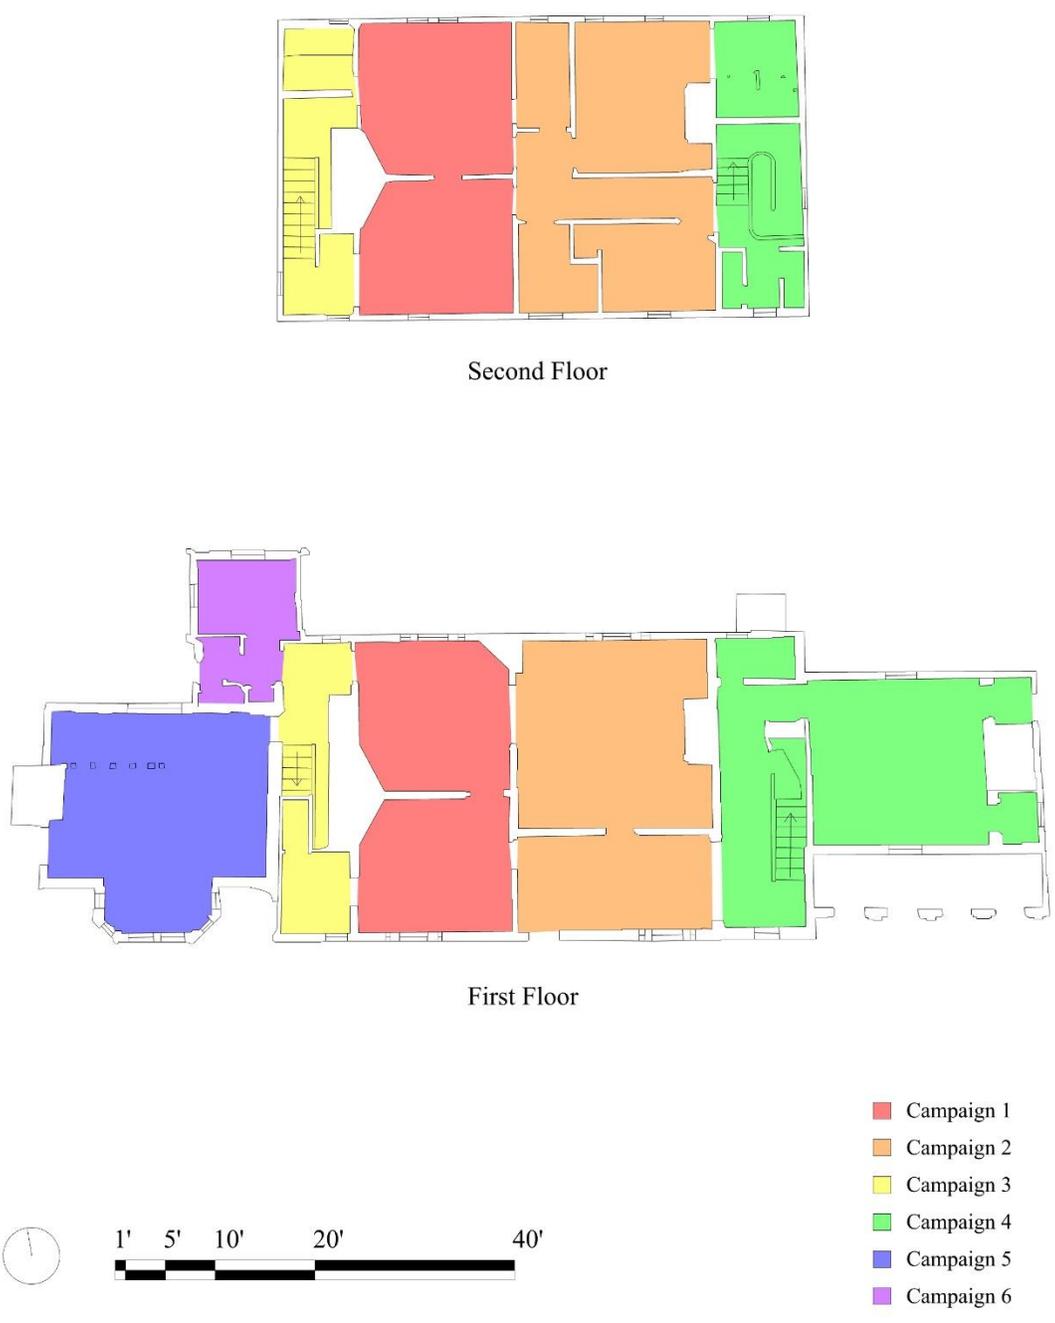
Figure 47: A map of the locations of the campaigns including both the first and second floor. The floor plan was drawn from 3D data collected at Sylvania to an accurate scale. The different campaigns that are assessed in this chapter are denoted by color and are arranged on the key in chronological order.

In this analysis, the discussion of the house will be divided into different “campaigns” (Fig 47). The word “campaign” is used to describe a portion of the house that is speculated to have been designed and built at the same time. In this discussion, Sylvania is divided into six campaigns to simplify the analysis of its physical evidence. The division of these campaigns is based on the initial theories of construction that were suggested by the 1958 HABS survey and a 2005 National Park Service survey. The campaigns are numbered based on their speculated age, with Campaign One being the oldest according to HABS and Campaign Six being the newest

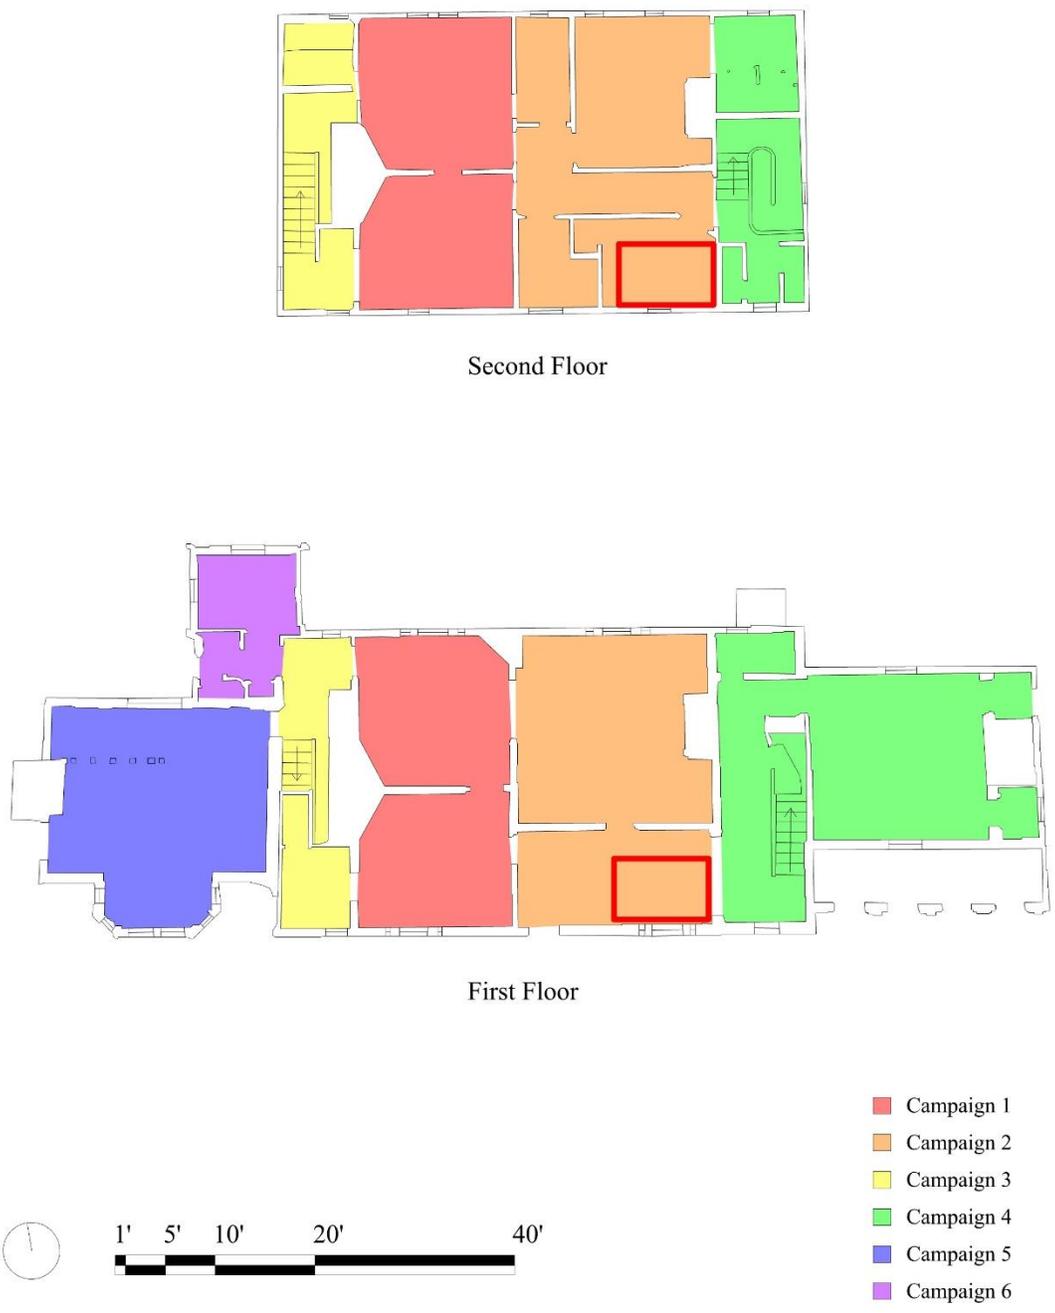
Figure 48: The location of the original staircase in the southeast corner of Campaign Two. In his theory, Doug Gilpin proposes that the original staircase was in the southeast corner of Campaign Two. Physical evidence for this staircase has been found in this location in the cellar and on the second floor.

Figure 48: The location of the original staircase in the southeast corner of Campaign Two. In his theory, Doug Gilpin proposes that the original staircase was in the southeast corner of Campaign Two. Physical evidence for this staircase has been found in this location in the cellar and on the second floor.

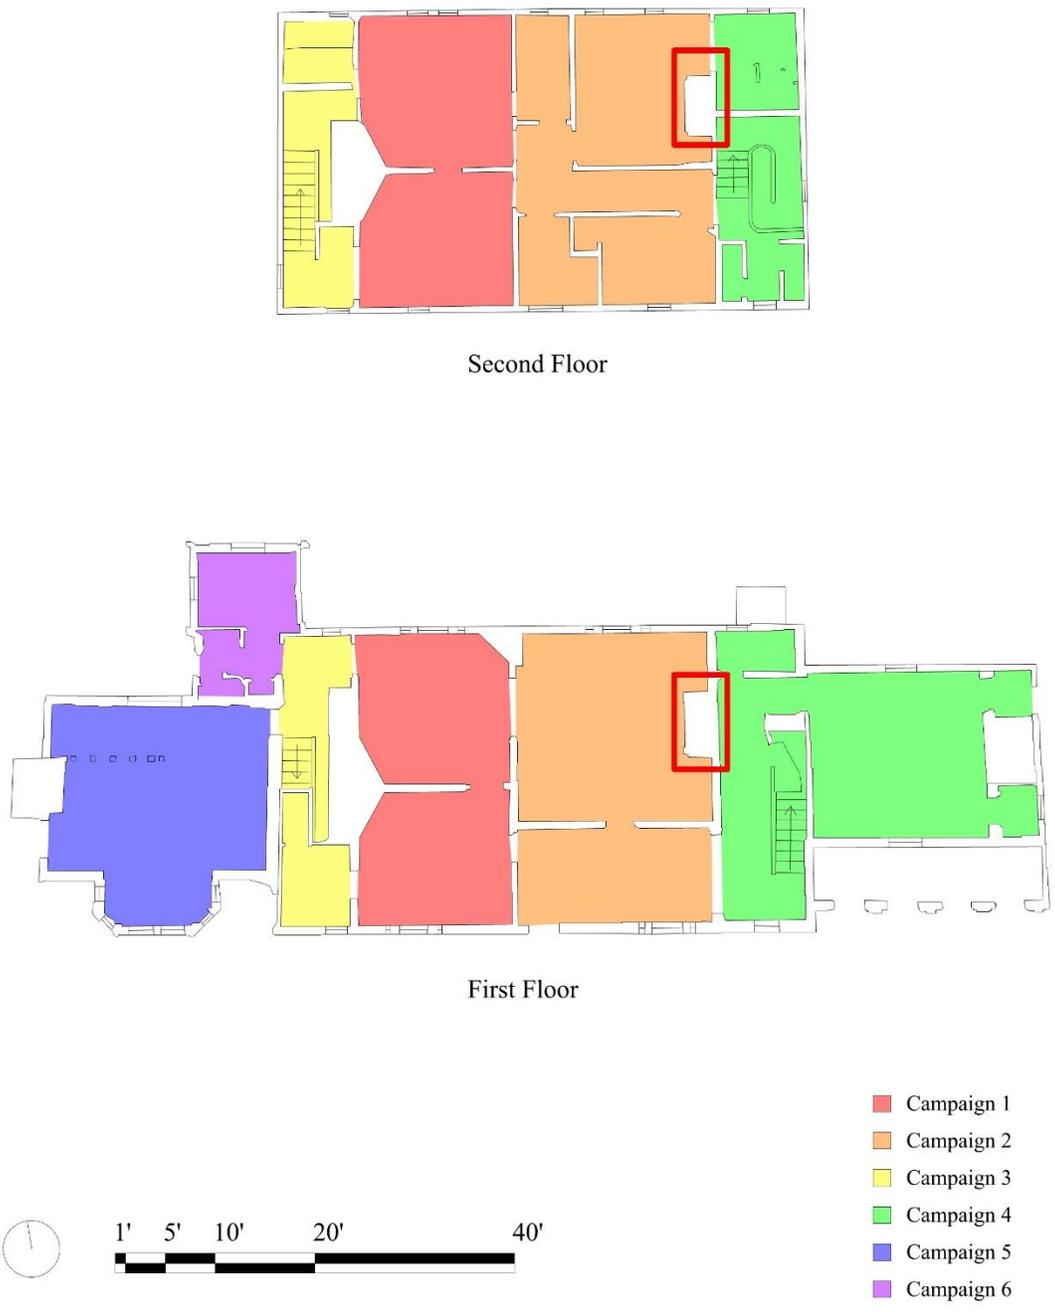
Figure 49: The location of the rebuilt chimney on the eastern end of Campaign Two. Doug Gilpin proposes that the original chimney on the east end of the house was replaced by the current chimney when Campaign Four was added. He speculates that the reasoning for this was to move the chimney into the interior of Campaign Two to make room for the hallway in Campaign Four. The evidence for its reconstruction is present in the cellar, where the brick pattern differs from the rest of the cellar.

Figure 49: The location of the rebuilt chimney on the eastern end of Campaign Two. Doug Gilpin proposes that the original chimney on the east end of the house was replaced by the current chimney when Campaign Four was added.

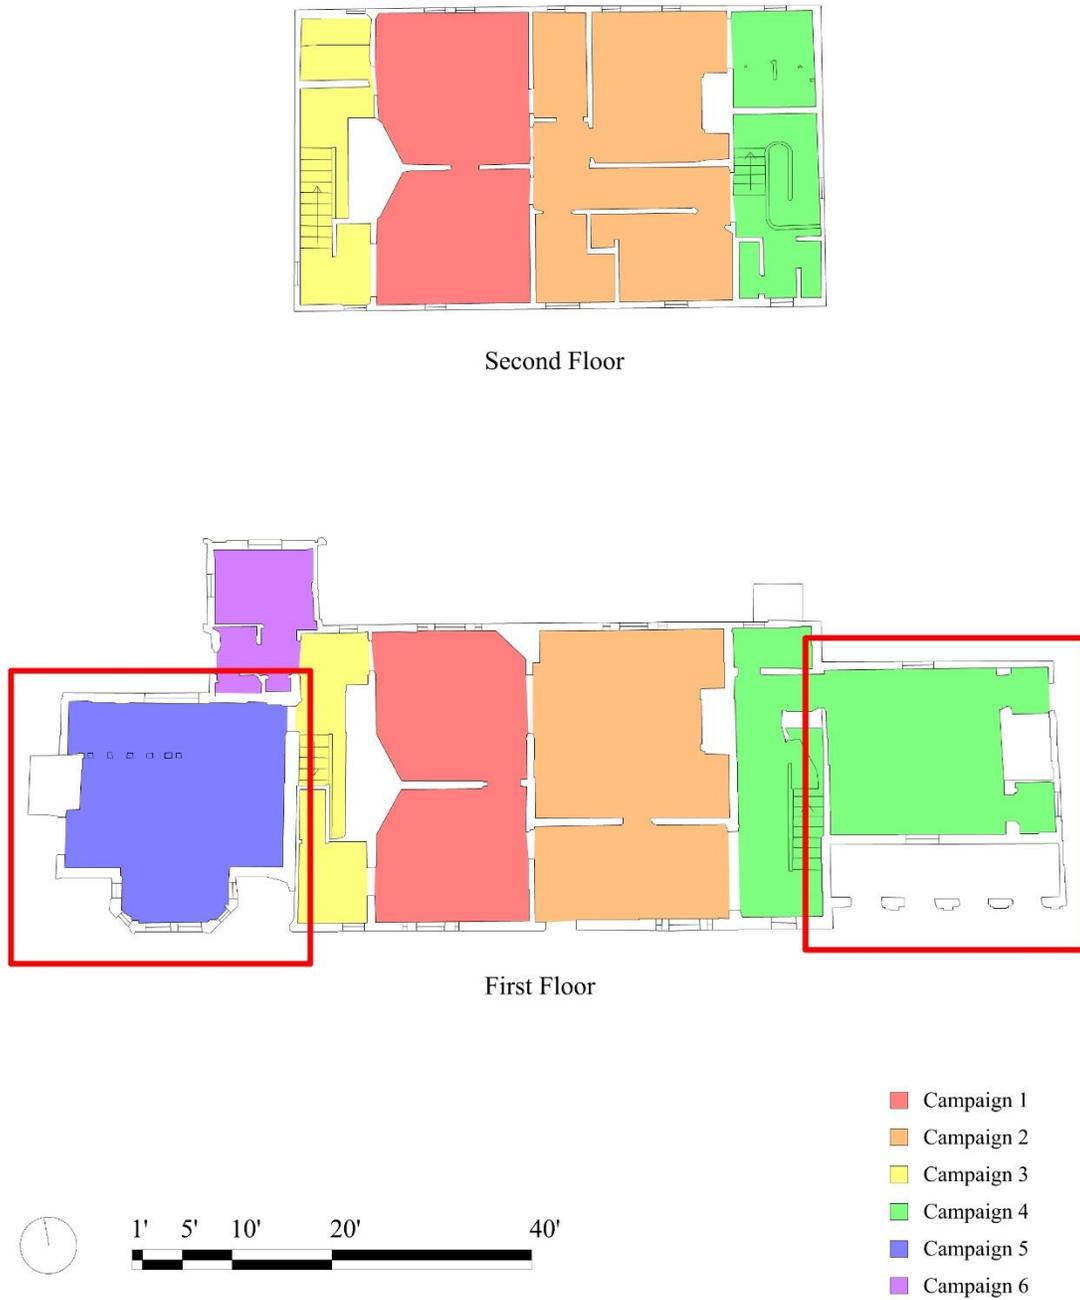
Figure 50: The location of the side wing additions, with the wing attached to Campaign Four on the right, and the wing defined as Campaign Five on the left.

Another question about the house is whether the side wings were added at the same time or not (Fig 50). Since there is a large gap in documentation of the house between 1815 and 1911, the two wings and their order of construction are undocumented. HABS assumes that the two were built at the same time around 1850.⁸⁴ Again, Gilpin has a different theory. Gilpin speculates that the eastern wing was added at the same time as the eastern stair hall in the second half of the 19th century. This assumption is based on circular sawn framing in the roof and its more Italianate style. For the western wing, Gilpin theorizes that it was added to the house in the 20th

century, before 1911, but that it may have been an older recycled structure. Gilpin notes that the cornice and exterior details differ between the two wings, prompting the assumption that they were added at different dates.⁸⁵ With these questions in mind, the physical evidence at Sylvania can be analyzed and compared to bring more clarity to the differing theories for its sequence of construction.

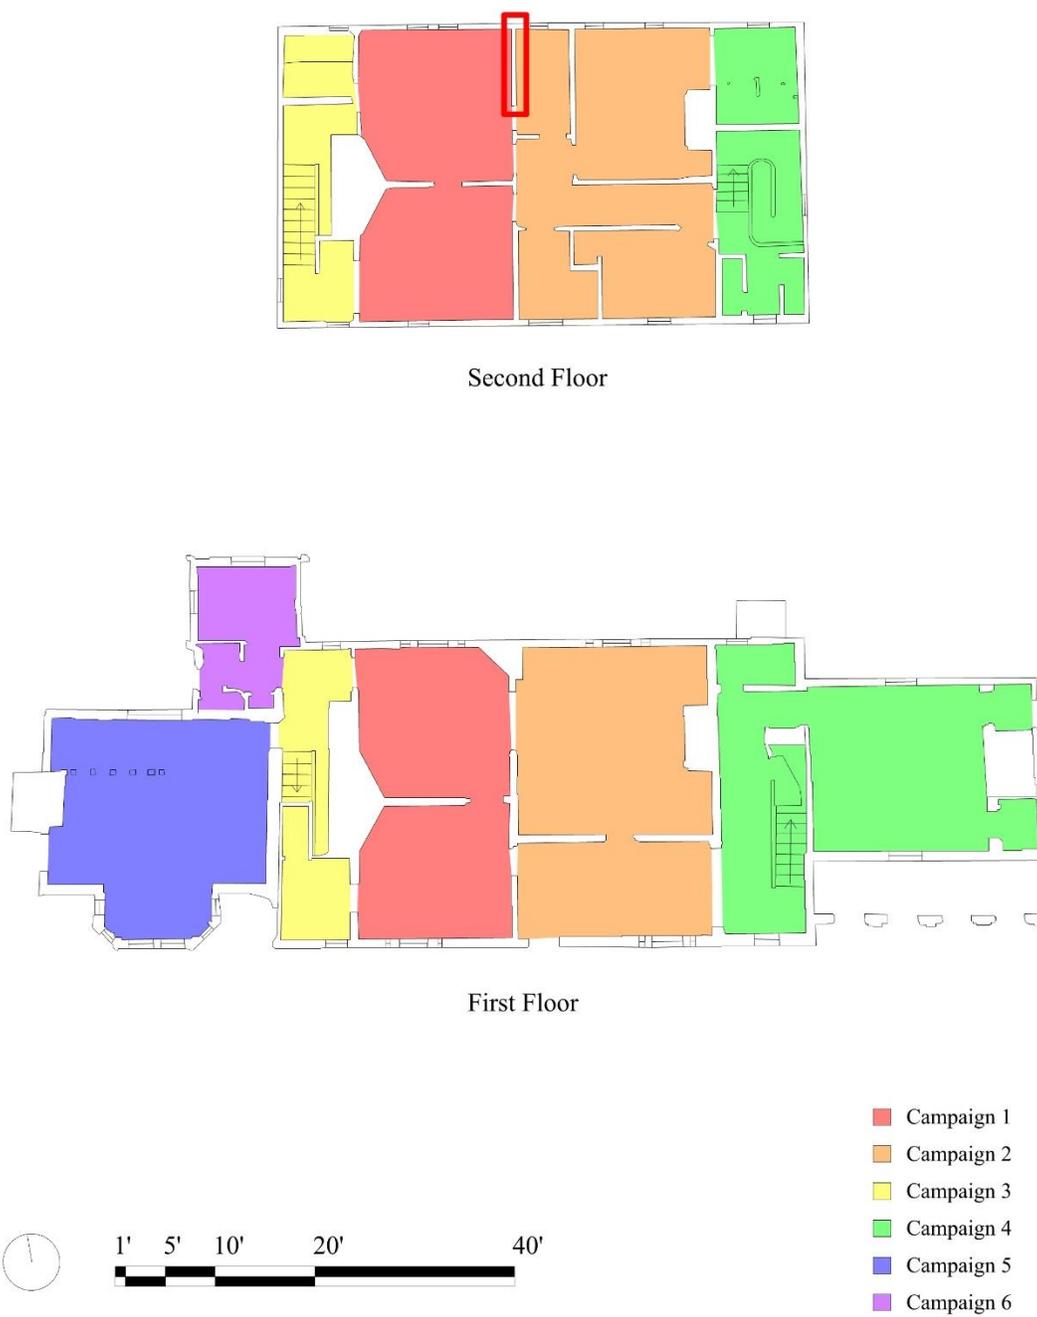
Figure 54: The location of the second-floor wall dividing Campaign One and Campaign Two with mortise and tenon construction is highlighted in red. This wall is the only exposed wall upstairs.
