The Six Building Campaigns at Sylvania:

The Transformation of Sylvania from a Folk Plantation House to a Fashionable Plantation,

1790-1865

Victoria Mae Bitrick

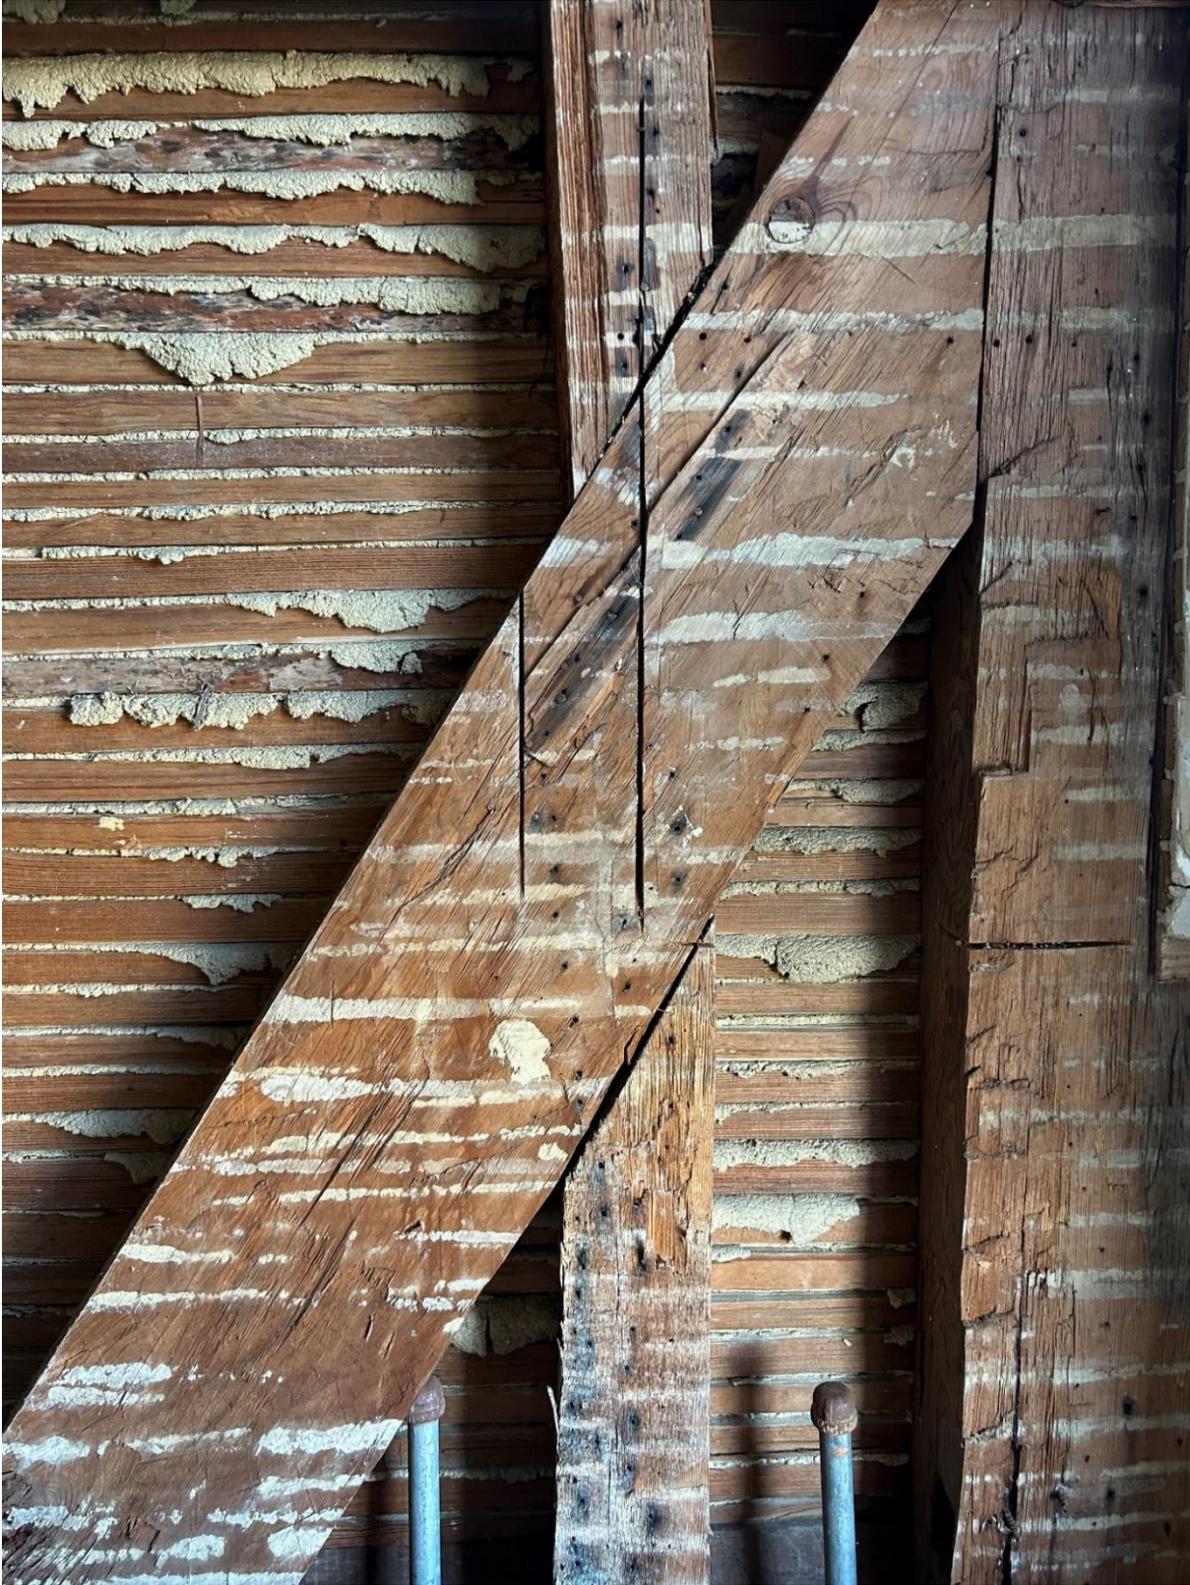
Figure 55: Photo of structural members on the second floor dividing Campaign One and Campaign Two. According to Mark Kutney, there is evidence for mortise and tenon construction joining the cross brace.

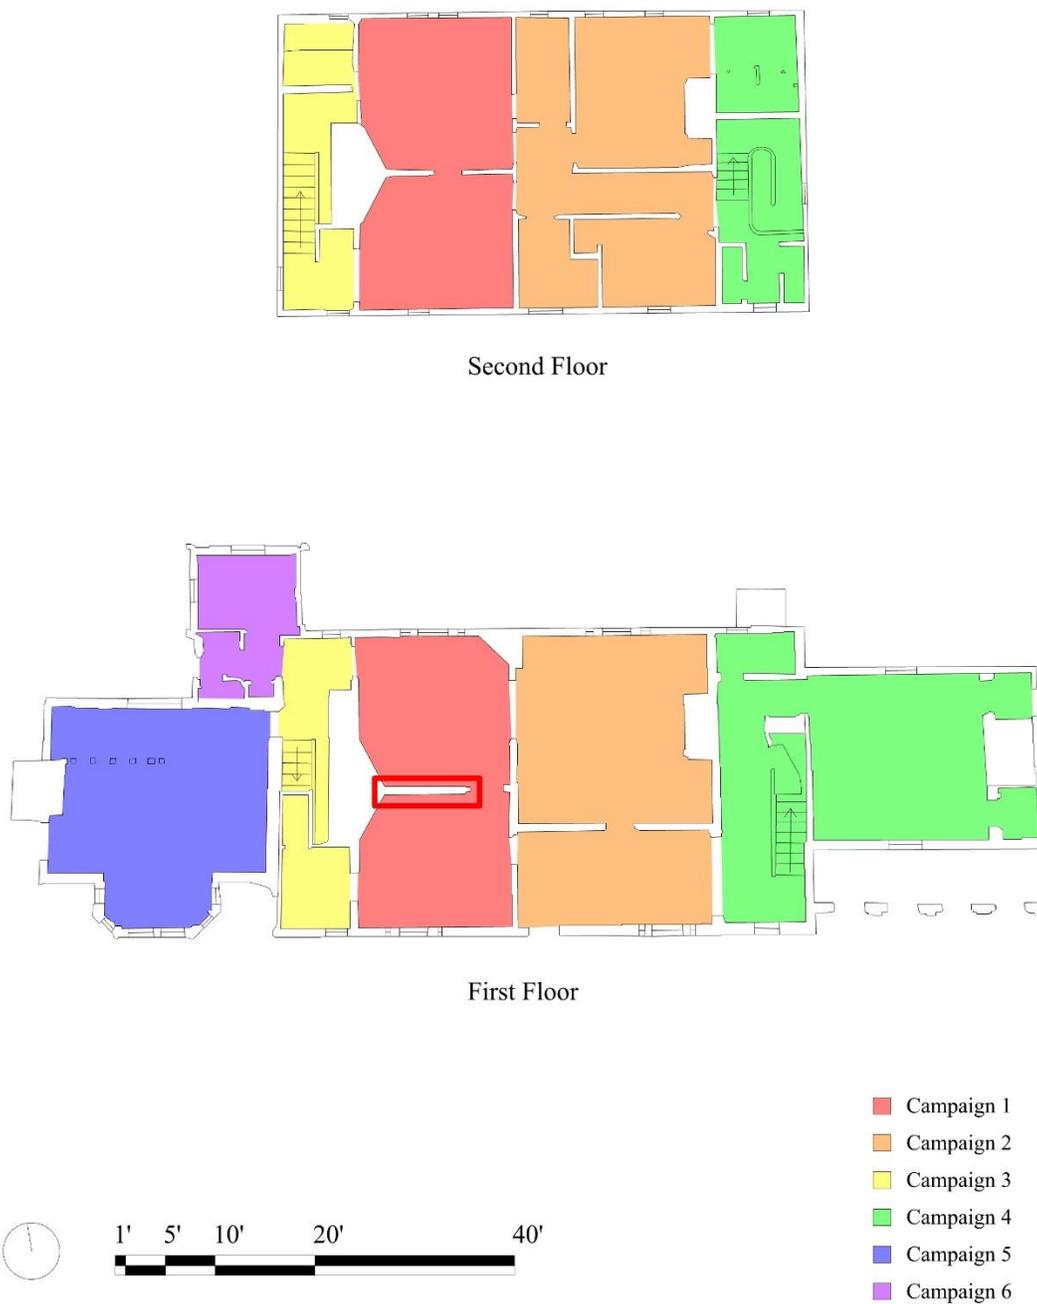
Figure 56: The location of the first-floor wall with mortise and tenon construction dividing the two rooms in Campaign One.

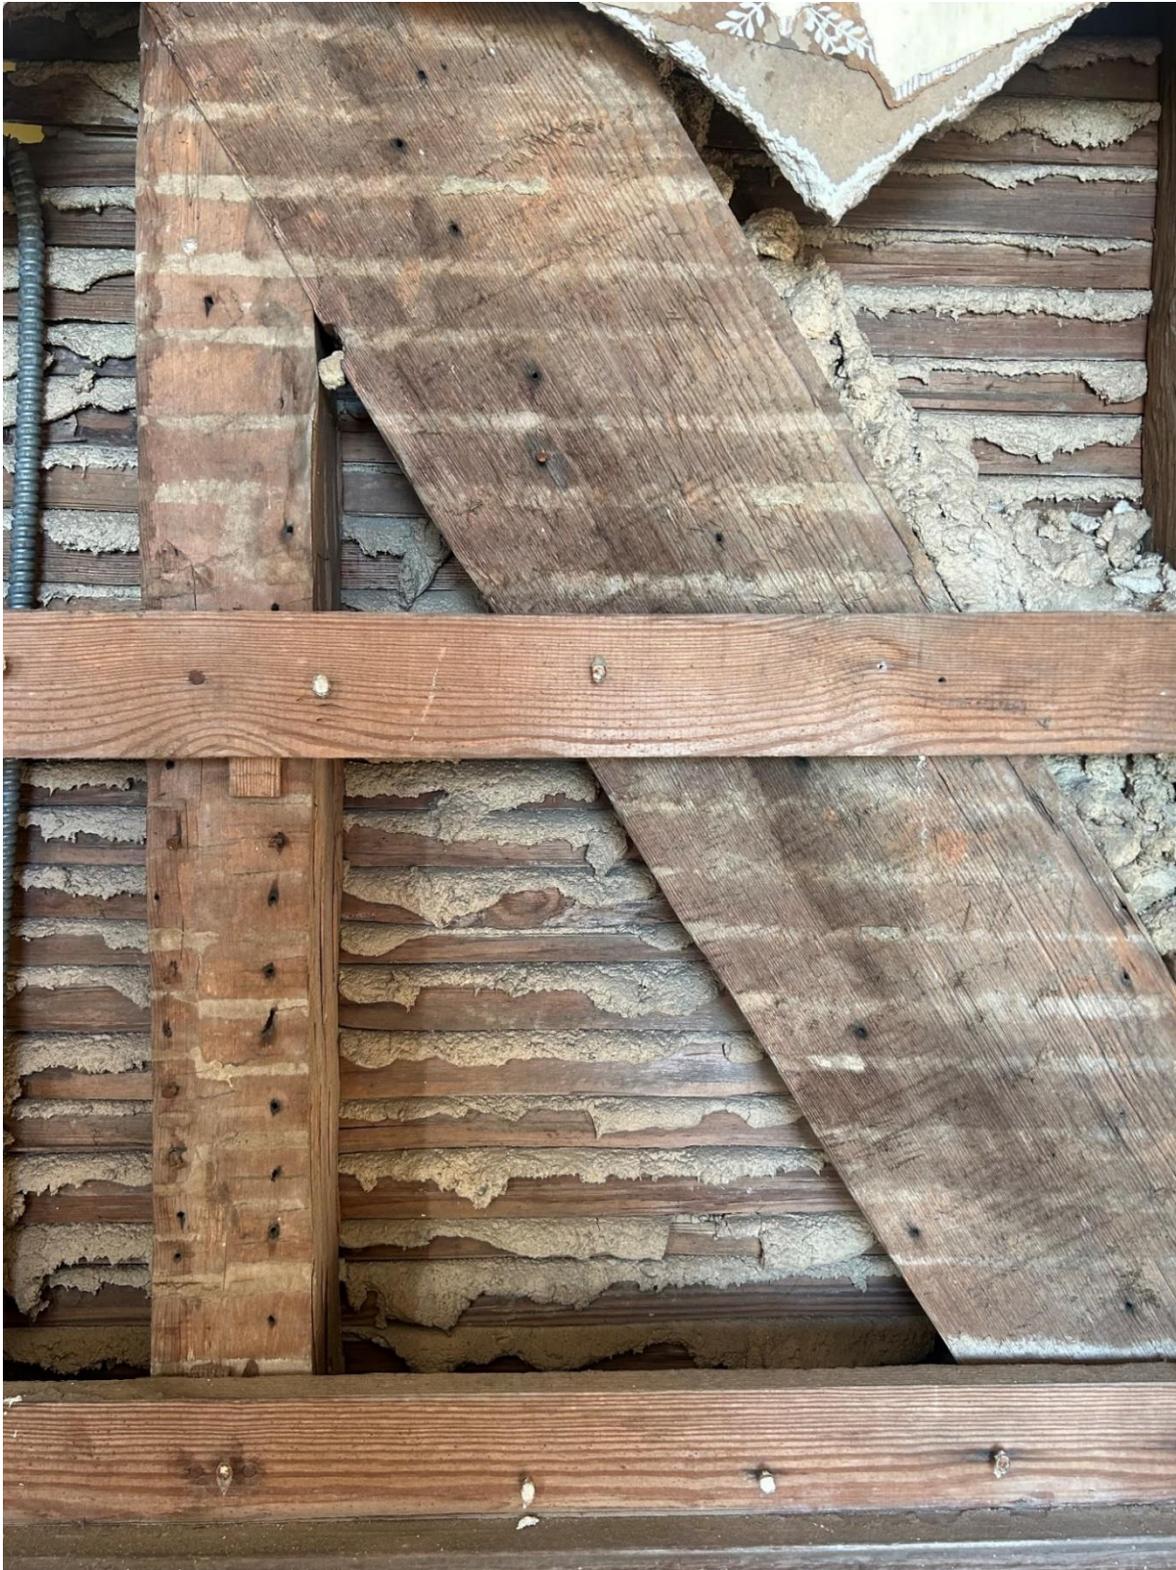
Figure 57: A photo of the visible structural members on the first-floor wall of Campaign One that divides its two rooms. The cross brace is the diagonal wood member in the photo.

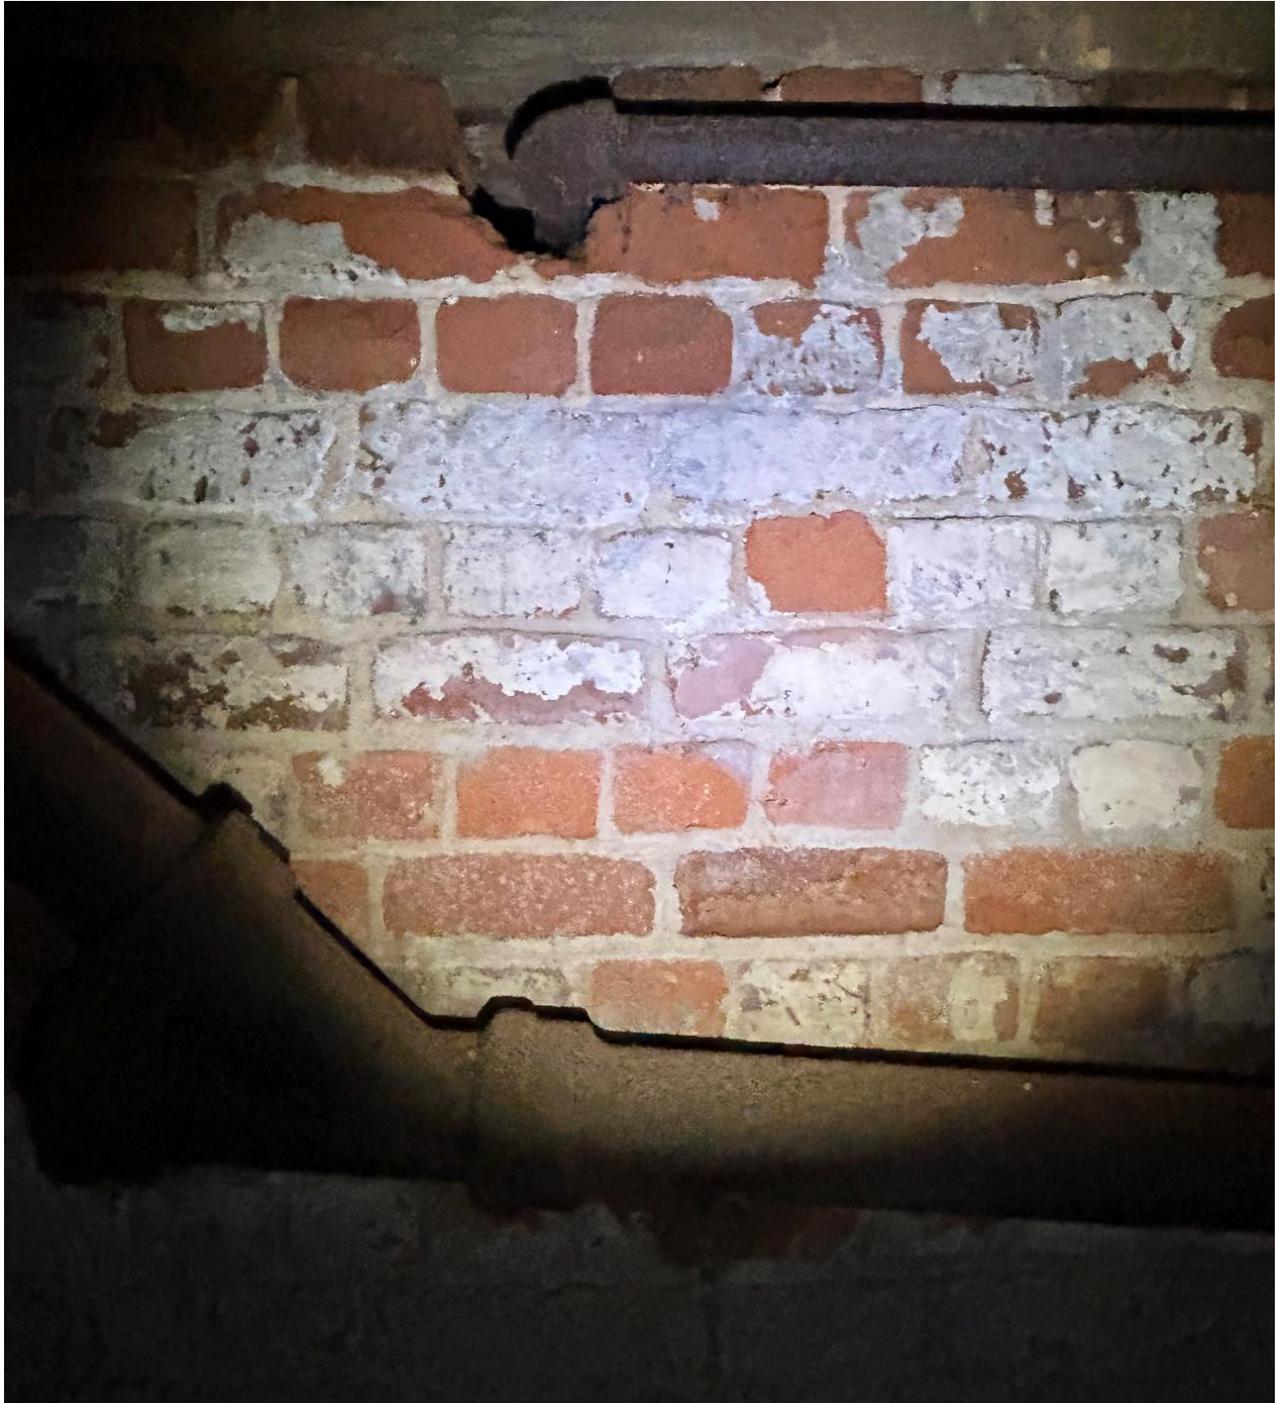
Figure 59: The English bond present on the cellar wall separating Campaign One from Campaign Two with a pattern of alternating headers and stretchers.

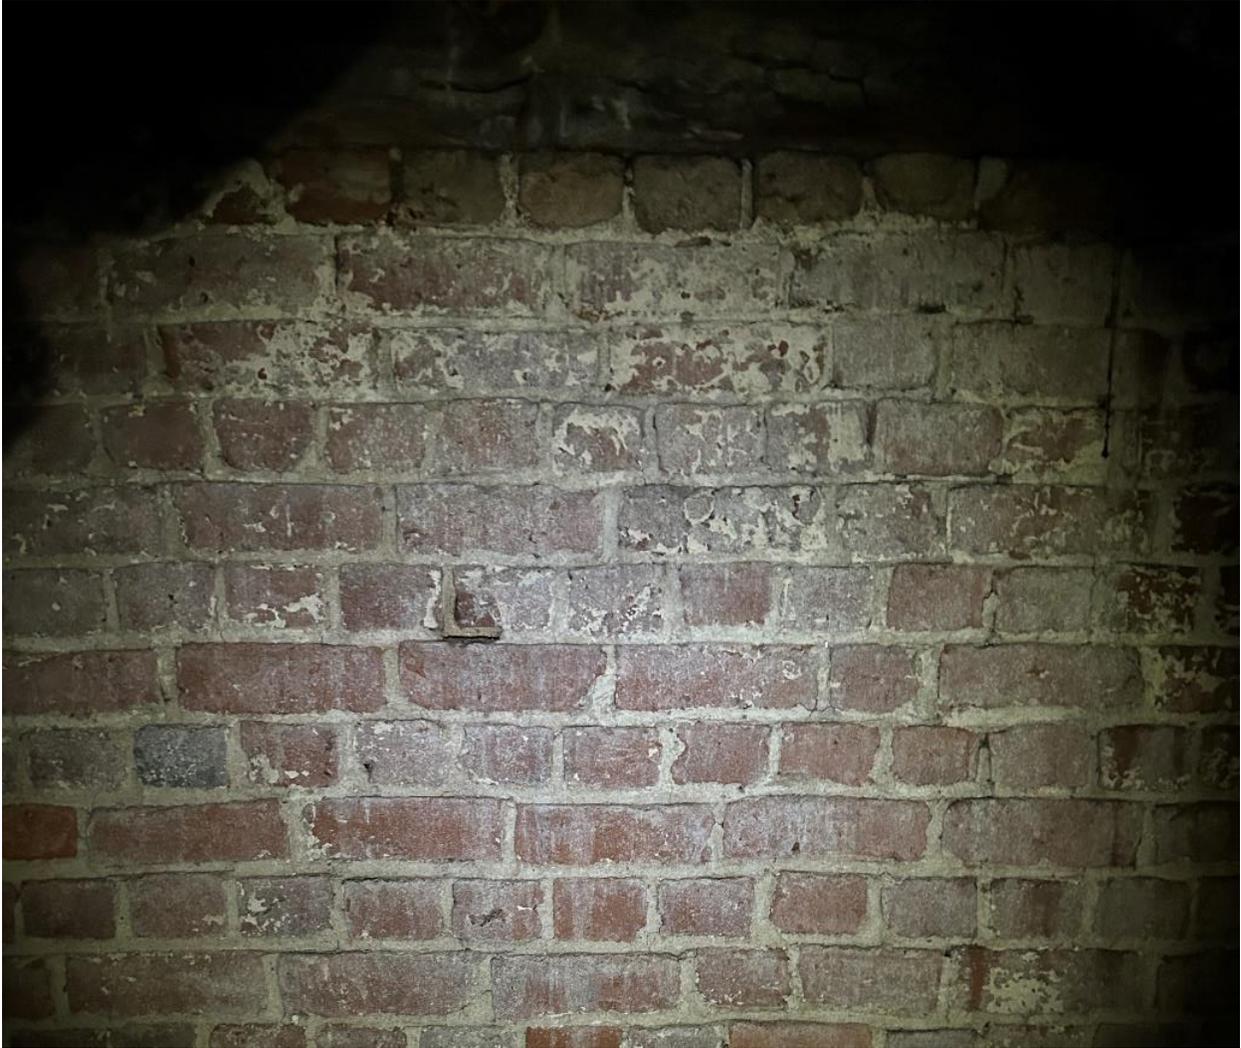
Figure 60: English bond on the southern cellar wall under Campaign Two.

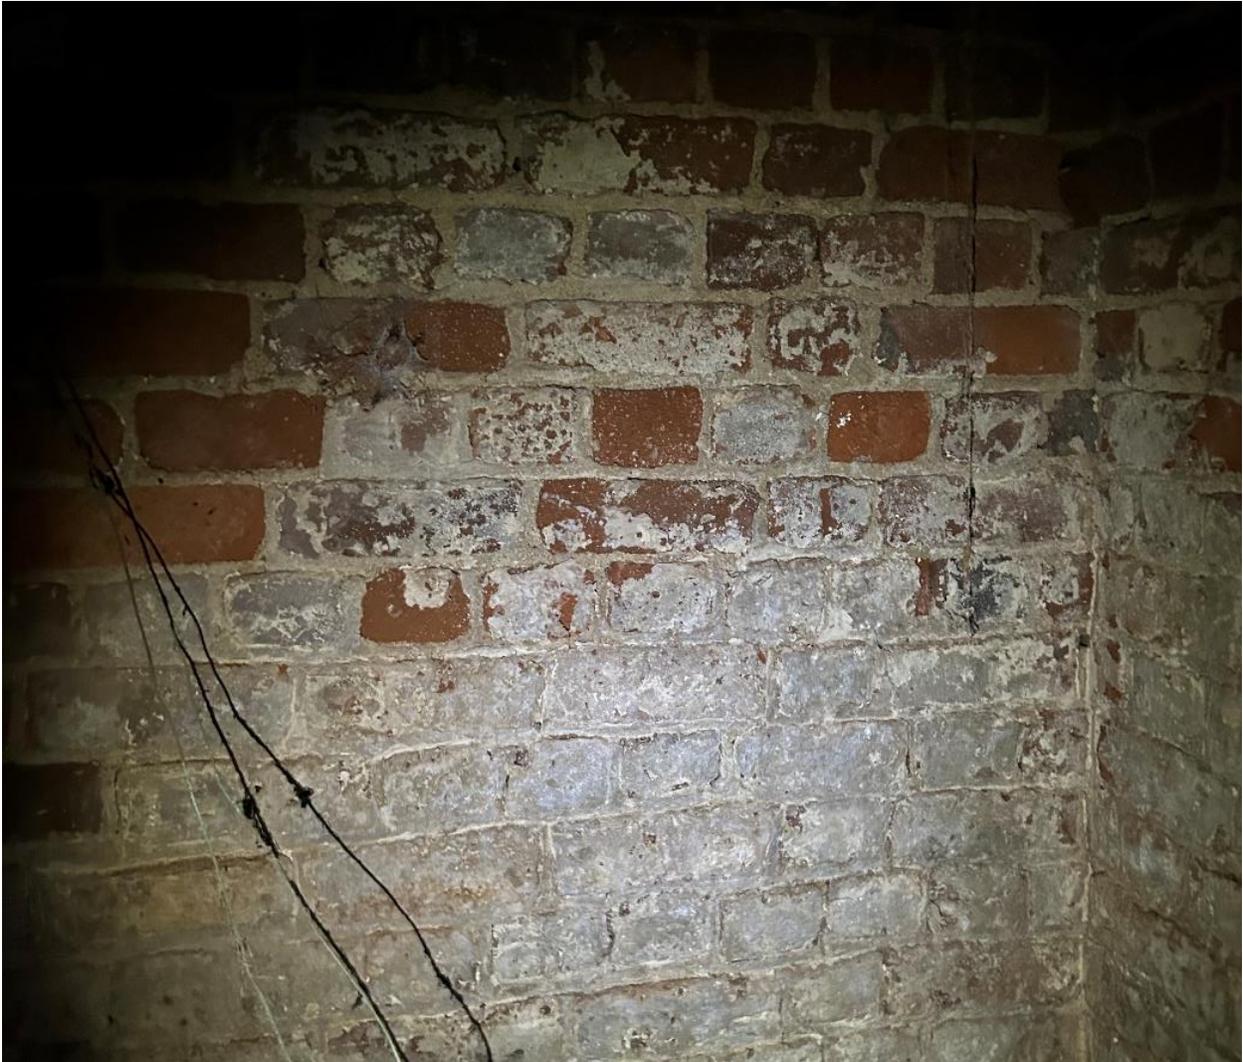
Figure 61: English bond on the eastern cellar wall under Campaign Two.

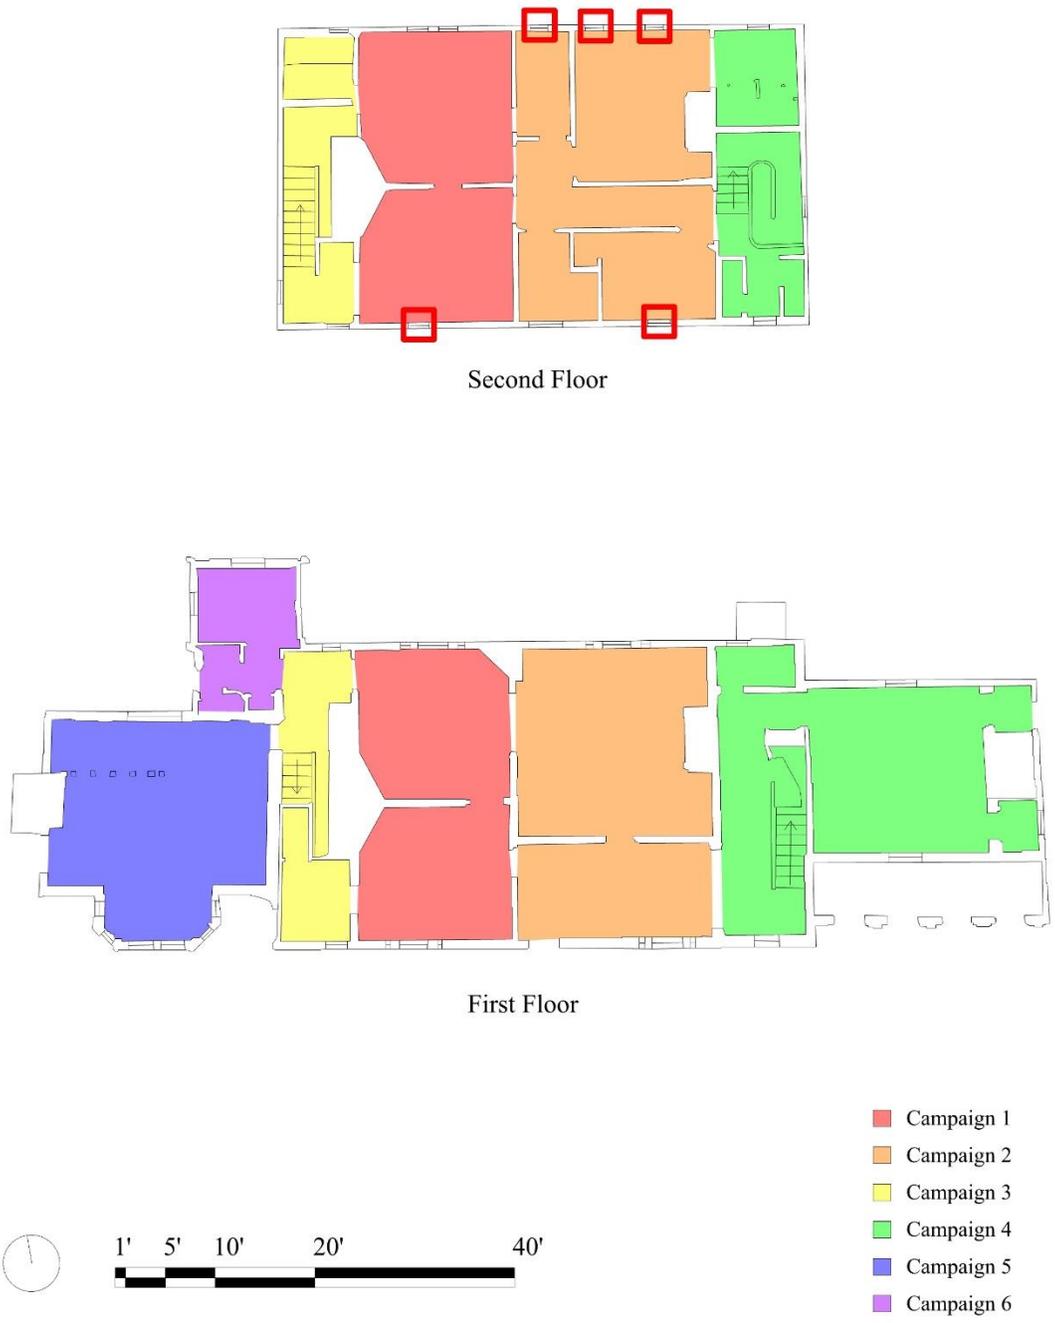
Figure 63: The location of the windows with matching trim that are in Campaign One and Campaign Two. The tripartite windows on the first floor are excluded since they are later additions. The double window on the north side of the second floor is also excluded. The southern window on the second floor of Campaign One matches the windows found on the second floor of Campaign Two, implying that those windows were added at the same time.

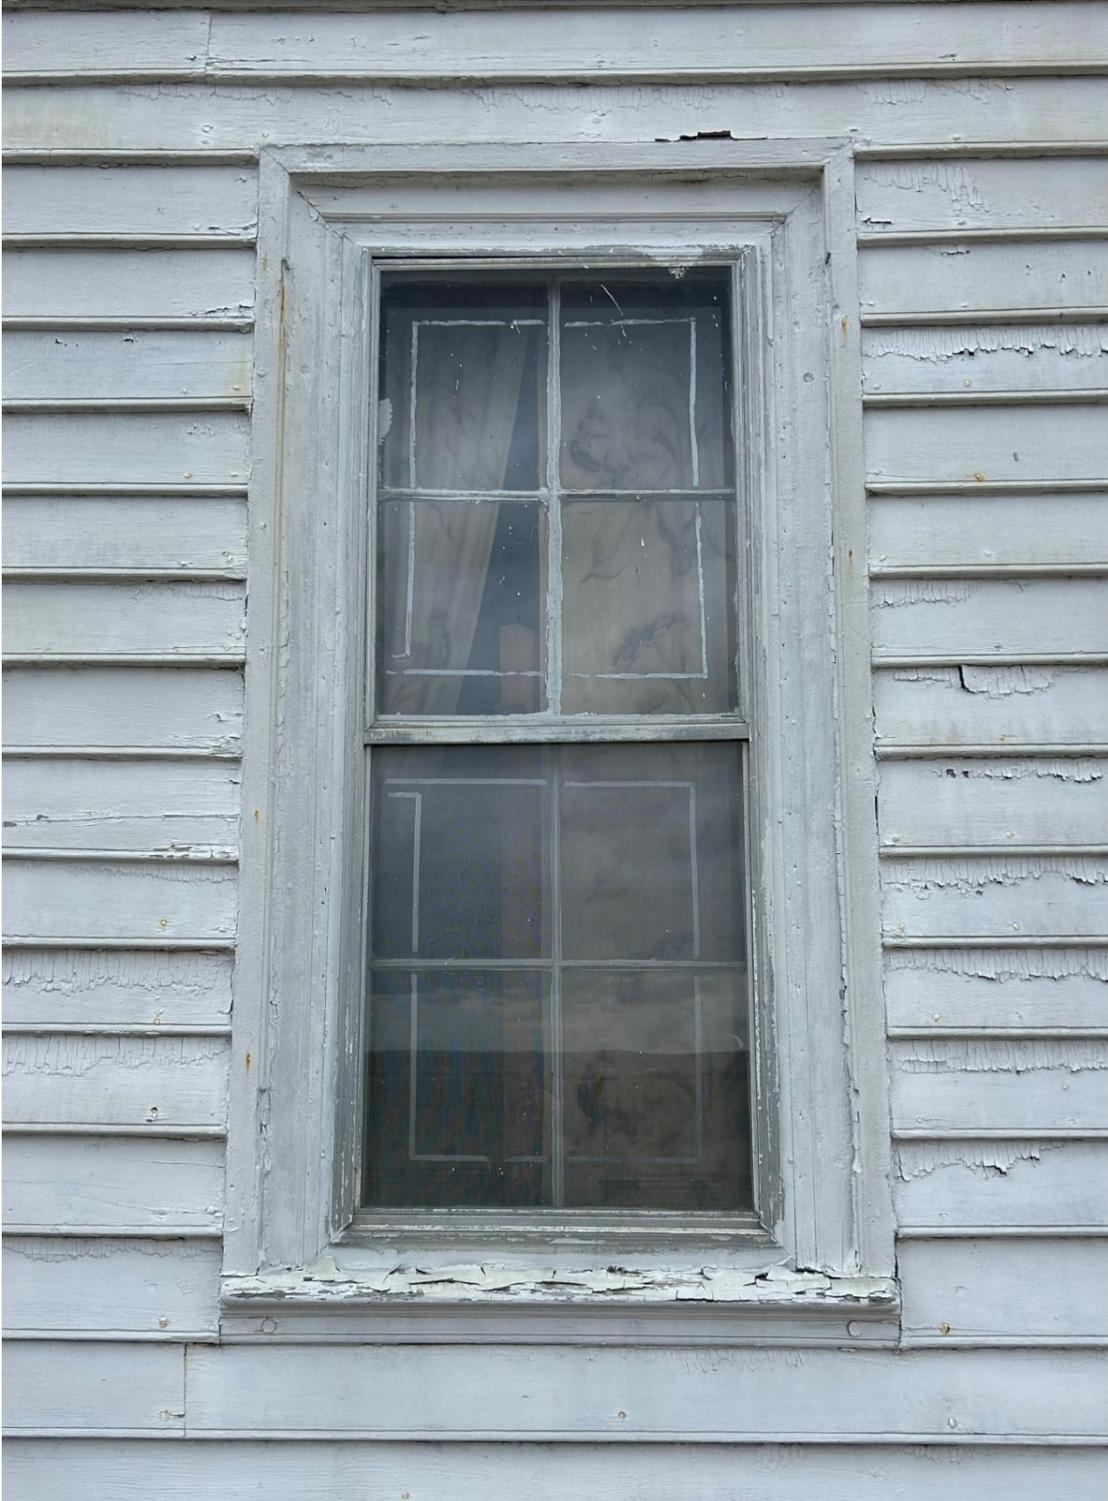
Figure 64: An example of a federal style exterior window trim found on the South elevation, according to Doug Gilpin. This window is in Campaign Three and matches those seen on the second floor of Campaign One and Campaign Two that were highlighted in Figure 63.

Figure 64: An example of a federal style exterior window trim found on the South elevation, according to Doug Gilpin. This window is in Campaign Three and matches those seen on the second floor of Campaign One and Campaign Two that were highlighted in Figure 63.

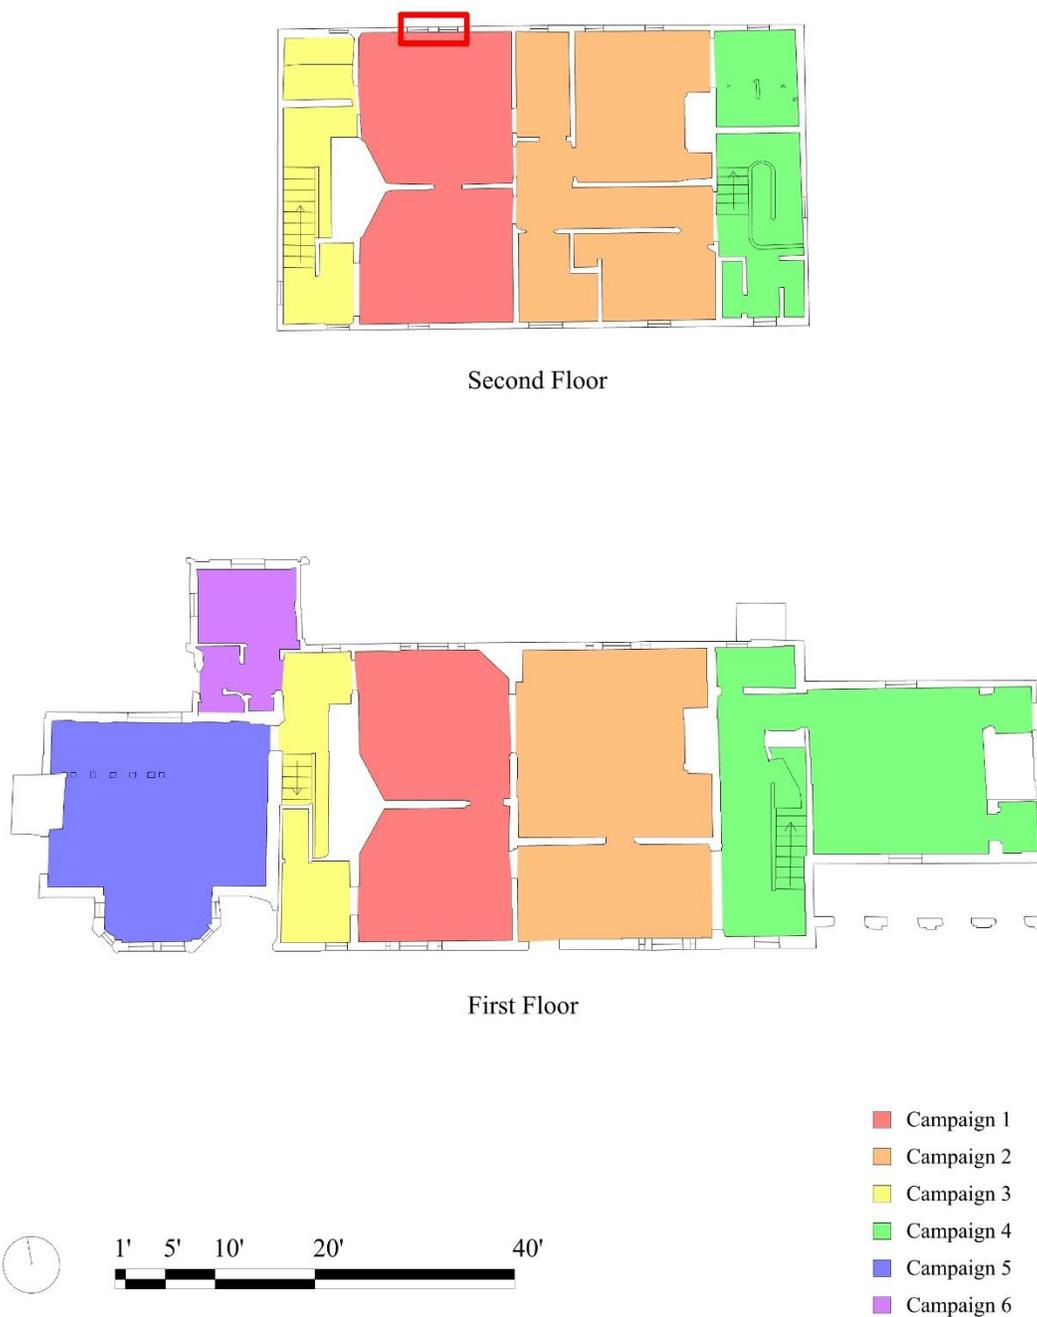
Figure 65: The location of double window in Campaign One that does not match any other window found in Campaign One and Campaign Two. This window is thought to be a later modification, as the only other double window found in the house is in Campaign Five.

Figure 65: The location of double window in Campaign One that does not match any other window found in Campaign One and Campaign Two. This window is thought to be a later modification, as the only other double window found in the house is in Campaign Five.

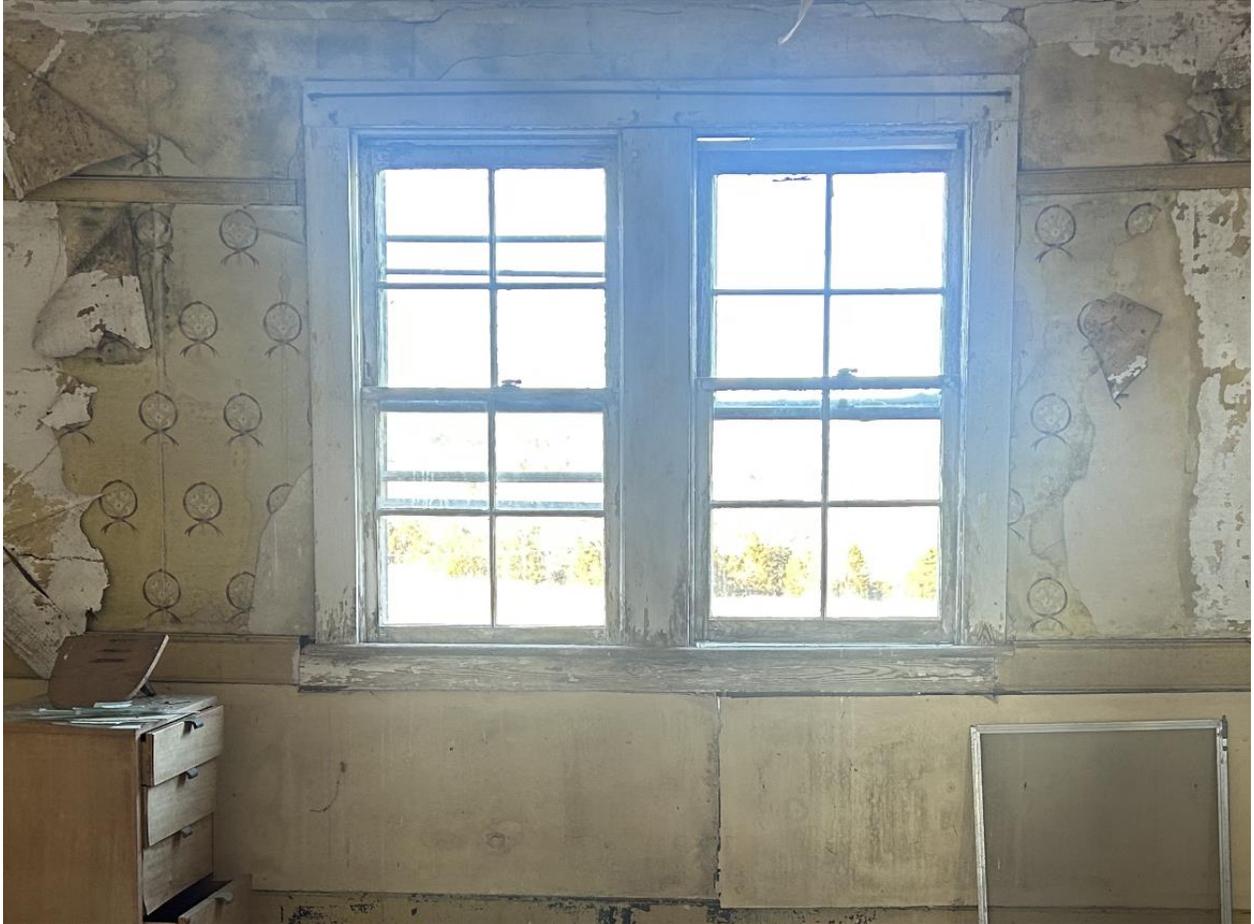
Figure 66: A photo of the double window on the northern end of the second floor of Campaign One. The trim surrounding this window is simpler than the other trims on the second floor.

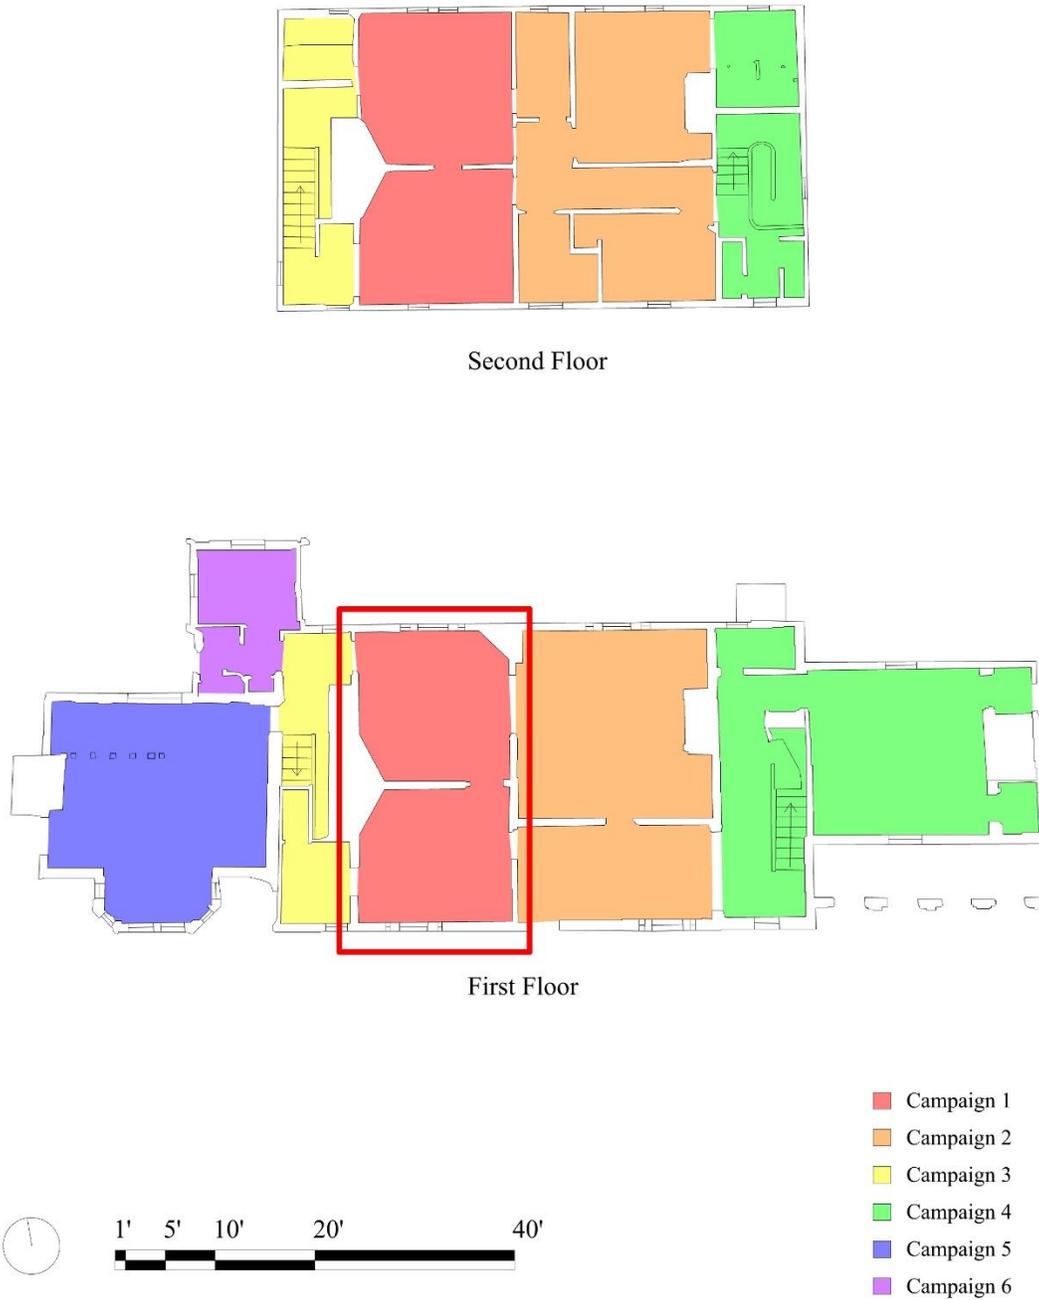
Figure 67: The location of matching baseboard and chair rails on the first floor of Campaign One. These baseboards and chair rails are not found anywhere else in the house.

Figure 67: The location of matching baseboard and chair rails on the first floor of Campaign One. These baseboards and chair rails are not found anywhere else in the house.

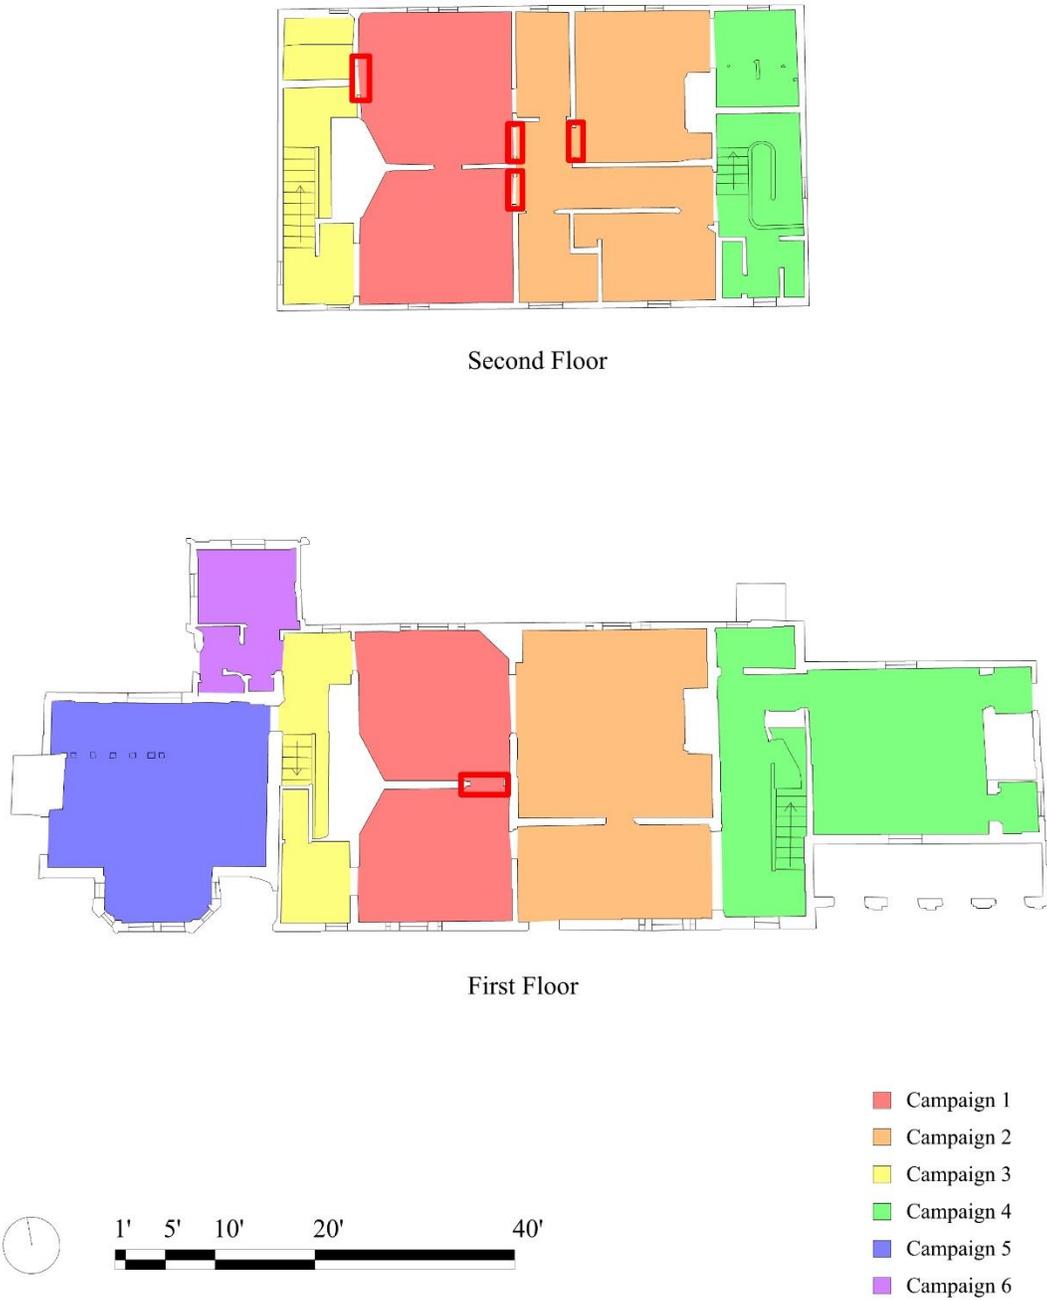
Figure 68: The location of the matching door trims shared between Campaign One and Campaign Two located on the first and second floors.

A look at the door trims in Campaign One offers interesting information about the campaign as well. On the first floor of Campaign One, there are two main door trims used. One of them matches the trim used in Campaign Three, making it likely that those were altered or added during Campaign Three's renovation. There is another door trim profile that only appears once on the first floor, but four times on the second floor of Campaign One and Campaign Two (Fig 68). On the first floor of Campaign One, this trim appears on the door connecting its two rooms. On the second floor, the trim is present on the doors connecting Campaign One to the hallway in Campaign Two and the door connecting Campaign One to Campaign Three. This trim also appears on a door connecting the northeast bedroom in Campaign Two to the hallway. The occurrence of these trims in both campaigns supports the theory that Campaign One and Campaign Two always existed together. The use of this trim on the first-floor door connecting the two rooms in Campaign One is interesting because if it did exist apart from Campaign Two, that would have been the only connection between those two rooms, making that door an original door. However, this trim appearing on the doors linking Campaign One and Campaign Two imply that that trim was used when the two Campaigns existed together. Since the openings on the first floor between Campaign One and Campaign Two are known to be more modern, the original trim evidence in that area has been removed.

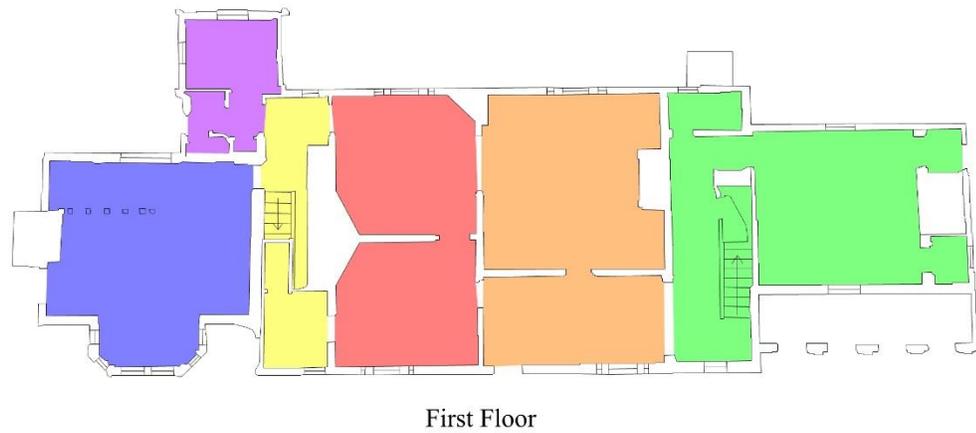
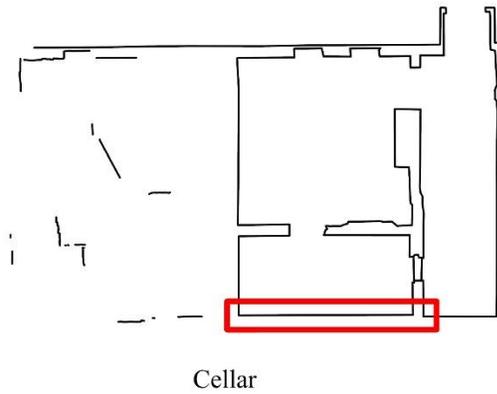
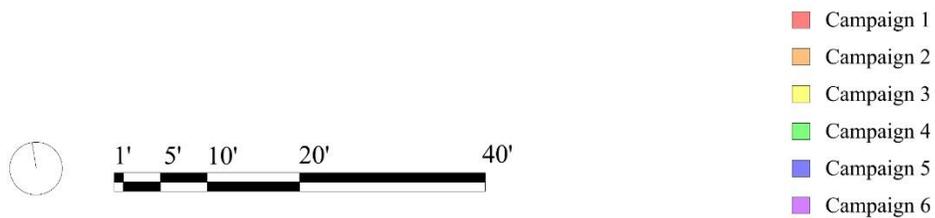
Figure 69: The location of the southern cellar wall under Campaign Two with Flemish bond on its exterior face and English bond on its interior face. This wall is consistent with most of the walls found in the cellar under Campaign Two.

Figure 69: The location of the southern cellar wall under Campaign Two with Flemish bond on its exterior face and English bond on its interior face. This wall is consistent with most of the walls found in the cellar under Campaign Two.

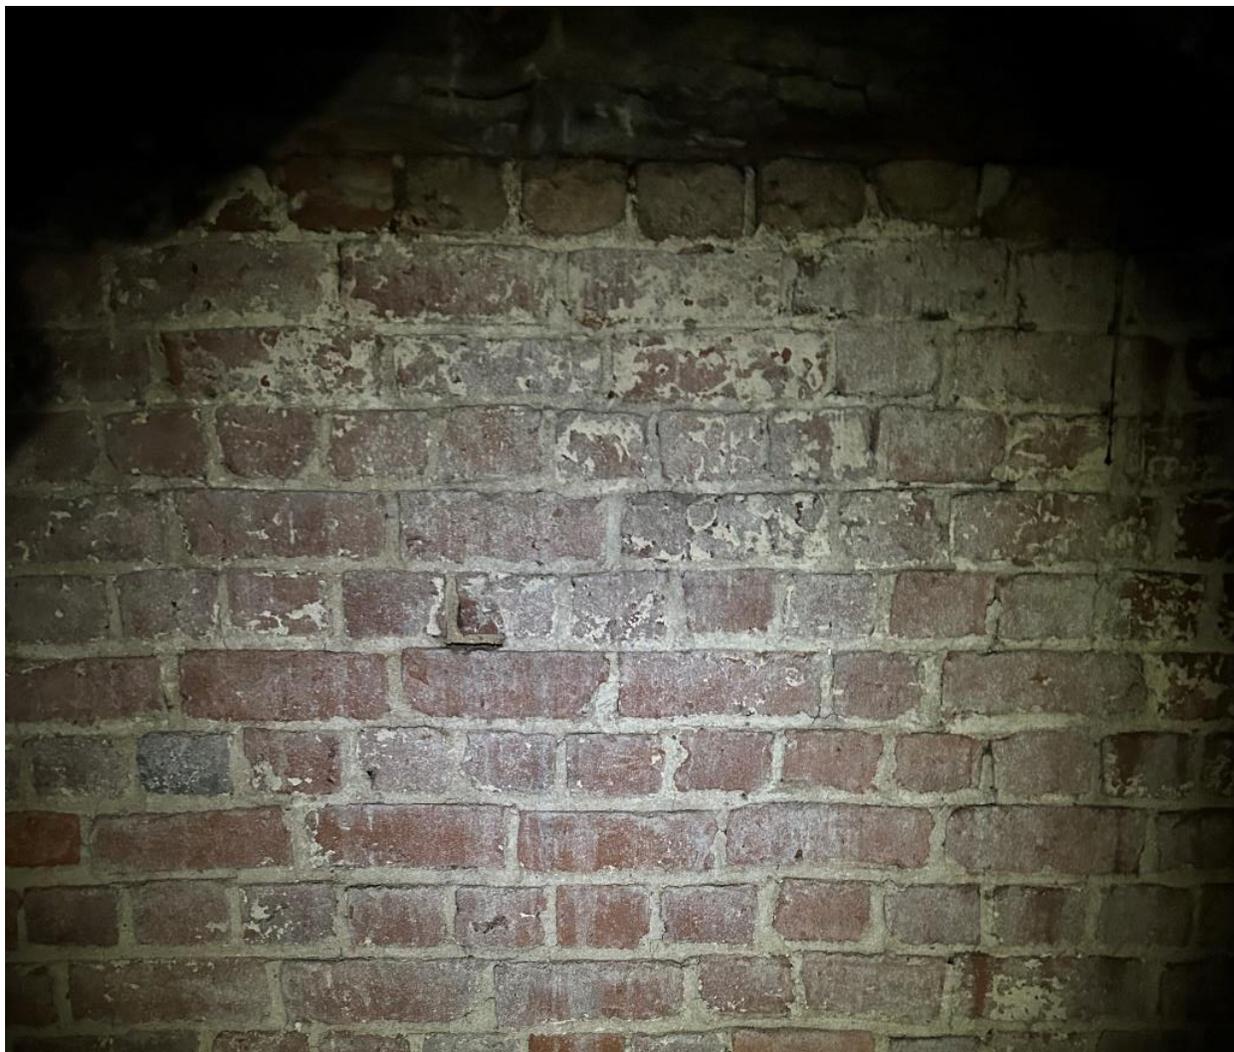
Figure 70: English bond on the southern cellar wall under Campaign Two.

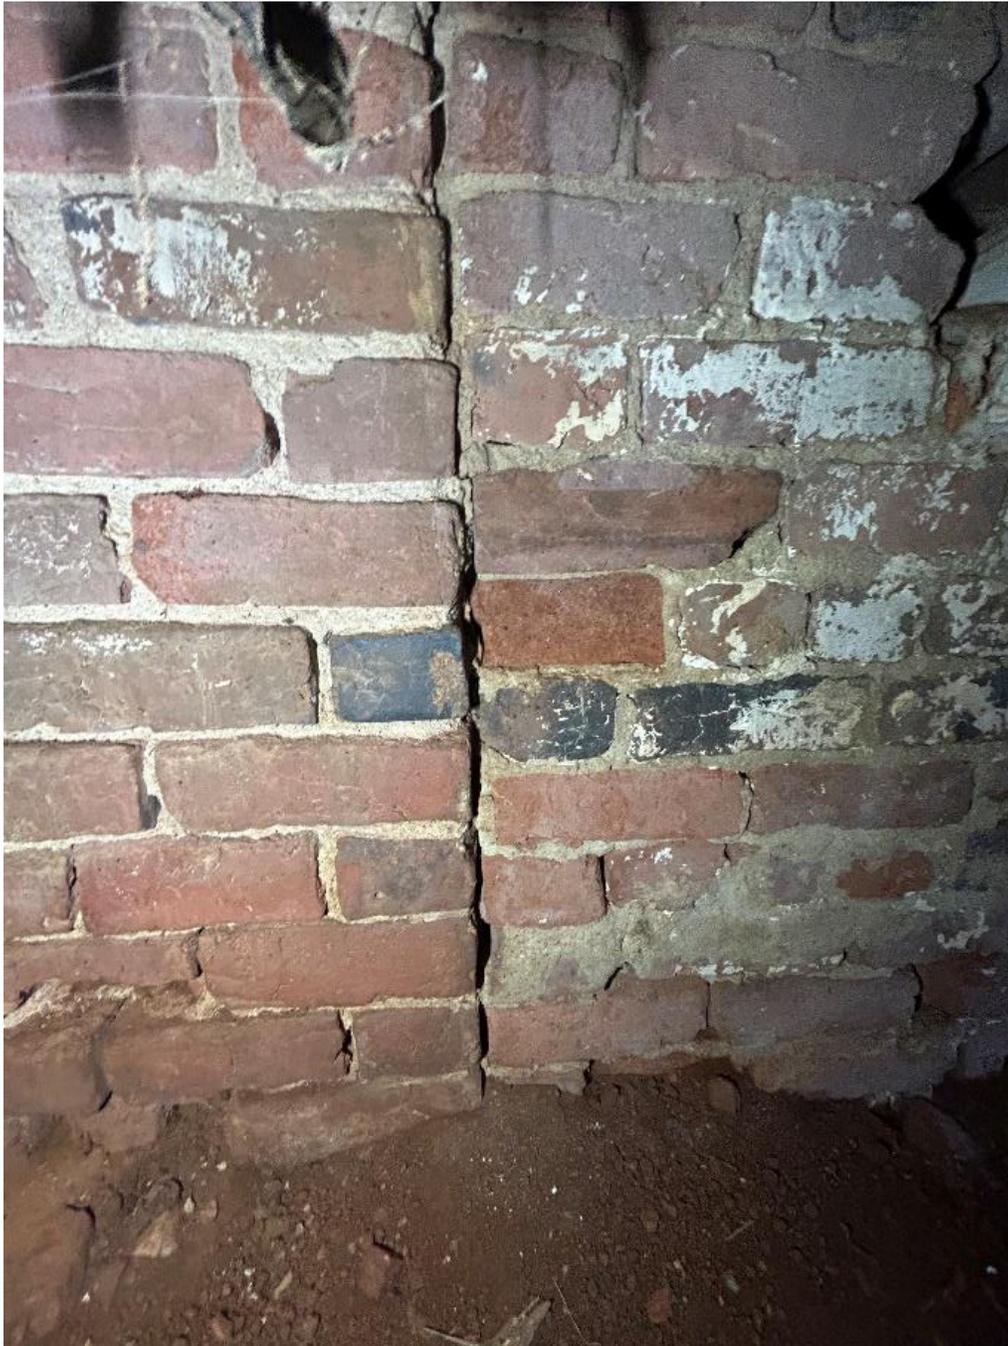
Figure 72: The break in cellar wall between Campaign Two and Campaign Four.

On the eastern brick wall in the cellar of Campaign Two, the wall has a clear break between the wall supporting the east wall of the southern entrance hall and the east wall of the large northern room (Fig 72-73). The wall under the entrance hall is English Bond and has a barred window (Fig 74-75). The window is joined with pegs, giving it an older date.¹⁰⁴ The English bond is consistent with Campaign One's wall, again indicating that the two campaigns are close in age or the same age. The eastern wall under the northern room in Campaign Two does not have an English bond. Instead, it has an irregular pattern of 1 header course, 4 stretcher courses, 1 header course, 6 stretcher courses, 1 header course, 2 stretcher courses, 1 header course, and 3 stretcher courses (Fig 76). This portion of the wall has been altered to allow room for piping, indicating the entire wall had been tampered with. Furthermore, since it is adjacent to the rebuilt chimney, it is possible that this wall was altered when the chimney was rebuilt.¹⁰⁵
