The Six Building Campaigns at Sylvania:

The Transformation of Sylvania from a Folk Plantation House to a Fashionable Plantation,

1790-1865

Victoria Mae Bitrick

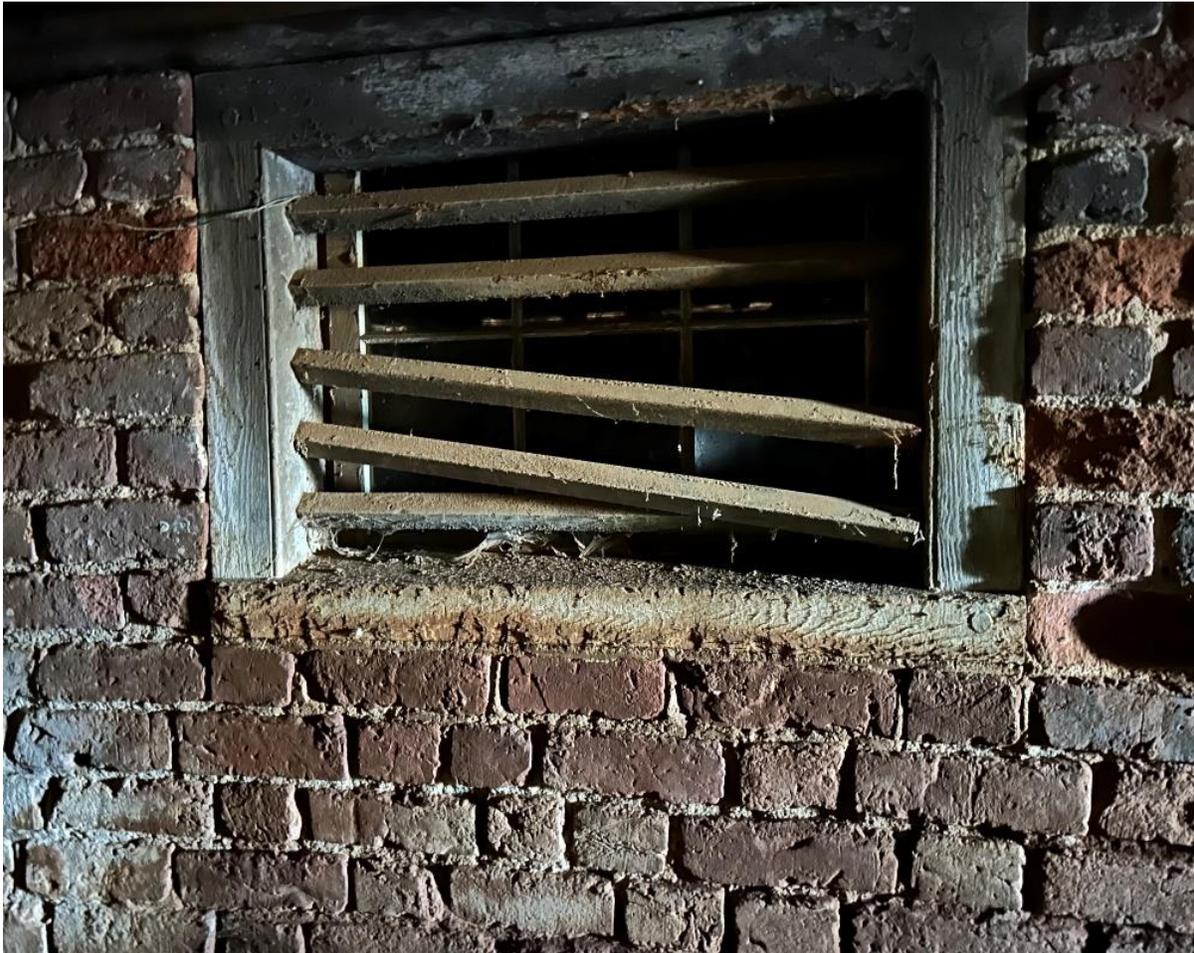
Figure 74: The barred window in the eastern wall of Campaign Two that now divides Campaign Two from Campaign Four. The barred side faces out into Campaign Four's cellar.

On the eastern brick wall in the cellar of Campaign Two, the wall has a clear break between the wall supporting the east wall of the southern entrance hall and the east wall of the large northern room (Fig 72-73). The wall under the entrance hall is English Bond and has a barred window (Fig 74-75). The window is joined with pegs, giving it an older date.¹⁰⁴ The English bond is consistent with Campaign One's wall, again indicating that the two campaigns are close in age or the same age. The eastern wall under the northern room in Campaign Two does not have an English bond. Instead, it has an irregular pattern of 1 header course, 4 stretcher courses, 1 header course, 6 stretcher courses, 1 header course, 2 stretcher courses, 1 header course, and 3 stretcher courses (Fig 76). This portion of the wall has been altered to allow room for piping, indicating the entire wall had been tampered with. Furthermore, since it is adjacent to the rebuilt chimney, it is possible that this wall was altered when the chimney was rebuilt.¹⁰⁵

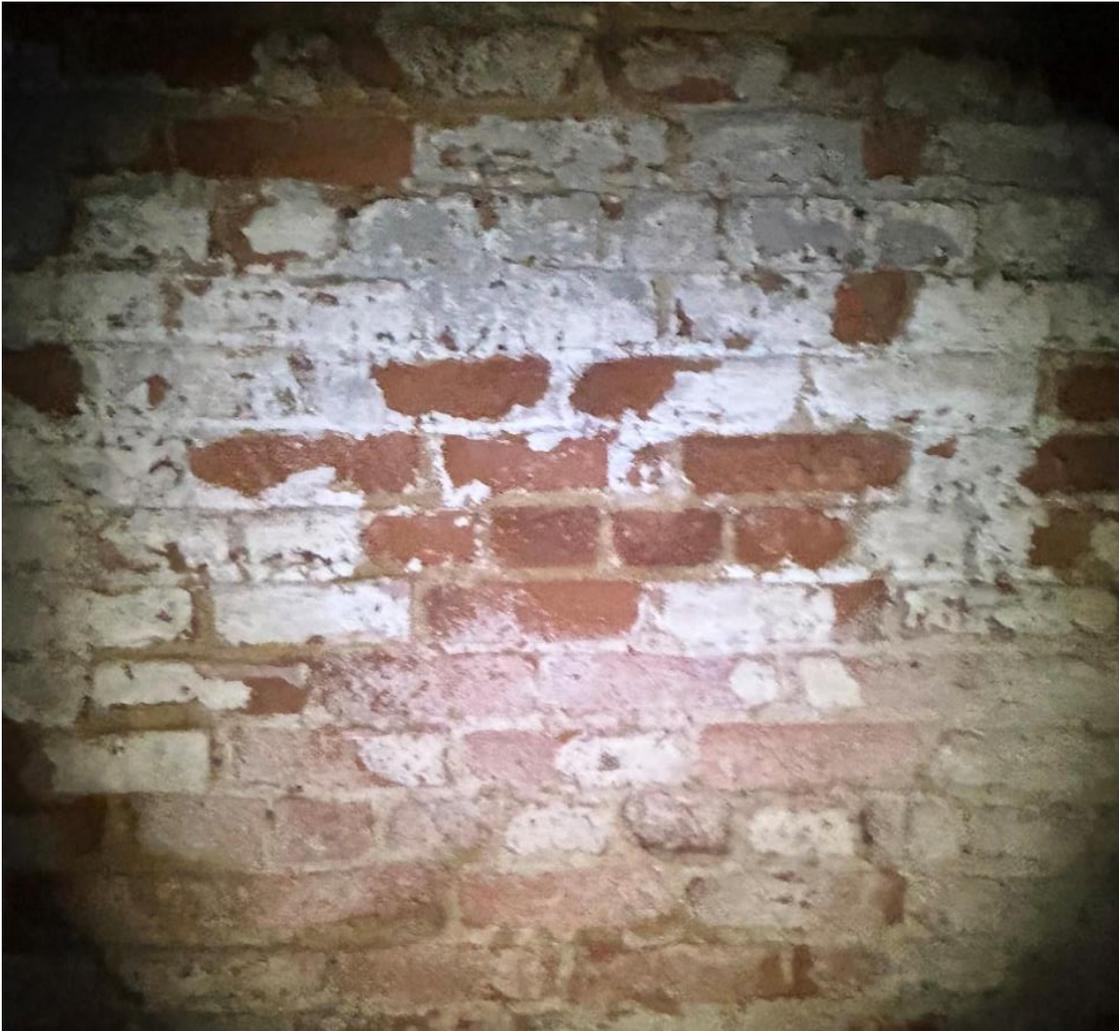
Figure 77: One-to-three bond on the wall dividing the north and south ends of Campaign Two's cellar. This is the only location with One-to-three bond in Campaign Two. It is also seen on the diagonal wall under Campaign One, shown in Figure 114.

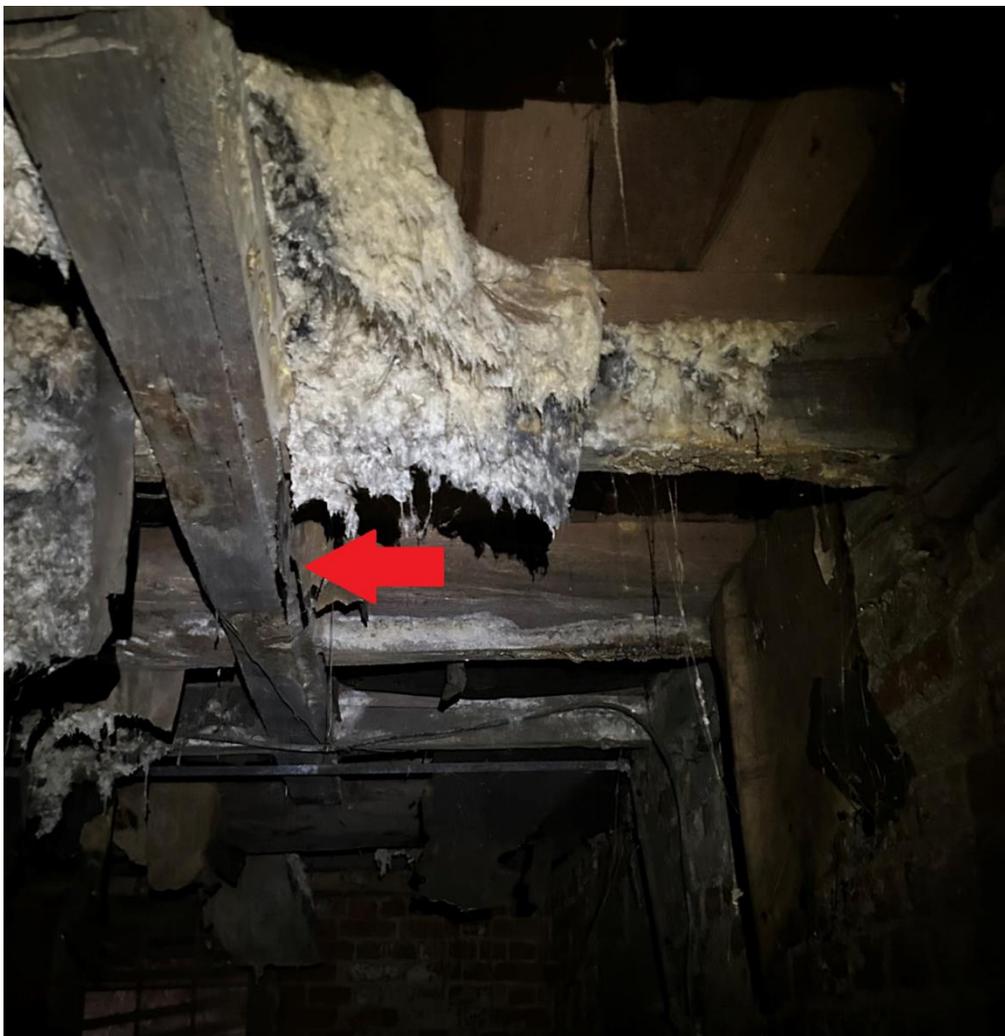
Figure 80: The arrow points to the cross bracing indicating where an original stair was in southeast corner of the cellar in Campaign Two. This bracing is perpendicular to the floor joists, and it is not present in any other location in the cellar. Its location corresponds to the evidence for stairs seen on the second floor. The National Park Service survey also proposed evidence for the outline of the stairs on the brick wall to the right of the bracing, but this evidence is not visible today.

Figure 81: The location of evidence in the cellar and in the second-floor southeast bedroom for the original staircase in the southeast corner of the first and second floor of Campaign Two. In the cellar, the evidence for the staircase is the cross bracing seen on the ceiling in Figure 80. On the second floor, the evidence for the staircase in this location are the ghost marks and the missing chair rail seen in Figures 82-84.

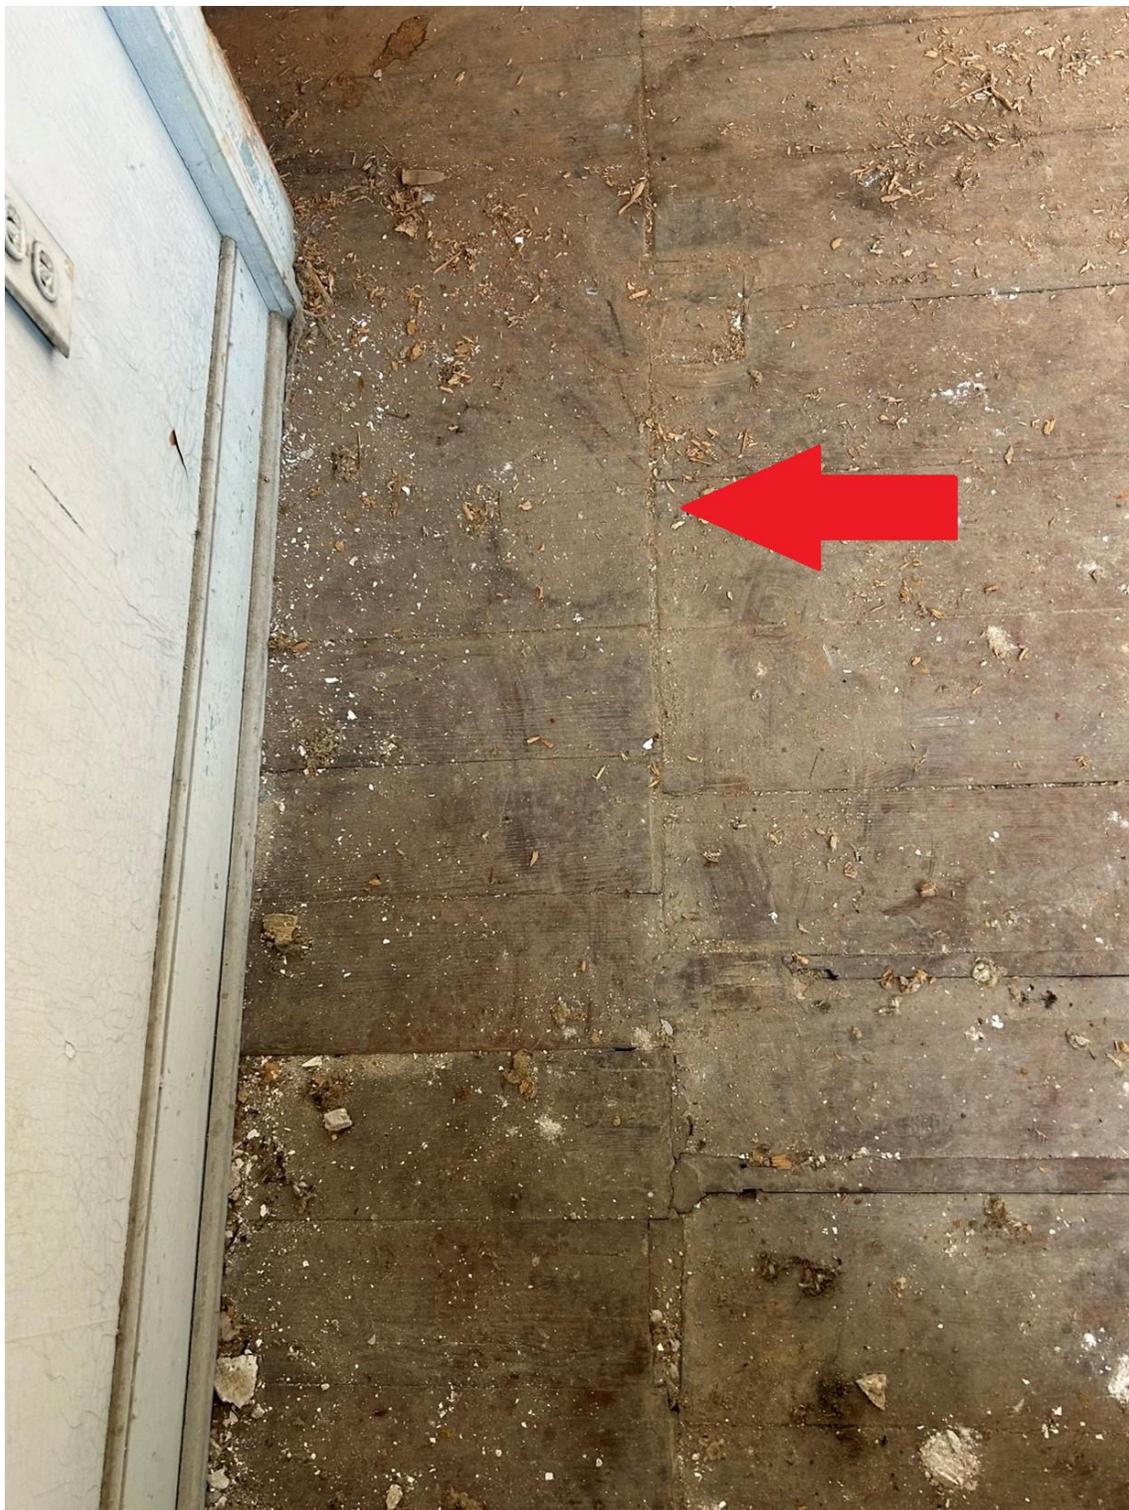
Figure 82: The ghost marks of an old wall are visible where a distinct line in the flooring runs across the floor. The ghost mark of a wall member, seen in Figure 83, is located along this line. This photo was taken in the southeast bedroom in Campaign Two. The ghost marks are adjacent to the evidence for the original stair in the cellar.

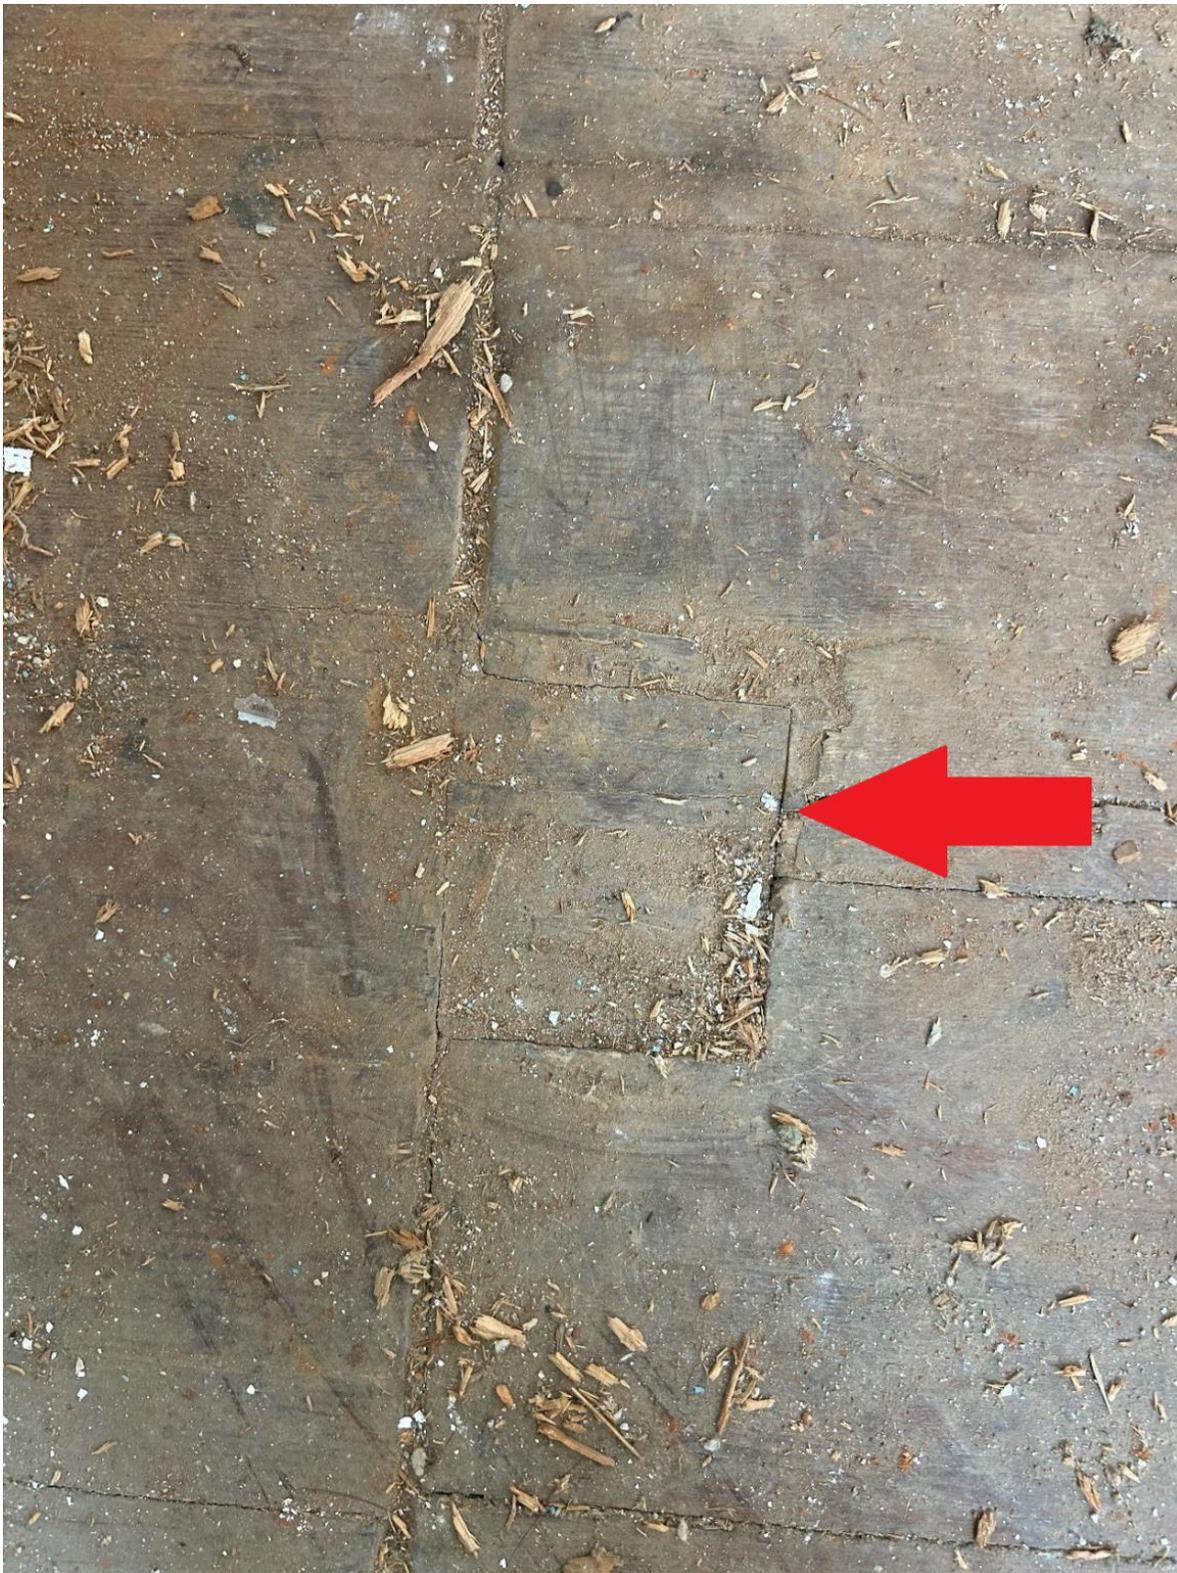
Figure 83: One of the ghost marks of a wall member in the southeast bedroom in Campaign Two that corresponds to the evidence for the original staircase in the cellar.

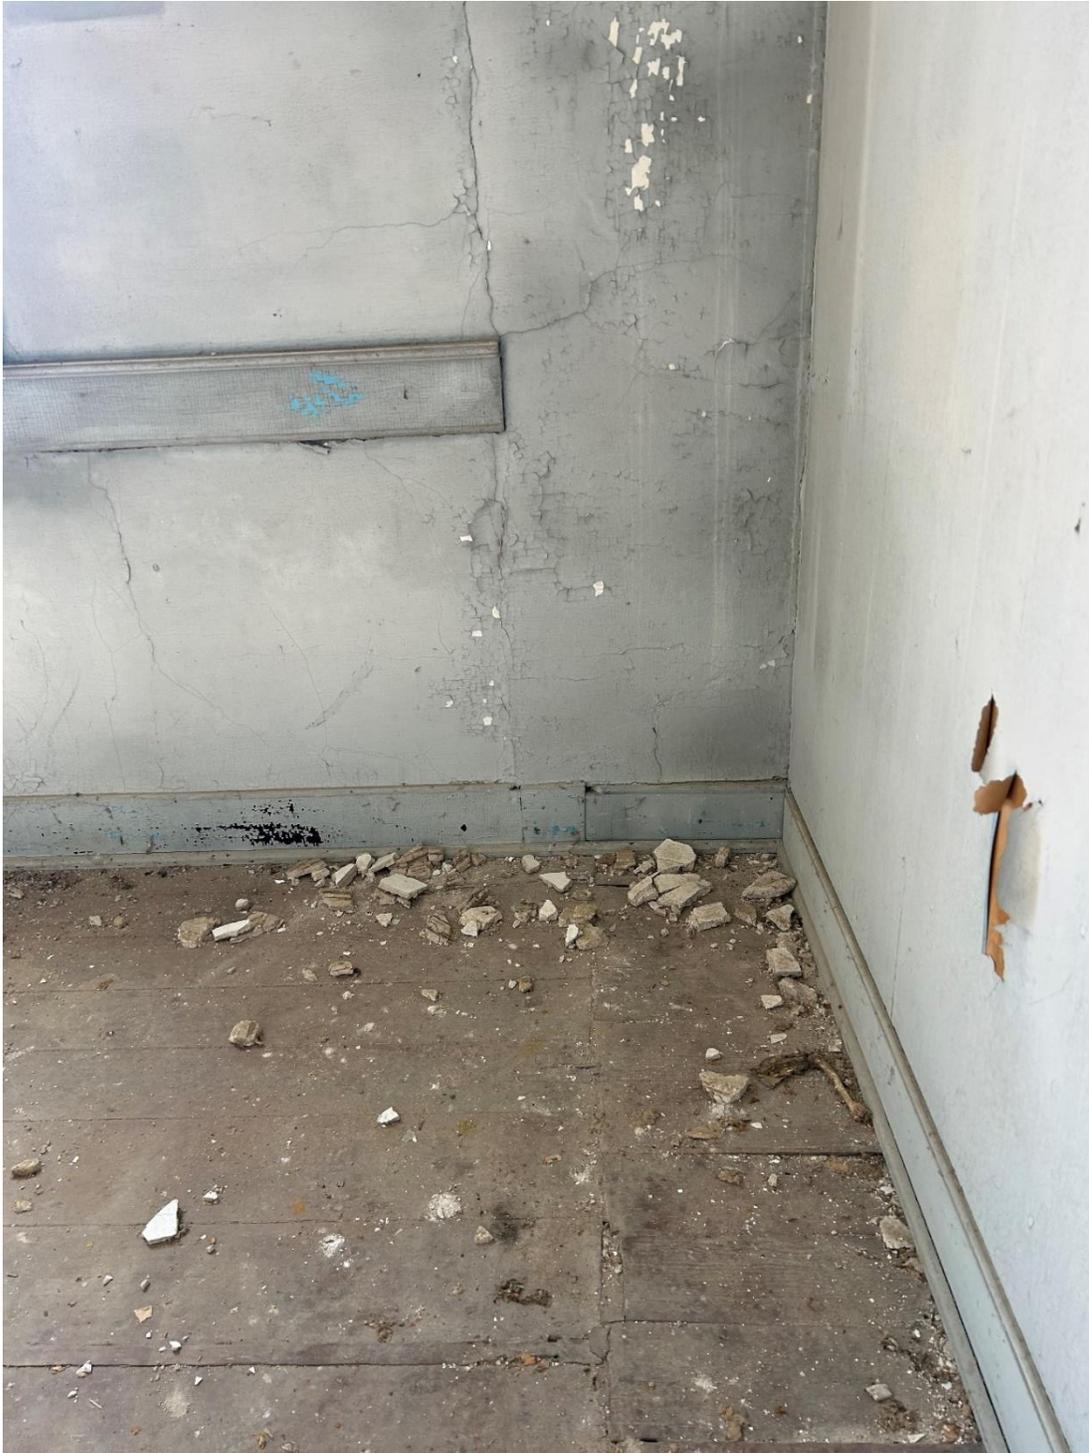
Figure 84: The area where the chair rail stops in the southeast bedroom in Campaign Two that coincides with the ghost marks of an older wall shown in Figures 82 and 83.

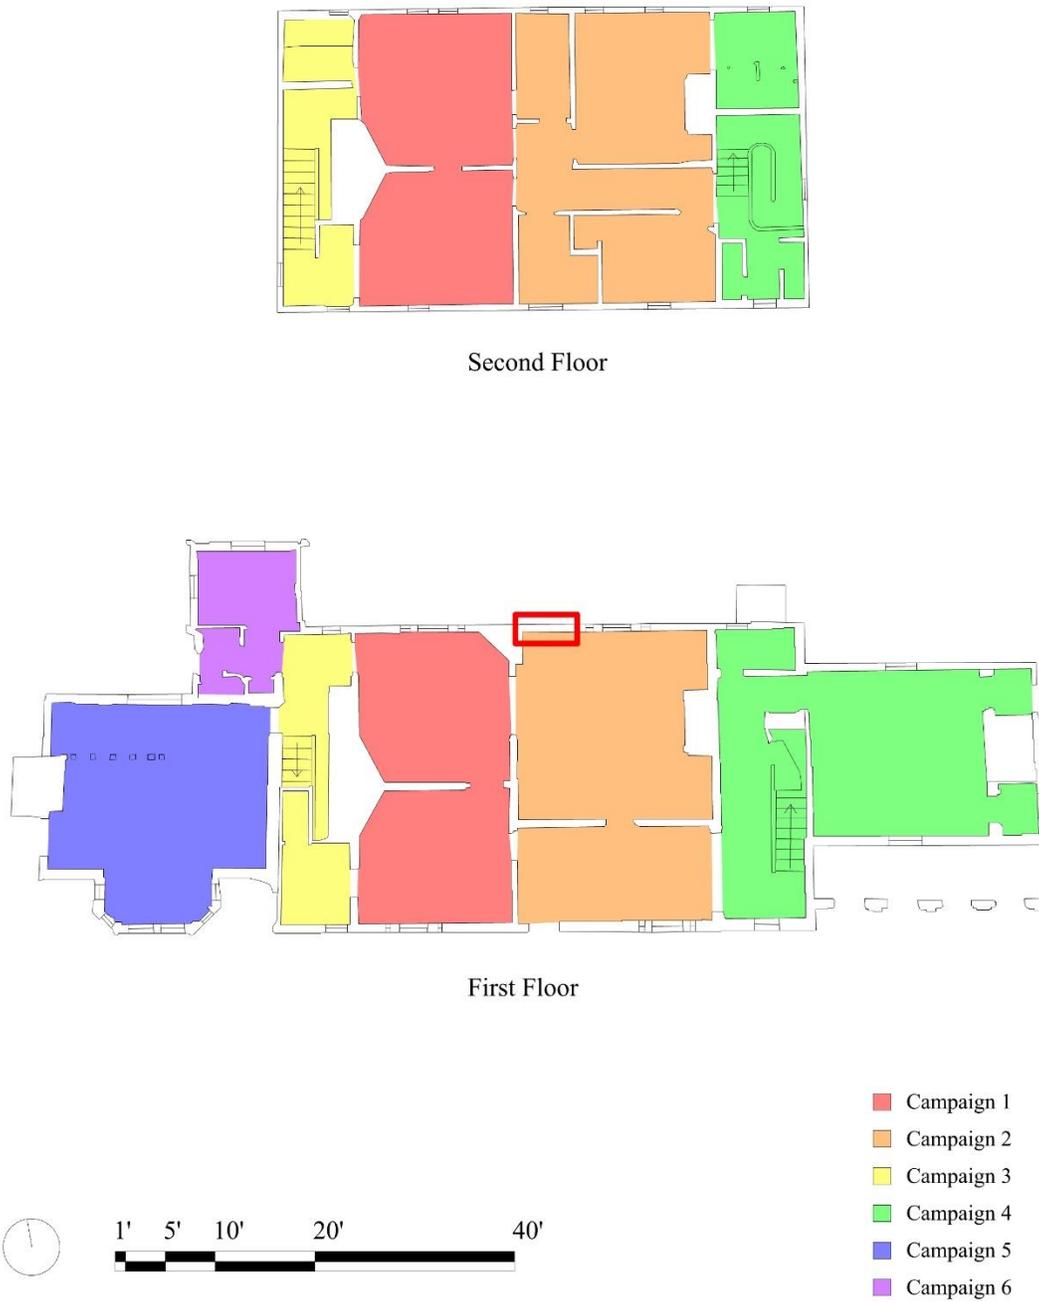
Figure 85: The location of door sill evidence for an exterior door on the northern elevation.

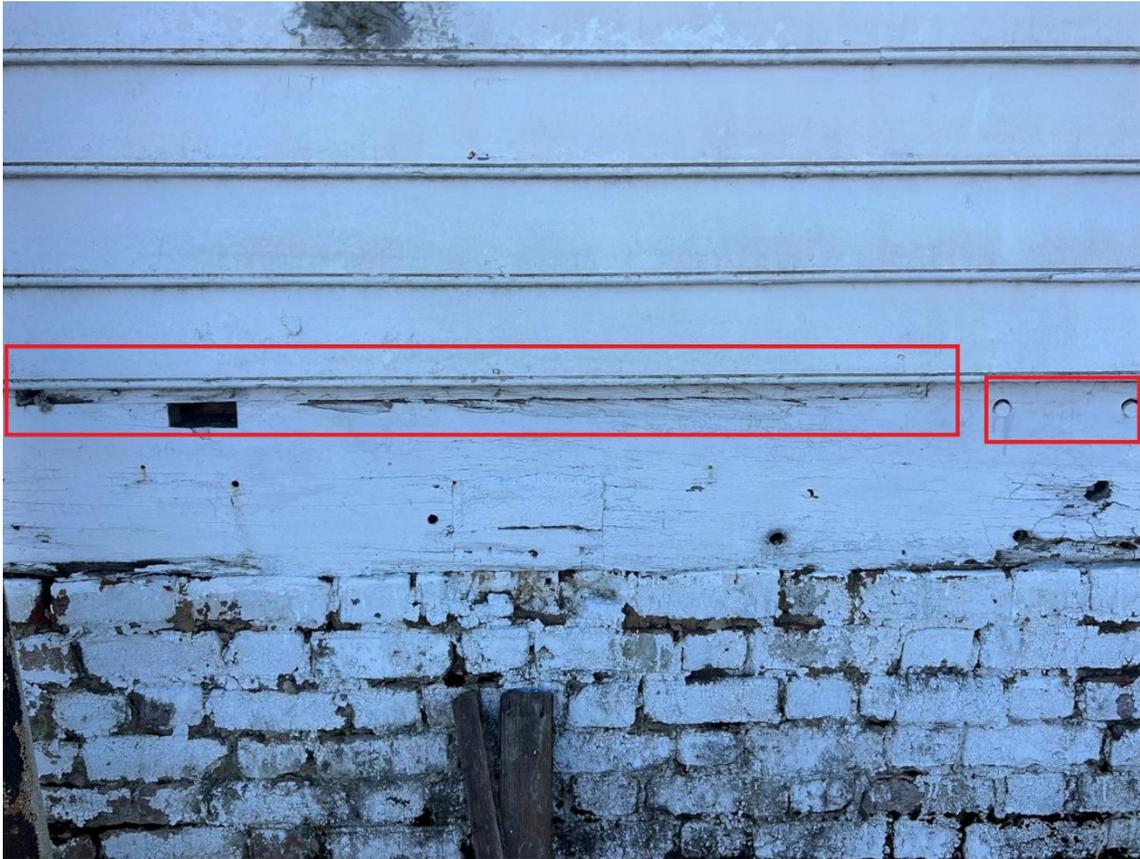
Figure 86: The door sill and pegs visible on north elevation sill plate that indicate the location of the original northern exterior door.

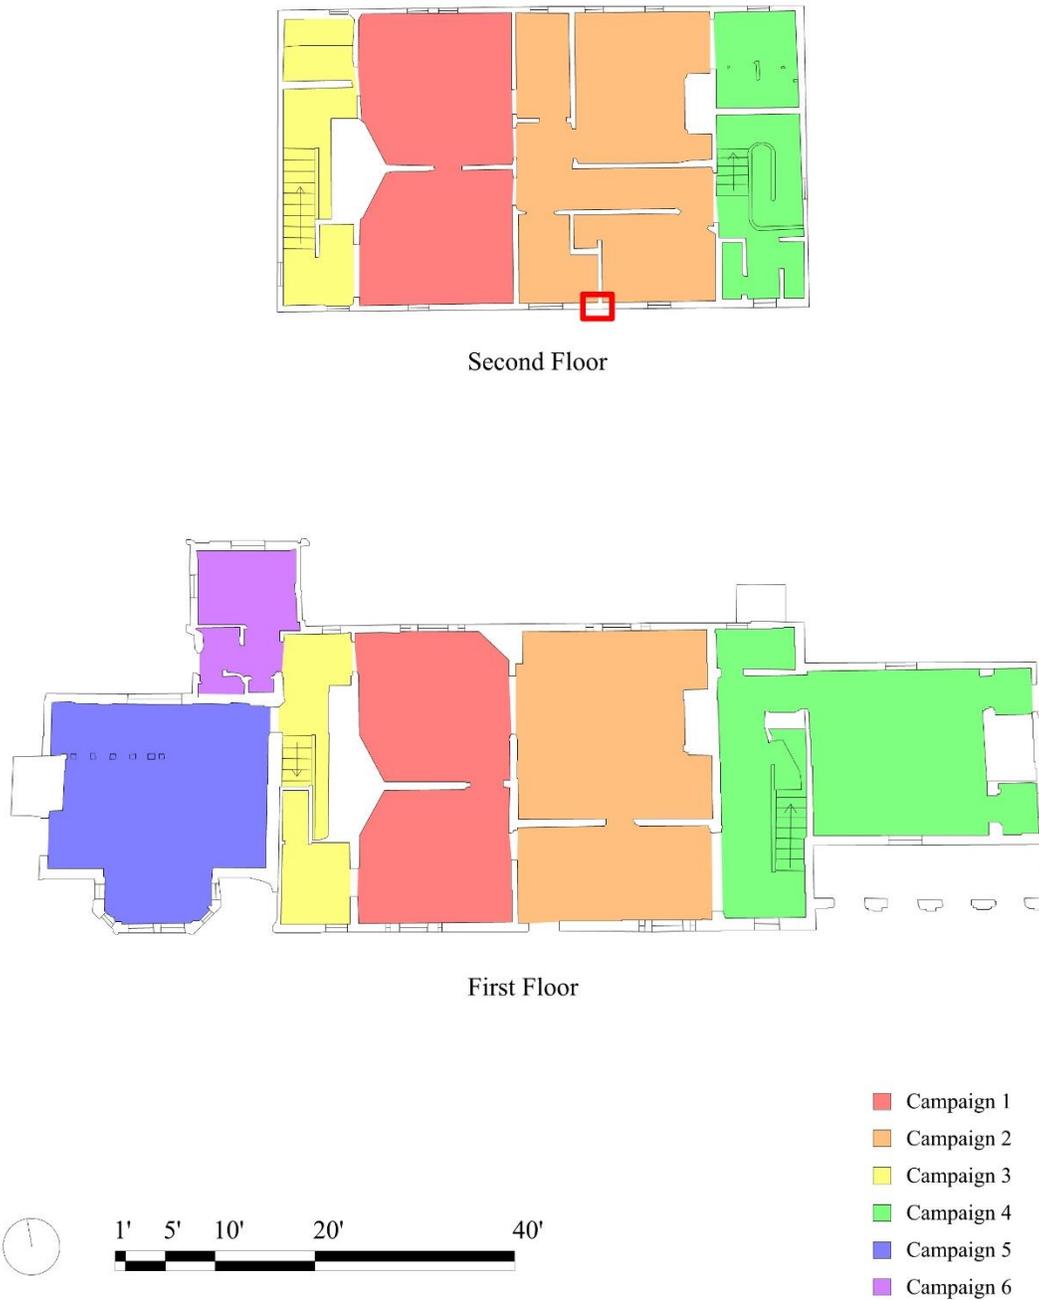
Figure 87: The location of the removed window on the second floor that was proposed by Doug Gilpin. Gilpin proposed that a window might have been in this location, matching the adjacent window on the north side. This window would have been removed when the bathroom wall was moved.

porch would have been like the porch seen in the 1802 Mutual Assurance Policy and in earlier photos of Sylvania's south elevation.¹¹⁴ Interestingly, the 2005 survey also notes the likely removal of a window that would have existed on the second-floor south elevation of Campaign Two, where the bathtub is now located in the southern bathroom (Fig 87). This window placement would have made the arrangement of the second-floor windows on the south side of Campaign Two identical to that on the north side of Campaign Two.¹¹⁵ However, there is no accessible physical evidence of this window.

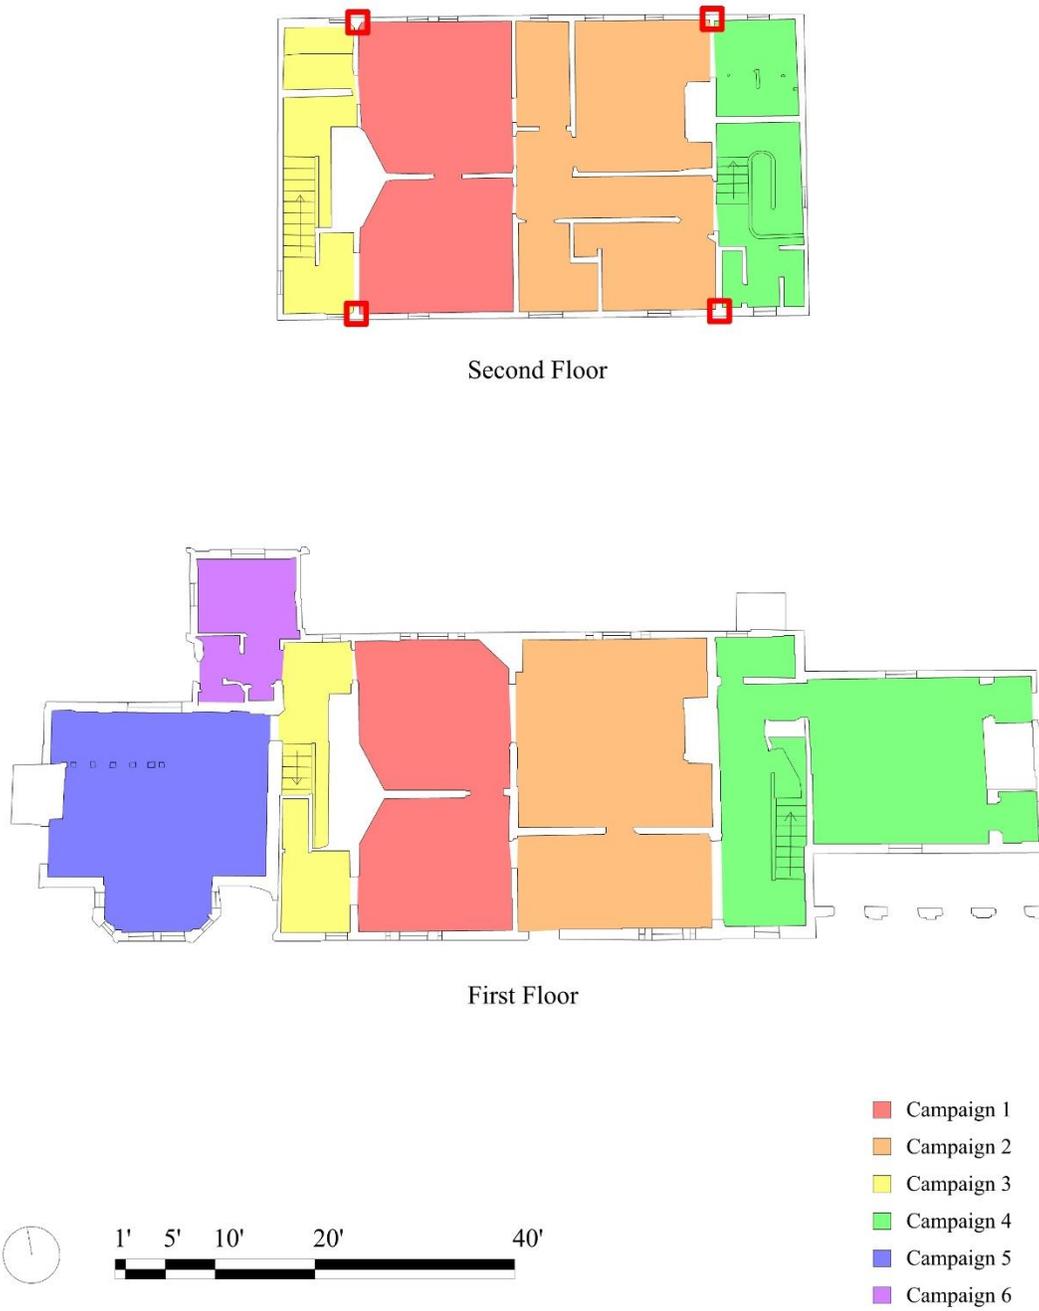
Figure 88: The locations of the mortise and tenon corners of the original house framing found in the attic.

Figure 88: The locations of the mortise and tenon corners of the original house framing found in the attic.

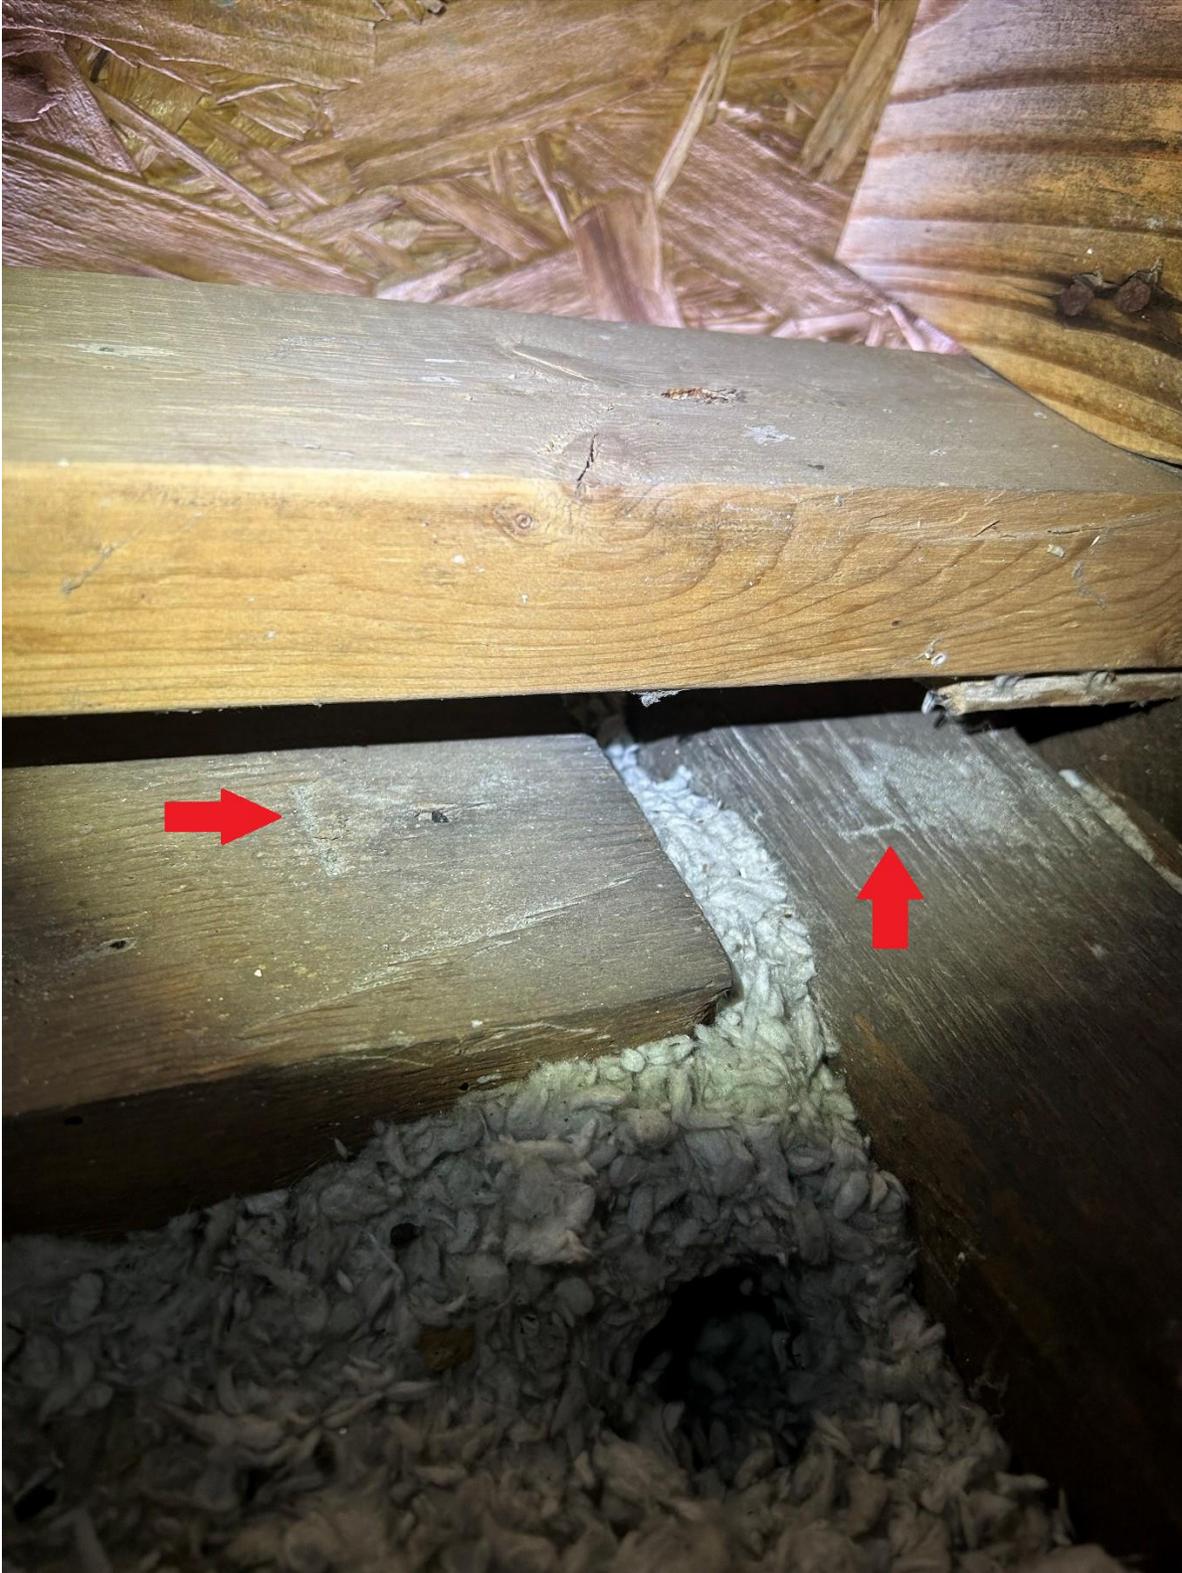
Figure 89: The original northeast corner of the attic above Campaign Two with roman numeral "I".

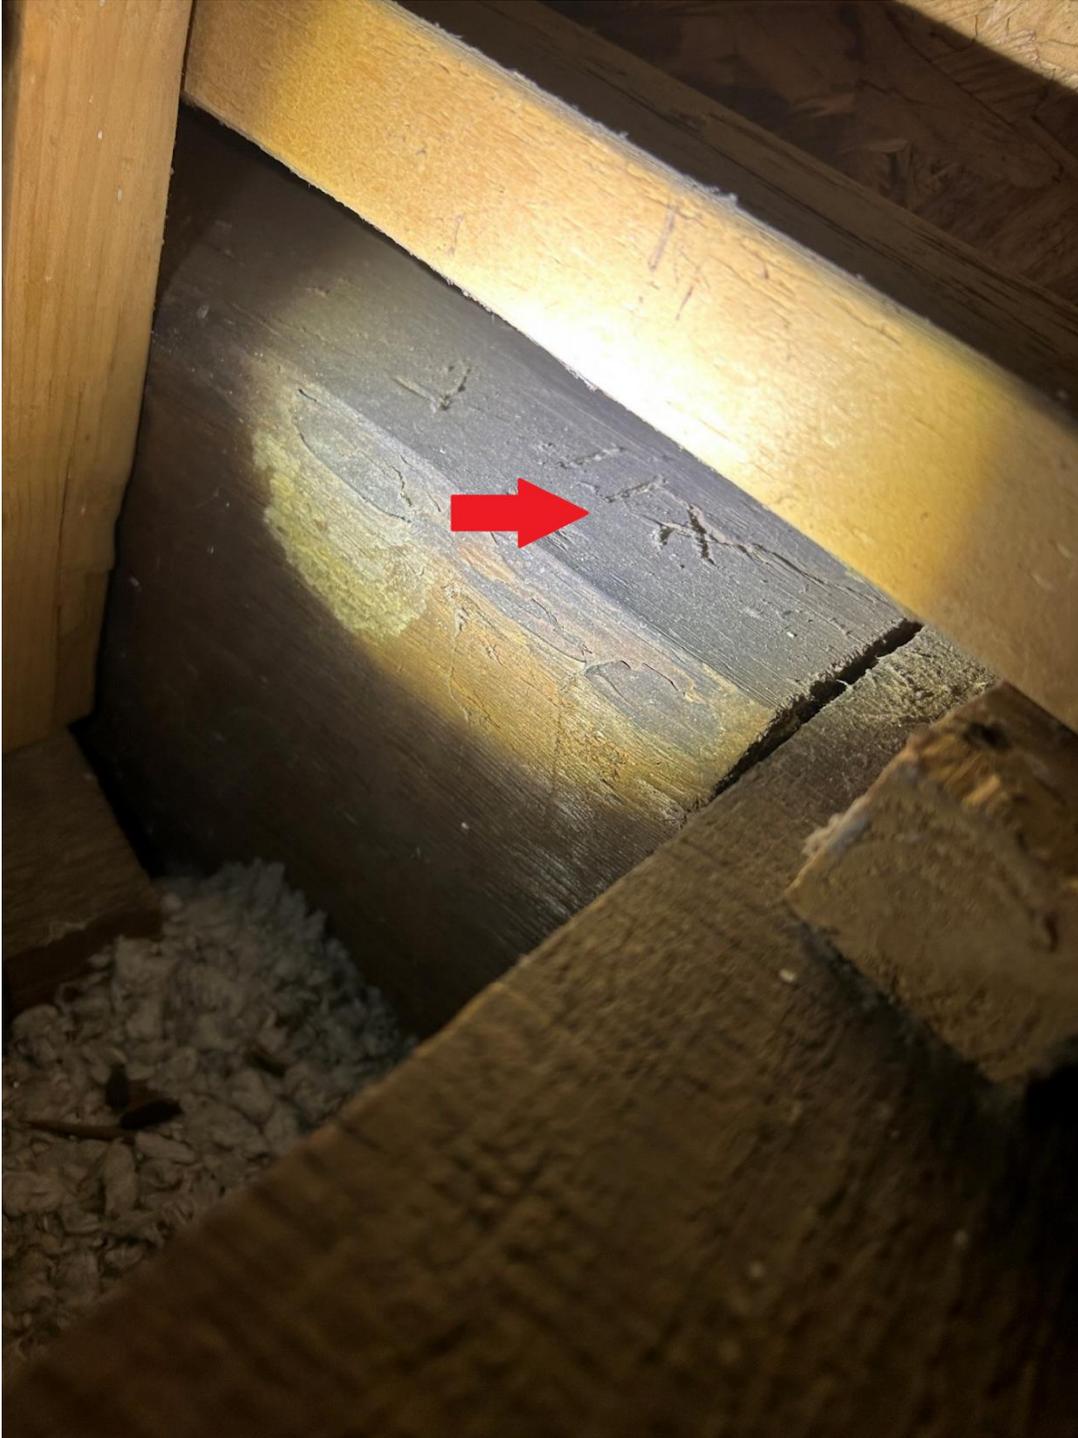
Figure 90: The northern end of the attic where Campaign One and Campaign Two meet with roman numeral “IIX”.

and Campaign Two, roman numerals are visible. Roman numerals can be a helpful discovery because they were used to mark different structural members before construction to signify where that member should be located. At the northeastern corner of Campaign Two, the roman numeral “I” is visible (Fig 89). Moving west toward Campaign One, the numerals continue in chronological order. Where Campaign One and Two meet, the numerals “IIX” and “IX” are found (Figs 90-91). Moving farther west into Campaign One, the numerals continue in chronological order until they reach “XIX” at the northwest corner of Campaign One (Fig 92). The continuity of roman numeral markings in chronological order from Campaign Two to Campaign One is significant because it clearly indicates that the two campaigns were constructed at the same time. If the two were constructed at separate dates, there would not be a chronological continuity between the two campaigns. Furthermore, the original corners of the house are still intact in the attic, clearly marking that Campaign One and Campaign Two were constructed together.

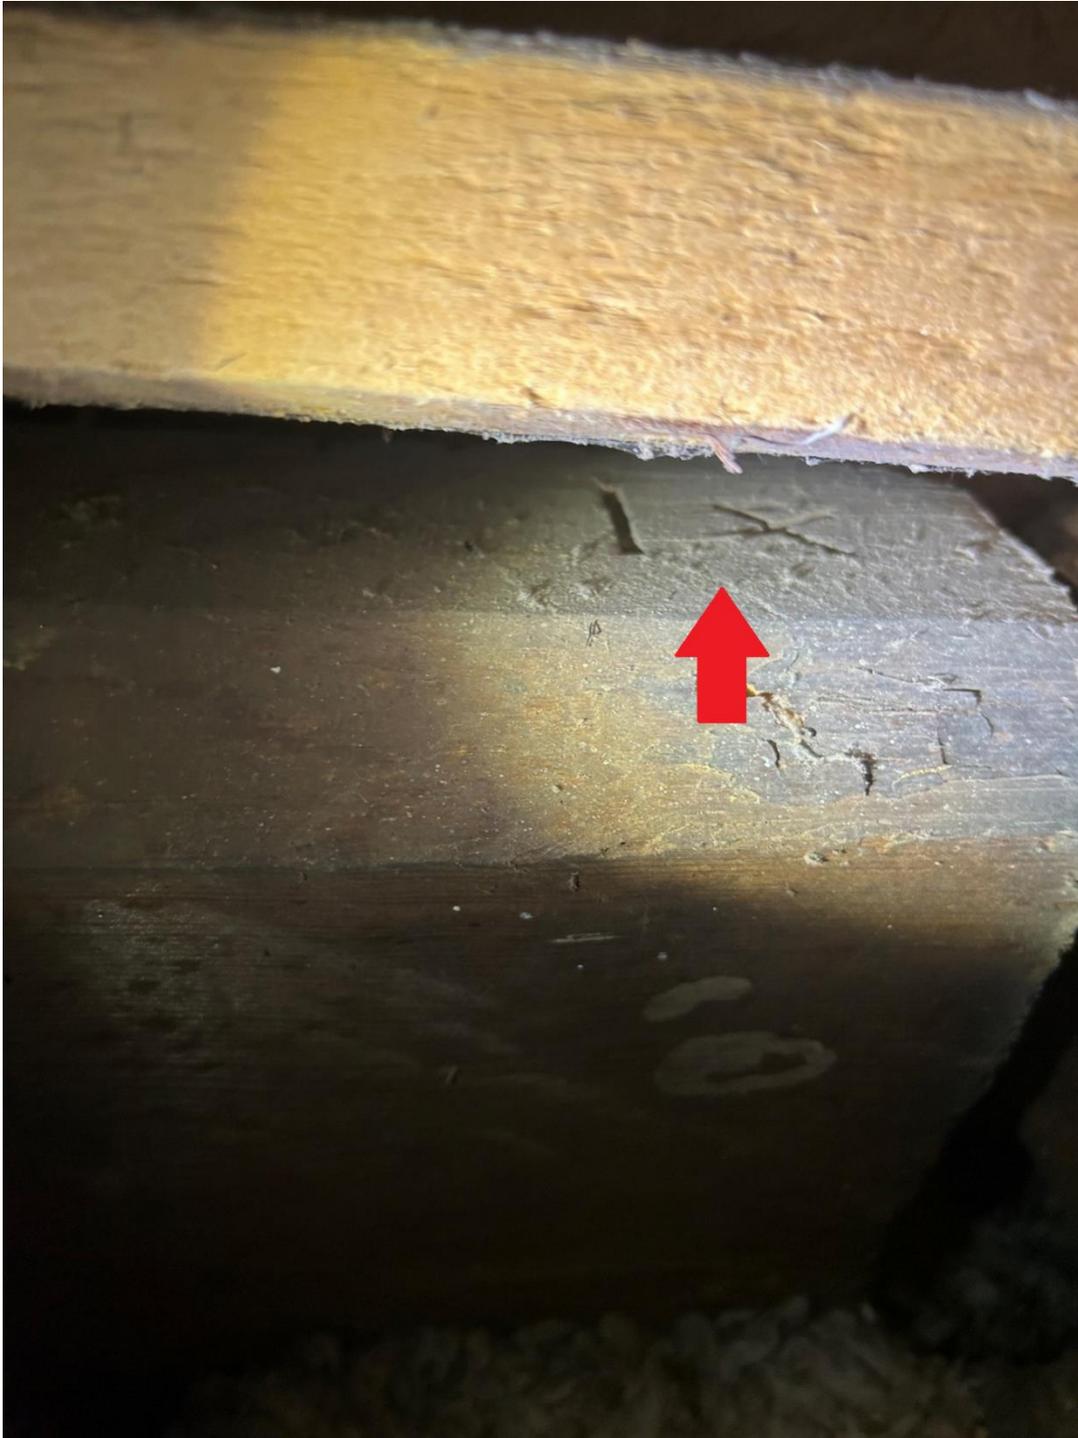
Figure 91: The northern end of the attic where Campaign One and Campaign Two meet with roman numeral "IX".

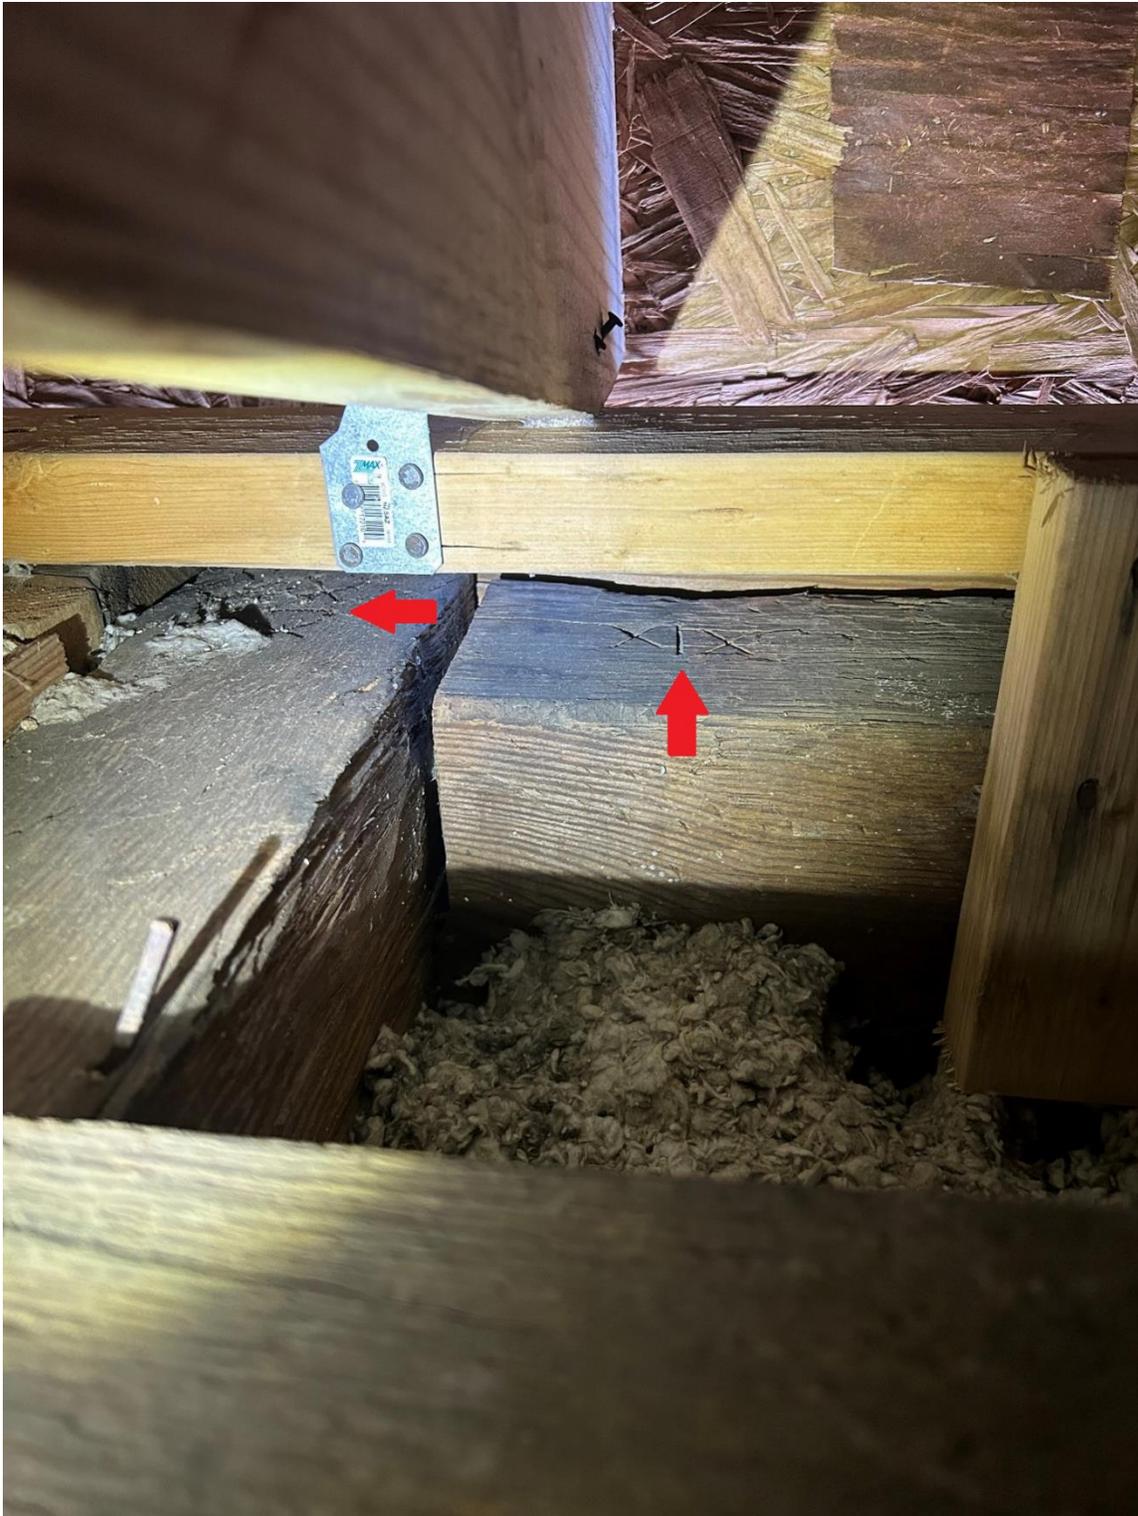
Figure 92: The original northwest corner of the attic in Campaign One with roman numeral “XIX”.

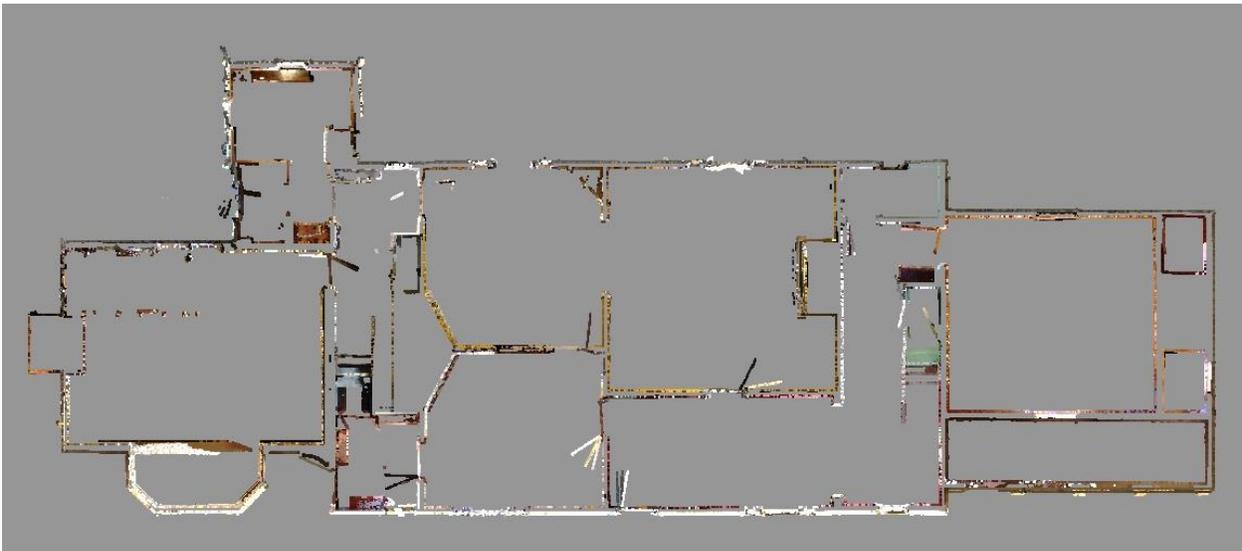
Figure 93: The first-floor plan of Sylvania, with north facing up, generated by 3D data. There is no central passage present in the current plan.

Assessing the 3D data from Campaign One and Campaign Two provides fascinating information about their spatial relationships. A comparison of the spatial layout of the first and second floors of these campaigns alludes to potential changes made to the first-floor layout (Figs 93-95). Looking at the second-floor plan, the layout seems to replicate a central passage plan. The central passage plan is a common domestic floor plan used in late 18th century Virginia houses, with its popularity growing in the second and third quarters of the 18th century. The reasoning for the addition of a central passage dividing the rooms in a home is attributed to a desire of social separation, especially between the planter and the enslaved and between private and more public spaces in the home. The passage introduced a sense of control and separation of the social spaces in a plantation house, providing a physical barrier between the entrance to a home and its more intimate spaces that allowed the planter to filter where guests went in the
