The Six Building Campaigns at Sylvania:

The Transformation of Sylvania from a Folk Plantation House to a Fashionable Plantation,

1790-1865

Victoria Mae Bitrick

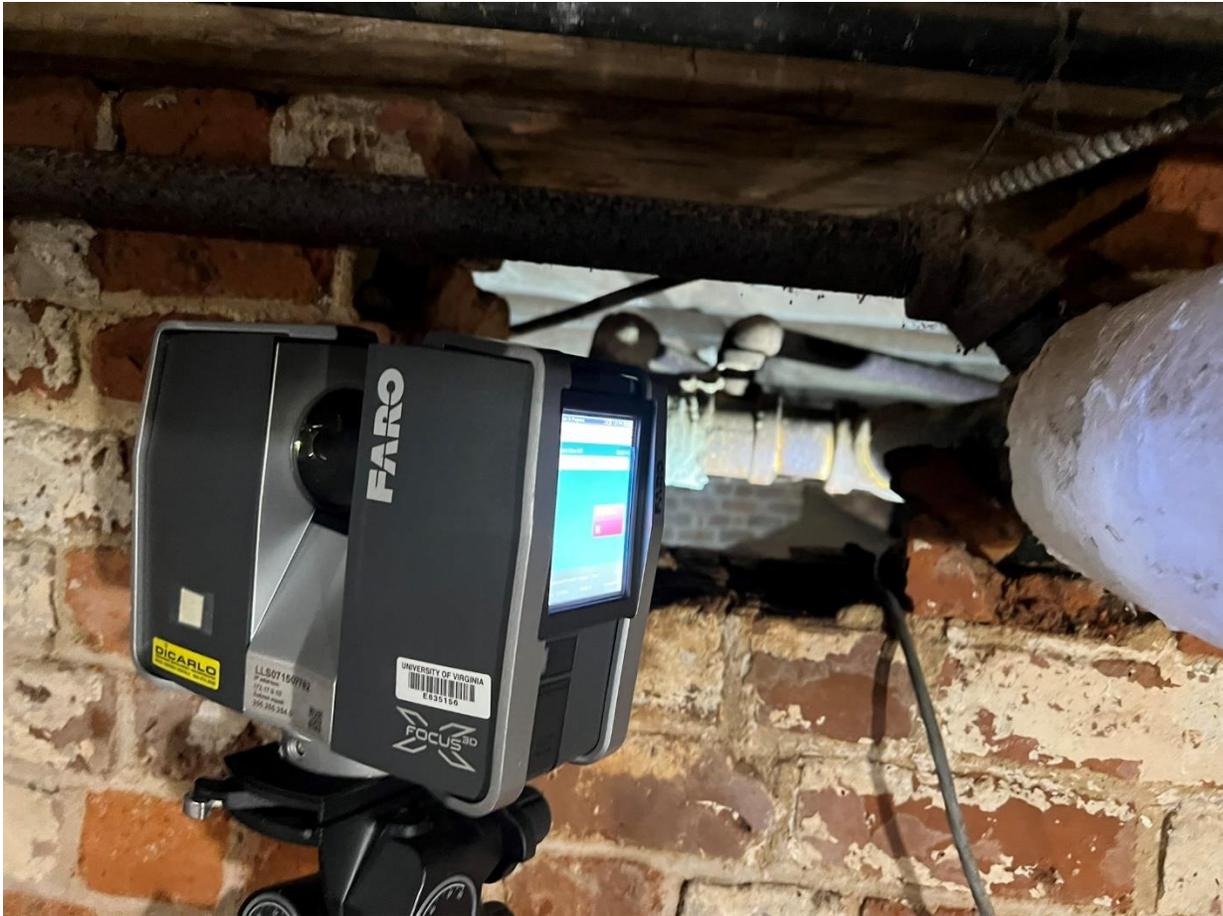
Figure 101: Photo taken of the hole in the cellar wall dividing Campaign One from Campaign Two, looking into the cellar under Campaign One. The diagonal wall with One-to-three bond is visible in the background, and the FARO Focus scanner is in the foreground. Photo taken by Will Rourk on March 3, 2025.

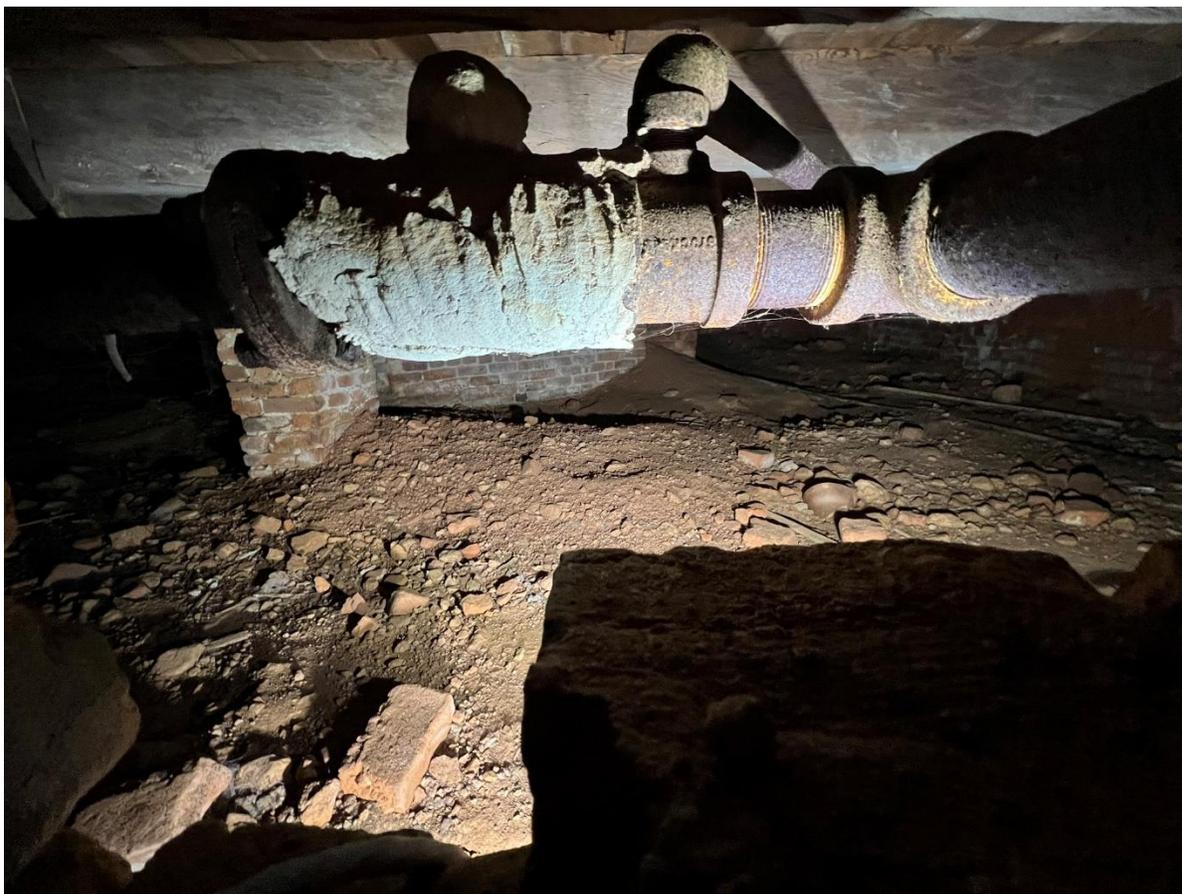
Figure 102: Photo taken from the hole in the cellar wall dividing the cellar under Campaign One from Campaign Two, looking into the inaccessible cellar under Campaign One. The brick column, diagonal brick wall with a One-to-three bond, and the northern wall to the right are visible. Photographed by Will Rourk on March 3, 2025.

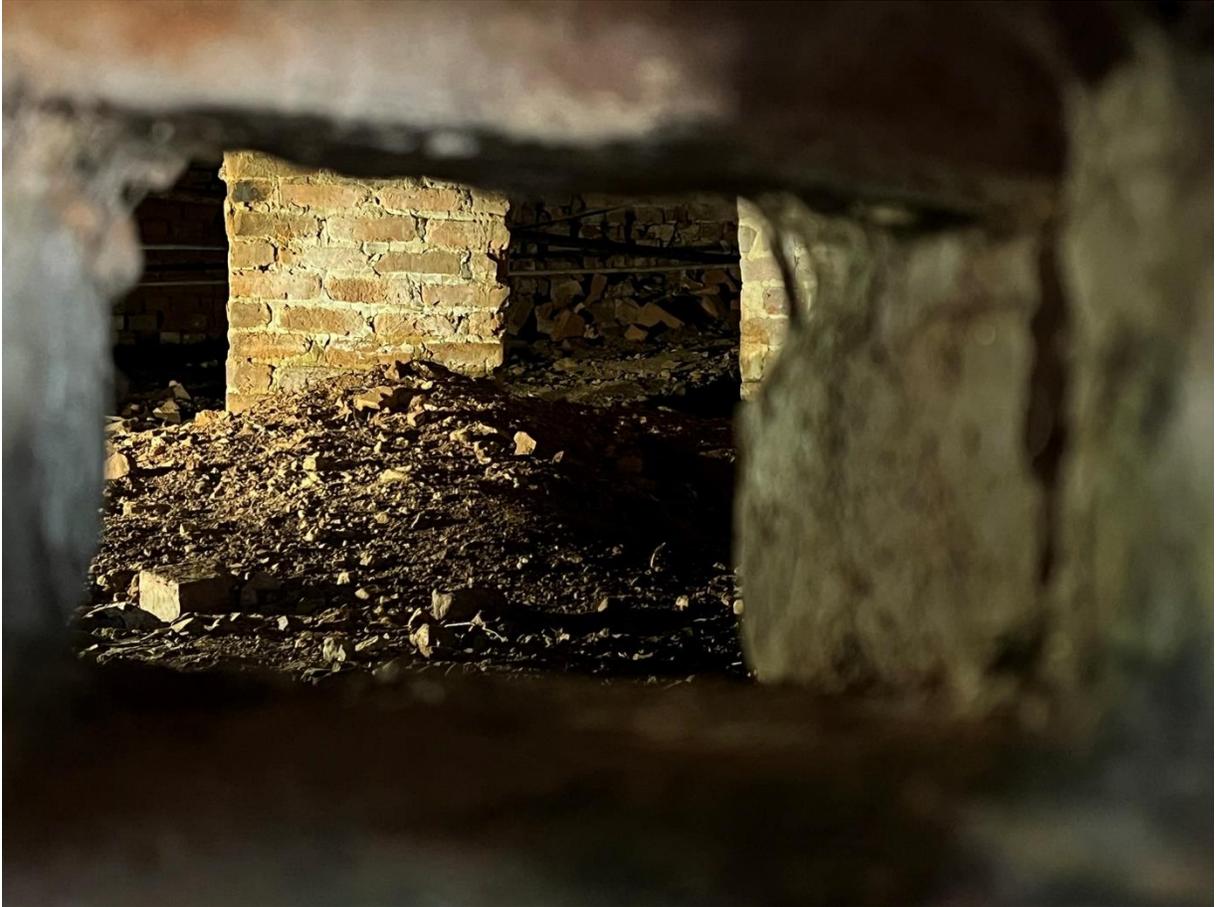
Figure 104: Image of the brick column in the cellar under Campaign One pictured in the center, taken from the hole in the northern exterior brick wall under Campaign One. Behind the column, the back southern wall of the cellar is visible. To the right of the column, the edge of the diagonal wall with one-to-three bond is visible. Photographed by Will Rourk on March 3, 2025.

Figure 117: The location of the column seen in Figures 104 and 105 looking from the hole in the northern brick wall. The northern face of the column was captured by 3D data and is pictured in the cellar floor plan.

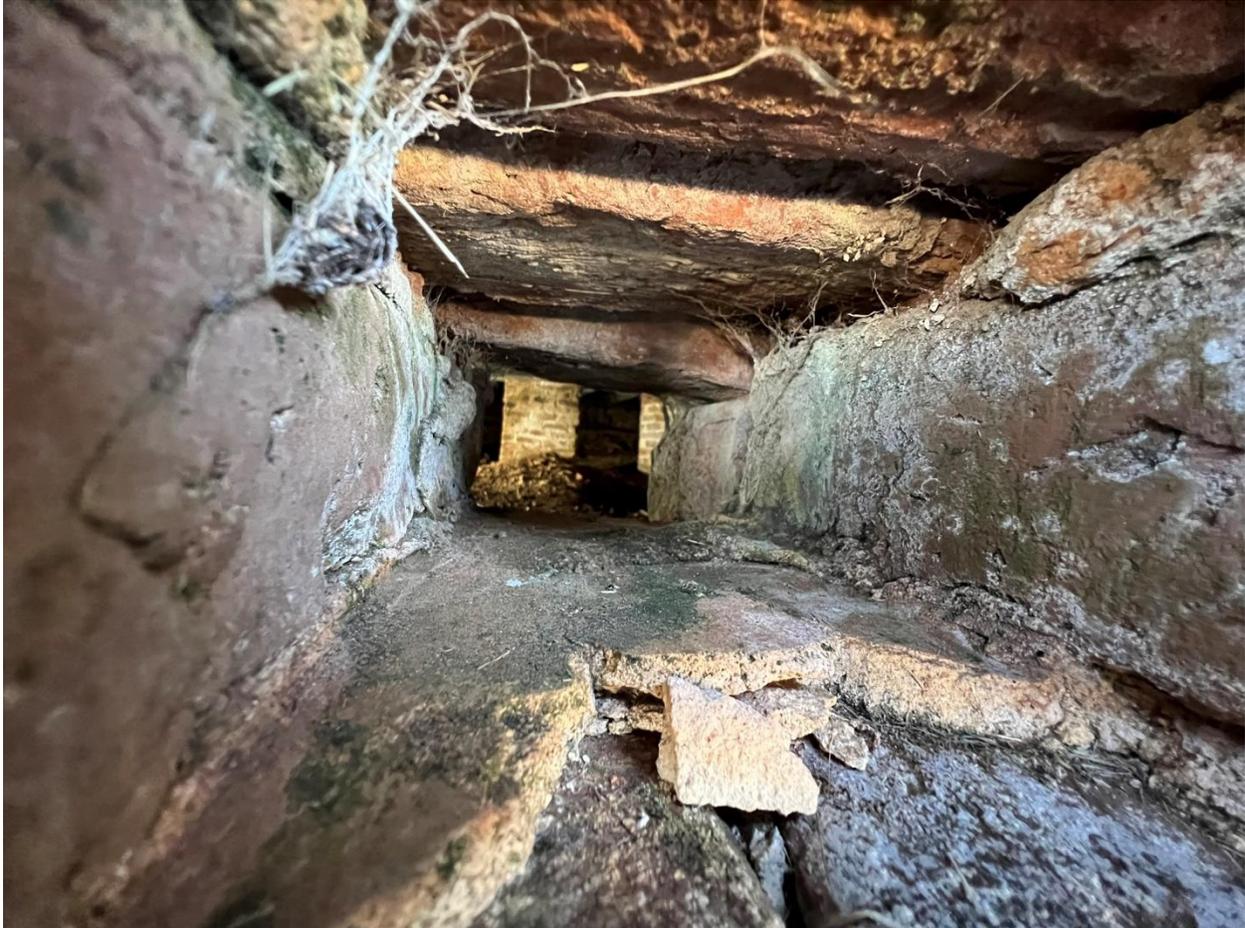
Figure 105: Photo taken from the hole in the northern exterior brick wall under Campaign One, looking into the inaccessible cellar under Campaign One. The brick column and the edge of the diagonal wall in the cellar are visible in the background. Photographed by Will Rourk on March 3, 2025.

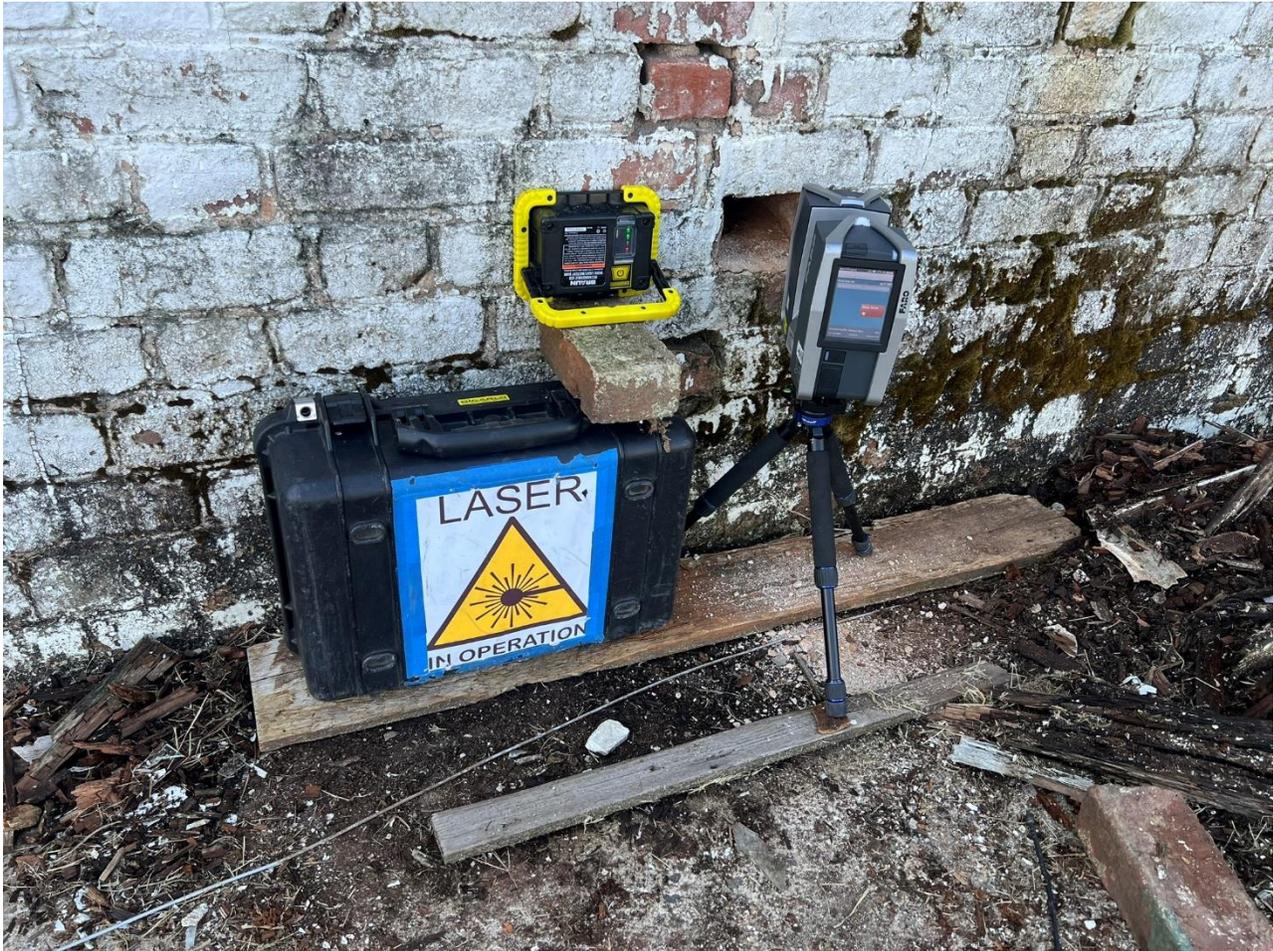
Figure 106: Photo of the hole in the northern foundation wall that views the inaccessible cellar. A 3D scan was taken from this location to capture the dimensions of the brick column seen in Figures 104 and 105. Photographed by Will Rourk on March 28, 2025.

Figure 106: Photo of the hole in the northern foundation wall that views the inaccessible cellar. A 3D scan was taken from this location to capture the dimensions of the brick column seen in Figures 104 and 105. Photographed by Will Rourk on March 28, 2025.

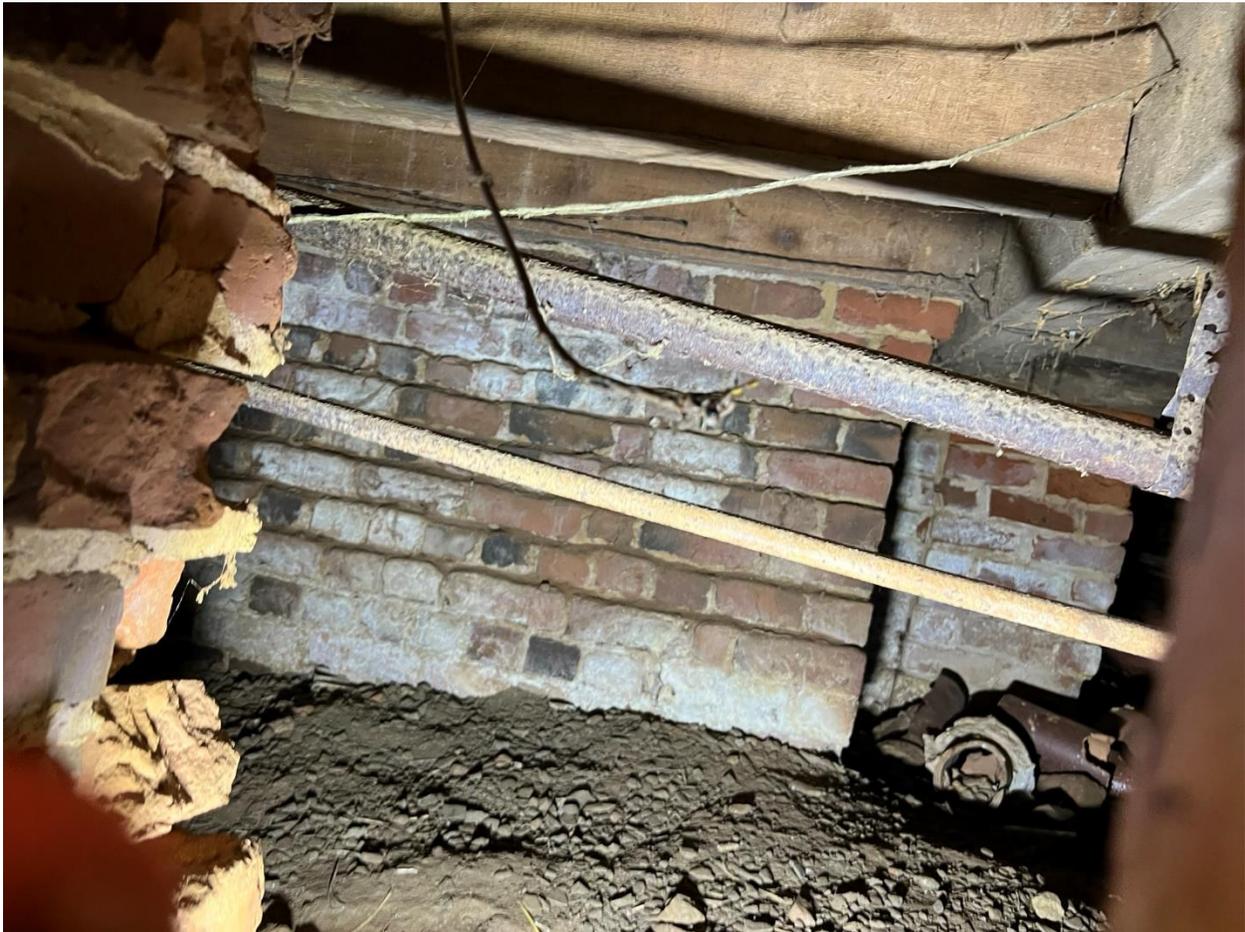
Figure 108: Photo taken from the hole in the west wing, looking into the cellar under Campaign One and Campaign Three. Campaign One's chimney is visible in the background with English bond. Photographed by Will Rourk on March 3, 2025.

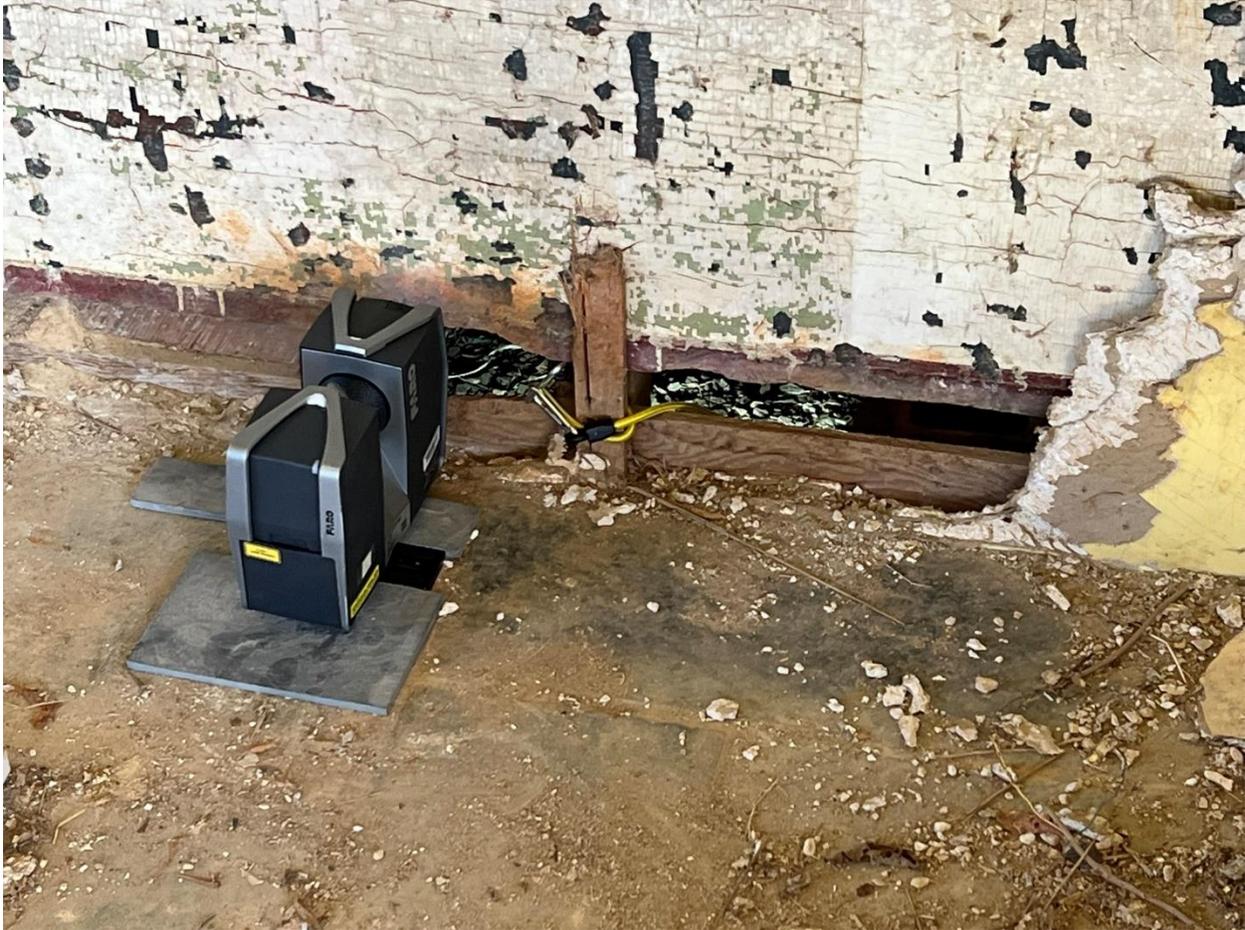
Figure 109: Photo of the hole in the west wing that views the inaccessible cellar under Campaign Three. Two 3D scans were taken from this location to capture the dimensions and location of the chimney base. Photographed by Will Rourk on March 29, 2025.

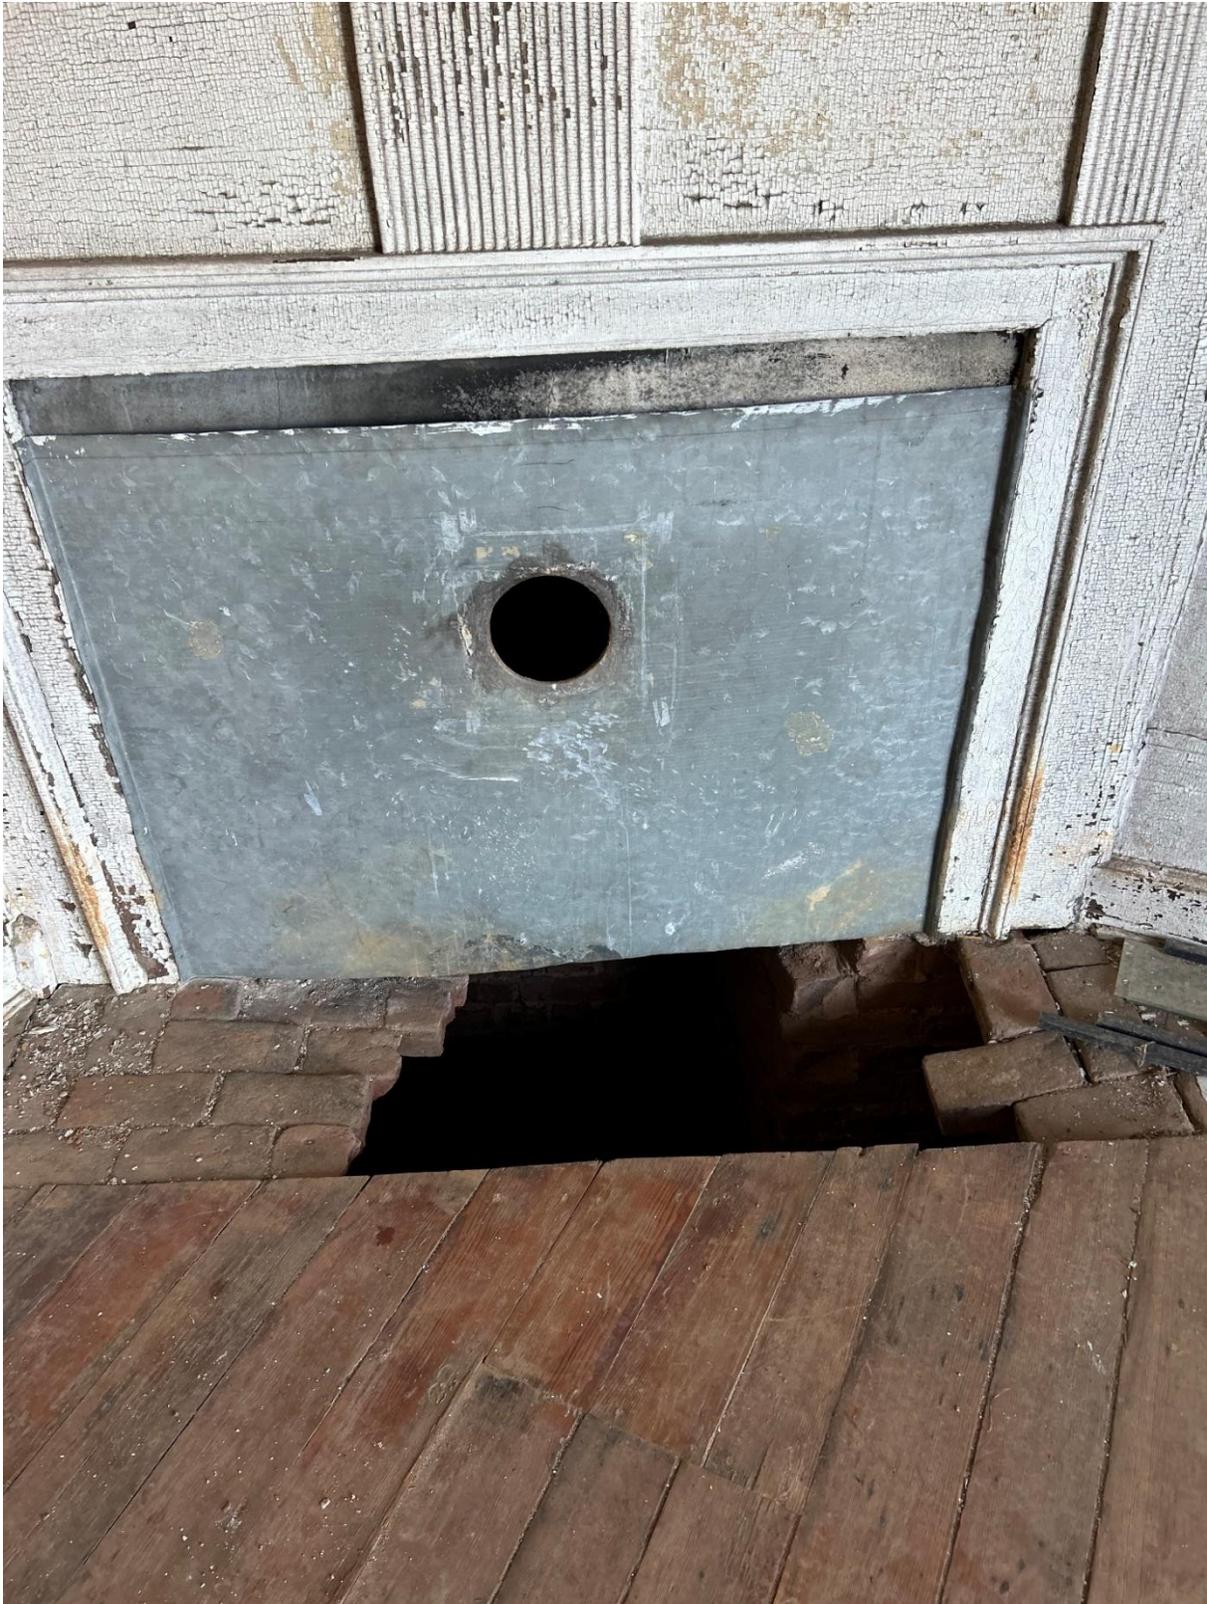
Figure 111: The location of cavity under the hearth in the first-floor northern room of Campaign One.

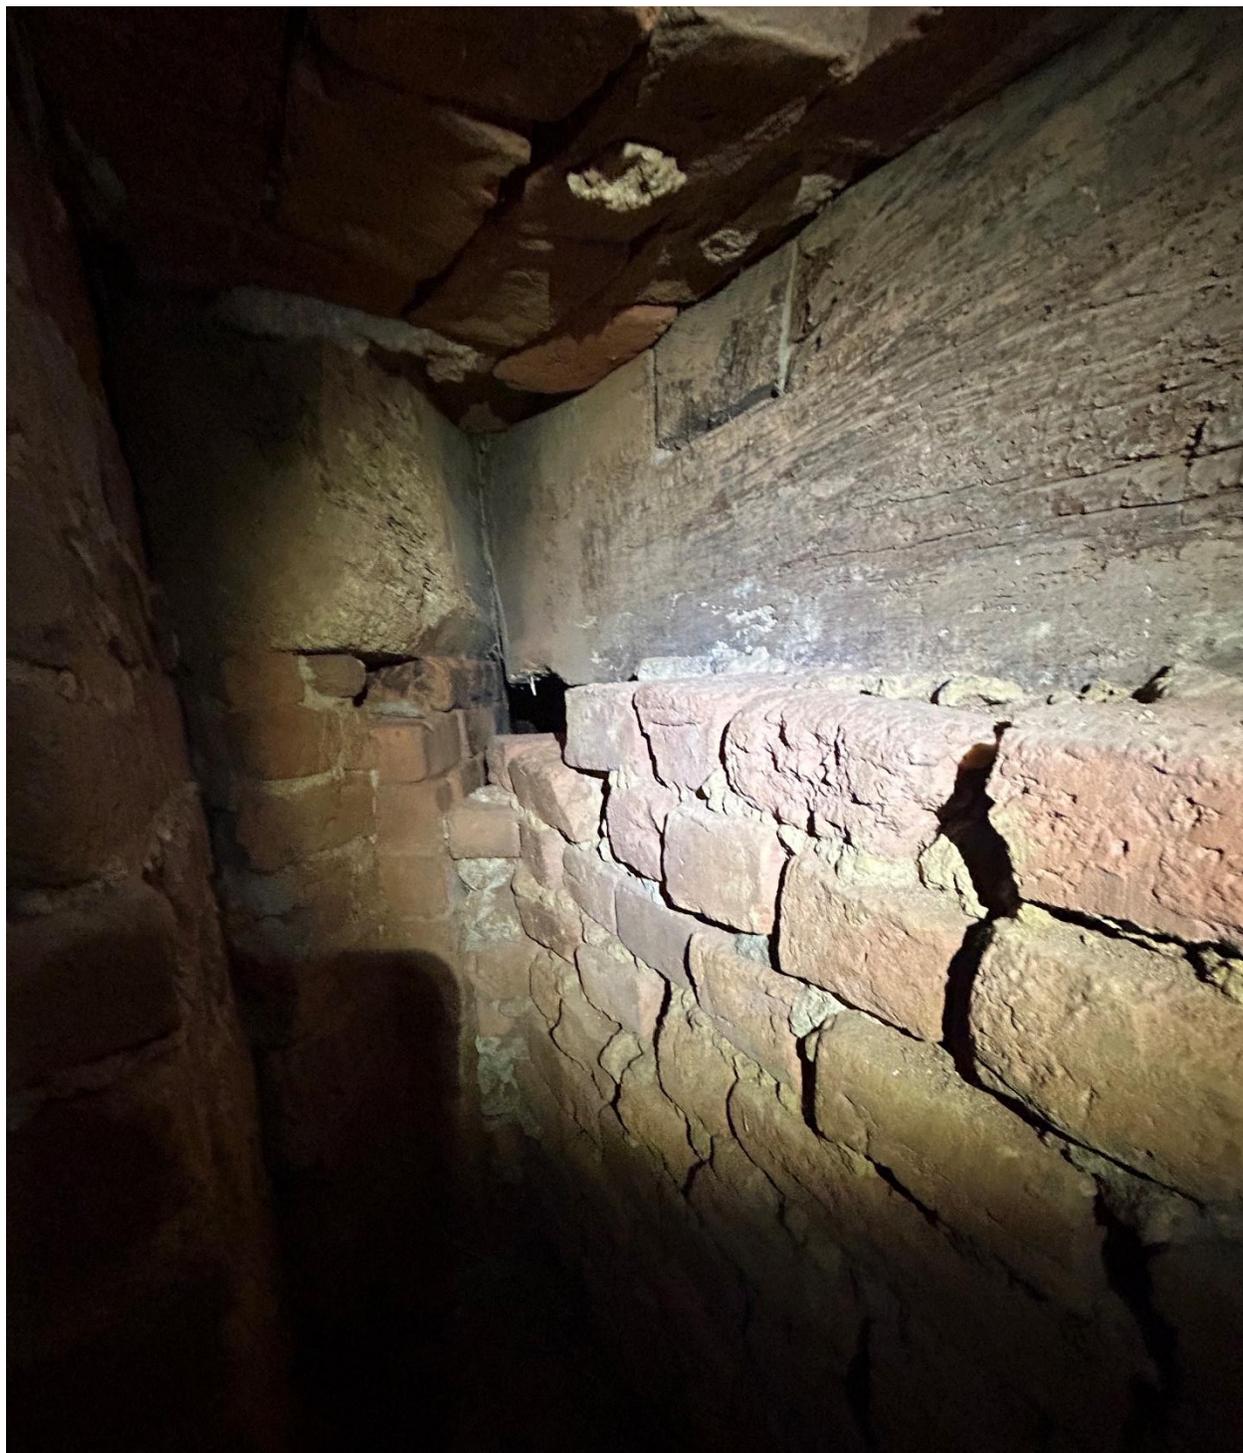
Figure 112: Photo taken inside the cavity under the hearth in Campaign One. The diagonal wall with One-to-three bond that is seen in the 3D scan data is to the right, and to the left is the wall supporting the corner chimney.

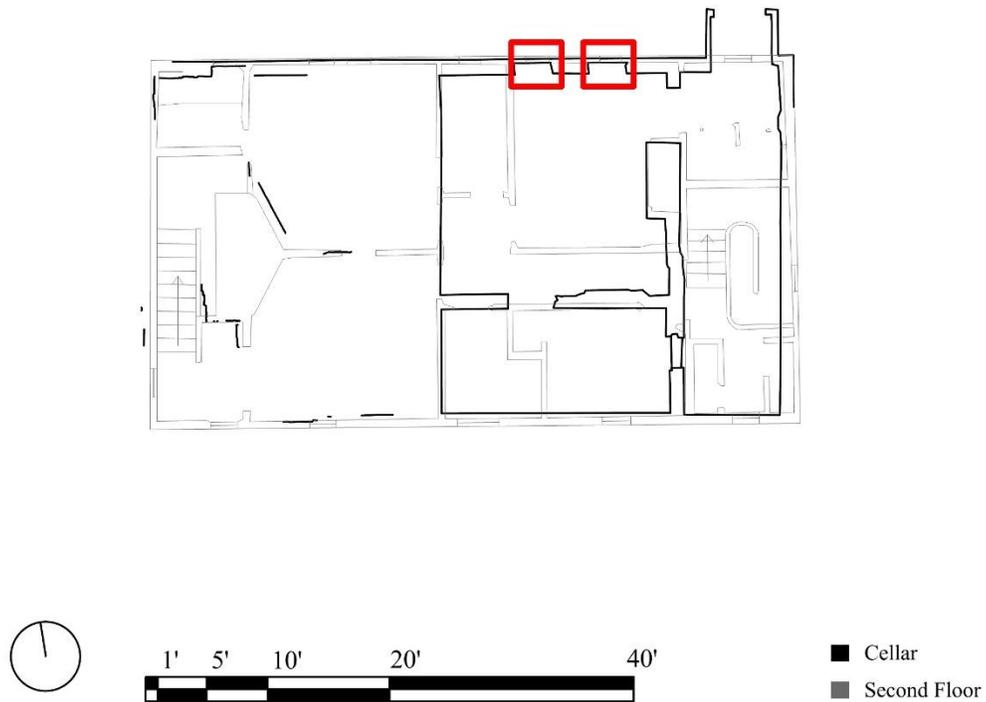
Figure 124: The location of the closed off windows on the northern wall of the cellar under Campaign Two. These windows align with the second-floor windows on the northern wall of Campaign Two. Since these windows share a direct relationship, it is possible that this relationship once existed on the first floor as well.

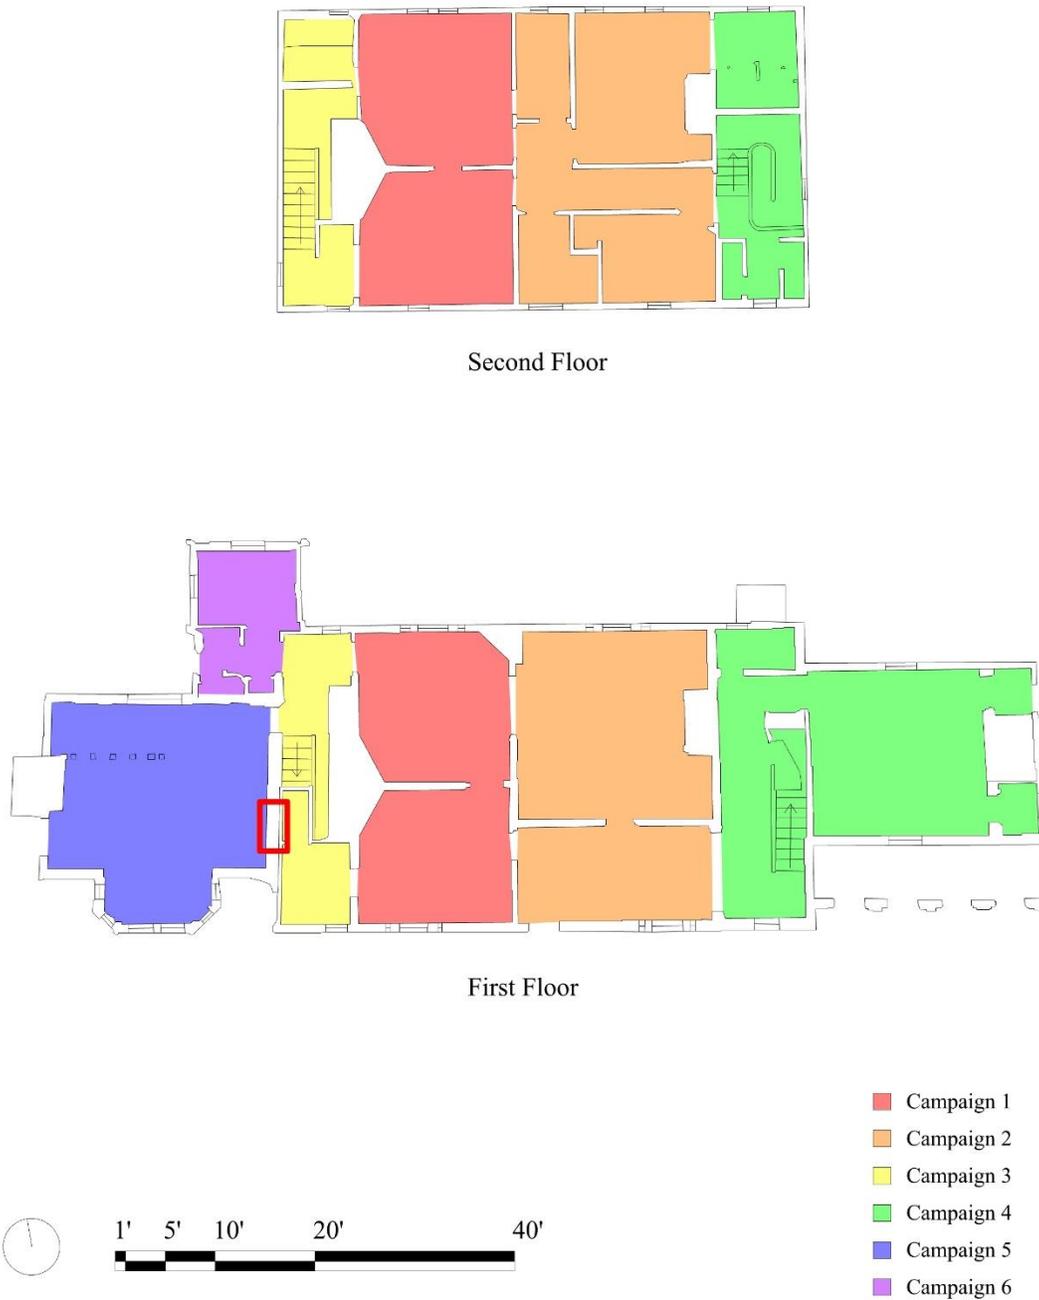
Figure 125: The location of the hole in the west wing wall that is shared with Campaign Three. This hole reveals the original siding on the exterior of Campaign Three and a view into the cellar under Campaign Three.

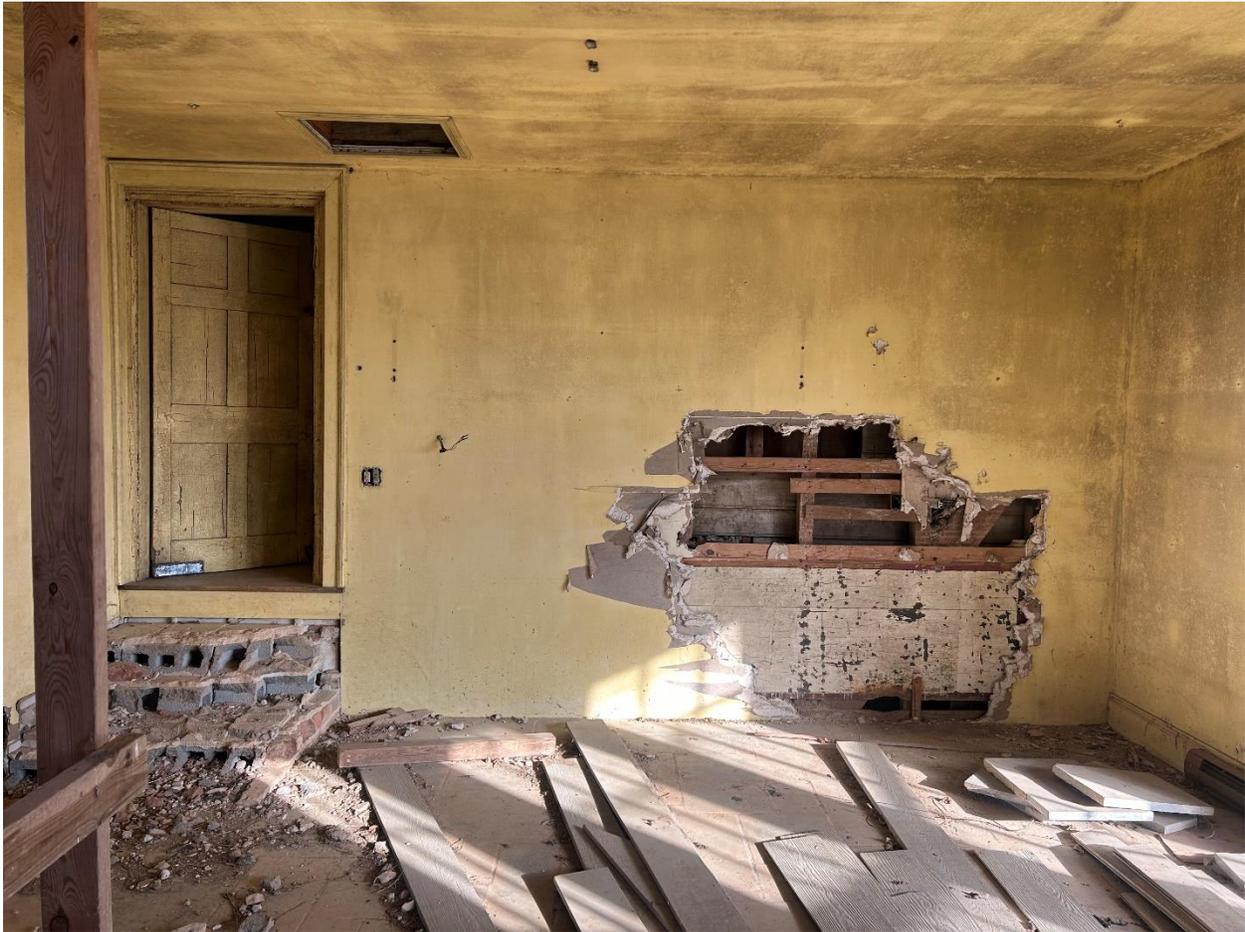
Figure 126: Photo of the hole in the west wing that reveals Campaign Five's original wainscot preserved under the drywall and Campaign Three's exterior siding behind Campaign Five's structural members. This hole reveals how Campaign Five is built against the exterior of Campaign Three.

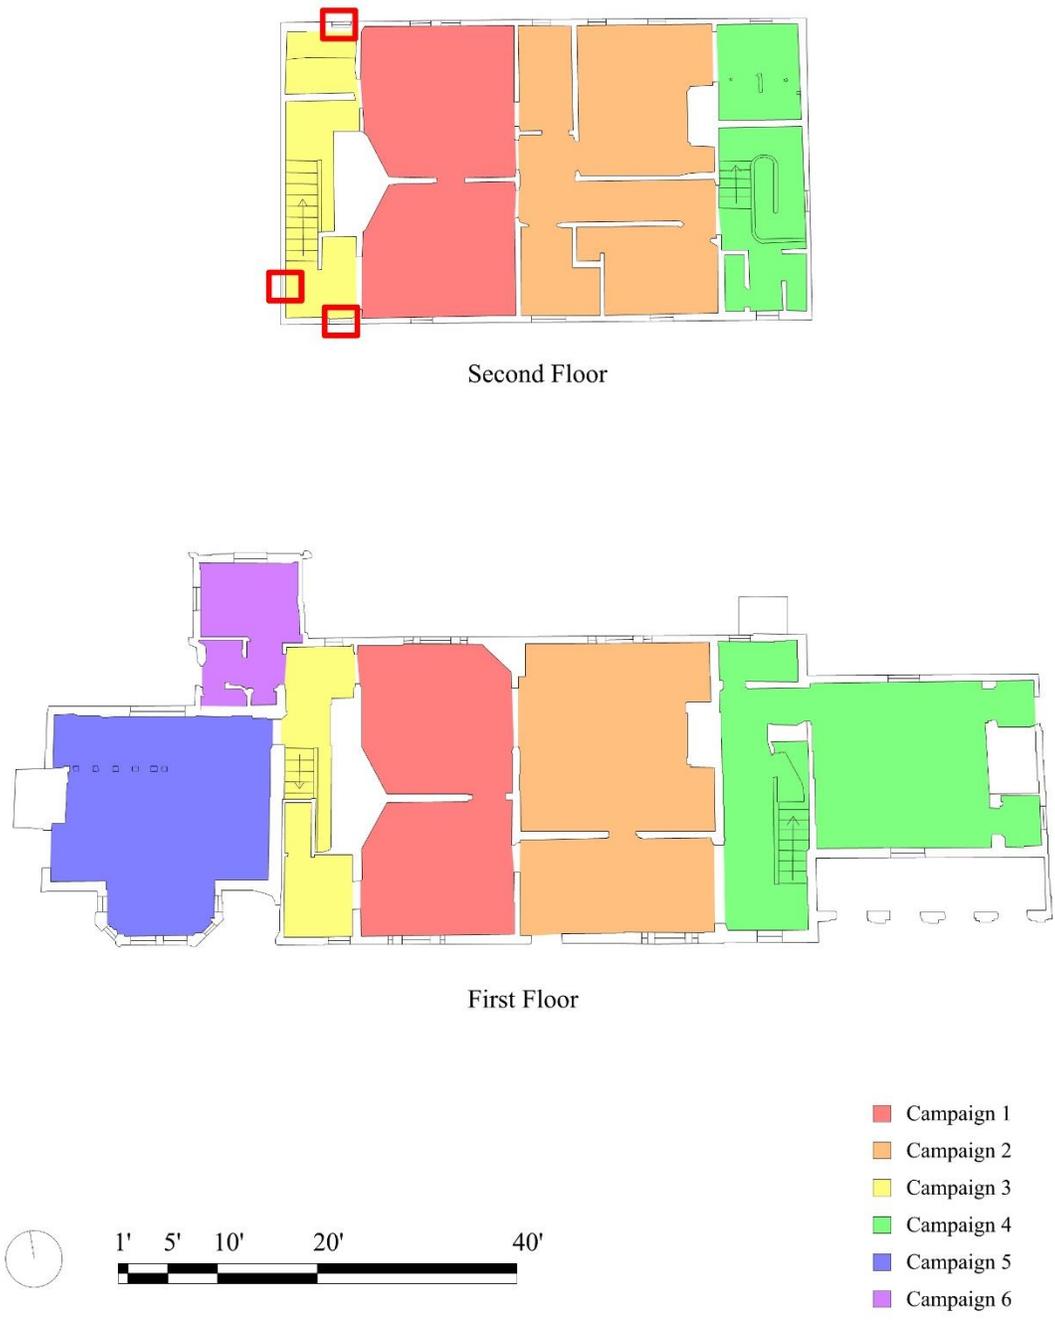
Figure 127: The location of windows on the second floor of Campaign Three that have matching trim.

The trim on the windows in Campaign Three differ depending on the area (Fig 127). On the north end of Campaign Three, the interior window trims match those used on the second floor of Campaign One and Campaign Two. However, on the south side of the second floor of Campaign Two, a different trim is used that matches trim found in Campaign Four. The same pattern is present with the exterior trim around the windows, with the majority of Campaign Three's

windows matching Campaign One and Campaign Two except for the second-floor southern windows and the north facing northern window. However, there is one window on the west side of the second floor of Campaign Three that has trim matching the first-floor windows in Campaign Three. Since most of the second-floor window trims match those in Campaign Four, it is probable that those windows were added at or around the same time. Meanwhile, the first-floor windows match those used in Campaigns One and Two, indicating that the first-floor windows of Campaign Three likely existed before its second level windows. Whether the windows were added between the enlargement of the shed between 1802 and 1805 is unclear, since the trim on those windows matches the later addition of Campaign Four.

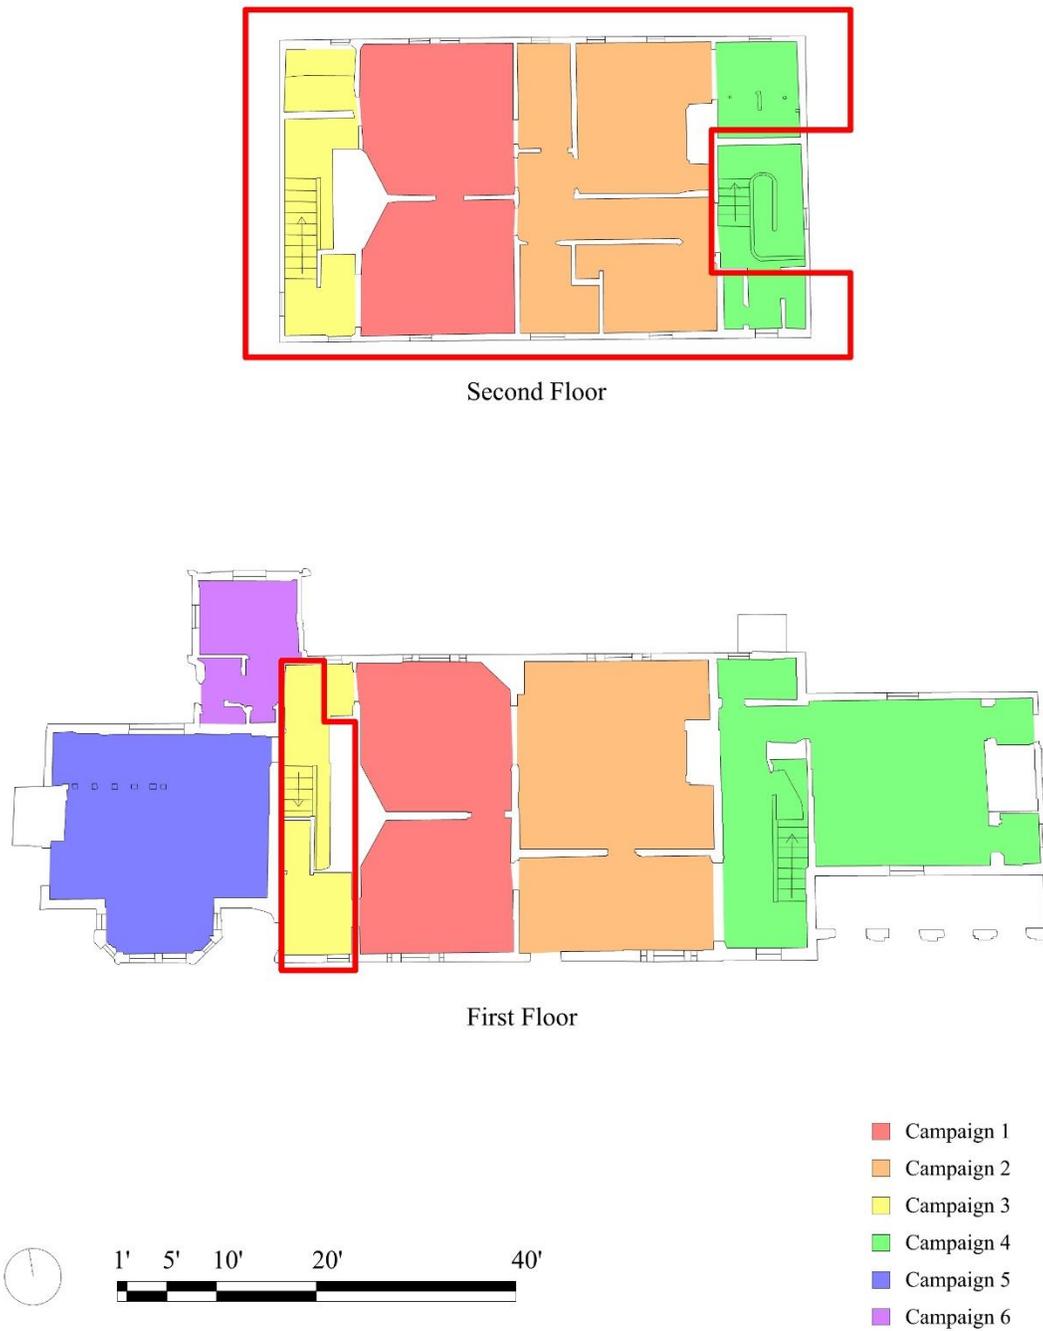
Figure 128: The location of baseboards that match Campaign Three’s baseboards. While none of the baseboards on the first-floor match Campaign Three and its staircase, most of the baseboards on the second floor match the Campaign Three staircase.

The baseboards on the first level of Campaign Three are mostly consistent on the first floor except for its eastern wall. The baseboards primarily used match those used on the entirety of the second floor, suggesting that they were installed at the same time (Fig 128). This may indicate that the upstairs trim was redone when Campaign Three's stairs were added, since the same trim also lines the stairs in Campaign Three. This trim is also used for the baseboards in the southeast bedroom where Campaign Two's stairs were, indicating that this trim was added after the removal of those stairs. Therefore, it is likely that the stairs in Campaign Three replaced the original stairs in Campaign Two. The trim does not match the trim used along the grand stairs in Campaign Four, but it does match the trim used for the landing at the top of those stairs. The Campaign Three staircase must postdate 1802, as "the shed" was not enlarged to have a second story until 1805.

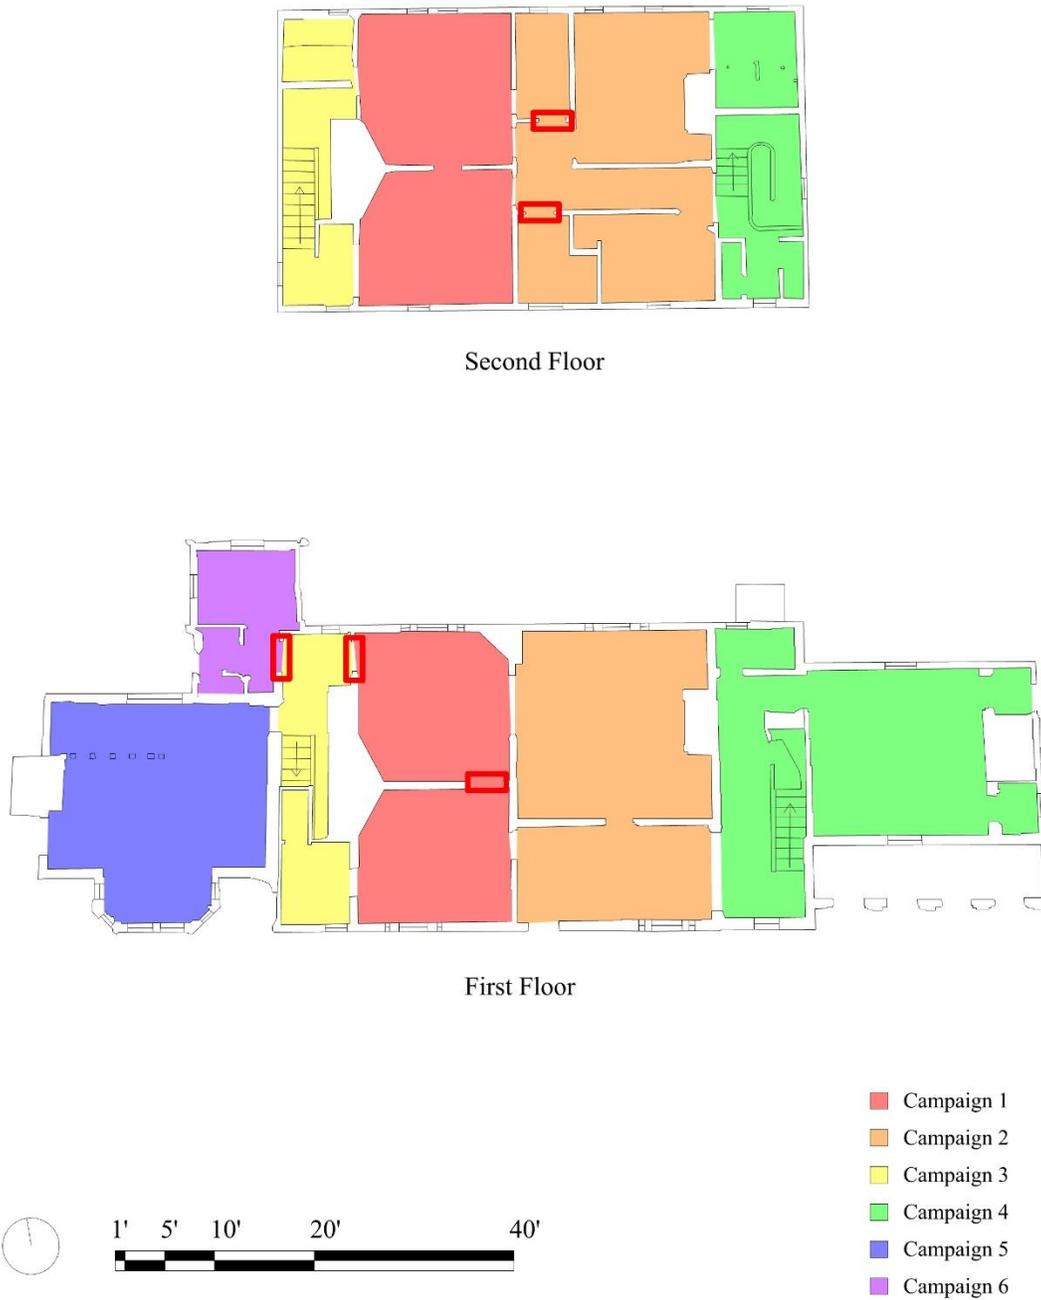
Figure 129: The location of door trims that match Campaign Three's door trims. On the second floor, Campaign Three's door trims are found on the doors that enter the enclosed ends of the central passage, indicating that these rooms may have been enclosed during the Campaign Three renovation.

Figure 129: The location of door trims that match Campaign Three's door trims. On the second floor, Campaign Three's door trims are found on the doors that enter the enclosed ends of the central passage, indicating that these rooms may have been enclosed during the Campaign Three renovation.

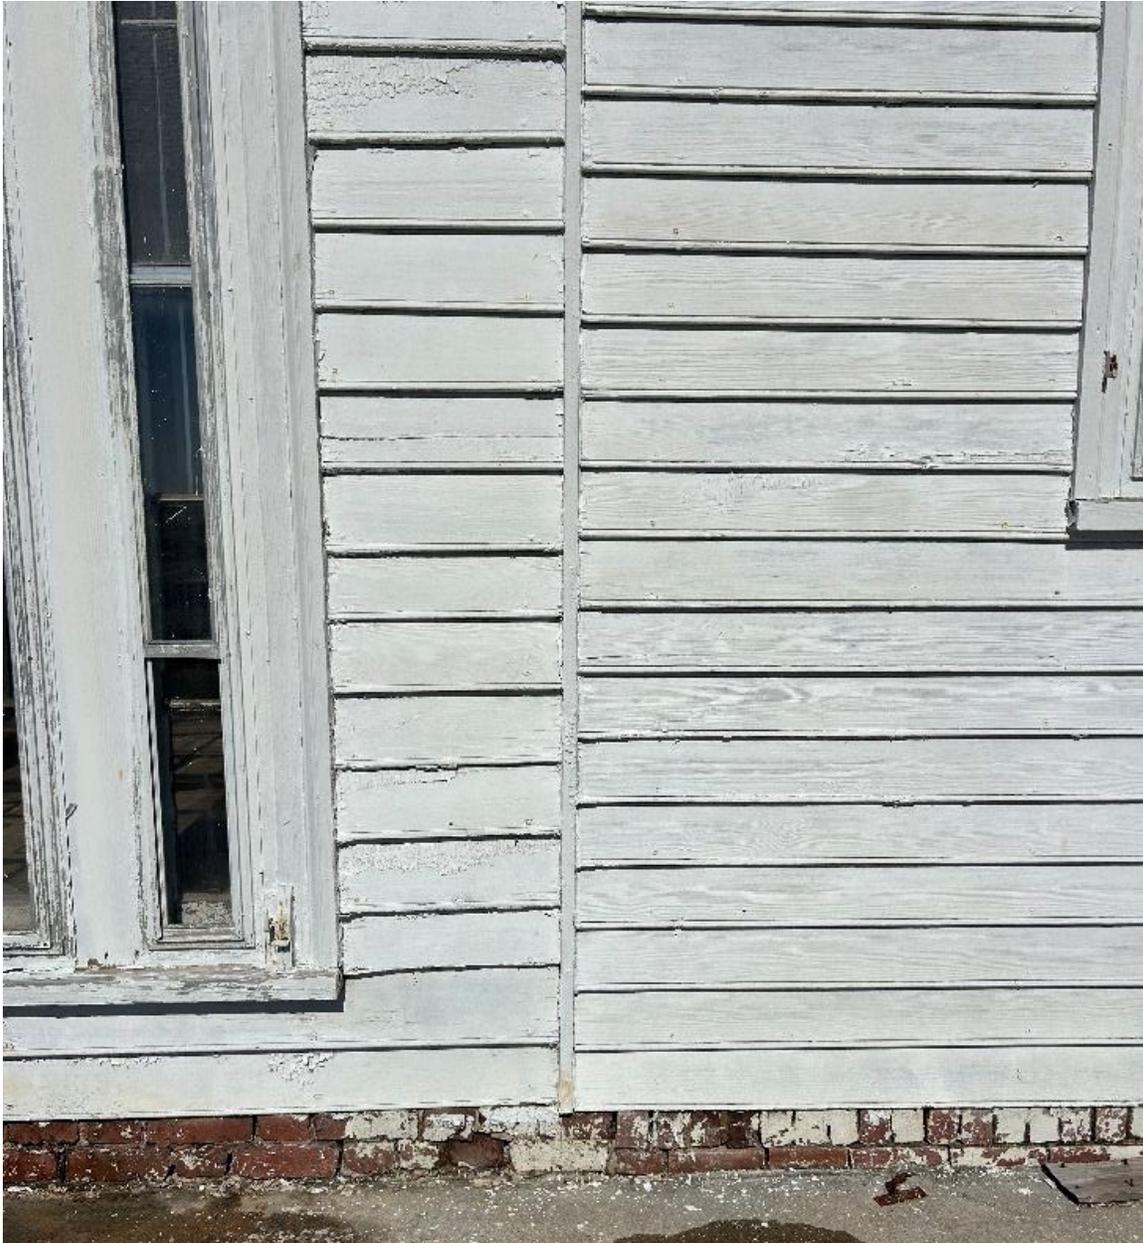
Figure 130: The southern exterior wall where Campaign Two and Campaign Four meet with a visible break in the siding. Below, the brick bond also changes at this point. Both clues indicate that the two campaigns were built at separate times.

of the main block of the house (Fig 130). Although Campaign Four is visibly different from the rest of the main block of the house, the HABS survey incorrectly estimates that Campaign Four was built at the same time as Campaign Two and Campaign Three around 1800.¹⁴⁰ However, there is a large amount of physical evidence that discredits HABS' proposal.
