The Six Building Campaigns at Sylvania:

The Transformation of Sylvania from a Folk Plantation House to a Fashionable Plantation,

1790-1865

Victoria Mae Bitrick

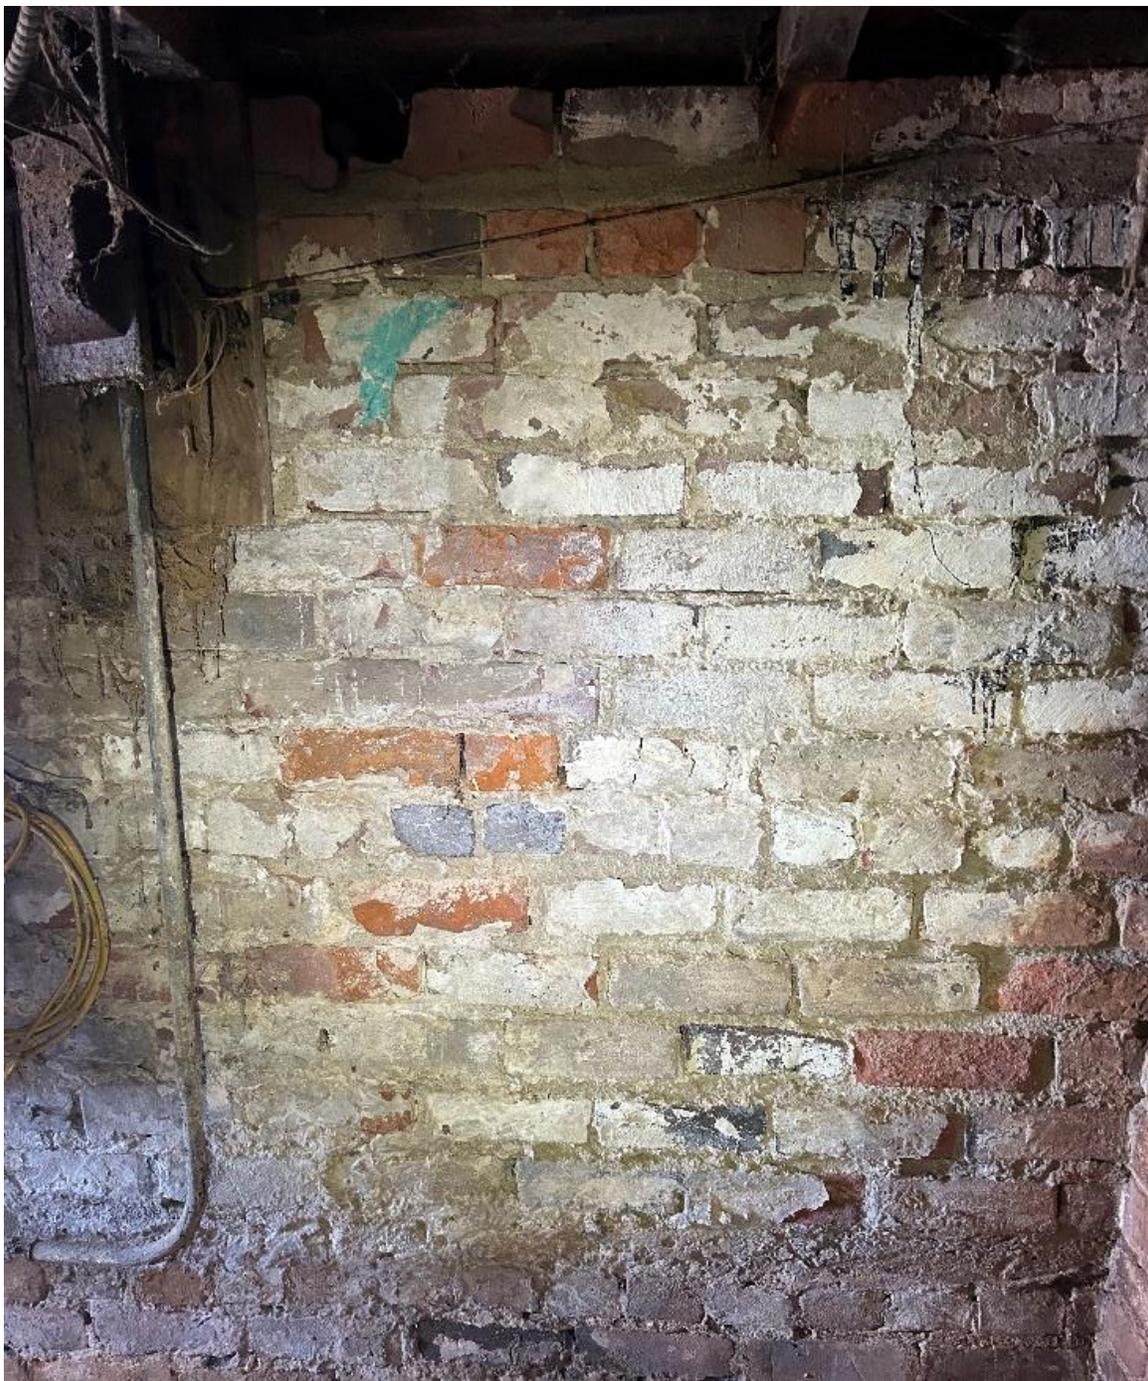
Figure 131: One-to-seven brick bond on the east cellar wall under Campaign Four. This brick bond is consistent on the brick walls dating to Campaign Four.

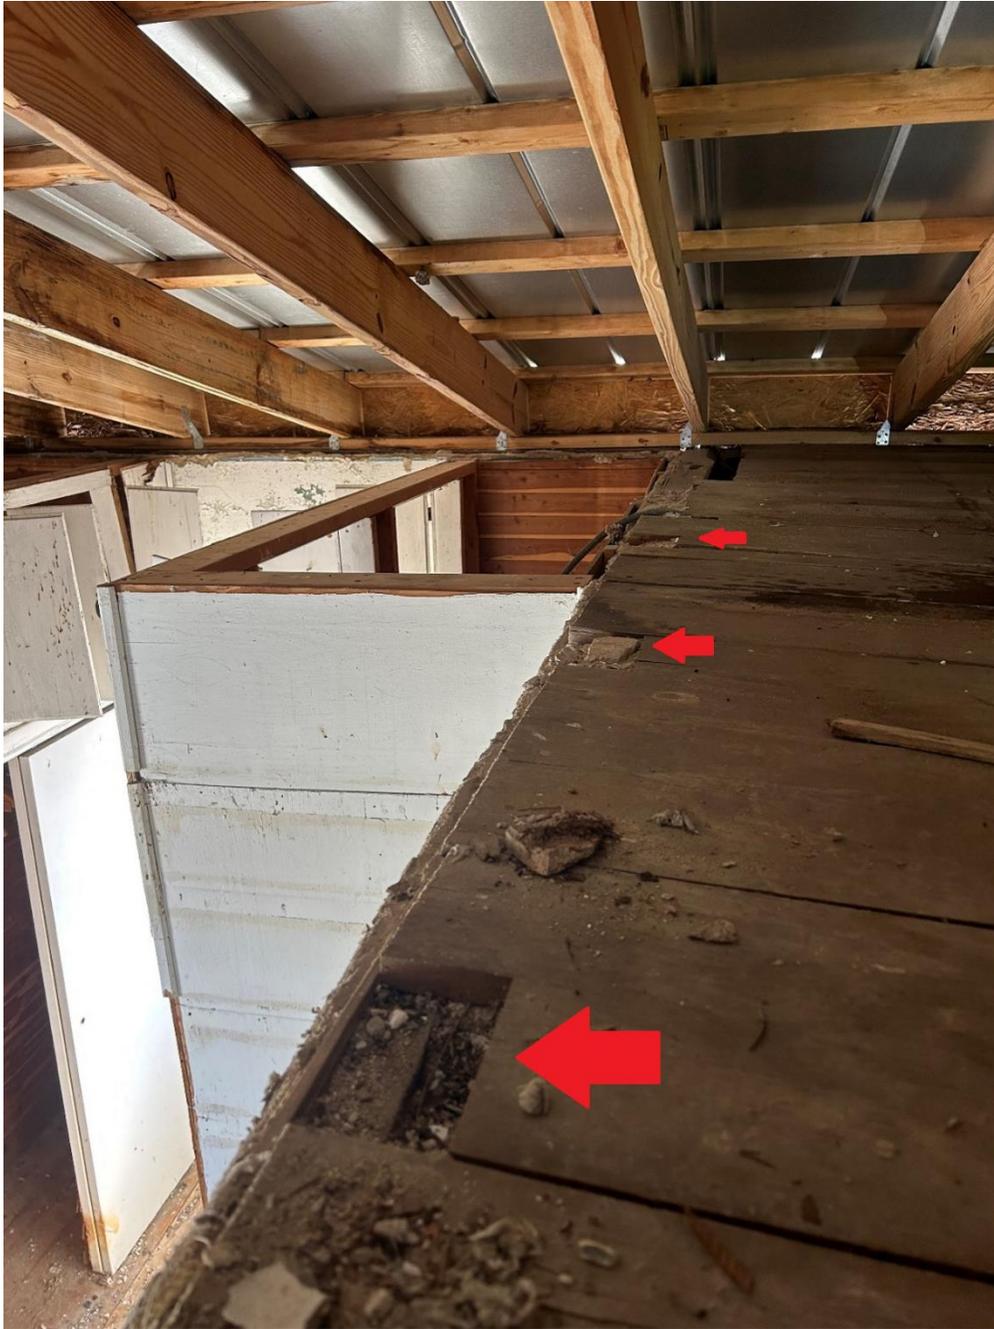
Figure 133: The ghost marks of original roof gable's structural members found on the eastern end of Campaign Two in the attic.

Figure 133: The ghost marks of original roof gable's structural members found on the eastern end of Campaign Two in the attic.

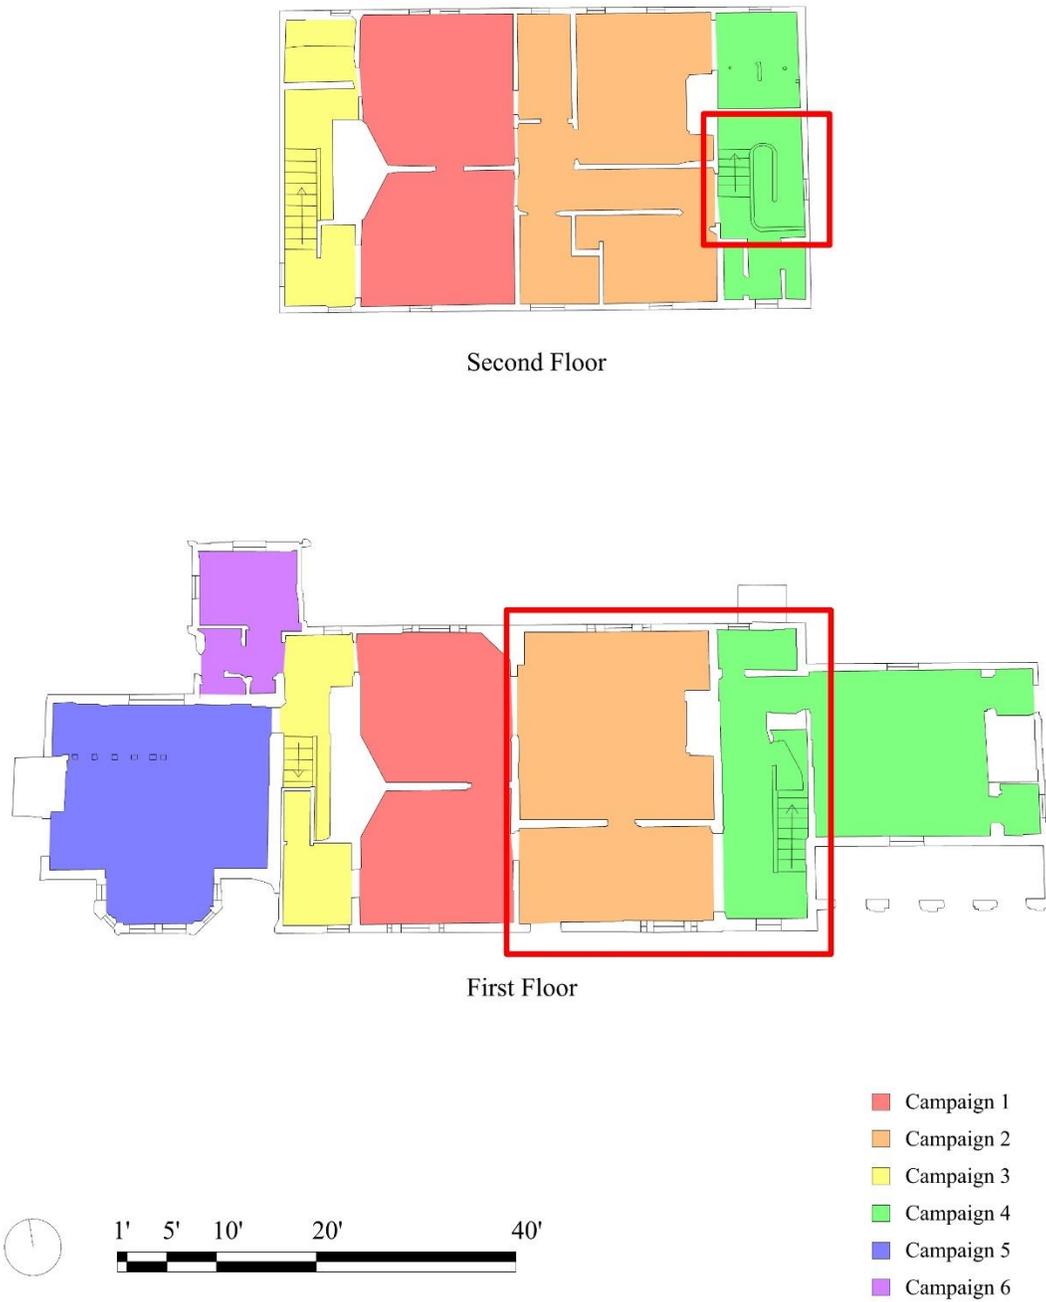
Figure 134: The locations where baseboards match the baseboards found in Campaign Four. The only area that matches Campaign Four’s baseboards is the first floor of Campaign Two.

Figure 134: The locations where baseboards match the baseboards found in Campaign Four. The only area that matches Campaign Four's baseboards is the first floor of Campaign Two.

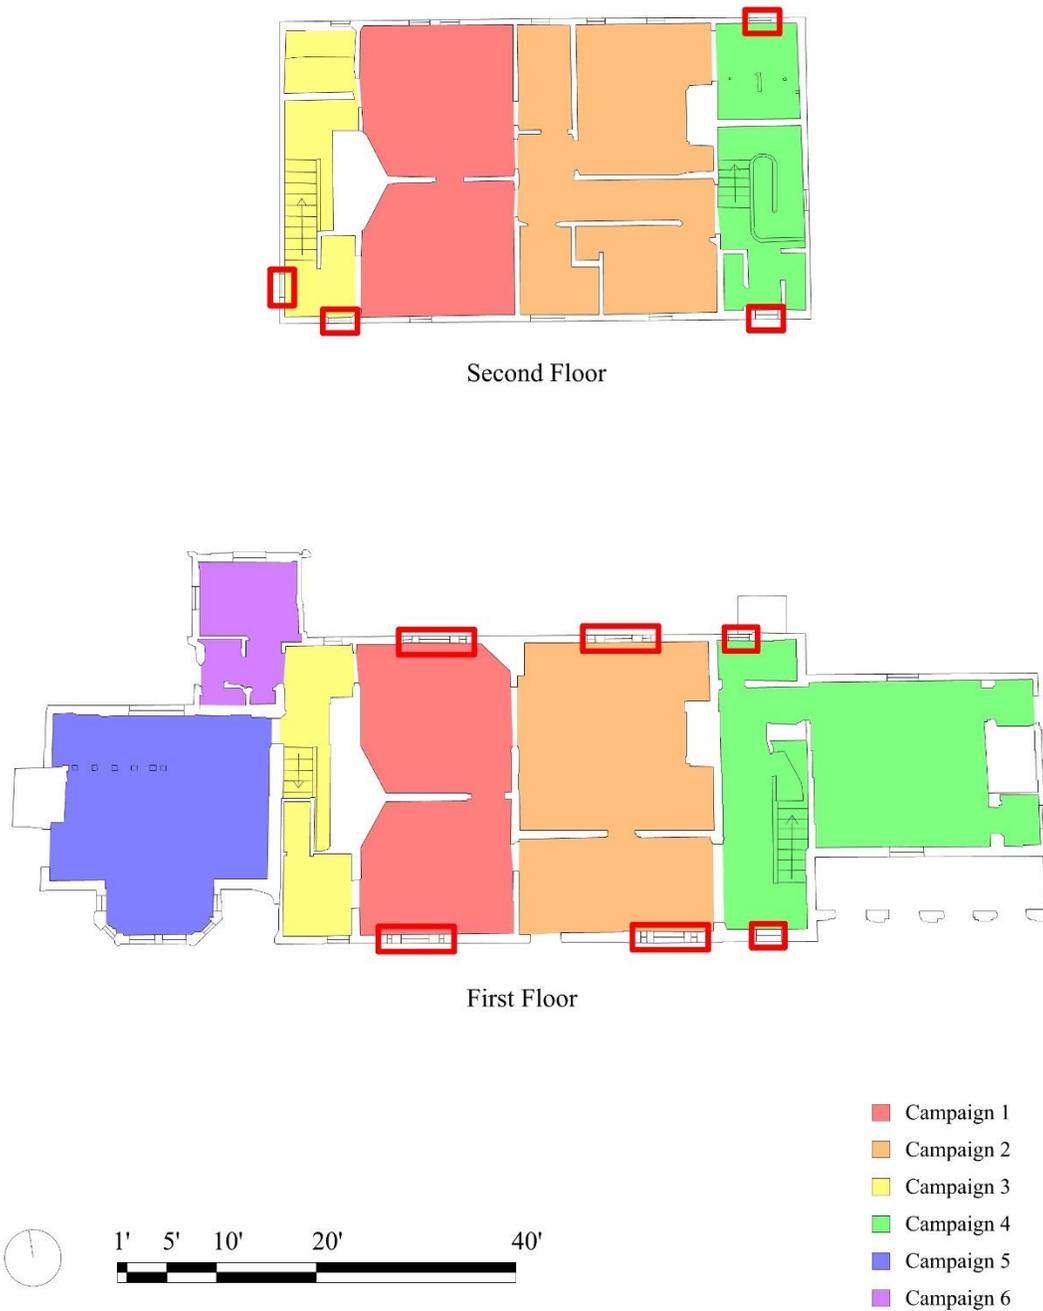
Figure 135: The locations of windows with trim matching Campaign Four’s window trim. All the tripartite windows match Campaign Four’s trim, suggesting that they were added at the same time as Campaign Four. Two windows on the second floor of Campaign Three also match Campaign Four.

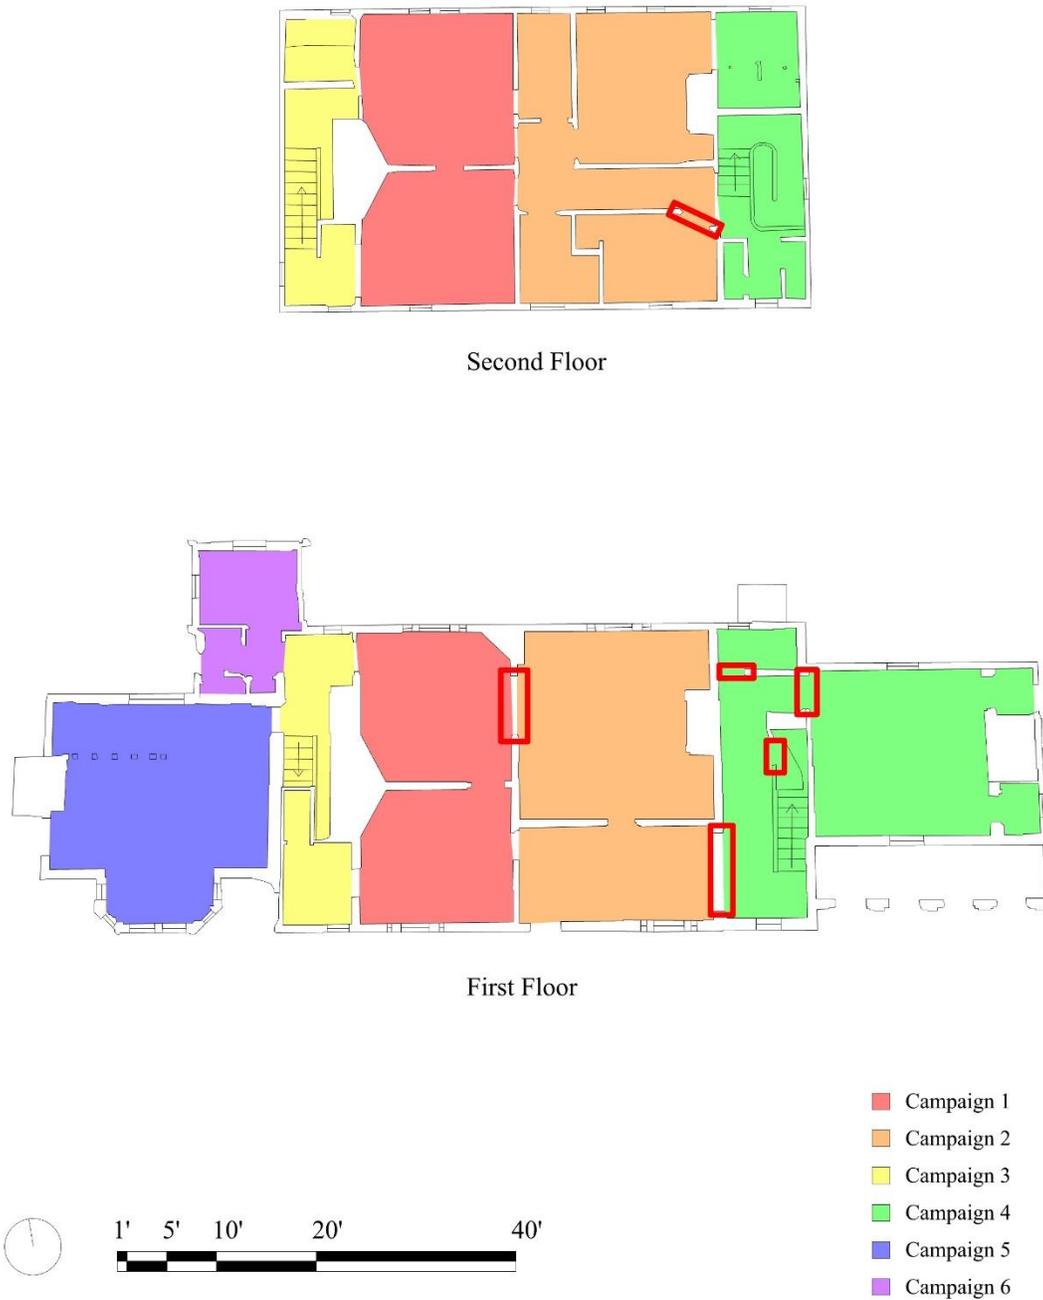
Figure 136: The location of door trims matching Campaign Four's door trims. The arch, opening between Campaign One and Campaign Two on the first floor, and the southeast bedroom door match Campaign Four's trim, suggesting that these openings were added when Campaign Four was added.

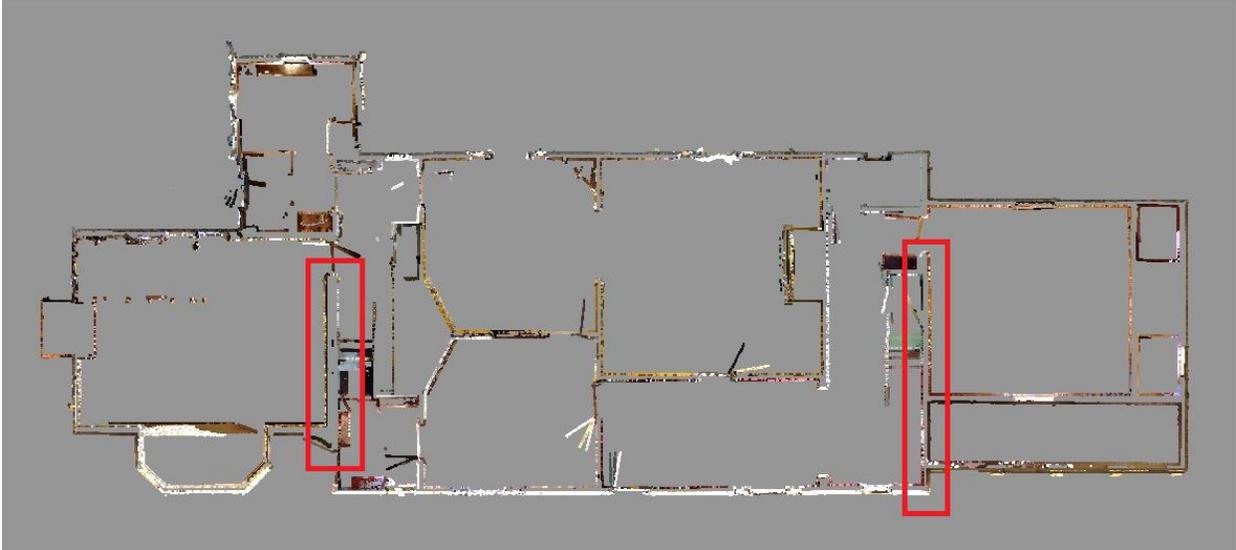
Figure 137: The thicknesses of walls joining the side wings to the main block of the house, shown on the first-floor plan generated by 3D data. The data reveals that the wall dividing Campaign Three and the west wing(left) is much thicker than the wall dividing Campaign Four's stair hall and the east wing(right).

fifteen inches thick. Taking this into account, it is likely that the wings were not added at the same time as Gilpin and the National Park Service survey suggest.

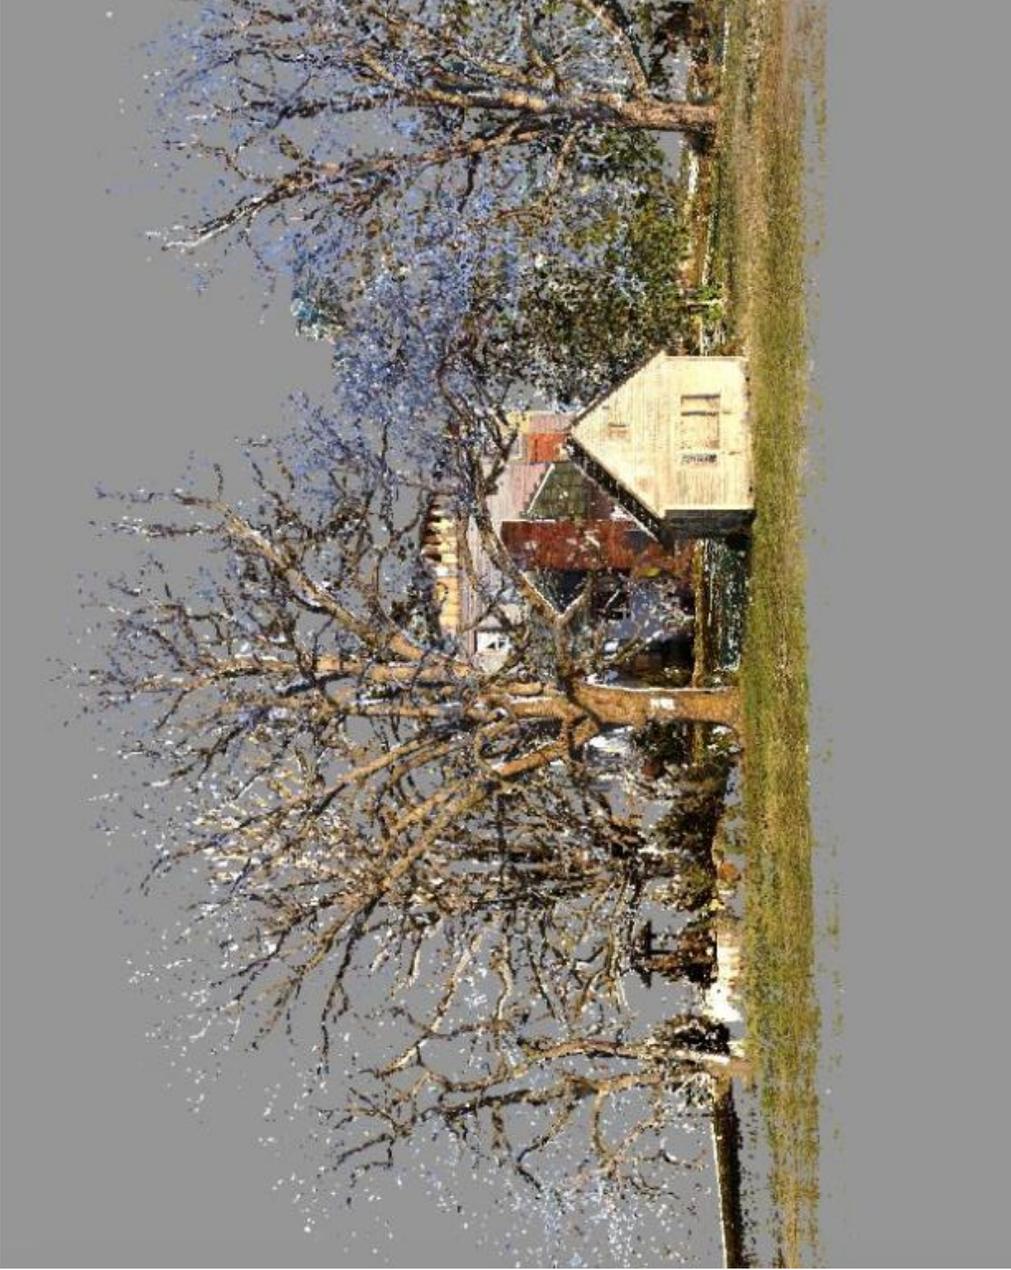
Figure 141: A view of the 3D data collected from Sylvania's site, facing east. The surviving outbuilding is captured in the foreground with the main house in the background. This view of the data provides interesting information about how the two structures are organized in relationship to each other and the landscape, as well as how they compare in scale.

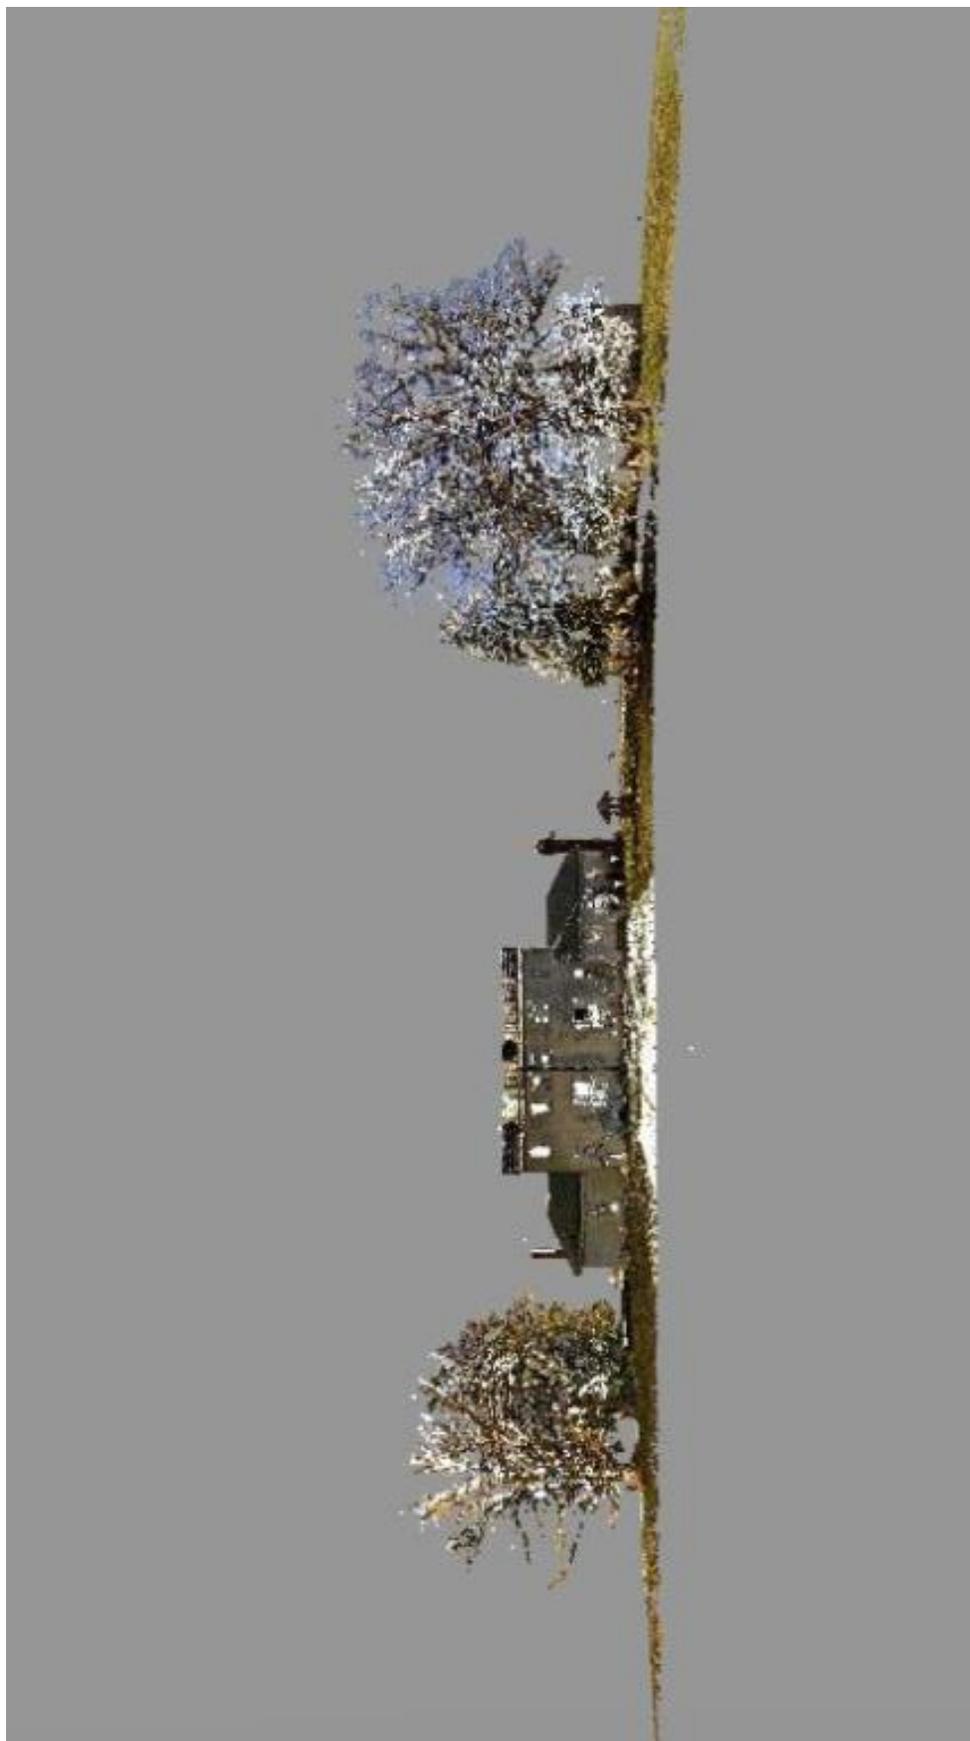
Figure 142: A view of the 3D data collected from Sylvania's site, facing south. The main house is visible near the center, with the well just to its right. The outbuilding is mostly obscured by trees from this viewpoint.

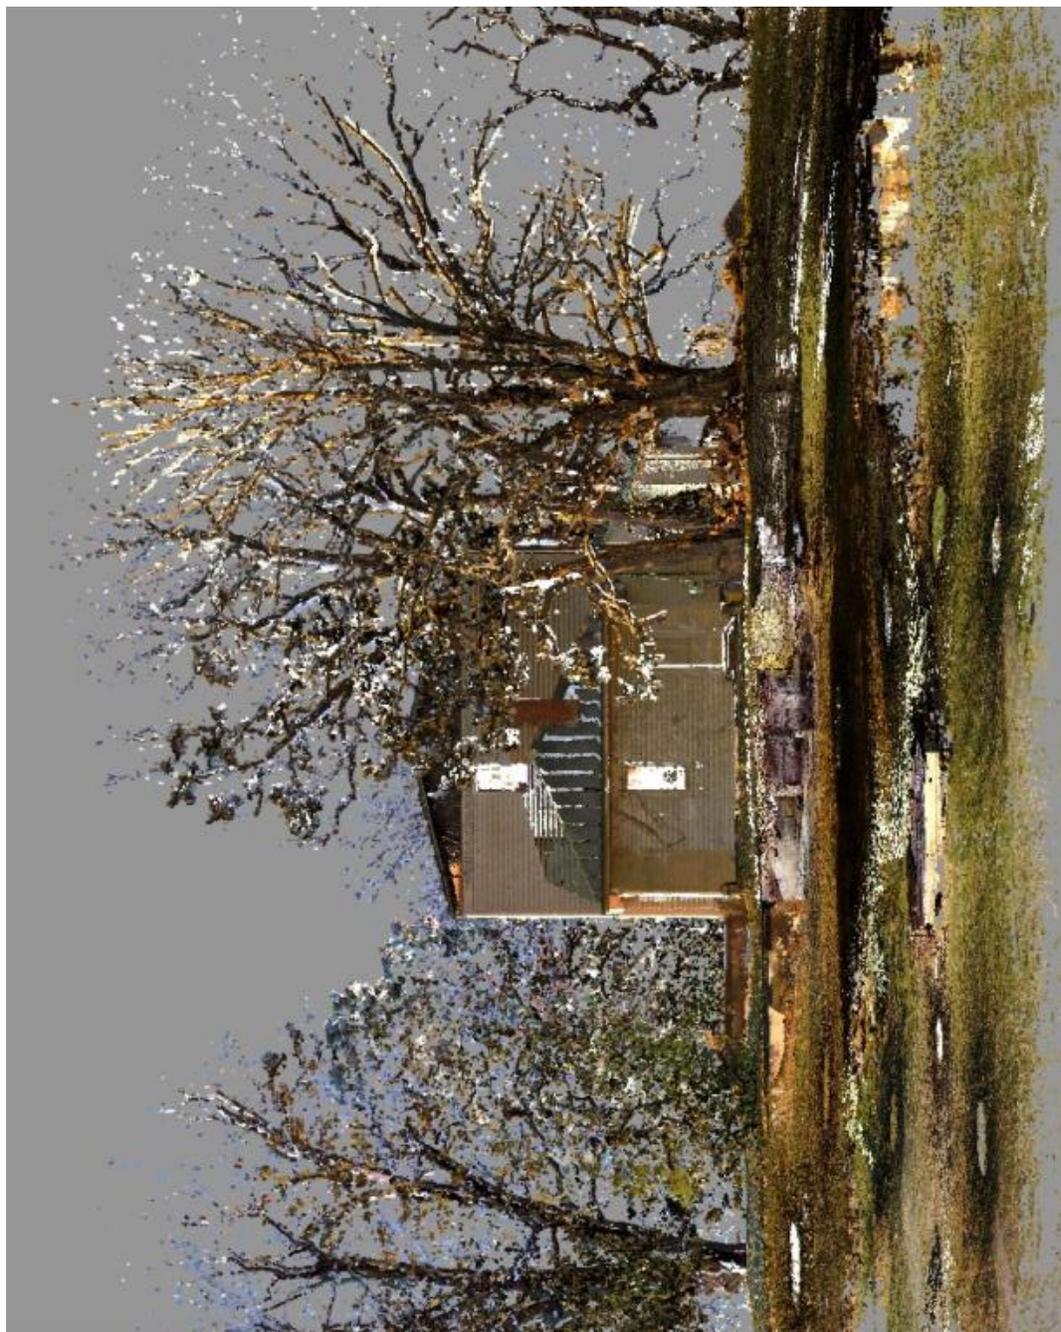
Figure 143: A view of the 3D data collected at Sylvania's site, facing west. From this viewpoint, only the main house is visible. Below the house, data collected from the cellar appears.

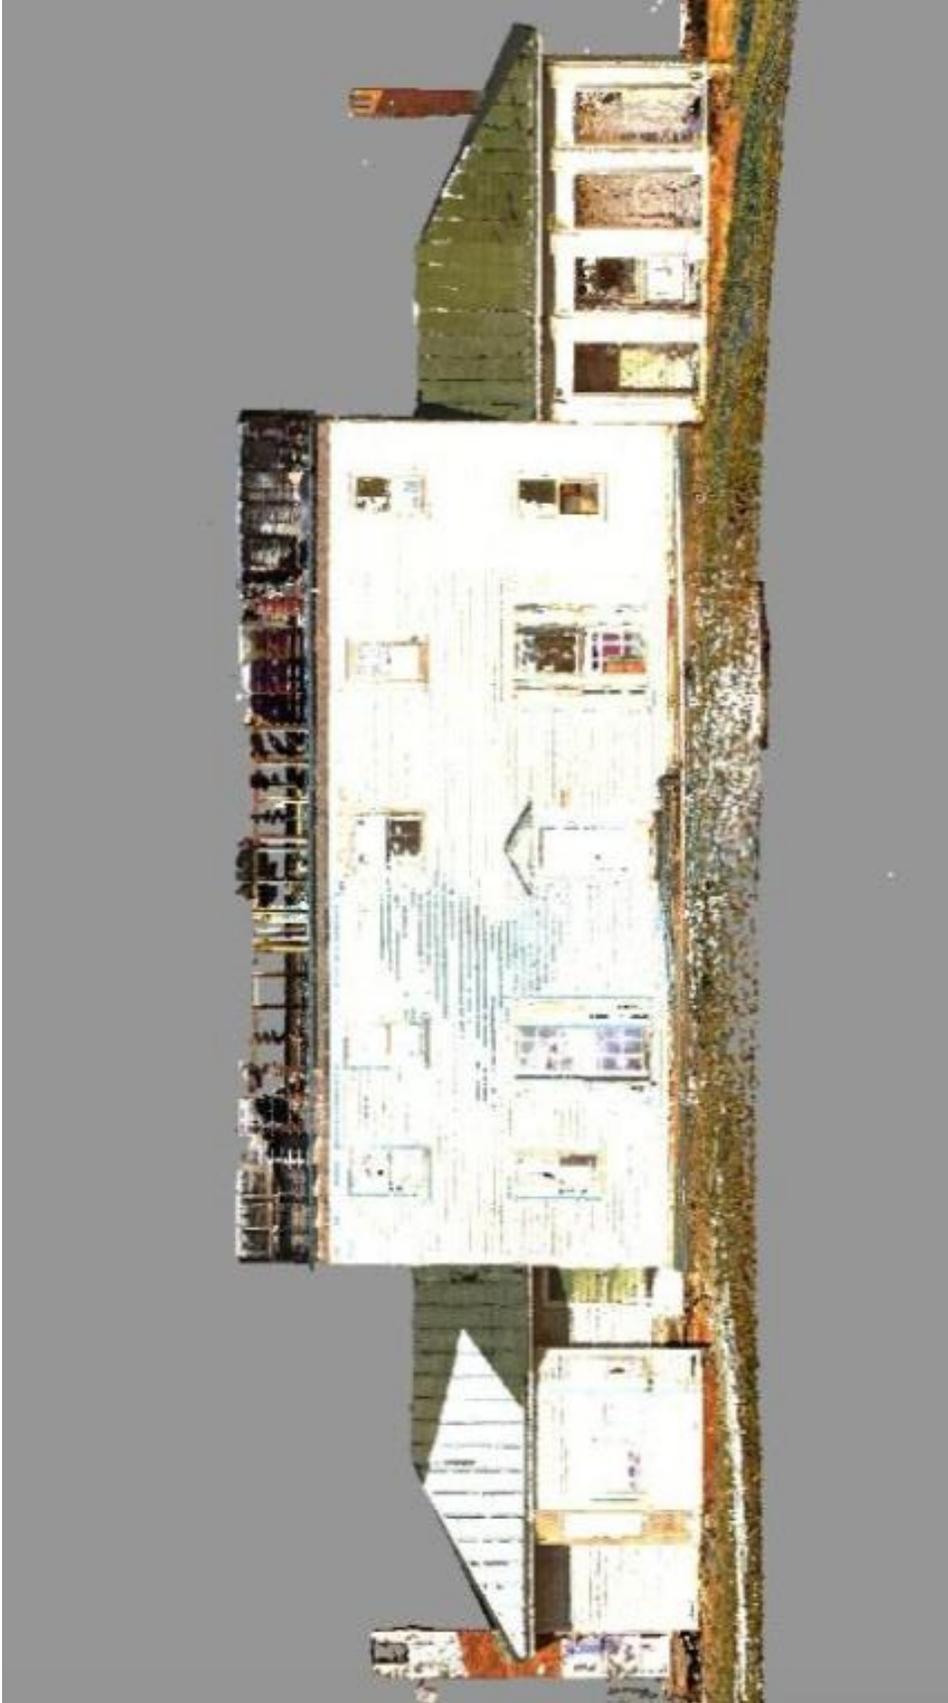
Figure 144: A view of the south elevation of the main house. From this view, the joist information in the attic is visible. This information appears here because our scanners were not placed high enough to capture 3D data from the top of the roof, and we did not have the equipment to do so.

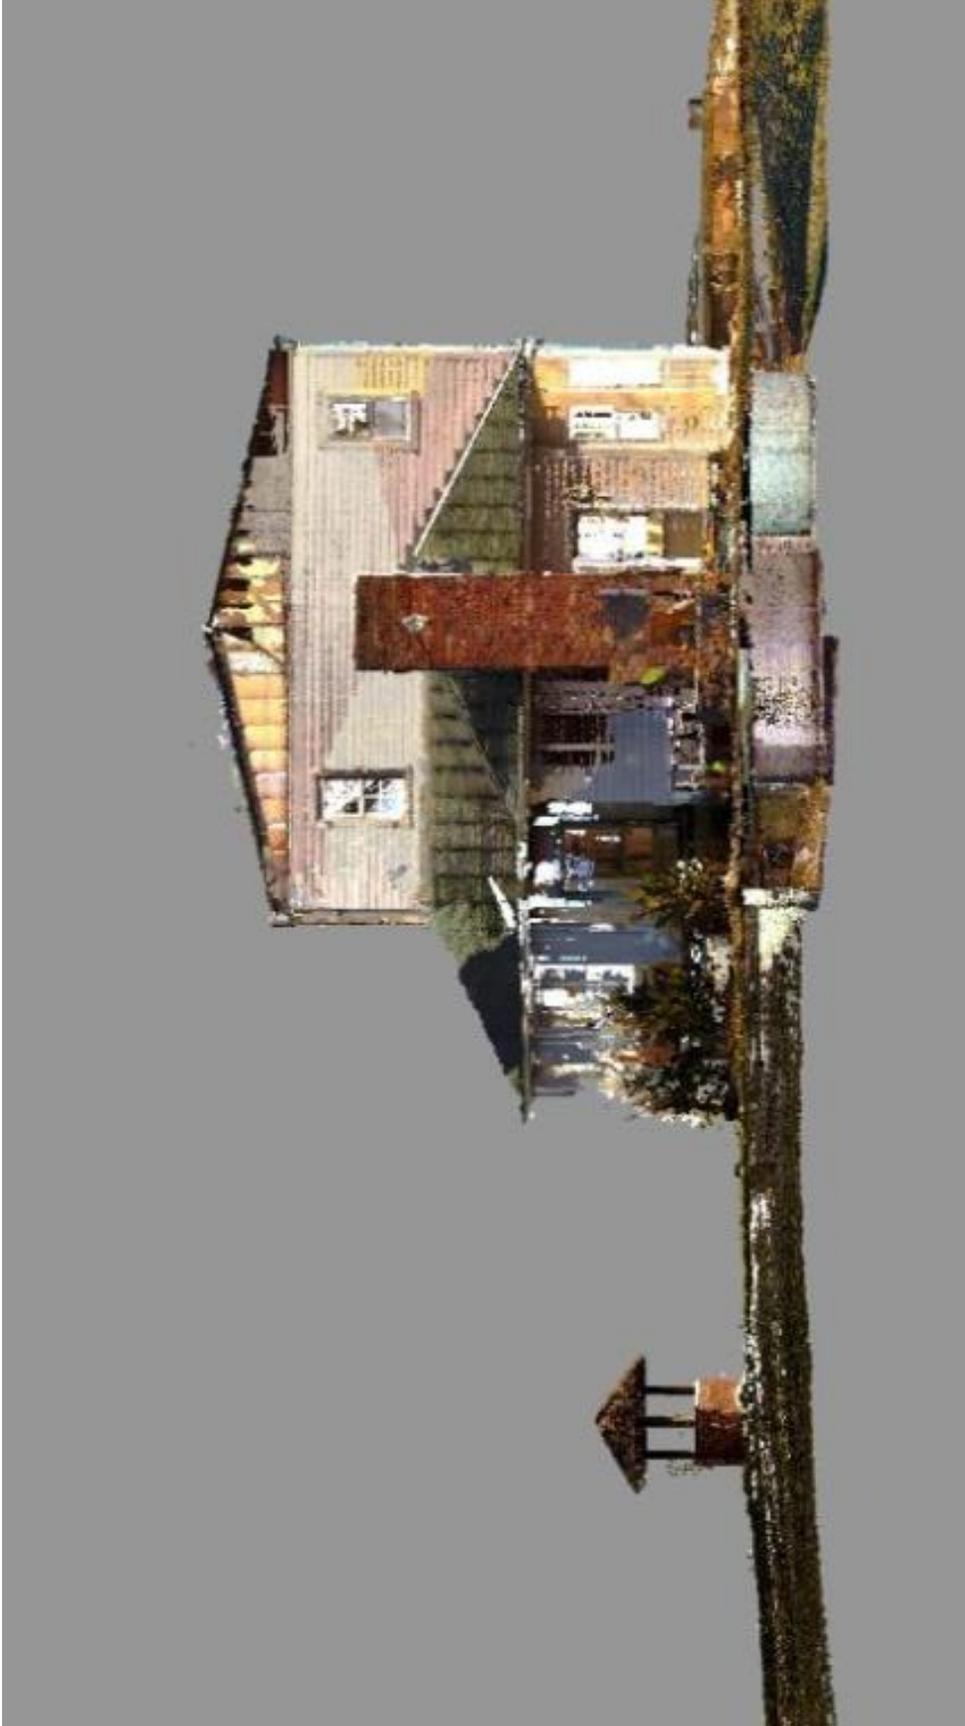
Figure 145: A view of the west elevation of the main house. Data collected from the cellar appears in this view as well. This viewpoint offers interesting information about how the cellar is situated in relationship with the house.

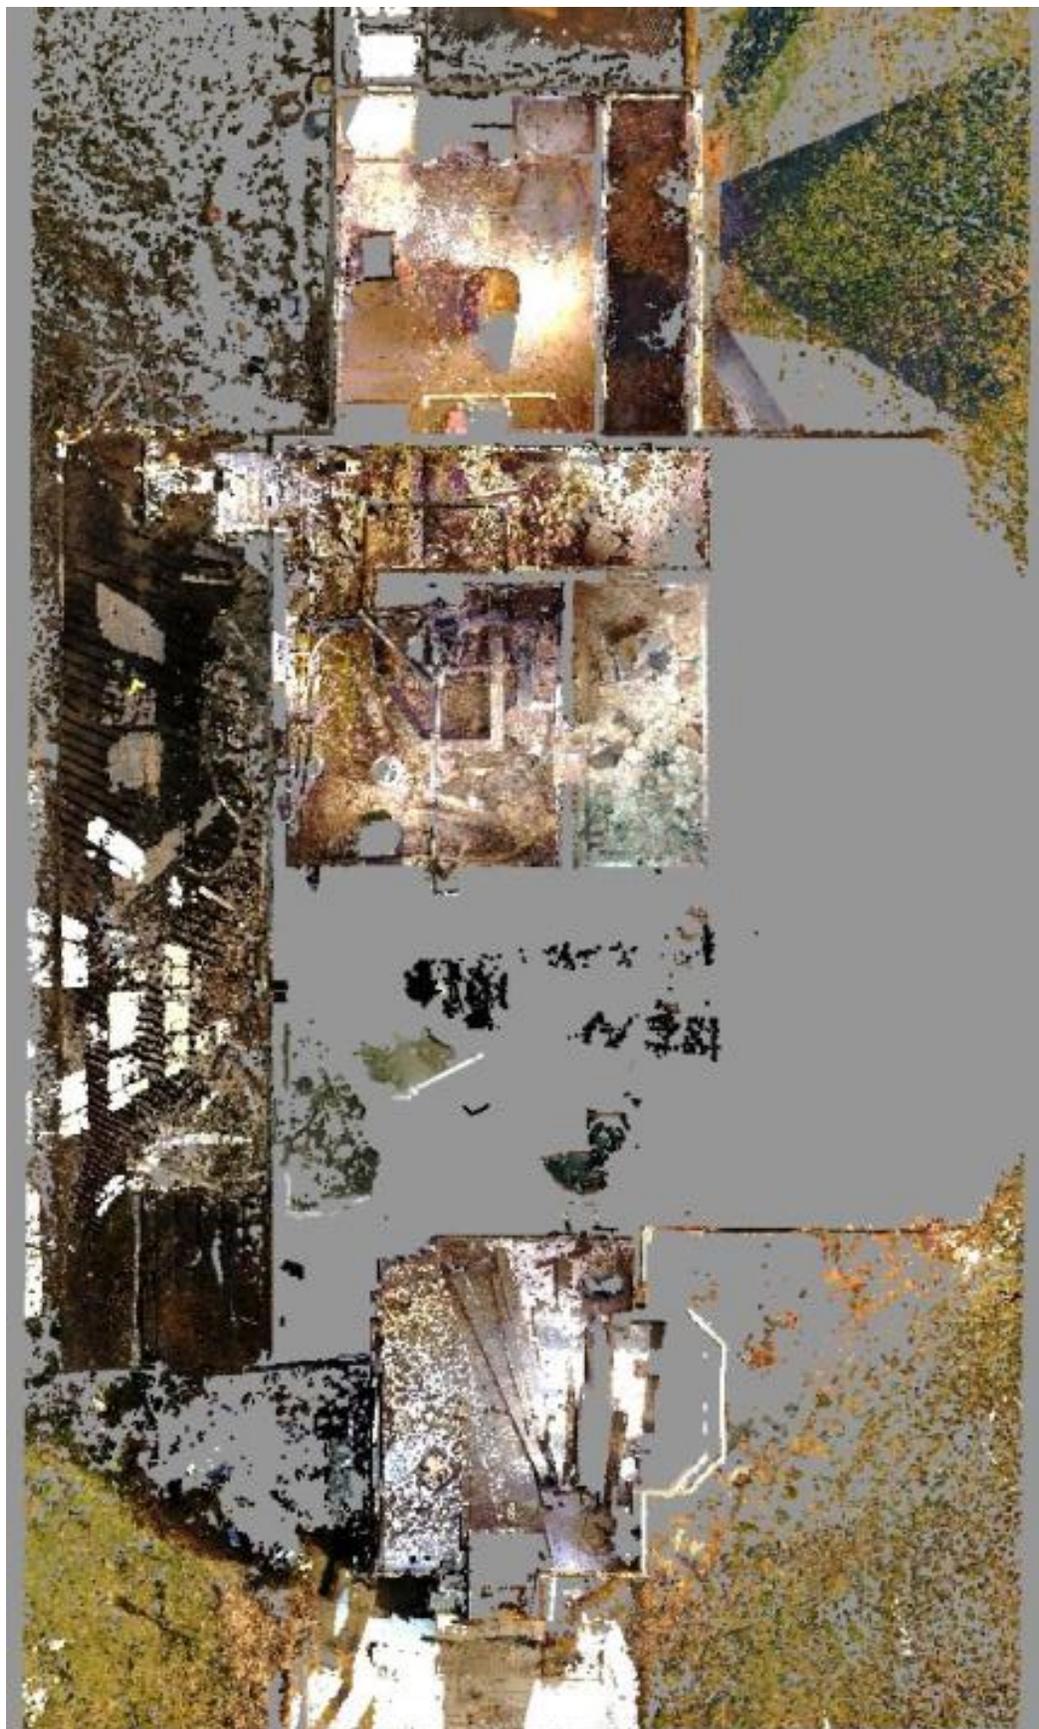
Figure 148: A perspective of the floor plans of the accessible cellar under Campaign Two and the inaccessible cellar under Campaign One and Campaign Three. The two side wings also appear in this perspective.

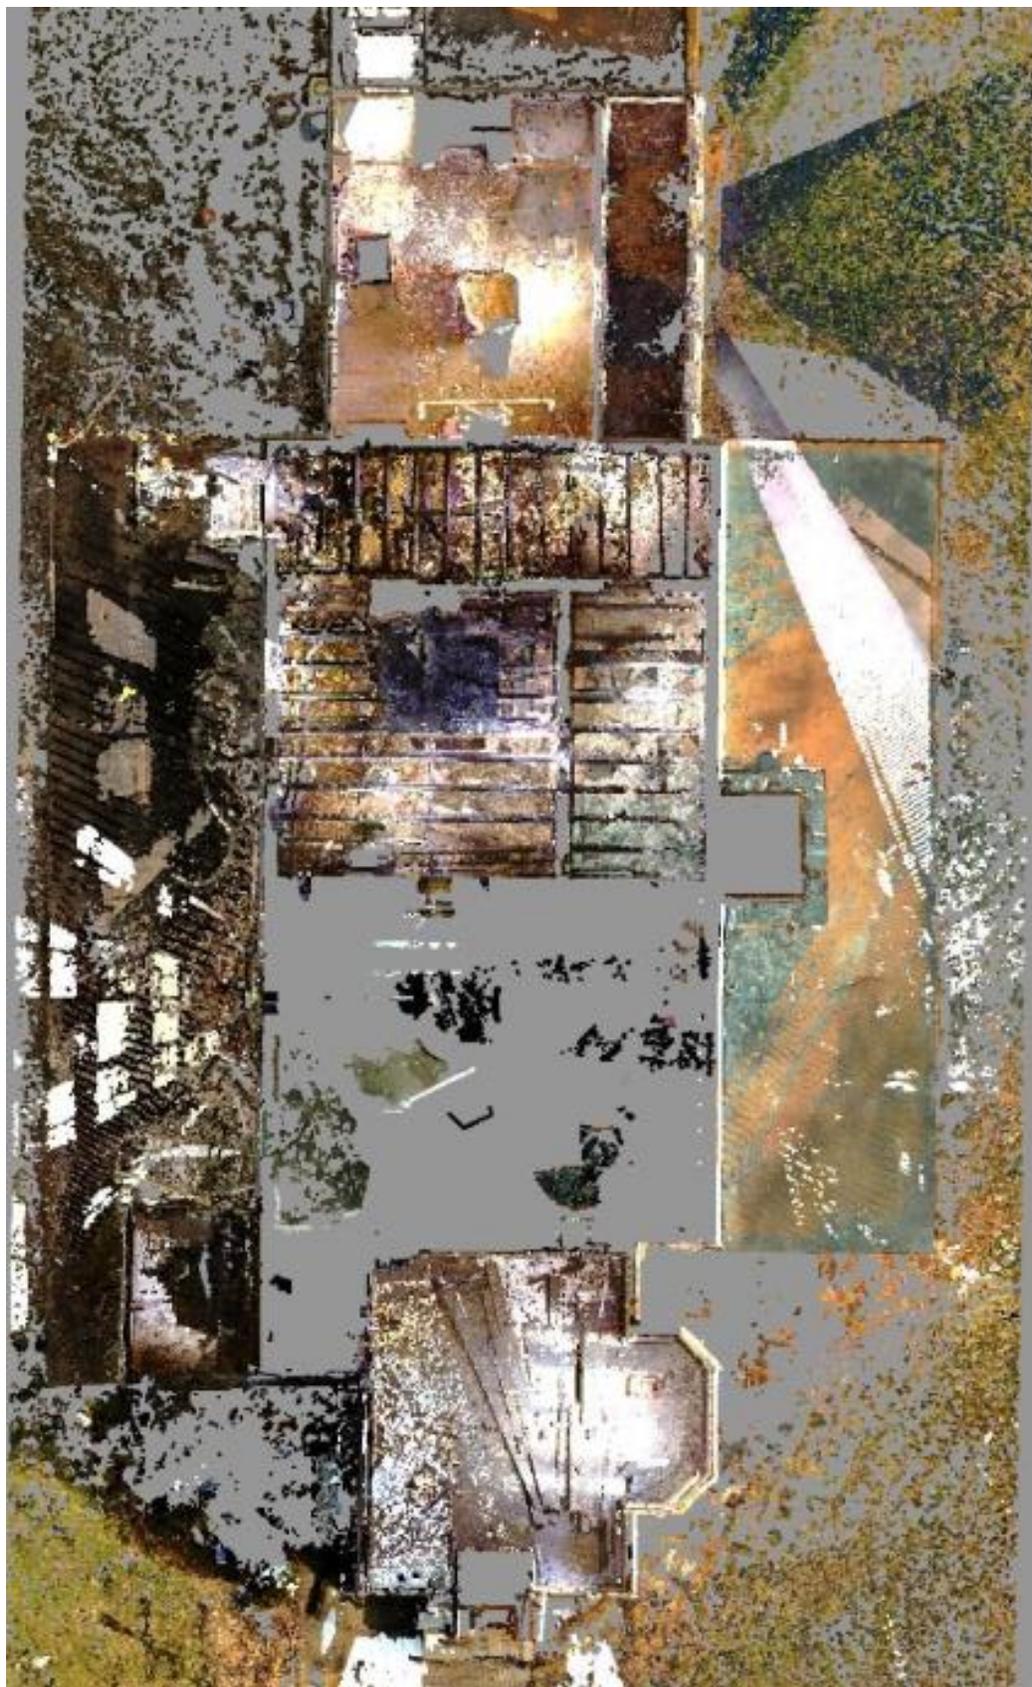
Figure 149: Another perspective of the floor plans of the two cellars. From this perspective, 3D data captured the joist information in the accessible cellar.

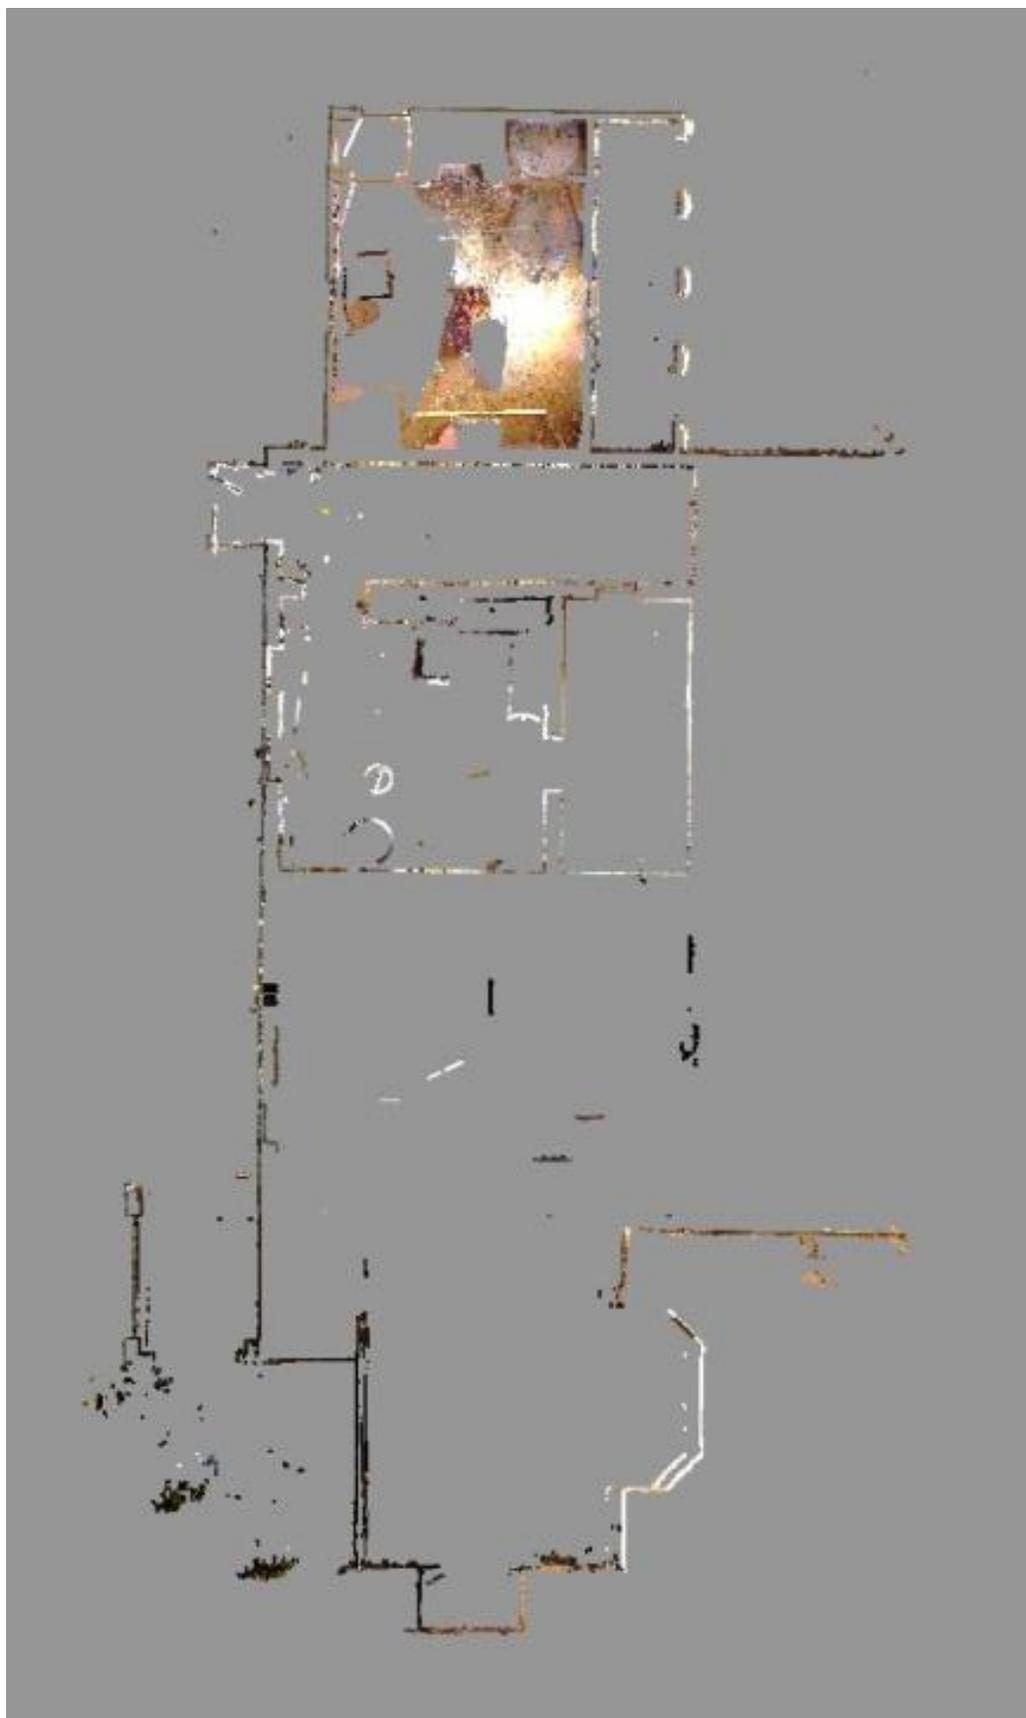
Figure 150: The floor plan of the cellars generated from 3D data. The accessible cellar's plan is depicted clearly by the 3D data with its walls and main features. The inaccessible cellar's plan depicts the different features that were captured by the 3D data collected from the 3 holes in the cellar walls.
