The Six Building Campaigns at Sylvania:

The Transformation of Sylvania from a Folk Plantation House to a Fashionable Plantation,

1790-1865

Victoria Mae Bitrick

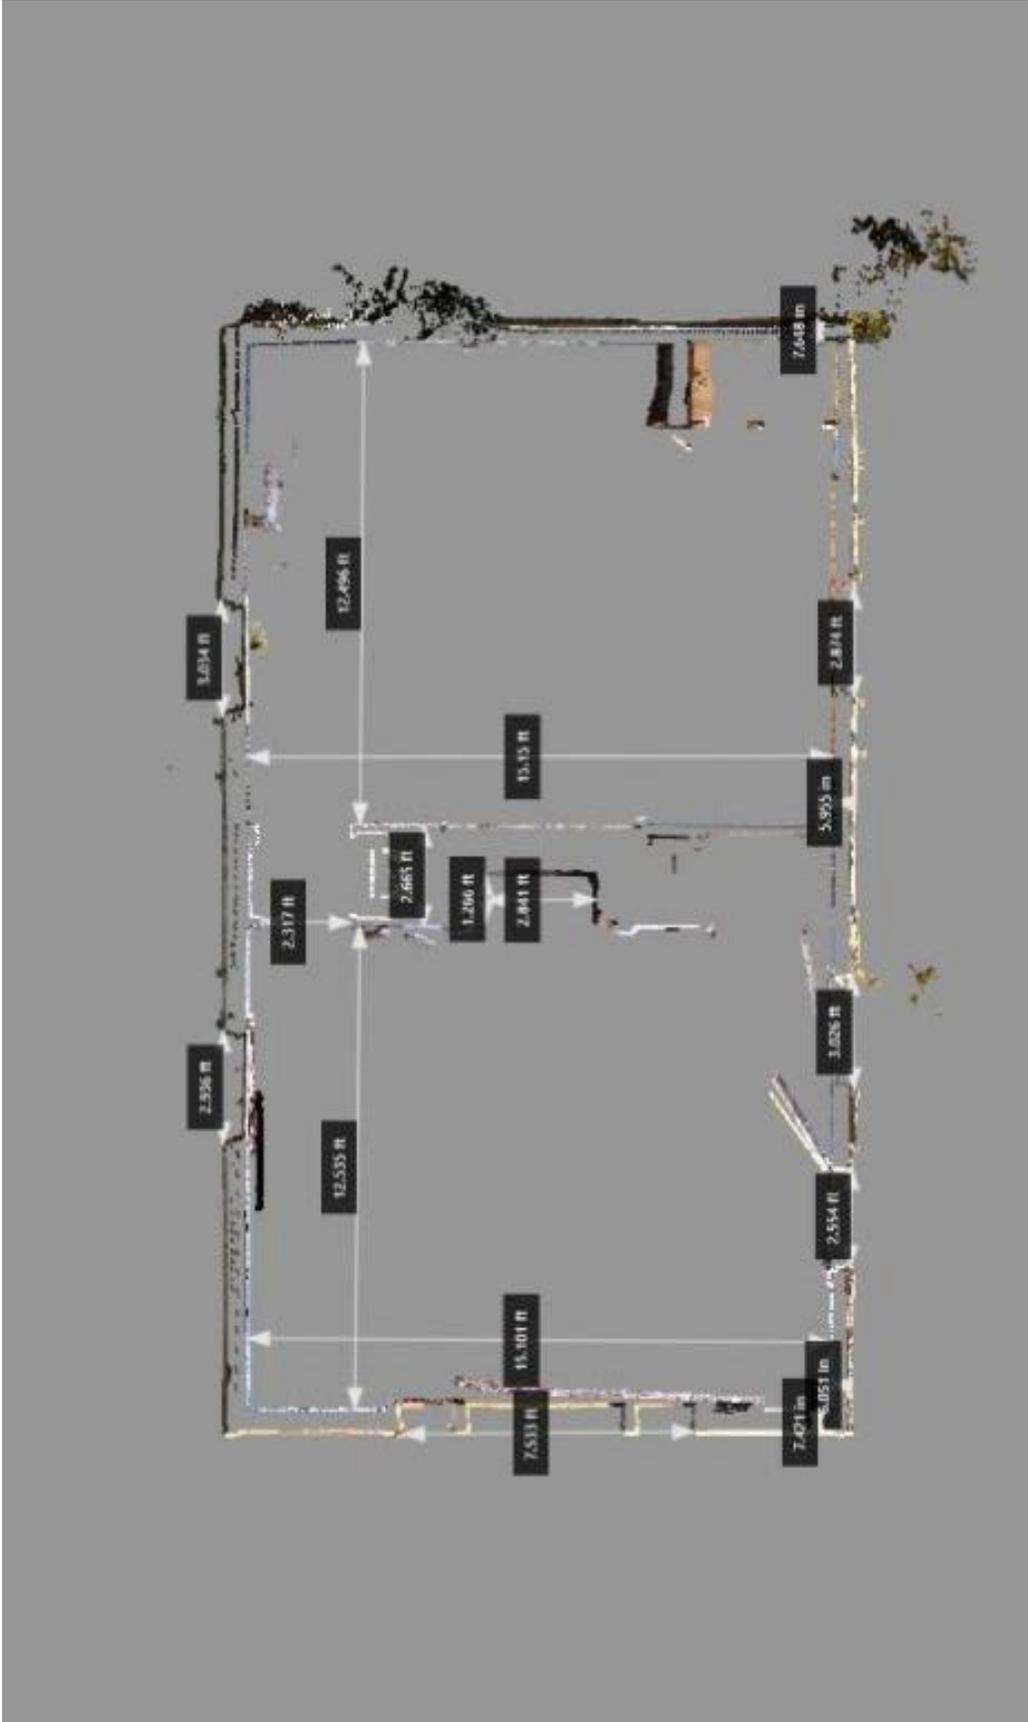
Figure 182: A view of the first-floor plan of the outbuilding with measurements drawn from the 3D data.

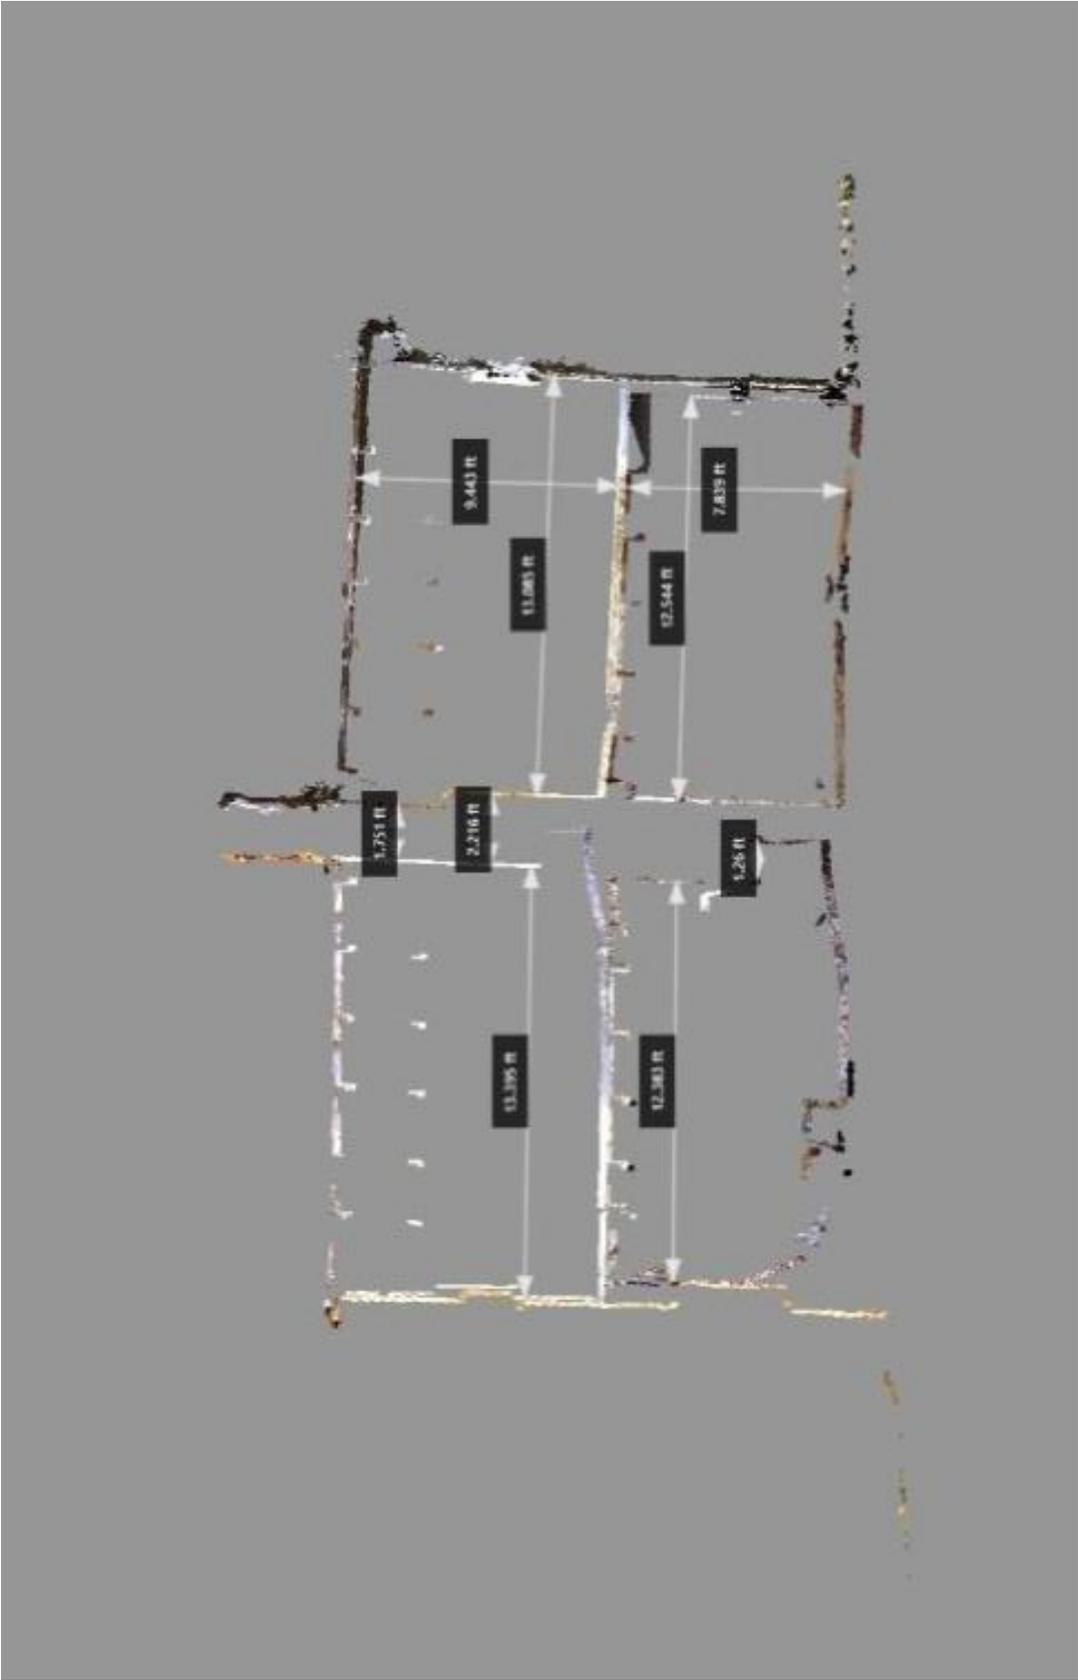
Figure 191: A section of the outbuilding with measurements drawn from the 3D data.

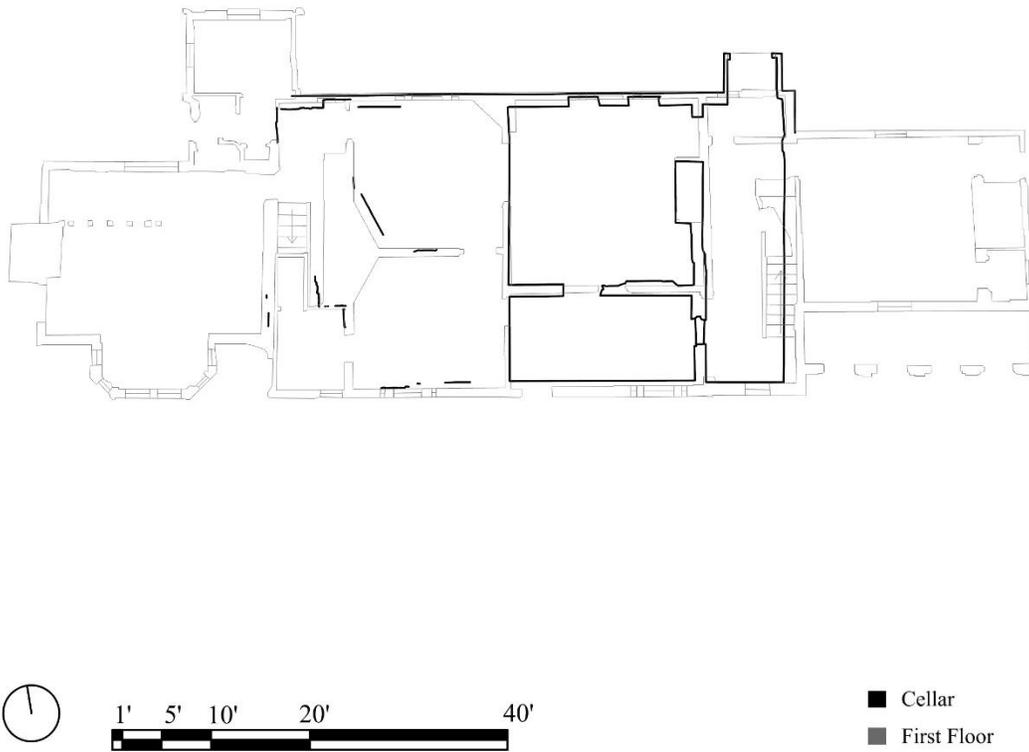
Figure 196: The first-floor plan of Sylvania that I traced from 3D data overlaid over the cellar floor plan that I traced from 3D data.

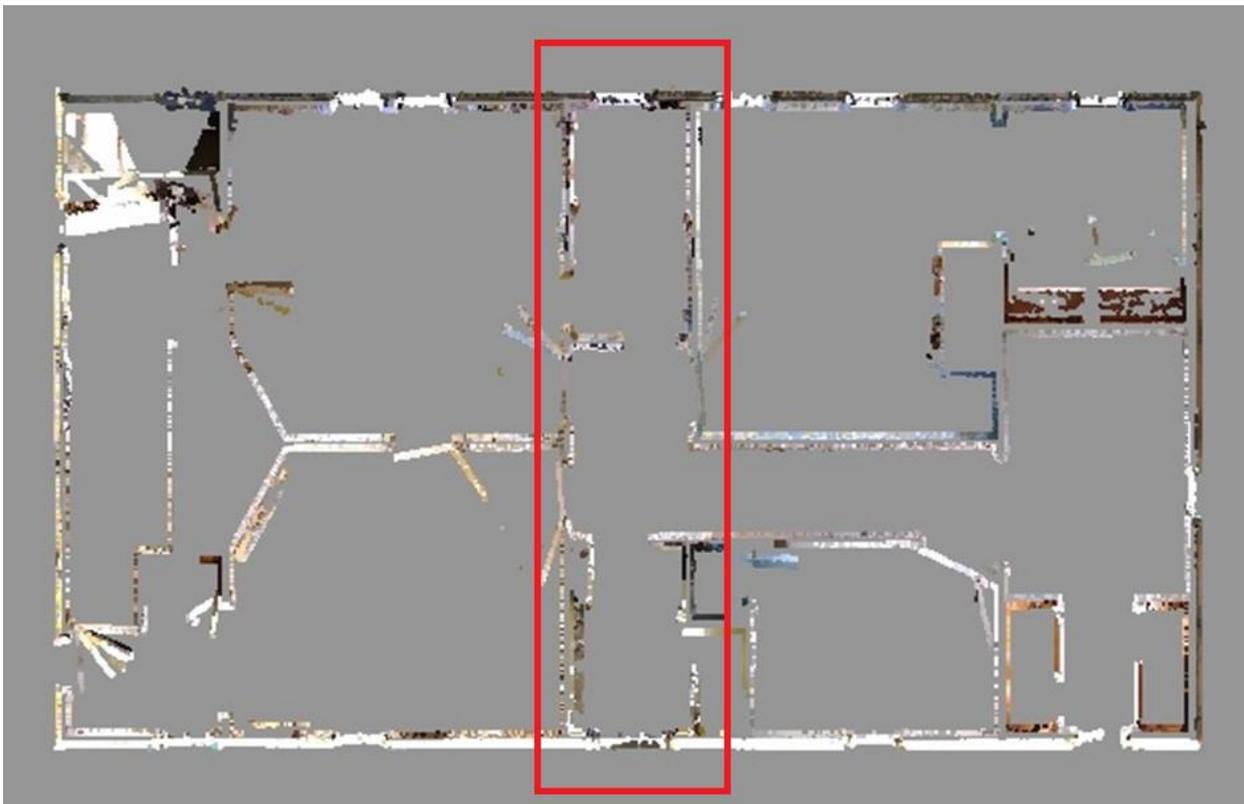
Figure 198: A view of the second-floor plan of Sylvania generated from 3D data with the location of the central passage highlighted in red.

When I looked at the second-floor plan data, I immediately noticed that there appeared to be a central passage in the middle of the plan (Fig 198). Although the ends of the passage have been enclosed to accommodate the bathrooms, its form as a passage became clear when I looked at the data in plan view. After I identified the location of the central passage, my next question was: why is there no central passage on the first floor? To answer this question, I looked back at my proportional analysis of the floor plans.

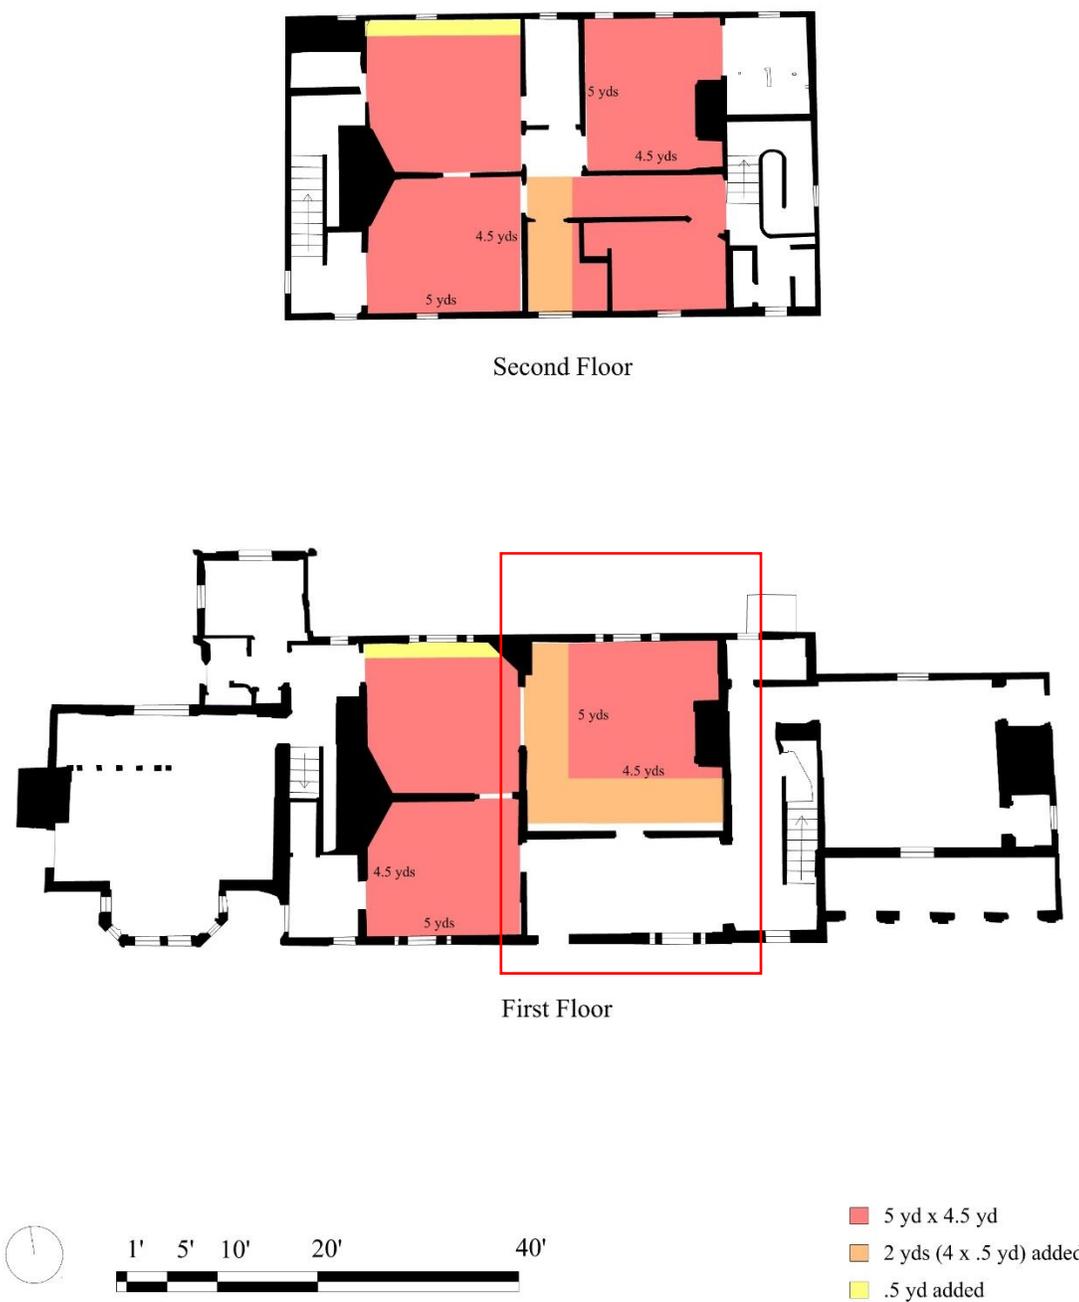
Figure 199: The area on the first floor of Sylvania where its proportional relationships are lost.

Looking at the proportions, I realized that the area where the central passage should have been on the first floor was part of the area where the proportional relationships were also lost (Fig 199). This led me to the question: was the first floor of this part of the house modified later, but not the second floor? While I could not answer this question with 3D data, by looking at the trim in the house I confirmed that the first floor of this portion of the house did indeed match a later addition to the house, while its adjacent area upstairs matched an earlier portion of the house. This led me to theorize that when the newer addition was added, sometime around the mid-19th century, that area on the first floor was renovated to match that new addition. When this renovation happened, I theorized that the central passage was removed from the downstairs plan to enlarge those rooms, but it was maintained upstairs, explaining why the trim downstairs is more modern than the trim upstairs.

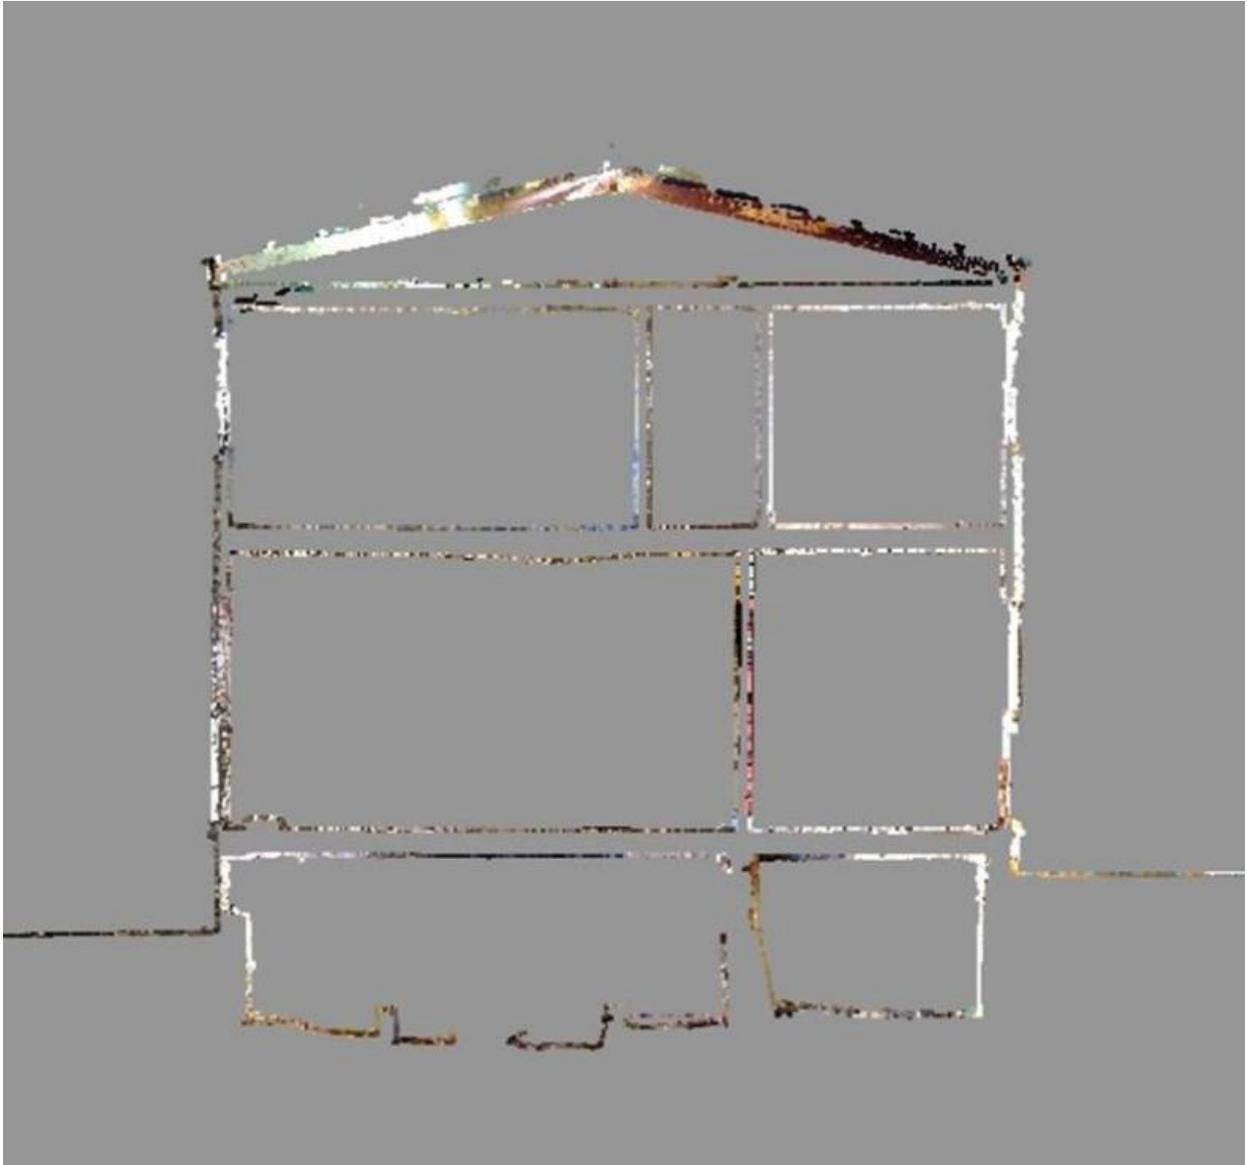
Figure 201: The section was taken from Campaign Two where the first floor was later modified and does not retain its original proportional relationships.

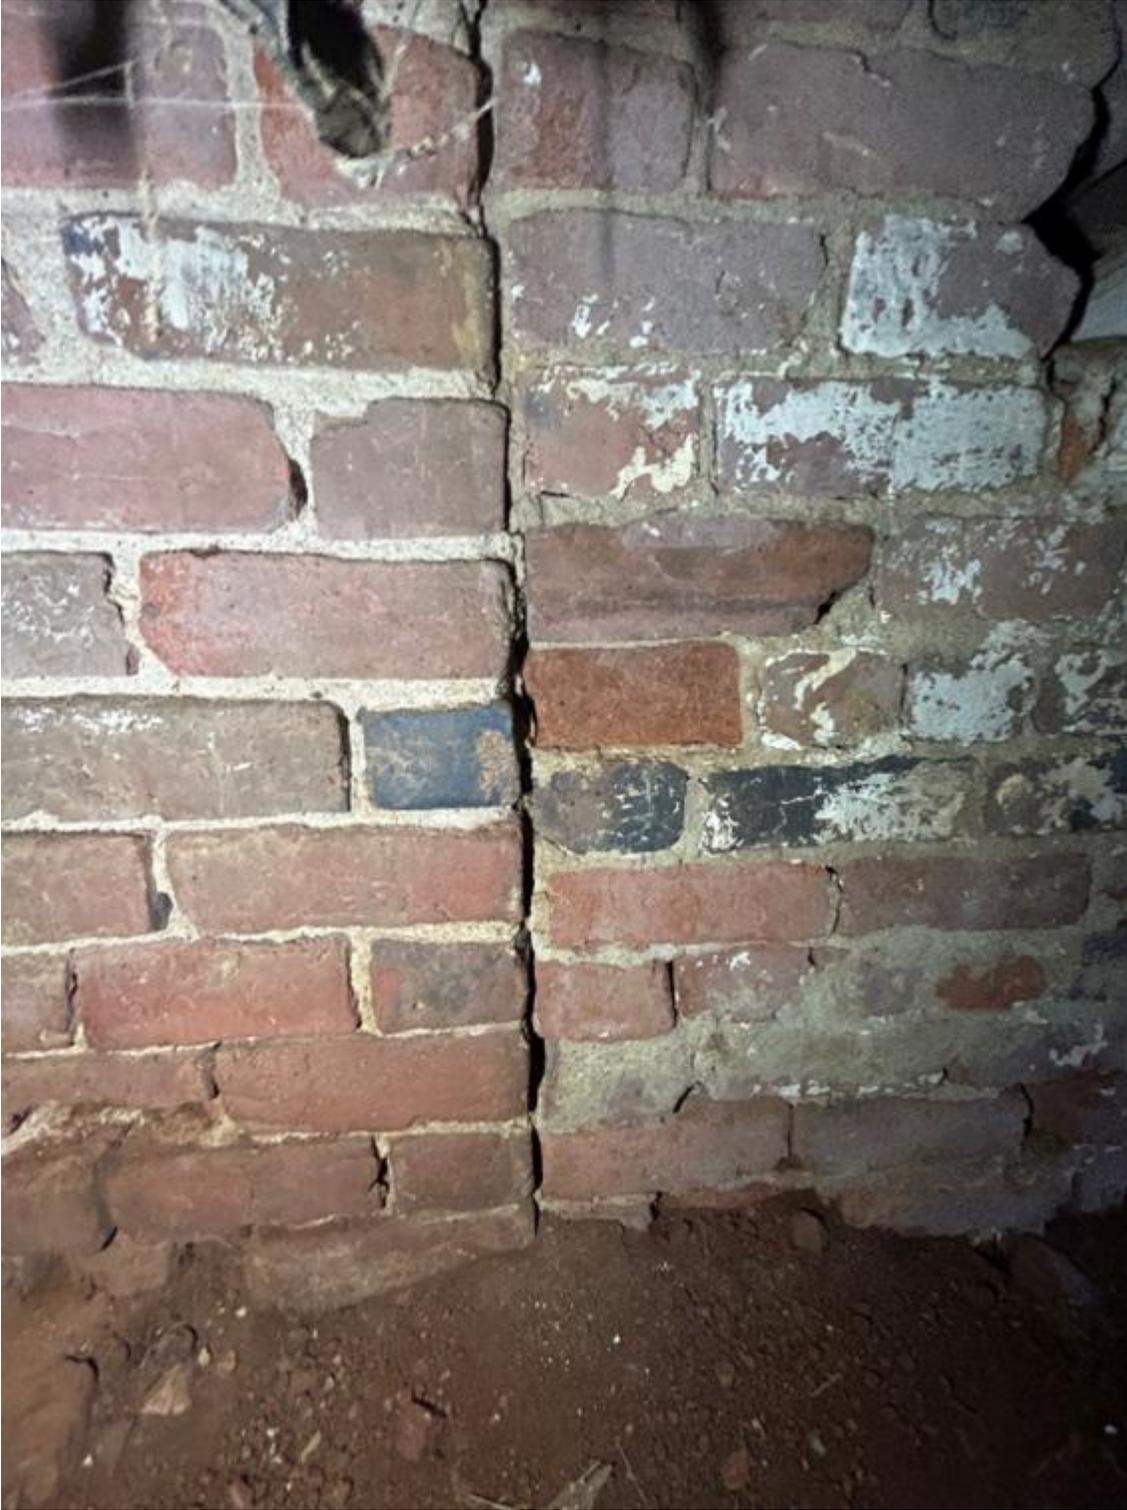
Figure 202: The break in the cellar wall that divides Campaign Two from Campaign Four.

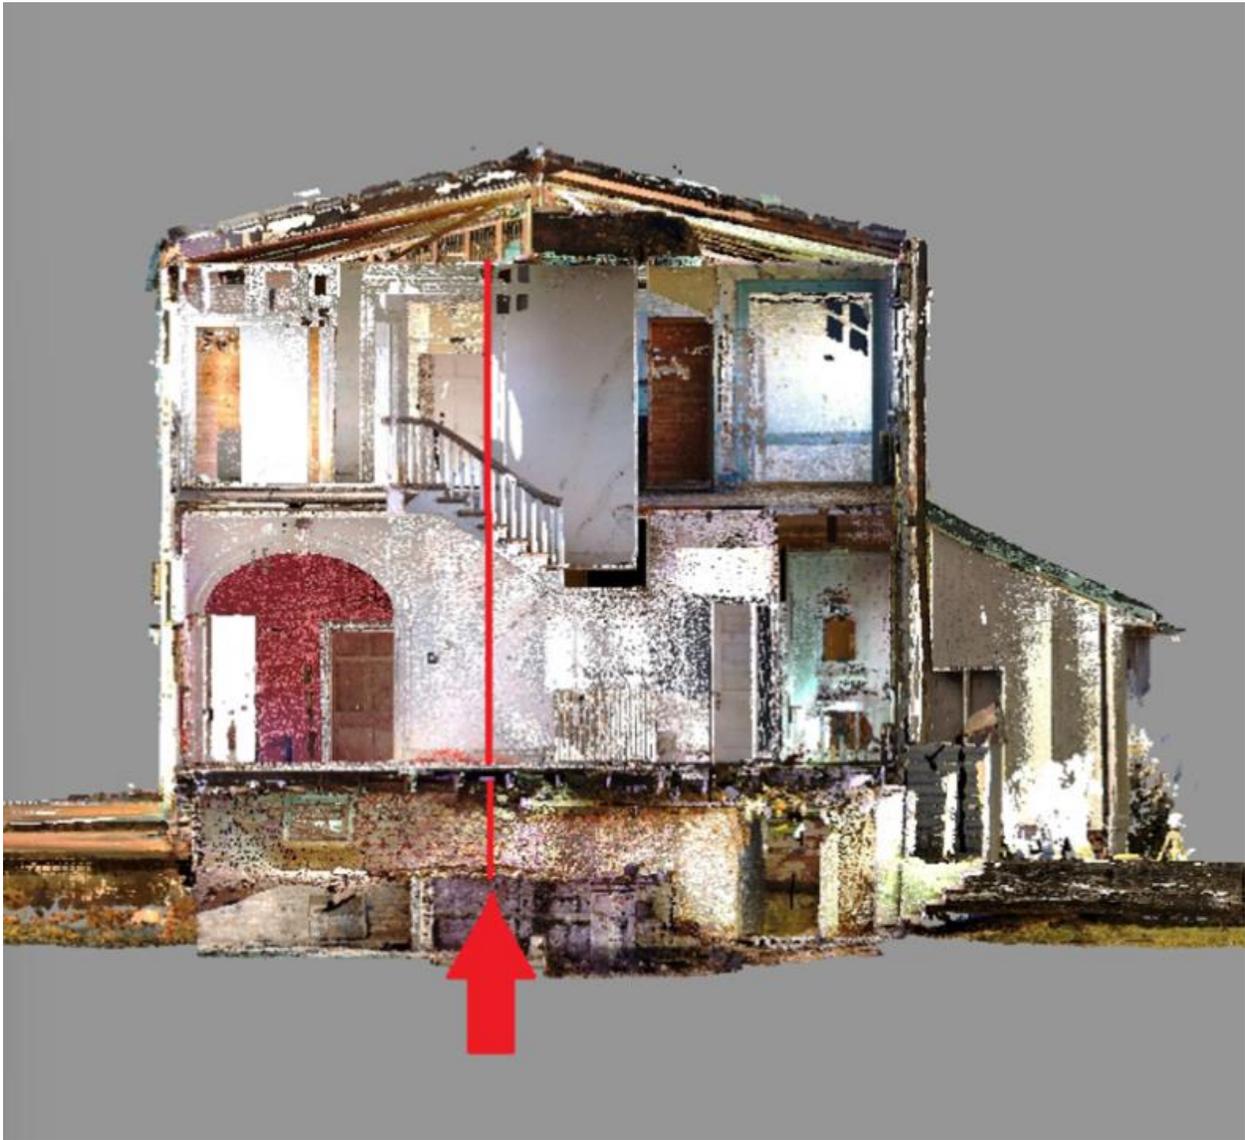
Figure 204: A section perspective view looking at the break in the cellar wall in relationship with the spaces above it. By drawing a line from that break straight up to the second floor, it is found that that break aligns with a wall on the second floor.

Figure 204: A section perspective view looking at the break in the cellar wall in relationship with the spaces above it. By drawing a line from that break straight up to the second floor, it is found that that break aligns with a wall on the second floor.

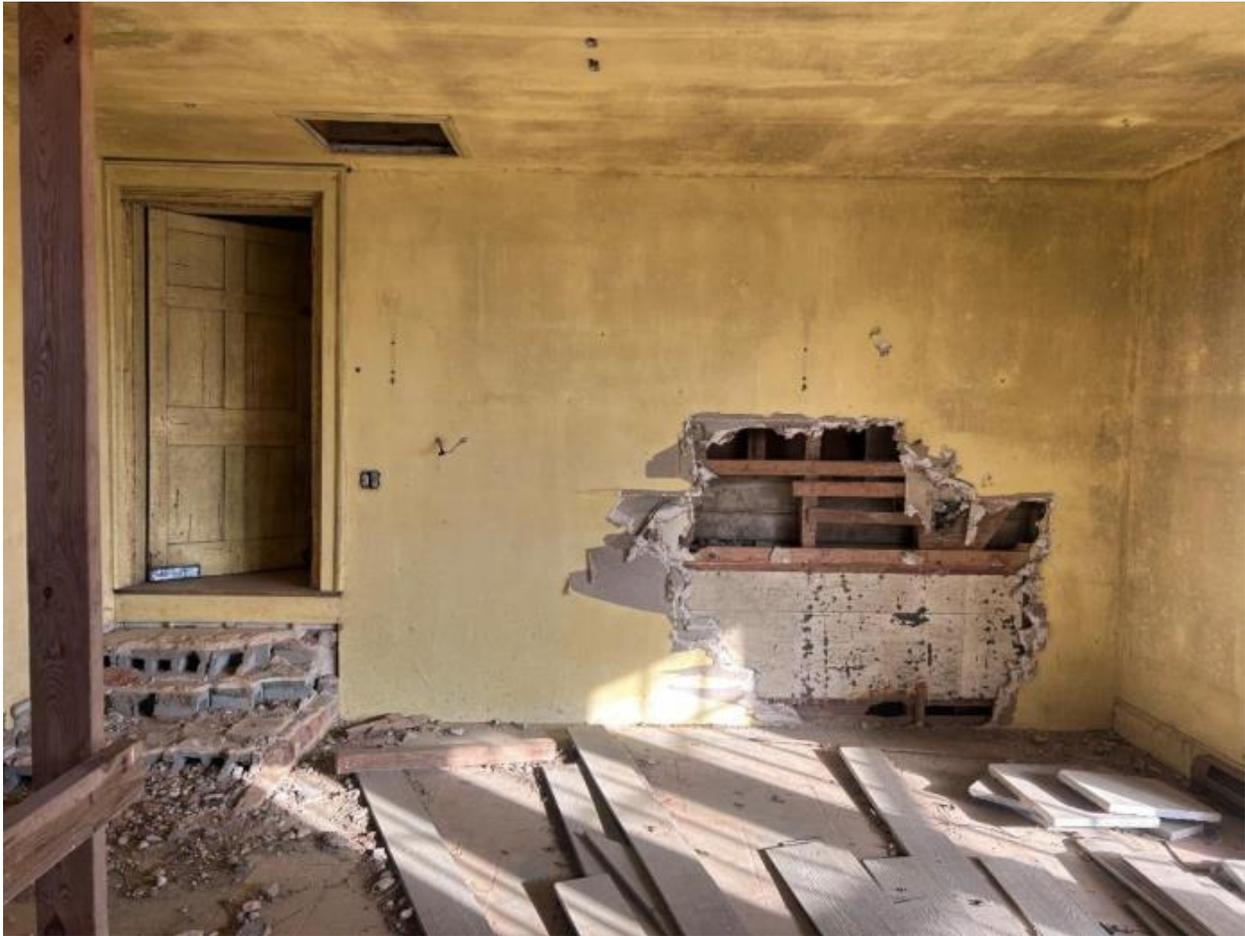
Figure 205: A photo of the hole in the wall that divides Campaign Five from Campaign Three.
Courtesy of Will Rourk.

In one of the wings, Campaign Five, a hole in the wall reveals that the wing was a structure that was pushed against the main block of the house rather than constructed with it (Fig 205). While this information is revealed in this wing, it was unknown whether the other wing in Campaign Four had a similar construction method. To analyze this without access to the original materials in the other wing, I looked at 3D data for answers.

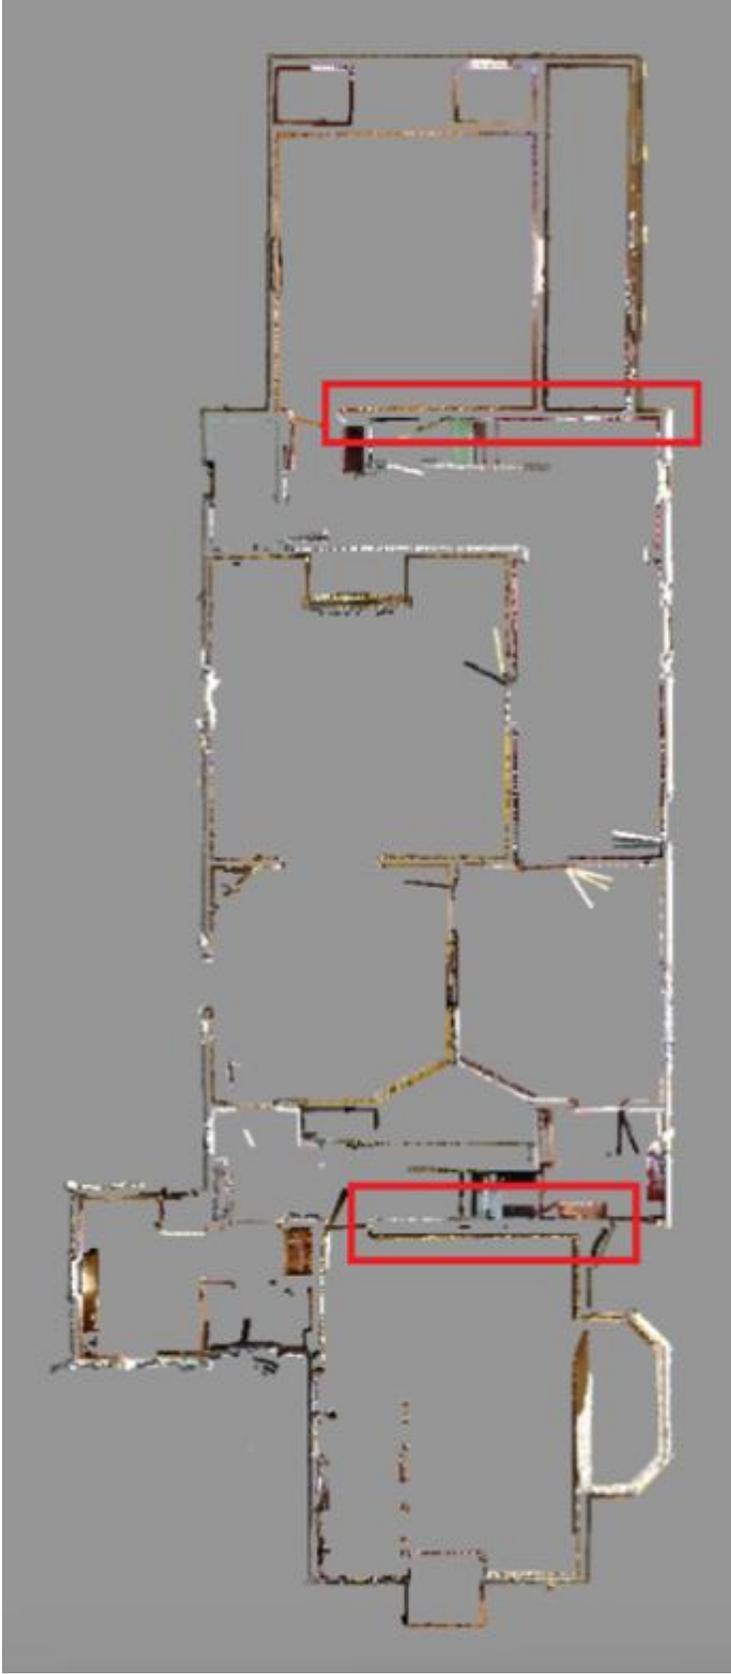
Figure 206: The location of the two walls joining the wings to the main portion of the house. The hole in the Campaign Five wall is in the wing to the left, and that wall is twice as thick as the wall joining the right wing to the house.

When I looked at the first-floor plan generated from 3D data, I measured the thickness of the walls joining those wings to the house (Fig 206). While Campaign Five had a wall measuring about 15 inches thick, the wall joining Campaign Four's wing to the rest of Campaign Four only measured 8 inches thick. This difference is important because Campaign Four's wall joining the wing to the house being thinner implies that this wing was not pushed up against the house in the same manner that Campaign Five was. While this difference does not prove that the two wings were constructed at different dates, it does imply that the two wings were constructed with different methods.

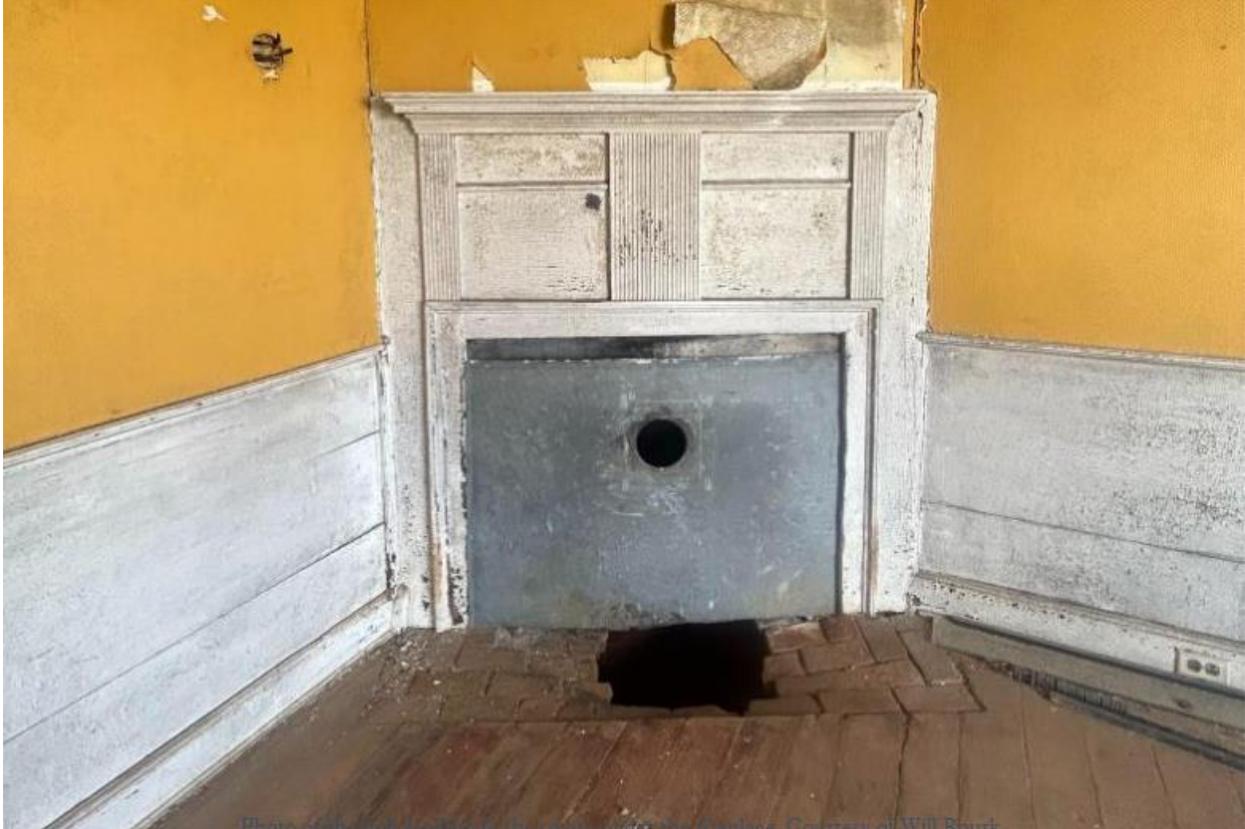
Figure 207: The hole in the floor under one of the corner fireplaces.

One of the biggest mysteries that I encountered in Sylvania was the discovery that there is a second inaccessible cellar next to the cellar that is currently accessible. I initially discovered this cellar while exploring the house with Mark Kutney. Mark and I were exploring the hole in the floor in one of the corner fireplaces in Campaign One when we discovered that there was a small cavity under this fireplace (Fig 207). When Mark and I explored the cavity, we found a small hole in one of its brick walls where we could look inside the inaccessible cellar under Campaign One (Figs 208-209).

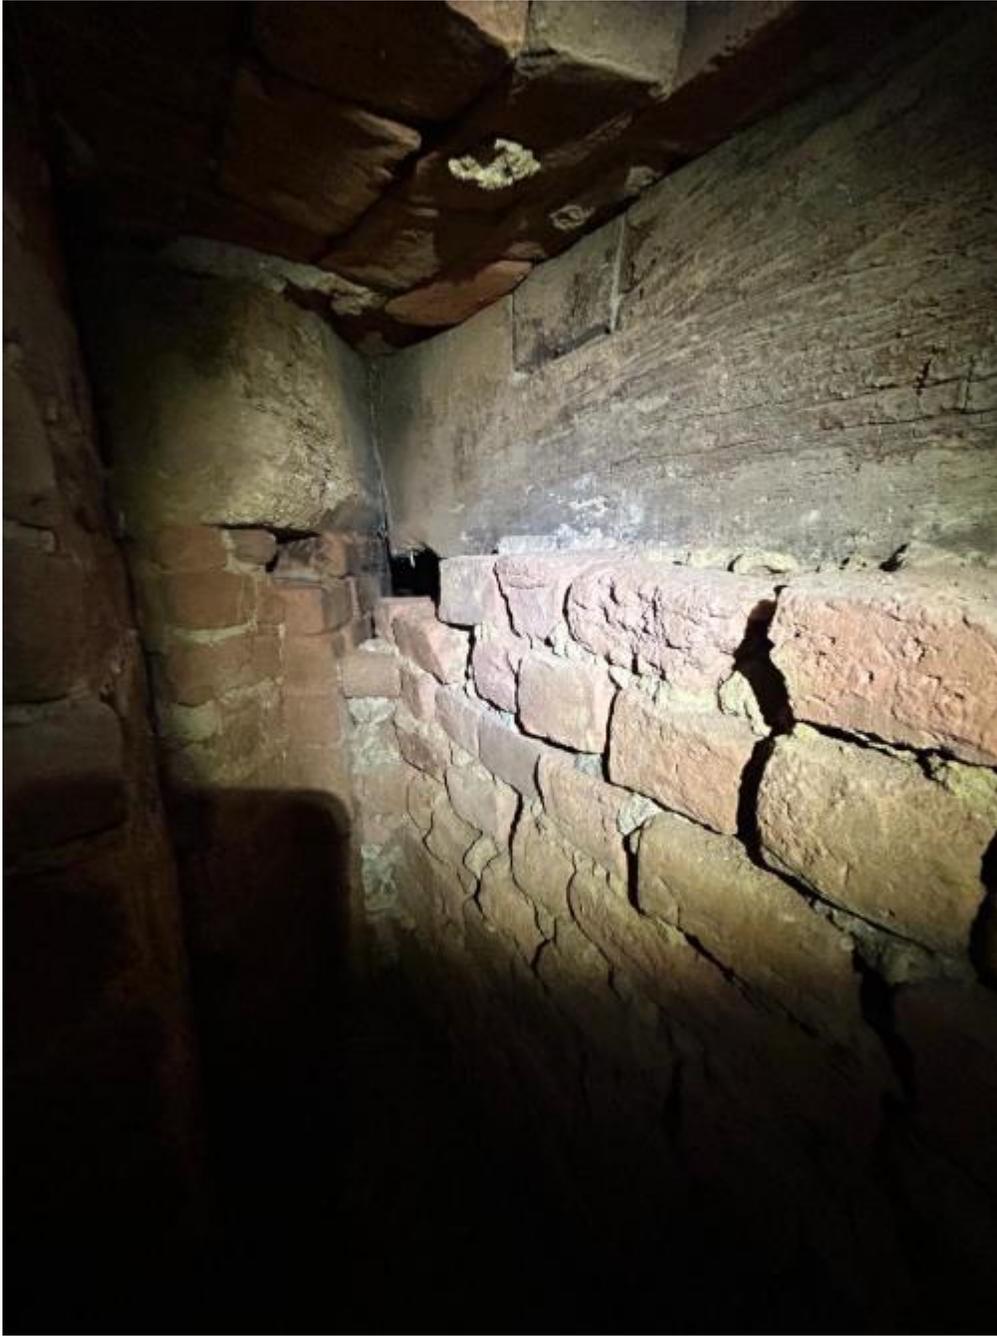
Figure 208: A photo taken inside the cavity under the hole in the fireplace floor.

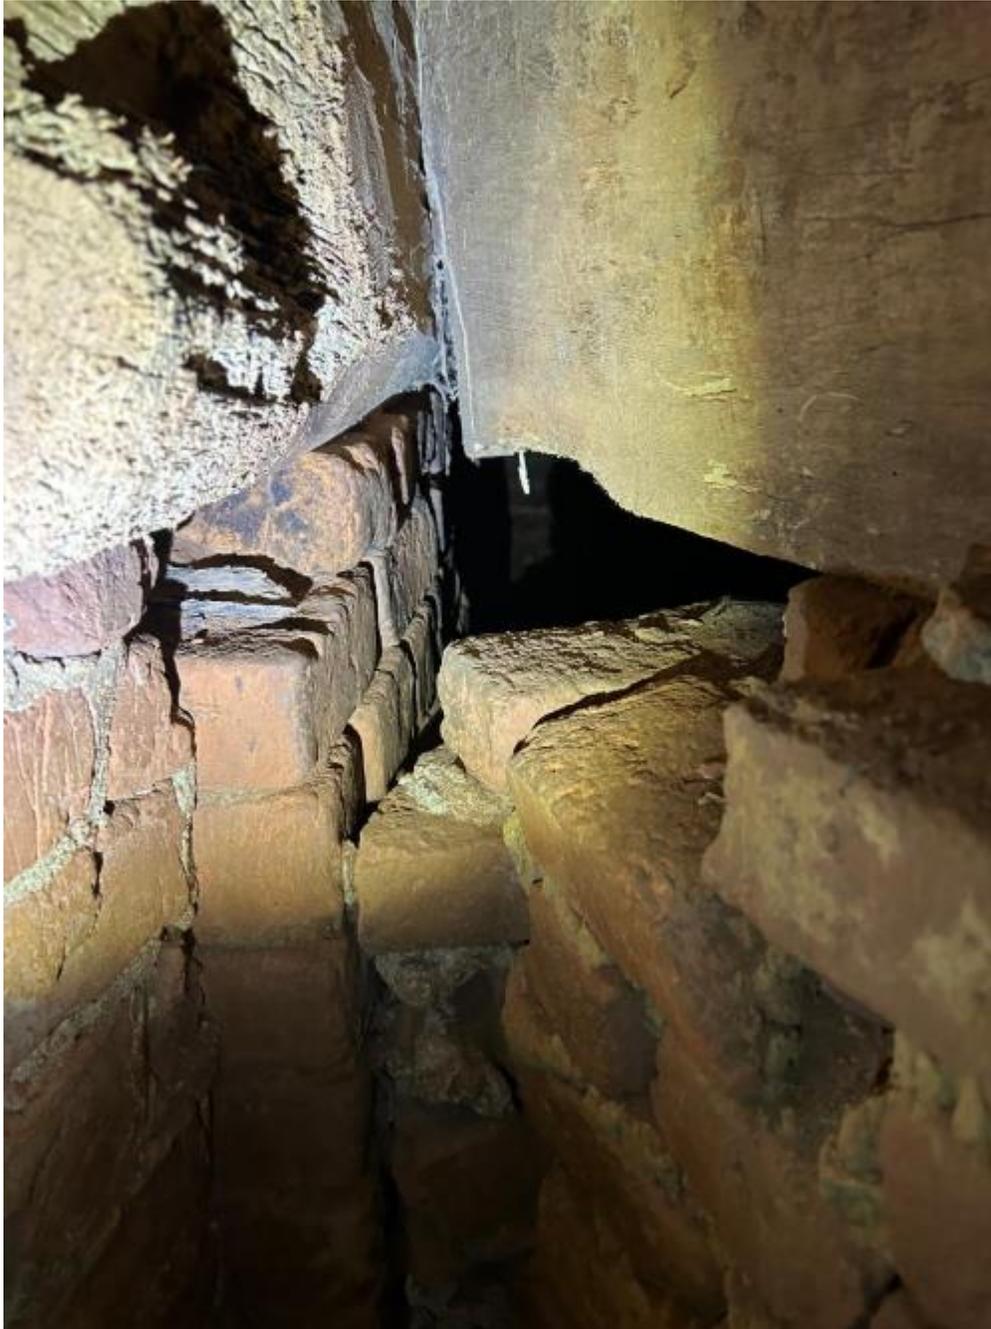
Figure 209: The hole in the cavity wall where we discovered the inaccessible cellar on the other side of the cavity wall.

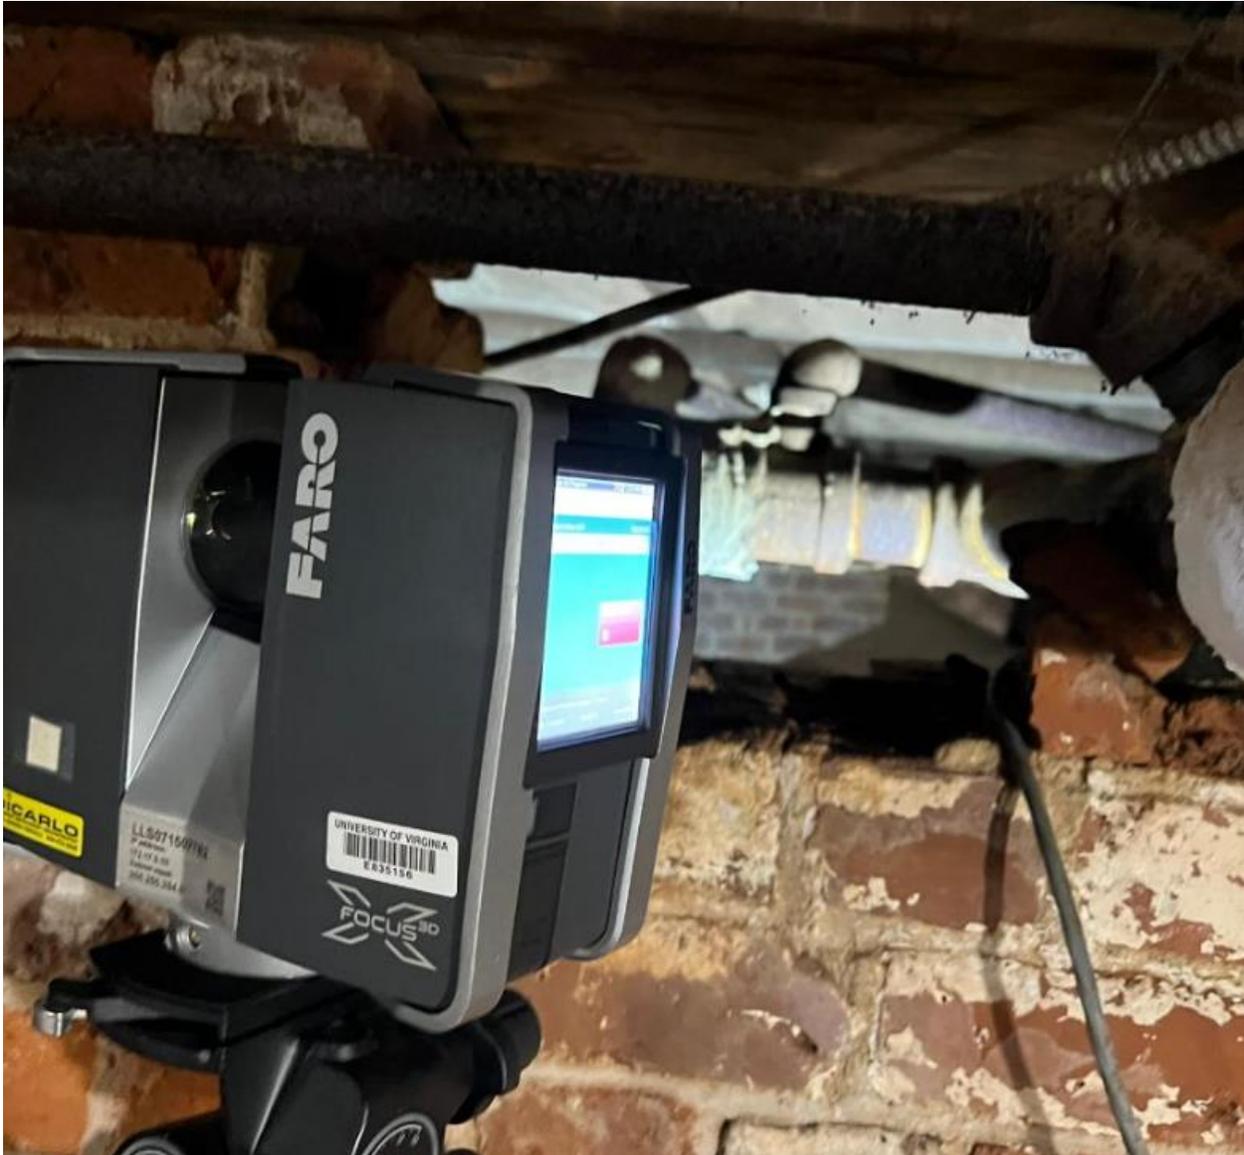
Figure 210: One of the holes viewing the inaccessible cellar from the accessible cellar. We set up a FARO Focus 3D LiDAR scanner in front of this hole to collect 3D data. Courtesy of Will Rourk.

When we searched for an access point to this cellar, we were unsuccessful. However, we found three other holes in the house that viewed the cellar (Figs 210-215). Unfortunately, none of these holes were large enough to physically access the cellar. However, Will Rourk theorized that these holes may be large enough to collect enough data from the cellar to gather some of its dimensions. Looking through the holes, we were interested in a few features that we could see: two supporting columns, the base of the corner chimney, a bricked in window or door, and the corners of the cellar. If we could use 3D scanners to collect the dimensions for where these

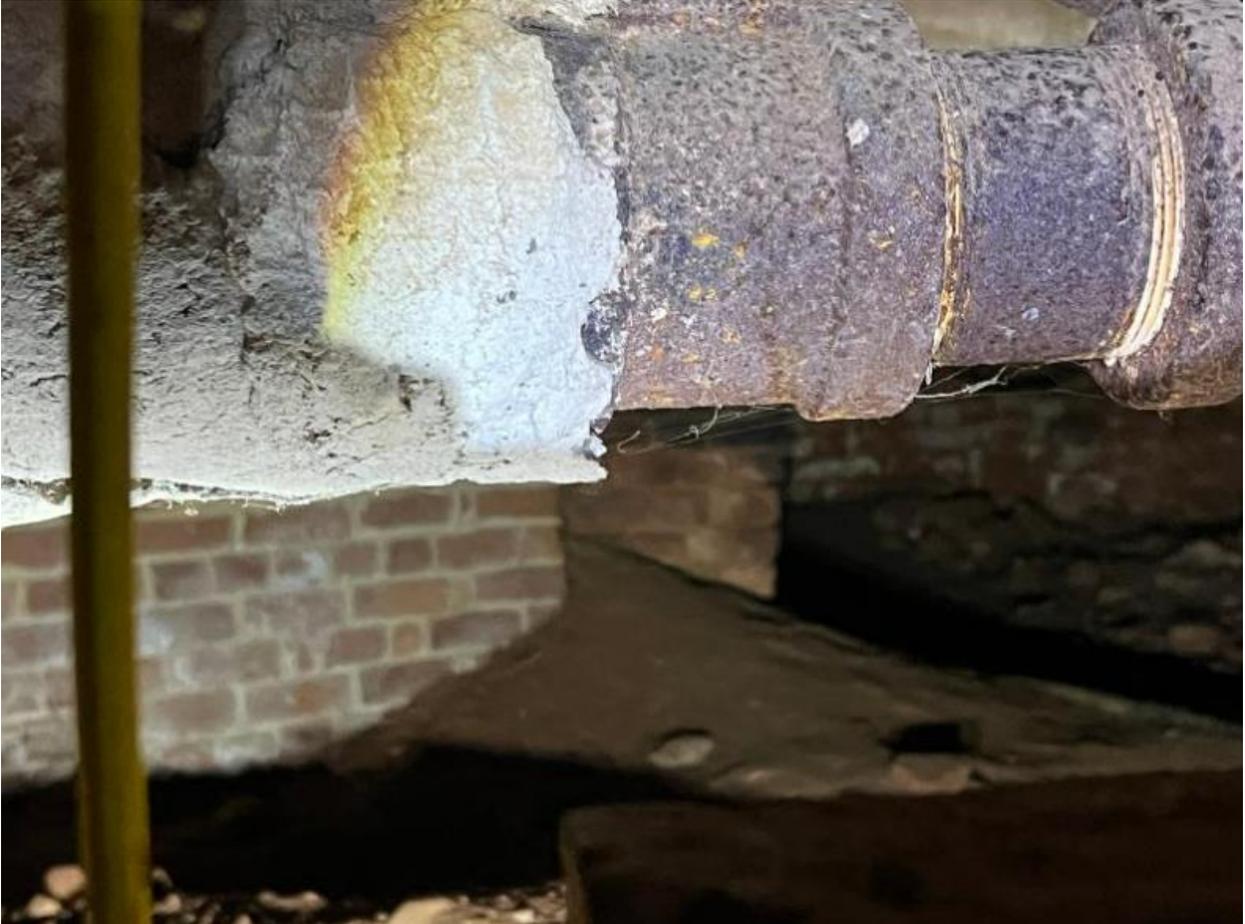
Figure 211: The view of the inaccessible cellar from the hole in the cellar wall seen above. From here, the chimney base, back corner of the cellar, and a bricked off window or door are visible.
Courtesy of Will Rourk.
