The Six Building Campaigns at Sylvania:

The Transformation of Sylvania from a Folk Plantation House to a Fashionable Plantation,

1790-1865

Victoria Mae Bitrick

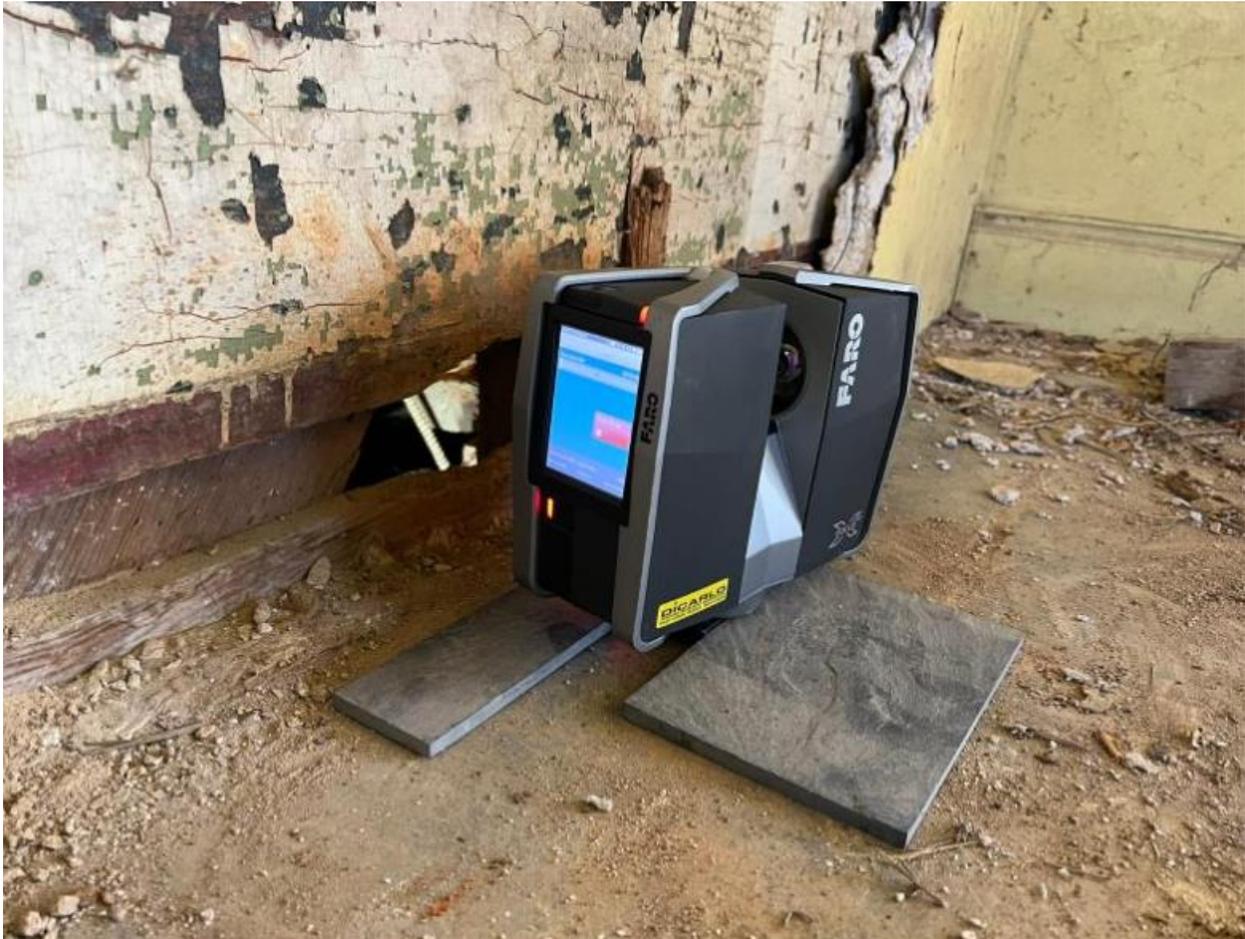
Figure 212: A photo of our scanner setup looking through the hole in the first-floor wing in Campaign Five viewing the inaccessible cellar. This scan was especially tricky because of how low the hole was. We stabilized the base of the scanner with tiles to ensure that the scanner did not move. This was experimental, but it worked well. Courtesy of Will Rourk.

To set up the 3D scanners, we had to set up the scanning environment to collect as much data as possible. We ended up scanning through three of the four holes that view the cellar. One hole was in the wall dividing the two cellars, one was in the northern exterior wall, and one was in the wall dividing Campaign Five from the cellar under Campaign Three. We chose not to attempt to scan in the fireplace cavity due to safety concerns for both ourselves and the scanning equipment since the brick hearth floor is unstable and could collapse on ourselves or the scanning equipment. For the three holes we used, we shined light into the cellar and carefully positioned the scanner to capture as much data as possible. We had to take extra caution to ensure that we had enough clearance between the scanner and the wall to ensure that the scanner would not hit the wall during its rotation.

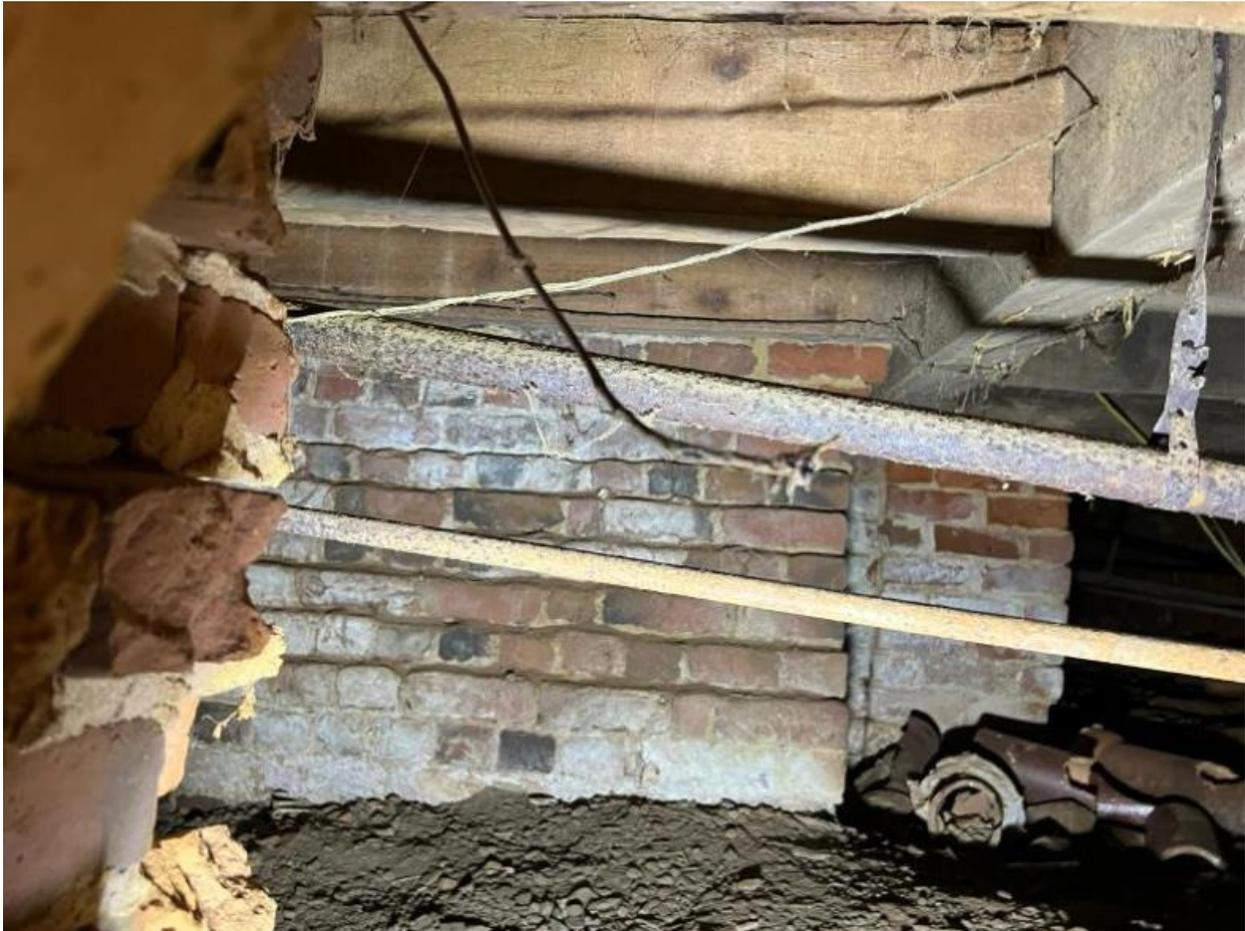
Figure 213: The view of the cellar from the hole in Campaign Five, seen above. From this hole, the base of the chimney, a supporting column, and floor joists are visible. We positioned the scanner carefully to focus on the chimney base and the column beside it. Courtesy of Will Rourk.

When we searched for an access point to this cellar, we were unsuccessful. However, we found three other holes in the house that viewed the cellar (Figs 210-215). Unfortunately, none of these holes were large enough to physically access the cellar. However, Will Rourk theorized that these holes may be large enough to collect enough data from the cellar to gather some of its dimensions. Looking through the holes, we were interested in a few features that we could see: two supporting columns, the base of the corner chimney, a bricked in window or door, and the corners of the cellar. If we could use 3D scanners to collect the dimensions for where these

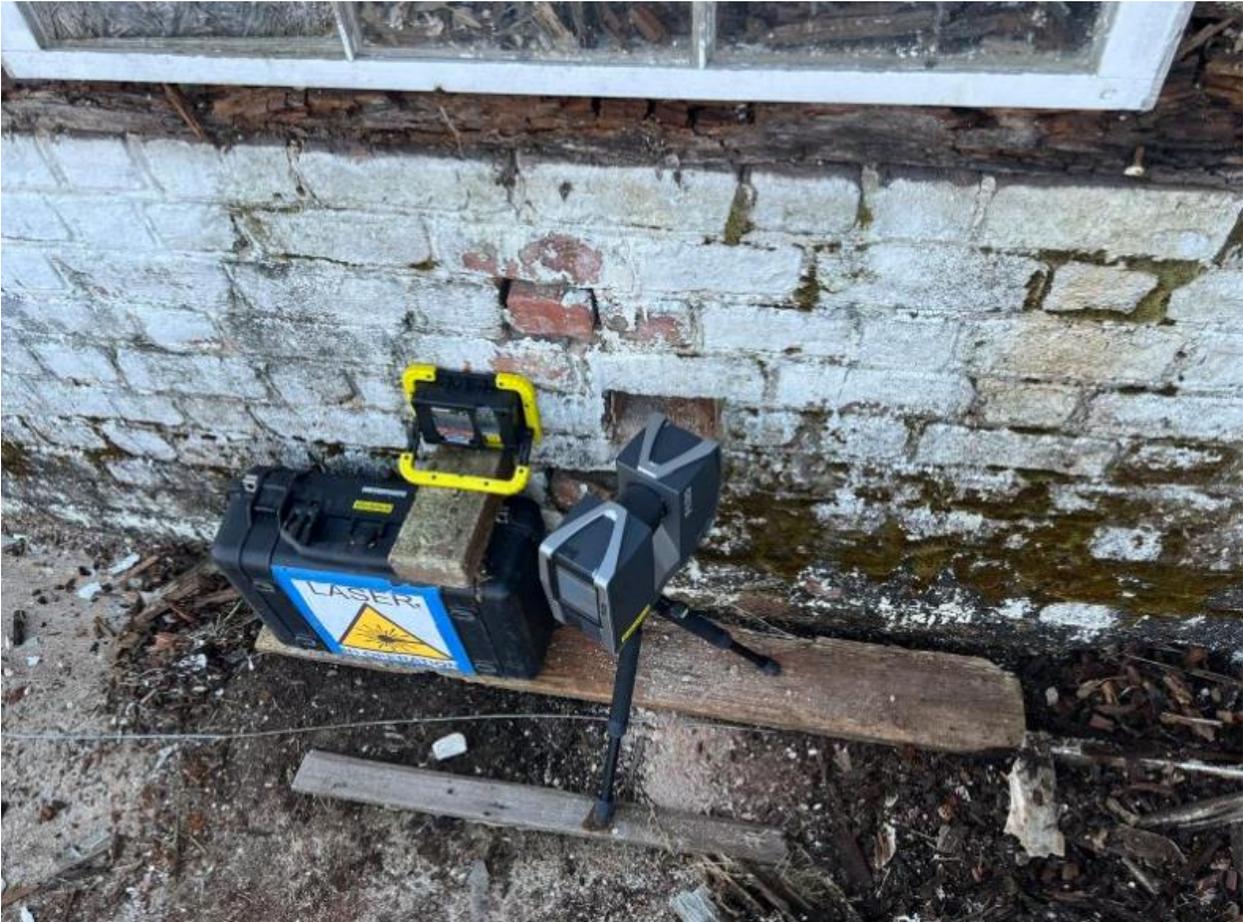
Figure 214: Photo of our scanner setup looking through the hole in the exterior brick wall into the inaccessible cellar. This hole was the smallest hole that we used, so it was challenging to position the scanner perfectly to gather as much data as possible. Courtesy of Will Rourk.

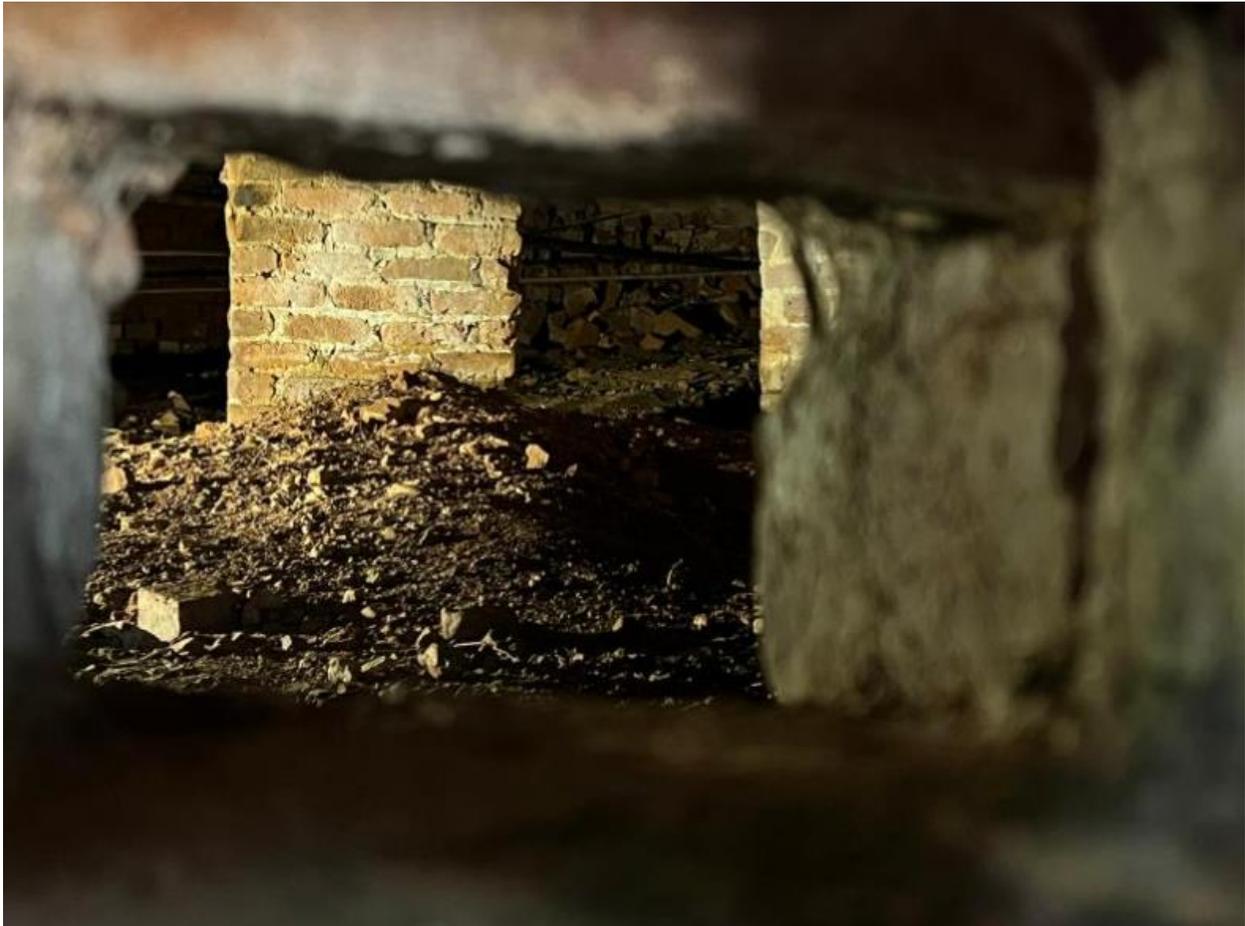
Figure 215: The view from the hole in the exterior brick wall, seen above. A supporting column, the edge of the chimney base, and the back cellar wall are visible. Courtesy of Will Rourk.

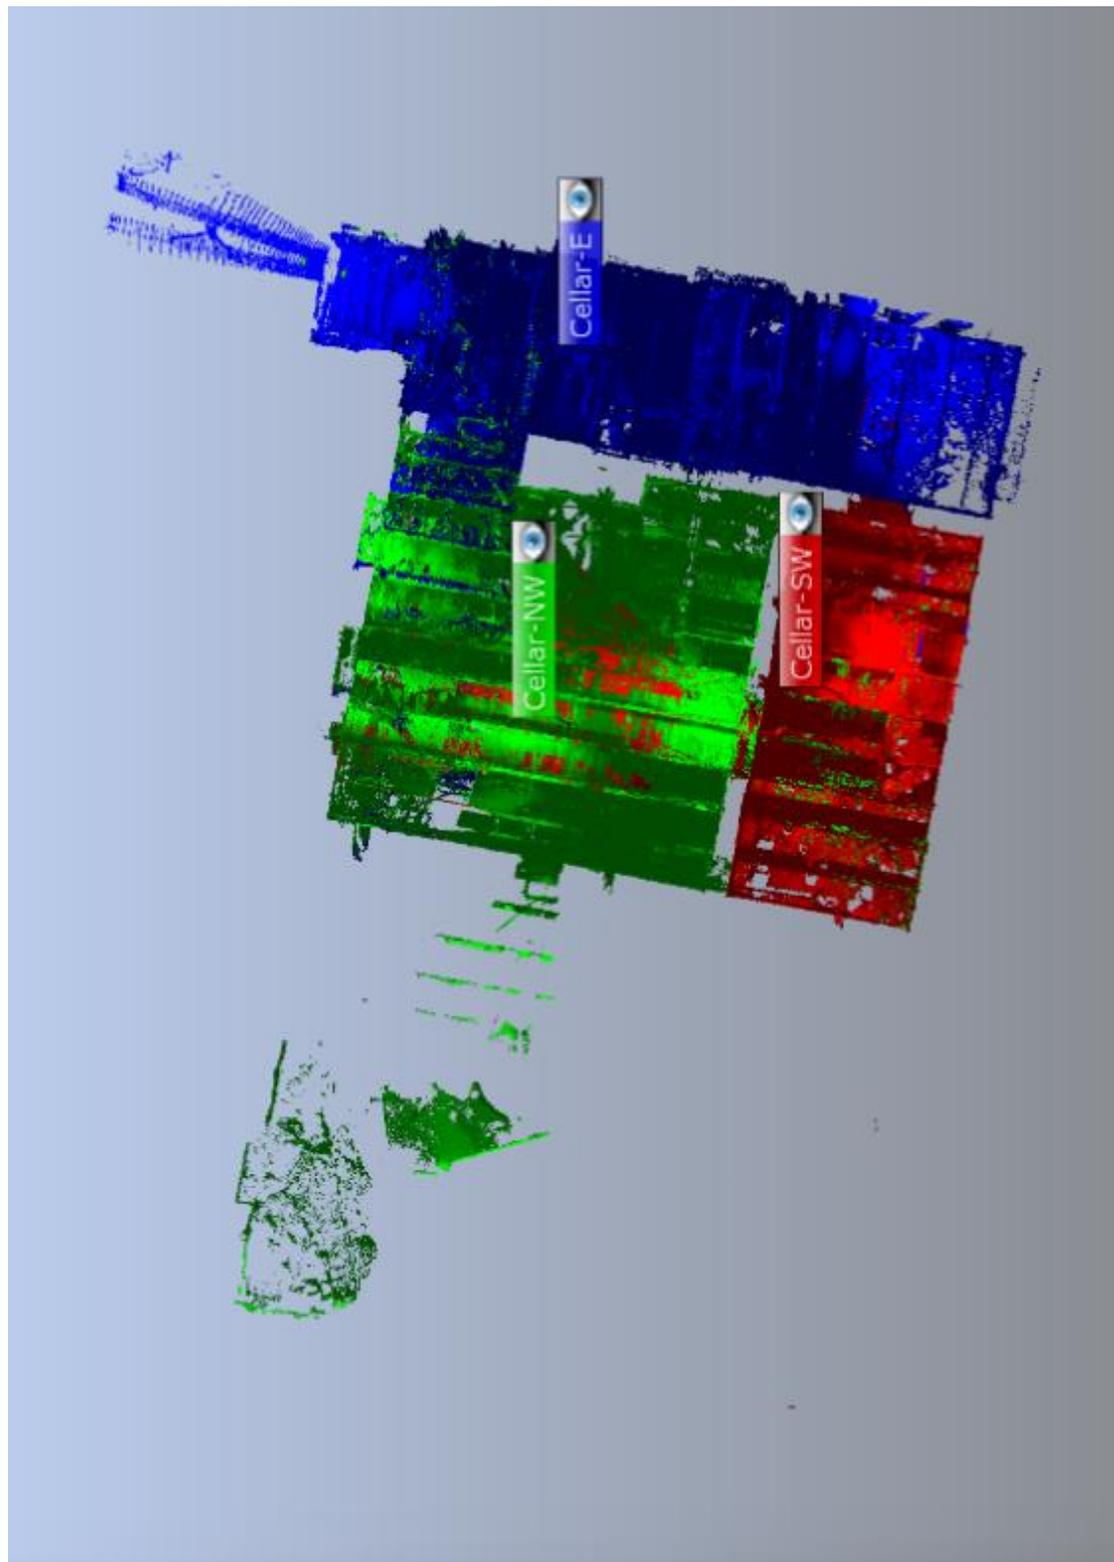
Figure 216: A view of some of the cellar data after registration in FARO Scene. On the right side, the accessible cellar data is seen in plan view. To the left of the cellar, some of the data collected from the hole in the cellar wall appears after registration. This data includes joist information, the corner of the cellar, the bricked in door or window, and the diagonal cavity wall.

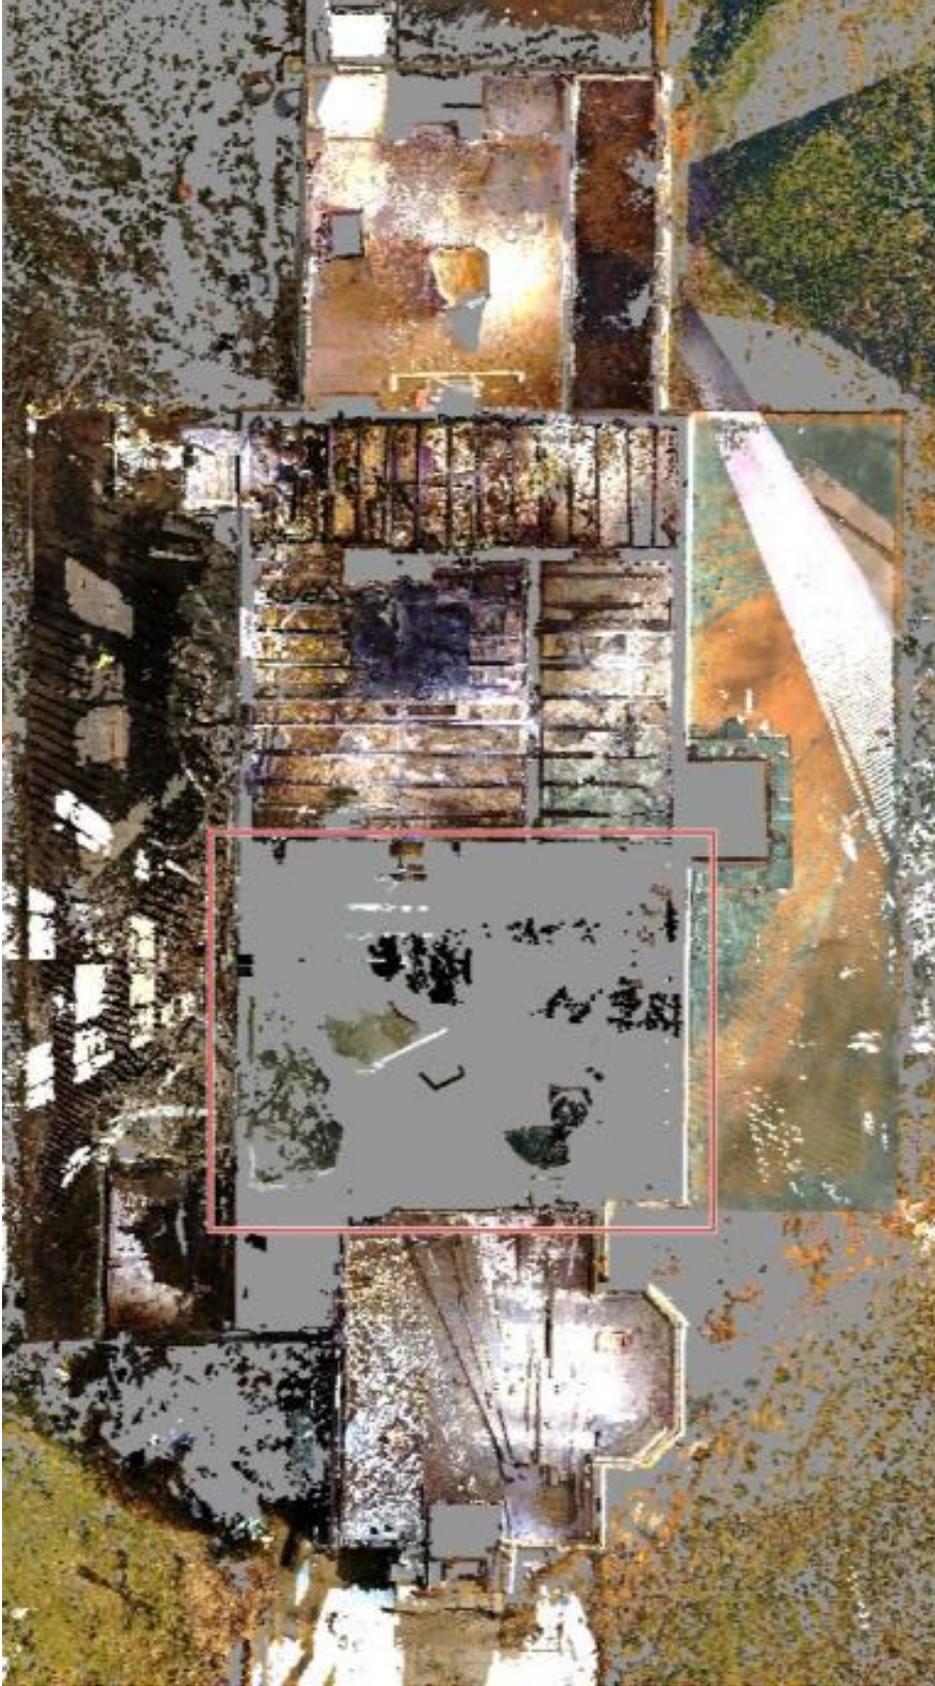
Figure 217: This floor plan view in Autodesk ReCap captures a view of all the data that we collected from in the inaccessible cellar.

After data collection, I registered the cellar data in FARO Scene and registered it with the previous data I had collected in the accessible cellar and the rest of the house. Since this method of data collection was experimental, I was unsure if it would yield useful data. However, I was thrilled when registration revealed that our scans had collected interesting data for the cellar's main features (Figs 216-218).
