Ytterbium Silicate Environmental Barrier Coatings

A Dissertation

Presented to  
the faculty of the School of Engineering and Applied Science  
University of Virginia

Bradley T. Richards

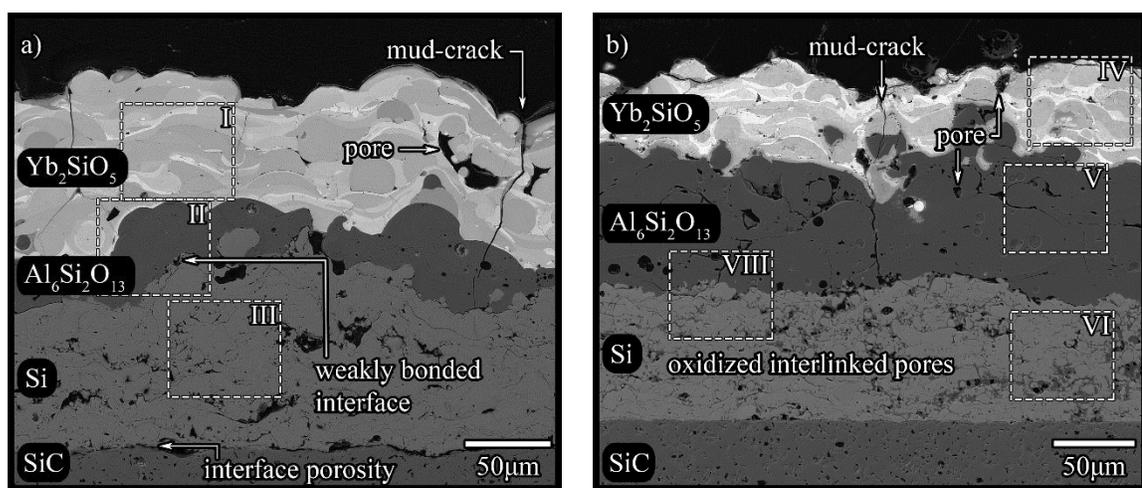
Figure 2.4: BSE micrographs of  $\text{Yb}_2\text{SiO}_5/\text{Al}_6\text{Si}_2\text{O}_{13}/\text{Si}$  three layer EBC; (a) as-fabricated and (b) after a 20 hour stabilization anneal in air at  $1300^\circ\text{C}$ . Dashed boxes indicate regions where higher magnification micrographs are subsequently analyzed.

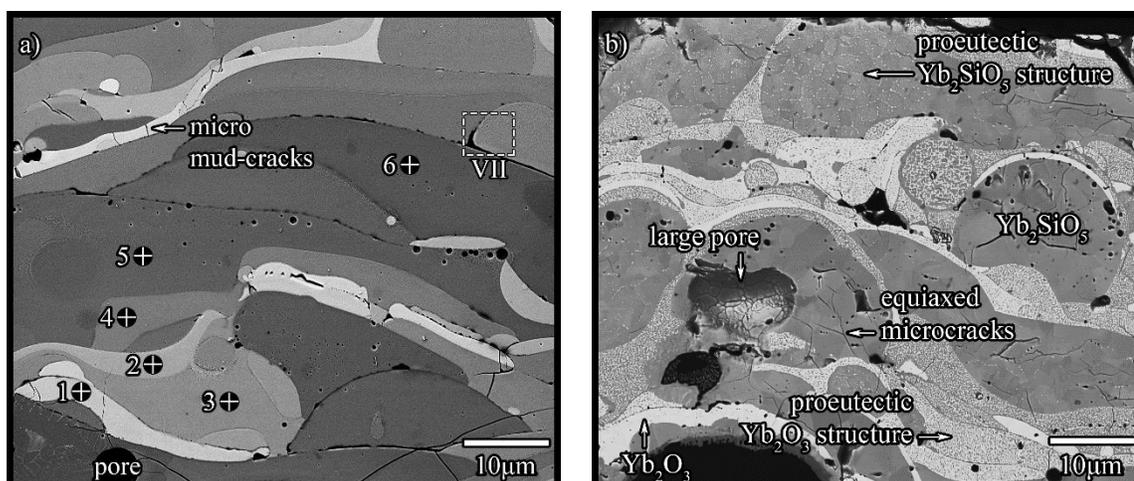
Figure 2.5: High magnification micrographs of the  $\text{Yb}_2\text{SiO}_5$  topcoats from; (a) region I in the as-deposited micrograph- Figure 2.4(a), and (b) region IV in the annealed condition micrograph- Figure 2.4(b).

Micro-mud-cracking was observed in the most silicon depleted droplets, Figure 2.5(a). If a rule of mixtures is assumed for the CTE and elastic modulus of such splats,

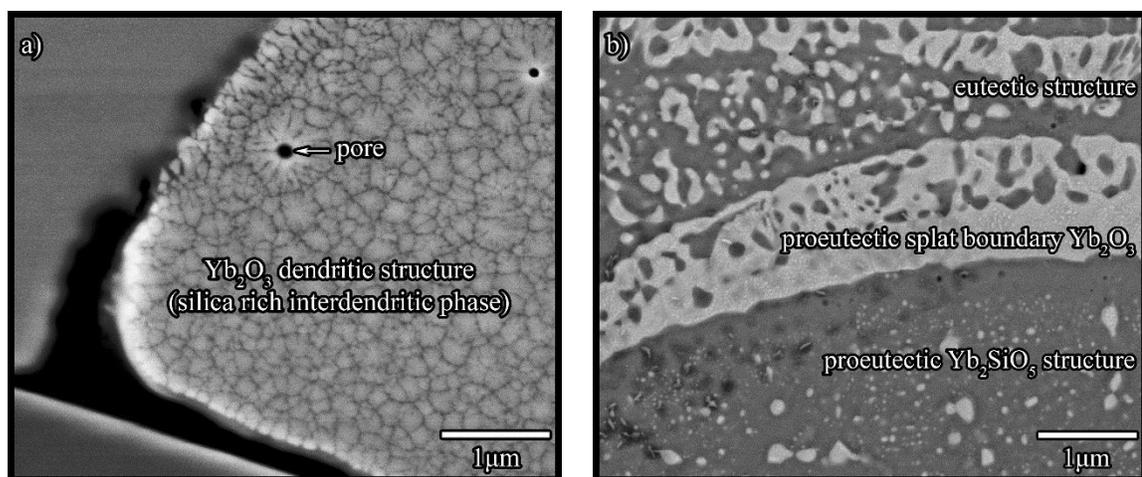
Figure 2.6: High magnification views of (a) region VII in the as-deposited coating shown in Figure 2.5(a), and (b) annealed topcoat near a splat boundary.

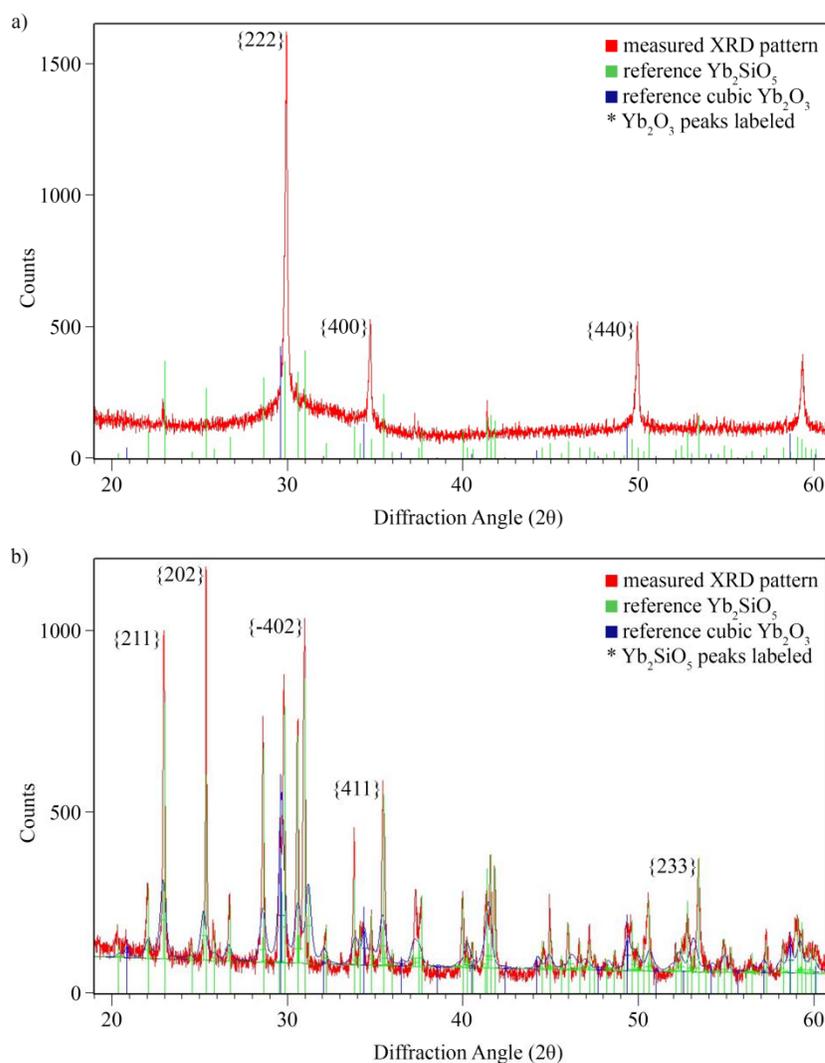
Figure 2.10: XRD patterns for the nominally ytterbium monosilicate topcoat; (a) as-deposited and (b) annealed. Peaks are indexed for  $\text{Yb}_2\text{O}_3$  in (a) and  $\text{Yb}_2\text{SiO}_5$  in (b). Reference peaks for both phases in (a) and calculated Rietveld refinement pattern in (b) are also shown.

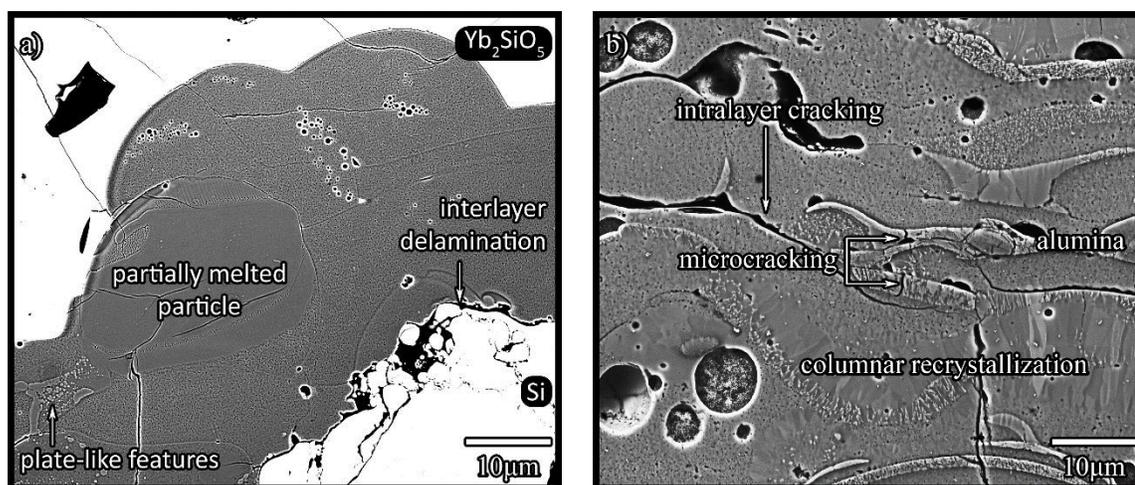
Figure 2.11: High magnification micrographs of the mullite intermediate layer from (a) region II in as-deposited Figure 2.4(a) and (b) region V in annealed Figure 2.4(b).

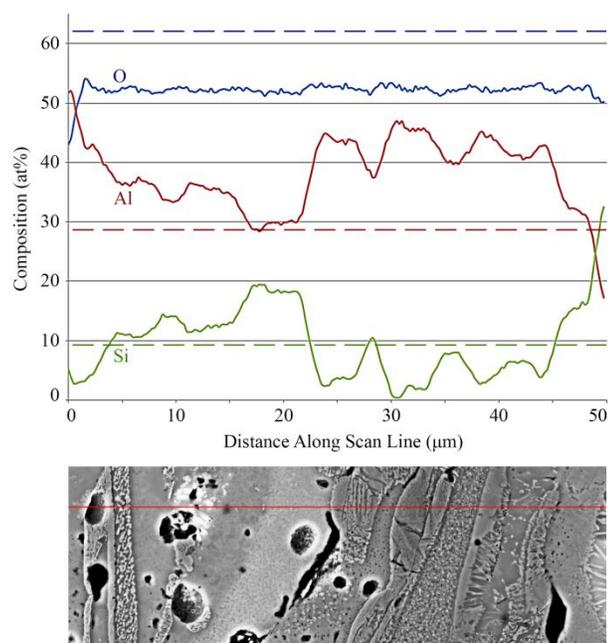
Figure 2.12: EDS line scan of annealed mullite layer. The initial  $3\text{Al}_2\text{O}_3:2\text{SiO}_2$  molar mullite composition is indicated by dashed lines. Note that 40at% Al- 60at% O is the composition of alumina. The location of the line scan is indicated on the micrograph.

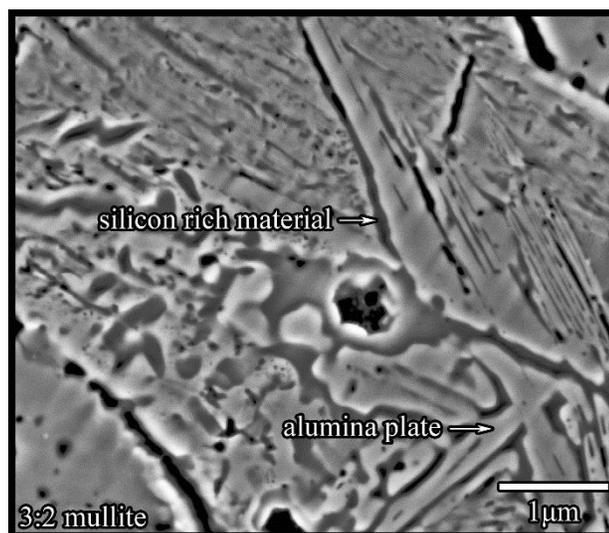
*Figure 2.13: High magnification view of phase decomposition into alumina plate separated by silicon rich material in the annealed mullite coat.*

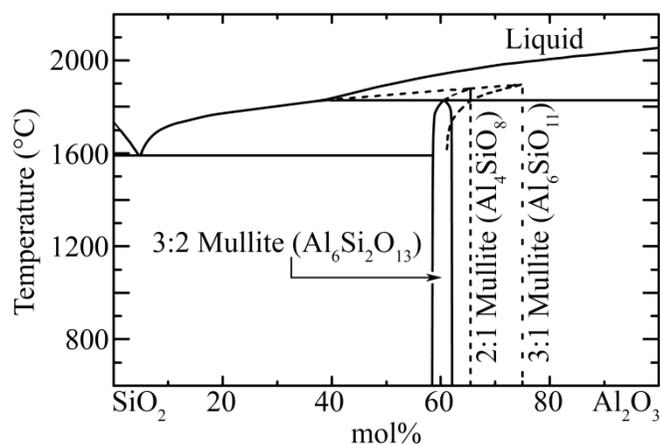
Figure 2.15: Alumina-Silica binary phase diagram. Dashed lines indicate the boundaries of metastable phases (modified and redrawn)<sup>85</sup>.

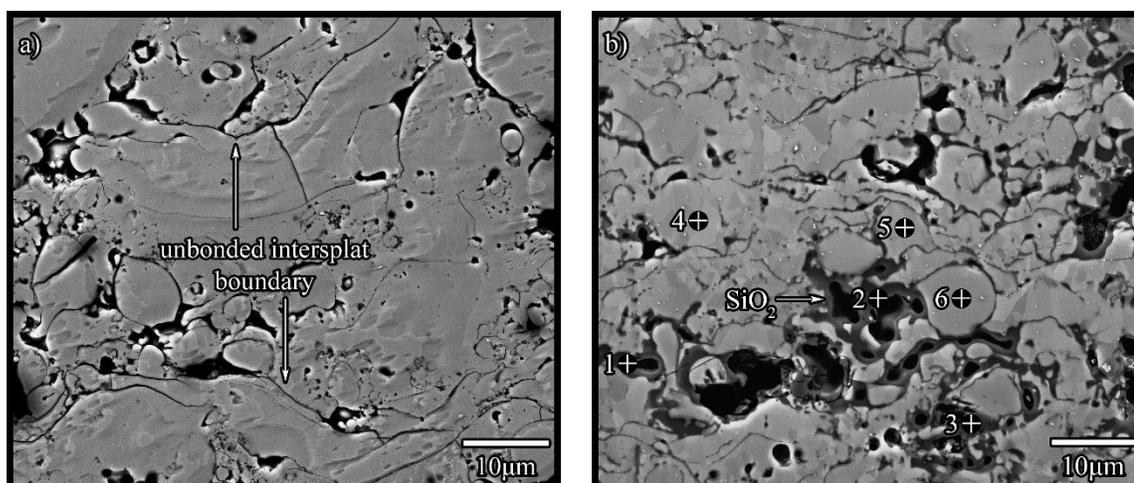
Figure 2.16: High magnification micrographs of the silicon bond coat from (a) region III in as-deposited Figure 2.4(a), and (b) region VI after annealing in air (20 h at 1300 °C) from Figure 2.4(b).

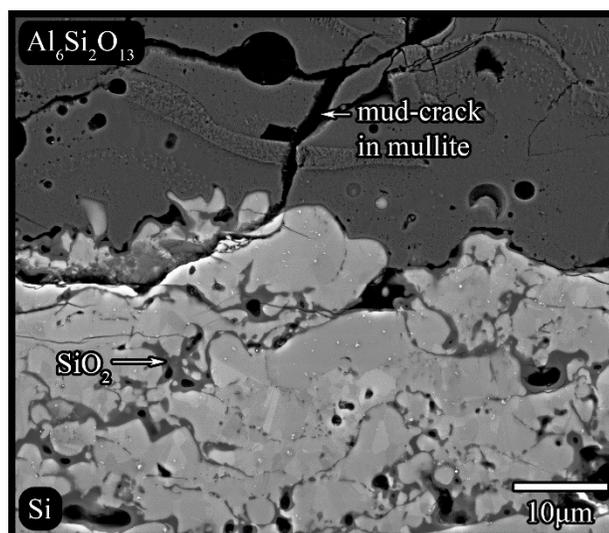
Figure 2.17: High magnification view corresponding to region VIII in Figure 2.4(b) showing a mud-crack penetrating the mullite coat and terminating in the upper few micrometers of the silicon bond coat.

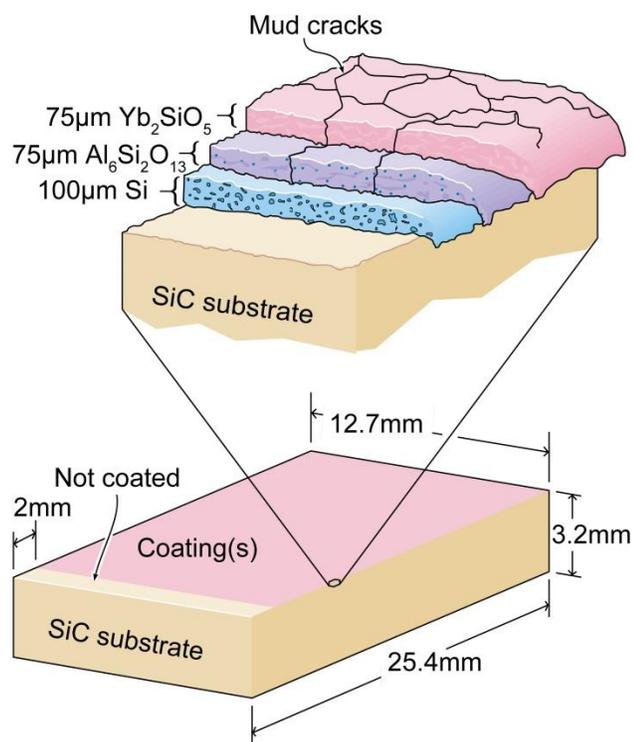
Figure 3.1: Schematic illustration of the tri-layer EBC covered SiC samples showing the coating structure and side edge coverage of the substrate.

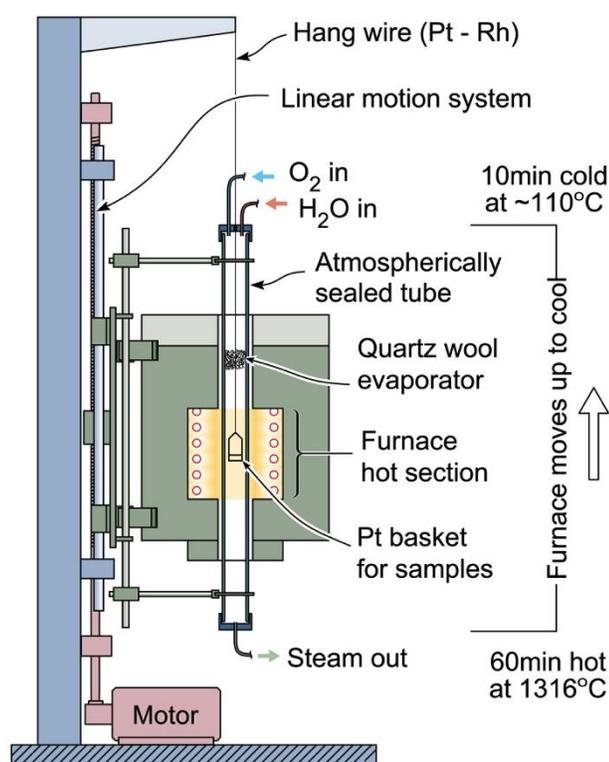
*Figure 3.2: Schematic illustration of the steam-cycling furnace in the configuration that subjected the samples to the hot part of a steam cycle (60 min at 1316°C). The furnace was then translated vertically while maintaining the sample stationary, thereby removing the sample from the furnace hot zone and subjecting it to the cold part of a steam cycle (10 min at 110°C).*

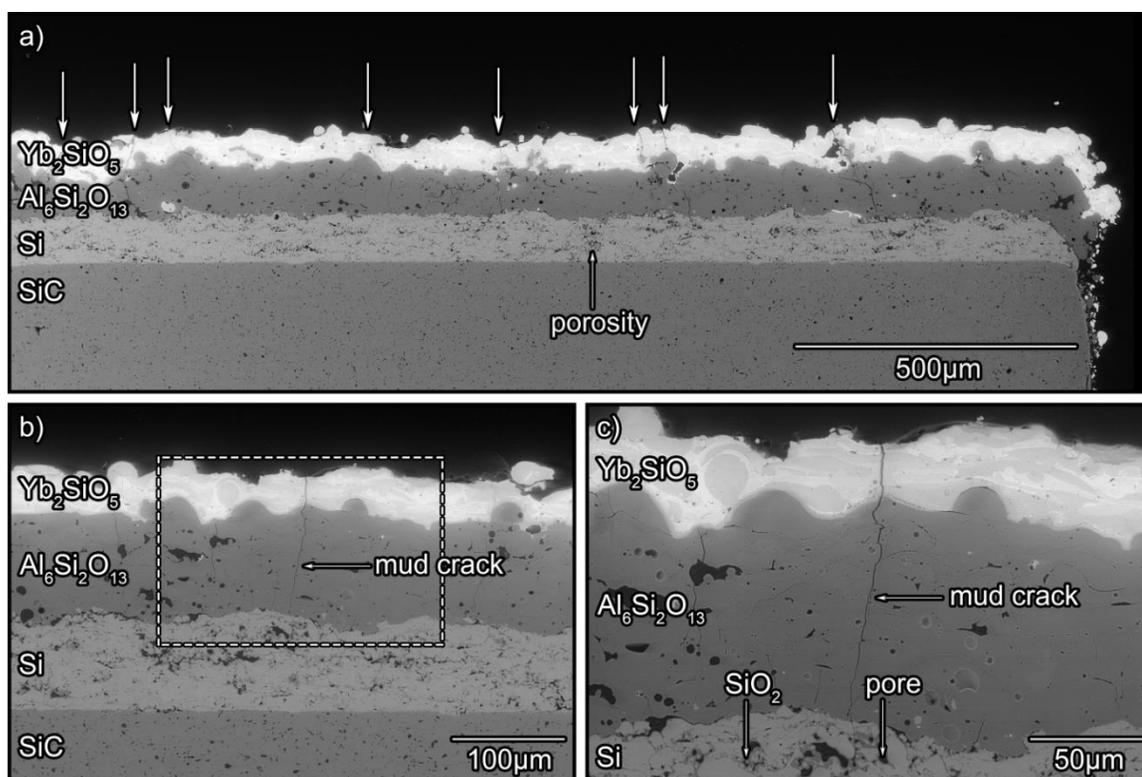
Figure 3.3: (a) Low magnification BSE mode SEM image of the 1300°C annealed EBC with mud cracks indicated by arrows. (b) Shows a higher magnification view of the coating in a region where a mud crack penetrated the ytterbium monosilicate and mullite layers. (c) A high magnification view of the dashed box area in (b) showing arrest of the mud crack at the mullite – silicon bond coat interface.

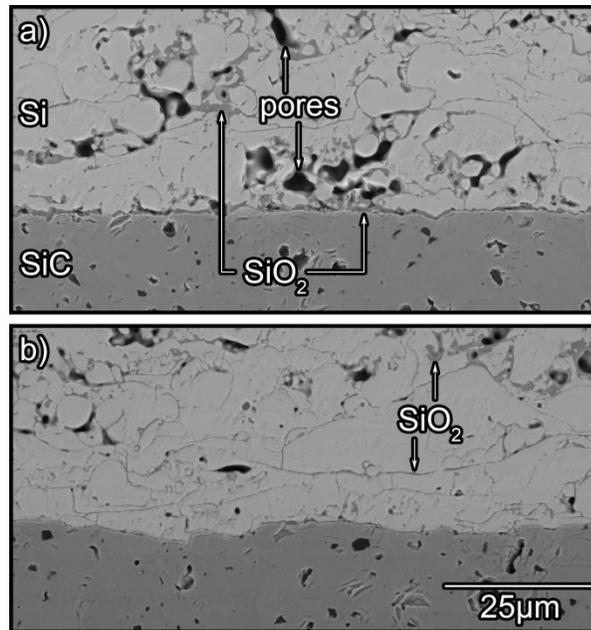
*Figure 3.4: The Si – SiC interface of (a) an annealed sample in a region of relatively poor adherence with oxidized pore structures and poor interfacial bonding and (b) an interfacial region of higher quality in the same annealed specimen.*

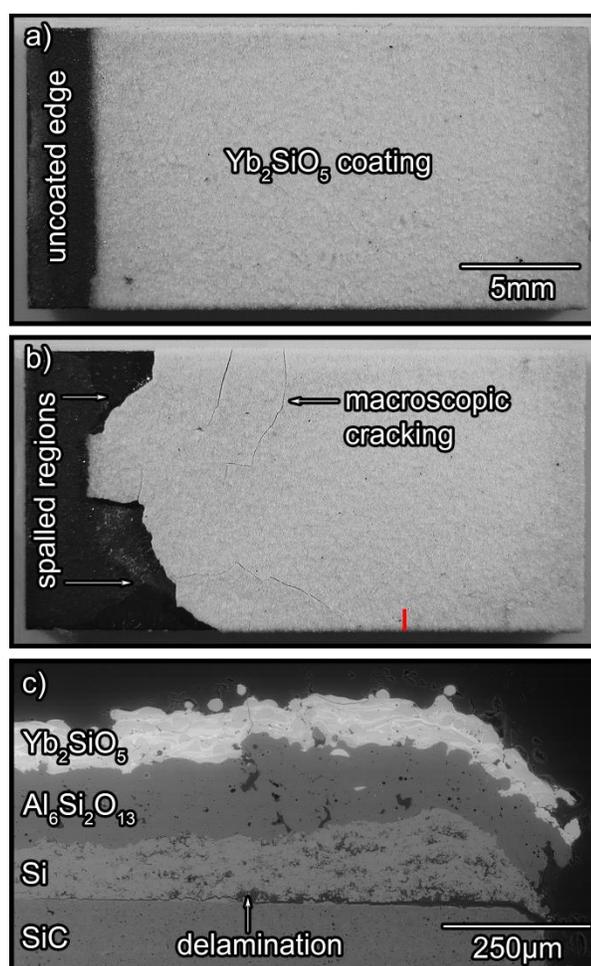
Figure 3.5: Images of an EBC covered sample. (a) Optical image of top surface after annealing. (b) Optical image of the top surface of the same sample after it had delaminated following 50 steam cycles at 1316°C. (c) SEM cross-section (in BSE mode) of the delaminated sample shown in (b). The red bar in (b) indicates the location of the cross section shown in (c).

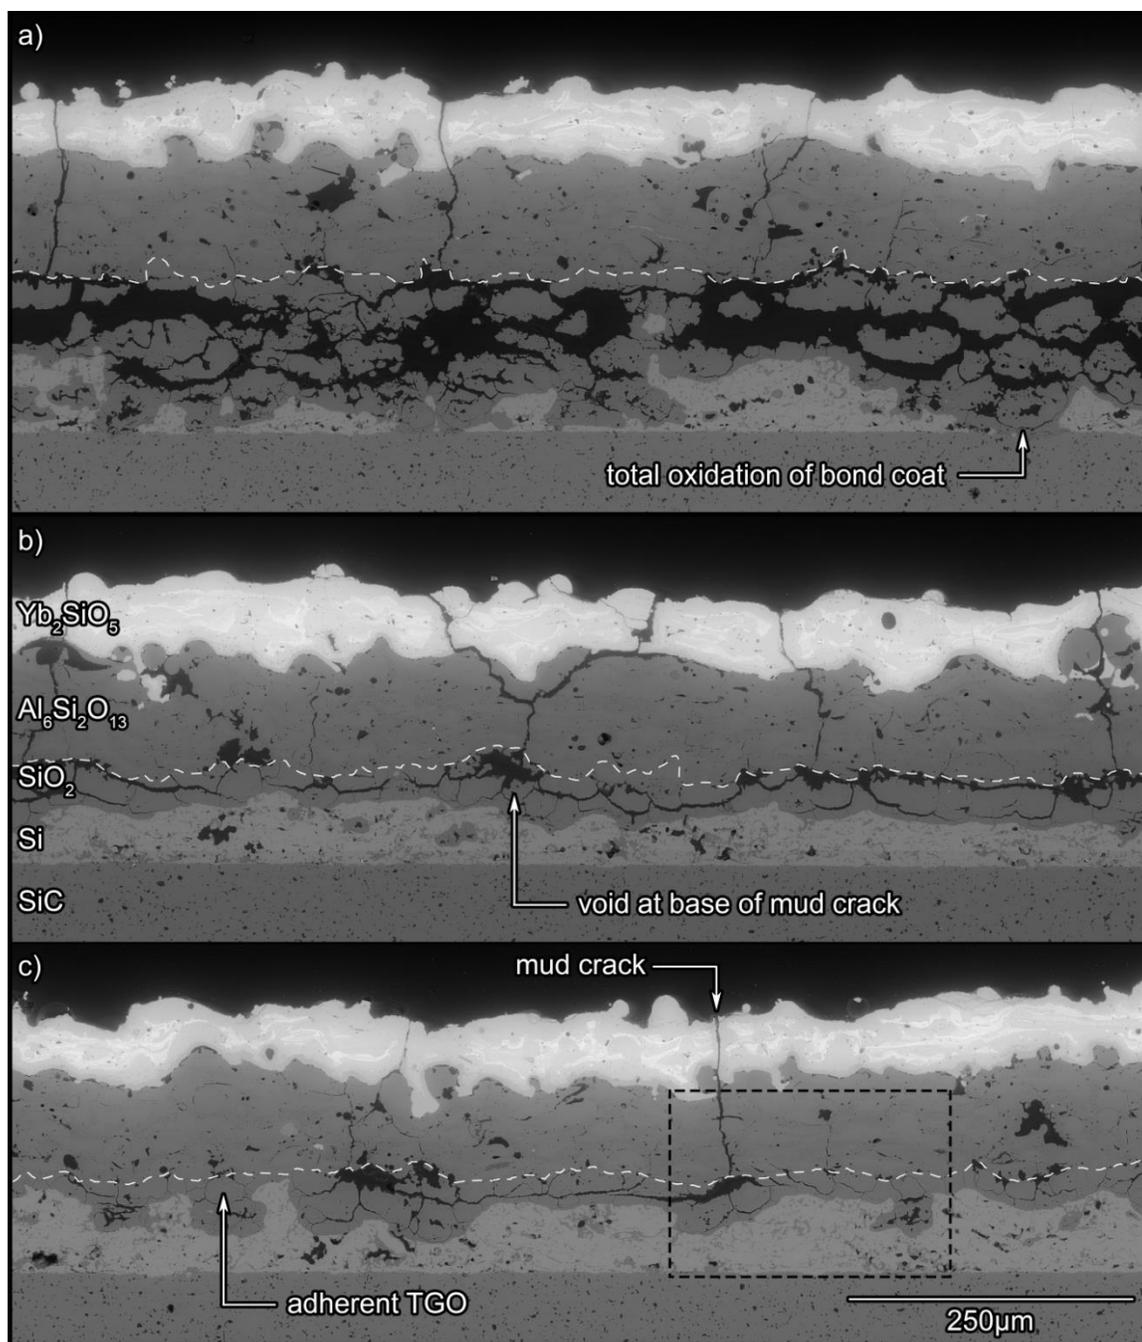
Figure 3.6: Cross sectional BSE micrographs of the same failed coating after 600 1-hour steam cycles at 1316°C with serial sections at (a) 1mm, (b) 3mm, and (c) 5mm from the coating edge. The dashed white line shows the TGO-mullite interface. The boxed section in (c) indicates the region subjected to compositional analysis.

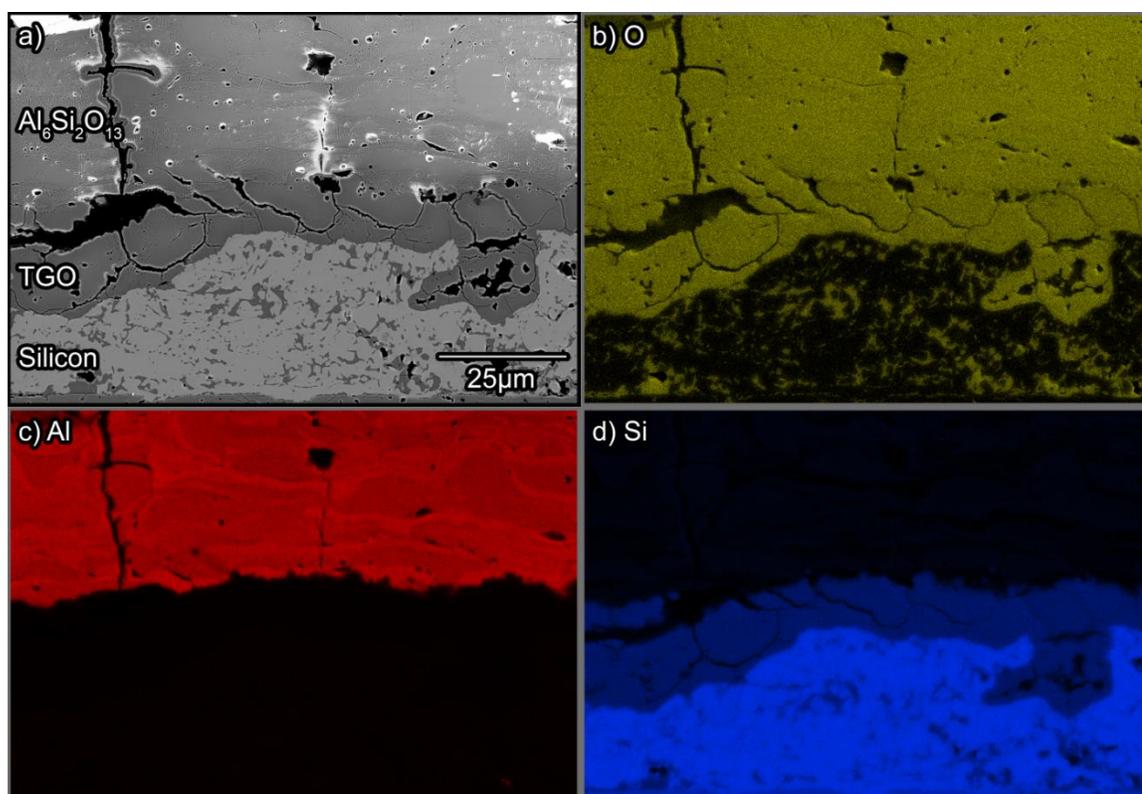
Figure 3.7: (a) A SEM image taken in BSE mode of a mud-crack root intersection with an adherent silica TGO –  $\text{Al}_6\text{Si}_2\text{O}_{13}$  interface as identified in Figure 3.6(c). (b) An oxygen, (c) aluminum, and (d) silicon dot map of the same region.

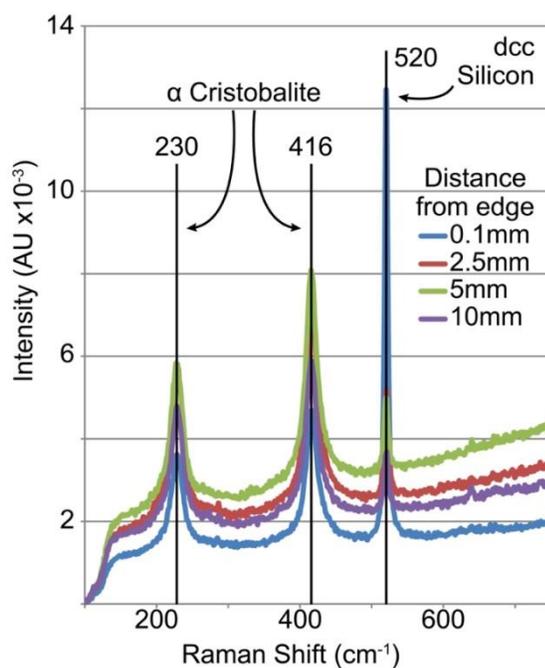
Figure 3.8: Raman spectra from the thermally grown (silica) oxide at the Si-mullite interface as a function of distance from the edge of the coated sample.

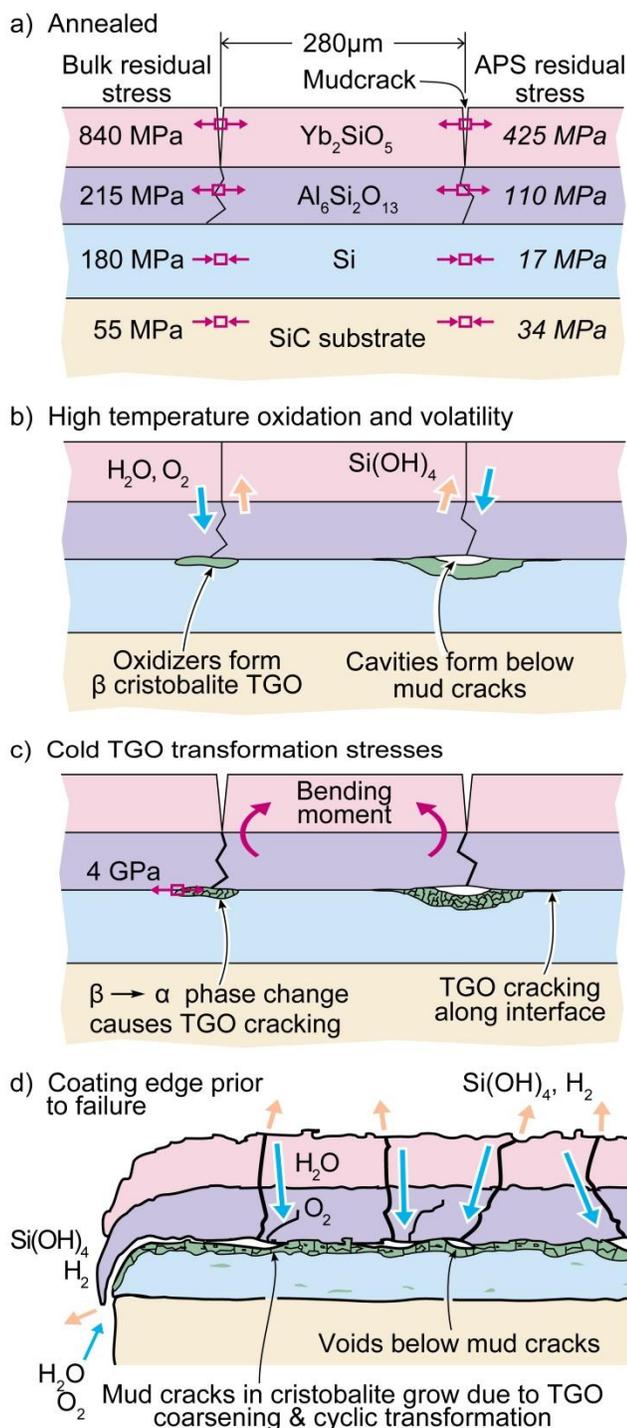
Figure 3.13: The damage mechanism sequence in an  $\text{Yb}_2\text{SiO}_5/\text{Al}_6\text{Si}_2\text{O}_{13}/\text{Si}$  tri-layer EBC applied to an  $\alpha$ -SiC substrate. (a) Shows the initial damage and stress states in the annealed EBC, (b) shows reaction at  $1316^\circ\text{C}$  and (c) details mechanical damage at low temperature. (d) Schematic of the edge localized damage and failure.

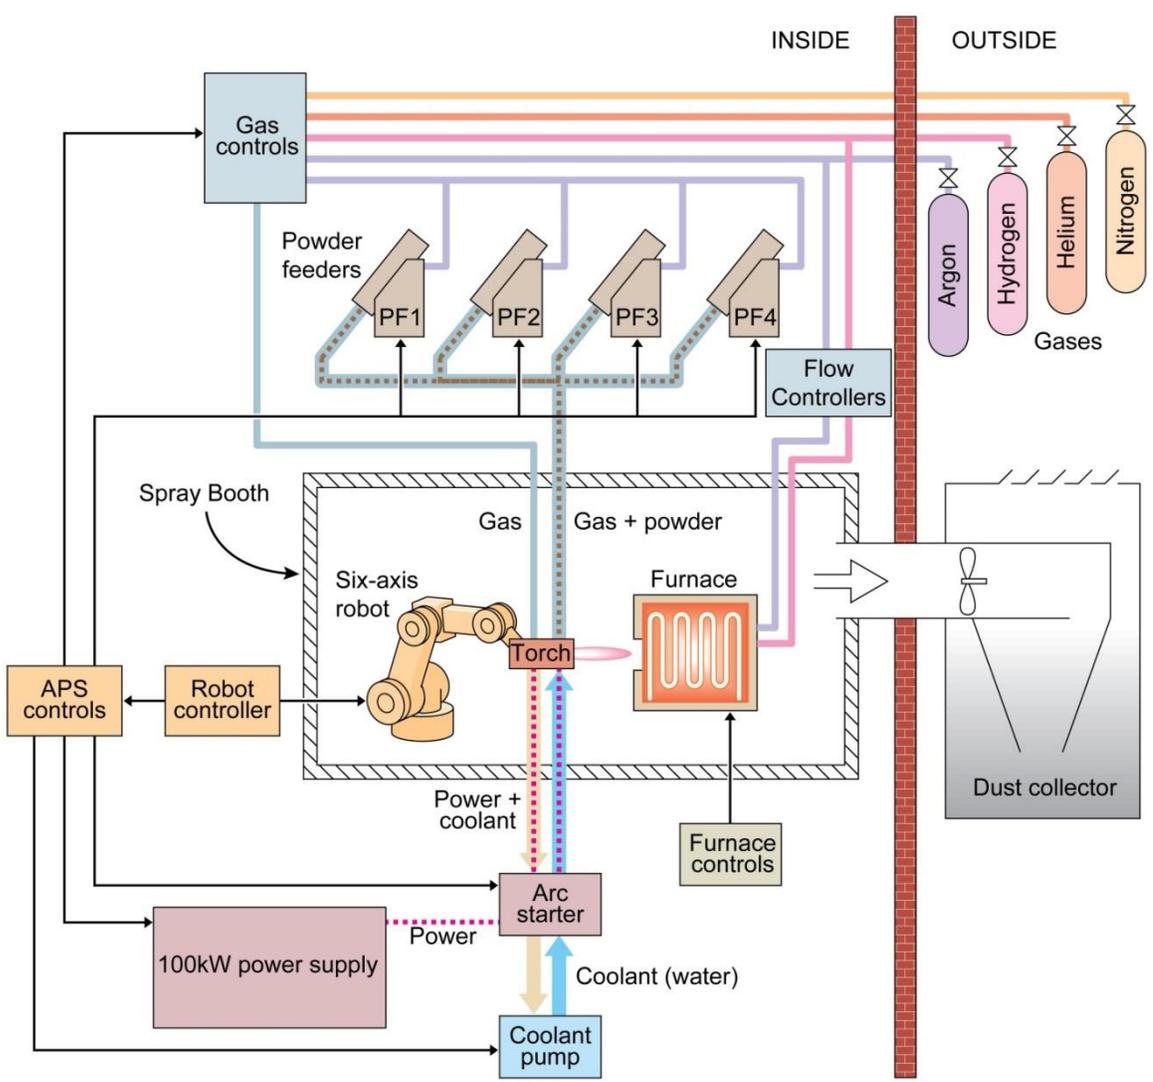
Figure 4.1: Schematic illustration of the configuration of UVA's APS lab.

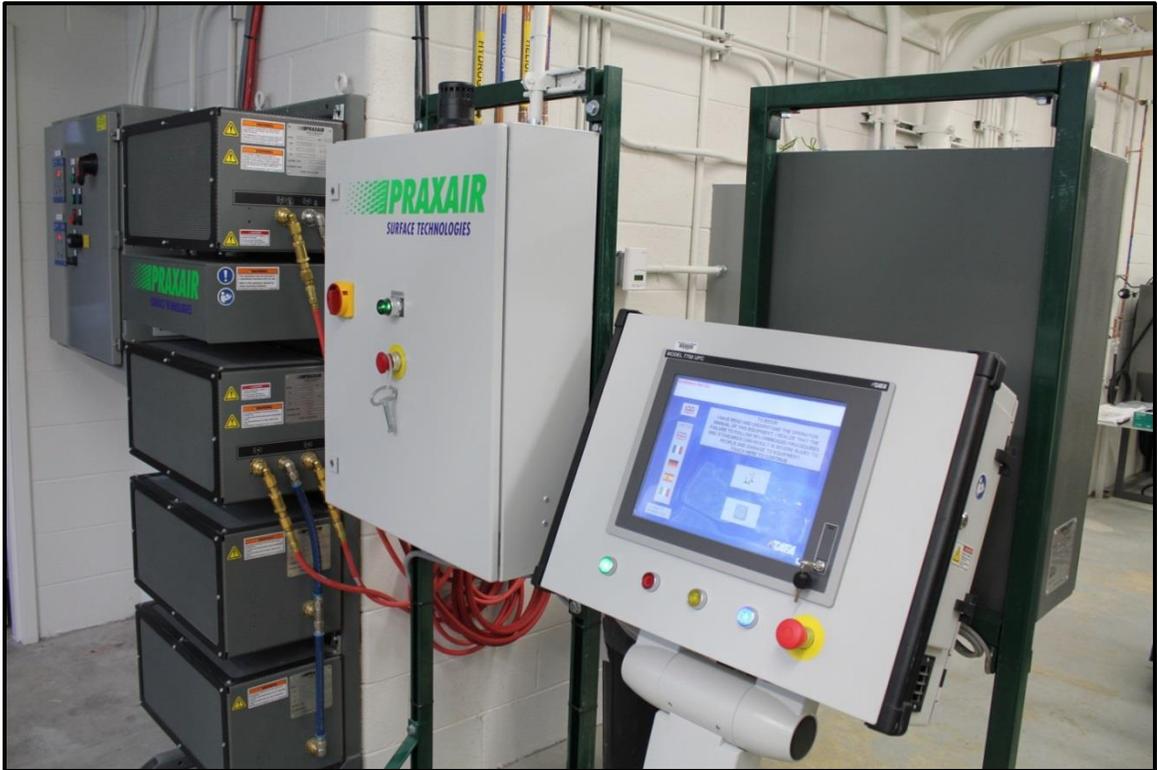
*Figure 4.2: Photography of the process gas handling and primary controls of UVA's APS system.*

The APS lab is located in the Observatory Mountain Engineering Research Facility (OMERF). This location was determined to be the most suitable for a large deposition system due to its remoteness from central grounds, large laboratory space, and availability of the ~150 kW of power that can be drawn by the APS system and its ancillary equipment during peak operation. The control interfaces of the lab are set up in an open floor plan that promotes awareness of equipment operation and provides access to all equipment. The primary control system is shown in Figure 4.2.

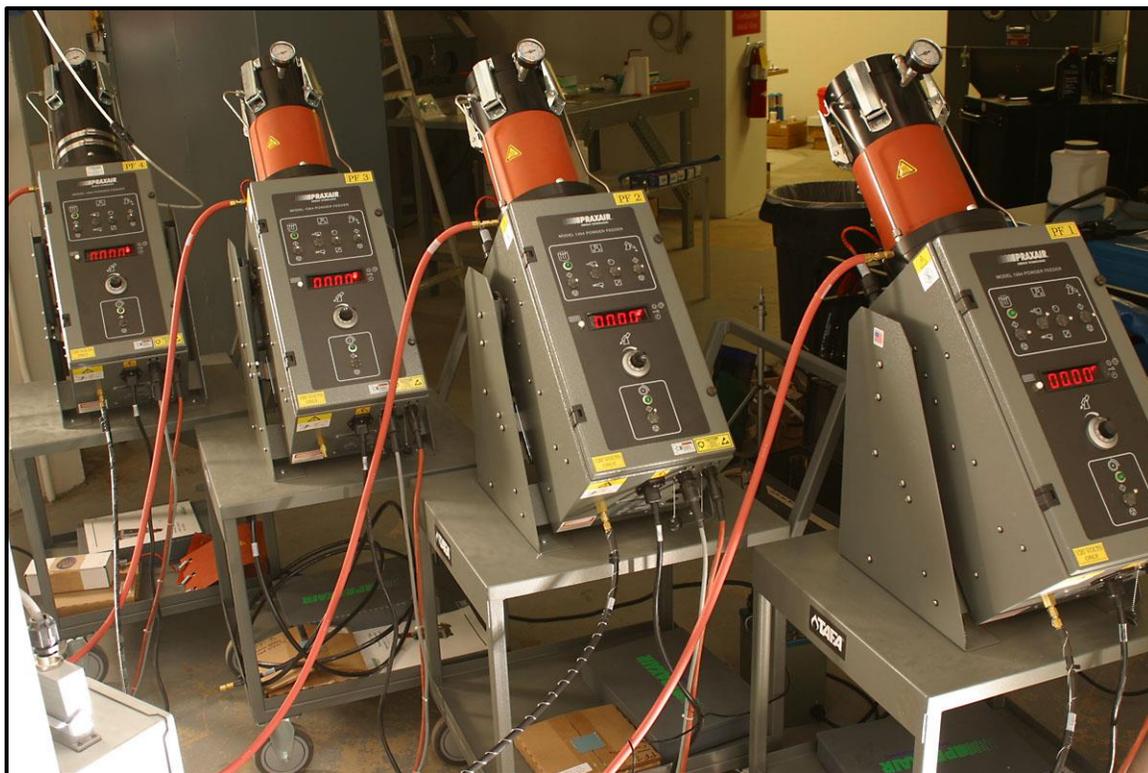
*Figure 4.3: The four powder feeders that can be connected to the APS torch.*

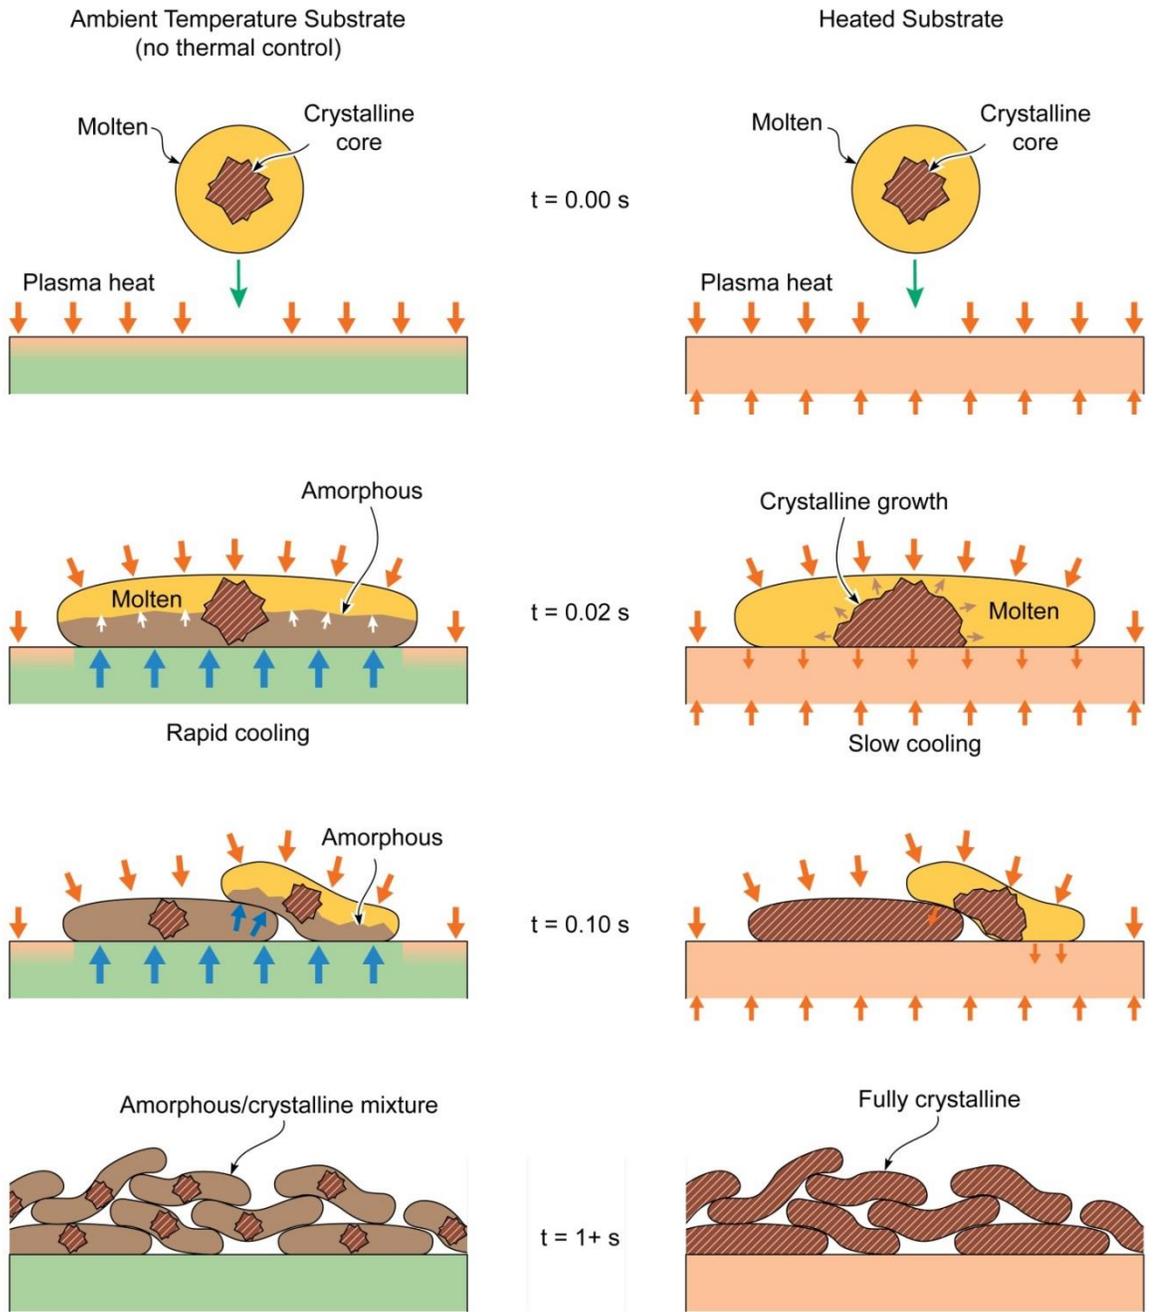
Figure 4.4: Schematic illustration of the effect of substrate heating upon crystallinity of splats deposited by APS.

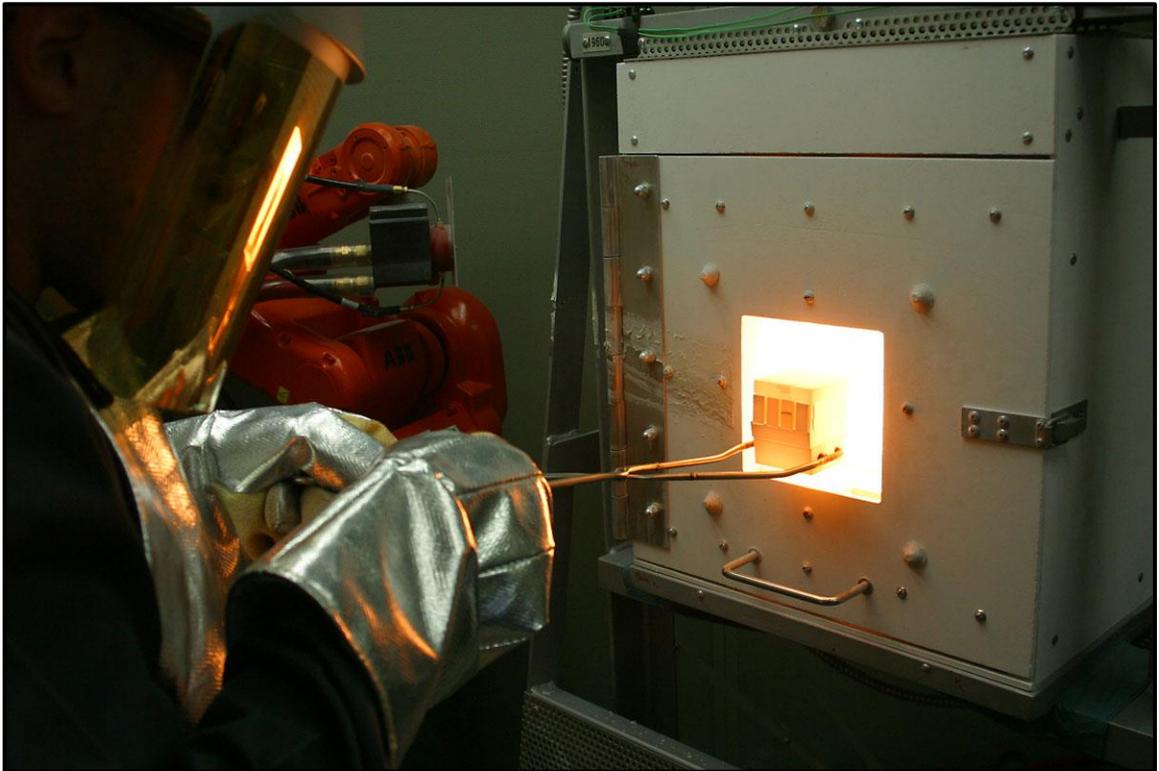
*Figure 4.5: Photograph of Brad Richards removing a deposition fixture with four coated samples from the high temperature deposition furnace.*

furnace. This furnace is capable of holding a 1500 °C internal temperature with the deposition window open, as pictured in Figure 4.5. Though elevated temperature deposition resolves issues with deposition of amorphous materials, it also introduces a host of other logistical issues with fixturing samples for deposition. Superalloy fixtures were tested but were found to be insufficient for the extreme oxidizing environment. Aluminosilicate insulation fixtures comparable to those used at NASA Glenn were tested, but these had the disadvantage of overlapping the front of the sample, and their light weight often lead to movement inside the deposition furnace during APS processing.

Instead, SiC fixtures were custom designed and fabricated to hold the SiC substrates during deposition. One of these fixtures is shown being removed from the furnace in Figure 4.5. The fixtures had sufficient weight to remain stationary during the deposition, and their rigidity allows for gripping of substrates by grooves cut into their edges, thereby allowing one entire surface of the substrate to be coated inside the furnace. The fixture therefore solves an issue identified in Chapter 3 associated with exposed edges resulting from uncoated parts of the sample face. Due to the extreme thermal shock associated with loading and unloading the fixtures from a 1200 °C operating environment to ambient conditions, the sample fixtures were made out of stacks of 6 mm SiC plates machined to the desired shape.

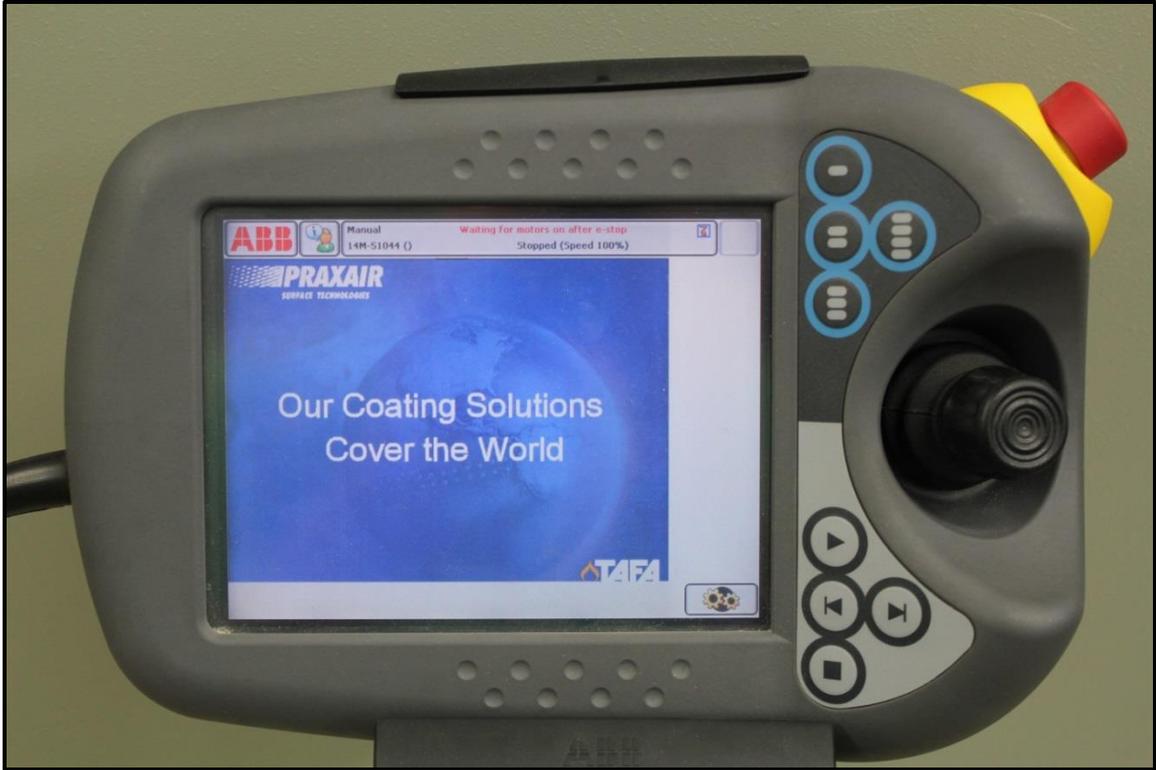
*Figure 4.6: Control pendant of the ABB IRB-140 robot that runs the APS system.*

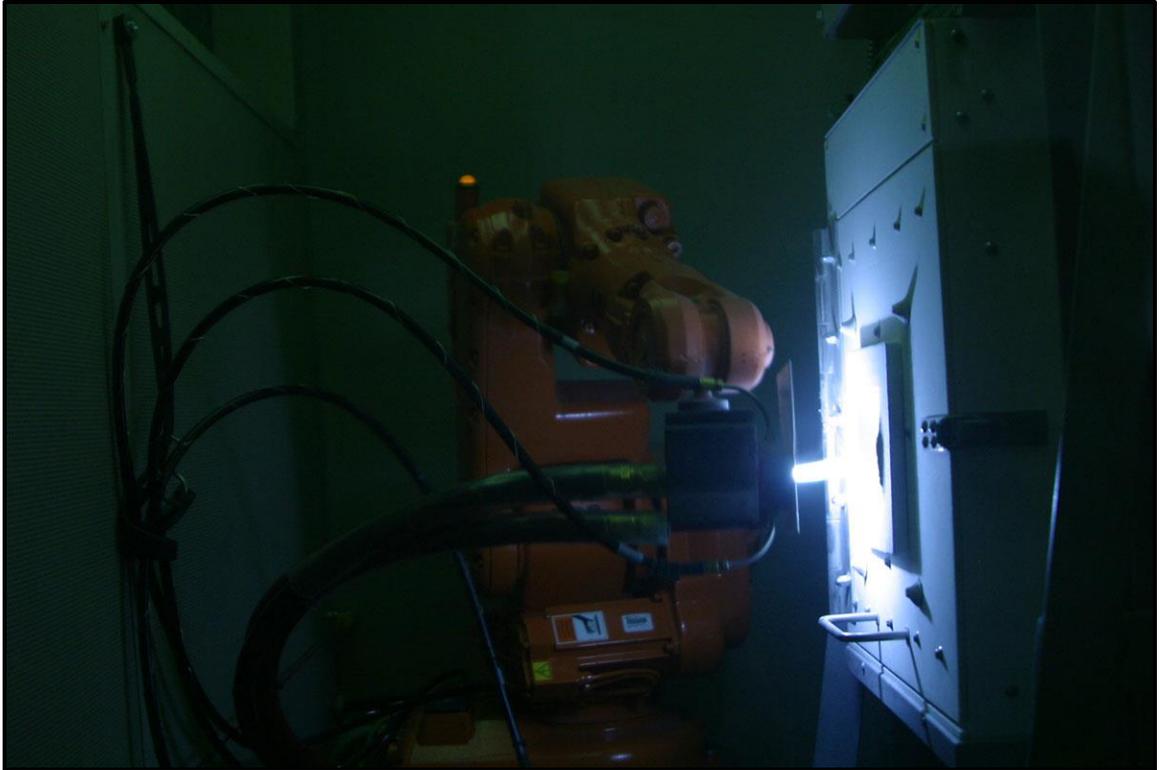
*Figure 4.7: Live plasma spraying into the high temperature deposition furnace.*

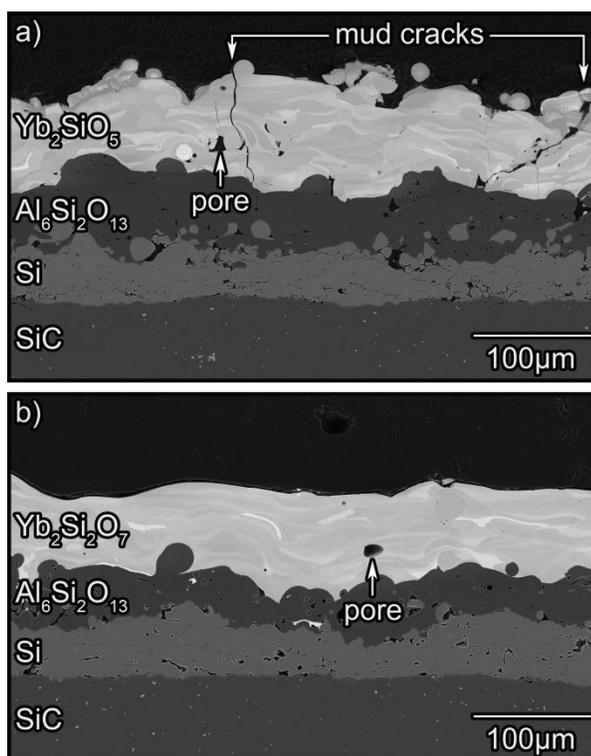
Figure 5.2: As-deposited tri-layer EBC systems deposited on a monolithic  $\alpha$ -SiC substrate. (a) Ytterbium monosilicate and (b) ytterbium disilicate topcoats both deposited on mullite using silicon bond coated substrates. The SEM images were collected in BSE mode and so the whitest contrast phases contained the highest concentration of the highest atomic number element (ytterbium).

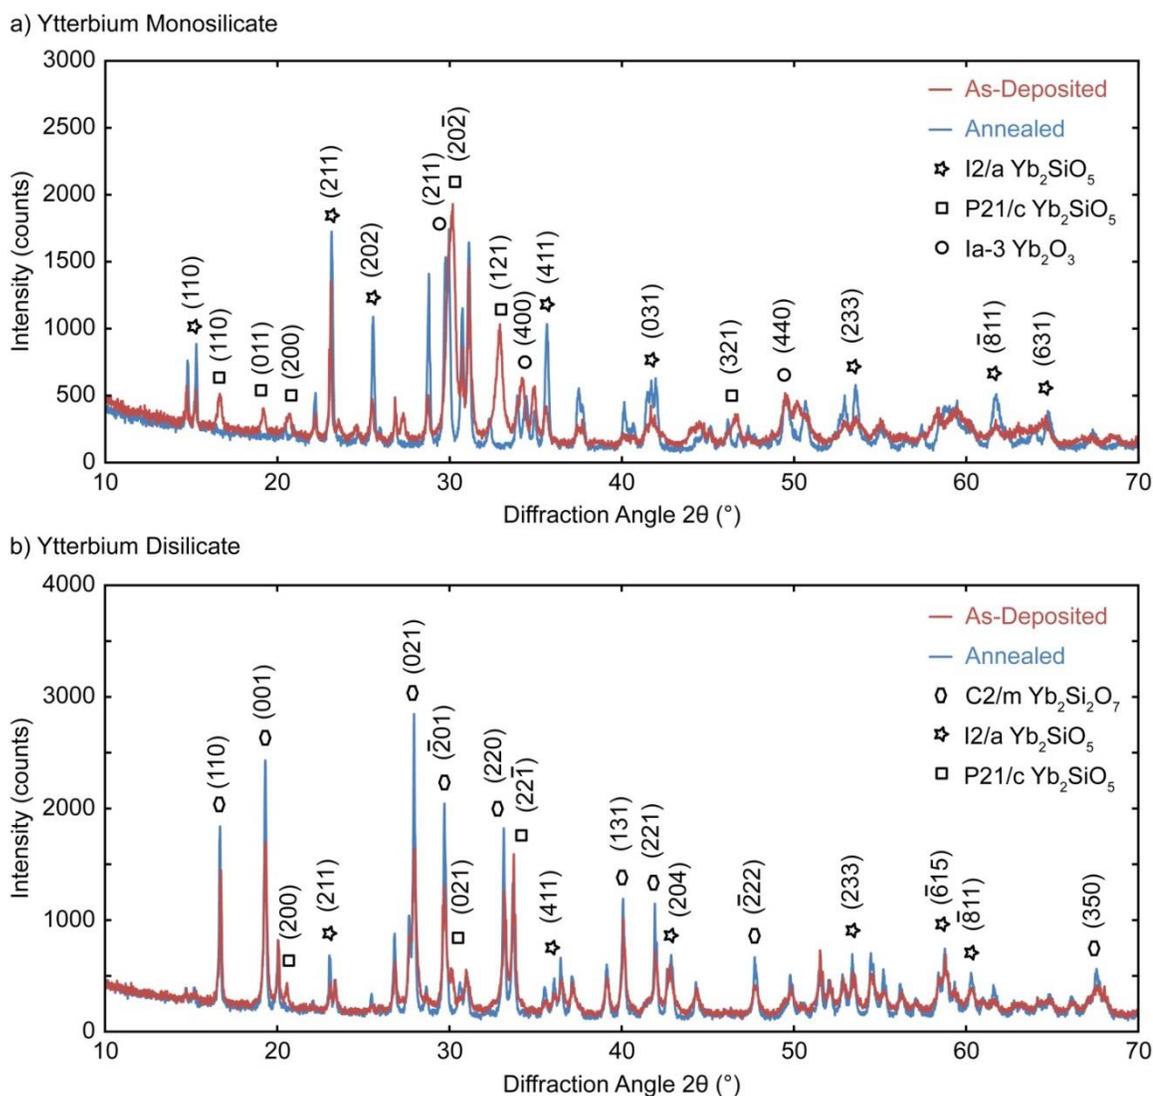
Figure 5.3: X-ray diffraction patterns of as-deposited and annealed topcoats. (a) Ytterbium monosilicate and (b) ytterbium disilicate both deposited using the *S* combination of deposition parameters.
