Ytterbium Silicate Environmental Barrier Coatings

A Dissertation

Presented to  
the faculty of the School of Engineering and Applied Science  
University of Virginia

Bradley T. Richards

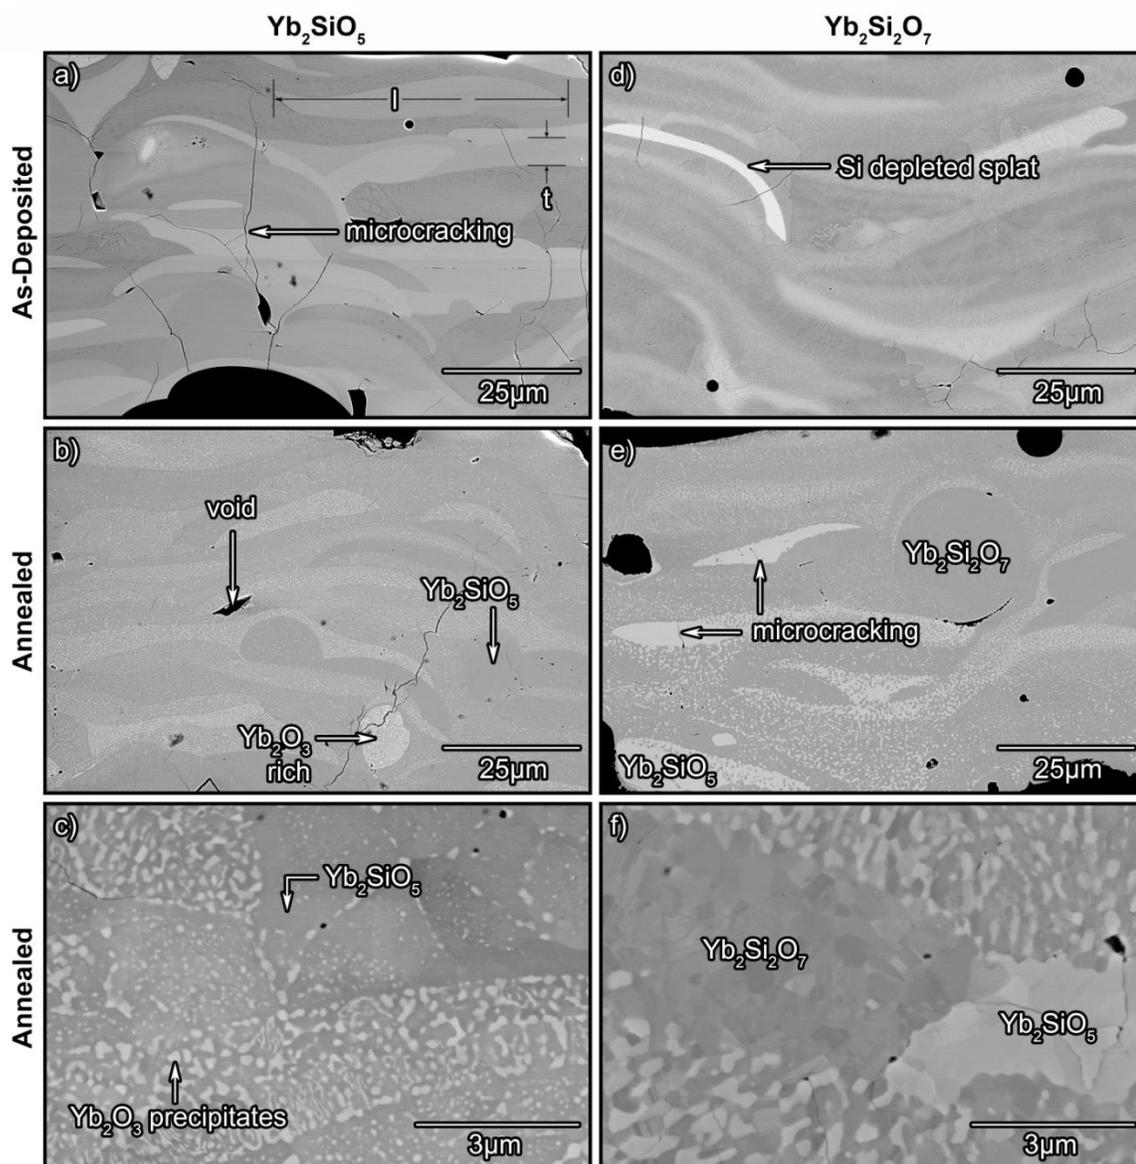
Figure 5.4: BSE mode SEM micrographs of the ytterbium silicate layers deposited using the S combination of deposition parameters. (a) As-deposited, (b) annealed, and (c) high magnification annealed ytterbium monosilicate layer. (d), (e), and (f) correspond to as-deposited, annealed, and high magnification annealed ytterbium disilicate layers.

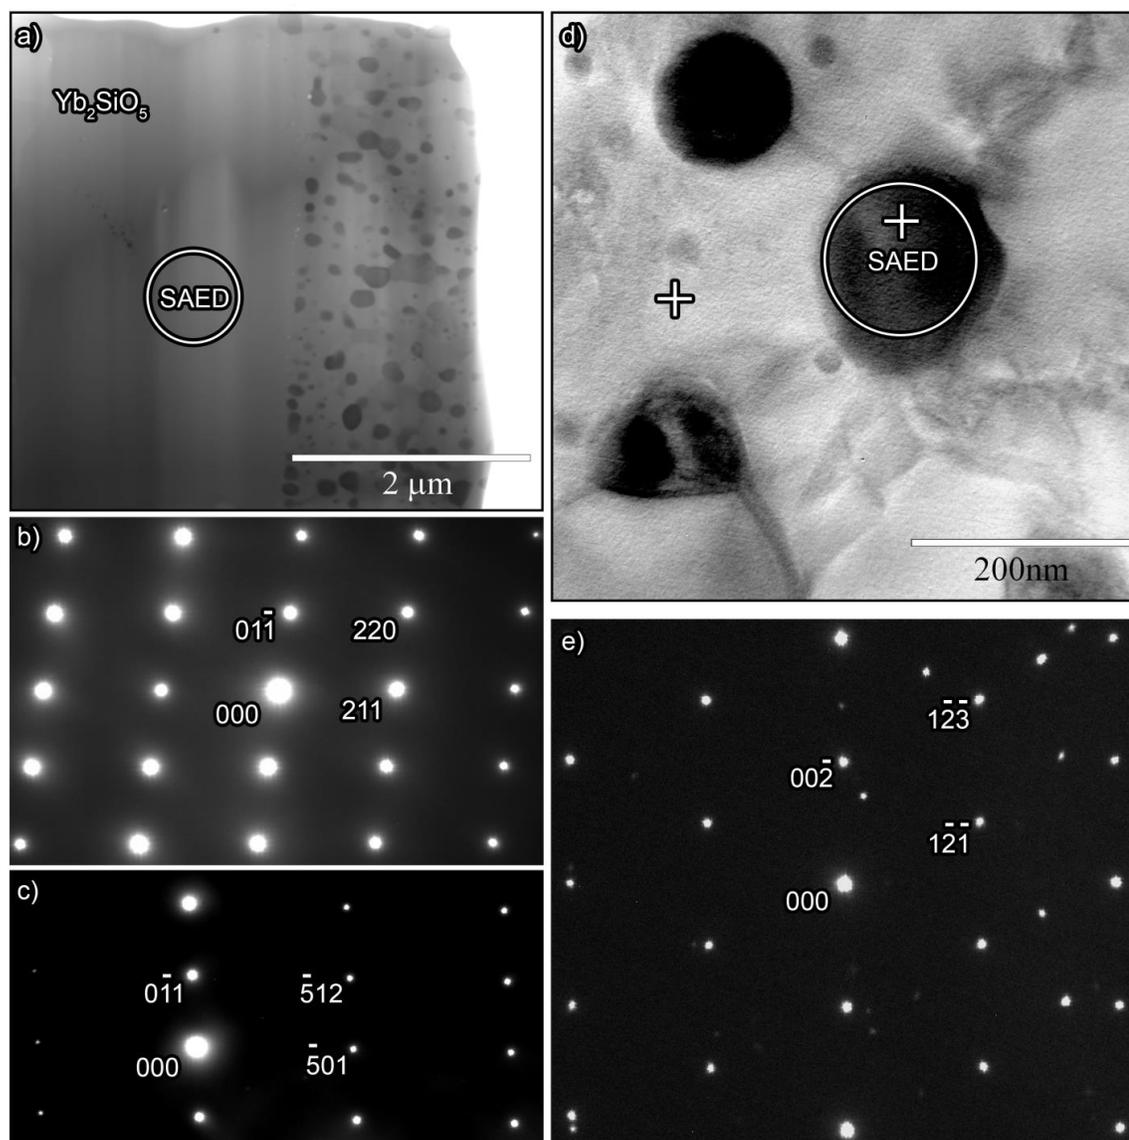
Figure 5.5: (a) Bright field TEM image of the ytterbium monosilicate coating. (b) The  $[\bar{1}11]$  and (c) the  $[0\bar{1}1]$  selected area electron diffraction (SAED) zone axis patterns from the monoclinic  $Yb_2SiO_5$  phase. (d) High magnification bright field image of the precipitated phase in the  $Yb_2SiO_5$  matrix. (e) Shows the cubic  $Yb_2O_3$  precipitate diffraction pattern along the  $[210]$  zone axis.

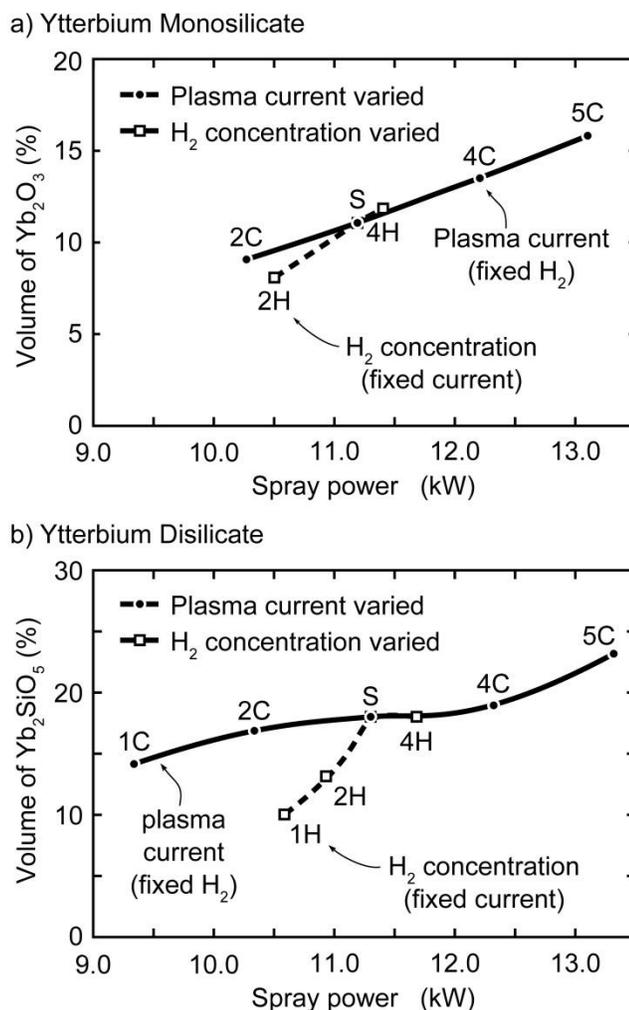
Figure 5.7: Volume fraction of second phase precipitates in annealed coatings plotted against plasma spray power. (a)  $\text{Yb}_2\text{O}_3$  precipitated in ytterbium monosilicate coatings. (b)  $\text{Yb}_2\text{SiO}_5$  precipitated in ytterbium disilicate coatings.

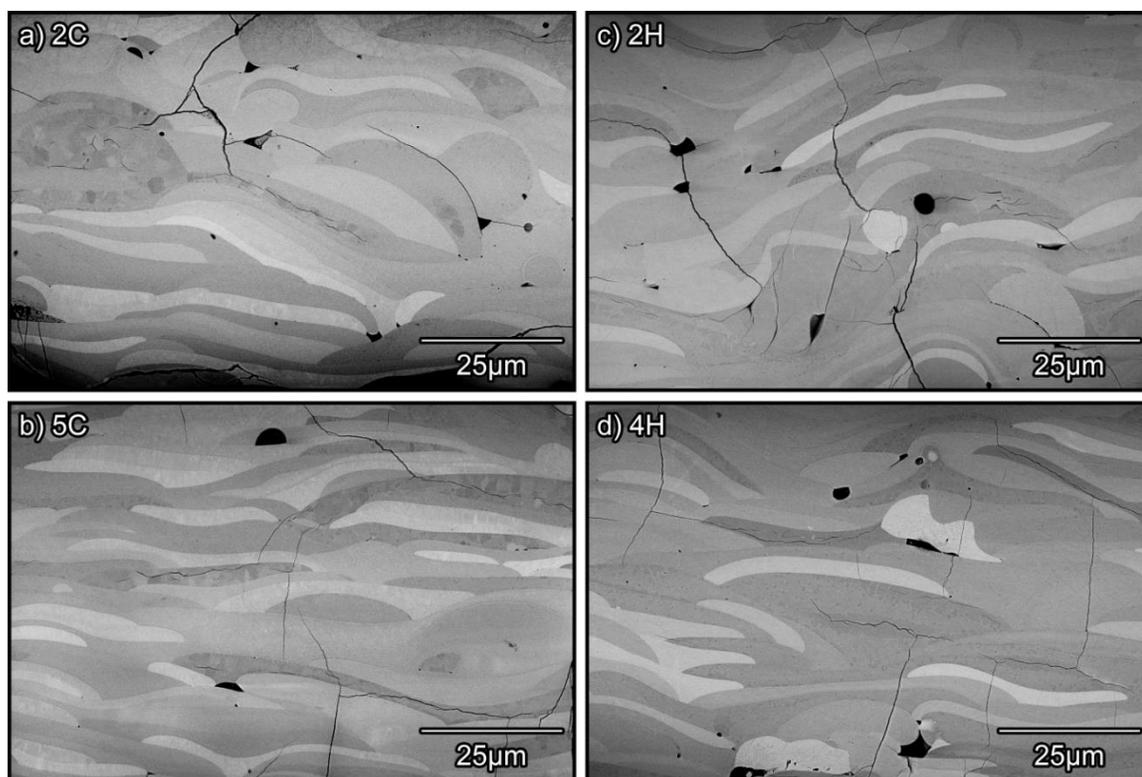
Figure 5.8: BSE mode SEM micrographs of as-deposited ytterbium monosilicate coatings deposited using different combinations of spray parameters. (a) 2C coating, (b) 5C coating, (c) 2H coating, and (d) 4H coating.

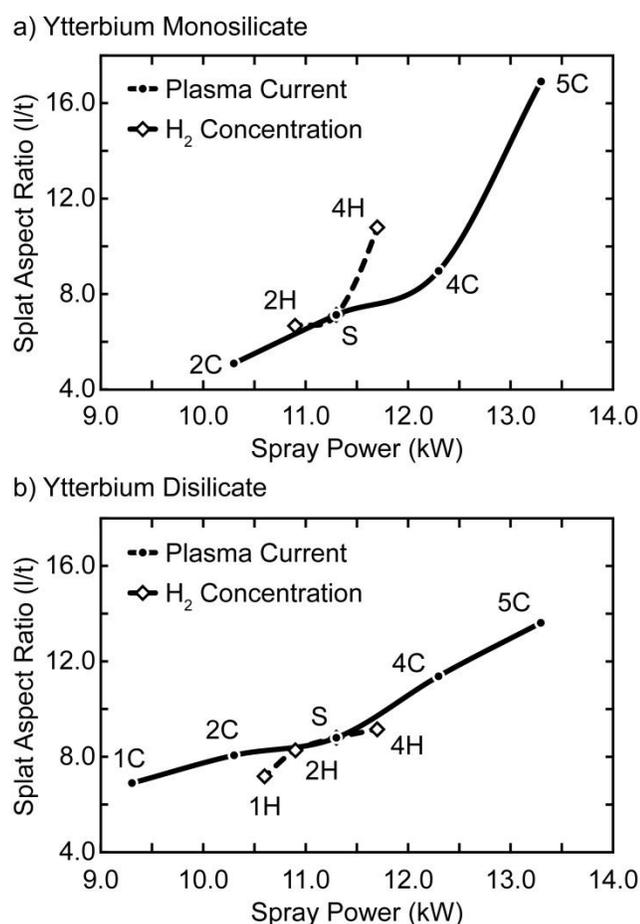
Figure 5.10: Variations in average splat aspect ratio ( $l/t$ ) as a function of plasma spray power for (a) ytterbium monosilicate and (b) ytterbium disilicate coatings in the as deposited condition.

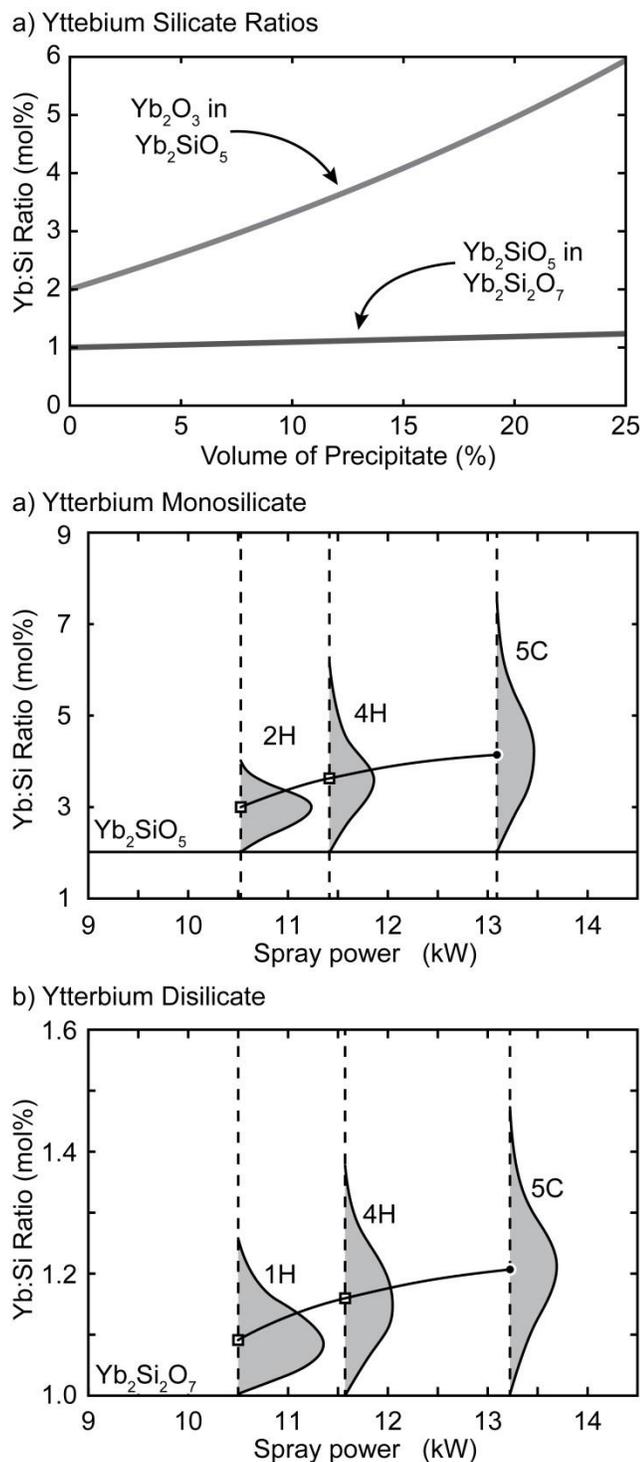
Figure 5.11: (a) Yb:Si ratio dependence upon molar volumes of second phases. Average Yb to Si ratios and BSE contrast based estimates of the composition variation in a coating for (b) the ytterbium monosilicate and (c) the ytterbium disilicate layers. BSE derived distributions were scaled by aligning the lowest Yb:Si ratio (darkest BSE contrast) end of the distribution with the stoichiometric compound and enforcing the average of the distribution to match that deduced from the phase volume fractions.

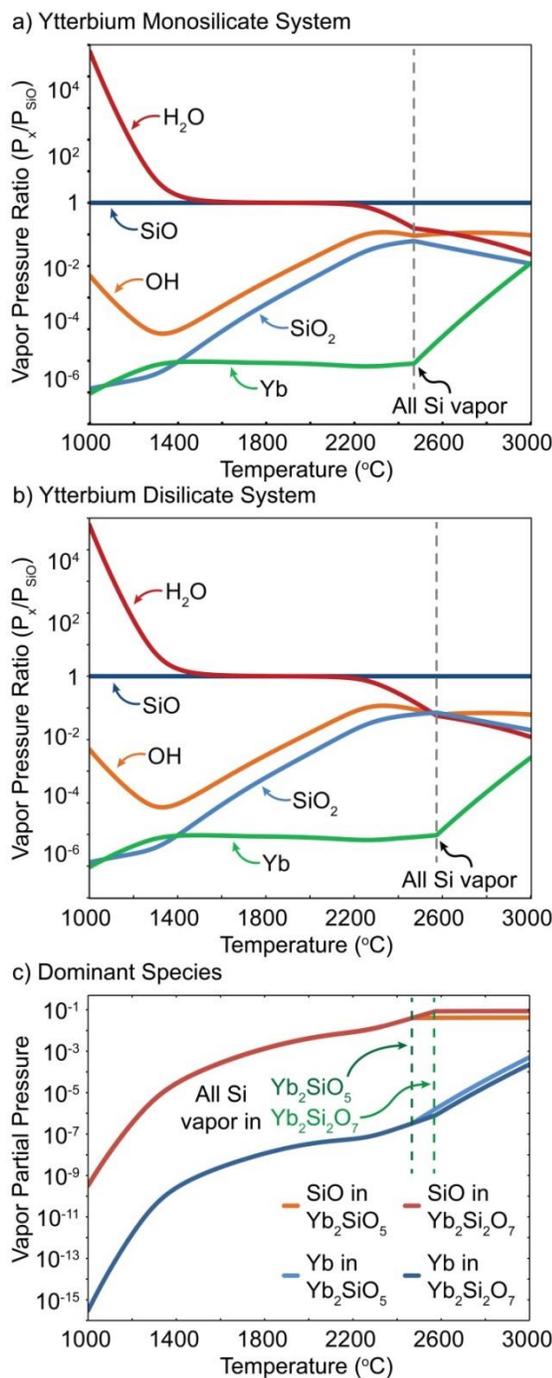
Figure 5.12: Partial pressure ratio of dominant vapor species to SiO as a function of temperature for the  $S$  spray parameter condition with (a)  $\text{Yb}_2\text{SiO}_5$  and (b)  $\text{Yb}_2\text{Si}_2\text{O}_7$  injected into the plume. (c) Calculated vapor partial pressures of dominant species. Partial pressures are calculated based on ideal thermochemical interactions.

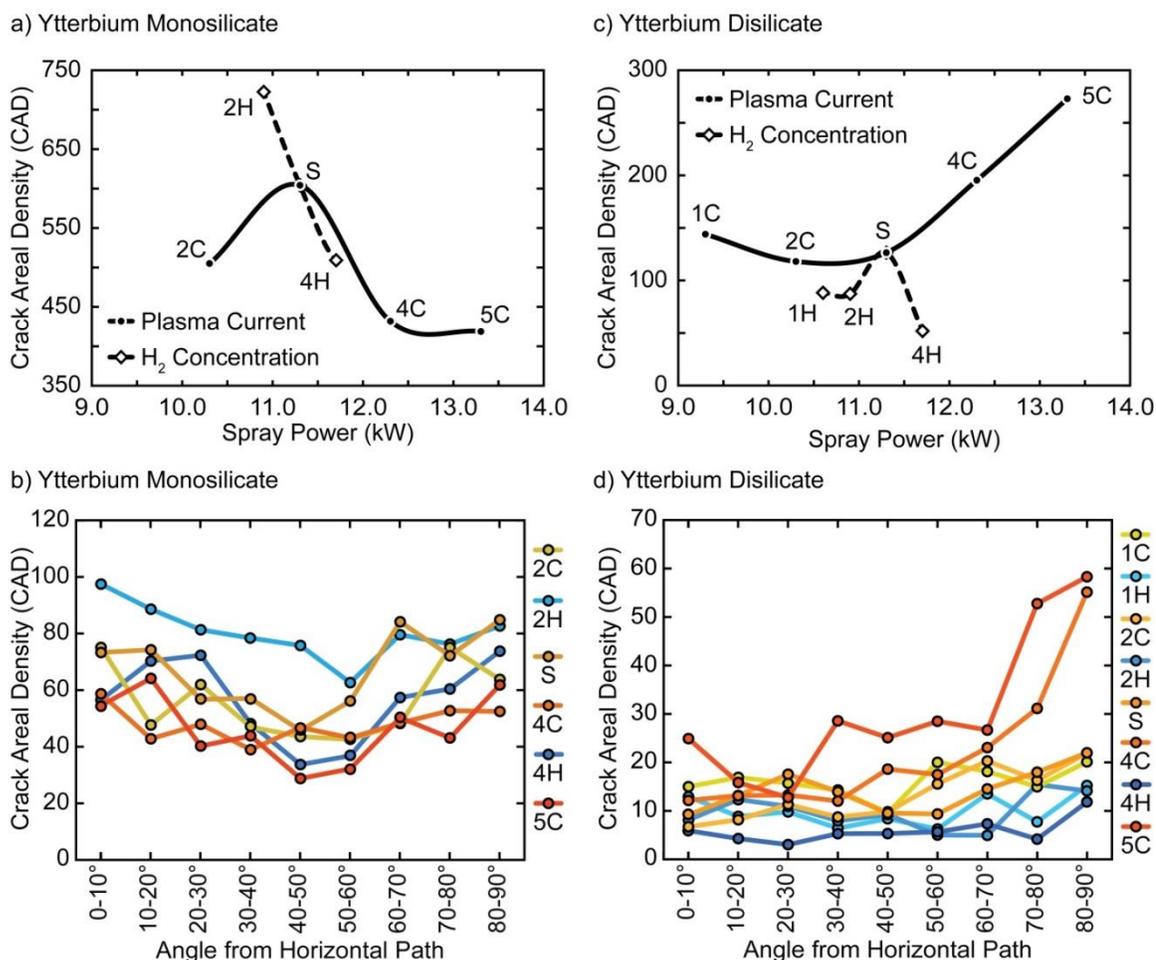
Figure 5.13: Crack areal density (CAD) of ytterbium silicate layers: micro-crack length (in  $\mu\text{m}$ ) per  $10,000\mu\text{m}^2$  of coating cross section. (a) Crack length of all orientations plotted as a function of plasma spray power for the ytterbium monosilicate layers. (b) Crack length as a function of angle of divergence from horizontal crack path in ytterbium monosilicate layers. A  $90^\circ$  angle indicates vertical (mud crack type) cracking. The plots in (c) and (d) are similar data for ytterbium disilicate layers.

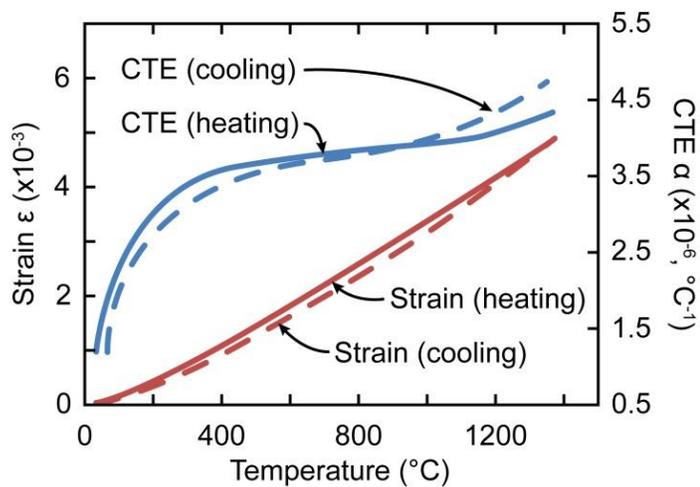
Figure 5.14: Thermal strain and expansion coefficient of 100 hour annealed 95% dense spark plasma sintered (SPS) ytterbium disilicate ( $\text{Yb}_2\text{Si}_2\text{O}_7$ ).

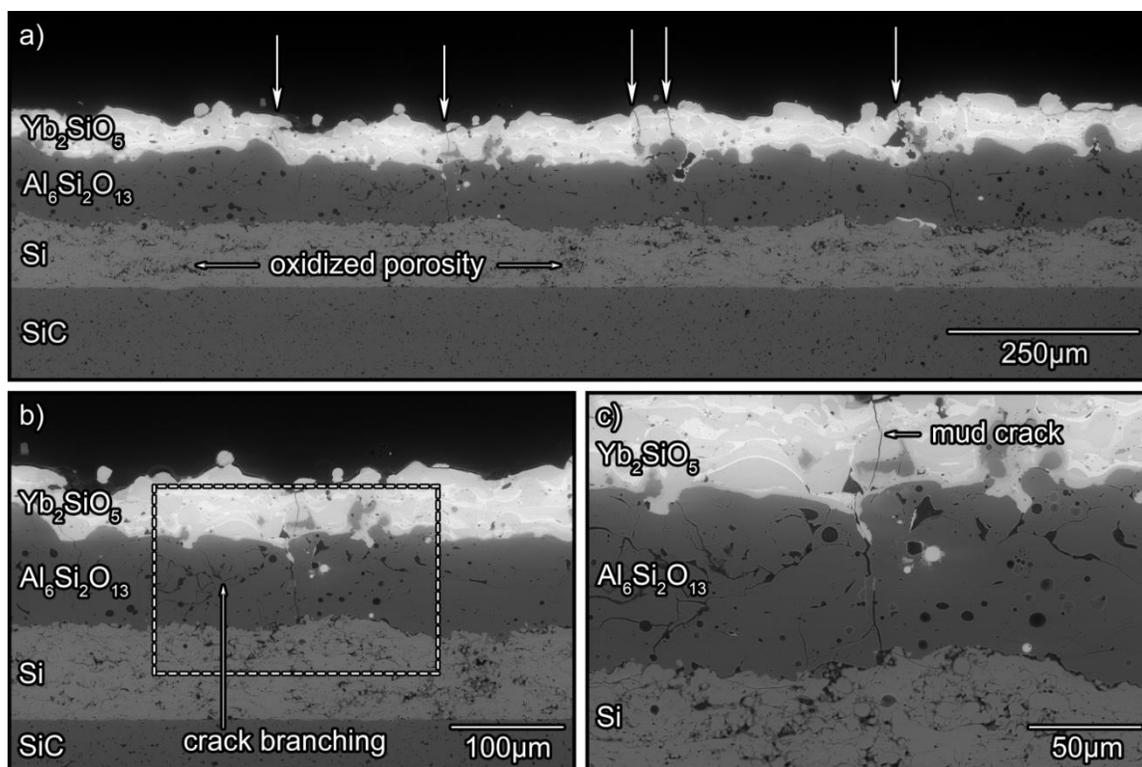
Figure 6.1: BSE images of an annealed tri-layer EBC deposited using high power plasma spray parameters from Chapter 2. (a) The three layers on a SiC substrate with mud cracks indicated. (b) Higher magnification view showing penetration of a mud crack, and (c) zoom of boxed region in (b) showing a higher magnification view of the mud crack within the EBC.

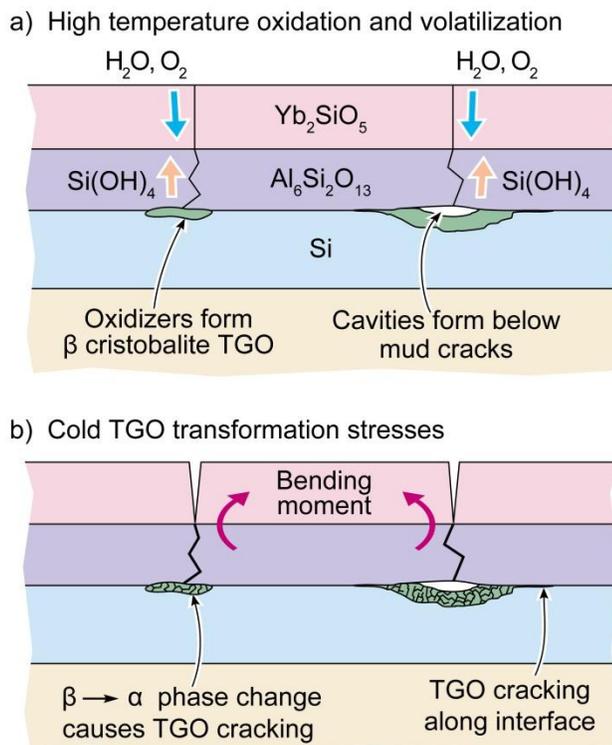
Figure 6.2: Schematic illustration of the failure mechanism of high power deposited tri-layer EBCs on a SiC substrate (see Chapter 3).

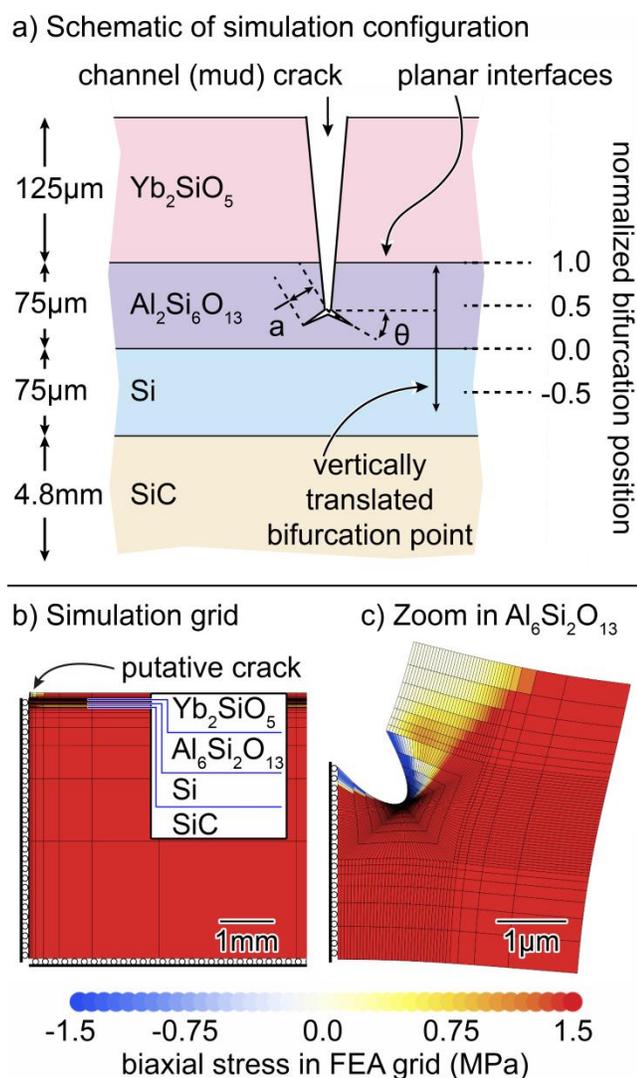
Figure 6.4: (a) Shows a schematic of the cracking configuration simulated with the relevant dimensions and scaling features indicated. (b) Part of the actual mesh simulated with (c) a higher magnification view of the putative crack in the  $\text{Al}_6\text{Si}_2\text{O}_{13}$  layer using 5x displacement magnification to show mesh behavior. (b) and (c) are for a normalized bifurcation position of 0.8 (parent crack length of  $140\mu\text{m}$ ) with  $\theta = 45^\circ$  and  $a = 1\mu\text{m}$ .

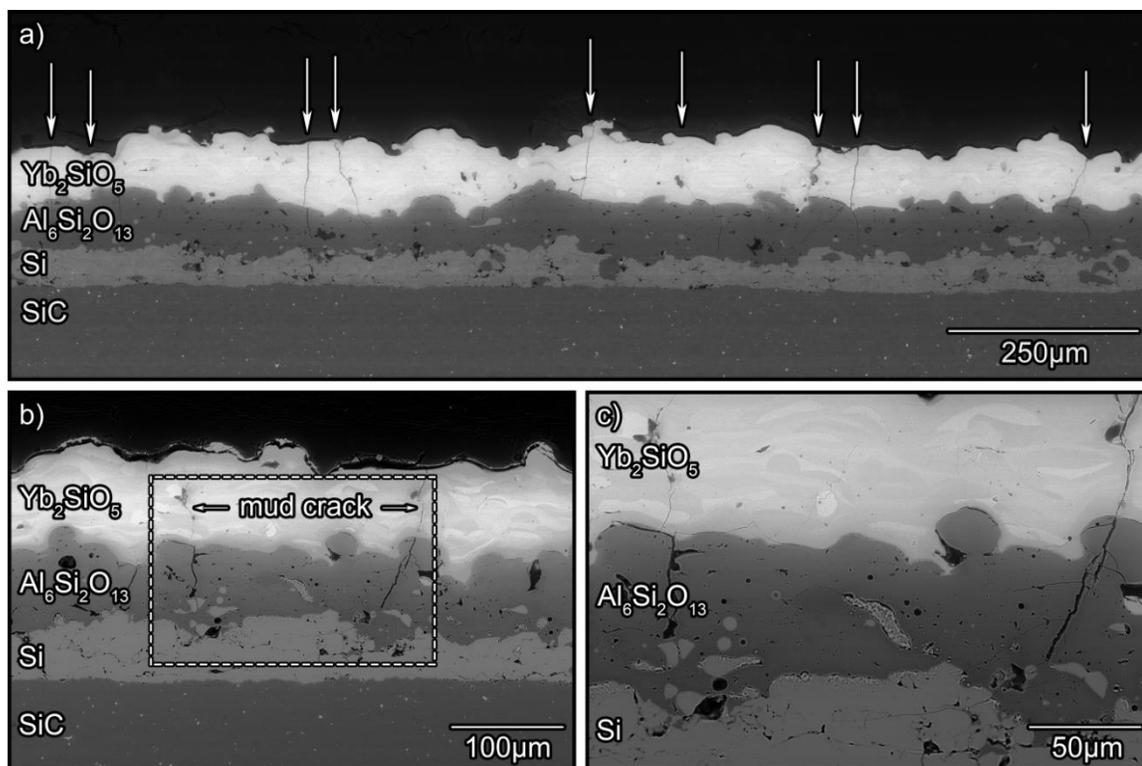
Figure 6.5: BSE images of an annealed tri-layer EBC deposited using optimized low power plasma spray parameters. (a) The three layers on a SiC substrate with mud cracks indicated. (b) Higher magnification view showing two mud cracks and (c) zoom of boxed region in (b) showing the penetration of the two mud cracks into the  $\text{Al}_6\text{Si}_2\text{O}_{13}$  layer.

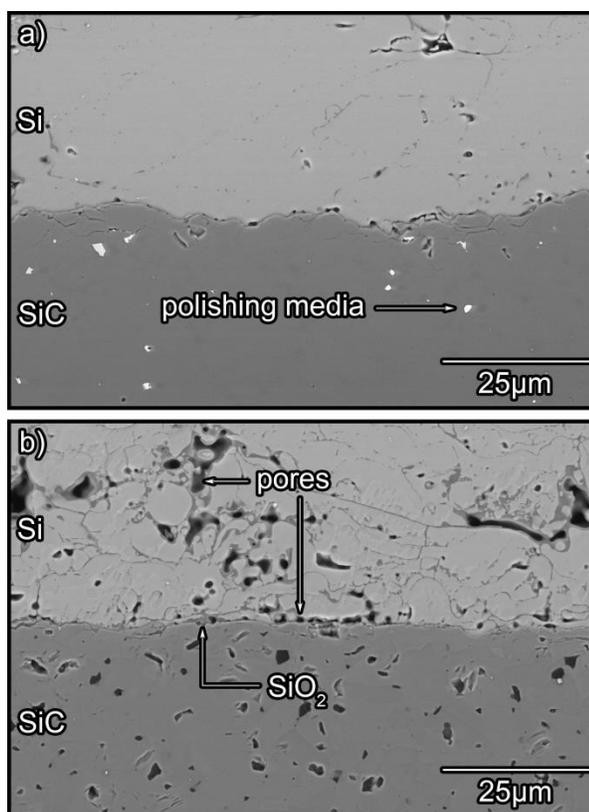
*Figure 6.6: (a) Shows a typical Si – SiC interface of the low power deposited EBC with a well-bonded interface and limited porosity. (b) The Si – SiC interface formed when using high power plasma spray deposition parameters and no reducing gas flow.*

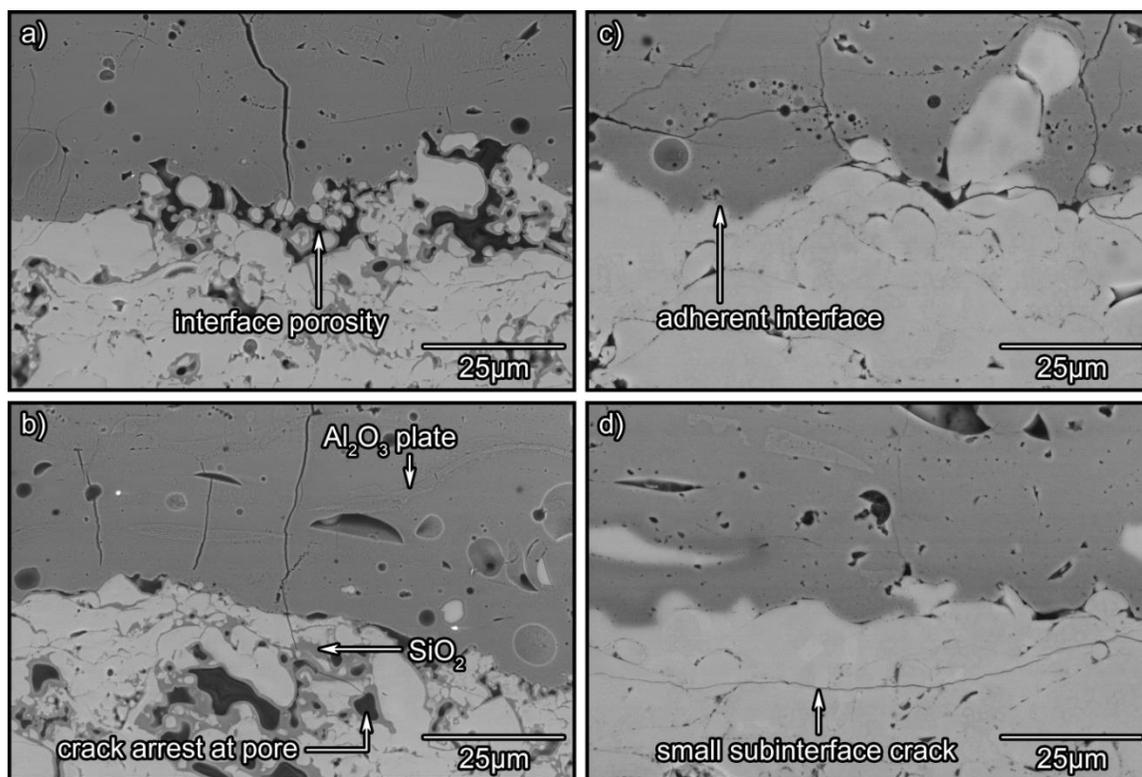
Figure 6.7: BSE images of  $\text{Al}_6\text{Si}_2\text{O}_{13}$  – Si interfaces in the annealed tri-layer EBC system. High power deposited interfaces are shown in (a) and (b) whereas (c) and (d) show the same interface in low power EBCs where the Si layer was deposited using a reducing gas flow.

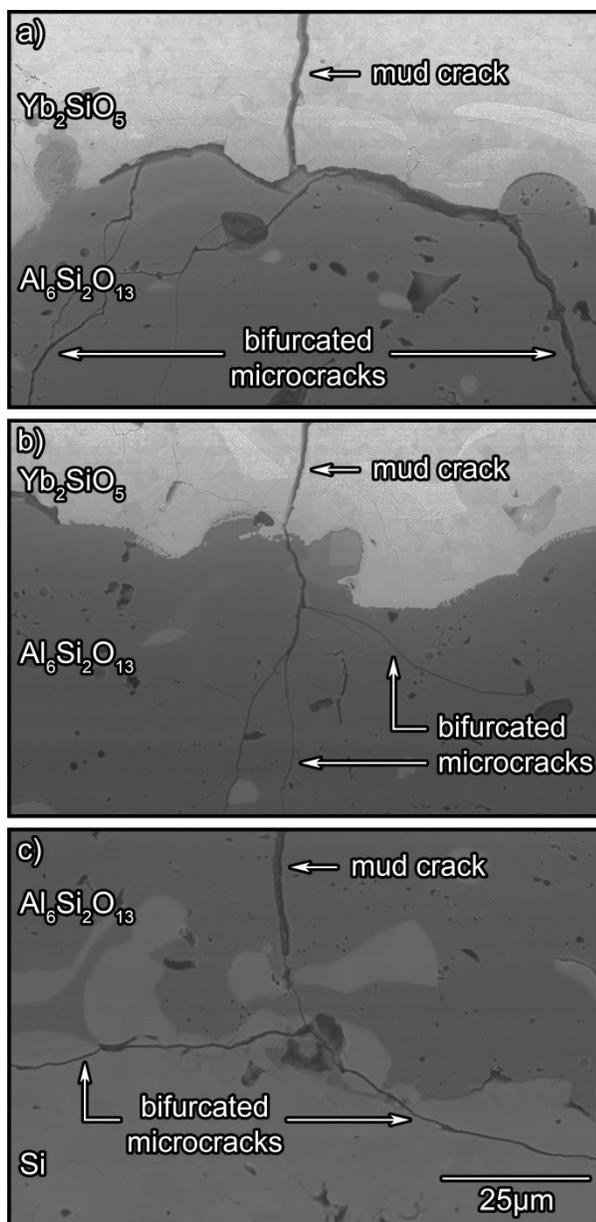
Figure 6.8: BSE micrographs of mud crack bifurcation in stabilization annealed low power  $Yb_2SiO_5/Al_6Si_2O_{13}/Si$  EBCs plasma sprayed onto  $\alpha$ -SiC. (a) Shows a bifurcation at the  $Yb_2SiO_5 - Al_6Si_2O_{13}$  interface, (b) bifurcation within the  $Al_6Si_2O_{13}$  layer, and (c) bifurcation at the  $Al_6Si_2O_{13} - Si$  interface. In all three cases the resultant trajectory of the bifurcated crack ligaments was directed toward the silicon bond coat.

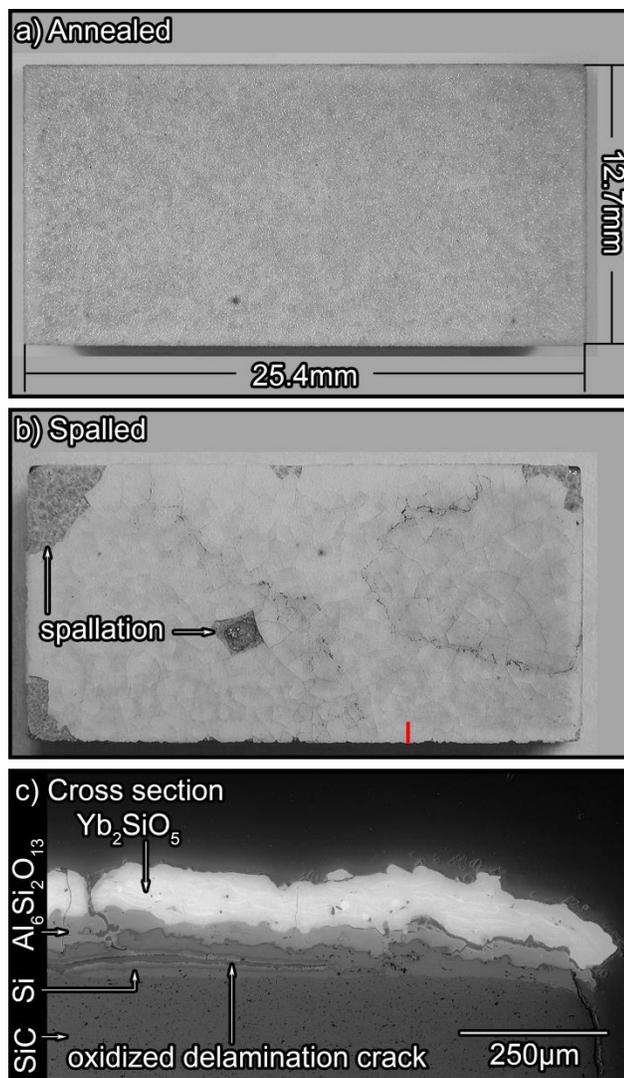
Figure 6.10: (a) Shows an annealed tri-layer EBC deposited using low power plasma spray parameters. The same sample after 250 steam cycles at 1316°C is imaged optically in (b) and its cross section near an edge in (c) using BSE mode SEM imaging. The red bar in (b) indicates the location of the section shown in (c).

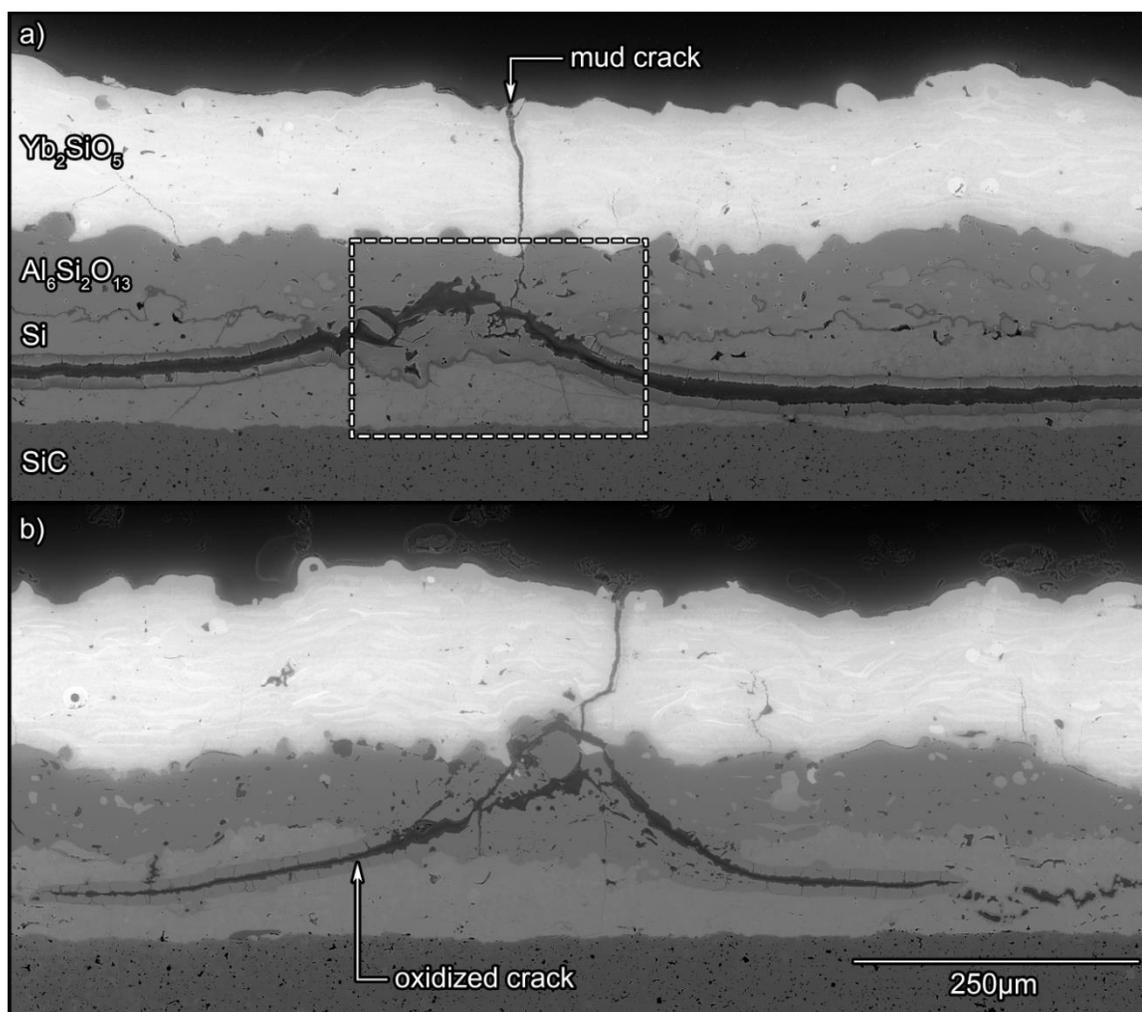
Figure 6.11: Cross sectional BSE micrographs of the same failed coating presented in Figure 8 after 250 1-hour steam cycles at  $1316^\circ\text{C}$  with cross-sections at (a) 1mm and (b) 3mm from the coating edge. Note the oxide layer that has formed on the bifurcated crack faces in the silicon bond coat.

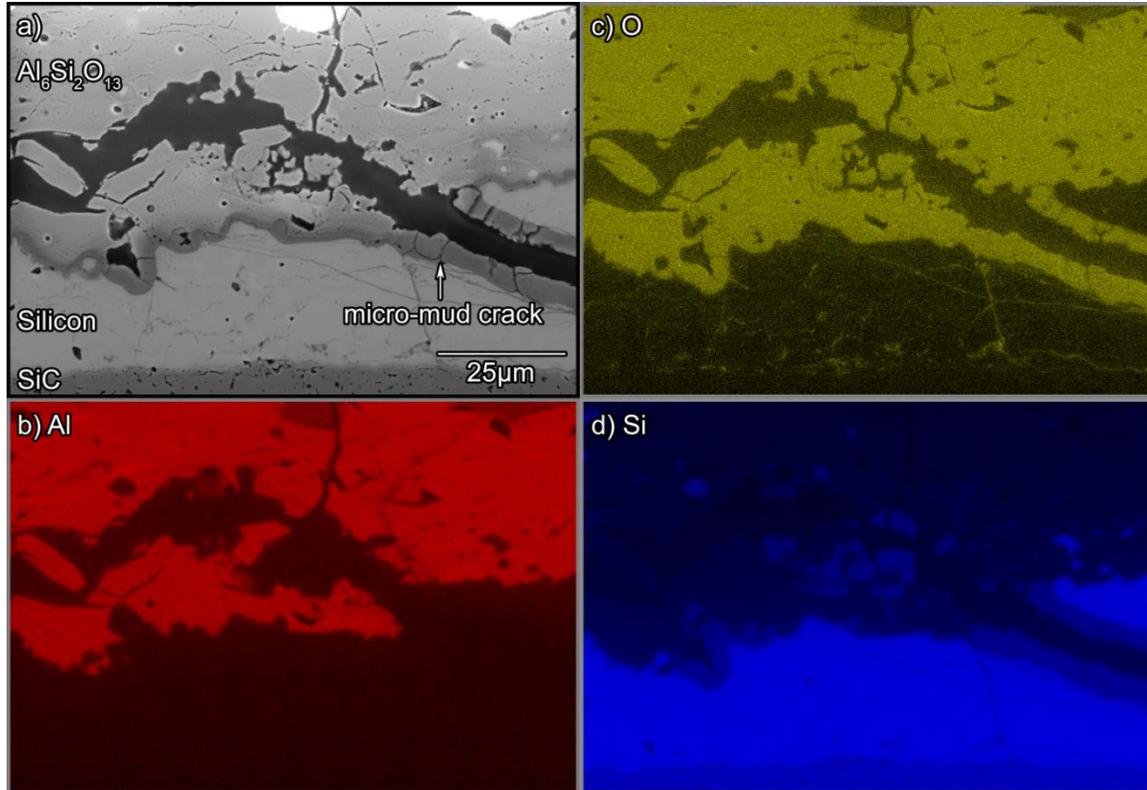
Figure 6.12: (a) BSE mode image of mud-crack and bifurcated delamination cracks for the dashed box region in Figure 9. EDS dot maps are shown for (b) aluminum, (c) oxygen and (d) silicon signals for the same region.

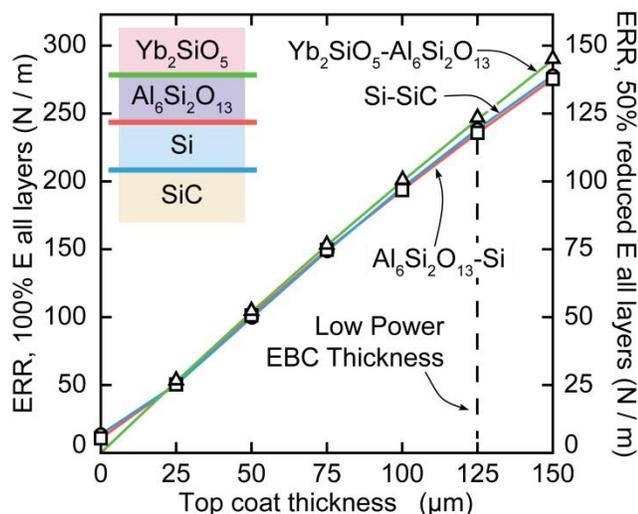
Figure 6.13: The ERR for delamination at the various interfaces in the tri-layer EBC as a function of topcoat thickness prior to TGO growth. Results using bulk (left) and APS (right) estimated elastic moduli are shown.

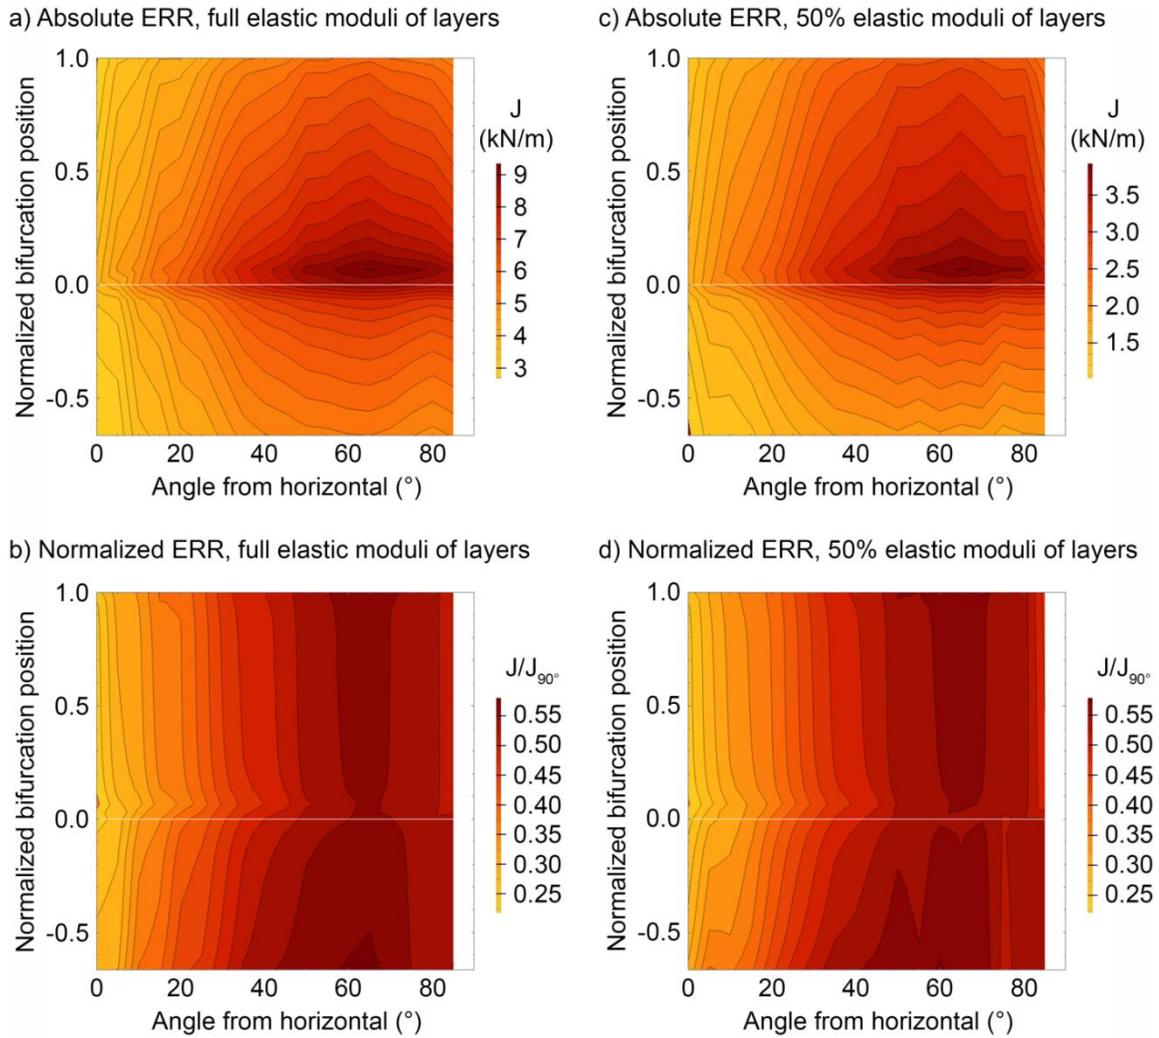
Figure 6.14: FEA computed ERR maps for bifurcation cracking as a function of putative crack angle and bifurcation depth in low power deposited EBCs. Subplots (a) and (b) show the absolute and normalized ERR using the bulk material elastic moduli for coating layers given in Table 6.2. Subplots (c) and (d) show analogous ERR results for coating layers with 50% of the bulk elastic moduli, summarized in Table 6.2. The normalized ERR results were obtained by dividing the ERR for bifurcated crack extension by that for a vertically penetrating single crack.

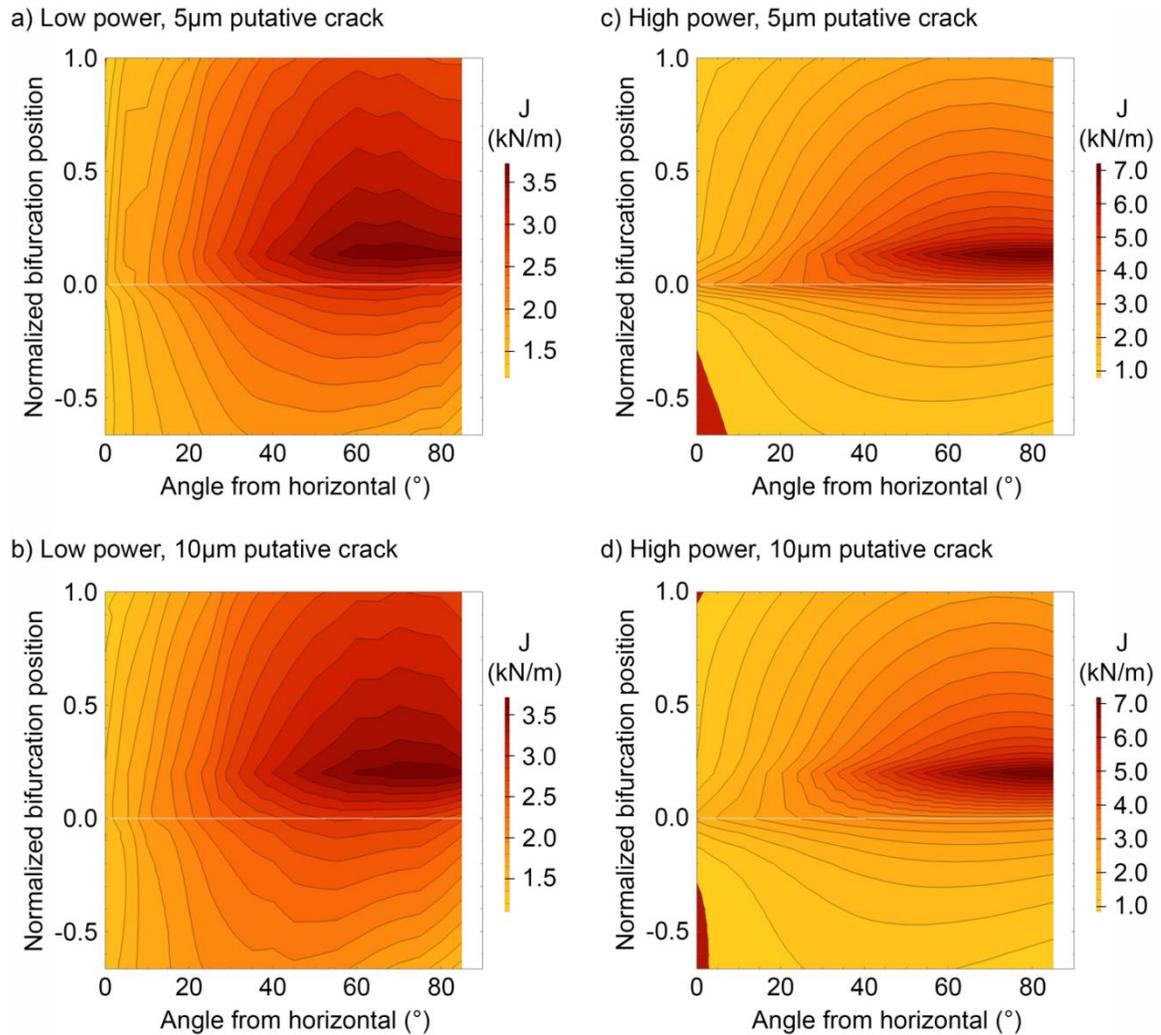
*Figure 6.15: FEA computed ERR maps for bifurcation cracking as a function of putative crack angle and bifurcation depth. Subplots (a) and (b) show the absolute ERR for 5 $\mu\text{m}$  and 10 $\mu\text{m}$  putative cracks in the low power EBC using the 50% reduced elastic moduli for coating layers given in Table 6.2. Subplots (c) and (d) show analogous ERR results for high power layers using the reduced elastic moduli given in Table 6.2.*

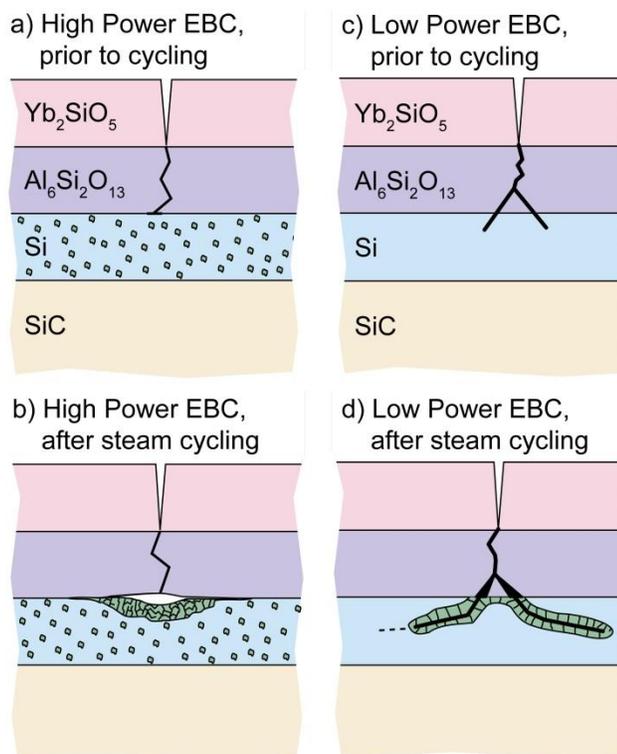
*Figure 6.16: Schematic illustration of the differences in failure mode for (a) high and (c) low power deposited tri-layer EBCs in the annealed condition. The fracture mechanisms that develop during steam-cycling are shown in (b) and (c) for high and low power deposition respectively.*

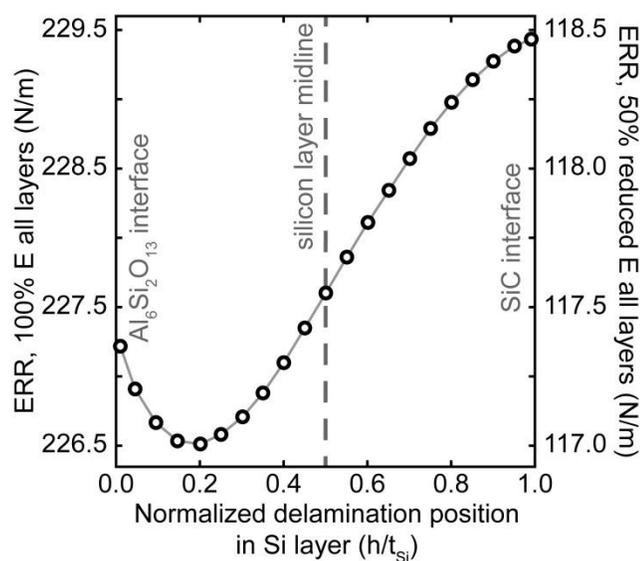
Figure 6.17: The ERR for delamination as a function of normalized penetration depth into the Si layer of the tri-layer EBC.

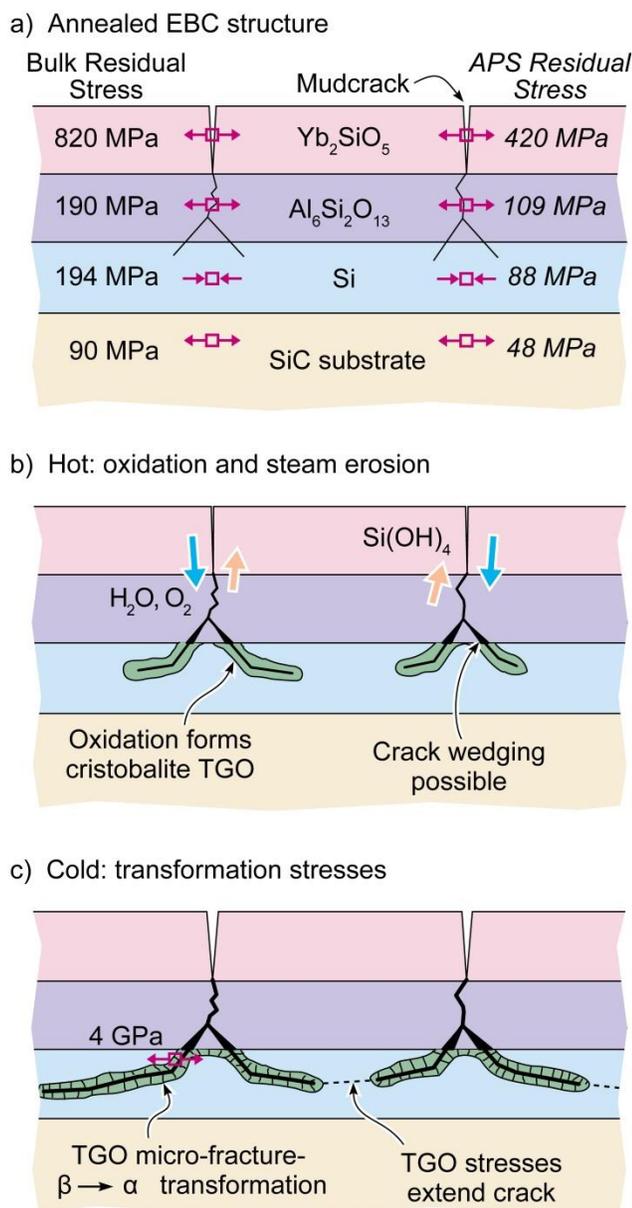
*Figure 6.18: Damage mechanisms contributing to failure of the tri-layer EBC. (a) Shows the stresses in the post annealed coating system. (b) Illustrates the damage mechanisms active during high temperature exposure and (c) shows the mechanical damage that develops during cooling of the sample.*

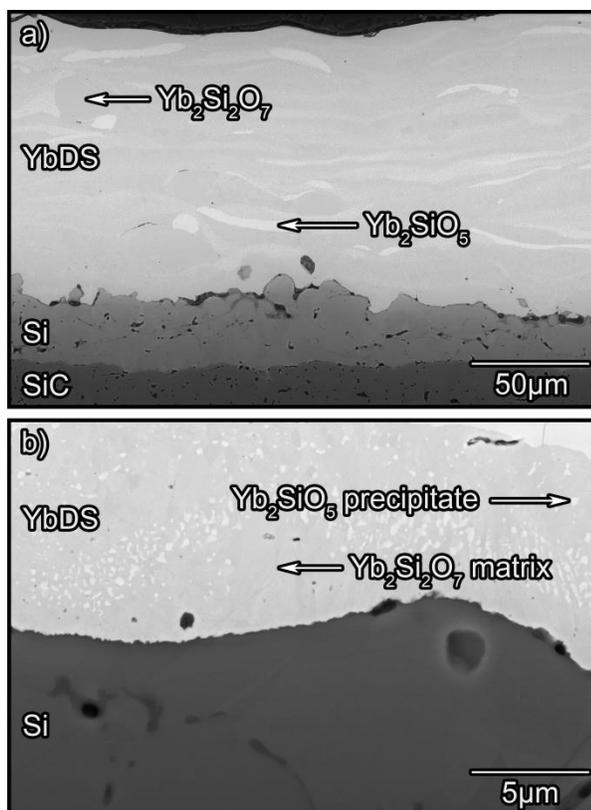
Figure 7.2: BSE images of an annealed YbDS/Si bi-layer coating deposited onto  $\alpha$ -SiC. (a) Low magnification image showing two phases in the YbDS topcoat. (b) High magnification view of the YbDS – Si interface showing interface structure and small  $\text{Yb}_2\text{SiO}_5$  (YbMS) precipitates in the YbDS topcoat.
