Ytterbium Silicate Environmental Barrier Coatings

A Dissertation

Presented to  
the faculty of the School of Engineering and Applied Science  
University of Virginia

Bradley T. Richards

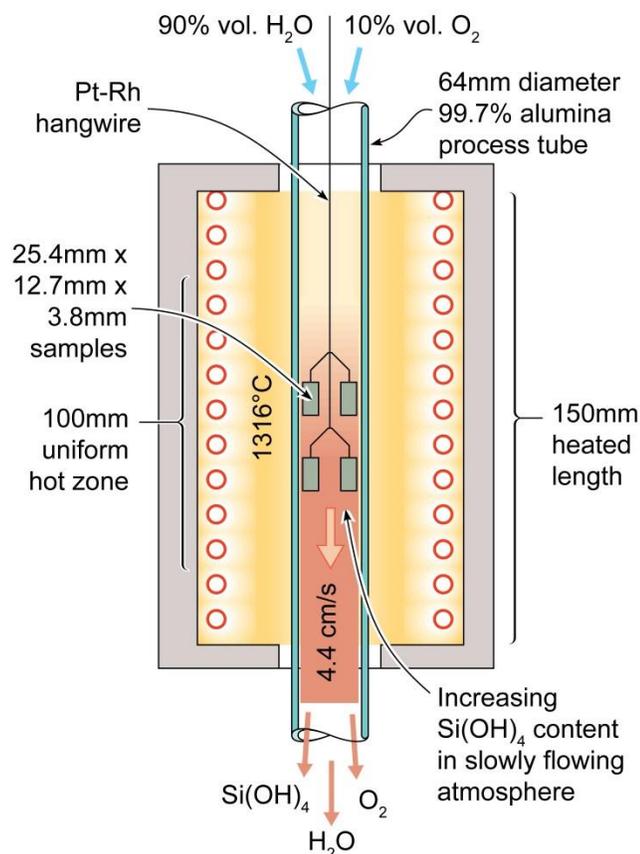
*Figure 7.3: Schematic illustration of the testing configuration and environment local to the samples during the 1316°C hot cycle of steam-cycling.*

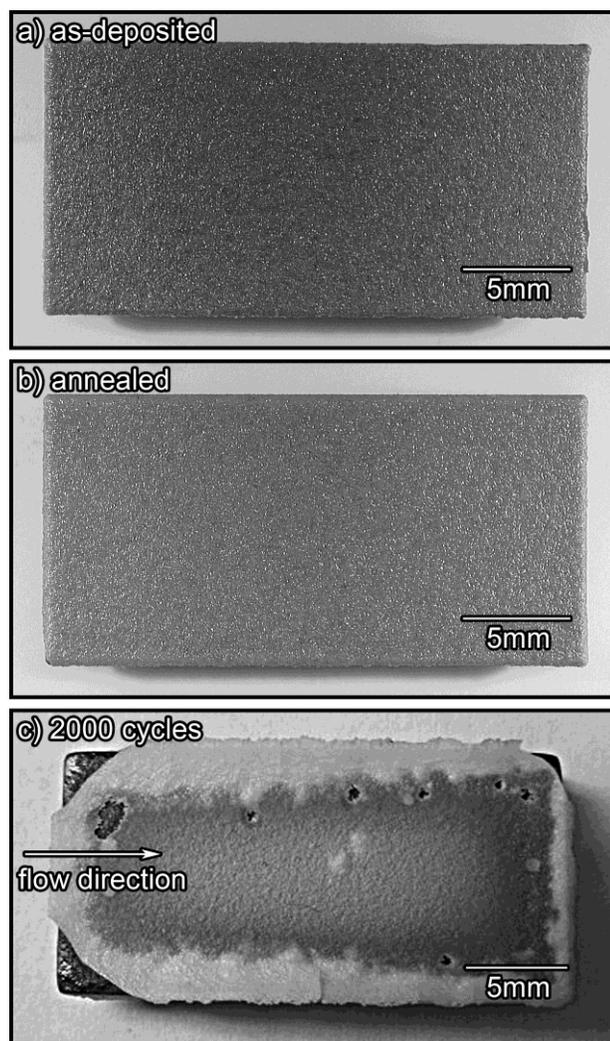
*Figure 7.4: Optical images of YbDS/Si coated SiC substrates. (a) As-deposited, (b) annealed, and (c) after 2,000 steam cycles at 1316°C with the gas flow direction indicated.*

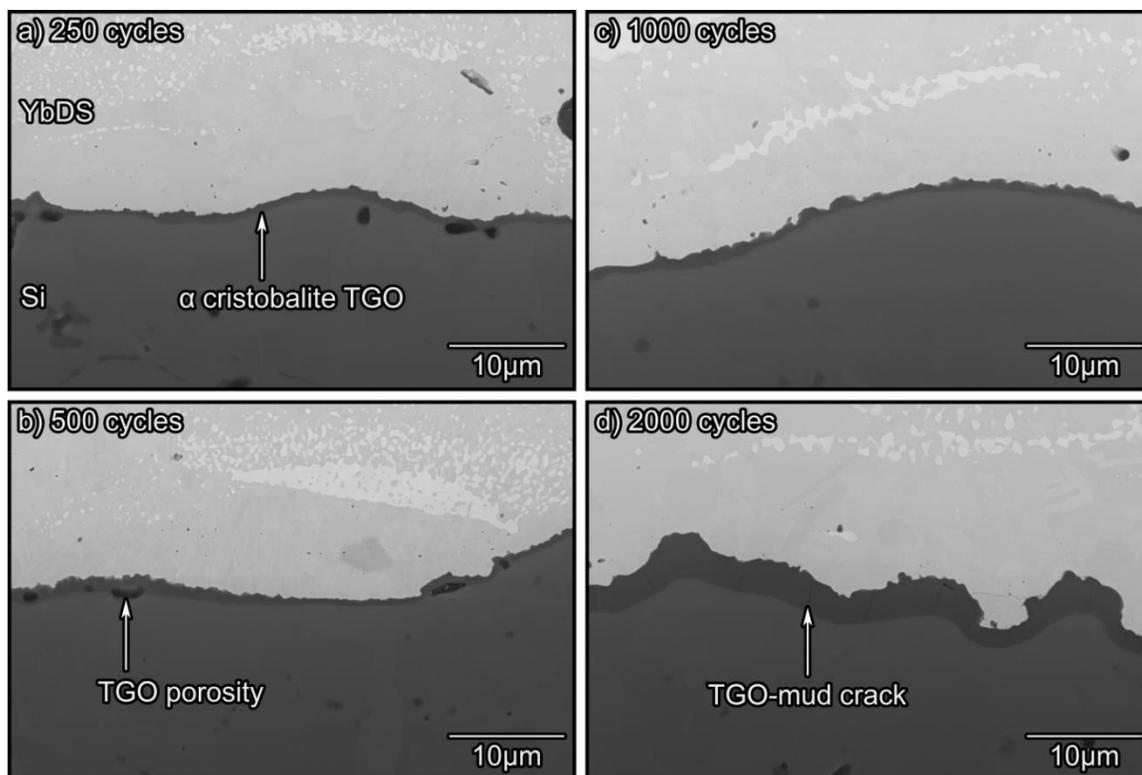
Figure 7.6: BSE micrographs of the YbDS – Si interface after steam-cycling showing the development of a thermally grown oxide (TGO). (a) After 250, (b) 500, (c) 1,000, and (d) 2,000 cycles at 1316°C with 90% $H_2O$ /10% $O_2$  flowing at 44mm/s.

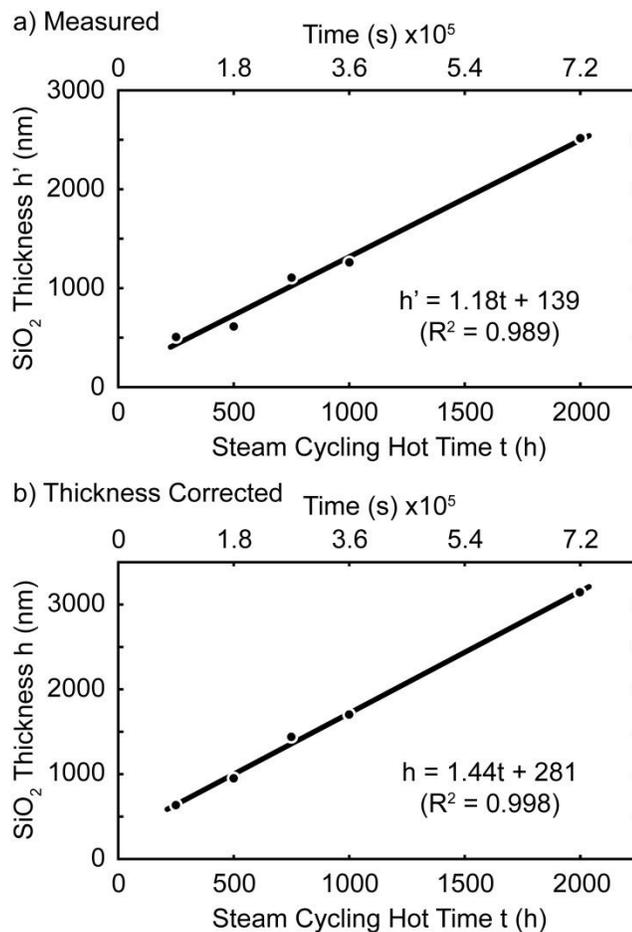
Figure 7.7: Plots of SiO<sub>2</sub> TGO thickness as a function of accumulated exposure time at 1316°C for a bi-layer EBC. (a) Average thicknesses measured from multiple samples with varying YbDS layer thickness. (b) Average thicknesses normalized for thermally grown silica beneath a 100µm thick YbDS layer.

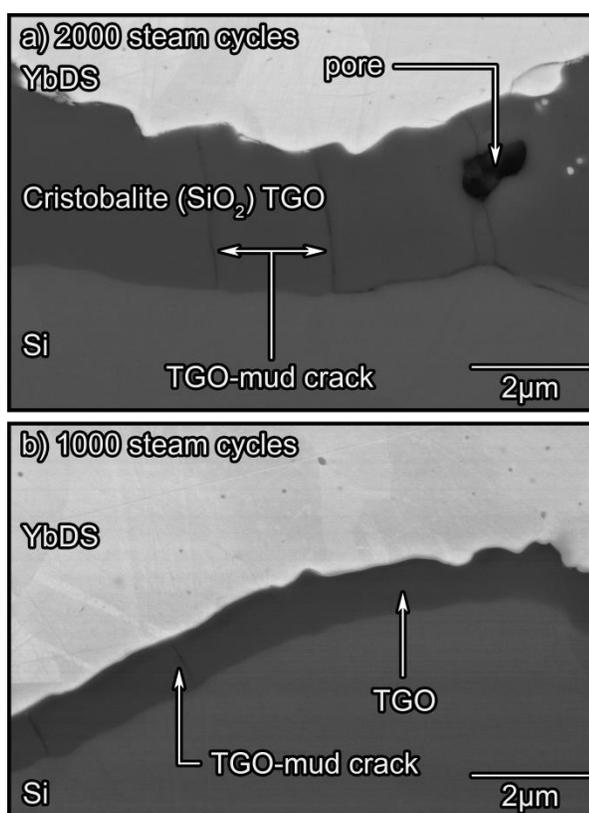
Figure 7.8: BSE micrograph of the thermally grown cristobalite (SiO<sub>2</sub>) oxide at the YbDS – Si interface during steam-cycling. (a) TGO at the YbDS – Si interface after 2,000 steam cycles, (b) after 1,000 steam cycles.

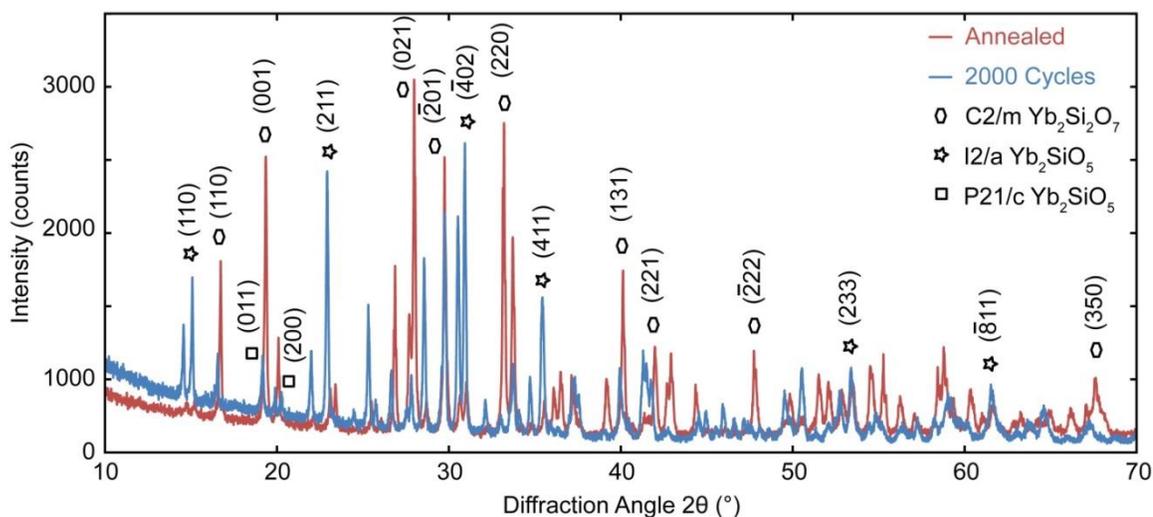
Figure 7.9: X-ray diffraction patterns of the annealed and 2,000 steam-cycle sample surfaces. All peaks of the patterns have been indexed using equilibrium YbDS (C2/m) and equilibrium I2/a and metastable P21/c YbMS peaks. The slightly raised background of the 2,000 cycle pattern results from a very thin layer of epoxy on the surface that was used to prevent spallation during handling.
