**Safe Care and Restoration of Vintage Tools and Equipment**

A Thesis presented to the Graduate Faculty  
of the University of Virginia in Candidacy for the Degree of  
Master of Fine Arts

## Example Tool Restoration

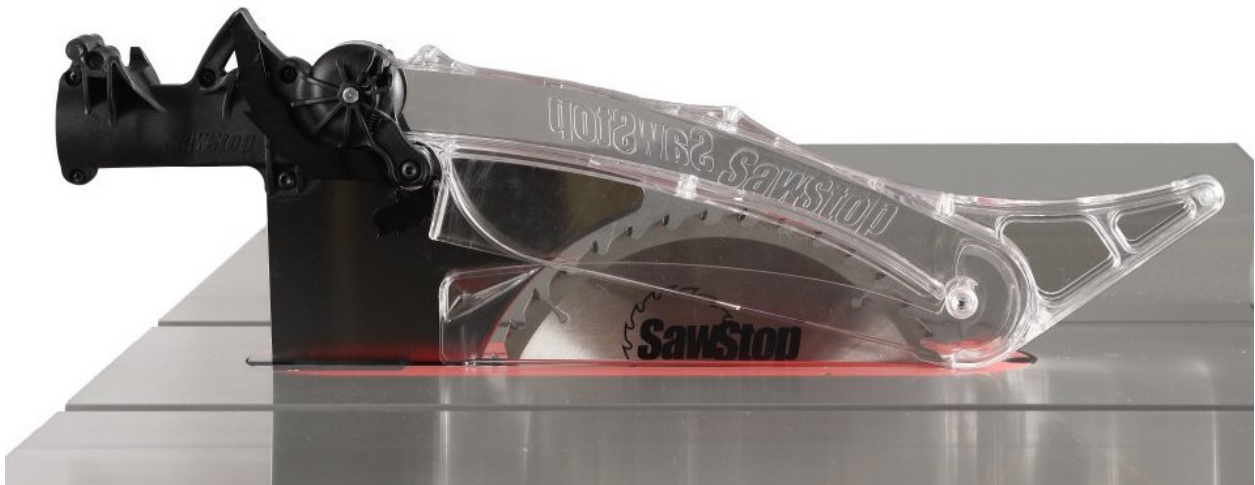
Advertisement from "The Woodworker," Feb. 1898.

The following figures show an illustration of the National Saw Guard Company's table saw guard, along with a modern guard.

The materials are different, and the modern SawStop guard has added side shielding, but the form factor of the two guards is surprisingly similar. During the early years of blade guarding for worker safety, these shields were not required. This means that finding a vintage

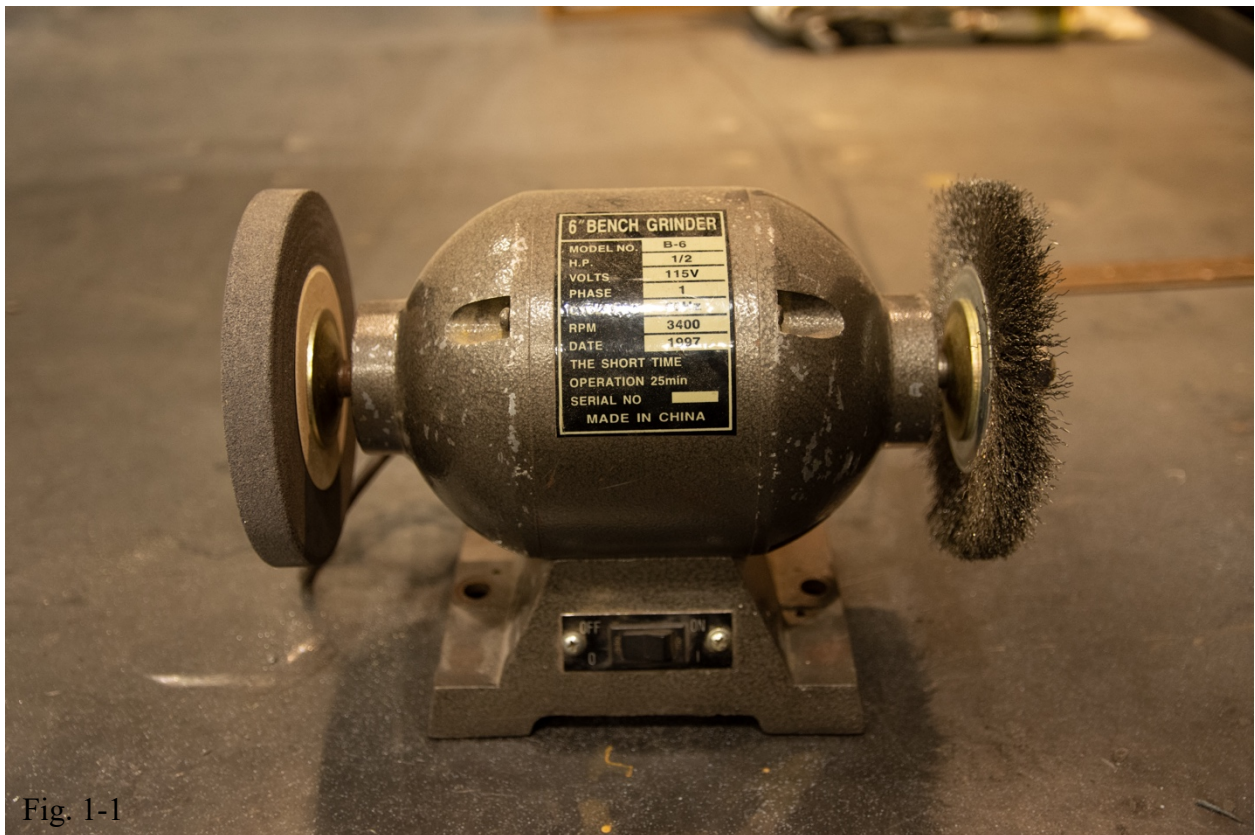
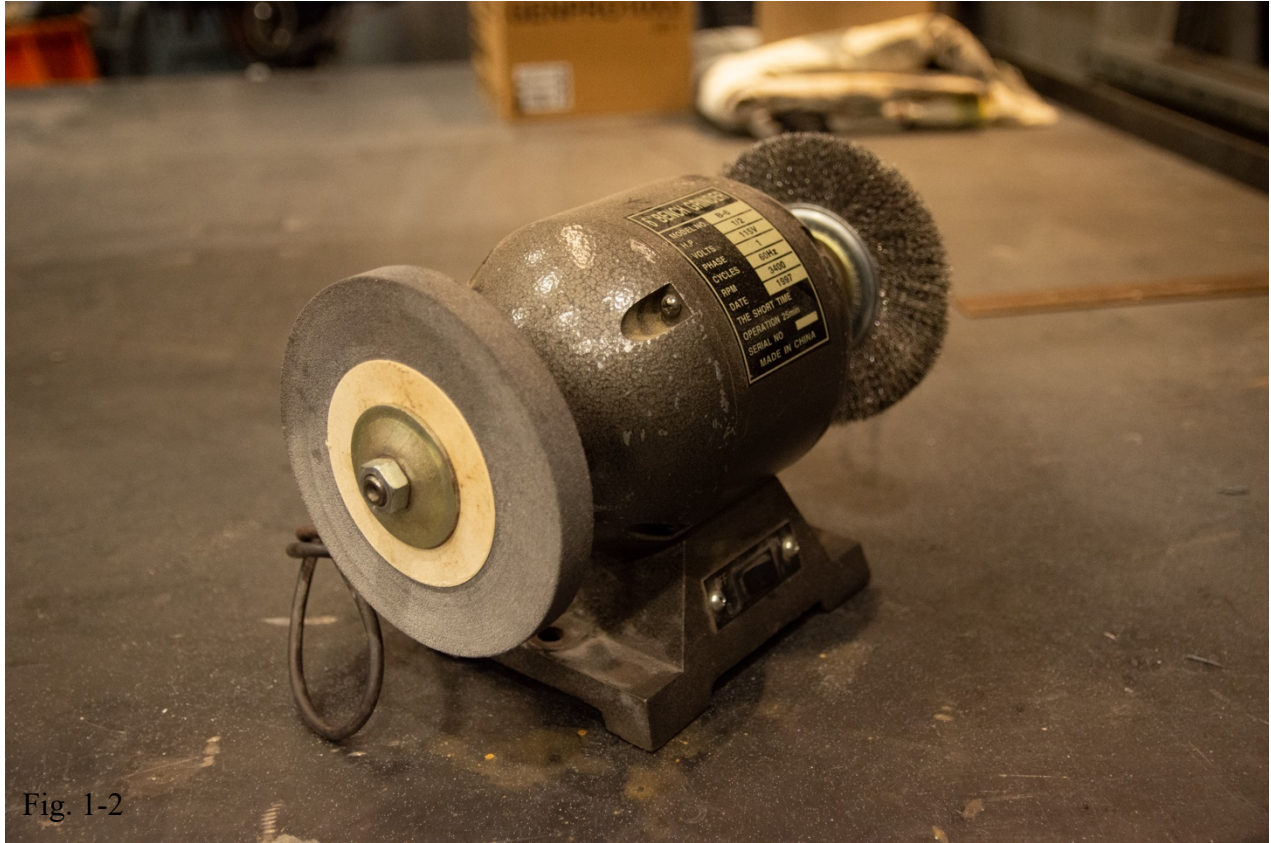
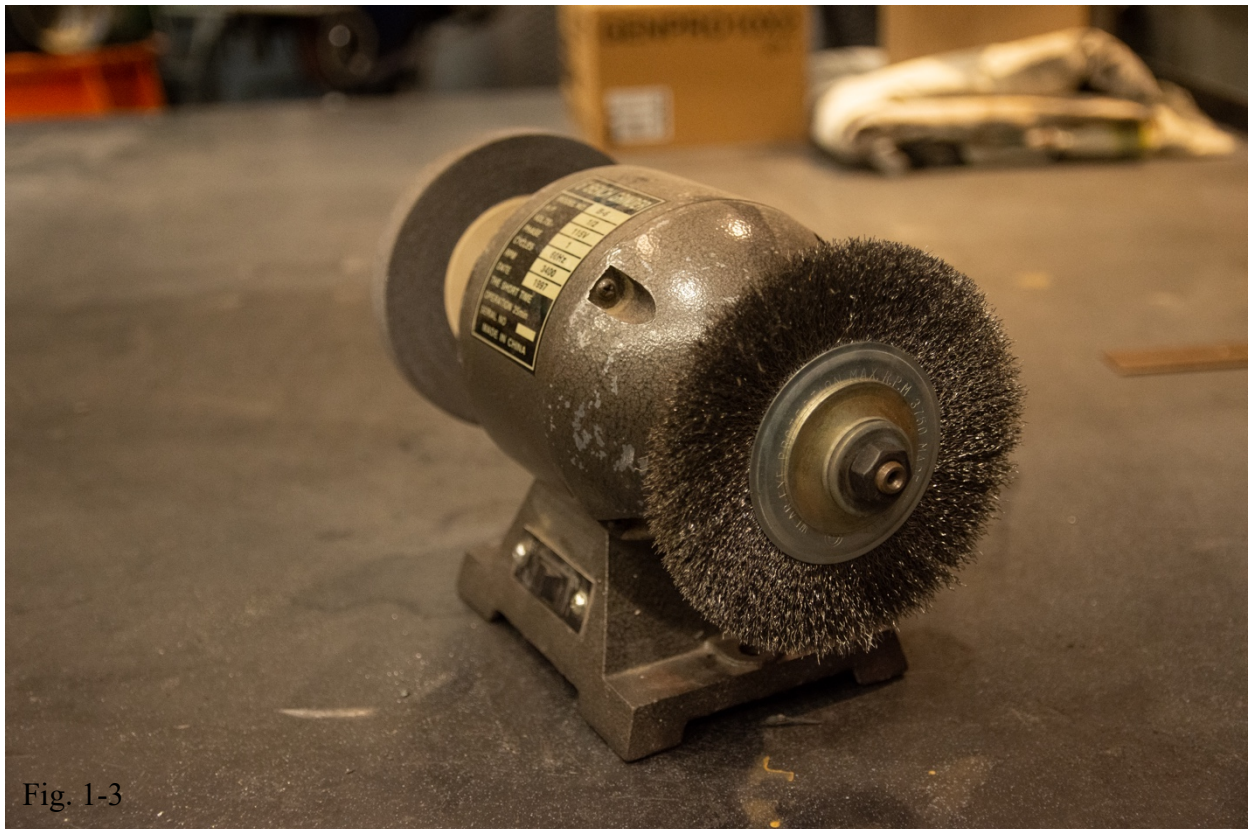
Fig. 1-1

To explore the potential difficulties of tool restoration, the best way to begin is to restore a tool in need of care. We started with a bench grinder; This tool is from 1997 and is not as old as some of the examples explored in earlier sections of this document. Despite its relatively new age, it is more than old enough for the tool to have received abuse. The tool is shown in Fig. 1-1, 1-2, 1-3, and 1-4.

This particular bench grinder has no protective hoods and work rest. It was likely used in someone's home, where the rules and regulations of OSHA do not apply. Once we bring the tool into the shop, we must correct these failings for reasons of both safety and legality.

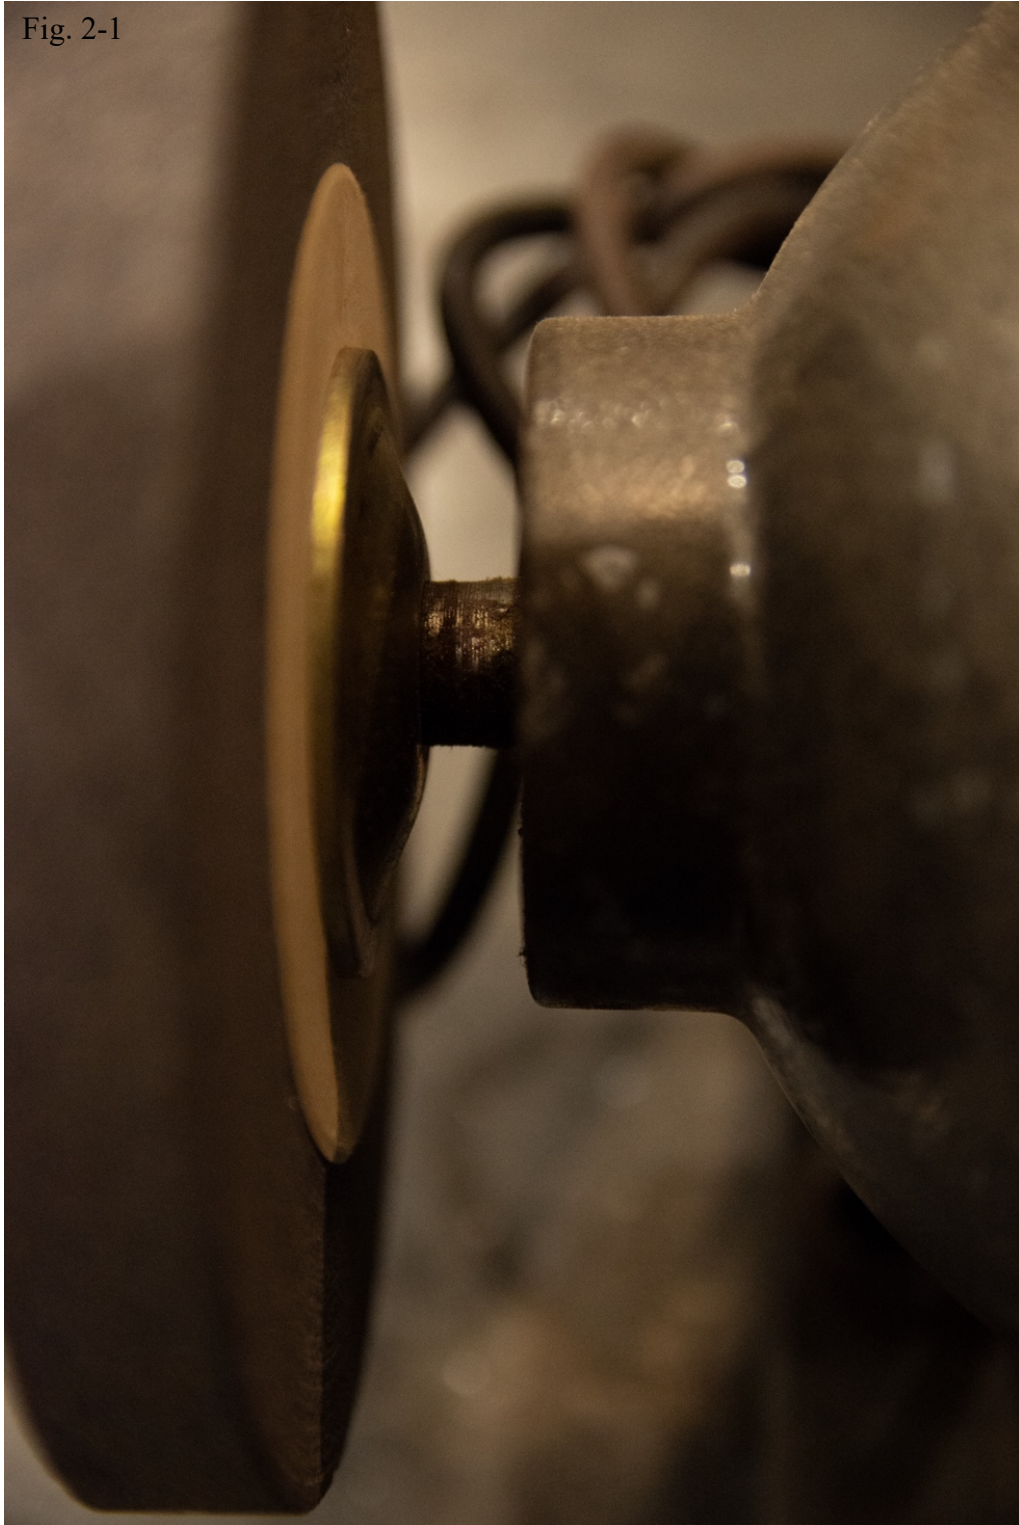
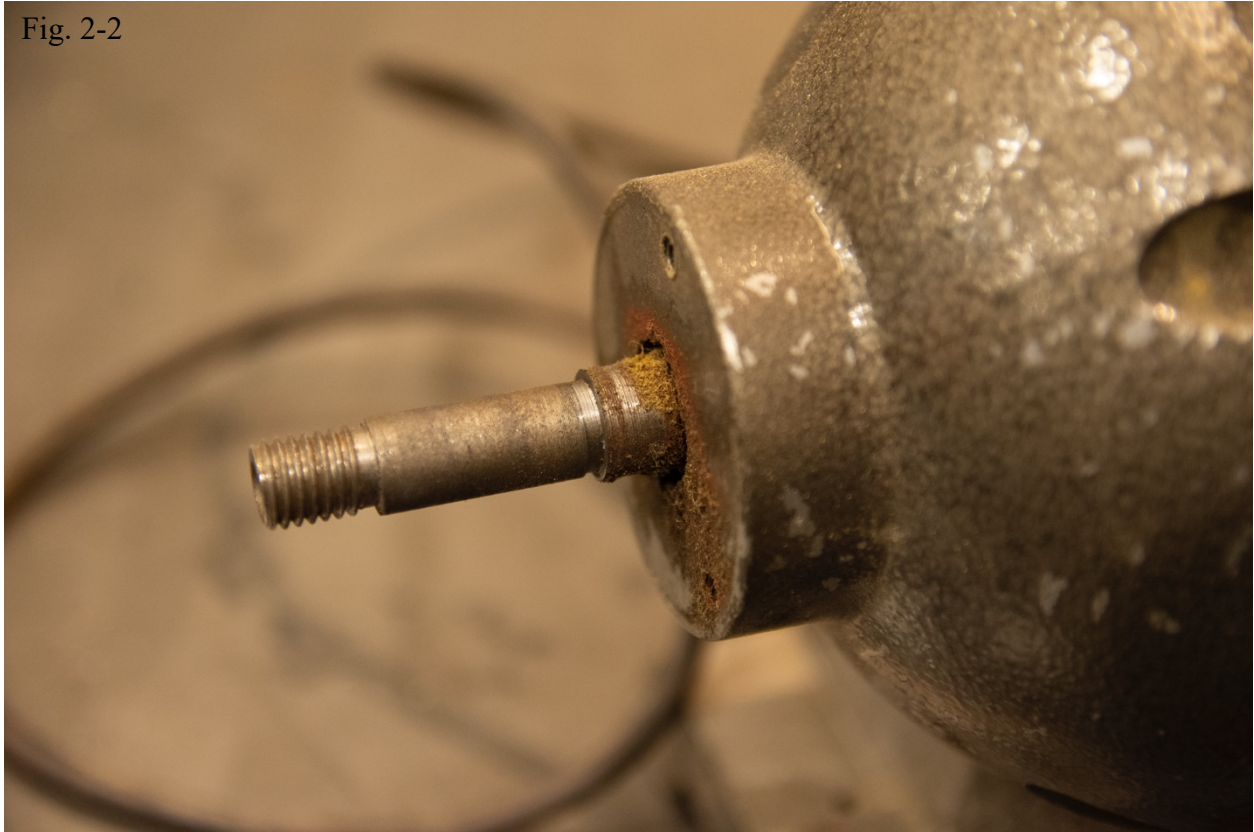
Fig. 2-1

Furthermore, the shaft of the tool had quite a bit of grime and rust built up. While unlikely to become a hazard, this buildup could compromise the operation of the tool if it was allowed to go unchecked (see Fig. 2-1, 2-2).

After the vibration was corrected it was time to clean the grime off of the tool's shaft. I did this with a steel brush. (Fig. 4-1). I then gave the tool a general cleaning with an abrasive pad and degreaser. I was also able to clean out the tool's casing thoroughly with a pneumatic nozzle.

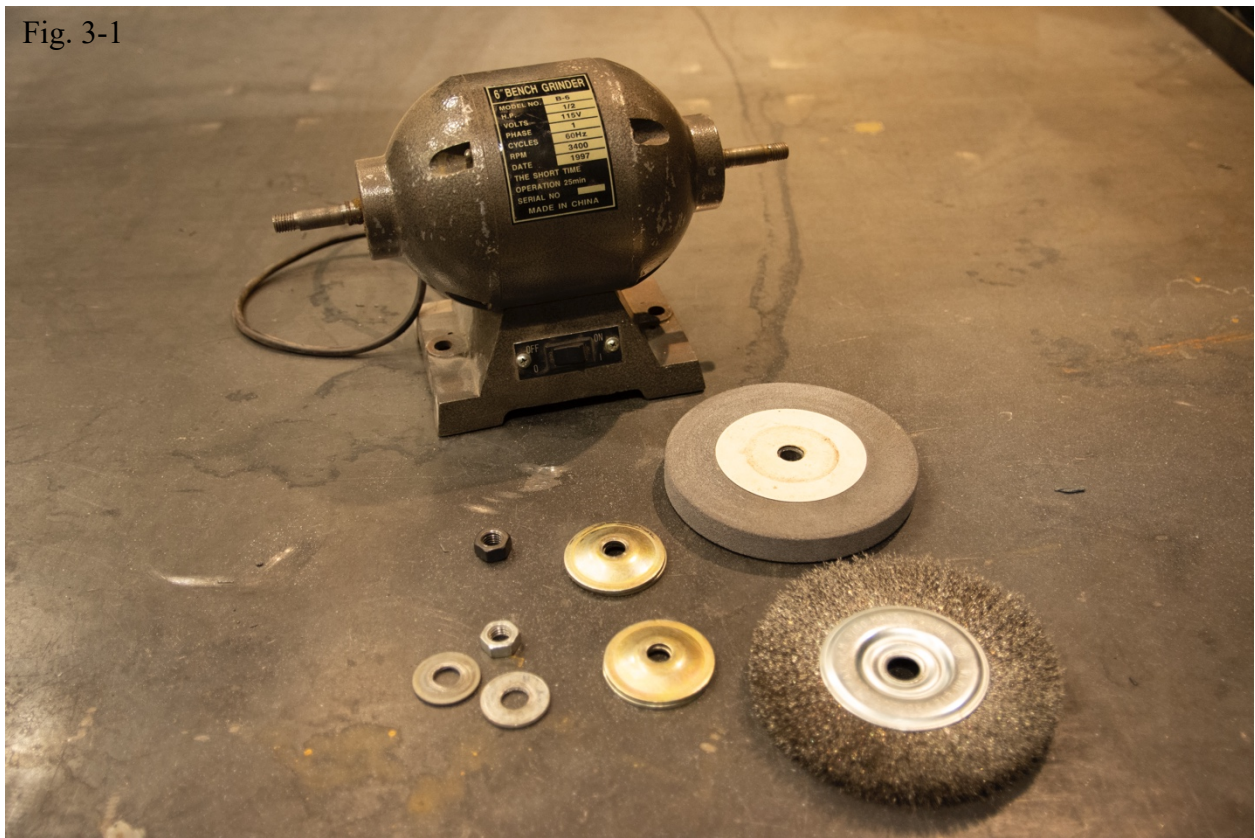
Fig. 3-1

The first step was testing to see that the motor itself was functional and it was not seized or damaged. After testing the tool, it became apparent that it had some major issues with its balance which resulted in extreme vibration while in operation. This needed to be fixed because it could result in damage to the tool or unsafe operation.

I began by trying to level the wheel using a diamond grinder wheel dresser. The wheel was shaped and flattened, but this yielded no result in correcting the vibration issue. I then stripped the tool down to its bare shafts (Fig 3-1) and discovered the likely cause: the tool's previous owner had outfitted is grinder with a wire wheel intended for a different size shaft. This overly-large arbor hole had allowed the wire wheel to slip out of concentricity with the

tool's shaft resulting in oscillation of  $\pm 3/16"$  (4.76mm). Though this may not sound like much, it could be the cause of the huge vibrations in the tool.

With the wire wheel removed from the tool, I turned it on again to find that the vibration was gone.

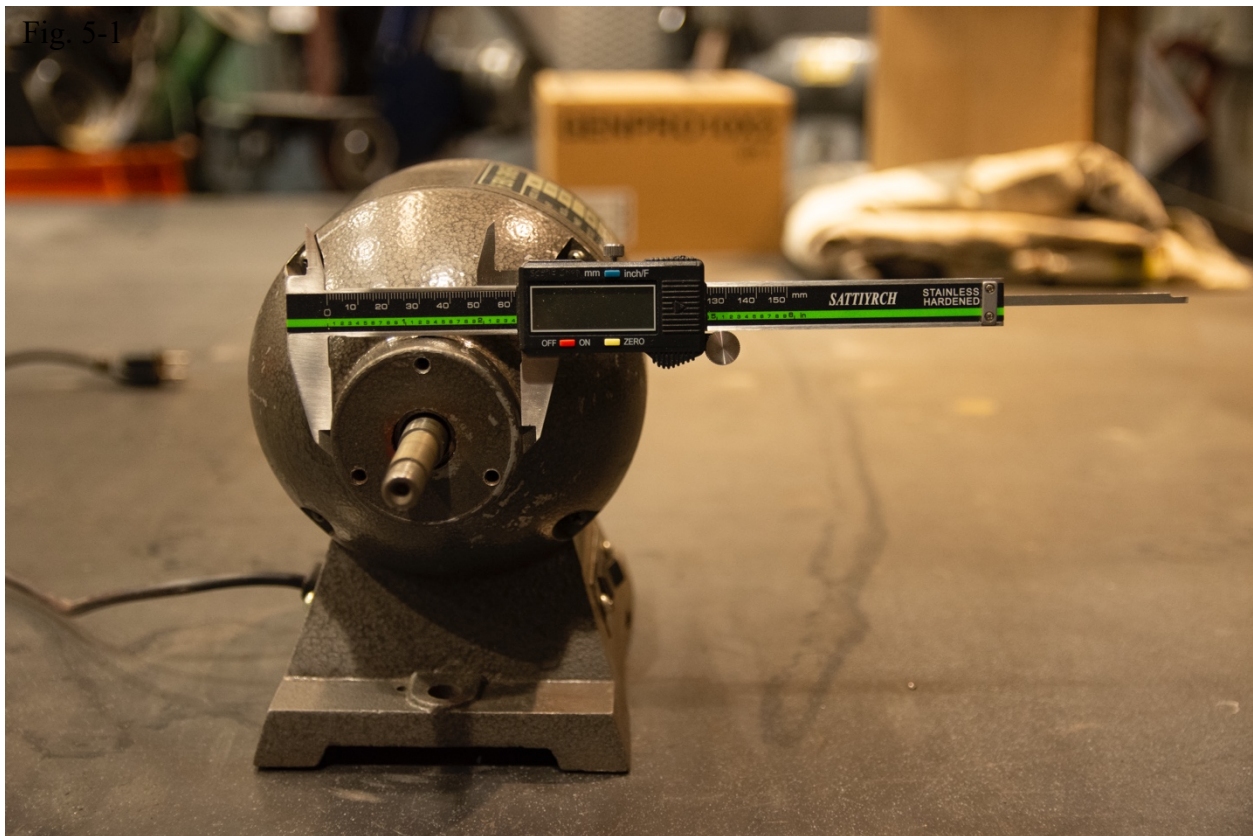
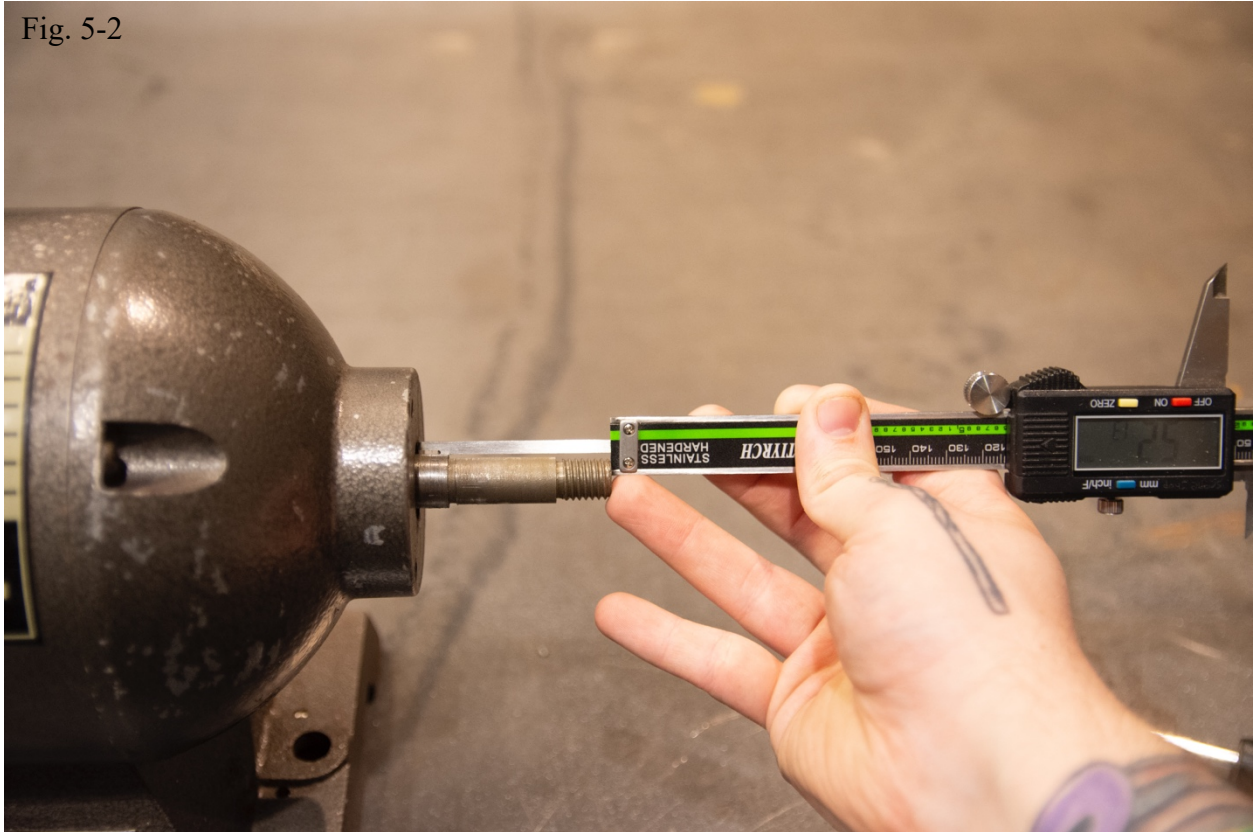
Fig. 5-2

My next step was to get a few key measurements of the tool to source or build the necessary guards. I already knew that the wheel diameter the tool accepts is 6 inches (also sold as 152mm wheels). Next, I needed to measure the diameter of the casing's side faces and the length of the exposed shaft (Figs. 5-1, 5-2).

These measurements came out to 62mm and 52mm, respectively. In addition to the guarding and work rest issues, the grinder's power cable had at some point been purposefully un-grounded by means of physical removal of its ground pin (Fig 6-1). The purpose for doing this would be to make a grounded cable (3-prong) fit into an ungrounded (2-prong) outlet or extension cord. This is very dangerous. It also goes against the standards and regulations set forth for shop equipment.

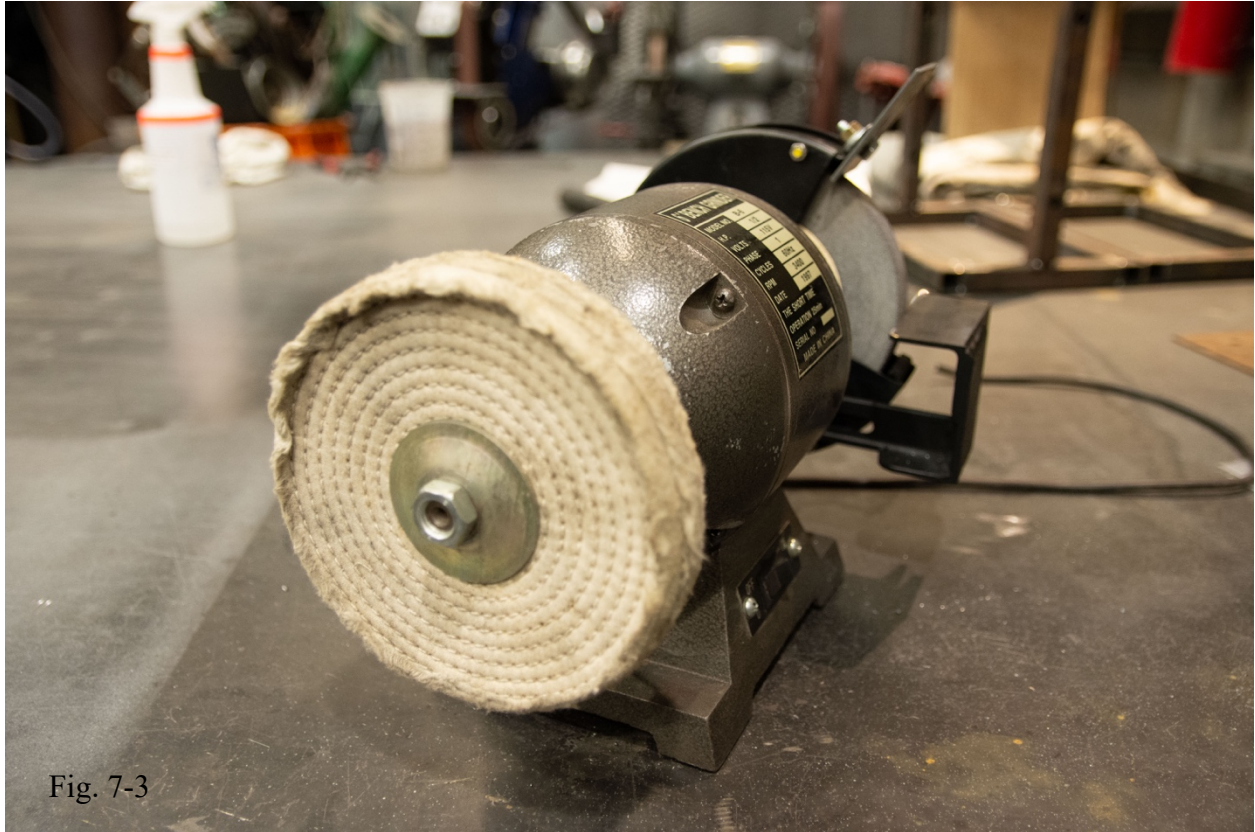
Fig. 7-2

With all the proper guards in place, I replaced the tool's power cable with a new one that was both grounded and properly shielded. My results yielded a 2022 ANSI and OSHA compliant working bench grinder seen in figs. 7-1 through 7-4.

Once the guard for the right side of the tool was installed, I fabricated a work rest for that side from angle iron and plate steel. I also fabricated the upper guard,

commonly known as a “spark arrest.” I fabricated these parts making sure to add necessary slots allowing for the required adjustability. OSHA requires that the work rest and spark arrest be able to adjust to remain no further than 1/8 inch from the grinding wheel as the wheel wears down.
