# **Locating Inca Terraces at Saqsaywaman to Restore the Original Drainage System and Protect the Great Walls**

**A Thesis**

**Presented to  
the faculty of the School of Engineering and Applied Science  
University of Virginia**

**Gina Lisette O'Neil**

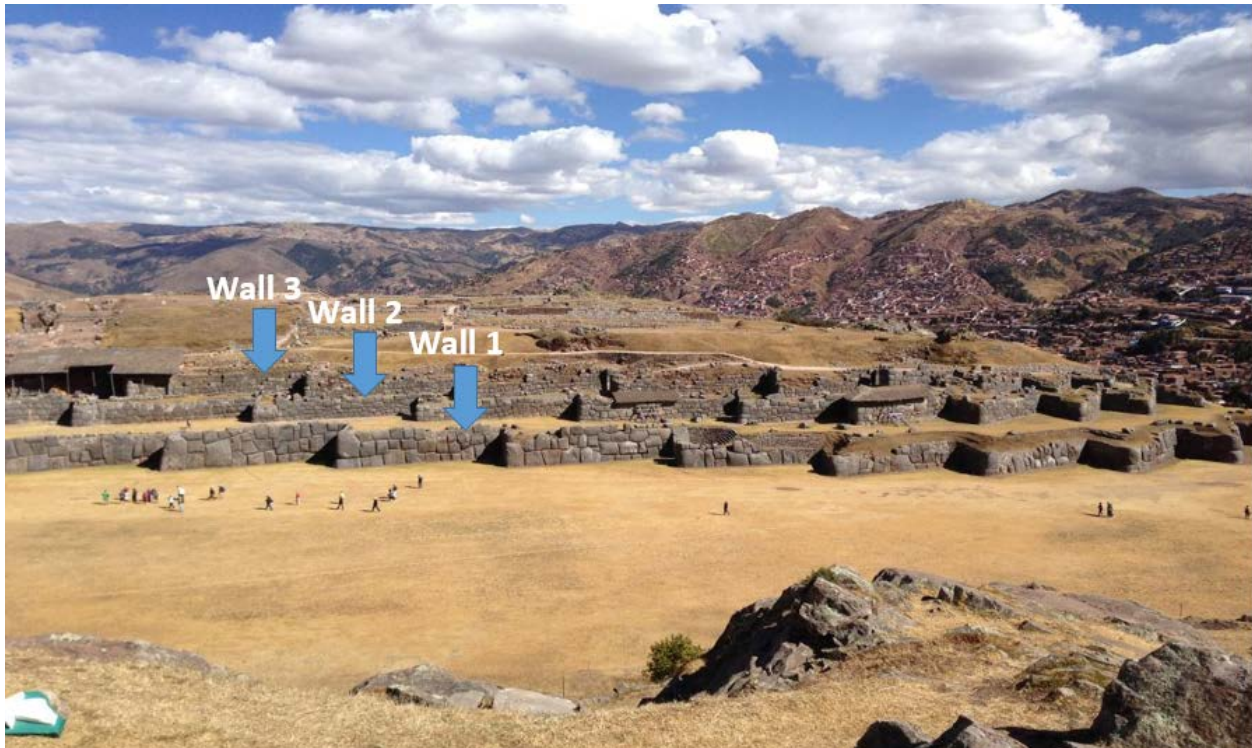
*Figure 2: The Great Walls of Saqsaywaman with labels for reference [12]*

Overlooking Cusco, Peru sits perhaps the most remarkable Inca engineering feat, Saqsaywaman (Figure 1). The most striking and impressive part of the complex are the three monolithic walls that delineate the north side of the site. Pictured in Figure 2, each of the three main walls is separated by approximately fifteen feet wide terraces running the full length of each wall. These walls are constructed of stones measuring over fifteen feet in height and weighing over 200 tons [5]. The precision and manpower necessary to construct the walls are testaments to the extent of power once held by the Inca Empire.

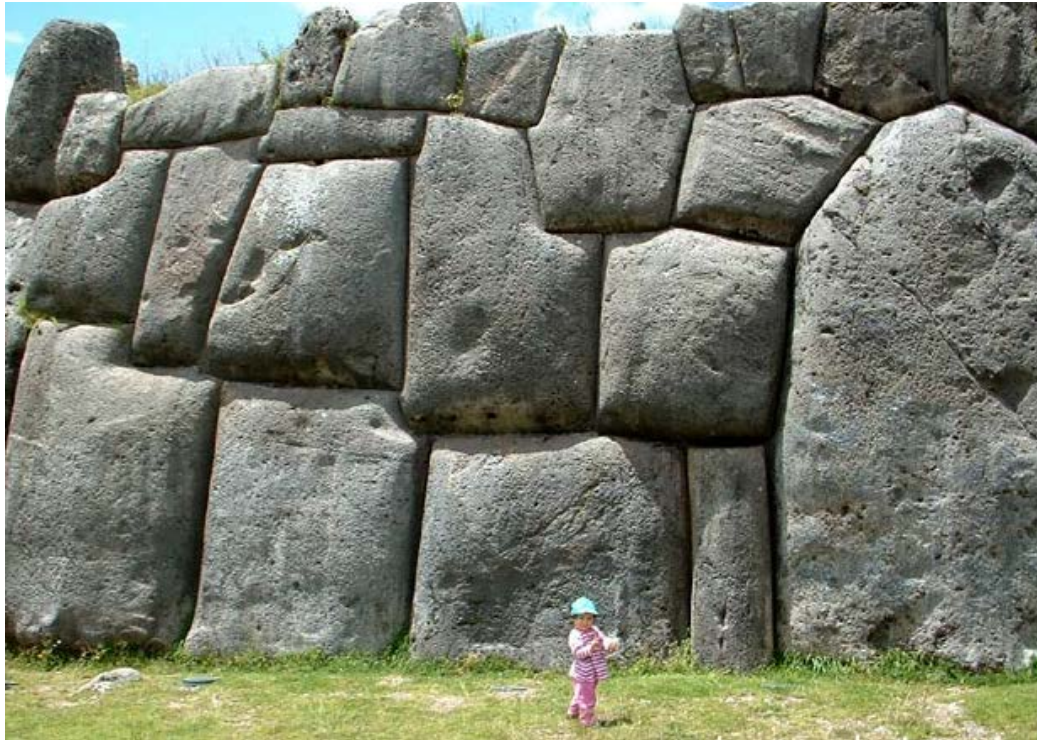
hand carved and fit each stone together without the use of mortar. Figure 3 illustrates the extraordinary size and fit of these stones.

*Figure 3: Stones of the Great Walls of Saqsaywaman [1]*

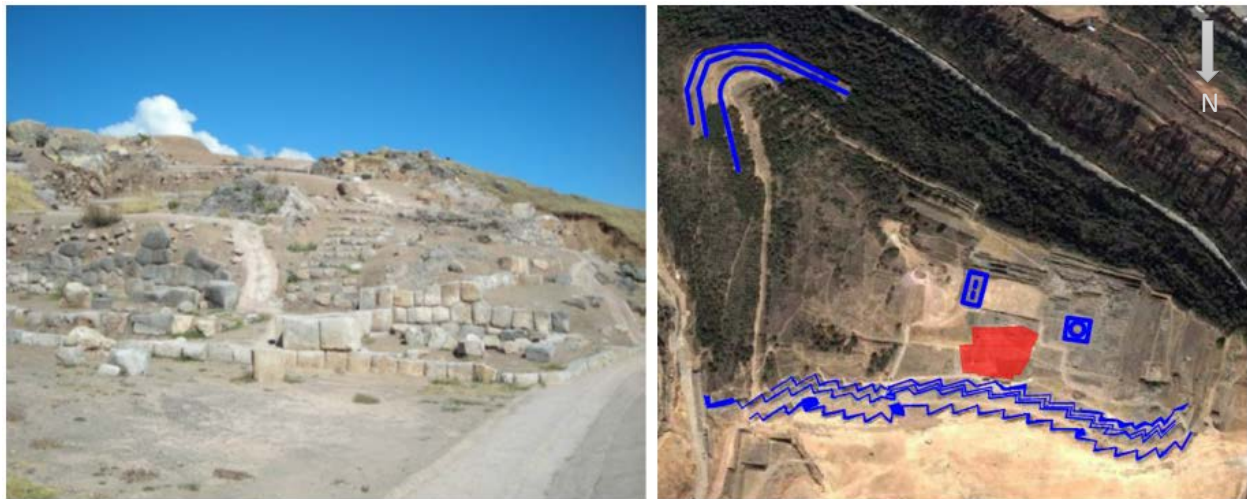
Previous studies have concluded that the years of maltreatment at the site have resulted in the destruction of utilitarian Inca structures. The effect of these losses is best summarized as the disruption of the original Inca drainage system. Without an effective method of diverting storm water away from remaining structures, they face an imminent threat of failure. The first realization of this threat came in 2009, after the addition of an impervious clay ground cover meant to preserve excavated ruins above the third wall (Figure 4).

*Figure 4: Cementitious clay ground cover (left) and location relative to rest of site (right) [11]*

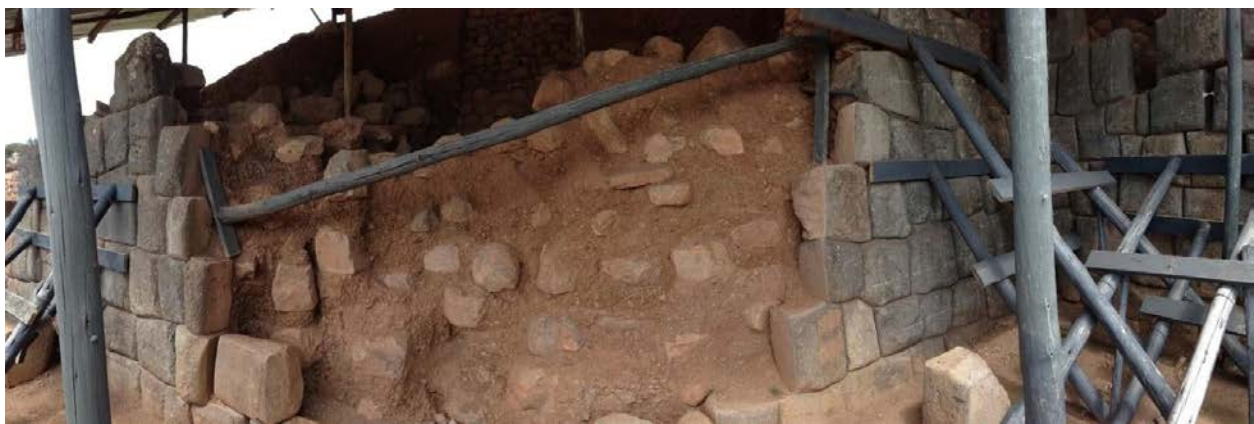
The addition of impervious ground cover increased runoff towards the third wall, leading to a major collapse along the wall (Figure 5). A hydrologic analysis of the site performed by Wildfire *et al.* determined the cause of the collapse to be a large buildup of hydrostatic pressure behind the stones of the walls, pushing them outward. It was concluded that the hydrostatic pressure buildup

was caused by a 70% increase in runoff resulting from the addition of the cementitious clay [17]. The INC has attempted to abate excess runoff in this section, and additional locations around the site, with the implementation of ad hoc drainage channels. However, these unsophisticated hydrologic systems were unable to properly control runoff [11]. The realization that uncontrolled runoff continued to pose a threat to the site motivated a complete evaluation of the runoff at Saqsaywaman.

*Figure 5: Collapsed section of 3<sup>rd</sup> Wall due to increased runoff [12]*

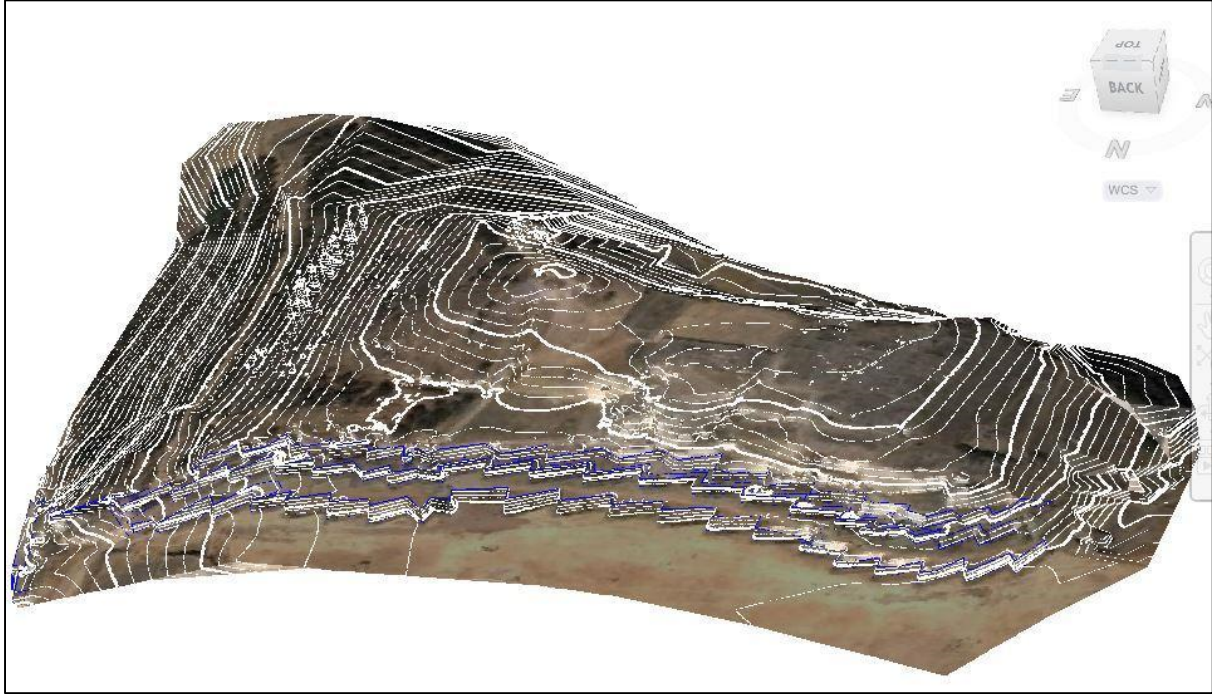
*Figure 6: Screenshot of completed AutoCAD Topographic Model*

The three dimensional model of Saqsaywaman was used to generate flow patterns due to topography at the site. Figure 7 shows present-day runoff patterns with arrows that indicate both direction and quantity of runoff. The patterns show that most of the water beginning at the northern portion of the site is channeled directly towards the walls. Having no method to divert runoff along any of the terraces, water can continue to flow over the Great Walls to lower terraces. It is not consistent with Inca design to allow water to cross terraces freely, as is shown in this simulation. Instead, it would be expected that Inca engineers would have implemented a hydrologically

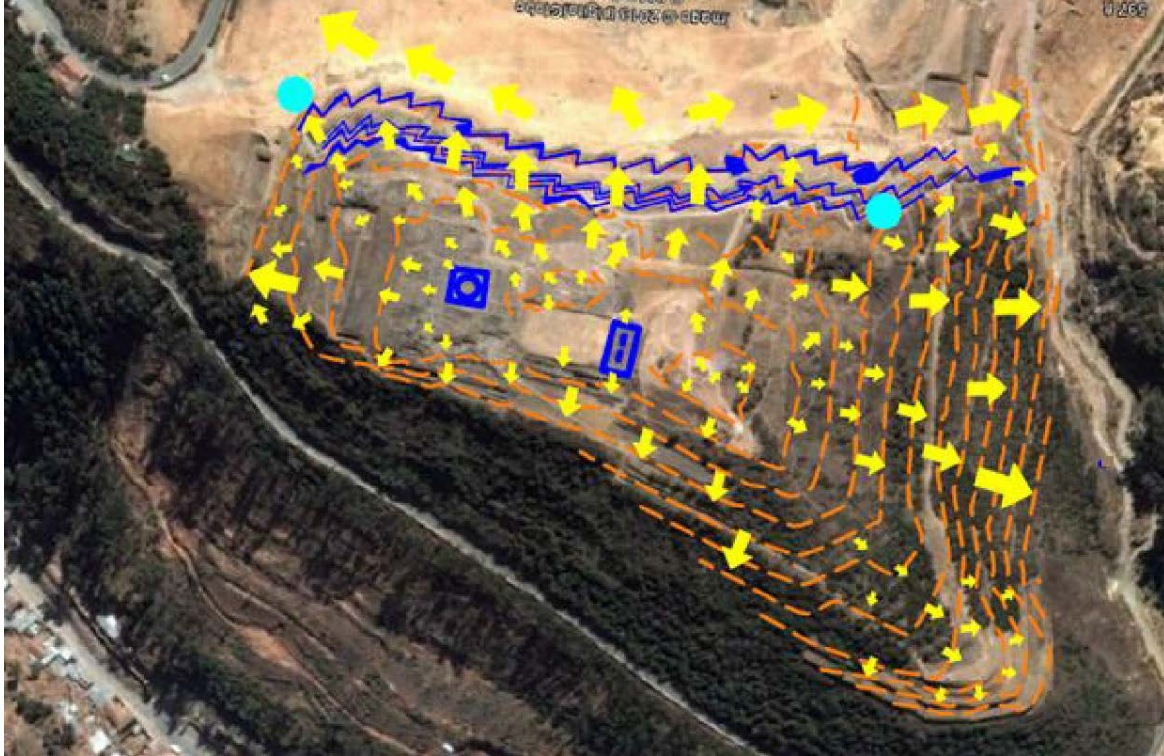
*Figure 7: Current Runoff Patterns at Saqsaywaman [11]*

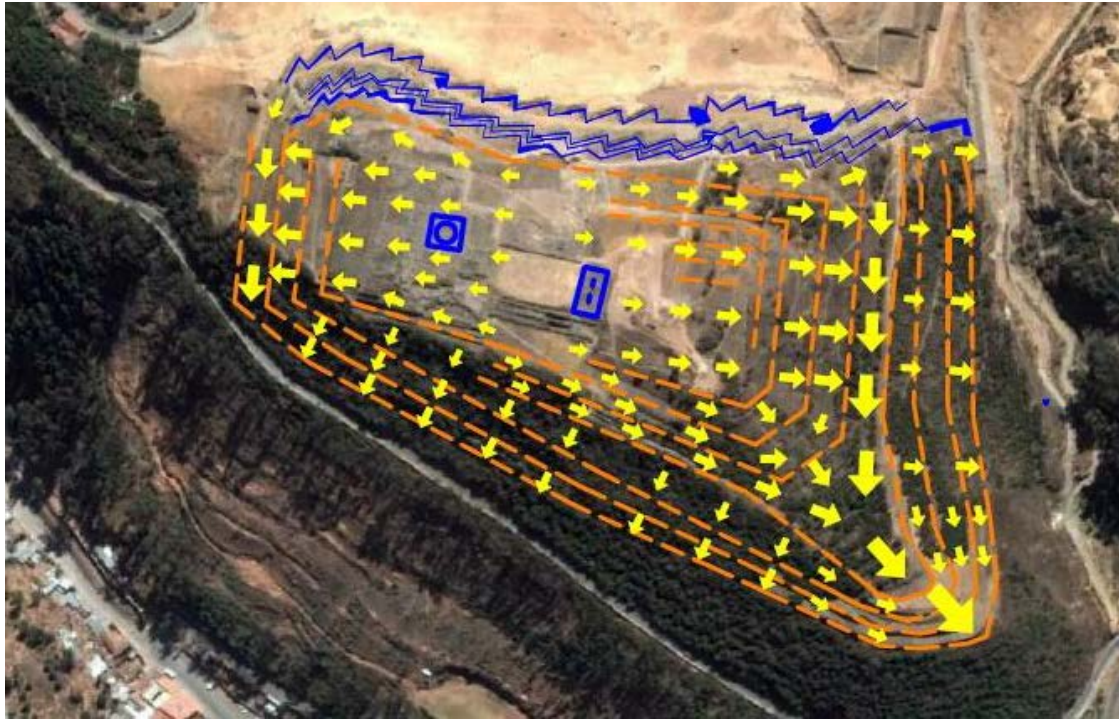
Figure 9: Runoff patterns at Saqsaywaman with terracing as proposed by Gasparini and Margolies [11]

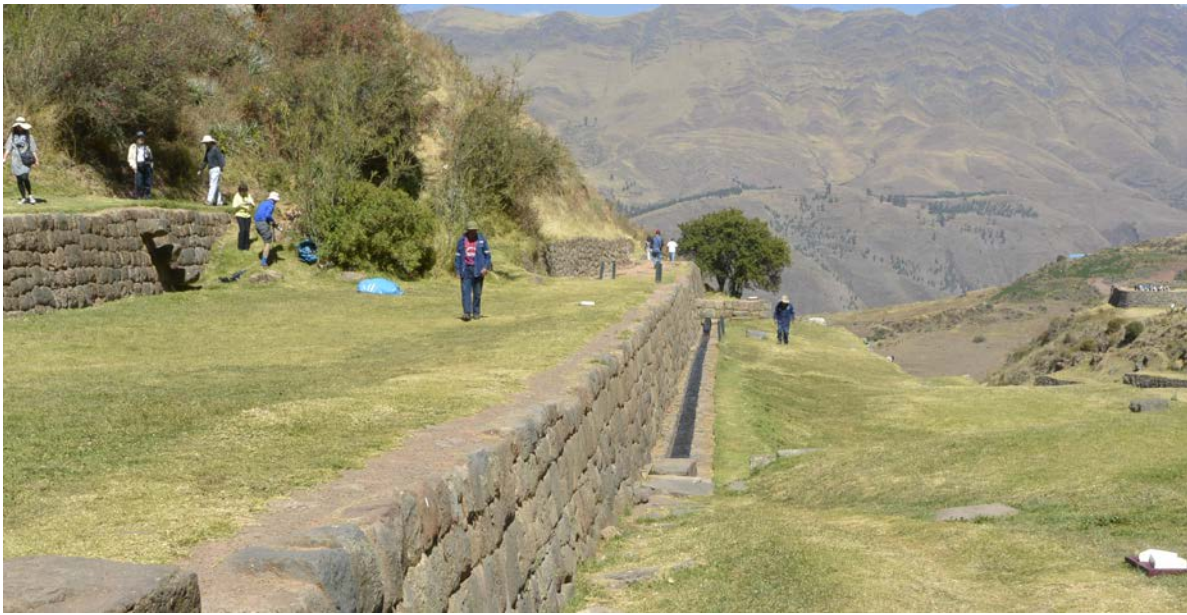
Assuming consistency among Inca architectural techniques, two additional conditions would be met by an Inca terracing system: (ii) runoff would be transported via base channels along terraces and (iii) runoff would only move from terrace to terrace through controlled drops. Tipon is an Inca site where there still exists a well-defined and functioning runoff management system that meets these conditions. This system consists of terraces with base channels, which serve the purpose of directing storm runoff (Figure 10).

*Figure 10: Base channels used to direct runoff at Tipon [12]*

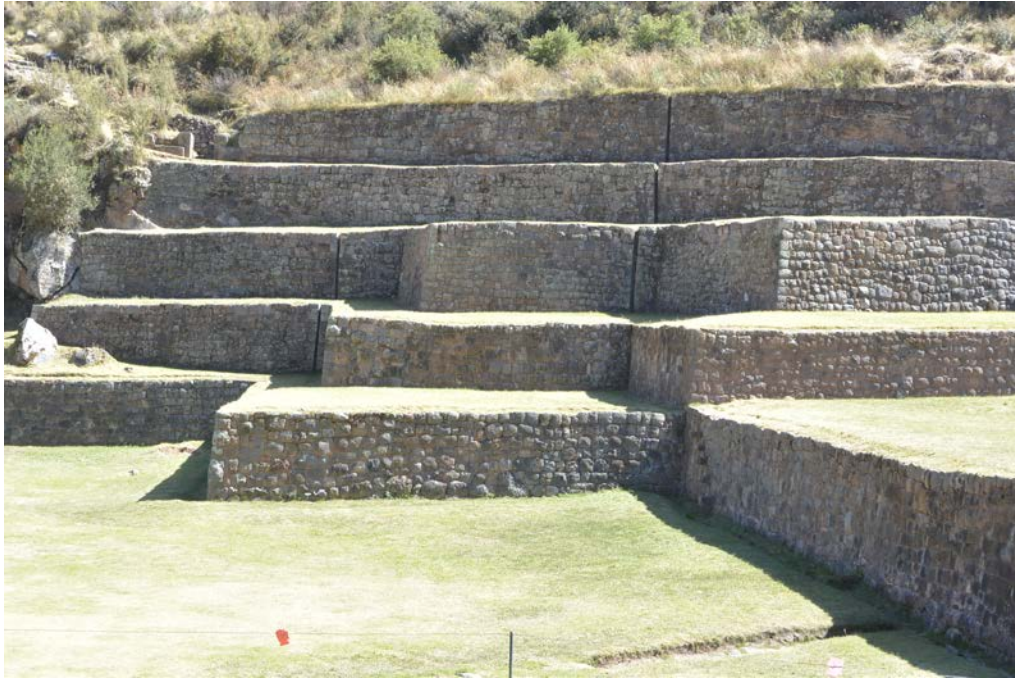
As seen in Figure 11, Tipon terraces also feature controlled drops along which runoff is transferred from higher terraces to lower ones.

*Figure 11: Controlled drops built into terraces at Tipon [12]*

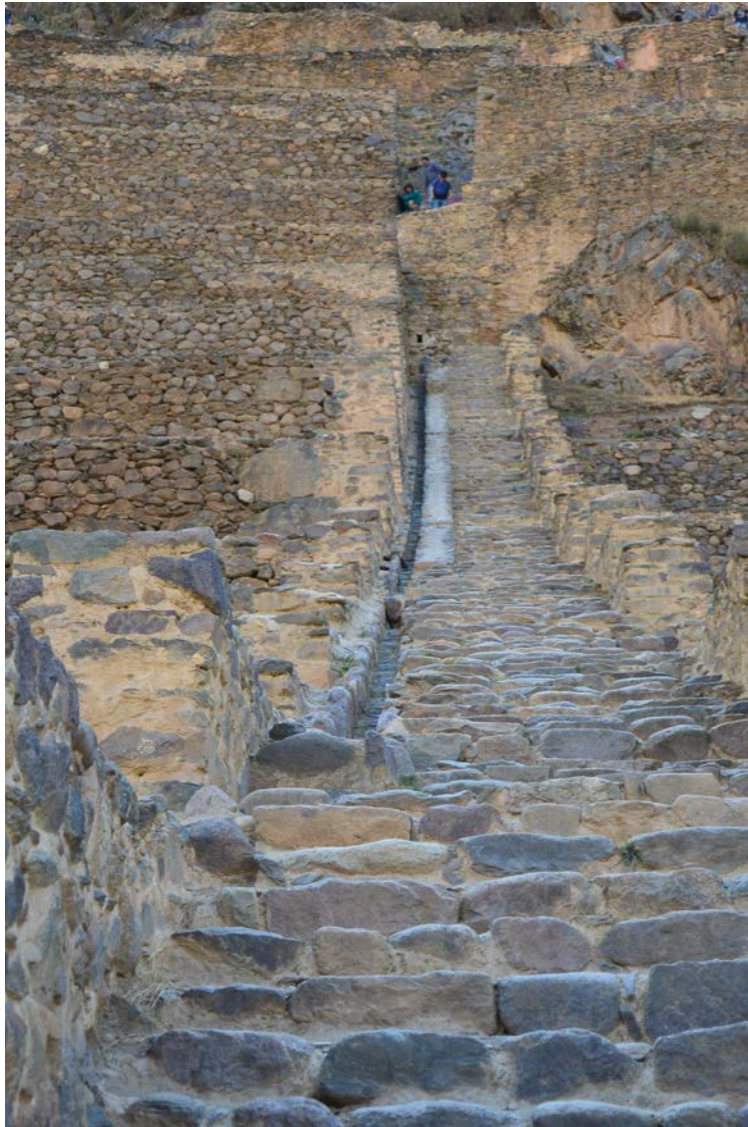
Ollantaytambo, a Sun Temple built by the Incas, has a different method of transporting water from terrace to terrace. At this site, stairways are constructed with base channels and act as the

mechanism to transport water to lower elevations (Figure 12). This alternate hydraulic drop is also seen at Suchana, a small Inca structure located directly across from Saqsaywaman (Figure 13).

*Figure 12: Hydraulic drop along stairs at Ollantaytambo [12]*

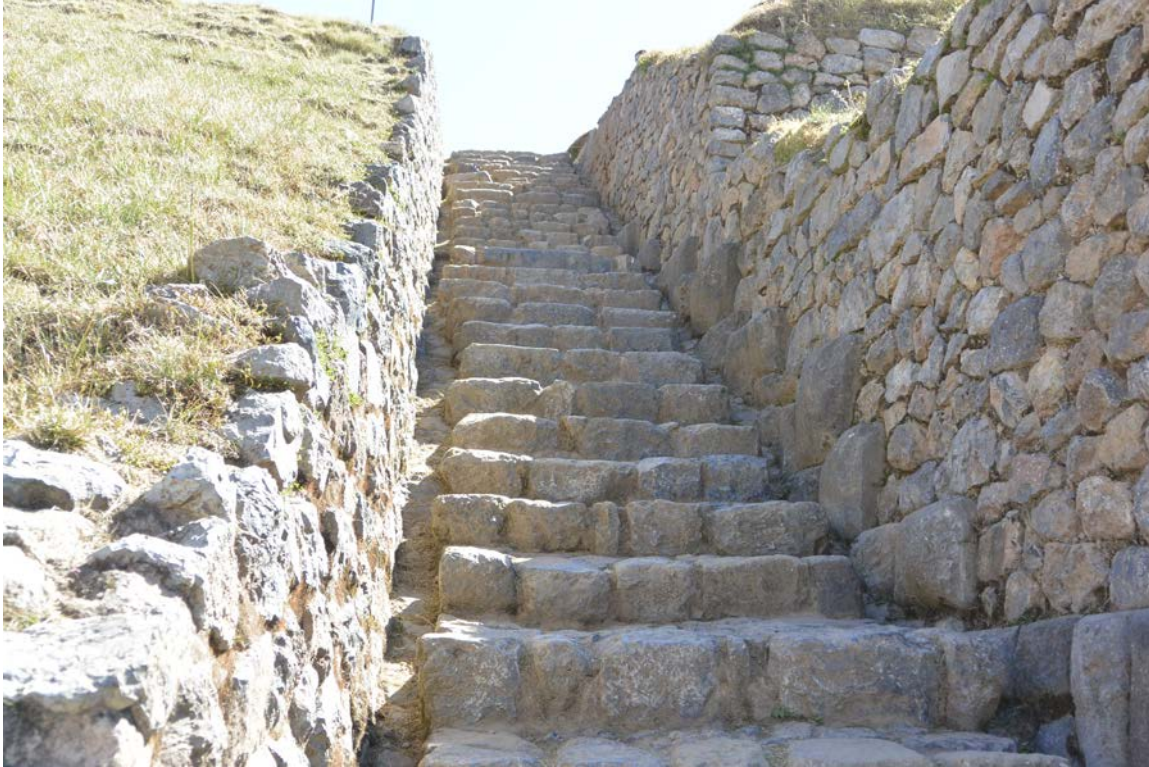
*Figure 13: Hydraulic drop along stairs at Suchana*

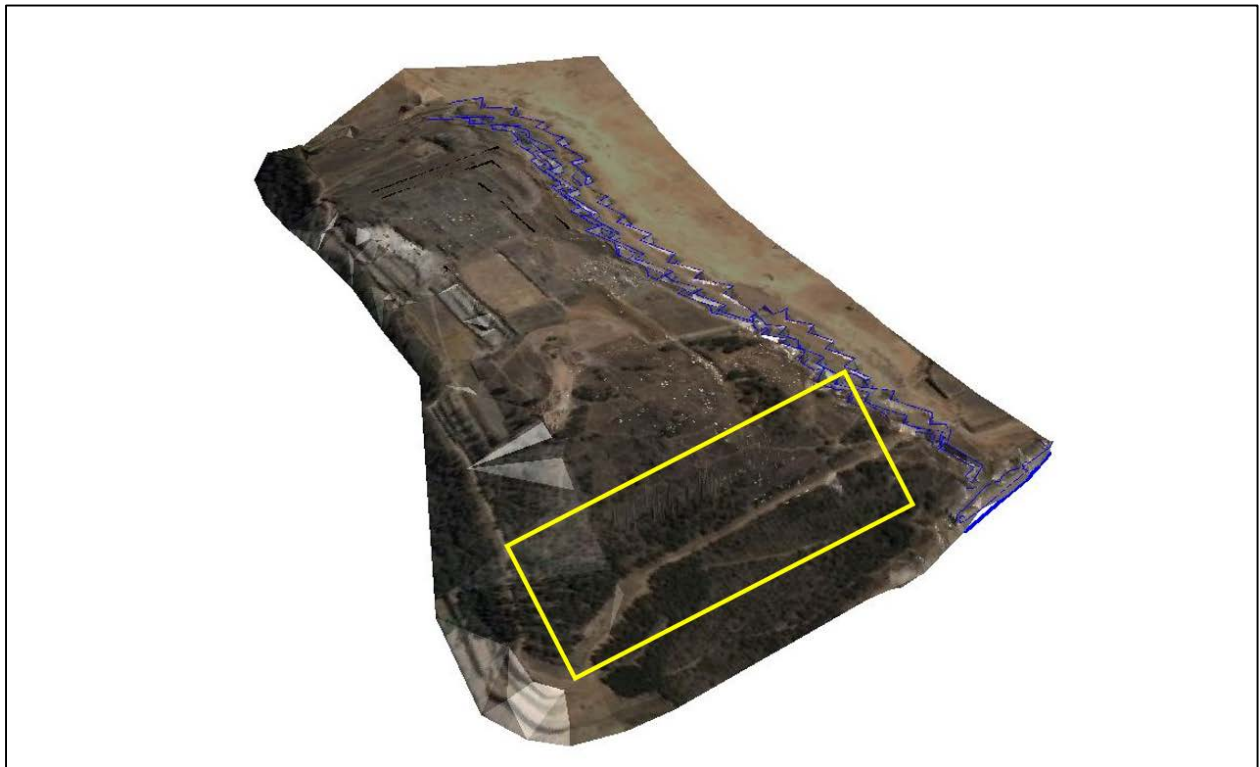
face the Great Walls, terracing along this sector is still crucial to the redirection of runoff. The objective of this research was to implement a holistic terrace system that not only diverts runoff away from the walls, but continues to channel it to a final drainage location. For this reason, most Total Station data collection occurred in the area indicated in Figure 15.

*Figure 15: Area of 2014 Survey Data Collection, shown on 3D Topographic Model of Saqsaywaman*

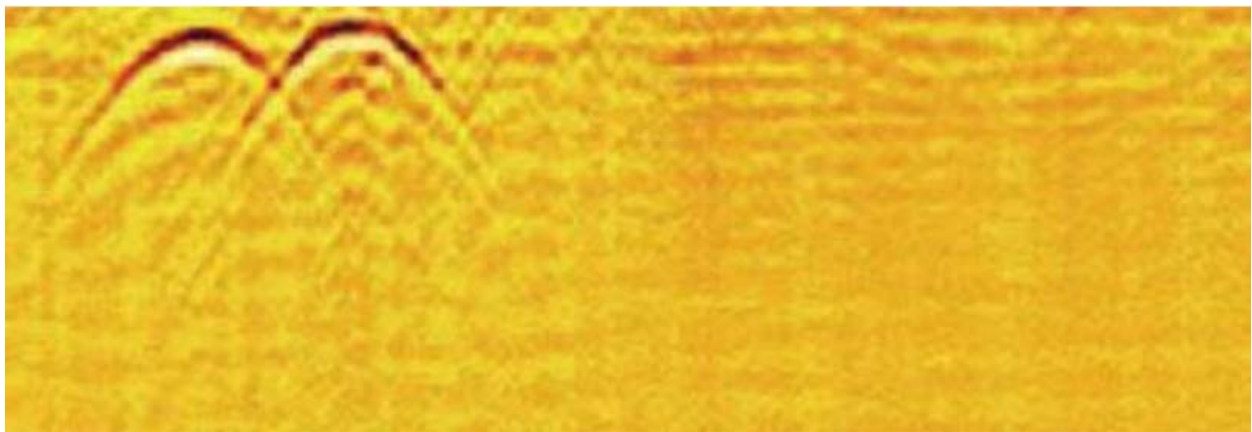
The Ground Penetrating Radar (GPR) was operated by the GPR team, consisting of UVa and UNI engineers. The Quantum Imager Ground Penetrating Radar was used for 2015 data collection. Using the same principles by which sonar systems detect objects under water, GPR uses radio waves, at approximately 200MHz, to detect objects in the soil medium. When radio waves impact a substance of a different density from the ambient soil, some of the energy of the wave is reflected back and the GPR determines how deep underground the obstruction is [13]. Figure 16 shows an example GPR return curves detecting obstructions, which look like dark hyperbolas on a yellow ambient background.

*Figure 16: Example of GPR return curve indicating a subsurface structure [13]*

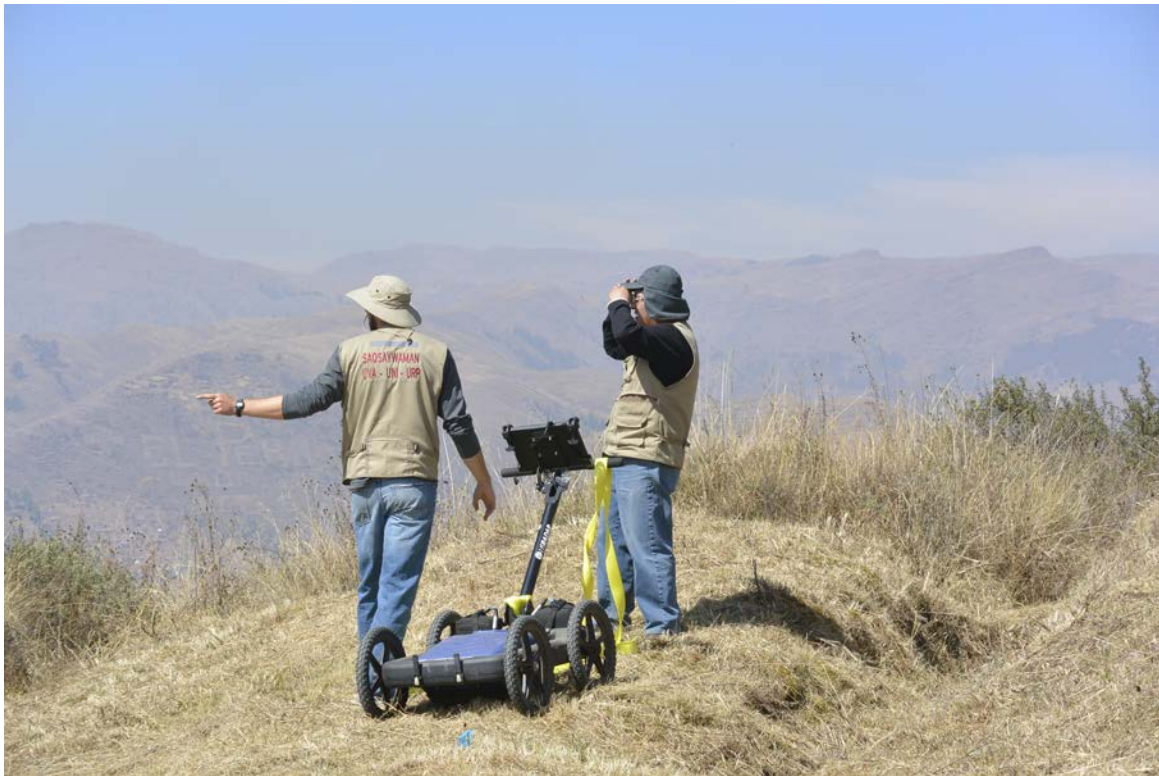
data needed to meet the second objective. The GPR team took most of its measurements in the same eastern portion of the site as the Total Station team. Additionally, GPR runs were taken anywhere that Seismic Refraction runs were taken, not only to document locations but also to be able to directly compare anomalies between both techniques. Figure 17 shows GPR data being collected at Saqsaywaman with the Quantum Imager.

*Figure 17: UVa and UNI engineers using the Quantum Imager to conduct GPR analyses at Saqsaywaman, 2015 [12]*

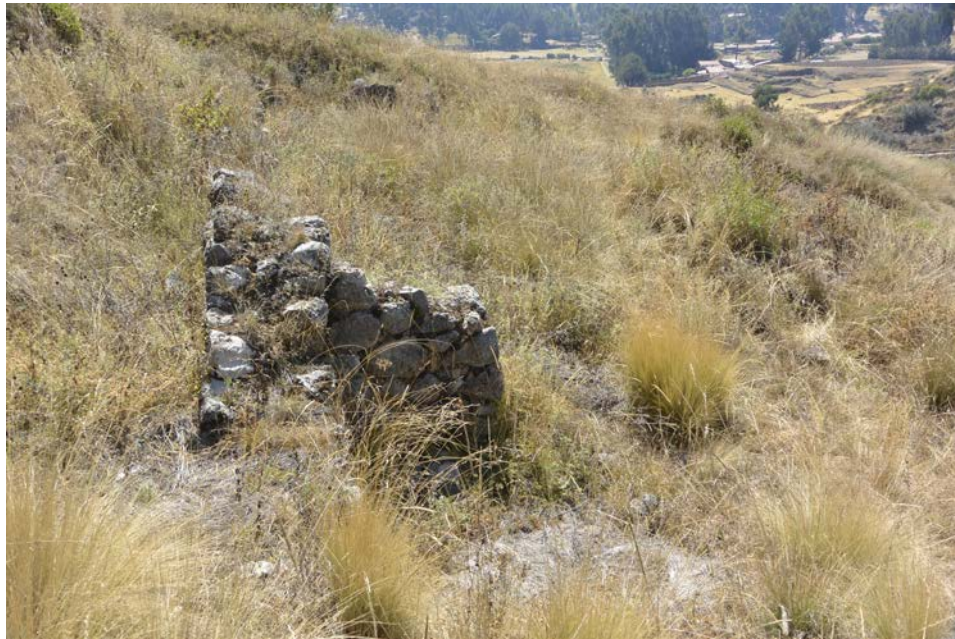
Remains. Structural Remains refer to small collections of exposed stone that may have been foundations of ancient structures or fragmented terrace remains (Figure 22).

*Figure 22: Example of Structural Remains at Saqsaywaman [12]*

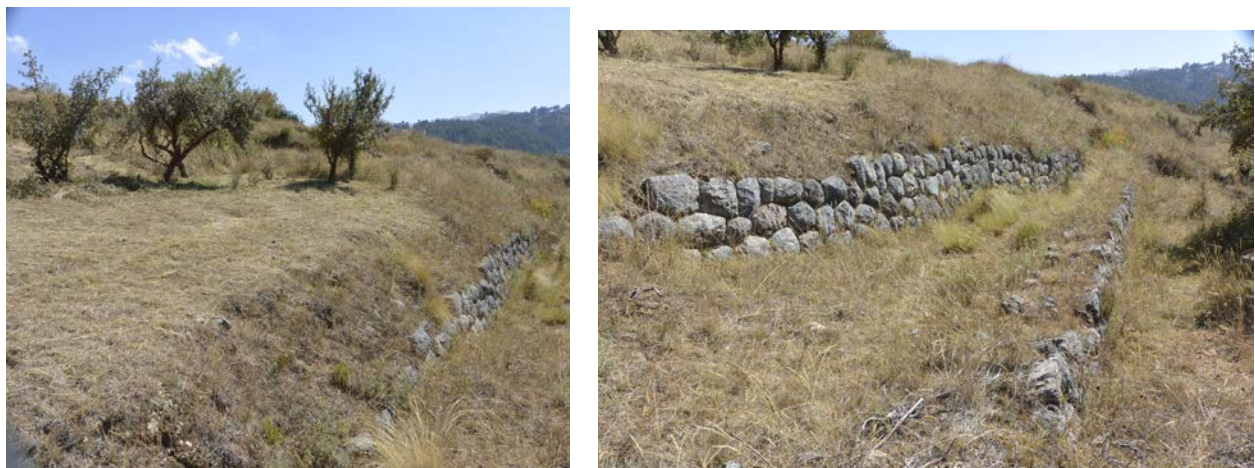
Terrace Remains refer to larger collections of exposed stone in a linear arrangement or to a sudden drop in elevation which indicates buried terraces (Figure 23).

*Figure 23: Example of Terrace Remains at Saqsaywaman. Left shows a buried terrace, Right shows exposed terrace wall [12]*

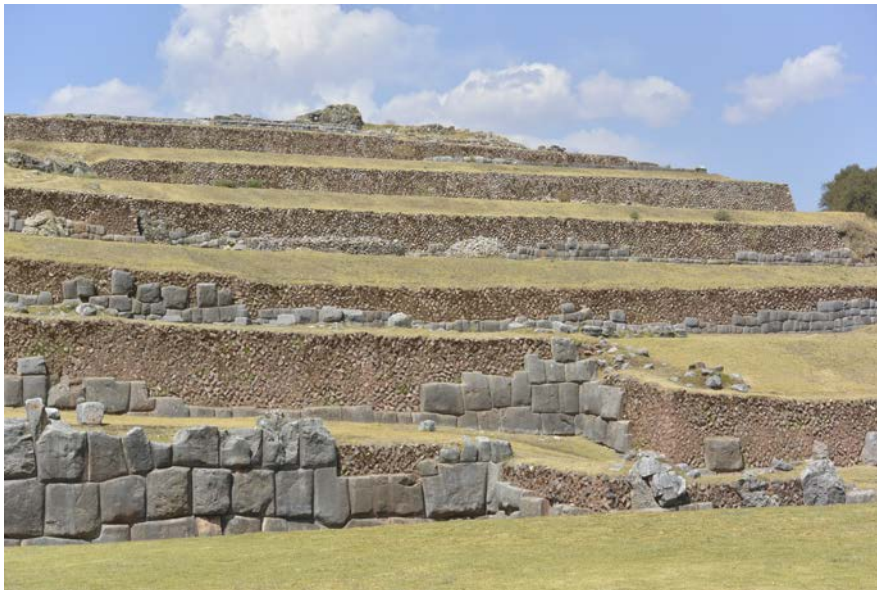
In addition to structural and terrace remains, existing terraces on the west side of the site were considered to be visual evidence (Figure 24). Survey data of these terraces were converted to line features and assigned elevation data with the same process as previously described. These line features and their elevation data would be used as starting points for proposed Inca Terraces, with the assumption that Inca terraces typically follow contour lines and wrapped around the entirety of Inca sites. A GIS map displaying the categorized visual evidence can be seen in Figure 25.

*Figure 24: Existing Terraces on west side of Saqsaywaman [12]*

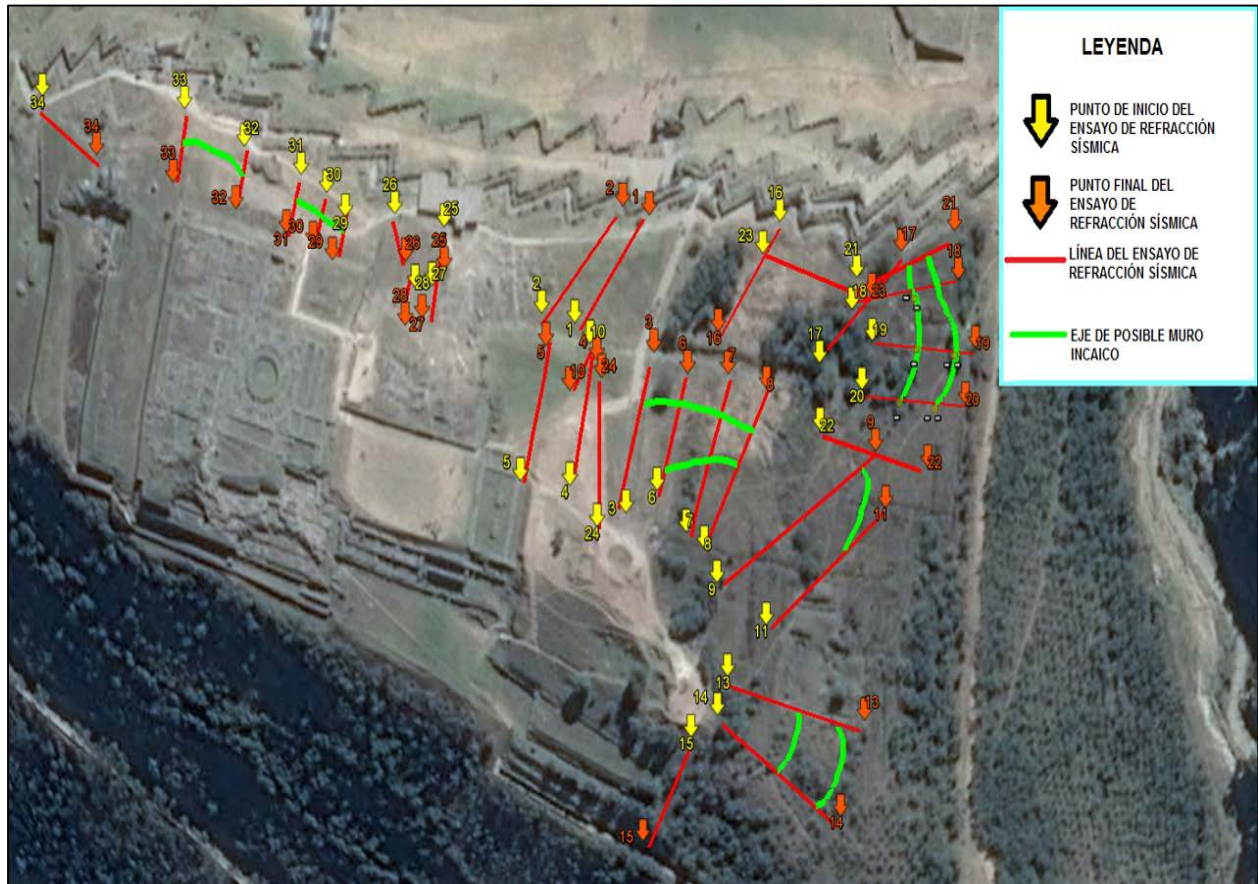
As previously stated, anomalies detected by Seismic Refraction analyses were summarized for each run in Table 4. In Table 4, an anomaly found along a run has a corresponding distance from the run starting point at which the anomaly was found. The Seismic Refraction team also provided an accompanying figure indicating start points of each run (Figure 26). Another point feature class had to be created from the locations of these anomalies to complete Task 2. To do so, the seismic run referenced in Figure 26 was located in Figure B2 (Appendix), and the corresponding distance to anomaly from Table 4 was measured in ArcGIS. At this location, a point feature was created.

Figure 26: Seismic Run labels corresponding to Table 5, yellow arrow indicates start of run, orange arrow indicates end of run. Provided by “Saqsaywaman Geophysical Report”

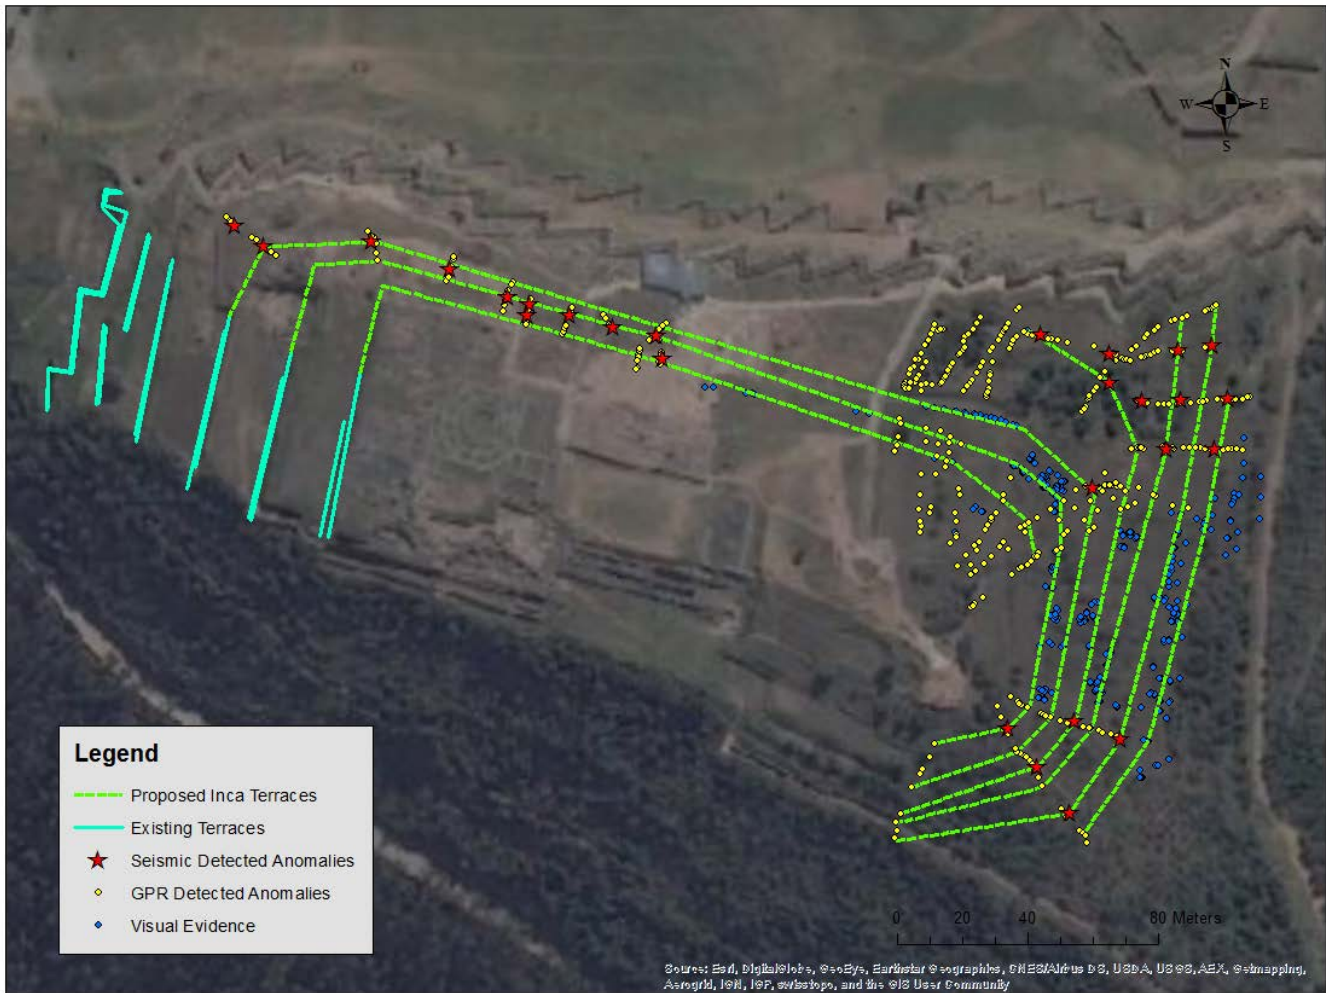
Using only the data and assumptions presented here, the location of Inca Terraces were best determined to be in the arrangement shown in Figure 28.

*Figure 28: Inca Terrace Configuration based on 2015 Data Collection*

The proposed terrace configuration in Figure 28 can only be validated through archeological research. While the proposed terrace is only a first approximation of the original Inca terracing, the research on which it is based makes it a worthwhile foundation for future work.

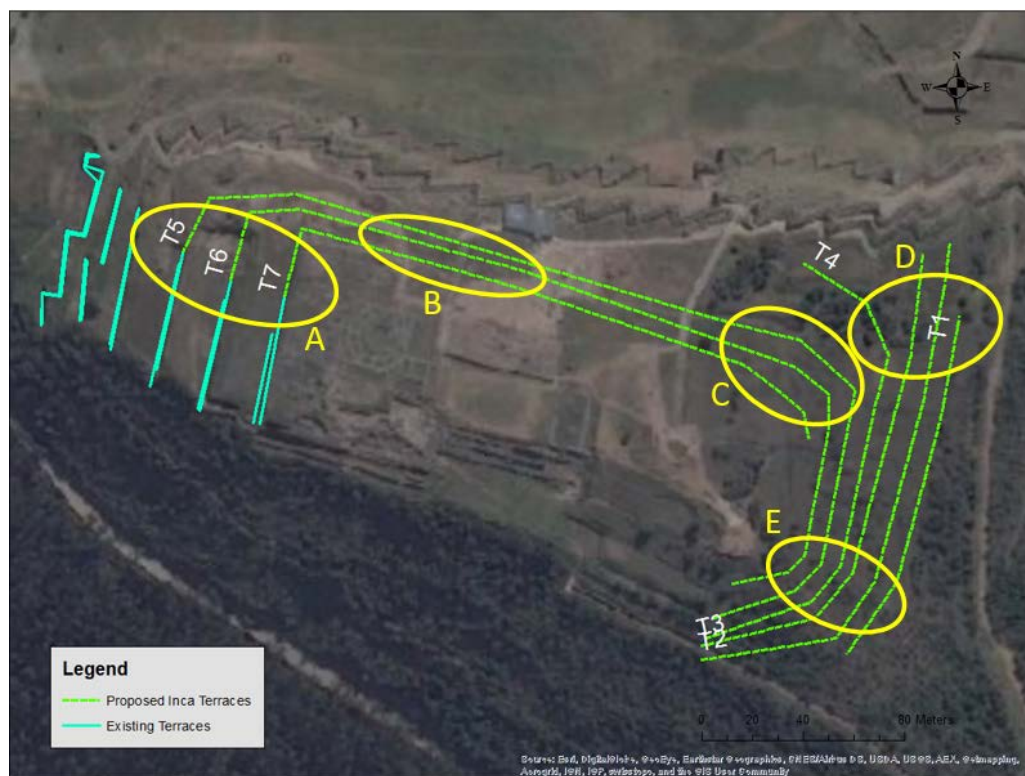
Figure 29 shows all proposed Inca Terraces (labeled T1-T7) as well sections (A-E) that highlight important areas. Terraces were drawn in ArcGIS by creating new line features and snapping to significant points. When drawing in proposed terraces, there was a high priority to snap lines to points of agreement between any three of the sets of data. Visual evidence represented physical

evidence of ruins so these points served as guidelines for including or excluding subsurface data. In Section A, Terraces 5, 6, and 7 were chosen to begin at the corners of existing terraces. The existing terraces are presently well defined and if assumed to be at a similar topography to that of time of original construction, the starting elevations of Terraces 5, 6, and 7 are good approximations for Inca-era elevations. These terraces were further delineated by snapping to Seismic Refraction anomalies that overlapped with GPR anomalies, in Section B. Defining the curves along T5, T6, and T7 in Section C was guided by the Visual Evidence pattern which also overlapped GPR anomalies. The start and end of Terraces 1-4 was guided by the agreement between Seismic Refraction and GPR anomalies in Sections D and E. One may notice that T1, T2, and T3 are unique in that they do not curve upon meeting the north side of the site. It is plausible that these terraces could have merged into drainage channels at the corners of the Great Walls.

Figure 29: Labeled Proposed Inca Terrace Configuration

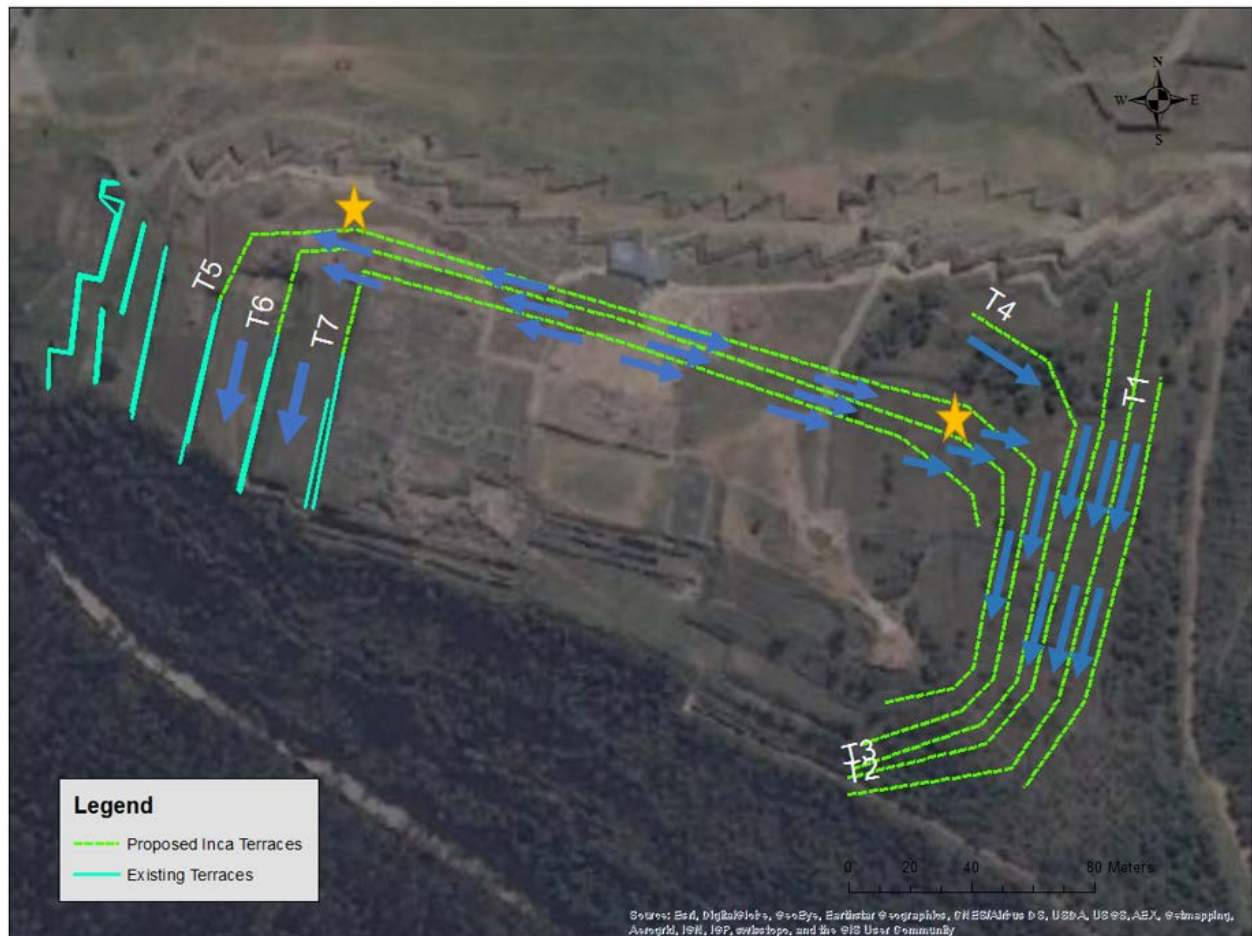
Assuming the proposed terraces met these three conditions, runoff would be efficiently diverted away from the Great Walls as shown in Figure 30. As shown, runoff would travel laterally along north facing terraces, flowing either east or west based on dividing location proposed by Lohr [11]. Upon reaching the turns at the starred locations, runoff would cross onto subsequent terraces through controlled drops, like those discussed in Tipon or Ollantaytambo. Runoff would continue to travel laterally along the bases of north-south running terraces until reaching some drainage outlet in the southeast or southwest corners of the site.

*Figure 30: Flow patterns resulting from implementation of Inca Terrace Configuration*

Second, this work demonstrates that the proposed terrace configuration is capable of managing runoff in a way that protects the Great Walls and the entire site from further degradation. However,

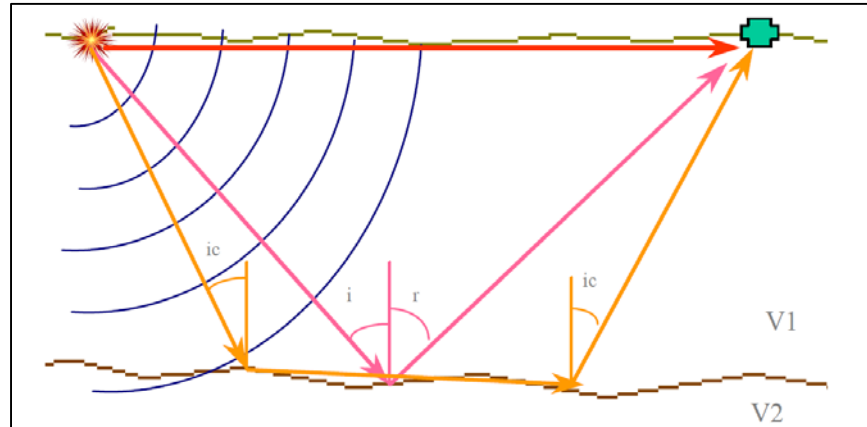
El ensayo de refracción sísmica es un método de exploración geofísica que permite determinar la estratigrafía del subsuelo en forma indirecta, basándose en el cambio de las propiedades dinámicas de los materiales que lo conforman. Este método consiste en la medición de los tiempos de viaje de las ondas compresionales (Ondas P) y algunas veces de las ondas de corte (Ondas S) generadas por una fuente de energía impulsiva a unos puntos localizados a distancias predeterminadas a lo largo de un eje sobre la superficie del terreno (Gráfico N° 01).

**Gráfico N° 01: Refracción de las ondas sísmicas**

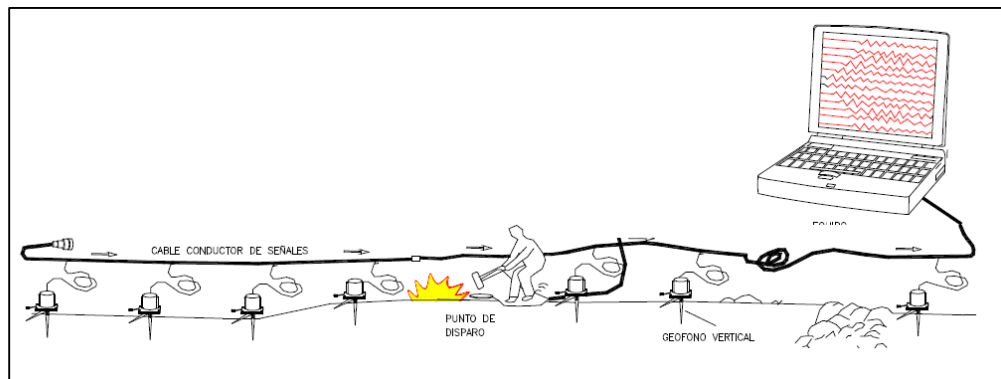
La energía que se propaga en forma de ondas, es detectada, amplificada y registrada de tal manera que puede determinarse su tiempo de arribo en cada punto. El tiempo cero o inicio de la grabación es generado por un dispositivo de arranque o “trigger” que activa el sistema de adquisición de datos al momento de producirse el impacto o explosión. La diferencia entre el tiempo de arribo y el tiempo cero permite evaluar el tiempo de propagación de las ondas desde la fuente de energía hasta el lugar en que éstas son registradas, como se aprecia en la Gráfico N° 02.

**Gráfico N° 02: Diagrama del ensayo de refracción sísmica**

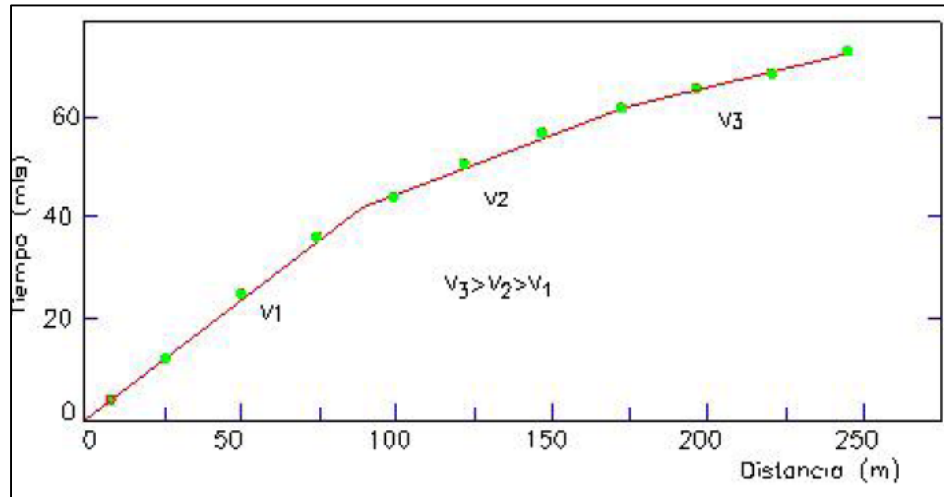
Los datos consisten en tiempos de viajes y distancias, siendo el tiempo de viaje el intervalo entre el tiempo cero y el instante en que el detector empieza a responder a la perturbación. Esta información tiempo-distancia (Dromocrónica) es procesada para obtener una interpretación en la forma de velocidades de propagación de ondas y la estructura de los estratos del subsuelo, según se observa en la Gráfico N° 03.

**Gráfico N° 03: Dromocrónica del ensayo de refracción sísmica**
