Restoring and Preserving the Incan Cultural Wonder of Saqsaywaman

A Thesis Presented to The Faculty and Staff of Engineering and Applied Science University of Virginia

> > by Kenneth Scott Lohr May 2014

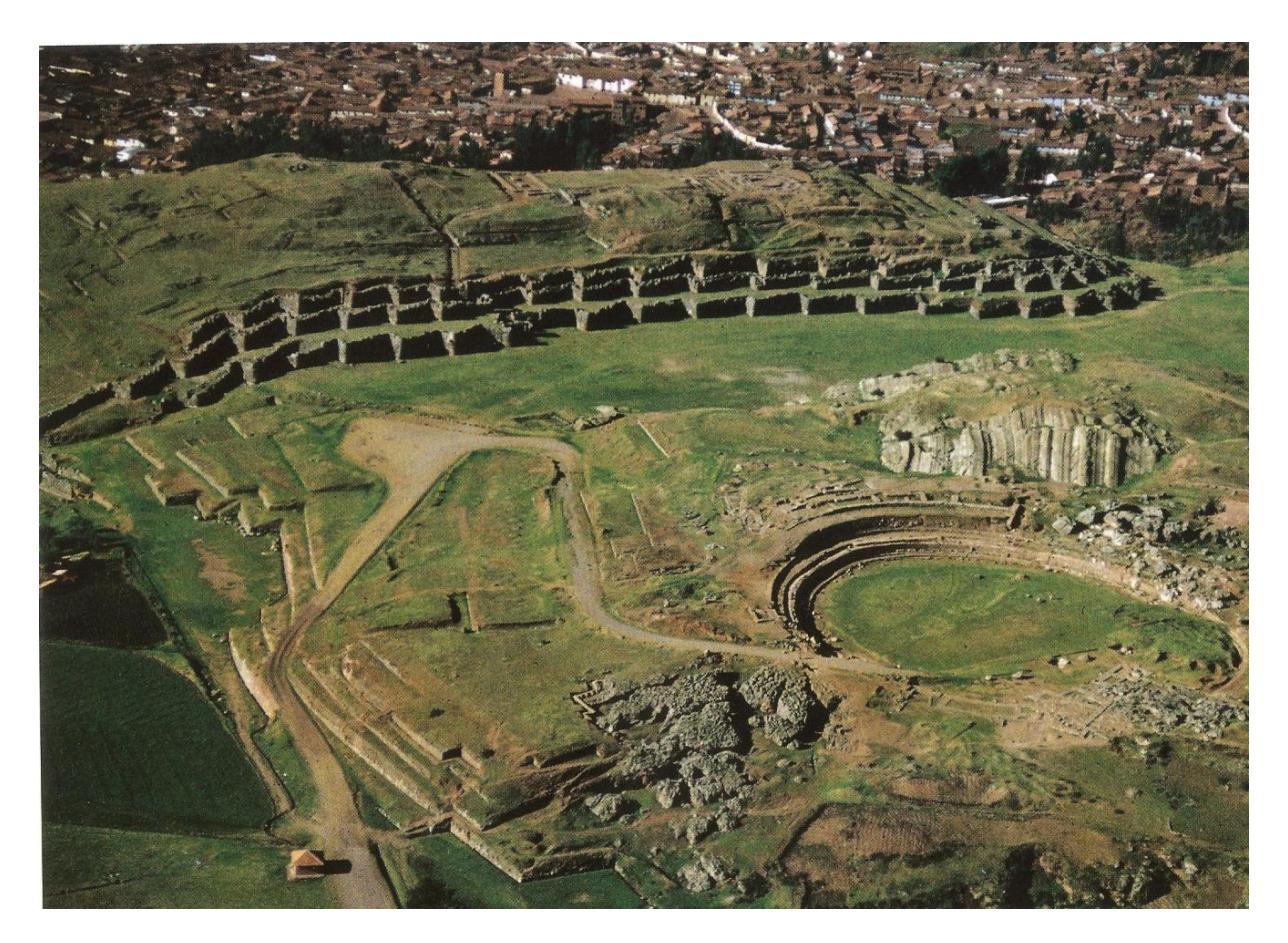
A photo by Reinhard (figure 5) shows a view of Saqsaywaman prior to recent large scale excavation work. The topography shown in this picture is very different from the current topography and very little of the ruins can be seen above the main terrace walls. The ground cover has also changed dramatically over the years as Saqsaywaman has become a major tourist attraction. The large amount of tourist foot traffic has since worn down the grass causing much of the site to become compacted dirt.

Figure 5. Old Photo of Unexcavated Saqsaywaman (Reinhard, 2011)

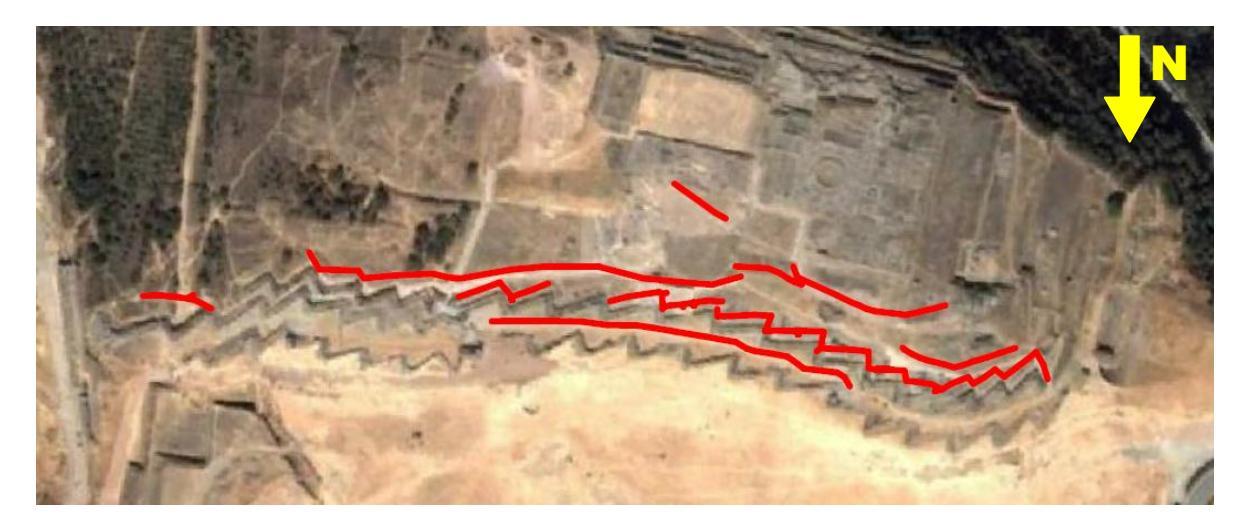
Figure 16. Location of Major Ad-hoc Drainage Channels

Clay channels, which will be referred to as ad-hoc drainage channels, have been constructed in order to try to catch the water flowing from the top of the hill and carry it safely off to the side into the ravine in order to protect the third wall. These channels however were not well designed. They vary widely in width, depth, and slope, which causes the carrying capacity of the channels to fluctuate about their length. Some areas of the channel are very large and can easily carry all of the water that flows into it, while other areas are too small and cannot come close to carrying the water that it receives during a large rainstorm. This causes these channels to overflow in several locations. This acts to concentrate the water and make it flow to the third wall at several locations where large quantities of water will flow over the wall. One of the key areas of this concentration is the area of original and still the largest collapse. The locations of these channels are shown below in figure 16. An in depth analysis of these channels will be shown later in the report which will show the carrying capacity of the different sections of the channels and the locations of major problems.

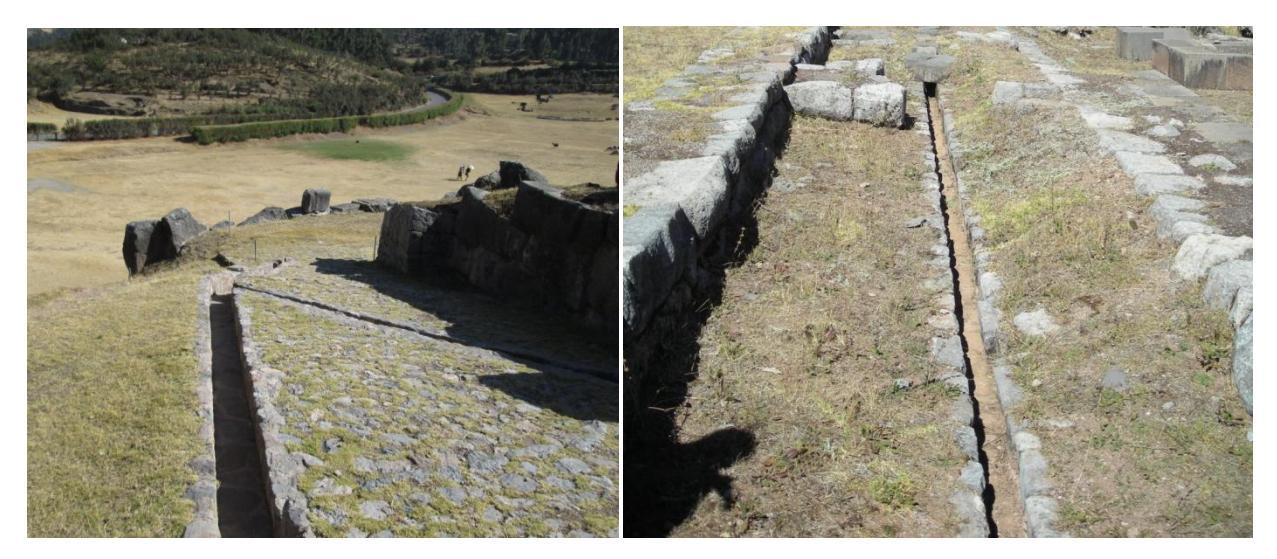
There is also a relatively new drainage channel that has been constructed on the west side of the complex. This channel is unique in that it has been constructed to look more like an Inca constructed drainage channel. This can be seen below in figure 20, showing the new channel on the left and a channel constructed by the Incas, atop Mayuqmarka, on the right.

Figure 20. New Inca Type Drainage Channel (left) and Original Inca Drainage Channel (right) near Mayuqmarka (Lohr, 2013)

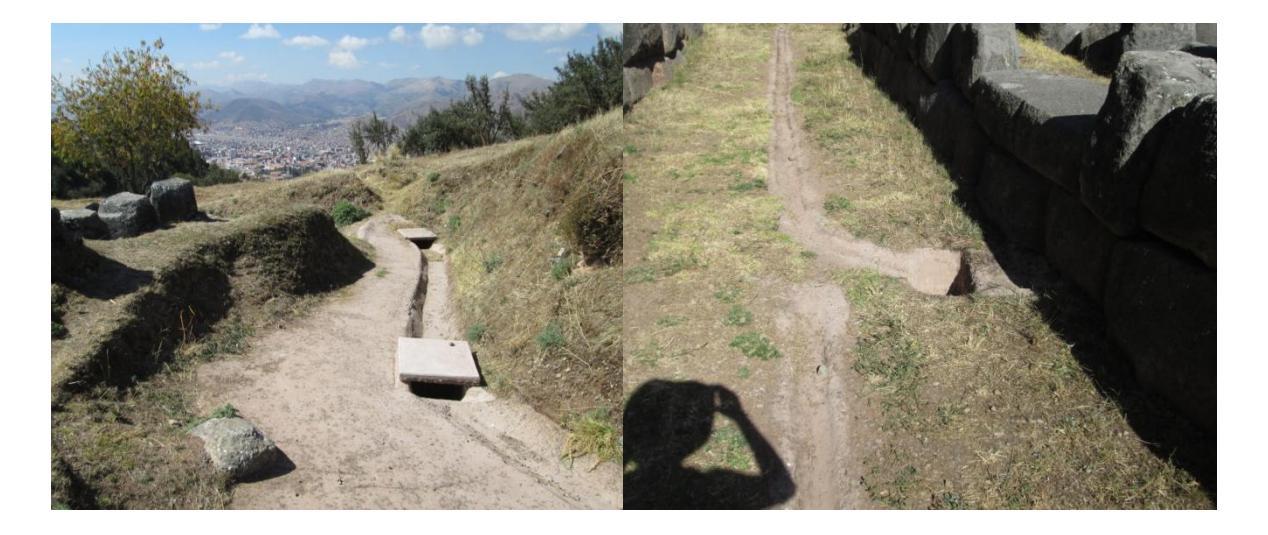
Some of the channels have small basins which are assumed to be sediment basins with the purpose of causing turbulence in the water which allows sediment in the water to settle out to the bottom of the basin rather than flowing with the water. This allows the sediment basins to be cleaned occasionally rather than having large amounts of sediments being deposited where the water is finally absorbed into the ground. The largest of the sedimentary basins can be found on the drainage channel located just above the third wall while smaller ones can be found along the second terrace channels just before the water flows into a drainage port. Both of these types of sediment basins can be seen below in figure 21.

Figure 21. Sediment Basin along Major Ad-hoc Channel (left) and along Second Terrace (right) (Lohr, 2013)

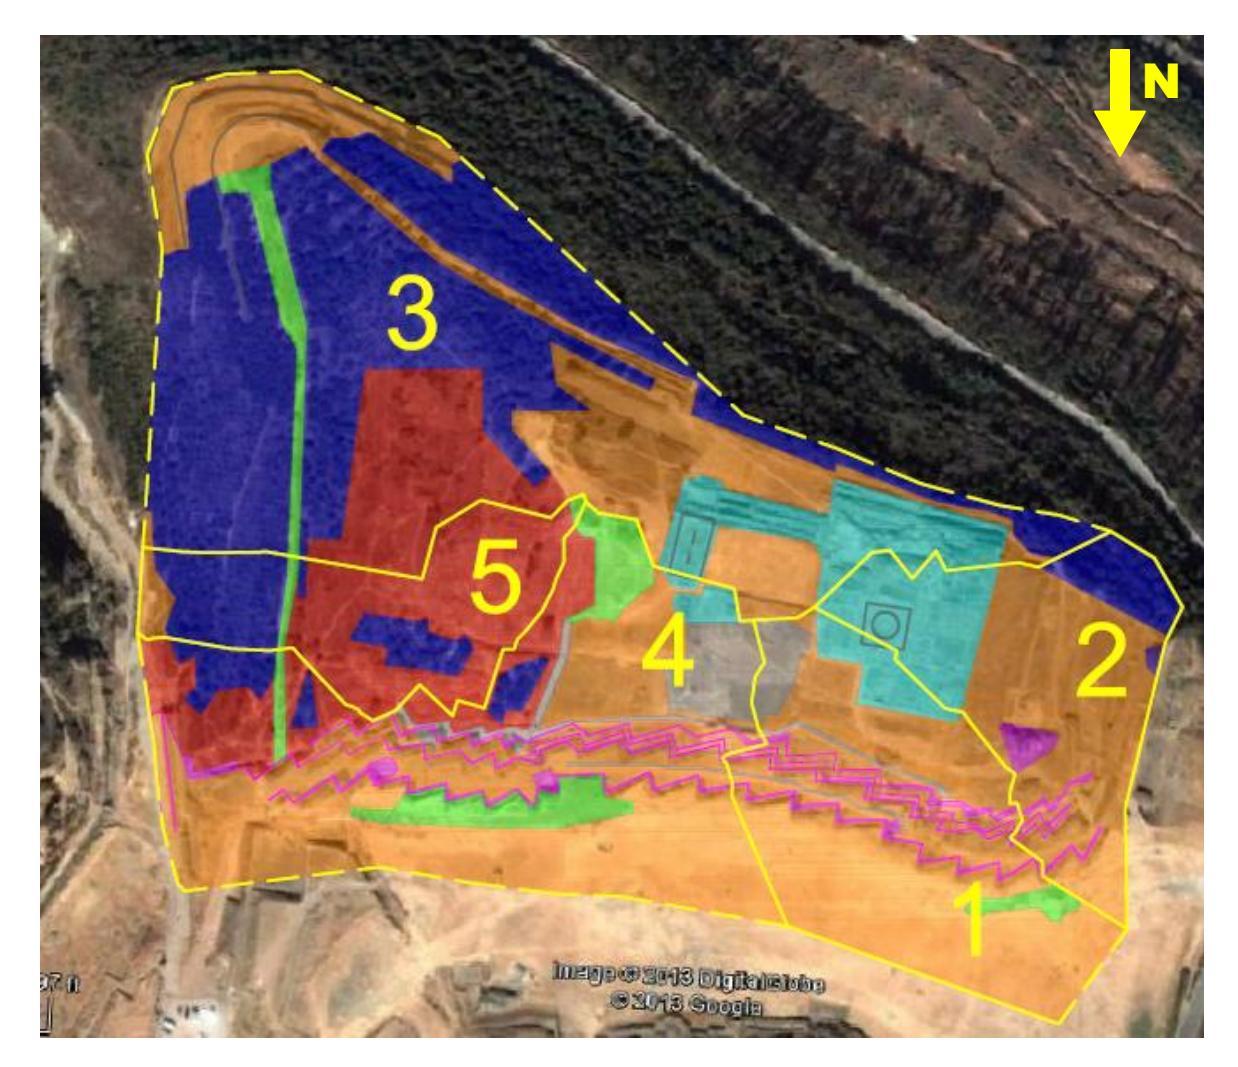
Figure 36. Current Ground Cover: Trees (Royal Blue); Stone (Pink); Short Grasses (Orange); Compacted Dirt (Green); Clay (Gray); Tall Grasses (Red); 10% Stone and 90% Short Grasses (Light Blue)

The majority of the south eastern side of the site is small trees seen in royal blue, while the majority of the west side of the site is short grasses (orange). There is a section of tall grass in the center east portion of the site. The major contributor to the total clay area (gray) is the 2009 excavation sector but there are also some clay drainage channels scattered about. The stone (pink) is represented by the terrace walls as well as some of the ruins near Mayuqmarka. There is some compacted dirt (green) in several highly trafficked portions of the site where grass no longer grows.

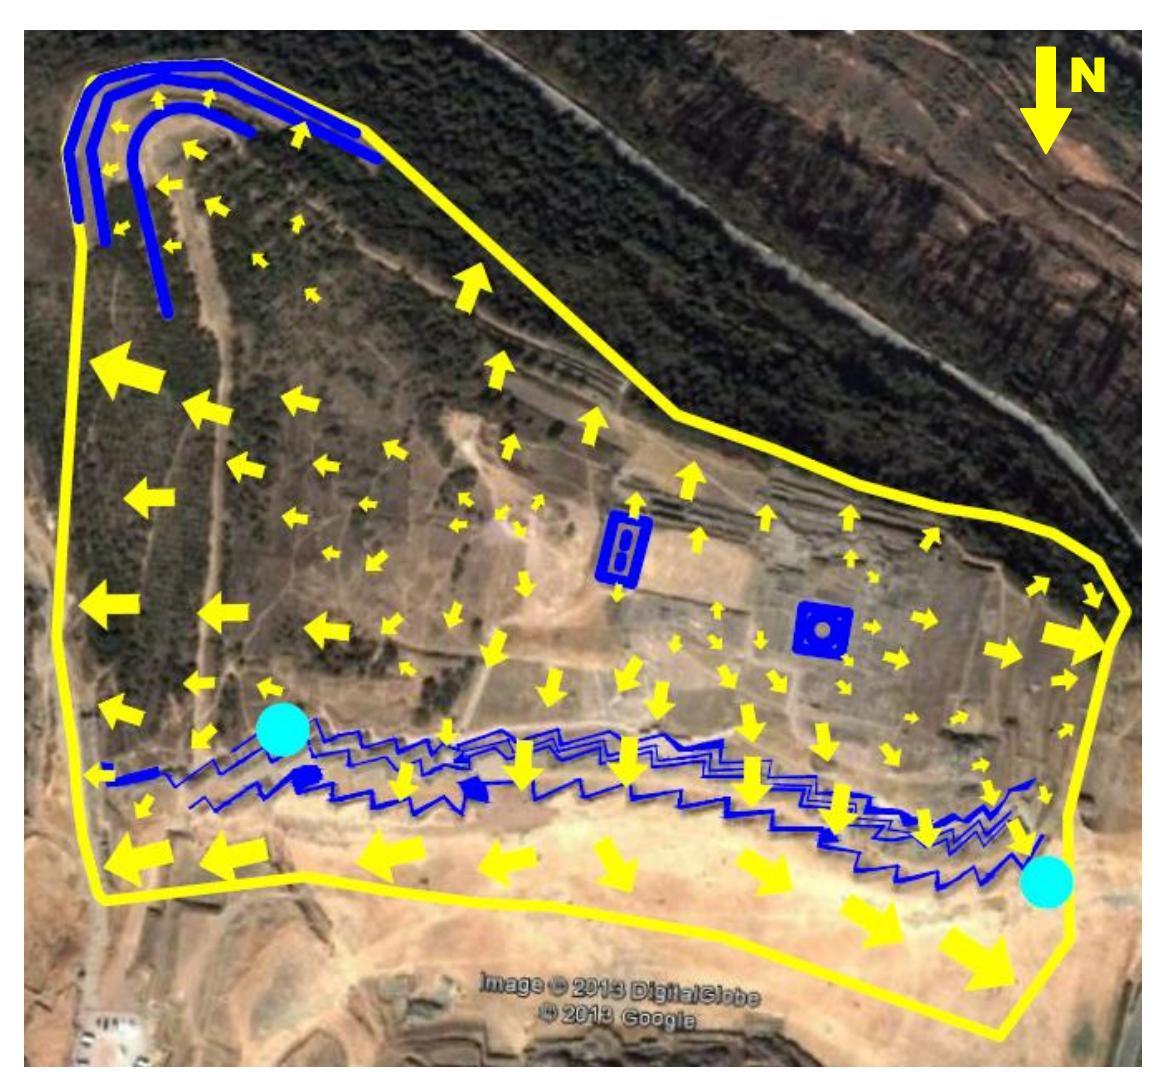
Figure 37. Graphical Representation of Rational Method Runoff Flow

The water runoff flow can also be shown in graphical form as shown below in figure 37. The blue lines represent reference object and the blue circle are depression areas where water pooling occurs. The yellow lines show the location and direction of the water runoff and their size is

proportional to the volume of runoff. This figure shows that most of the water from the northern half of the site eventually makes its way to the walls. The locations of most of the collapsed sections of wall are located in the middle of the map on the third wall. This correlated with the majority of the water flow reaching the walls.

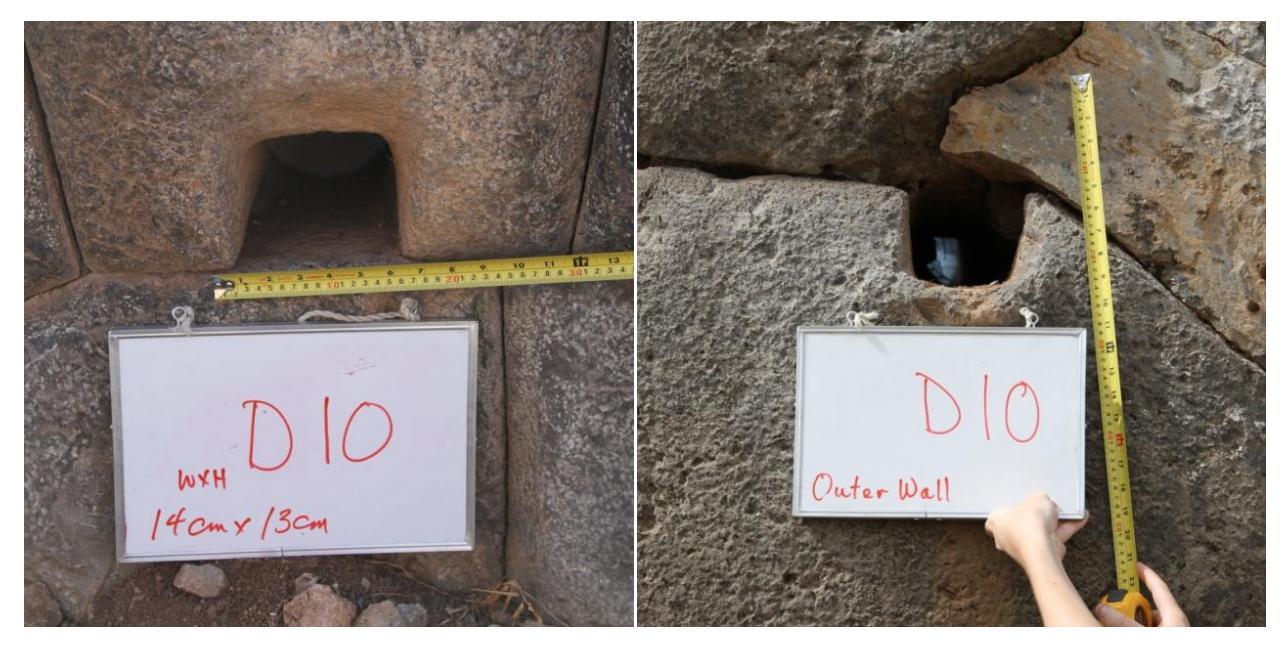
The drainage ports are designed to collect the water that lands on the second terrace during precipitation and carry the water safely through the second wall and onto the first terrace. The inlets and outlets of a drainage port can be seen below in figure 39. Outlet locations vary from being around 4 meters above the terrace below to half a meter below.

Figure 39. Drainage Port Inlet (left) and Outlet (right) (Miksad, 2010)

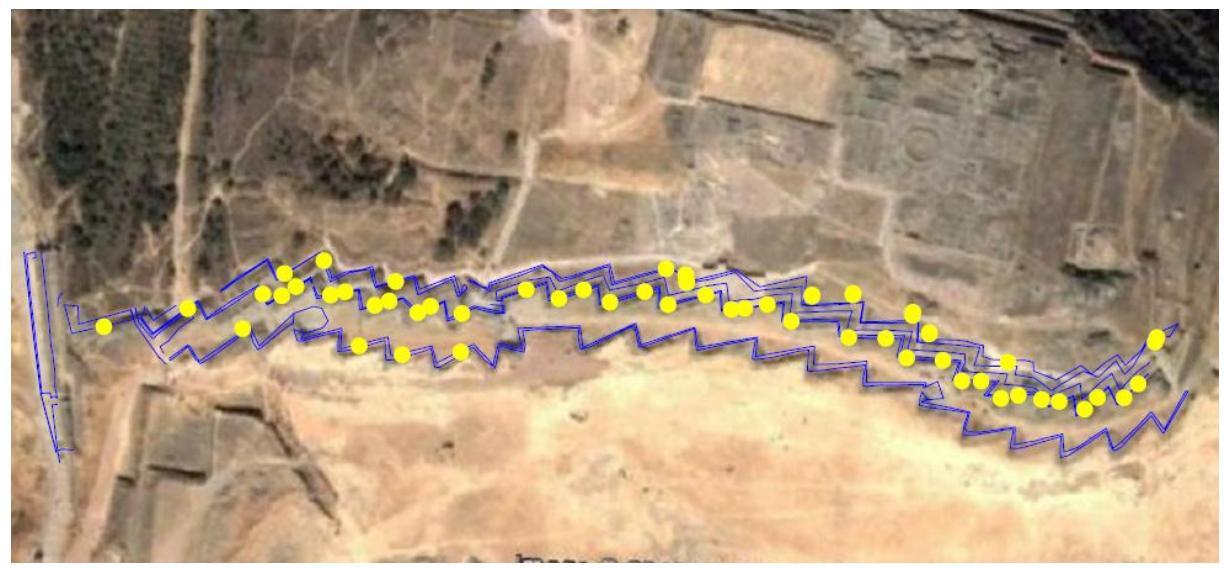
Figure 40. Map of Drainage Port Locations

There are 45 drainage ports located at the site. These drainage ports are mainly located along the second terrace but there are several on the first terrace. There are also remains of drainage ports in the form of carved channels that are currently located at the third terrace wall. Most of these channels are not currently located within the wall itself so their original location is unknown. It is possible that these were functioning drainage ports at one time, but since the walls have deteriorated and many of the stone have been taken from the walls and used in the city to construct buildings, they are no longer functioning. Figure 40 shows the location of all of the drainage ports at the site while figure 41 shows one of the channel stones found near the third wall.

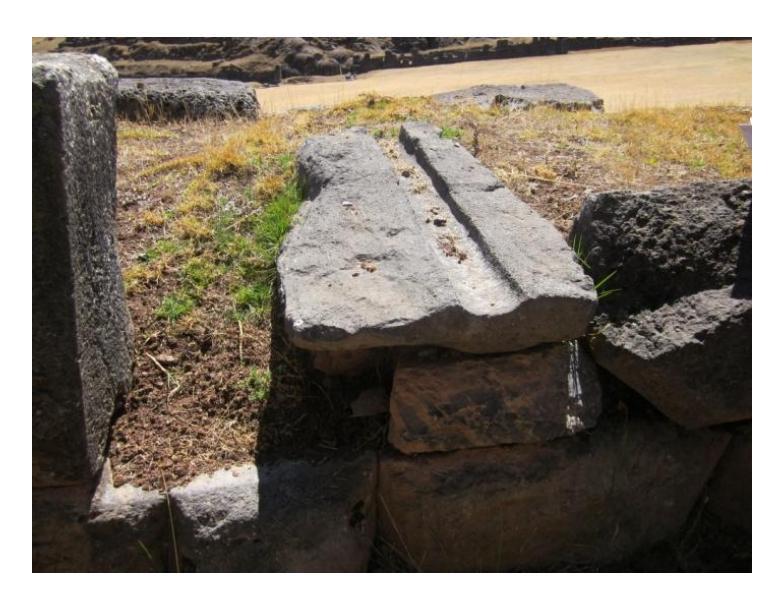
Figure 41. Drainage Port Stones at Third Wall (Jeffers, 2013)

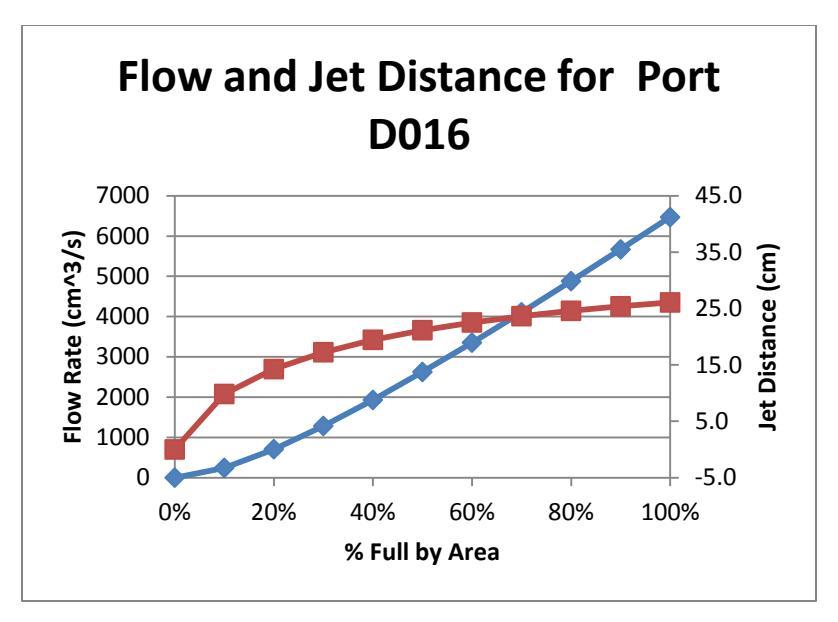
An in-depth analysis of drainage port D16 is shown graphically in figure 44 and numerically in table 4. The volumetric flow rate is shown in blue while the jet distance is shown in red. The volumetric flow rate increase slowly at first, but then is near linear after it reaches 30 percent capacity. This is because the flow is directly proportional to the area and hydraulic radius to the two-thirds power. The jet distance for the Woodburn equation grows very rapidly at first but then flattens out asymptotically. This is well represented by a square root function due to the fact that the velocity increases by less with each increase in flow rate because of the greater area.

Figure 44. Graphical Representation of Drainage Port D16 flow (Torp, 2014) Volumetric Flow (Blue) Jet Distance (Red)

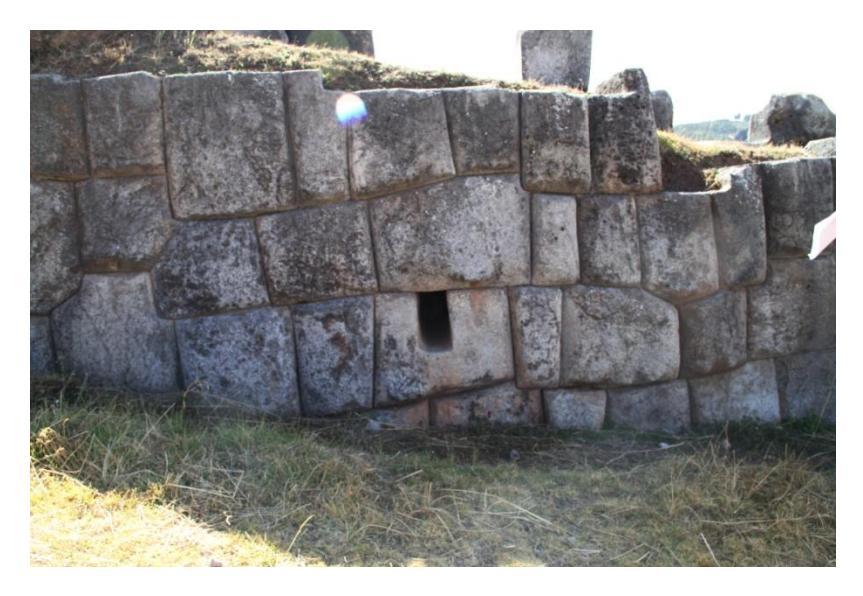
One drainage port in particular stands out from the rest. Drainage port D43 is much larger than the rest of the drainage ports and it slopes in the opposite direction. Instead of carrying water from the second terrace through the second terrace wall to the first terrace this port carries water from the first terrace to the second terrace. This port has since been named "El Grande" and can be seen below in figure 46. It is located in the second terrace wall on the eastern side of the complex. El Grande has dimensions that are 16 cm in width and 22 cm in height giving it a total area of 528 square centimeters which is nearly twice as large as the next biggest port.

Figure 46. El Grande Port Outlet (Miksad, 2010)

One possible purpose for this large port is to collect runoff from the first terrace and safely carry it through the second wall so it can safely by directed down into the nearby ravine. This would prevent large amounts of water from flowing down the end of the first terrace towards the secondary entrance that is located on the east terraces. The port however is not large enough to carry all of the water from the east half of the first terrace during a normal storm event.

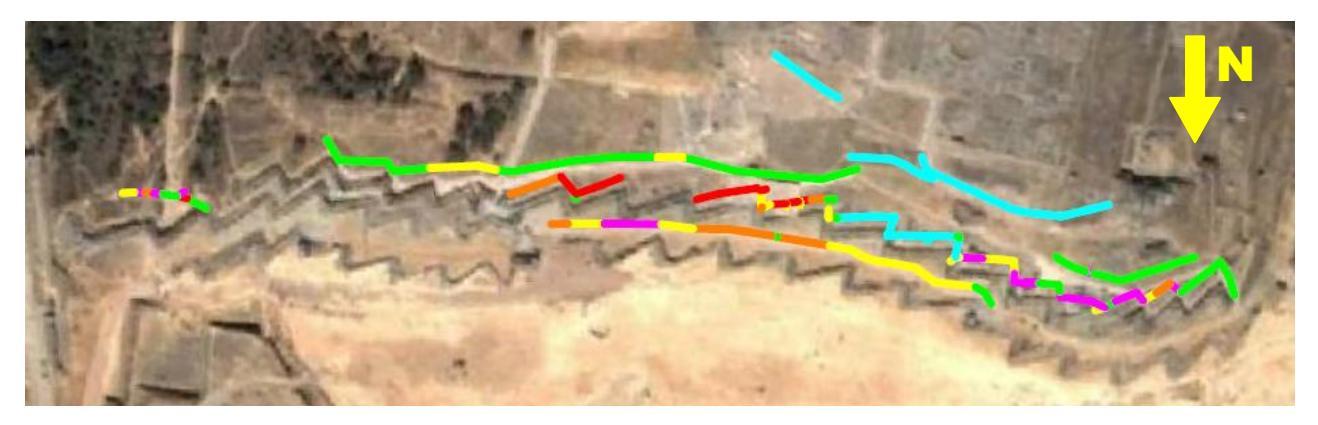
The ad hoc drainage channels that are around the site carry large amounts of water. I wanted to determine just how much water they could safely carry and then compare this to the amount of water they would need to carry during a large storm event. Figure 47 below shows the current drainage canal systems. The canal sections are color coded by their max flow capacities in cubic centimeters per second as follows: Red: 0-100, Orange: 100-250, Yellow: 250-500, Magenta: 500-1000, Green: greater than 1000, and Cyan: not enough data.

Figure 47. Current Drainage Channel Flow Capacities (Red: 0-100, Orange: 100-250, Yellow: 250-500, Magenta: 500-1000, Green: greater than 1000, Cyan: not enough data)

The first recommendation is a short term solution. In order to prevent further damage to the walls, the drainage channels should be modified so they can carry the runoff load during a major storm event. The main problem areas were highlighted earlier in this report. At these problem areas, the channels can be enlarged so that they can handle the water runoff loads during larger storm events.

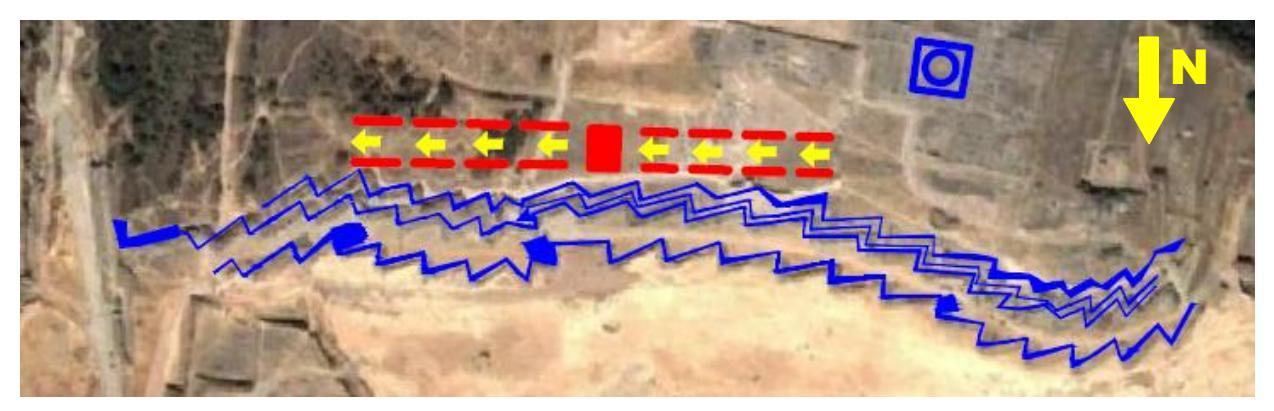
Figure 49. Location and Flow Direction of the Recently Discovered Gravel Drain

Recent excavations at Saqsaywaman have uncovered a gravel drain that is located just above the third wall. The exact location of the excavation is shown in figure 49. The excavation took place just above the third wall to the west of the main staircase that leads up to the tourist lookout.

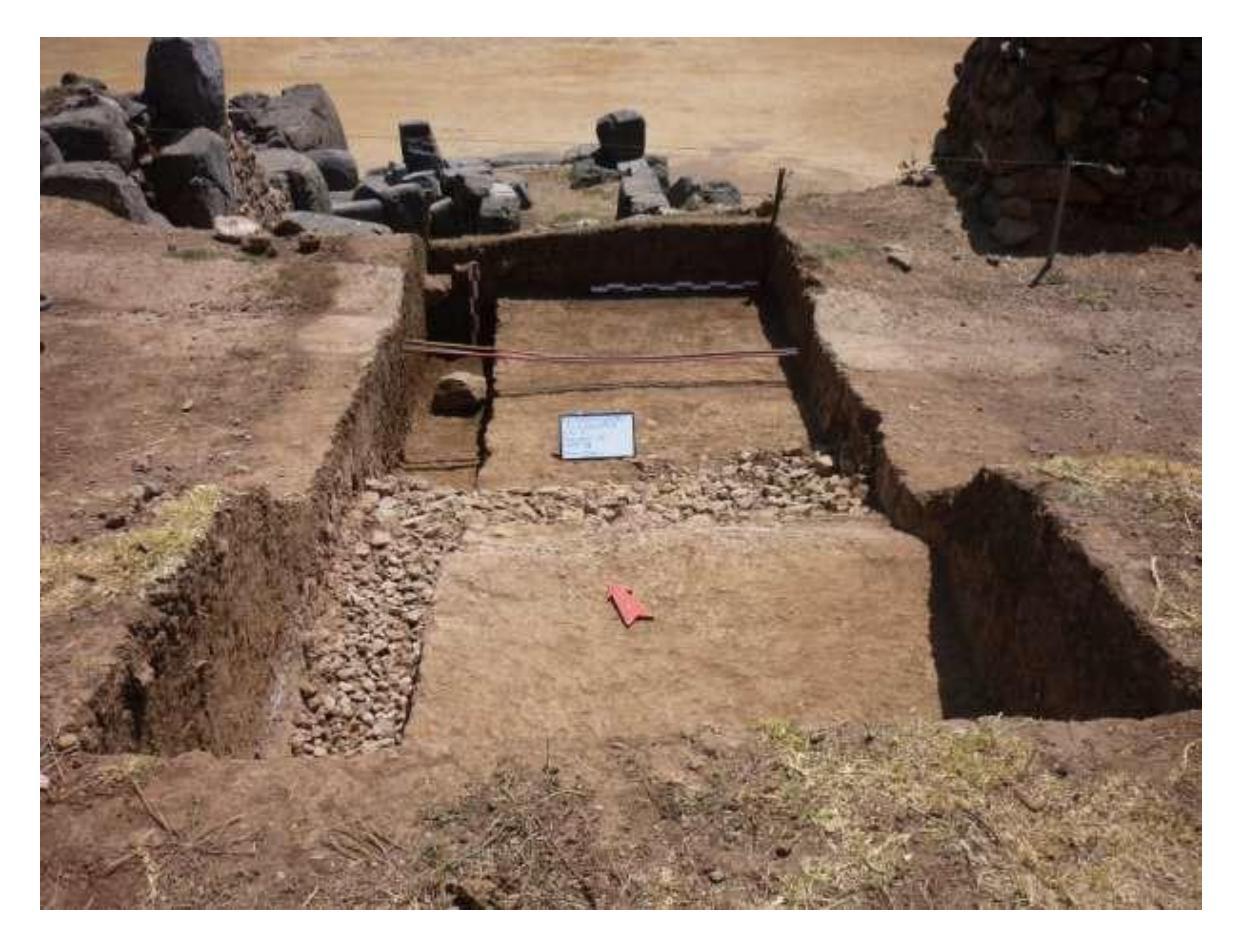
Figure 50 shows the actual excavation of the gravel drain. It is believed that this gravel drainage system was designed to function similarly to a modern French drain. The water would percolate into the gravel where it would then follow the gravel channel to carry the water to the desired location where the channel would end. This drain was probably used to capture any water that was heading towards the third wall and was designed to carry the water to the east where it could harmlessly flow into the ravine. Figure 51 shows the location of the gravel drain relative to the rest of the site and shows where it is perceived to travel.

Figure 50: Actual Excavation of the Gravel Drain Located above the Third Wall (Palma, 2013)

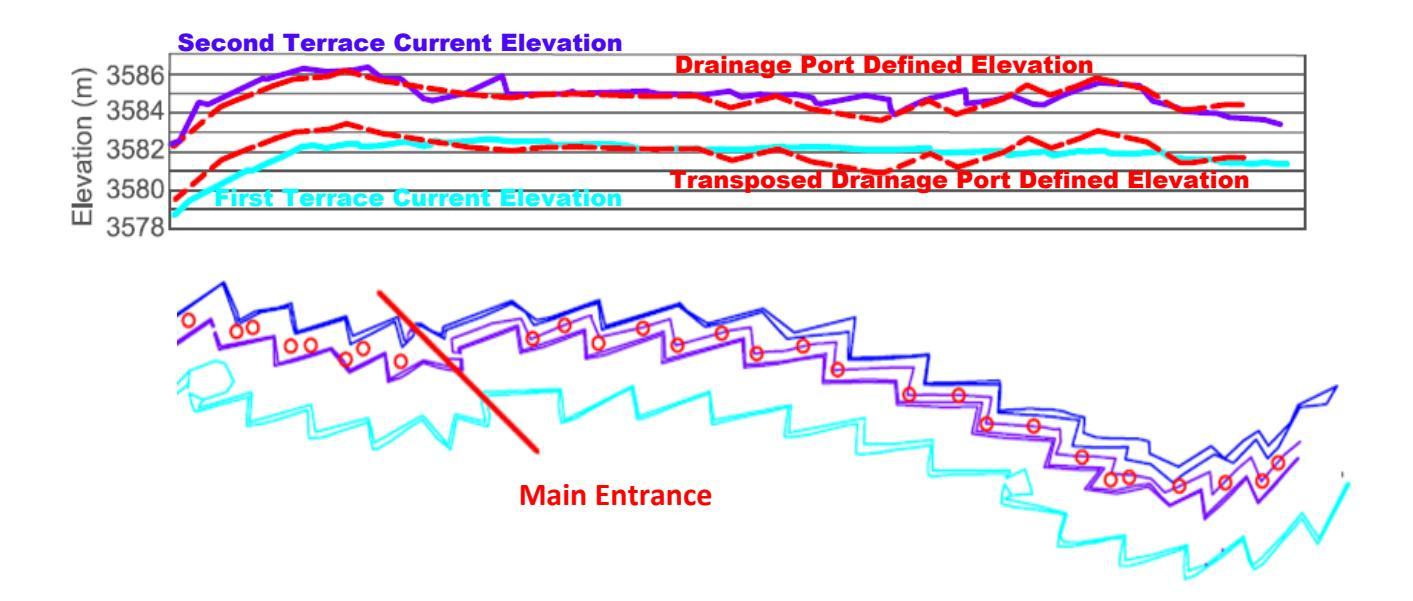
Based on this proposal I mapped out the current ground level of the second terrace and compared it to the inlet elevation of the drainage ports (figure 55). Here the current ground level on the second terrace is shown in purple and the proposed ground level based off the port inlet elevations is dashed in red. It appears that the current elevation does not align very well with the elevation defined by the drainage port inlets. Many of the drainage ports are above the current ground level and there are also some below it. The drainage port defined elevation is not perfectly smooth in all areas. There are several spikes and valleys mainly located on the east side. These would be used in order to funnel the water into drainage ports so there would be less total runoff along the terrace that could cause erosion.

terrace. This map is shown in figure 55 where the cyan line is the current ground level of the first terrace and the red dashed line is the drainage port defined ground level transposed onto the first terrace. The existing ground level on the first terrace is much smoother than the existing ground level of the second terrace. Figure 55 shows that the terraces are relatively evenly spaces with an average of around 3 meters separating them in elevation. The red circles represent the drainage ports locations along the second terrace.

Figure 55. Proposed Terraces Elevation View (Current First Terrace Elevation in Cyan, Current Second Terrace Elevation in Purple, Drainage Port Defined Elevation Dashed in Red)

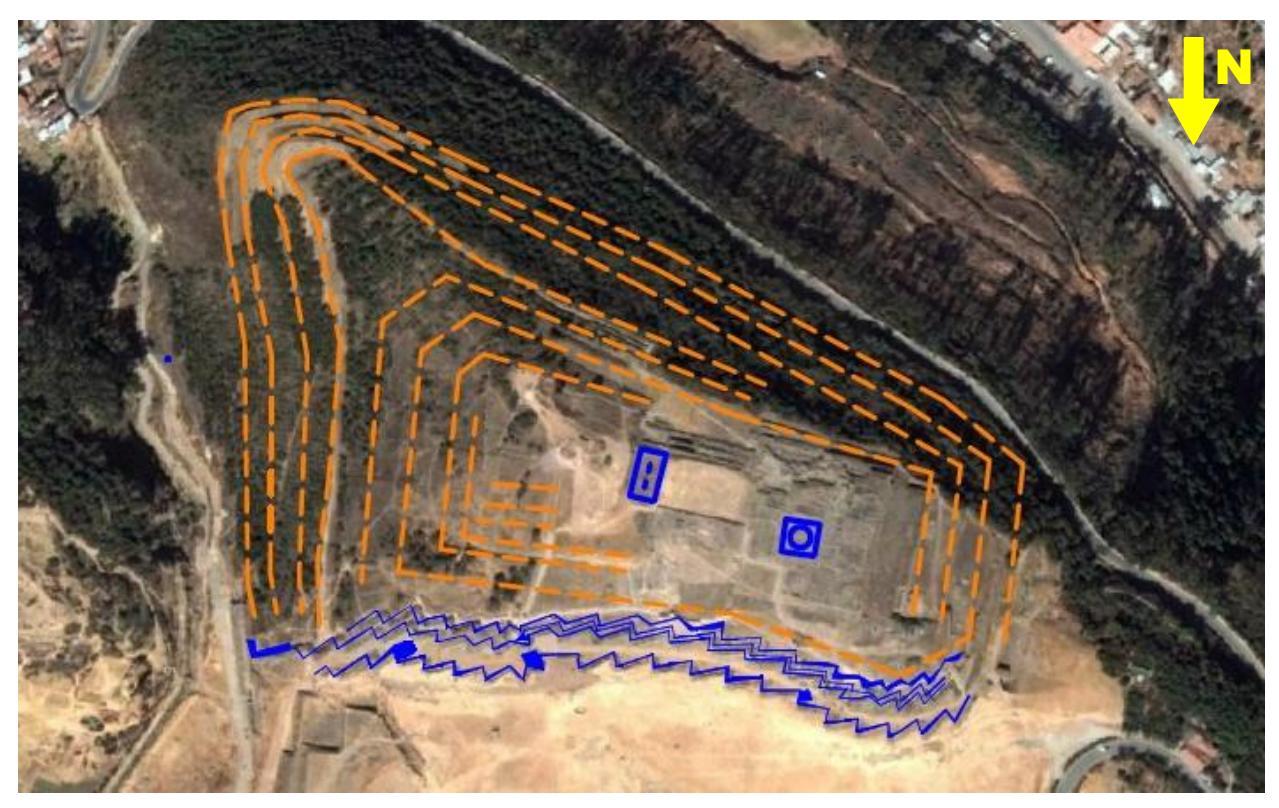
Figure 57. Gasparini & Margolies Terraces Represented in 3-D Model

If there were terraces at Saqsaywaman like the ones shown by Gasparirni and Margolies, then the water flow patterns above the walls would be much different than as seen today. Figure 57 shows a representation of the terraces in Gasparini's map drawn onto the new model. The dashed orange lines represent possible locations of terraces. The new flow directions based off this terraces layout are represented in figure 58. The vary drastically from the current flow patterns because now most of the water is shed laterally to the east and west and a little water flows off the back of the site to the south but no water is directed towards the wall. This flow pattern makes much more sense hydraulically from an engineering standpoint and agrees with the layout of most other Inca sites such as Tipon and Machu Picchu.

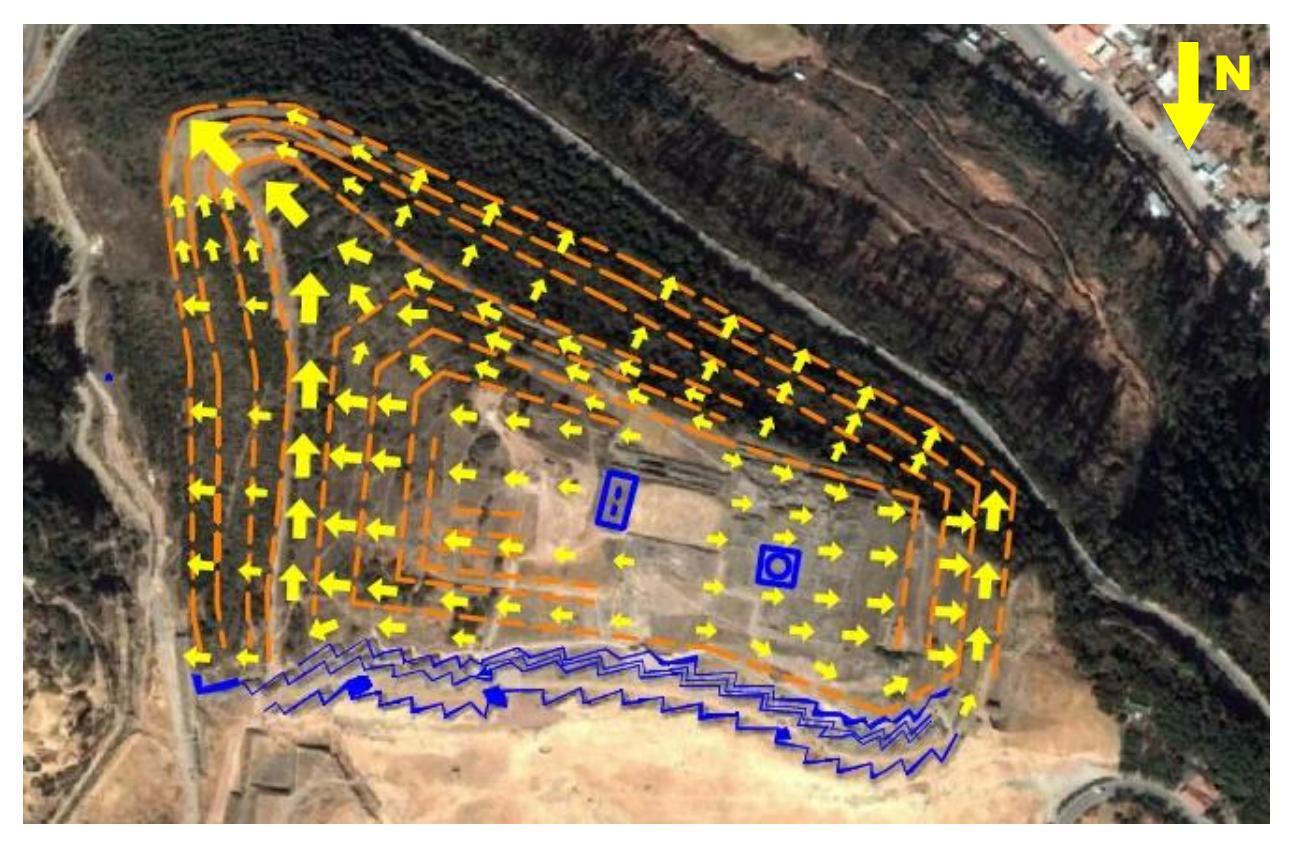
Figure 58. New Runoff Patterns with Terraces Layout

Comparing the flow patterns from figure 58 and 59 above reveals some very interesting points. The first major difference is irregularity of the flow in the current runoff patterns. The water flows in all directions throughout the site. It is much like a mountain where there is one high point and the flow pattern looks like concentric circles. The proposed terrace layout has a much more uniform flow pattern. Most of the water flows to the East, West, or North along defined sheets of flow. The second major difference is that the current flow pattern causes water to flow to the south over the main terrace walls, while in the terraces layout the water all flows to the east and west and none of the water flows to the south, thus avoiding the terrace walls. This would avoid the current problem of water buildup behind the third wall.

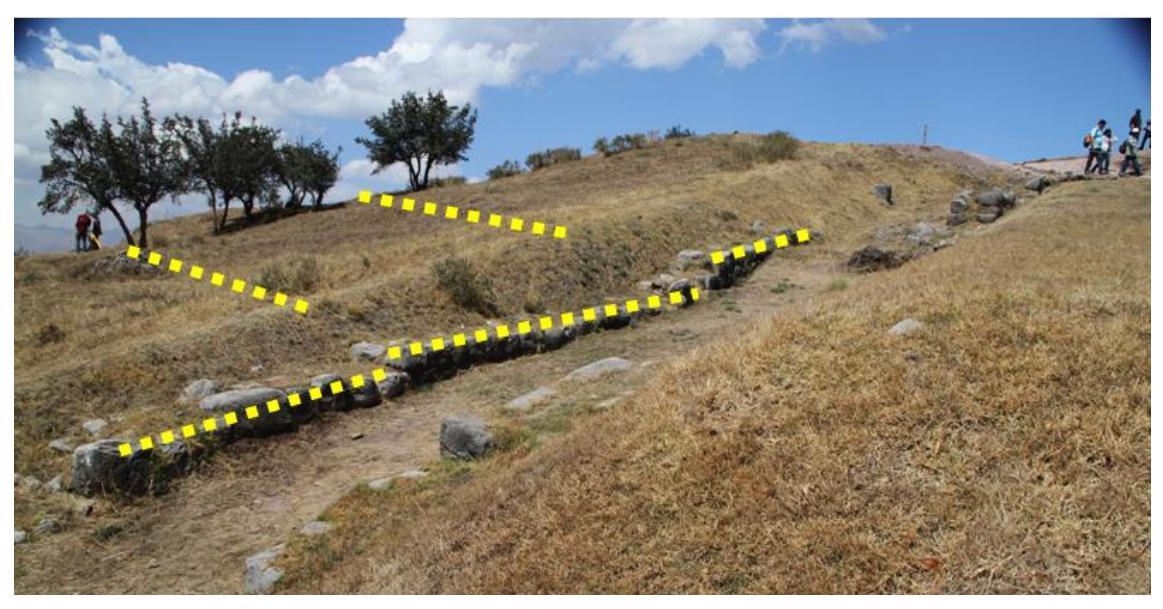
There is also other evidence that these terraces once existed. There are piles of stone rubble that could easily be the remnants of old terrace walls located just to the east of the new pedestrian walkway. There are also steps in the side wall of the old walkway that goes to the top of the lookout. These steps are shown in figure 60 and could be remnants of the sides of the old terraces. The current topography shows slight signs of terracing along the slope up to the lookout. There are several small flat areas located along the hillside to the left of the old walkway. These flat portions align with the piles of stones and the drops in the walkway which all suggest that there were once terraces located on this hillside (figure 61). The opposite flow

Figure 60. Step Down in Walls of Old Walkway to Top of Tower Sector (Miksad, 2013)

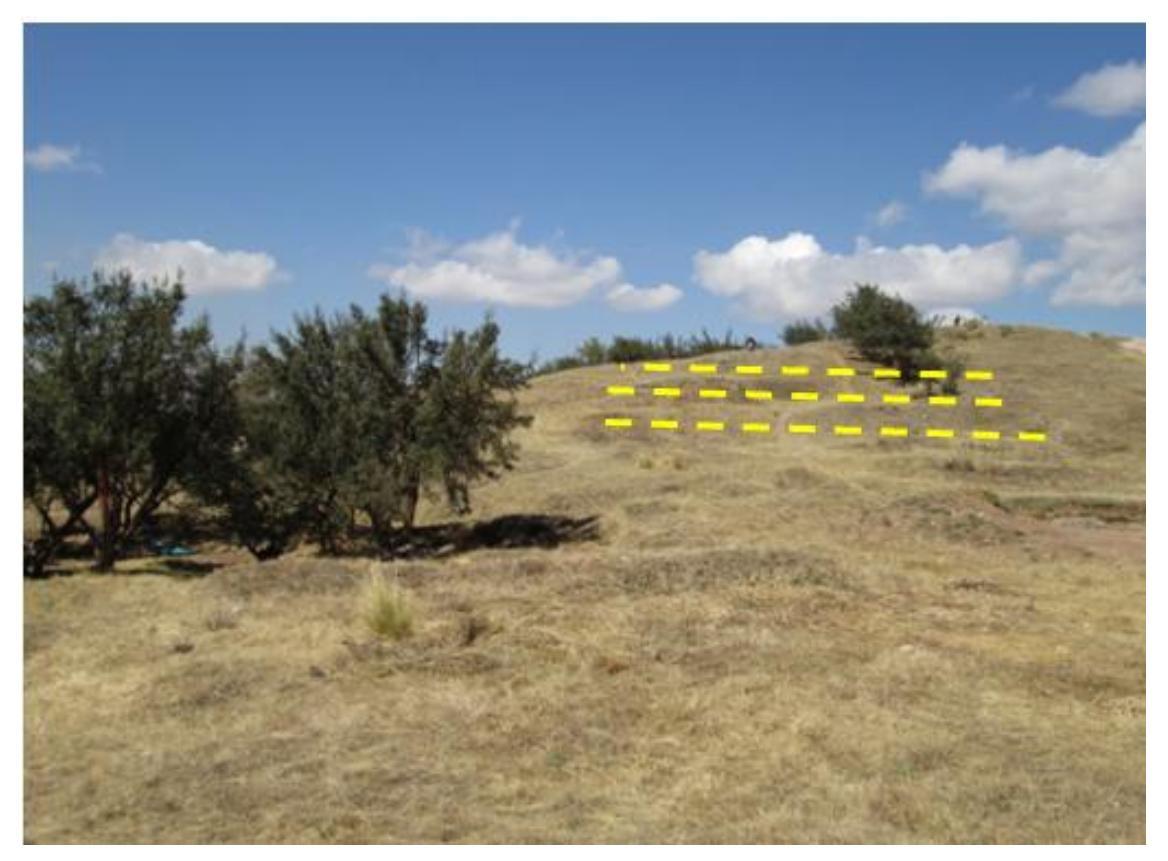
Figure 61. Signs of Possible Inca Terraces in Current Topography (Lohr, 2013)
