**Optimizing Surface Texturing for YSZ Thermal-Barrier-Coating on Inconel
718 Substrate to Mitigate High Stresses/Strains**

A Technical Report submitted to the Department of Materials Science & Engineering

Presented to the Faculty of the School of Engineering and Applied Science
University of Virginia • Charlottesville, Virginia

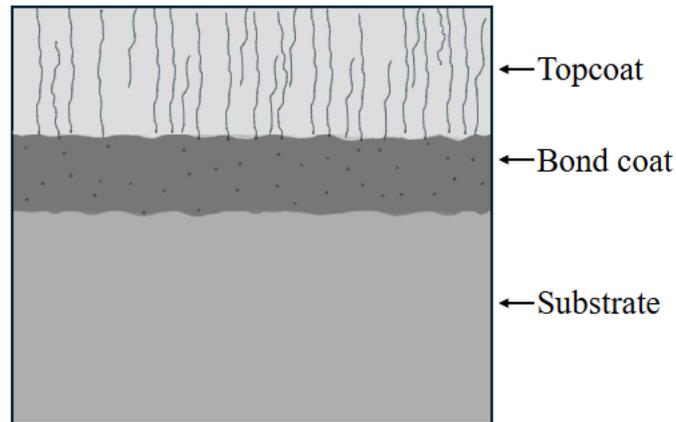
Figure 1: Dense Vertical Cracks (DVCs) as seen in a thermal barrier coating system

composed of a metallic bond coat for proper adhesion and a ceramic topcoat composed of Yttria-Stabilized-Zirconia (YSZ) with low thermal conductivity, as seen in Figure 1. While effective at reducing the amount of heat to which the substrate is exposed, the varied coefficients of thermal expansion (CTEs) of the different components within the coating system, when combined with thermal cycling, make the system susceptible to high stresses and, subsequently, coating spallation, oxidation, and failure.

The induction of Dense Vertical Cracking (DVC) is the primary method for improving strain tolerance of the coating, as it allows for the accommodation of the different CTEs. DVCs in the coating are currently generated through manipulating air plasma spray parameters close to the substrate surface; however, this is not conducive to coating complex geometries. Rolls-Royce has thus tasked the team with designing an alternate method of producing DVCs within the TBC topcoat.

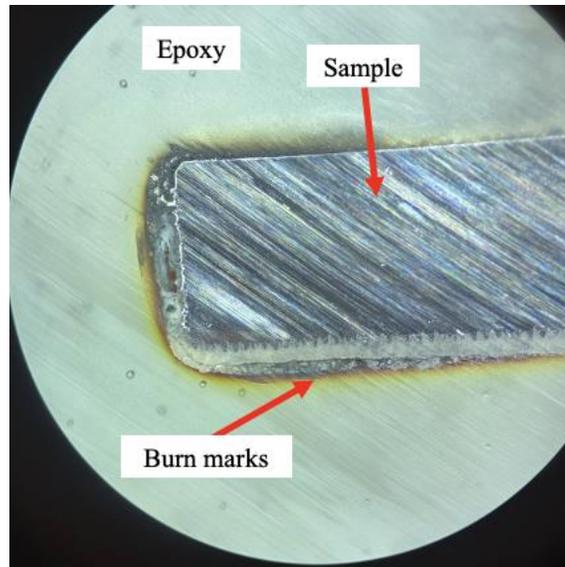
Figure 3: Mounted sample after being cut too fast, showing burnt TBC and some epoxy melting. After the saw was slowed down, the rest of the sample remained unburned.

Sectioning of mounted samples was first attempted using the same cutting speeds (0.15 mm/s) and saw blade (Aluminum Oxide) as the unmounted IN718. This proved to be too fast, and the epoxy mounted around the samples prevented heat dissipation from the sample, resulting in some TBC burning and epoxy melting (Figure 3). To prevent this, cutting speed was reduced to 0.015-0.03 mm/s, resulting in a 40-minute sectioning time per sample. This posed a severe bottleneck in the sample characterization process, so cutting had to be planned out well in advance.

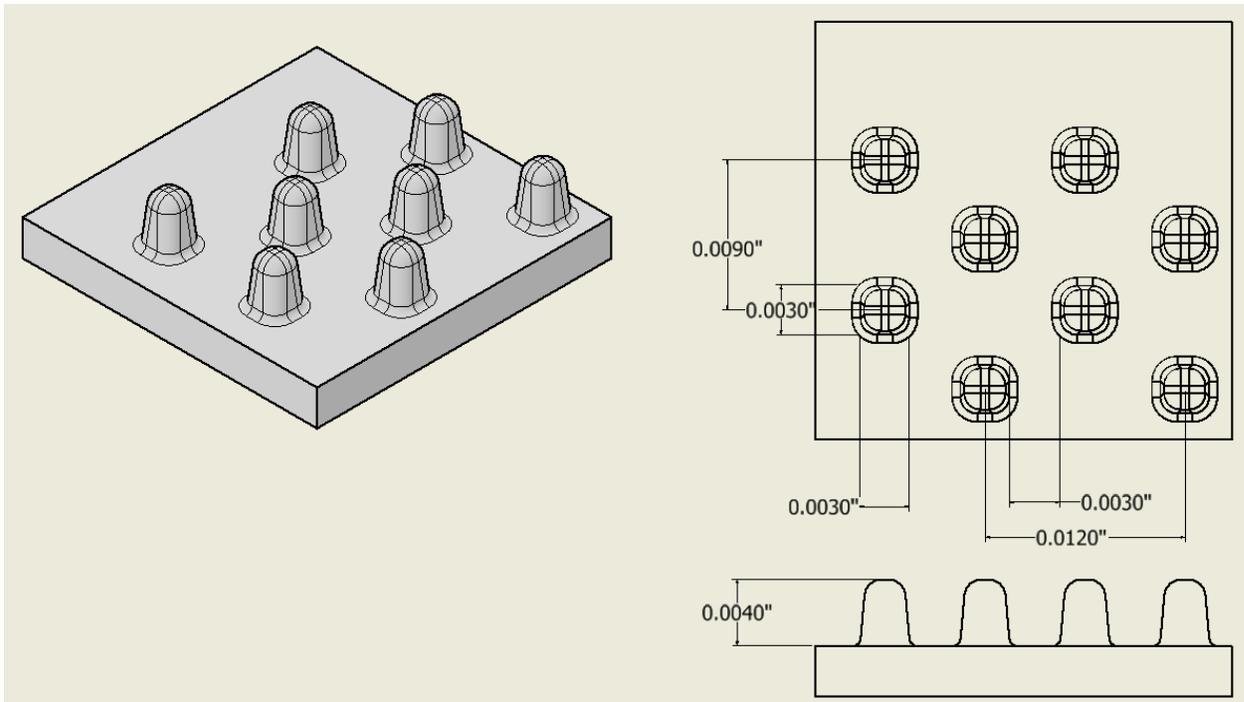
Figure 4: Dimensioned view of rounded spikes design.

For this project, the team conducted a literature review to see what textures had been tested for adhesion and DVC inducing properties in the past. Based on this review and industry partner discussions, three textures were developed and were to be laser ablated into the bond coat before TBC application. These textures are the rounded spikes (T1), grid pattern (T2), and grown texture (T3), shown with dimensions in Figure 4, Figure 5, and Figure 6. The grown texture was not seen in literature, but PulseTex has reported promising adhesion results with its use. Note that dimensions were provided in imperial units to comply with Rolls-Royce standards. These drawings were submitted to PulseTex and used as their reference for producing the textures.

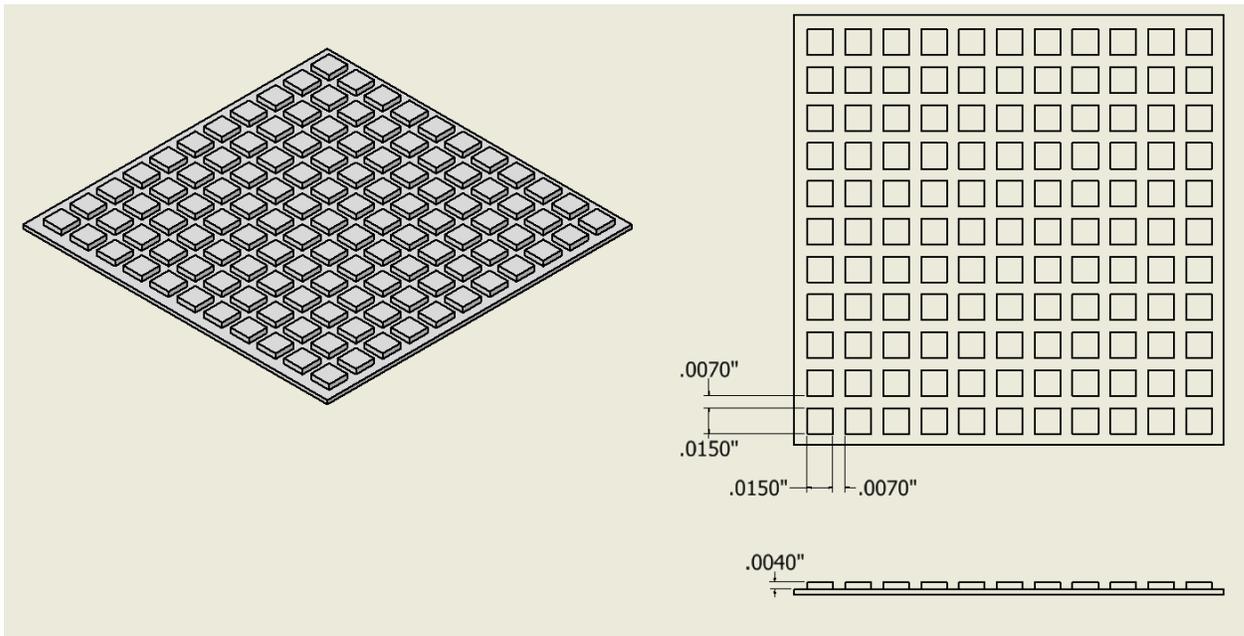
Figure 5: Dimensioned view of grid pattern design.

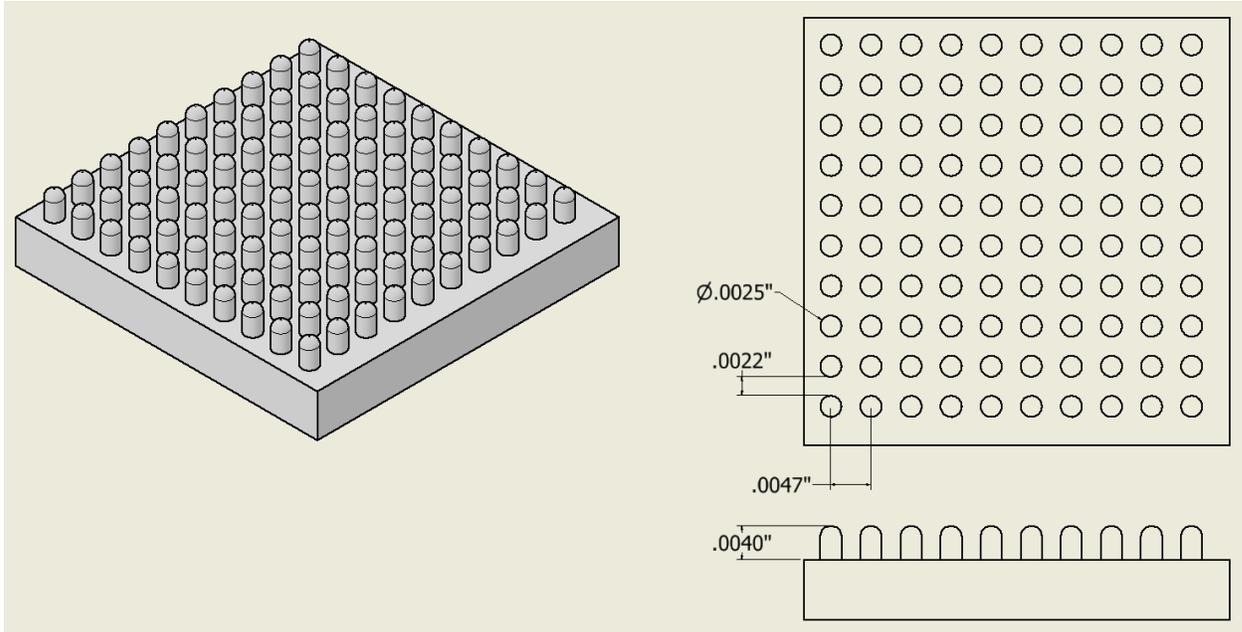
Figure 6: Dimensioned view of grown columnar texture. Dimensions are a rough estimate as the process is less controlled than ablation.

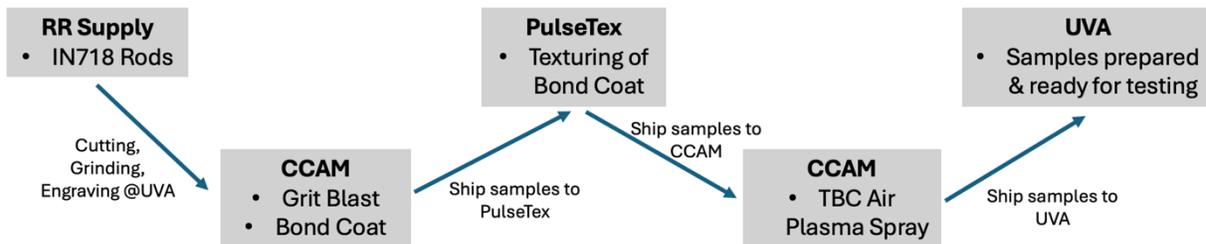
Figure 7: Sample generation pathway.

In order to produce samples with the desired textures built into the coating system, the following sample generation pathway was used (Figure 7).

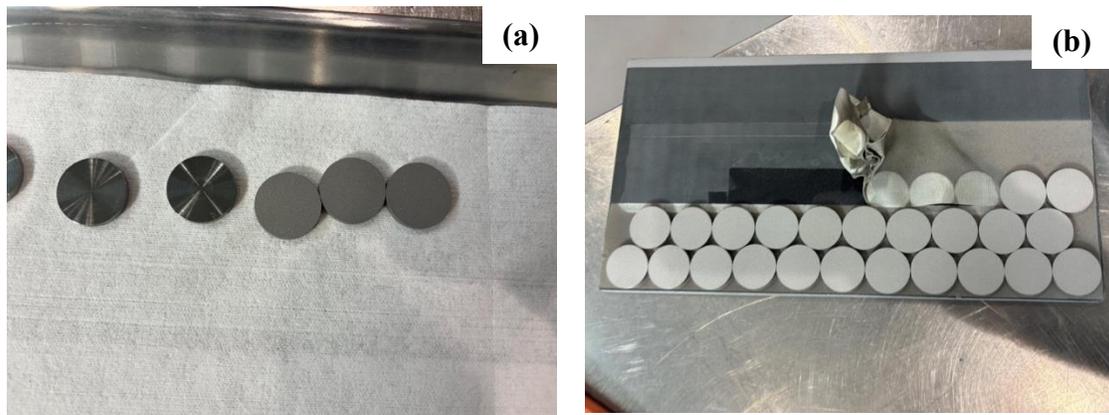
Figure 8: Samples after grit blasting; (a) comparison of machined (left) and grit blast (right) samples, (b) grit blast samples on a tray after being taken out of chamber.

On November 20th, the team traveled to the CCAM facility in Disputanta, VA to oversee the grit blasting and bond coat application of the samples. To prepare the samples for bond coat application, they were grit blast to roughen the surfaces and improve adhesion. Grit blasting was done in a chamber at CCAM using Aluminum Oxide 60 grit at 50 psi. CCAM decided to use a manual grit blaster due to the simple surface geometry of the samples and to avoid time required to program the automatic grit blaster. Thicknesses and masses were measured after this step to use as a baseline to calculate bond coat thicknesses after application.

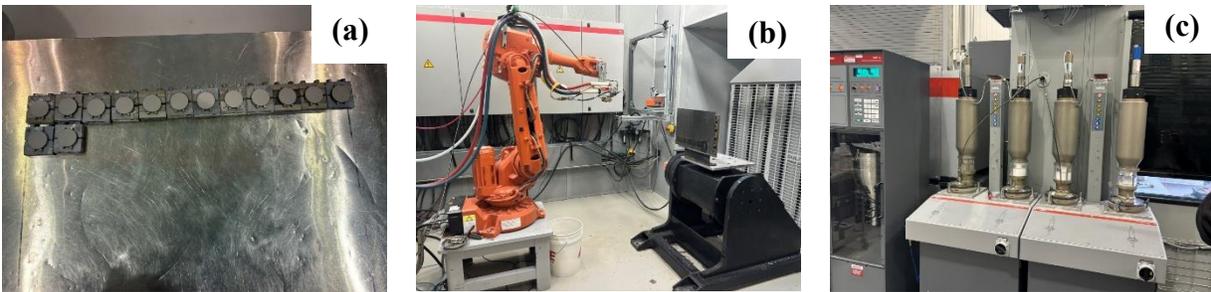
Figure 9: (a) Samples in holders being placed on magnetic board for spraying, (b) Robotic arm used for spraying, (c) Plasma powders fed into the gun.

At CCAM, the team put all grit blasted samples into sample holders. These holders clamped samples and were placed onto a magnetic board in the spray chamber. The bond coat was then sprayed according to specified bond coat parameters using a robotic arm. The plasma spraying itself was very bright, so the chamber was blacked out to prevent eye damage. Tecnar software was used to monitor spray particle velocity and temperature, complimented by an in-house software to monitor more parameters. The samples were sprayed in two batches due to space limitations within the chamber.

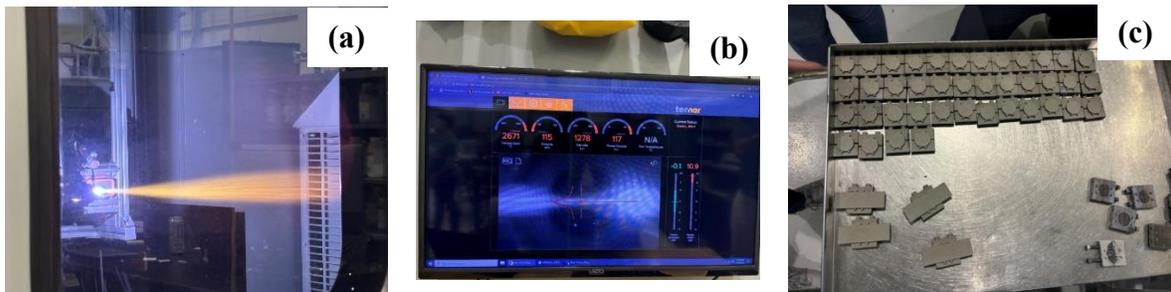
Figure 10: (a) Plasma spraying of the bond coat, (b) Monitoring of spray parameters on Tecnar software, (c) Samples after bond coat application.

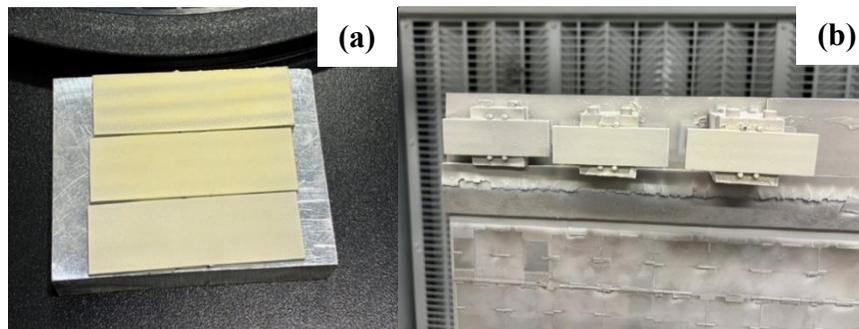
Figure 11: (a) 3 steel samples after TBC application, (b) Staggered samples on board after TBC spraying.

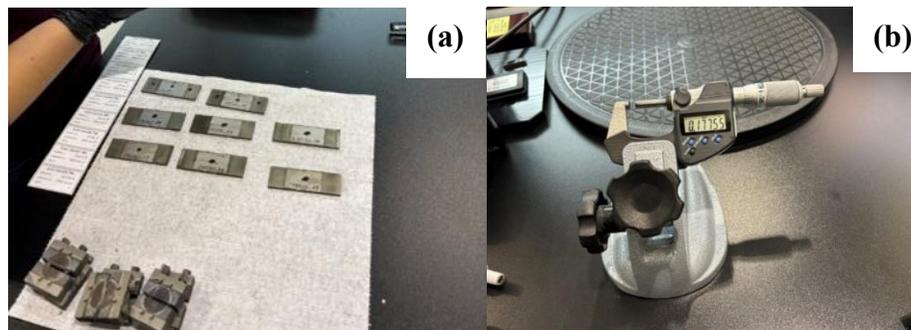
Figure 12: (a) Scale used to measure masses of steel samples before TBC spraying, (b) Caliper used to measure sample thicknesses before and after spraying.

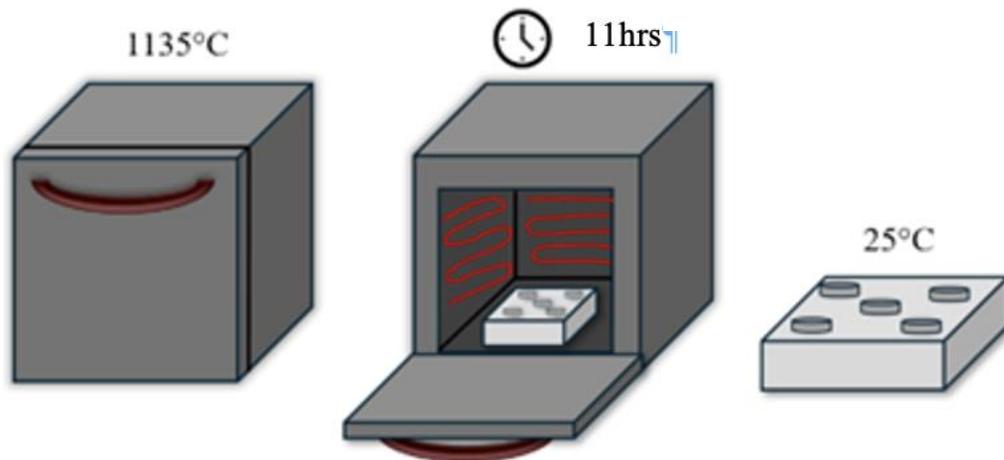
Figure 13: Thermal cycling experimental setup.

In order to test the efficacy of the textures in improving coating performance, thermal cycling tests were conducted. With modifications made to the original testing plan (see Project Challenges), 2 furnaces were reserved from February 10th- March 7th. During each cycle, samples were heated in each furnace (CM Rapid Temp Furnace 1200 Series, Bloomfield, NJ) to 1135°C for 11 hours, then taken out for 1 hour to cool on a block of alumina before being put back in for another cycle. During cycling, 2 of each texture were put in each furnace to eliminate the possibility of an entire set of textures failing due to an individual furnace malfunction. Samples were individually weighed after each cycle to monitor mass change possible associated with oxide growth and TBC spallation. Significant analysis regarding mass loss/gain was not conducted as it was not possible to distinguish between mass gain from oxide growth and mass loss from spallation. After each cycle, a picture was taken of all the samples to track coating behavior. Further information regarding equipment and cycle timing can be found in Appendix B. The experimental procedure is shown in the diagram depicted in Figure 13.

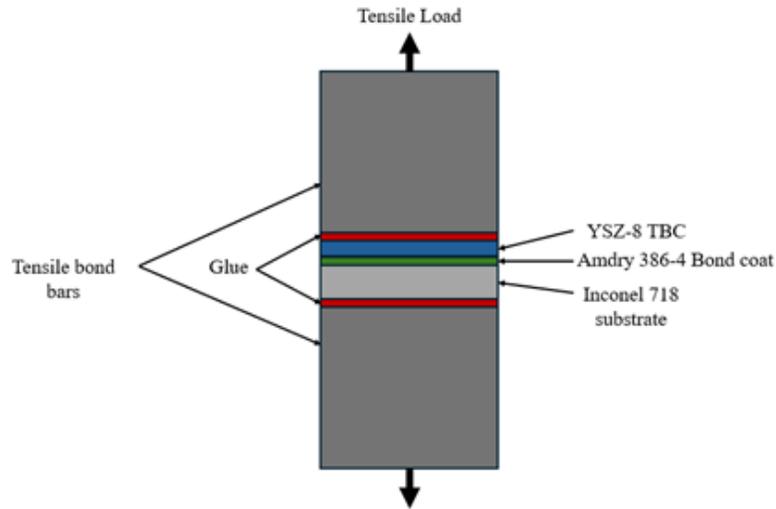
Figure 14: Tensile adhesion testing setup.

The team sent 12 samples to Rolls-Royce for adhesion sampling. This is made up of three samples of each of the three laser produced textures and three grit blasted samples. The samples underwent tensile adhesion testing in accordance with ASTM standard C633. The adhesive used for the testing was FM1000. Bond strength of the adhesive was recorded to be a minimum of 9900psi, which was used to compare the values measured for coated samples. All coated samples were found to have failed at significantly lower stresses, eliminating the possibility of failure within the glue. Thus, all tested samples failed somewhere in the coating system. The tensile adhesion testing setup is shown in Figure 14.

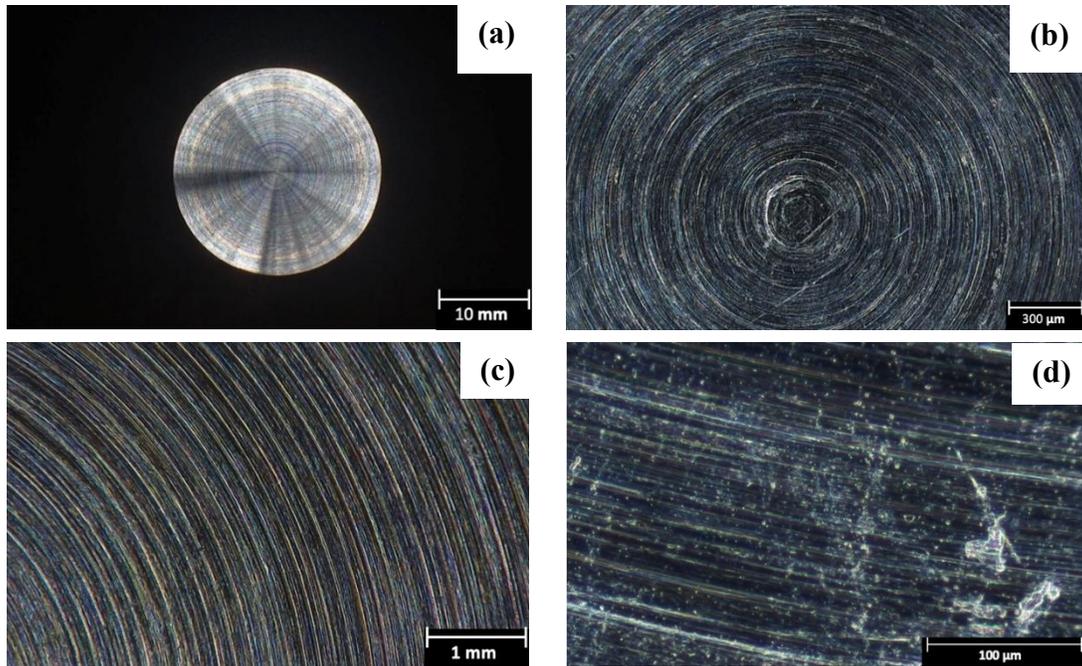
Figure 15: Micrographs of a lathe-cut IN718 sample taken by the Hirox Optical microscope at various magnifications; (a) overview of machined sample at 5X, (b) center of machined sample at 140X, (c) lathe marks at 50X, and (d) lathe marks at 1000X.

Before coating the IN718 substrates for testing, it was important to establish its baseline properties. Optical micrographs of the IN718 samples were taken as-cut (by the lathe) and after grinding to verify desired surface quality.

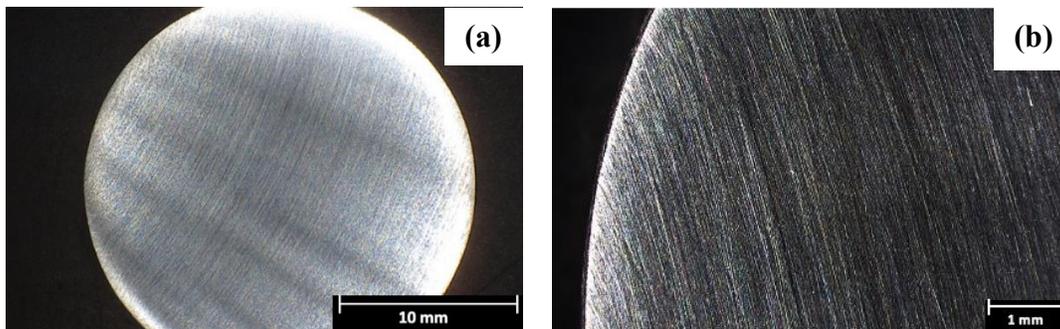
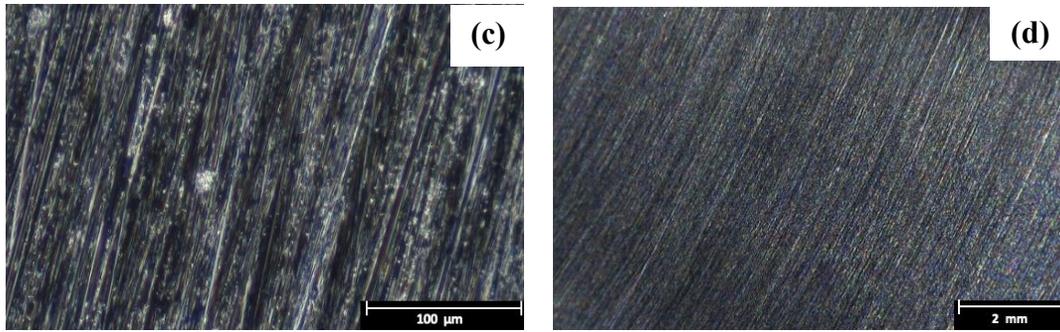
Figure 16: Micrographs of a lathe-cut IN718 sample after polishing with 180 grit sandpaper taken by the Hirox Optical microscope at various magnifications; (a) overview at 10X, (b) edge of sample at 30X, (c) polish of sample at 1000X, (d) polish of sample at 30X.

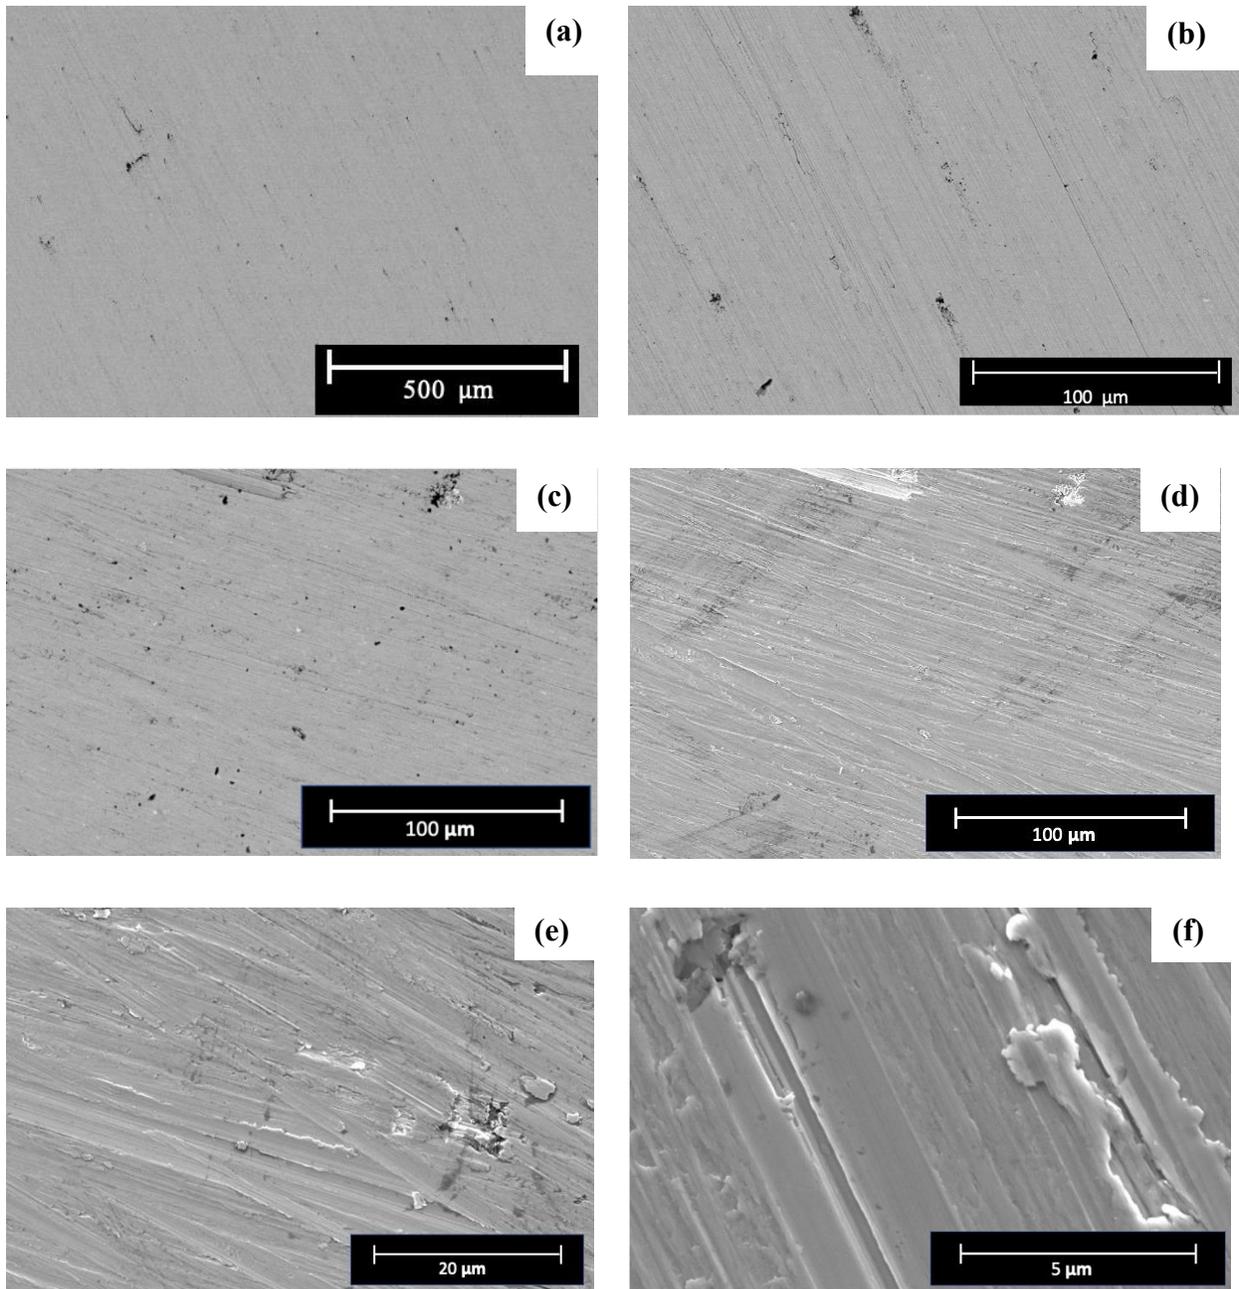
Figure 17(a), (b), (c), (d), (e), (f): Micrographs of a lathe-cut IN718 sample after polishing with 180 grit sandpaper taken by the Quanta 650 scanning-electron-microscope in BSE mode at various magnifications.

The team also studied the substrate using the SEM (Figure 17) and conducted EDS analysis (Figure 18) to verify composition. Understanding the substrate composition was critical in order

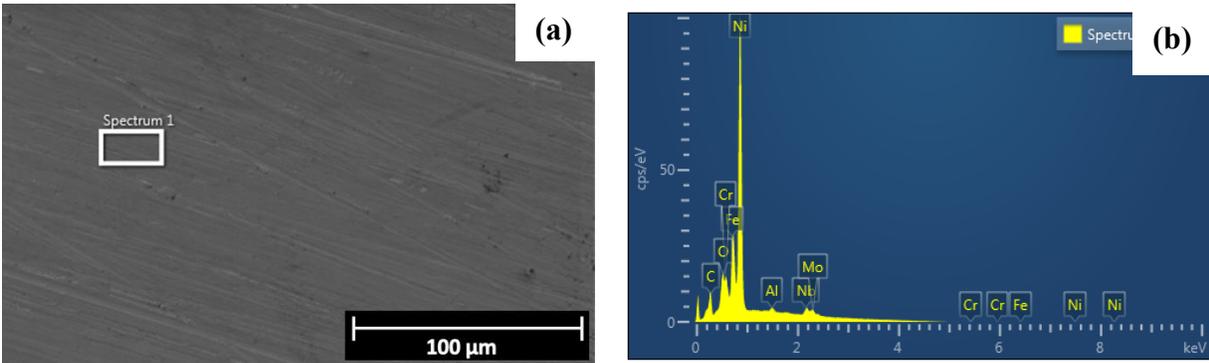
Figure 18: EDS compositional analysis performed on IN718 sample. (a) Inspected region and (b) Corresponding spectrum.

to later understand how the coating system was impacted by the elements of the substrate, especially after thermal testing. The EDS results (Table 10) showed elemental composition within normal range for IN718, as can be seen in Table 11.

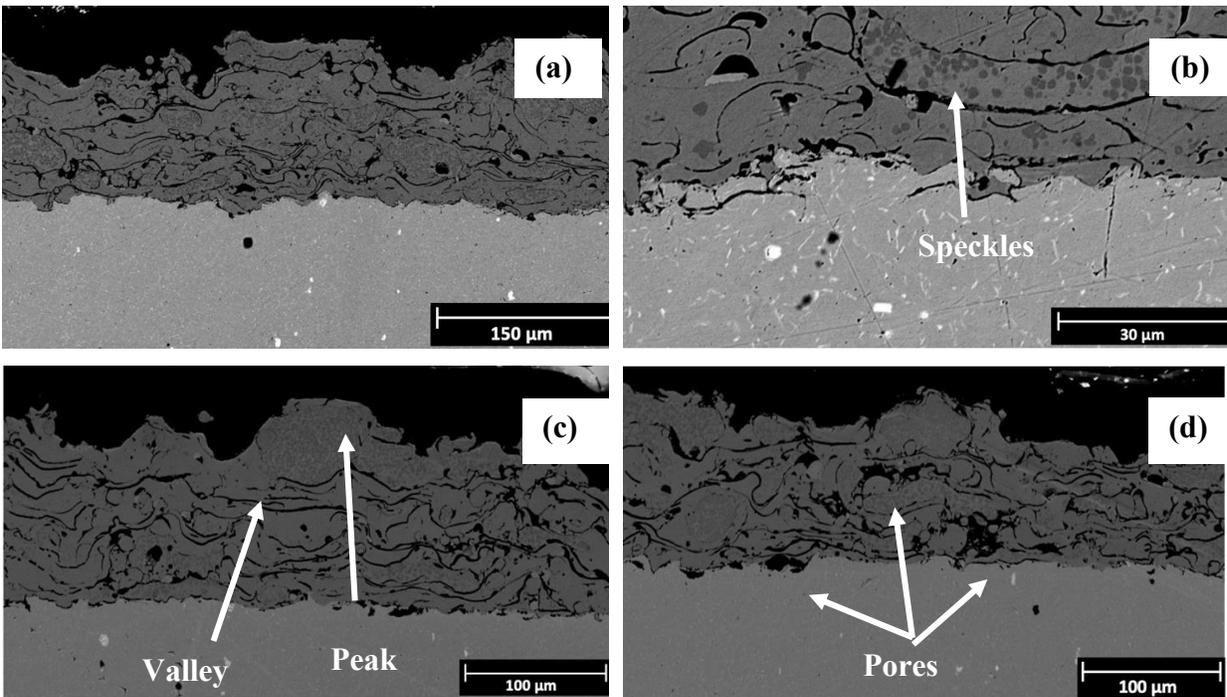
Figure 19: BSE SEM micrographs of bond coat/substrate interface. (a) Wide view of interface at 1000X, (b) High magnification view of interface taken at 5000X showing the roughness of the substrate, (c) Peaks and valleys seen in the bond coat profile, and (d) Porosity found in the coating.

One of the bond coated samples was then cross-sectioned and imaged using the Phenom SEM to inspect the bond coat-substrate interface and the profile of the bond coat before TBC application. Micrographs are shown below in Figure 19. The micrographs show a distinct, mildly rough interface between bond coat and substrate, peaks and valleys at the top of the layer, visible splats, and porosity formed during the spraying process. Microscopy also revealed “speckles” throughout the bond coat.

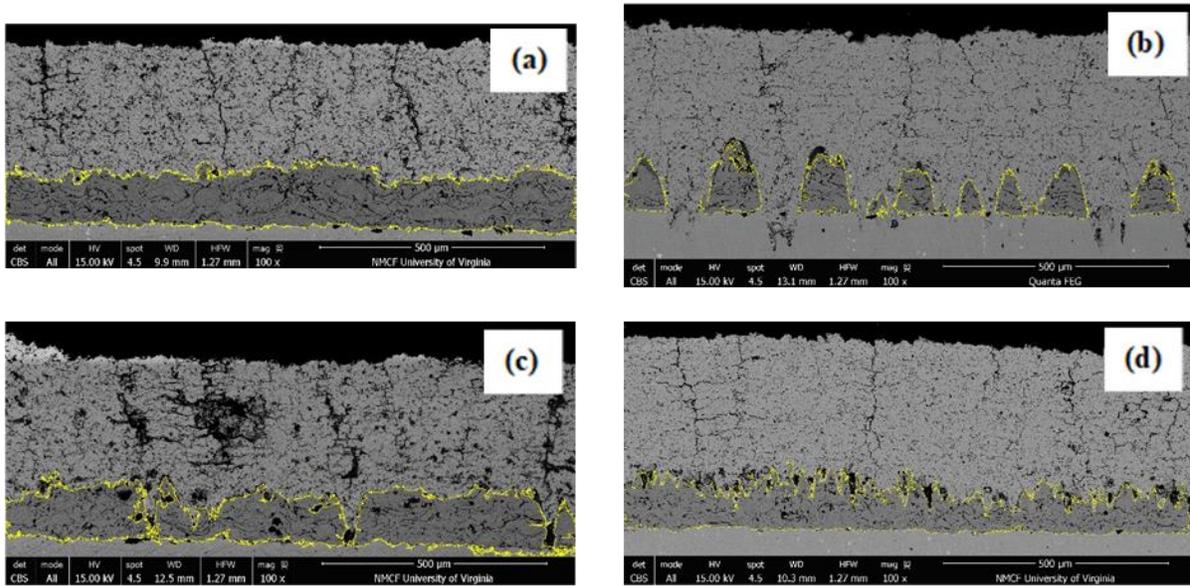
Figure 20: Examples of the area selection utilized for determining the average bond layer thickness of each texture. (a) GB, (b) T1, (c) T2, and (d) T3.

The average bond coat thickness of the as-sprayed samples for each texture was measured from 3-4 SEM micrographs taken at 100X magnification. Utilizing the ImageJ software, the area of the bond coat in each image was determined. Below, in Figure 20, is a representation of the area selection. The average length was then determined utilizing the formula below:

Dividing the total area across the micrographs by the total length of the micrographs results in a thickness measurement averaged across all the micrographs.

The most important results of this ImageJ analysis are the minimum thicknesses. At the minimum, the T1 and T2 sample analyzed had a minimum bond coat thickness of 0 μm . In fact, outside of these sampled micrographs, there were many areas where missing bond coat was noted throughout analysis for the project. This meant that in several locations, the laser ablated all the way through the bond coat into the substrate – something that was not intended and facilitated oxidation mechanisms that contributed to poor performance in thermal cycling tests (See Discussion of Results).

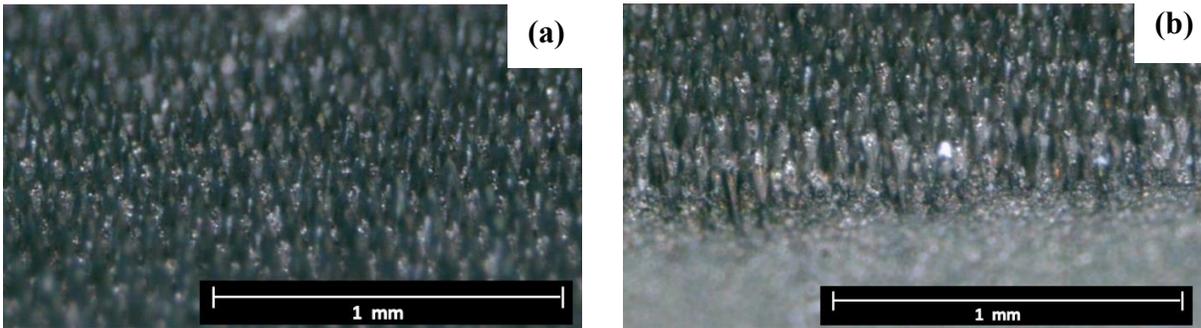
Figure 21: Optical micrograph of rounded spikes texture produced by PulseTex.

Using ablative laser technology, PulseTex produced selected textures. Preliminary optical micrographs taken at an angle were supplied by PulseTex and are in Figure 21, Figure 22, and Figure 23. The team then took more detailed SEM micrographs to examine the textures from a top-down view. These micrographs can be seen in the following section in Figure 24, Figure 25, and Figure 26.

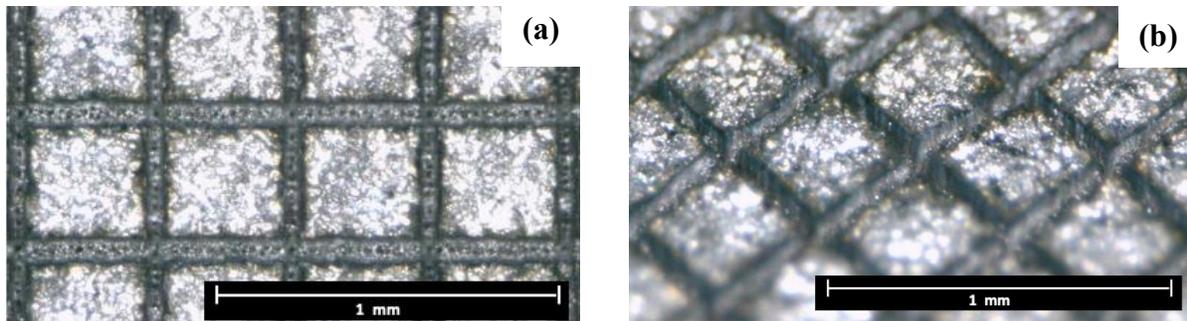
Figure 22: Optical micrographs of grid pattern texture produced by PulseTex.

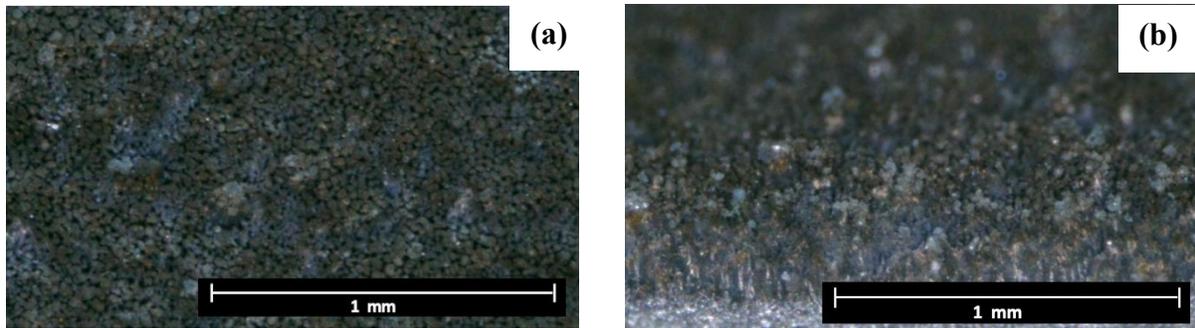
Figure 23: Optical micrographs of grown texture produced by PulseTex.

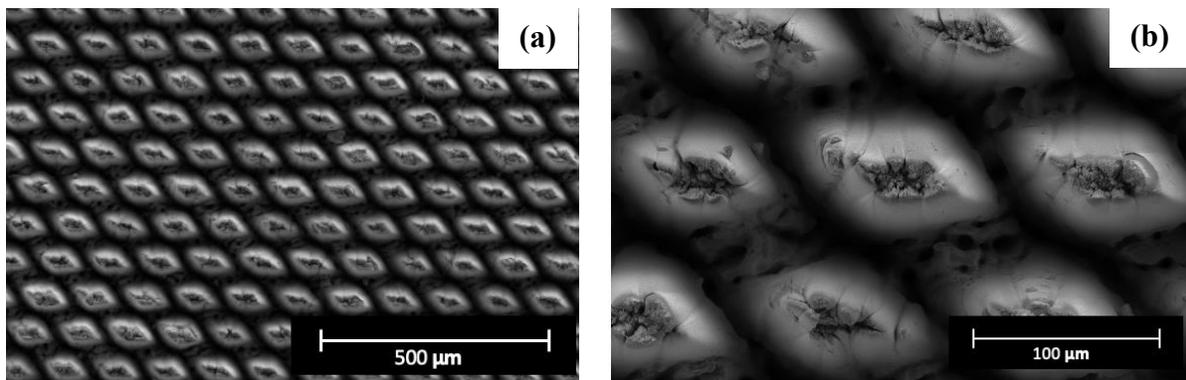
Figure 24(a), (b): SEM micrographs of rounded spike textured sample.

The micrographs shown below are the results from SEM completed using the Quanta 650 to inspect the textured samples prior to bond coat application. The secondary electron detectors were used in order to capture micrographs that best showed the surface topography.

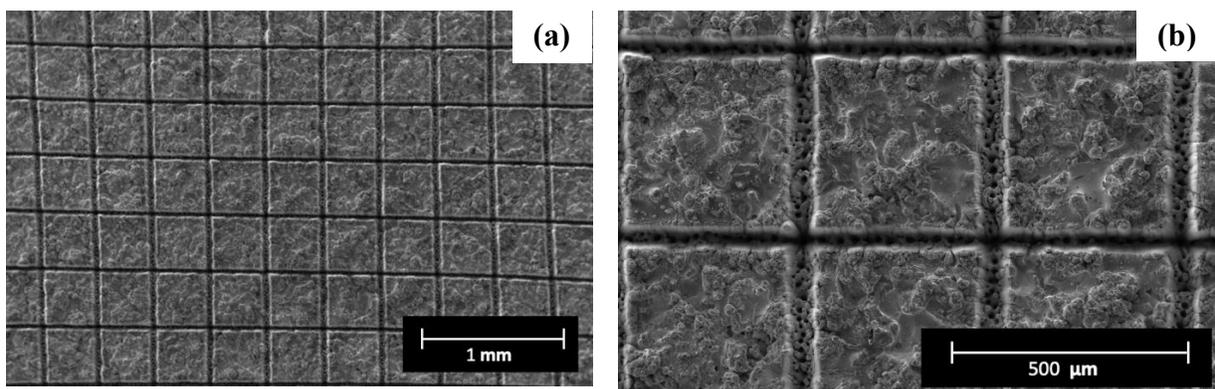
Figure 25(a), (b): SEM micrographs of grid pattern texture sample.

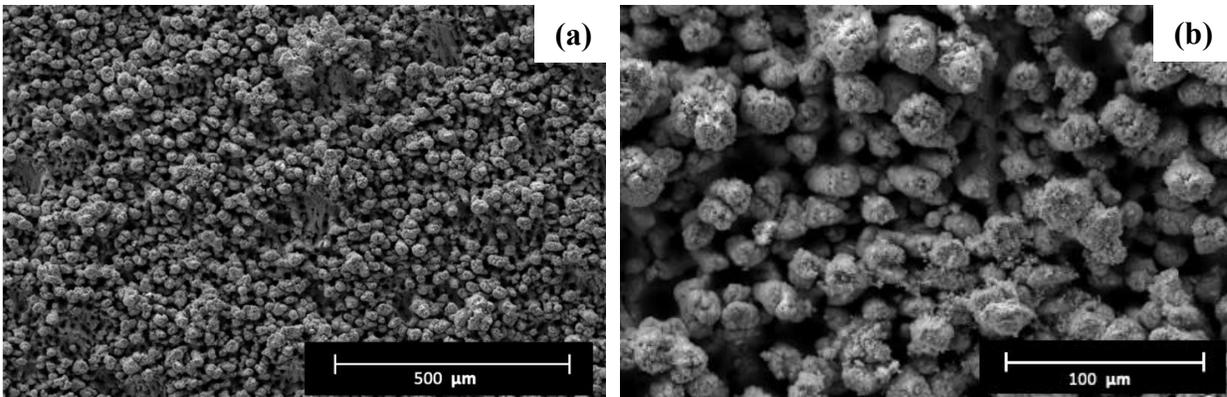
Figure 26: (a), (b): SEM micrographs of grown texture sample.

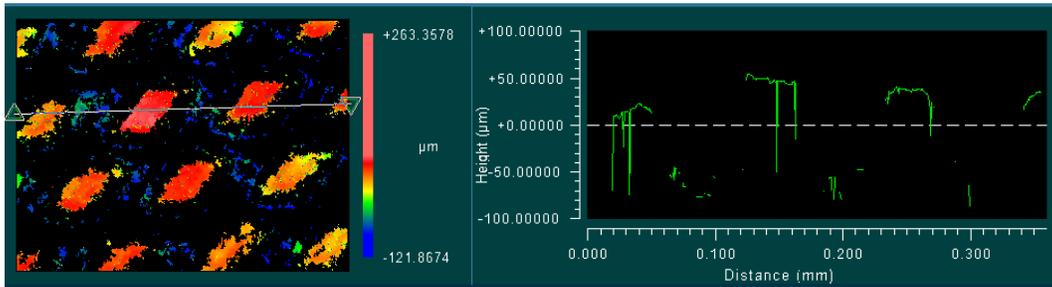
Figure 27: Zygo profilometry scan of rounded spike texture at 20X.

The T1 scan required an “extended” scan length of 350μm along with the offset to maximize the number of data points collected. Here, scan length refers to the depth of the scan. The

objective in a regular “bipolar” scan starts at an initial position, moves down half the scan length then scans upward. The objective in an extended scan only scans upwards, starting at a lower initial position. While the peaks of the rounded spikes appear very clearly, the sides and grooves did not, as seen in Figure 27. Based on the surface profile, the rounded spikes have an average depth of about 120 μm .

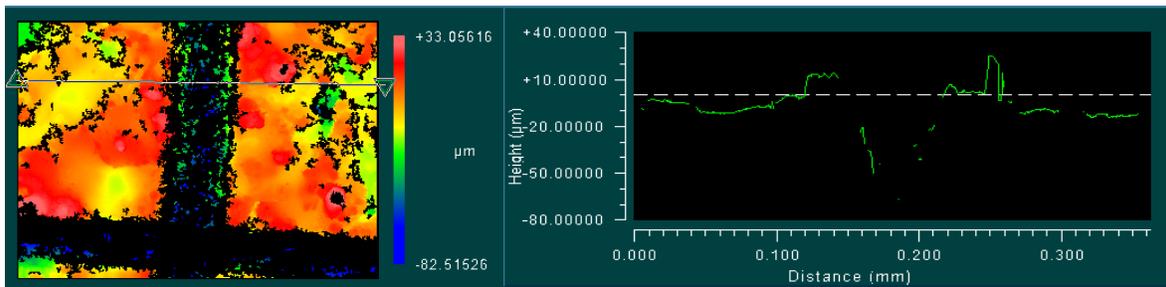
Figure 28: Zygo profilometry scan of grid pattern at 20X.

The scans for T2 and T3 required a regular bipolar scan with a scan length of 150 μm . The T2 scan focused on part of two grid squares and the groove in between them, having similar issues to the T1 scan (Figure 28). Based on the surface profile, the depth of the grid pattern is about 80 μm .

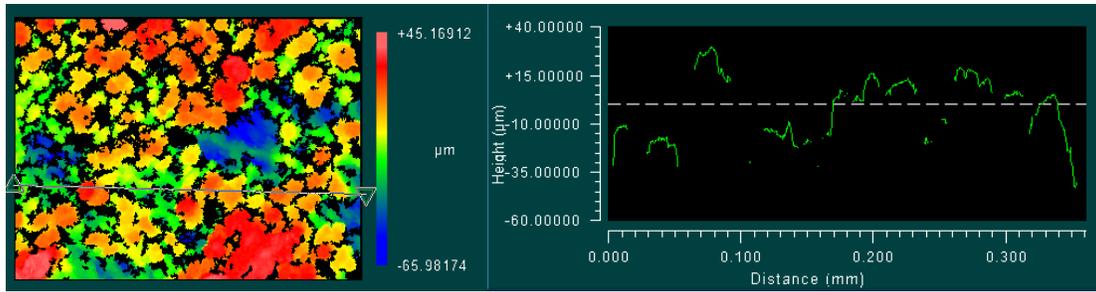
Figure 29: Zygo profilometry scan of grown texture at 20X.

With the grown column texture, it is extremely difficult to determine the average depth due to the large variation of heights, as seen in Figure 29.

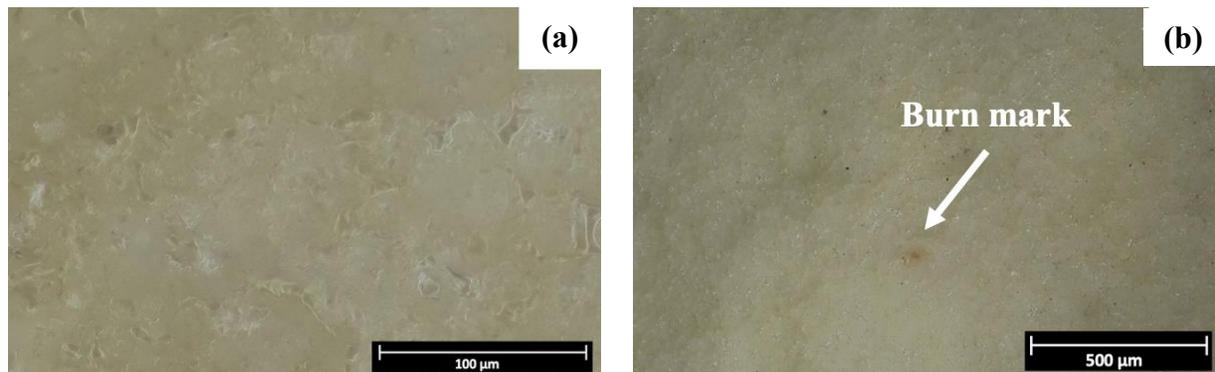
Figure 30: Optical Micrographs of the as-sprayed TBC surface; (a) at 1000X, and (b) 140X.

In order to choose a set of TBC spray parameters to use on textured samples, CCAM applied a set of 9 different spray parameters on steel samples. The 9 steel samples with the 9 different spray parameter configurations were analyzed in order to choose the most optimal TBC spray parameter for the IN718 samples. The TBC surface was first observed using optical microscopy, as seen in Figure 30. These micrographs show a rough surface, as expected from the plasma spraying method, and possible burn marks.

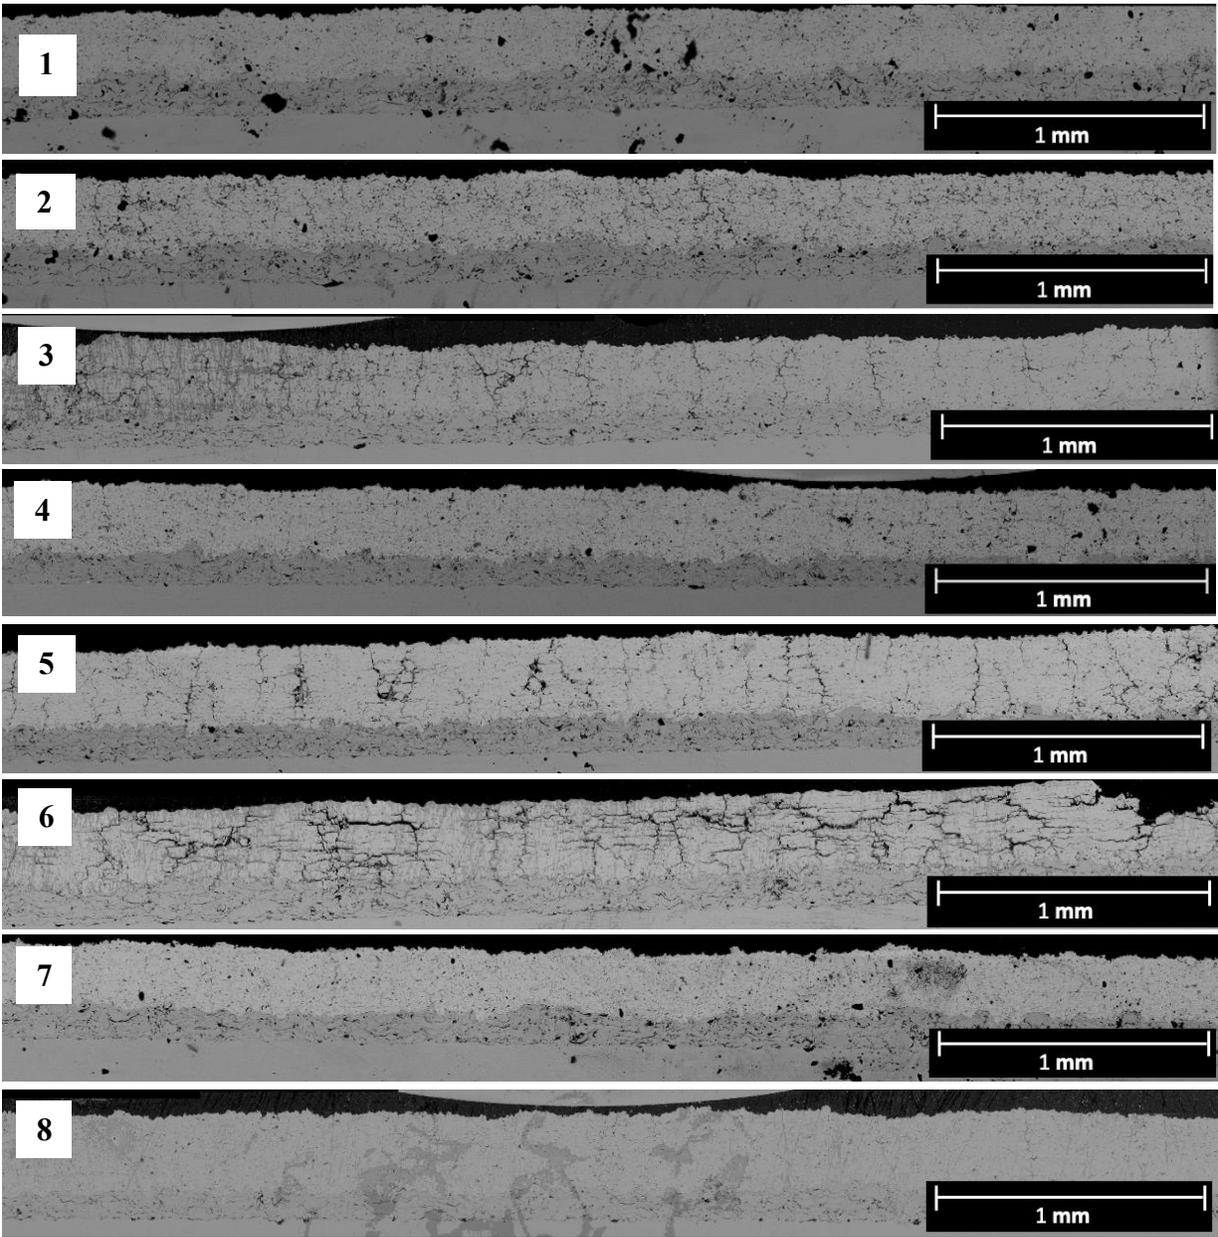
Figure 31: Cross-sections of the nine different TBC steel samples corresponding to spray parameters in

The group cross-sectioned, mounted, and polished the TBC steel samples for SEM analysis to determine their microstructure. These views are made up of 6 micrographs taken at 150X in Back Scattered Electron mode (BSE) and then stitched together in ImageJ. The 9 different micrographs are shown in

Through this analysis, the team learned what kinds of DVCs may form. The vertical cracks that can be seen prominently in spray parameters 3 and 4 of

are the kind of DVC formation desired. However, vertical cracks can also develop horizontal branches, as seen in spray parameter 6, which can cause spallation and breaking off of entire sections of coating. This is something that should be avoided.

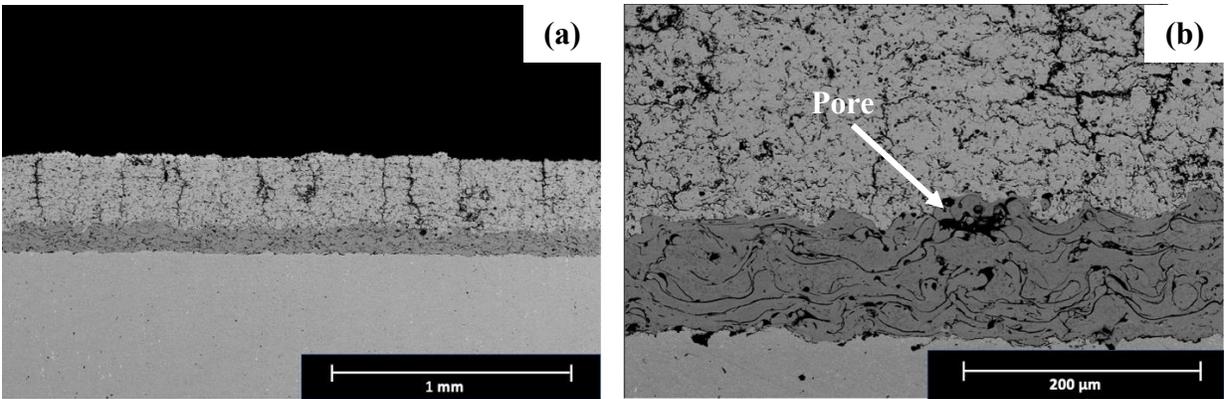
Figure 32: BSE SEM taken for the non-textured, grit-blasted as-sprayed sample. It is observed that the DVCs tend to follow a random pattern.

SEM was conducted for as-sprayed GB, displayed in Figure 32. The micrographs show that the bond coat covers the substrate relatively uniformly. The DVCs appear to be wider than originally anticipated on this unexperimented sample and they fall randomly. There are some pores located in the bond coat.

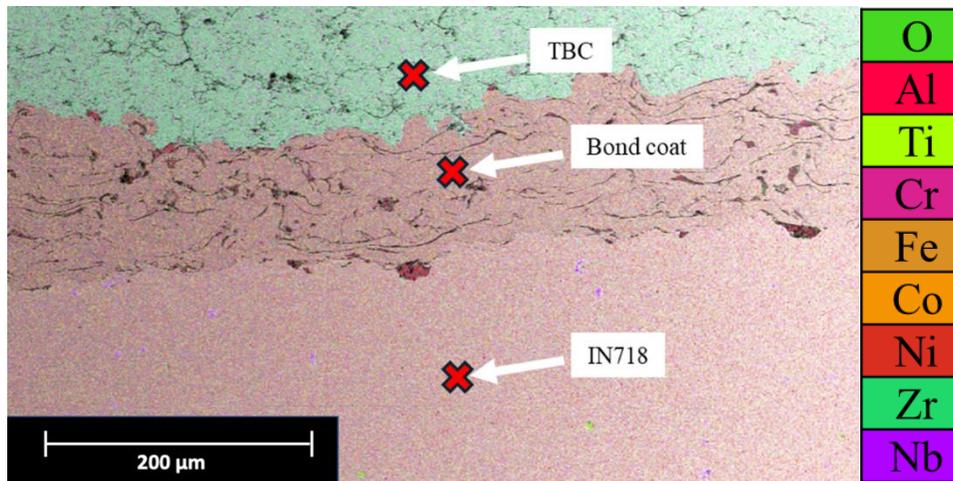
Figure 33: EDS of as-sprayed GB sample. Shows the expected three regions of TBC, bond coat, and IN718.

The team conducted EDS to examine compositional anomalies and supplement SEM micrographs. Note that EDS was conducted on the Phenom SEM XL which is not calibrated for exact values, so compositional information should only be used to compare to other EDS and not nominal compositional values. Figure 33 and Table 14 show EDS obtained for the GB sample. There are three distinct regions—IN718, bond coat, and TBC—as expected.

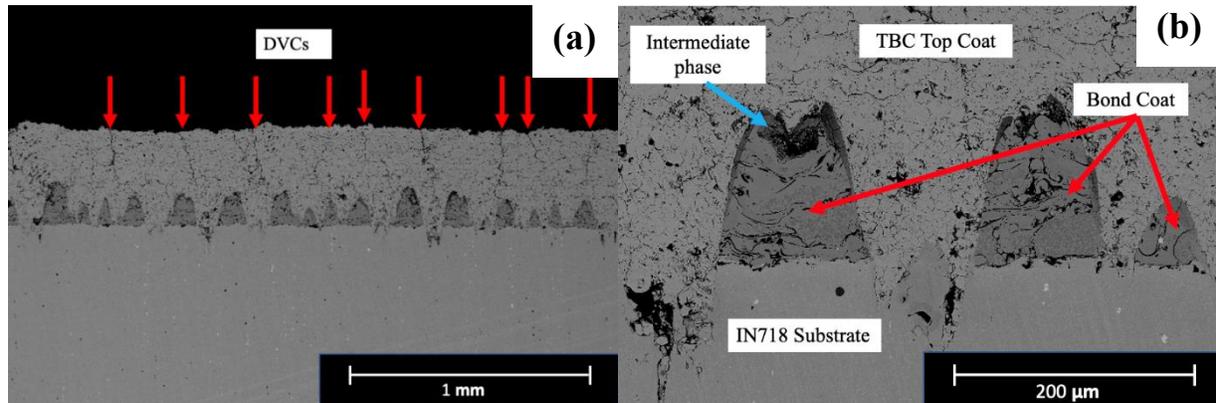
Figure 34: BSE SEM micrographs of coated rounded spike textured sample at (a) 50X and (b) 250X. Micrographs show that most of the bond coat was removed during ablation.

Shown in Figure 34 are micrographs of the untested, fully coated T1 rounded spike samples. As expected, there are three primary regions: (1) IN718 substrate, (2) bond coat with texture, and (3) TBC topcoat. There is also an unexpected intermediate phase that is found at the interface between the bond coat and the TBC. Further investigation into this phase can be found in the following section that covers Energy Dispersive Spectroscopy (EDS).

It is important to note what is missing from the micrograph, namely a continuous layer of bond coat between the texture and the IN718 substrate. According to the designs submitted to PulseTex by the team, it was anticipated that the texture would make up less than half of the bond coat thickness. The micrographs, however, reveal that the entire bond coat is either textured or missing. In the spaces between spikes, there is no bond coat, resulting in contact between the TBC and IN718 substrate. This feature is detrimental and could be the failure initiation site for thermal testing that depends on the strain for differing expansion between layers. Furthermore, in the regions missing the bond coat, there is also damage to the substrate that is not consistent with surface roughness from the grinding and grit blasting previously conducted. This indicates that

laser parameters developed by PulseTex may have been too aggressive for the bond coat and caused its complete removal and laser penetration into the substrate.

The team supplemented micrographs with EDS to investigate unexpected regions within the coating system. One such region of note is the “intermediate phase” labeled in Figure 34(b). Shown in Figure 35 and Table 15 are the results of EDS analyzing each region of the coating system. EDS was done on the Phenom XL G2 SEM, which is not properly calibrated, meaning that the exact compositions found by the EDS are not to be accepted as accurately reflecting the exact composition of the sample.
