**Optimizing Surface Texturing for YSZ Thermal-Barrier-Coating on Inconel
718 Substrate to Mitigate High Stresses/Strains**

A Technical Report submitted to the Department of Materials Science & Engineering

Presented to the Faculty of the School of Engineering and Applied Science
University of Virginia • Charlottesville, Virginia

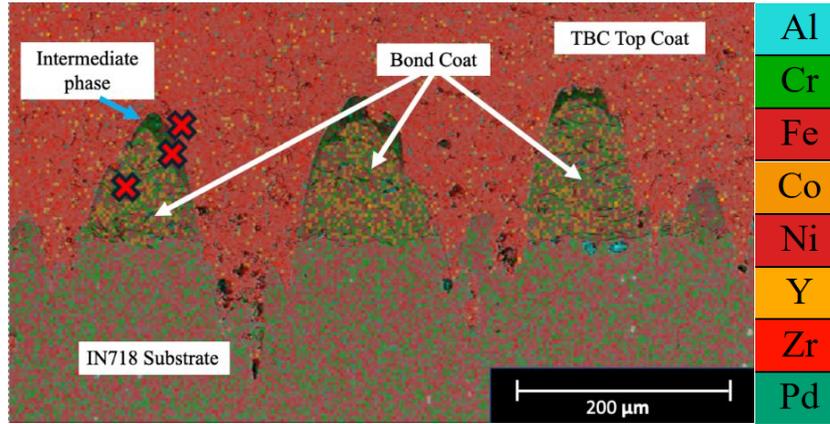
Figure 35: Map EDS of rounded spike coated sample. Shows four distinct regions: IN718 substrate, bond coat, intermediate phase, and TBC topcoat. Point EDS was conducted on regions with red X.

The team supplemented micrographs with EDS to investigate unexpected regions within the coating system. One such region of note is the “intermediate phase” labeled in Figure 34(b). Shown in Figure 35 and Table 15 are the results of EDS analyzing each region of the coating system. EDS was done on the Phenom XL G2 SEM, which is not properly calibrated, meaning that the exact compositions found by the EDS are not to be accepted as accurately reflecting the exact composition of the sample.

These results clearly show that there is a compositional difference between the intermediate region and the rest of the coating system. The most significant differences are that, relative to the bond coat, the intermediate layer is iron and nickel rich, and it is cobalt and aluminum deficient. Note that neither the bond coat nor the TBC contain iron, meaning the only place in the system it could originate from is the substrate. This suggests that at the end of the laser process the substrate may have been ablated resulting in free nickel and iron within the system which then diffused into the top layer of the bond coat, resulting in a layer that is deficient in aluminum and cobalt relative to the rest of the bond coat. This theory is supported by the presence of an intermediate layer on spikes that are next to deep trenches in the substrate. The effects of such a layer are unknown; they could potentially be seen during testing, though given the missing bond

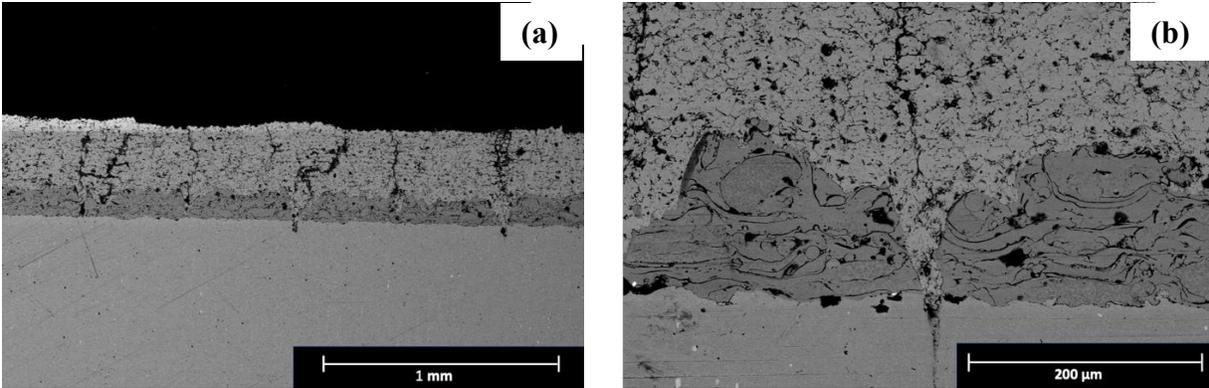
Figure 36: BSE SEM of T2 grid pattern at different magnifications (a,b). It is observed that the laser went through the entire bond coat at spots, allowing the TBC to be in contact with the surface.

SEM was conducted for as-sprayed T2, displayed in Figure 36. The micrographs show that for some of the grid lines, the laser went all the way through the bond coat and into the IN718 substrate. This allowed the TBC to come into direct contact with the substrate at those points. It is also observed that the DVCs appear wider than originally anticipated, and they tend to fall in line with the grid lines. DVCs appear at the trenches independent of full ablation of the bond coat; even in trenches where bond coat remains, DVCs appear.

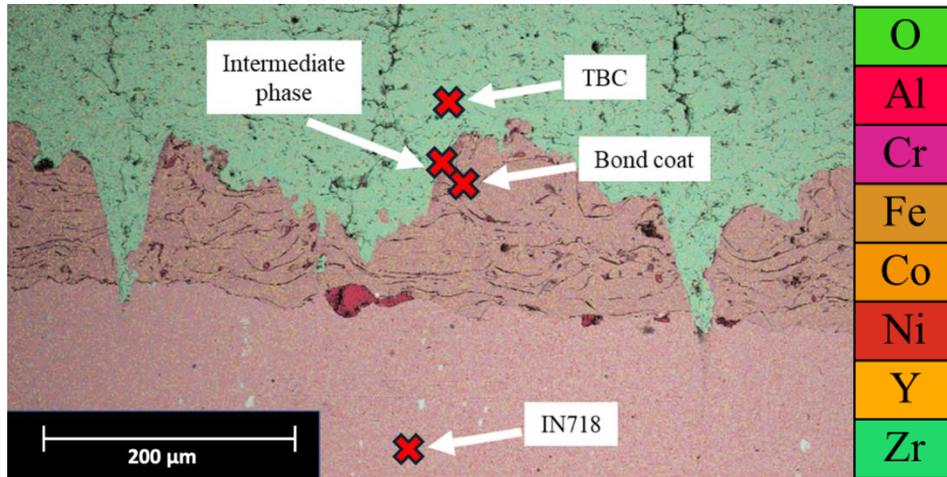
Figure 37: EDS of T2 sample. Shows four distinct regions that include IN718, bond coat, TBC, and an intermediate phase between the bond coat and TBC.

EDS conducted on T2, displayed in Figure 37 and Table 16, showed IN718, bond coat, TBC, and an intermediate phase, similar to T1 when the laser penetrated through the bond coat to the substrate. This intermediate phase is found at the interface between the bond coat and the TBC. This phase is a nickel rich, oxidized layer on top of the ablated texture, presumably formed during laser ablation when the laser penetrated through the bond coat to the substrate. The layer is less prominent than it was in T1, likely due to less penetration of the substrate.

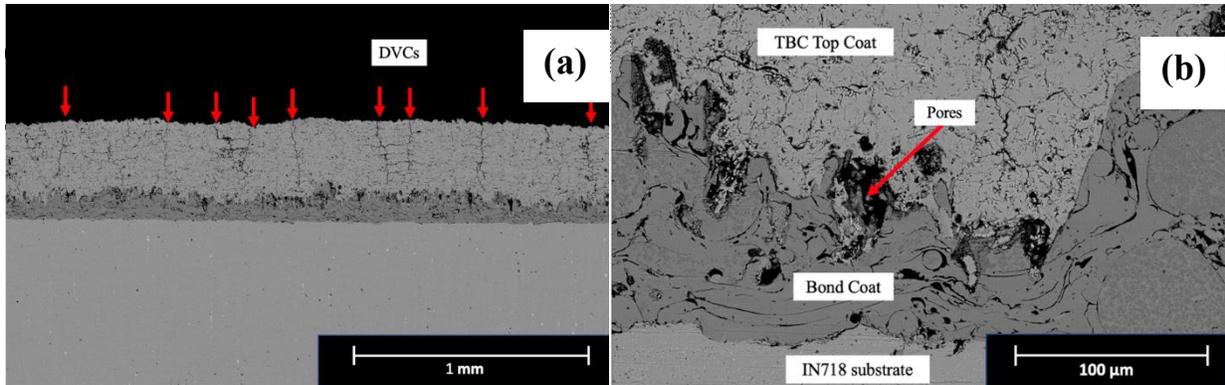
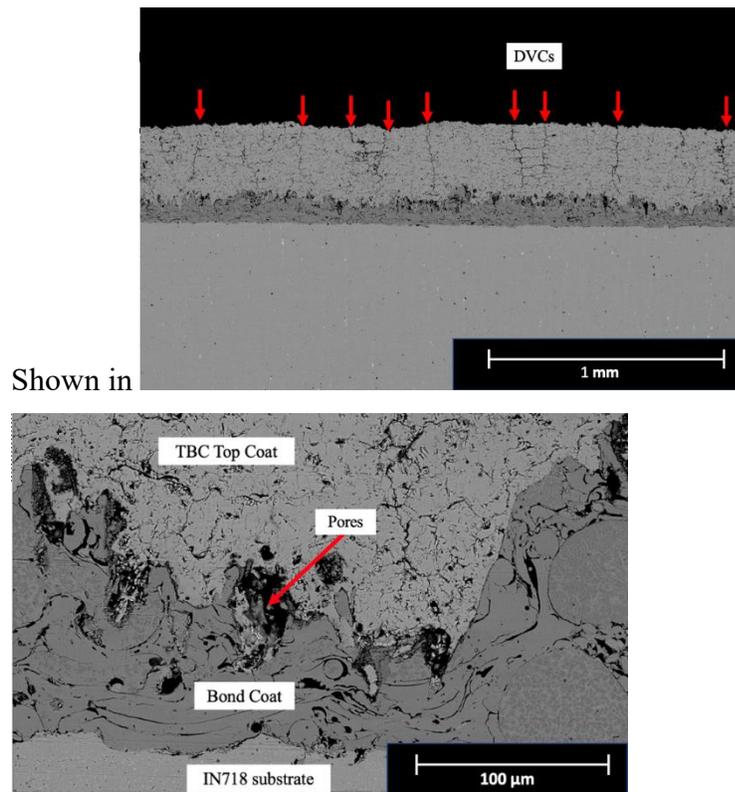
Figure 38: BSE SEM of as-sprayed T3 grown texture sample at (a) 50X and (b) 400X. Micrographs show some porosity at bond coat/TBC interface.

Figure 38 are micrographs of the unexperimented, fully coated T3 grown texture samples. Similar to the T1 texture, there are observable DVCs induced within the topcoat. The grown texture does not follow a uniform pattern, so the bond coat appears to have varying levels of depth. Unlike the T1 rounded spikes texture, it appears that all the substrate is covered in the bond coat. However, there are noticeable pores between the topcoat and the bond coat, indicating that perhaps the powder particle size of the topcoat was not small enough to fill in all the small crevices.

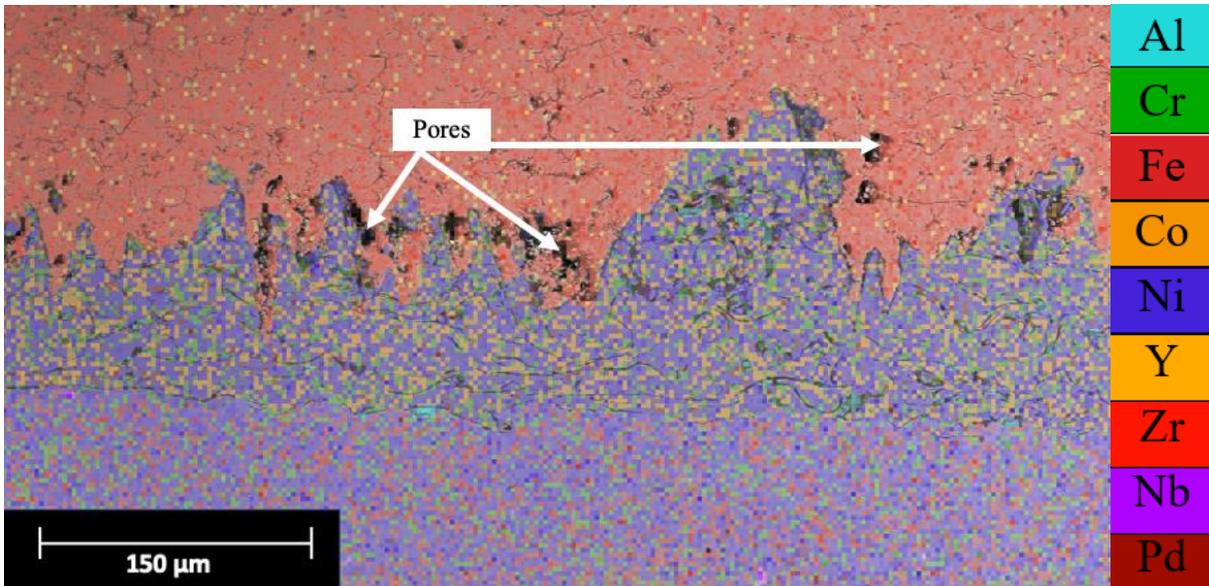
Figure 39: EDS map of grown texture coating system. Shows distinct substrate, bond coat, and TBC layers with some porosity at bond coat/TBC interface.

Microscopy for T3 was also supplemented with EDS, shown below in Figure 39. The EDS shows 3 clear phases (substrate, bond coat, TBC), with no intermediate phase seen in T1 and T2. The only abnormal compositional features are aluminum clusters in the bond coat, which were also seen in T1. There are, however, regions with no compositional information which indicates the presence of porosity at the bond coat/TBC interface. This could prove to be detrimental to coating adhesion, offering failure initiation sites.

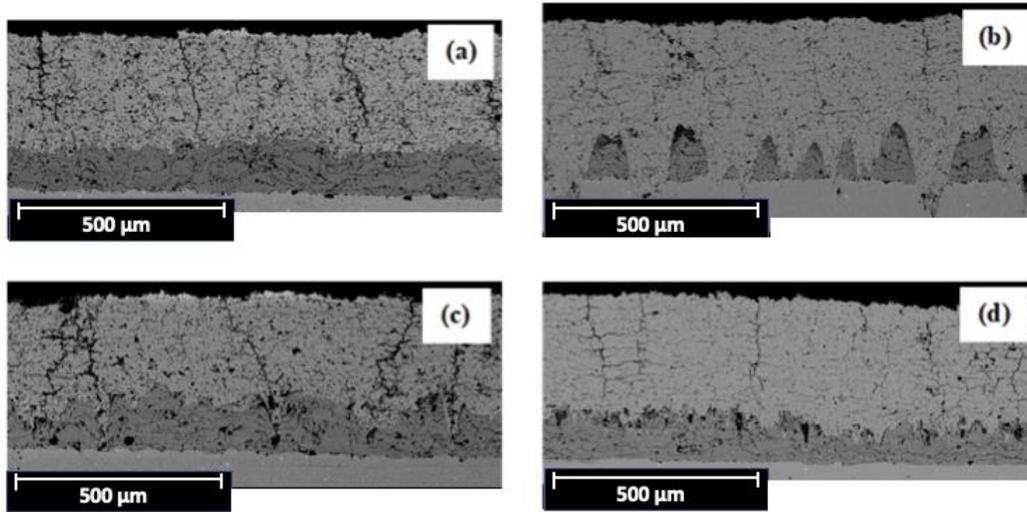
Figure 40: BSE micrographs of as-sprayed samples at 100X; (a) GB, (b) T1, (c) T2, and (d) T3.

The linear density shows that there is not a statistical difference in the spacing of the DVCs. However, some qualitative conclusions can be made; GB and T2 have larger crack widths, and vertical cracks tended to terminate internally in regions with bond coat depressions. This is most notably visualized in T1 and T2 where the cracks seem to prefer terminating in areas where the laser had subtracted bond coat material.

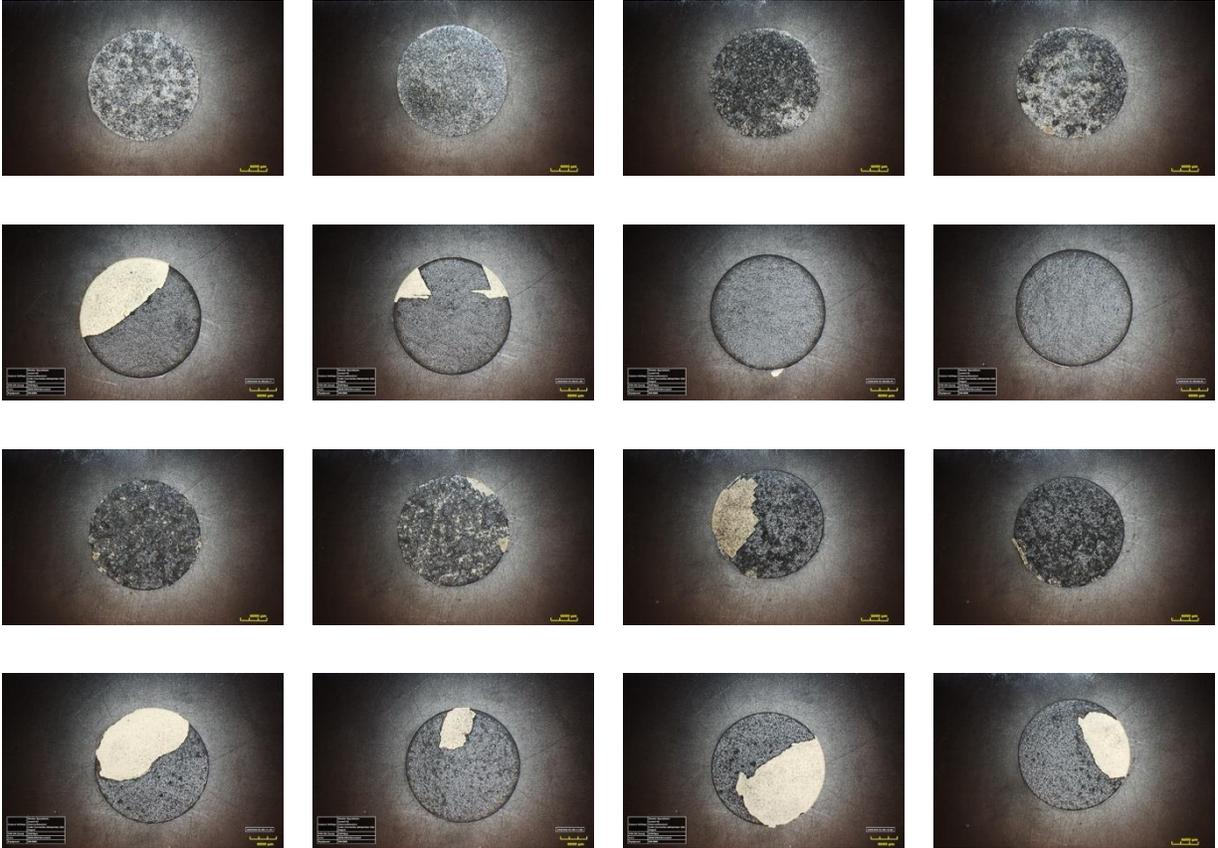
Figure 41: Overview shots of each sample after they had been removed from furnace cycle testing due to reaching >50% spallation.

Thermal cycling led to spallation and coating failure far sooner than Rolls-Royce expected. All 16 samples surpassed the 50% limit after 16 cycles, with the first 4 samples reaching this threshold after only 2 cycles. Figure 41 shows optical micrographs of each sample surface at the point where they surpassed the 50% spallation threshold.

- Row 1: GB, or grit blasted samples
- Row 2: T1, or rounded spike texture

- Row 3: T2, or grid texture
- Row 4: T3, or grown texture

Using these overview shots, the team conducted image analysis in ImageJ to calculate the final percentage of spallation for each sample. It should be noted that these spallation values are underestimated, as much of the coatings remaining in the overview shots were not fully attached to the substrates.

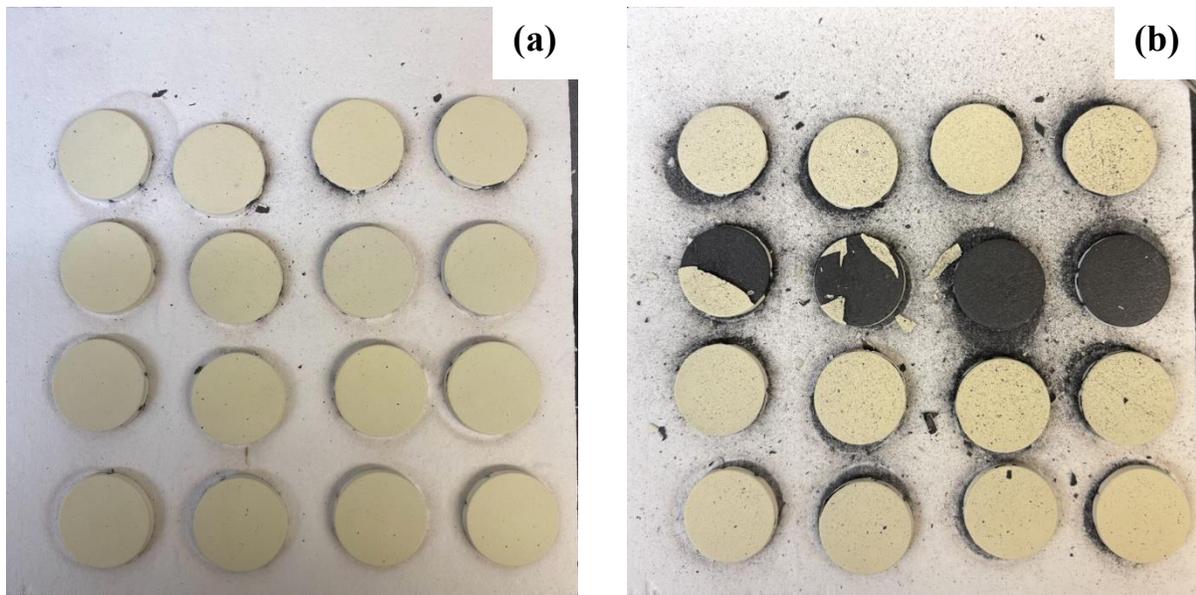
Figure 42: Samples after 1 cycle (left) vs after 2 cycles (right). All T1 samples have surpassed 50% spallation.

The first samples to fail, after only 2 cycles, were the T1 rounded spike textured samples. All 4 T1 sample coatings fully or partially failed during the cooling period after their second cycle, with coating cracking and popping off over the span of 2-5 minutes after they had been removed from the furnace. Many parts of the coating flew across the room and were collected by hand afterwards.

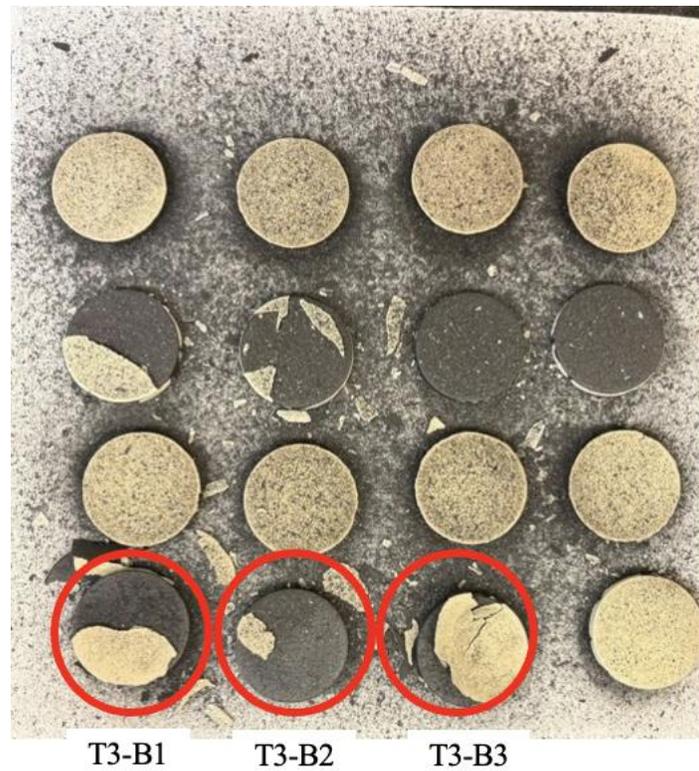
Figure 43: Samples after 9 cycles, showing T3-B1 and T3-B2 with over 50% spallation and T3-B3 beginning to fail.

The next coatings to fail were T3-B2 (after 7 cycles) and T3-B1 (after 9 cycles). At this point, another T3 coating was also delaminating, as can be seen in Figure 43, but it had not yet reached the 50% threshold. T3-B3 later failed after cycle 10.

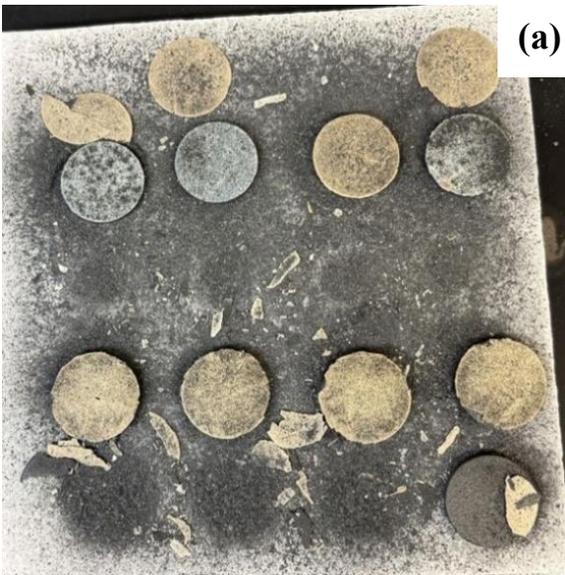
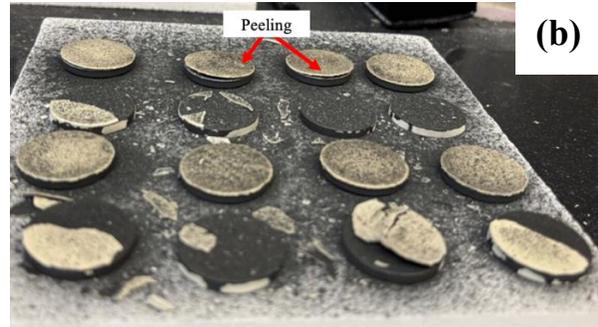
Figure 44: (a) Samples after 13 cycles, showing failure of GB samples and the last T3 sample. Note: the missing samples are because the team removed the samples that had previously failed (T1-B1—T1-B4 and T3-B1—T3-B4) to begin characterization, and (b) Side view of samples 3-4 cycles before GB failure, showing the beginning of peeling.

After 13 cycles, GB-B1, GB-B2, and GB-B4 and the final T3 sample, T3-B4, surpassed 50% spallation. As can be seen in Figure 44, the GB samples had coatings come off cleanly in one or two sheets. The team noticed that for 3-4 cycles before failure, the coatings had been peeling off (Figure 44(b)). Note the missing samples in Figure 44 are because the samples that had previously failed were removed (T1 samples and T3-B1-3) to begin characterization.

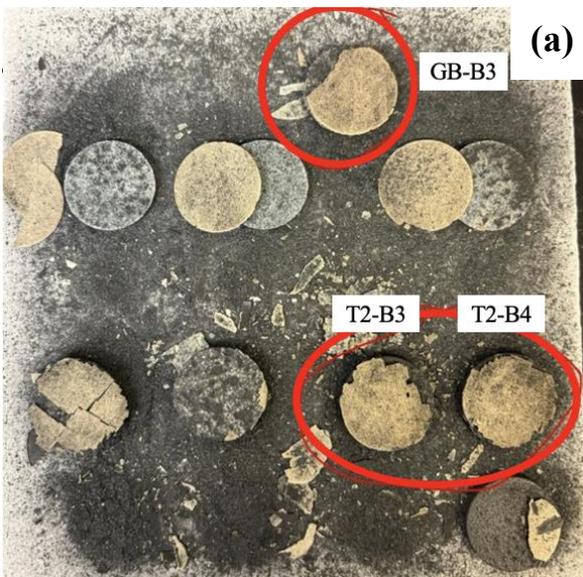
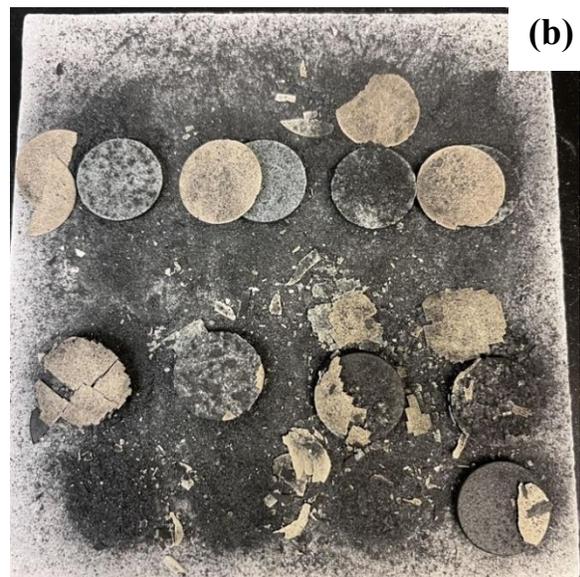
Figure 45: (a) Samples after cycle 15, showing that only GB-B3, T2-B3, and T2-B4 remain (circled), and (b) Samples after cycle 16, all samples have reached 50% spallation threshold.

Lastly, after cycles 15 and 16, all samples had reached the 50% spallation. The last samples to fail were GB-B3, T2-B3, and T2-B4.

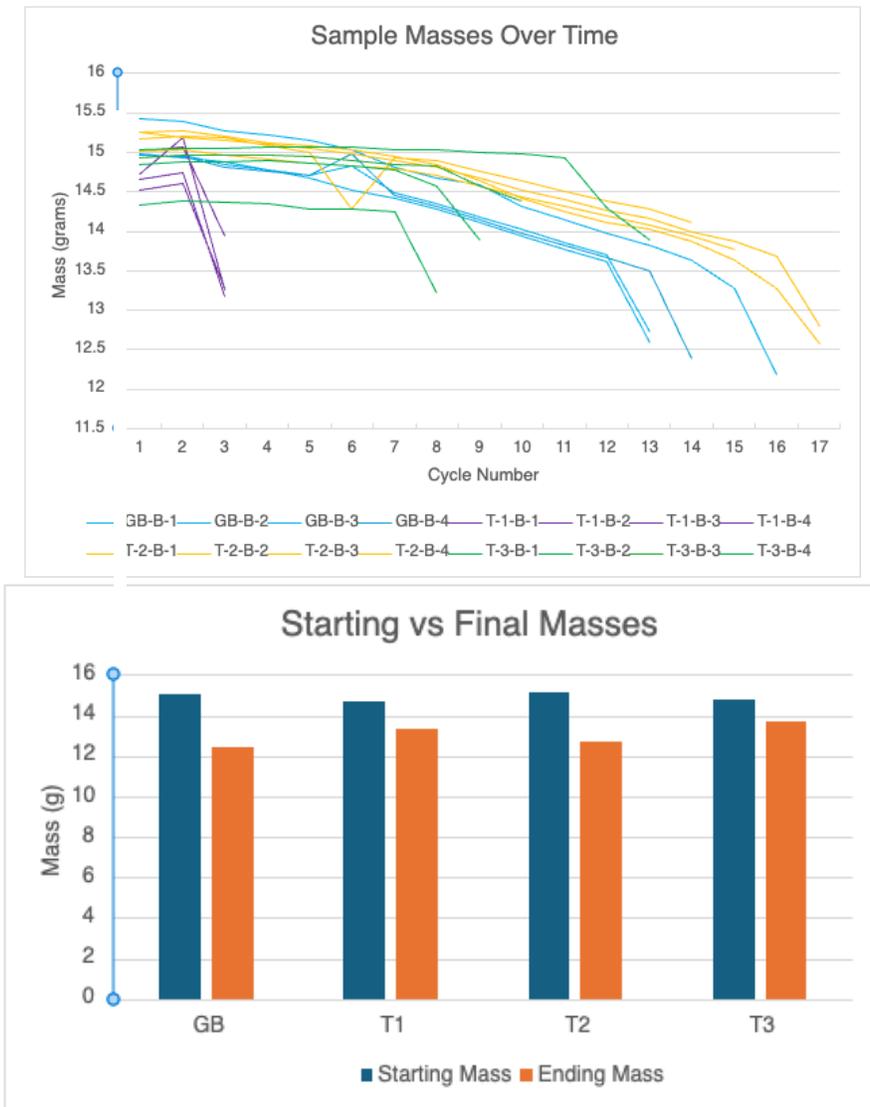
Figure 46: (a) Plot of mass loss of each sample over time, and (b) histogram showing starting and ending masses of each sample.

Figure 46(a) shows a plot of masses over time, grouped by texture type. The mass drop-off at the end of each sample lifetime coincides with when coating was partially or completely lost. Figure 46(b) shows the initial and final masses of each of the samples. Of note, the GB and T2 samples lost more mass than the T1 and T3 samples. This aligns with results in Table 18 showing that these textures suffered higher percentages of spallation at failure.

Qualitatively, it was noted that most of this mass loss was due to oxidization of the IN718 substrate and coating spallation. Although mass was monitored primarily to track oxidation growth between the substrate, bond coat, and TBC – it is impossible to distinguish what amount of the mass fluctuations were due to oxide growth in these areas.

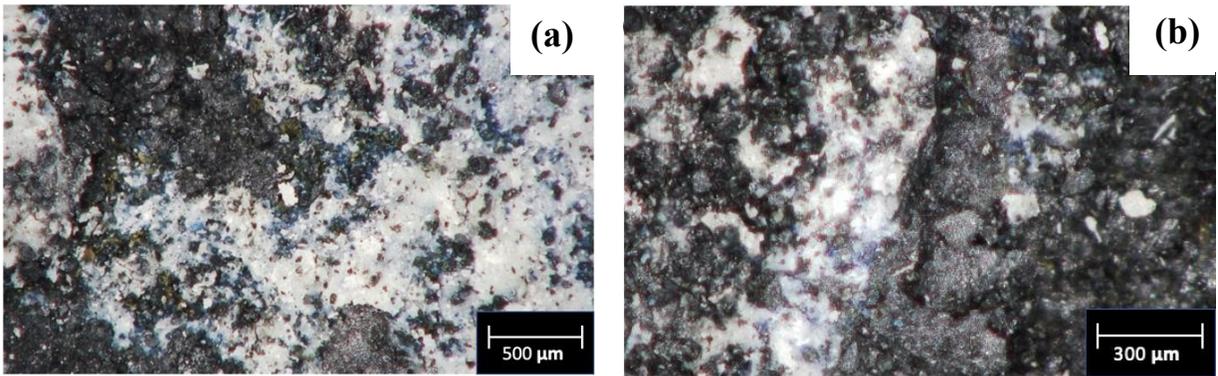
Figure 47: Optical micrographs of TBC remnants on grit blasted samples at (a) 100X and (b) 150X.

Upon inspection of optical micrographs of the grit blasted samples, the team observed that despite the TBC coatings appearing to have peeled off in one or two sheets during furnace testing, some of the ceramic remained attached to the bond coat (Figure 47). This leftover TBC is not visible without looking under the microscope and is only present on some parts of the surface. Rolls-Royce explained that the coating fills surface texture well and confirmed that remnants should be expected to be found on the surface.

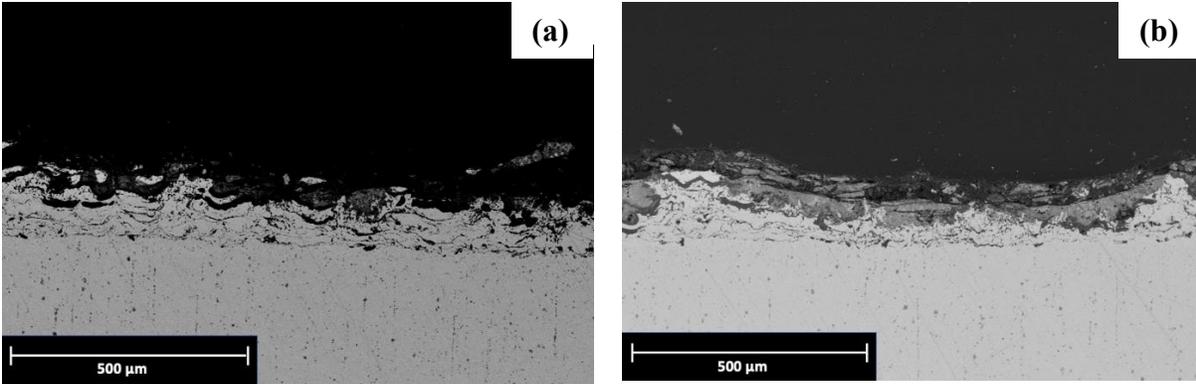
Figure 48: BSE SEM of GB long furnace cycled samples. The remaining bond coat and TGO are visible. The TBC spalled off the sample.

SEM micrographs were taken for the GB long furnace cycled samples and are shown in Figure 48. The TBC had completely spalled off from the samples so the remaining substrate with remaining bond coat was imaged. Unlike the as-sprayed sample, contrast in this sample does not show a difference between the bond coat and IN718, suggesting a change in composition from the as-sprayed sample. The bond coat is observed to have remained adhered to the substrate and thermally grown oxide (TGO) grew on the bond coat/TBC interface.

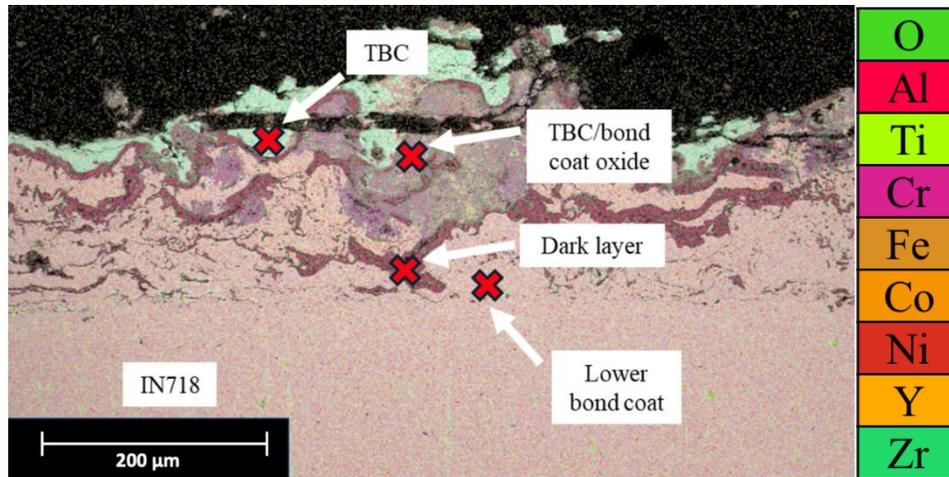
Figure 49: EDS of cycled GB sample. Shows residual TBC, TBC/bond coat oxide, dark layer within the bond coat, underlying bond coat, and IN718.

After cycling, samples were analyzed using EDS, seen in Figure 49 and Table 20. The EDS showed five regions within the sample: residual TBC, an oxide at the TBC/bond coat interface, dark layers throughout the bond coat, underlying bond coat, and IN718. In previous discussions, Rolls-Royce explained that after failure, cycled samples should have a small amount TBC still adhered to the bond coat. The GB sample was the first sample to exhibit this, which confirms that this sample had adequate adhesion of the TBC to the bond coat. Below the TBC there is a layer of oxide at the interface between the TBC and the bond coat, as well as the remaining bond coat with dark layers running through it. Compositional values reveal that the oxide at the TBC/bond coat interface is chromium rich, while the dark layers running through the bond coat are aluminum rich. Individual EDS maps that highlight these features are seen in Figure 50.

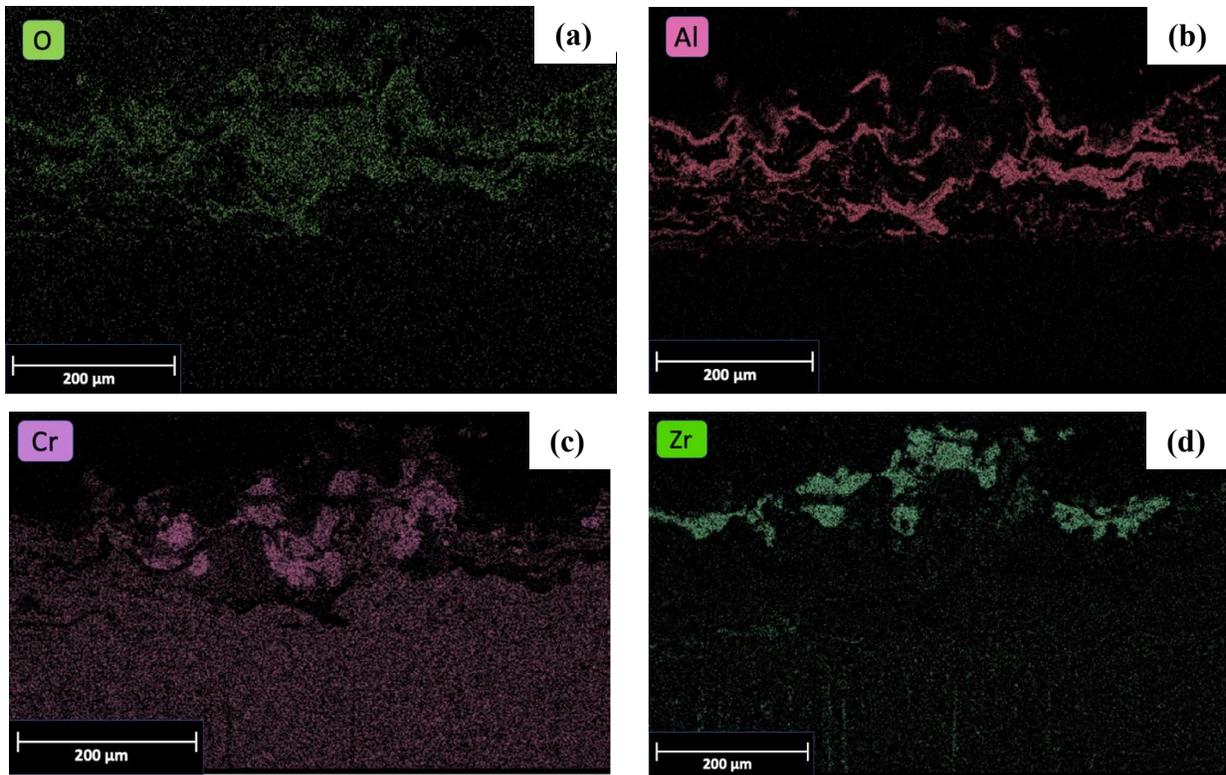
Figure 50: Cycled grit blast map EDS separated by element. (a) Oxygen, (b) Aluminum, (c) Chromium, and (d) Zirconium. Highlights remaining TBC, chromium oxide at TBC/bond coat interface, and aluminum oxide within the bond coat.

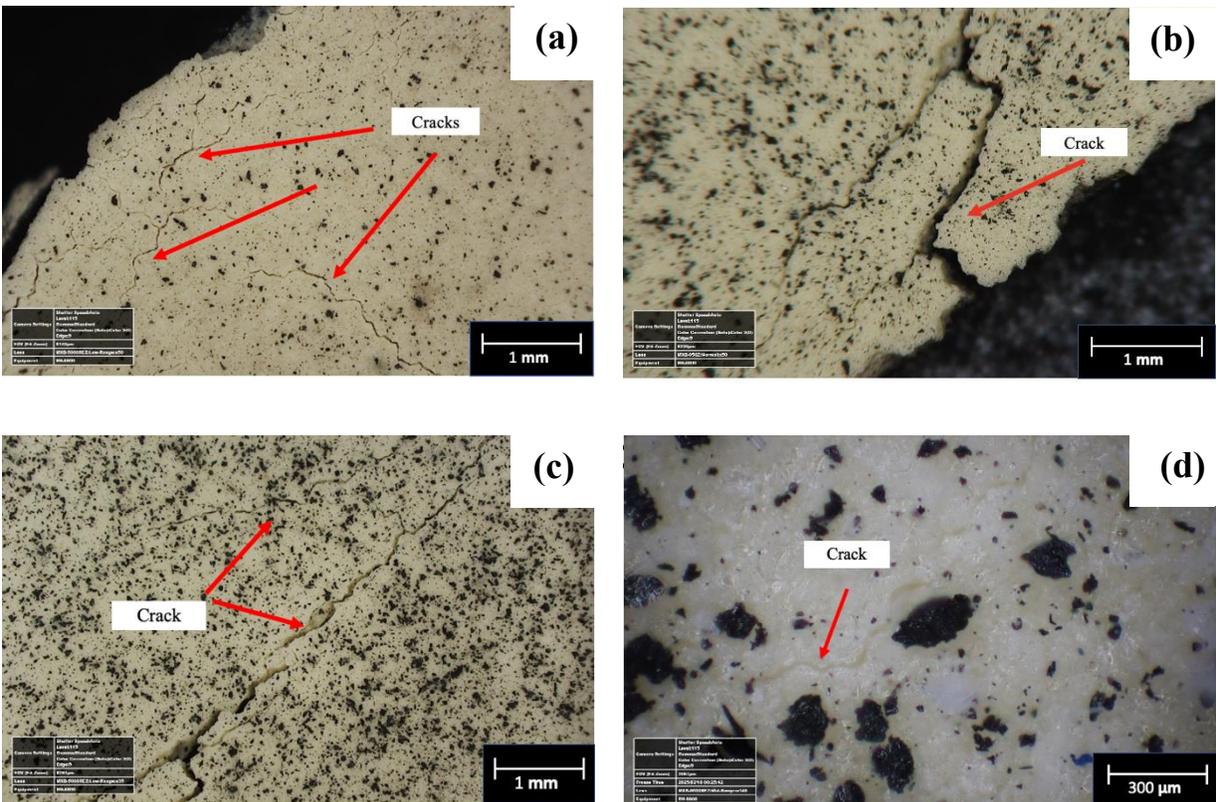
Figure 51: Optical micrographs of T1 sample surfaces after furnace cycling: (a) a sample edge showing chipping of TBC and crack profiles at 50X, (b) edge of TBC showing cracking at 50X, (c) mid-TBC surface crack at 50X, and (d) microcrack in the TBC at 3000X.

Optical micrographs taken of the T1, rounded spike, surfaces showed interesting crack patterns in the remaining TBC left after furnace cycling (Figure 51(a-c)). In addition to surface cracks, there was also visible chipping of the TBC on the edges of the sample, Figure 51(a).

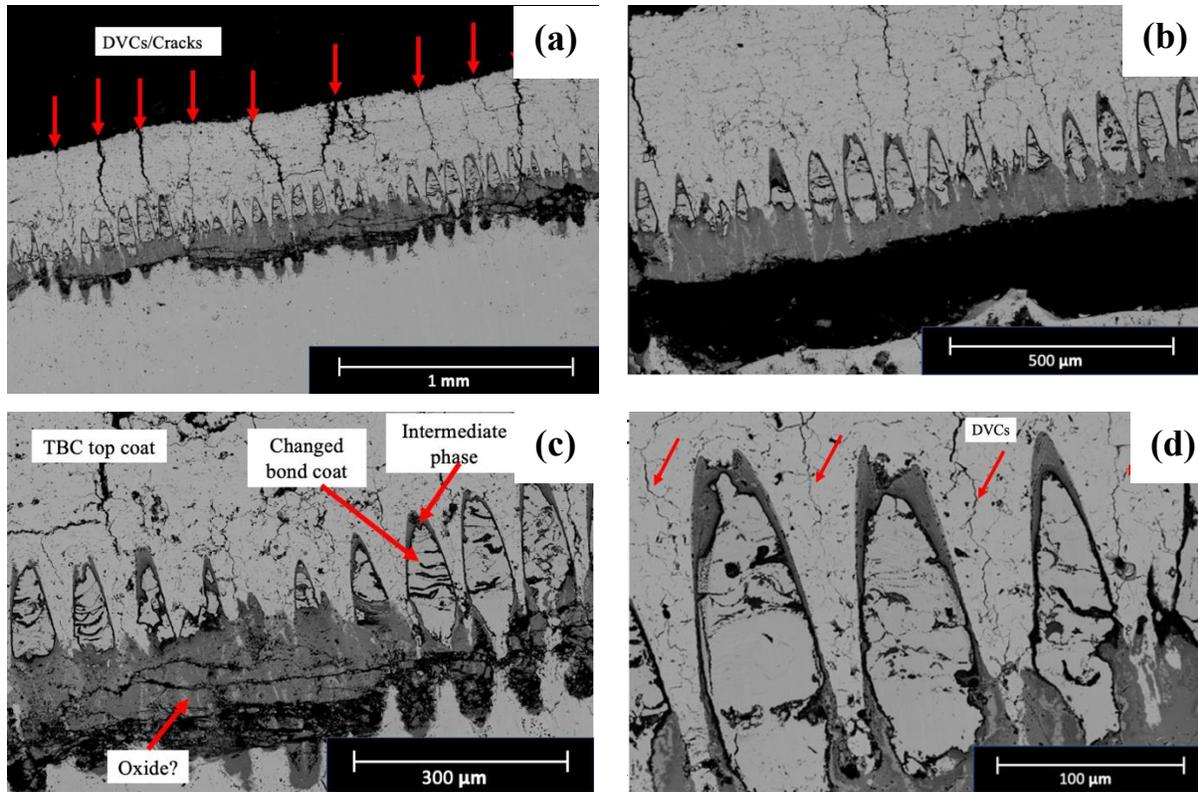
Figure 52: BSE SEM micrographs of T1 samples. A new layer formed between the substrate and the TBC, resulting in the delamination of this layer from the substrate, pinching the spikes in the process.

The bond coat separated from the IN718 substrate, along with the topcoat. The bond coat and the topcoat remain in contact. An oxide also appears to have formed on the bottom of the bond coat. On the top of the bond coat spikes, an intermediate phase appears to have formed. This is explored further in the EDS characterization section that follows. It should also be noted that within the bond coat spikes, in these BSE micrographs, the contrast of the bond coat differs from the sample which has not been cycled. There was a significant contrast difference between TBC, bond coat, and substrate in as-sprayed micrographs, and the absence of that here indicates a possible change in elemental composition sprayed sample. Due to this suspected change in the composition, EDS was completed after the SEM.

The SEM micrographs of the T1 sample (Figure 52) provide information on the failure mechanism. Within the topcoat of the furnace cycled sample, DVCs are visible. The DVCs were also visible in the T1 sample that was not furnace cycled. In this furnace cycled sample, the DVCs appear to have grown in width, indicating that during the heating and cooling, tensile stresses were exerted onto the topcoat by the bond coat and substrate, and therefore stretching the topcoat. When looking more closely at the DVC location within the topcoat, in relation to the bond coat “spikes,” the DVCs appear to fall in a uniform manner in-between the bond coat spikes. This would indicate that between these spikes, the topcoat is experiencing tensile stresses, perhaps stretching the topcoat. This tensile stress could have been exhibited during the time when the sample was heating up in the furnace as the YSZ, with a lower thermal expansion coefficient, naturally expanded less than the IN718 and bond coat which have higher thermal

expansion coefficients. However, it cannot be concluded whether these DVCs had any effect on the lifespan of the T1 sample in the furnace cycling, since the T1 samples failed first, likely due to the lack of a bond coat between the topcoat and the IN718 in the spaces between the spikes.

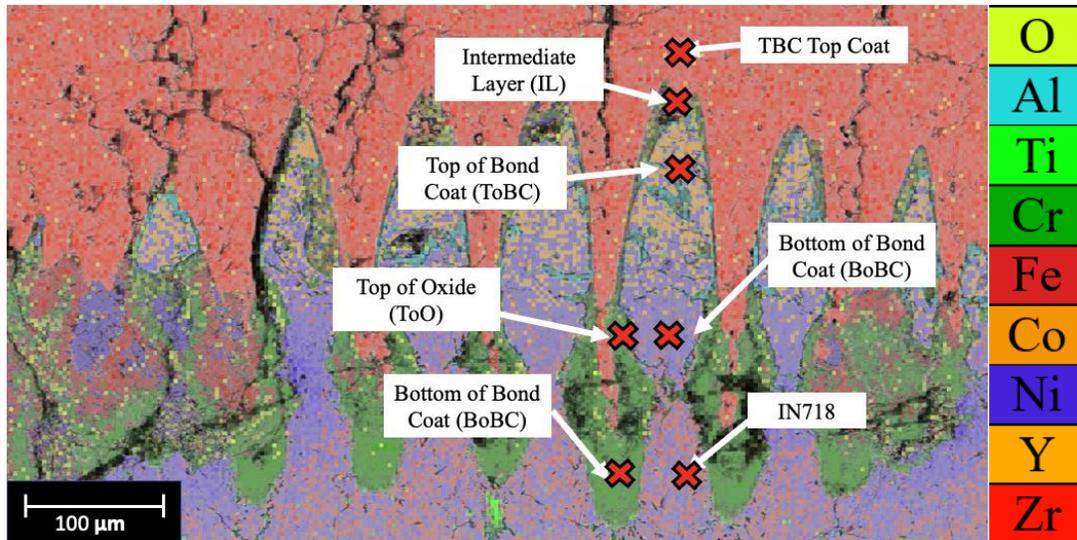
Figure 53: Map and point EDS of thermally cycled rounded spike sample. Map shows distinct chromium-rich region at substrate/bond coat interface and composition gradient in rounded spikes.

EDS map results of the cycled sample, Figure 53, show a chromium layer formed at the bottom of the trenches in between spikes. Point EDS was done on 7 regions within the sample including the TBC, intermediate layer, top of bond coat spikes, bottom of bond coat spikes, top of "oxide", bottom of "oxide", and IN718.

Table 21 includes compositional information from each point. The team assumed that the chromium layer was an oxide since TGOs are expected to grow during thermal cycling. The TBC shows minimal compositional differences compared to the as-sprayed condition. The intermediate phase has significantly less nickel and more aluminum, chromium, cobalt, and oxygen. This suggests that oxygen diffused through the TBC and the intermediate layer has become a complex oxide.

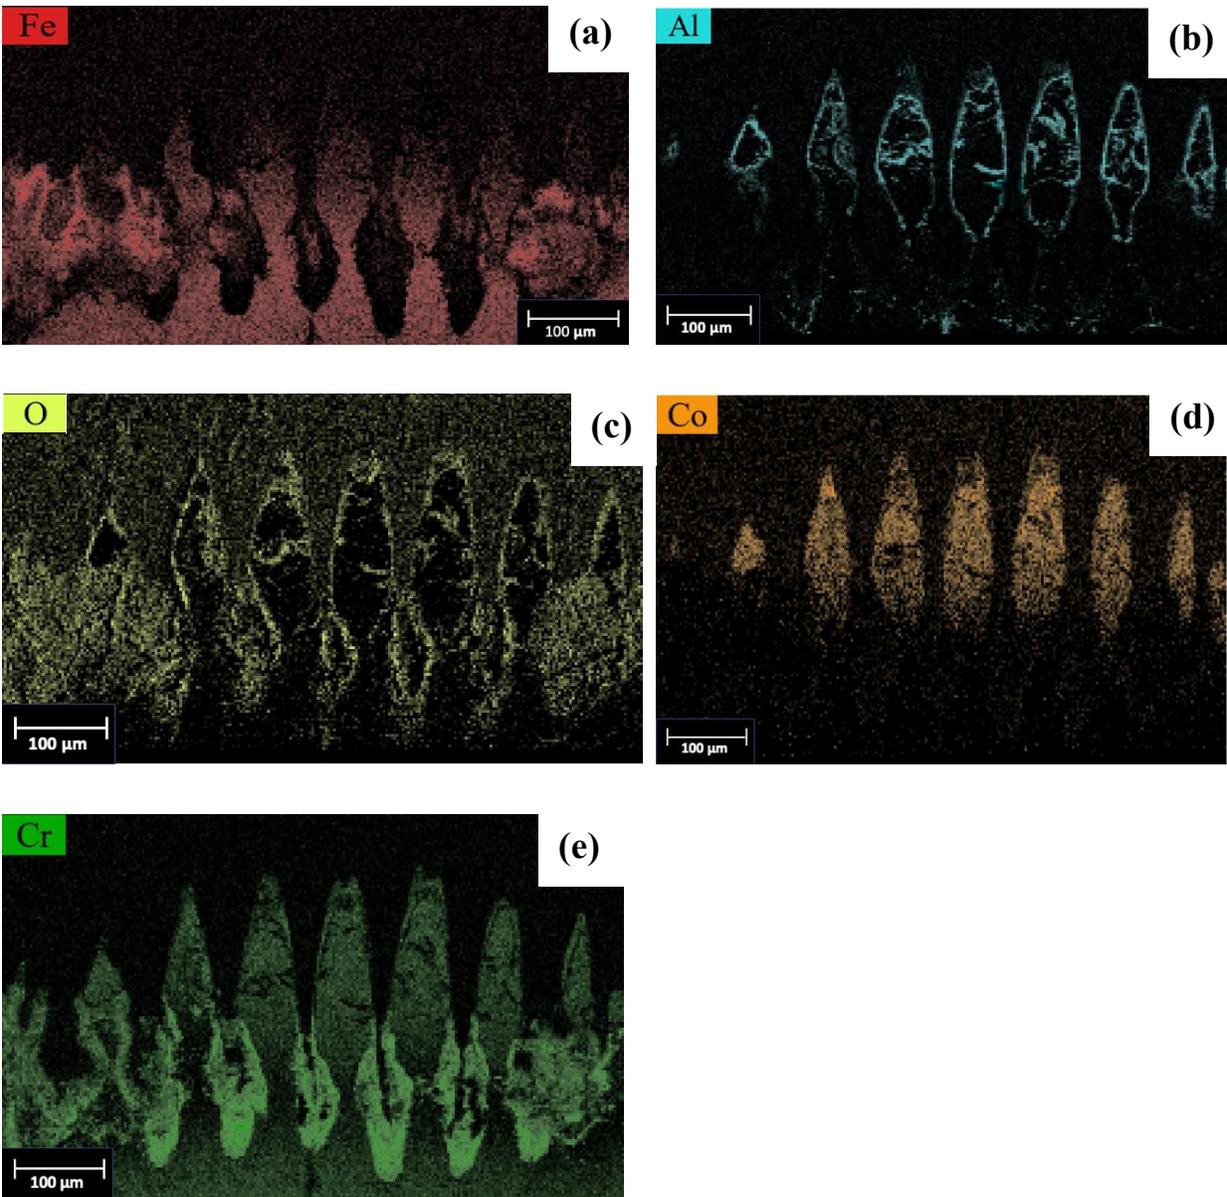
Figure 54: Select EDS maps of thermally cycled rounded spike sample. Shows concentration gradients and segregation within the spikes. (a) Iron, (b) Aluminum, (c) Oxygen, (d) Cobalt, and (e) Chromium.

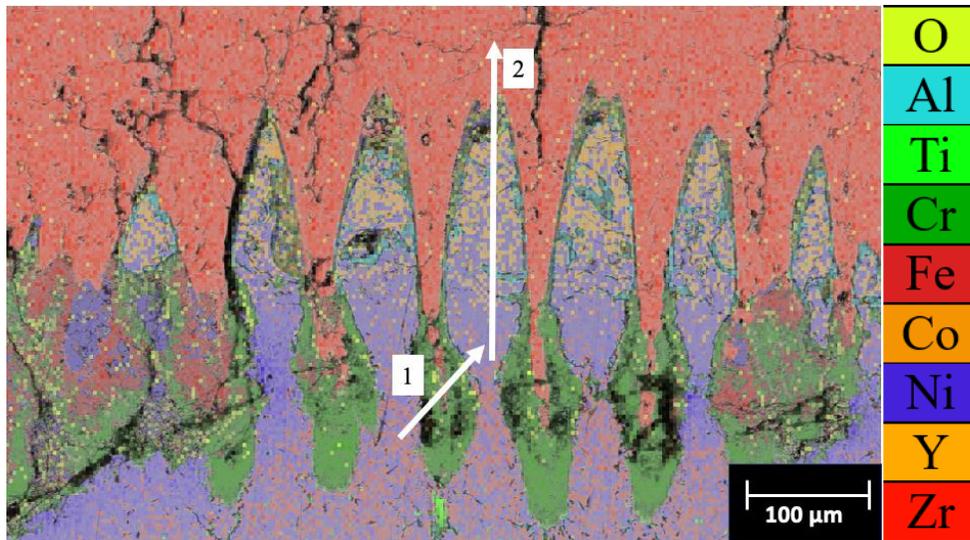
Figure 55: Line scan EDS of thermally cycled rounded spike samples. Line (1) captures chromium rich region and Line (2) captures concentration gradient up the spike.

An additional line scan EDS was conducted to analyze the chromium rich region, shown in Figure 55 and Figure 56. It was previously asserted that the team expected this to be a chromium oxide, which has been justified by the line scan. In the central region of the line scan that correlates to the suspected oxide, chromium and oxygen are the dominant species, with some regions being richer in chromium. This chromium likely oxidized at the bottom of the spikes, resulting in the chromium deficient region in the adjacent bond coat.

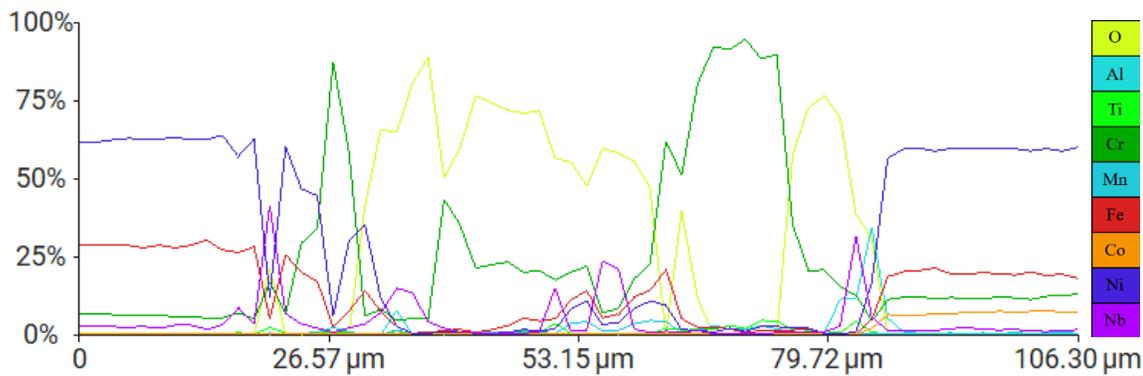
Figure 56: Line scan (1) results showing pure chromium rich region suggestion a chromium oxide.

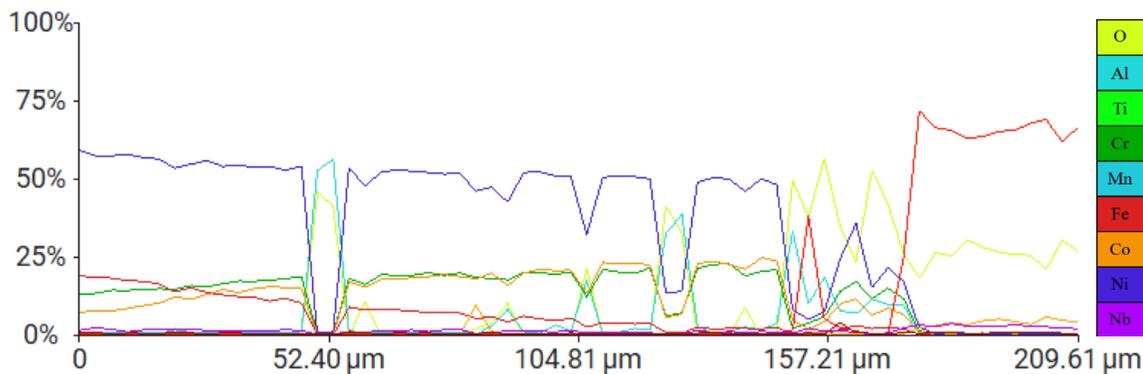
Figure 57: Line scan (2) results. Shows decrease in iron and nickel going up the spike, slight chromium deficiency at the bottom of the spike, and cobalt increase going up the spike.

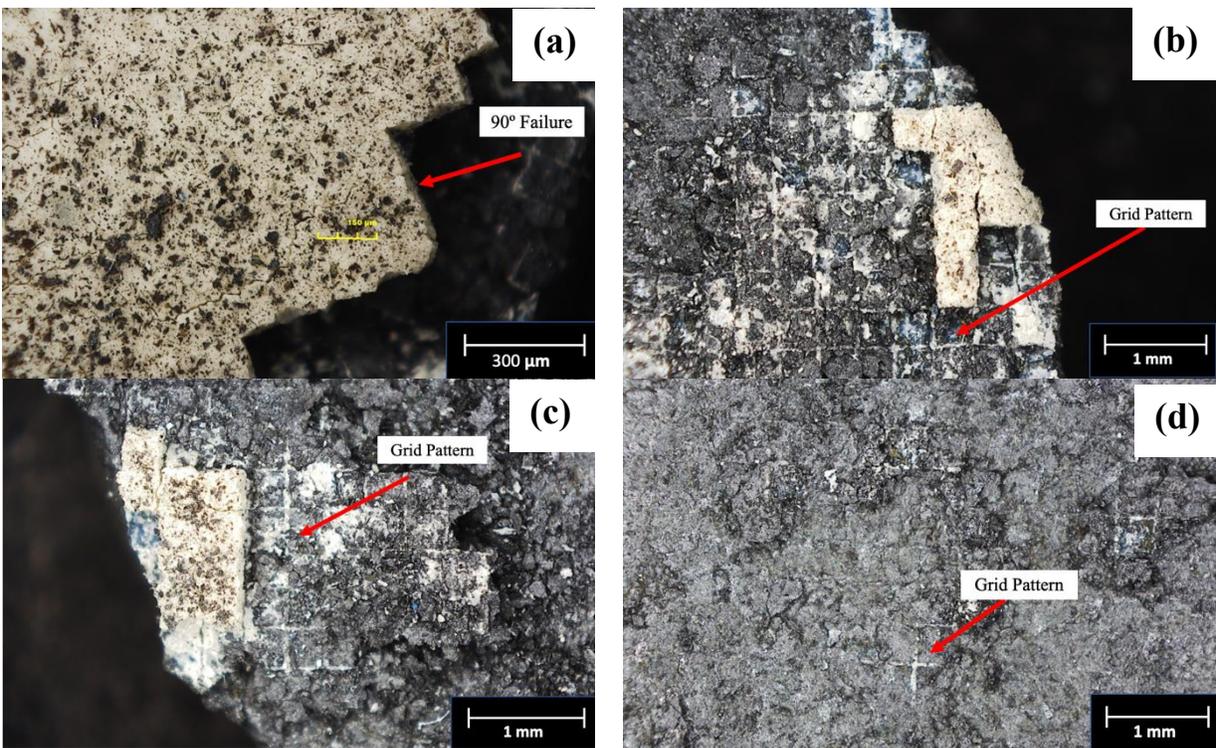
Figure 58: Optical micrographs of T2 sample surfaces after furnace cycling: (a) TBC edge showing zig-zag failure at 150X, (b) grid pattern in bond coat revealed with remaining TBC following this grid payment at 50X, (c) TBC and bond coat failure at 50X, and (d) a substrate surface where the bond coat grid pattern had been destroyed at 35X.

Optical micrographs of the T2 grid pattern surfaces reveal an interesting coating failure geometry. As can be seen in Figure 58(a), the TBC coating failed in 90° along the lines of the grid pattern upon which it was sprayed, Figure 58(b). In the process of spallation there are two failure mechanisms that were noticed. As seen in Figure 58(b,c), there are zones in which the topcoat remains within the trenches between raised grids, indicating a minimal depth of damage to the bond coat. However, as shown in the case of Figure 58(d), there are also cases in which the trenches are not visible, indicating that the bond coat was ripped out of that area or that the spalled top layer took a portion of the bond coat with it. This will be discussed further in the Discussion of Results section.

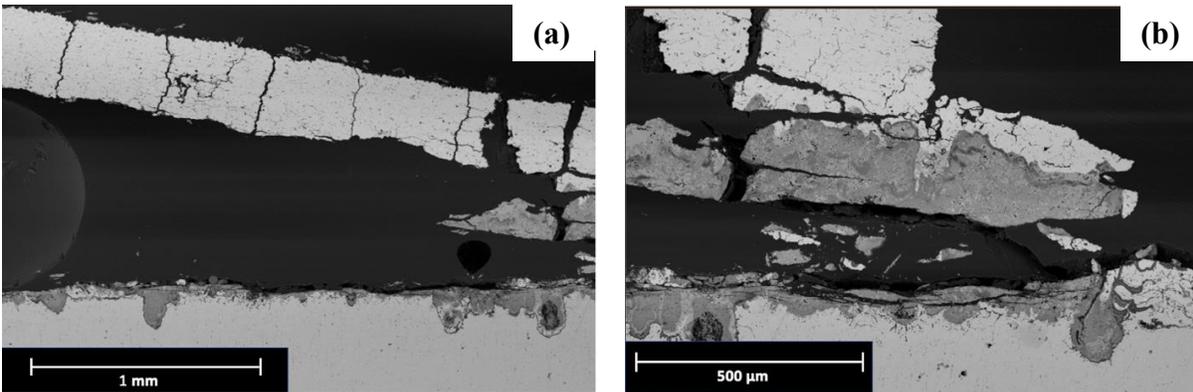
Figure 59: BSE SEM micrographs of the T2 long furnace cycled sample. The TBC completely delaminated, and the bond coat appears to have remained partially on the substrate.

SEM micrographs were taken for the T2 long-furnace-cycled samples and are shown in Figure 59. The TBC had completely delaminated from the sample and most of the bond coat also came off from the substrate, with a few spots showing remaining bond coat. TGO is also observed within the trenches made by the laser when texturing. The DVCs in the delaminated TBC are noticeable and appear regularly spaced, although it is difficult to confirm if this is due to the spacing of the trenches.
