**Optimizing Surface Texturing for YSZ Thermal-Barrier-Coating on Inconel
718 Substrate to Mitigate High Stresses/Strains**

A Technical Report submitted to the Department of Materials Science & Engineering

Presented to the Faculty of the School of Engineering and Applied Science
University of Virginia • Charlottesville, Virginia

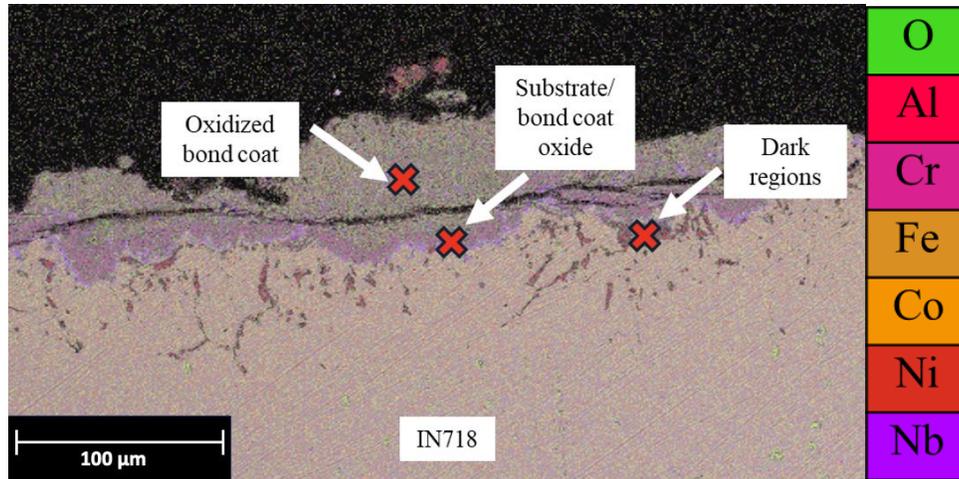
Figure 60: EDS of cycled T2 sample. Shows oxidized bond coat, substrate/bond coat oxide, dark regions within the substrate, and IN718.

EDS on cycled T2 samples revealed no residual TBC on the surface. Remaining on the sample was the substrate, some bond coat with two different oxidized regions, and dark regions within the substrate, similar to what was seen in previously characterized cycled samples. The top layer of remaining bond coat did not have the same composition as the uncycled bond coat layer, with the cycled being richer in iron and oxygen and less rich in nickel, indicating that there was diffusion between the substrate and bond coat that affected this region. At the bottom of this region is chromium oxide between the substrate and oxidized bond coat. The dark layers in the substrate were found to be aluminum oxide, which has been previously seen in cycled samples. Figure 61 shows individual EDS maps highlighting the notable regions.

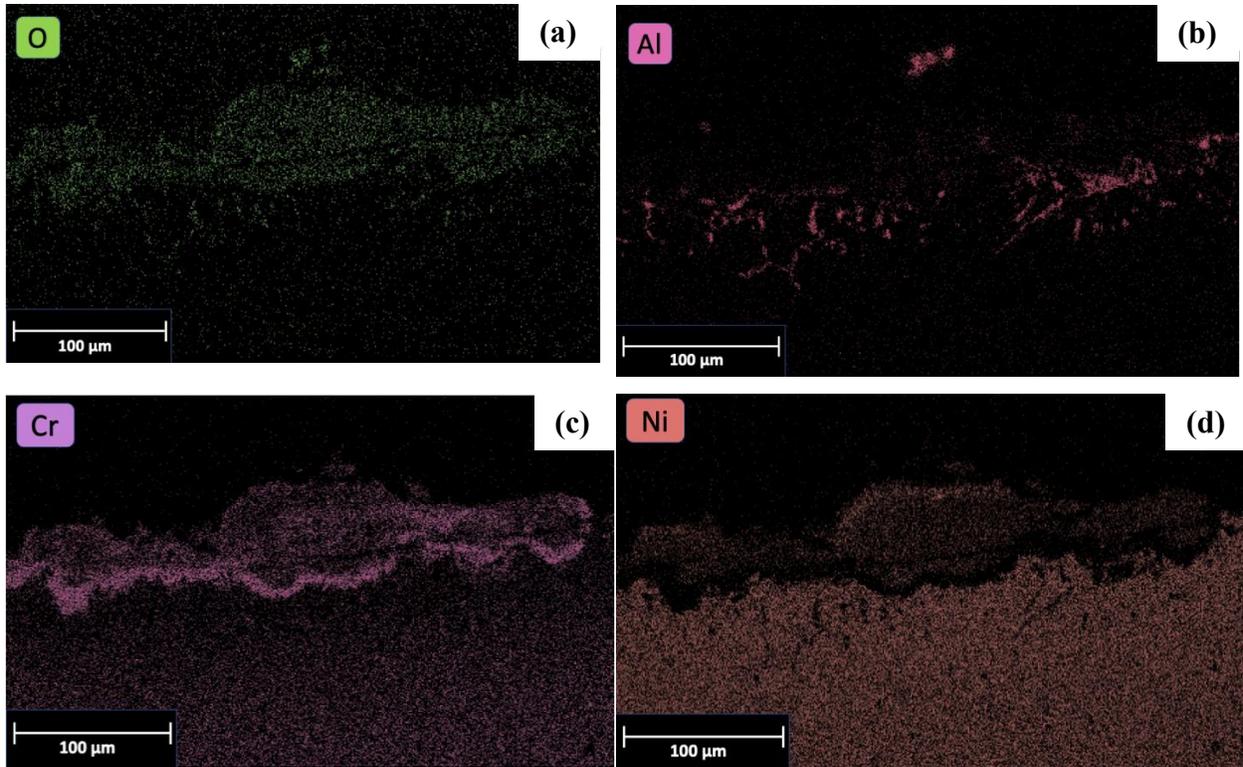
Figure 61: Cycled T2 map EDS separated by element. (a) Oxygen, (b) Aluminum, (c) Chromium, and (d) Nickel. Highlights oxidized bond coat, chromium oxide at substrate/bond coat interface, and aluminum oxide within the substrate.

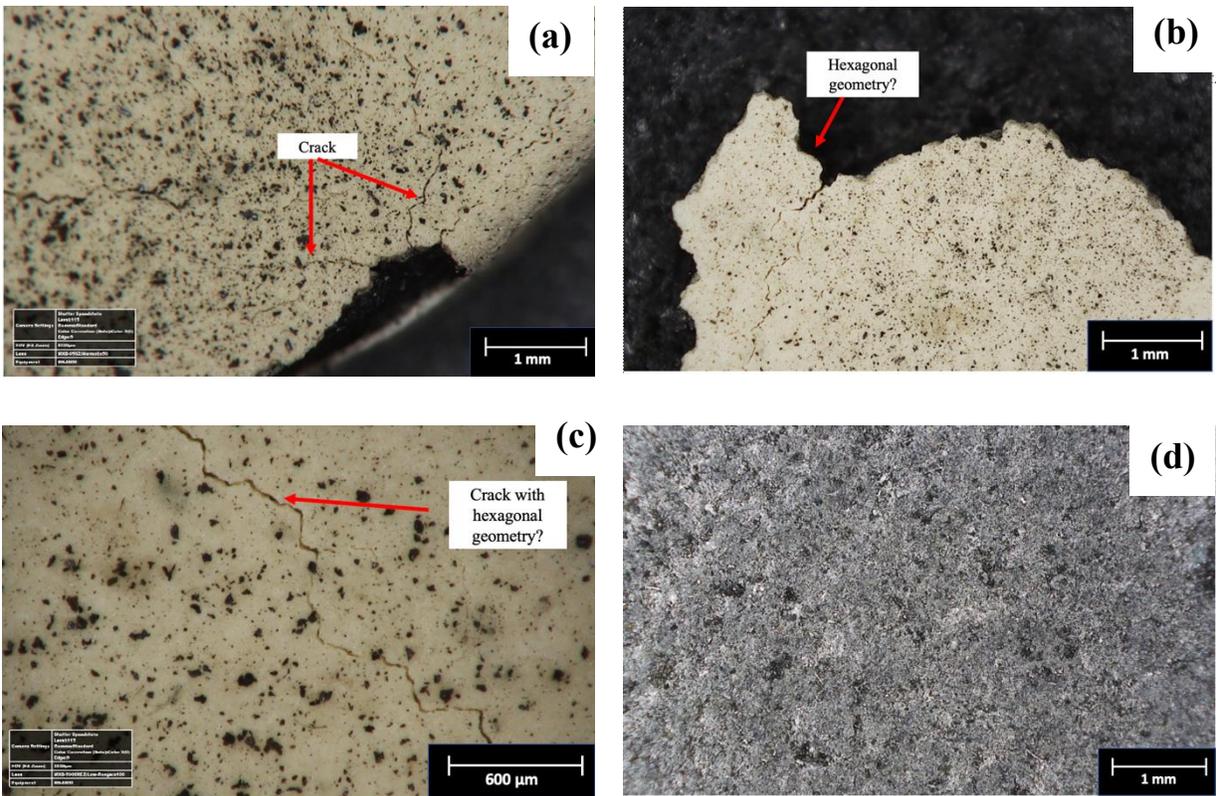
Figure 62: Optical micrographs of T3 sample surfaces after furnace cycling: (a) cracks around an area where a piece of TBC chipped off at 50X, (b) edge of TBC peeling off substrate at 50X, (c) crack geometry in TBC at 100X, and (d) base metal that TBC has come off from at 50X.

Optical micrographs of the T3, grown texture, surfaces reveal some interesting crack patterns. As shown in Figure 62(b,c), the cracks appear to follow a jagged hexagonal geometry, although the reasons for this are not understood. Figure 62(a) also shows some chips in the TBC on the edge of the samples. The substrate surface after coating failure can be seen in Figure 62(d).

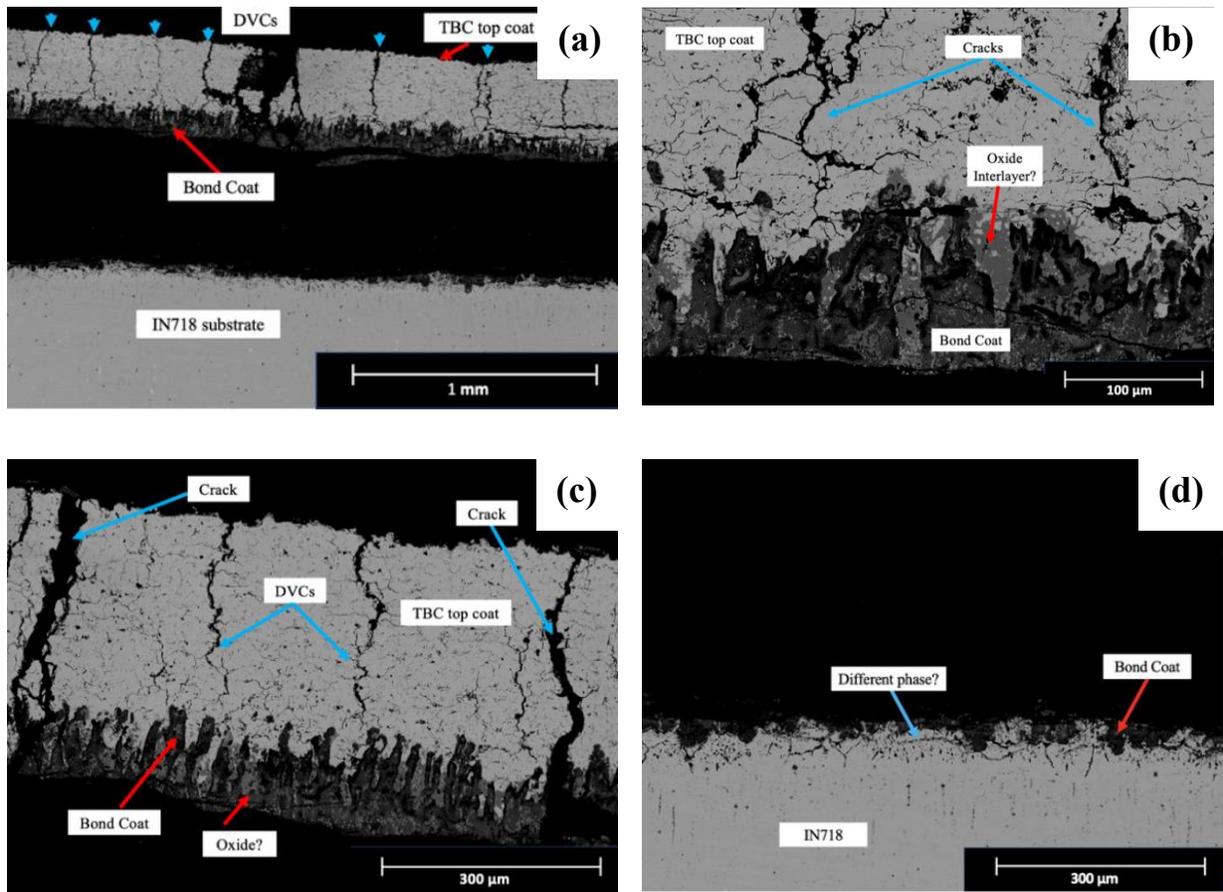
Figure 63: BSE SEM micrographs of T3 sample after furnace cycling. The delaminated topcoat/bond coat from the substrate can be observed along with the DVCs and an unknown interlayer.

The SEM micrographs of the T3 sample provide information on the failure mechanism. The topcoat, along with most of the bond coat intact, completely delaminated from the IN718 substrate. DVCs and large cracks formed in the topcoat, wider than the DVCs in the sample that have not been furnace cycled. Since the T3 texture does not have the same uniformity as the rounded spikes in T1, the DVCs do not follow uniform spacing as they do in T1.

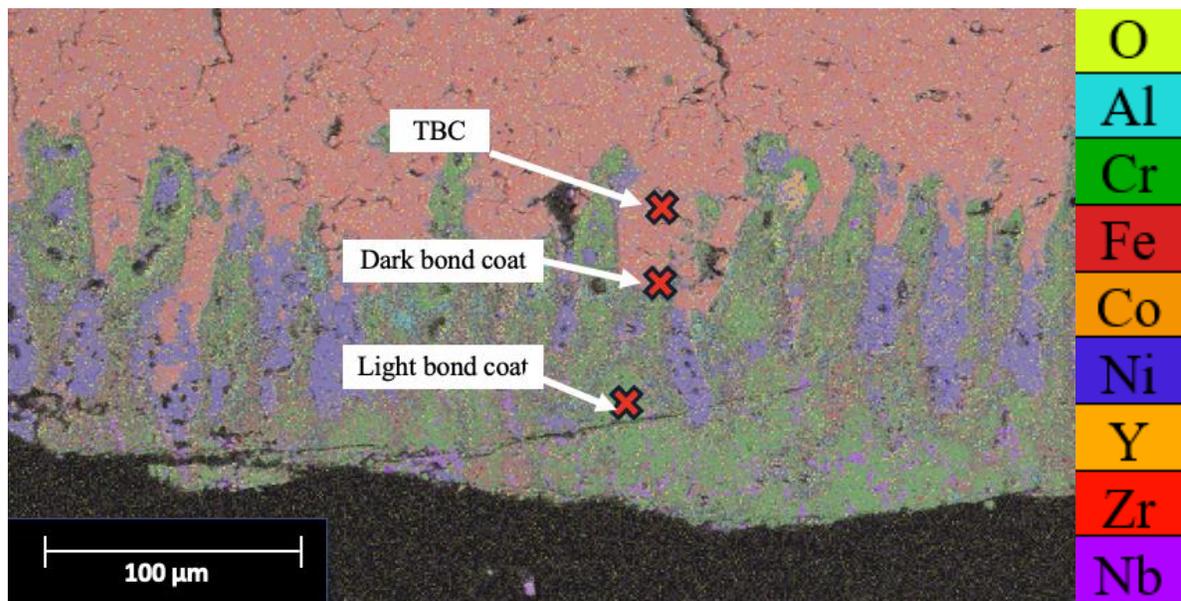
Figure 64: EDS map of spalled off coating. Shows 2 distinct regions within the bond coat, including an aluminum rich region.

Further analysis of the failed coating was done with the help of EDS. The EDS map, Figure 64, exhibits significant segregation. There are three visible regions within the spalled coating: (1) TBC, (2) lighter bond coat, and (3) darker bond coat. Point EDS was done on these regions, plus a darker region to confirm that it was porosity within the coating. The lighter region was consistent with the bond coat including oxygen diffusion, while the darker region tended to be aluminum and oxygen rich, suggesting an aluminum oxide. Individual EDS maps verifying this hypothesis are seen in **Error! Reference source not found.** The TBC did not exhibit any notable compositional changes. Since there was total delamination of the coating, it was also important to analyze the substrate for any remaining bond coat. Results of this EDS are shown in Figure 66 and Table 24. Initial inspection suggested that there was some remaining bond coat on

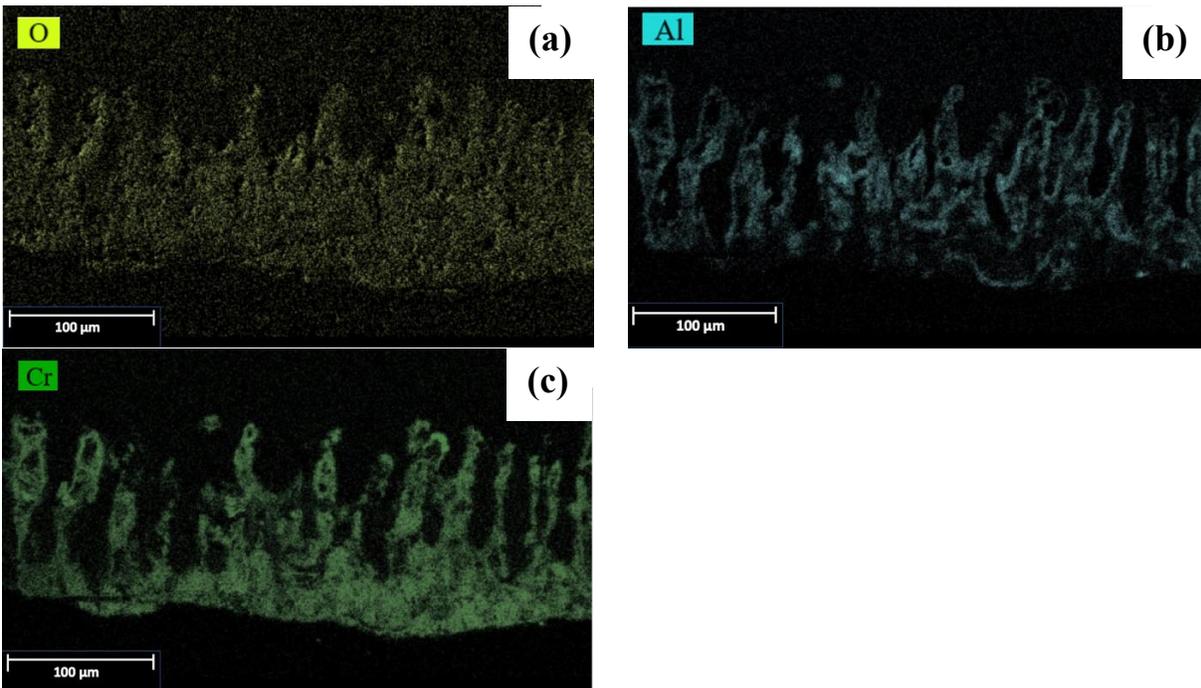
Figure 65: Individual EDS maps of T3 coating. (a) Oxygen, (b) Aluminum, and (c) Chromium.

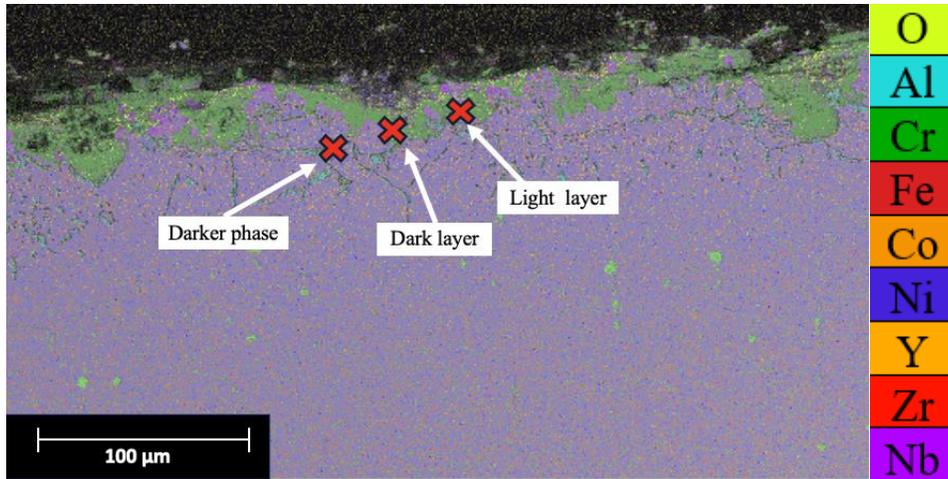
Figure 66: Substrate/bond coat interface EDS map for T3. Shows chromium remnants on surface after complete delamination.

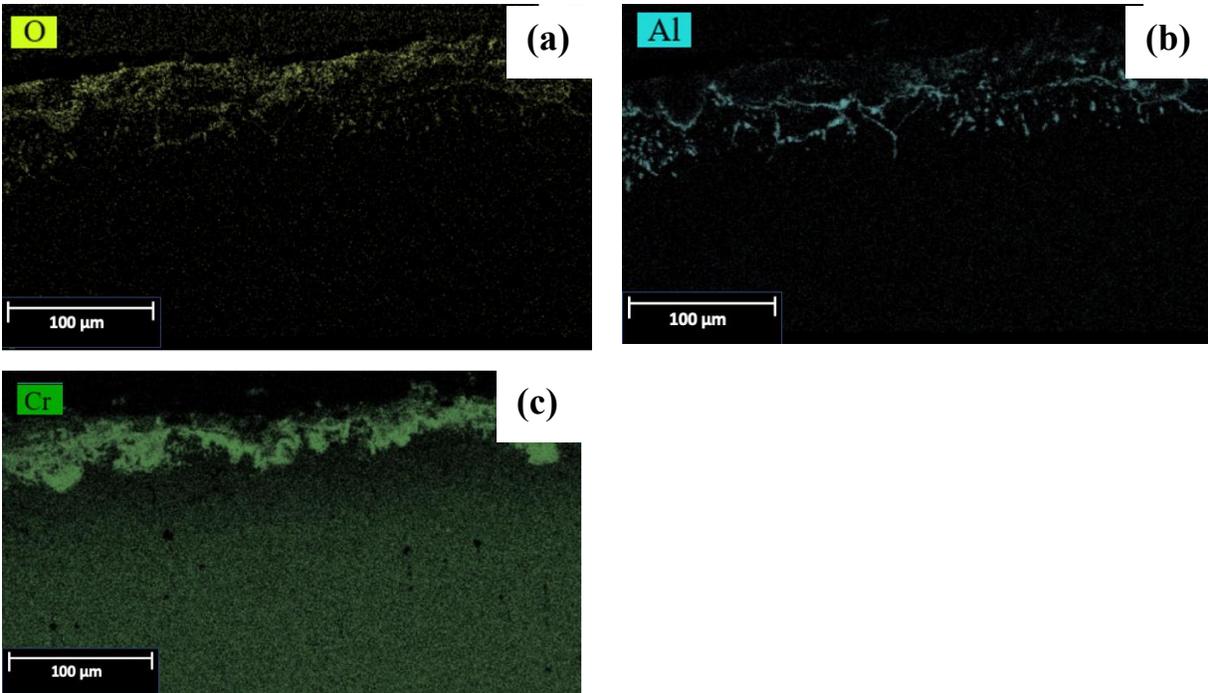
Figure 67: Individual EDS maps of T3 substrate. (a) Oxygen, (b) Aluminum, and (c) Chromium.

the surface, however EDS disproved this. The darker region was revealed to be chromium and oxygen rich (Figure 67). Furthermore, at the top of the substrate, the team observed a dark phase that looked like cracks, but EDS showed them to be aluminum rich regions. It is theorized that these are regions of aluminum oxide along the substrate grain boundaries that formed when oxygen diffusion reached the substrate.

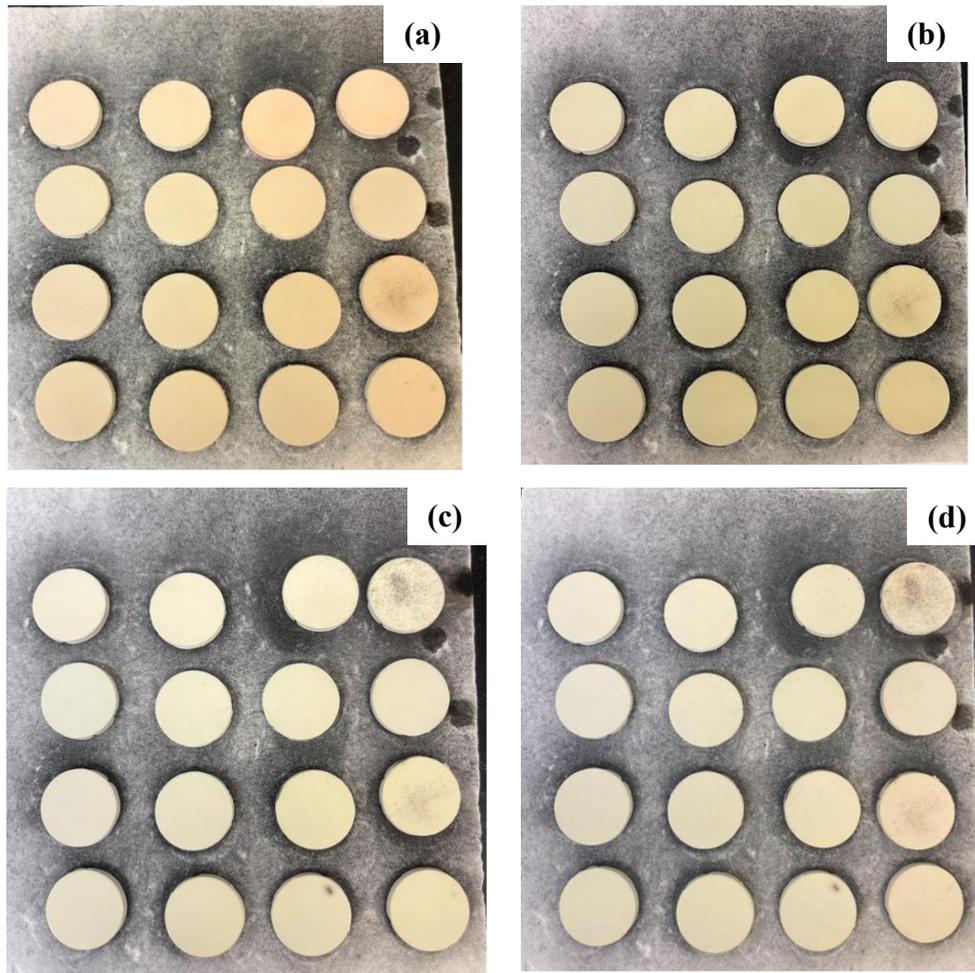
Figure 68: (a) Samples after one accelerated thermal cycle, first column retired. (b) Samples after two accelerated cycles, second column retired. (c) Samples after 3 accelerated thermal cycles, third column retired. At this point, some burning of the GB sample in the 4th column was observed. (d) Samples after 4 accelerated thermal cycles. No failure or spallation can be seen after the completion of the accelerated thermal cycling.

Samples were photographed after each of the 4 accelerated thermal cycles. Overall, none of the samples experienced spallation or failure after the completion of the series of accelerated thermal cycles. Slight burning on the surface of a GB sample was noted after 3 cycles—see Figure

68(a)—but this did not seem to be significant and was likely due to debris on the surface of the coating rather than the coating itself.

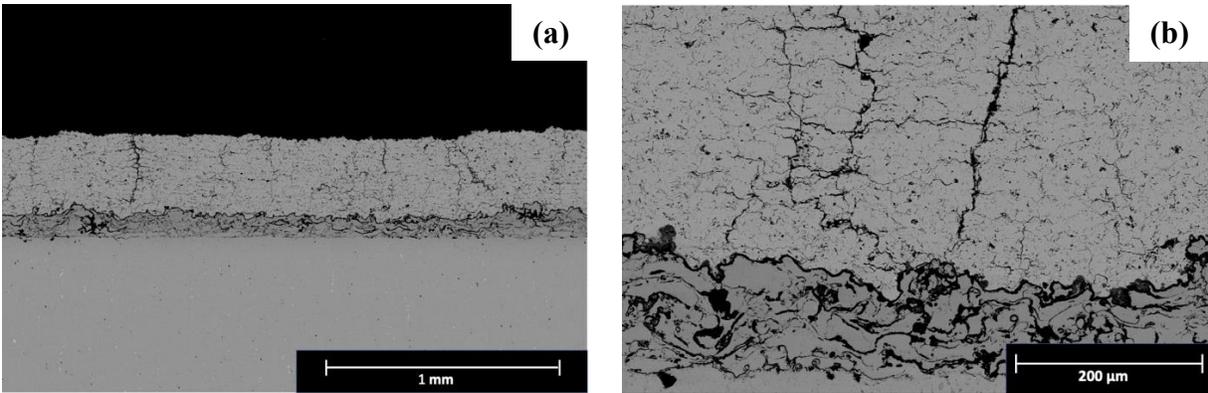
Figure 69: BSE SEM for the GB sample undergone 4 short furnace cycles. The TGO has started growing between the bond coat/TBC interface.

Upon initial visual inspection, the GB sample which underwent 4 short furnace cycles did not appear to experience spallation to significant coating damage. Once cross-sectioned and examined using the SEM, a TGO was shown to have started forming on the bond coat/TBC interface as shown in Figure 69. The DVCs appear to follow a random pattern as predicted.

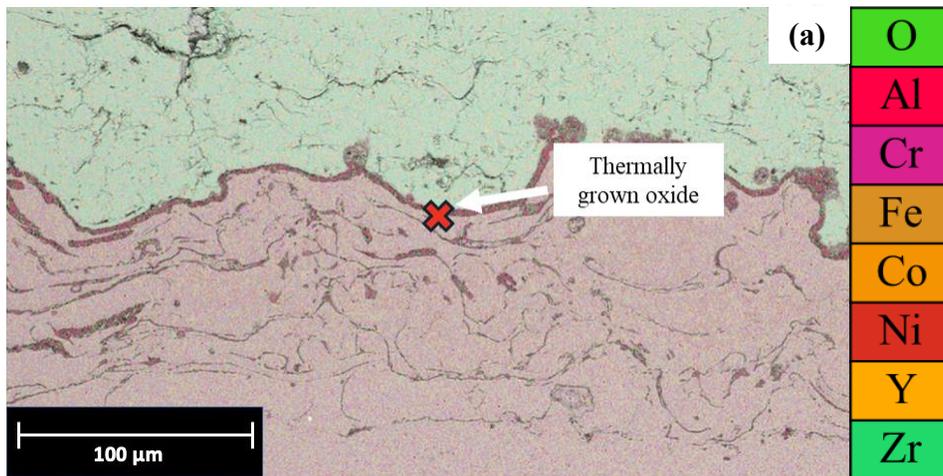
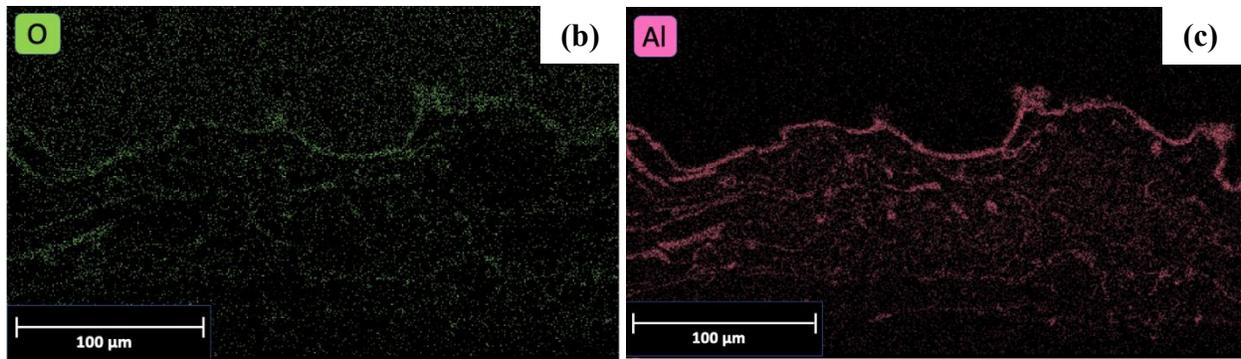
Figure 70: EDS of grit blast sample after 4 cycles. Shows early formation of aluminum oxide at TBC/bond coat interface. (a) Full EDS map, (b) Oxygen map, and (c) Aluminum map.

EDS completed on the grit blast sample after 4 cycles is displayed in Figure 70 and Table 25. These results very clearly identify the TGO at the TBC/bond coat interface as an aluminum oxide originating from aluminum within the bond coat.

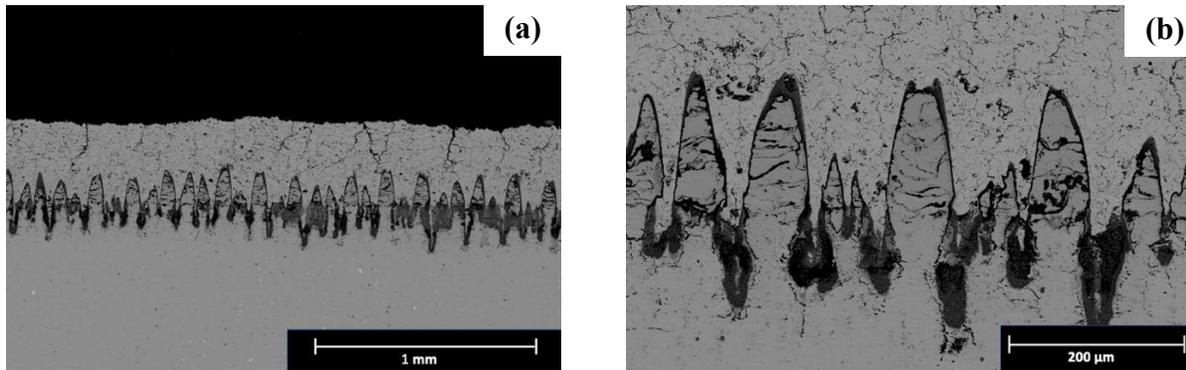
Figure 71: BSE SEM for the T1 sample subjected to 4 short furnace cycles. TGO appears to have grown in between the rounded spikes deep into the substrate along the bond coat/TBC interface.

Upon initial visual inspection, the T1 sample which underwent 4 short furnace cycles did not appear to experience spallation to significant coating damage. Once cross-sectioned and examined using the SEM, a TGO was shown to have started forming in the spaces between the rounded spikes deep into the substrate as shown in Figure 71. This is consistent with the TGO observed for the T1 samples subject to long furnace cycling. A darker layer surrounding the spikes at the bond coat/TBC interface suggests the presence of another TGO, which was further investigated with EDS. The bond coat also appears to have changed composition as the contrast

between the bond coat and substrate is no longer apparent. The DVCs appear to follow a random pattern, unlike the DVC pattern observed for the T1 samples for the long furnace cycling.

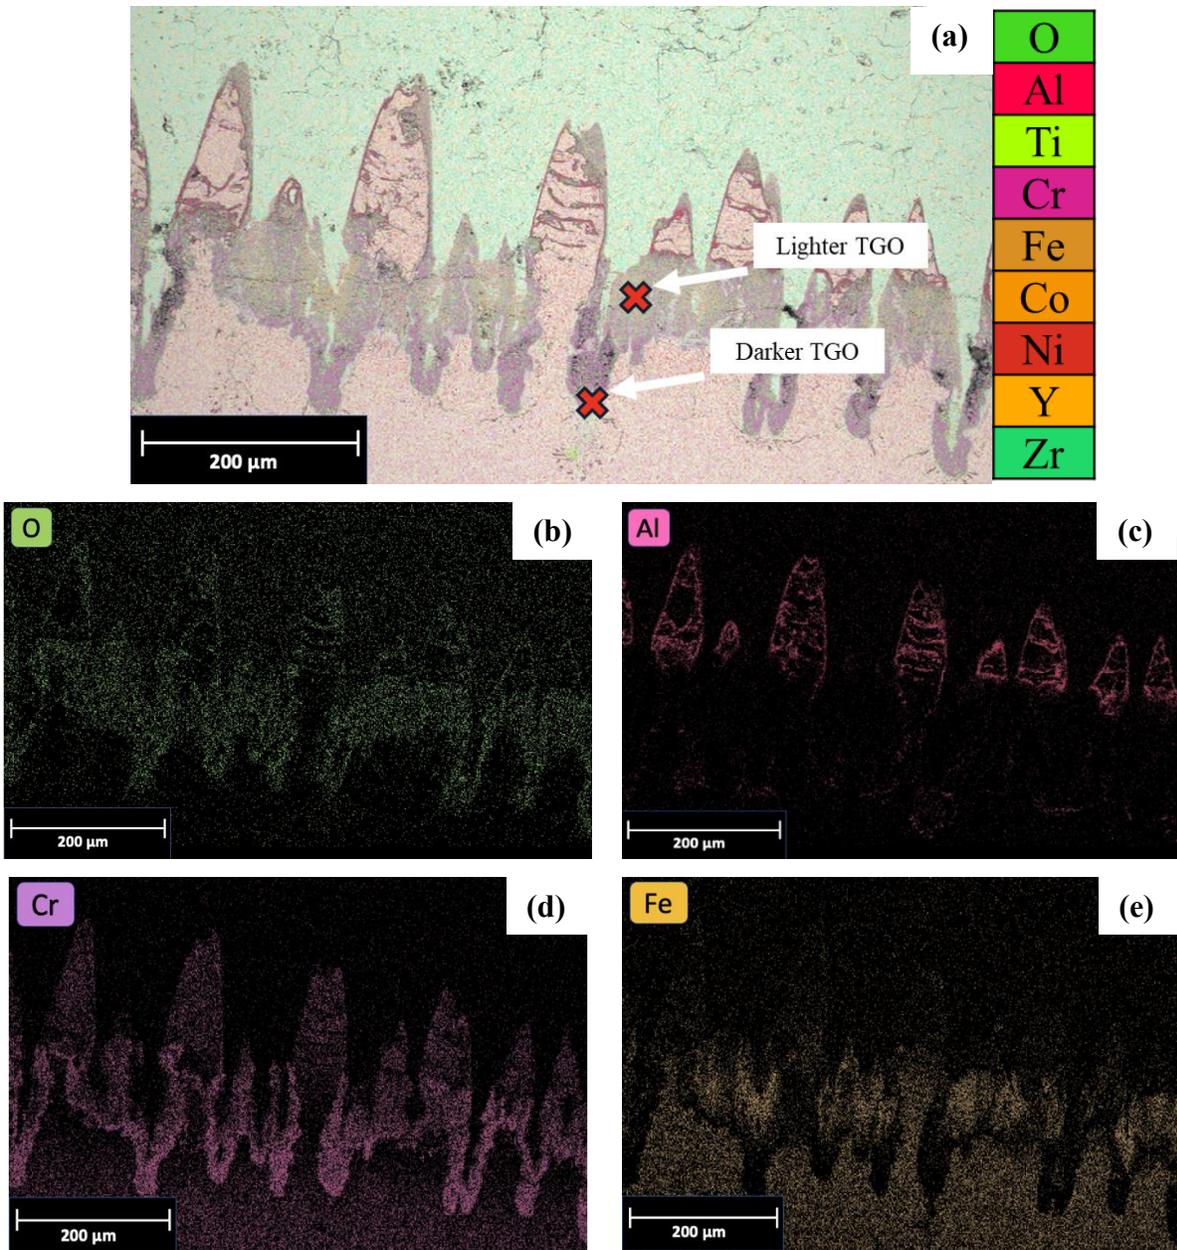
Figure 72: EDS of T1 after 4 cycles. Shows early formation of aluminum, chromium, and iron oxides at different interfaces within the coating system. (a) Full EDS map, (b) Oxygen map, (c) Aluminum map, (d) Chromium map, and (e) Iron map.

EDS on T1 accelerated cycling is shown below in Figure 72 and Table 26

Table 26 and displays a far more complex oxidation pattern than the grit blast samples. There is a lighter TGO that sits in between the top of the textured spikes and the underlying bond coat, completely separating it in two. EDS shows this region to have higher iron and chromium concentrations, with the iron decisively coming from the substrate. The dark TGO is found between rounded spikes and are rich in chromium. A chromium deficient region in the substrate surrounding the TGO suggests that the chromium originated from the substrate and not the bond coat. As was seen in the samples cycled to failure (see Thermal Cycling Results and Characterization), oxides at the substrate/bond coat interface cut off the top of the bond coat spikes, leading to failure. However, these results indicate that the oxide formed at the TBC/bond coat interface and not at the substrate. Additionally, Figure 72(c) shows an EDS map of aluminum to be used in comparison with findings from the grit blast samples. While it seems there is a small layer of aluminum oxide covering the bond coat spikes, likely the same oxide seen at the TBC/bond coat substrate in grit blast samples, this is clearly overpowered by the chromium and iron oxides present, resulting in the premature failure previously recorded. Given that these elements originated from the substrate, the team concluded that direct exposure of the substrate to the TBC is catastrophic for thermal performance.

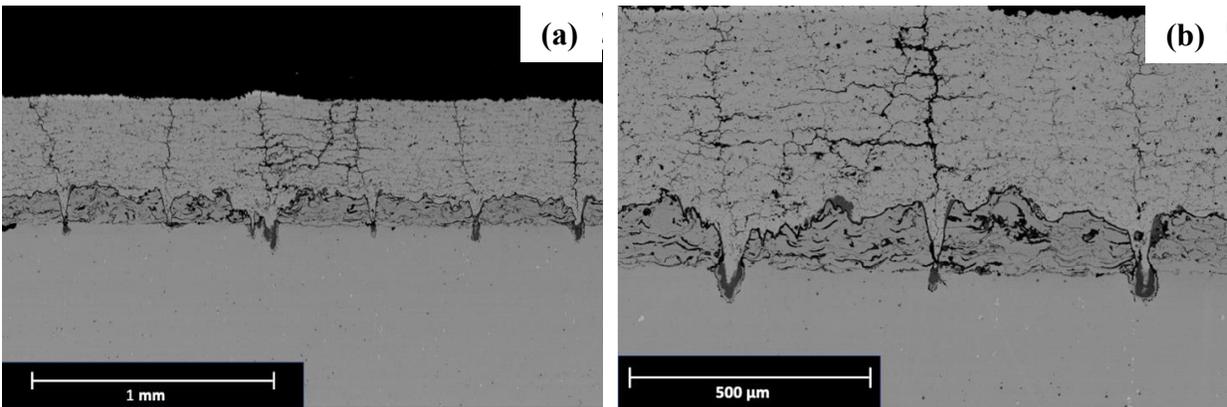
Figure 73: BSE SEM for the T2 sample subjected to 4 short furnace cycles. TGO appears to have grown in the trenches where the TBC is in contact with the substrate and in the interface between the bond coat and the TBC.

Upon initial visual inspection, the T2 sample which underwent 4 accelerated furnace cycles did not appear to experience spallation to significant coating damage. Once cross-sectioned and examined using the SEM, a TGO was observed at interface between the bond coat and the TBC, the composition of which was identified with EDS. Some TGO is also observed to have formed in the trenches at the interface with the substrate. DVCs appear to follow a very uniform pattern, falling in line with the preplanned grid “trenches” formed by the laser.

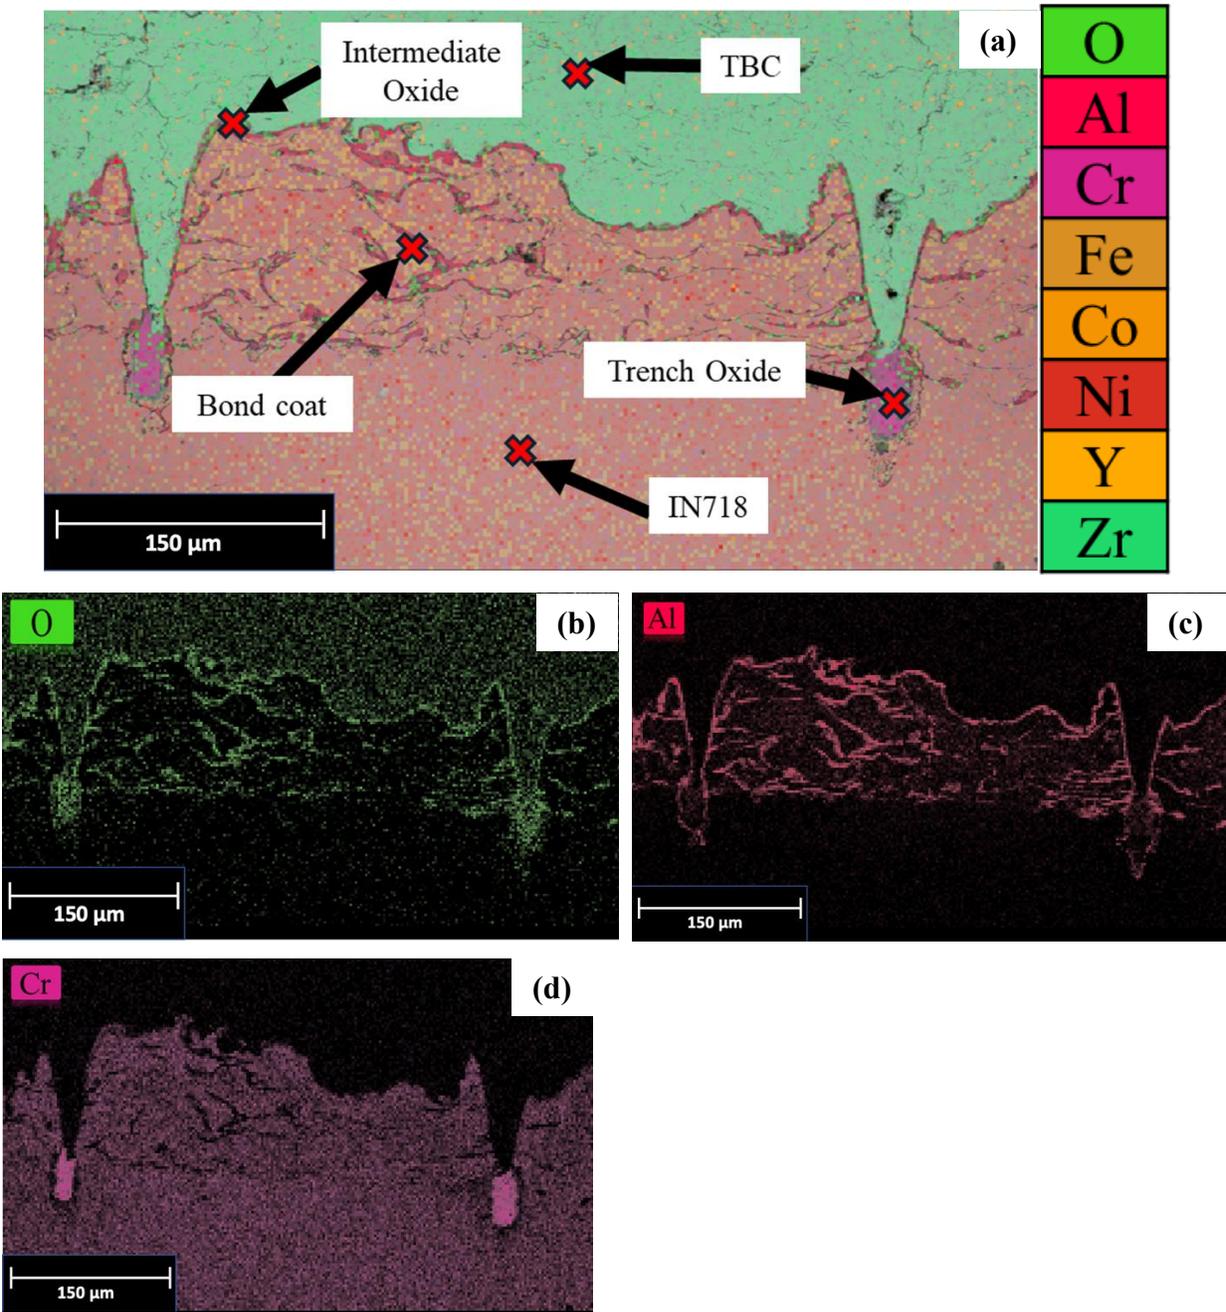
EDS of T2 after 4 short thermal cycles is seen below in Figure 74 and Table 27. Results show a thin layer of aluminum oxide formed at the interface between the bond coat and the TBC. Furthermore, the region between trenches preferentially formed chromium oxide, but there is a small layer of aluminum oxide that surrounds the chromium oxide. Both oxides can be clearly seen in individual EDS maps in Figure 74. A chromium deficient region in the substrate surrounding the chromium oxide is observed, similar to that seen in T1, suggesting that the chromium originated from the substrate.

Figure 74: EDS of T2 after 4 cycles. Shows early formation of aluminum and chromium oxides at different interfaces within the coating system. (a) Full EDS map, (b) Oxygen map, (c) Aluminum map, and (d) Chromium map.

In Figure 86, a progression of the oxide growth over time for the T2 (grid pattern texture) samples is shown in the three micrographs. The as-sprayed, accelerated furnace-cycled, and long furnace cycled samples for the T2 morphology are shown in chronological order. The EDS data (Figure 74) indicates that the oxide forming on the bond coat/topcoat interface is an aluminum oxide, and the oxide forming in the grid trenches is chromium oxide. The IN718 substrate, with a higher percentage of chromium than the bond coat, reacts with the oxygen, and chromium oxide grows outwards in the trenches. Delamination is observed to have occurred in most locations between the substrate and the bond coat, although more bond coat remains adhered to the substrate compared to T1. The samples with the T2 texture lasted the longest for the long furnace cycling experiment at 15 cycles, although still significantly less than the expected number of cycles of 50-100. This performance may be explained by more uniform arrangement of the DVCs. In the T2 textured samples, in both the as-sprayed and the furnace cycled samples, the

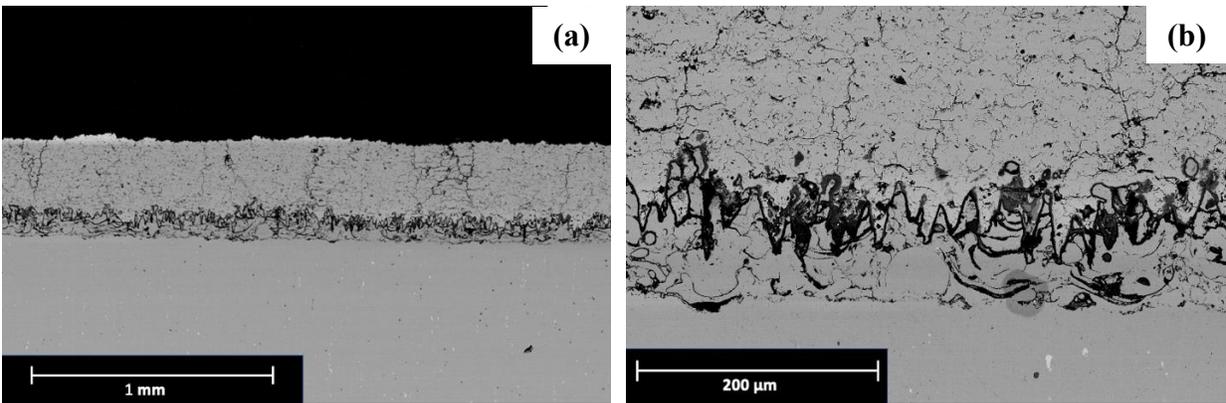
Upon initial visual inspection, the T3 sample which underwent 4 accelerated furnace cycles did not appear to experience spallation to significant coating damage. Once cross-sectioned and examined using the SEM, a TGO was observed at interface between the bond coat and the TBC, which was confirmed with EDS. The DVCs appear to follow a random pattern as observed for the T3 cycle which underwent long furnace cycling

Figure 75: BSE SEM for the T3 sample subjected to 4 short furnace cycles. TGO appears to have grown on the interface between the bond coat and the TBC.

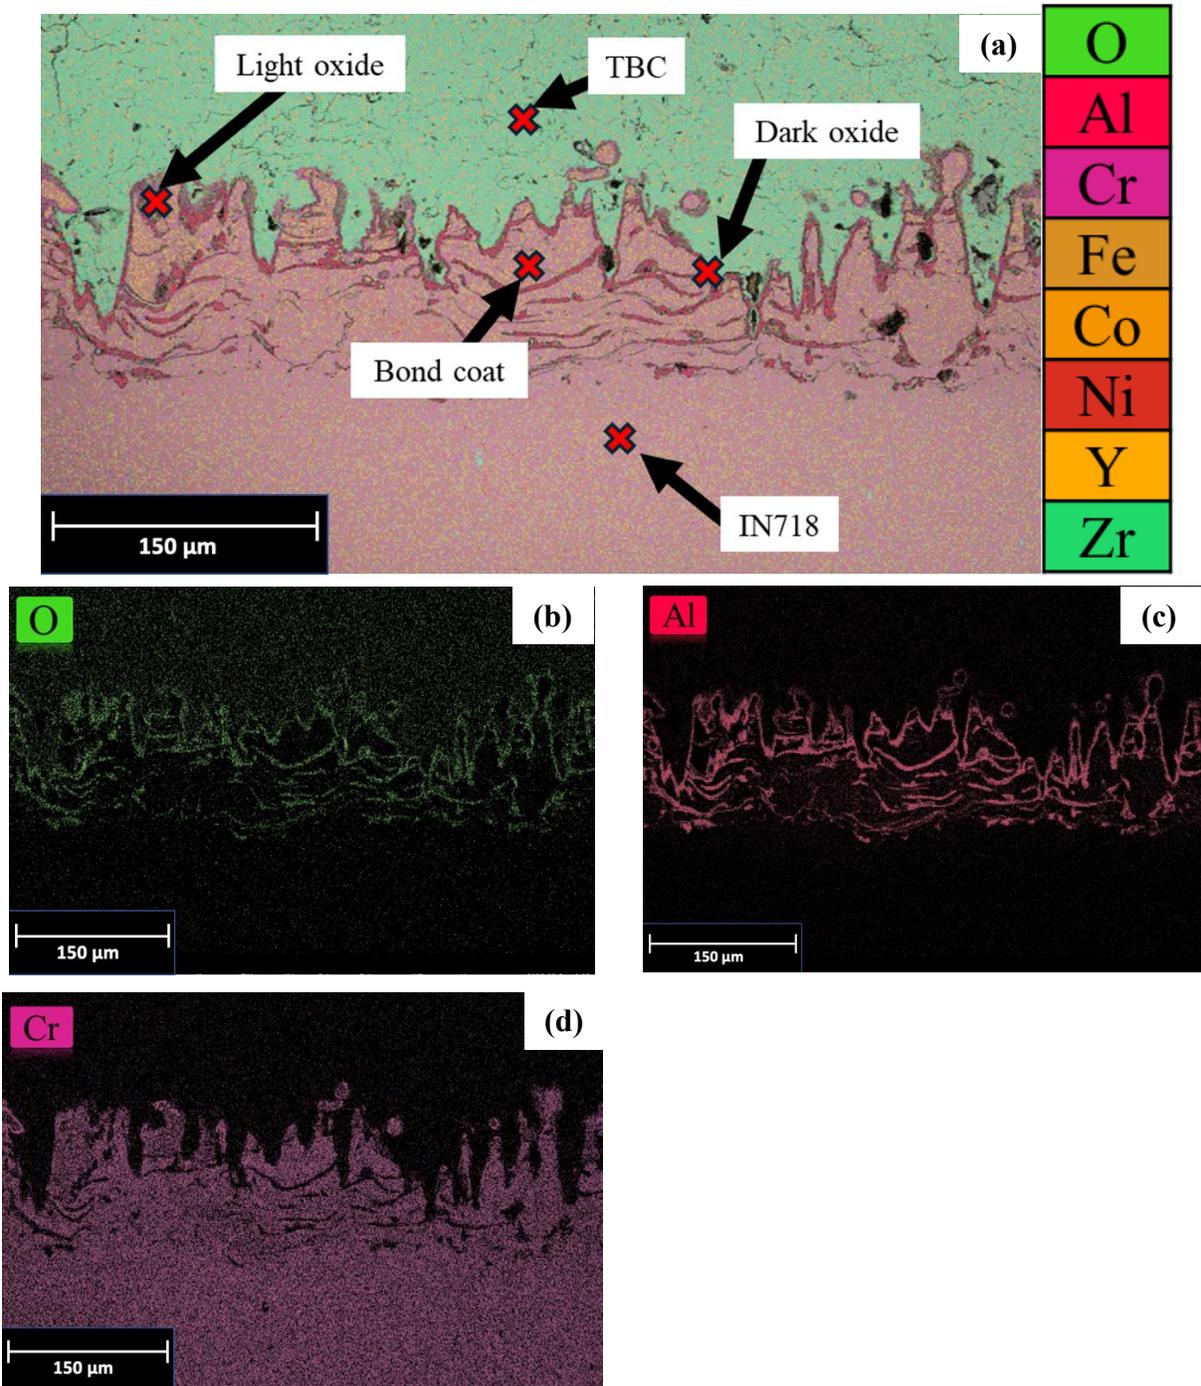
Following SEM, EDS was conducted on the accelerated cycle samples, shown below in Figure 76 and Table 28. These results show the growth of a lighter oxide and a darker oxide. The darker oxide is the preferred aluminum oxide, while the lighter oxide is rich in nickel and aluminum, suggesting early oxidation of the bond coat.

Figure 76: EDS of T3 after 4 cycles. Shows early formation of aluminum and chromium oxides at different interfaces within the coating system. (a) Full EDS map, (b) Oxygen map, (c) Aluminum map, (d) Chromium map.

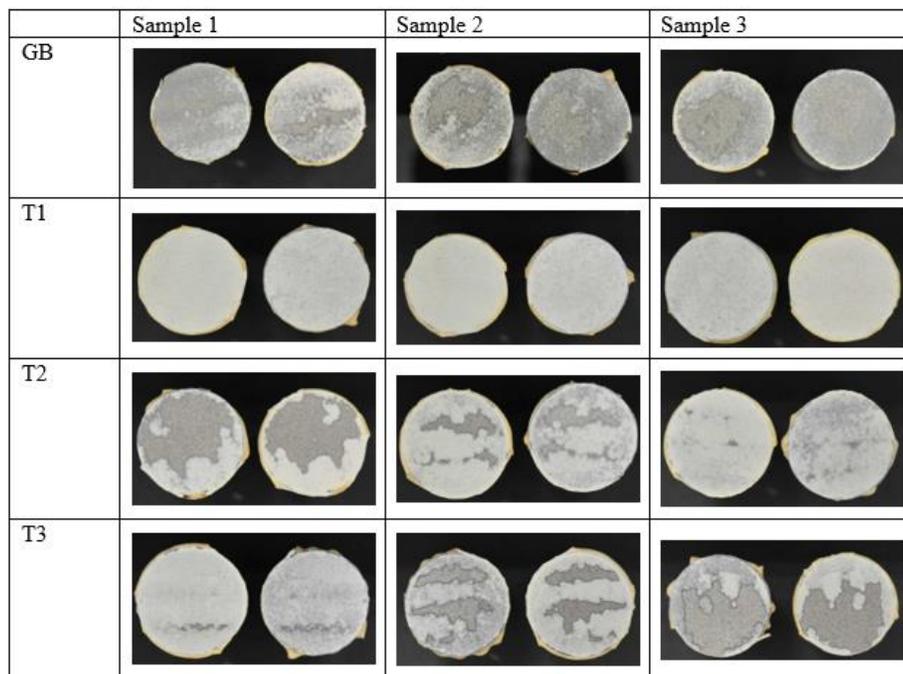
Micrographs in Figure 77 show that T1 had the most homogeneous fracture surface that propagates through the TBC, while the other samples have regions show failure through the bond coat and the TBC. The optical microscopy that follows helped the team discern the nature of the failure.

Figure 77: Fracture surfaces of adhesion tested samples. Samples exhibit failure through the TBC as well as through the bond coat.

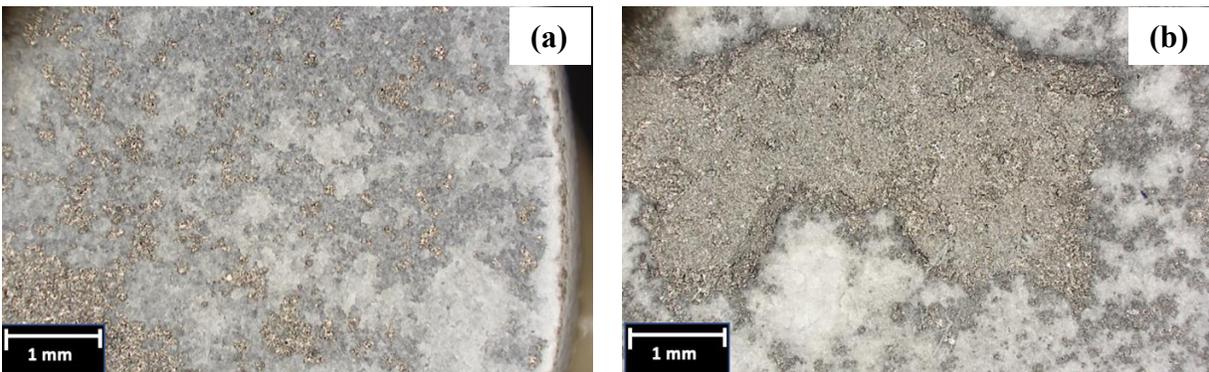
imaging the metal side. Figure 78 shows the metal side of a GB sample. Most of the surface looked like what can be seen in Figure 78(a), where primary failure seems to have occurred at the TBC/bond coat interface, with some bond coat also coming out. The exception to this can be seen in Figure 78(b), where a region of bond coat has been completely torn out, indicating failure within the bond coat, perhaps extending to the bond coat/substrate interface.

Figure 78: Optical micrographs of the metal side of a GB sample, post-adhesion testing; (a) surface showing mostly TBC failure, and (b) section of the surface where some bond coat has been torn out.

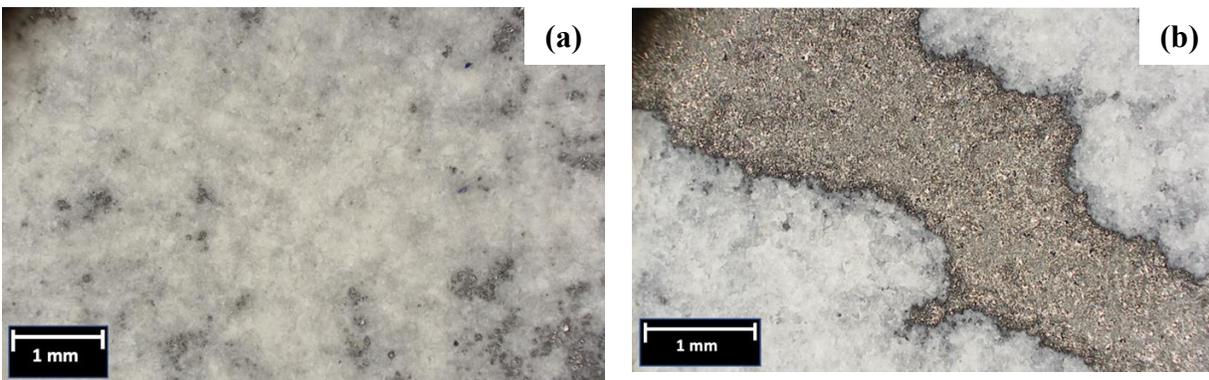
To confirm that the chunk of bond coat we observed in Figure 79(b) had come out on the coating side, the team imaged the coating side of the same GB sample. As expected, most of the coating was TBC with small speckles of bond coat, consistent with our earlier assessment of a TBC/bond coat interface failure. Indeed, the team did find the region of bond coat that had been torn out (Figure 79(b)), corroborating that there was some small degree of bond coat-substrate failure.

Figure 79: Optical micrographs of the coating side of a GB sample, post-adhesion testing; (a) what most of the coating-side surface looks like, showing that most of what was pulled off was coating, with only some small amounts of bond coat, and (b) a region of the coating-side surface showing a section of bond coat that was torn out – likely corresponding with the area torn out from the metal-side surface in Figure 78(b).

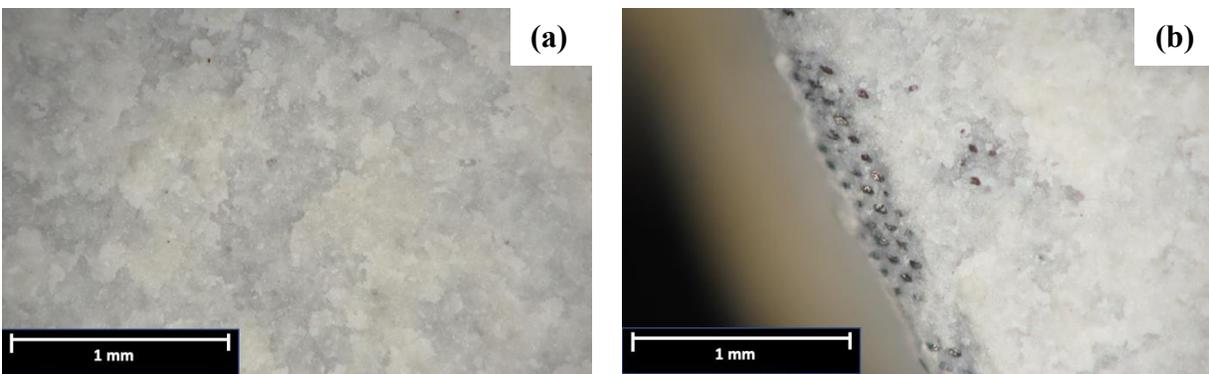
Figure 80 shows metal-side micrographs for a T1 sample. As TBC is continuously visible, the team has determined that this was primarily an intra-TBC failure. Figure 80(b) shows a small amount of the bond coat texture visible around an edge and confirms that the TBC texture was able to fill in the gaps of this texture.

Figure 80: Optical micrographs of the metal side of a T1 sample, post-adhesion testing; (a) what most of the metal-side surface looks like, showing that virtually all failure is within the TBC, and (b) edge exposing top of bond coat texture.

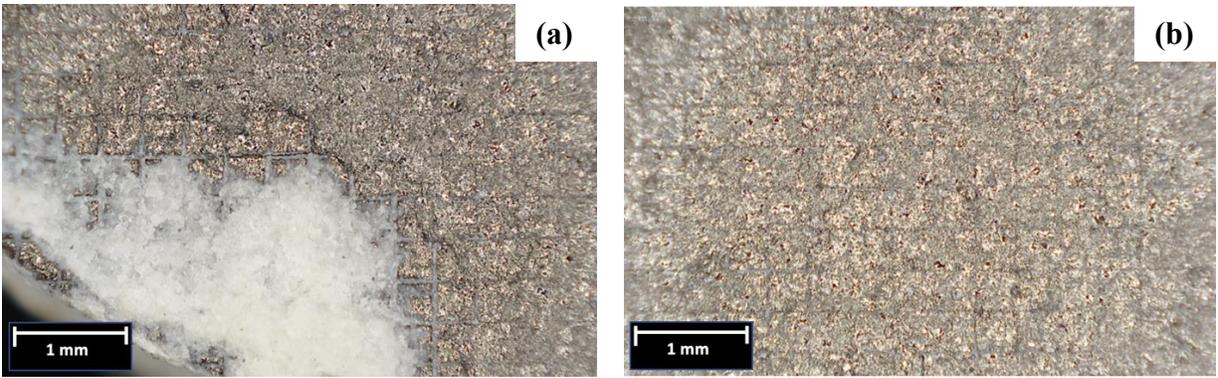
Figure 81 shows the metal-side surface of a T2 sample after adhesion testing. Overall, the fracture location seems to be variable. From these views, it is clear that there was intra-TBC failure, TBC-bond coat failure, and intra-bond coat failure. Figure 81(b) shows a region of the T2 metal surface where the bond coat had been mostly removed, leaving behind only a faint outline of the grid. Based on the team's earlier observations about the T2 grid pattern texture ridges piercing through the bond coat and into the substrate, it can be deduced that this fracture occurred within the bond coat close to the substrate.

Figure 81: Optical micrographs of the metal side of a T2 sample, post-adhesion testing; (a) a region showing TBC failure, interface failure, as well as bond coat failure, and (b) what left over bond coat looked like.

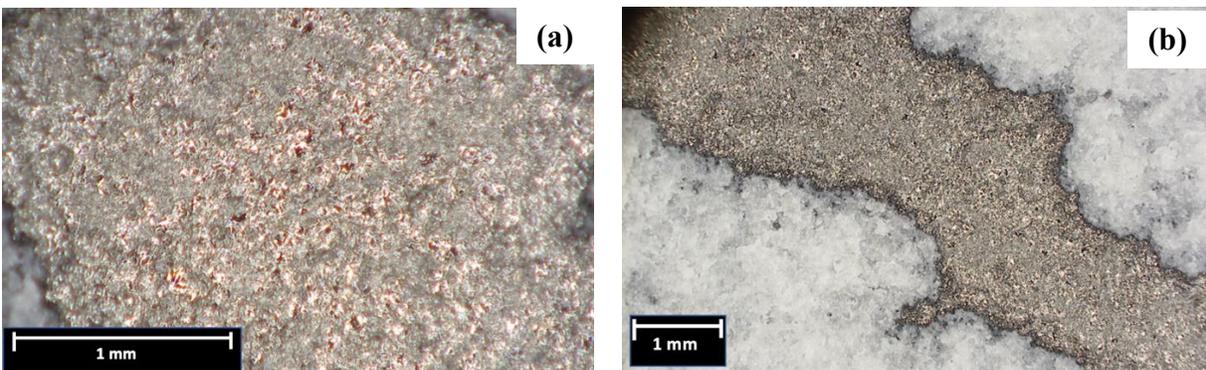
Figure 82 shows micrographs of the metal-side surface of a T3 sample. Like the T2 sample, failure did not occur in just one region of the coating system. It seems that there was intra-TBC failure, as well as bond coat-substrate failure.

Figure 82: Optical micrographs of the metal side of a T3 sample, post-adhesion testing; (a) a region of exposed bond substrate and (b) an area showing failure within TBC as well as at the bond coat/TBC interface.
