**Optimizing Surface Texturing for YSZ Thermal-Barrier-Coating on Inconel
718 Substrate to Mitigate High Stresses/Strains**

A Technical Report submitted to the Department of Materials Science & Engineering

Presented to the Faculty of the School of Engineering and Applied Science
University of Virginia • Charlottesville, Virginia

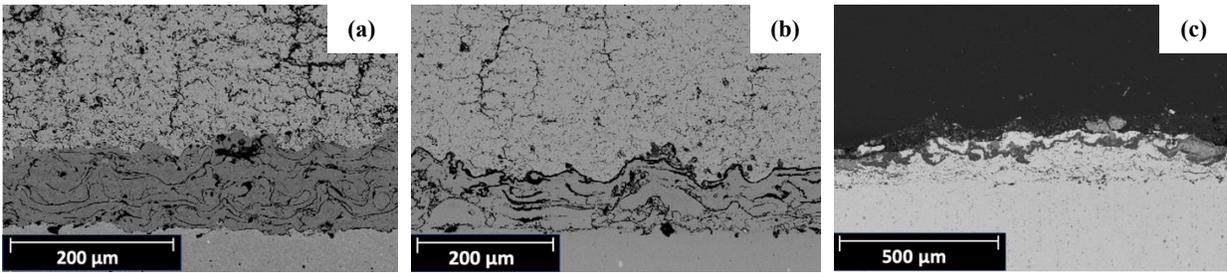
In Error! Reference source not found., a progression of the oxide growth over time for the GB (nontextured) samples is shown in the three micrographs. The as-sprayed, accelerated furnace-cycled and long furnace cycled samples for the GB morphology are shown in chronological order. Although varying in thickness, the bond coat is observed to completely cover the substrate, and the oxide begins by growing on the bond coat/topcoat interface. This oxide appears to grow to such an extent in thickness that it allows for the topcoat to delaminate from the bond coat. As observed in the EDS analysis of GB samples for long furnace cycling (Figure 49) and accelerated thermal cycling (Figure 70), the bond coat acts as an oxygen protector for the substrate. Oxides will form at the bond coat/TBC interface first, preventing the oxygen from diffusing through to the substrate. The bond coat in GB samples covered the entirety of the substrate, unlike some of the other textures. Complete coverage is expected, meaning this would be the most representative sample of actual TBC system oxidation. Because the GB samples had this full coverage, unlike the textured samples, oxide growth was limited to the bond coat/TBC interface and thus provided the second longest average furnace cycle lifetime. It is also observed that the TBC for the GB samples delaminated mostly in one piece as observed in the optical micrographs (Figure 45). The surface profile of the bond coat was relatively regular, allowing for uniform oxide growth. Uniform oxide growth across the entire bond coat/TBC interface likely resulted in a uniform stress distribution that caused complete delamination of the TBC.

Figure 83: Bond coat/TBC interface progression of GB sample from (a) as-sprayed, (b) 4 short thermal cycles, and (c) failure after long thermal cycles. Shows TGO growth that contributed to coating failure.

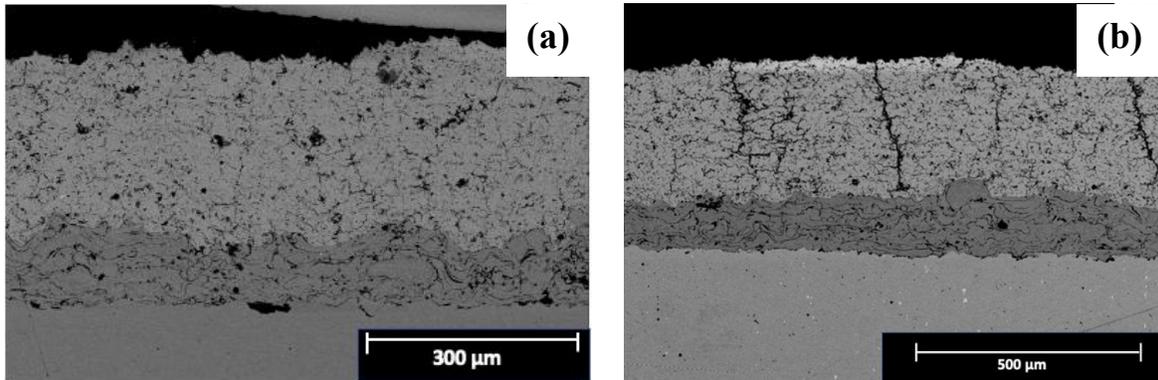
In Figure 84(a), an SEM micrograph of the TBC layer sprayed onto test steel sample using chosen spray parameter 4 displays a small number of DVCs that are less developed with minimal branching observed. Comparatively, the as-sprayed samples for each of the 4 texture types have shown much more DVC development and substantial branching. Figure 84(b) shows a direct comparison of DVC development in the as-sprayed grit blast sample. There is no reason for difference between Figure 84(a) and Figure 84(b), given they were both theoretically applied using the same spray parameters on the same bond coat surface – yet there is still an obvious difference. A mix-up of spray parameters is not implausible as there had already been confusion with the spray distance corresponding to spray parameter 4 earlier (the spray parameter sheet

Figure 84: (a) BSE SEM micrograph of the test steel sample sprayed using spray parameter 4, and (b) BSE SEM micrograph of an as-sprayed grit blast sample which had TBC applied using supposedly the same spray parameters.

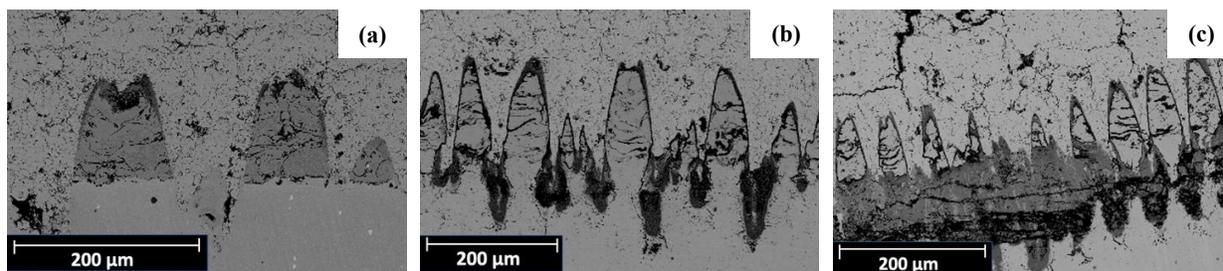
In Figure 85, a progression of the oxide growth over time for the T1 (rounded spike texture) samples is shown in the three micrographs. The as-sprayed, accelerated furnace cycled, and long furnace cycled samples for the T1 morphology are shown in chronological order. The bond coat did not completely cover the substrate, leaving portions of the substrate in between the rounded spikes exposed directly to the topcoat. This allowed rapid chromium oxide growth in these areas between the rounded spike bond coat, since the bond coat was absent to protect from oxygen ingress. The chromium oxide initiated between bond coat spikes and quickly grew underneath the bond coat, leading to failure at the bond coat/substrate interface. This oxide growth over time is shown in the long furnace cycled sample in Figure 85(c).

Aluminum oxide forms at the interface between the bond coat spikes and TBC, as expected from behavior observed in the GB samples. This observation was validated by Rolls-Royce, stating that aluminum oxide forms first in the system, followed by chromium oxide when all aluminum has been depleted from the bond coat. This behavior, however, was not observed; chromium oxide at the substrate/bond coat interface dominates. This is caused by the lack of aluminum in the substrate, relative to the bond coat. The bond coat contains approximately 12

Figure 85: Bond coat/TBC interface progression of T1 from (a) as-sprayed, (b) 4 short thermal cycles, and (c) failure after long thermal cycles. Shows TGO growth that contributed to coating failure.

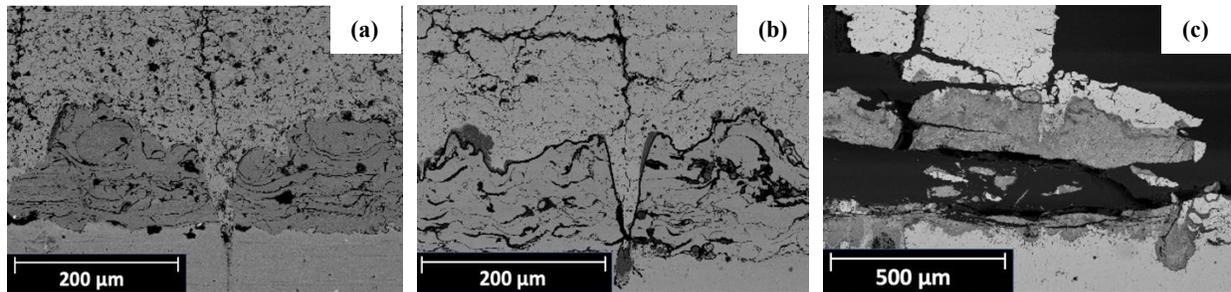
In Figure 86, a progression of the oxide growth over time for the T2 (grid pattern texture) samples is shown in the three micrographs. The as-sprayed, accelerated furnace-cycled, and long furnace cycled samples for the T2 morphology are shown in chronological order. The EDS data (Figure 74) indicates that the oxide forming on the bond coat/topcoat interface is an aluminum oxide, and the oxide forming in the grid trenches is chromium oxide. The IN718 substrate, with a higher percentage of chromium than the bond coat, reacts with the oxygen, and chromium oxide grows outwards in the trenches. Delamination is observed to have occurred in most locations between the substrate and the bond coat, although more bond coat remains adhered to the substrate compared to T1. The samples with the T2 texture lasted the longest for the long furnace cycling experiment at 15 cycles, although still significantly less than the expected number of cycles of 50-100. This performance may be explained by more uniform arrangement of the DVCs. In the T2 textured samples, in both the as-sprayed and the furnace cycled samples, the

DVCs appear to fall in line with the grid line trenches. This more uniform arrangement of the DVCs may have allowed for more stress relief within the system during the heating and cooling caused by the different coefficients of thermal expansion.

Figure 86: Bond coat/TBC interface progression of T2 from (a) as-sprayed, (b) 4 short thermal cycles, and (c) failure after long thermal cycles. Shows TGO growth that contributed to coating failure.

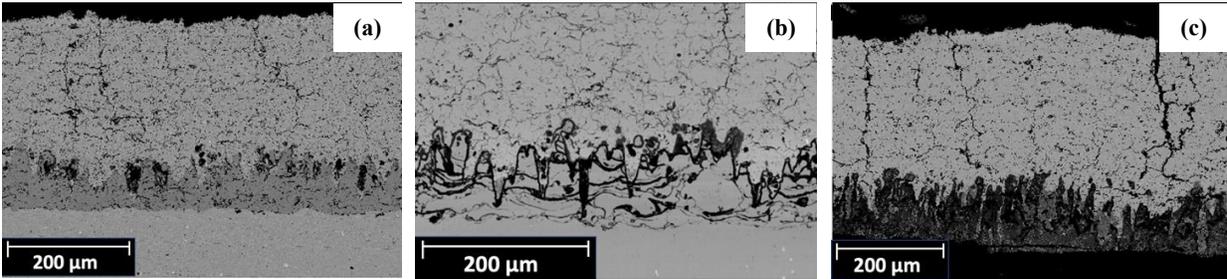
In Figure 87, a progression of the oxide growth over time for the T3 (grown pattern texture) samples is shown in the three micrographs. The as-sprayed, accelerated furnace-cycled, and long furnace cycled samples for the T3 morphology are shown in chronological order. The accelerated furnace cycling micrograph shows the aluminum oxide growth on the bond coat/topcoat interface. However, the long furnace cycling shows that the bond coat mostly delaminated from the substrate and remained in contact with the TBC topcoat. This may indicate that the oxide growth occurred on the substrate/bond coat interface. The main evidence for this oxide growth allowing the delamination on the substrate/bond coat interface is in the EDS data (Figure 76) showing oxygen on the delaminated coating and the remaining substrate. The grown texture was primarily designed to increase adhesion of the bond coat and the topcoat and not make the DVC arrangement uniform. Since the DVCs are arranged randomly, this may be one factor to explain the poorer performance of the T3 samples compared to the T2 samples during long furnace cycling. The T3 samples lasted an average of 9 cycles during the long furnace cycling. The irregularity of the bond coat thickness also allowed for more oxygen ingress towards the substrate/bond coat interface, creating the fast-growing chromium oxide. The bond coat however appeared to completely cover the substrate, unlike T1 and T2, which comparatively could have protected the substrate more from the rapid oxide growth. The large number of pores between the

Figure 87: Bond coat/TBC interface progression of T3 from (a) as-sprayed, (b) 4 short thermal cycles, and (c) failure after long thermal cycles. Shows TGO growth that contributed to coating failure.

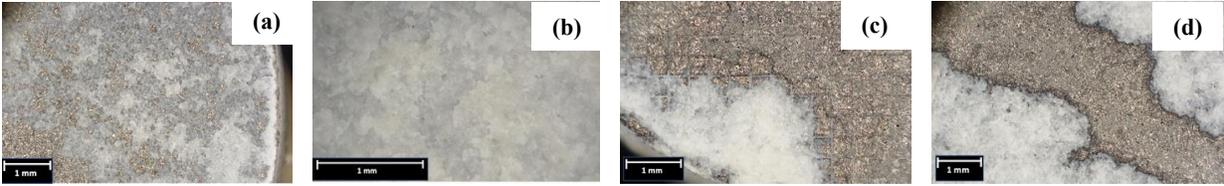
Figure 88: Comparison of adhesion tested metal surfaces; (a) GB, (b) T1, (c) T2, and (d) T3.

Of all the samples, only the GB sample failed primarily along the TBC/bond coat interface. This indicates weak mechanical interlocking between these two layers in the coating system. By contrast, T1 samples failed completely through the TBC layer. This indicates that the TBC/bond coat interface was stronger than the TBC itself due to mechanical interlocking provided by the rounded spikes. These micrographs also confirmed that TBC was successfully deposited in between the rounded spikes, as corroborated by cross-sectional SEM micrographs. The team believes that the increased rounded spike surface area covered by the TBC contributed to this increased interface strength.

The T2 and T3 samples failed in a far less homogenous way. T2 samples showed failure primarily within the TBC and within the bond coat, with a smaller fraction of the surface displayed some TBC/bond coat interface failure. This means that for most of the surface area, the TBC and bond coat strengths were lower than that of the bond coat/TBC interface, hinting at high mechanical interlocking, but not as high as was displayed in T1 samples. The T3 samples showed all failure within the TBC or at the bond coat/substrate interface. Again, this shows that the TBC and bond coat/substrate interface were weaker than the TBC/bond coat interface, indicating high mechanical interlocking.

These findings roughly align with average coating strengths. T1 and T3 samples, which displayed zero or close to zero TBC/bond coat interface failure, failed at the highest loads. T2 samples, which displayed a small amount of TBC/bond coat interface failure, failed at a slightly lower load. Finally, the GB samples, which failed almost entirely along the TBC/bond coat interface, failed at a significantly lower load. From this, the team has concluded that the rounded spike and grown textures provide the most additional mechanical interlocking between the TBC/bond coat interface. This also makes sense from a geometry standpoint, as those textures provide the most increased vertical surface contact which would oppose axial force.

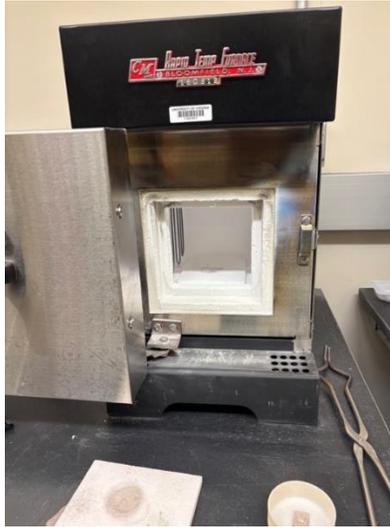
Figure B.1: One of the two furnaces in the Opila lab used for thermal cycling.

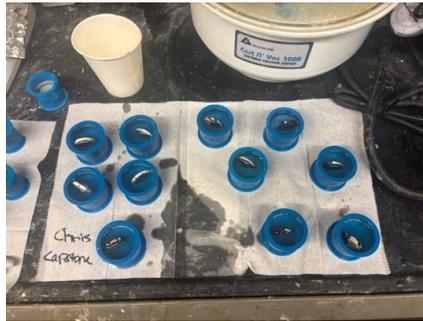
Figure C.1: Samples placed in epoxy for mounting post-furnace-cycling.

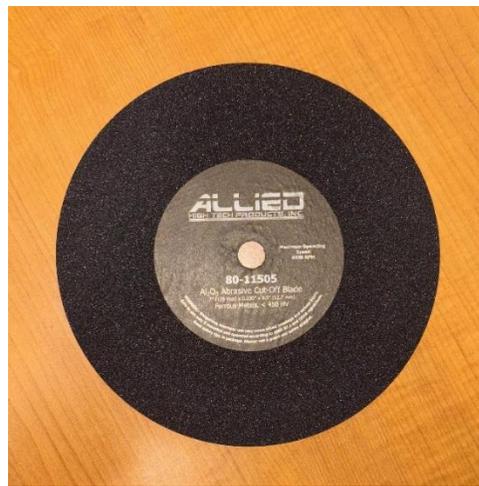
Figure C.2: Image of resin bond Al₂O₃ blade.
