# **IMPLEMENTATION OF LASER ABLATION COATING REMOVAL TECHNIQUE FOR STEEL COMPONENTS ON VDOT BRIDGES**

A Thesis

Master of Science in Material Science and Engineering

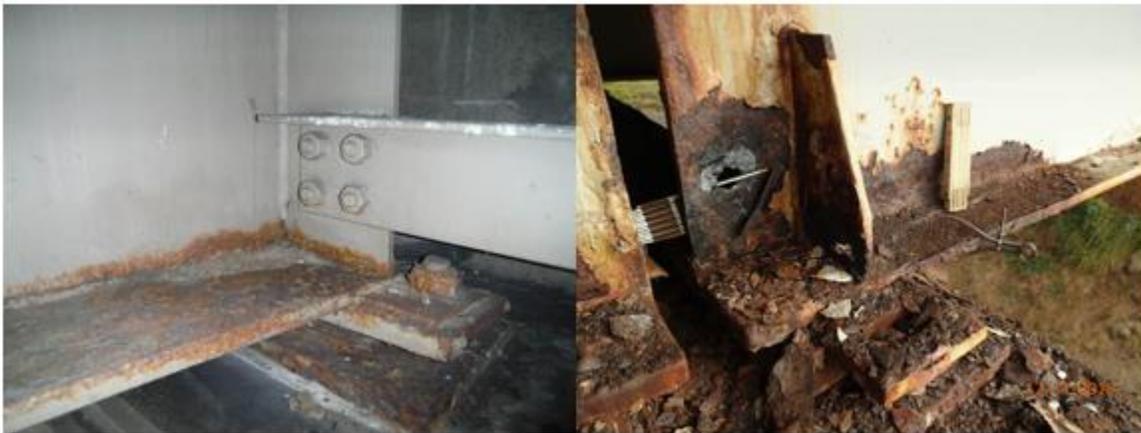
*Figure 1.1. Photographs showing beam end corrosion damage due to routine salt exposure. <sup>1</sup>*

One of the most common methods of preventing corrosion of steel bridge components is with the use of polymeric coatings. This is an effective corrosion mitigation technique, however with time, coatings require maintenance in order to effectively protect the underlying steel, as weathering and exposure can slowly deteriorate these coating systems and leave the steel vulnerable to corrosion. This can be seen near the ends of some bridge beams where excessive corrosion damage has occurred due to leaking deck joints resulting in frequent salt exposure. (Figure 1.1)<sup>[1]</sup>.

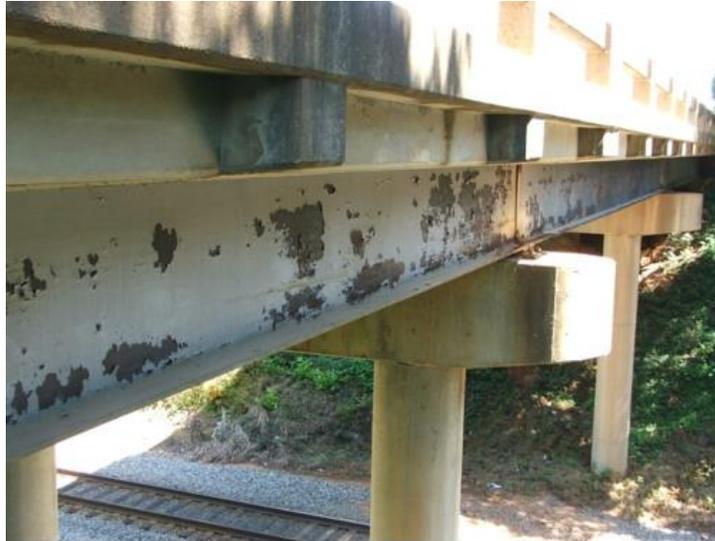
*Figure 1.2. A bridge showing coating detachment due to weathering and exposure of bridge I-beams, highlighting the importance of coating adhesion.<sup>1</sup>*

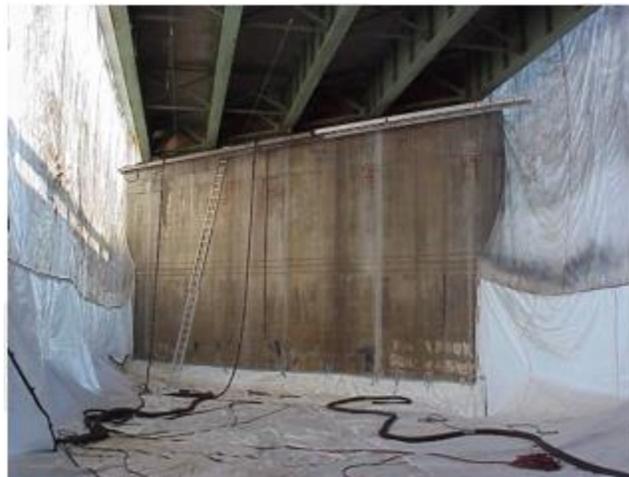
*Figure 1.3. An example of bridge containment set up during a de-coating operation, which increases maintenance costs due to the time, materials, and labor required for assembly.<sup>1</sup>*

In consideration of coating repairs, determining the optimal method for maintaining the coating system and protecting the structural steel can be complex and costly. This involves ensuring that the surface is prepared properly, as well as determining that the coating will adhere to the substrate, which is key for mitigating corrosion damage, (Figure 1.2)<sup>1</sup>. In addition, coating work in the field must meet worker field safety regulations as well as ensure environmental compliance through the proper containment of all materials (Figure 1.3)<sup>1</sup>.

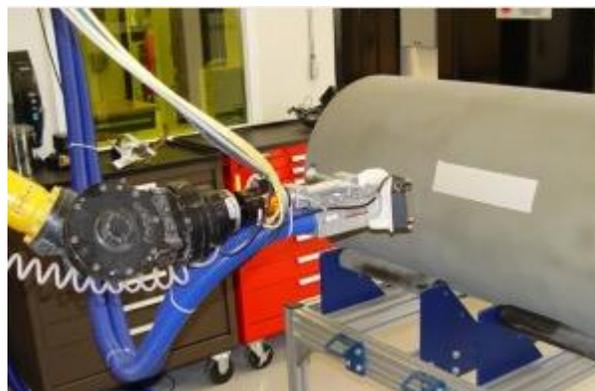
*Figure 1.4. Lasertronics laser system in use by the US Naval Undersea Warfare Center, Keyport, WA, for cleaning test torpedoes.<sup>20</sup>*

For example, the U.S. Navy has found laser cleaning applications for submerged ship surfaces, as well as dry parts of decking and ship superstructure, and even for such niche applications as cleaning test torpedoes. (Figure 1.4)<sup>20</sup>.

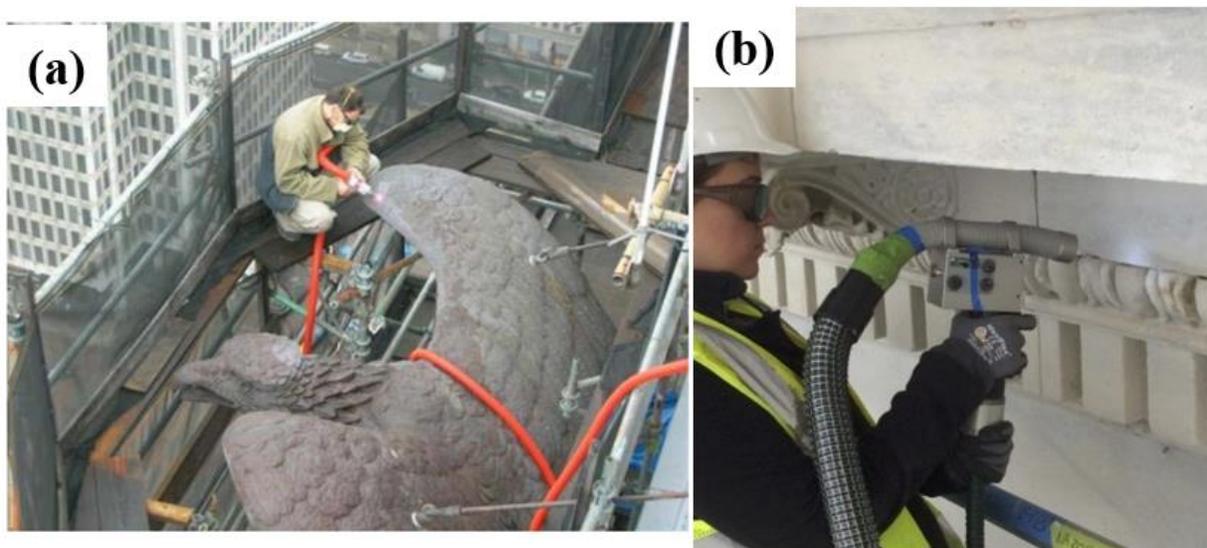
*Figure 1.5. (a) Laser surface cleaning of bronze statuary on the Philadelphia City Hall. (b) Laser cleaning exterior marble on the U.S. Capitol Building in Washington, D.C.<sup>21,22</sup>*

In commercial civilian settings laser cleaning has found uses in cleaning building facades, exteriors, and even sculptures and ornaments. The Philadelphia City Hall<sup>21</sup>, US Capitol Building (Figure 1.5)<sup>22</sup>, and Canadian Parliament building<sup>23</sup> are examples of prominent landmarks that have been successfully cleaned using LACR technology.

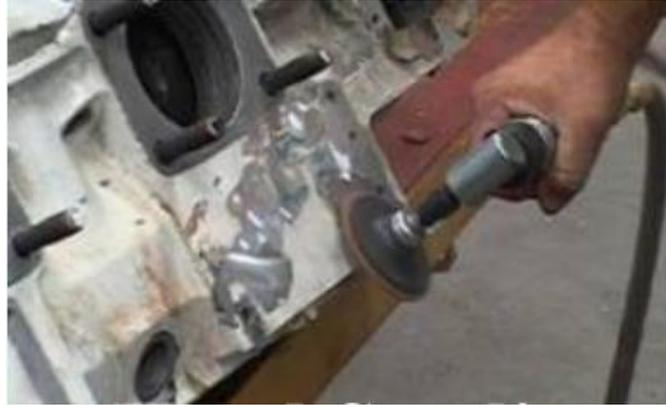
*Figure 1.6. Power sanding a paint coating from an off aircraft component. <sup>16</sup>*

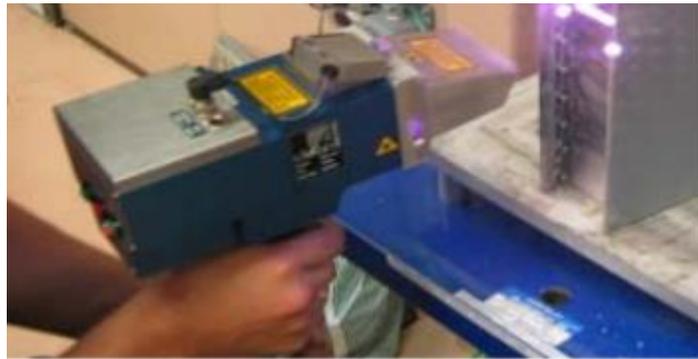
*Figure 1.7. Hand held laser system used in phase 1 of the laser coatings removal program at AFRL<sup>16</sup>*

AFRL Phase I of this project involved the use of a low power, light-weight, hand held laser system to clean aerospace parts, as shown in Figure 1.7<sup>16</sup>. AFRL was able to determine that this provided a cost effective, safety compliant, and selective stripping of the coating system that was environmentally friendly and increased the facility capacity.

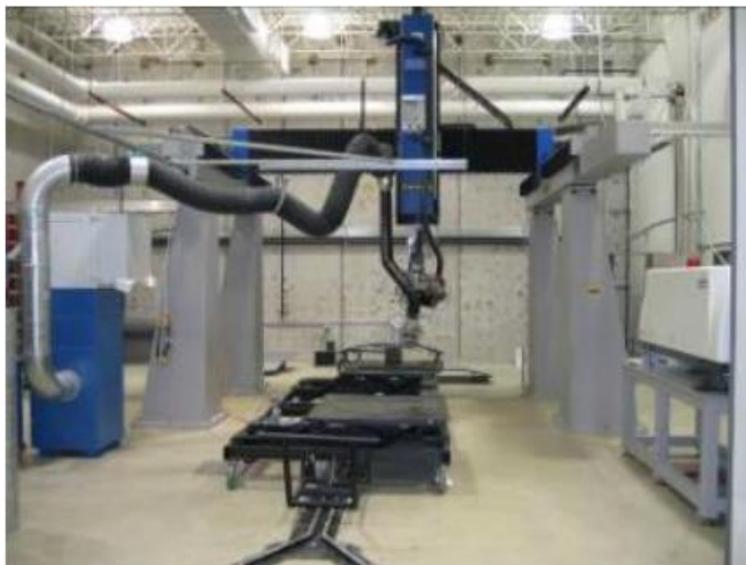
*Figure 1.8. The robotic laser coating removal system (RLCRS) that was used for phase 2 of the AFRL's laser coatings removal program. <sup>16</sup>*

AFRL Phase II involved developing a robotic laser coating removal system (RLCRS) to replace chemical and mechanical coating removal methods used on large off-equipment components. The major benefits of completing this phase included reducing the stripping time, therefore increasing production, as well as allowing for the replacement of chemical strippers such as MEK (methyl ethyl ketone), PMB (*p*-methoxybenzyl), and wheat starch. Figure 1.8<sup>16</sup> shows an image of the RLCRS system used in this phase of the study, and table 1.1<sup>16</sup> shows some of the consistent laser parameters that were used.

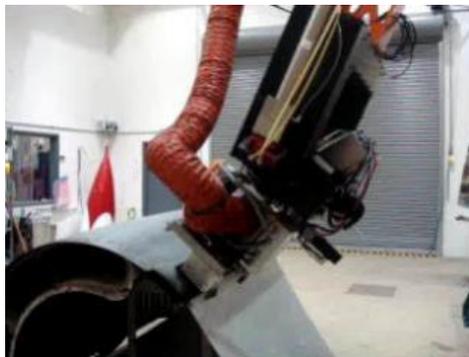
*Figure 1.9. The laser automated de-coating system (LADS) with the ARLCRS system removing paint from an off aircraft component. (AFRL)<sup>16</sup>*

Phase III of the AFRL program sought out to replace the laser automated de-coating system (LADS) with an Advanced Robotic Laser Coating Removal System (ARLCRS). The requirements of this advanced system include the ability to strip A-10, F-16 and C-130 radomes and other various candidate off-aircraft parts, and to integrate contour following robotics in order to maintain accurate stand-off and focal length distances. This required a turntable and robotic track system to access most part areas, and this all needed to be done with commercially available and production proven laser components. Phase III was more involved because it required robotic system design and construction which necessitated a robotics and integration company, evaluating a preliminary design, making modifications, finalizing them, and then performing testing and debugging before it could actually be implemented to compare it's performance against baseline data. For this application a high quality CO<sub>2</sub> laser was selected with an average output of 8kW of power. The robot system operated with no part specific programming and a bank of seven laser distance sensors that detect changes in part geometry. An advanced control logic dynamically adjusts input from sensors and adapts robot trajectory to maintain stand-off distance and perpendicularity to the part surface. Figure 1.9<sup>16</sup> shows an image of the system in use while laser cleaning an off aircraft component.

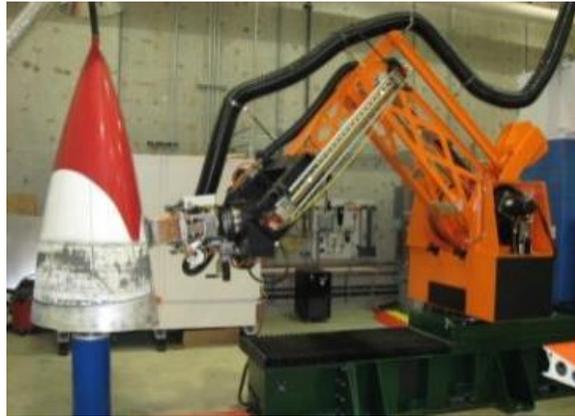
*Figure 1.10. Laser cleaning of an F-16 radome using the LADS system. (AFRL)<sup>16</sup>*

The ARLCRS system began operation stripping F-16 radomes in April 2009, and improved stripping time from 4+ hours to strip an F-16 radome to about half an hour. Figure 1.10<sup>23</sup> shows the system in use on an F-16 radome.

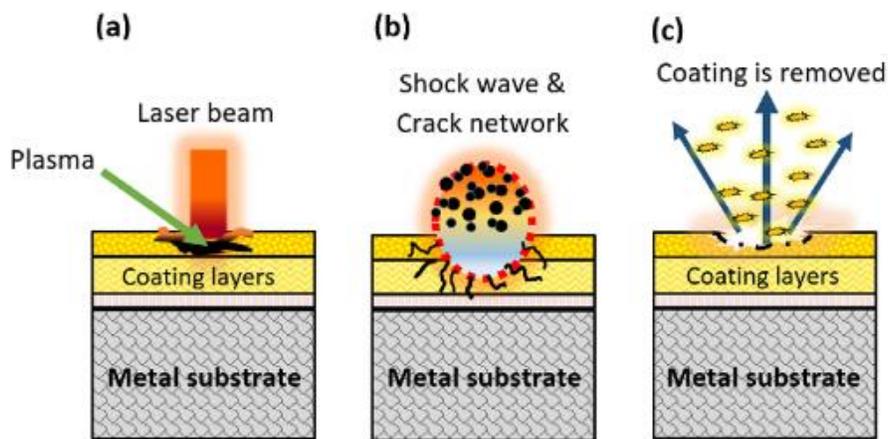
*Figure 2.1 Schematic depiction of the process of laser ablation as used for coating removal A.) The incoming laser pulse rapidly heats up the coating which causes a plasma to form. B.) The continually expanding plasma causes a shockwave to mechanically remove the volume of material that absorbs the laser light as well as spread pressure and thermal cracks throughout the adjacent material. C.) After the plasma has been generated the resulting pressure wave forces the ablated material in the form of particulate to expand outwards away from the surface. Diagram adopted from [25].*

represented as the rapid heating of the surface layers of the material undergoing ablation there by forming a plasma, which in turn creates a shockwave that ejects the ablated material outwards as fine particles. Ideally, the substrate below the coating that is targeted for removal is protected from damage by keeping the laser energy density below the damage threshold. Although the precise details of these events take place at exceptionally fast speeds and are challenging to accurately model and study, the overall process can be understood schematically as shown in figure 2.1.<sup>25</sup>

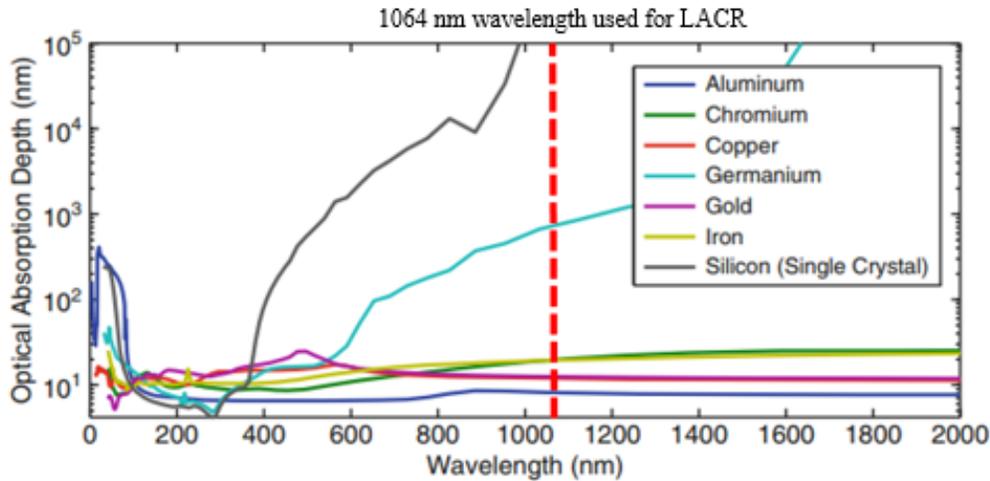
Figure 2.2. Optical absorption depths for several materials over a range of wavelengths. A dashed red line marks 1064 nm, the wavelength produced by the laser used for LACR. [26]

where  $I_0$  is the intensity just inside the surface after accounting for reflection loss. Another important parameter to define is the optical penetration, or absorption depth, defined as  $\delta = 1/\alpha$ , which is the depth in the material at which the intensity of the transmitted light drops to  $1/e$  of its initial value at the surface. Figure 2.2 shows the absorption depths as a function of wavelength in nanometers for different metals and semiconductors.<sup>26</sup> Since A36 is low carbon steel, the yellow colored iron line in the figure is a good representation of the steel used in this study, and a vertical dashed line at 1064 nm shows the wavelength that was in use by the CL1000 Nd:YAG laser that was used for LACR.

It can be noted that there is some appreciable variation in the absorption depth of different materials depending on the wavelength, with a minimum absorption depth located roughly in the UV range of the spectrum.

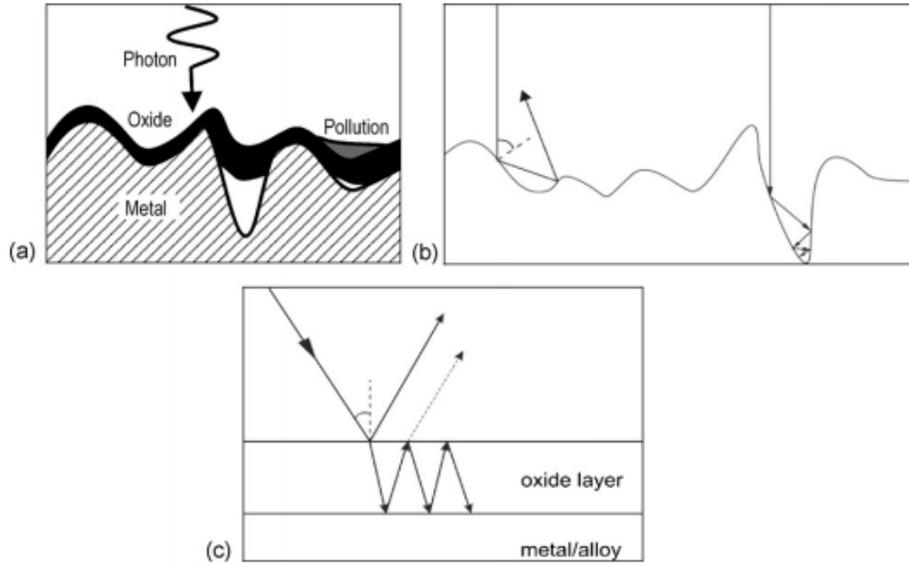
Figure 2.3. Various mechanisms which affect the absorptivity of real engineering surfaces: (a) a typical cross section of a metallic engineering surface. (b) high angle absorptance and multiple reflections due to surface roughness. (c) multiple reflections within an oxide layer. <sup>27</sup>

Figure 2.3 <sup>27</sup> diagrams how surface features can affect the absorptance of light onto metal substrates.

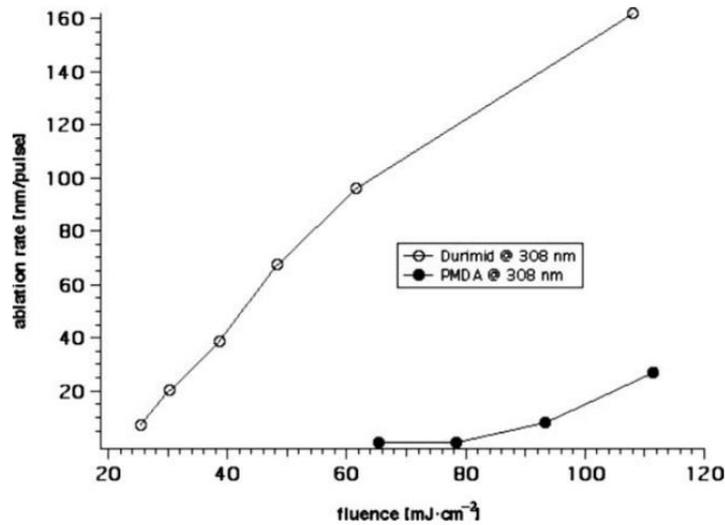
Figure 2.4. The ablation rates of a photosensitive polyimide (Duramid) and PMDA (kapton like polymer) at the irradiation wavelength of 308 nm.<sup>26</sup>

The laser ablation of organic materials, specifically polymers, has been a topic of intense research since 1982, due to its many potential applications. Ranging from thin film deposition techniques such as MAPLE (matrix assisted pulsed laser evaporation),<sup>28,29</sup> polymer surface processing and patterning for electronic materials,<sup>30,31</sup> microfluidic devices,<sup>32-34</sup> and even biomedical applications in surgery,<sup>35,36</sup> polymer laser ablation has been a subject of intense study.<sup>37,38</sup> The details of laser ablation of polymers depends on both the laser parameters, including the type of laser being used, as well as the optical and thermal properties of the material undergoing ablation. Figure 2.4<sup>26</sup> shows how the difference in the photo stability of two different polymers, despite both being the same type of polymers, polyimides, their response to laser irradiation can differ drastically.

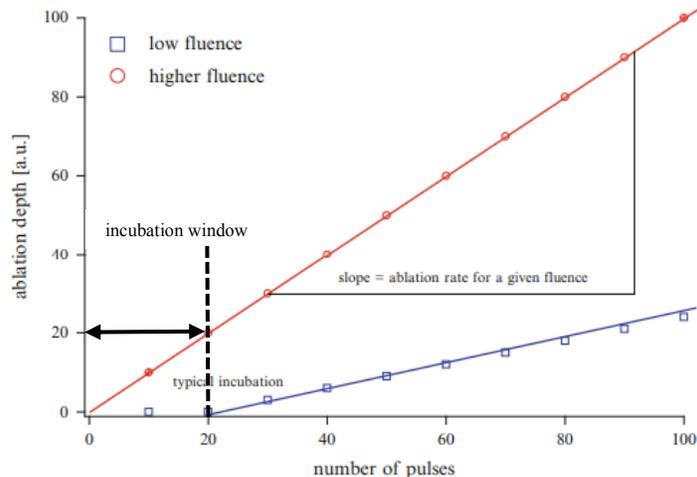
Figure 2.5 Plot of ablation depth vs. pulse number, which is used to determine the ablation rate for a given fluence. The typical feature of incubation, ie., ablation starts only after a certain number of pulses is shown for the lower curve. It is labeled with black lines as the incubation window.<sup>39</sup>

For example the ablation rate can be defined as either the depth of the ablation crater after one pulse at a given fluence, or as the slope of a linear fit to a plot of the ablation depth versus the number of pulses for a given fluence. Values for the ablation rate do not just depend on the method of determination, but on the nature of the polymeric material itself. For example in some materials ablation does not start directly with the first pulse, but after multiple pulses, or multiple pulses are needed to create an ablation crater deep enough to measure. When ablation does not start with the first laser pulse, this process is referred to as incubation. It is due to the physical or chemical modifications of the surface from the first few laser pulses, which usually results in an increase in the absorption of the laser wavelength irradiation. Incubation is normally only observed for polymers with a lower absorption coefficient at the laser wavelength. Figure 3<sup>39</sup> shows the typical appearance of incubation in plots of ablation depth versus the number of pulses.

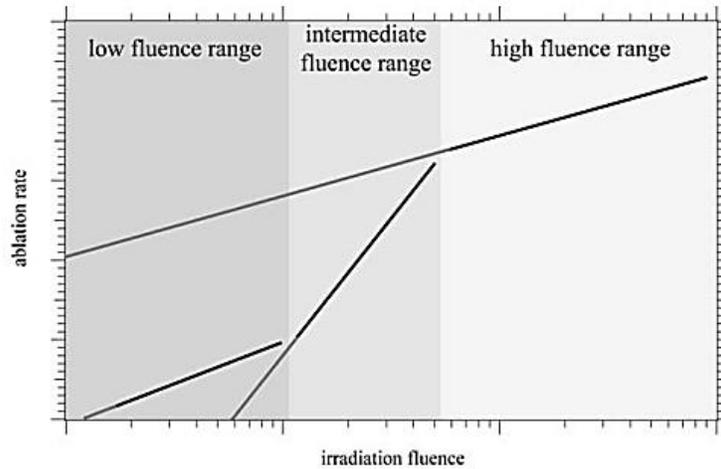
Figure 2.6 Schematic plot of the three fluence ranges which are typically observed for polymer. The three ranges are indicated with different shades of gray. <sup>39</sup>

In this plot, the intersection of the extending gray lines with the x-axis represent the threshold fluence for each fluence range, which in turn shows the schematic ablation rate, outlined in black lines. In addition to differing ablation rates within each fluence range, the effective absorption coefficient can also differ according to the fluence.

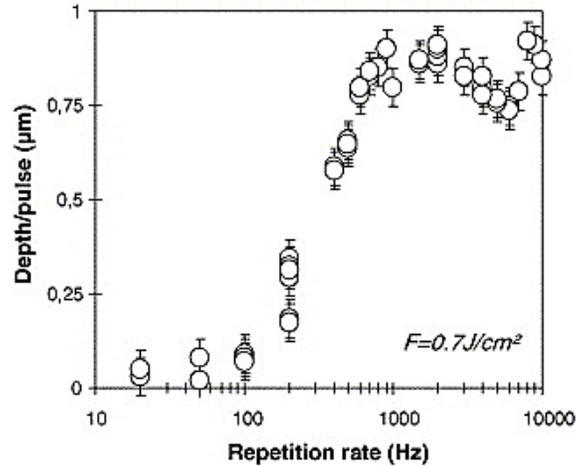
Figure 2.7. Depth per pulse as a function of the repetition rate for 100 pulses, at  $F = 0.7 \text{ J/cm}^2$  and 100 ns pulse duration. Depth per pulse increases as a function of the repetition rate due to heat accumulation in the material pulse per pulse in a “thermal confinement regime”.<sup>40</sup>

A group in France, Francois Brygo et al., studied the effect of laser fluence, repetition rate, and pulse duration effects on the Nd:YAG laser ablation of grey epoxy paint from concrete. Using “etching curves”, graphs that give an indication of laser ablation efficiency by plotting the volume of material removed per laser pulse versus the laser fluence, the authors determined that higher repetition rates resulted in higher ablation efficiencies. Figure 2.7 <sup>40</sup> shows how the depth removed per pulse drastically increases with repetition rate.

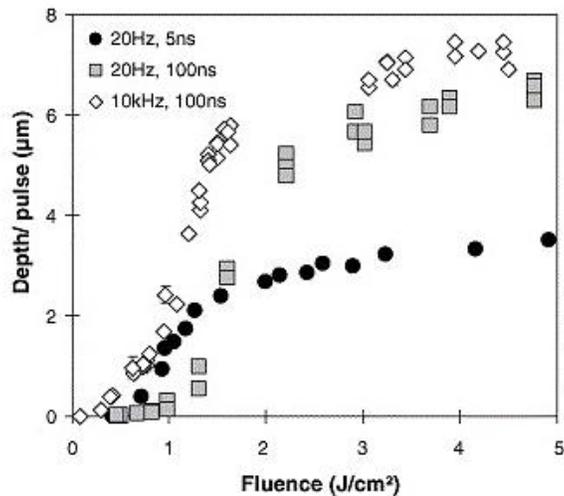
Figure 2.8. Depth per pulse as a function of the fluence for three sets of experimental condition: (1) 5 ns pulse duration, 20 Hz; (2) 100 ns pulse duration, 20 Hz; (3) 100 ns pulse duration, 10 KHz with 50 pulses. High repetition rate experiments were made with an air jet (5 bar pressure).<sup>40</sup>

The researchers theorized that the accumulation of heat with the number of pulses at high repetition rate suggested that the ablation threshold fluence should decrease at higher repetition rates compared to lower repetition rates. Figure 2.8<sup>40</sup> shows that this was indeed the case.

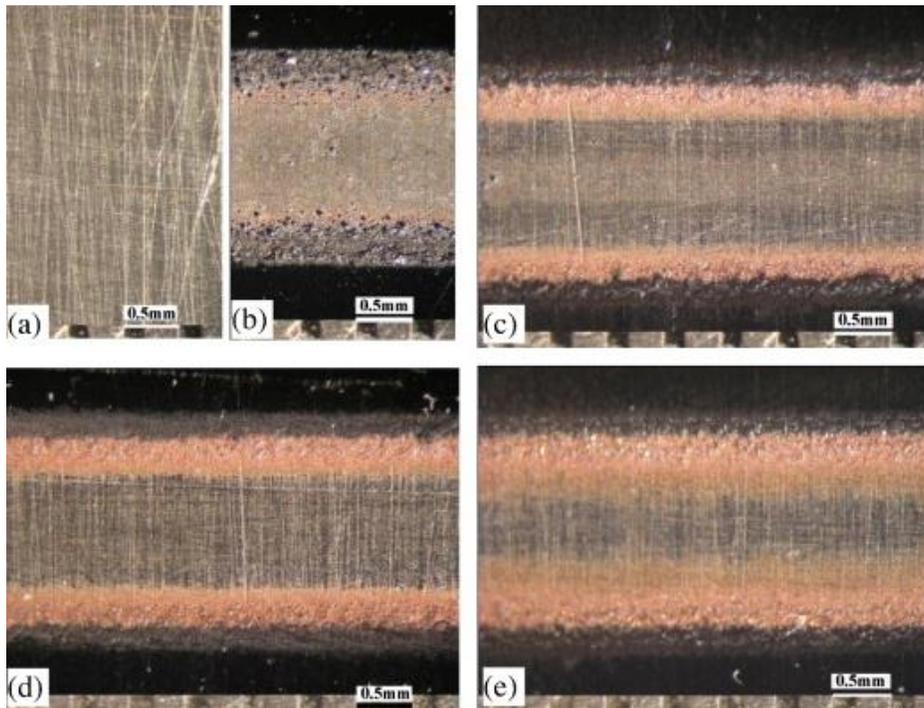
*Figure 2.9. (a) Photograph of the bare base metal prior to painting. (b) The laser cleaned surface showing the ash layer left behind on the surface after laser cleaning,  $v = 8000$  mm/min, (c) slight melting at the central zone of the laser cleaned track,  $v = 8000$  mm/min, (d) complete paint removal,  $v = 9000$  mm/min, and (e) partial paint removal,  $v = 14,000$  mm/min; residual ash has been wiped out in photographs (c) – (e), laser power = 300 W and continuous laser operation was used in each example.<sup>41</sup>*

Figure 2.9<sup>41</sup> shows optical micrographs of the bare stainless steel substrate surface and of paint removed tracks at different processing conditions. Because a ventilation or vacuum system was not in use, thin layers of ash remained on the sample surface, although the authors reported that this layer could easily be removed with light brushing or wiping with tissue paper. Figure 2.9c, 2.9d, and 2.9e show the laser cleaned surface at different laser processing conditions, and surface melting, complete paint removal, and partial paint removal are all shown respectively.

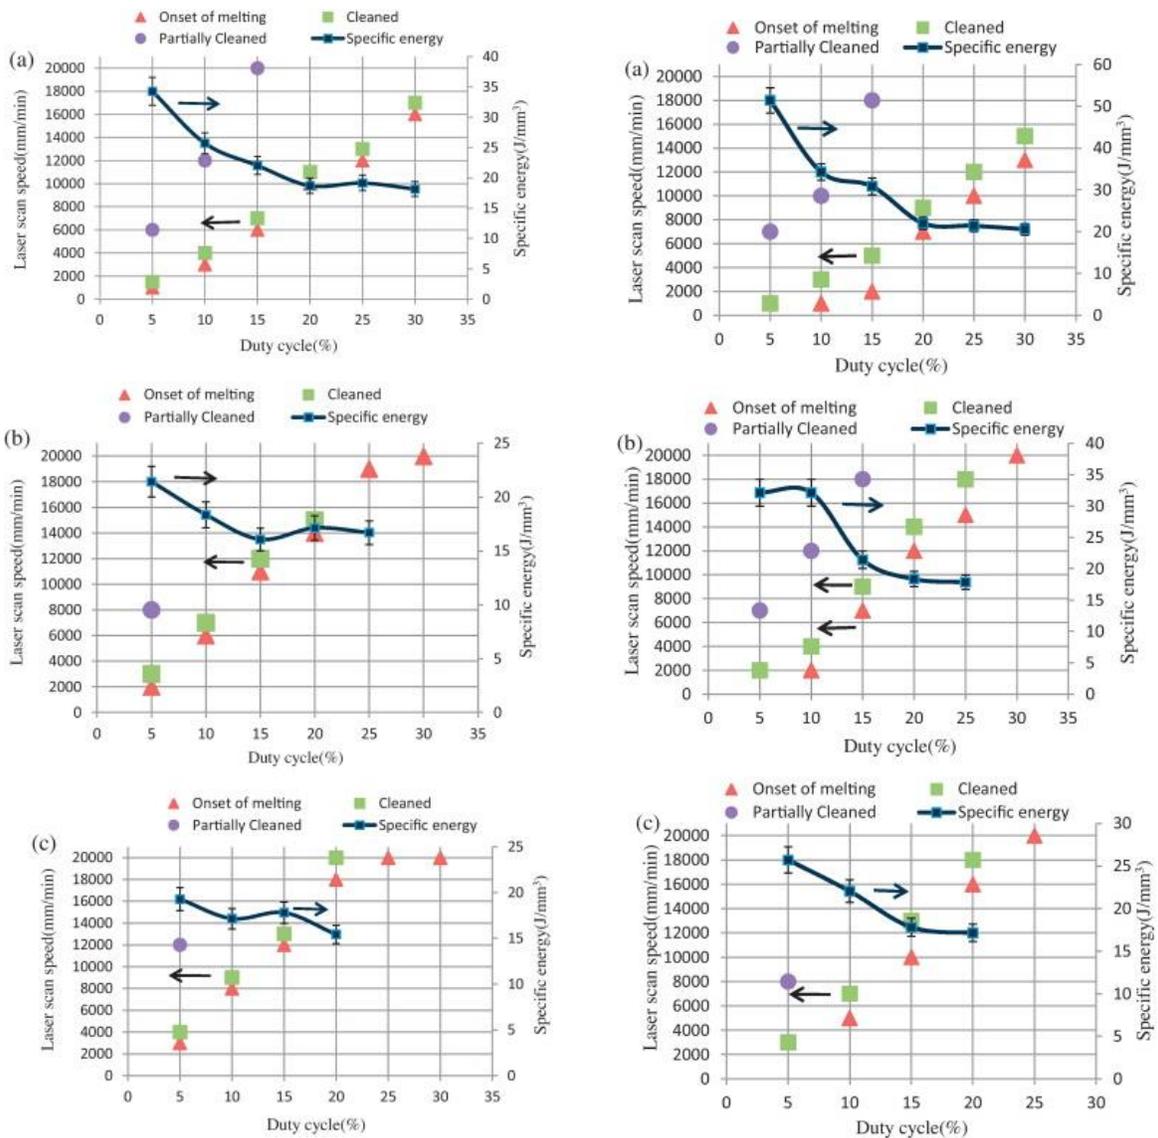
Figure 2.10 (left) and 9 (right) depicting the variation of laser scan speed and specific energy with duty cycle for different peak laser powers. Figure 8 (stainless steel substrate) and figure 9 (aluminum alloy substrate): (a) = 1200 W, (b) = 1500 W, (c) = 1800 W.<sup>41</sup>

1200- 1800 W range. Variations with laser scan speed and specific energy with duty cycle at different peak laser powers are shown in figure 2.10 (a-c) and 2.10(a-c)<sup>41</sup> for both stainless steel and aluminum alloy substrates respectively. The general trend the authors reported was that the laser scan (paint removal speed) increased with duty cycle as the pulse on-time and the input laser energy increased.

The specific energy tends to decrease with increasing duty cycle, and it was found that the laser energy in a single pulse of duration of 10  $\mu\text{s}$  duration was not always sufficient to remove the entire thickness of the paint at the point of incidence, and therefore a number of pulses were required to completely remove the coating, especially when the duty cycle was low. For the stainless steel substrate the best laser parameters from a process efficiency standpoint were a specific energy of 15  $\text{J}/\text{mm}^3$ , at 20% duty cycle and 1800 W peak laser power. Likewise for the aluminum substrate, the best results were obtained at 17  $\text{J}/\text{mm}^3$  at 20% duty cycle and 1800 W peak laser power.

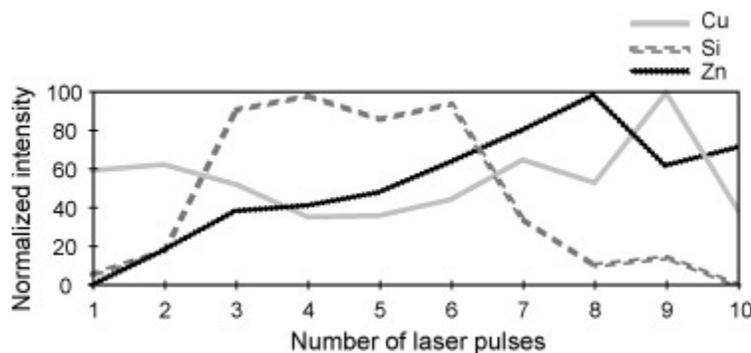
Figure 2.11. Depth profiles of Cu(I) 324.754 nm, Zn(I) 334.502 nm and Si(I) 288.158 nm emission lines corresponding to 10 consecutive laser pulses on a brass sample with sand finish coated by ink.<sup>12</sup>

In order to determine the effectiveness of laser cleaning, various analytical techniques such as FTIR and LIBS have been used. By comparing the chemical composition, using LIBS and FTIR spectra before and after cleaning, the effect of the laser cleaning on the surface can be studied. Mateo et al.<sup>12</sup> cleaned brass surfaces coated with various contaminants such as varnish, ink, lacquer, and an oxide using a Nd:YAG laser, and used real time LIBS in the process to study the change in chemical composition during the cleaning. Figure 2.11<sup>12</sup> shows a depth profile of Cu, Si, and Zn as the number of laser pulses increases. This profile reflects a sand finished brass sample that was coated with ink. The copper was attributed to impurities in the ink, and the silicon was impregnated into the surface from the sand finishing. The Zinc corresponds to the ablation of brass, and can be used to confirm that the substrate has been reached and is being ablated.

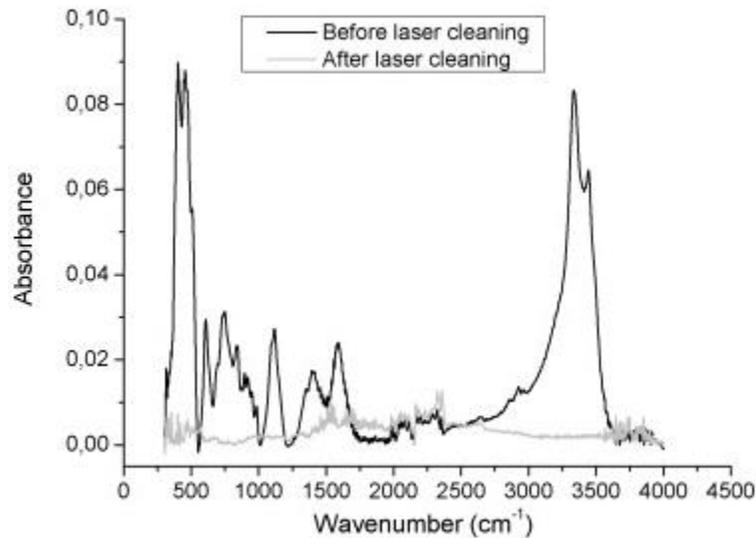
Figure 2.12. ATR-FTIR spectra of a brass sample with mirror finish coated by oxide before (dark line) and after (light line) laser cleaning.<sup>12</sup>

In addition, FTIR (figure 2.12)<sup>12</sup> was used to analyze the surface both before and after the laser cleaning.

The peaks present before laser cleaning at around  $400 - 600 \text{ cm}^{-1}$  were attributed to copper and zinc oxides whereas the peaks around 3332 and 1092 corresponded to copper acetates. The rest of the peaks were attributed to zinc acetates which arose as by products to the oxidation procedure used in sample preparation.

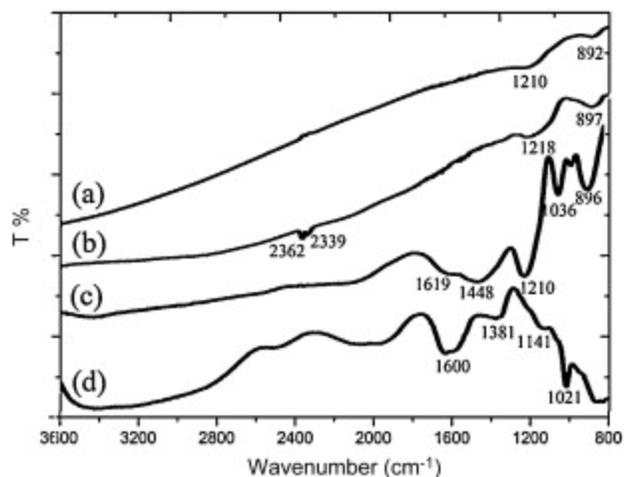
Figure 2.13. FTIR spectra collected from the surface of (a) steel substrate of the original piston, (b) laser cleaned surface, (c) thin contamination layer, and (d) thick contamination layer.<sup>14</sup>

Other groups have used laser cleaning for a variety of applications, such as Guan et al.,<sup>14</sup> who used a pulsed Nd:YAG laser to remove carbonaceous deposits from the heads of piston engines. The authors confirmed the cleaning by use of SEM, EDS, FTIR, and XPS. Figure shows the FTIR spectrum of the laser cleaned piston head, the original piston head, as well as spectra of a thin and thick contamination layer. It can be seen that the original piston's spectra is very close to that of the laser cleaned piston head. (see figure 2.13)<sup>14</sup>.

The large peaks at 1210, 1036, and 890  $\text{cm}^{-1}$  were due to iron oxides and carboxylates that were found on the surface of the piston head. The tiny peaks at 2362 and 2339 were attributed to  $\text{CO}_2$  or  $\text{COOH}$  contamination due to atmospheric exposure.

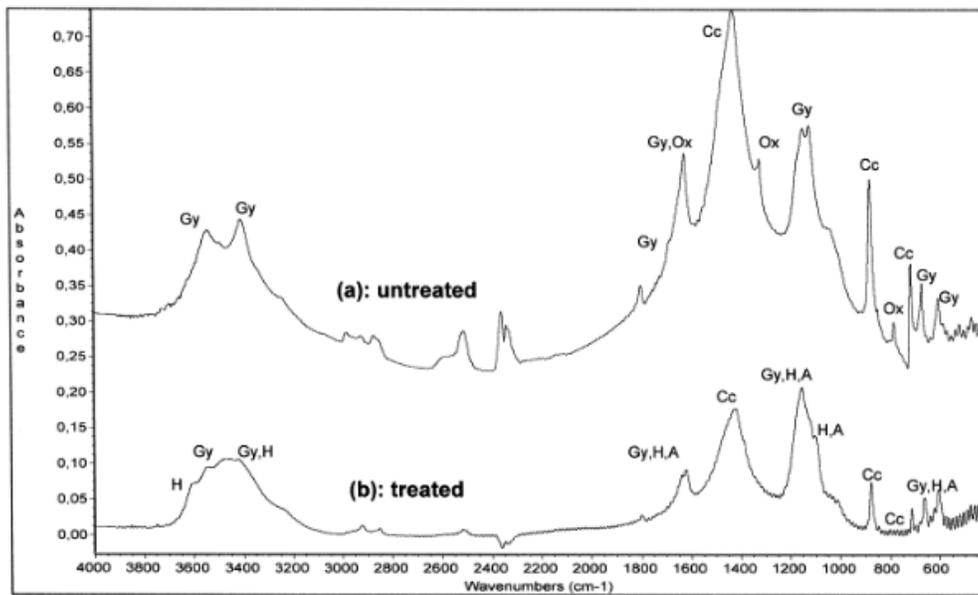
Figure 2.14. Spectra of a compact black crust before (a) and after treatment with a XeCl excimer laser (b), Gy – gypsum; Cc = calcite; Ox = calcium oxalate; H = hemihydrate; A = anhydrite.<sup>5</sup>

Figure 2.14<sup>5</sup> shows the FTIR spectra of the marble both before and after laser treatment. It is evident from the FTIR data that the amount of gypsum (Gy) has decreased after laser treatment while the amount of hemihydrate (H) and anhydrite (A) has increased. This alteration in the mineral structure is due to the laser treatment. LIBS was also used to monitor the change in composition as the laser treatment progressed. After gathering an initial composition spectrum before lasing the surface, this composition was observed to decrease with depth, indicating that the contaminating layer was being removed successfully. Particularly, a decrease in the amount of potassium was observed with further lasing, indicating the removal of biological material from the surface. Figure 2.15<sup>5</sup>, shows successive LIBS spectra with increased amounts of laser processing, corresponding to the depth within the sample from the surface. As depth (equivalent to pulse #) increases, the decreasing potassium peaks can be observed.

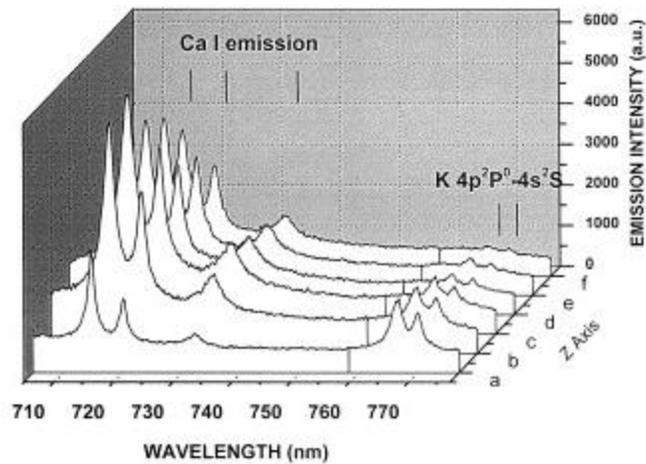
*Figure 2.15. Successive LIBS spectra during the KrF laser excimer assisted removal of biological crust on the Pentelic marble. The correspondence is (a) 1<sup>st</sup>-, (b) 2<sup>nd</sup>-, (c) 5<sup>th</sup>-, (d) 12<sup>th</sup>-, (e) 20<sup>th</sup>- and 32<sup>nd</sup>-pulse. <sup>5</sup>*

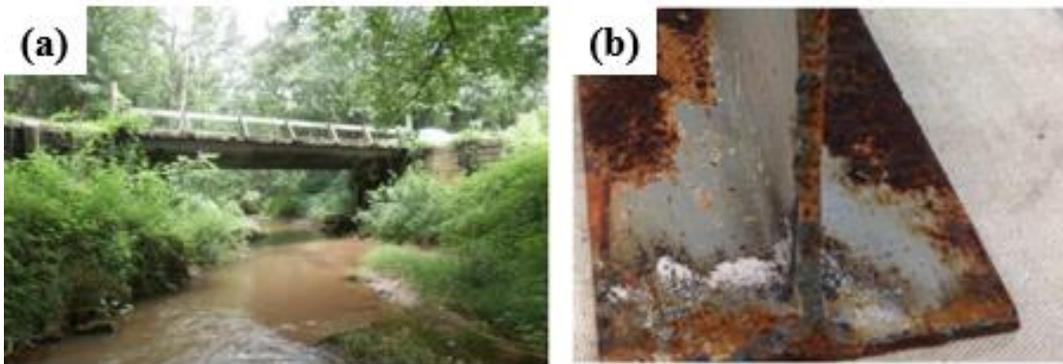
Figure 3.1 (a) The bridge from which the 20 I-beam samples were taken from, as well as (b) a close-up of one of the I-beam sections.

Phase 1 consisted of sample generation and the initial test to laser clean bridge components. Twenty 1' I-beam bridge sections were removed by VDOT from the bridge on Route 685 (Telegraph Road) over Stinking River located in Pittsylvania County, Structure # 6096, (figure 3.1) and were transported to Norton Sandblasting, in Chesapeake, Virginia, for a LACR demonstration on October 26, 2016. During this demonstration both University of Virginia and VDOT representatives were present, along with an EI Group (industrial hygiene

The bridge from which the samples were taken from was originally built in 1932, and the beams themselves circa 1925, and as such the I beam sections showed large amounts of corrosion damage, tar, paint, and debris that had accumulated over the years. Due to the thickness of the rust layers, a metal scraper was used manually to remove flakes of rust before laser cleaning began. Figure 3.4 shows an example of a laser cleaned area surrounded by the original condition of the surface. The number of passes required to clean the surface depended on the thickness, composition of the coating, operator experience, as well as the speed and motion used for the laser optic. The heaviest scale required roughly 3-6 passes to remove all visible coatings and reach the substrate.

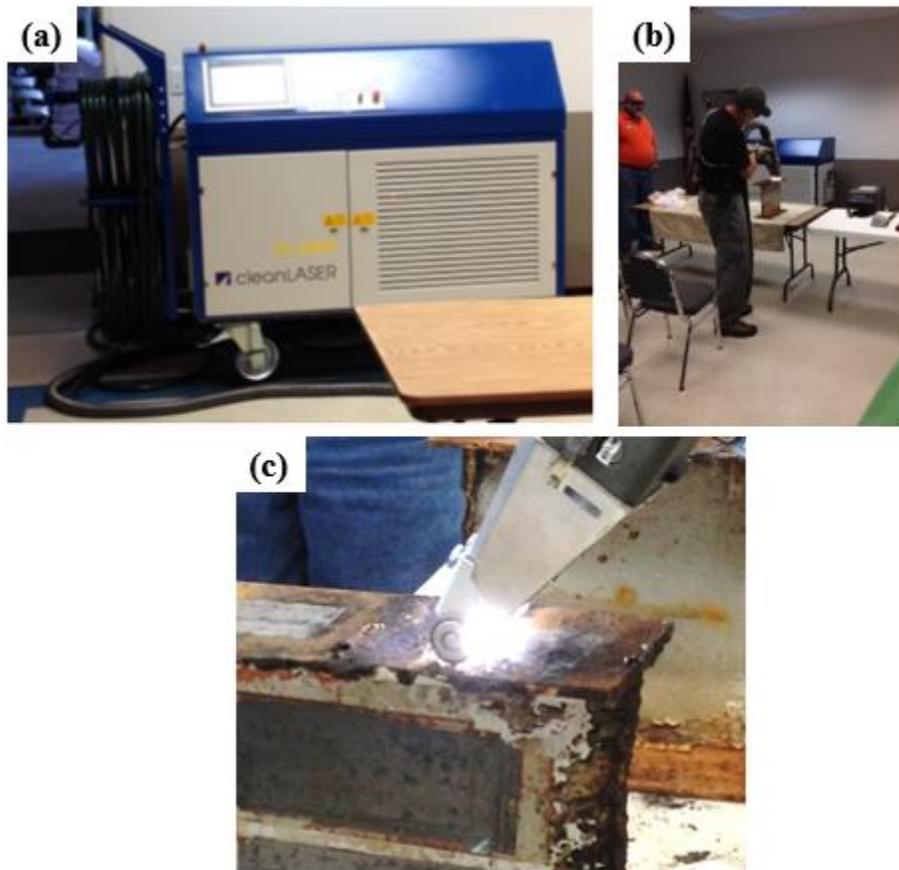
*Figure 3.3. (a) The CL1000 laser cleaning system, (b) operation of the laser, and (c) a close-up of the laser cleaning process on one of the I-beams.*

The processing was performed using an Adapt Laser Systems model CL1000QNd:YAG operating at a fundamental wavelength of 1064 nm and delivering 1 kW of average power. As each I-beam section was cleaned the process was documented and recorded in addition to the industrial hygiene analysis. Figure 3.2 shows the laser unit, an operator from Adapt Laser Systems using the laser to clean a sample, as well as a close up of the laser beam surface interaction. It should be noted that the visible light present at the end of the optic head is not the laser light itself (which is invisible to humans due to its infrared wavelength), but actually plasma generated by the laser heat and ablation of the surface coatings.

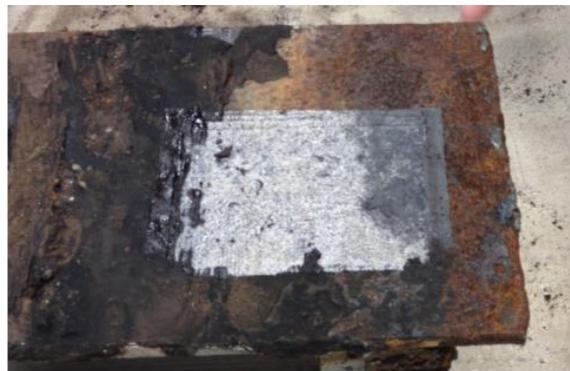
*Figure 3.4. A visual comparison between the laser cleaned surface area and the surrounding condition of the I-beam surface prior to cleaning.*

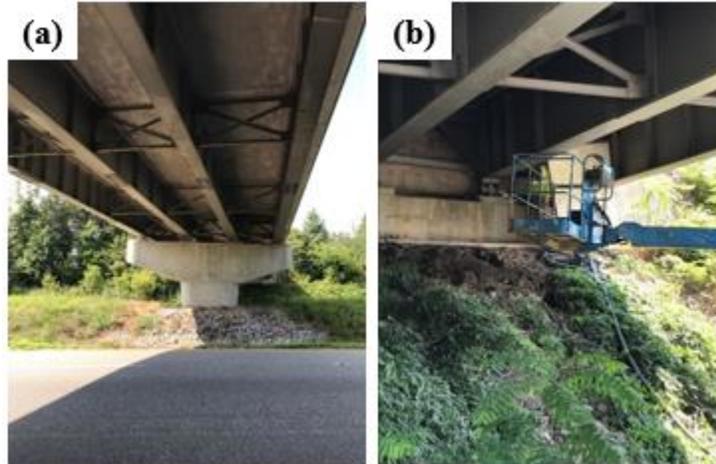
*Figure 3.5. (a) Underside of the bridge on Rt. 605 in Farmville VA, where the onsite LACR testing took place. (b) Boom crane used to elevate the operator to the cleaning area.*

Phase II, consisted of an onsite demonstration of the feasibility of using the LACR laser system on a standing bridge structure. After a couple days of preliminary set-up, the laser testing started on August 15, 2017, on Route 695 in Farmville, VA. Figure 3.5 and 3.6 shows the underside of the bridge where the LACR cleaning was attempted. The laser generator, filtration unit, electrical generator, and associated equipment were housed and operated from a trailer that was parked on the side of the road below the bridge and a boom lift was used to bring the laser operator and laser optic within working distance of the bridge components.

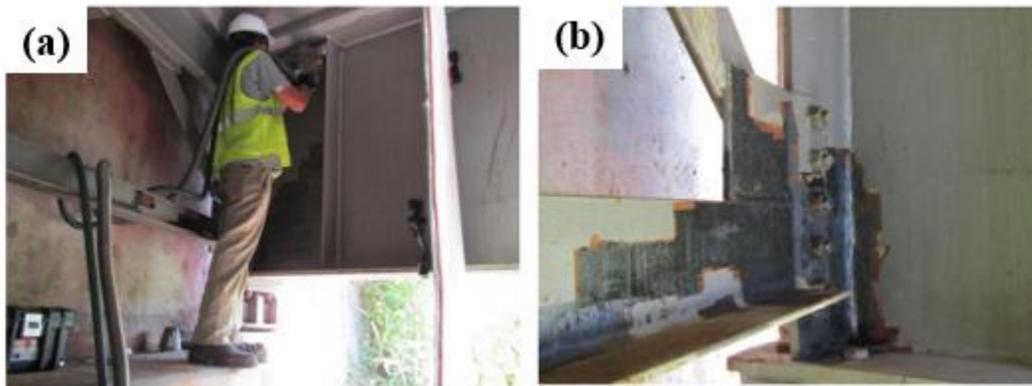
*Figure 3.6. (a) The LACR system in use to clean a component of the beam end. (b) The exposed surface after laser cleaning.*

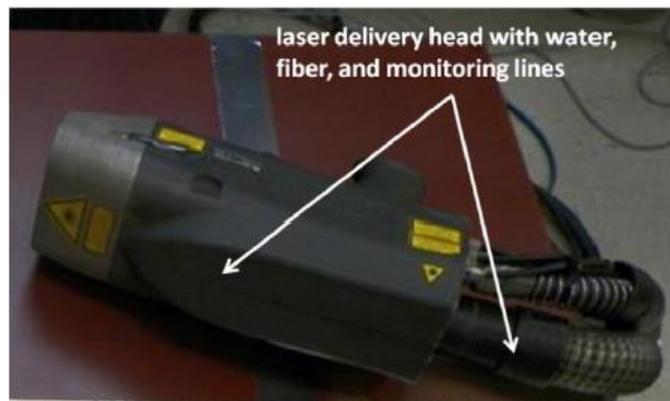
*Figure 3.7<sup>43</sup>. Photo showing the bulky and lengthy cables exiting the back of the laser optic.*

problem free, the beam ends and bearings were difficult to reach for cleaning due to the limited space and tight and unusual geometries present in these areas. Due to the length of the laser optic head and the exiting optic and vacuum lines from the back (figure 3.7<sup>43</sup>), it was not possible to fit and use the laser properly to clean these parts of the beams, which are the priority areas for cleaning due to excessive corrosion damage that occurs here as discussed in the introduction.

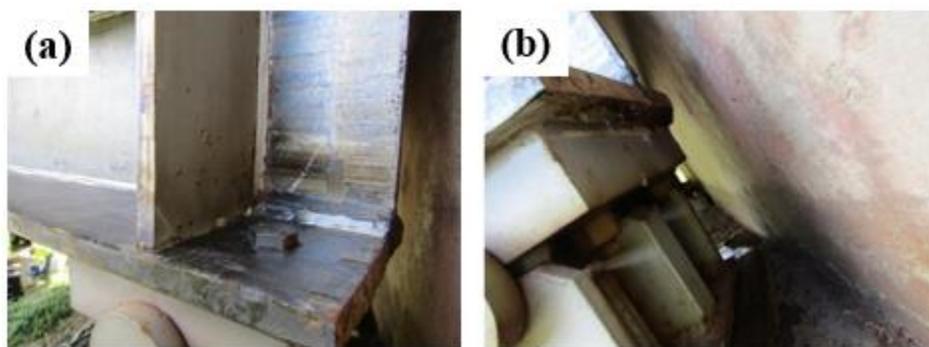
*Figure 3.8. Areas on the bridge structure that could not be reached with the laser for cleaning: (a) Beam ends facing concrete abutments. (b) Beam bearing also directly next to a concrete abutment.*

Figure 3.8 shows some of the areas on beam ends that were difficult or impossible to reach with the laser system. In order to address these concerns, a further laser test was planned as Phase III.

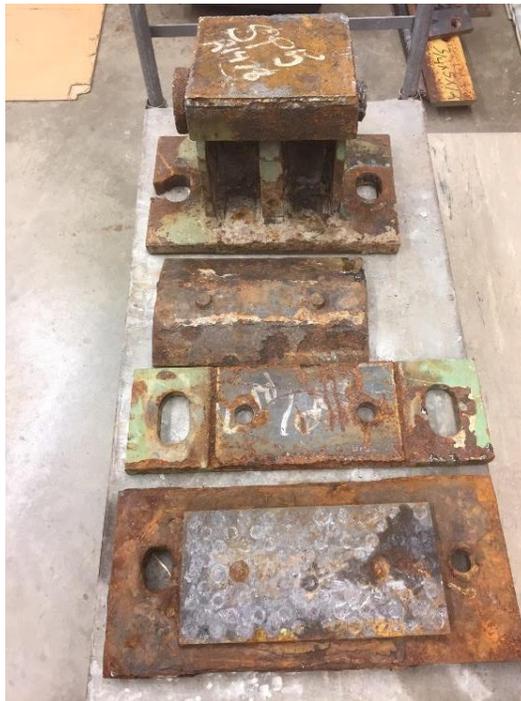
Phase III consisted of a third laser test designed to determine the capability of the Adapt Laser system to effectively clean harder access areas such as bridge beam ends and bearings. For this demonstration, which took place on November 9, 2017, a bridge bearing that was provided by VDOT was transported to Norton Sandblasting in Chesapeake, VA, to perform the laser cleaning. A bridge bearing was chosen due to the recessed areas that could be used in this phase III test. The bearing consisted of 5 different pieces, three of which made up the actual bearing and three other flat pieces that were part of the full assembly. (Figure 3.9).

*Figure 3.9. The partially disassembled bridge bearing used in Phase III.*

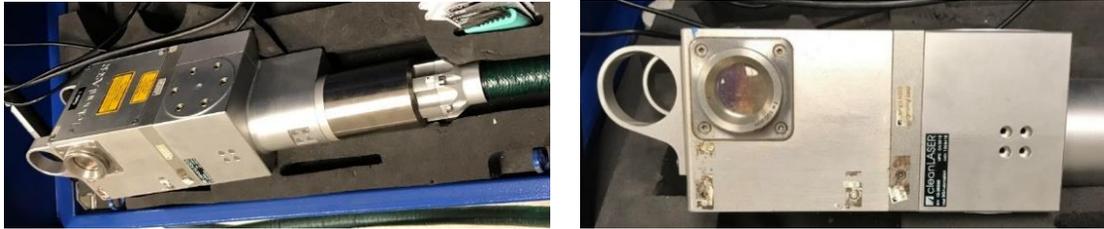
In order to evaluate the ability for the laser to clean tighter areas, the Clean Laser 500W system was used with the CleanCUBE H15 head, which consists of a laser optic head with a light

aperture that is 90 degrees to the incoming optic cable line, allowing for a more maneuverable optic that also takes up less space. (Figure 3.10).

*Figure 3.10. CleanCUBE H15 optic used with the 500 Watt laser.*

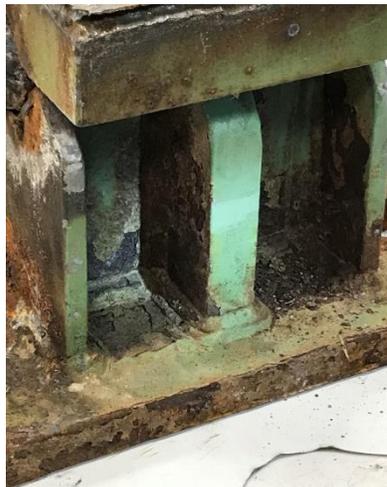
The targeted area for the laser test was one of the recessed areas underneath the bearing pin because this was the toughest part of the bearing to get access to with the laser (figure 3.11). After surface scale and dirt was removed by hand with a metal scraper and wire brush, the first attempt at laser cleaning used the 500 Watt laser and Clean Cube H15 optic.

*Figure 3.11. Underside of the bearing used for testing.*

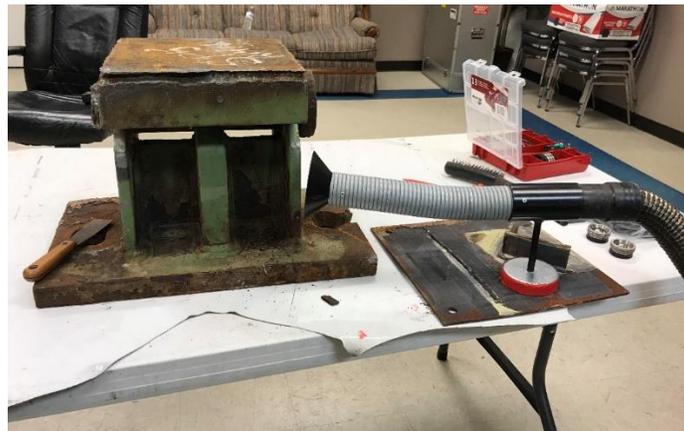
Another one of the downsides to the use of this optic head was the absence of an integrated vacuum system, which had to be externally mounted in the vicinity of the area being cleaned. This meant that environmental hygiene and safety was not as strictly enforced as it typically is when a vacuum nozzle is built into the laser optic head. During this demonstration an industrial hygiene survey was not in place and therefore the effectiveness of the external vacuum system could not be determined, although it is presumably not as effective as when an integrated vacuum nozzle is used with the optic head, which ensures that the material removal follows the precise position of the laser. Figure 3.12 shows the set up used with the external vacuum nozzle in use.

*Figure 3.12. External vacuum hose placement near the site to be laser cleaned.*

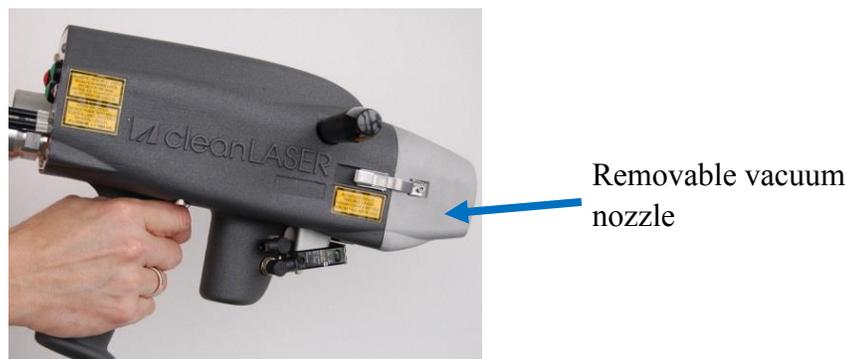
The 500W laser and CleanCUBE optic appeared to remove most of the outer layer of rust and remaining paint after multiple passes, however the 1000W laser was also tested afterwards. In order to test the 1000W laser which had a lengthier sized optic unit, the vacuum nozzle was removed in order to shorten the length of the laser head by a couple of inches (figure 3.13<sup>2</sup>). As expected the 1000W laser easily removed any remaining rust and left a surface that looked almost the same as the bearing surface after the 500W laser cleaning. However even with the vacuum nozzle on the 1000W optic laser head removed, the device was still too large for use in cleaning bridge beam ends and bearings. This leaves the 500W laser with the

*Figure 3.13. The CL1000 laser optic with the removable vacuum nazzle labeled.*
