# **IMPLEMENTATION OF LASER ABLATION COATING REMOVAL TECHNIQUE FOR STEEL COMPONENTS ON VDOT BRIDGES**

A Thesis

Master of Science in Material Science and Engineering

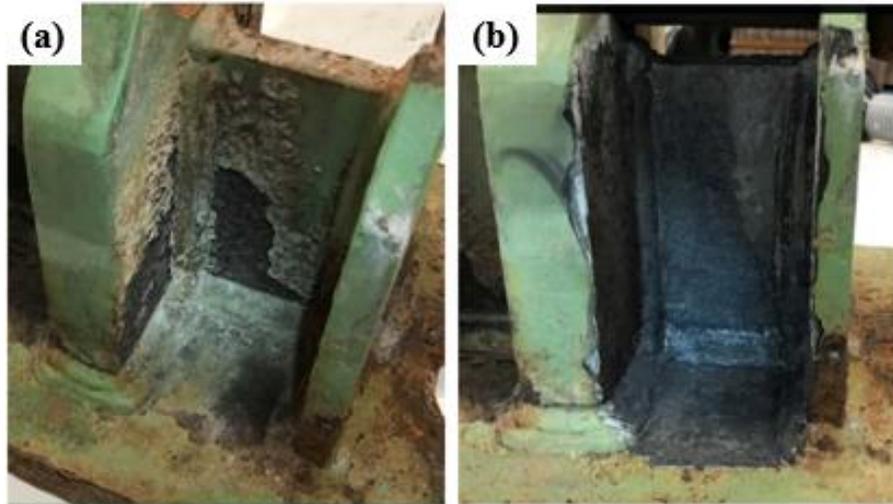
CleanCUBE H15 head as the only potentially viable option for cleaning these harder access areas. Figure 3.14 shows a before and after photo of the bearing after laser cleaning using both the 500W, and 1000W system.

*Figure 3.14. The bearing both (a) before and (b) after cleaning using the 500W and 1000W laser systems.*

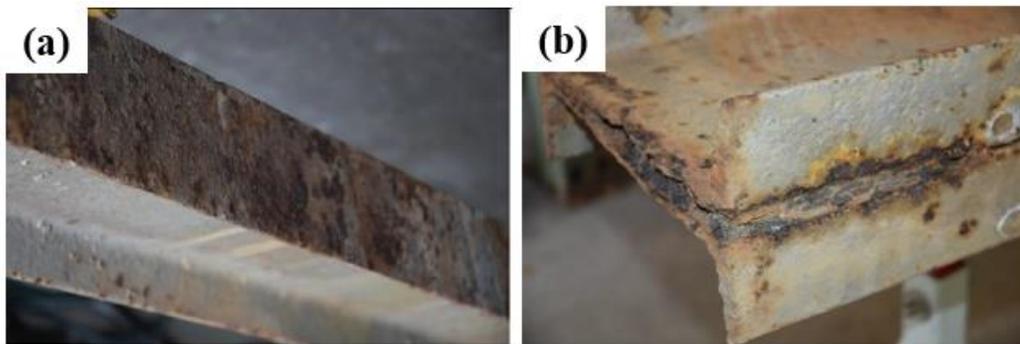
During this study two beams were transported to Norton Sandblasting by VDOT to be laser cleaned. These beams were labeled beams A and B, and varied in appearance. Beam A consisted of rolled beams with a silver/grey paint with an obvious rust colored secondary layer that adhered to the base metal during scraping and which broke away as a powder. Beam B was a welded C-beam also with a silver/grey paint which was easily scraped from the beam to base metal during the scraping in large chips, as shown in figure 3.15. Four inch by four inch grids were outlined in tape and paint samples were scraped off of each beam (shown in figure 3.16) for chemical analysis by the contract chemical company, Marine Chemist Service. Samples were screened for lead, chromium, cadmium, and polychlorinated biphenyls (PCBs).

Figure 3.15. (a). Beam A, and (b) Beam B, both used in the VDOT lead abatement study.<sup>44</sup>

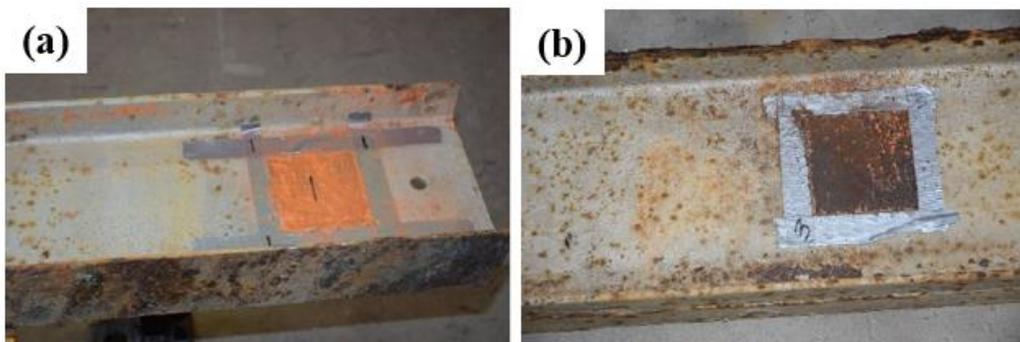
Figure 3.16. The 4 x 4 inch grids where scraped paint samples were taken from. (a) Beam A, (b) Beam B.<sup>44</sup>

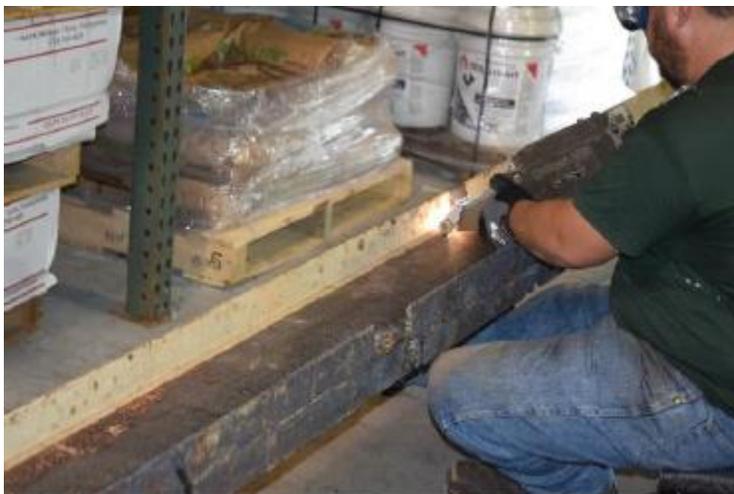
During the laser cleaning operation a CL1000 laser system equipped with a TEKA CM 500 laser fume extractor unit consisting of a HEPA filter and activated carbon filter to capture lead debris before releasing the air as exhaust. This is the same filter and containment setup as was used in Phase I, Phase II, and Phase III. During the operation personal samples were worn by each operator in their breathing zone for metal fume, PBCs, and hexavalent chromium. The lead, cadmium, and chromium metal fume samples were collected from both employees on a single 37mm Mixed Cellulose Esther Filter (MCEF), at the end of the two beams, and at the laser air filter exhaust, which had a flow rate of approximately 2.0 liters per minute. After laser removal, lead wipe samples were also collected on a web and flange of each beam (4 total samples) and were analyzed by Marine Chemist Service. XRF samples were collected by an employee of Marine Chemist Service both before and after laser cleaning to document the amount of lead remaining on the beams and to compare the effectiveness of removal using the laser with and without the roller guide. Figure 3.17 shows a laser operator using the laser during LACR cleaning of one of the beams.

*Figure 3.17. A laser operator using the CL 1000 system to remove contaminants from a steel I-beam at Norton Sandblasting.* <sup>44</sup>

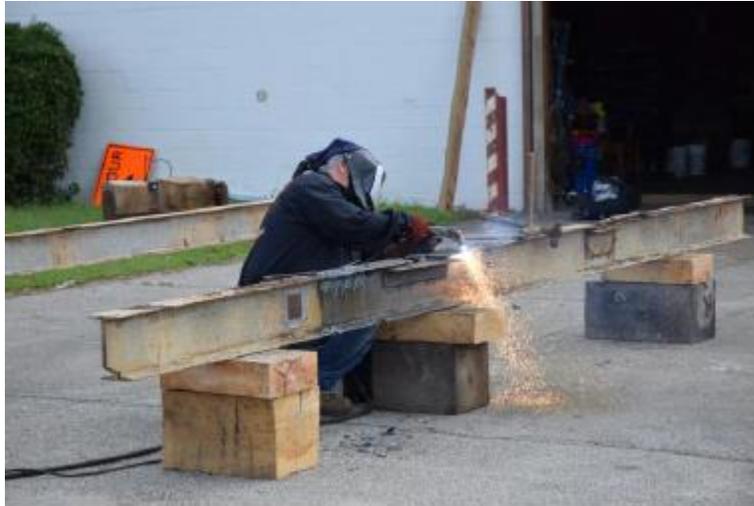
Figure 3.18 shows a VDOT employee plasma cutting an I-beam and the resulting sparks and fumes that are released from the process. The resulting spark and fumes seen in the photograph are the cause for hazardous contamination concern, and therefore it is the aim of the industrial

*Figure 3.18. A VDOT employee plasma cutting an I-beam that was previously laser cleaned.*<sup>44</sup>

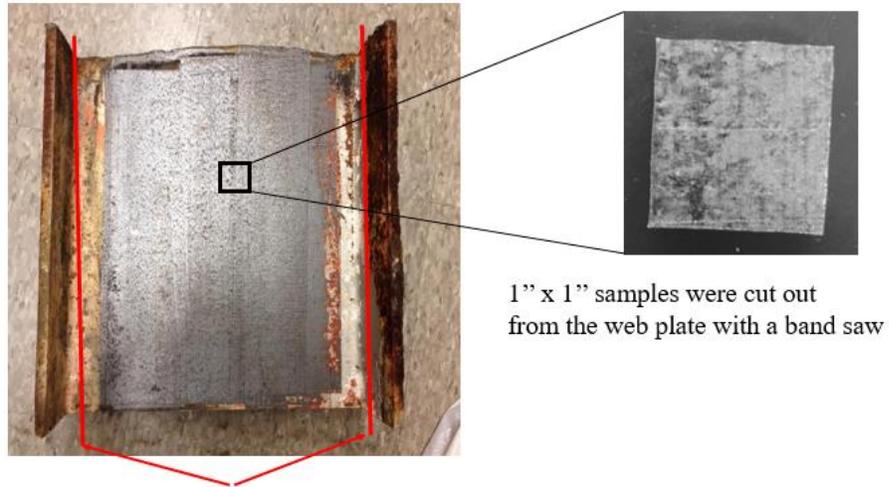
The I-beams that were processed in Phase I of the project were used for cross sectional, planar, and metallurgical analysis, as well as for providing dog bone samples later used in tensile and fatigue tests. For metallurgical, cross sectional, and planar analysis, the flanges of the beams were removed using a cutting torch, and a band saw was subsequently used to cut out roughly 1'' by 1'' pieces for analysis. (Figure 3.19). The samples were cut from the middle of the I-beam web to avoid any metallurgical effects of thermal damage from torch cutting heat applied to the sides.

1" x 1" samples were cut out from the web plate with a band saw

Flanges were cut away from the webbing using a welding torch

*Figure 3.19. Preparation of samples for cross sectional and metallurgical analysis.*

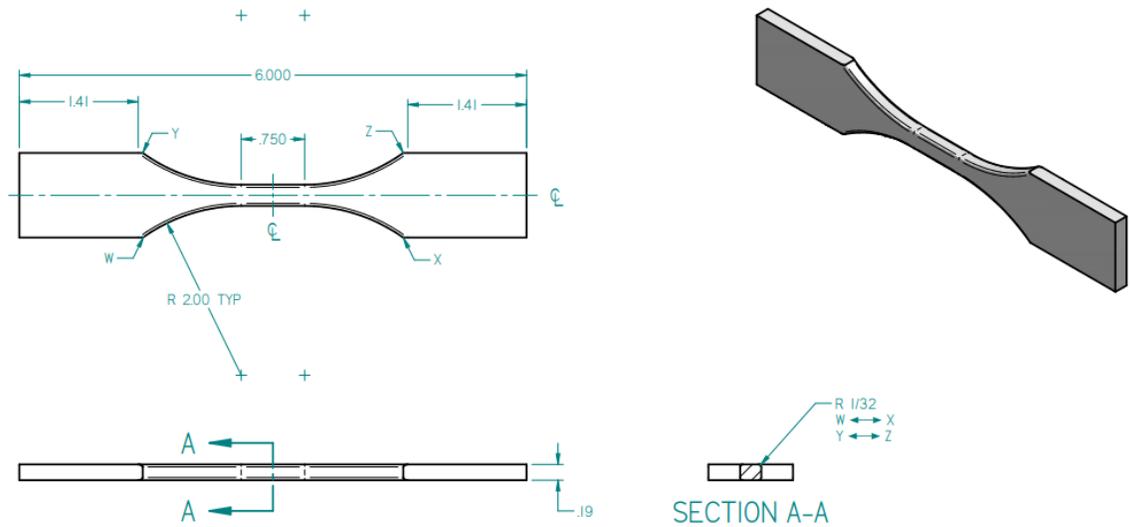
Several of the laser processed beams and one of the grit blasted beams were brought to Valley Precision Inc. (Waynesboro, VA), for cutting out dog bone samples. Dog bones were water jet cut out from the webs of the processed I-beams according to ASTM E8, and one of the sides of the dog bones specimens was then surface ground to a smooth finish. Sharp edges were also rounded using the same surface grinding tool. Figure 3.20 shows the dimensions that were used for the dog bone specimens, and figure 3.21 shows a schematic of how the dog bones were cut from the I-beams.

*Figure 3.20. Dog bone sample dimensions.*

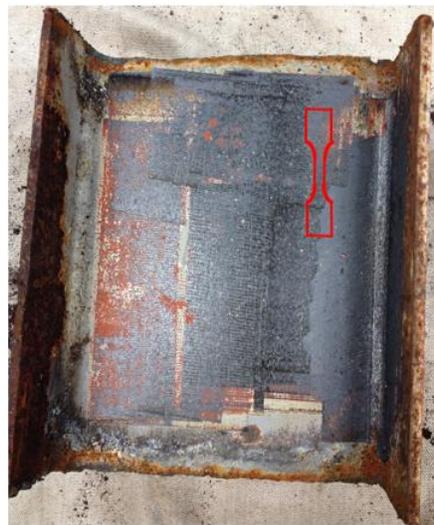
*Figure 3.21. Outline of how the dog bone samples were water jet cut from the I-beams.*

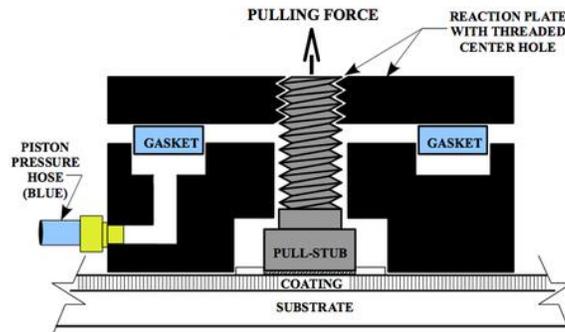
After the beams in phase 1 were laser cleaned, a set number were repainted with standard epoxy paint for coating adhesion testing, using the pneumatic adhesion tensile testing instrument (PATTI) device. The PATTI device is used to test the coating adhesion of the paint to the underlying substrate, and conforms to ASTM D4541 and D7234 standards for coating adhesion testing. It works by slowly leaking in pressurized gas to a piston that is screwed to an aluminum 'stub' that is attached to the paint coating with a high strength epoxy. As the pressure inside the piston increases, the force applied to the stub also increases until it reaches the adhesion strength of paint at which point the stub and paint layer suddenly break away from the surface, and the corresponding burst pressure is recorded. Figure 3.22<sup>45</sup> shows a schematic of the PATTI piston assembly, illustrating how the increasing air pressure inside the chamber applies a force to the rubber gasket, in turn creating an upward pulling force on the stub. The recorded burst pressure is used to calculate the tensile pull-off tensile strength using the equation [3.1]<sup>45</sup>:

Figure 3.22. Schematic cross section of the PATTI adhesion testing device.<sup>45</sup>

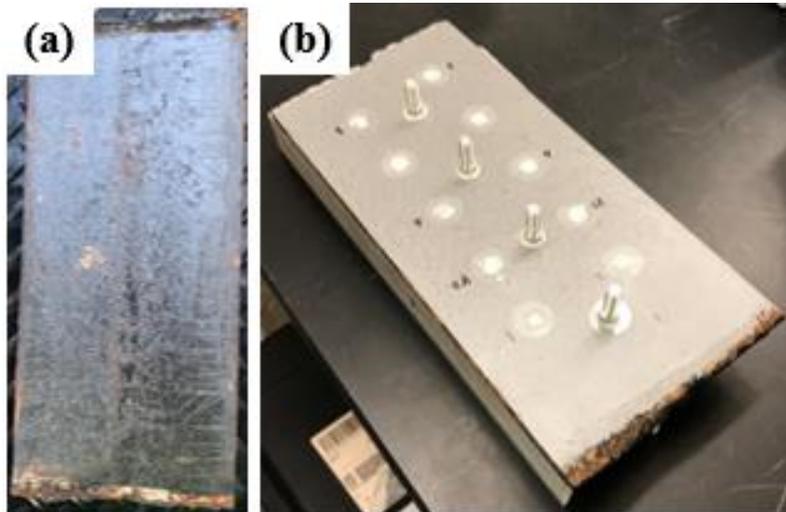
Figure 3.23 shows the surface of a laser cleaned flange, and then the repainted surface with the PATTI pull-stubs attached.

Figure 3.23. LACR cleaned I-beam flange (a) before and (b) after repainting with PATTI stubs attached.

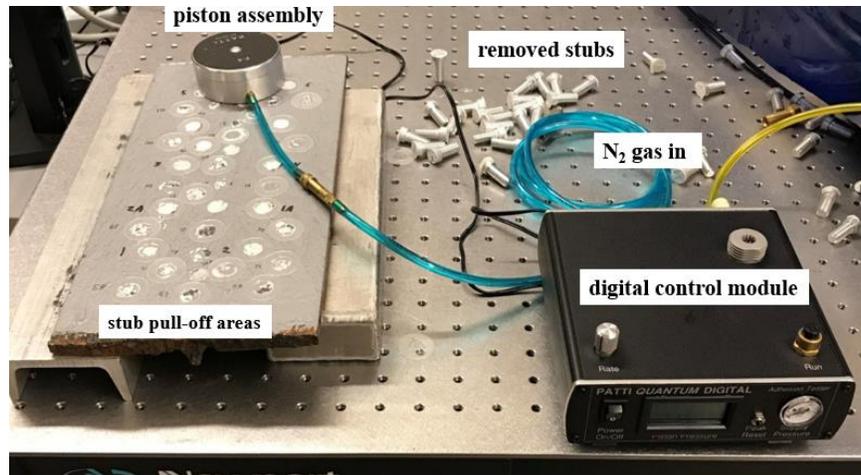
the underlying substrate. Figure 3.24 shows the PATTI testing set up and labels for each of the parts and functions of the device.

Figure 3.24. PATTI testing set up with each component labeled.

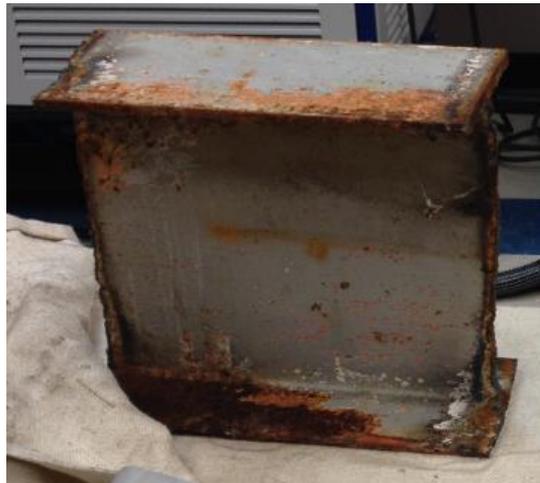
The first results that were obtained in this project were the general observations made during the phase I processing of the I-beam sections at Norton Sandblasting. During this demonstration, the process of laser coating removal was documented and provided a sense of the effectiveness and feasibility of using the laser to remove paint, rust, tar, and dirt from the beams. The I-beam sections used were from a bridge built in the 1930s, and were covered in thick rust, scale, paint tar, and dirt. Before any laser cleaning was attempted, the large scale debris was scraped away using a metal hand scraper. After bulk flakes of scale were removed mechanically, the laser testing began. Figure 4.1 shows a typical I-beam section that was used in phase 1.

*Figure 4.1. Sample I-beam section used in phase I.*

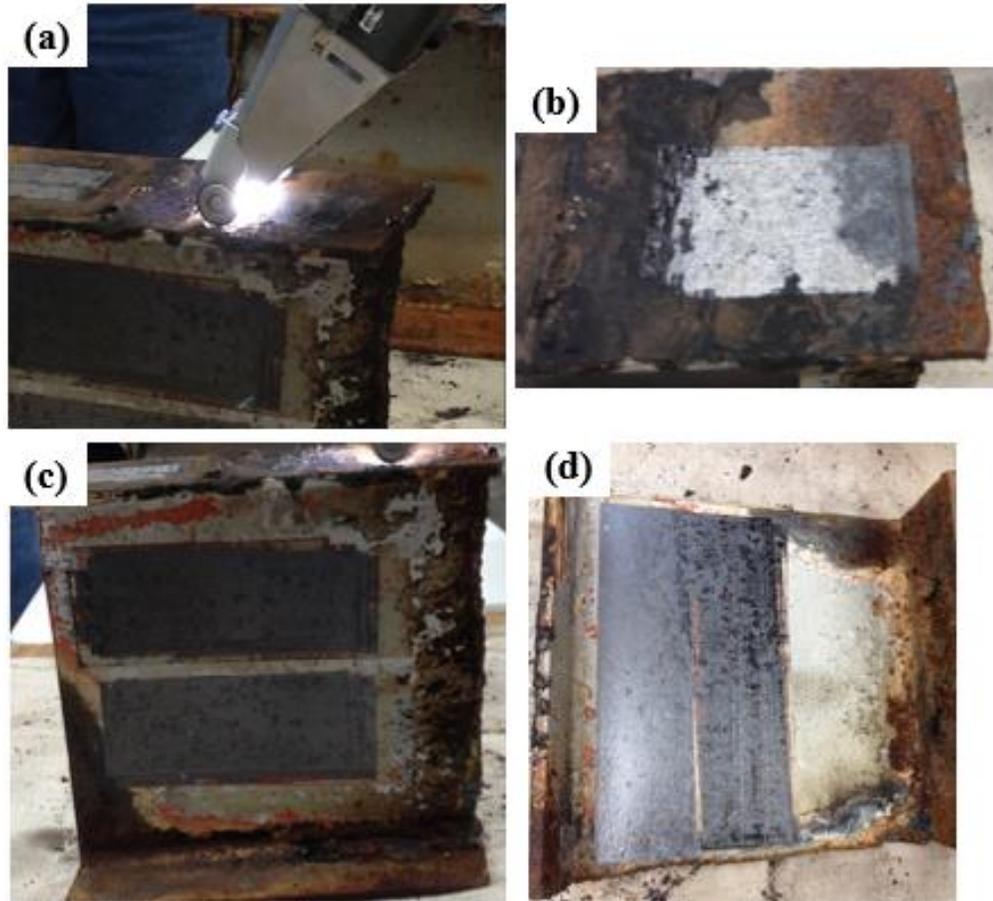
Due to the heavily decayed and dirty state of the I-beams, multiple laser passes were required to reach the substrate of the beams. In general it required between 3 and 6 passes before all the rust, paint, tar, and other detritus was removed. The number of passes needed depended on the operator experience, the speed of the laser movement and motions, as well as the state of the portion of the I-beam undergoing cleaning. The thickness and composition of the coating affected the rate of laser cleaning. Figure 4.2 shows what a portion of the cleaned I-beam looks like compared to the original state of the beam.

*Figure 4.2. (a) Laser cleaning interaction, (b) cleaned I-beam surface on a beam flange, (c,d), two parallel laser cleaned tracks.*

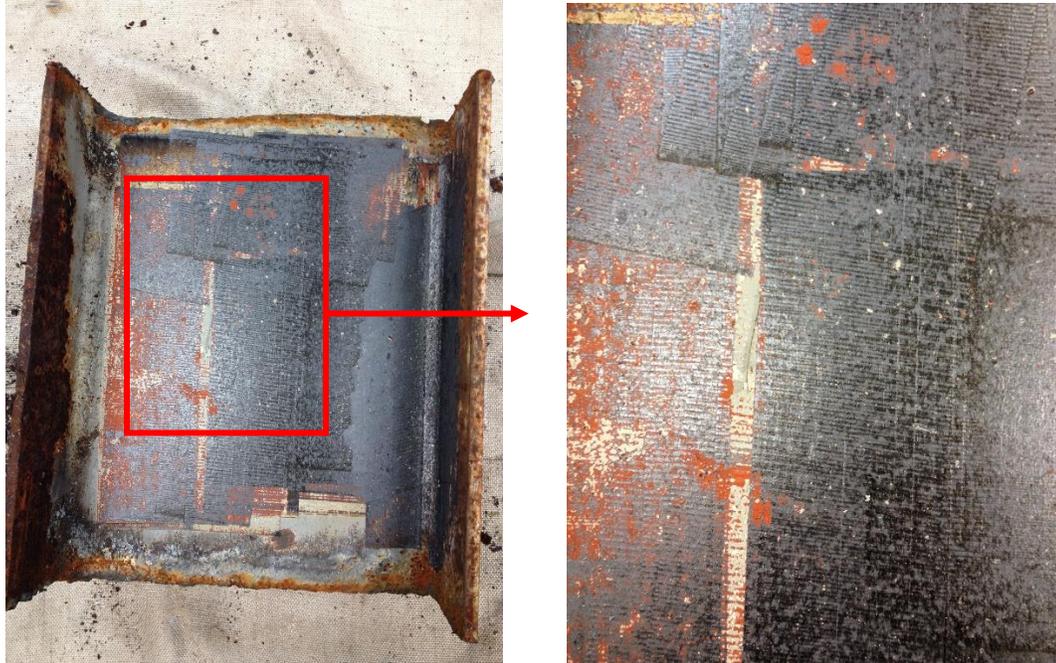
Upon initial cleaning of the I-beams, some of the first observations also included the presence of laser “tracks”, streaks that were parallel to the scanning laser beam and appeared darker in color than the surrounding substrate (figure 4.3). The appearance depended on the laser parameters that were used, including scan speed, pulse frequency, and the actual motion of the laser by the operator. In addition to the “darker” and “lighter” color of these laser tracks, there also appears to be splotchy areas consisting of this darker color and lighter colored areas surrounding these spots as well.

*Figure 4.3. Laser “tracks” left behind on the surface after laser cleaning. Between the tracks the random surface pattern of darker and lighter colored regions can be seen.*

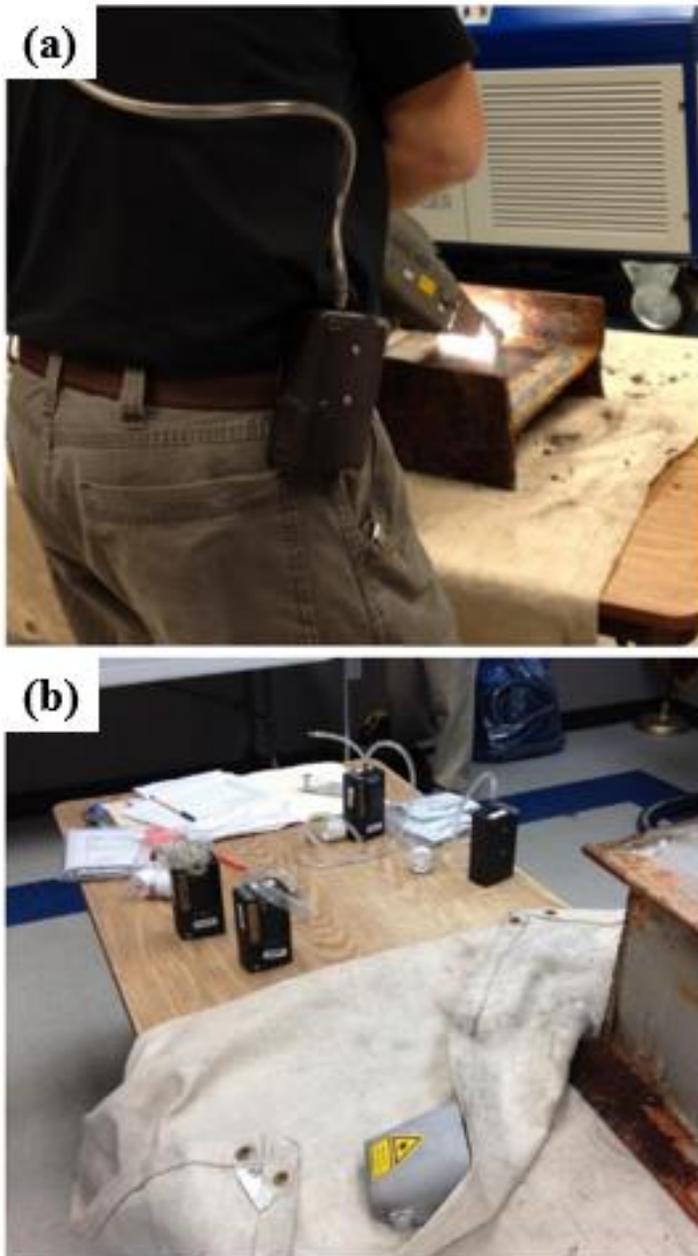
with NIOSH method 7300 to capture contaminants emitted in the air associated with the simulated bridge coating removal operation. Figure 4.4 shows the personal samples worn by the laser operator.

*Figure 4.4 Personal industrial hygiene sampling set up. (a) The laser operator wearing a VOC collector on his belt with a tube leading to his breathing zone. (b) VOC collecting units used for area placement.*

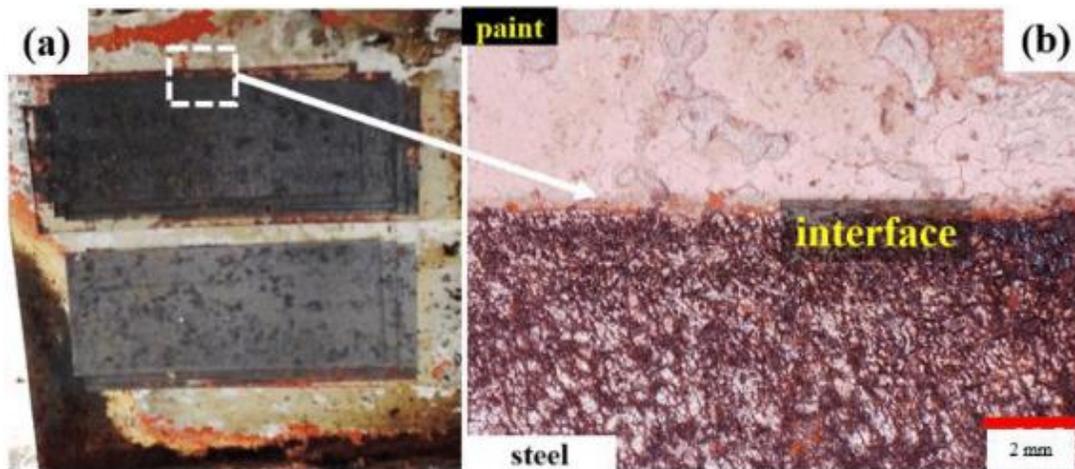
Analysis of the laser cleaned, grit blasted, and base material included optical and electron microscopy. Figure 4.5 shows the interface between the laser cleaned surface and the paint coating that was present on the base material before cleaning. Optical microscopy shows a fairly clean interface with a distinct boundary between the cleaned and exposed substrate and the paint.

*Figure 4.5.* (a) Macroscopic and (b) optical microscopic view of the interface between the painted and laser cleaned surfaces.

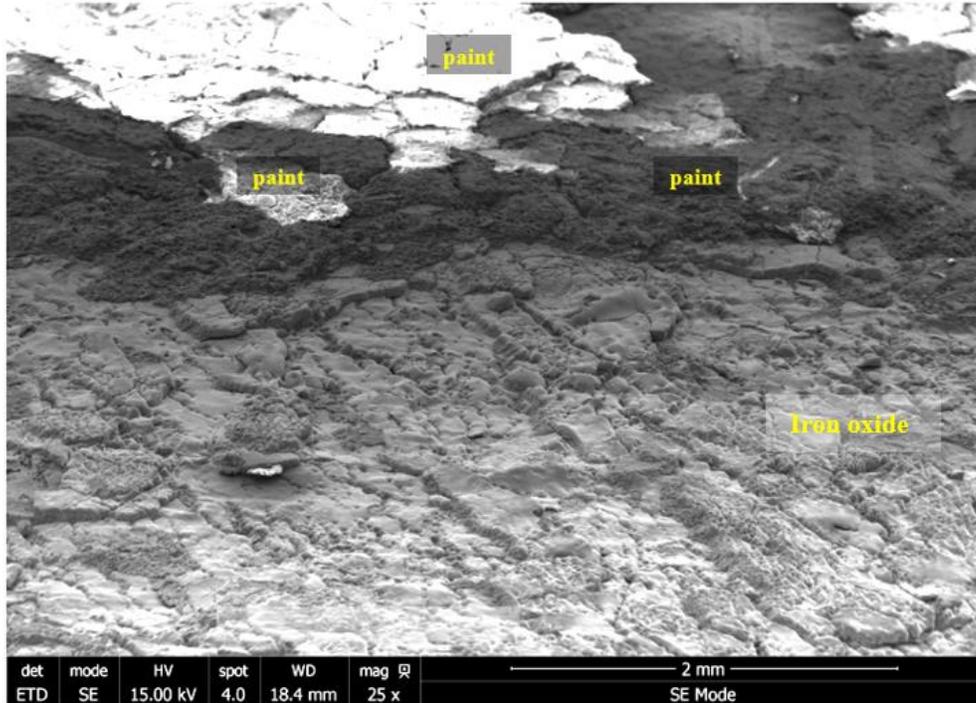
However, under closer examination using electron microscopy, it becomes clear that the interface between the paint and the underlying substrate is broken without a clean boundary between the paint layers and the underlying substrate. The thickness of the paint coatings that taper down to the substrate depend on how the different paint layers have been removed, meaning that the laser parameters are one factor that dictate the interface between the paint and the underlying substrate. Figure 4.6 shows this paint substrate interface as imaged in the SEM.

*Figure 4.6. SEM micrograph showing the paint to substrate interface.*

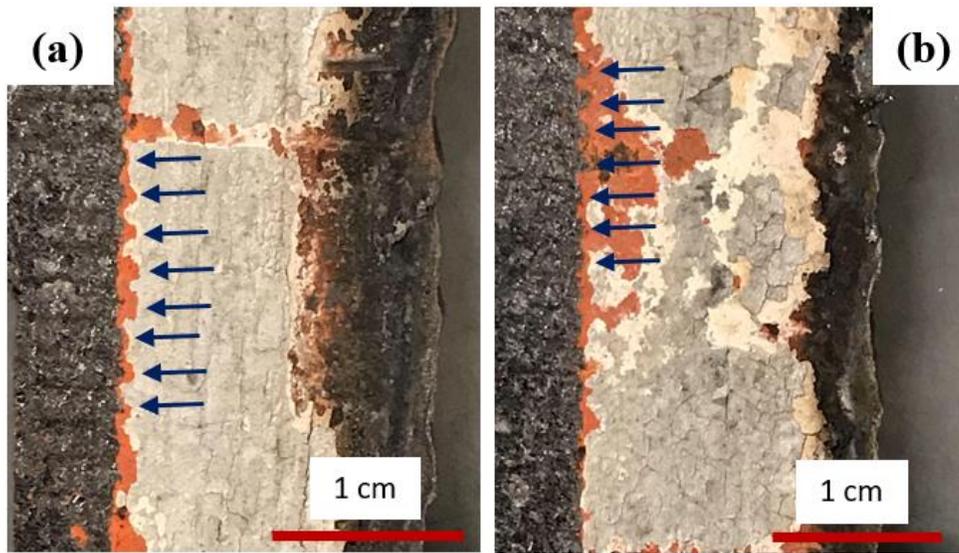
In certain places along this paint to laser cleaned surface, the effect of the laser scan can be observed. As the laser scans back and forth it removes the top most layer of paint before removing lower paint coats and eventually reaching the underlying substrate. In figure 4.7, arrows indicate the areas of removed upper paint coat and the exposed lower paint coat, as well as the removed bottom paint coat which exposes the substrate. These areas of removed coatings match up with the laser tracks which can be seen on the completely cleaned surface adjacent to the paint.

*Figure 4.7. a.) Arrows indicating where the top layer of paint has been removed by the laser scan path. b.) Arrows indicating where all the paint has been removed by the laser scan exposing the underlying substrate.*

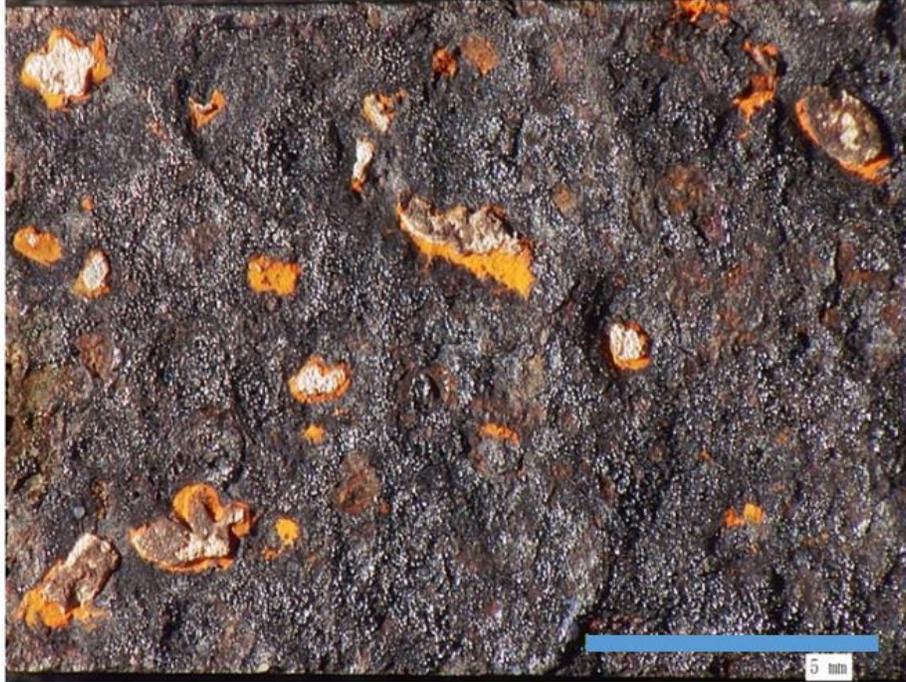
Further planar microscopy on the laser cleaned surface shows how clusters of red paint remain on some spots on the surface (figure 4.8). It is suspected that further laser passes would allow for complete removal of all the residual paint. It is interesting to note the difference in appearance of the laser cleaned surface in some areas, depending on the specific laser parameters that were used in combination with the coating system, in other words the varying condition of the paint layers at different areas of the beams. Figure 8 shows a “rocky” mineral type of surface which contrasts to a shinier, more metal surface present in other regions.

*Figure 4.8. Macro scale optical micrograph of the laser cleaned surface showing the remaining clusters of “red” base coat paint.*

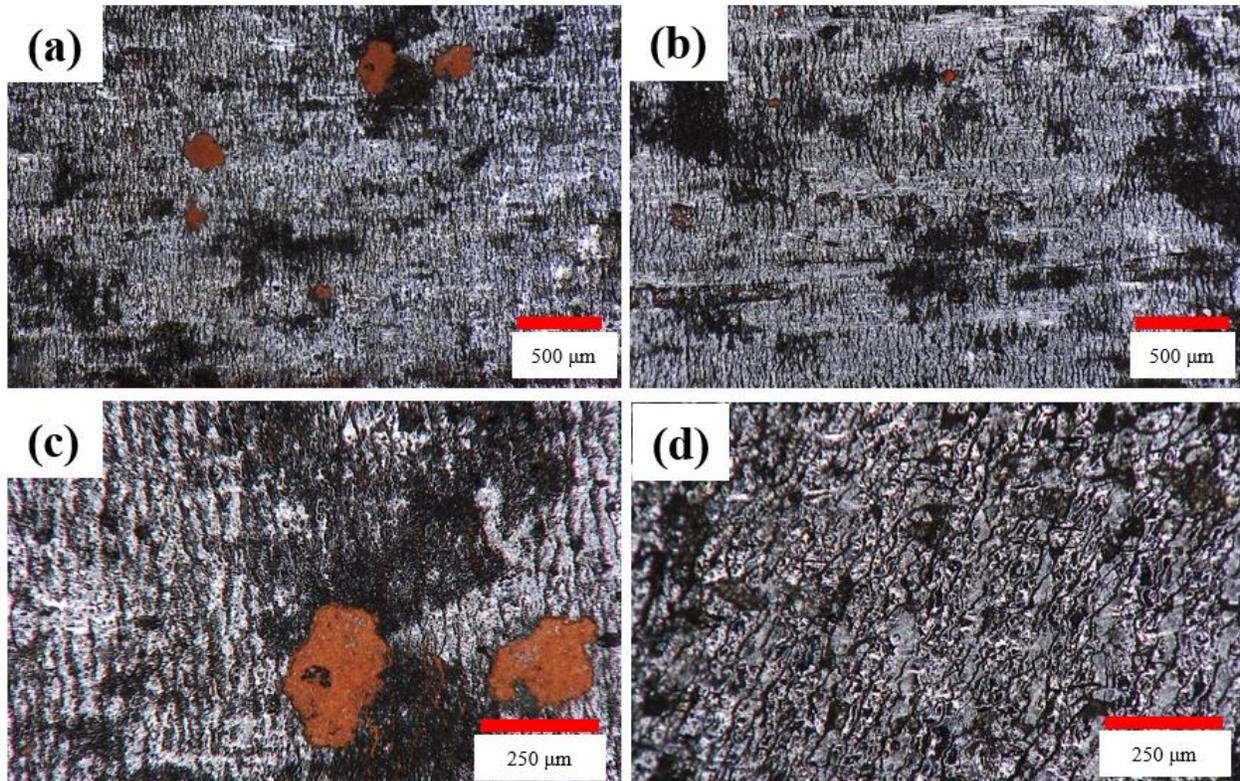
Optical microscopy of the laser cleaned surface reveals areas of high reflectance, and areas that appear darker with lower reflectance of light, that correspond to the random disordered distribution of reflective to non-reflective regions on the laser cleaned surface. These regions seem to vary throughout the surface randomly. Figure 4.9 shows optical micrographs of the laser cleaned surface that show these different areas.

*Figure 4.9. Optical micrographs showing the bright high reflective surface and the darker less reflective areas. A,b.) Clusters of red paint remaining on the surface, that vary in size depending on the number of laser passes. c.) Higher magnification optical micrograph of the clusters of paint remaining on the surface. d.) A laser cleaned region free from paint.*

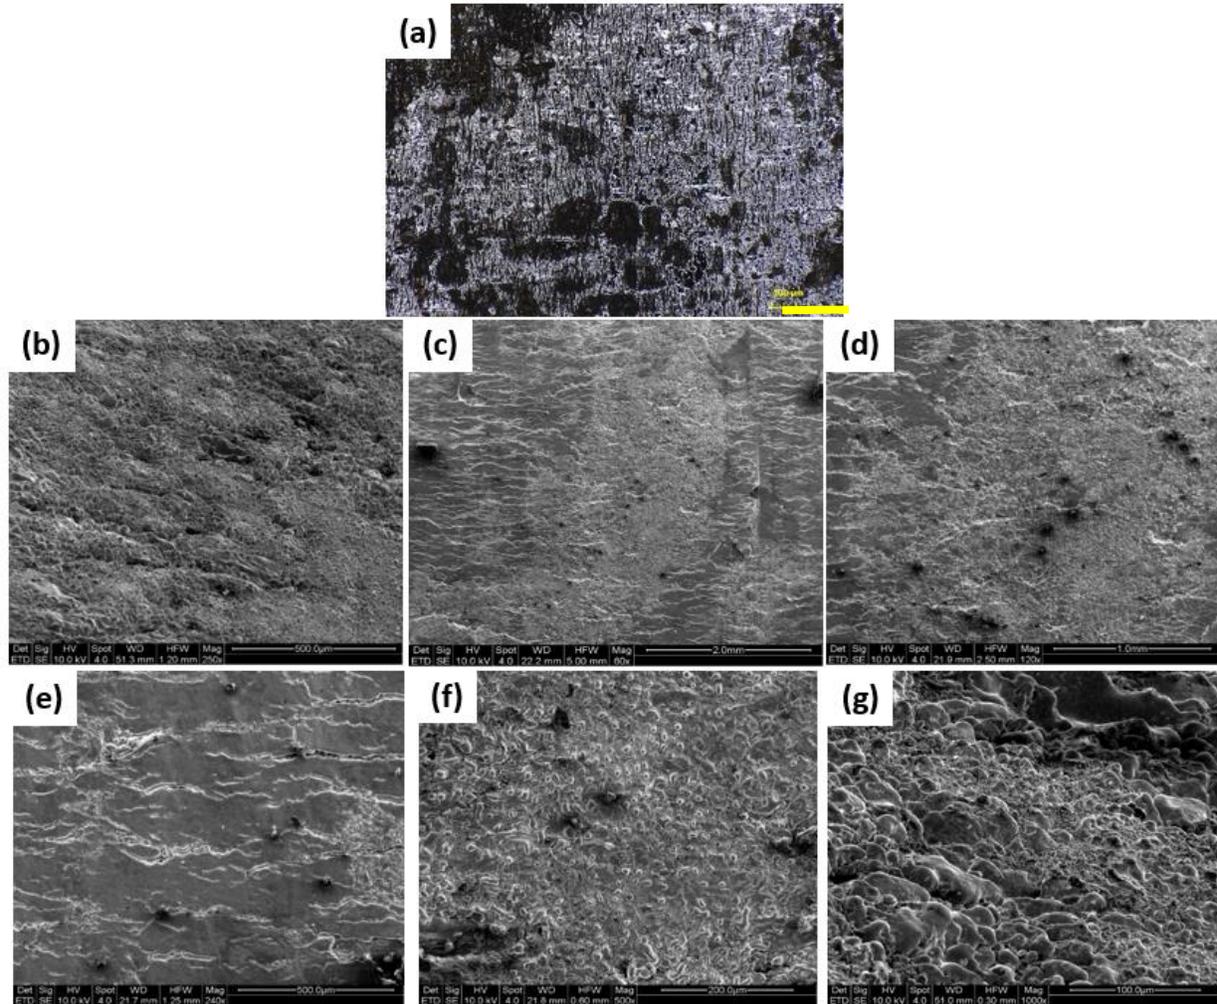
Using electron microscopy to gain a more detailed view of the surface, the surface topology is revealed more accurately. It is observed that the reflective “shiny” regions of the surface are relatively flatter, and therefore can reflect ambient light more efficiently than the rougher, courser areas, which are much less reflective to visible light and therefore appear dark. In figure 4.10, SEM micrographs of the surface show how regions on the surface with different roughness cause the light to be reflected differently, resulting in the shiny or dark appearance of the surface in different regions.

Figure 4.10. (a.) Optical micrograph showing the random distribution between the optically bright, reflective surface and the darker rougher surface regions. Scale bar = 500  $\mu\text{m}$  (b.) SEM micrograph of the surface topology in the darker, less reflective surface area. (c.) SEM micrograph showing the difference in surface topology between the smoother surface and the rough surface (streaking down the middle of the image). (d.) Higher magnification of region shown in c. (e.) High magnification SEM of the smooth reflective surface. (f.) SEM micrograph of a rougher, darker surface region. (g.) High magnification of the region shown in f.

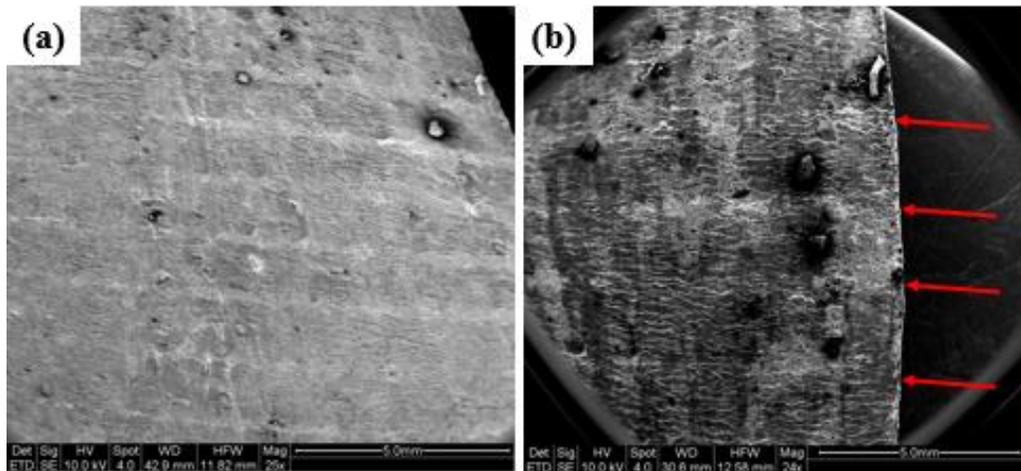
SEM also helped to reveal the laser tracks that were observed simply by eye. In order to see these tracks the sample had to be tilted to a high angle of approximately 60 degrees, at which point the tracks become apparent using a secondary electron detector. Figure 4.11 shows the laser tracks that were observed by tilting the sample in the SEM.

*Figure 4.11. a.) Tilting the sample in the SEM allows visualizing the laser tracks produced on the surface due to the laser material interaction. b.) Using higher contrast helps to define each individual “track”, indicated with red arrows.*

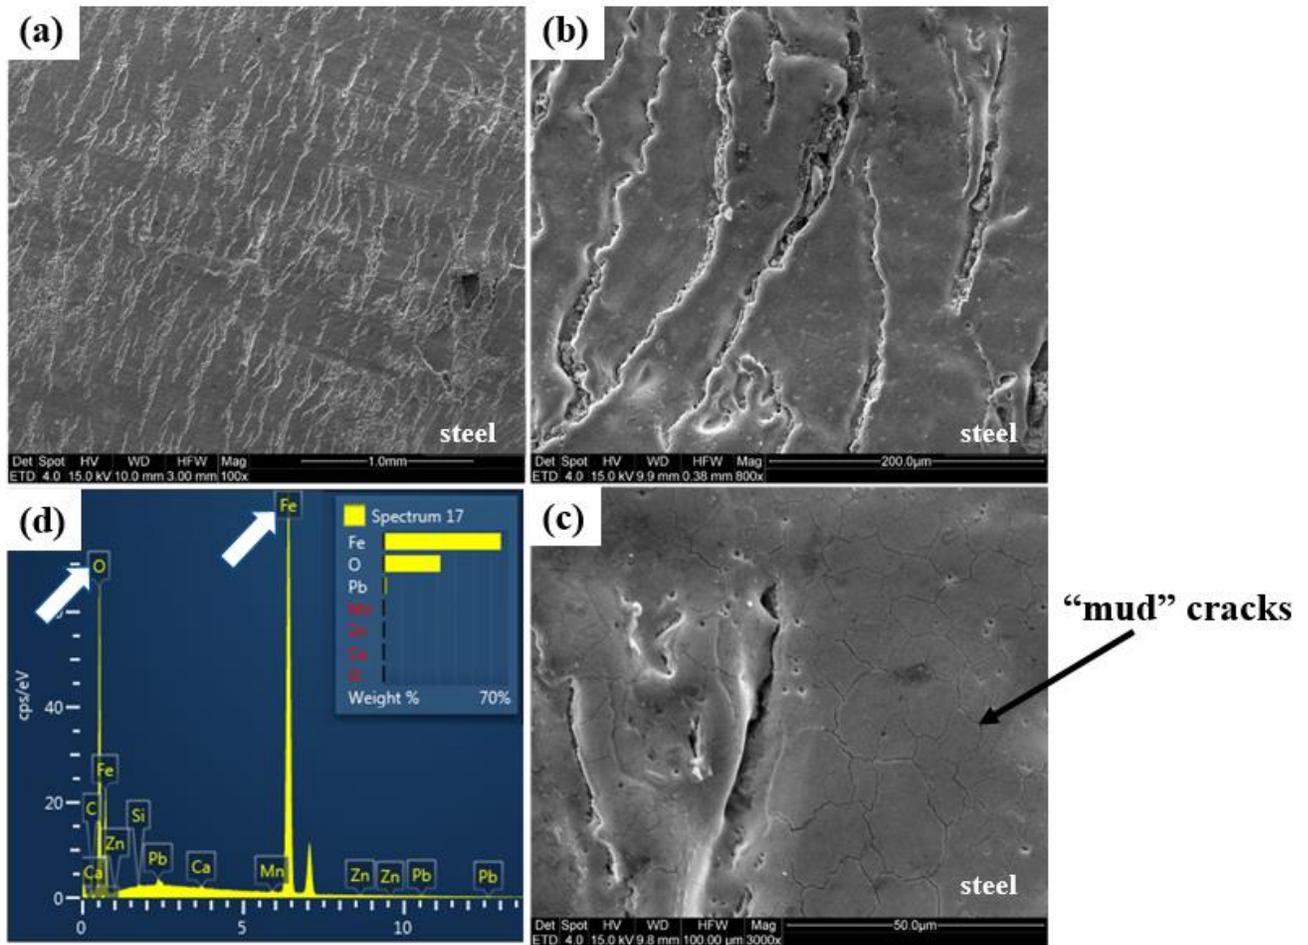
Despite the shiny metallic appearance of the laser cleaned surface, compositional analysis with energy dispersive spectroscopy (EDS) shows that the laser cleaned surface actually consists of an iron oxide. At higher magnifications tiny “mud” cracks can be observed in the iron oxide surface that remains (figure 4.12).

Figure 4.12. a,b.) SEM micrographs showing the laser cleaned surface topology. c.) “Mud” like cracks seen at high magnification. d.) EDS scans showing the iron oxide composition of the laser cleaned surface.

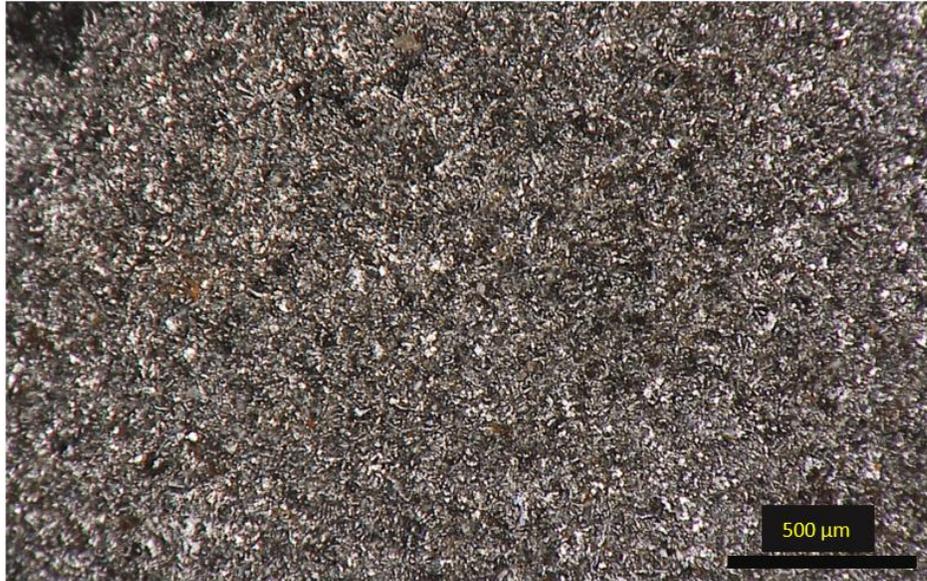
In contrast to laser cleaning, grit blasting appeared to do a more thorough job of removing all the layers of paint. While spots with paint or rust may remain in areas of the I-beam depending on how meticulously a specific area of the surface was blasted, in general the grit blasted surface was devoid of paint and/or oxides, as seen by the naked eye. In addition, the grit blasted surface has a different macroscopic appearance, and seems to be rougher as well as cleaner to the naked eye. Figure 4.13 shows the grit blasted surface as seen with optical microscopy.

*Figure 4.13. The grit blasted surface seen using optical microscopy.*

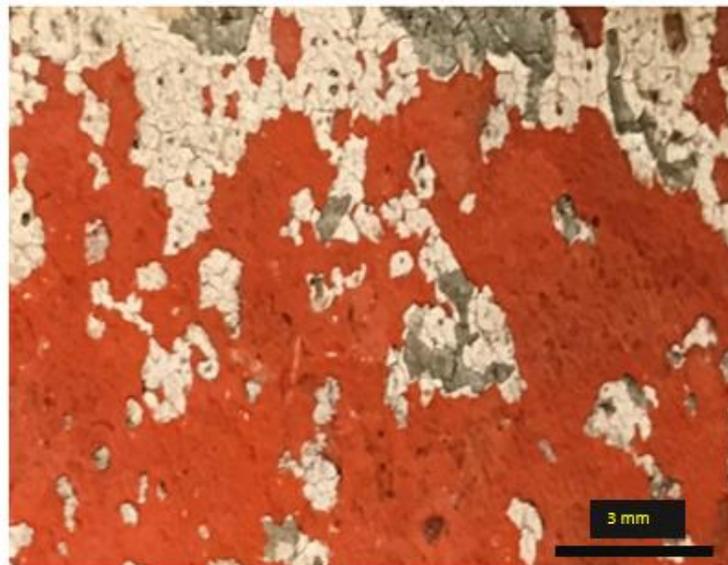
In addition to planar analysis of the laser cleaned and grit blasted surfaces, the base material that was still covered in paint was also studied. Figure 4.14 shows the paint layers that cover the I-beams before any processing, and the paint coat from bottom to top can be observed. The red paint makes up the first coat, followed by the white colored paint and then the grey top coat.

*Figure 4.14. Macro optical image of the paint layers covering the I-beams. From bottom to top: red paint, white coat, and grey top paint coat.*

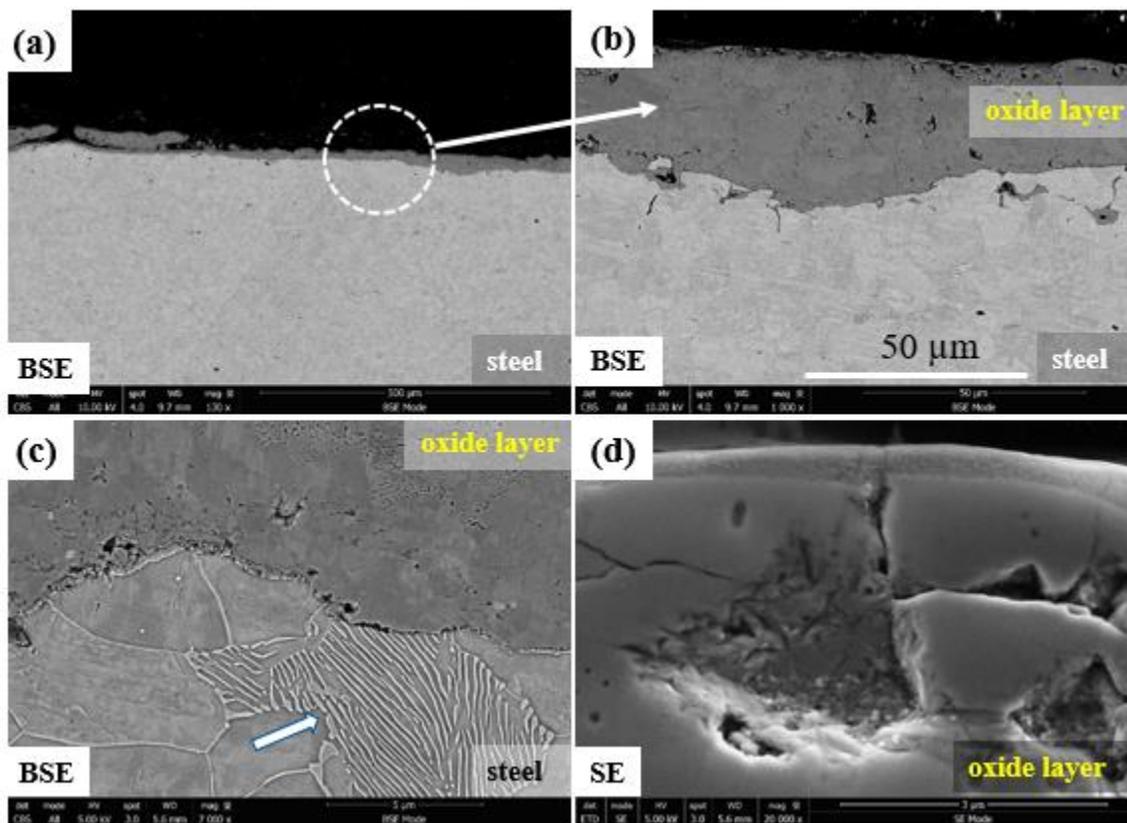
Cross sections of the laser cleaned substrate revealed the presence of a semi-continuous iron oxide layer. It varies roughly from 100  $\mu\text{m}$  to 20  $\mu\text{m}$  across the surface, and in some places is not present at all. Figure 4.15 shows a cross section of the laser cleaned substrate and the oxide layer that remains.

Figure 4.15. Cross section analysis of the laser cleaned surface shows the a,b.) Iron oxide layer on the surface, c.) intact metal microstructure directly below the iron oxide surface layer, and d.) the laser melted top most region of the iron oxide surface.

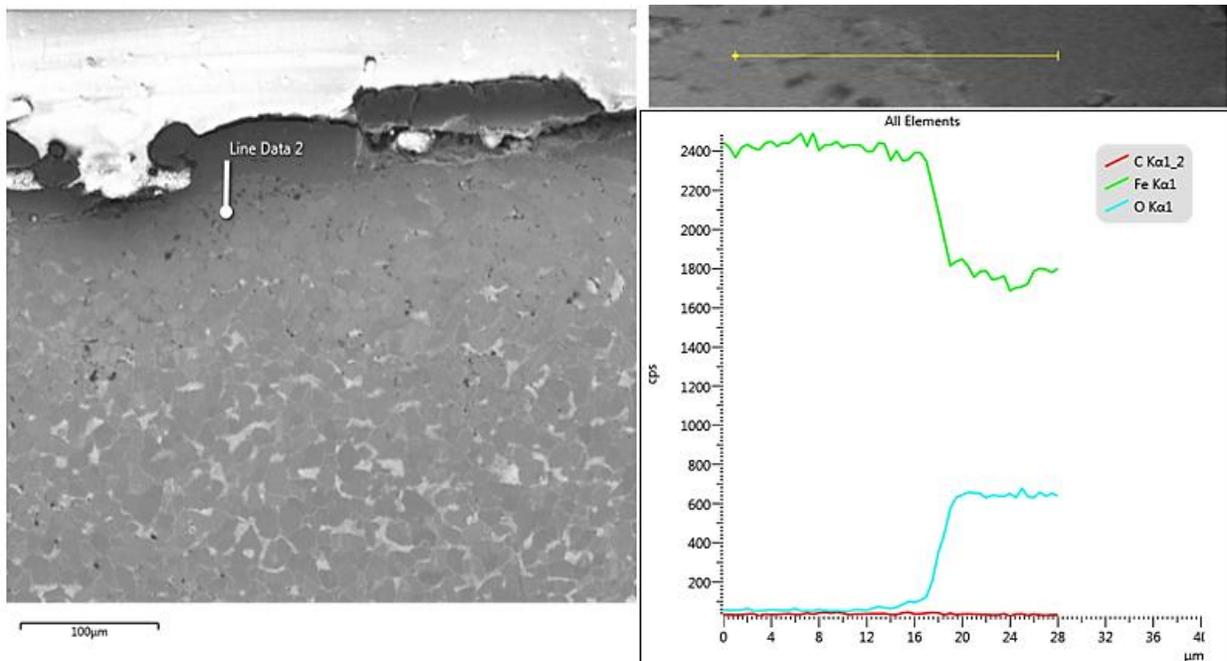
Underneath the iron oxide layer, the pearlite microstructure of the steel is observed, suggesting that any heat transferred to the underlying steel, if any at all, is not enough to cause significant melting or thermal damage to the steel microstructure. Using EDS, a line scan (figure 4.16) shows the abrupt transition from the iron oxide layer to the underlying steel, which compositionally as well as structurally appears to be unaffected by the laser heat.

*Figure 4.16. Line scan between the I-beam metal and the iron oxide surface layer.*

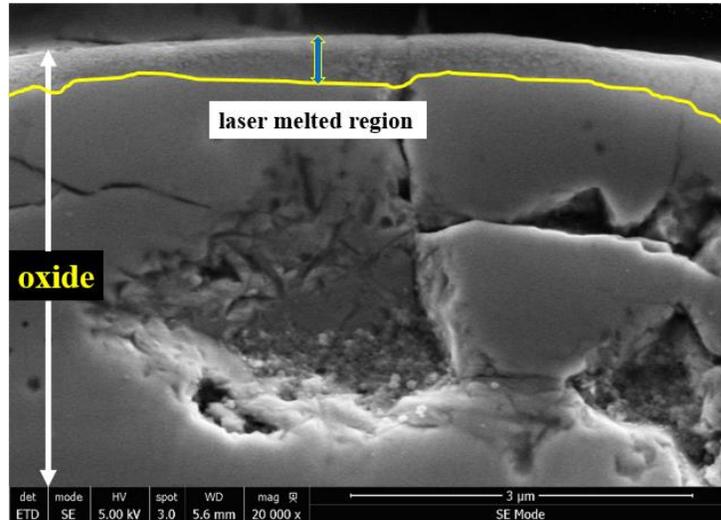
At high magnifications the melting of a thin surface region of the iron oxide, on the order of 1  $\mu\text{m}$  or less in depth below the oxide surface, can be seen. This finding corroborates the observation of surface melting, and it indeed seems to be the case that the very near surface region of the iron oxide layer undergoes melting due to the laser heat input. Figure 4.17 shows in detail the oxide layer with the melted region indicated.

*Figure 4.17. High magnification SEM shows the melted surface region of the iron oxide layer. As expected, grit blasted sample cross sections lack the oxide layer that is found on laser cleaned samples. Instead, the near surface region of the cross sections revealed the deformation of grains due to the forces imparted to the metal during grit blasting. Up to a depth of roughly 10 μm, the grains are flattened and disfigured compared to the undeformed grains below them. Figure 4.18 shows SEM micrographs of grit blasted sample cross sections, and the near surface grains that have been deformed due to grit blasting.*

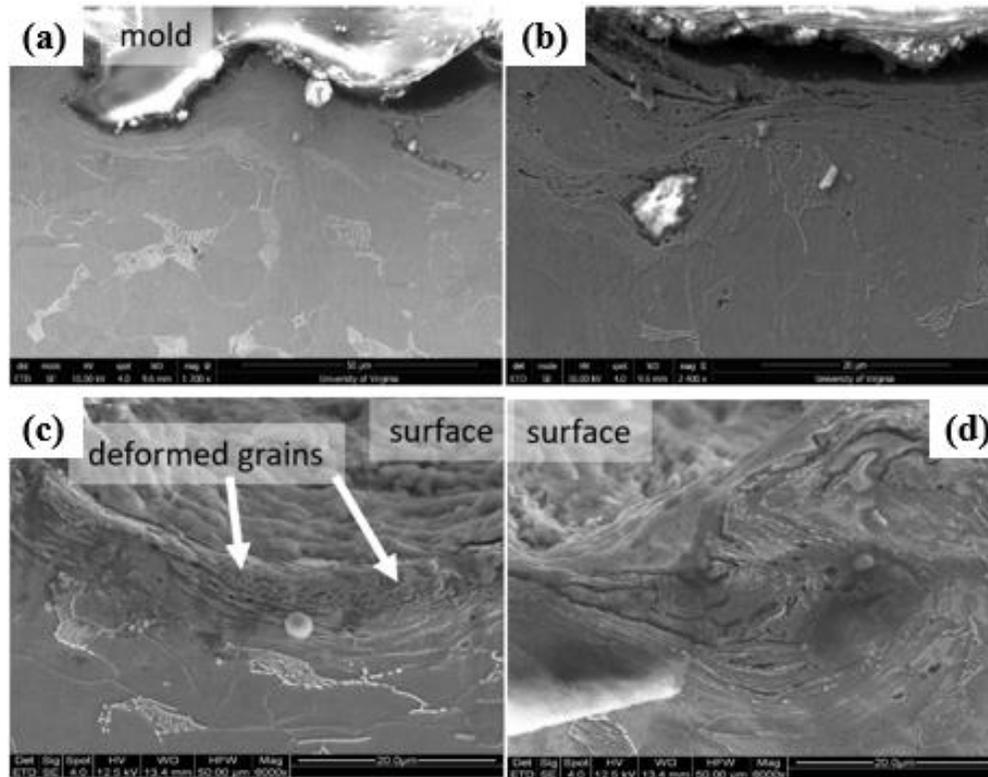
Figure 4.18. Grit blasted sample cross sections showing the deformed grains in the surface region. (a) scale bar = 50  $\mu\text{m}$ , (b) = 20  $\mu\text{m}$ , (c) = 20  $\mu\text{m}$ , (d) = 20  $\mu\text{m}$ .

Aside from the deformed grains at the surface, the roughness of the grit blasted surface is implied by the high amplitude of peaks and valleys in the profile view of the cross section surface. This is in contrast to the relatively smooth cross section surface profile of the laser cleaned samples.
