# **IMPLEMENTATION OF LASER ABLATION COATING REMOVAL TECHNIQUE FOR STEEL COMPONENTS ON VDOT BRIDGES**

A Thesis

Master of Science in Material Science and Engineering

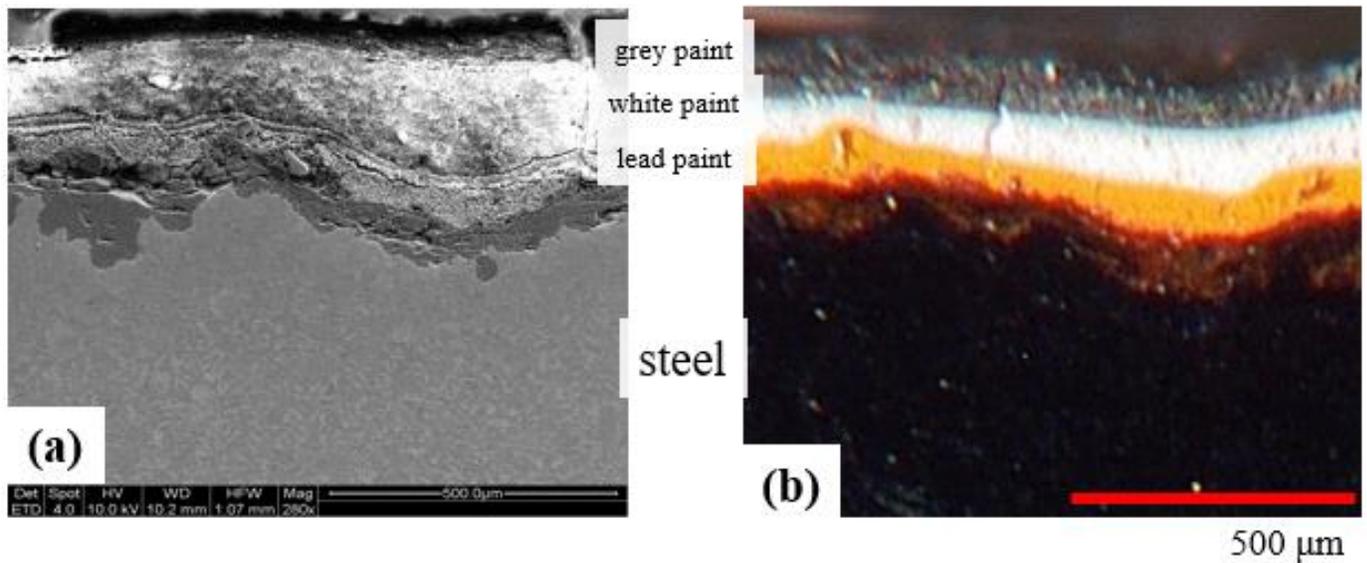
Cross sections of the base metal show that underneath the three paint coats, the iron oxide layer that is observed after laser cleaning is already present. Therefore the I-beams used in Phase I were never originally grit blasted, and the process of laser cleaning removes the top paint layers in turn exposing the iron oxide that is observed on laser cleaned samples. Figure 4.19 shows a cross section of the base metal using both electron microscopy and optical microscopy. This clearly shows the different layers of paint as well as the iron oxide layer and steel.

Figure 4.19. SEM (a) and an optical micrograph (b) of a cross section of the base material showing the layers of paint and iron oxide.

Because this oxide layer is present on the steel even before it was originally painted, this suggests that it is oxide that has formed after the I-beam was made in a steel mill, and has since remained on the surface of the steel.

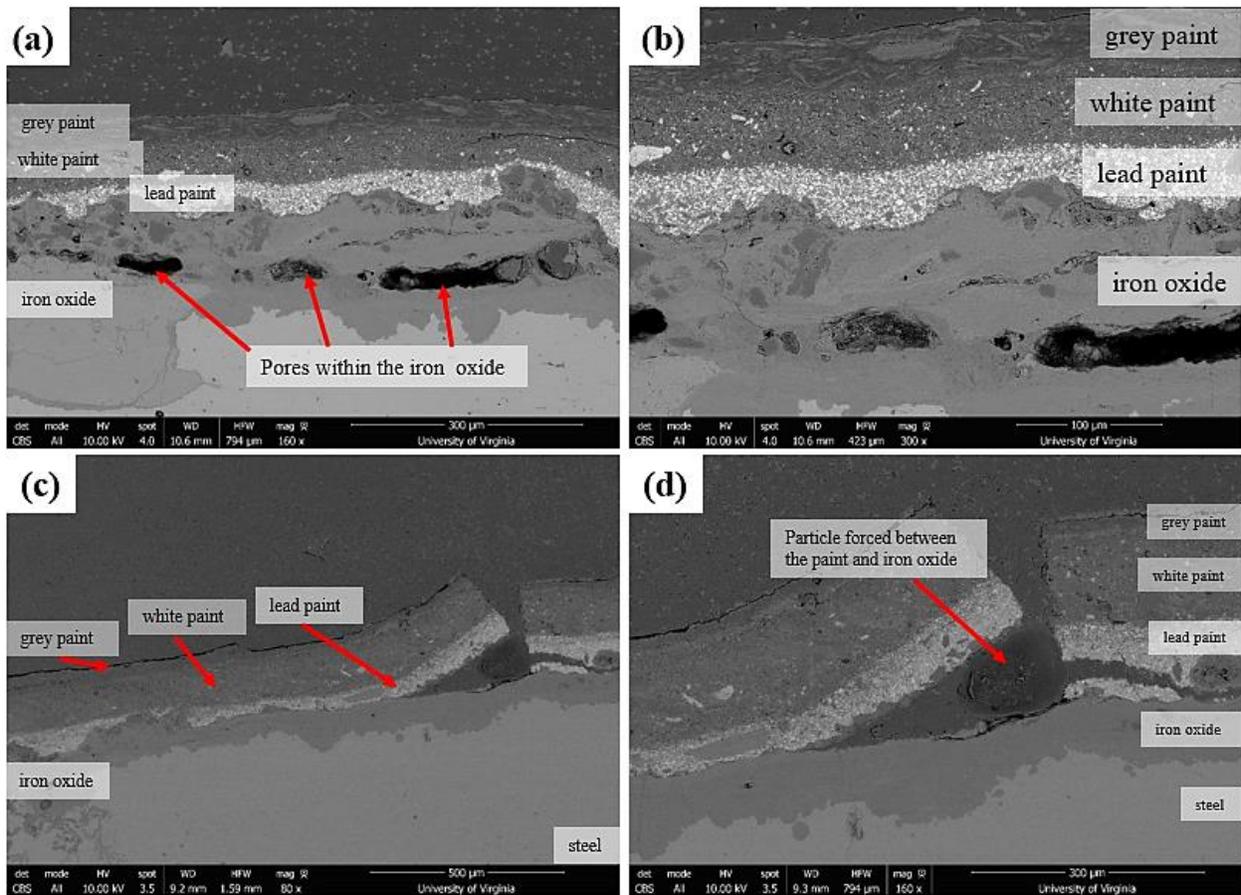
SEM backscatter electron (BSE) imaging also helps to provide an idea of the composition of the paint and oxide layers. Because backscatter images provide z contrast, meaning that higher atomic weight elements appear brighter than lighter elements, which appear darker, certain paint layers such as the lead paint and the iron oxide will stand out from other layers with different compositions. Figure 4.20 shows SEM backscatter micrographs of the base metal cross sections. The lead containing base coat appears the brightest as expected, because of the high atomic weight of lead atoms. In addition to the lead paint the iron oxide layer is strongly contrasted from the steel because of the relatively high oxygen content of the oxide. Aside from the composition of the paint and iron oxide layers, these micrographs further characterize the aged and rough state of the coatings on these beams. In Figure 20 (a) and (b) large pores can be observed within the oxide layer, which ideally would not be present on freshly coated steel. Parts (c) and (d) also

clearly show particulate that has been forced into the coating, creating an opening to the underlying substrate.

Figure 4.20. (a) BSE micrograph showing the steel, iron oxide, and three paint layers. (b) High magnification micrograph of (a), showing the pores that are present in the oxide layer. (c) BSE micrograph of an embedded particle between the iron oxide and the adjacent paint layers. (d) Higher magnification micrograph of (c), detailing the region containing the embedded particle.

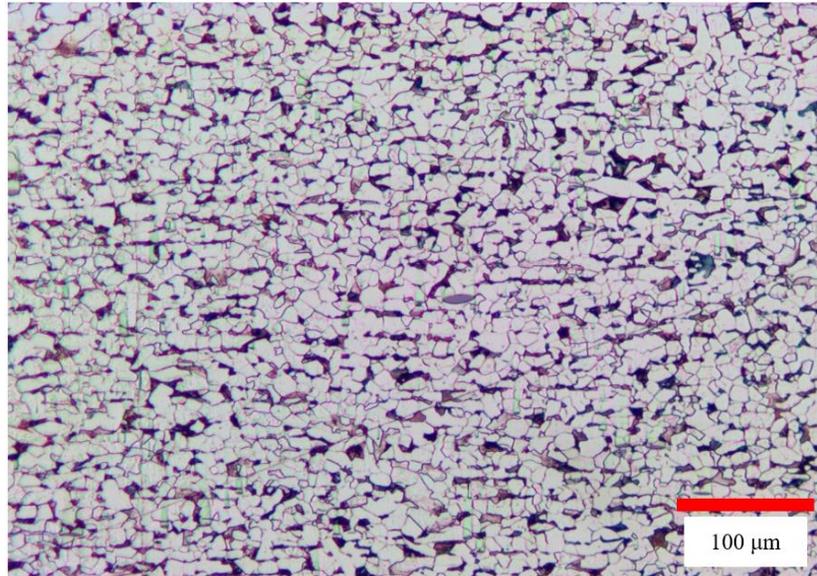
in figure 4.21, the grains have a lateral shape that seems to be “stretched” out in the horizontal direction. This is due to the rolling during the manufacturing of the I-beam, which shapes the grains into the laterally stretched shape that they exhibit.

*Figure 4.21. Optical microscopy showing the textured microstructure due to the rolling of the steel into the I-beam shape.*

In figure 4.21 the darker grains are pearlite colonies, and the lighter grains are alpha ferrite. The darker pearlite grains help to bring out the rolling direction by providing contrast to the microstructure in the optical micrograph. Steel stringers or inclusions, were also observed in the microstructure as well. Figure 4.22, shows a higher magnification view of the etched microstructure. Dispersed between the alpha ferrite and pearlite, the steel stringers appear as dark grey “metallic” colored particles. These stringers are also stretched out along the rolled direction of the beam along with the adjacent grains showing the same texture. MnS inclusions are common impurities in steels and can be categorized as specific types. In this case the MnS inclusions appear to be type II inclusions (more information in appendix A1).

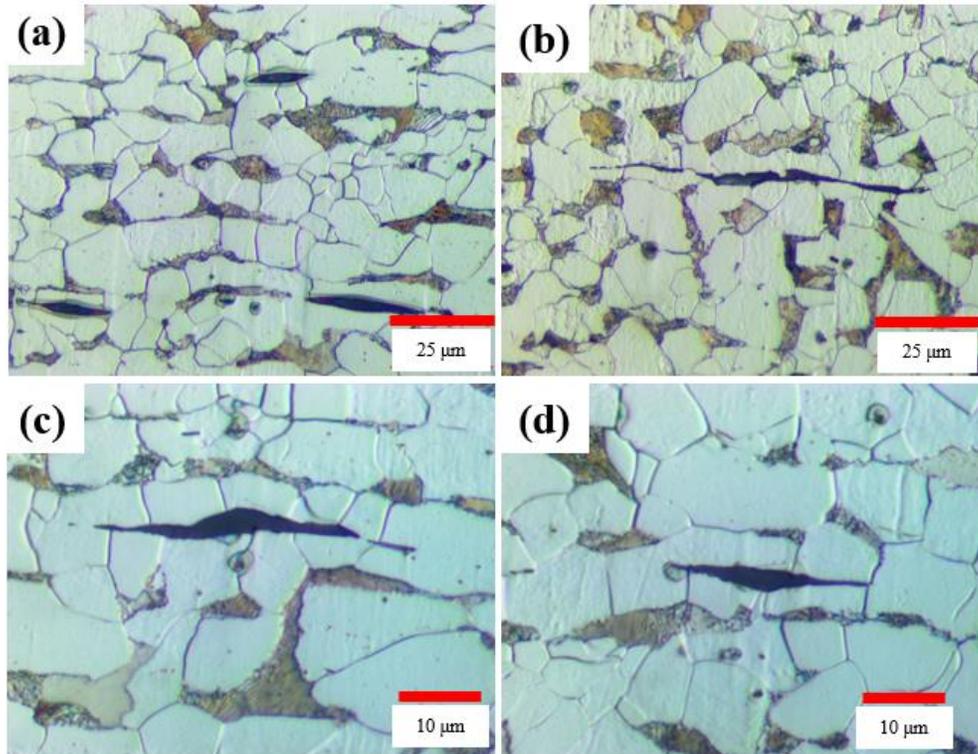
*Figure 4.22. Steel stringers present in the A36 steel microstructure. (a,b): 50x magnification, (c,d): 100x magnification*

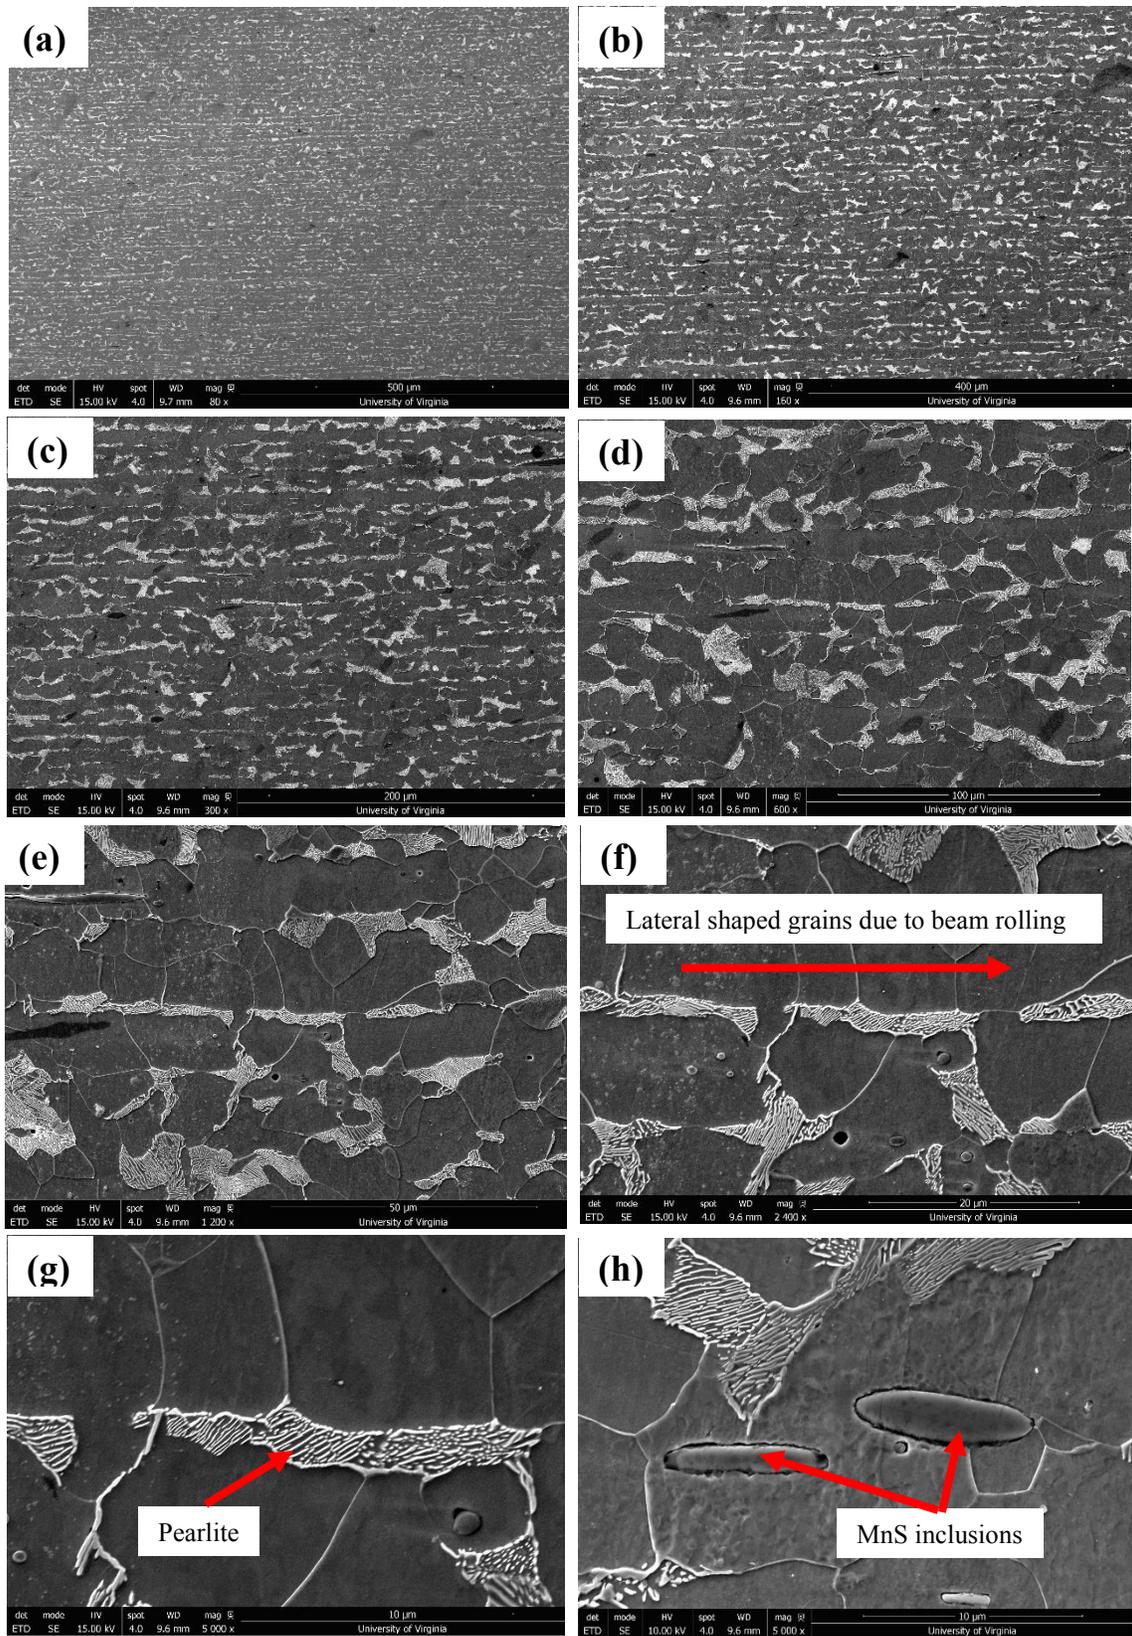
In addition to optical microscopy, electron microscopy provided further characterization of the steel microstructure. With the higher resolution and magnification provided with electron microscopy, more detail in the microstructure can be observed. In high magnification micrographs the lamellar structure of the pearlite phase can be discerned much more easily than in the optical micrographs, and the steel stringers can be observed in more detail. (Figure 4.23).

Figure 4.23. SEM micrographs of increasing magnification showing the steel microstructure and texture. a.) 80x, b.) 160x, c.) 300x, d.) 600x, e.) 1200x, f.) 2400x, g., h.) 5000x.

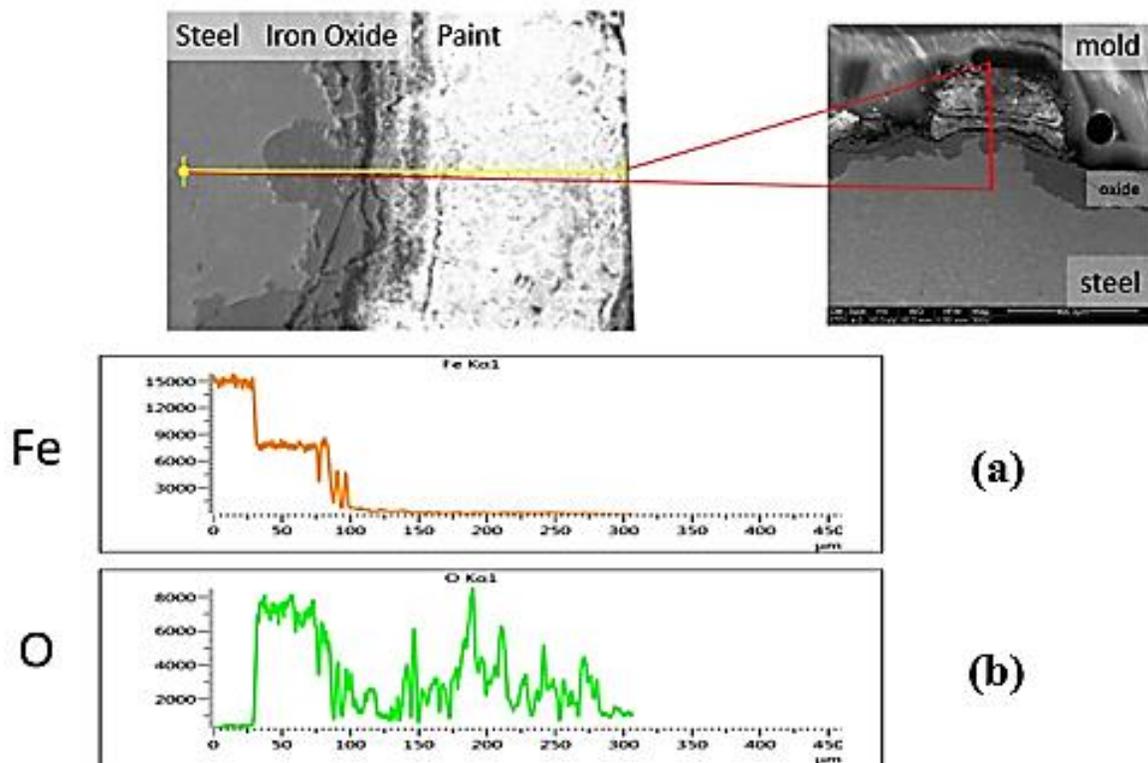
To study the layers of paint present on the base material, cross sections were analyzed with both optical and SEM, and in addition, EDS was used to study the composition of the different paint coats. It was determined that there are three different layers, a red base coat, white layer, and a top coat of grey paint. Figure 4.24 shows an EDS line scan from the top paint layer through to the steel, and by plotting the oxygen and iron content, the transition from steel, to the iron oxide layer, and to the top layers of paint can be seen.

Figure 4.24. EDS line scan delineating the transition from paint to iron oxide surface layer to steel. (a) Shows a clear transition in iron content from steel, to iron oxide, and paint. (b) Likewise shows the low oxygen content of the steel compared to the high oxygen content within the iron oxide layer, followed by the variable amount of oxygen present in the paint.

It is clear that the steel is nearly devoid of oxygen, or that it is at least present in a low enough amount to not be detected by EDS, and therefore the steel can be considered to be unaffected chemically by the adjacent iron oxide layer. The oxide layer is easily detected by the EDS line

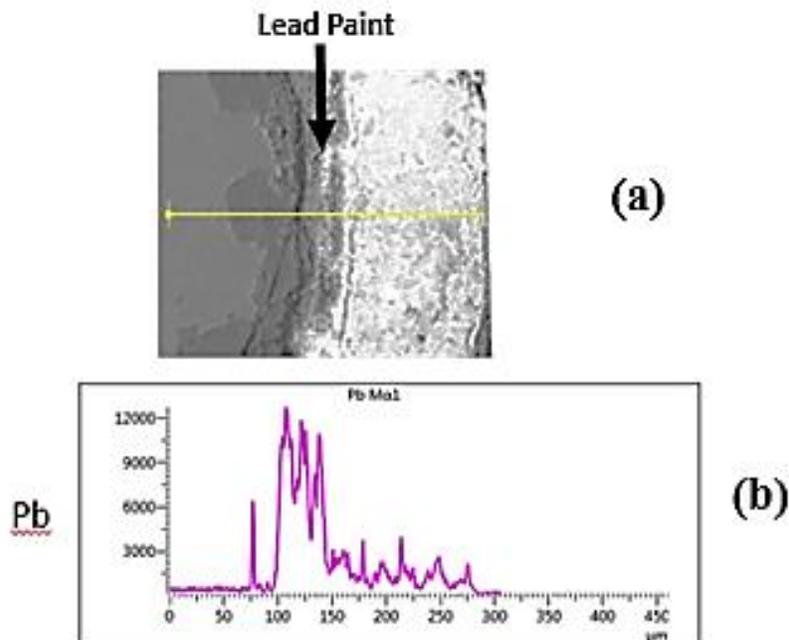
Figure 4.25. EDS line scan shows the concentration of Pb within the red lead paint base coat. (a) Indicating the line scan that was measured on the sample cross section. (b) Lead  $M_{\alpha 1}$  EDS spectrum shows the concentration of lead in the base coat of paint.

Using the same line scan to analyze the lead paint layer, it is apparent that the lead is mostly present in the base coat of paint (reaching a maximum of 13000 counts), with lead levels varying throughout the upper layers as well. (Figure 4.25). There also appears to be Zn, Na, Ti, and Si present in the outer paint layers as measured with EDS line scans (figure 4.26).

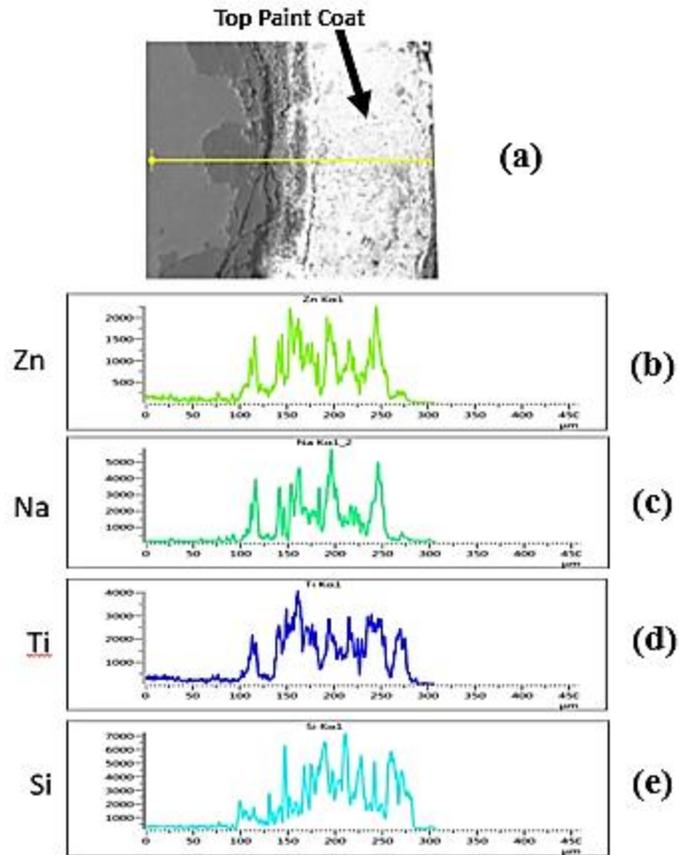
Figure 4.26. EDS line scan providing a compositional profile of the paint layers. There is a strong correlation between Zn (b) and Na (c), slightly less with Ti (d), and peaks mismatched the most with Si (e).

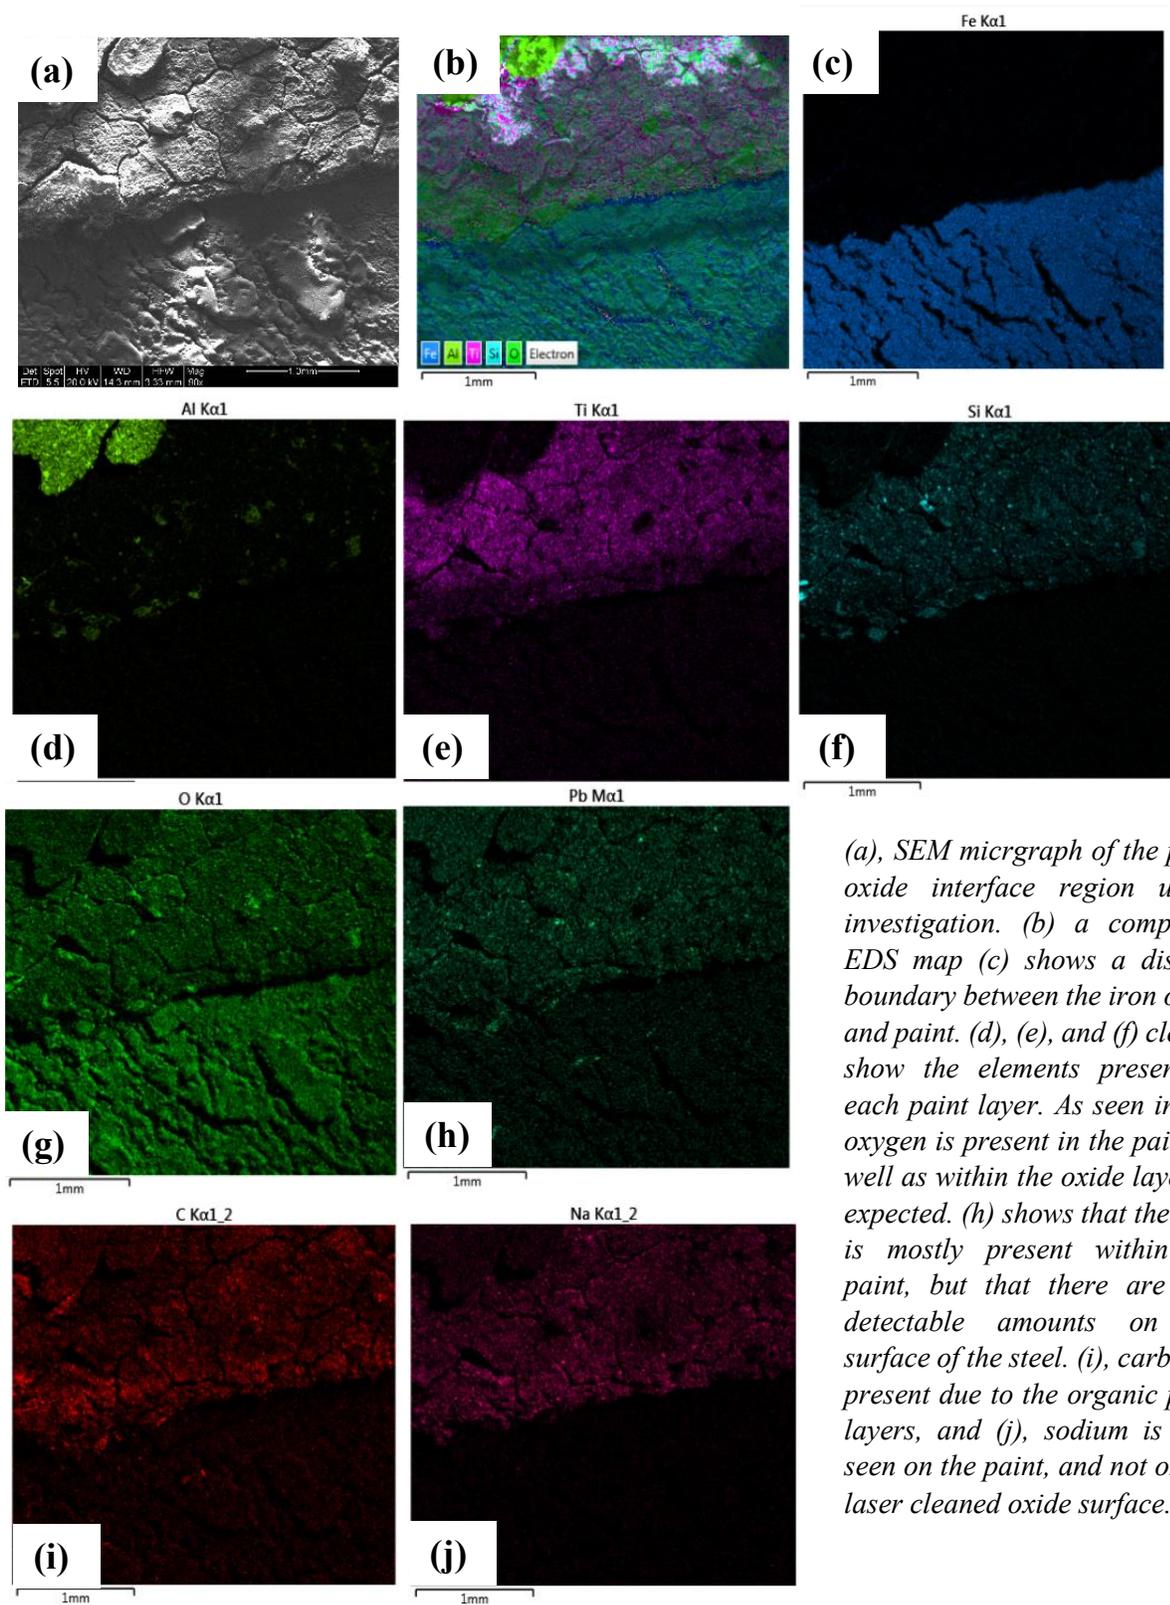
Location 1:

*Figure 4.28. Several different locations along the paint substrate interface shown using EDS color maps to help identify the composition of different paint coats. (Appendix A2).*

Figure 4.28 shows an EDS color map of a select location along the paint and iron oxide surface interface. (Also see Appendix A2) These EDS maps help to distinguish the features that are observed in the accompanying SEM micrographs.

Comparing these EDS maps reveals the composition of each paint layer as well as the cleanliness of the laser cleaned surface. There is a sharp distinct boundary between the paint and the substrate as observed in a majority of the maps, and even between some of the paint layers. For example, in location 1, C, Na, Si, and Al are not detected on the iron oxide surface in large amounts, but only on the paint regions. Also at location 1, the laser cleaned surface has high signals of iron, and oxygen. This helps confirm that the iron oxide surface nearly exclusively consists of iron and oxygen, with minimal contamination that may have possibly been introduced during the laser cleaning process. In addition, there is a clear distinction between the top aluminum containing paint coat and the middle titanium paint, as seen in the EDS maps. These suggests that some each paint layer is composed of distinct elements that can be used to characterize them. Furthermore, by comparing EDS map scans to optical images allows identification of what paints contains which pigments and elements. Near the edges of samples, the paint tends to flake off to varying degrees, this reveals the separate paint layers. By revealing different paint layers in various areas this allowed for direct EDS characterization of each paint coating. Figure 4.29 shows optical micrographs of the painted surface, where each paint layer is clearly seen.

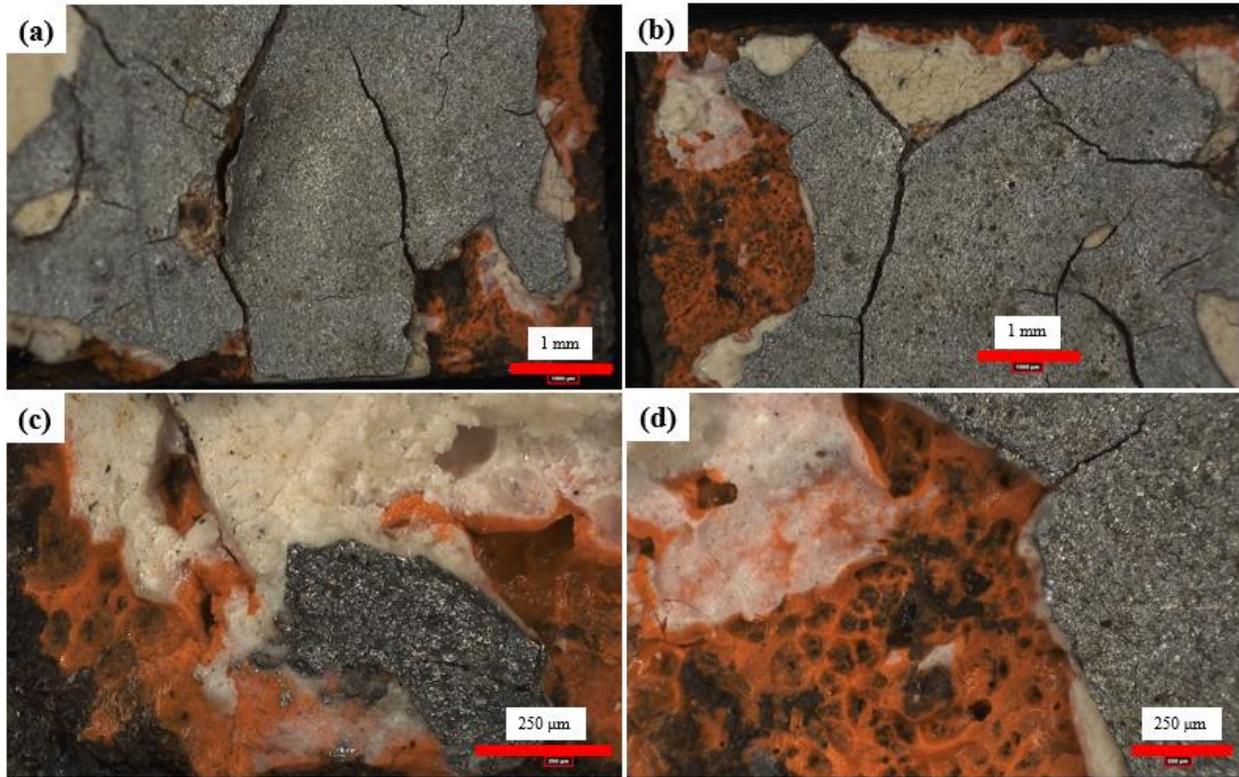
*Figure 4.29. Optical micrographs of the base metal surface, containing several layers of paint that were removed during LACR.*

It is apparent from optical microscopy that the top layer of paint is the silver or grey colored layer, the layer below that is white colored, and that the base coat is a bright orange color. Aside from the colors of the paint, other characteristics such as the texture can be observed. The top grey paint has cracks continuously running throughout the surface, likely due to aging and exposure to sunlight over the decades of use that these bridge beams have been through. The white colored paint has a "mineral", rocky, look, as does the orange base coat that seems to mix, or adhere more strongly to the adjacent white paint than the top coat does. By direct comparison of these optical micrographs with EDS maps collected in the SEM, this leads to easy identification of each paint layer by composition. Figure 4.30 shows optical micrographs along with EDS maps of the same surface location in order to identify paint compositions. (More EDS maps are shown in appendix A3).

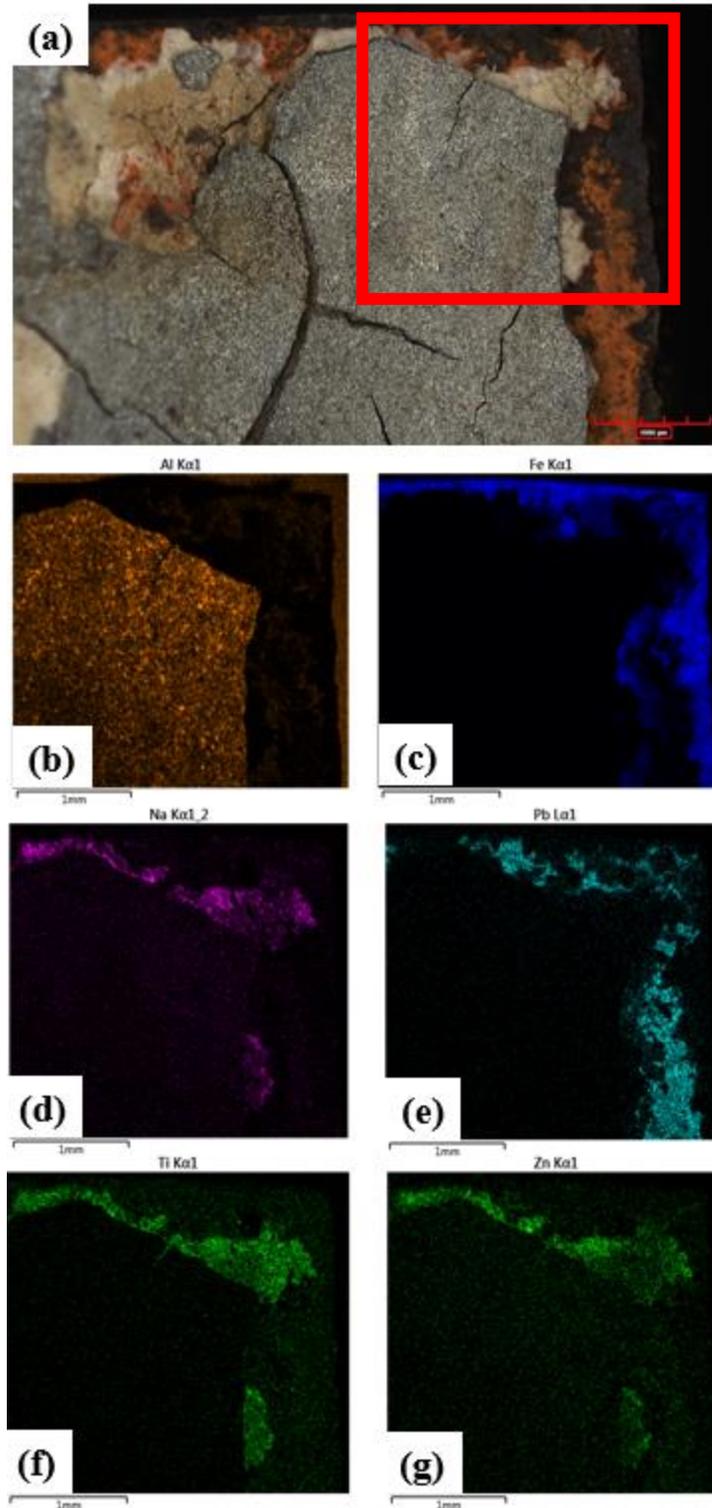
Figure 4.30. A red box over the optical micrograph (a), shows the region mapped in EDS. The elements in each map are as follows: (b): Al (c): Fe (d): Na (e): Pb (f): Ti (g): Zn. All scale bars = 1 mm. (Appendix A3).

From EDS analysis each layer can distinctly be identified. The top paint layer is clearly high in aluminum content, the second white colored layer is high in both zinc and titanium, whereas the base orange paint coat contains lead. Analyzing base metal samples still containing paint, the morphology of the paint constituents or pigments can be identified. For example figure 4.31 show EDS maps of a cross section of the top most, aluminum, paint layer. It is clear that the aluminum is concentrated in round disc-like shapes, and because this is a cross sectional view, it provides a side cut viewing angle of these aluminum flakes. A common top coat of paint is aluminum flake paint, containing flakes of aluminum, which is likely the type of paint that was used as a top coat in this bridge coating system.

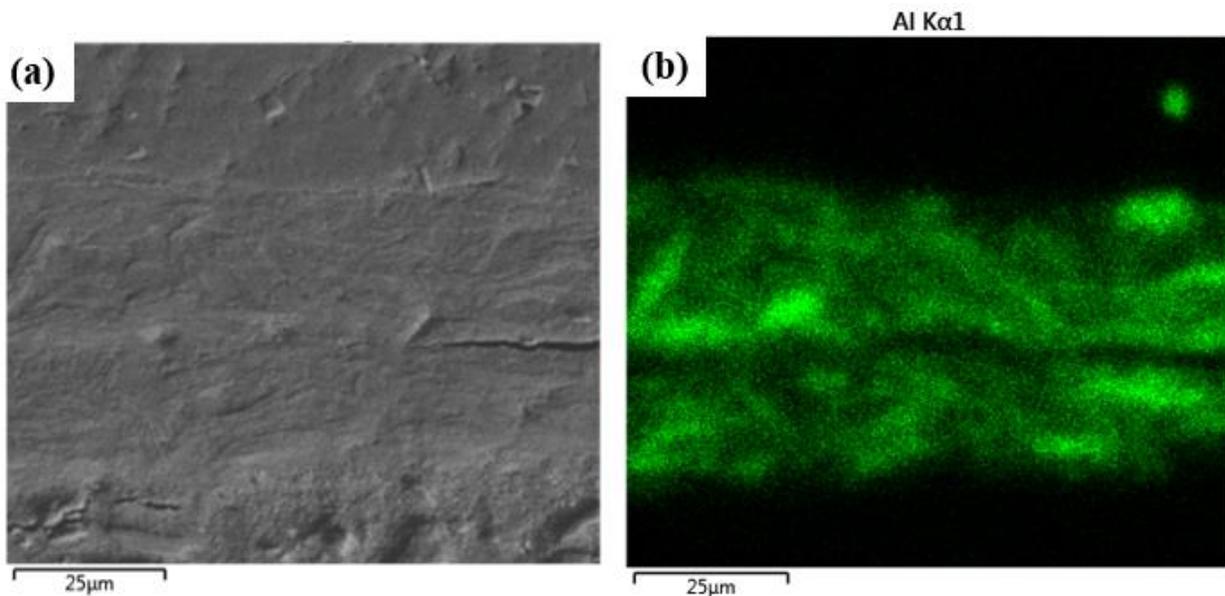
*Figure 4.31. (a) SEM micrograph of the area examined by EDS. Above the aluminum paint is the epoxy mold used to mount samples, and below is the white titanium and zinc layer. (b) The aluminum K-alpha one EDS map, showing the aluminum paint layer, especially highlighting the individual aluminum flakes within the paint.*

EDS has determined that the main elements constituting the paint are lead in the orange base layer, zinc and titanium in the white middle coat, and aluminum flakes in the top paint coat.

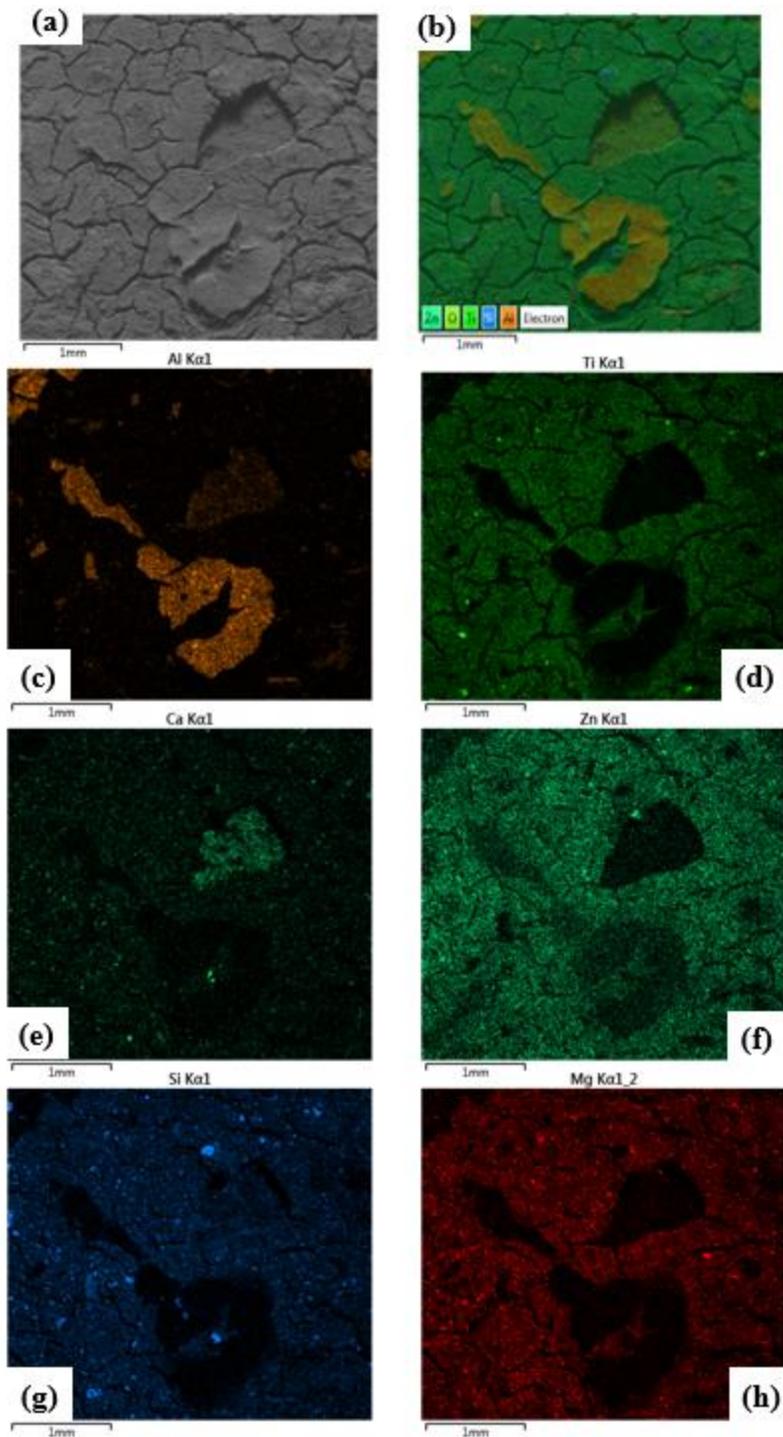
Figure 4.32. Paint EDS mapping not only confirms the composition of each paint layer, but also reveals the presence of specific concentrated signal points for some elements, such as Ti (d), Ca (e), Mg (f), Si (g), and Mg (h). Scale bar = 1 mm in each micrograph.

throughout the paint in smaller, or even trace amounts. These include elements such as silicon, magnesium, sodium, and calcium. Figure 4.32 shows another composition EDS map of an area with all three paint layers exposed. Again, it is obvious that the top layer of paint is aluminum, followed by the white colored titanium and zinc paint, and then the base lead paint. However, these maps also reveal another feature of the paint, as seen on the silicon and magnesium maps, these are specific spots that shows localized high levels of specific elements, particularly titanium, calcium, silicon, and magnesium. Through higher magnification EDS analysis, the reasons for these elements presence is explained by the observation of pieces of inorganic minerals that are embedded within the paint. In figure 4.33 a higher magnification sequence of EDS maps shows one of these particles. Through EDS it is clear that this inorganic particle embedded in the paint consists of silicon, magnesium, and oxygen, and it's outline is clearly traced by the zinc and titanium paint matrix that surrounds it. These and other inorganic silicates are scattered throughout the white paint layer, and therefore explain the concentration of elements that are seen in the EDS maps of figure 4.31. This suggests that the second "white colored" layer of paint is a mineral silicate paint, a type of epoxy paint often used due to its hydrophobicity and great weathering properties. Due to the application at hand, bridge coating protection, it is logical that this type of paint was chosen as a component in the coating system.

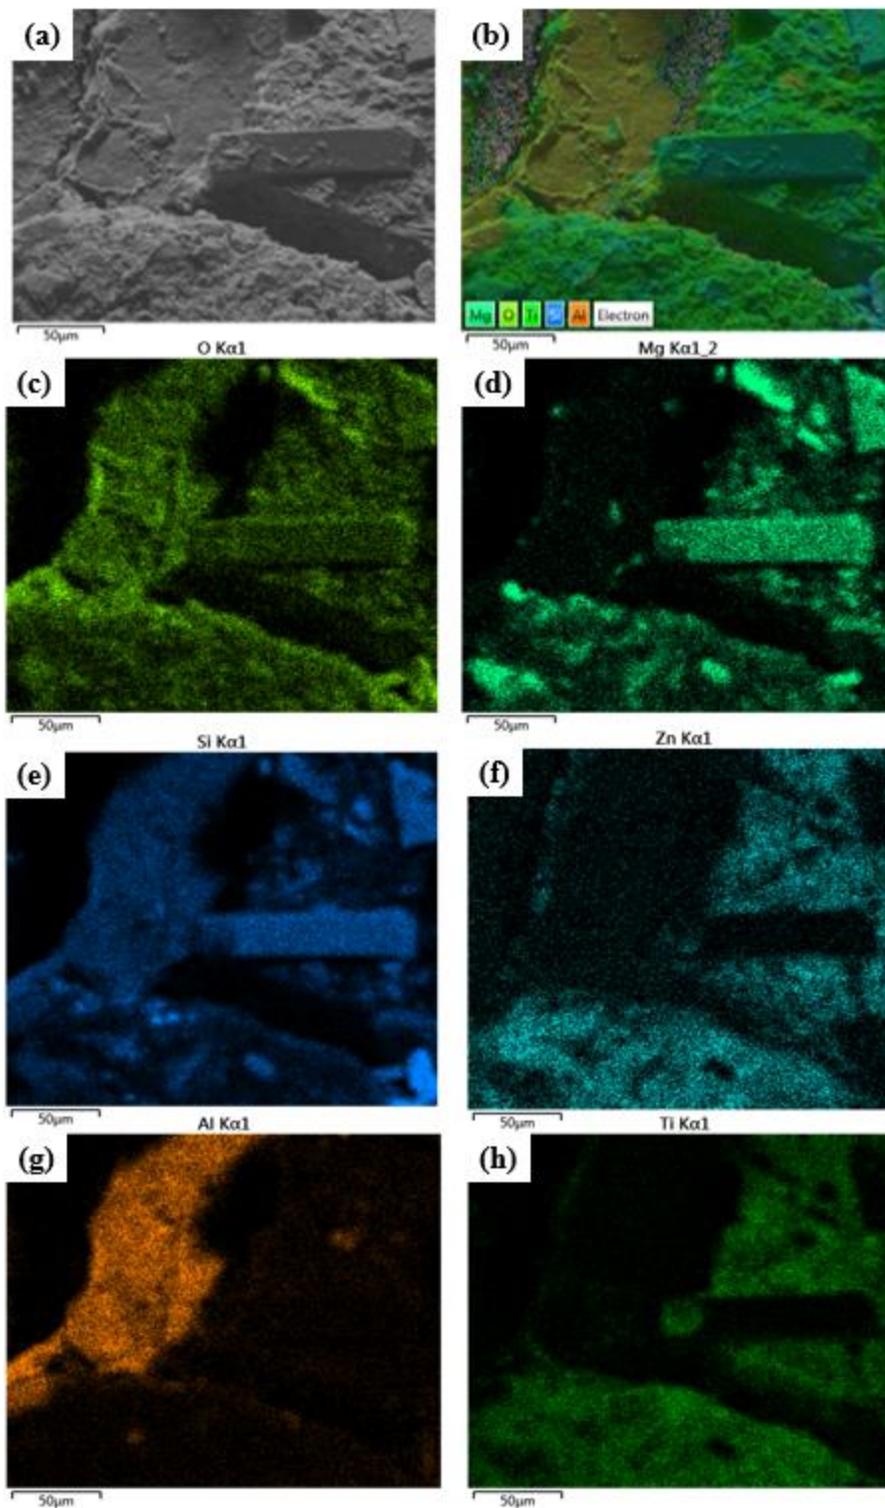
Figure 4.33. EDS maps detailing a piece of inorganic mineral that is embedded within the titanium and zinc paint. These are scattered throughout the paint and explain the highly concentrated elemental points seen in figure 31. Scale bars = 50 μm.

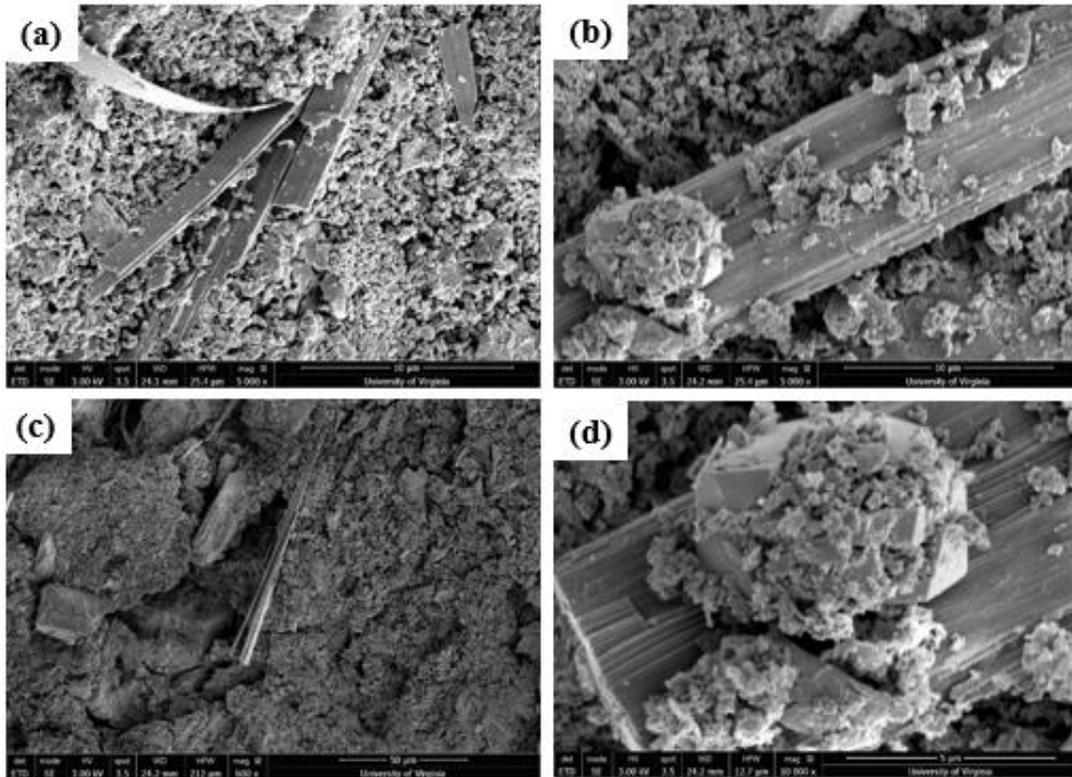
*Figure 4.34. Morphology of crystals that are scattered throughout the zinc/titanium paint.*

Apart from the large scale, macroscopic view of the paint, upon closer examination in the SEM these microscopic components can be observed. Figures 4.34, 4.35, 4.36, and 4.37, show examples of different particles that were found to exist within the white titanium and zinc paint layer. Figure 4.34 shows wooden “plank” like crystals that are scattered throughout the paint matrix, figure 4.35 shows particles with distinct crystal like morphologies, and figure 4.36 and 4.37 show SEM micrographs of spherical particles that were scattered throughout the white paint layer.

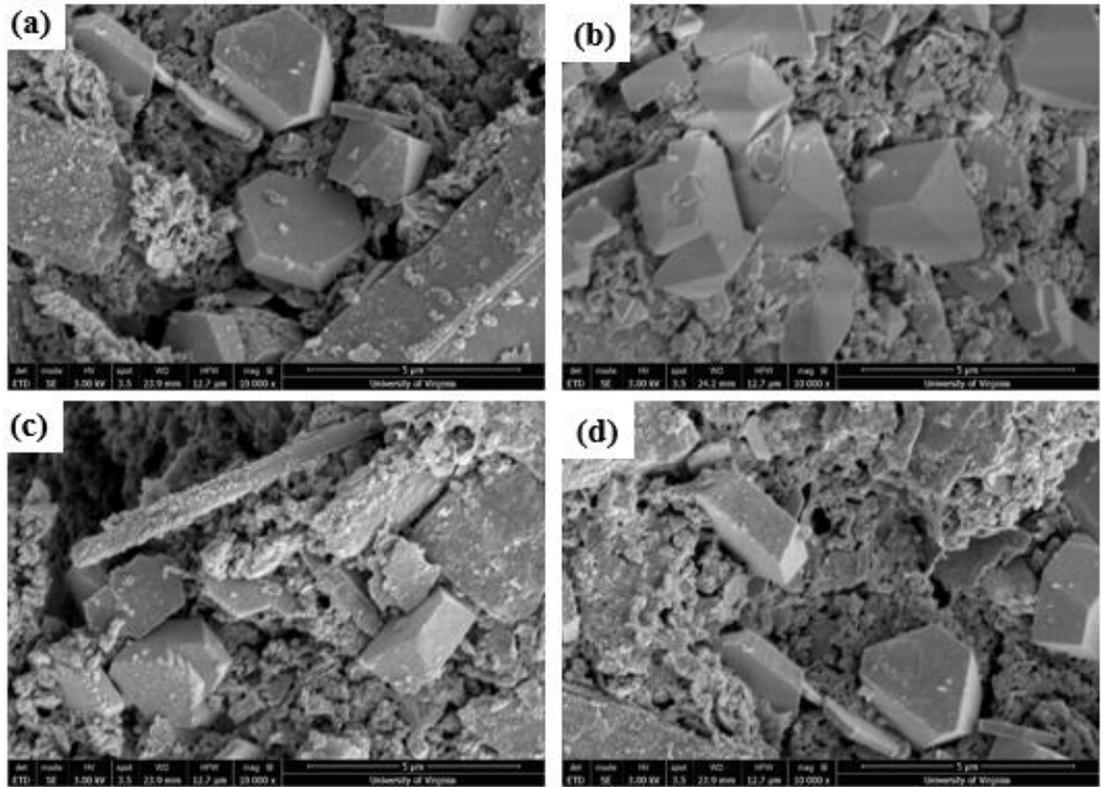
Figure 4.35. Various crystals that are present throughout the zinc/titanium paint.

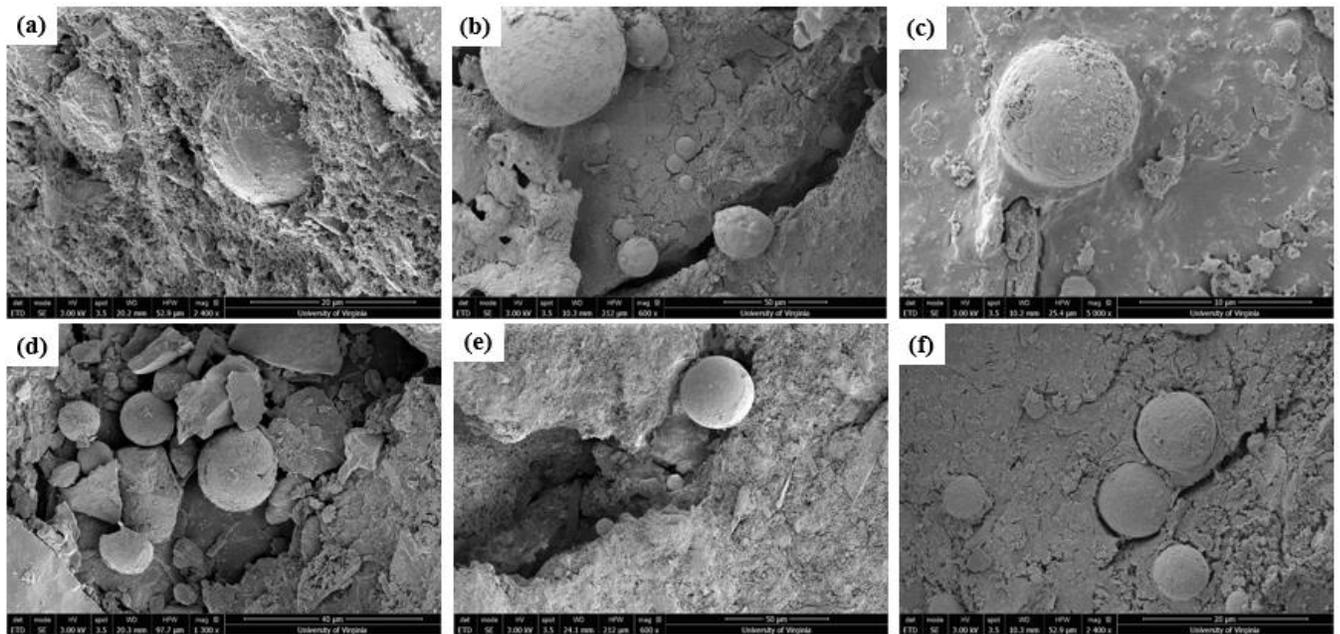
Figure 4.36. SEM micrographs of spherical particles found within the zinc and titanium paint.

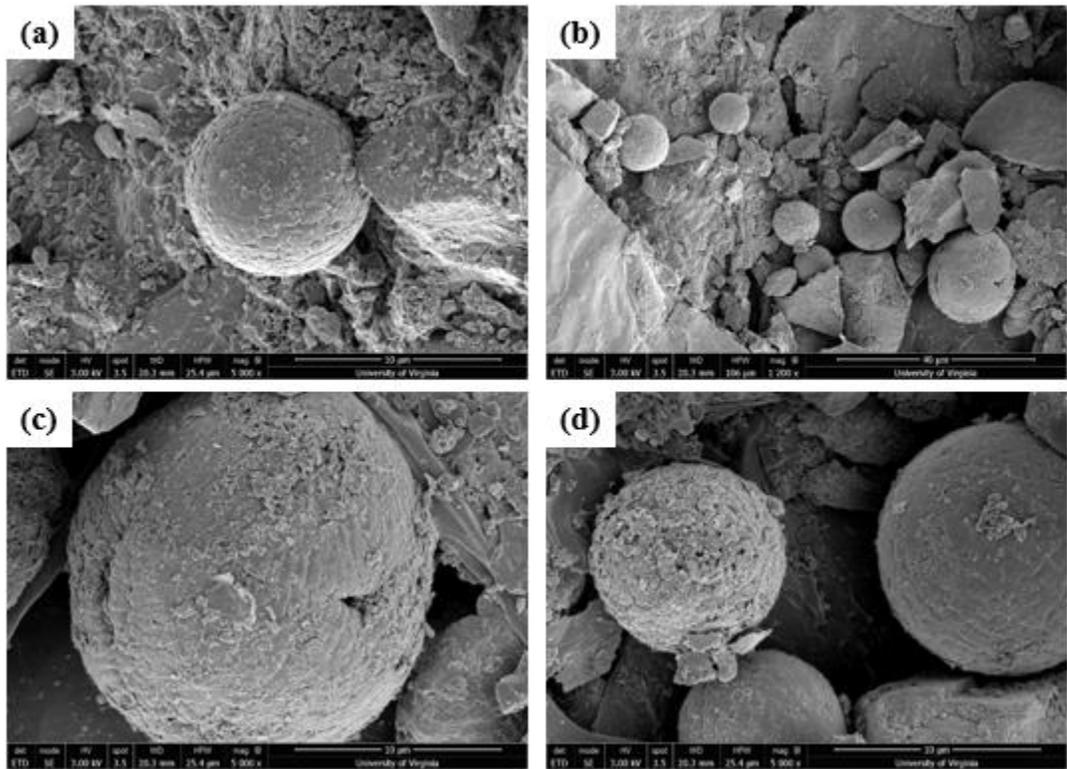
Figure 4.37. High magnification SEM micrographs of the spherical particles shown in figure 35.

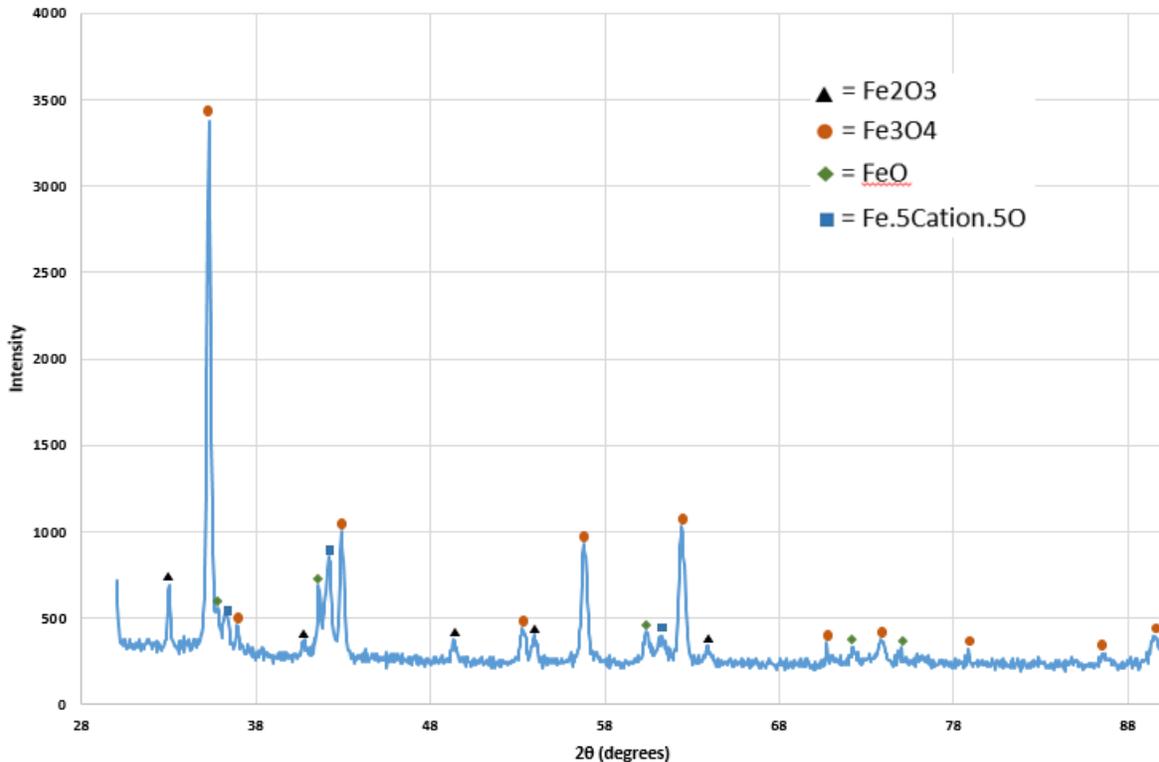
*Figure 4.38. X-ray diffraction scan of the LACR surface. Four different iron oxide phases were observed, as indicated in the plot.*

In addition to EDS and XRF compositional analysis, which showed that the laser cleaned surface is an iron oxide mill scale, or rust, x-ray diffraction (XRD) helped to confirm the presence of the iron oxide, as well as give insight to the various types of iron oxides present, which have different crystal structures. Figure 4.38 shows an XRD scan performed on the laser cleaned surface with the different iron oxide phases present.

XRD analysis shows that four different iron oxide phases were present, Fe<sub>2</sub>O<sub>3</sub>, Fe<sub>3</sub>O<sub>4</sub>, Fe<sub>2</sub>O, and a variation of the Fe<sub>2</sub>O phase in which half the iron cations are replaced with different cations, Fe<sub>0.5</sub>Cation<sub>0.5</sub>O. The cations that replace iron (II) may be a different size and therefore can distort the unit cell, thereby causing a slight shift in the peak positions. The precise identity of the cation was not identified, however it could possibly be a transition metal element that was introduced to the molten oxide from the paint during laser irradiation.
