# **IMPLEMENTATION OF LASER ABLATION COATING REMOVAL TECHNIQUE FOR STEEL COMPONENTS ON VDOT BRIDGES**

A Thesis

Master of Science in Material Science and Engineering

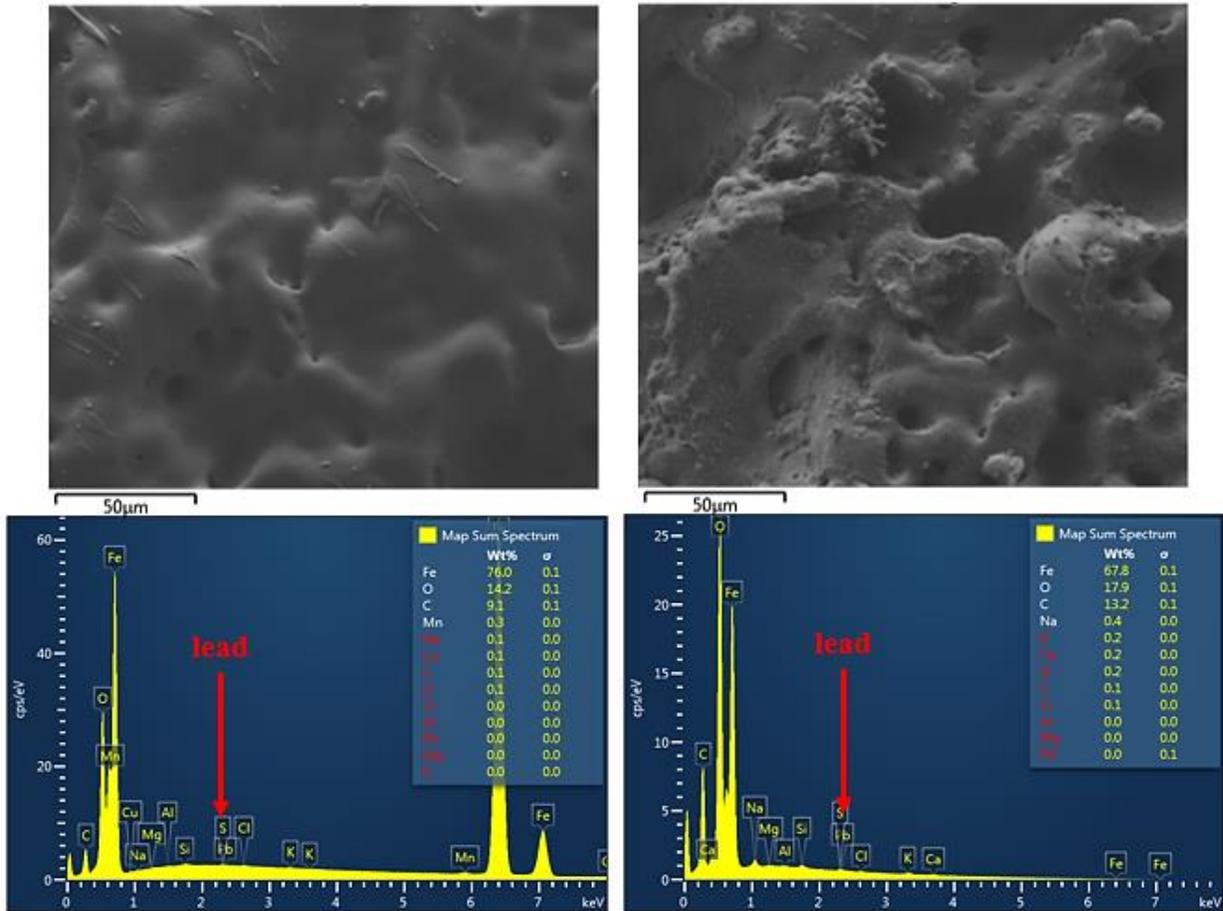
Figure 4.39 (i). SEM micrographs of two different surface areas of the LACR cleaned surface. In both regions Fe, O, and C predominate the composition of the surface, with the remaining elements only present in trace amounts.

Regarding lead, the element under investigation, lead consistently appeared in EDS analysis, however only in trace amounts. In fact, computer EDS data analysis consistently placed lead at the bottom of the list of trace elements, (shown in red on the EDS spectra composition list), suggesting that while lead is present, it is only scattered throughout the surface in very small amounts. This agrees with the results of the lead wipe tests and prior chemical analysis performed by the VDOT contracted company, Marine Chemist Service. While lead definitely

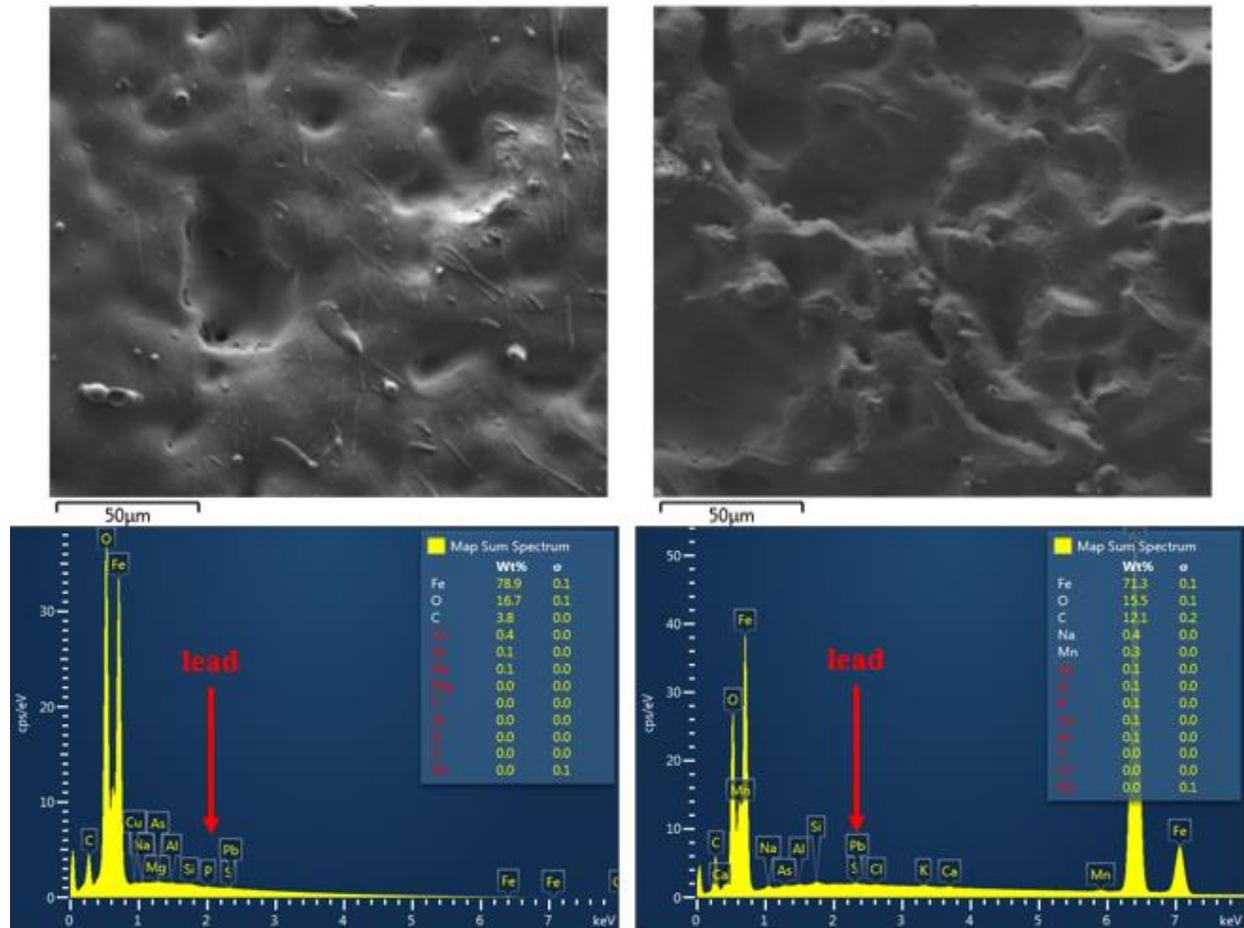
Figure 4.40 (ii). Two more surface areas that were selected for EDS analysis. Again, lead is only present in very small amounts.

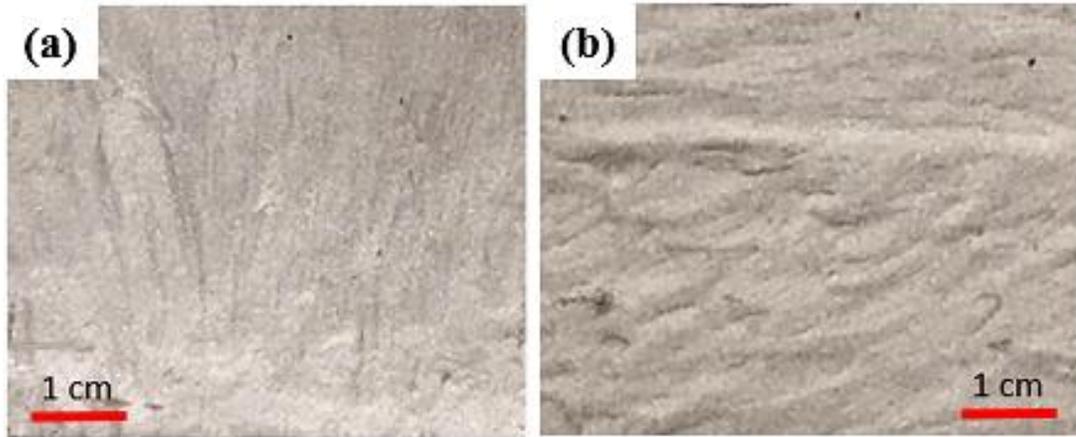
Figure 4.41. (a): thinner smoother paint, (b) thick, rough paint surface texture.

Using the PATTI adhesion testing device, the adhesion of repainted epoxy paint on laser cleaned beams was assessed. As could be roughly observed macroscopically, the reapplied paint appeared to vary in roughness and therefore thickness, across different repainted beams and within beams themselves. Beams with a heavily applied paint coating left brush strokes easily visible, whereas thinner coatings seemed to be smoother. Figure 4.41 shows macroscopic photographs of these two different paint conditions.

Upon testing these different painted regions, a course correlation between the paint thickness and the adhesion strength of the paint was observed, with a higher coating adhesion for thicker, rougher paint areas. For thin paint coat areas the average pull off tensile strength was determined to be 1721 psi, as opposed to 2094 psi for the thicker regions. These values were determined by averaging the pull off tensile strength recorded for over 50 pull tests for each paint condition.

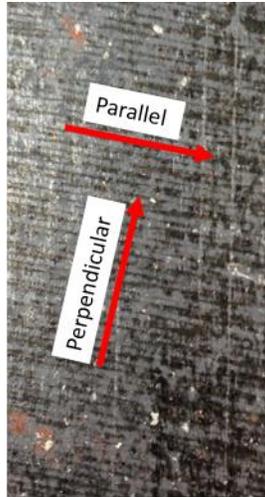
*Figure 4.42. Profilometry measurements that were recorded in parallel and perpendicular directions to the laser tracks.*

Using a surface profilometer, the surface roughness of different processed surfaces was investigated. The biggest variable for surface roughness was the grit blasted surface condition versus the laser cleaned surface. Besides the difference in processing condition, for the laser cleaned surface there are laser tracks present from the laser surface interaction. In order to determine if these tracks were associated with any roughness of the surface, profilometry measurements were taken both parallel and perpendicular to the tracks, as shown in figure 4.42.

As expected, the gritblasted surface had a rougher profile, with an average roughness value of  $9.86\ \mu\text{m}$ . Both laser cleaned surface measurements had lower average roughness values, of  $5.41\ \mu\text{m}$  and  $5.26\ \mu\text{m}$  for the profiles perpendicular and parallel to the laser tracks respectively.

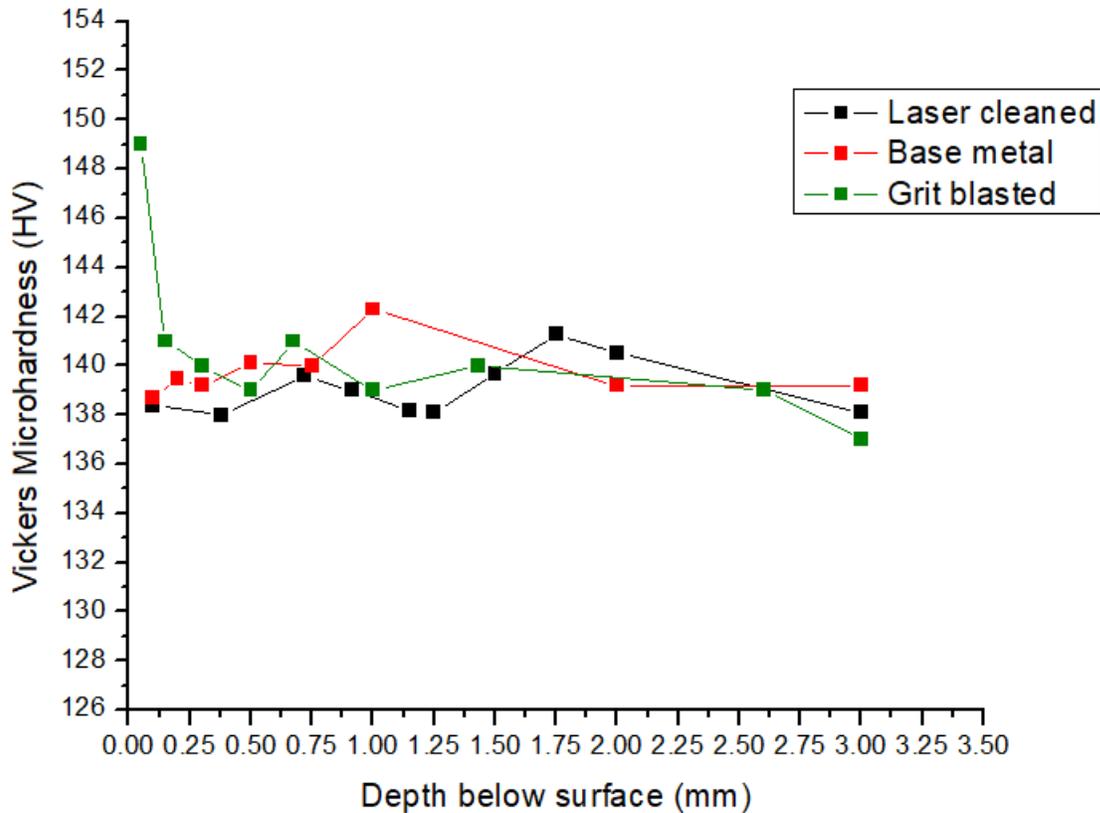
Figure 4.43. Hardness profile of all three processing conditions from the surface into the bulk of the material.

Vickers hardness tests were performed on samples in the as-received, grit blasted and laser-cleaned conditions. The focus of hardness testing was to determine whether there was any effect on the hardness of the steel due to laser cleaning, and to compare the hardness of laser cleaned samples with the hardness of the grit blasted condition. Hardness was measured as a function of depth into the material from the processed surface, at roughly  $75\ \mu\text{m}$  intervals. Ten hardness measurements were made at each depth into the steel and averaged. Figure 4.43 shows the hardness results for the three different processing conditions. The base metal showed little variation in hardness with depth, with an average hardness of  $\sim 140\ \text{HV}$  were observed. Laser-cleaned metal also showed essentially no change in hardness with depth. At  $75\ \mu\text{m}$  below the surface a Vickers hardness of about  $139\ \text{HV}$  is seen, and three millimeters into the metal, roughly

in the middle of the entire beam cross section, the hardness is measured to be 138 HV. The highest value of hardness is 141 HV at roughly 1.75 millimeters in the metal, whereas the lowest hardness measured is 138 at roughly 1.2 millimeters into the metal. This small range of hardness values shows how little variation in hardness is present in laser cleaned samples. Cross sectional analyses showed that the near surface region was heated and melted (to a depth of  $\sim 1 \mu\text{m}$ ), however the underlying metal seems to be unaffected by the heat. In contrast, grit blasted samples have a higher hardness near the surface (149 HV), but the hardness quickly drops off and reaches the values observed in the base metal, and nearly constant into the middle of the cross section. At 75  $\mu\text{m}$  below the surface in the grit blasted samples the hardness is 149 HV, and quickly drops to 140 HV within 0.25 millimeters into the steel. The elevated hardness at the surface is due to the deformation imparted by the grit blasting.

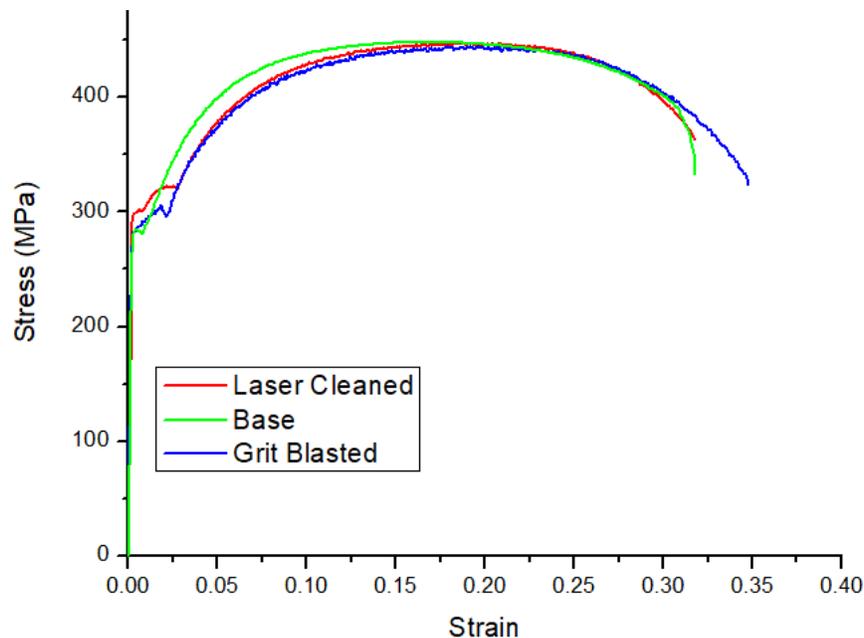
*Figure 4.44. Stress strain curves for base, grit blasted, and laser cleaned metal.*

Tensile testing was completed on base metal, grit blasted, and laser cleaned samples to determine the effects of different processing conditions on the strength of the metal. It was shown that laser cleaning had negligible effects on the strength, as all three processing conditions showed the same yield and ultimate tensile strength of 280 MPa and 440 MPa, respectively, which matches the mechanical properties of A36 steel which has a minimum yield strength of 275 MPa and an UTS ranging from 400-550 MPa.<sup>46</sup> No appreciable differences in the ductility were observed either, with all samples falling between 30% and 40% elongation vs. the minimum value of 23% for A36. (Figure 4.44).

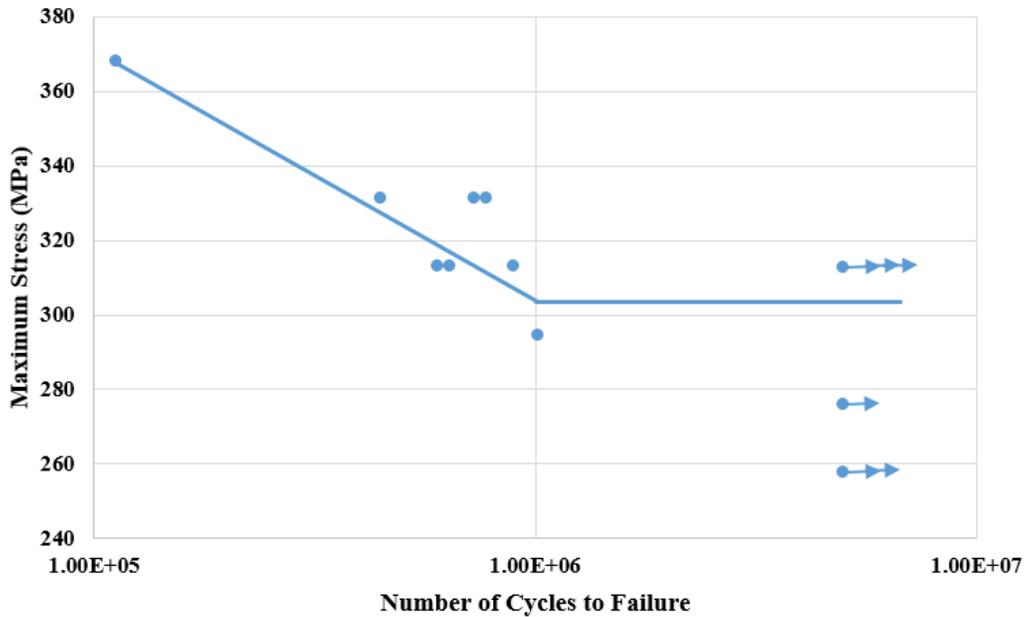
Figure 4.45. SN curve for LACR fatigue samples. Arrows on points at  $5 \times 10^6$  represent run out tests. The blue line provides a guide for the eye through the data.

tests from phase I were also used in fatigue testing. Using a pull-pull set up in which the sample is always in tension, with a fatigue ratio,  $R$ , of 0.1, and 10 Hz frequency, the fatigue tests were run with a maximum stress ranging from 258 to 368 MPa, to fill out a SN curve. Figure 4.45 shows a fatigue SN curve for the fatigue tests.

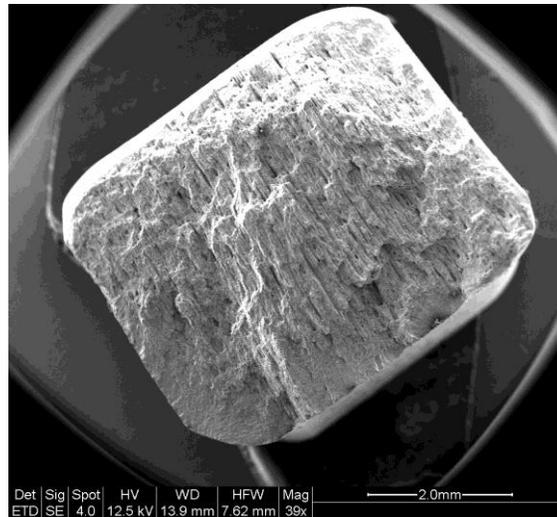
*Figure 4.46. Fracture surface of a specimen stressed at the yield strength of the material.*

The first dog bone sample that was tested used a maximum stress of 368 MPa, where the dog bone broke within a relatively short amount of cycles, roughly 122,000. Figure 4.46 shows the fracture surface of this sample.

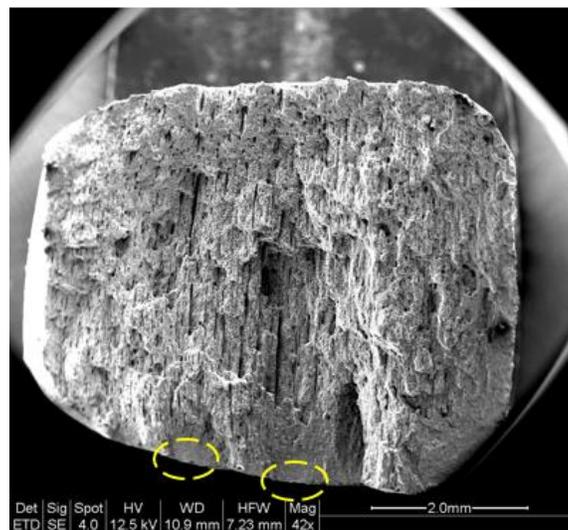
*Figure 4.47. Fatigue surface of the sample fatigued at the yield strength of steel. Crack initiation sites are marked in yellow.*

On this sample, two crack initiation sites were observed, which grew and eventually caused failure. In figure 4.47, the initiation sites are marked in yellow and the crack growth regions can be seen radiating outward from these spots.

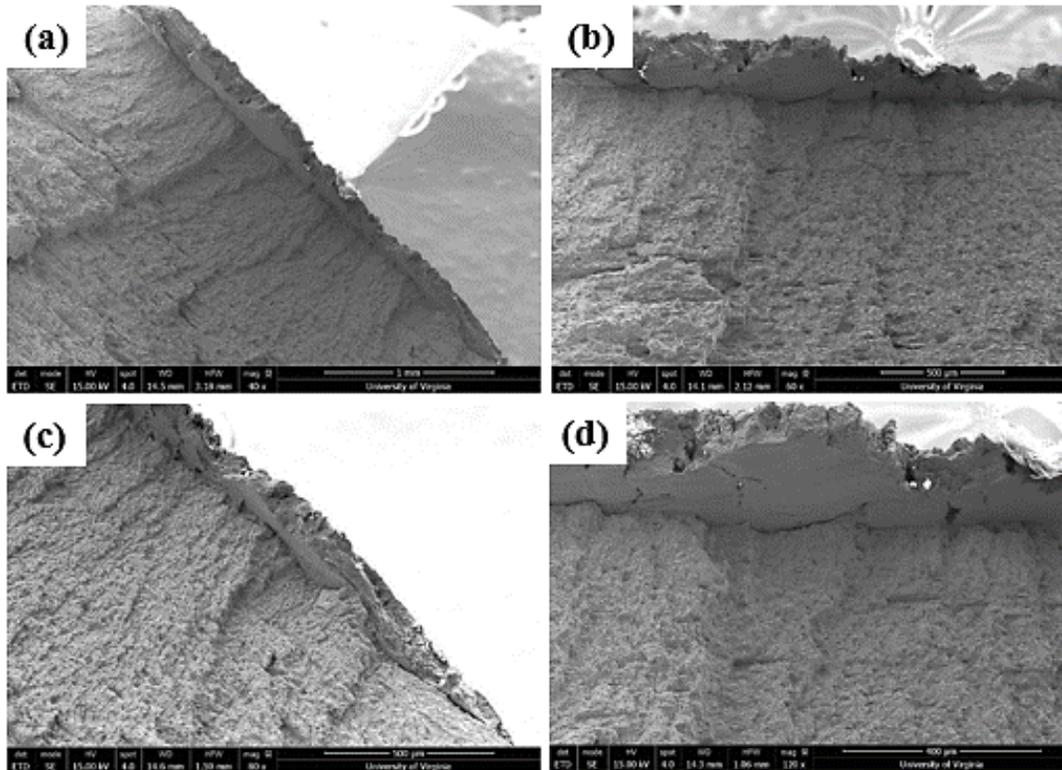
*Figure 48. The exposed oxide layer left on one of the fracture surfaces of the sample that failed at 1,000,000 cycles.*

After this initial test, the maximum stress was decreased to 295 MPa. For this sample, which ran for approximately 1,000,000 cycles, the oxide layer debonded from the steel and left the layer

exposed on one of the fracture surfaces. Figure 4.48 shows SEM micrographs of the fractured surface and the exposed oxide layer that was left remaining on one of the fracture surfaces.

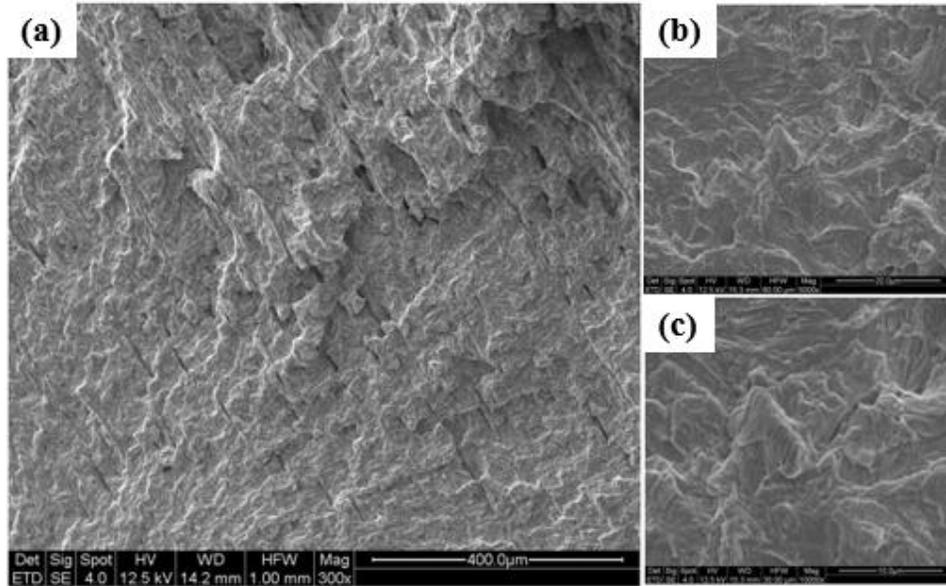
Figure 49. Representative SEM micrograph of the crack growth surface on LACR fatigue samples. a.) 300x, b.) 1000x, c.) 10,000x.

The region of crack propagation and growth appeared similar on all the fatigue samples, figure 49 shows a representative micrograph of the crack growth surface. Fatigue crack growth striations can be observed at higher magnifications.

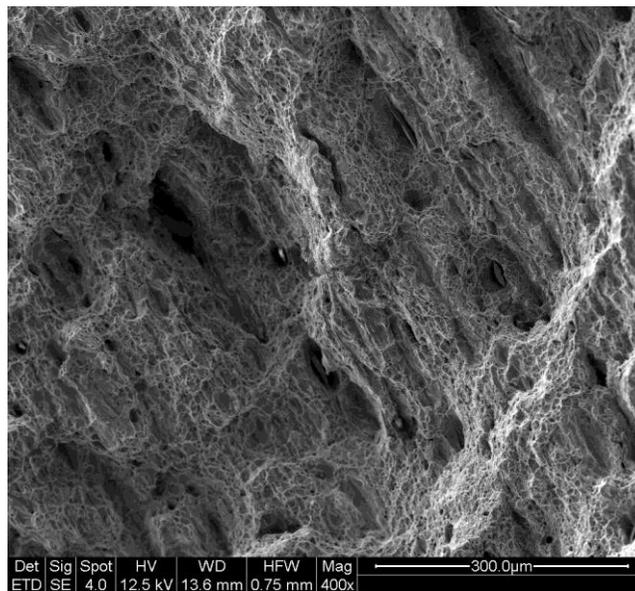
Figure 50. Ductile fracture surface showing the debonding between intermetallic particles and the steel matrix.

All of the samples also exhibited debonding between the steel matrix and intermetallic MnS particles embedded into the steel matrix. Figure 50 shows the ductile fracture surface of the 368 MPa sample, where crevices of varying depth were observed surrounding the intermetallic particles.

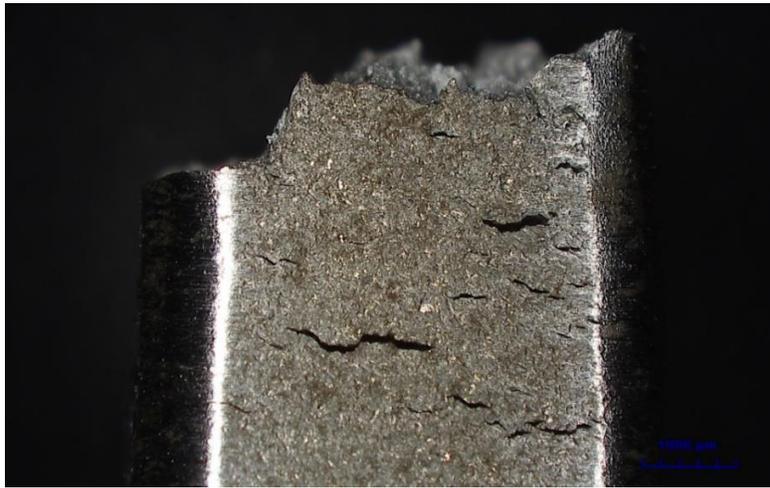
*Figure 51. Secondary cracks observed on the outside surface near the final point of failure.*

In addition to the fracture surface itself, observations were made on the outer surface of the fracture samples. Secondary cracks were observed on both sides of the final fracture of the dog bone samples. Figure 51 shows secondary cracks that could be seen near the final fracture of the 368 MPa maximum stress fatigued dog bone.

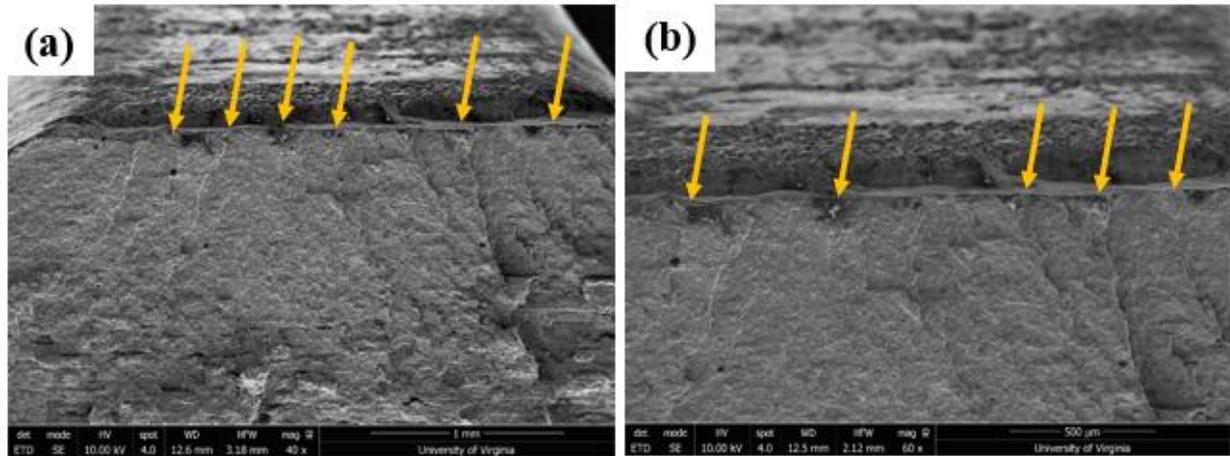
Figure 52. (a) Direct view of the crack propagation from the iron oxide surface layer through to the bulk material showing the interaction of the crack growth with the inclusions. (b) Higher magnification micrograph of (a). Yellow arrows indicates regions below the iron oxide surface where cracks appear to have initiated.

Looking directly at the fracture surface provides a different angle of the crack growth and debonding of the steel inclusions from the matrix. Figure 52 is a SEM micrograph of the fatigue surface as viewed from this angle. In these micrographs the traces of the aftermath of the crack can be seen radiating downward from the iron oxide layer, and splitting or changing direction once one of the intermetallic inclusions is reached.

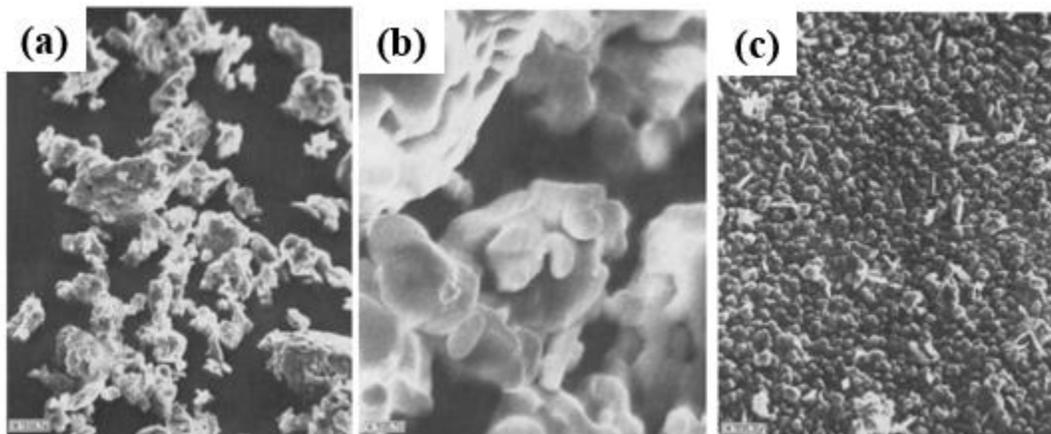
*Figure 5.1. SEM micrographs of  $Pb_3O_4$  (II, IV) oxide powder. a.) The dry powder at 2,400x magnification. b.) the dry powder at 12,000x magnification. c.) Lead oxide powder applied in solution to an iron cathode, magnification 2,400x.<sup>48</sup>*

Red lead paste is a simple mixture of the mixed valence  $Pb_3O_4$  (II, IV) oxide crushed powder and linseed oil, which is used as the organic binder to keep the powdered red lead pigment in suspension and make it spreadable for application. This paint mixture was made by crushing  $Pb_3O_4$  (II, IV) oxide powders to smaller particle sizes and then dispersing the thin powder into linseed oil, a mixture of fatty acids that were extracted from a flax plant and that had great binding and suspension properties for paints during this time.<sup>49-54</sup> Figure 5.1<sup>48</sup> shows SEM micrographs of the dry  $Pb_3O_4$  (II, IV) oxide powder as well as after it is applied as a slushy to an iron cathode.

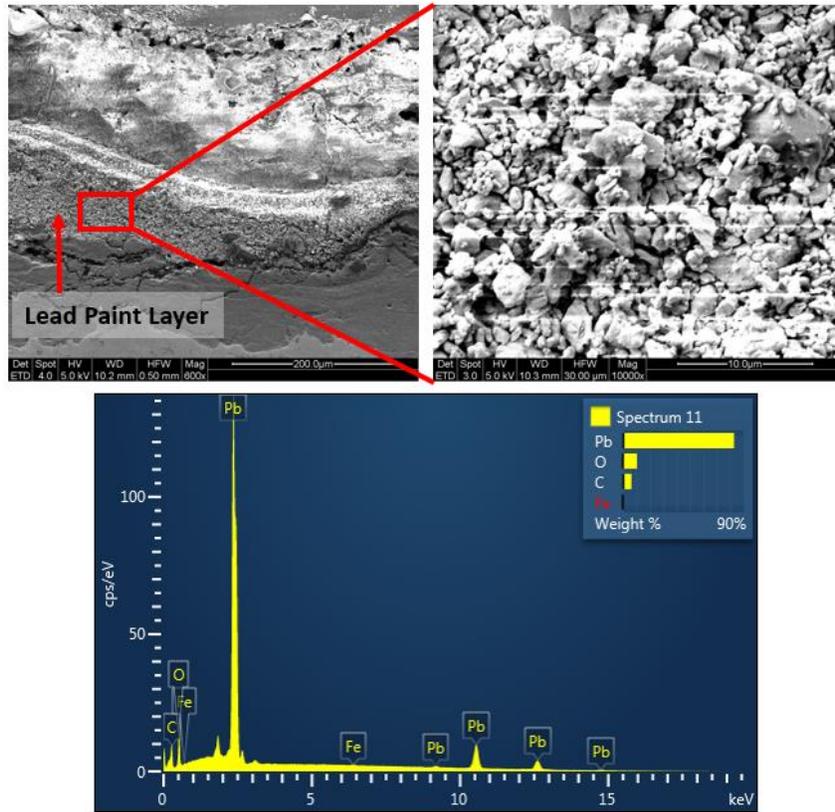
Figure 5.2. SEM micrographs show the details of the red base paint layer on the base sample cross sections. The variation in particle size is comparable to that seen in figure 5.1, where the particles are presumably the crushed  $Pb_3O_4$  (II, IV) oxide crystals used for the red lead paint. EDS confirms the presence of lead in the coating.

EDS analysis of base metal samples revealed that the base paint layer was high in lead and oxygen, and contained carbon as well, which correlates well with the composition of red lead paste due to the lead oxide and organic linseed oil that provided the binding and adhesiveness of the paste. (Figure 5.2). In addition the base paint layer has a bright orange-red color very similar to that of  $Pb_3O_4$  (II, IV) oxide. (Figure 5.3).

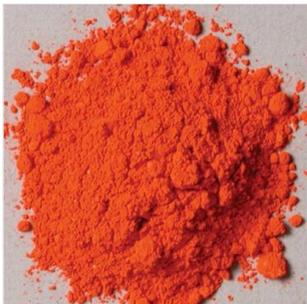
Figure 5.3. Macroscopic appearance of crushed  $Pb_3O_4$  (II, IV) oxide, the inorganic pigment used in the red leaded base coat of paint applied to the bridge beams.

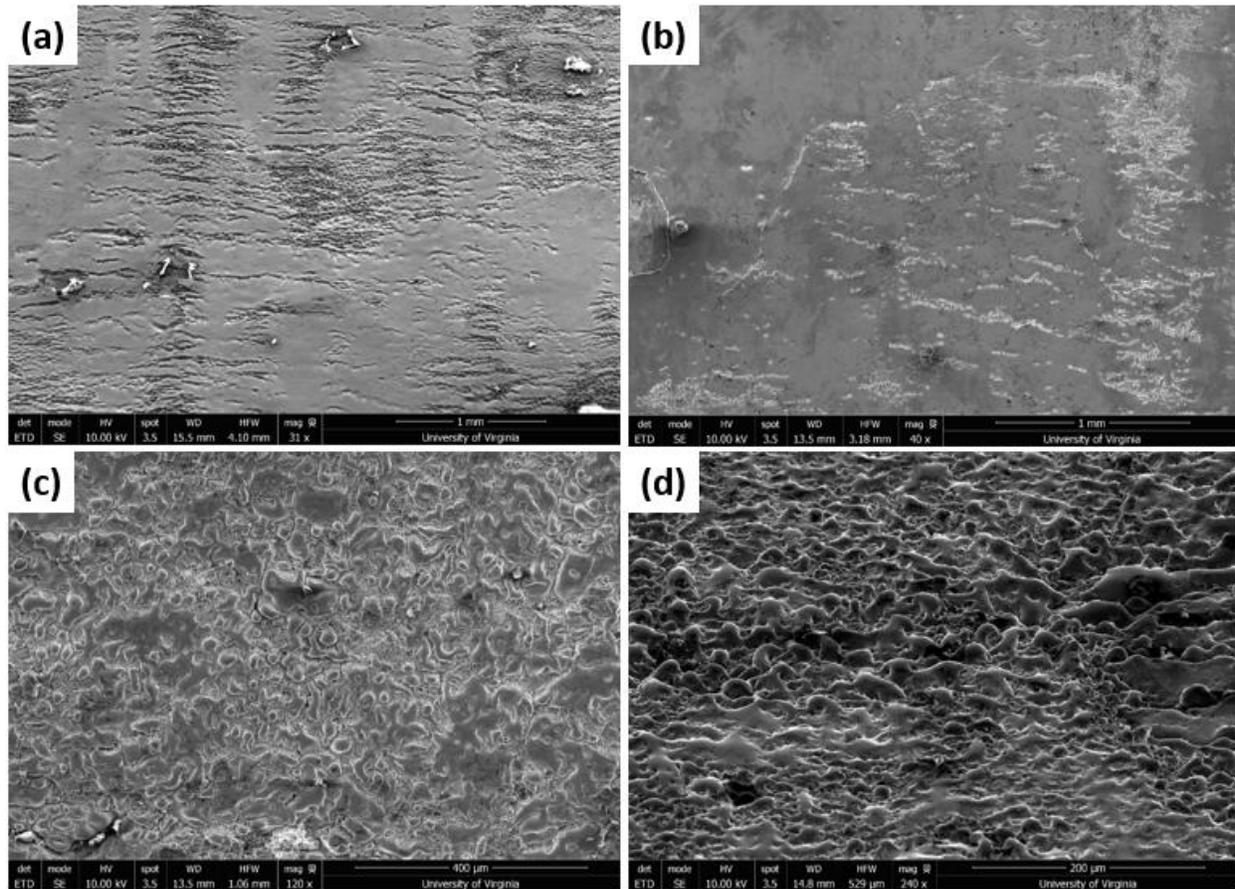
*Figure 5.4. Low magnification SEM micrographs showing the different types of surfaces left after LACR, and their distribution throughout the surface. (a). A relatively even distribution of the flat surface and the rough surface topology. (b). An area that predominately consists of the flat surface, with a few rougher regions present. (c). A top down view of the rougher surface region. (d). a tilted side view of the rougher surface region.*

In the results, the different surface features after LACR were briefly introduced. These mostly consisted of the smoother “reflective areas” and the rougher, darker, or less reflective areas which were distributed across the surface. These observations were attributed to the difference in surface topology as seen in the SEM, and further SEM analysis helps to reveal more detail about the LACR surface. In figure 5.4, SEM micrographs show the distribution between these two different surfaces. In figure 5.4 (a), there is an even amount of rough surface area to smoother surface area, and these two regions are both evenly spread over the surface. This is in contrast to (b), in which a large area of the surface in the micrograph is the flat and reflective type, with relatively very little area consisting of the rougher surface profile. This exemplifies how the distribution of these two surface profiles varies over the entire LACR surface, and that large swaths of surface area can be dominated by the flatter or the rougher profiles. Figure 5.4 part (c)

and (d) show higher magnification images of the rougher surface profiles, from a top down view and at a high tilting angle respectively.

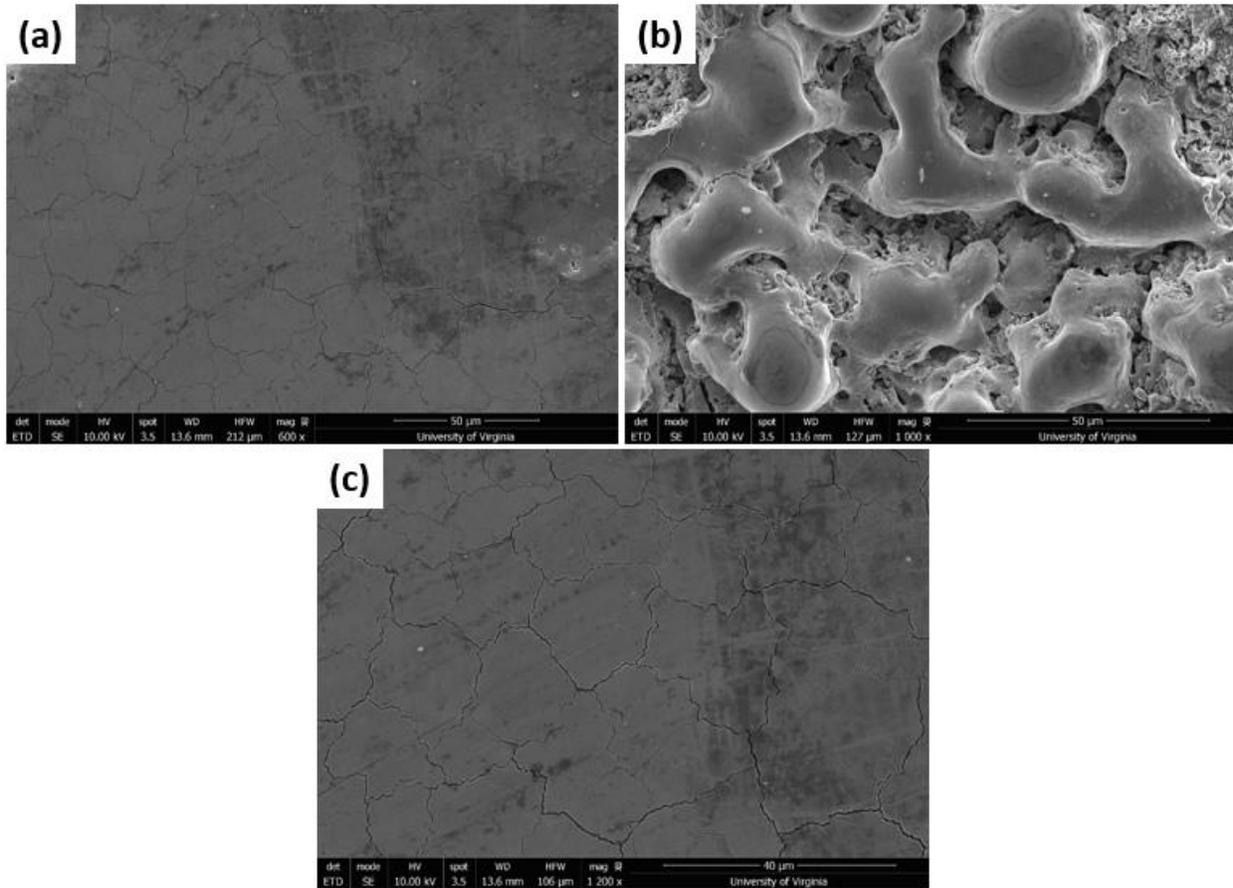
*Figure 5.5. A comparison between the flat surface regions and the rough surface regions. In (a) and (b) both scale bars are 50 μm and allows direct comparison between the scale of the rough surface features compared to the flat surface. (c) shows the flatter surface at higher magnification, where the mud cracks can be easily seen.*

Figure 5 shows how the rougher area contains raised areas, with valleys in between these peaks, giving rise to the roughness of the surface. The scale bars in part (a) and (b) are the same, and this gives a sense for how the rough surface compares to the bright reflective smooth surface, which is very flat in this particular area. Also apparent from these images are the “mud” cracks that are present throughout the LACR surface. They are even present on the rougher areas,

however they are more difficult to see due to the peaks and valleys of the raised and lowered surface compared to the flat surface of the smoother areas.

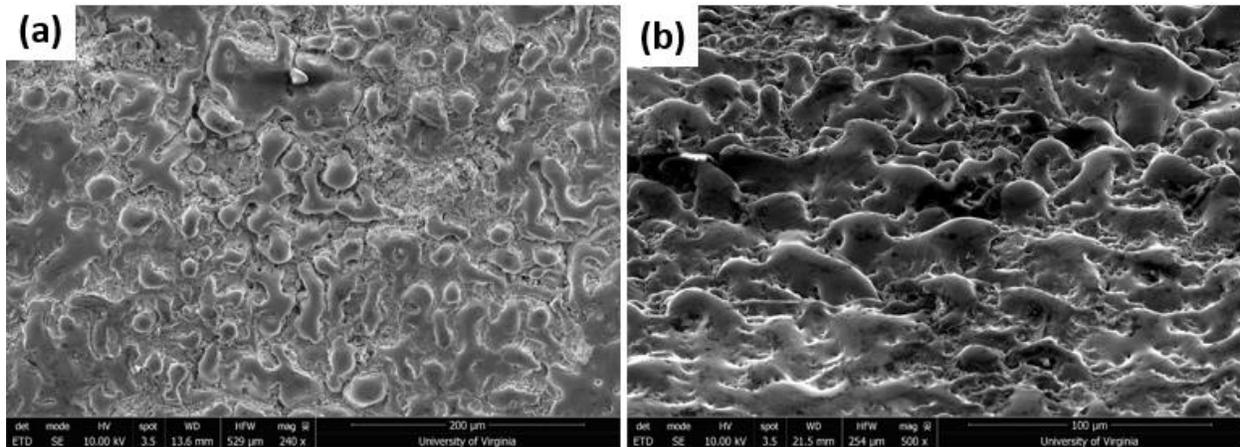
*Figure 5.6. (a) A Top-down view allows views of the valleys in the rough regions of the surface, as well as gives an idea for the area taken up by the peaks compared to the area filled by the valleys. (b) A tilted SEM view gives a side profile of the rough region where the smooth surface of the peaks is visible and the rough tortuous valley are hidden from view.*

Figure 5.6 (a) shows another top down view of this surface, whereas figure 5.6 (b) shows a profile view from a tilted angle. When viewed directly downward the detailed feature of the valleys can be seen whereas from a side view the smoother sides and tops of the peaks are the focus of the image. The tops and sides of the peaks are smooth in appearance whereas the valleys are much rougher and tortuous.

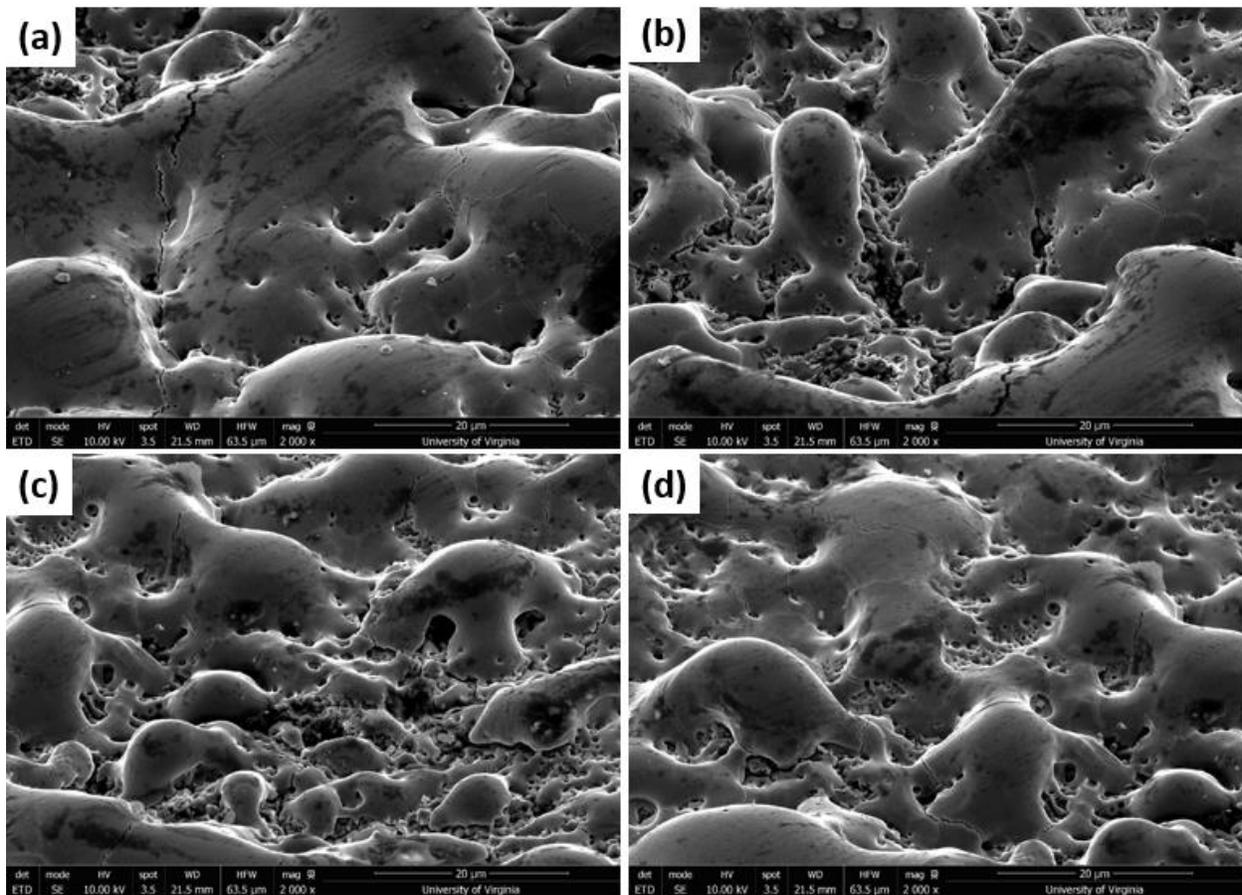
*Figure 5.7. SEM micrographs of the tilted sample at high angles ( $\sim 55^\circ$ ). Tilting allows a better visualization of the heights between the peaks and valleys that are not discernable from top down perspectives. Comparing (a) and (c) shows the difference between areas containing more of the smooth “peak” like surface compared to surface with more of the tortuous rough “valley” like appearance of the surface. (b) and (d) show the range of distances observed between the peak to valley heights.*

Figure 5.7 shows higher magnification SEM micrographs from a tilted view of the same rough surface region. The variability of the surface topology at this length scale becomes obvious once viewed from this tilted angle. In some spots the surface is smoother and rounded, as in figure 5.7 (a), however in others it is rougher and the peaks are not as well defined, as seen in figure 5.7 (c). Figure 5.7 parts (b) and (d) also contrast the difference in height between the valleys and peaks within this overall rougher region of the surface, where in (b) the peaks are relatively high from the surrounding valleys compared to peak to valley distance in (d).

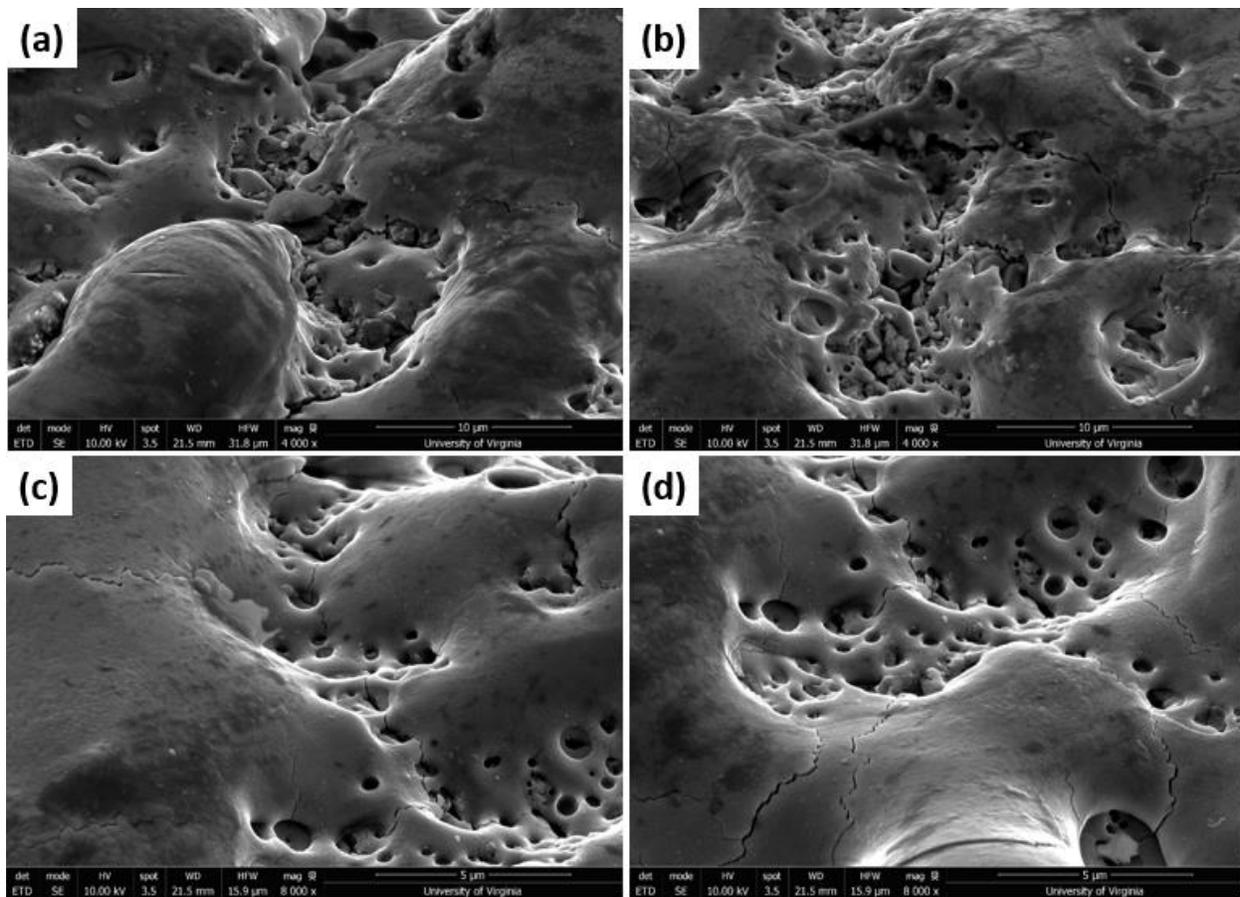
*Figure 5.8. Holes are observed in the valleys of the rougher regions, however they are not as commonly seen on the tops of the peaks. Also in (c) and (d), the mud cracks can be seen on the surface, across the valleys and peaks in this region.*

At higher magnifications tiny (roughly  $0.5 - 3.0 \mu\text{m}$ ) holes are seen in the valleys, however not on the peaks of the rough LACR surface regions, (figure 5.8). Also, the cracks in the surface can still be seen in these images.

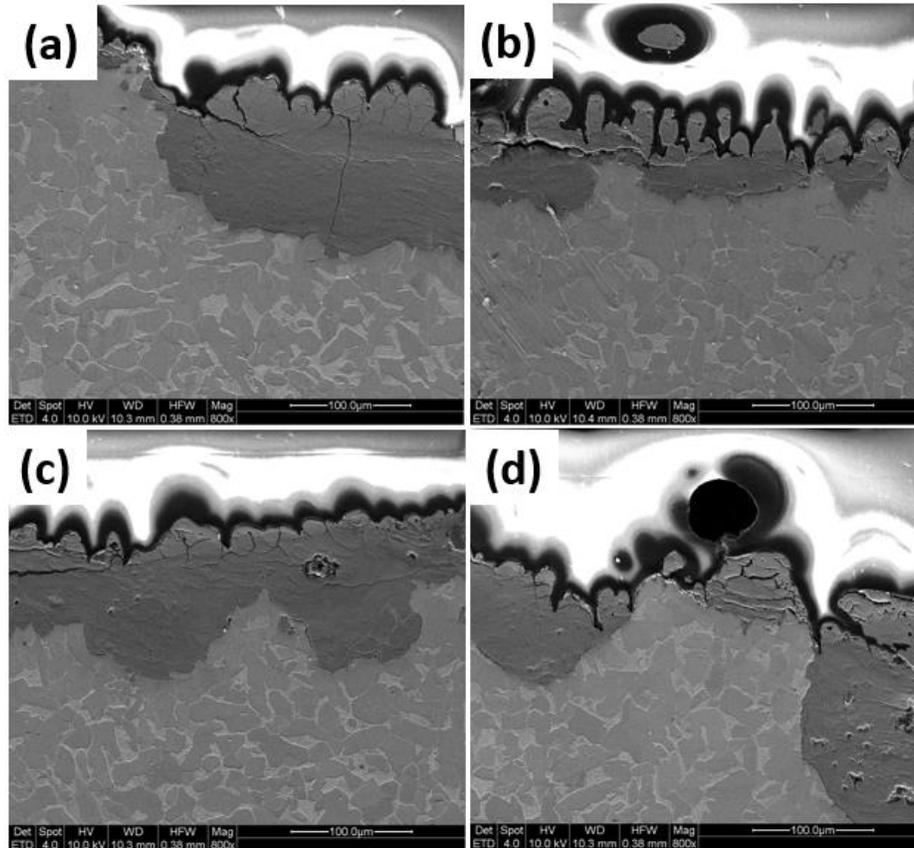
*Figure 5.9. Cross sectional SEM micrographs of LACR sample surfaces showing the variation in the oxide layer surface throughout one of the rough surface regions. (a) The oxide surface peaks are relatively spaced out compared to (b), where they are very close together and have large peak to valley distances. In (c) and (d), cross sections show how the peaks can be smaller in some areas and that the oxide layer is not always continuous across the entire surface, respectively.*

Multiple cross sections of the LACR samples helped to study the iron oxide layer that was left on the surface after LACR treatment. Cross sections helped also reveal the two different surface topologies, the smooth and the rough regions. In the rough surface regions, cross sections show a tumultuous surface where the peaks and valleys that were observed on the surface are now presented as cross sections. As seen on the surface, there is a variation in the shape of these features, as shown in figure 5.9. It can be noted that the spacing and height of these peaks is different from one area to another, matching the observations from surface microscopy.

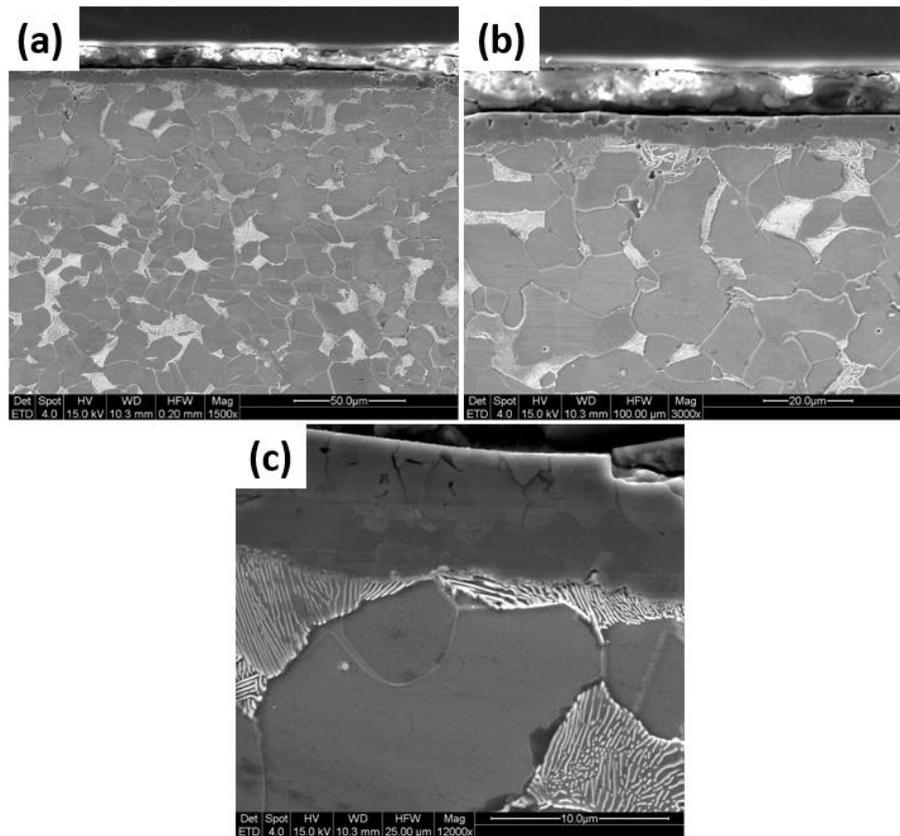
*Figure 5.10. SEM micrographs of LACR sample cross sections. (a) Showing the flat oxide surface corresponding to the reflective flat LACR surface regions. (b) higher magnification of (a). (c) High magnification SEM showing that the steel microstructure is unaltered all the way up to the oxide surface layer.*

In contrast, the smooth reflective parts of the LACR surface are much flatter in cross section as expected. As shown in figure 5.10, the microstructure of the underlying steel seems to be unaffected up to the iron oxide surface layer as evidenced by the unaltered pearlite ferrite grains right up to the oxide.

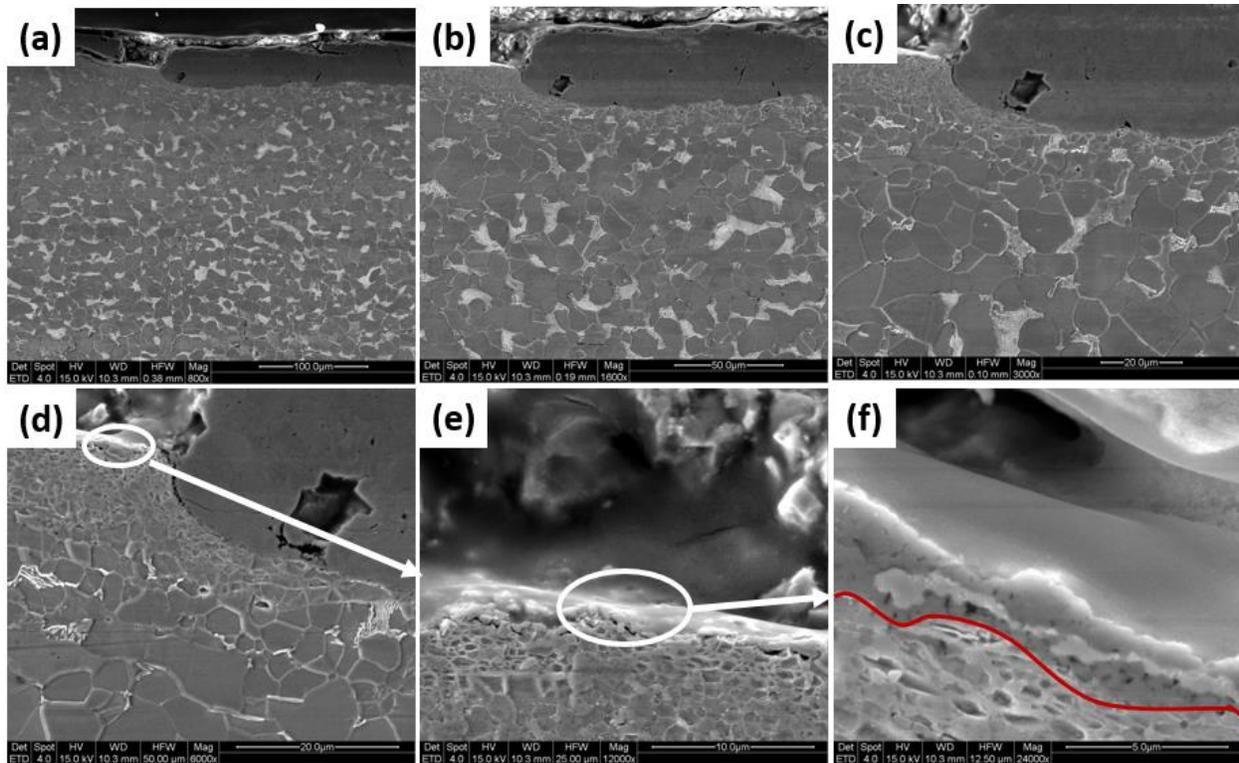
*Figure 5.11. SEM micrographs of a LACR sample cross section showing the effects of laser damage directly on exposed steel adjacent to the iron oxide surface layer. (a), (b), (c), Successively higher magnification micrographs showing the effect of laser heat on the near surface steel compared to the bulk microstructure. (d), (e), (f), Higher magnification micrographs showing the surface region that was affected by the laser heat, outlined specifically in red in (f).*

As already mentioned, the iron oxide layer across the steel surface is not continuous at every point, and in some places exposes the steel directly to the laser beam. In these regions there is an effect on the surface that alters the appearance of the near surface region of the metal, along with the microstructure further into the steel. In figure 5.11, an exposed part of the steel adjacent to an end of the iron oxide is seen in cross section, revealing the effect of the laser on the metal. At lower magnifications, the decrease in grain size compared to the bulk material can be seen, and at higher magnifications the near surface region that was affected by the direct laser light is outlined in red.
