# **IMPLEMENTATION OF LASER ABLATION COATING REMOVAL TECHNIQUE FOR STEEL COMPONENTS ON VDOT BRIDGES**

A Thesis

Master of Science in Material Science and Engineering

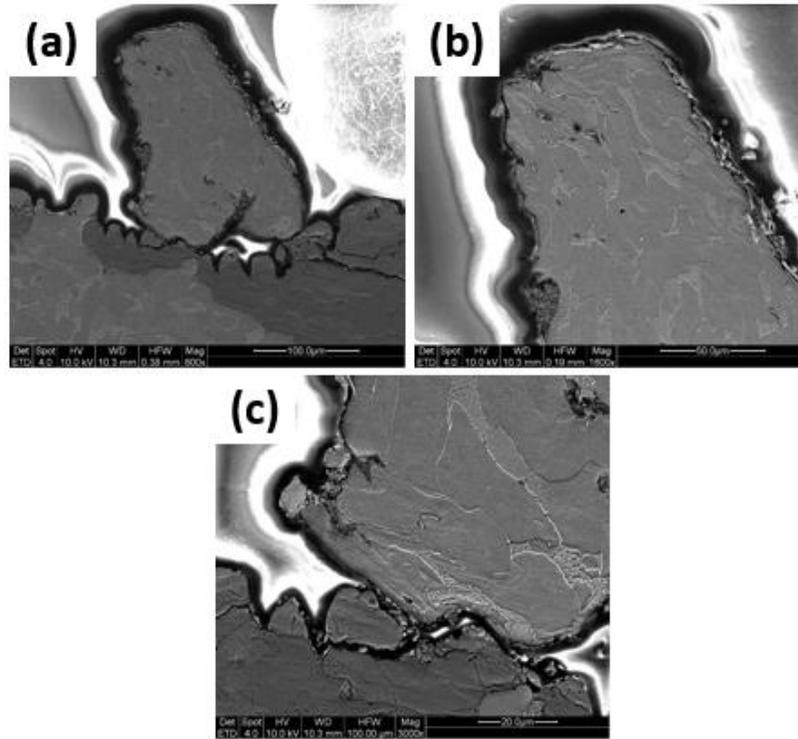
*Figure 5.12. A chipped piece of steel laying on top of the surface of the laser cleaned steel. (a), the full view of the chipped steel particle. (b) The top portion of the chip, (c) and bottom where the chip interfaces with the iron oxide surface layer.*

Throughout the surface of the laser cleaned steel, there are chips and surface scratches that change the surface topology and roughness, mostly due to the initial rough surface of the I-beams before undergoing LACR. Figure 5.12 shows a piece of steel that is lying on top of the oxide layer, confirmed to be steel by the microstructure. Because this piece of steel is outside the bulk I-beam material, the microstructure is different than that of the bulk steel, as seen in the micrographs. For example there is no indication of a texture due to hot rolling, and the size distribution of ferrite grains and pearlite is much different from that of the bulk steel. This may be due to multiple factors such as deformation of the metal if scraping is what caused it to pull

away from bulk material, or even that it was exposed to more heat energy from the laser beam due to the fact that more surface area is exposed compared to the steel underneath the surface.

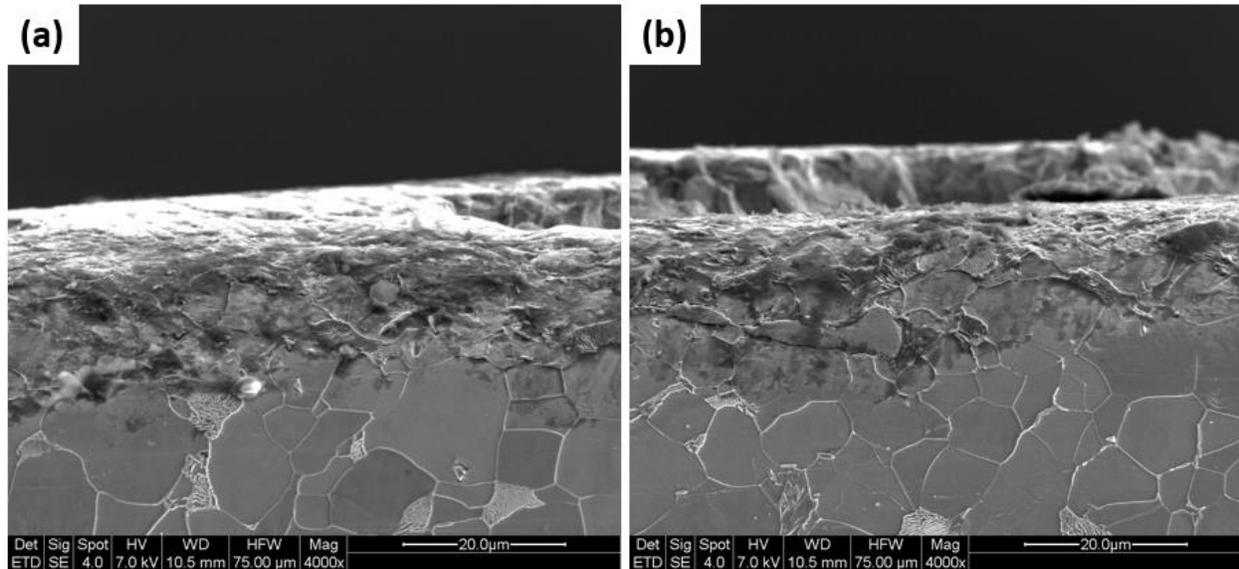
*Figure 5.13. Rounded polished edges on cross sectional samples show the transition from steel to iron oxide. Also both (a) and (b) shows the roughness of the iron oxide surfaces.*

In addition, cross sections with rounded edges between the steel and the iron oxide layer help to show the transition between the two materials. Figure 5.13 shows cross sections of laser cleaned samples with rounded edges at the transition between these two regions. These micrographs also show the roughness throughout the oxide layer. Towards the right side of 13a, a step in the oxide thickness can be seen, and in the in the background of 5.13b a similar step can be observed across the entire surface.

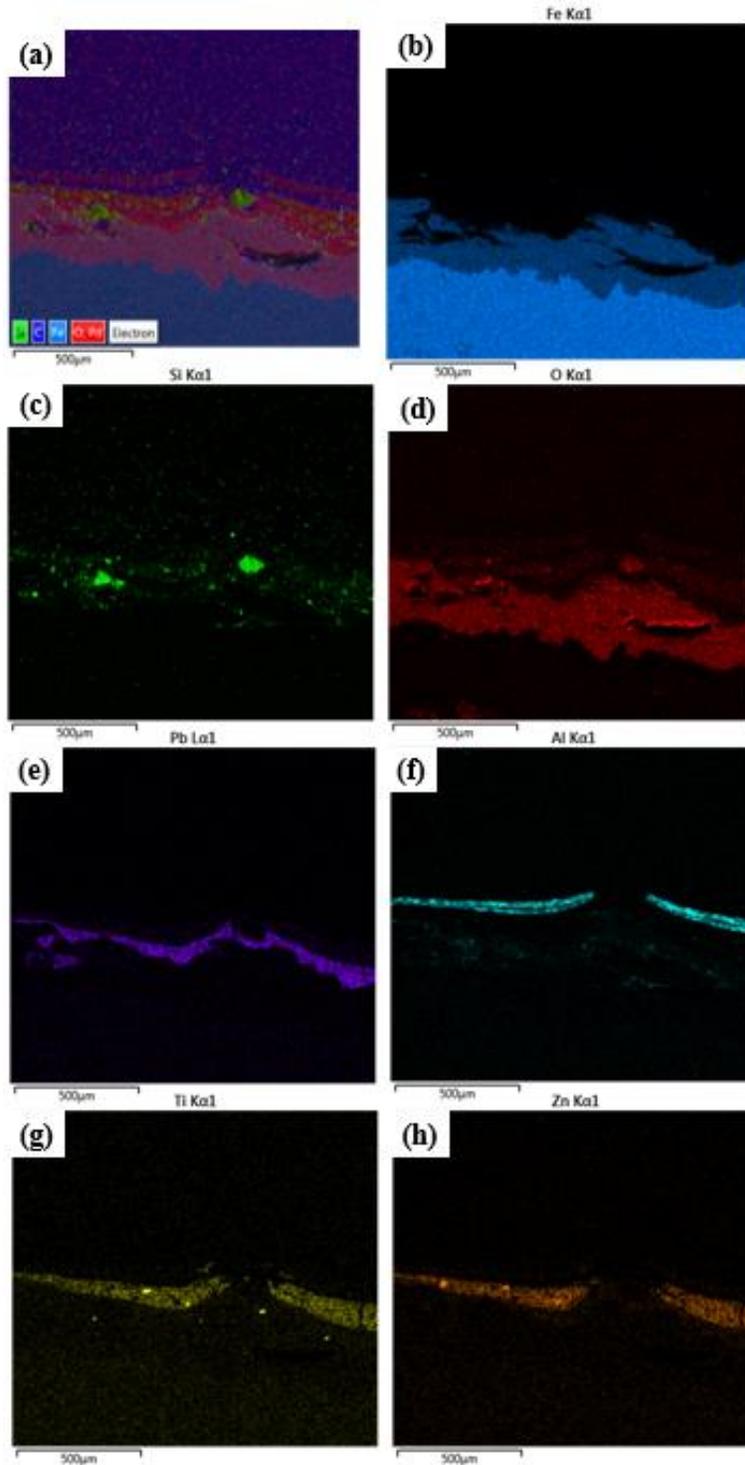
Figure 5.14. EDS maps of base metal cross sections. As described in the results, the base layer paint contains Pb (e), the middle layer Ti (g) and Zn (h), and the top paint coat consists of Al (f). The Fe (b) and O (d) maps also depict the oxide layer. Pieces of silicate minerals are observed in the silicon map (c), which are dispersed throughout the Ti and Zn paint layer.

In addition to SEM analysis of laser cleaned cross sections, EDS helped to confirm the cleanliness of the steel after LACR. By comparing cross section samples in EDS before and after laser cleaning, the removal of the paint is clear. Figure 5.14 shows EDS maps of a base metal sample in cross section showing each layer of paint. As explained in the results, the composition of each layer in cross section is consistent with what was observed using planar EDS maps of the paint surface, where a base paint layer of lead is covered with the white colored paint which contains both titanium and zinc, followed by a top layer of aluminum paint.

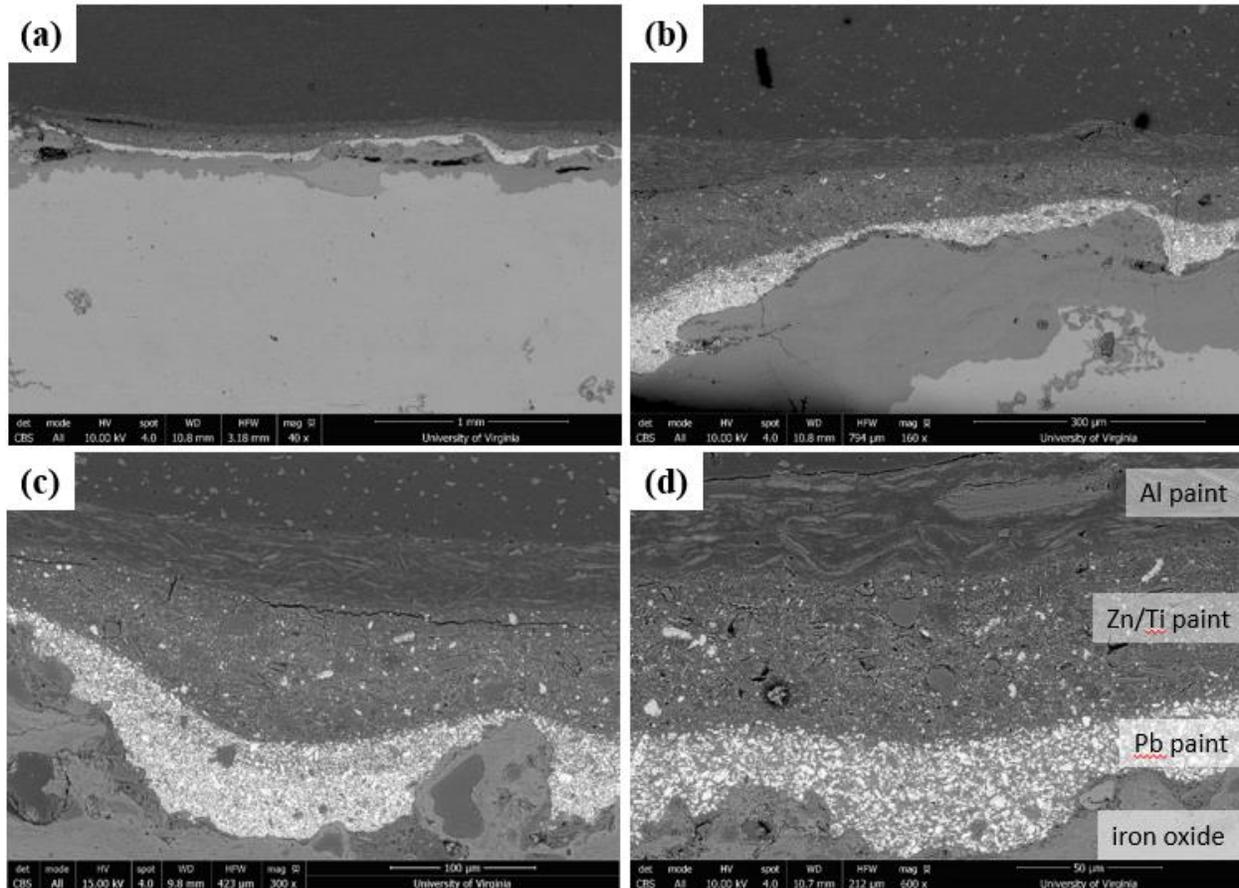
Figure 5.15. BSE micrographs of the paint and iron oxide layers on the base metal surface. (a) 40x magnification show a large scale size of the surface coatings compared to the bulk material. (b) 100x magnification. (c) and (d), showing the variation in coating thickness across the surface. The bottom layer is the iron oxide, followed by the lead paint, appearing brightest in BS imaging mode, zinc/titanium middle paint layer, and the aluminum flake paint top coat.

In addition to EDS maps of base metal paint cross sections, BSE micrographs provide another method of determining each layer apart from each other. Figure 5.15 shows BSE micrographs of cross sections prior to laser cleaning in increasing magnification.

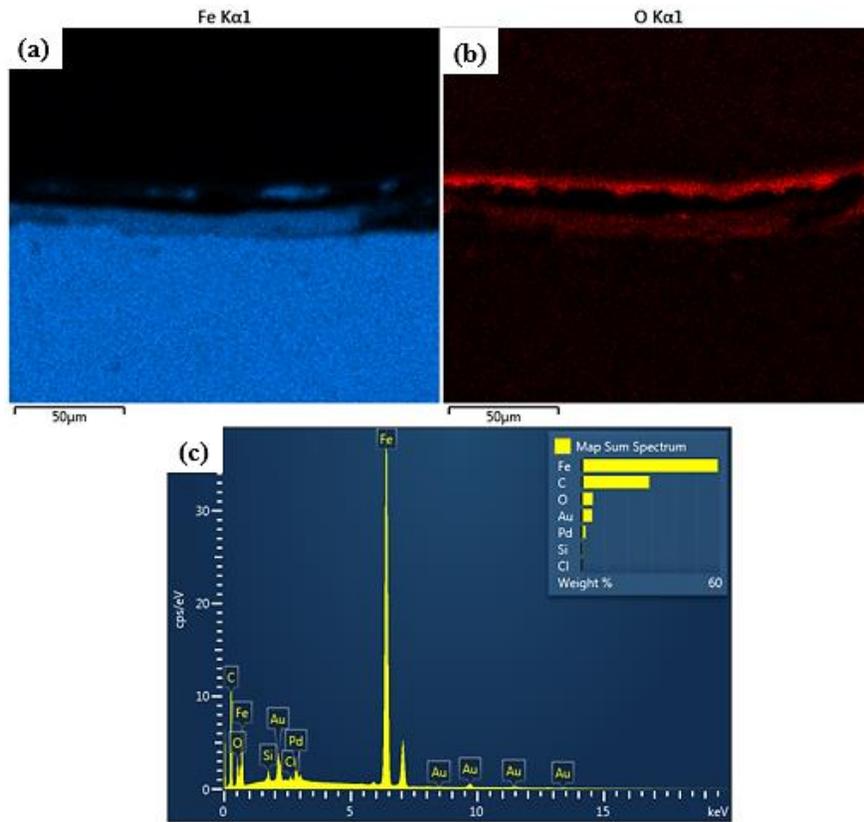
*Figure 5.16. EDS maps and spectrum for a laser cleaned sample cross section help to confirm that the coating has been removed, and show the iron oxide layer that remains on the surface. The carbon peaks are due to the sample epoxy mold, and the Au/Pd peaks are from sputter coating.*

EDS map scans of laser cleaned surface cross sections showed that the iron oxide remained, but that all of the paint layers have been removed. Figure 5.16 shows EDS maps and an EDS spectrum of a cross section of a laser cleaned sample. The iron oxide surface layer can be seen as well as the bulk steel of the samples, which is very high in iron content. EDS confirms the

cleanliness of the sample by showing no residual paint, which would show up either as lead, zinc or titanium, or aluminum.

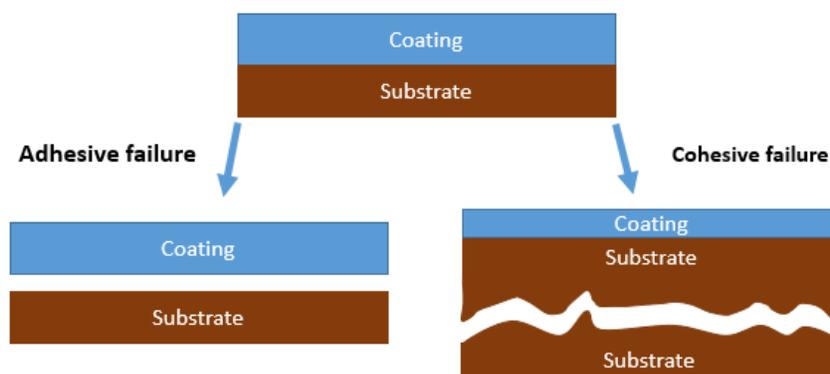
*Figure 5.17. Schematic showing adhesive versus cohesive failure between a coating and substrate. Note that in adhesive failure the coating to substrate bond is actually broken whereas in cohesive regime the bond between the substrate and coating is left intact, and the overall failure is due to a mechanical break in the substrate or coating itself.*

When testing coating strength and adhesiveness, it is important to understand different types of coating failures. In general, coating failure can be grouped into two types, adhesive failure and cohesive failure. Adhesive failure refers to a breaking of the bond between the coating and the substrate, resulting in the overall failure of the coating due to loss of adhesiveness between the coating and the substrate. In contrast, cohesive failure is when the coating or substrate itself mechanically fails, also resulting in ultimately breaking the coating-substrate piece into two separate pieces, however in this instance the coating to substrate bond is never truly broken. These two modes of coating failure are diagrammed in a schematic in figure 5.17.

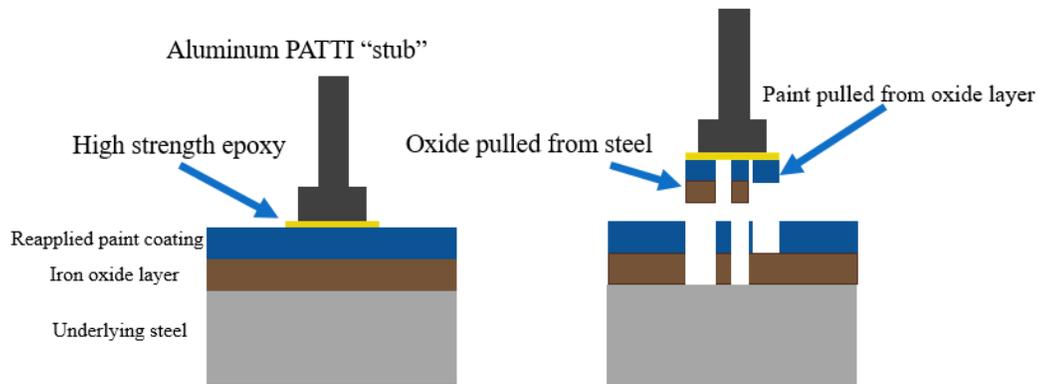
*Figure 5.18. A schematic diagram explaining how PATTI test stubs removed both reapplied paint from the surface oxide, as well as the oxide from the underlying steel. This implies that the paint to oxide bond is stronger in many cases than the oxide to metal interface.*

During PATTI coating adhesion testing of the repainted LACR treated beams, it was observed that not only was the reapplied paint coating removed from the substrate (the iron oxide layer on top of the steel), but that the oxide layer itself was sometimes broken away from the underlying steel. A schematic explaining how this occurs is shown in figure 5.18.

The significance of this is that the recorded coating adhesion is not only representative of the adhesion strength between the reapplied paint and the substrate, the iron oxide layer, but also includes the adhesion strength of the iron oxide to the steel. This also implies that the paint adheres so well to the iron oxide layer that this interface is more strongly bound together than the iron oxide layers adherence to the steel.

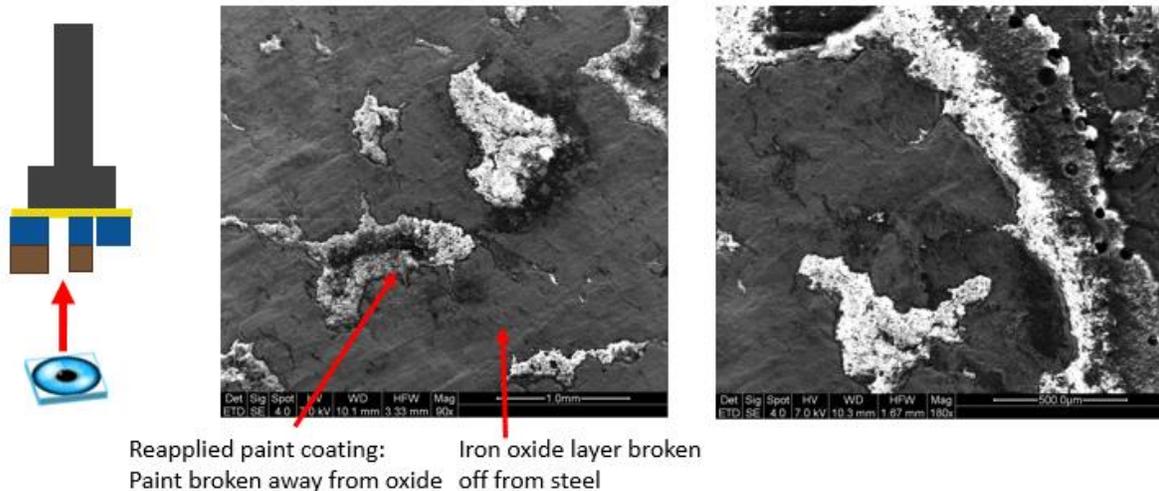
*Figure 5.19. SEM micrographs of the PATTI stub surface after testing. Both iron oxide and paint was found on the stub surface, proving that the adhesion of the paint to the oxide as well as the oxide to the steel was measured during PATTI testing.*

Figure 5.19 shows SEM micrographs of the PATTI stub surface, and shows the region on the stub surface where the paint was removed from the oxide, which shows up as paint on the stub, and also shows regions where the oxide itself has broken off of the steel, appearing as the iron oxide layer on the stub itself. In addition to the removed paint and oxide, the high strength epoxy is also seen, mostly on the perimeter of the stub. The insulating epoxy and paint both charge in

the SEM very easily compared to the iron oxide, and therefore this helps with identifying these materials.

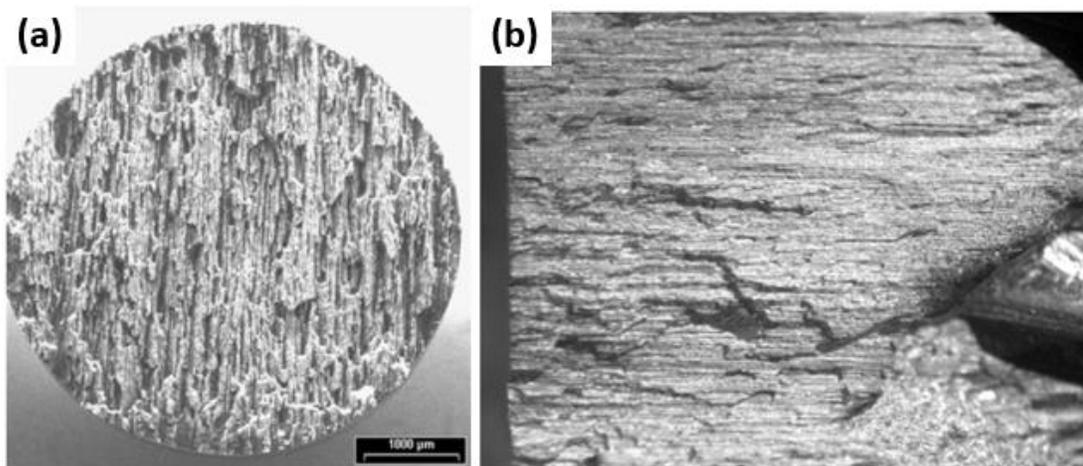
*Figure 5.20. Typical fracture surface of high sulfur steel. a.) Fracture surface of high sulfur steel with 40 HRC at strain amplitude 0.275%<sup>72</sup> b.) Optical image of the typical woody appearance of a resulfurized steel in ductile overload on a plane parallel to the longitudinal direction.<sup>68</sup>*

MnS inclusions have been known to cause detrimental effects to the fatigue behavior of steel, and in the I-beam steel used in this study the failure mechanism reflected the presence of MnS inclusions and matched the commonly seen appearance of fracture surfaces of other manganese sulfide inclusion containing steel. This included the “woody” appearance of the fatigue fracture surface that is caused by the inclusions, which can introduce or accentuate anisotropic mechanical responses to the host steel when placed under certain stress states. This type of fracture surface is well documented in MnS inclusion containing steels, as seen in figure 5.20.<sup>68,72</sup> These fracture surfaces are from sulfur containing steels that have fatigued and left a “grainy” surface appearance due to the nonmetallic inclusions in the steel.

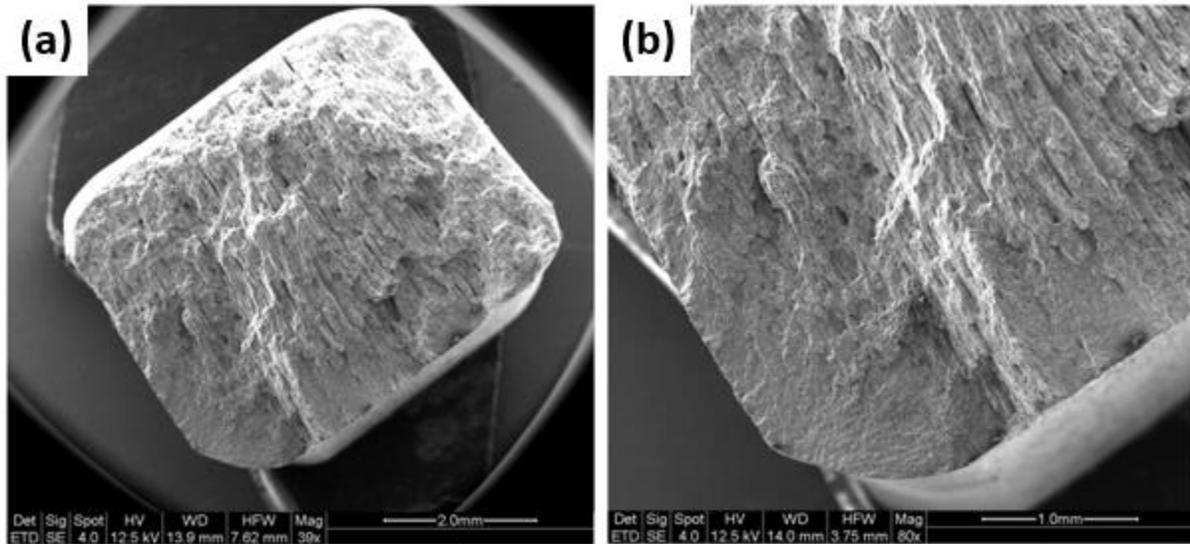
*Figure 5.21. Low magnification SEM micrographs of a fatigue fracture surface stressed at the highest maximum highest stress level tested (368 MPa). a.) 39x b.) 40x magnification.*

The same surface texture is apparent from the LACR fatigue samples. This was easily attributed to the MnS inclusions that were originally observed in the microstructure of the I-beam metal. Figure 5.21 shows low magnification SEM images of representative fracture surfaces of the LACR dog bones.

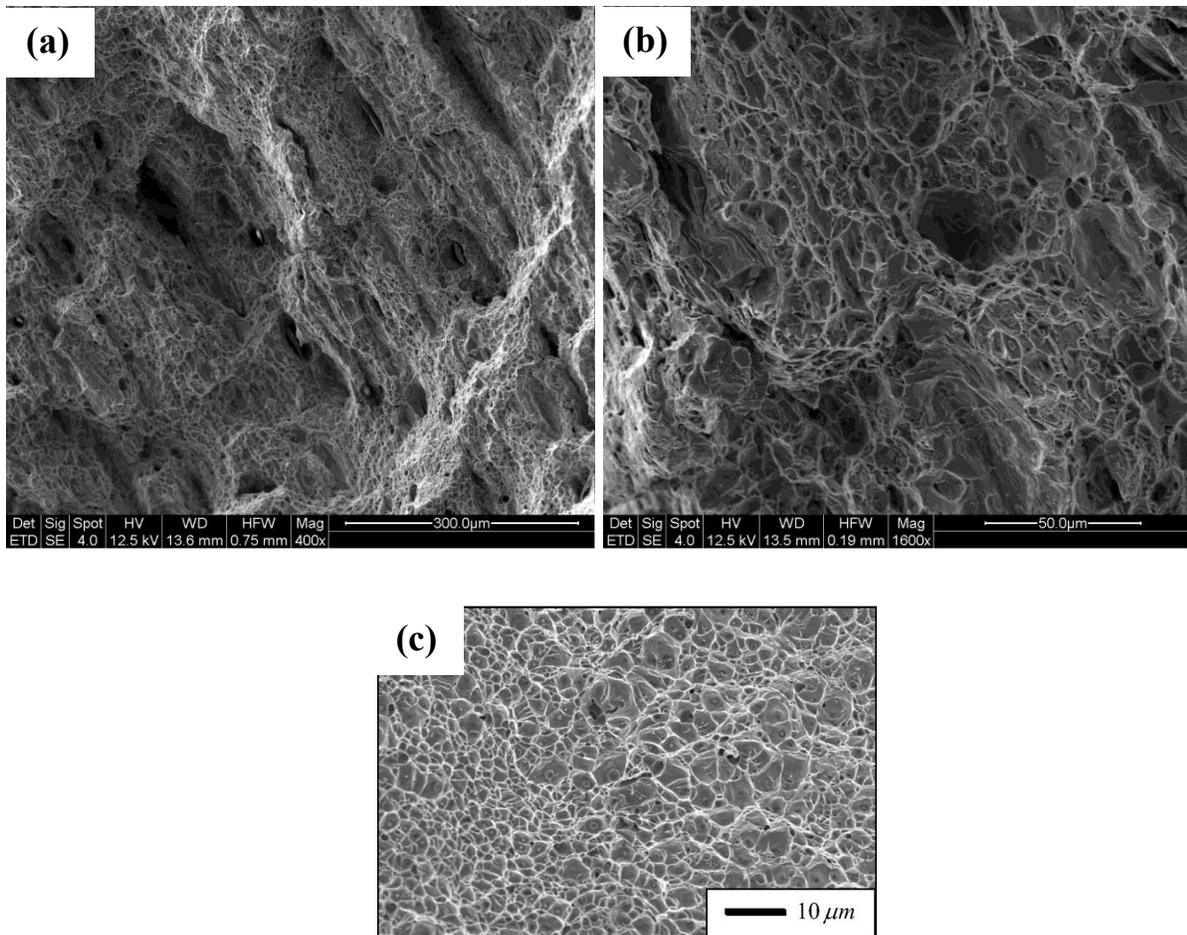
Figure 5.22. a.) SEM micrograph of the fracture surface showing the holes of varying depths surrounding the MnS inclusions. b.) Higher magnification of image (a). c.) Literature SEM micrograph showing the dimpled surface of a ductile A36 steel fracture surface.<sup>73</sup> One can note the similarity seen in the surface texture to image (b).

It was interesting to note holes of different depths on the fracture surface which had inclusions of varying dimensions present at the bottom. Upon closer examination of the fracture surface the dimpled texture of the surface is brought out, a typical surface texture for the ductile failure of low carbon steel. Figure 5.22<sup>73</sup> shows the holes that were observed on the fracture surface and how the surface texture compares to a literature SEM micrograph of a ductily failed A36 steel sample. The dimpled surface is easily distinguished and the similarity to the literature micrograph can be directly observed.

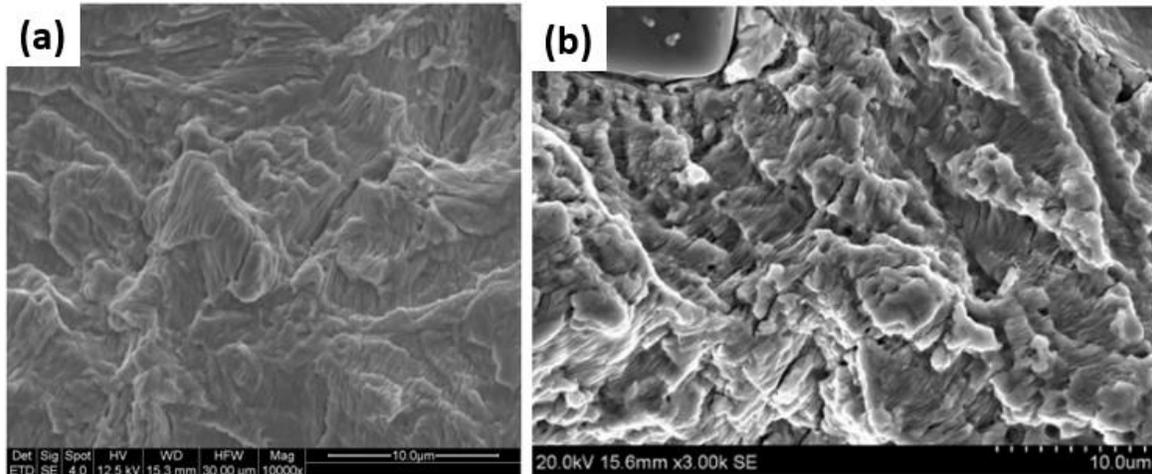
Figure 5.23. a.) Higher magnification SEM micrograph showing individual fatigue striations that are observed on the area of slow crack growth and propagation. b.) Literature SEM micrograph showing fatigue striations next to a MnS inclusion (top left).<sup>24</sup>

At even higher magnifications in the SEM, individual fatigue striations can be seen on the fracture surface (figure 5.23)<sup>68</sup>. These correspond to the incremental growth of the crack from the point of initiation to the beginning of ductile failure at which point the remainder of the thickness of the sample is quickly broken apart by plastic deformation of the metal, corresponding to the region with the “woody” grainy appearance at lower magnifications. In contrast to the ductile fracture region the area of crack growth is much flatter and does not exhibit the deep holes surrounding the MnS inclusions that are present on the ductile fracture surface.

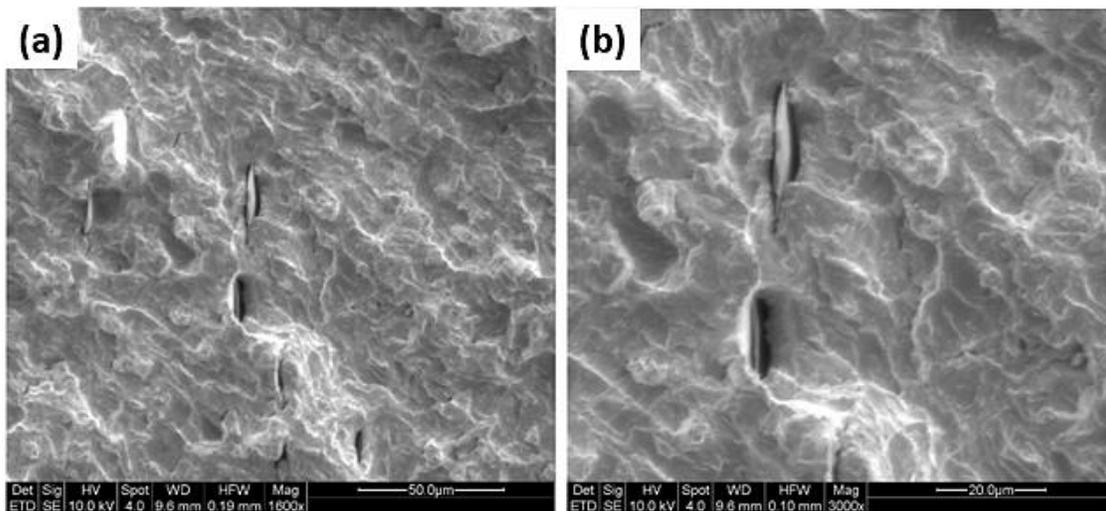
Figure 5.24. a.) SEM micrograph of the crack propagation area showing MnS inclusions. Notice that they are still located relative to each other as they were before fatigue testing, (same distance apart) determined by comparisons with cross sections. B.) higher magnification of the left image.

Figure 5.24 shows MnS inclusions on the flat crack propagation surface region. Their positions relative to each other are consistent with the inclusions that were observed on the cross sections. This makes sense considering that the steel between the inclusions is not plastically deformed, and therefore the inclusions maintain the same spacing or separation distance between them.

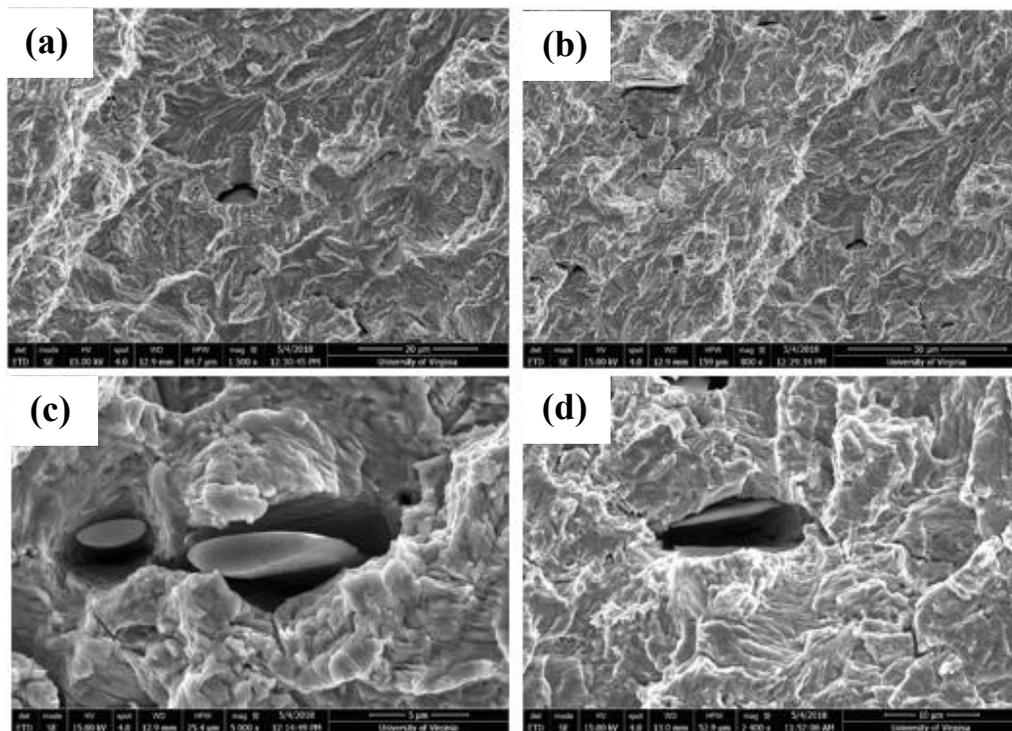
*Figure 5.25. SEM micrographs showing the different state of MnS inclusions on the fatigue surface. a.),b.) Inclusions that are recessed below the surface, and not fully exposed. c.) High magnification SEM showing the size of the gap that exists between some of the inclusions and the surrounding steel matrix. d.) A MnS inclusion that appears to be split in two, presumably from the growth of a fatigue crack.*

It is interesting to note that compared with high magnification micrographs from the literature of fatigue failed samples containing nonmetallic inclusions, on the LACR fatigue fracture surfaces the inclusions are often not flush with the fracture surface, even in flatter regions of crack propagation. (Figure 5.25). In some cases the inclusions appear to be “below” the surface, and there often seem to be a gap between the inclusion itself and the surrounding steel matrix. In some cases, the inclusion seems to have split into two separate pieces itself. (Figure 5.25 d).

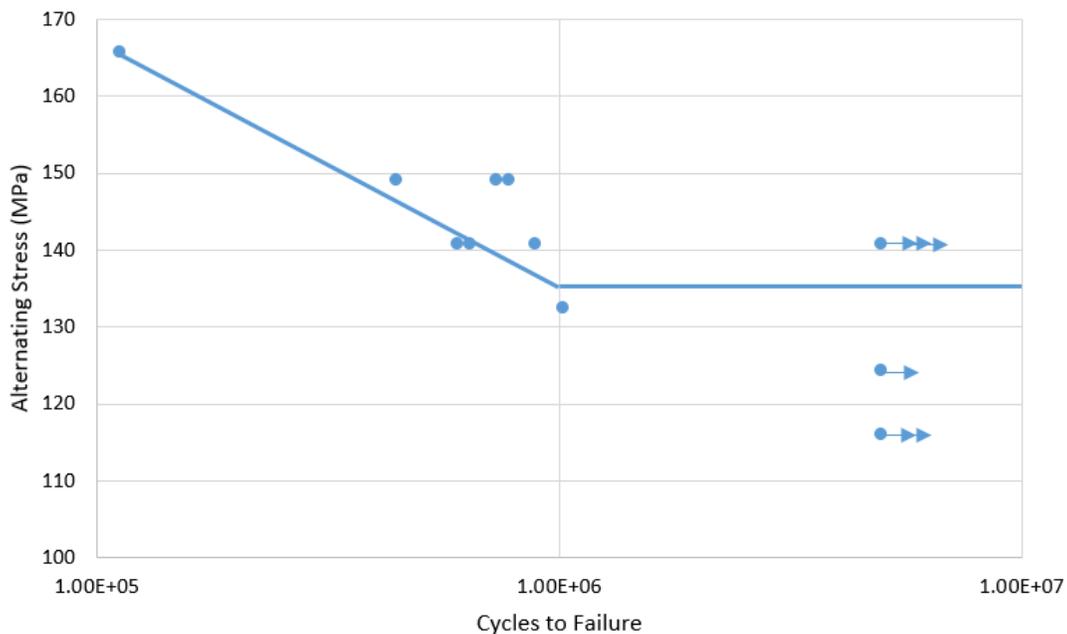
Figure 5.26. SN fatigue curve for the LACR dog one specimens. A line as a guide for the eye is included through the data as well as an endurance limit at roughly 135 MPa. Single arrow points denote run out tests, and double and triple arrow points represent two unfailed samples at the same stress value.

Figure 5.26 plots the SN curve of the LACR dog bones. A line has been drawn through the data to represent the fatigue behavior, including an endurance limit of 135 MPa. When compared to literature data, the fatigue behavior of the LACR metal was similar to that of A36 steel, suggesting that the LACR process has very little if any effect on the fatigue life of the steel.

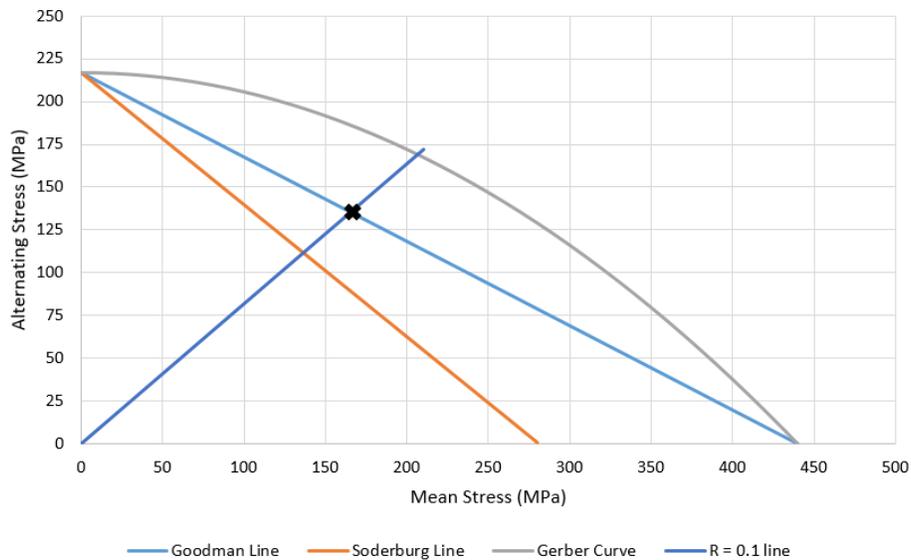
Figure 5.27. A Goodman diagram demonstrates that LACR treated samples do not appear to show any degradation in fatigue performance. An X placed along the fatigue ratio of  $R = 0.1$  line represents the endurance limit and falls nearly directly onto the Goodman line.

In order to validate the fatigue performance of laser cleaned steel, the endurance limit determined from the SN curve was plotted on a Goodman Diagram, which also includes the Soderberg Line and Berger Curve (figure 5.27). These models are used to predict the effect of varying mean stresses and stress amplitudes on the fatigue life of a component. Fatigue data points inside these boundaries are predicted to have an infinite life without failure, whereas fatigue points outside these boundaries are expected to have a finite life and break due to fatigue

As can be seen in figure 5.27, the stress levels corresponding to the endurance limit falls directly onto the Goodman line, marked with an X. Because this value is outside the boundary of the Goodman line this substantiates that LACR treatments do not appear to degrade the fatigue performance of the laser cleaned steel.

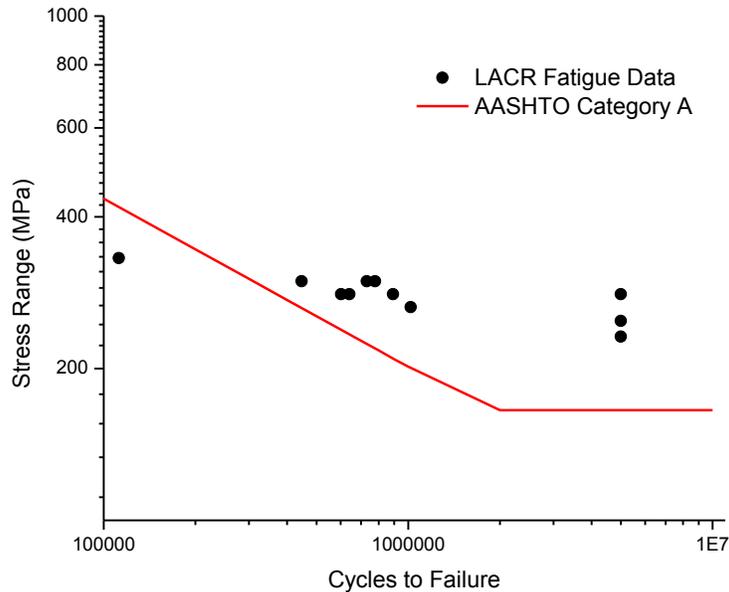
Figure 5.28. LACR fatigue data graphed with the AASHTO Category A Fatigue, demonstrating how LACR samples meet AASHTO fatigue requirements, other than for the highest stressed sample.

Where A is a constant that defines the fatigue category, N is the number of stress cycles, and  $\Delta F$  represents the nominal fatigue resistance, the red line drawn in figure 5.28.

The LACR samples fall within the AASHTO Category A fatigue, meaning that a value of A = 25,000,000,000 applies and a stress value for the infinite life region of 24 ksi (165 MPa) is used.<sup>76</sup> Figure 5.28 shows a plot of the LACR fatigue data along with the AASHTO category A

fatigue specification. It can be seen that all the fatigue data points fall above this line, except for the sample at the highest stress value, which failed below this category guideline.

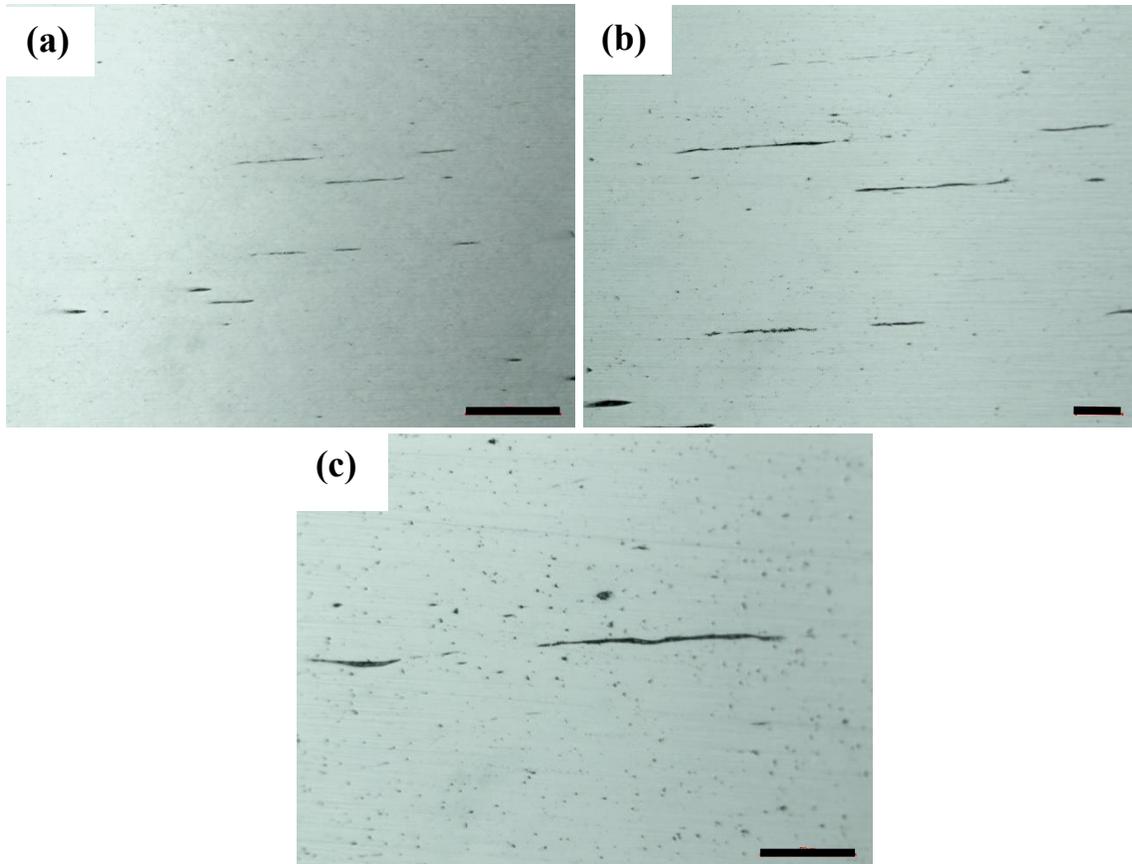
*Figure A1. Unetched micrographs of I-beam cross sections showing the morphologies of the MnS inclusions in the steel at different magnifications. The groupings of inclusions and the flat drawn out shape due to rolling are indicative of type II MnS inclusions. a.) scale bar = 200  $\mu\text{m}$ , b.) scale bar = 100  $\mu\text{m}$ , c.) scale bar = 50  $\mu\text{m}$ .*

From comparison of the MnS inclusions observed in the microstructure of the I-beam steel, it was determined that they are likely type II MnS inclusions. This conclusion was mainly based off of the fact that the inclusions are located between grains, in other words at grain boundaries, and also that these inclusions are often found in close proximity to each other, indicative of the colony characteristic seen in type II MnS inclusions. Figure A1 shows unetched micrographs of some of the inclusions found in the cross sections of the I-beam steel. When compared to type II inclusions from the literature, it is resemblance between these morphologies is clear.

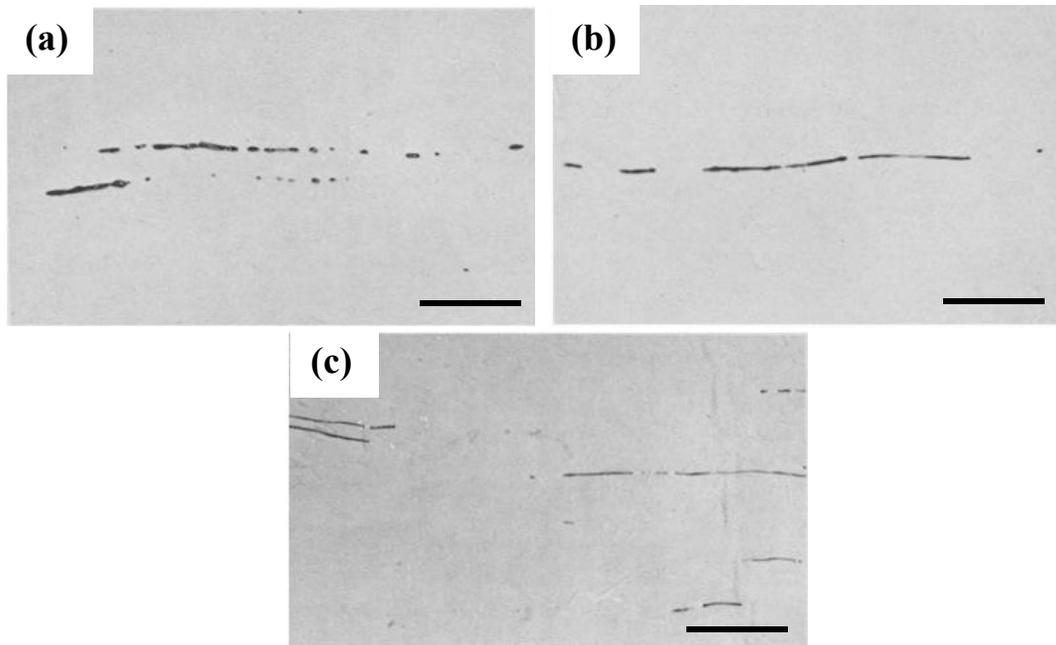
*Figure A2. Literature micrographs of MnS type II inclusions in unetched steel with a sulfur content of 0.013%, with heat treatments at 925°C. a.) No heat treatment, b.) 5 hr heat treatment, and c.) 10 hr heat treatment. (All scale bars at 20  $\mu\text{m}$ .)<sup>78</sup>*

Figure A2<sup>78</sup> shows classified MnS type II inclusions from literature in a low carbon steel with a sulfur content of 0.013%, whereas in ASTM A36 steel the sulfur content is kept below 0.05% sulfur as a maximum concentration.

This means that both steels have roughly the same sulfur composition for type II MnS inclusions. In addition, EDS analysis shows no measurable amount of oxygen left in the steel matrix, which rules out the possibility of type I MnS inclusions which are usually found in oxygen containing steels. In addition, the thin elongated plate like morphologies can be seen in both the literature and I-beam MnS inclusions, which is indicative of hot rolling, where the originally spherical like inclusions become elongated along with the steel grain as they are deformed from the hot rolling process.

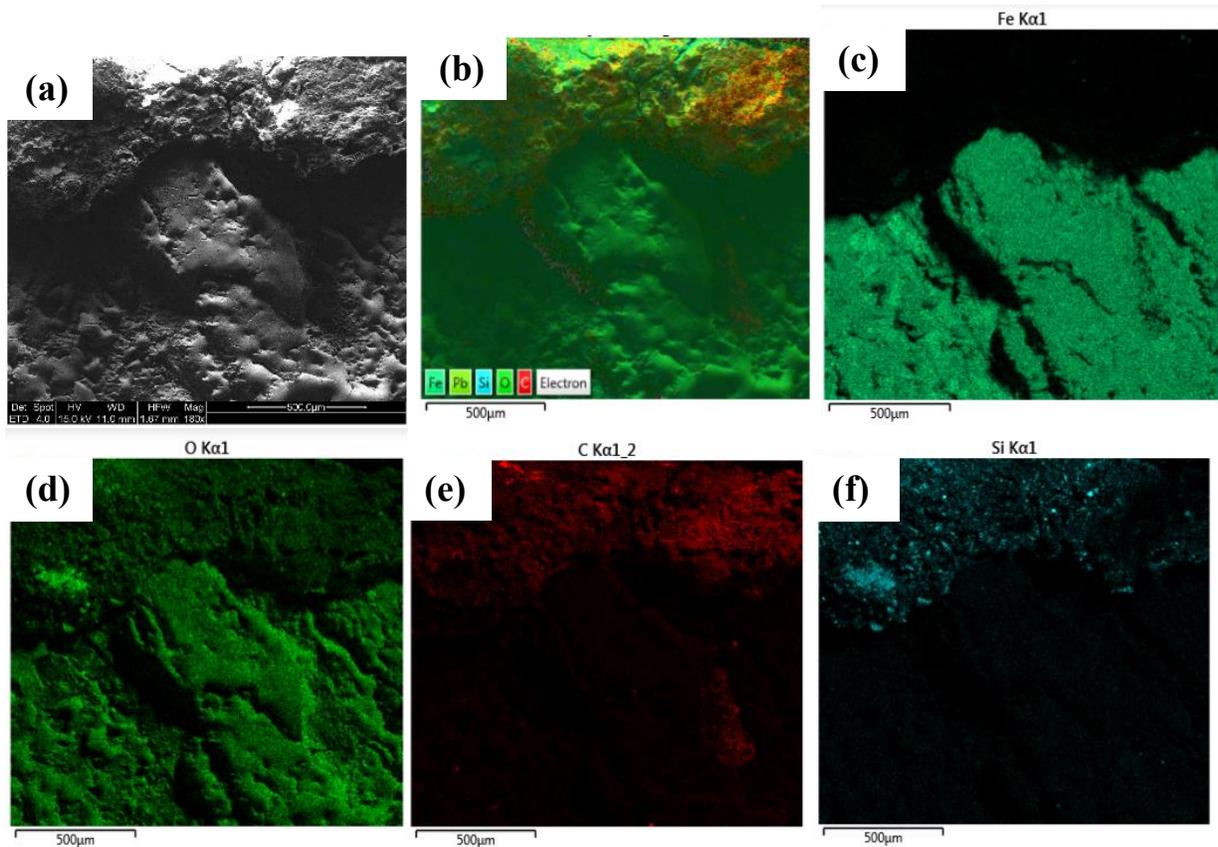
A2: Paint Interface EDS Maps: Location 2:

(a), SEM micrograph of the paint oxide interface. Again, (c) shows a clear distinction between the paint and the cleaned iron oxide surface. (d) oxygen is present throughout the paint as well as iron oxide. (e) Carbon is mostly contained within the paint, and not on the cleaned surface. (f), shows sporadic locations of silicon within the paint, but not on the cleaned surface. (g) shows that lead is still present on the cleaned oxide, however in smaller amounts compared to the painted regions. (h) Titanium is clearly present within the paint only, but is not detected on the cleaned iron oxide surface.

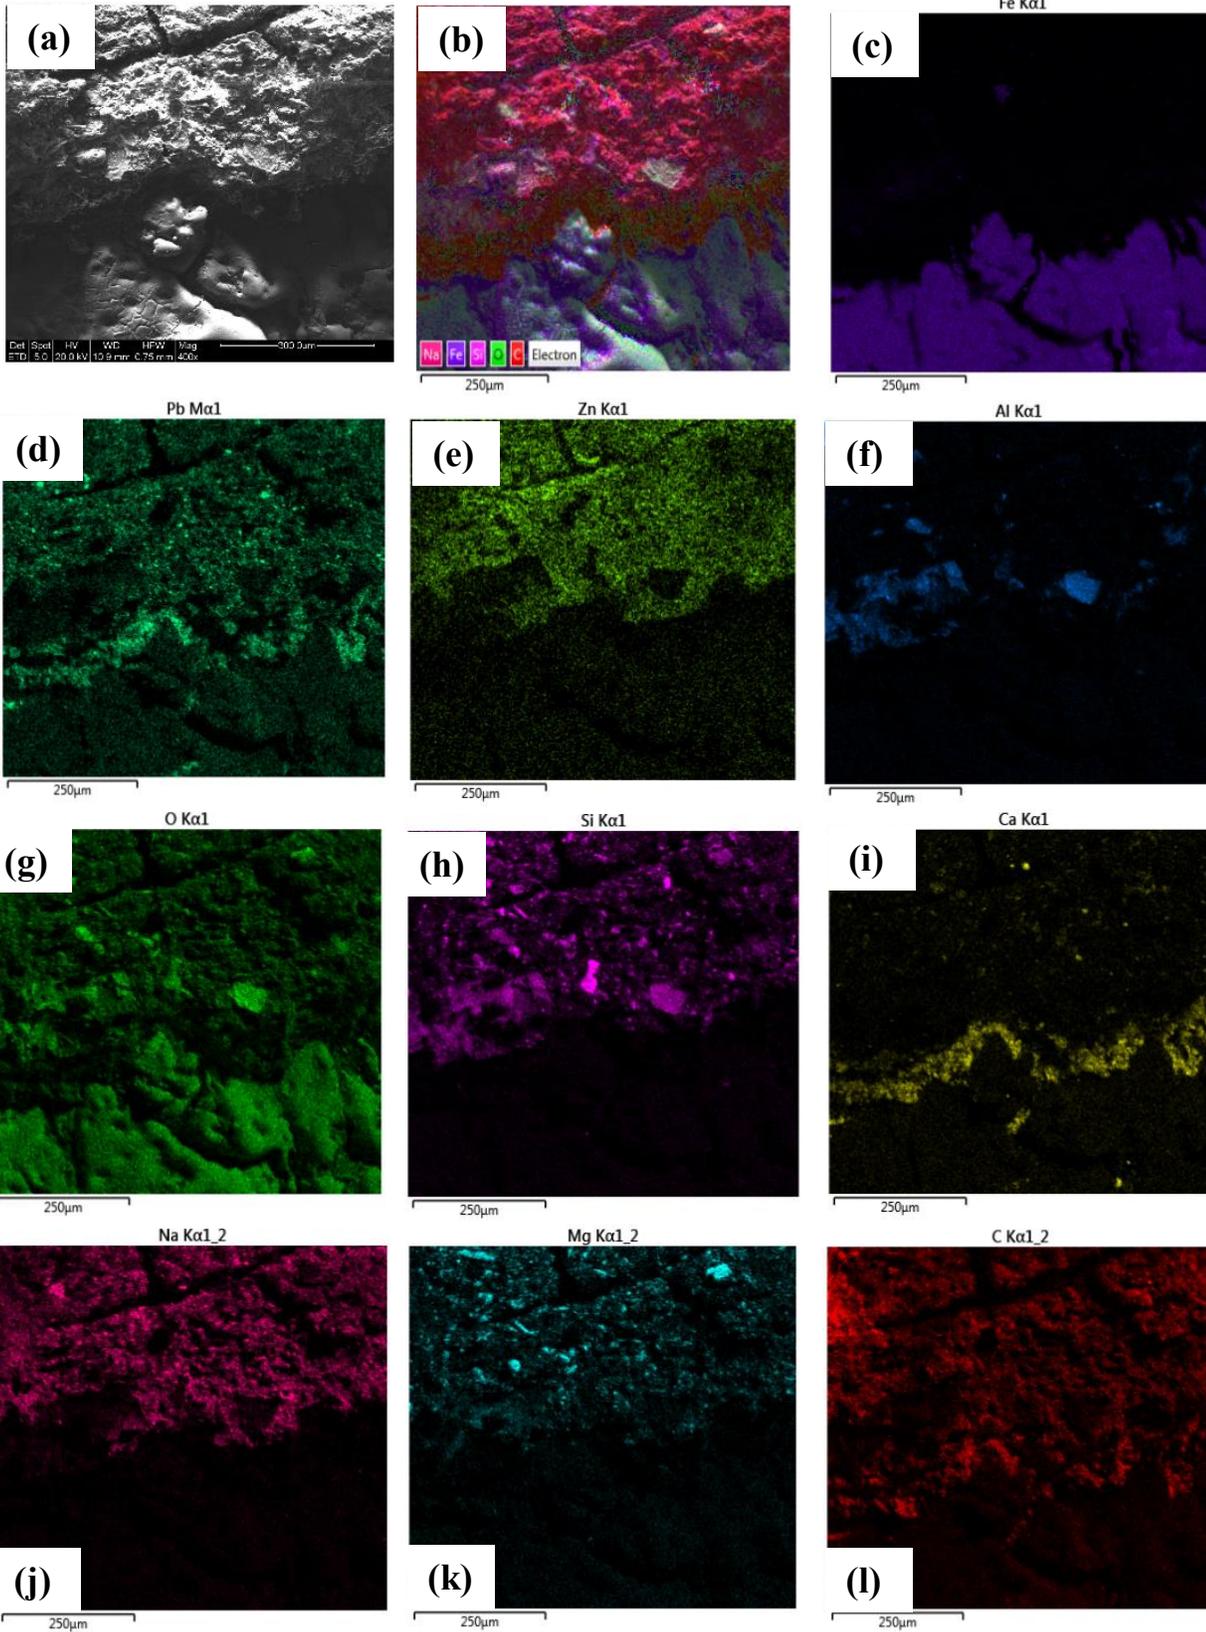
Location 3:

*Location 3: (a), SEM micrograph of the paint oxide interface region to be analyzed with EDS. (b) composite map showing all elements measured. (c) Clear boundary between the iron oxide and paint is delineated by the iron EDS signal. (d) shows that lead is present mostly within the paint, however also on the cleaned surface, albeit to a lesser extent. (e) and (f), Zinc and aluminum are representative of specific paint layers. (g), oxygen map showing the high oxygen content of the iron oxide, (h), silicon map showing that it is associated with the paint. (i), calcium is present within the paint however it is concentrated along the paint to oxide interface. (j), sodium is also only present within the paint. (k) magnesium is similar to silicon in that it is only appears in sporadic locations within the paint. (l), carbon is mostly due to the organic materials used in the paints, although it is also found on the cleaned surface in smaller quantities.*

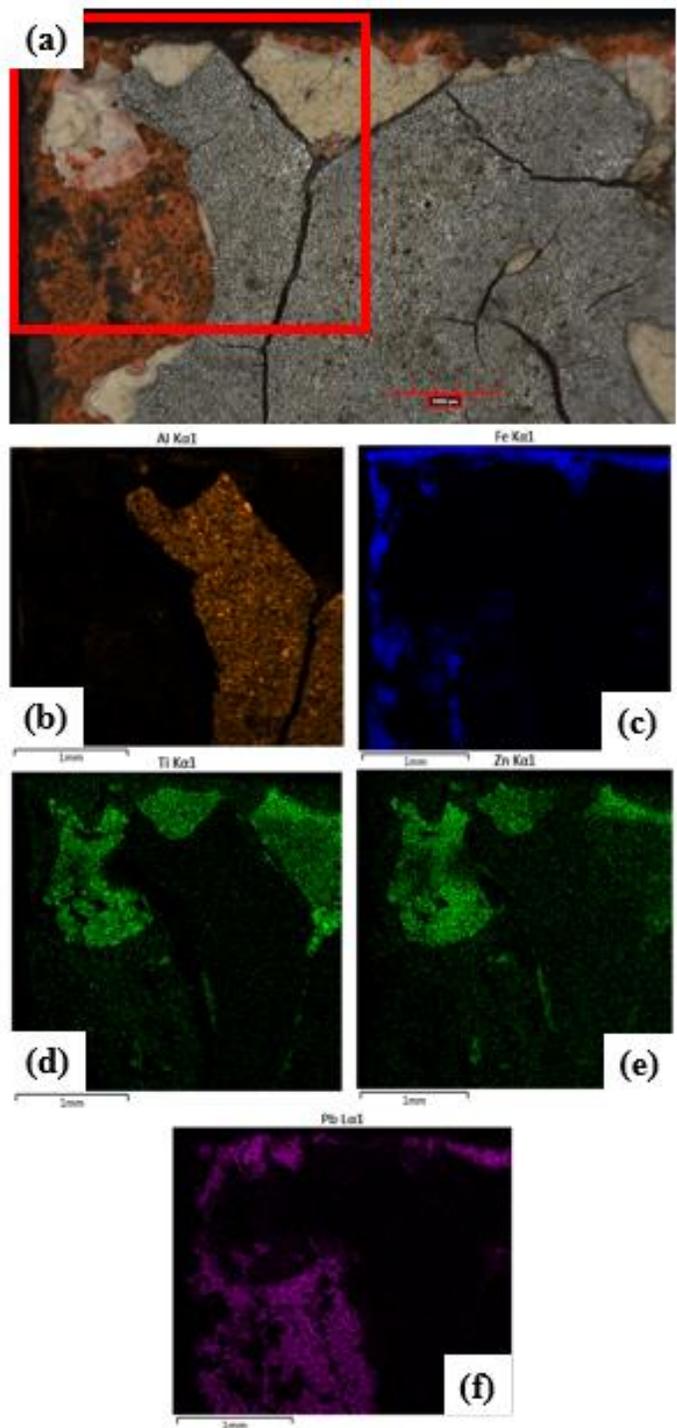
Figure A3 (ii). A red box over the optical micrograph (a), shows the region mapped in EDS. The elements in each map are as follows: (b): Al (c): Fe (d): Ti (e): Zn (f): Pb. All scale bars = 1 mm.
