# **IMPLEMENTATION OF LASER ABLATION COATING REMOVAL TECHNIQUE FOR STEEL COMPONENTS ON VDOT BRIDGES**

A Thesis

Master of Science in Material Science and Engineering

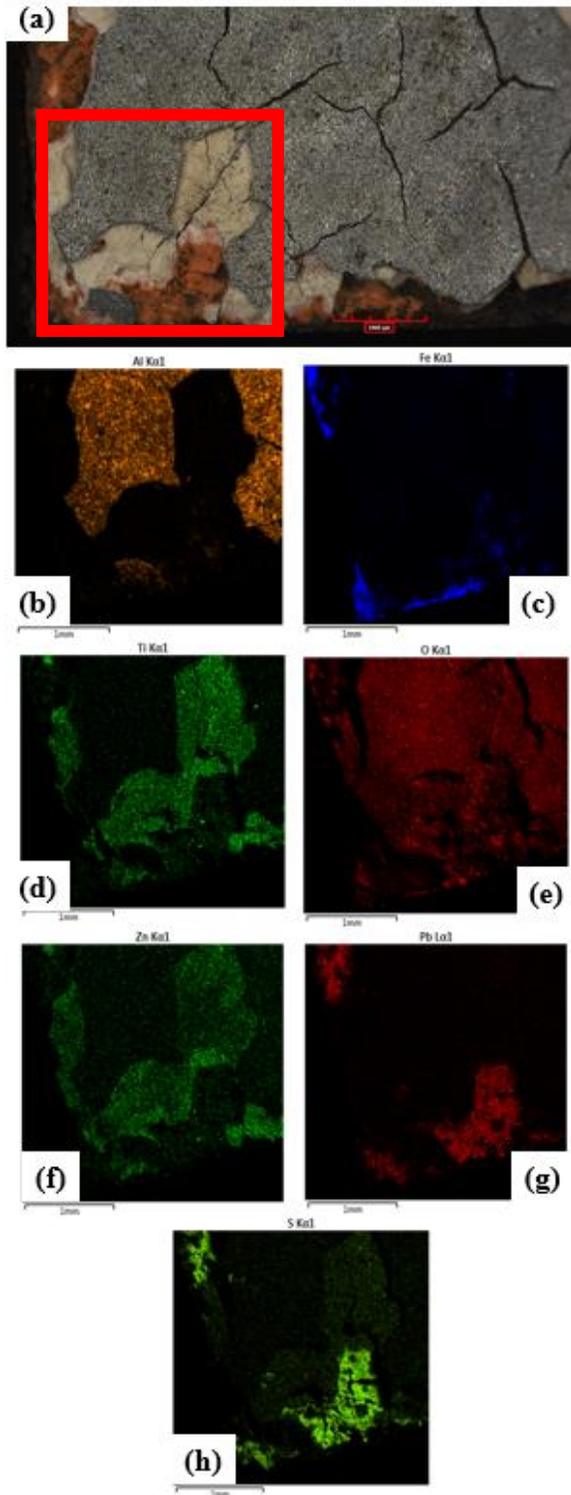
Figure A4 (iii). A red box over the optical micrograph (a), shows the region mapped in EDS. The elements in each map are as follows: (b): Al (c): Fe (d): Ti (e): O (f): Zn (g): Pb (h): S. All scale bars = 1 mm.

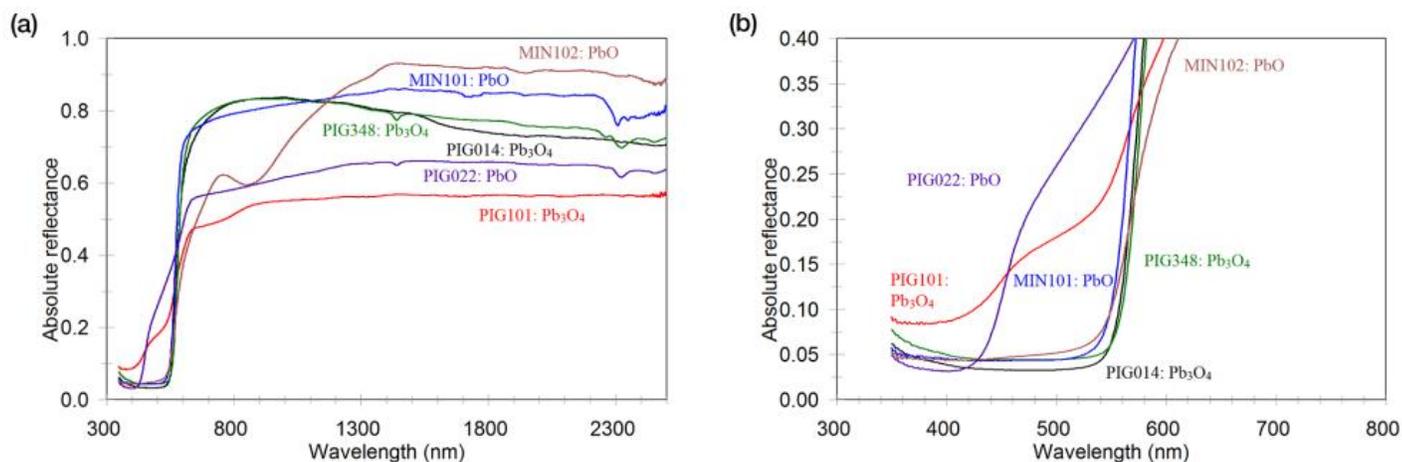
Figure B1. a.) 350-2500 nm reflectance spectra of powdered lead oxide pigments. b.) Same as (a), showing the details in the low wavelength-low reflectance region. The Nd:YAG laser used for LACR produces infrared light at 1064 nm, as marked in (a).<sup>79</sup>

Literature shows that  $\text{Pb}_3\text{O}_4$  (II, IV) oxide pigment is very reflective in the region of infrared light that the laser operates in. The Nd:YAG laser used for LACR produces light at 1064 nm, and at this wavelength the reflectance of lead oxide is roughly 0.80 absolute reflectance as measured by near-infrared spectroscopy. Figure B1<sup>79</sup> shows a near infra-red reflectance spectra of various lead oxides, and the most notable feature is a large absorption edge at about 550 nm, where the reflectance quickly rises from around 0.05 to 0.80 absolute reflectance. This explains the color of the pigment as observed in the visible light spectrum range. As described in Chapter 4, pigments alter the appearance of a coating by the selective absorption or scattering of light, in addition to possible transmittance. Electromagnetic radiation encountering an object meets one of these three fates, and any or all three can occur completely or partially on any part of the

electromagnetic spectrum. This means that the reflectivity and absorptivity of pigments are independent of each other, and the visible light coloration bears no saying on the optical behavior of the pigment in ranges outside the visible range of the spectrum. In this case, the  $\text{Pb}_3\text{O}_4$  (II, IV) oxide is highly reflective at visible wavelengths of 550 nm to 750 nm, corresponding to yellow, orange, and red light, thus giving the pigment is bright orangey-red color. This high reflectivity continues into the near infrared spectrum, (750 to 1,400 nm).

The very low reflectance (0.05 absolute reflectance) between wavelengths of 380 nm to 550 nm correspond to the violet, blue, and green colored parts of the visible spectrum, and the low reflectance is likely balanced by high absorption. This means that in the visible part of the spectrum the longer orange and red wavelengths are reflected from lead oxide, whereas the shorter blue green wavelengths are absorbed.

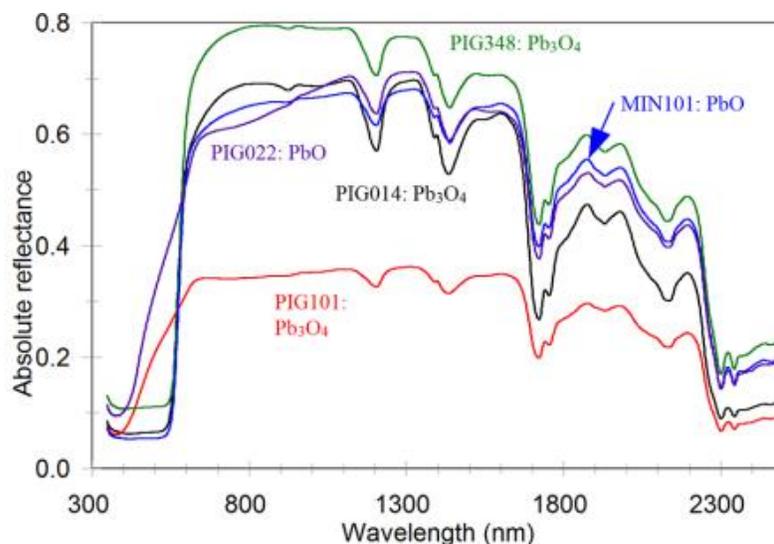
Figure B2. Same reflectance spectra as shown in figure 1, however for lead oxide pigments boiled in linseed oil, the common binder used in red lead paste. Above roughly 1100 nm the spectra are dominated by the linseed oil spectral features, however the organic binder does not affect the spectral properties of the lead oxides, as the position of the absorption edge and the spectral slope are generally unaltered.<sup>79</sup>

Figure B2<sup>79</sup> shows another near infrared spectra of lead oxides, similar to figure B1a, however this time the lead oxides were mixed with boiled linseed oil, giving an even better indication of the optical properties of the red lead paint which uses linseed oil as the binder medium for the pigment.

At first glance the impact on the spectra due to the linseed oil is readily seen. At wavelengths above about 1100 nm sharp dips are attributed to the organic linseed oil molecules, however the sharp absorption peak position and slope does not seem to be affected by the presence of the oil. This is important because this means that neither the visible appearance of the pigment nor the laser reflective behavior is altered by mixing with linseed oil, both of which match observation. When compared to the reflectance values of  $Pb_3O_4$  (II, IV), both titanium dioxide and zinc oxide have almost identical reflectance behaviors. Figure B3<sup>80,81</sup> shows reflectance values for both titanium dioxide and zinc oxide as a function of wavelength. Each of these pigments has a sharp absorption edge within the visible light spectrum (roughly 450 nm for  $Pb_3O_4$  (II, IV), 400 nm for  $TiO_2$ , and 380 nm for  $ZnO$ ), which imparts the given color to each of these pigments. More importantly, each of these pigments is also highly reflective at a wavelength of 1064 nm (0.80 absolute reflectance for  $Pb_3O_4$  (II, IV), 0.95 absolute reflectance for  $TiO_2$ , and roughly 0.80

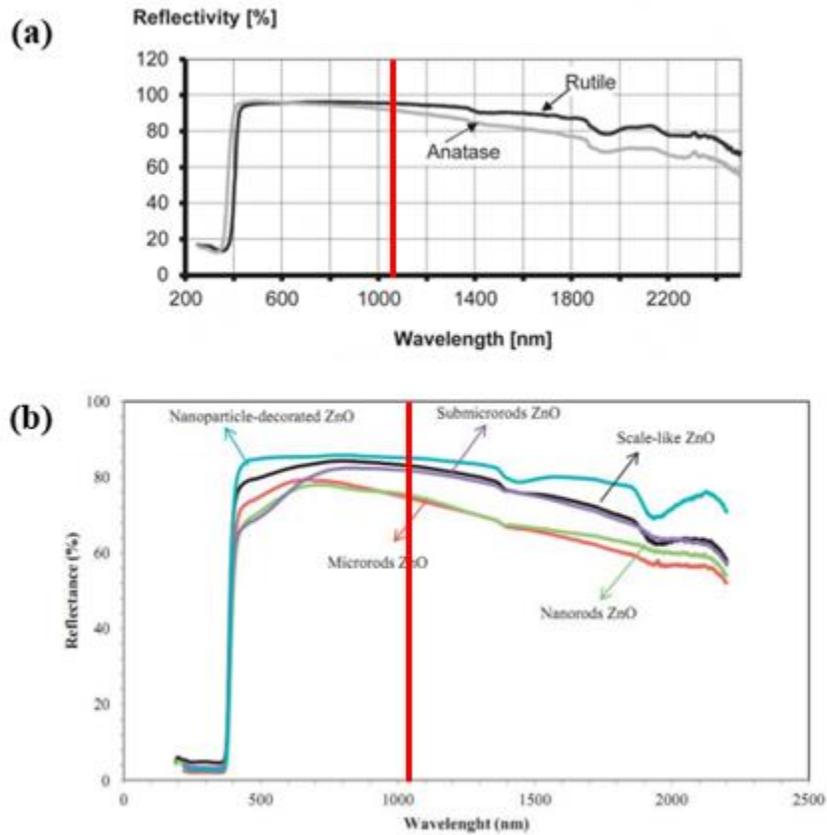
Figure B3. Near UV/VIS and NIR reflectance values for (a) TiO<sub>2</sub> and (b) ZnO pigments. Red vertical lines mark 1064 nm, the wavelength used by the CL1000 laser used for LACR<sup>80,81</sup>

absolute reflectance for ZnO), which corresponds to the wavelength of the CL1000 laser used for LACR in this project. Because each of these pigments has about the same reflectance values at the laser wavelength used, this means that optical reflectivity cannot account for any difference in the ease of coating removal for each paint layer.
