Mitigating Overheight Vehicle Collisions for Low Clearance Bridges

A Research Paper submitted to the Department of Engineering and Society

Marc Michaud
Spring, 2020

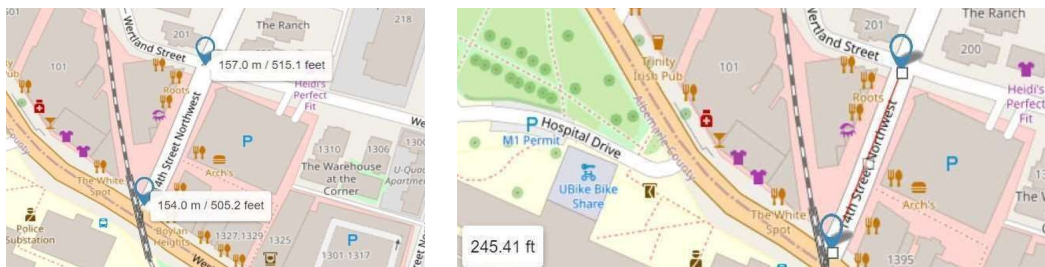
the sign warns any and all vehicles over 10 feet of a possible collision. Many of these accidents have made the local news, so why is it that it continues to happen again and again. The light duty box trucks involved in the collisions have an interior height clearance of 6 feet 6 inches in addition to a ground clearance of about 3 feet, the total clearance comes to about 9 feet 6 inches. In theory OVCs should not occur on the corner with a six inch differential clearance height. The elevation at the intersection of 14th Street Northwest and Main Street is 502 feet, there is a rise in elevation in all directions with the highest elevation being 515.1 feet at a distance of approximately 245.41 feet away which yields a slope of 5.24 percent for the road. The slope is important because if the road were to have a slope of less than 1 percent it would be considered relatively flat and the marked clearance at the bridge wouldn't pose such a big issue.

The roads near the bridge that the box trucks are on would not be considered flat so the marked sign would have to take into account a sloped truck not a flat one. A sloped truck would need enough distance to clear the bridge and that is near impossible with the steep rise of 14th Street and main Street for the typical light duty box truck. On average box trucks are 16 feet in length. Let's consider this scenario: the vehicle in question, a 16 feet light duty box truck, is traveling down 14th to make a right or a left at Main Street. The box truck in question has a height clearance of 9 feet 6 inches. The box portion of the truck is 10 feet long. When the initial

6 feet of the car where the driver is located clears the bridge the top of the box is on a road elevation of 505.2 feet, this puts the top of the box at 514.7 feet with the bottom of the bridge being at 512 feet, a collision will happen. Based on this information the clearance of the bridge should be approximately 7 feet instead of 10. If the truck is traveling on Main Street though , with the same previous principles the clearance sign should say 9 feet. For this 14th Street Bridge , the preventive warning sign is the main factor behind OVCs.
